UT to JUMPING RUN CREEK STREAM & WETLAND RESTORATION MONITORING REPORT (YEAR 1 OF 5)

Cumberland County, North Carolina EEP Project Number 92345

Status of Plan: Final Construction Completed: 2010 Data Collected: 2010 Submission Date: March 2011

Stantec Consulting Services Inc 801 Jones Franklin Road, Suite 300 Raleigh, NC 27606

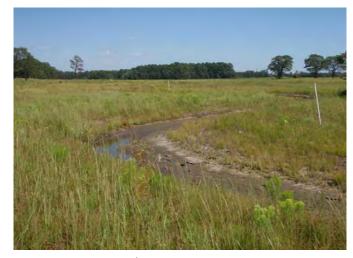
Sta 50+30 Loo	king Downstream

River Basin	Cape Fear River
Watershed	Jumping Run Creek
XS ID	XS-2, Pool, STA 50+30
Drainage Area(sq. mi.)	1.2
Date	9/1/2010
Field Crew	N. Jean

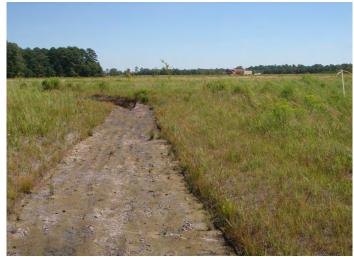
_
くけっ んつエタフ	Looking	Downstream
31a 02±07	LUUKIIIE	DOWNSHEam

River Basin	Cape Fear River
Watershed	Jumping Run Creek
XS ID	XS-5, Riffle, STA 62+87
Drainage Area(sq. mi.)	1.2
	9/1/2010
Field Crew	N. Jean

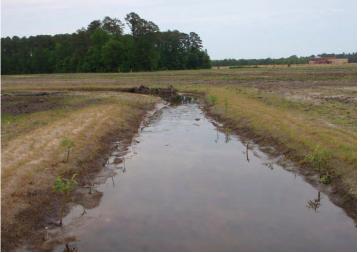
C+0 CQ + 24	مماناهم	Downstream
3ld 08+24	LOOKINE	Downstream

Photo Station S7. Cross-section 7 at Station 68+24 (Missing)

River Basin	Cape Fear River
Watershed	Jumping Run Creek
XS ID	XS-7, Riffle, STA 68+24
Drainage Area(sq. mi.)	1.2
Date	9/1/2010
Field Crew	N. Jean

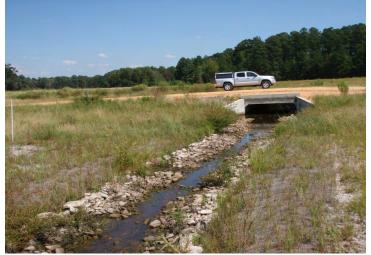
C+~ 7/1.0	11 001/10	g Downstream
NA /4+8	д гоокии	o i mwnsiream

River Basin	Cape Fear River
Watershed	Jumping Run Creek
XS ID	XS-8, Riffle, STA 74+84
Drainage Area(sq. mi.)	1.2
Date	9/1/2010
Field Crew	N. Jean

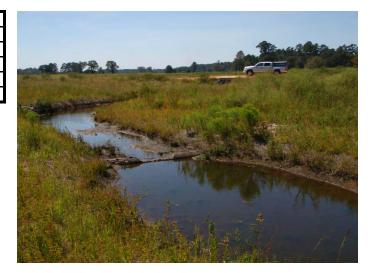
Sta 75+30 Looking Downstream

River Basin	Cape Fear River
Watershed	Jumping Run Creek
XS ID	XS-9, Pool, STA 75+30
Drainage Area(sq. mi.)	1.2
Date	9/1/2010
Field Crew	N. Jean

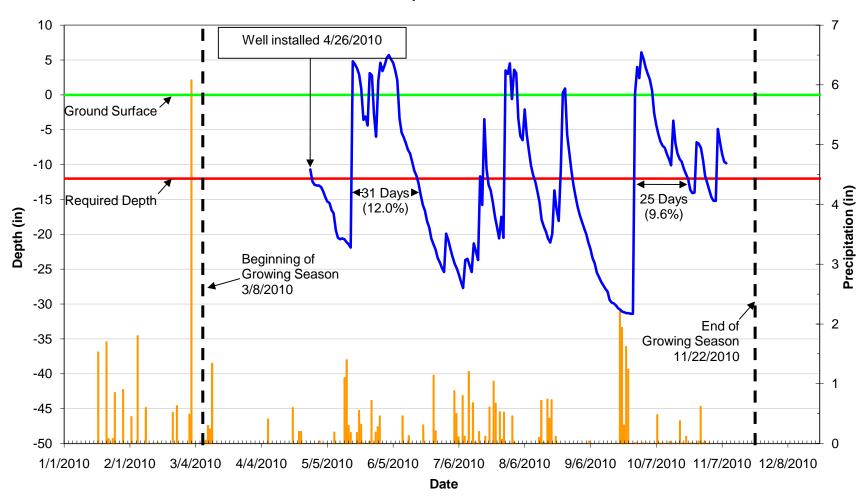
2010 Groundwater Data Well UTJRC-1 (SN: 000009BEBD4E) Riparian wetland

Grouna	water Results I	or years 1 - 5		
Wetland Type	Guage	Success Criteria Achieved/Max Consecutive Days During Growing Season (Percentage)				
		Riparian	GW1	Yes/31 days (12		
percent)						
Riparian	GW2	Yes/44 days (17				
		percent)				
	GW3	Yes/140 days				
Riparian		(54 percent)				
Non-	GW4	No				
Riparian						
	GW5	Yes/63 days (24				
Riparian		percent)				
Riparian	GW6	No				
Non-	GW7	Yes/63 days (24				
Riparian		percent)				
	CWO	Yes/63 days (24				
Riparian	GW8	percent)				
_	GW9	Yes/141 days				
Riparian		(55 percent)				
Non-	GW10	Yes/62 days (24				
Riparian		percent)				
	CW11	Yes/54 days (21				
Riparian	GW11	percent)				
-	GW12	Yes/147days				
Riparian		(57 percent)				
Non-	GW13	Yes/45 days (17				
Riparian		percent)				
Riparian	GW14	Yes/44 days (17				
		percent)				
•	GW15	Yes/73 days (28				
Riparian		percent)				
na	Reference	Yes/63 days (24				
		percent)
