**UT to Little Coharie Creek (Roseboro Site)
Stream Restoration Project
Sampson County
North Carolina**

**CU: 030030006
DENR Contract No. 004578
EEP Project No. 314**

**Monitoring Year 5 of 5
Data Collection: May through November 2013
Submission Date: November 27, 2013**

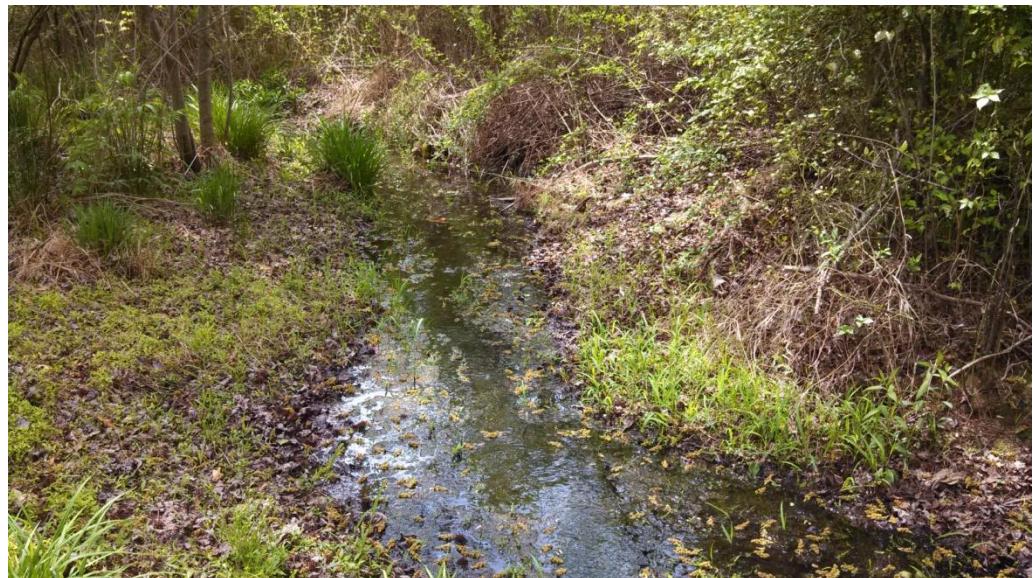
10 - Northern Reach Station 0+50 – Looking upstream

The Northern Reach channel profile has areas that appear to have sediment deposition also. This sediment deposition may be caused by vegetation growing within the bankfull channel. Asiatic daylily and cattail are growing within the stream bed, causing disruption of sediment transport on parts of the project..

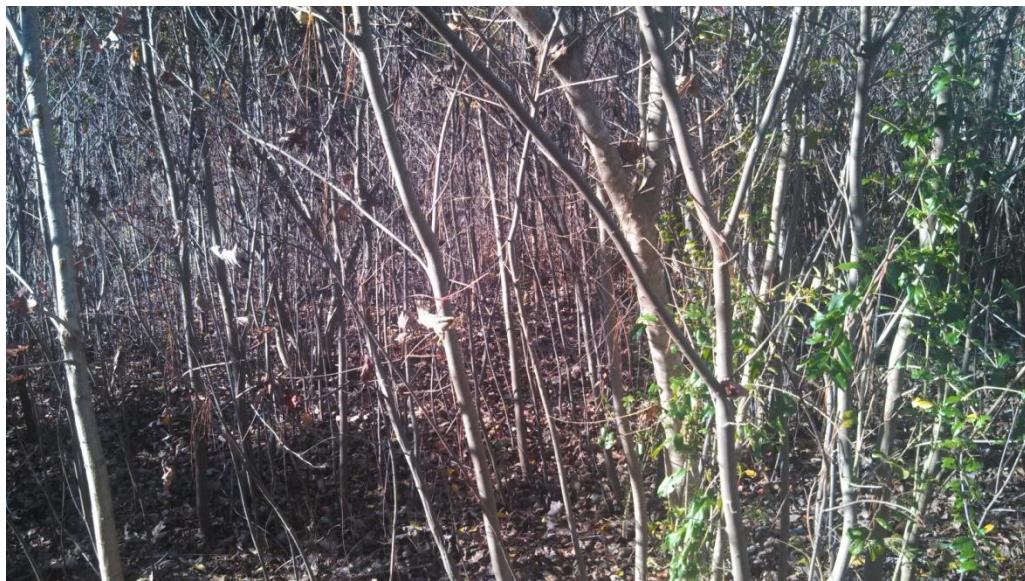
Vegetation Plot 1

Seven (7) permanent vegetation plots were established and used in annual vegetation monitoring. Vegetation plots VP3, VP4, and VP6 exceed the minimum success requirements. Vegetation monitoring plots VP1, VP2, VP5, and VP7 fall below the minimum success requirements. By visual observation, a majority of the site is diverse and numerous of planted stems species. For 2013, MY5, the vegetation monitoring identified stem counts below the minimum success criteria for MY5 resulting in an average density of 240 planted stems per acre for the entire site. The vegetative success criteria based on the US Army Corps of Engineers Stream Mitigation Guidelines (USACE, 2003) will require the survival of 260 planted woody stems per acre at the end of the year 5 monitoring period. UT to Little Coharie Creek utilizes a CVS Level 2 protocol for vegetation data collection. This protocol does include volunteer stems during data collection. For vegetation success criteria, only the planted stems are used to determine stems per acre. Vegetation plot locations are identified in Appendix C. Invasive vegetation species Chinese privet (*Ligustrum sinense*), Japanese honeysuckle (*Lonicera japonica*), mimosa (*Mimosa sp.*), kudzu (*Pueraria lobata*), and Asiatic daylily (*Commelina communis*) have been identified onsite and the location of each are depicted in Figure 2. Multiflora rose (*Rosa multiflora*) and fescue (*Festuca sp.*) have also been identified onsite. Supplemental planting for UT to Little Coharie will be completed in December 2013 and during early 2014, the site will be treated for invasive vegetation.

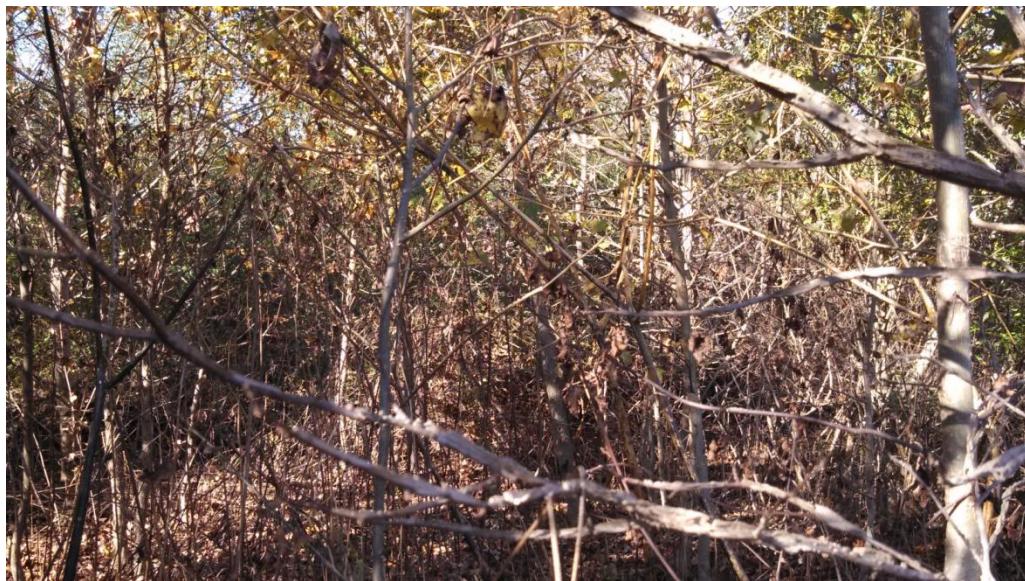
Vegetation Plot 6

In the Winter/Spring of 2011, a wild fire from an adjacent land parcel to the north of the Northern Tributary, caused damage to planted areas as well as easement fencing west of vegetation plot 6. Site damage was minimal and repairs to easement fencing were completed during 2012.
