YEAR 2 MONITORING REPORT

UT TO NEUSE RIVER (BIG DITCH) STREAM RESTORATION SITE

Wayne County, North Carolina

DMS Project No.: 92682

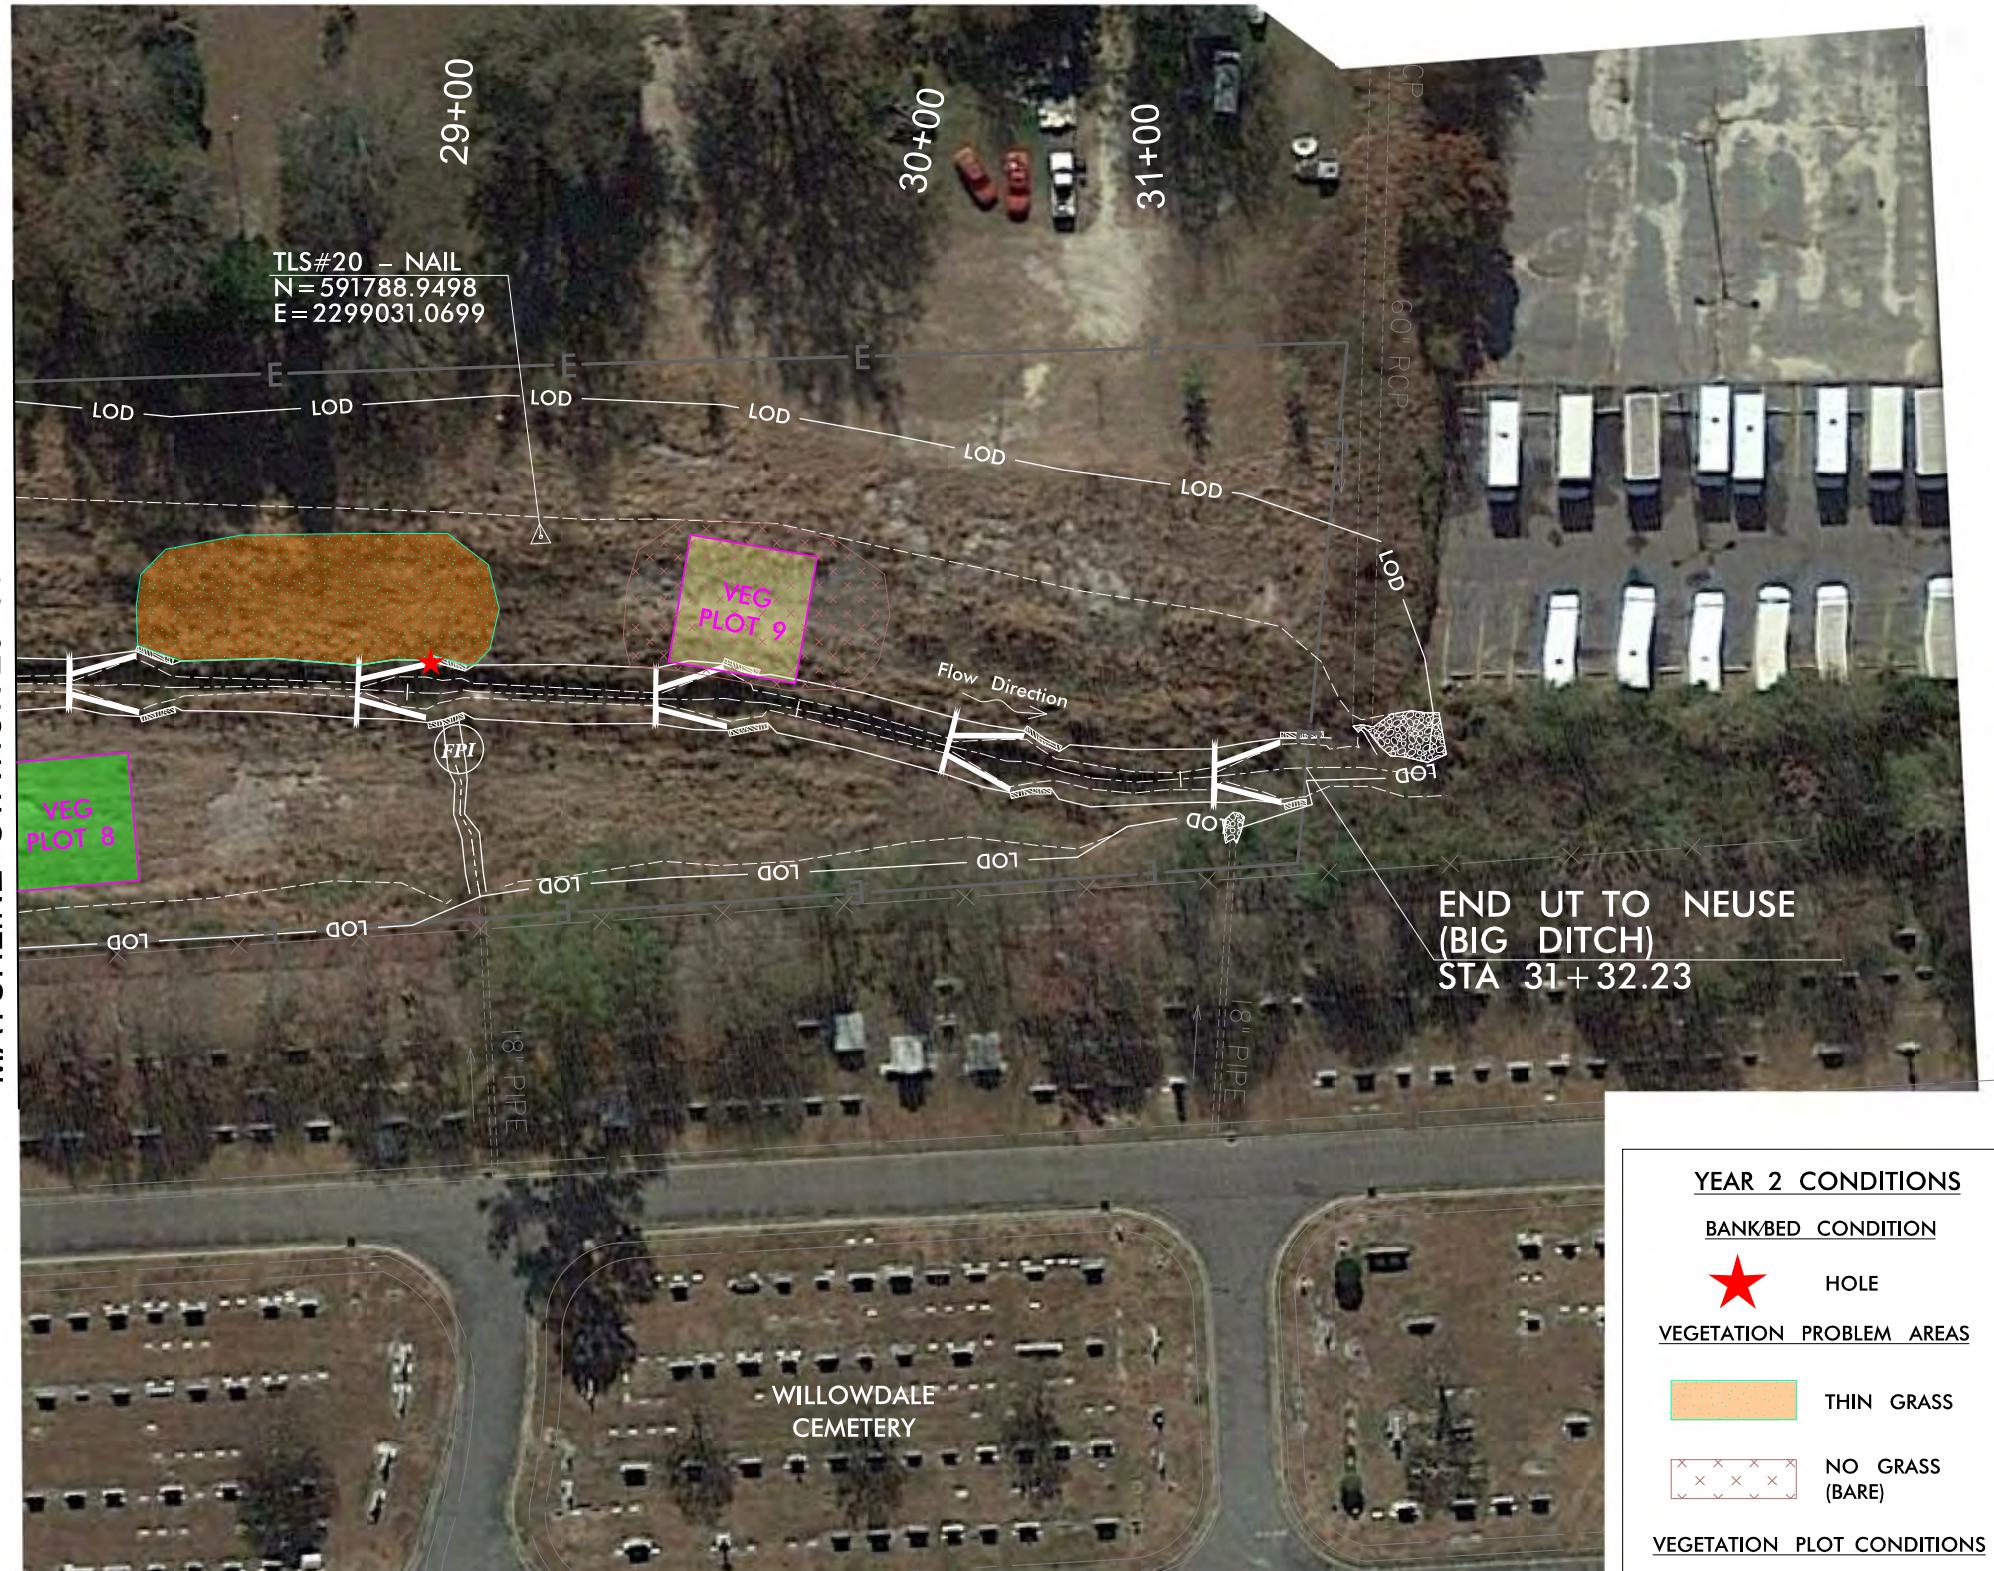
DATE: 09-8-15
CCPV
YEAR 2
FIGURE
2.3

YEAR 2 CONDITIONS	
BANKBED CONDITION	
	HOLE
VEGETATION PROBLEM AREAS	
	THIN GRASS
	NO GRASS (BARE)
VEGETATION PLOT CONDITIONS	
	CRITERIA MET
	CRITERIA UNMET

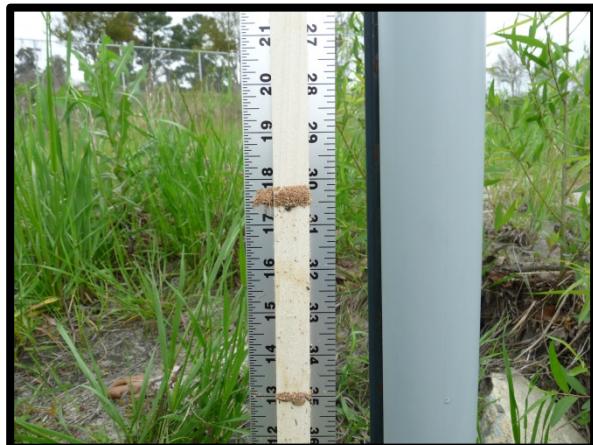
Figure 6.1 Crest Gauge 8/20/2014

Date	Crest Gauge Info		Gauge Reading (ft)	Gauge Elevation (ft)	Crest Elevation (ft)	Bankfull Elevation (ft)	Height above Bankfull (ft)	Photo
	Site	Sta.						
4/28/2014	XS 4	26+00	1.46	70.8	72.26	71.53	0.73	6.1
8/20/2014	XS 4	26+00	3.04	70.8	73.84	71.53	2.31	6.2
3/13/2015	XS 4	26+00	Visual	Visual	Visual	Debris lines above bankfull	Debris lines above bankfull	6.3
9/02/2015	XS 4	26+00	3.77	70.8	74.57	71.53	3.04	6.4
