Valley Fields Farm Stream Restoration Project

Monitoring Report: Year 04

Davidson County, North Carolina
Upper Yadkin River Basin
Cataloging Unit 030401030
EEP Project ID #407

December 2014

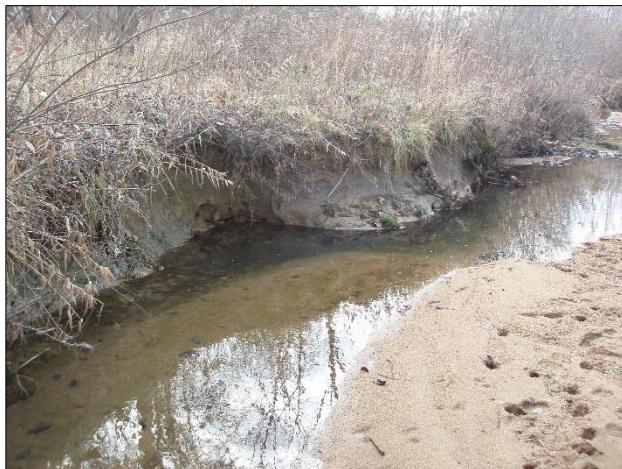
Bank erosion (Station 55+00) – 12/18/2014

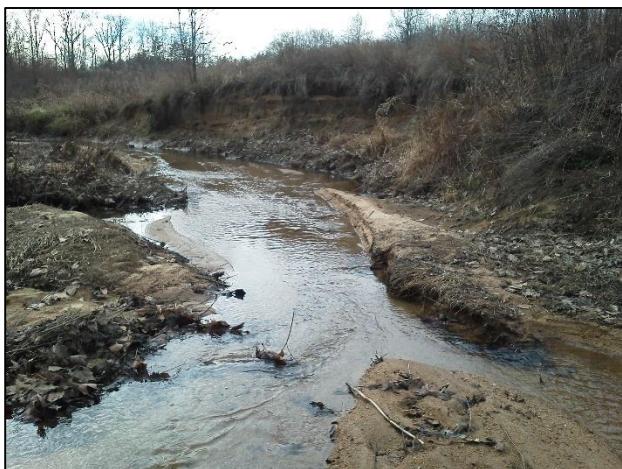
Bank erosion (Station 95+75) – 12/18/2014

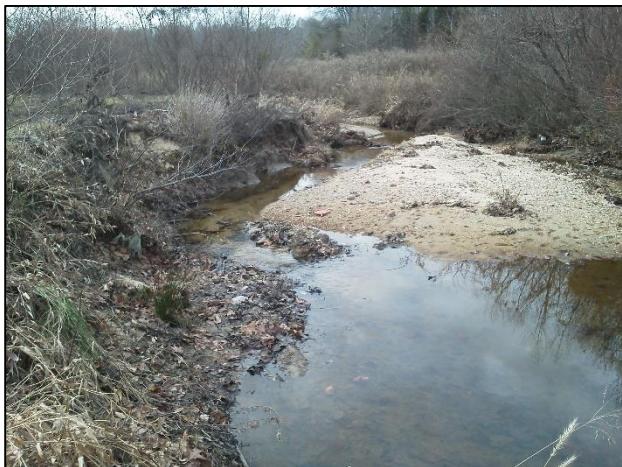
Bank erosion (Station 1515+00) and deposition
(typical along Reaches A and B) – 12/18/2014

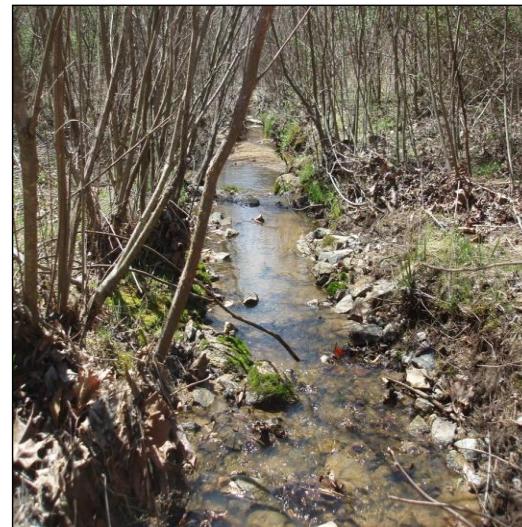
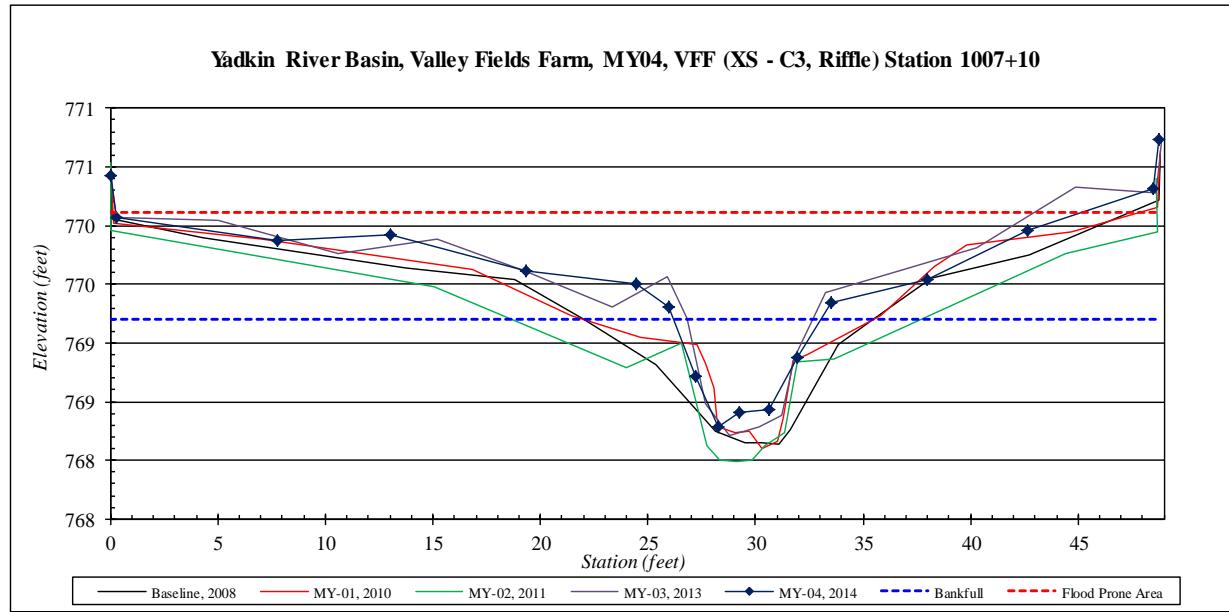
River Basin:	Yadkin
Watershed:	Valley Fields Farm, MY04
XS ID	VFF (XS - C3, Riffle) Station 1007+10
Drainage Area (sq mi):	0.2
Date:	4/2/2014
Field Crew:	T. Seelinger, M. Koss

SUMMARY DATA	
Bankfull Elevation:	769.2
Bankfull Cross-Sectional Area:	3.8
Bankfull Width:	6.8
Flood Prone Area Elevation:	770.1
Flood Prone Width:	37.8
Max Depth at Bankfull:	0.9
Mean Depth at Bankfull:	0.6
W / D Ratio:	12.2
Entrenchment Ratio:	5.6
Bank Height Ratio:	1.0

Stream Type C5

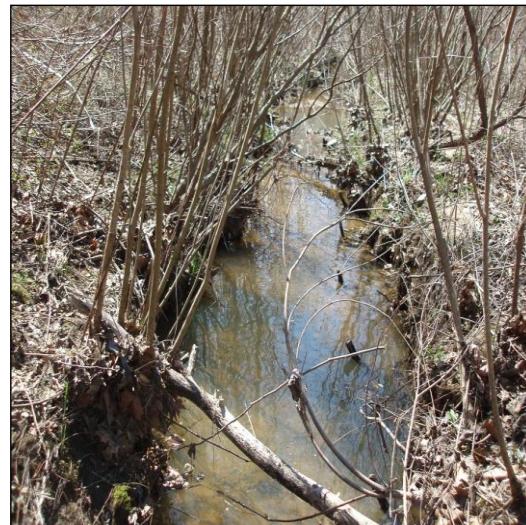
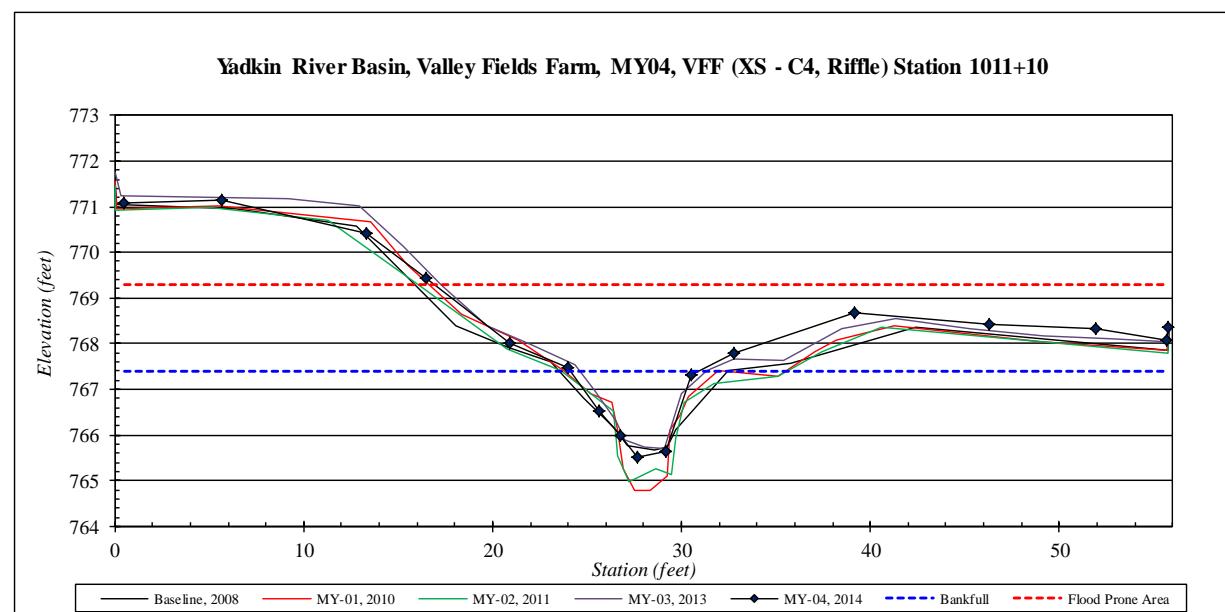
River Basin:	Yadkin
Watershed:	Valley Fields Farm, MY04
XS ID	VFF (XS - C4, Riffle) Station 1011+10
Drainage Area (sq mi):	0.2
Date:	4/2/2014
Field Crew:	T. Seelinger, M. Koss

SUMMARY DATA	
Bankfull Elevation:	767.4
Bankfull Cross-Sectional Area:	7.4
Bankfull Width:	6.7
Flood Prone Area Elevation:	769.3
Flood Prone Width:	38.9
Max Depth at Bankfull:	1.9
Mean Depth at Bankfull:	1.1
W / D Ratio:	6.1
Entrenchment Ratio:	5.8
Bank Height Ratio:	1.0

Stream Type C5

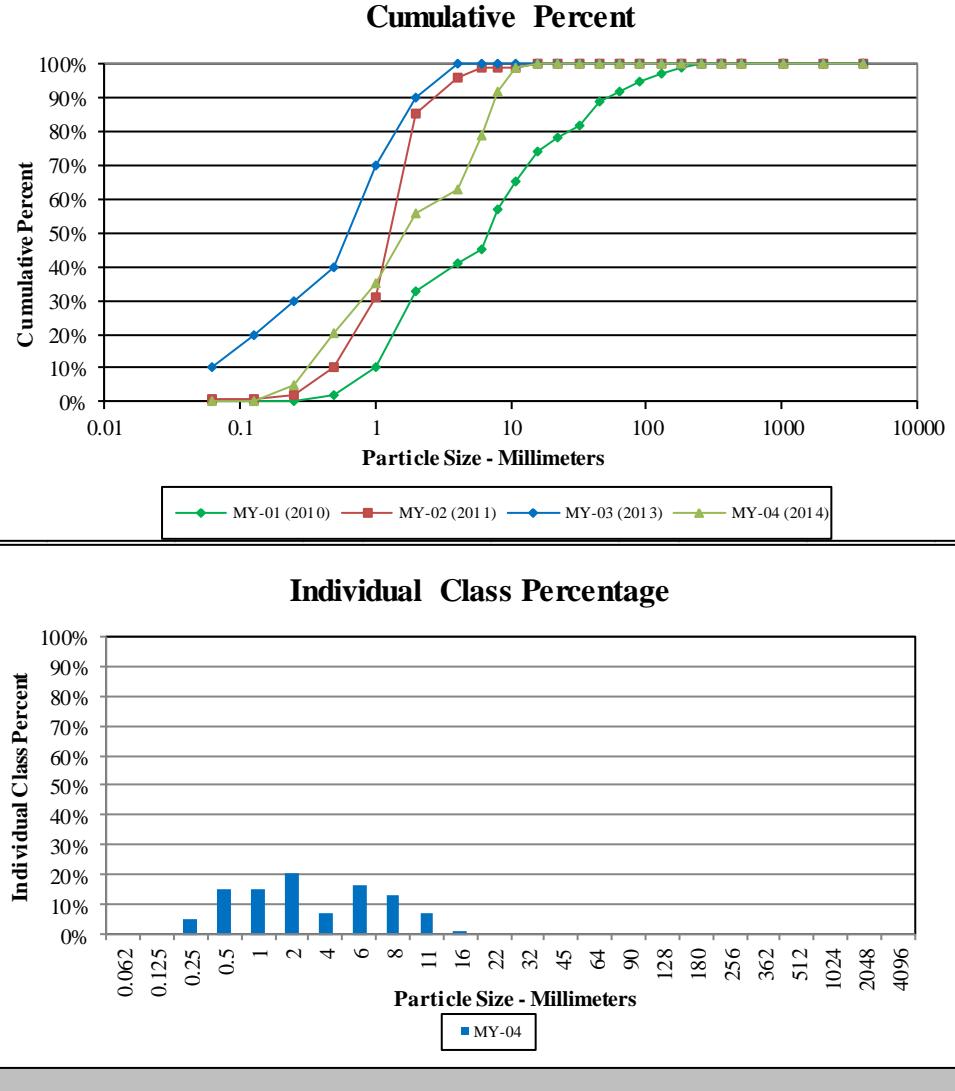
Cross-Section A1 Riffle - VFF MY-04					
Particle	Millimeter	Material	Count	Item %	Cum %
Silt/Clay	< 0.062	S/C		0%	0%
Very Fine	.062 - .125	S		0%	0%
Fine	.125 - .25	A	5	5%	5%
Medium	.25 - .50	N	15	15%	20%
Coarse	.50 - 1	D	15	15%	35%
Very Coarse	1 - 2	S	20	20%	56%
Very Fine	2 - 4		7	7%	63%
Fine	4 - 5.7	G	16	16%	79%
Fine	5.7 - 8	R	13	13%	92%
Medium	8 - 11.3	A	7	7%	99%
Medium	11.3 - 16	V	1	1%	100%
Coarse	16 - 22.6	E		0%	100%
Coarse	22.6 - 32	L		0%	100%
Very Coarse	32 - 45	S		0%	100%
Very Coarse	45 - 64			0%	100%
Small	64 - 90	C		0%	100%
Small	90 - 128	O		0%	100%
Large	128 - 180	B		0%	100%
Large	180 - 256	L		0%	100%
Small	256 - 362	B		0%	100%
Small	362 - 512	L		0%	100%
Medium	512 - 1024	D		0%	100%
Lrg- Very Lrg	1024 - 2048	R		0%	100%
Bedrock	>2048	BDRK		0%	100%
		Total	99	100%	100%
Size (mm)		Type			
D50	1.7	silt/clay	0%		
D84	6.7	sand	56%		
D95	9.2	gravel	44%		
		cobble	0%

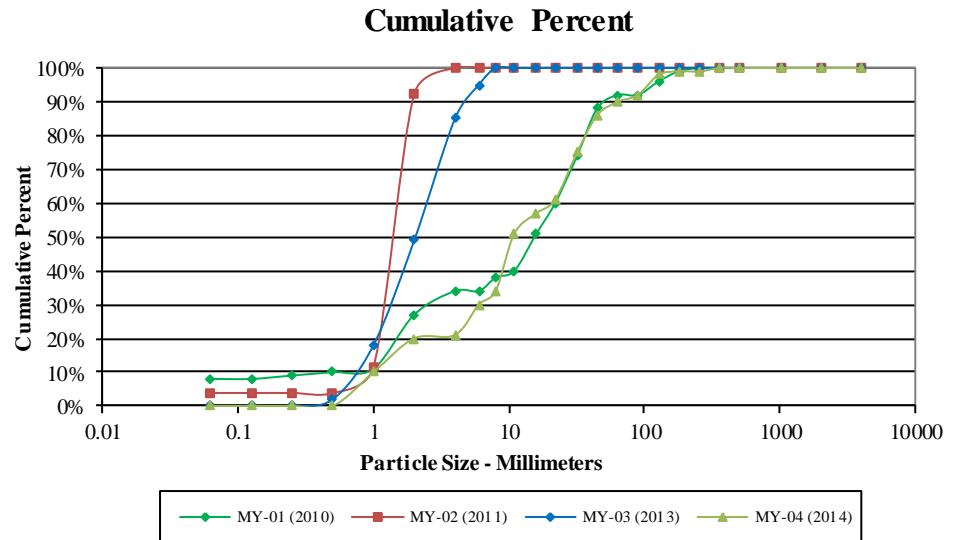
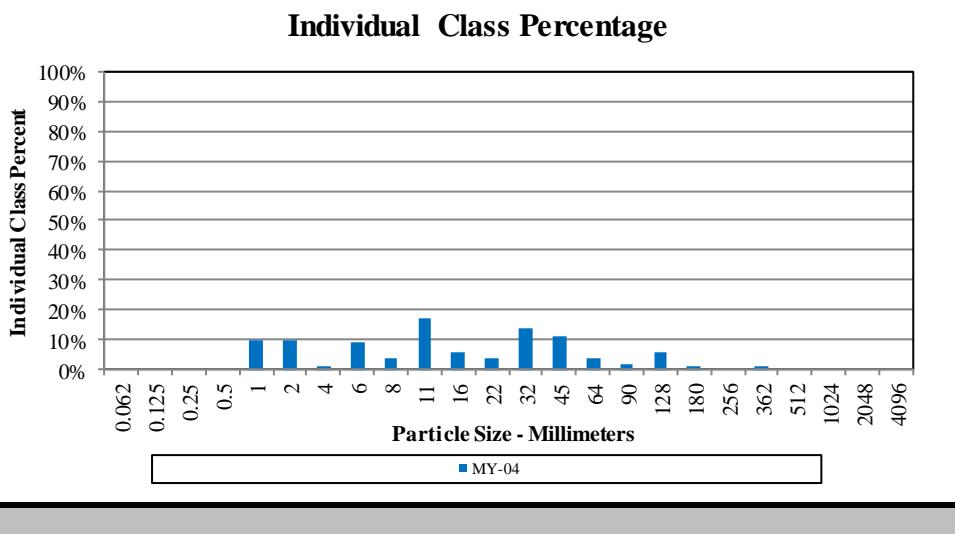
Cross-Section A3 Riffle - VFF MY-03					
Particle	Millimeter	Material	Count	Item %	Cum %
Silt/Clay	< 0.062	S/C		0%	0%
Very Fine	.062 - .125	S		0%	0%
Fine	.125 - .25	A		0%	0%
Medium	.25 - .50	N		0%	0%
Coarse	.50 - 1	D	10	10%	10%
Very Coarse	1 - 2	S	10	10%	20%
Very Fine	2 - 4		1	1%	21%
Fine	4 - 5.7	G	9	9%	30%
Fine	5.7 - 8	R	4	4%	34%
Medium	8 - 11.3	A	17	17%	51%
Medium	11.3 - 16	V	6	6%	57%
Coarse	16 - 22.6	E	4	4%	61%
Coarse	22.6 - 32	L	14	14%	75%
Very Coarse	32 - 45	S	11	11%	86%
Very Coarse	45 - 64		4	4%	90%
Small	64 - 90	C	2	2%	92%
Small	90 - 128	O	6	6%	98%
Large	128 - 180	B	1	1%	99%
Large	180 - 256	L		0%	99%
Small	256 - 362	B	1	1%	100%
Small	362 - 512	L		0%	100%
Medium	512 - 1024	D		0%	100%
Lrg- Very Lrg	1024 - 2048	R		0%	100%
Bedrock	>2048	BDRK		0%	100%
		Total	100	100%	100%
Size (mm)		Type			
D50	11	silt/clay	0%		
D84	42	sand	20%		
D95	110	gravel	70%		
		cobble	9%

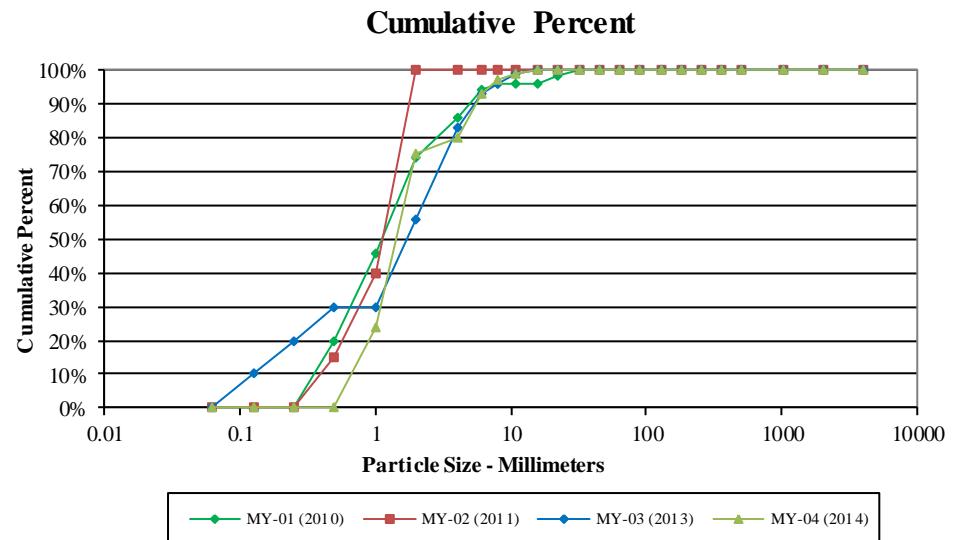
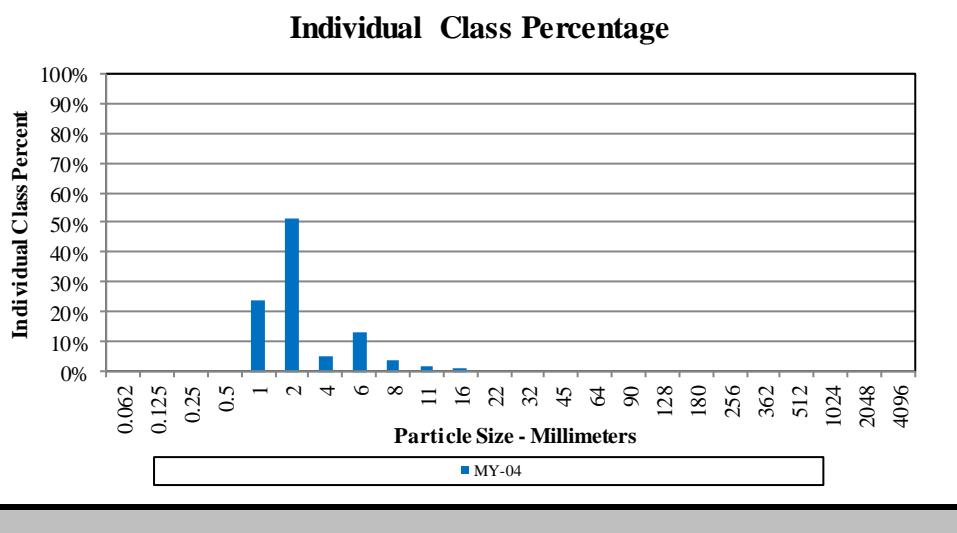
Cross-Section A10 Riffle - VFF MY-03					
Particle	Millimeter	Material	Count	Item %	Cum %
Silt/Clay	< 0.062	S/C		0%	0%
Very Fine	.062 - .125	S		0%	0%
Fine	.125 - .25	A		0%	0%
Medium	.25 - .50	N		0%	0%
Coarse	.50 - 1	D	24	24%	24%
Very Coarse	1 - 2	S	51	51%	75%
Very Fine	2 - 4		5	5%	80%
Fine	4 - 5.7	G	13	13%	93%
Fine	5.7 - 8	R	4	4%	97%
Medium	8 - 11.3	A	2	2%	99%
Medium	11.3 - 16	V	1	1%	100%
Coarse	16 - 22.6	E		0%	100%
Coarse	22.6 - 32	L		0%	100%
Very Coarse	32 - 45	S		0%	100%
Very Coarse	45 - 64			0%	100%
Small	64 - 90	C		0%	100%
Small	90 - 128	O		0%	100%
Large	128 - 180	B		0%	100%
Large	180 - 256	L		0%	100%
Small	256 - 362	B		0%	100%
Small	362 - 512	L		0%	100%
Medium	512 - 1024	D		0%	100%
Lrg- Very Lrg	1024 - 2048	R		0%	100%
Bedrock	>2048	BDRK		0%	100%
		Total	100	100%	100%
Size (mm)		Type			
D50	1.4	silt/clay	0%		
D84	4.5	sand	75%		
D95	6.9	gravel	25%		
		cobble	0%
