LYLE CREEK MITIGATION SITE Catawba County, NC DENR Contract 003241 NCEEP Project Number 94643

Baseline Monitoring Document and As-Built Baseline Report FINAL Data Collection Period: March-May 2012 Draft Submission Date: June 15, 2012 Final Submission Date: July 17, 2012

LYLE CREEK MITIGATION SITE Baseline Monitoring Document and As-Built Baseline Report

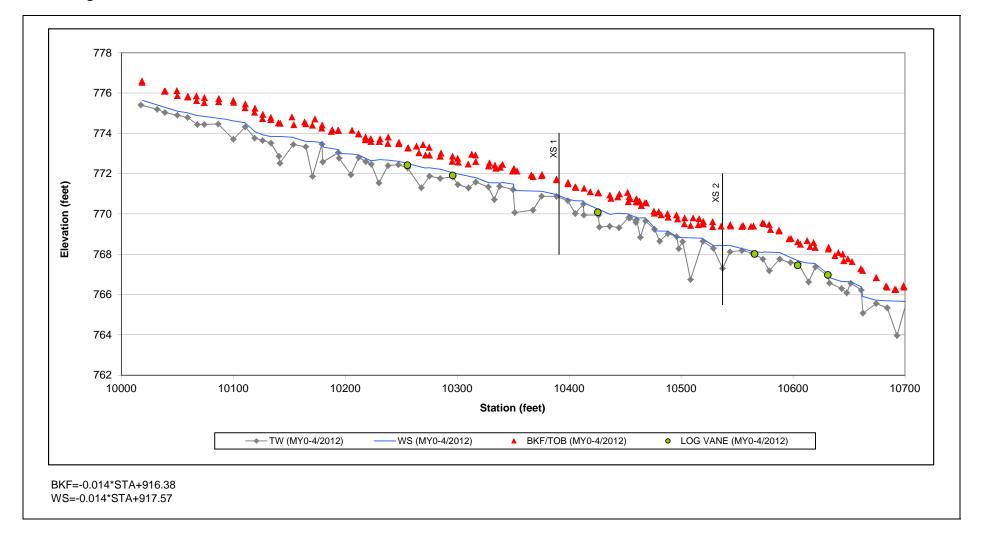
Appendix 2. Morphological Summary Data and Plots Figure 3a. Longitudinal Profile Plots Lyle Creek Mitigation Site (EEP Project No. 94643) UT1 Reach 1 Upper Monitoring Year 0 of 5

The baseline (MY-0) profile numbers are closely matched to the design parameters. Although some of the baseline parameters fall outside of the design ratios, the installed stream meets the design intent. These changes are most likely due to the small dimension of the channel, where slight grade changes within construction tolerances and slight shifts in survey data collection locations can significantly impact calculation of facet slopes and other profile parameters. The plotted longitudinal profile and related summary data can be found in Appendix 2.

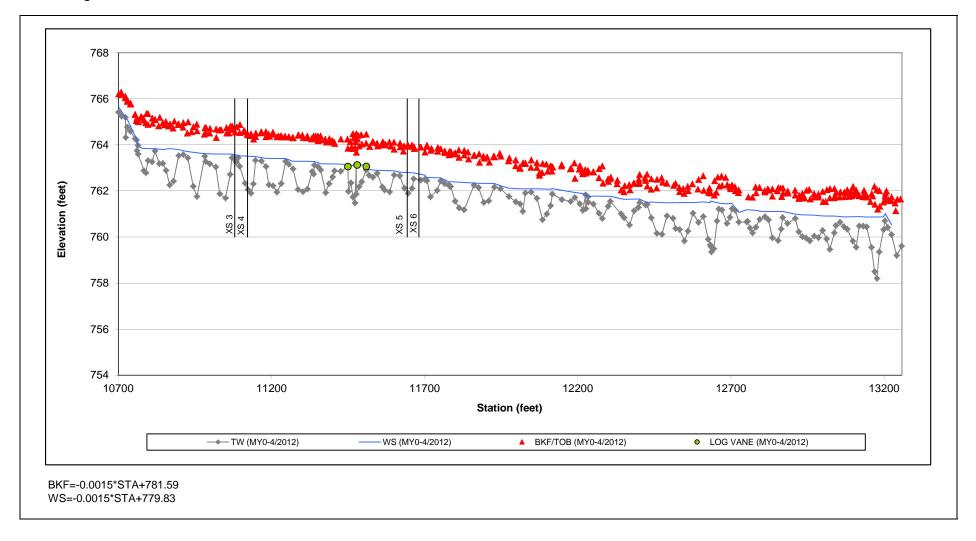
Appendix 2. Morphological Summary Data and Plots Figure 3b. Longitudinal Profile Plots Lyle Creek Mitigation Site (EEP Project No. 94643) UT1 Reach 1 Lower Monitoring Year 0 of 5

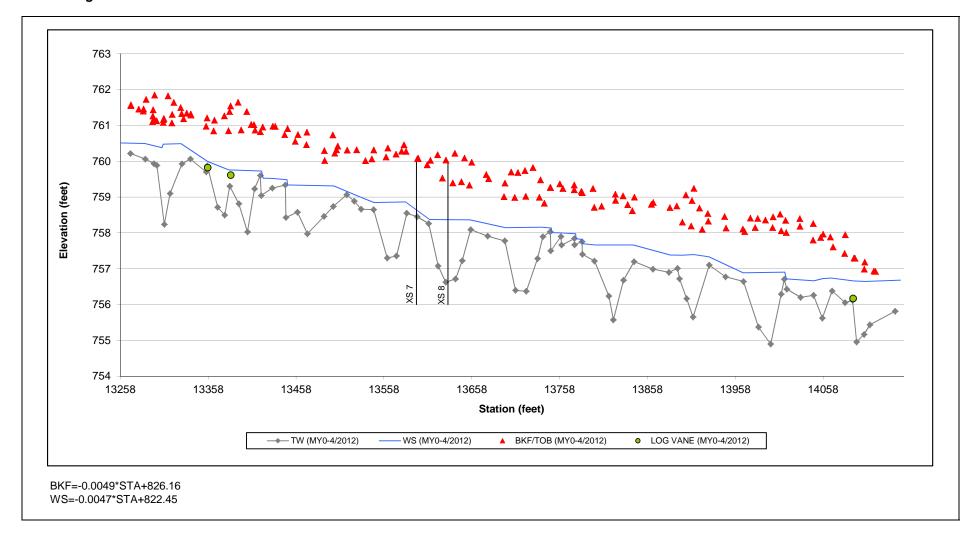
Appendix 2. Morphological Summary Data and Plots Figure 3c. Longitudinal Profile Plots Lyle Creek Mitigation Site (EEP Project No. 94643) UT1 Reach 2 Monitoring Year 0 of 5

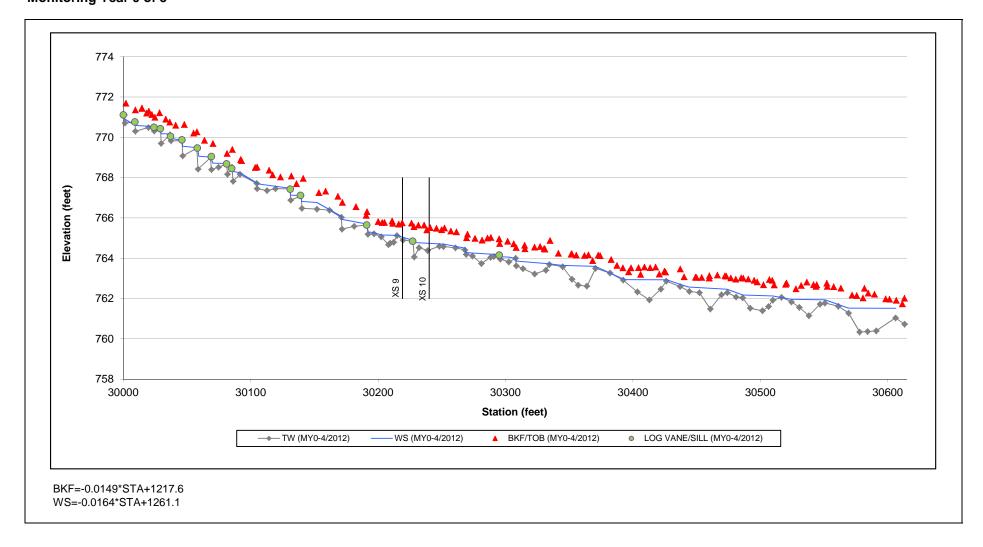
Appendix 2. Morphological Summary Data and Plots Figure 3d. Longitudinal Profile Plots Lyle Creek Mitigation Site (EEP Project No. 94643) UT1A Monitoring Year 0 of 5

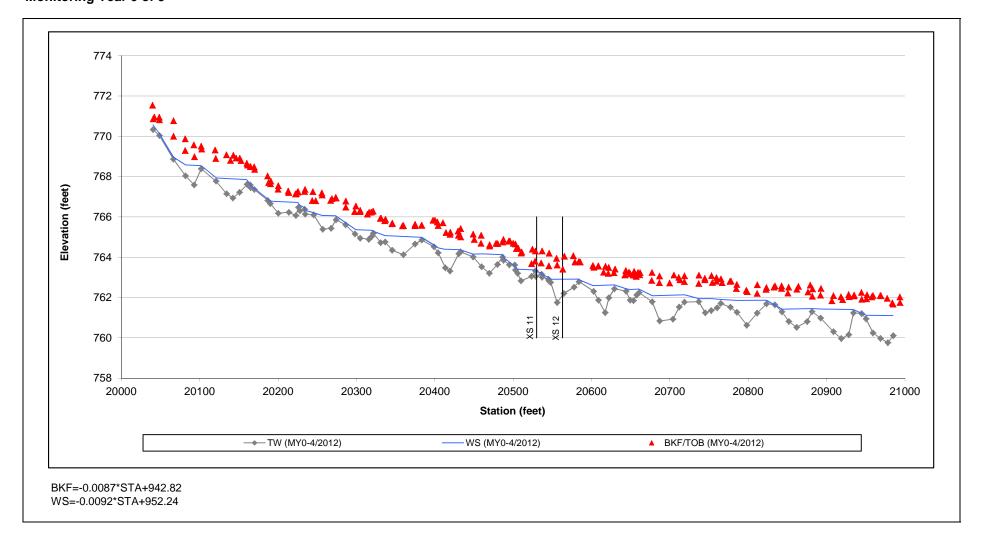
Appendix 2. Morphological Summary Data and Plots Figure 3e. Longitudinal Profile Plots Lyle Creek Mitigation Site (EEP Project No. 94643) UT1B Monitoring Year 0 of 5

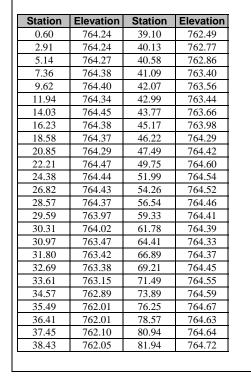
Appendix 2. Morphological Summary Data and Plots Figure 4d. Cross-Section Plots Lyle Creek Mitigation Site (EEP Project No. 94643) UT1 Reach 1 Lower, Cross-Section 4 (Pool) Monitoring Year 0 of 5

Summary Data		
Bankfull Elevation (ft)	764.4	
Bankfull Cross-Sectional Area (ft2)	22.5	
Bankfull Width (ft)	20.7	
Flood Prone Area Elevation (ft)	N/A	
Flood Prone Width (ft)	N/A	
Max Depth at Bankfull (ft)	2.4	
Mean Depth at Bankfull (ft)	1.1	
W/D Ratio	19.0	
Entrenchment Ratio	N/A	
Bank Height Ratio	1.0	
Stream Type	N/A

The baseline (MY-0) dimension numbers are closely matched to the design parameters. Although some of the baseline parameters fall outside of the design ratios, the installed stream meets the design intent. These changes are most likely due to the small dimension of the channel, where slight grade changes within construction tolerances and slight shifts in survey data collection locations can significantly impact dimension ratio calculations. Summary data and cross-section plots can be found in Appendix 2.

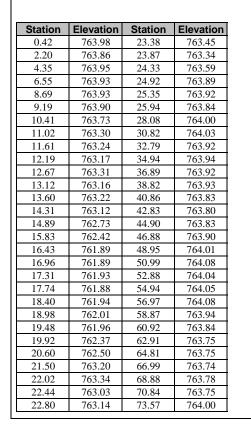
Appendix 2. Morphological Summary Data and Plots Figure 4e. Cross-Section Plots Lyle Creek Mitigation Site (EEP Project No. 94643) UT1 Reach 1 Lower, Cross-Section 5 (Pool) Monitoring Year 0 of 5

River Basin Catawba 03050		0101
Watershed NCDWQ Subbasin 03-		03-08-32
XS ID	5	
Drainage Area	315 Acre	8
Date	4/2012	
Field Crew	Dewberr	Ý
S	ummary Data	
Bankfull Elevation (ft) 763.9		763.9
Bankfull Cross-Sectional Area (ft2)		16.5
Bankfull Width (ft)		16.6
Flood Prone Area Elevation (ft)		N/A
Flood Prone Width (ft)		N/A
Max Depth at Bankfull (ft)		2.1
Mean Depth at Bankfull (ft) 1.0		1.0
W/D Ratio		16.7
Entrenchment Ratio		N/A
Bank Height Ratio		1.0
Stream Type		N/A

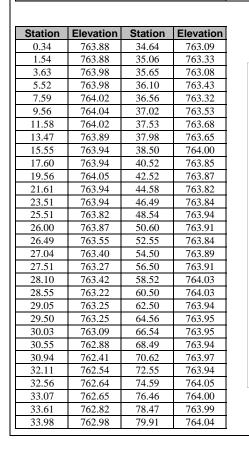
Appendix 2. Morphological Summary Data and Plots Figure 4f. Cross-Section Plots Lyle Creek Mitigation Site (EEP Project No. 94643) UT1 Reach 1 Lower, Cross-Section 6 (Riffle) Monitoring Year 0 of 5

Summary Data	
Bankfull Elevation (ft)	763.9
Bankfull Cross-Sectional Area (ft2)	9.0
Bankfull Width (ft)	12.3
Flood Prone Area Elevation (ft)	765.3
Flood Prone Width (ft)	79.6
Max Depth at Bankfull (ft)	1.5
Mean Depth at Bankfull (ft)	0.7
W/D Ratio	16.8
Entrenchment Ratio	2.2+
Bank Height Ratio	1.0
Stream Type	C

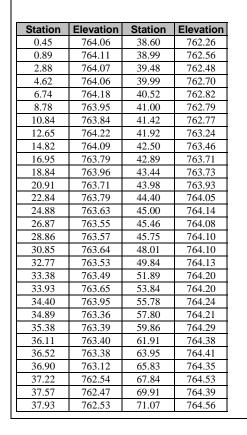
Appendix 2. Morphological Summary Data and Plots Figure 4I. Cross-Section Plots Lyle Creek Mitigation Site (EEP Project No. 94643) UT1B, Cross-Section 12 (Pool) Monitoring Year 0 of 5

River Basin	Catawba 03050	101					
Watershed	NCDWQ Subbasin (03-08-32					
XS ID	12						
Drainage Area	845 Acres						
Date	4/2012						
Field Crew	Dewberry						
Su	ummary Data						
Bankfull Elevation (ft		763.5					
Bankfull Cross-Section	onal Area (ft2)	4.6					
Bankfull Width (ft)		7.8					
Flood Prone Area Ele	vation (ft)	N/A					
Flood Prone Width (ft	t)	N/A					
Max Depth at Bankful	ll (ft)	1.2					
Mean Depth at Bankf	ull (ft)	0.6					
W/D Ratio		13.1					
Entrenchment Ratio	N/A						
Bank Height Ratio		1.0					
Stream Type		N/A

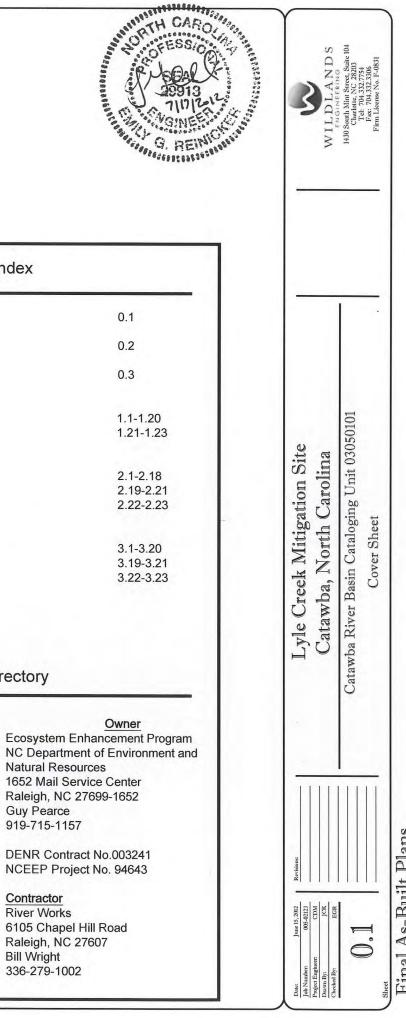
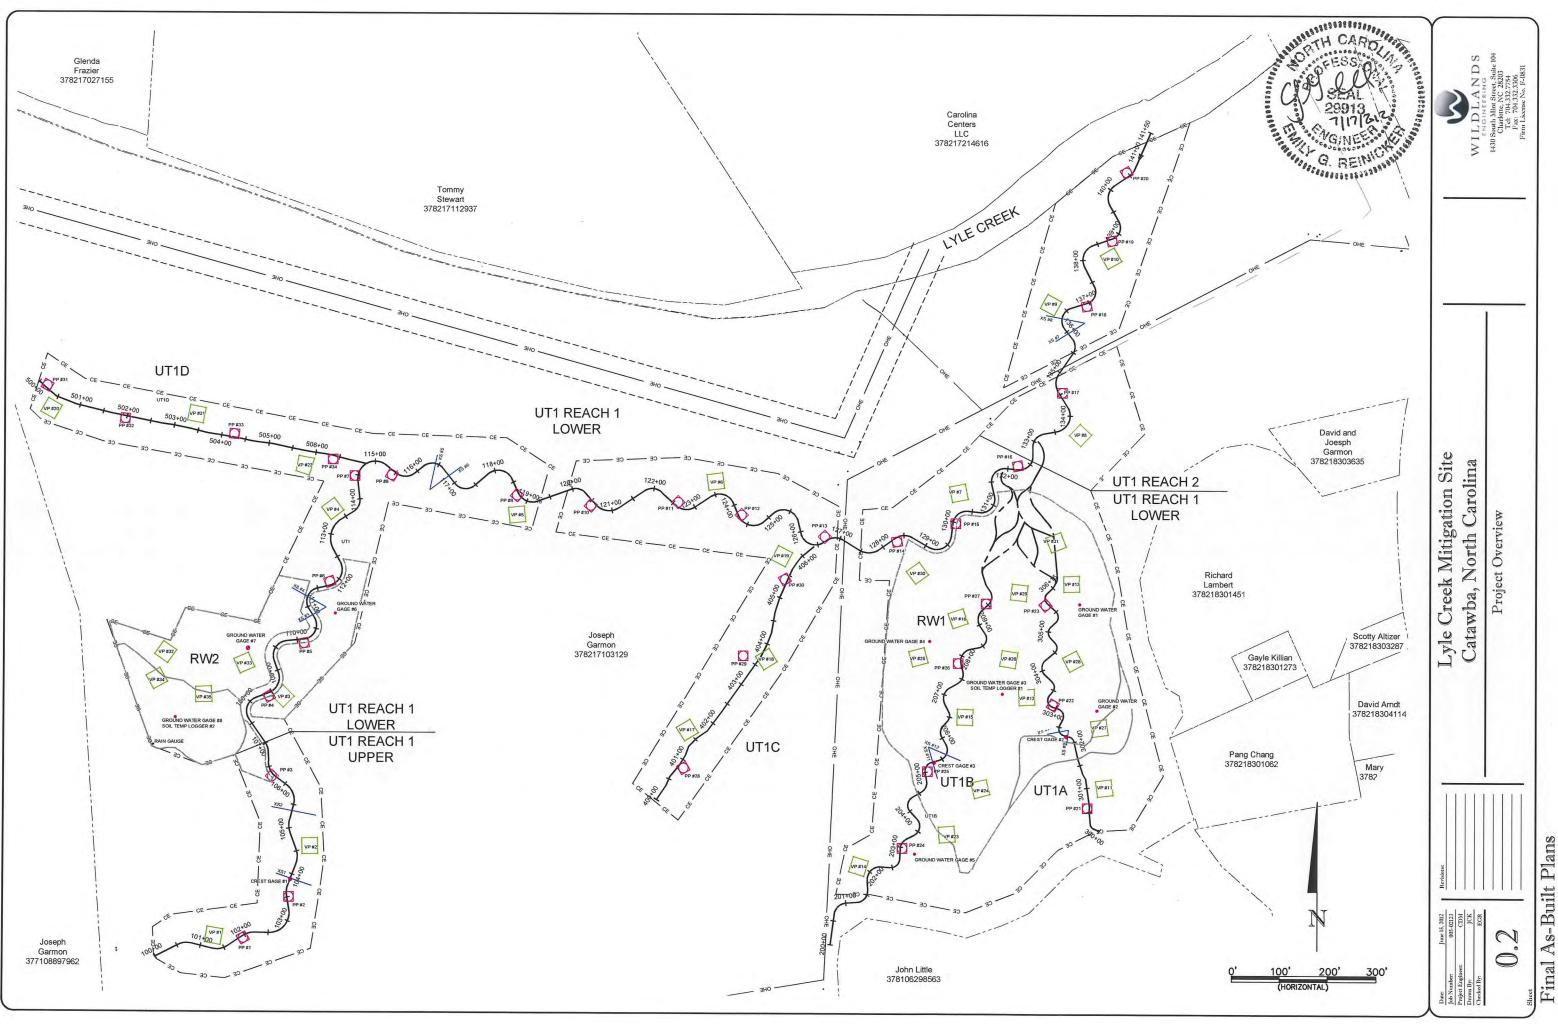
APPENDIX 4. As-Built Plan Sheets

Lyle Creek Mitigation Site Catawba County, NC Catawba River Basin Cataloging Unit 03050101 for Sheet Index North Carolina Ecosystem Enhancement Program **Cover Sheet Project Overview** General Notes and Symbols **Construction Plans** Stream Plan and Profile Wetlands As-Built Plans Stream Plan and Profile Wetlands **Cross Sections Overlay Plans** SITE Stream Plan and Profile Profiles PROGRAM **Cross Sections Project Directory** Vicinity Map Not to Sca Engineering Wildlands Engineering, Inc. License No. F-0831 1430 South Mint Street, Ste 104 FINAL Charlotte, NC 28203 **AS-BUILT PLANS** Emily G. Reinicker, PE 704-332-7754 & RECORD DRAWINGS **ISSUED JULY 17, 2012** Surveying Dewberry and Davis, Inc. REACH ORIGINS 6135 Lakeview Road Charlotte, NC 28269 Reach Latitude Longitude John B. Primm, PLS UT1 Reach 1 N35°42'33.8" W81°05'08.7" UT1 Reach 2 N35°42'38.2" W81°05'06.1" 704-509-9918 UT1A N35°42'36.8" W81°04'45.0" License: F-0679 UT1B N35°42'34.4" W81°04'51.7" Survey information provided: UT1C N35°42'37.2" W81°04'56.2" Post-Construction As-Built Survey UT1D N35°42'45 6' W81°05'12.0" Date of Completed Survey: 4-17-2012

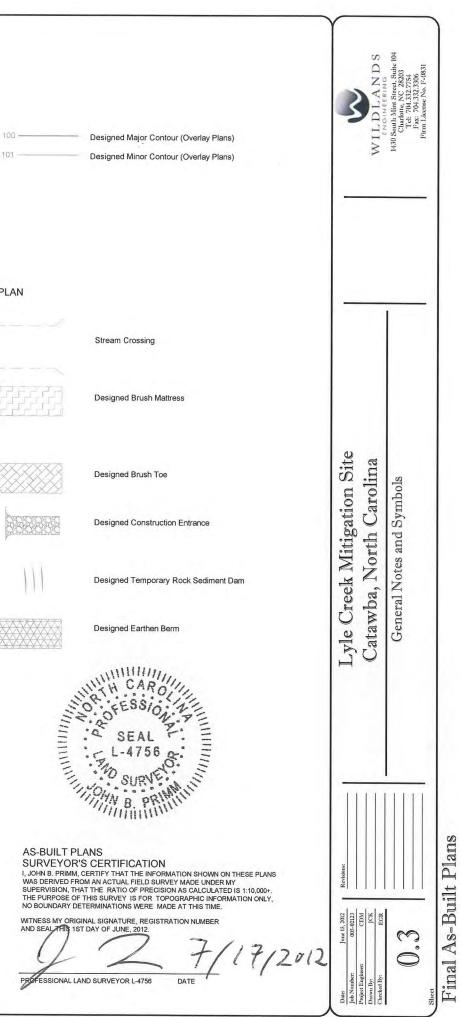
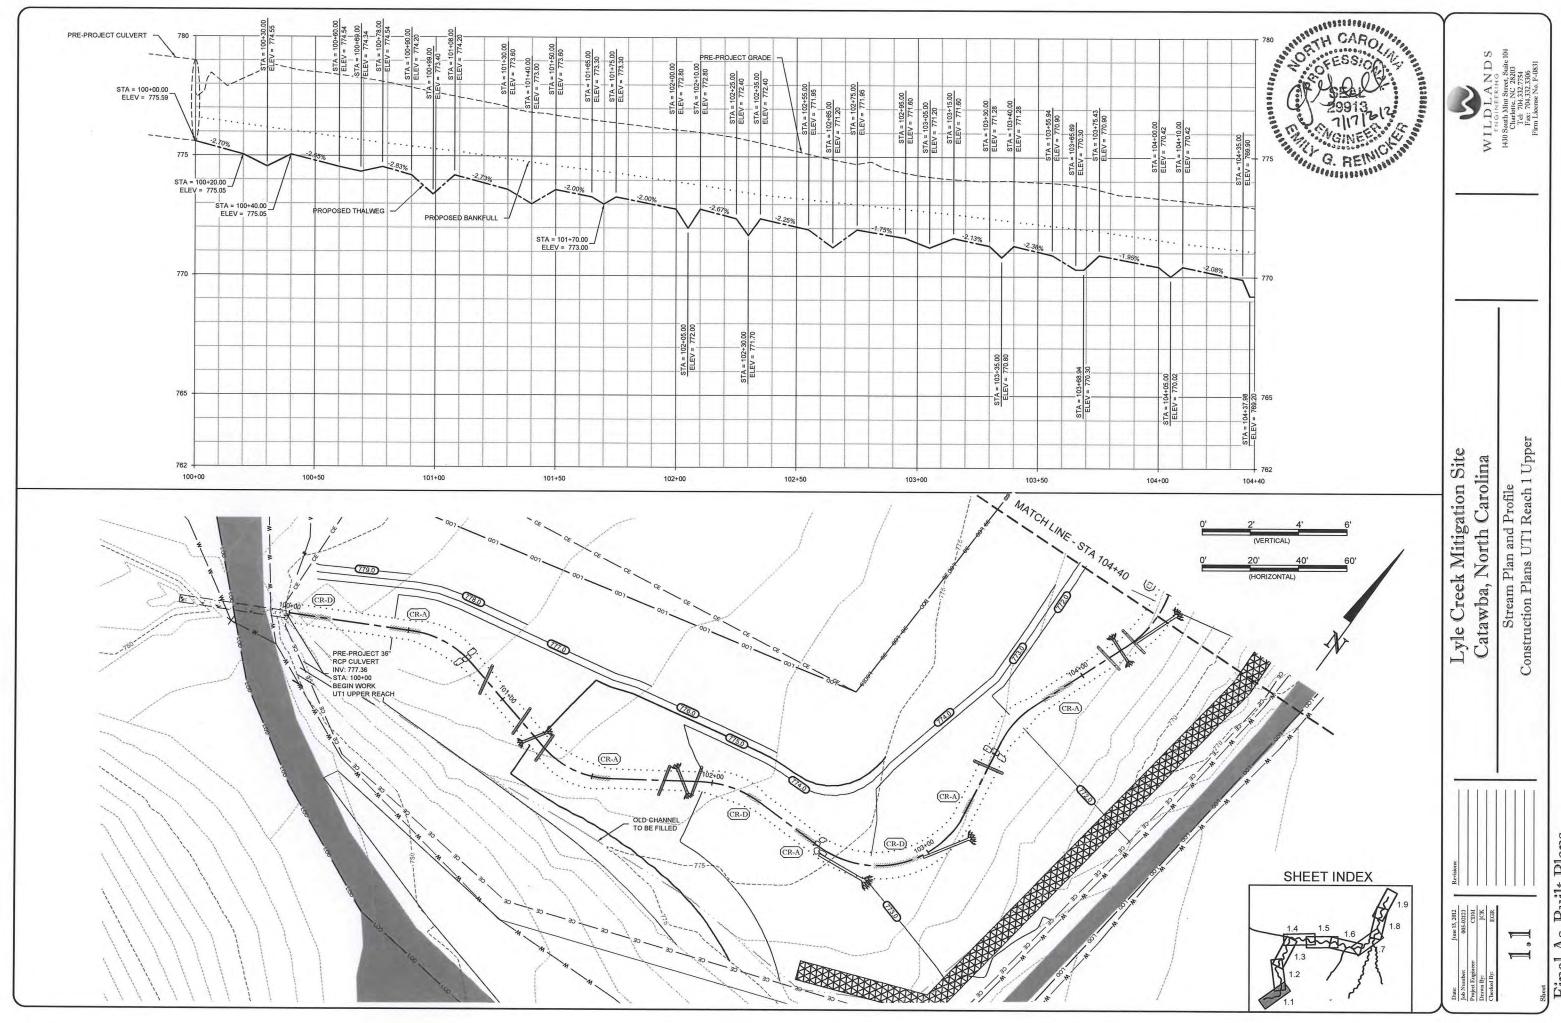
Designed Rock "A" Vane

Designed Angled Log Step Pool
