# **As-built Baseline Monitoring Report**

**Mill Dam Creek Restoration Site  
Yadkin River Basin - 03040101  
Monitoring Year 00  
DEQ Contract 6898  
DMS Project Number 97136**

**DWR #: 18-1349  
USACE Action ID: 2016-01335  
Yadkin County, North Carolina**

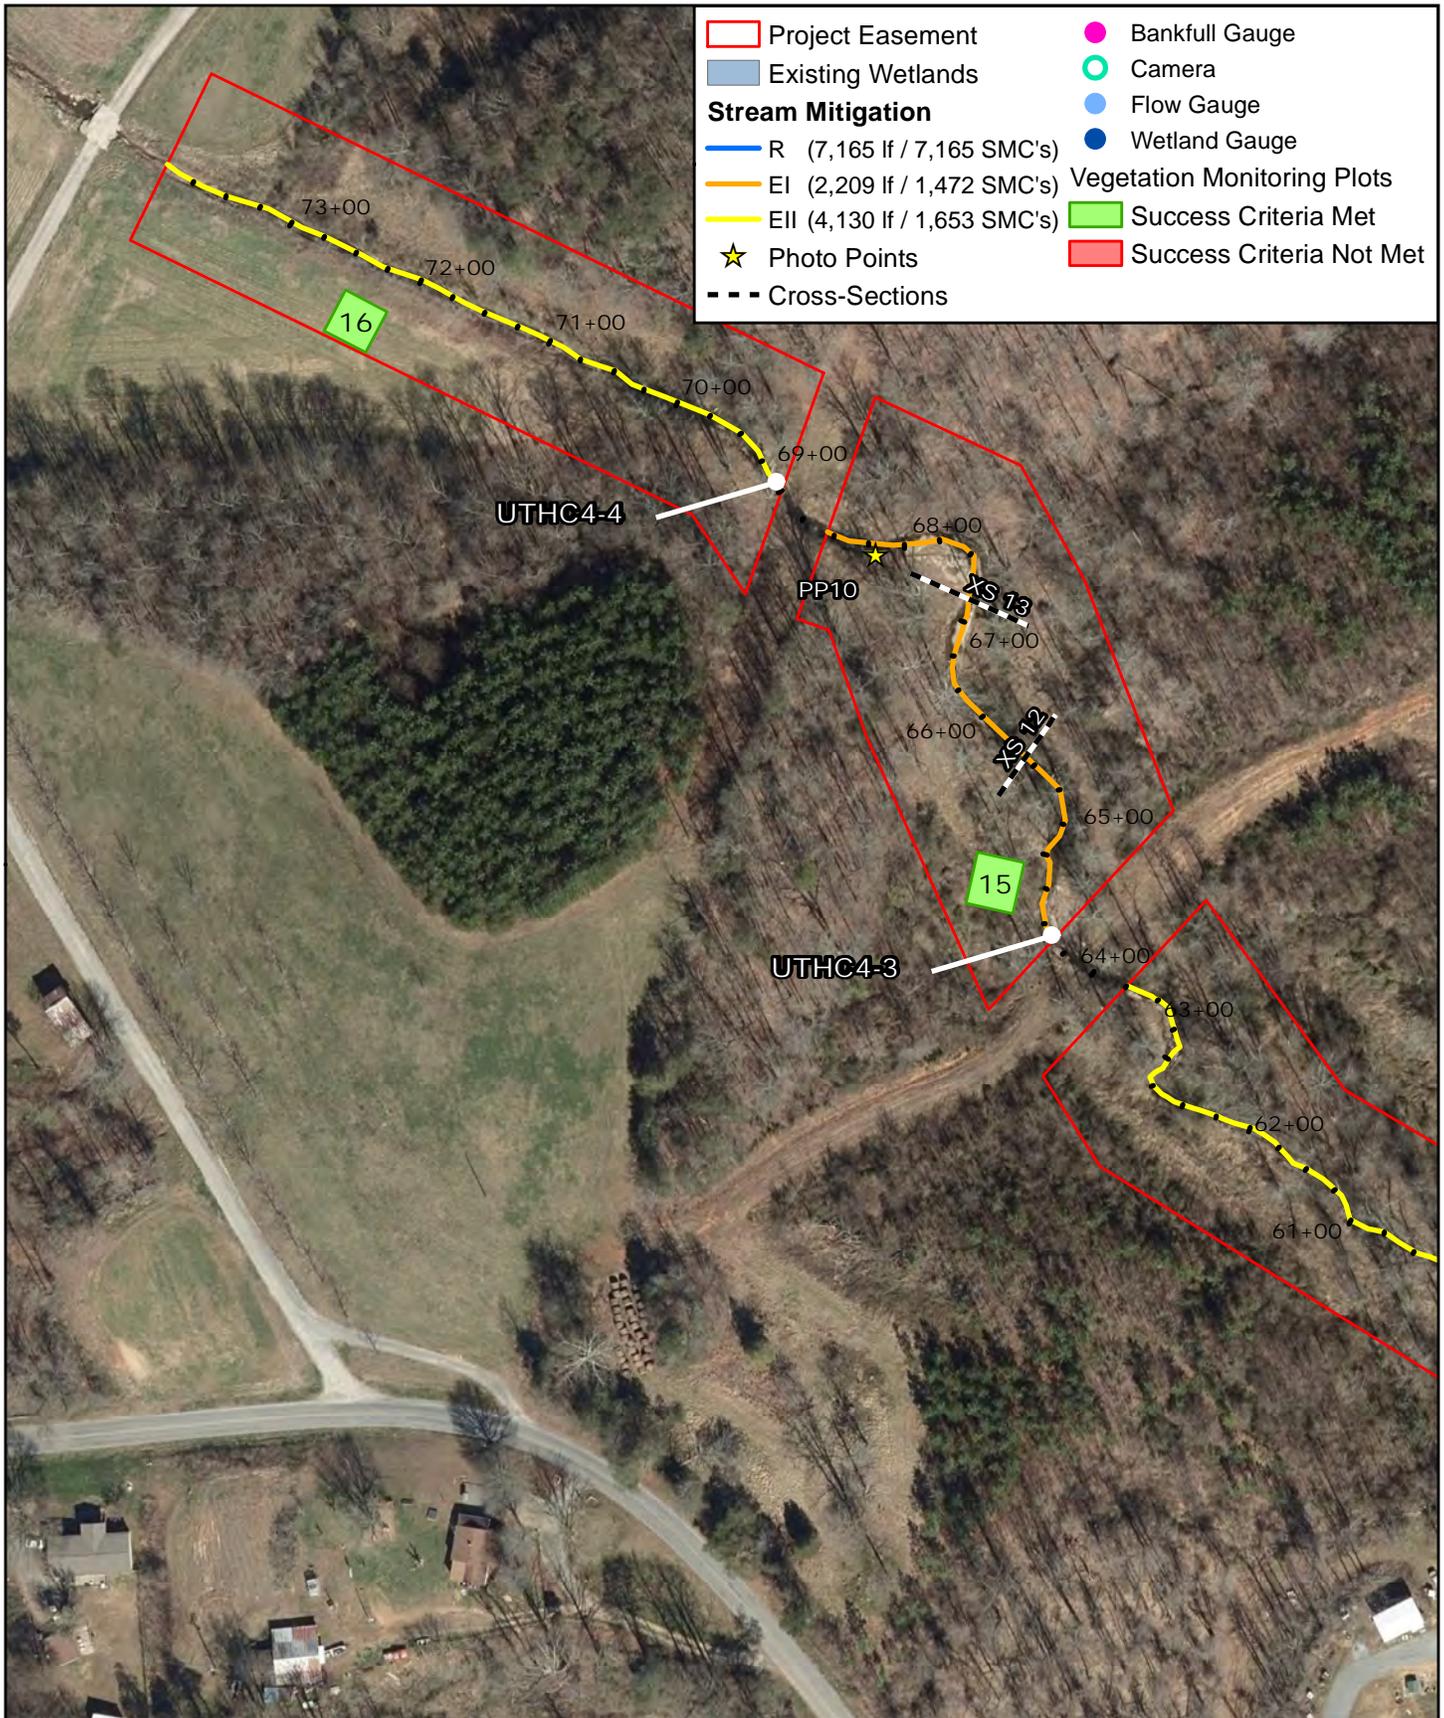
**Current Conditions Plan View**  
**Mill Dam Creek Restoration Site**  
**DMS Project #97136**  
**Yadkin County, NC**  
**Page 6**

- Project Easement
- Existing Wetlands
- Stream Mitigation**
- R (7,165 lf / 7,165 SMC's)
- EI (2,209 lf / 1,472 SMC's)
- EII (4,130 lf / 1,653 SMC's)
- ★ Photo Points
- Cross-Sections
- Bankfull Gauge
- Camera
- Flow Gauge
- Wetland Gauge
- Vegetation Monitoring Plots**
- Success Criteria Met
- Success Criteria Not Met

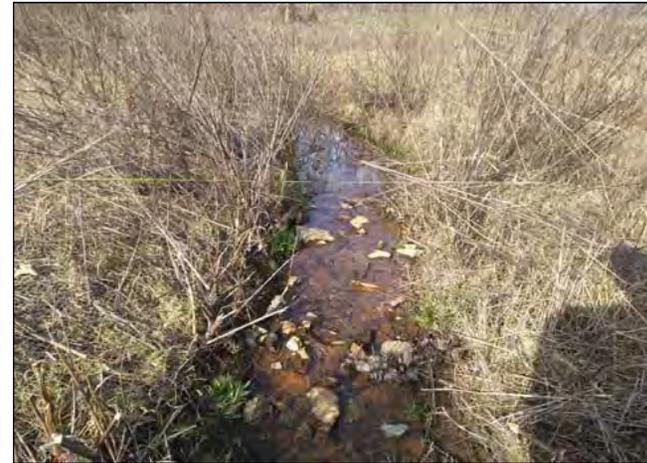
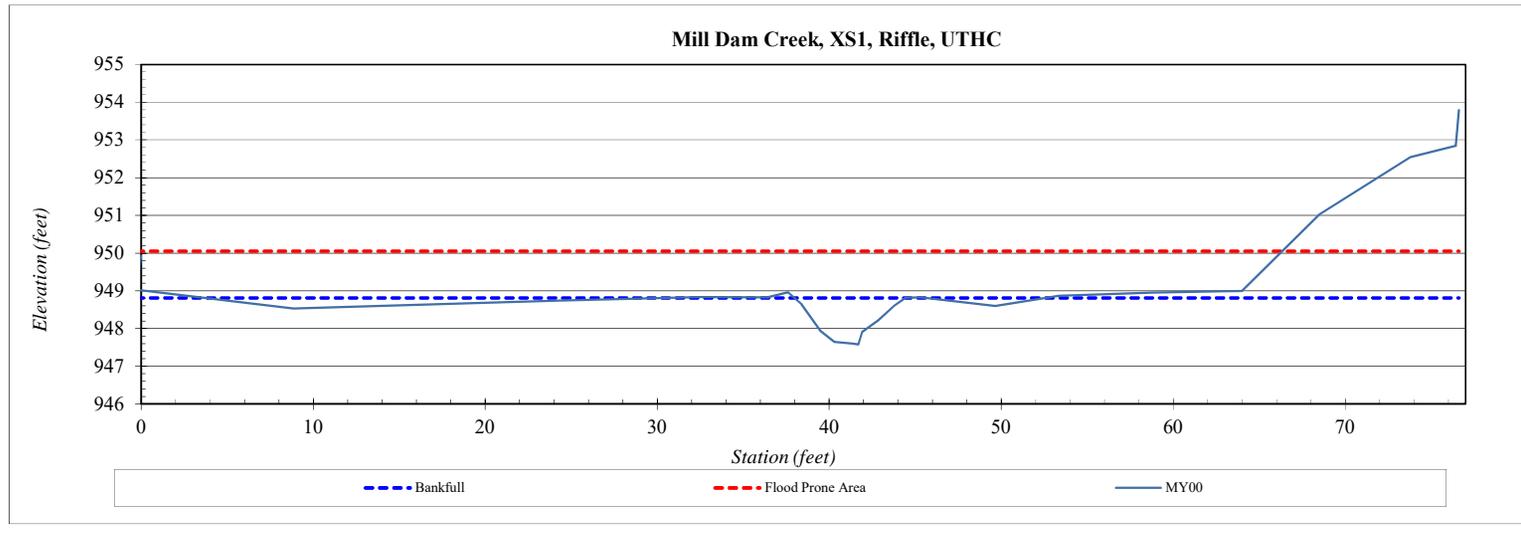
<b>River Basin:</b>	Yadkin River
<b>Site:</b>	Mill Dam Creek
<b>XS ID</b>	XS1
<b>Drainage Area (sq mi):</b>	0.18
<b>Date:</b>	1/29/2020
<b>Field Crew:</b>	TS, KB

SUMMARY DATA	
<b>Bankfull Elevation (ft) - Based on AB-Bankfull Area</b>	948.81
<b>Bankfull Cross-Sectional Area:</b>	4.5
<b>Total Cross-Sectional Area:</b>	4.5
<b>Bankfull Width:</b>	6.0
<b>Flood Prone Area Elevation:</b>	950.05
<b>Flood Prone Width:</b>	66.3
<b>Max Depth at Bankfull:</b>	1.2
<b>Mean Depth at Bankfull:</b>	0.7
<b>W / D Ratio:</b>	8.2
<b>Entrenchment Ratio:</b>	11.0
<b>Bank Height Ratio:</b>	1.0
<b>Thalweg Elevation:</b>	947.58

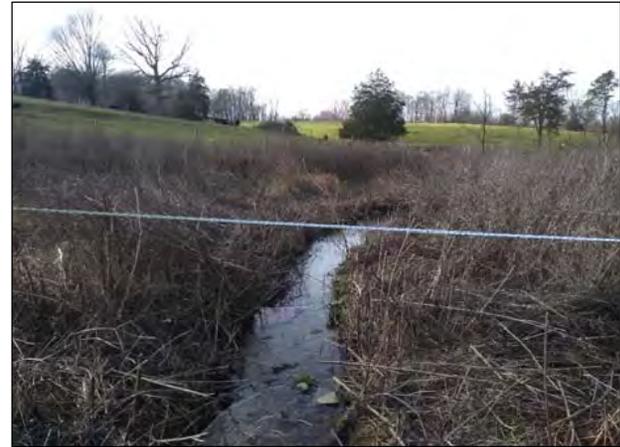
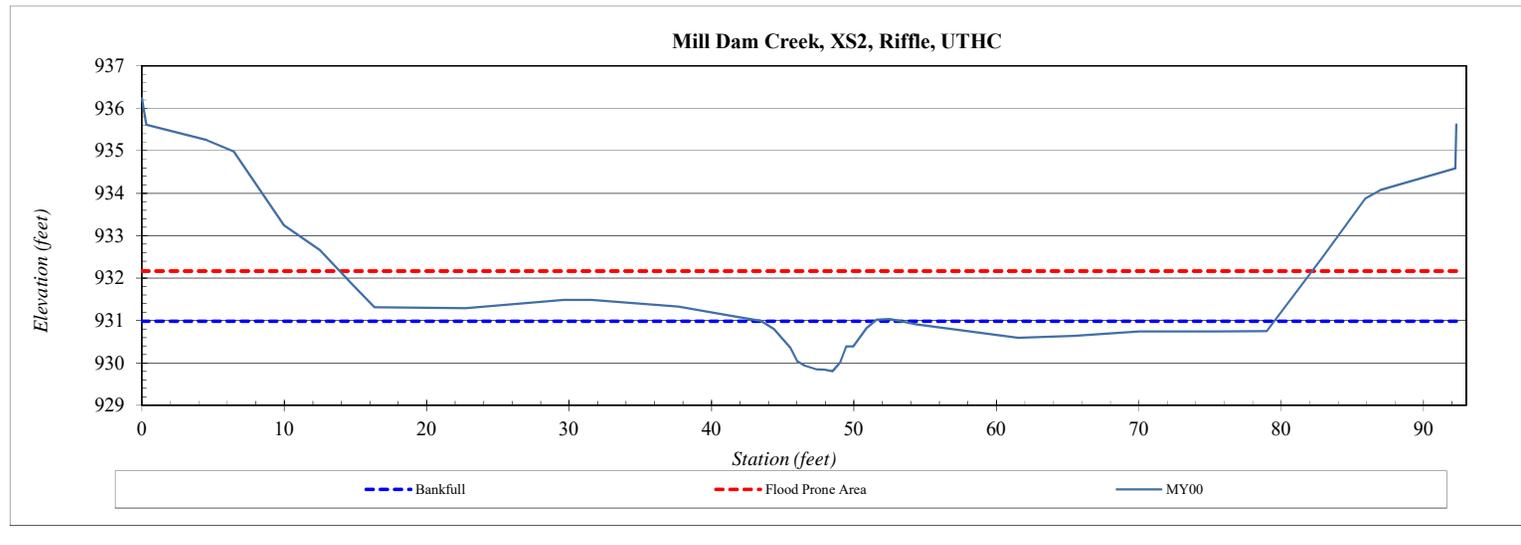
<b>River Basin:</b>	Yadkin River
<b>Site:</b>	Mill Dam Creek
<b>XS ID</b>	XS2
<b>Drainage Area (sq mi):</b>	0.18
<b>Date:</b>	1/29/2020
<b>Field Crew:</b>	TS, KB

SUMMARY DATA	
<b>Bankfull Elevation (ft) - Based on AB-Bankfull Area</b>	930.99
<b>Bankfull Cross-Sectional Area:</b>	5.3
<b>Total Cross-Sectional Area:</b>	5.3
<b>Bankfull Width:</b>	8.0
<b>Flood Prone Area Elevation:</b>	932.17
<b>Flood Prone Width:</b>	68.3
<b>Max Depth at Bankfull:</b>	1.2
<b>Mean Depth at Bankfull:</b>	0.7
<b>W / D Ratio:</b>	12.1
<b>Entrenchment Ratio:</b>	8.6
<b>Bank Height Ratio:</b>	1.0
<b>Thalweg Elevation:</b>	929.81

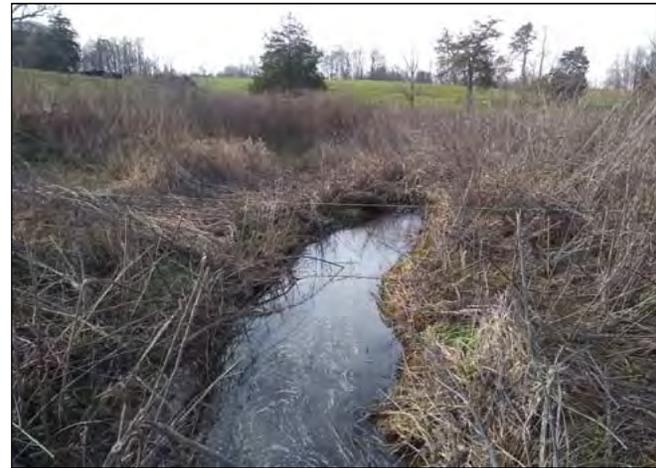
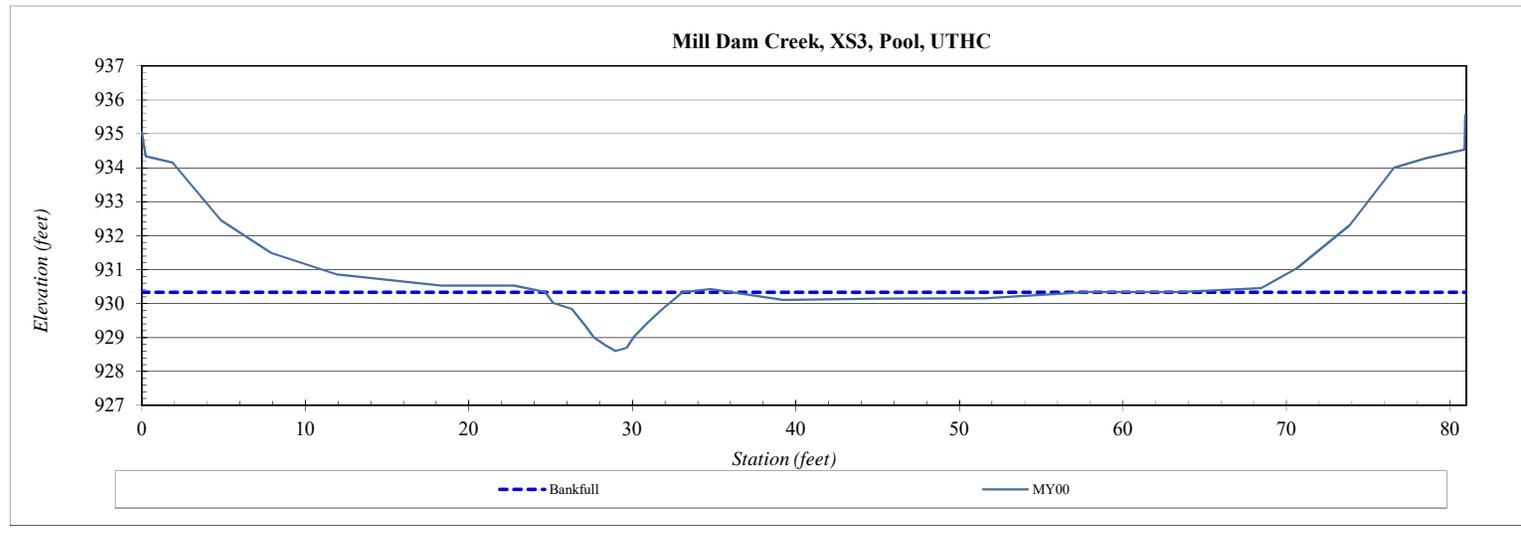
<b>River Basin:</b>	Yadkin River
<b>Site:</b>	Mill Dam Creek
<b>XS ID</b>	XS3
<b>Drainage Area (sq mi):</b>	0.18
<b>Date:</b>	1/29/2020
<b>Field Crew:</b>	TS, KB

SUMMARY DATA	
<b>Bankfull Elevation (ft) - Based on AB-Bankfull Area</b>	930.33
<b>Bankfull Cross-Sectional Area:</b>	7.4
<b>Total Cross-Sectional Area:</b>	7.4
<b>Bankfull Width:</b>	8.4
<b>Flood Prone Area Elevation:</b>	---
<b>Flood Prone Width:</b>	---
<b>Max Depth at Bankfull:</b>	1.7
<b>Mean Depth at Bankfull:</b>	0.9
<b>W / D Ratio:</b>	---
<b>Entrenchment Ratio:</b>	---
<b>Bank Height Ratio:</b>	---
<b>Thalweg Elevation:</b>	928.60

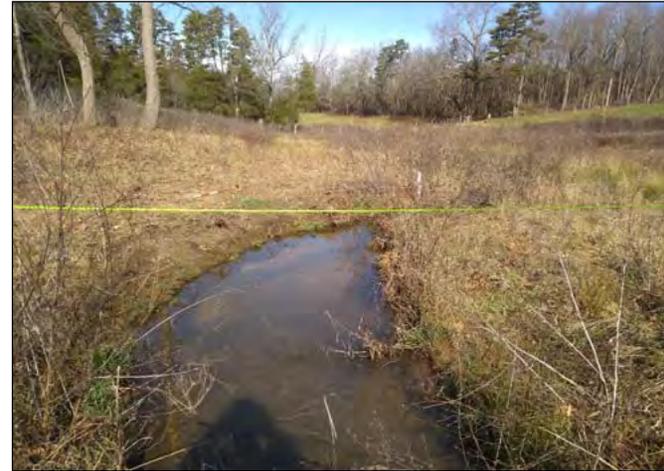
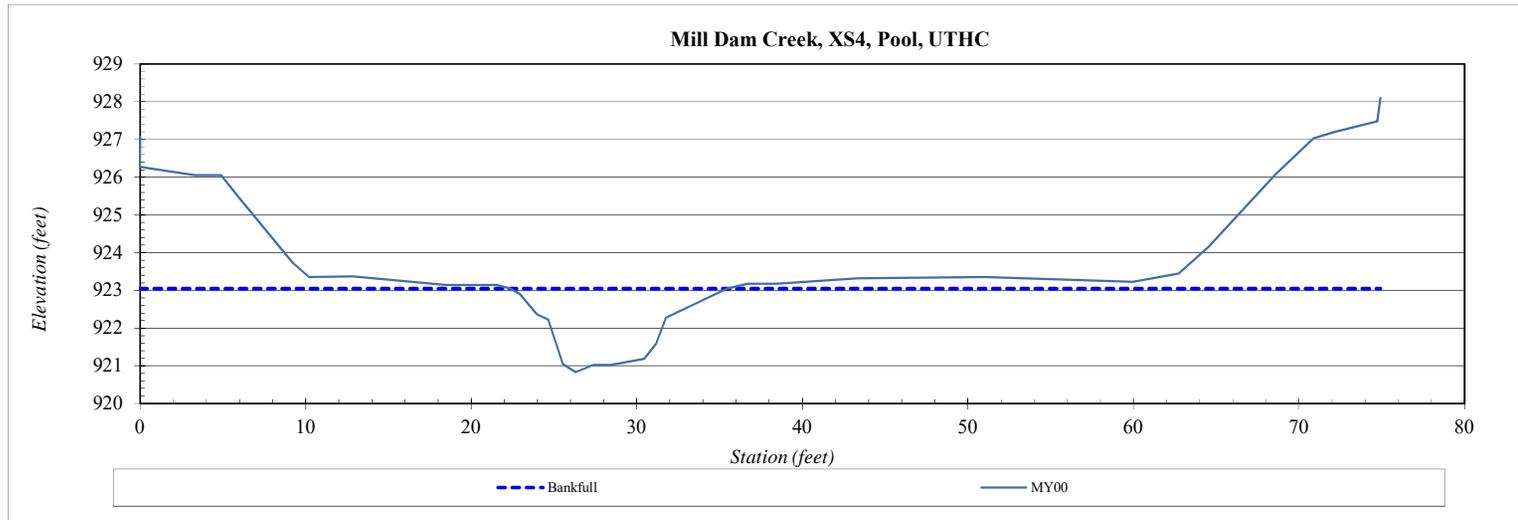
<b>River Basin:</b>	Yadkin River
<b>Site:</b>	Mill Dam Creek
<b>XS ID</b>	XS4
<b>Drainage Area (sq mi):</b>	0.18
<b>Date:</b>	1/17/2020
<b>Field Crew:</b>	TS, KB

SUMMARY DATA	
<b>Bankfull Elevation (ft) - Based on AB-Bankfull Area</b>	923.05
<b>Bankfull Cross-Sectional Area:</b>	15.4
<b>Total Cross-Sectional Area:</b>	15.4
<b>Bankfull Width:</b>	13.1
<b>Flood Prone Area Elevation:</b>	---
<b>Flood Prone Width:</b>	---
<b>Max Depth at Bankfull:</b>	2.2
<b>Mean Depth at Bankfull:</b>	1.2
<b>W / D Ratio:</b>	---
<b>Entrenchment Ratio:</b>	---
<b>Bank Height Ratio:</b>	---
<b>Thalweg Elevation:</b>	920.83

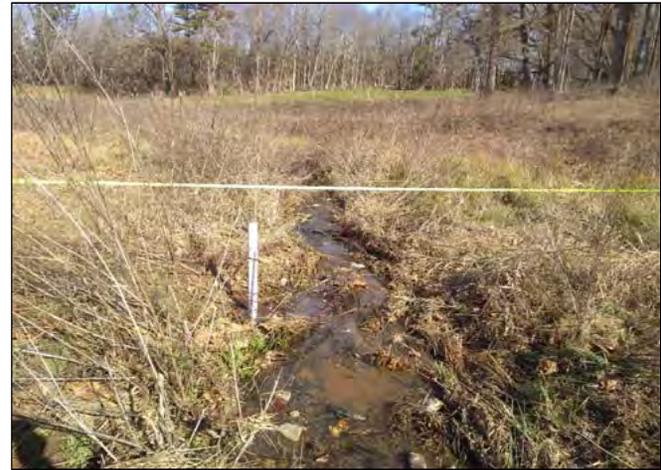
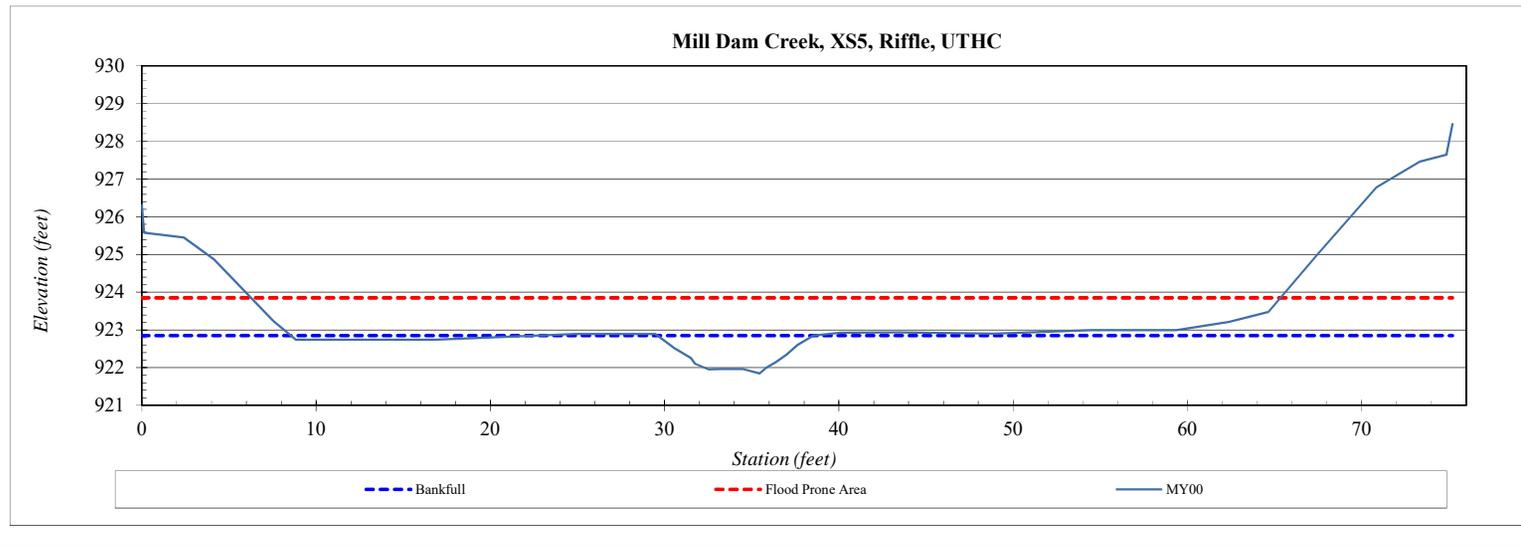
<b>River Basin:</b>	Yadkin River
<b>Site:</b>	Mill Dam Creek
<b>XS ID</b>	XS5
<b>Drainage Area (sq mi):</b>	0.18
<b>Date:</b>	1/17/2020
<b>Field Crew:</b>	TS, KB

SUMMARY DATA	
<b>Bankfull Elevation (ft) - Based on AB-Bankfull Area</b>	922.85
<b>Bankfull Cross-Sectional Area:</b>	5.5
<b>Total Cross-Sectional Area:</b>	5.5
<b>Bankfull Width:</b>	8.9
<b>Flood Prone Area Elevation:</b>	923.85
<b>Flood Prone Width:</b>	59.1
<b>Max Depth at Bankfull:</b>	1.0
<b>Mean Depth at Bankfull:</b>	0.6
<b>W / D Ratio:</b>	14.4
<b>Entrenchment Ratio:</b>	6.6
<b>Bank Height Ratio:</b>	1.0
<b>Thalweg Elevation:</b>	921.85

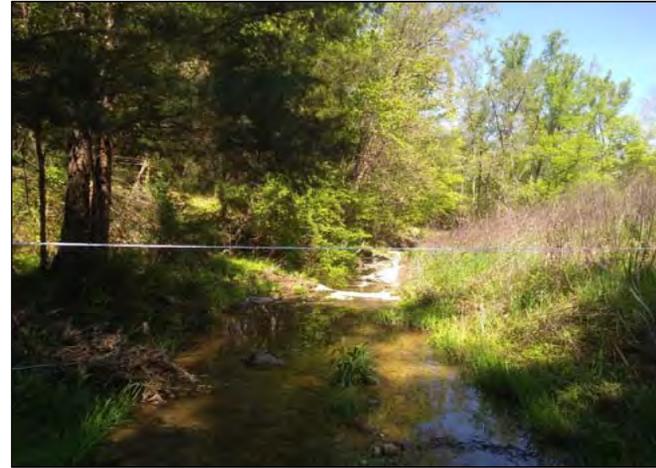
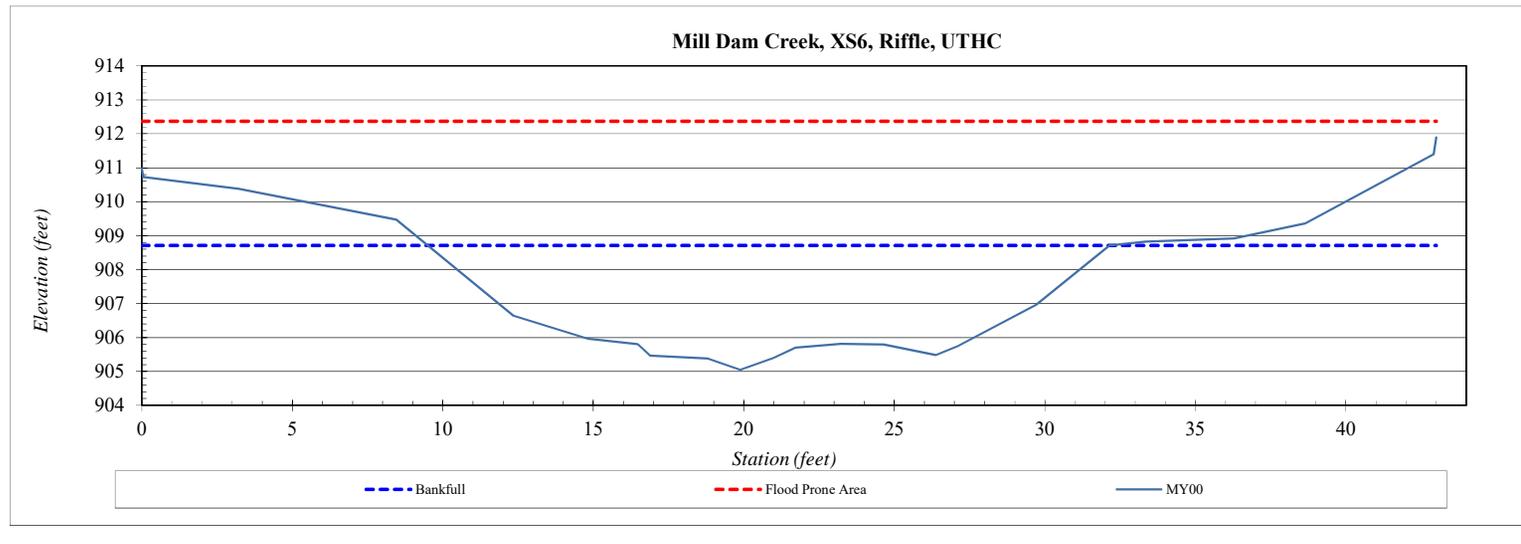
<b>River Basin:</b>	Yadkin River
<b>Site:</b>	Mill Dam Creek
<b>XS ID</b>	XS6
<b>Drainage Area (sq mi):</b>	0.22
<b>Date:</b>	4/15/2020
<b>Field Crew:</b>	TS, KB

SUMMARY DATA	
<b>Bankfull Elevation (ft) - Based on AB-Bankfull Area</b>	908.71
<b>Bankfull Cross-Sectional Area:</b>	55.5
<b>Total Cross-Sectional Area:</b>	55.5
<b>Bankfull Width:</b>	22.6
<b>Flood Prone Area Elevation:</b>	912.37
<b>Flood Prone Width:</b>	43.0
<b>Max Depth at Bankfull:</b>	3.7
<b>Mean Depth at Bankfull:</b>	2.5
<b>W / D Ratio:</b>	9.2
<b>Entrenchment Ratio:</b>	1.9
<b>Bank Height Ratio:</b>	1.0
<b>Thalweg Elevation:</b>	905.05

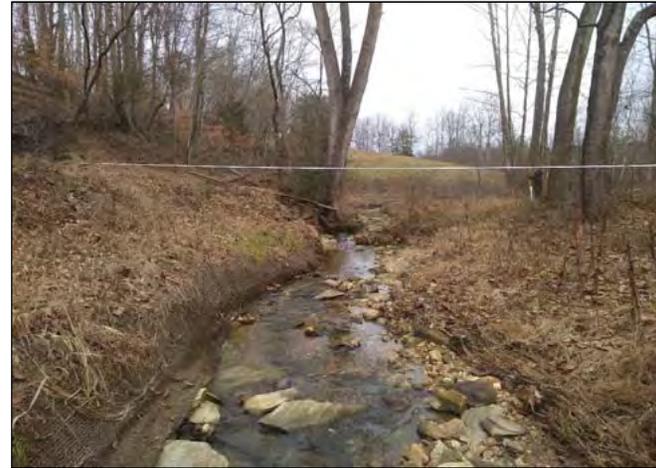
<b>River Basin:</b>	Yadkin River
<b>Site:</b>	Mill Dam Creek
<b>XS ID</b>	XS7
<b>Drainage Area (sq mi):</b>	0.22
<b>Date:</b>	1/30/2020
<b>Field Crew:</b>	TS, KB

SUMMARY DATA	
<b>Bankfull Elevation (ft) - Based on AB-Bankfull Area</b>	883.72
<b>Bankfull Cross-Sectional Area:</b>	16.7
<b>Total Cross-Sectional Area:</b>	16.7
<b>Bankfull Width:</b>	12.9
<b>Flood Prone Area Elevation:</b>	885.67
<b>Flood Prone Width:</b>	37.6
<b>Max Depth at Bankfull:</b>	2.0
<b>Mean Depth at Bankfull:</b>	1.3
<b>W / D Ratio:</b>	9.9
<b>Entrenchment Ratio:</b>	2.9
<b>Bank Height Ratio:</b>	1.0
<b>Thalweg Elevation:</b>	881.77

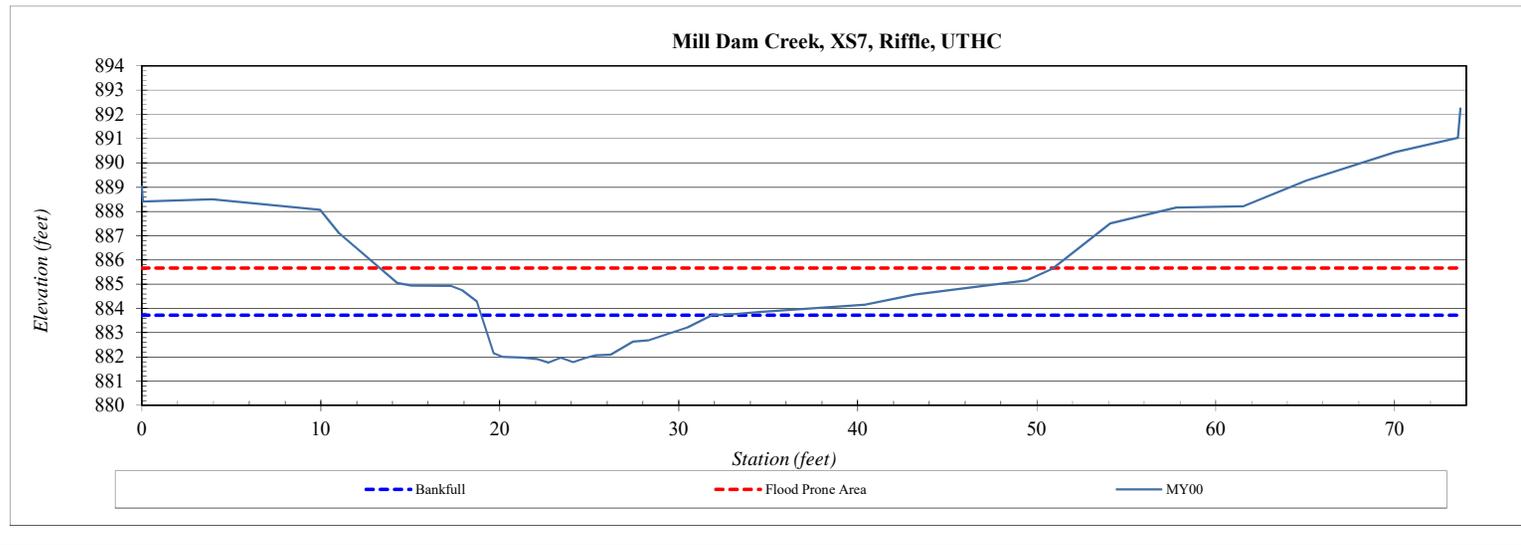
Station	Elevation
0.0	889.02
0.1	888.41
3.9	888.50
10.0	888.07
11.0	887.10
14.3	885.05
15.1	884.94
17.3	884.92
17.9	884.75
18.7	884.29
19.7	882.15
20.2	882.00
21.3	881.97
22.1	881.90
22.7	881.77
23.4	881.97
24.1	881.78
24.8	881.96
25.4	882.06
26.2	882.08
27.4	882.63
28.3	882.67
30.5	883.22
31.8	883.72
33.0	883.76
34.5	883.85
40.4	884.15
43.2	884.56
49.4	885.15
50.9	885.64
54.1	887.49
57.8	888.16
61.5	888.21
65.1	889.27
70.0	890.44
73.5	891.03

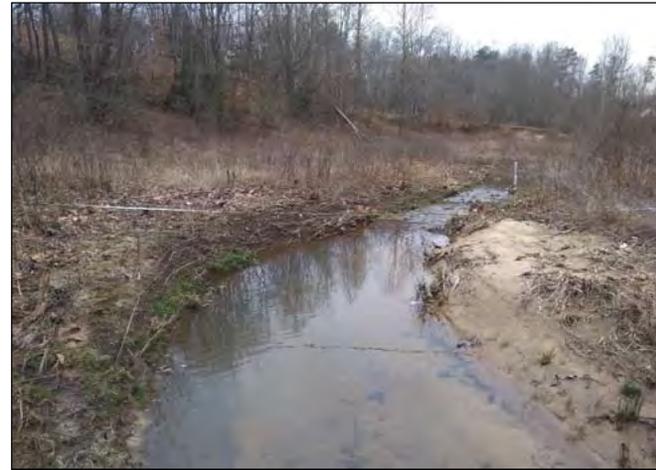
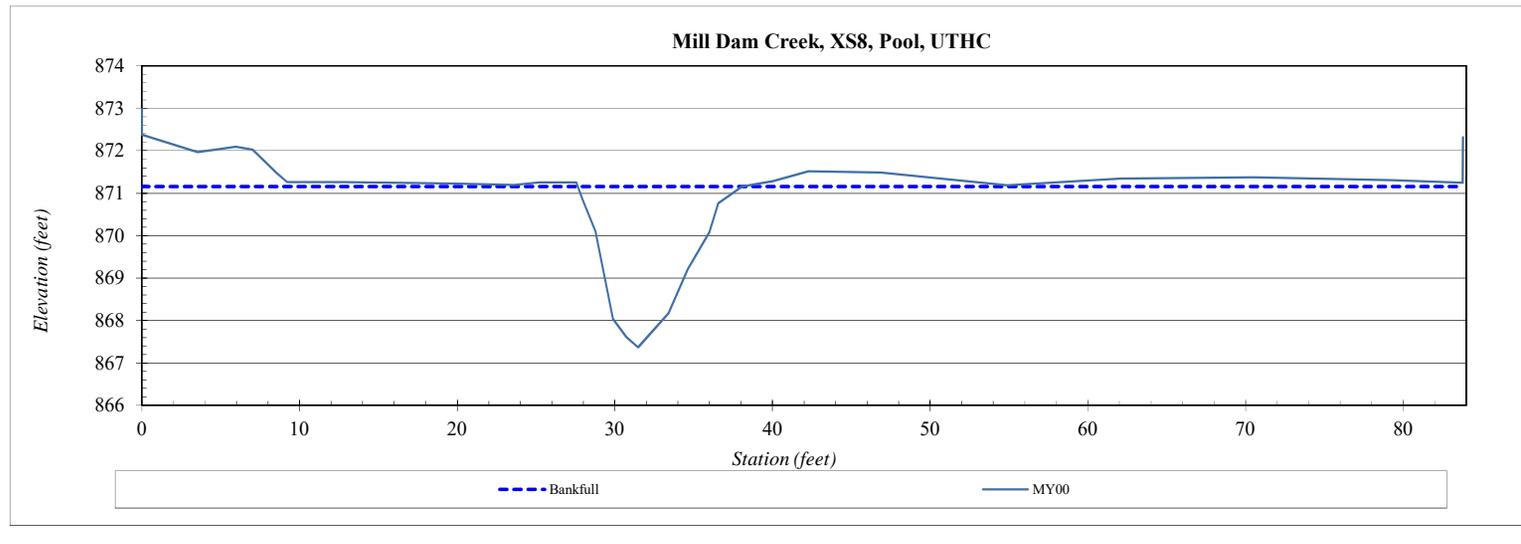
<b>River Basin:</b>	Yadkin River
<b>Site:</b>	Mill Dam Creek
<b>XS ID</b>	XS8
<b>Drainage Area (sq mi):</b>	1.07
<b>Date:</b>	1/30/2020
<b>Field Crew:</b>	TS, KB

Station	Elevation
0.0	872.99
0.0	872.38
3.5	871.97
6.0	872.10
7.0	872.03
8.5	871.48
9.2	871.26
12.6	871.26
17.4	871.24
20.1	871.22
23.6	871.19
25.2	871.25
27.6	871.26
28.0	870.83
28.8	870.11
29.9	868.04
30.7	867.62
31.5	867.37
33.4	868.17
34.6	869.21
36.0	870.08
36.6	870.77
38.0	871.16
40.0	871.28
42.3	871.52
46.9	871.48
54.9	871.19
62.1	871.35
70.6	871.37
79.3	871.30
83.8	871.24
83.8	872.32

SUMMARY DATA	
<b>Bankfull Elevation (ft) - Based on AB-Bankfull Area</b>	871.16
<b>Bankfull Cross-Sectional Area:</b>	20.8
<b>Total Cross-Sectional Area:</b>	20.8
<b>Bankfull Width:</b>	10.4
<b>Flood Prone Area Elevation:</b>	---
<b>Flood Prone Width:</b>	---
<b>Max Depth at Bankfull:</b>	3.8
<b>Mean Depth at Bankfull:</b>	2.0
<b>W / D Ratio:</b>	---
<b>Entrenchment Ratio:</b>	---
<b>Bank Height Ratio:</b>	---
<b>Thalweg Elevation:</b>	867.37

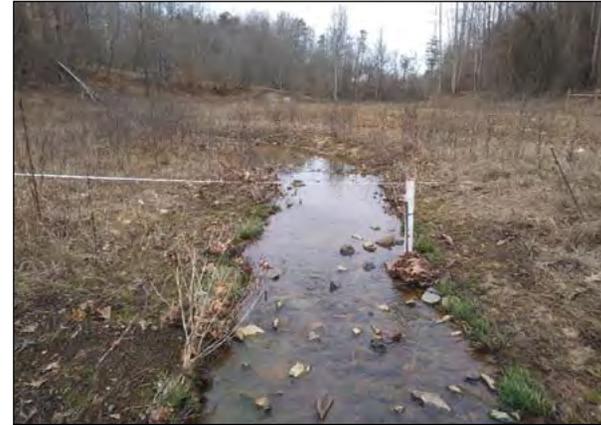
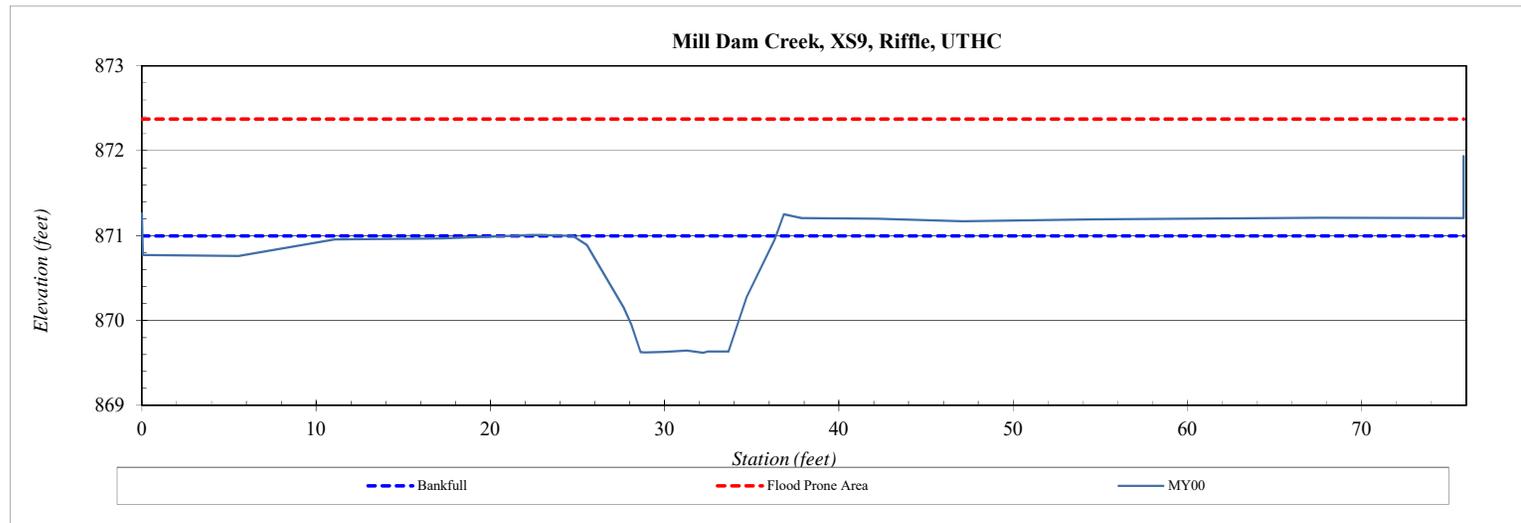
<b>River Basin:</b>	Yadkin River
<b>Site:</b>	Mill Dam Creek
<b>XS ID</b>	XS9
<b>Drainage Area (sq mi):</b>	0.46
<b>Date:</b>	1/30/2020
<b>Field Crew:</b>	TS, KB

Station	Elevation
0.0	871.26
0.1	870.77
5.6	870.76
11.1	870.96
17.2	870.97
22.6	871.01
24.8	871.00
25.5	870.89
27.7	870.15
28.1	869.95
28.6	869.63
28.9	869.62
29.5	869.63
30.1	869.63
31.3	869.65
32.2	869.62
32.5	869.63
33.7	869.63
34.7	870.28
36.3	870.95
36.8	871.25
37.9	871.20
42.2	871.20
47.1	871.17
54.7	871.19
62.5	871.20
67.6	871.21
75.8	871.21
75.8	871.94

SUMMARY DATA	
<b>Bankfull Elevation (ft) - Based on AB-Bankfull Area</b>	871.00
<b>Bankfull Cross-Sectional Area:</b>	10.6
<b>Total Cross-Sectional Area:</b>	10.6
<b>Bankfull Width:</b>	10.9
<b>Flood Prone Area Elevation:</b>	872.37
<b>Flood Prone Width:</b>	75.8
<b>Max Depth at Bankfull:</b>	1.4
<b>Mean Depth at Bankfull:</b>	1.0
<b>W / D Ratio:</b>	11.1
<b>Entrenchment Ratio:</b>	7.0
<b>Bank Height Ratio:</b>	1.0
<b>Thalweg Elevation:</b>	869.62

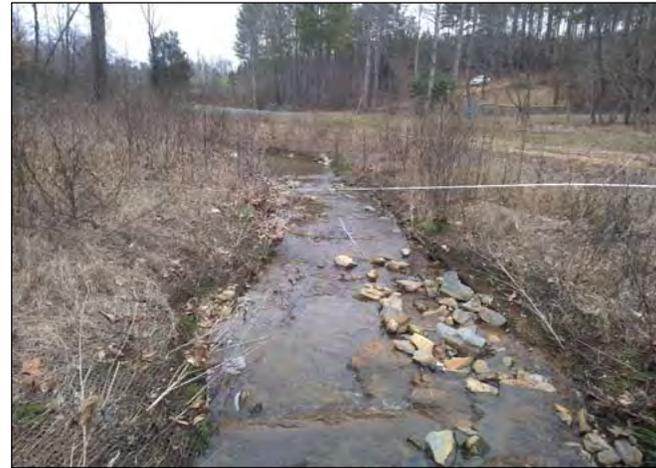
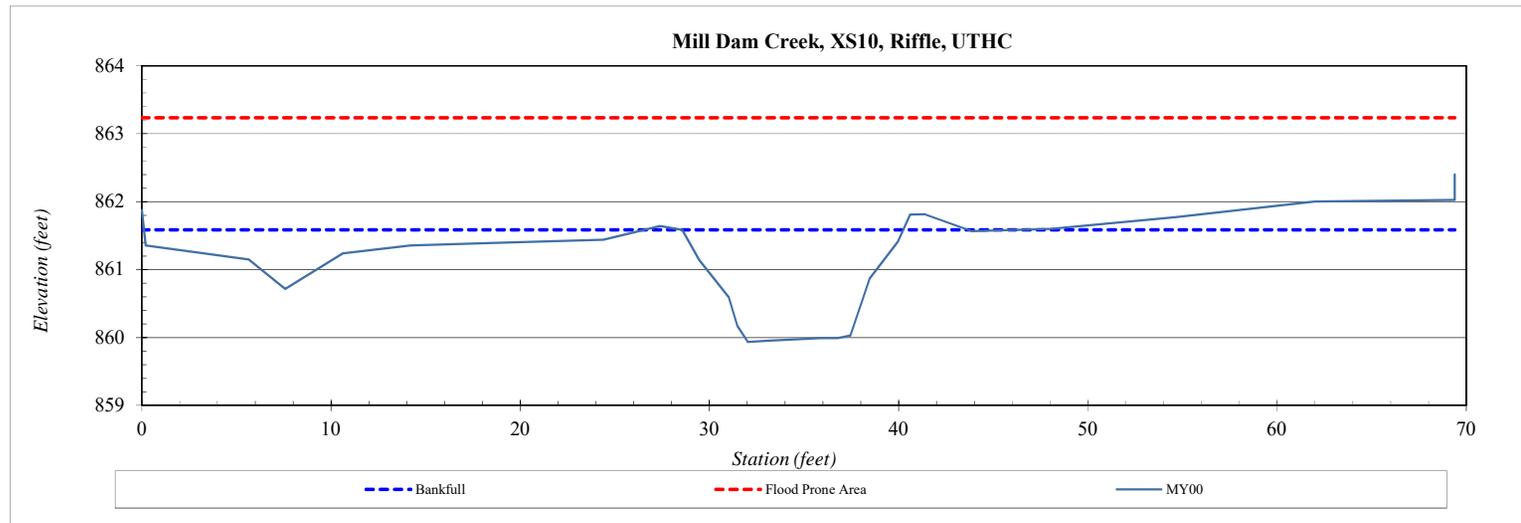
<b>River Basin:</b>	Yadkin River
<b>Site:</b>	Mill Dam Creek
<b>XS ID</b>	XS10
<b>Drainage Area (sq mi):</b>	0.46
<b>Date:</b>	1/30/2020
<b>Field Crew:</b>	TS, KB

Station	Elevation
0.0	861.88
0.2	861.35
5.7	861.15
7.6	860.72
10.6	861.24
14.2	861.35
18.6	861.39
24.4	861.44
27.4	861.64
28.6	861.59
29.5	861.14
31.0	860.59
31.5	860.17
32.0	859.93
33.1	859.95
34.5	859.97
35.8	859.99
36.8	859.99
37.5	860.02
38.5	860.87
40.0	861.41
40.6	861.81
41.4	861.81
43.9	861.57
48.0	861.60
54.7	861.77
62.0	862.00
69.4	862.03
69.4	862.40

SUMMARY DATA	
<b>Bankfull Elevation (ft) - Based on AB-Bankfull Area</b>	861.59
<b>Bankfull Cross-Sectional Area:</b>	13.3
<b>Total Cross-Sectional Area:</b>	13.3
<b>Bankfull Width:</b>	11.7
<b>Flood Prone Area Elevation:</b>	863.24
<b>Flood Prone Width:</b>	69.4
<b>Max Depth at Bankfull:</b>	1.7
<b>Mean Depth at Bankfull:</b>	1.1
<b>W / D Ratio:</b>	10.2
<b>Entrenchment Ratio:</b>	5.9
<b>Bank Height Ratio:</b>	1.0
<b>Thalweg Elevation:</b>	859.93

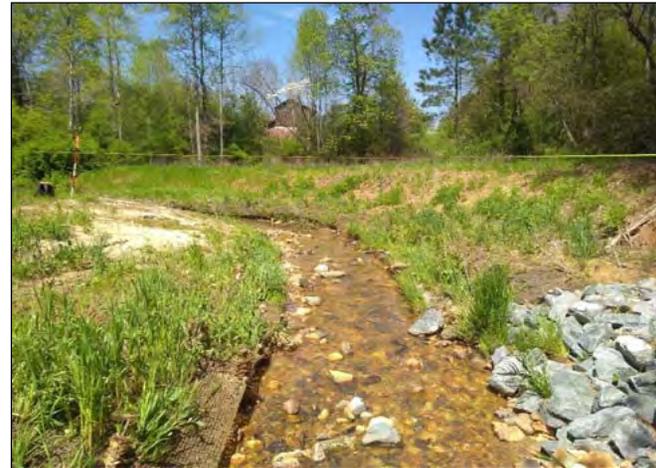
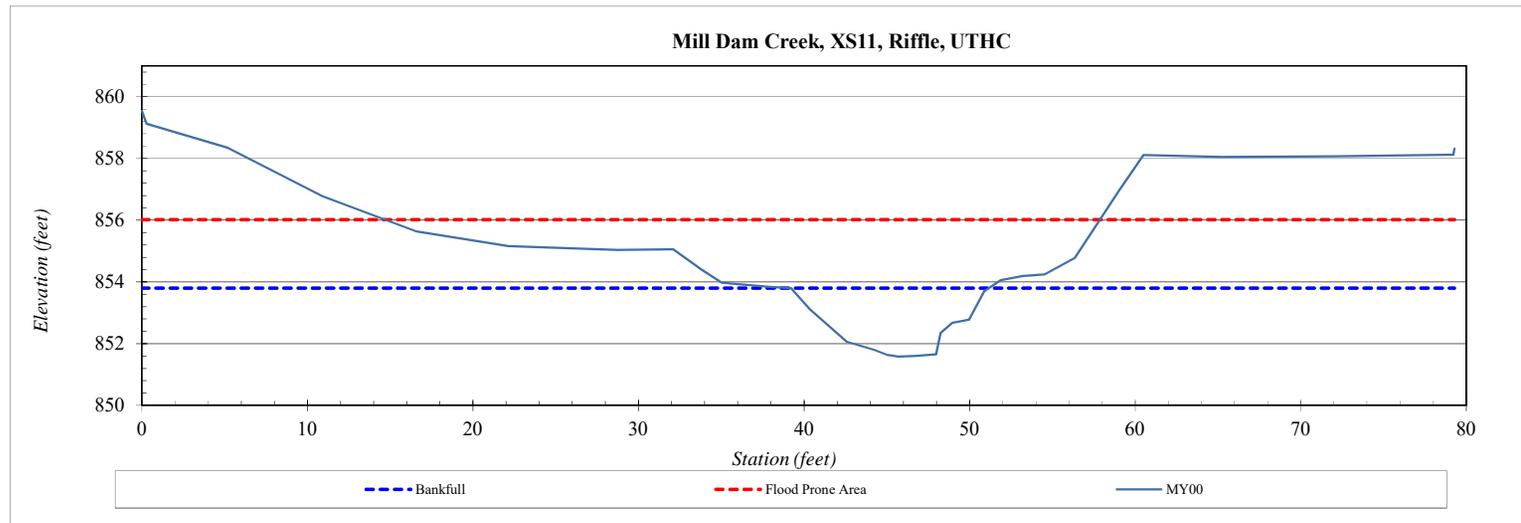
<b>River Basin:</b>	Yadkin River
<b>Site:</b>	Mill Dam Creek
<b>XS ID</b>	XS11
<b>Drainage Area (sq mi):</b>	0.46
<b>Date:</b>	4/15/2020
<b>Field Crew:</b>	TS, KB

Station	Elevation
0.0	859.54
0.3	859.12
5.2	858.34
10.9	856.77
16.6	855.63
22.1	855.16
28.7	855.03
32.1	855.06
33.8	854.40
35.1	853.97
37.9	853.84
39.2	853.80
40.4	853.11
42.6	852.06
43.2	851.97
44.2	851.80
45.1	851.63
45.7	851.58
46.7	851.59
48.0	851.65
48.2	852.34
49.0	852.67
50.0	852.77
50.9	853.70
51.9	854.05
53.2	854.18
54.5	854.24
56.4	854.79
59.0	856.96
60.5	858.11
65.2	858.05
72.0	858.07
79.2	858.12
79.3	858.32

SUMMARY DATA	
<b>Bankfull Elevation (ft) - Based on AB-Bankfull Area</b>	853.80
<b>Bankfull Cross-Sectional Area:</b>	17.3
<b>Total Cross-Sectional Area:</b>	17.3
<b>Bankfull Width:</b>	11.9
<b>Flood Prone Area Elevation:</b>	856.02
<b>Flood Prone Width:</b>	43.2
<b>Max Depth at Bankfull:</b>	2.2
<b>Mean Depth at Bankfull:</b>	1.4
<b>W / D Ratio:</b>	8.2
<b>Entrenchment Ratio:</b>	3.6
<b>Bank Height Ratio:</b>	1.1
<b>Thalweg Elevation:</b>	851.58

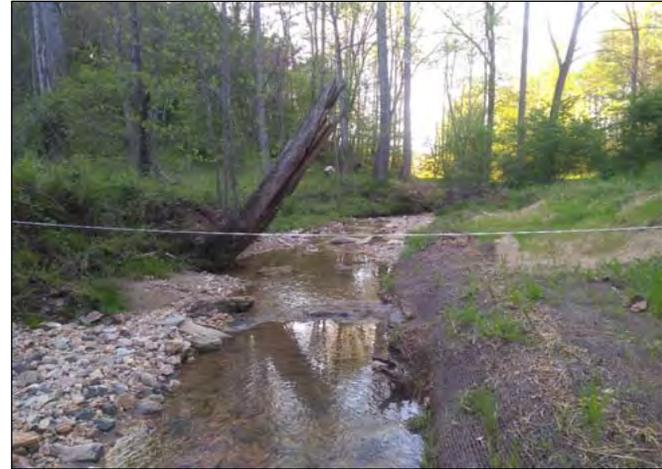
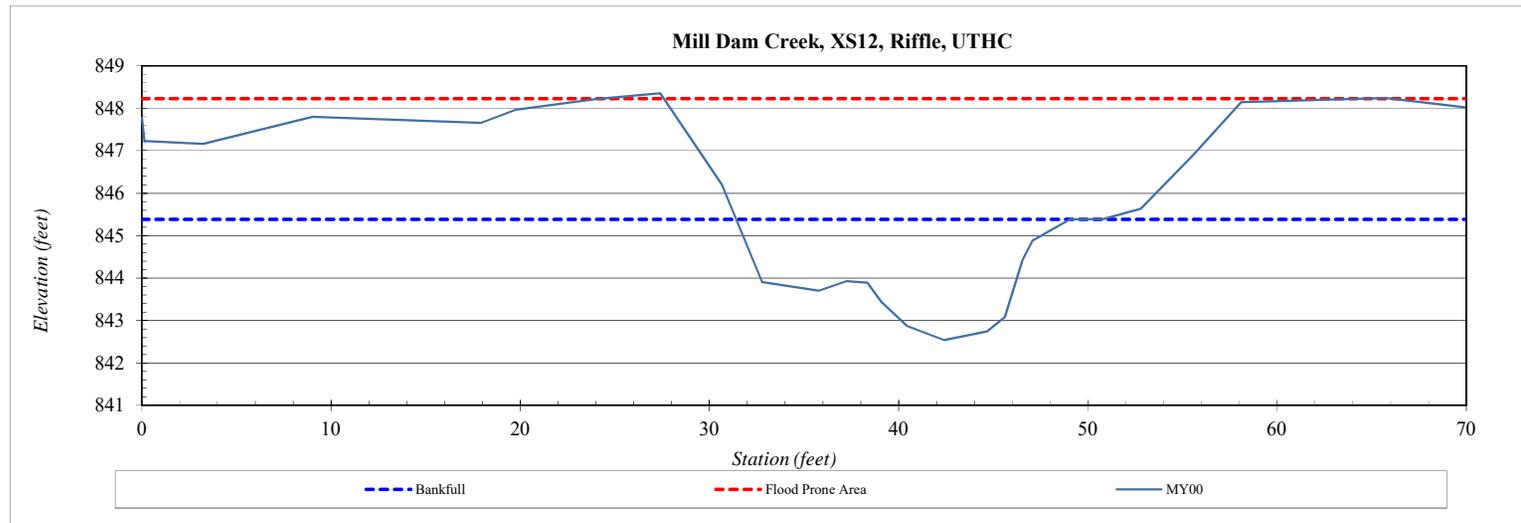
<b>River Basin:</b>	Yadkin River
<b>Site:</b>	Mill Dam Creek
<b>XS ID</b>	XS12
<b>Drainage Area (sq mi):</b>	0.61
<b>Date:</b>	4/15/2020
<b>Field Crew:</b>	TS, KB

Station	Elevation
0.0	847.79
0.1	847.23
3.2	847.16
9.0	847.80
17.9	847.66
19.7	847.97
24.0	848.22
27.4	848.35
30.6	846.21
32.8	843.91
35.8	843.70
37.2	843.93
38.4	843.89
39.1	843.41
40.4	842.87
42.4	842.54
44.7	842.74
45.6	843.08
46.5	844.40
47.1	844.89
49.0	845.38
50.8	845.39
52.8	845.63
55.6	846.91
58.1	848.14
65.7	848.24
69.9	848.02

SUMMARY DATA	
<b>Bankfull Elevation (ft) - Based on AB-Bankfull Area</b>	845.38
<b>Bankfull Cross-Sectional Area:</b>	30.2
<b>Total Cross-Sectional Area:</b>	30.2
<b>Bankfull Width:</b>	17.6
<b>Flood Prone Area Elevation:</b>	848.23
<b>Flood Prone Width:</b>	30.7
<b>Max Depth at Bankfull:</b>	2.8
<b>Mean Depth at Bankfull:</b>	1.7
<b>W / D Ratio:</b>	10.3
<b>Entrenchment Ratio:</b>	1.7
<b>Bank Height Ratio:</b>	3.2
<b>Thalweg Elevation:</b>	842.54

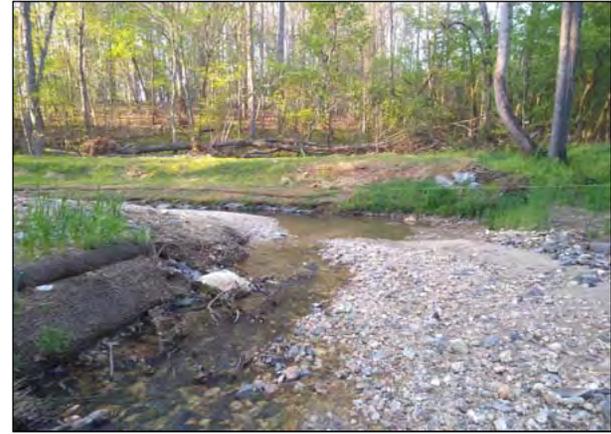
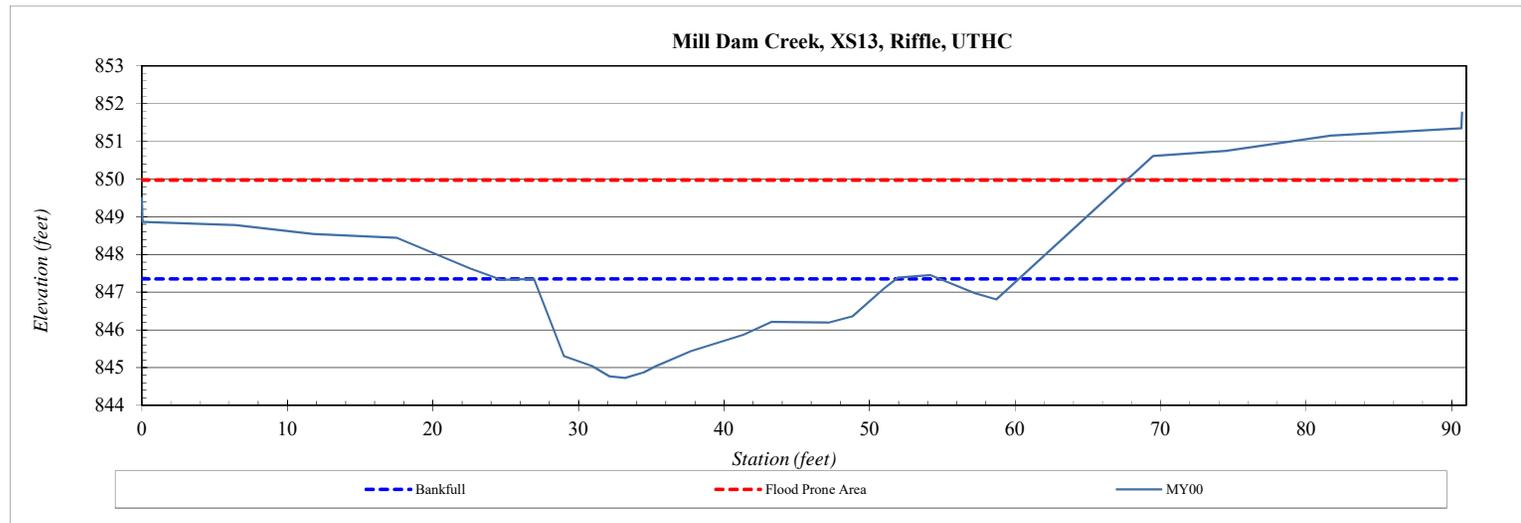
<b>River Basin:</b>	Yadkin River
<b>Site:</b>	Mill Dam Creek
<b>XS ID</b>	XS13
<b>Drainage Area (sq mi):</b>	0.04
<b>Date:</b>	4/15/2020
<b>Field Crew:</b>	TS, KB

Station	Elevation
0.0	849.49
0.0	848.86
6.4	848.78
11.8	848.54
17.6	848.44
22.6	847.63
24.7	847.33
26.9	847.35
29.0	845.31
30.9	845.05
32.2	844.77
33.2	844.73
34.5	844.88
35.3	845.04
37.7	845.45
41.3	845.88
43.2	846.21
47.2	846.20
48.8	846.36
51.0	847.09
51.9	847.39
54.2	847.45
57.2	846.98
58.7	846.81
69.5	850.61
74.5	850.74
81.7	851.15
90.7	851.34
90.7	851.76

SUMMARY DATA	
<b>Bankfull Elevation (ft) - Based on AB-Bankfull Area</b>	847.35
<b>Bankfull Cross-Sectional Area:</b>	38.7
<b>Total Cross-Sectional Area:</b>	38.7
<b>Bankfull Width:</b>	24.9
<b>Flood Prone Area Elevation:</b>	849.98
<b>Flood Prone Width:</b>	67.7
<b>Max Depth at Bankfull:</b>	2.6
<b>Mean Depth at Bankfull:</b>	1.6
<b>W / D Ratio:</b>	16.0
<b>Entrenchment Ratio:</b>	2.7
<b>Bank Height Ratio:</b>	1.0
<b>Thalweg Elevation:</b>	844.73

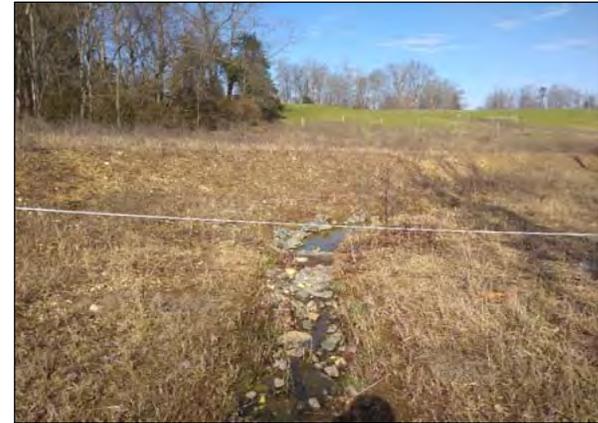
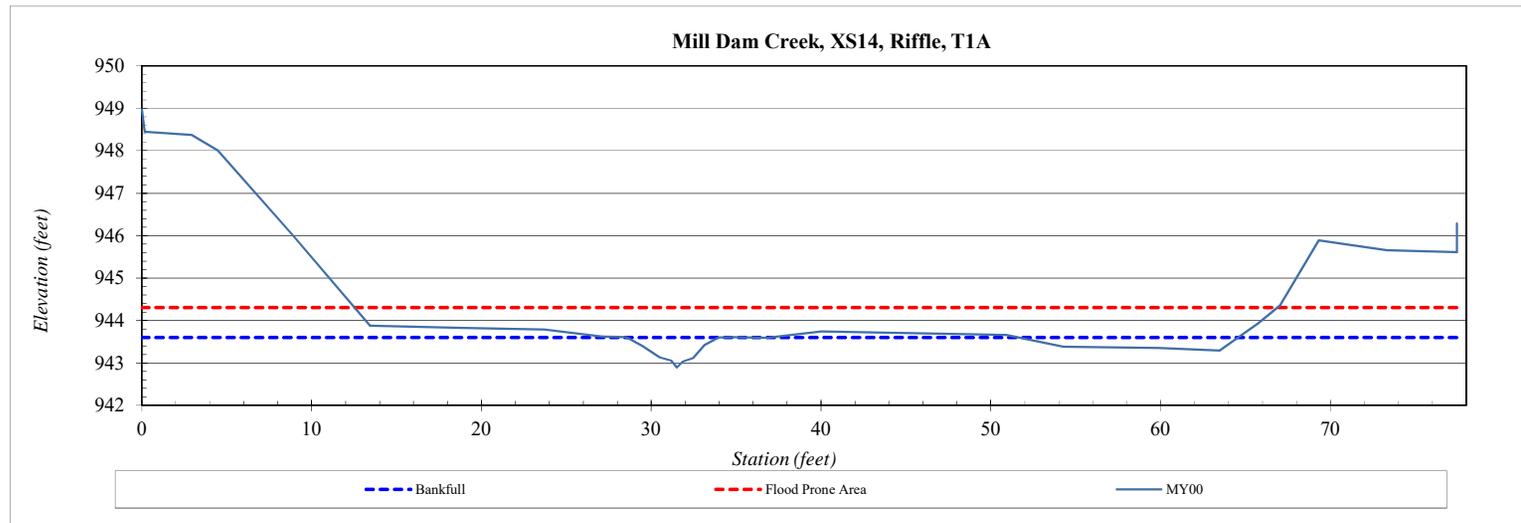
<b>River Basin:</b>	Yadkin River
<b>Site:</b>	Mill Dam Creek
<b>XS ID</b>	XS14
<b>Drainage Area (sq mi):</b>	0.04
<b>Date:</b>	1/29/2020
<b>Field Crew:</b>	TS, KB

Station	Elevation
0.0	948.98
0.2	948.44
2.9	948.37
4.5	948.01
8.9	946.01
13.5	943.87
19.0	943.83
23.7	943.78
27.1	943.62
28.6	943.60
29.5	943.39
30.5	943.13
31.2	943.06
31.5	942.89
31.9	943.04
32.5	943.12
33.1	943.43
33.9	943.60
34.8	943.60
36.8	943.59
40.0	943.74
43.9	943.71
50.9	943.66
54.3	943.38
57.1	943.37
59.9	943.35
63.5	943.29
65.8	943.94
67.1	944.36
69.3	945.88
73.3	945.65
77.5	945.61
77.5	946.29

SUMMARY DATA	
<b>Bankfull Elevation (ft) - Based on AB-Bankfull Area</b>	943.60
<b>Bankfull Cross-Sectional Area:</b>	1.8
<b>Total Cross-Sectional Area:</b>	1.8
<b>Bankfull Width:</b>	5.4
<b>Flood Prone Area Elevation:</b>	944.31
<b>Flood Prone Width:</b>	54.4
<b>Max Depth at Bankfull:</b>	0.7
<b>Mean Depth at Bankfull:</b>	0.3
<b>W / D Ratio:</b>	15.9
<b>Entrenchment Ratio:</b>	10.1
<b>Bank Height Ratio:</b>	1.0
<b>Thalweg Elevation:</b>	942.89

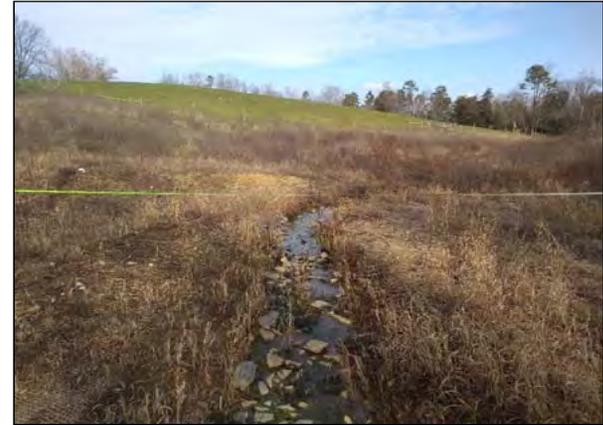
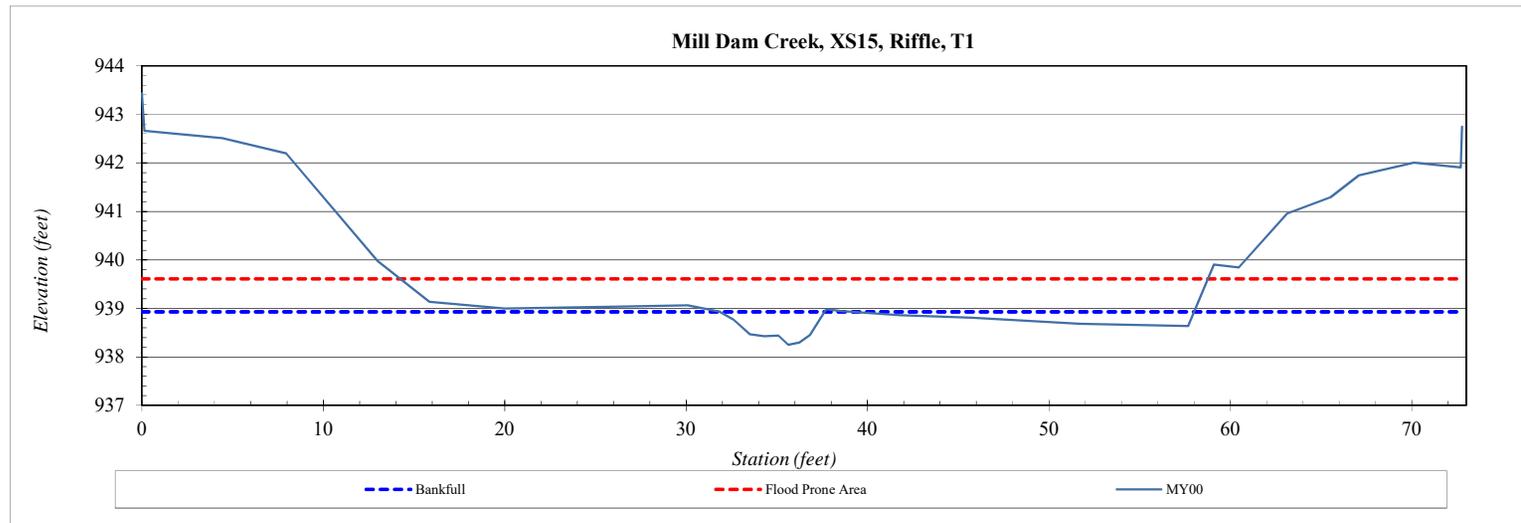
<b>River Basin:</b>	Yadkin River
<b>Site:</b>	Mill Dam Creek
<b>XS ID</b>	XS15
<b>Drainage Area (sq mi):</b>	0.07
<b>Date:</b>	1/29/2020
<b>Field Crew:</b>	TS, KB

Station	Elevation
0.0	943.44
0.2	942.66
4.4	942.51
8.0	942.20
13.0	939.98
15.9	939.14
20.0	938.99
26.3	939.04
30.1	939.06
31.9	938.93
32.6	938.77
33.5	938.47
34.3	938.43
35.1	938.43
35.6	938.25
36.2	938.29
36.8	938.45
37.7	938.99
38.5	938.94
41.8	938.86
45.8	938.80
51.7	938.68
57.7	938.63
59.1	939.90
60.4	939.84
63.1	940.96
65.5	941.29
67.1	941.74
70.1	942.00
72.7	941.90
72.8	942.74

SUMMARY DATA	
<b>Bankfull Elevation (ft) - Based on AB-Bankfull Area</b>	938.93
<b>Bankfull Cross-Sectional Area:</b>	2.3
<b>Total Cross-Sectional Area:</b>	2.3
<b>Bankfull Width:</b>	5.8
<b>Flood Prone Area Elevation:</b>	939.61
<b>Flood Prone Width:</b>	44.5
<b>Max Depth at Bankfull:</b>	0.7
<b>Mean Depth at Bankfull:</b>	0.4
<b>W / D Ratio:</b>	14.1
<b>Entrenchment Ratio:</b>	7.7
<b>Bank Height Ratio:</b>	1.0
<b>Thalweg Elevation:</b>	938.25
