# **As-built Baseline Monitoring Report**

**Mill Dam Creek Restoration Site  
Yadkin River Basin - 03040101  
Monitoring Year 00  
DEQ Contract 6898  
DMS Project Number 97136**

**DWR #: 18-1349  
USACE Action ID: 2016-01335  
Yadkin County, North Carolina**

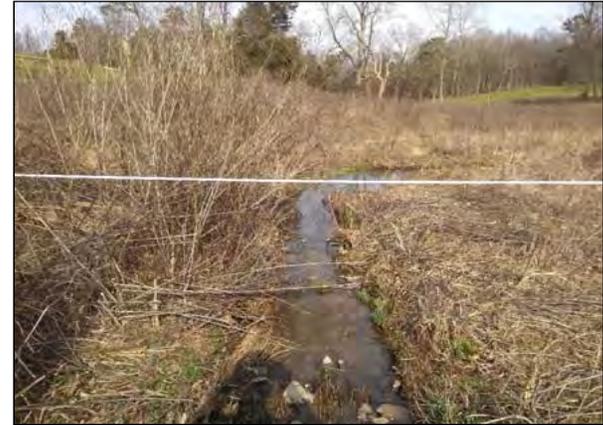
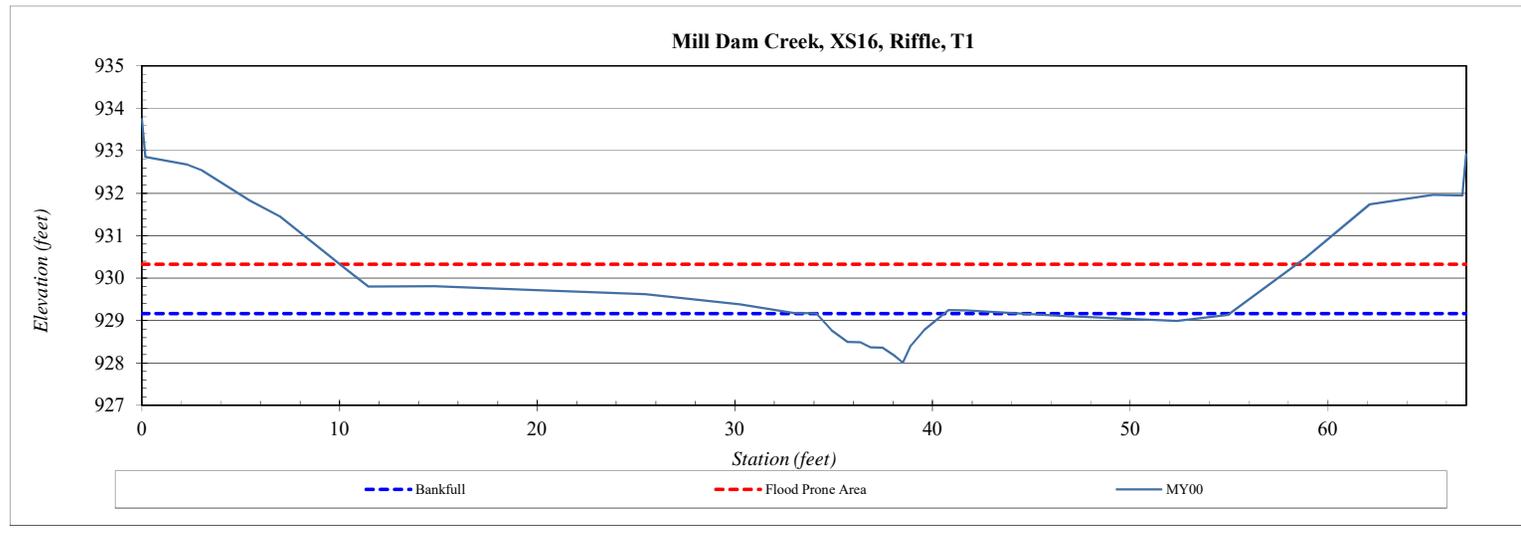
<b>River Basin:</b>	Yadkin River
<b>Site:</b>	Mill Dam Creek
<b>XS ID</b>	XS16
<b>Drainage Area (sq mi):</b>	0.07
<b>Date:</b>	1/29/2020
<b>Field Crew:</b>	TS, KB

Station	Elevation
0.0	933.74
0.2	932.86
2.3	932.67
3.0	932.54
5.4	931.84
7.0	931.46
10.4	930.19
11.5	929.80
14.8	929.80
19.4	929.73
25.5	929.62
30.3	929.38
33.0	929.17
34.1	929.17
34.9	928.77
35.7	928.49
36.4	928.48
36.9	928.36
37.5	928.36
38.1	928.18
38.5	928.01
38.9	928.41
39.6	928.77
40.8	929.24
41.7	929.23
46.5	929.11
52.4	928.99
54.9	929.13
58.9	930.48
62.1	931.73
65.3	931.96
66.8	931.95
67.0	932.92

SUMMARY DATA	
<b>Bankfull Elevation (ft) - Based on AB-Bankfull Area</b>	929.17
<b>Bankfull Cross-Sectional Area:</b>	3.9
<b>Total Cross-Sectional Area:</b>	3.9
<b>Bankfull Width:</b>	6.5
<b>Flood Prone Area Elevation:</b>	930.33
<b>Flood Prone Width:</b>	48.4
<b>Max Depth at Bankfull:</b>	1.2
<b>Mean Depth at Bankfull:</b>	0.6
<b>W / D Ratio:</b>	10.9
<b>Entrenchment Ratio:</b>	7.5
<b>Bank Height Ratio:</b>	1.0
<b>Thalweg Elevation:</b>	928.01

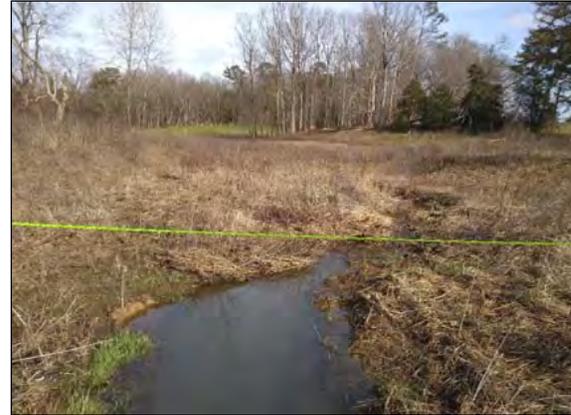
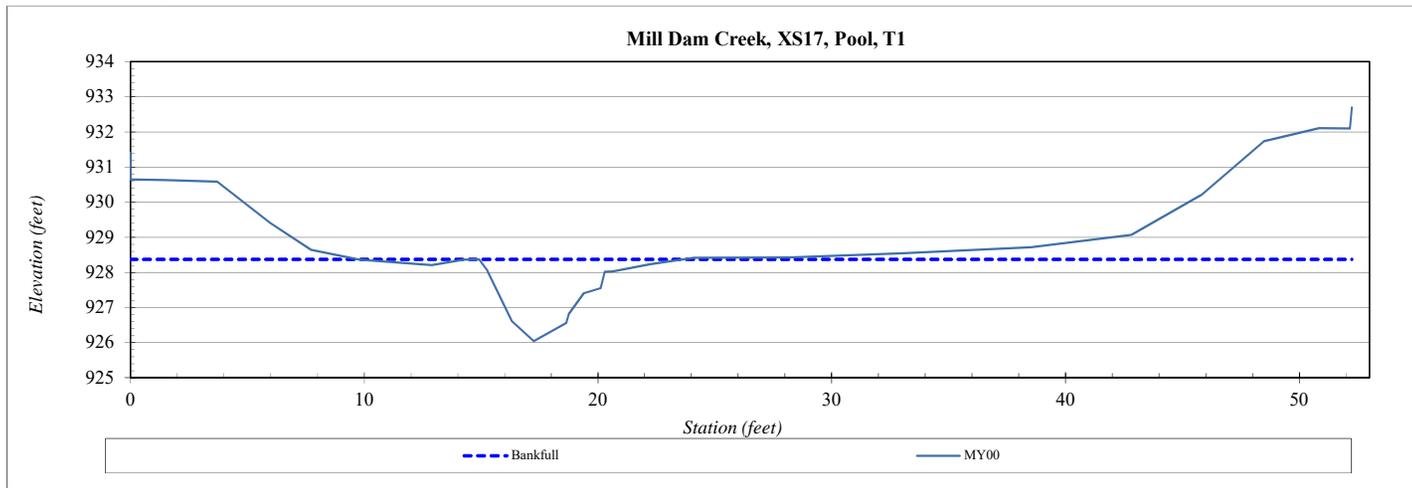
<b>River Basin:</b>	Yadkin River
<b>Site:</b>	Mill Dam Creek
<b>XS ID</b>	XS17
<b>Drainage Area (sq mi):</b>	0.07
<b>Date:</b>	1/29/2020
<b>Field Crew:</b>	TS, KB

Station	Elevation
0.0	931.41
0.0	930.64
1.5	930.63
3.7	930.58
6.0	929.40
7.7	928.64
9.8	928.36
12.9	928.21
14.2	928.36
14.9	928.37
15.3	928.05
16.3	926.62
17.3	926.04
18.6	926.55
18.8	926.81
19.4	927.40
20.1	927.54
20.3	928.02
20.6	928.02
22.2	928.23
24.1	928.42
28.2	928.42
33.0	928.55
38.5	928.72
42.8	929.07
45.8	930.20
48.5	931.73
50.9	932.11
52.2	932.10
52.2	932.70

SUMMARY DATA	
<b>Bankfull Elevation (ft) - Based on AB-Bankfull Area</b>	928.37
<b>Bankfull Cross-Sectional Area:</b>	8.3
<b>Total Cross-Sectional Area:</b>	8.3
<b>Bankfull Width:</b>	8.7
<b>Flood Prone Area Elevation:</b>	---
<b>Flood Prone Width:</b>	---
<b>Max Depth at Bankfull:</b>	2.3
<b>Mean Depth at Bankfull:</b>	1.0
<b>W / D Ratio:</b>	---
<b>Entrenchment Ratio:</b>	---
<b>Bank Height Ratio:</b>	---
<b>Thalweg Elevation:</b>	926.04

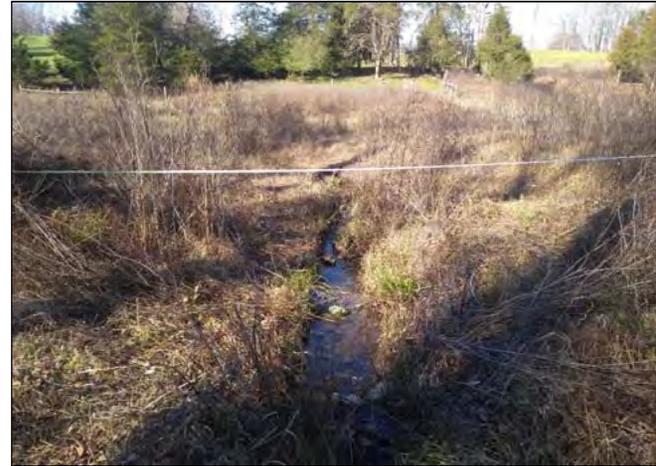
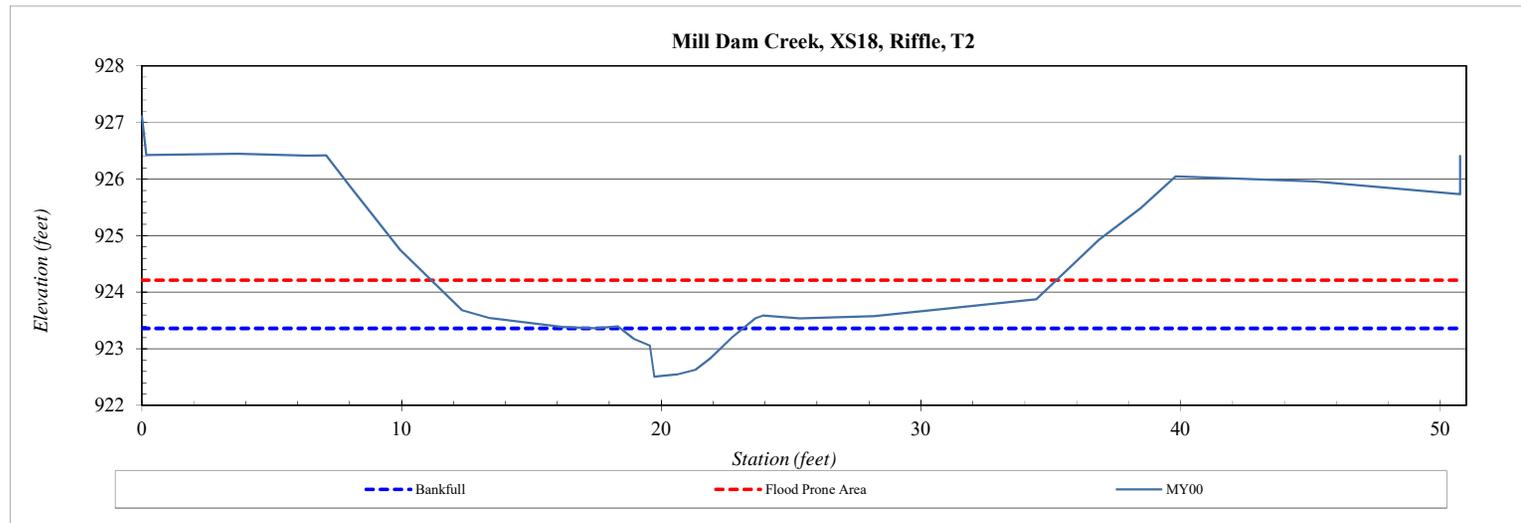
<b>River Basin:</b>	Yadkin River
<b>Site:</b>	Mill Dam Creek
<b>XS ID</b>	XS18
<b>Drainage Area (sq mi):</b>	0.02
<b>Date:</b>	1/17/2020
<b>Field Crew:</b>	TS, KB

Station	Elevation
0.0	927.11
0.2	926.43
3.7	926.45
6.4	926.41
7.1	926.42
8.0	925.88
9.9	924.75
12.3	923.68
13.4	923.54
16.2	923.39
17.5	923.36
18.3	923.40
18.9	923.18
19.6	923.06
19.7	922.51
20.6	922.55
21.3	922.63
21.9	922.83
22.7	923.21
23.6	923.54
23.9	923.58
25.3	923.54
28.2	923.57
34.4	923.87
36.8	924.92
38.5	925.49
39.8	926.05
45.2	925.96
50.8	925.73
50.8	926.40

SUMMARY DATA	
<b>Bankfull Elevation (ft) - Based on AB-Bankfull Area</b>	923.36
<b>Bankfull Cross-Sectional Area:</b>	2.3
<b>Total Cross-Sectional Area:</b>	2.3
<b>Bankfull Width:</b>	4.7
<b>Flood Prone Area Elevation:</b>	924.21
<b>Flood Prone Width:</b>	24.1
<b>Max Depth at Bankfull:</b>	0.9
<b>Mean Depth at Bankfull:</b>	0.5
<b>W / D Ratio:</b>	9.9
<b>Entrenchment Ratio:</b>	5.1
<b>Bank Height Ratio:</b>	1.0
<b>Thalweg Elevation:</b>	922.51

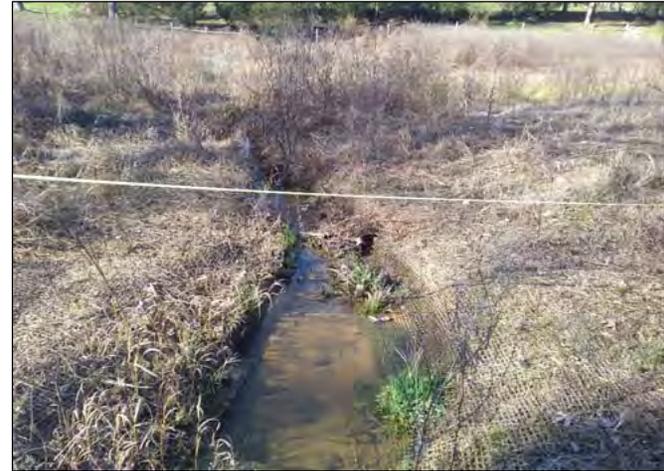
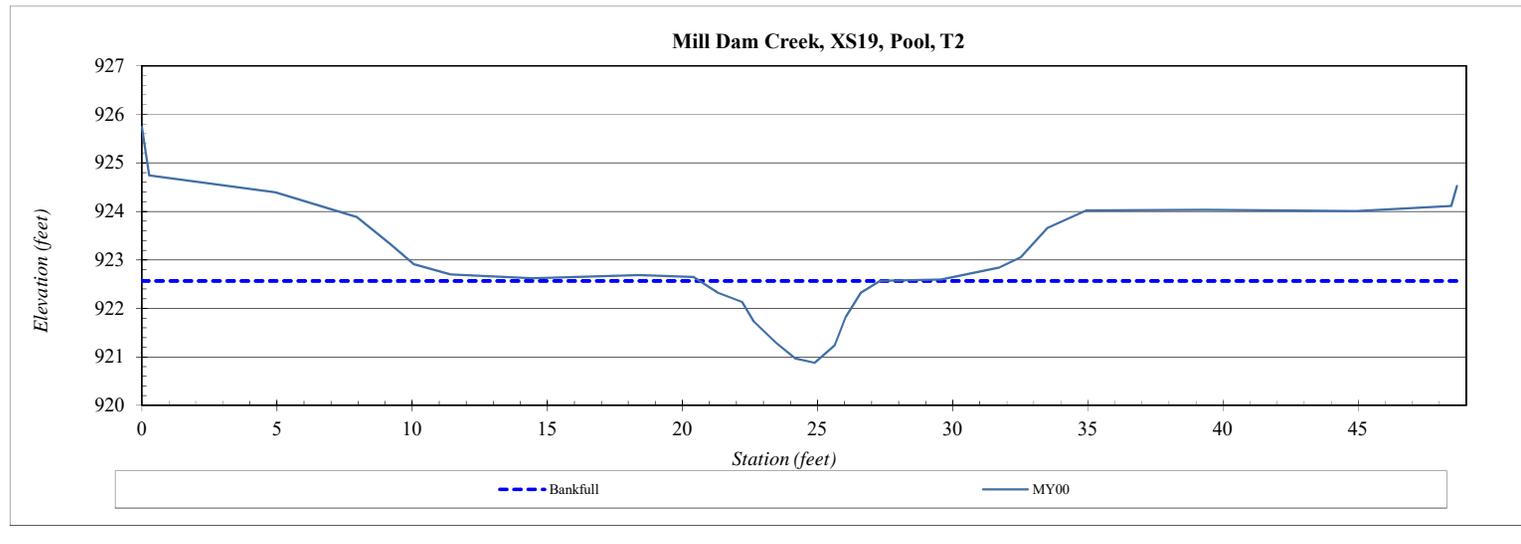
<b>River Basin:</b>	Yadkin River
<b>Site:</b>	Mill Dam Creek
<b>XS ID</b>	XS19
<b>Drainage Area (sq mi):</b>	0.02
<b>Date:</b>	1/17/2020
<b>Field Crew:</b>	TS, KB

Station	Elevation
0.0	925.74
0.3	924.74
4.9	924.39
8.0	923.88
9.2	923.34
10.1	922.91
11.4	922.70
14.5	922.62
18.4	922.69
20.4	922.64
21.3	922.32
22.2	922.13
22.6	921.72
23.5	921.29
24.2	920.96
24.9	920.88
25.6	921.24
26.0	921.82
26.6	922.33
27.3	922.57
29.6	922.60
31.7	922.84
32.5	923.06
33.5	923.66
34.9	924.02
39.4	924.03
44.9	924.01
48.4	924.11
48.7	924.53

SUMMARY DATA	
<b>Bankfull Elevation (ft) - Based on AB-Bankfull Area</b>	922.57
<b>Bankfull Cross-Sectional Area:</b>	5.6
<b>Total Cross-Sectional Area:</b>	5.6
<b>Bankfull Width:</b>	6.7
<b>Flood Prone Area Elevation:</b>	---
<b>Flood Prone Width:</b>	---
<b>Max Depth at Bankfull:</b>	1.7
<b>Mean Depth at Bankfull:</b>	0.8
<b>W / D Ratio:</b>	---
<b>Entrenchment Ratio:</b>	---
<b>Bank Height Ratio:</b>	---
<b>Thalweg Elevation:</b>	920.88

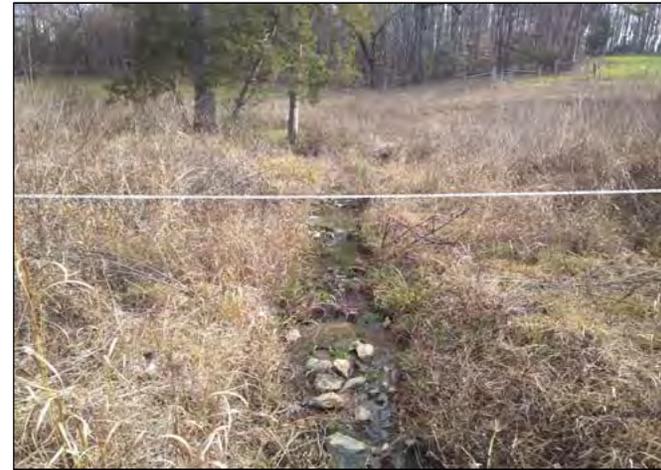
<b>River Basin:</b>	Yadkin River
<b>Site:</b>	Mill Dam Creek
<b>XS ID</b>	XS20
<b>Drainage Area (sq mi):</b>	0.01
<b>Date:</b>	1/17/2020
<b>Field Crew:</b>	TS, KB

Station	Elevation
0.0	921.14
0.2	920.33
7.2	919.96
14.3	919.42
17.4	919.25
18.7	918.75
19.9	918.19
21.3	917.97
23.9	917.98
26.0	917.79
26.4	917.69
27.0	917.45
27.4	917.28
27.7	917.14
28.3	917.19
29.3	917.16
29.9	917.13
30.3	917.00
30.4	917.45
31.1	917.71
31.6	918.01
32.9	917.92
35.5	917.70
37.5	917.75
39.3	918.69
41.2	919.55
44.3	919.89
47.3	920.28
47.3	920.91

SUMMARY DATA	
<b>Bankfull Elevation (ft) - Based on AB-Bankfull Area</b>	917.69
<b>Bankfull Cross-Sectional Area:</b>	1.9
<b>Total Cross-Sectional Area:</b>	1.9
<b>Bankfull Width:</b>	4.7
<b>Flood Prone Area Elevation:</b>	918.37
<b>Flood Prone Width:</b>	19.2
<b>Max Depth at Bankfull:</b>	0.7
<b>Mean Depth at Bankfull:</b>	0.4
<b>W / D Ratio:</b>	11.6
<b>Entrenchment Ratio:</b>	4.1
<b>Bank Height Ratio:</b>	1.0
<b>Thalweg Elevation:</b>	917.00

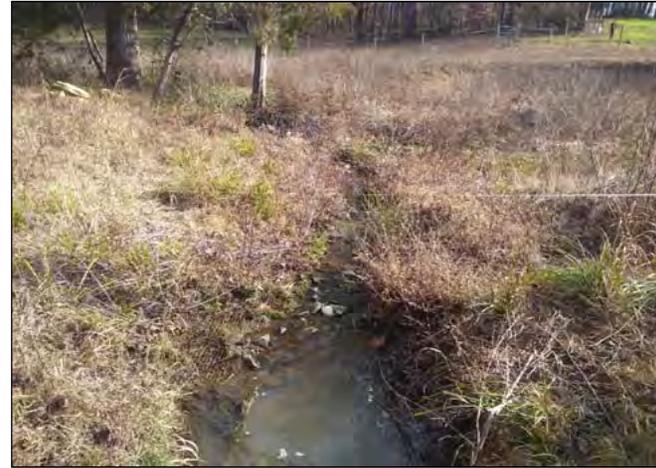
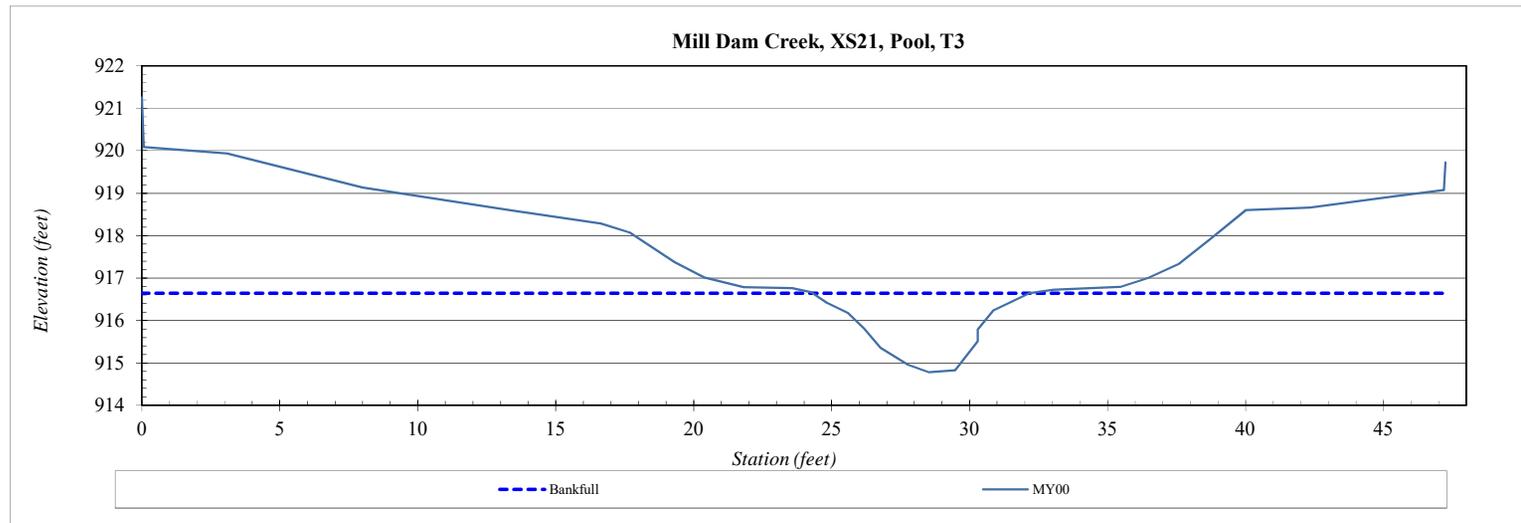
<b>River Basin:</b>	Yadkin River
<b>Site:</b>	Mill Dam Creek
<b>XS ID</b>	XS21
<b>Drainage Area (sq mi):</b>	0.01
<b>Date:</b>	1/17/2020
<b>Field Crew:</b>	TS, KB

Station	Elevation
0.0	921.26
0.1	920.09
3.1	919.94
8.0	919.13
13.4	918.60
16.6	918.29
17.7	918.07
19.3	917.37
20.4	917.01
21.8	916.78
23.6	916.76
24.3	916.66
24.8	916.42
25.6	916.18
26.2	915.81
26.8	915.36
27.8	914.96
28.5	914.78
29.5	914.82
30.3	915.50
30.3	915.78
30.9	916.25
31.6	916.47
32.1	916.64
33.0	916.73
35.5	916.79
36.5	917.00
37.6	917.34
38.7	917.93
40.0	918.60
42.3	918.66
45.5	918.93
47.2	919.07
47.2	919.73

SUMMARY DATA	
<b>Bankfull Elevation (ft) - Based on AB-Bankfull Area</b>	916.64
<b>Bankfull Cross-Sectional Area:</b>	7.7
<b>Total Cross-Sectional Area:</b>	7.7
<b>Bankfull Width:</b>	7.8
<b>Flood Prone Area Elevation:</b>	---
<b>Flood Prone Width:</b>	---
<b>Max Depth at Bankfull:</b>	1.9
<b>Mean Depth at Bankfull:</b>	1.0
<b>W / D Ratio:</b>	---
<b>Entrenchment Ratio:</b>	---
<b>Bank Height Ratio:</b>	---
<b>Thalweg Elevation:</b>	914.78

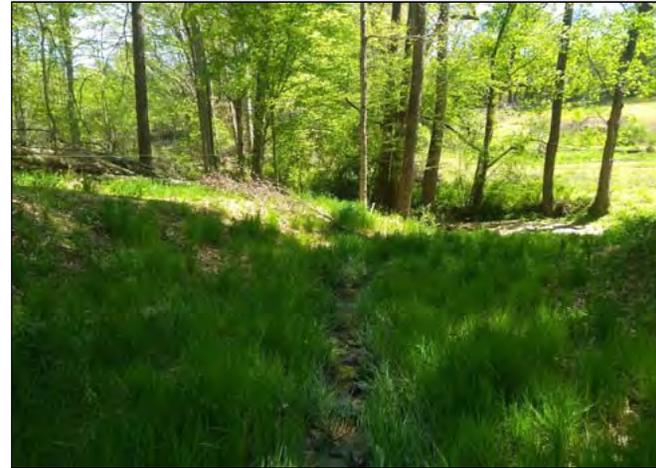
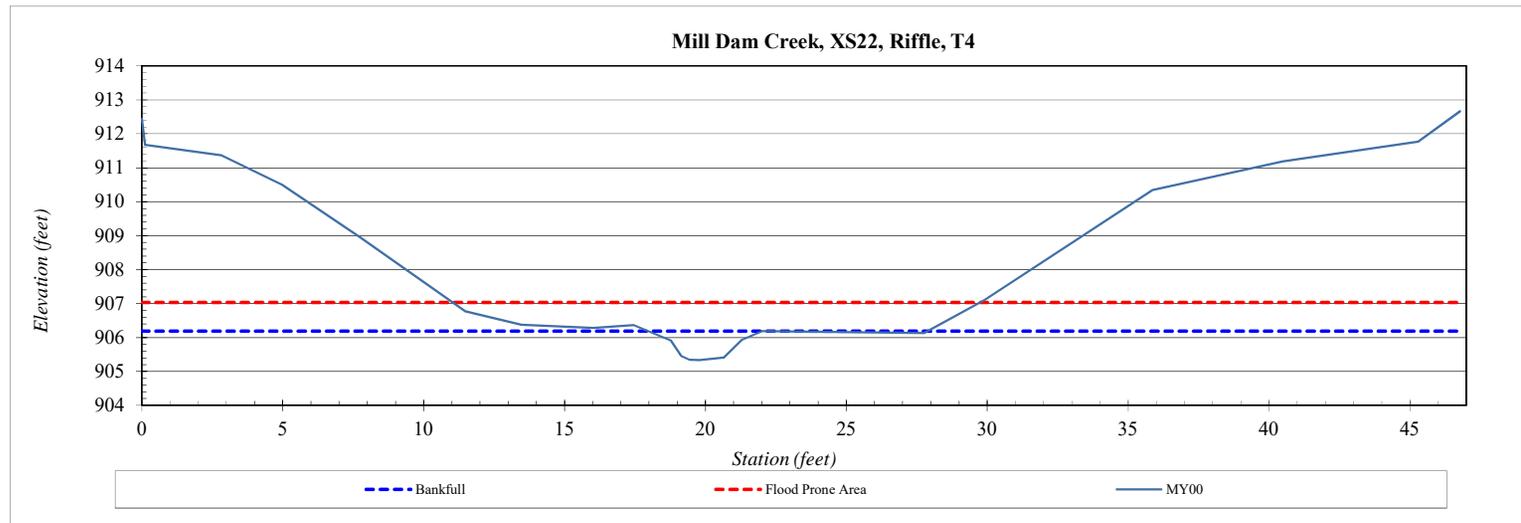
<b>River Basin:</b>	Yadkin River
<b>Site:</b>	Mill Dam Creek
<b>XS ID</b>	XS22
<b>Drainage Area (sq mi):</b>	0.01
<b>Date:</b>	4/15/2020
<b>Field Crew:</b>	TS, KB

Station	Elevation
0.0	912.44
0.1	911.68
2.8	911.36
5.0	910.51
7.8	908.94
11.5	906.77
13.5	906.37
16.0	906.28
17.5	906.37
18.8	905.91
19.1	905.46
19.5	905.34
19.8	905.34
20.6	905.41
21.3	905.93
22.0	906.18
23.9	906.17
27.8	906.12
29.9	907.10
35.9	910.34
40.5	911.19
45.3	911.77
46.8	912.67

SUMMARY DATA	
<b>Bankfull Elevation (ft) - Based on AB-Bankfull Area</b>	906.18
<b>Bankfull Cross-Sectional Area:</b>	1.9
<b>Total Cross-Sectional Area:</b>	1.9
<b>Bankfull Width:</b>	4.0
<b>Flood Prone Area Elevation:</b>	907.03
<b>Flood Prone Width:</b>	18.7
<b>Max Depth at Bankfull:</b>	0.8
<b>Mean Depth at Bankfull:</b>	0.5
<b>W / D Ratio:</b>	8.3
<b>Entrenchment Ratio:</b>	4.7
<b>Bank Height Ratio:</b>	1.0
<b>Thalweg Elevation:</b>	905.34

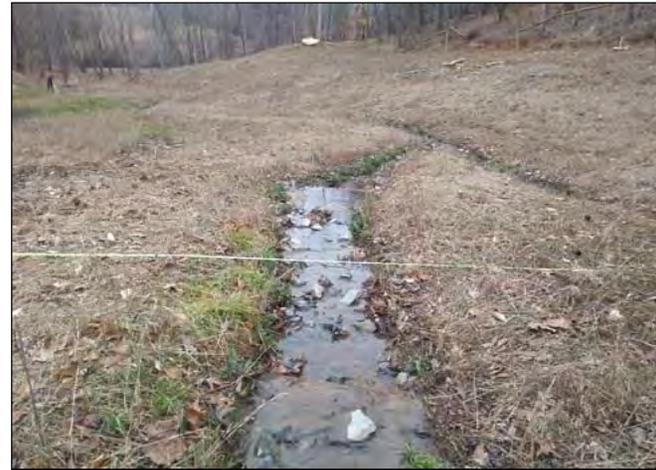
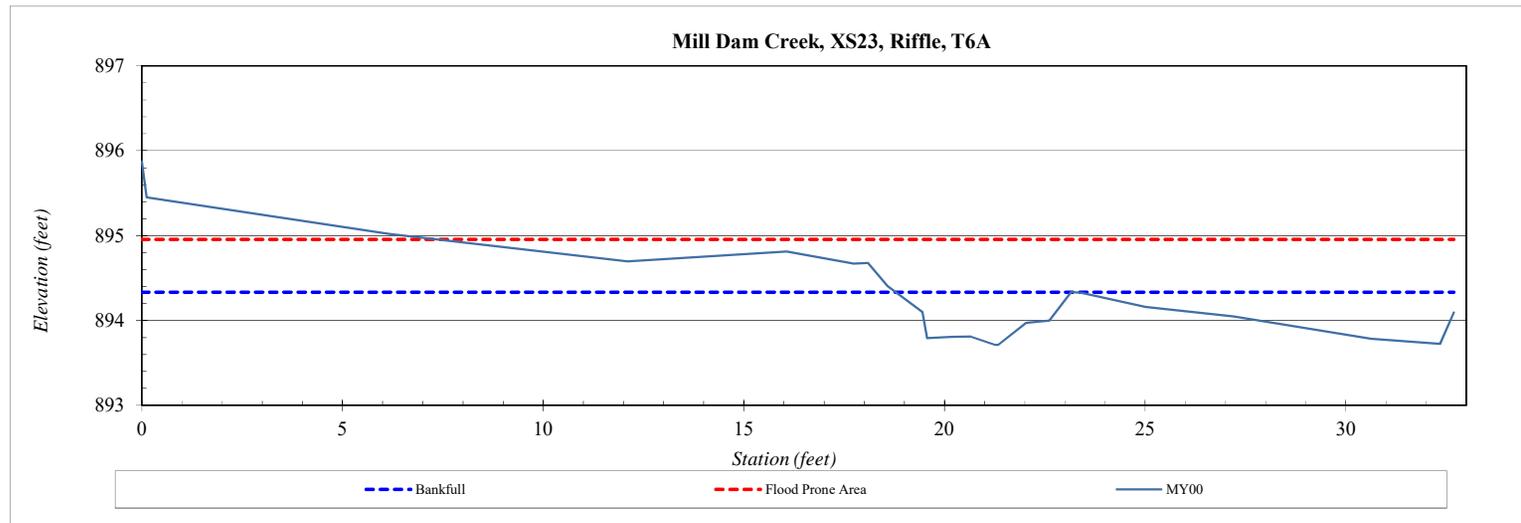
<b>River Basin:</b>	Yadkin River
<b>Site:</b>	Mill Dam Creek
<b>XS ID</b>	XS23
<b>Drainage Area (sq mi):</b>	0.01
<b>Date:</b>	1/30/2020
<b>Field Crew:</b>	TS, KB

Station	Elevation
0.0	895.87
0.1	895.45
6.2	895.02
12.1	894.70
16.1	894.81
17.7	894.67
18.1	894.68
18.6	894.41
19.4	894.10
19.6	893.79
20.2	893.81
20.7	893.81
21.3	893.71
21.3	893.71
22.0	893.97
22.6	894.00
23.2	894.33
23.4	894.33
25.0	894.16
27.2	894.05
30.6	893.78
32.3	893.72
32.7	894.09

SUMMARY DATA	
<b>Bankfull Elevation (ft) - Based on AB-Bankfull Area</b>	894.33
<b>Bankfull Cross-Sectional Area:</b>	1.7
<b>Total Cross-Sectional Area:</b>	1.7
<b>Bankfull Width:</b>	4.4
<b>Flood Prone Area Elevation:</b>	894.96
<b>Flood Prone Width:</b>	25.3
<b>Max Depth at Bankfull:</b>	0.6
<b>Mean Depth at Bankfull:</b>	0.4
<b>W / D Ratio:</b>	11.0
<b>Entrenchment Ratio:</b>	5.8
<b>Bank Height Ratio:</b>	1.0
<b>Thalweg Elevation:</b>	893.71

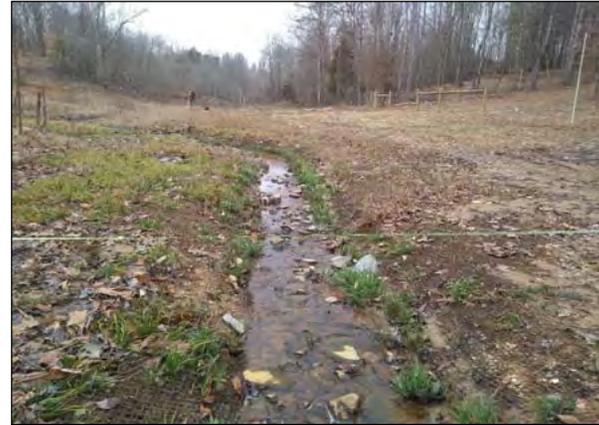
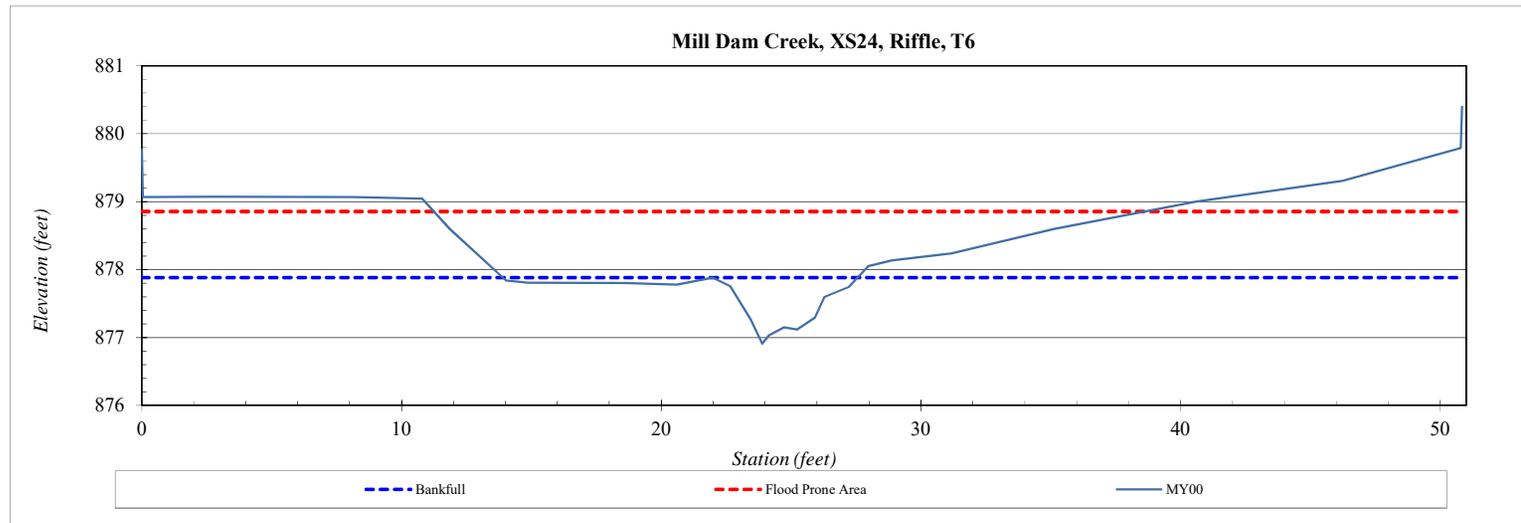
<b>River Basin:</b>	Yadkin River
<b>Site:</b>	Mill Dam Creek
<b>XS ID</b>	XS24
<b>Drainage Area (sq mi):</b>	0.07
<b>Date:</b>	1/30/2020
<b>Field Crew:</b>	TS, KB

Station	Elevation
0.0	879.77
0.0	879.07
2.8	879.07
8.2	879.07
10.8	879.04
11.9	878.60
14.0	877.84
14.9	877.80
18.6	877.80
20.6	877.78
22.0	877.88
22.7	877.75
23.4	877.26
23.9	876.91
24.1	877.03
24.7	877.15
25.2	877.12
25.9	877.30
26.3	877.60
27.2	877.75
28.0	878.05
28.9	878.13
31.2	878.24
35.1	878.60
40.6	879.00
46.2	879.30
50.8	879.79
50.8	880.40

SUMMARY DATA	
<b>Bankfull Elevation (ft) - Based on AB-Bankfull Area</b>	877.88
<b>Bankfull Cross-Sectional Area:</b>	2.6
<b>Total Cross-Sectional Area:</b>	2.6
<b>Bankfull Width:</b>	5.6
<b>Flood Prone Area Elevation:</b>	878.86
<b>Flood Prone Width:</b>	27.4
<b>Max Depth at Bankfull:</b>	1.0
<b>Mean Depth at Bankfull:</b>	0.5
<b>W / D Ratio:</b>	11.9
<b>Entrenchment Ratio:</b>	4.9
<b>Bank Height Ratio:</b>	1.0
<b>Thalweg Elevation:</b>	876.91

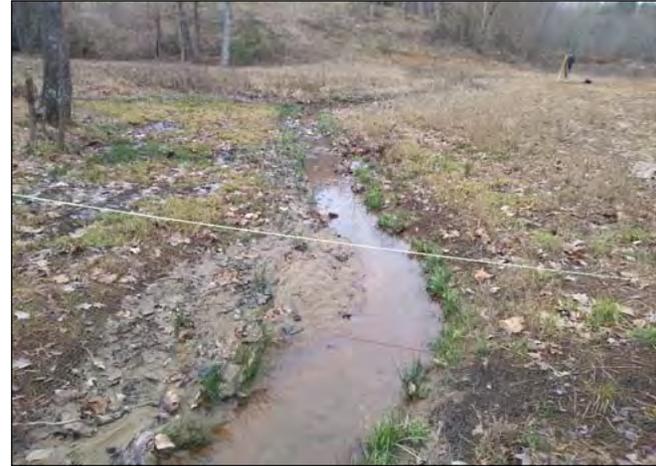
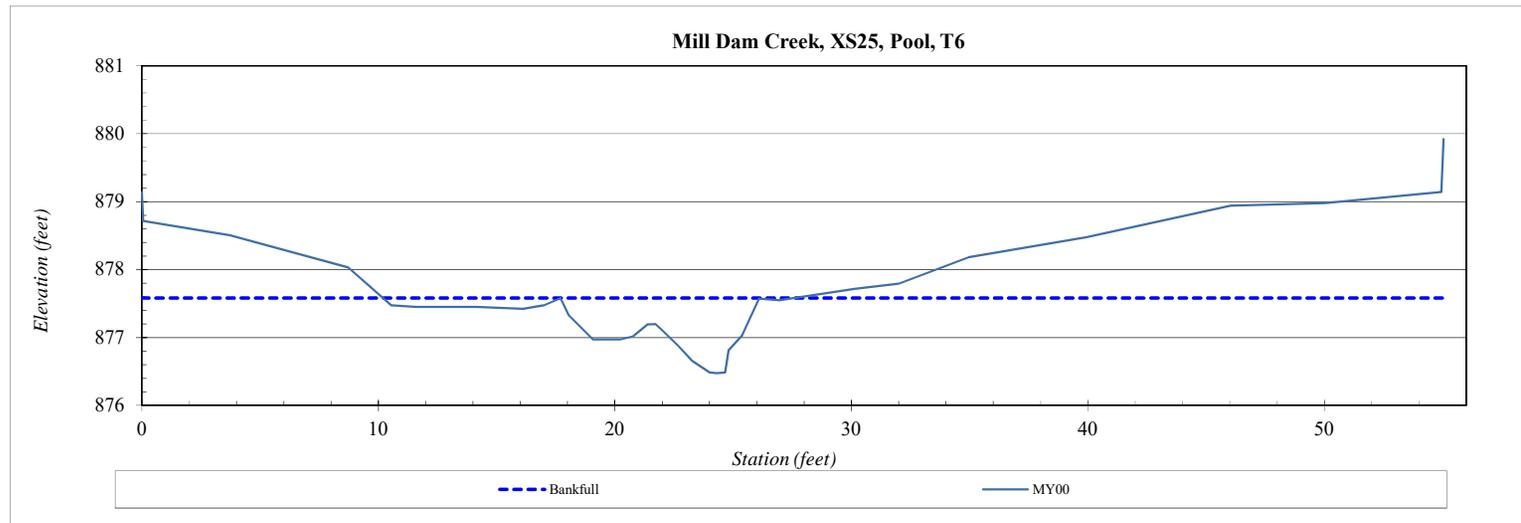
<b>River Basin:</b>	Yadkin River
<b>Site:</b>	Mill Dam Creek
<b>XS ID</b>	XS25
<b>Drainage Area (sq mi):</b>	0.07
<b>Date:</b>	1/30/2020
<b>Field Crew:</b>	TS, KB

Station	Elevation
0.0	879.14
0.1	878.72
3.7	878.50
8.7	878.03
10.5	877.47
11.6	877.45
14.2	877.45
16.1	877.42
17.0	877.47
17.7	877.58
18.0	877.33
19.1	876.97
20.2	876.97
20.8	877.02
21.4	877.19
21.7	877.19
22.2	877.06
22.7	876.87
23.3	876.66
24.0	876.48
24.3	876.48
24.7	876.48
24.8	876.81
25.4	877.03
26.1	877.57
27.0	877.55
30.2	877.72
32.0	877.79
35.0	878.18
39.9	878.48
46.0	878.94
50.0	878.98
54.9	879.14
55.0	879.92

SUMMARY DATA	
<b>Bankfull Elevation (ft) - Based on AB-Bankfull Area</b>	877.58
<b>Bankfull Cross-Sectional Area:</b>	5.1
<b>Total Cross-Sectional Area:</b>	5.1
<b>Bankfull Width:</b>	8.4
<b>Flood Prone Area Elevation:</b>	---
<b>Flood Prone Width:</b>	---
<b>Max Depth at Bankfull:</b>	1.1
<b>Mean Depth at Bankfull:</b>	0.6
<b>W / D Ratio:</b>	---
<b>Entrenchment Ratio:</b>	---
<b>Bank Height Ratio:</b>	---
<b>Thalweg Elevation:</b>	876.48

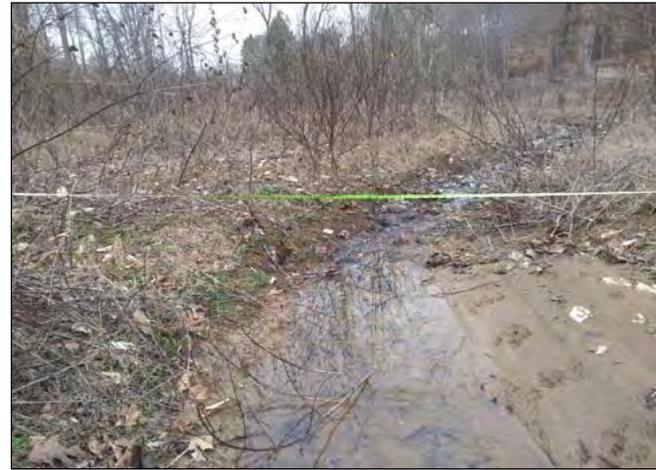
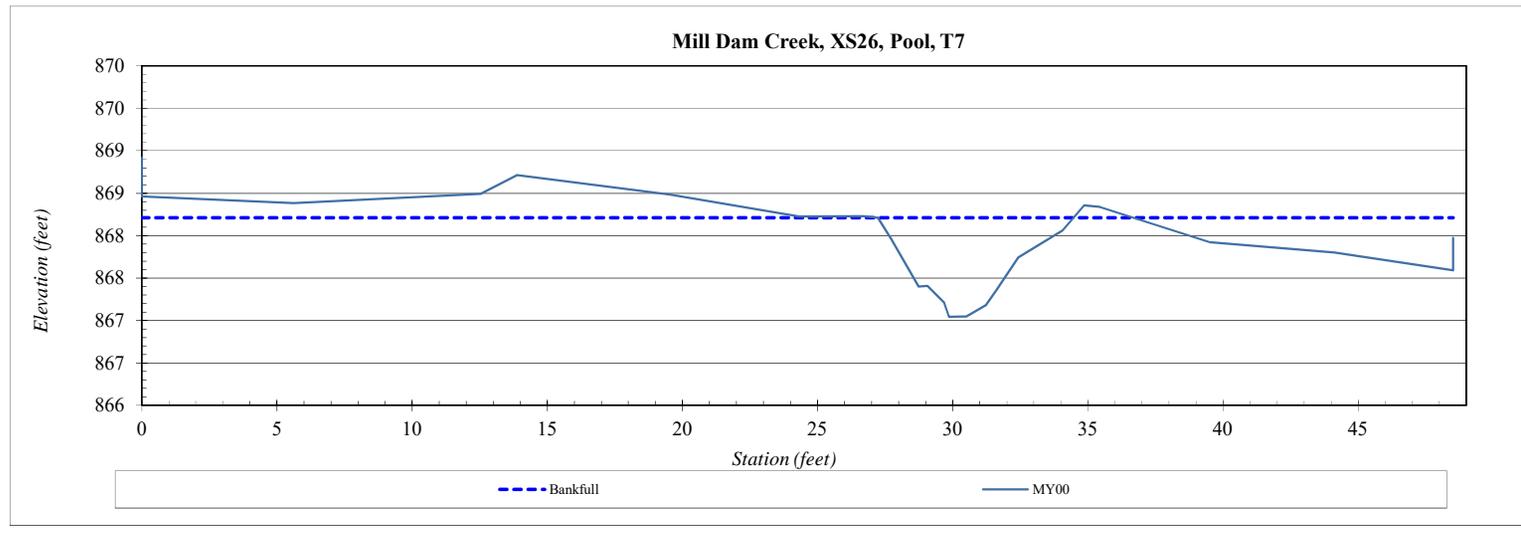
<b>River Basin:</b>	Yadkin River
<b>Site:</b>	Mill Dam Creek
<b>XS ID</b>	XS26
<b>Drainage Area (sq mi):</b>	0.07
<b>Date:</b>	1/30/2020
<b>Field Crew:</b>	TS, KB

Station	Elevation
0.0	868.92
0.0	868.46
5.6	868.38
12.5	868.49
13.9	868.71
19.5	868.49
24.3	868.23
26.7	868.23
27.2	868.21
27.7	867.96
28.7	867.40
29.1	867.41
29.7	867.21
29.9	867.05
30.5	867.05
31.2	867.18
31.6	867.36
32.4	867.74
34.1	868.06
34.9	868.36
35.5	868.34
39.5	867.92
44.1	867.80
48.5	867.59
48.5	867.97

SUMMARY DATA	
<b>Bankfull Elevation (ft) - Based on AB-Bankfull Area</b>	868.21
<b>Bankfull Cross-Sectional Area:</b>	4.6
<b>Total Cross-Sectional Area:</b>	4.6
<b>Bankfull Width:</b>	7.2
<b>Flood Prone Area Elevation:</b>	---
<b>Flood Prone Width:</b>	---
<b>Max Depth at Bankfull:</b>	1.2
<b>Mean Depth at Bankfull:</b>	0.6
<b>W / D Ratio:</b>	---
<b>Entrenchment Ratio:</b>	---
<b>Bank Height Ratio:</b>	---
<b>Thalweg Elevation:</b>	867.05

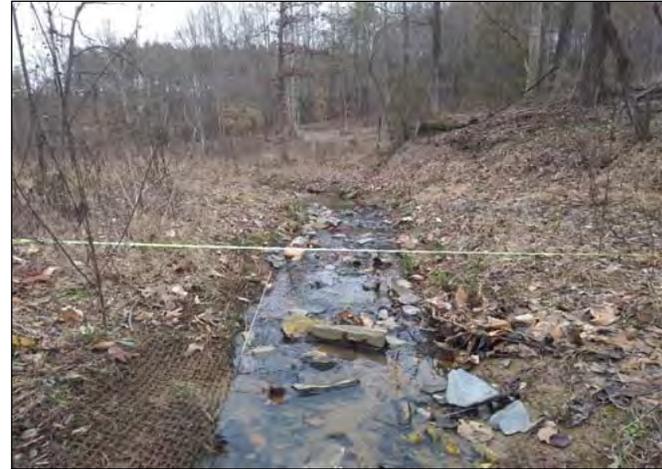
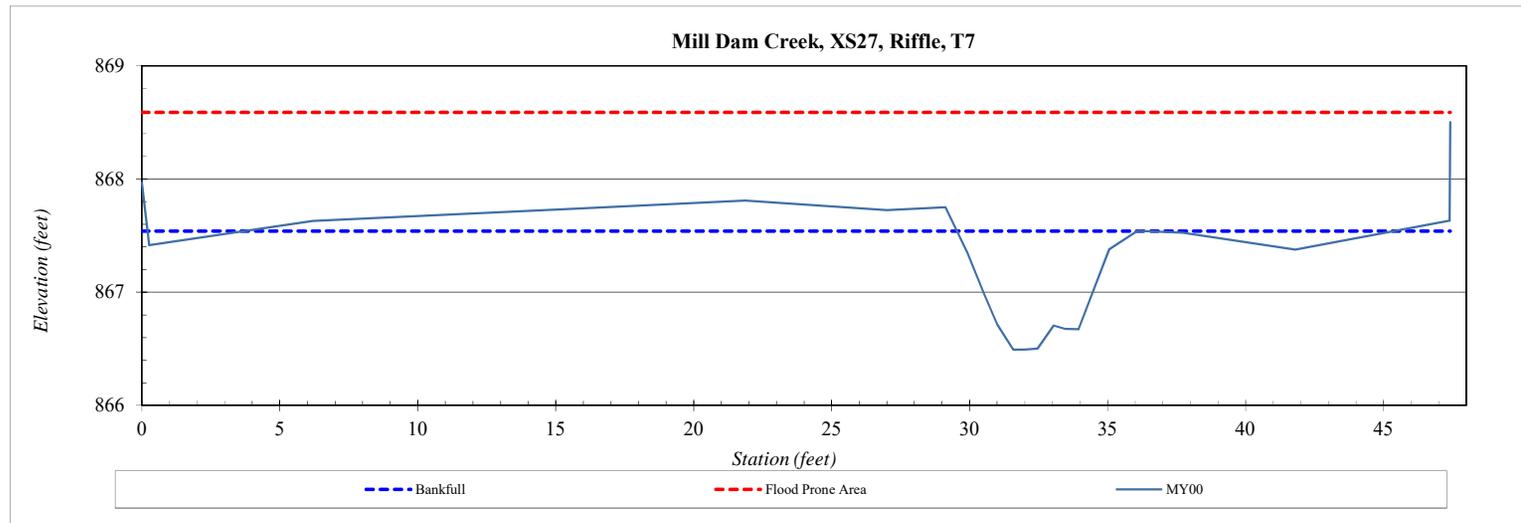
<b>River Basin:</b>	Yadkin River
<b>Site:</b>	Mill Dam Creek
<b>XS ID</b>	XS27
<b>Drainage Area (sq mi):</b>	0.07
<b>Date:</b>	1/30/2020
<b>Field Crew:</b>	TS, KB

Station	Elevation
0.0	867.97
0.3	867.42
6.2	867.63
15.3	867.73
21.9	867.81
27.0	867.73
29.1	867.75
29.9	867.35
30.5	866.98
31.0	866.72
31.6	866.49
32.0	866.49
32.5	866.50
33.1	866.71
33.5	866.68
34.0	866.67
35.1	867.38
36.1	867.54
37.7	867.53
41.8	867.38
47.4	867.63
47.4	868.50

SUMMARY DATA	
<b>Bankfull Elevation (ft) - Based on AB-Bankfull Area</b>	867.54
<b>Bankfull Cross-Sectional Area:</b>	4.3
<b>Total Cross-Sectional Area:</b>	4.3
<b>Bankfull Width:</b>	10.1
<b>Flood Prone Area Elevation:</b>	868.59
<b>Flood Prone Width:</b>	47.4
<b>Max Depth at Bankfull:</b>	1.0
<b>Mean Depth at Bankfull:</b>	0.4
<b>W / D Ratio:</b>	23.9
<b>Entrenchment Ratio:</b>	4.7
<b>Bank Height Ratio:</b>	1.0
<b>Thalweg Elevation:</b>	866.49

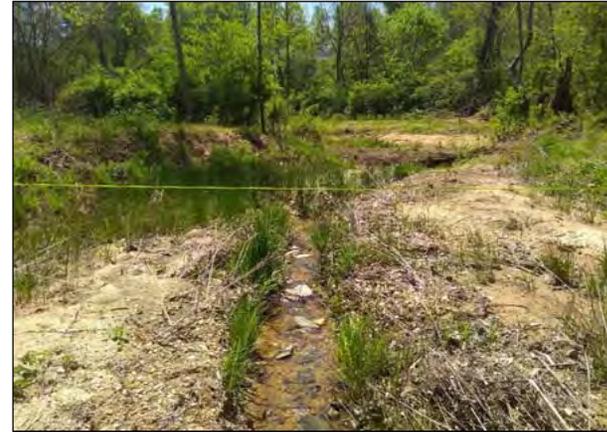
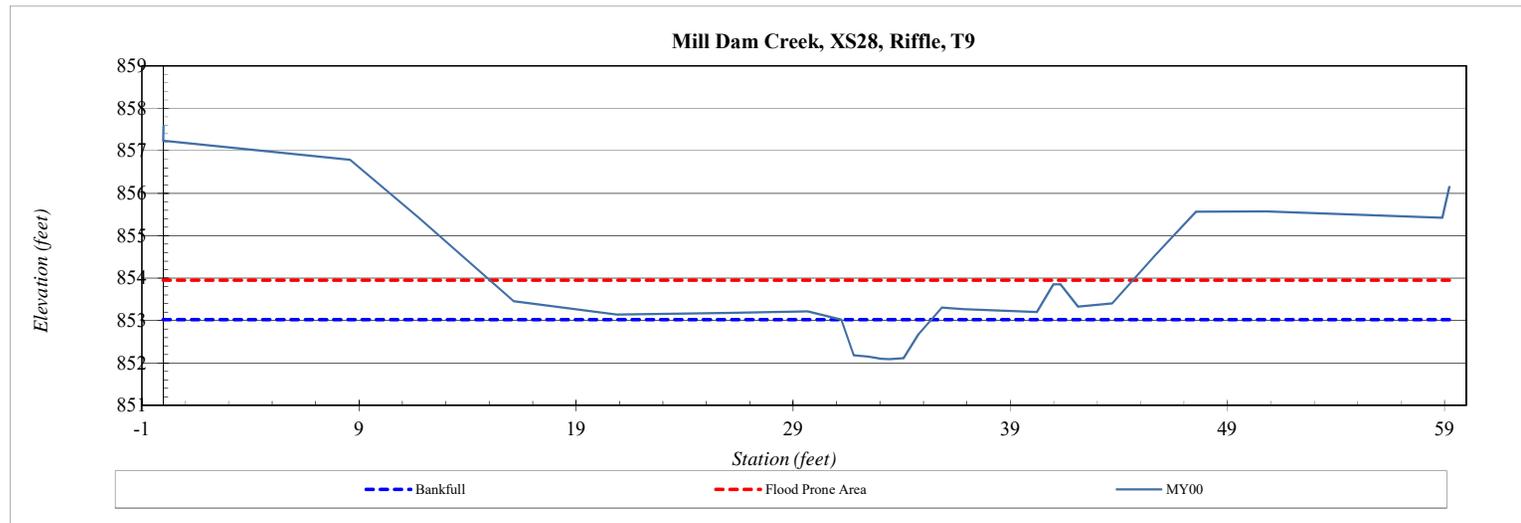
<b>River Basin:</b>	Yadkin River
<b>Site:</b>	Mill Dam Creek
<b>XS ID</b>	XS28
<b>Drainage Area (sq mi):</b>	0.04
<b>Date:</b>	4/15/2020
<b>Field Crew:</b>	TS, KB

Station	Elevation
0.0	857.58
0.0	857.24
4.9	856.98
8.6	856.78
11.8	855.41
16.1	853.45
20.9	853.14
25.9	853.18
29.7	853.21
31.2	853.02
31.8	852.18
32.4	852.15
33.0	852.09
33.5	852.09
34.1	852.11
34.8	852.69
35.8	853.30
36.8	853.27
40.2	853.19
41.0	853.85
41.3	853.85
42.1	853.32
43.7	853.40
45.7	854.54
47.5	855.56
50.8	855.57
58.9	855.42
59.2	856.15

SUMMARY DATA	
<b>Bankfull Elevation (ft) - Based on AB-Bankfull Area</b>	853.02
<b>Bankfull Cross-Sectional Area:</b>	2.8
<b>Total Cross-Sectional Area:</b>	2.8
<b>Bankfull Width:</b>	4.1
<b>Flood Prone Area Elevation:</b>	853.95
<b>Flood Prone Width:</b>	29.6
<b>Max Depth at Bankfull:</b>	0.9
<b>Mean Depth at Bankfull:</b>	0.7
<b>W / D Ratio:</b>	6.0
<b>Entrenchment Ratio:</b>	7.2
<b>Bank Height Ratio:</b>	1.0
<b>Thalweg Elevation:</b>	852.09

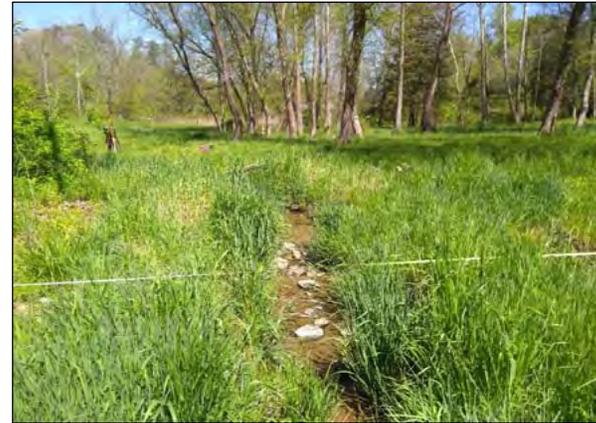
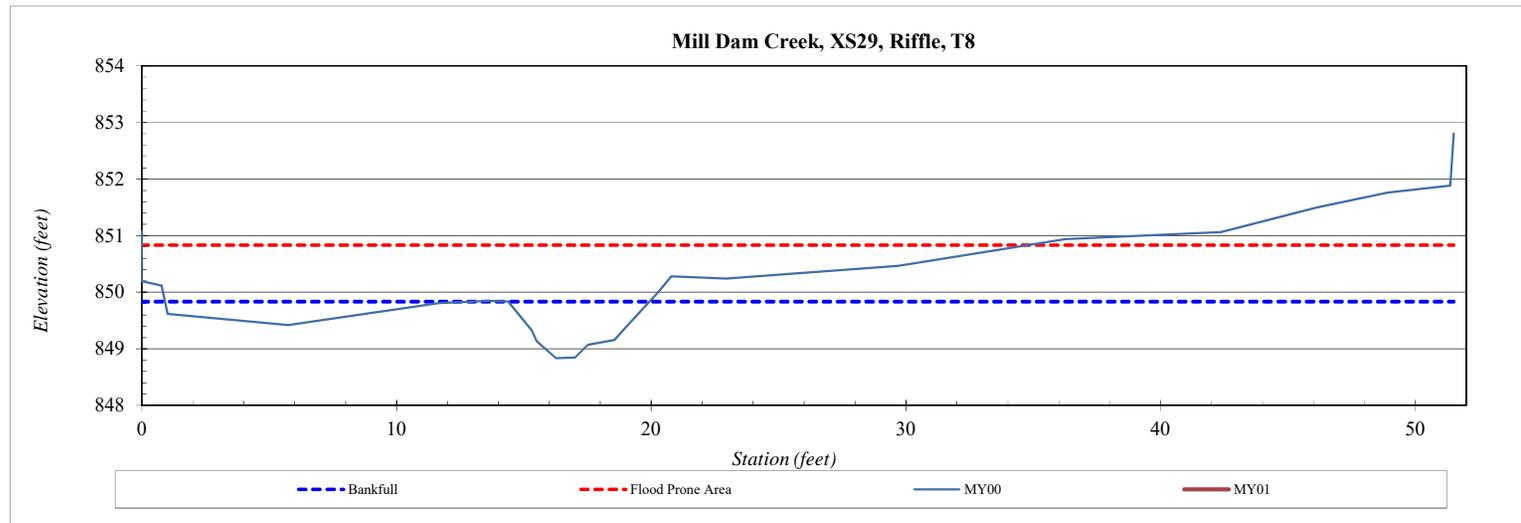
<b>River Basin:</b>	Yadkin River
<b>Site:</b>	Mill Dam Creek
<b>XS ID</b>	XS29
<b>Drainage Area (sq mi):</b>	0.03
<b>Date:</b>	4/16/2020
<b>Field Crew:</b>	TS, KB

Station	Elevation
0.0	851.08
0.0	850.19
0.8	850.12
1.0	849.61
5.7	849.42
11.7	849.81
13.6	849.85
14.4	849.83
15.3	849.33
15.5	849.14
16.3	848.84
17.0	848.84
17.5	849.07
18.5	849.15
19.0	849.38
20.3	850.02
20.8	850.28
23.0	850.24
29.7	850.46
36.3	850.94
42.4	851.06
46.1	851.50
48.9	851.76
51.4	851.89
51.5	852.80

SUMMARY DATA	
<b>Bankfull Elevation (ft) - Based on AB-Bankfull Area</b>	849.83
<b>Bankfull Cross-Sectional Area:</b>	3.4
<b>Total Cross-Sectional Area:</b>	3.4
<b>Bankfull Width:</b>	5.5
<b>Flood Prone Area Elevation:</b>	850.83
<b>Flood Prone Width:</b>	34.8
<b>Max Depth at Bankfull:</b>	1.0
<b>Mean Depth at Bankfull:</b>	0.6
<b>W / D Ratio:</b>	9.1
<b>Entrenchment Ratio:</b>	6.3
<b>Bank Height Ratio:</b>	1.0
<b>Thalweg Elevation:</b>	848.84

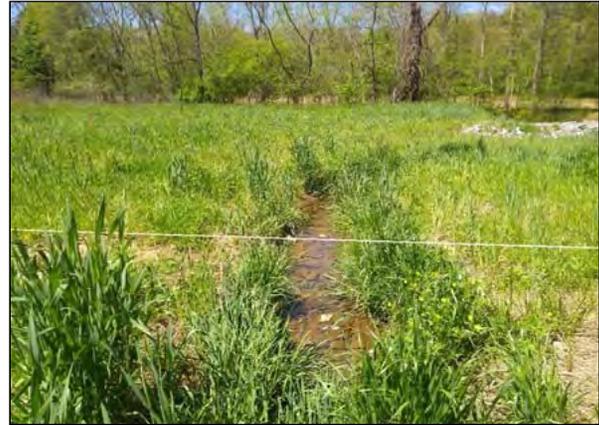
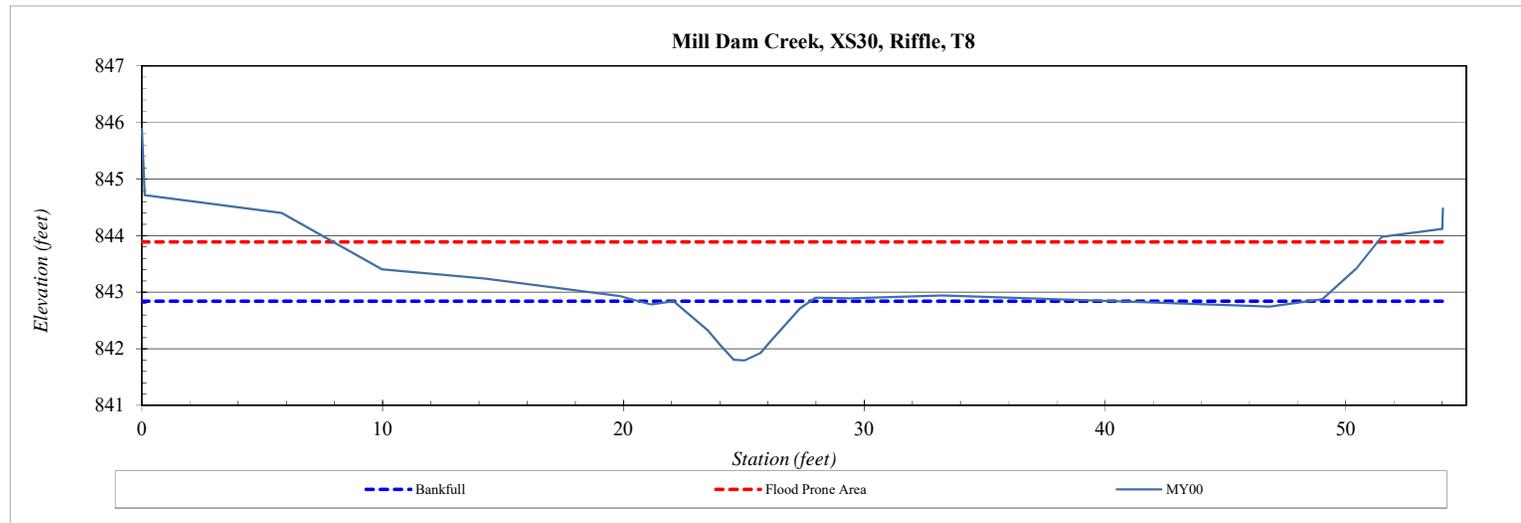
<b>River Basin:</b>	Yadkin River
<b>Site:</b>	Mill Dam Creek
<b>XS ID</b>	XS30
<b>Drainage Area (sq mi):</b>	0.03
<b>Date:</b>	4/16/2020
<b>Field Crew:</b>	TS, KB

Station	Elevation
0.0	845.89
0.1	844.71
5.8	844.40
10.0	843.40
14.3	843.24
19.9	842.93
21.2	842.78
22.1	842.84
23.5	842.33
24.0	842.07
24.6	841.80
25.0	841.79
25.7	841.93
26.1	842.12
27.3	842.72
28.0	842.90
29.4	842.89
33.3	842.94
41.2	842.83
46.8	842.74
49.0	842.87
50.4	843.41
51.5	843.98
54.0	844.12
54.0	844.48

SUMMARY DATA	
<b>Bankfull Elevation (ft) - Based on AB-Bankfull Area</b>	842.84
<b>Bankfull Cross-Sectional Area:</b>	3.2
<b>Total Cross-Sectional Area:</b>	3.2
<b>Bankfull Width:</b>	5.7
<b>Flood Prone Area Elevation:</b>	843.89
<b>Flood Prone Width:</b>	43.4
<b>Max Depth at Bankfull:</b>	1.0
<b>Mean Depth at Bankfull:</b>	0.6
<b>W / D Ratio:</b>	10.1
<b>Entrenchment Ratio:</b>	7.6
<b>Bank Height Ratio:</b>	1.0
<b>Thalweg Elevation:</b>	841.79

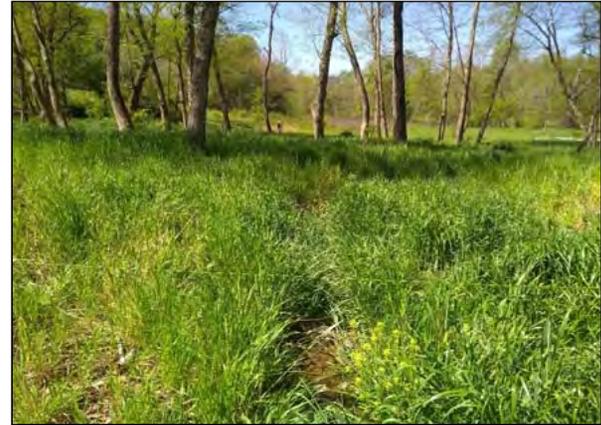
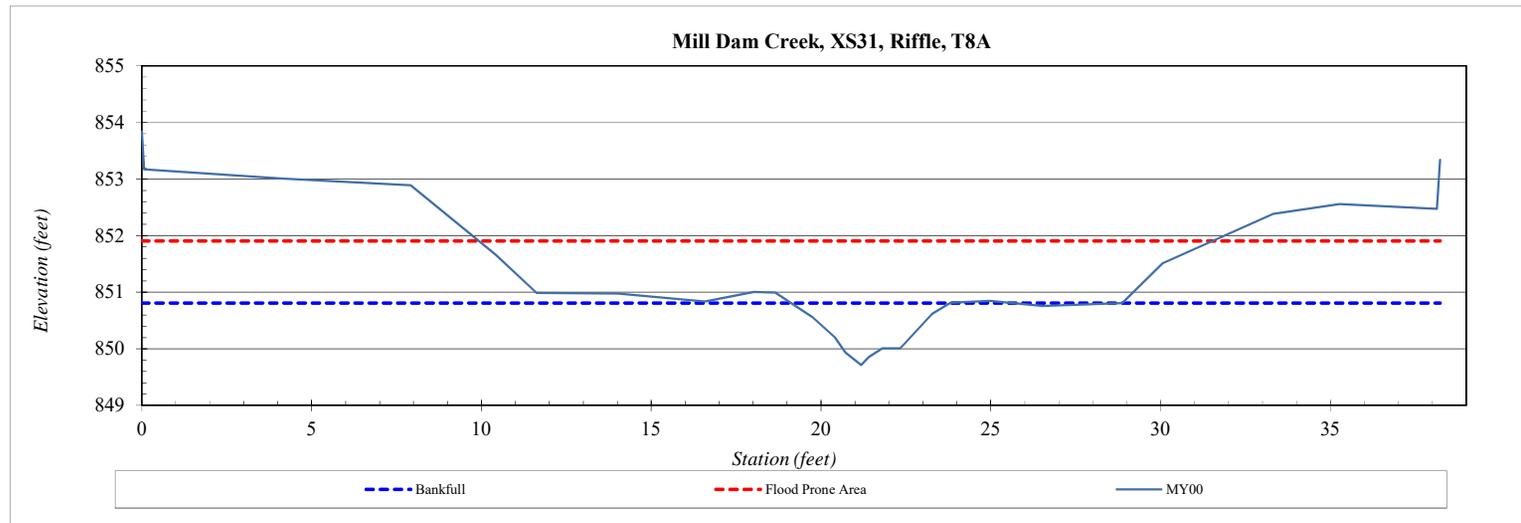
<b>River Basin:</b>	Yadkin River
<b>Site:</b>	Mill Dam Creek
<b>XS ID</b>	XS31
<b>Drainage Area (sq mi):</b>	0.01
<b>Date:</b>	4/16/2020
<b>Field Crew:</b>	TS, KB

Station	Elevation
0.0	853.84
0.1	853.17
4.2	853.01
7.9	852.89
10.4	851.66
11.6	850.99
14.0	850.98
16.6	850.84
18.0	851.00
18.7	850.99
19.7	850.56
20.4	850.20
20.7	849.93
21.2	849.71
21.4	849.86
21.8	850.01
22.3	850.01
23.3	850.62
23.8	850.81
25.0	850.84
26.5	850.76
28.9	850.81
30.1	851.52
33.3	852.38
35.3	852.56
38.1	852.47
38.2	853.34

SUMMARY DATA	
<b>Bankfull Elevation (ft) - Based on AB-Bankfull Area</b>	850.81
<b>Bankfull Cross-Sectional Area:</b>	2.6
<b>Total Cross-Sectional Area:</b>	2.6
<b>Bankfull Width:</b>	4.7
<b>Flood Prone Area Elevation:</b>	851.91
<b>Flood Prone Width:</b>	21.6
<b>Max Depth at Bankfull:</b>	1.1
<b>Mean Depth at Bankfull:</b>	0.5
<b>W / D Ratio:</b>	8.6
<b>Entrenchment Ratio:</b>	4.6
<b>Bank Height Ratio:</b>	1.0
<b>Thalweg Elevation:</b>	849.71

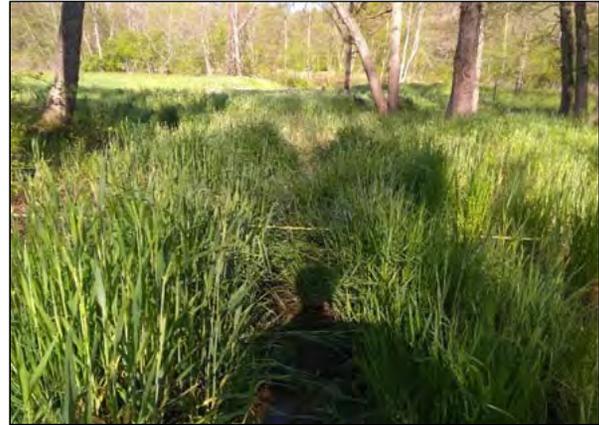
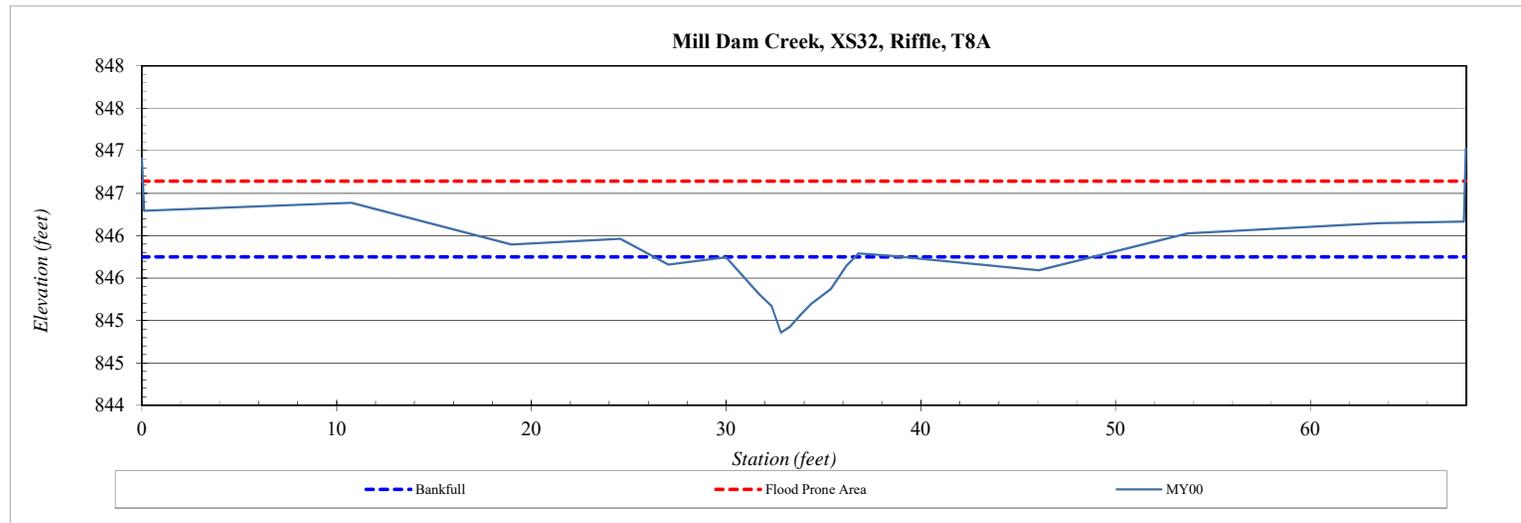
<b>River Basin:</b>	Yadkin River
<b>Site:</b>	Mill Dam Creek
<b>XS ID</b>	XS32
<b>Drainage Area (sq mi):</b>	0.01
<b>Date:</b>	4/16/2020
<b>Field Crew:</b>	TS, KB

Station	Elevation
0.0	846.91
0.1	846.29
10.8	846.39
19.0	845.90
24.6	845.96
27.0	845.66
30.0	845.75
31.7	845.31
32.3	845.17
32.8	844.86
33.3	844.93
33.8	845.07
34.4	845.20
35.4	845.37
36.2	845.65
36.8	845.79
38.4	845.76
46.1	845.59
53.7	846.03
63.5	846.15
67.9	846.17
68.0	847.03

SUMMARY DATA	
<b>Bankfull Elevation (ft) - Based on AB-Bankfull Area</b>	845.75
<b>Bankfull Cross-Sectional Area:</b>	2.9
<b>Total Cross-Sectional Area:</b>	2.9
<b>Bankfull Width:</b>	6.6
<b>Flood Prone Area Elevation:</b>	846.64
<b>Flood Prone Width:</b>	67.9
<b>Max Depth at Bankfull:</b>	0.9
<b>Mean Depth at Bankfull:</b>	0.4
<b>W / D Ratio:</b>	15.2
<b>Entrenchment Ratio:</b>	10.3
<b>Bank Height Ratio:</b>	1.0
<b>Thalweg Elevation:</b>	844.86
