# **As-built Baseline Monitoring Report**

**Mill Dam Creek Restoration Site  
Yadkin River Basin - 03040101  
Monitoring Year 00  
DEQ Contract 6898  
DMS Project Number 97136**

**DWR #: 18-1349  
USACE Action ID: 2016-01335  
Yadkin County, North Carolina**

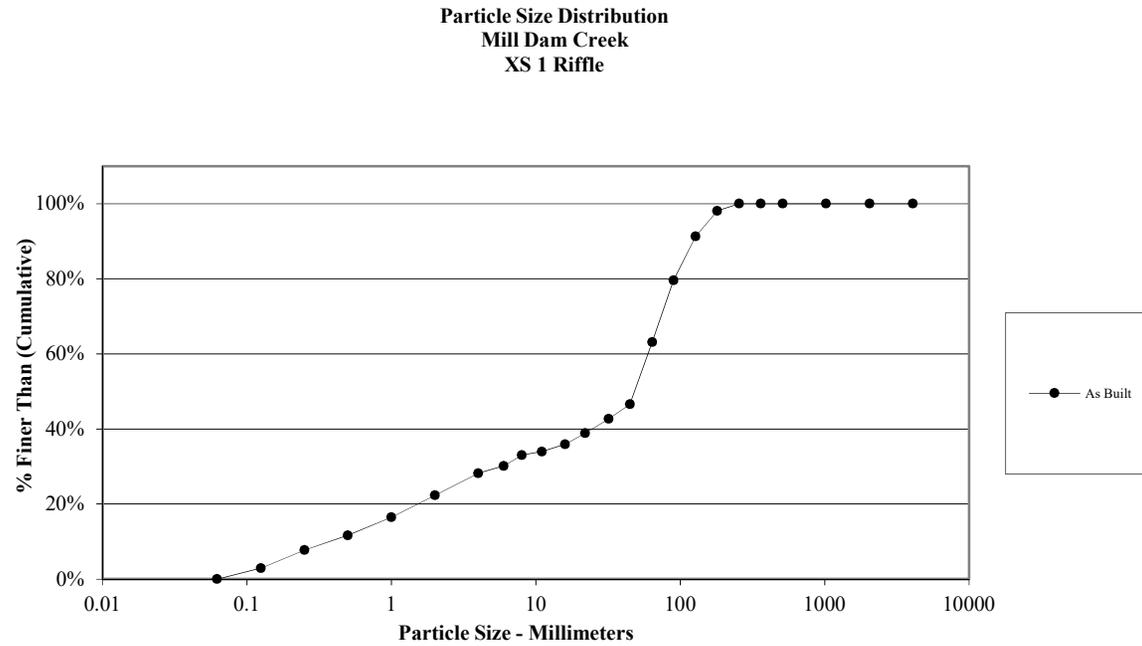
Cross-Section 1 Riffle - MY-00			
Particle	Millimeter		Count
Silt/Clay	< 0.062	S/C	
Very Fine	.062 - .125	S	3
Fine	.125 - .25	A	5
Medium	.25 - .50	N	4
Coarse	.50 - 1	D	5
Very Coarse	1 - 2	S	6
Very Fine	2 - 4		6
Fine	4 - 5.7	G	2
Fine	5.7 - 8	R	3
Medium	8 - 11.3	A	1
Medium	11.3 - 16	V	2
Coarse	16 - 22.6	E	3
Coarse	22.6 - 32	L	4
Very Coarse	32 - 45	S	4
Very Coarse	45 - 64		17
Small	64 - 90	C	17
Small	90 - 128	O	12
Large	128 - 180	B	7
Large	180 - 256	L	2
Small	256 - 362	B	
Small	362 - 512	L	
Medium	512 - 1024	D	
Lrg- Very Lrg	1024 - 2048	R	
Bedrock	>2048	BDRK	
		<b>Total</b>	<b>103</b>
Note:

Size (mm)	
D16	0.93
D35	13
D50	48
D65	67
D84	100
D95	150

Size Distribution	
mean	9.6
dispersion	26.8
skewness	-0.49

Type	
silt/clay	0%
sand	22%
gravel	41%
cobble	28%
boulder	0%
bedrock	0%
hardpan	0%
wood/det	0%
artificial	0%

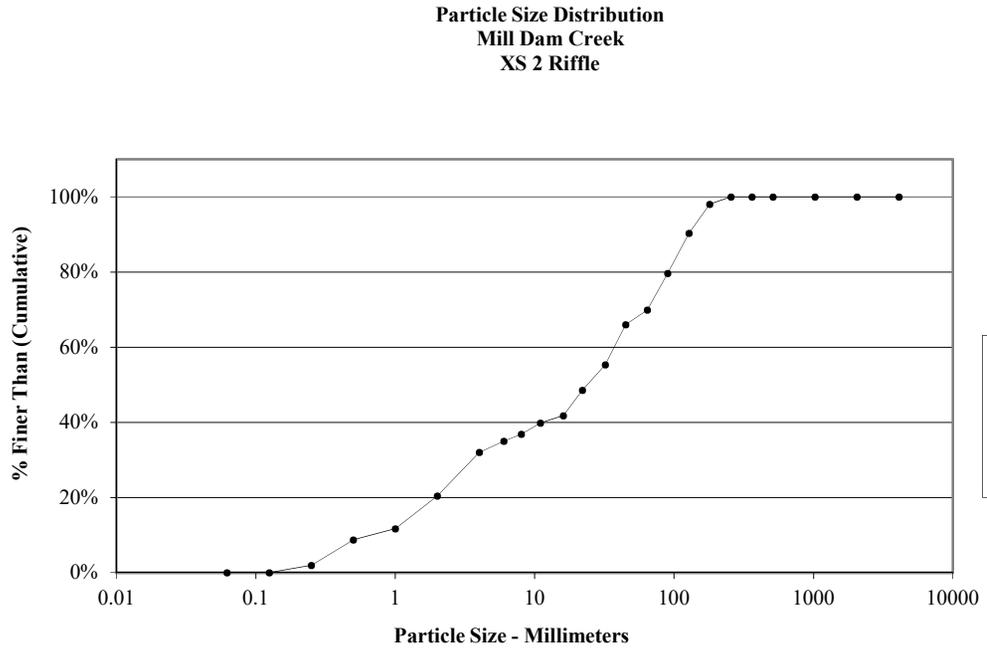
Cross-Section 2 Riffle - MY-00			
Particle	Millimeter		Count
Silt/Clay	< 0.062	S/C	
Very Fine	.062 - .125	S	
Fine	.125 - .25	A	2
Medium	.25 - .50	N	7
Coarse	.50 - 1	D	3
Very Coarse	1 - 2	S	9
Very Fine	2 - 4		12
Fine	4 - 5.7	G	3
Fine	5.7 - 8	R	2
Medium	8 - 11.3	A	3
Medium	11.3 - 16	V	2
Coarse	16 - 22.6	E	7
Coarse	22.6 - 32	L	7
Very Coarse	32 - 45	S	11
Very Coarse	45 - 64		4
Small	64 - 90	C	10
Small	90 - 128	O	11
Large	128 - 180	B	8
Large	180 - 256	L	2
Small	256 - 362	B	
Small	362 - 512	L	
Medium	512 - 1024	D	
Lrg- Very Lrg	1024 - 2048	R	
Bedrock	>2048	BDRK	
		<b>Total</b>	103

Size (mm)	
D16	1.4
D35	6
D50	24
D65	44
D84	100
D95	160

Size Distribution	
mean	11.8
dispersion	10.7
skewness	-0.23

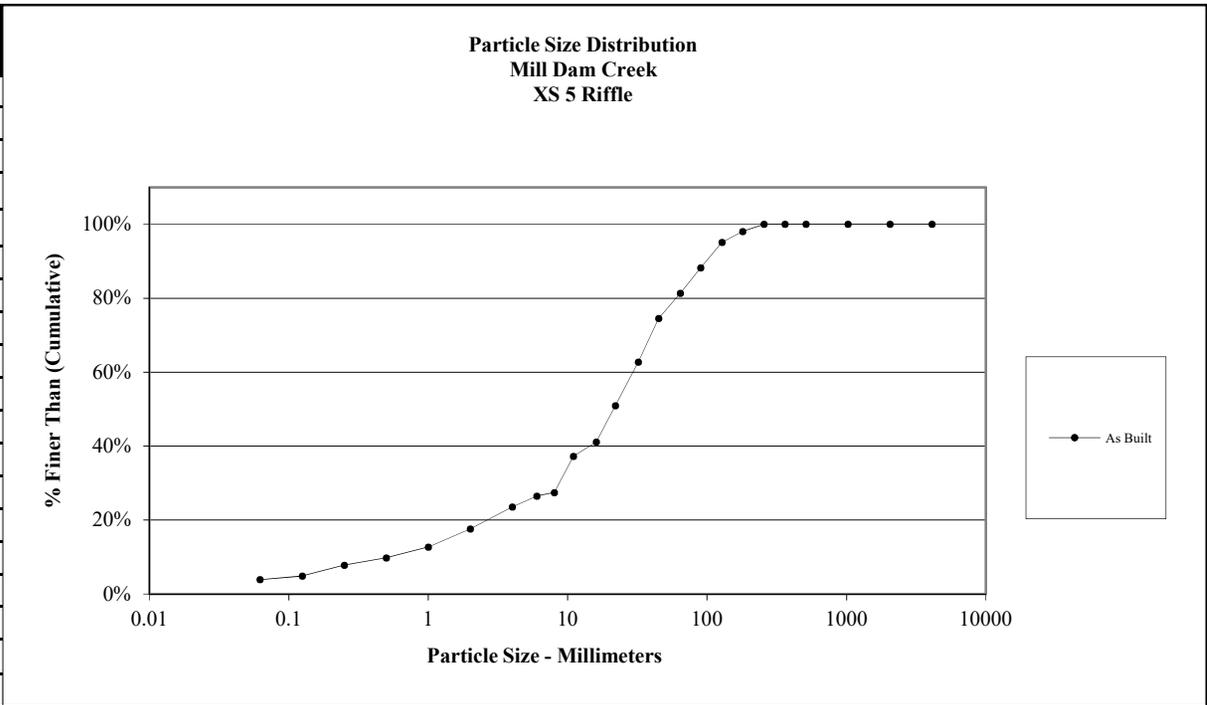
Cross-Section 5 Riffle - MY-00			
Particle	Millimeter		Count
Silt/Clay	< 0.062	S/C	4
Very Fine	.062 - .125	S	1
Fine	.125 - .25	A	3
Medium	.25 - .50	N	2
Coarse	.50 - 1	D	3
Very Coarse	1 - 2	S	5
Very Fine	2 - 4		6
Fine	4 - 5.7	G	3
Fine	5.7 - 8	R	1
Medium	8 - 11.3	A	10
Medium	11.3 - 16	V	4
Coarse	16 - 22.6	E	10
Coarse	22.6 - 32	L	12
Very Coarse	32 - 45	S	12
Very Coarse	45 - 64		7
Small	64 - 90	C	7
Small	90 - 128	O	7
Large	128 - 180	B	3
Large	180 - 256	L	2
Small	256 - 362	B	
Small	362 - 512	L	
Medium	512 - 1024	D	
Lrg- Very Lrg	1024 - 2048	R	
Bedrock	>2048	BDRK	
		<b>Total</b>	102
Note:

Size (mm)	
D16	1.6
D35	10
D50	21
D65	34
D84	73
D95	130

Size Distribution	
mean	10.8
dispersion	8.3
skewness	-0.22

Type	
silt/clay	4%
sand	14%
gravel	64%
cobble	19%
boulder	0%
bedrock	0%
hardpan	0%
wood/det	0%
artificial	0%

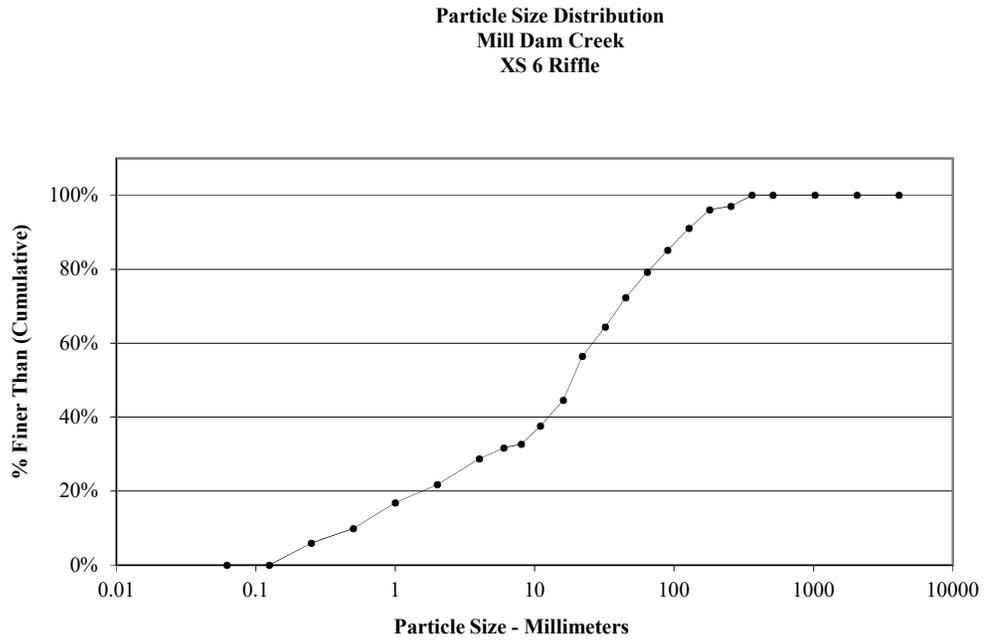
Cross-Section 6 Riffle - MY-00			
Particle	Millimeter		Count
Silt/Clay	< 0.062	S/C	
Very Fine	.062 - .125	S	
Fine	.125 - .25	A	6
Medium	.25 - .50	N	4
Coarse	.50 - 1	D	7
Very Coarse	1 - 2	S	5
Very Fine	2 - 4		7
Fine	4 - 5.7	G	3
Fine	5.7 - 8	R	1
Medium	8 - 11.3	A	5
Medium	11.3 - 16	V	7
Coarse	16 - 22.6	E	12
Coarse	22.6 - 32	L	8
Very Coarse	32 - 45	S	8
Very Coarse	45 - 64		7
Small	64 - 90	C	6
Small	90 - 128	O	6
Large	128 - 180	B	5
Large	180 - 256	L	1
Small	256 - 362	B	3
Small	362 - 512	L	
Medium	512 - 1024	D	
Lrg- Very Lrg	1024 - 2048	R	
Bedrock	>2048	BDRK	
		<b>Total</b>	101

Size (mm)	
D16	0.92
D35	9.3
D50	19
D65	33
D84	84
D95	170

Size Distribution	
mean	8.8
dispersion	12.5
skewness	-0.24

Type	
silt/clay	0%
sand	22%
gravel	57%
cobble	18%
boulder	3%
bedrock	0%
hardpan	0%
wood/det	0%
artificial	0%

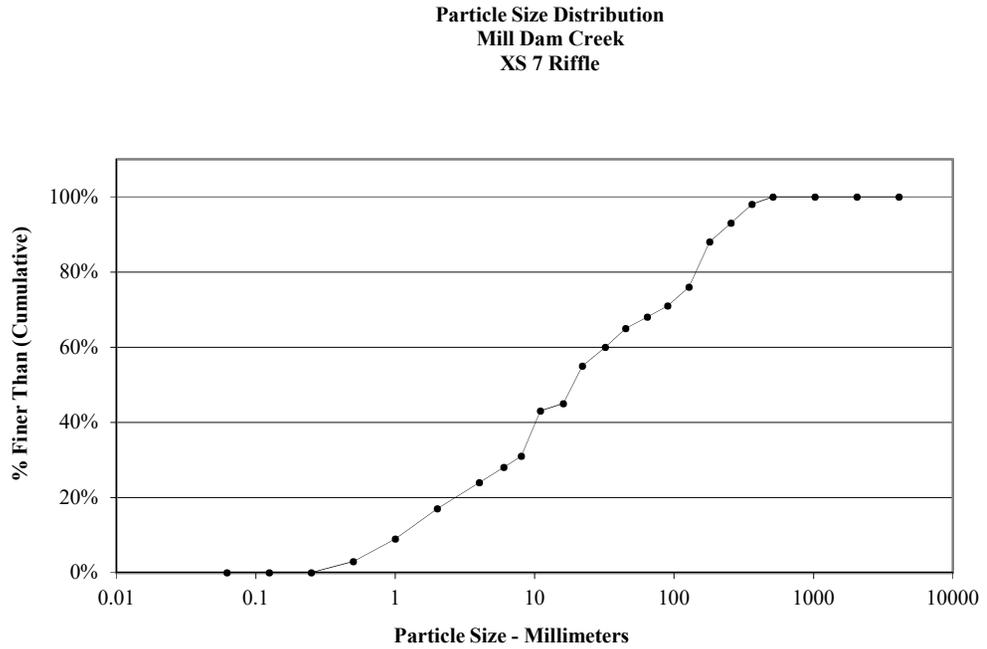
Cross-Section 7 Riffle -MY-00			
Particle	Millimeter		Count
Silt/Clay	< 0.062	S/C	
Very Fine	.062 - .125	S	
Fine	.125 - .25	A	
Medium	.25 - .50	N	3
Coarse	.50 - 1	D	6
Very Coarse	1 - 2	S	8
Very Fine	2 - 4		7
Fine	4 - 5.7	G	4
Fine	5.7 - 8	R	3
Medium	8 - 11.3	A	12
Medium	11.3 - 16	V	2
Coarse	16 - 22.6	E	10
Coarse	22.6 - 32	L	5
Very Coarse	32 - 45	S	5
Very Coarse	45 - 64		3
Small	64 - 90	C	3
Small	90 - 128	O	5
Large	128 - 180	B	12
Large	180 - 256	L	5
Small	256 - 362	B	5
Small	362 - 512	L	2
Medium	512 - 1024	D	
Lrg- Very Lrg	1024 - 2048	R	
Bedrock	>2048	BDRK	
		<b>Total</b>	100

Size (mm)	
D16	1.8
D35	8.9
D50	19
D65	45
D84	160
D95	290

Size Distribution	
mean	17.0
dispersion	9.5
skewness	-0.04

Type	
silt/clay	0%
sand	17%
gravel	51%
cobble	20%
boulder	7%
bedrock	0%
hardpan	0%
wood/det	0%
artificial	0%

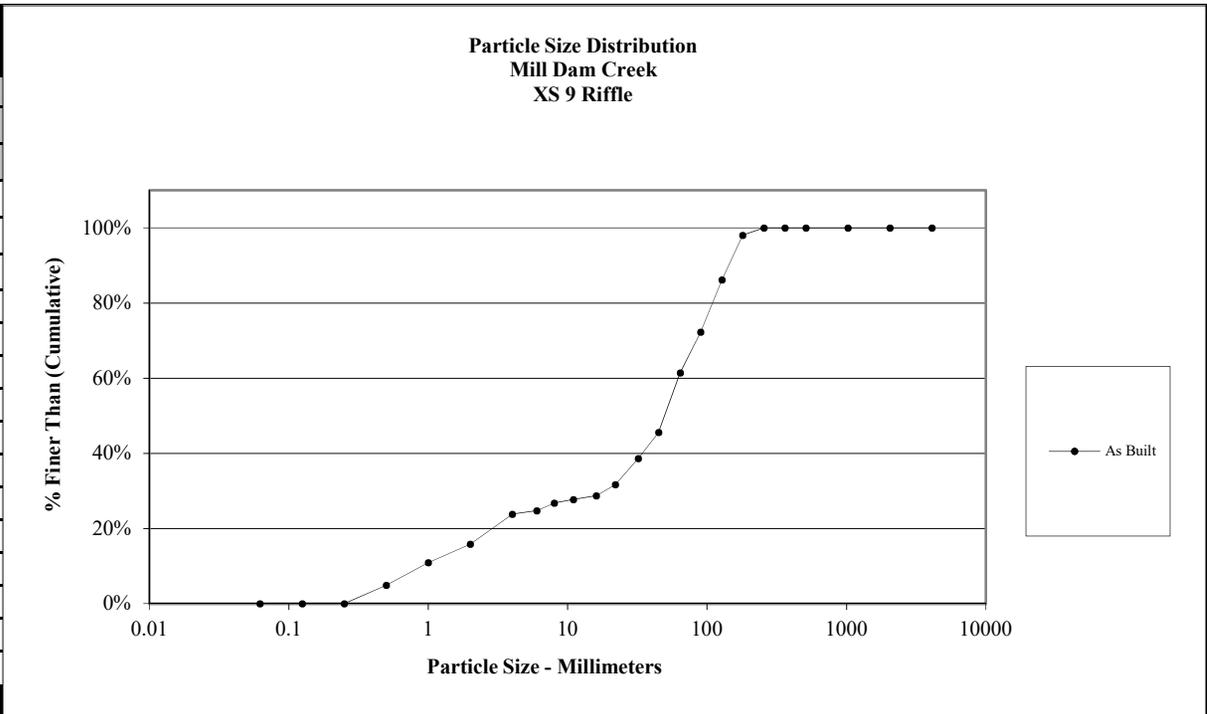
Cross-Section 9 Riffle - MY-00			
Particle	Millimeter		Count
Silt/Clay	< 0.062	S/C	
Very Fine	.062 - .125	S	
Fine	.125 - .25	A	
Medium	.25 - .50	N	5
Coarse	.50 - 1	D	6
Very Coarse	1 - 2	S	5
Very Fine	2 - 4		8
Fine	4 - 5.7	G	1
Fine	5.7 - 8	R	2
Medium	8 - 11.3	A	1
Medium	11.3 - 16	V	1
Coarse	16 - 22.6	E	3
Coarse	22.6 - 32	L	7
Very Coarse	32 - 45	S	7
Very Coarse	45 - 64		16
Small	64 - 90	C	11
Small	90 - 128	O	14
Large	128 - 180	B	12
Large	180 - 256	L	2
Small	256 - 362	B	
Small	362 - 512	L	
Medium	512 - 1024	D	
Lrg- Very Lrg	1024 - 2048	R	
Bedrock	>2048	BDRK	
		<b>Total</b>	101

Size (mm)	
D16	2
D35	26
D50	50
D65	72
D84	120
D95	170

Size Distribution	
mean	15.5
dispersion	13.7
skewness	-0.38

Type	
silt/clay	0%
sand	16%
gravel	46%
cobble	37%
boulder	0%
bedrock	0%
hardpan	0%
wood/det	0%
artificial	0%

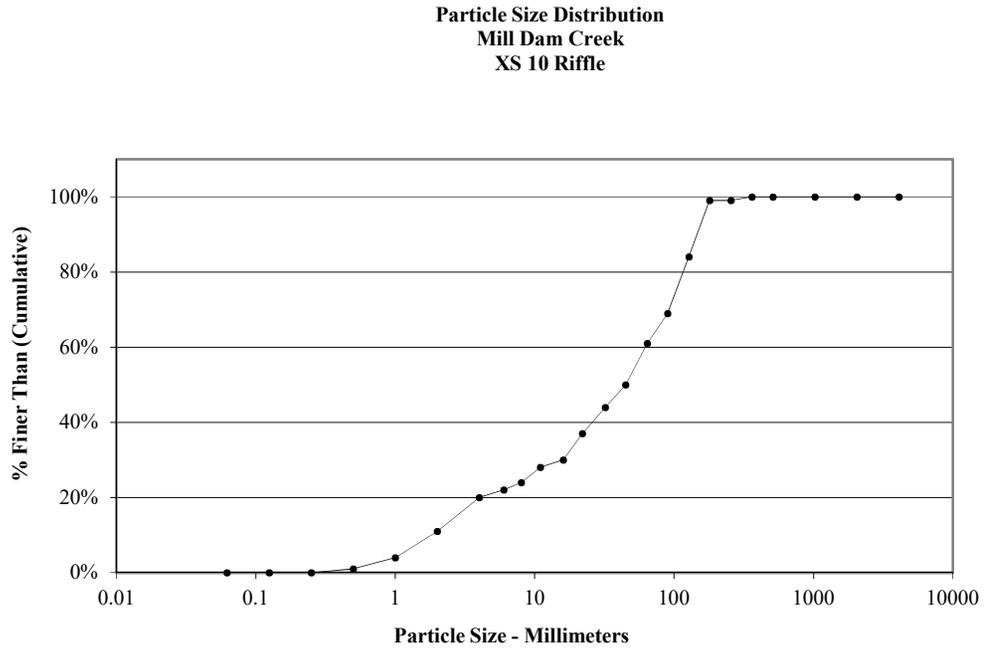
Cross-Section 10 Riffle - MY-00			
Particle	Millimeter		Count
Silt/Clay	< 0.062	S/C	
Very Fine	.062 - .125	S	
Fine	.125 - .25	A	
Medium	.25 - .50	N	1
Coarse	.50 - 1	D	3
Very Coarse	1 - 2	S	7
Very Fine	2 - 4		9
Fine	4 - 5.7	G	2
Fine	5.7 - 8	R	2
Medium	8 - 11.3	A	4
Medium	11.3 - 16	V	2
Coarse	16 - 22.6	E	7
Coarse	22.6 - 32	L	7
Very Coarse	32 - 45	S	6
Very Coarse	45 - 64		11
Small	64 - 90	C	8
Small	90 - 128	O	15
Large	128 - 180	B	15
Large	180 - 256	L	
Small	256 - 362	B	1
Small	362 - 512	L	
Medium	512 - 1024	D	
Lrg- Very Lrg	1024 - 2048	R	
Bedrock	>2048	BDRK	
		<b>Total</b>	100

Size (mm)	
D16	2.9
D35	20
D50	45
D65	76
D84	130
D95	160

Size Distribution	
mean	19.4
dispersion	9.2
skewness	-0.28

Type	
silt/clay	0%
sand	11%
gravel	50%
cobble	38%
boulder	1%
bedrock	0%
hardpan	0%
wood/det	0%
artificial	0%

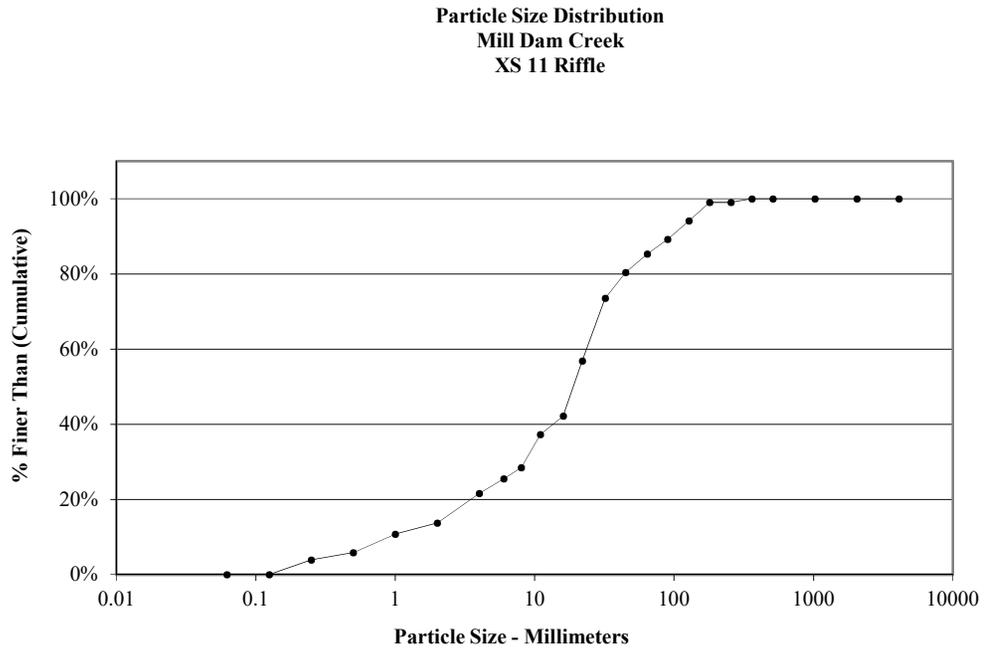
Cross-Section 11 Riffle -MY-00			
Particle	Millimeter		Count
Silt/Clay	< 0.062	S/C	
Very Fine	.062 - .125	S	
Fine	.125 - .25	A	4
Medium	.25 - .50	N	2
Coarse	.50 - 1	D	5
Very Coarse	1 - 2	S	3
Very Fine	2 - 4		8
Fine	4 - 5.7	G	4
Fine	5.7 - 8	R	3
Medium	8 - 11.3	A	9
Medium	11.3 - 16	V	5
Coarse	16 - 22.6	E	15
Coarse	22.6 - 32	L	17
Very Coarse	32 - 45	S	7
Very Coarse	45 - 64		5
Small	64 - 90	C	4
Small	90 - 128	O	5
Large	128 - 180	B	5
Large	180 - 256	L	
Small	256 - 362	B	1
Small	362 - 512	L	
Medium	512 - 1024	D	
Lrg- Very Lrg	1024 - 2048	R	
Bedrock	>2048	BDRK	
		<b>Total</b>	102

Size (mm)	
D16	2.4
D35	10
D50	19
D65	26
D84	58
D95	140

Size Distribution	
mean	11.8
dispersion	5.5
skewness	-0.18

Type	
silt/clay	0%
sand	14%
gravel	72%
cobble	14%
boulder	1%
bedrock	0%
hardpan	0%
wood/det	0%
artificial	0%

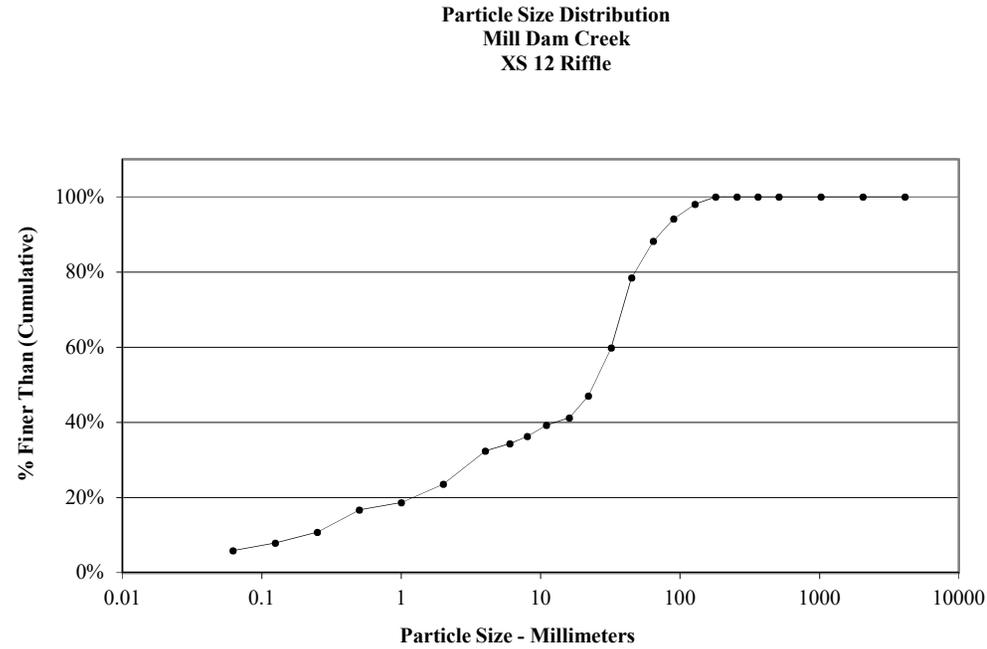
Cross-Section 12 Riffle - MY-00			
Particle	Millimeter		Count
Silt/Clay	< 0.062	S/C	
Very Fine	.062 - .125	S	2
Fine	.125 - .25	A	2
Medium	.25 - .50	N	
Coarse	.50 - 1	D	3
Very Coarse	1 - 2	S	6
Very Fine	2 - 4		14
Fine	4 - 5.7	G	3
Fine	5.7 - 8	R	2
Medium	8 - 11.3	A	6
Medium	11.3 - 16	V	5
Coarse	16 - 22.6	E	16
Coarse	22.6 - 32	L	17
Very Coarse	32 - 45	S	12
Very Coarse	45 - 64		9
Small	64 - 90	C	5
Small	90 - 128	O	1
Large	128 - 180	B	3
Large	180 - 256	L	
Small	256 - 362	B	1
Small	362 - 512	L	
Medium	512 - 1024	D	
Lrg- Very Lrg	1024 - 2048	R	
Bedrock	>2048	BDRK	
		<b>Total</b>	107

Size (mm)	
D16	2.5
D35	11
D50	20
D65	28
D84	48
D95	88

Size Distribution	
mean	11.0
dispersion	5.2
skewness	-0.23

Type	
silt/clay	0%
sand	12%
gravel	79%
cobble	8%
boulder	1%
bedrock	0%
hardpan	0%
wood/det	0%
artificial	0%

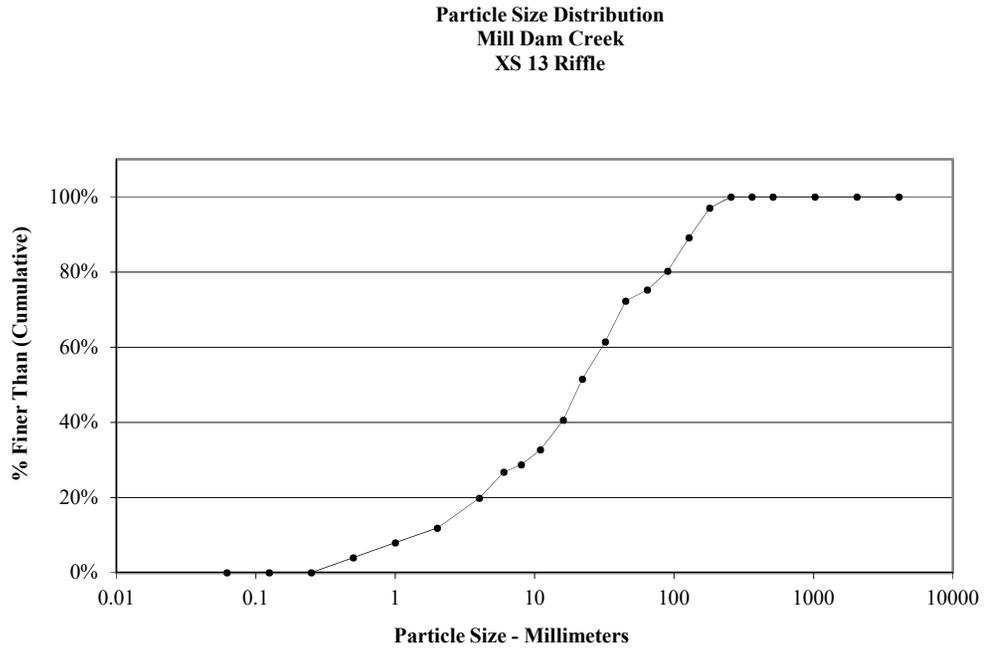
Cross-Section 13 Riffle - MY-00			
Particle	Millimeter		Count
Silt/Clay	< 0.062	S/C	
Very Fine	.062 - .125	S	
Fine	.125 - .25	A	
Medium	.25 - .50	N	4
Coarse	.50 - 1	D	4
Very Coarse	1 - 2	S	4
Very Fine	2 - 4		8
Fine	4 - 5.7	G	7
Fine	5.7 - 8	R	2
Medium	8 - 11.3	A	4
Medium	11.3 - 16	V	8
Coarse	16 - 22.6	E	11
Coarse	22.6 - 32	L	10
Very Coarse	32 - 45	S	11
Very Coarse	45 - 64		3
Small	64 - 90	C	5
Small	90 - 128	O	9
Large	128 - 180	B	8
Large	180 - 256	L	3
Small	256 - 362	B	
Small	362 - 512	L	
Medium	512 - 1024	D	
Lrg- Very Lrg	1024 - 2048	R	
Bedrock	>2048	BDRK	
		<b>Total</b>	101

Size (mm)	
D16	2.9
D35	12
D50	21
D65	36
D84	100
D95	160

Size Distribution	
mean	17.0
dispersion	6.0
skewness	-0.07

Type	
silt/clay	0%
sand	12%
gravel	63%
cobble	25%
boulder	0%
bedrock	0%
hardpan	0%
wood/det	0%
artificial	0%

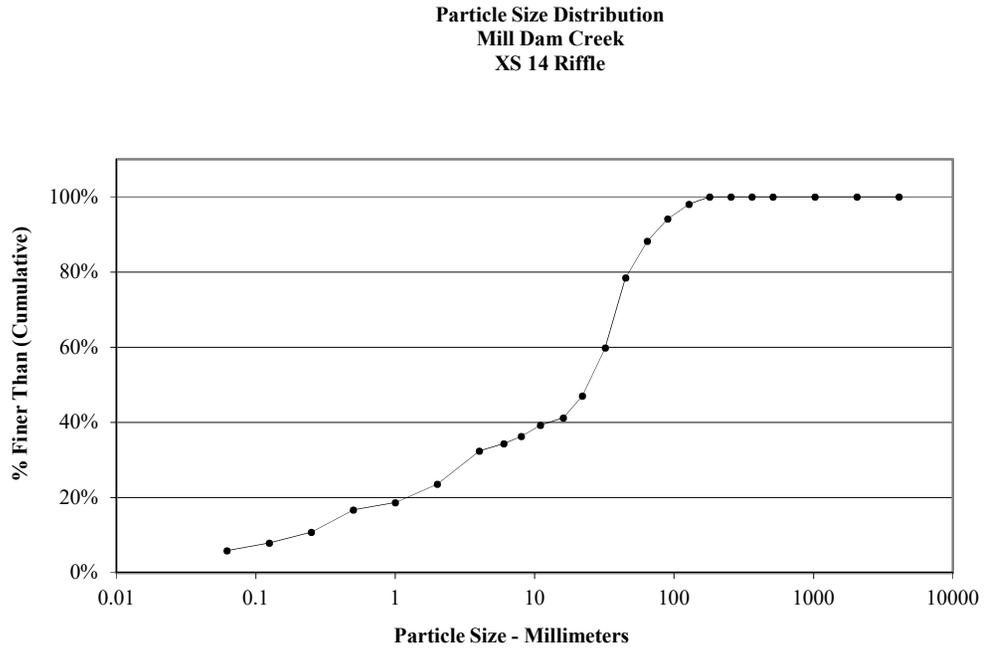
Cross-Section 14 Riffle - MY-00			
Particle	Millimeter		Count
Silt/Clay	< 0.062	S/C	6
Very Fine	.062 - .125	S	2
Fine	.125 - .25	A	3
Medium	.25 - .50	N	6
Coarse	.50 - 1	D	2
Very Coarse	1 - 2	S	5
Very Fine	2 - 4		9
Fine	4 - 5.7	G	2
Fine	5.7 - 8	R	2
Medium	8 - 11.3	A	3
Medium	11.3 - 16	V	2
Coarse	16 - 22.6	E	6
Coarse	22.6 - 32	L	13
Very Coarse	32 - 45	S	19
Very Coarse	45 - 64		10
Small	64 - 90	C	6
Small	90 - 128	O	4
Large	128 - 180	B	2
Large	180 - 256	L	
Small	256 - 362	B	
Small	362 - 512	L	
Medium	512 - 1024	D	
Lrg- Very Lrg	1024 - 2048	R	
Bedrock	>2048	BDRK	
		<b>Total</b>	102

Size (mm)	
D16	0.46
D35	6.6
D50	24
D65	35
D84	55
D95	97

Size Distribution	
mean	5.0
dispersion	27.2
skewness	-0.47

Type	
silt/clay	6%
sand	18%
gravel	65%
cobble	12%
boulder	0%
bedrock	0%
hardpan	0%
wood/det	0%
artificial	0%

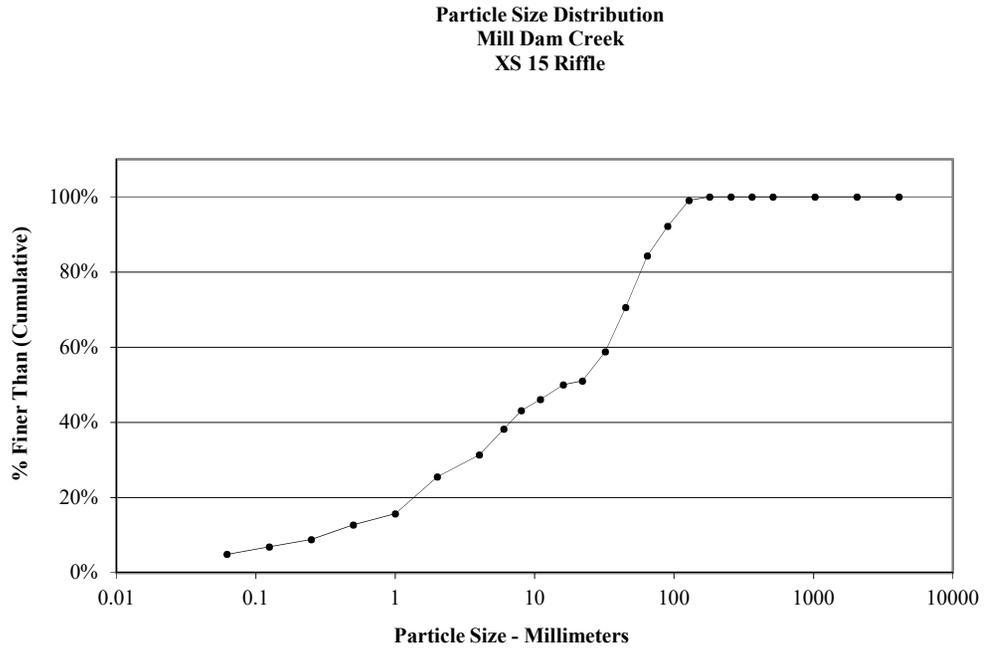
Cross-Section 15 Riffle - MY-00			
Particle	Millimeter		Count
Silt/Clay	< 0.062	S/C	5
Very Fine	.062 - .125	S	2
Fine	.125 - .25	A	2
Medium	.25 - .50	N	4
Coarse	.50 - 1	D	3
Very Coarse	1 - 2	S	10
Very Fine	2 - 4		6
Fine	4 - 5.7	G	7
Fine	5.7 - 8	R	5
Medium	8 - 11.3	A	3
Medium	11.3 - 16	V	4
Coarse	16 - 22.6	E	1
Coarse	22.6 - 32	L	8
Very Coarse	32 - 45	S	12
Very Coarse	45 - 64		14
Small	64 - 90	C	8
Small	90 - 128	O	7
Large	128 - 180	B	1
Large	180 - 256	L	
Small	256 - 362	B	
Small	362 - 512	L	
Medium	512 - 1024	D	
Lrg- Very Lrg	1024 - 2048	R	
Bedrock	>2048	BDRK	
		<b>Total</b>	102

Size (mm)	
D16	1
D35	5
D50	16
D65	38
D84	63
D95	100

Size Distribution	
mean	7.9
dispersion	10.0
skewness	-0.23

Type	
silt/clay	5%
sand	21%
gravel	59%
cobble	16%
boulder	0%
bedrock	0%
hardpan	0%
wood/det	0%
artificial	0%

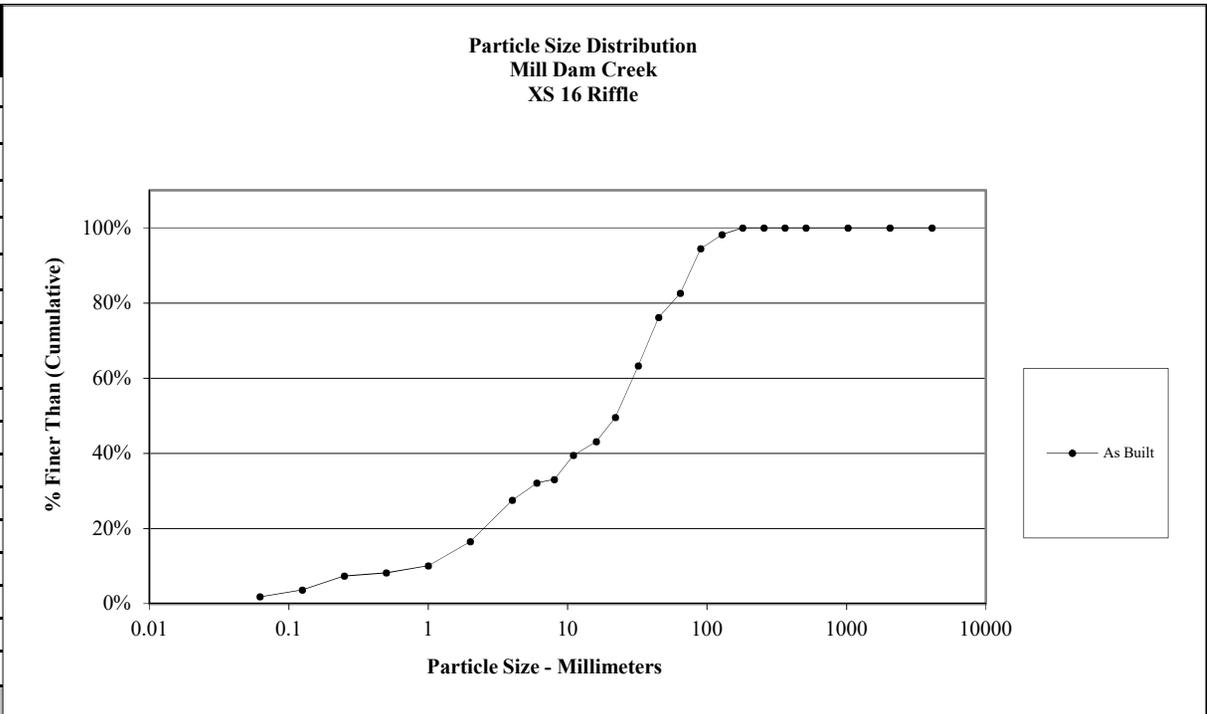
Cross-Section 16 Riffle - MY-00			
Particle	Millimeter		Count
Silt/Clay	< 0.062	S/C	2
Very Fine	.062 - .125	S	2
Fine	.125 - .25	A	4
Medium	.25 - .50	N	1
Coarse	.50 - 1	D	2
Very Coarse	1 - 2	S	7
Very Fine	2 - 4		12
Fine	4 - 5.7	G	5
Fine	5.7 - 8	R	1
Medium	8 - 11.3	A	7
Medium	11.3 - 16	V	4
Coarse	16 - 22.6	E	7
Coarse	22.6 - 32	L	15
Very Coarse	32 - 45	S	14
Very Coarse	45 - 64		7
Small	64 - 90	C	13
Small	90 - 128	O	4
Large	128 - 180	B	2
Large	180 - 256	L	
Small	256 - 362	B	
Small	362 - 512	L	
Medium	512 - 1024	D	
Lrg- Very Lrg	1024 - 2048	R	
Bedrock	>2048	BDRK	
		<b>Total</b>	109

Size (mm)	
D16	1.9
D35	8.8
D50	22
D65	33
D84	67
D95	94

Size Distribution	
mean	11.3
dispersion	7.3
skewness	-0.23

Type	
silt/clay	2%
sand	15%
gravel	66%
cobble	17%
boulder	0%
bedrock	0%
hardpan	0%
wood/det	0%
artificial	0%

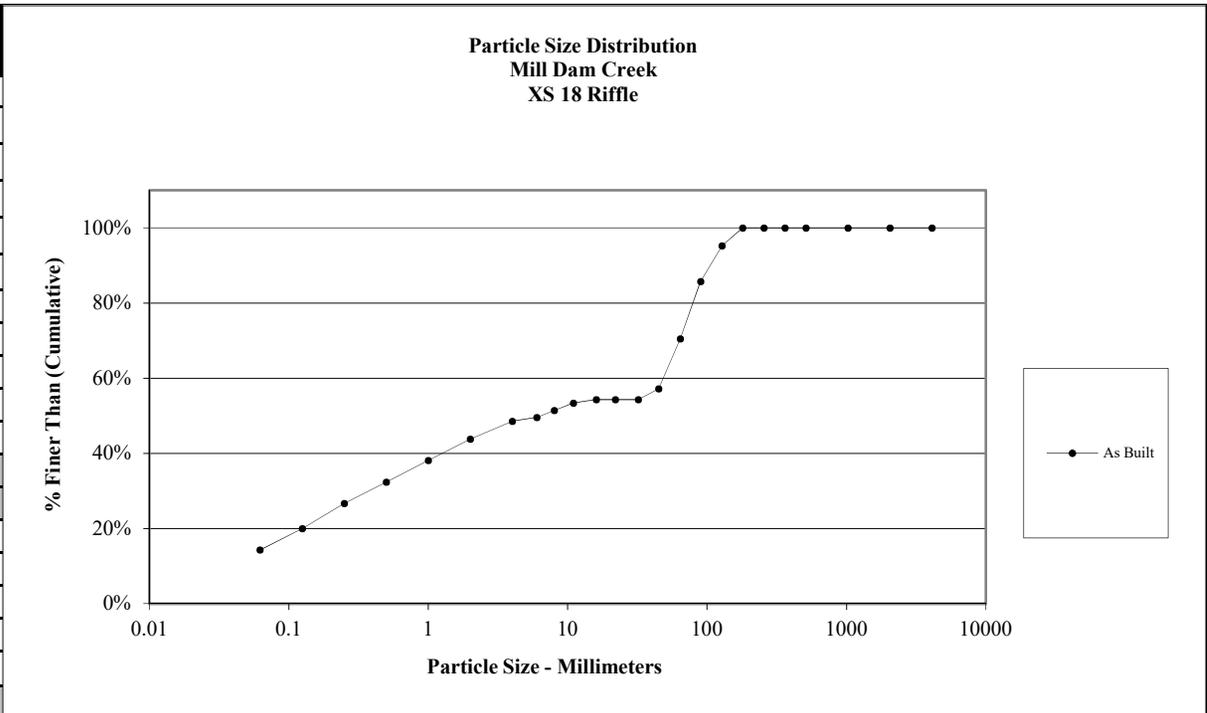
Cross-Section 18 Riffle - MY-00			
Particle	Millimeter		Count
Silt/Clay	< 0.062	S/C	15
Very Fine	.062 - .125	S	6
Fine	.125 - .25	A	7
Medium	.25 - .50	N	6
Coarse	.50 - 1	D	6
Very Coarse	1 - 2	S	6
Very Fine	2 - 4		5
Fine	4 - 5.7	G	1
Fine	5.7 - 8	R	2
Medium	8 - 11.3	A	2
Medium	11.3 - 16	V	1
Coarse	16 - 22.6	E	
Coarse	22.6 - 32	L	
Very Coarse	32 - 45	S	3
Very Coarse	45 - 64		14
Small	64 - 90	C	16
Small	90 - 128	O	10
Large	128 - 180	B	5
Large	180 - 256	L	
Small	256 - 362	B	
Small	362 - 512	L	
Medium	512 - 1024	D	
Lrg- Very Lrg	1024 - 2048	R	
Bedrock	>2048	BDRK	
		<b>Total</b>	105

Size (mm)	
D16	0.077
D35	0.69
D50	6.4
D65	55
D84	87
D95	130

Size Distribution	
mean	2.6
dispersion	48.4
skewness	-0.23

Type	
silt/clay	14%
sand	30%
gravel	27%
cobble	30%
boulder	0%
bedrock	0%
hardpan	0%
wood/det	0%
artificial	0%

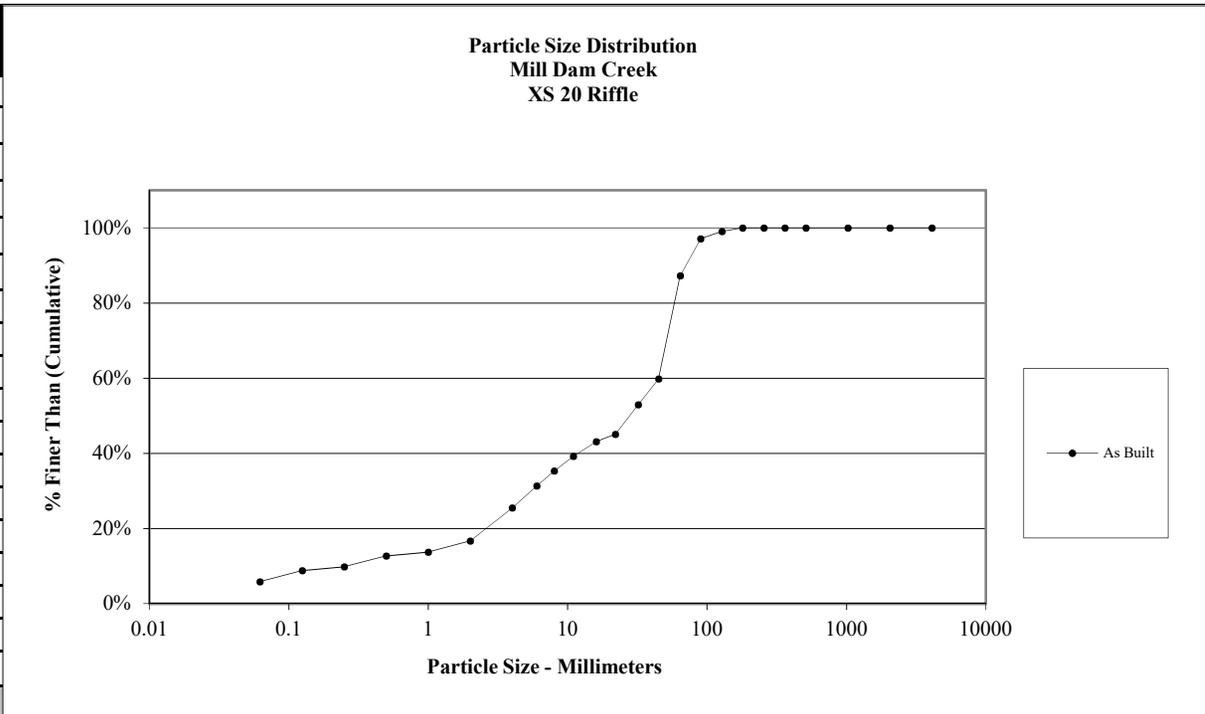
Cross-Section 20 Riffle - MY-00			
Particle	Millimeter		Count
Silt/Clay	< 0.062	S/C	6
Very Fine	.062 - .125	S	3
Fine	.125 - .25	A	1
Medium	.25 - .50	N	3
Coarse	.50 - 1	D	1
Very Coarse	1 - 2	S	3
Very Fine	2 - 4		9
Fine	4 - 5.7	G	6
Fine	5.7 - 8	R	4
Medium	8 - 11.3	A	4
Medium	11.3 - 16	V	4
Coarse	16 - 22.6	E	2
Coarse	22.6 - 32	L	8
Very Coarse	32 - 45	S	7
Very Coarse	45 - 64		28
Small	64 - 90	C	10
Small	90 - 128	O	2
Large	128 - 180	B	1
Large	180 - 256	L	
Small	256 - 362	B	
Small	362 - 512	L	
Medium	512 - 1024	D	
Lrg- Very Lrg	1024 - 2048	R	
Bedrock	>2048	BDRK	
		<b>Total</b>	102

Size (mm)	
D16	1.7
D35	7.8
D50	28
D65	48
D84	61
D95	84

Size Distribution	
mean	10.2
dispersion	9.3
skewness	-0.35

Type	
silt/clay	6%
sand	11%
gravel	71%
cobble	13%
boulder	0%
bedrock	0%
hardpan	0%
wood/det	0%
artificial	0%

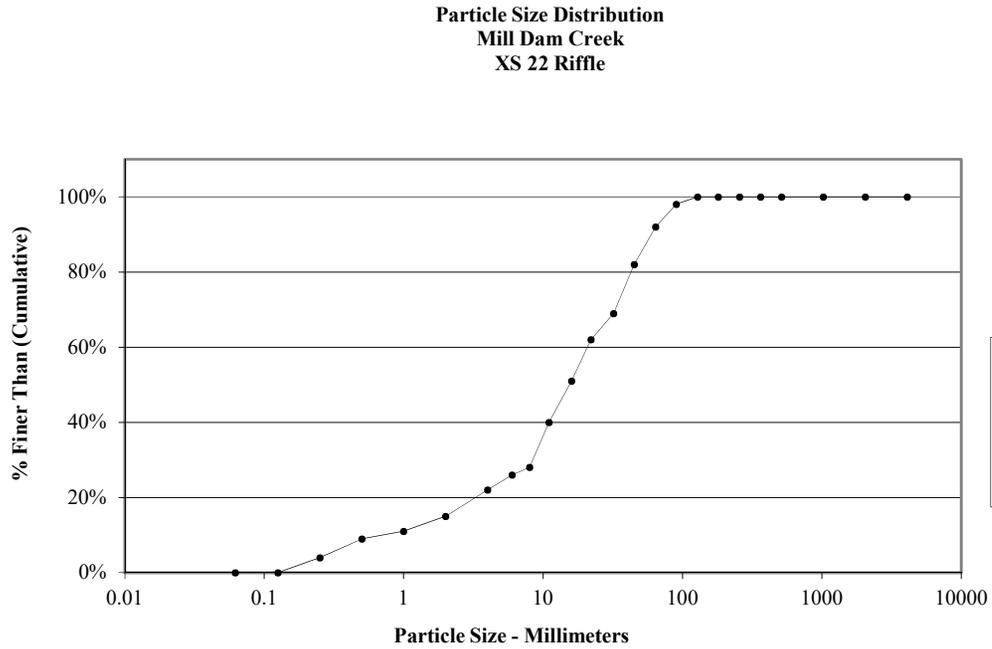
Cross-Section 22 Riffle - MY-00			
Particle	Millimeter		Count
Silt/Clay	< 0.062	S/C	
Very Fine	.062 - .125	S	
Fine	.125 - .25	A	4
Medium	.25 - .50	N	5
Coarse	.50 - 1	D	2
Very Coarse	1 - 2	S	4
Very Fine	2 - 4		7
Fine	4 - 5.7	G	4
Fine	5.7 - 8	R	2
Medium	8 - 11.3	A	12
Medium	11.3 - 16	V	11
Coarse	16 - 22.6	E	11
Coarse	22.6 - 32	L	7
Very Coarse	32 - 45	S	13
Very Coarse	45 - 64		10
Small	64 - 90	C	6
Small	90 - 128	O	2
Large	128 - 180	B	
Large	180 - 256	L	
Small	256 - 362	B	
Small	362 - 512	L	
Medium	512 - 1024	D	
Lrg- Very Lrg	1024 - 2048	R	
Bedrock	>2048	BDRK	
		<b>Total</b>	100

Size (mm)	
D16	2.2
D35	9.6
D50	15
D65	26
D84	48
D95	76

Size Distribution	
mean	10.3
dispersion	5.0
skewness	-0.14

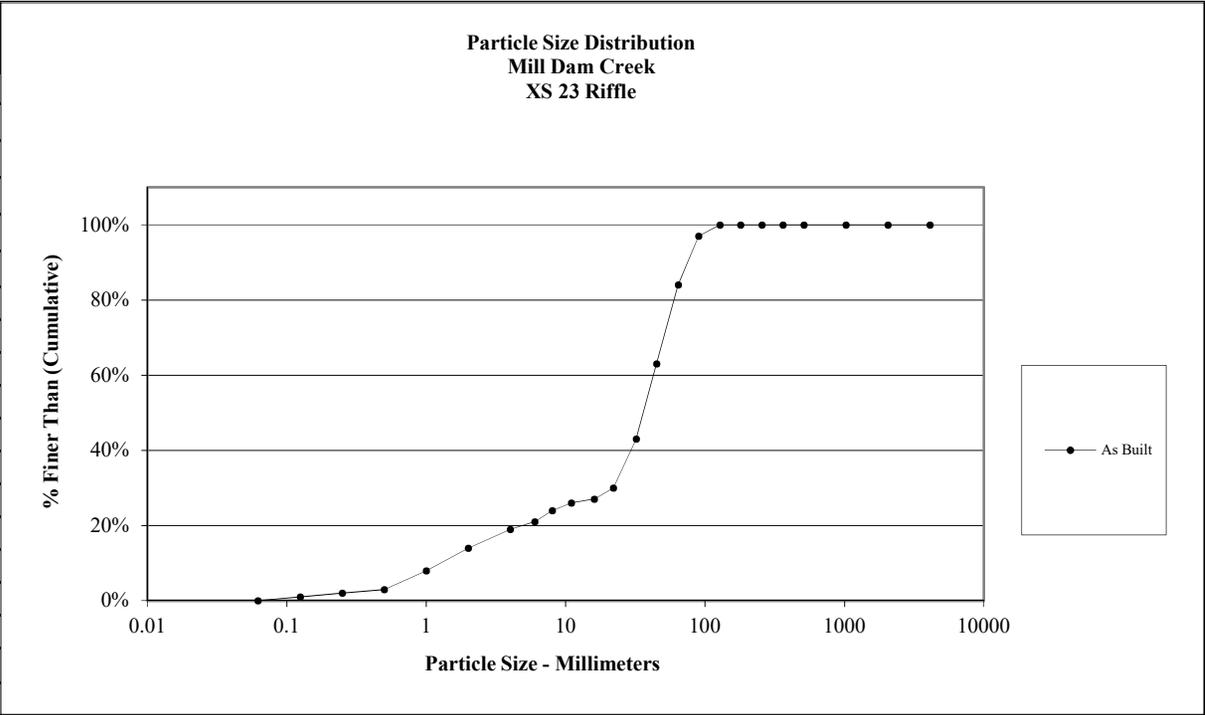
Cross-Section 23 Riffle - MY-00			
Particle	Millimeter		Count
Silt/Clay	< 0.062	S/C	
Very Fine	.062 - .125	S	1
Fine	.125 - .25	A	1
Medium	.25 - .50	N	1
Coarse	.50 - 1	D	5
Very Coarse	1 - 2	S	6
Very Fine	2 - 4		5
Fine	4 - 5.7	G	2
Fine	5.7 - 8	R	3
Medium	8 - 11.3	A	2
Medium	11.3 - 16	V	1
Coarse	16 - 22.6	E	3
Coarse	22.6 - 32	L	13
Very Coarse	32 - 45	S	20
Very Coarse	45 - 64		21
Small	64 - 90	C	13
Small	90 - 128	O	3
Large	128 - 180	B	
Large	180 - 256	L	
Small	256 - 362	B	
Small	362 - 512	L	
Medium	512 - 1024	D	
Lrg- Very Lrg	1024 - 2048	R	
Bedrock	>2048	BDRK	
		<b>Total</b>	100

Size (mm)	
D16	2.6
D35	25
D50	36
D65	47
D84	64
D95	85

Size Distribution	
mean	12.9
dispersion	7.8
skewness	-0.38

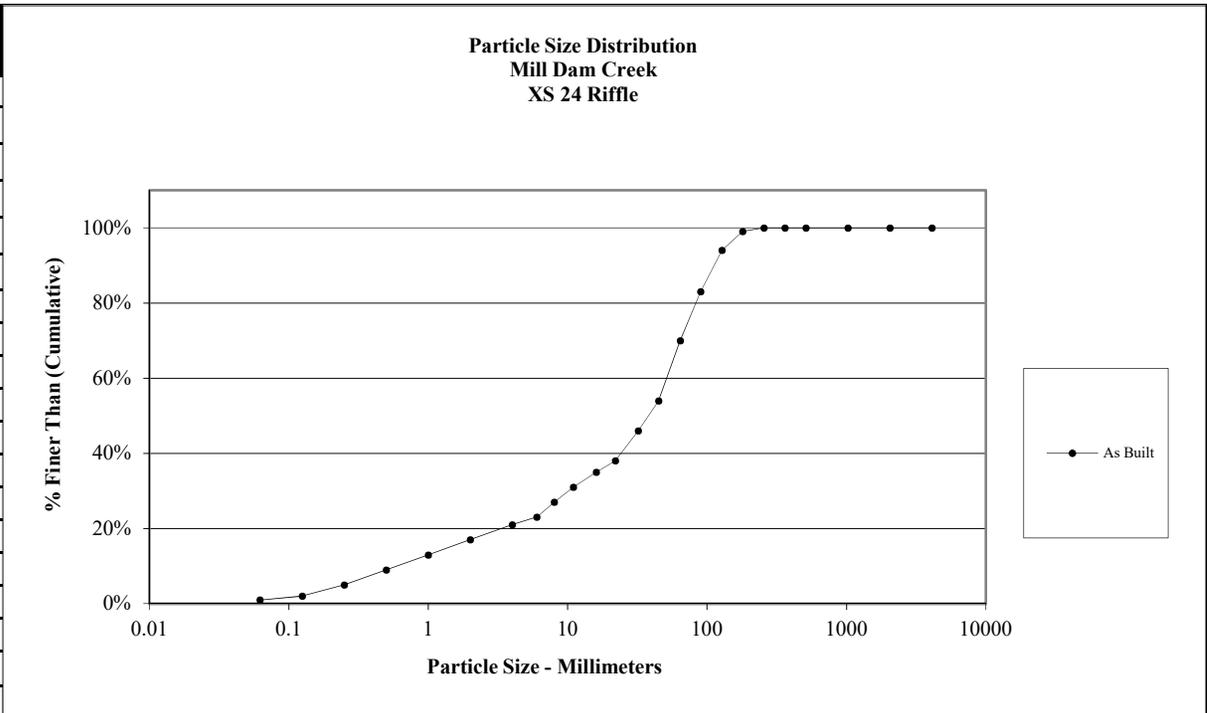
Cross-Section 24 Riffle - MY-00			
Particle	Millimeter		Count
Silt/Clay	< 0.062	S/C	1
Very Fine	.062 - .125	S	1
Fine	.125 - .25	A	3
Medium	.25 - .50	N	4
Coarse	.50 - 1	D	4
Very Coarse	1 - 2	S	4
Very Fine	2 - 4		4
Fine	4 - 5.7	G	2
Fine	5.7 - 8	R	4
Medium	8 - 11.3	A	4
Medium	11.3 - 16	V	4
Coarse	16 - 22.6	E	3
Coarse	22.6 - 32	L	8
Very Coarse	32 - 45	S	8
Very Coarse	45 - 64		16
Small	64 - 90	C	13
Small	90 - 128	O	11
Large	128 - 180	B	5
Large	180 - 256	L	1
Small	256 - 362	B	
Small	362 - 512	L	
Medium	512 - 1024	D	
Lrg- Very Lrg	1024 - 2048	R	
Bedrock	>2048	BDRK	
		<b>Total</b>	100

Size (mm)	
D16	1.7
D35	16
D50	38
D65	57
D84	93
D95	140

Size Distribution	
mean	12.6
dispersion	12.4
skewness	-0.36

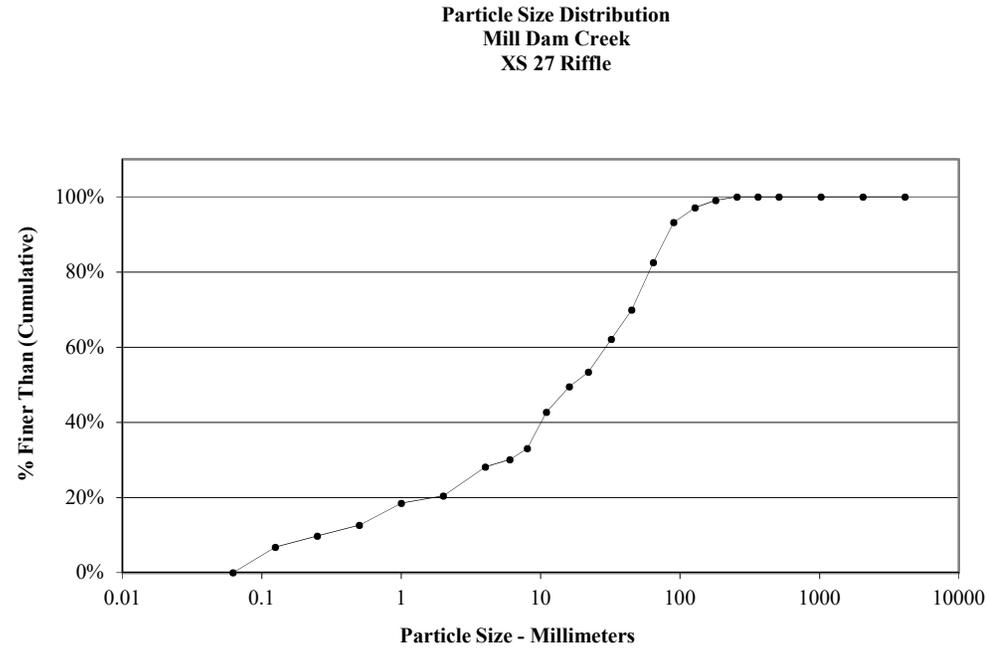
Cross-Section 27 Riffle - MY-00			
Particle	Millimeter		Count
Silt/Clay	< 0.062	S/C	
Very Fine	.062 - .125	S	7
Fine	.125 - .25	A	3
Medium	.25 - .50	N	3
Coarse	.50 - 1	D	6
Very Coarse	1 - 2	S	2
Very Fine	2 - 4		8
Fine	4 - 5.7	G	2
Fine	5.7 - 8	R	3
Medium	8 - 11.3	A	10
Medium	11.3 - 16	V	7
Coarse	16 - 22.6	E	4
Coarse	22.6 - 32	L	9
Very Coarse	32 - 45	S	8
Very Coarse	45 - 64		13
Small	64 - 90	C	11
Small	90 - 128	O	4
Large	128 - 180	B	2
Large	180 - 256	L	1
Small	256 - 362	B	
Small	362 - 512	L	
Medium	512 - 1024	D	
Lrg- Very Lrg	1024 - 2048	R	
Bedrock	>2048	BDRK	
		<b>Total</b>	103

Size (mm)	
D16	0.75
D35	8.5
D50	17
D65	36
D84	67
D95	110

Size Distribution	
mean	7.1
dispersion	13.3
skewness	-0.27

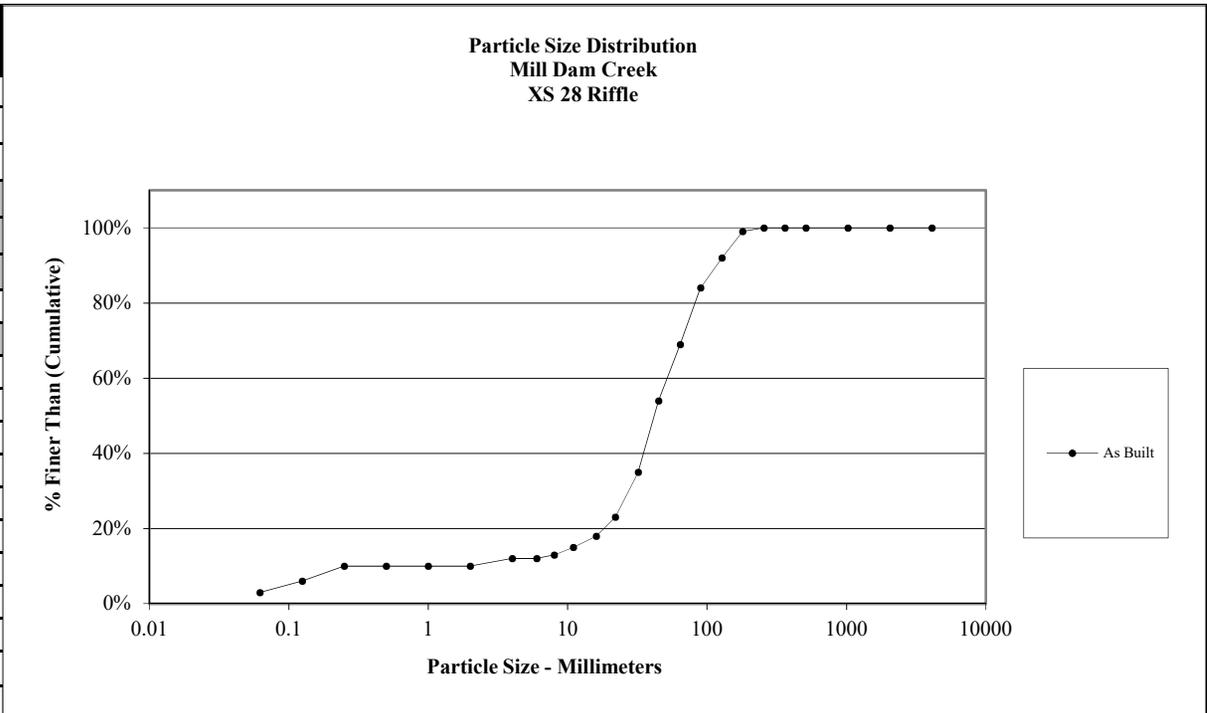
Cross-Section 28 Riffle - MY-00			
Particle	Millimeter		Count
Silt/Clay	< 0.062	S/C	3
Very Fine	.062 - .125	S	3
Fine	.125 - .25	A	4
Medium	.25 - .50	N	
Coarse	.50 - 1	D	
Very Coarse	1 - 2	S	
Very Fine	2 - 4		2
Fine	4 - 5.7	G	
Fine	5.7 - 8	R	1
Medium	8 - 11.3	A	2
Medium	11.3 - 16	V	3
Coarse	16 - 22.6	E	5
Coarse	22.6 - 32	L	12
Very Coarse	32 - 45	S	19
Very Coarse	45 - 64		15
Small	64 - 90	C	15
Small	90 - 128	O	8
Large	128 - 180	B	7
Large	180 - 256	L	1
Small	256 - 362	B	
Small	362 - 512	L	
Medium	512 - 1024	D	
Lrg- Very Lrg	1024 - 2048	R	
Bedrock	>2048	BDRK	
		<b>Total</b>	100

Size (mm)	
D16	12
D35	32
D50	42
D65	58
D84	90
D95	150

Size Distribution	
mean	32.9
dispersion	2.8
skewness	-0.11

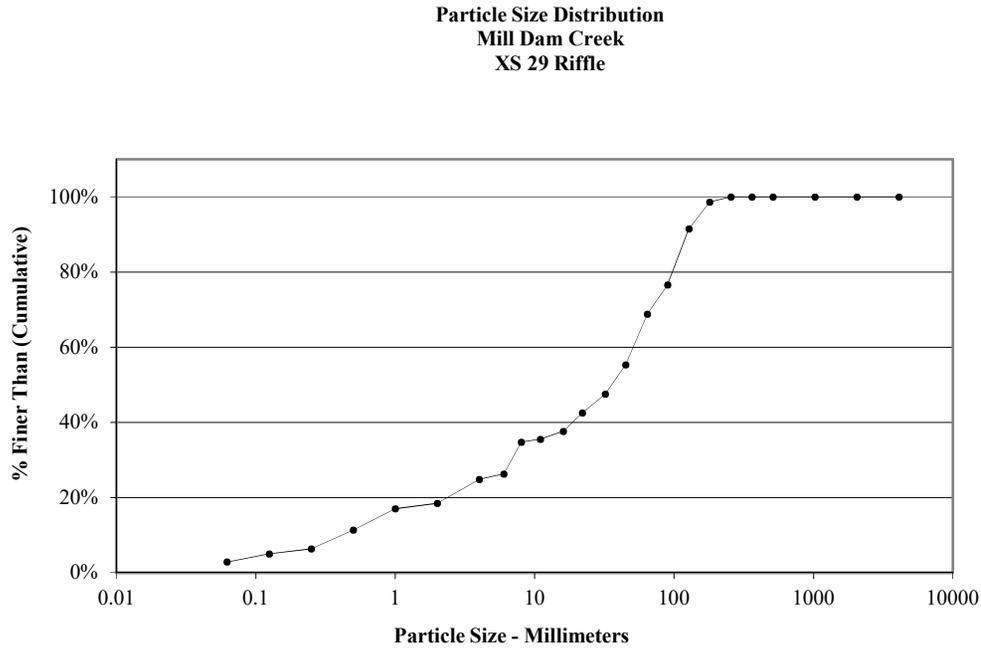
Cross-Section 29 Riffle - MY-00			
Particle	Millimeter		Count
Silt/Clay	< 0.062	S/C	4
Very Fine	.062 - .125	S	3
Fine	.125 - .25	A	2
Medium	.25 - .50	N	7
Coarse	.50 - 1	D	8
Very Coarse	1 - 2	S	2
Very Fine	2 - 4		9
Fine	4 - 5.7	G	2
Fine	5.7 - 8	R	12
Medium	8 - 11.3	A	1
Medium	11.3 - 16	V	3
Coarse	16 - 22.6	E	7
Coarse	22.6 - 32	L	7
Very Coarse	32 - 45	S	11
Very Coarse	45 - 64		19
Small	64 - 90	C	11
Small	90 - 128	O	21
Large	128 - 180	B	10
Large	180 - 256	L	2
Small	256 - 362	B	
Small	362 - 512	L	
Medium	512 - 1024	D	
Lrg- Very Lrg	1024 - 2048	R	
Bedrock	>2048	BDRK	
		<b>Total</b>	141

Size (mm)	
D16	0.88
D35	8.9
D50	36
D65	58
D84	110
D95	150

Size Distribution	
mean	9.8
dispersion	22.0
skewness	-0.39

Type	
silt/clay	3%
sand	16%
gravel	50%
cobble	31%
boulder	0%
bedrock	0%
hardpan	0%
wood/det	0%
artificial	0%

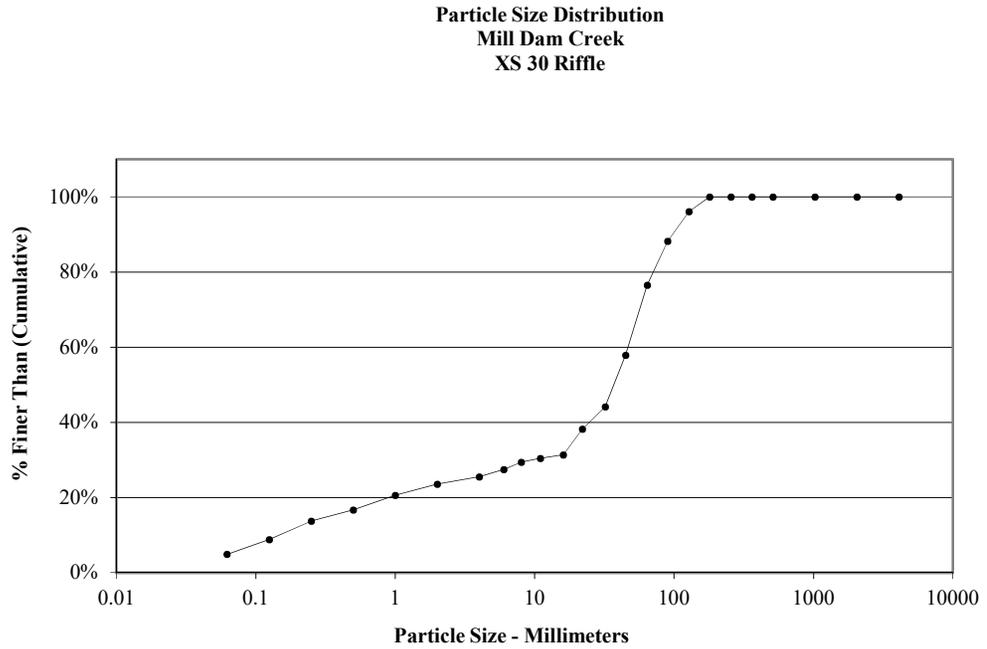
Cross-Section 30 Riffle - MY-00			
Particle	Millimeter		Count
Silt/Clay	< 0.062	S/C	5
Very Fine	.062 - .125	S	4
Fine	.125 - .25	A	5
Medium	.25 - .50	N	3
Coarse	.50 - 1	D	4
Very Coarse	1 - 2	S	3
Very Fine	2 - 4		2
Fine	4 - 5.7	G	2
Fine	5.7 - 8	R	2
Medium	8 - 11.3	A	1
Medium	11.3 - 16	V	1
Coarse	16 - 22.6	E	7
Coarse	22.6 - 32	L	6
Very Coarse	32 - 45	S	14
Very Coarse	45 - 64		19
Small	64 - 90	C	12
Small	90 - 128	O	8
Large	128 - 180	B	4
Large	180 - 256	L	
Small	256 - 362	B	
Small	362 - 512	L	
Medium	512 - 1024	D	
Lrg- Very Lrg	1024 - 2048	R	
Bedrock	>2048	BDRK	
		<b>Total</b>	102

Size (mm)	
D16	0.43
D35	19
D50	37
D65	52
D84	80
D95	120

Size Distribution	
mean	5.9
dispersion	44.1
skewness	-0.53

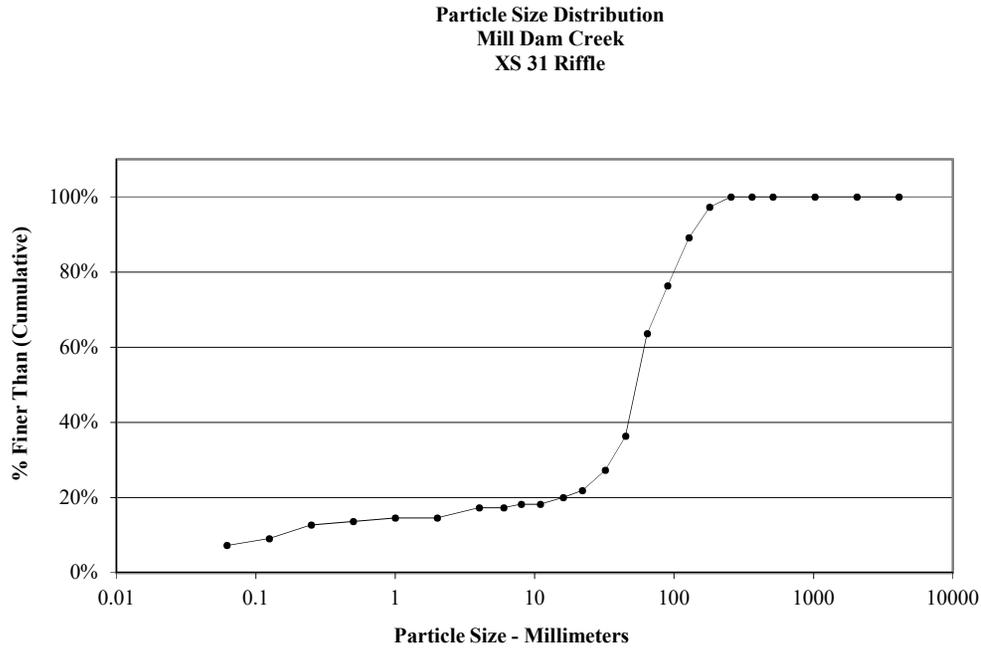
Cross-Section 31 Riffle - MY-00			
Particle	Millimeter		Count
Silt/Clay	< 0.062	S/C	8
Very Fine	.062 - .125	S	2
Fine	.125 - .25	A	4
Medium	.25 - .50	N	1
Coarse	.50 - 1	D	1
Very Coarse	1 - 2	S	
Very Fine	2 - 4		3
Fine	4 - 5.7	G	
Fine	5.7 - 8	R	1
Medium	8 - 11.3	A	
Medium	11.3 - 16	V	2
Coarse	16 - 22.6	E	2
Coarse	22.6 - 32	L	6
Very Coarse	32 - 45	S	10
Very Coarse	45 - 64		30
Small	64 - 90	C	14
Small	90 - 128	O	14
Large	128 - 180	B	9
Large	180 - 256	L	3
Small	256 - 362	B	
Small	362 - 512	L	
Medium	512 - 1024	D	
Lrg- Very Lrg	1024 - 2048	R	
Bedrock	>2048	BDRK	
		<b>Total</b>	110

Size (mm)	
D16	2.9
D35	43
D50	54
D65	66
D84	110
D95	160

Size Distribution	
mean	17.9
dispersion	10.3
skewness	-0.38

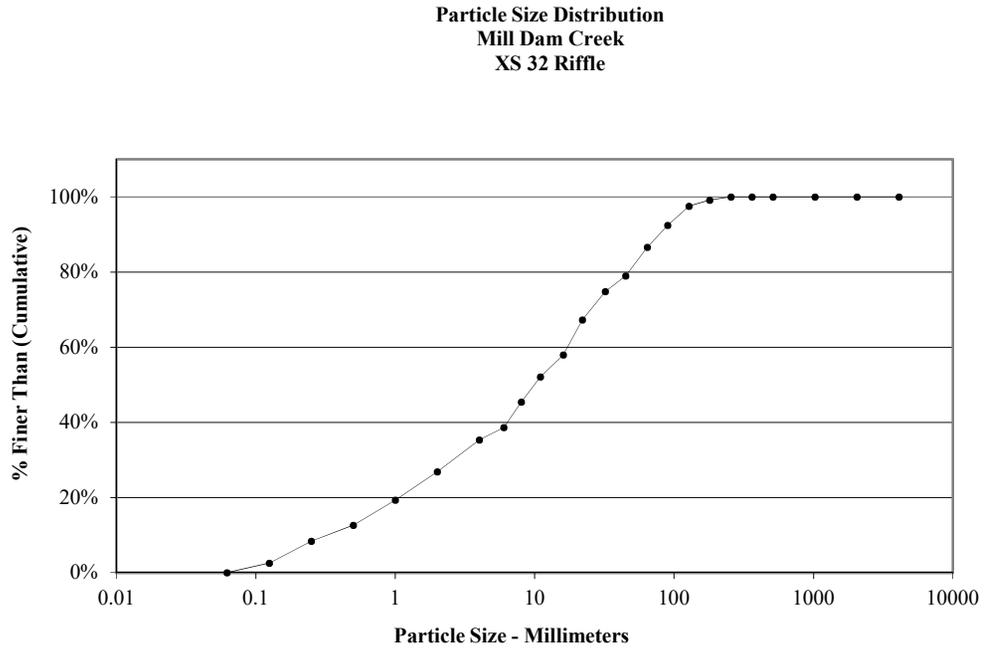
Cross-Section 32 Riffle - MY-00			
Particle	Millimeter		Count
Silt/Clay	< 0.062	S/C	
Very Fine	.062 - .125	S	3
Fine	.125 - .25	A	7
Medium	.25 - .50	N	5
Coarse	.50 - 1	D	8
Very Coarse	1 - 2	S	9
Very Fine	2 - 4		10
Fine	4 - 5.7	G	4
Fine	5.7 - 8	R	8
Medium	8 - 11.3	A	8
Medium	11.3 - 16	V	7
Coarse	16 - 22.6	E	11
Coarse	22.6 - 32	L	9
Very Coarse	32 - 45	S	5
Very Coarse	45 - 64		9
Small	64 - 90	C	7
Small	90 - 128	O	6
Large	128 - 180	B	2
Large	180 - 256	L	1
Small	256 - 362	B	
Small	362 - 512	L	
Medium	512 - 1024	D	
Lrg- Very Lrg	1024 - 2048	R	
Bedrock	>2048	BDRK	
		<b>Total</b>	119

Size (mm)	
D16	0.71
D35	3.9
D50	10
D65	20
D84	57
D95	110

Size Distribution	
mean	6.4
dispersion	9.9
skewness	-0.14
