# **As-built Baseline Monitoring Report**

**Mill Dam Creek Restoration Site  
Yadkin River Basin - 03040101  
Monitoring Year 00  
DEQ Contract 6898  
DMS Project Number 97136**

**DWR #: 18-1349  
USACE Action ID: 2016-01335  
Yadkin County, North Carolina**

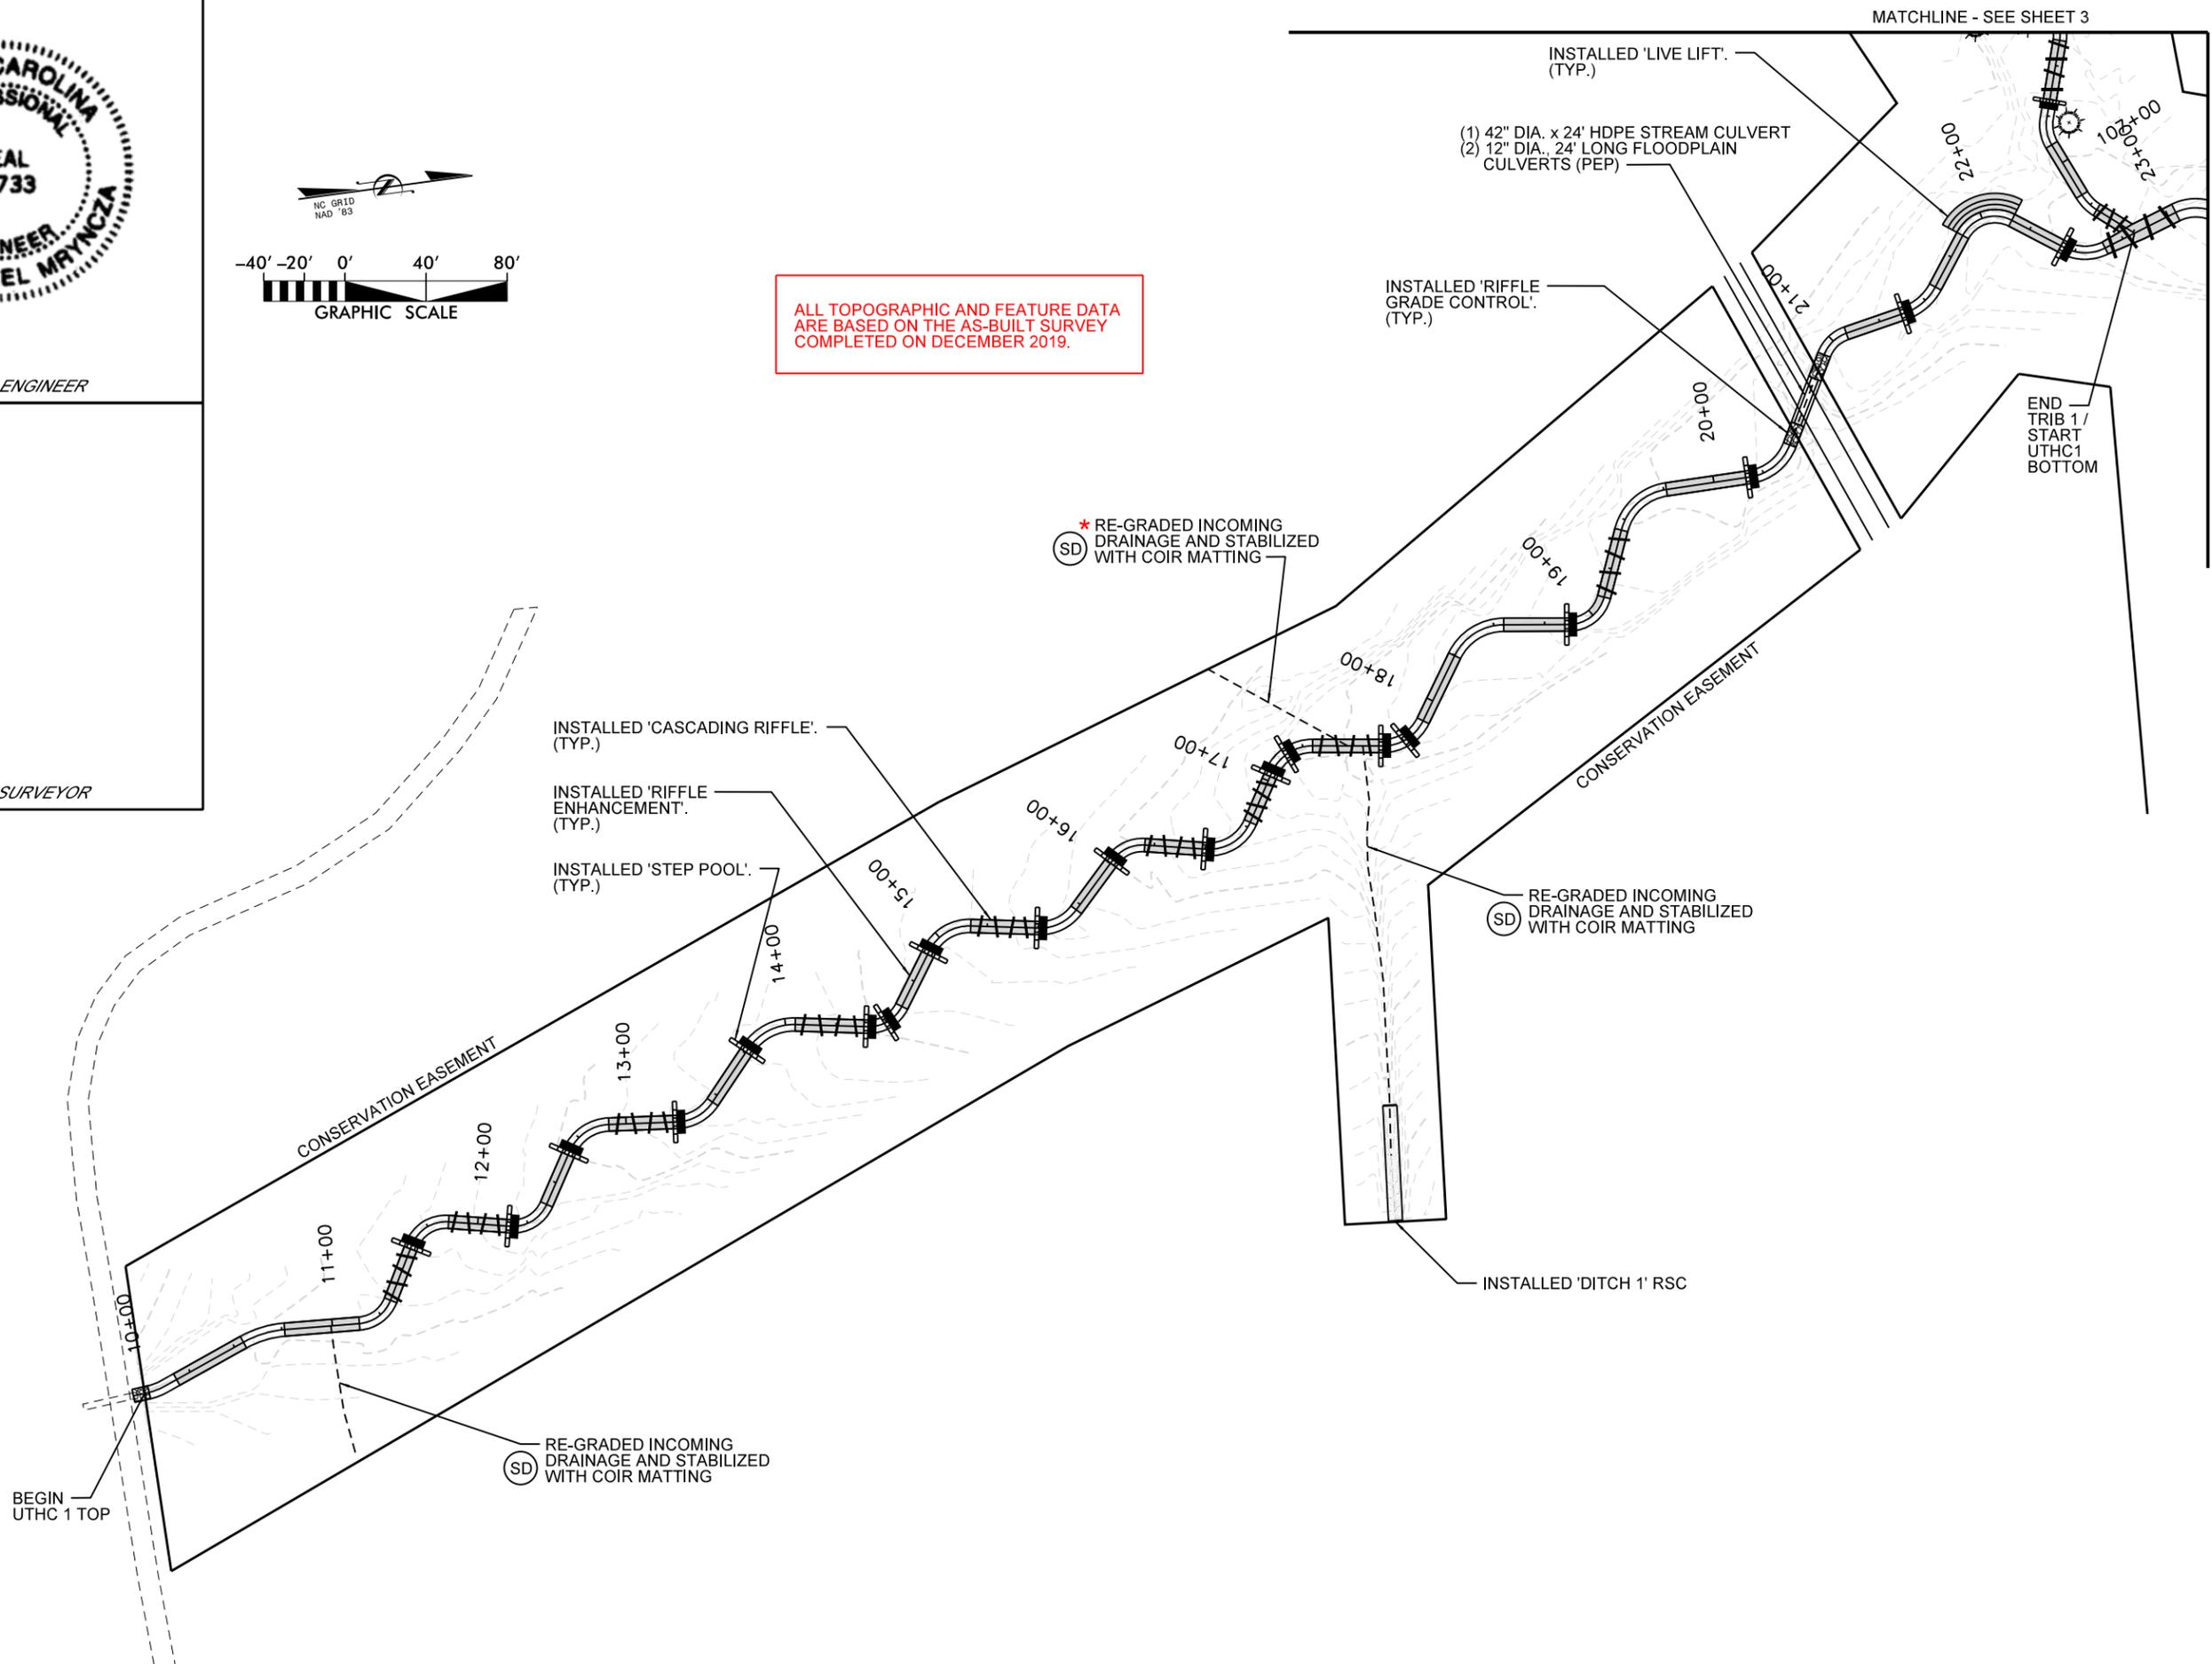
DATE: APRIL 2020  
SCALE: GRAPHIC  
SITE PLAN  
REACH: UTHC  
SHEET 4 OF 14

MILL DAM CREEK  
STREAM RESTORATION SITE  
YADKIN COUNTY, NORTH CAROLINA

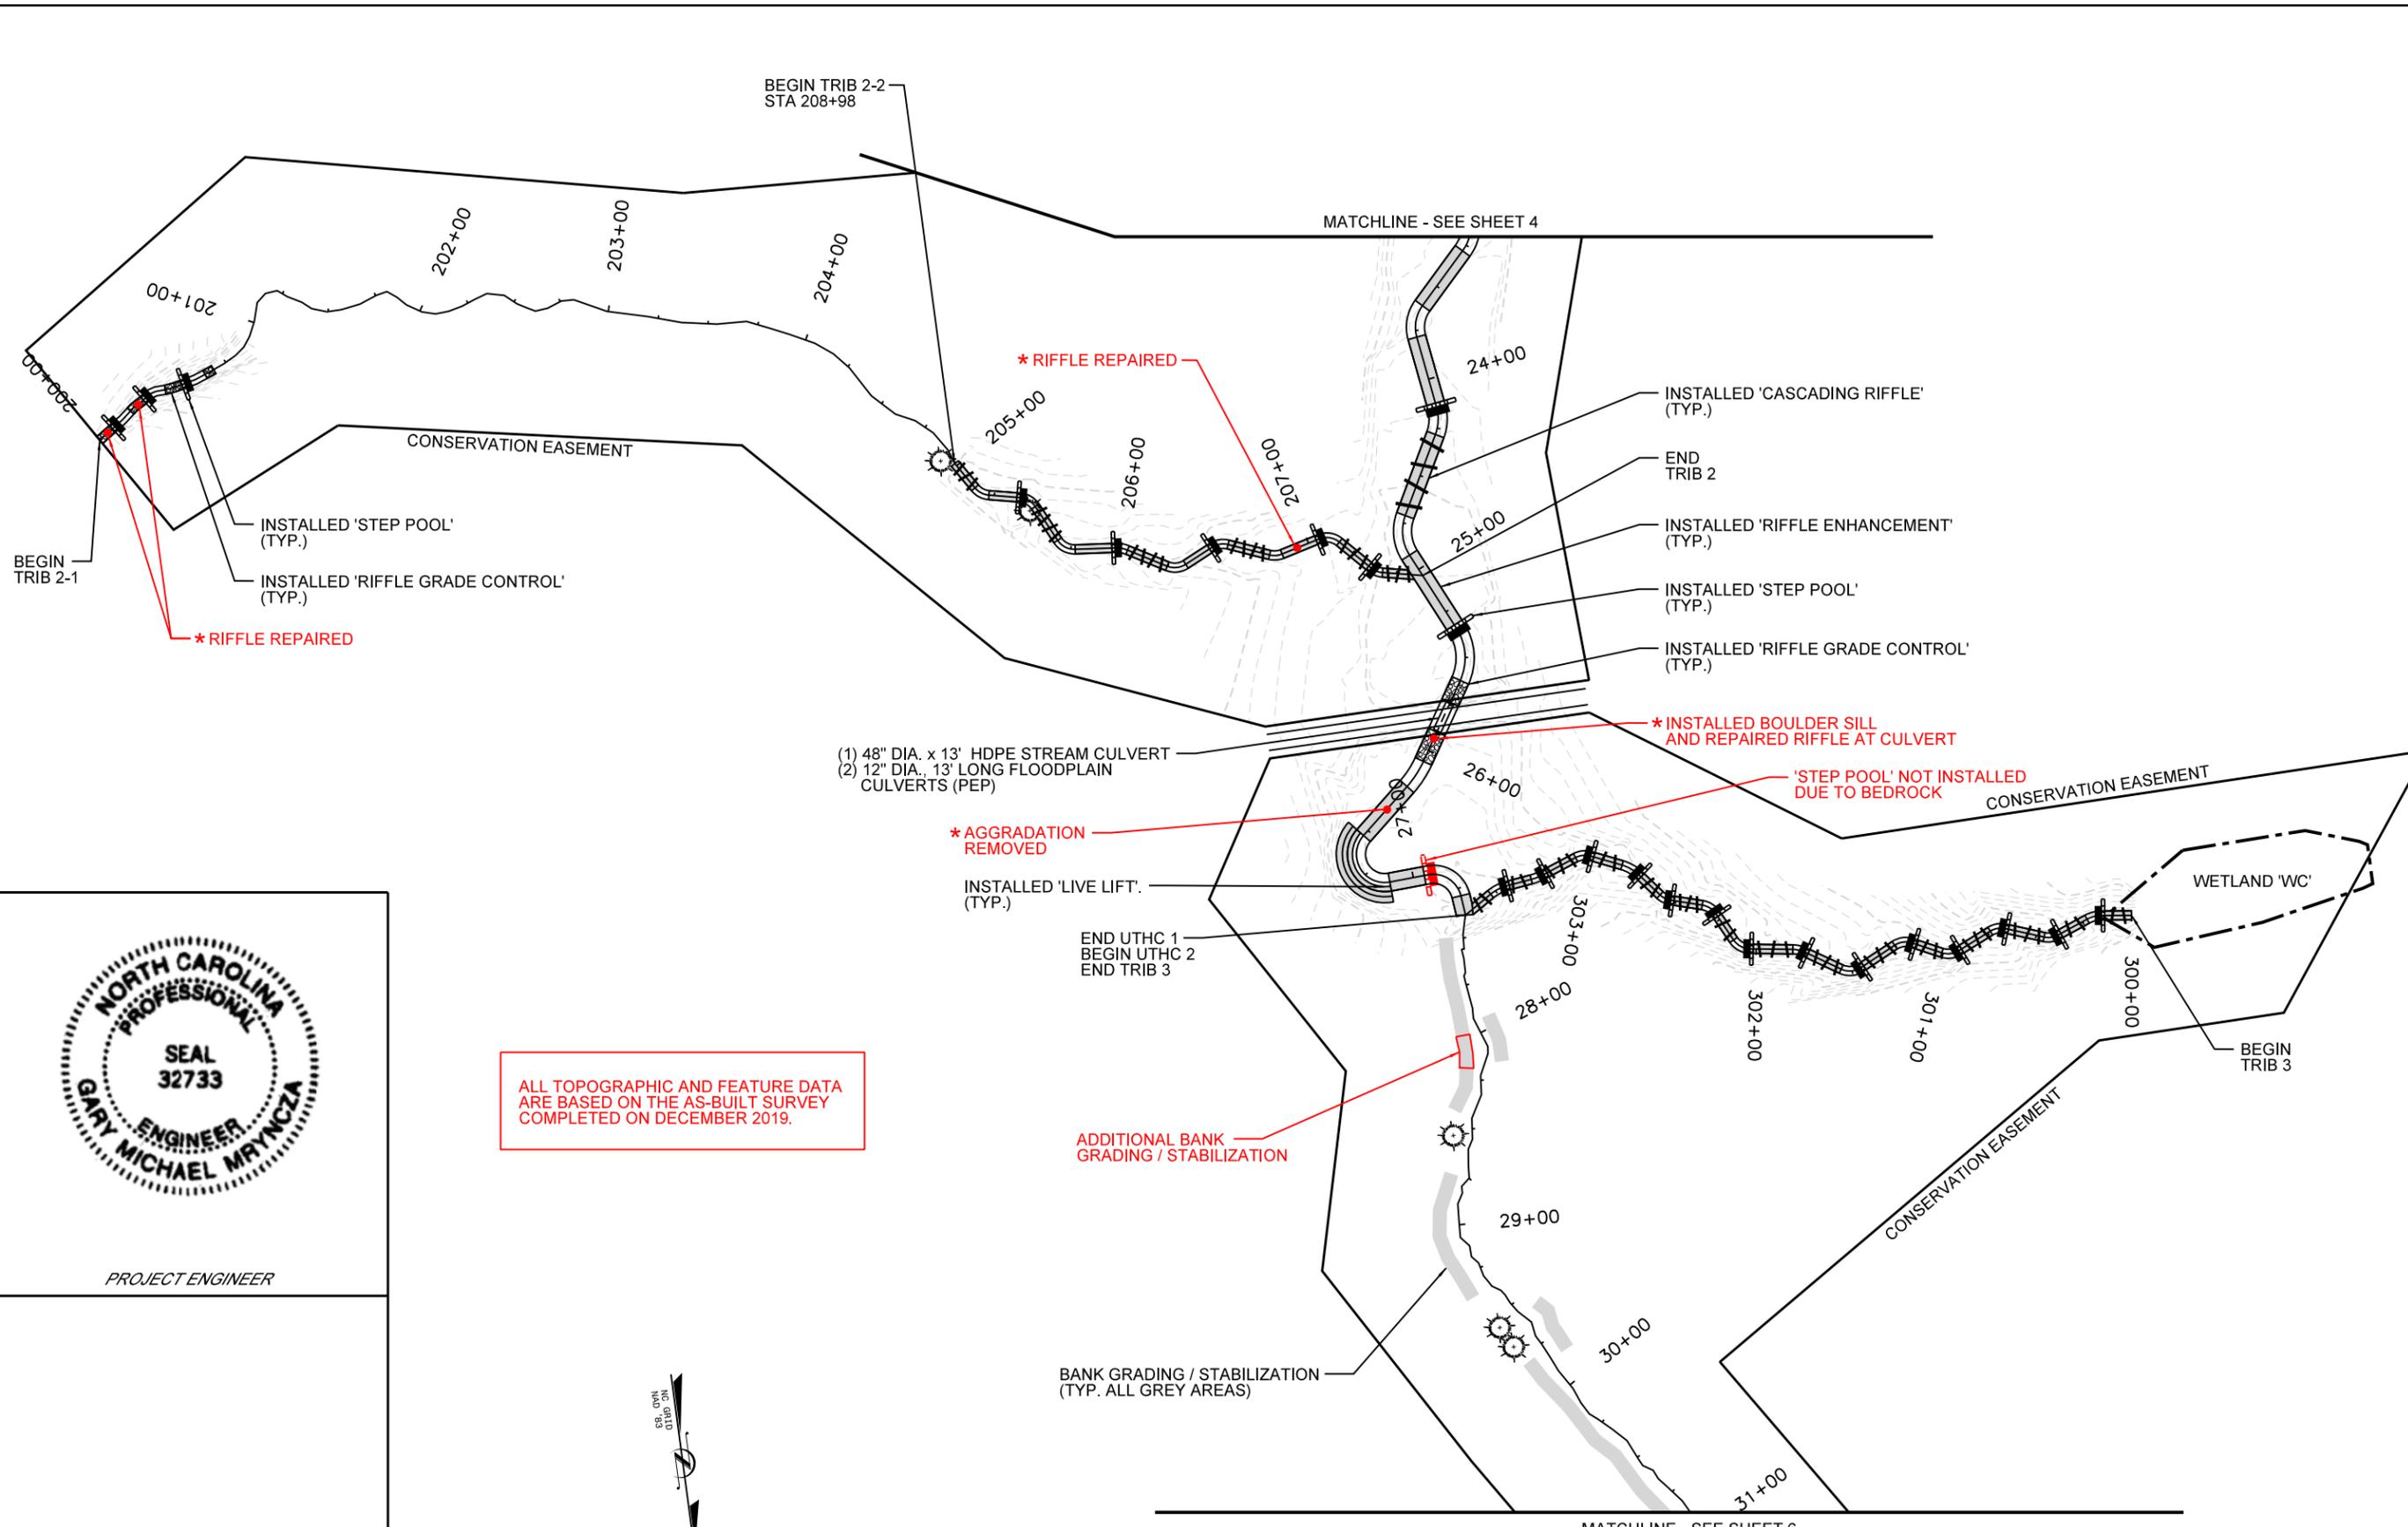
DATE: APRIL 2020  
 SCALE: GRAPHIC  
 SITE PLAN  
 REACH:  
 T2, T3, & UTHC  
 SHEET 5 OF 14

**MILL DAM CREEK  
 STREAM RESTORATION SITE**  
 YADKIN COUNTY, NORTH CAROLINA

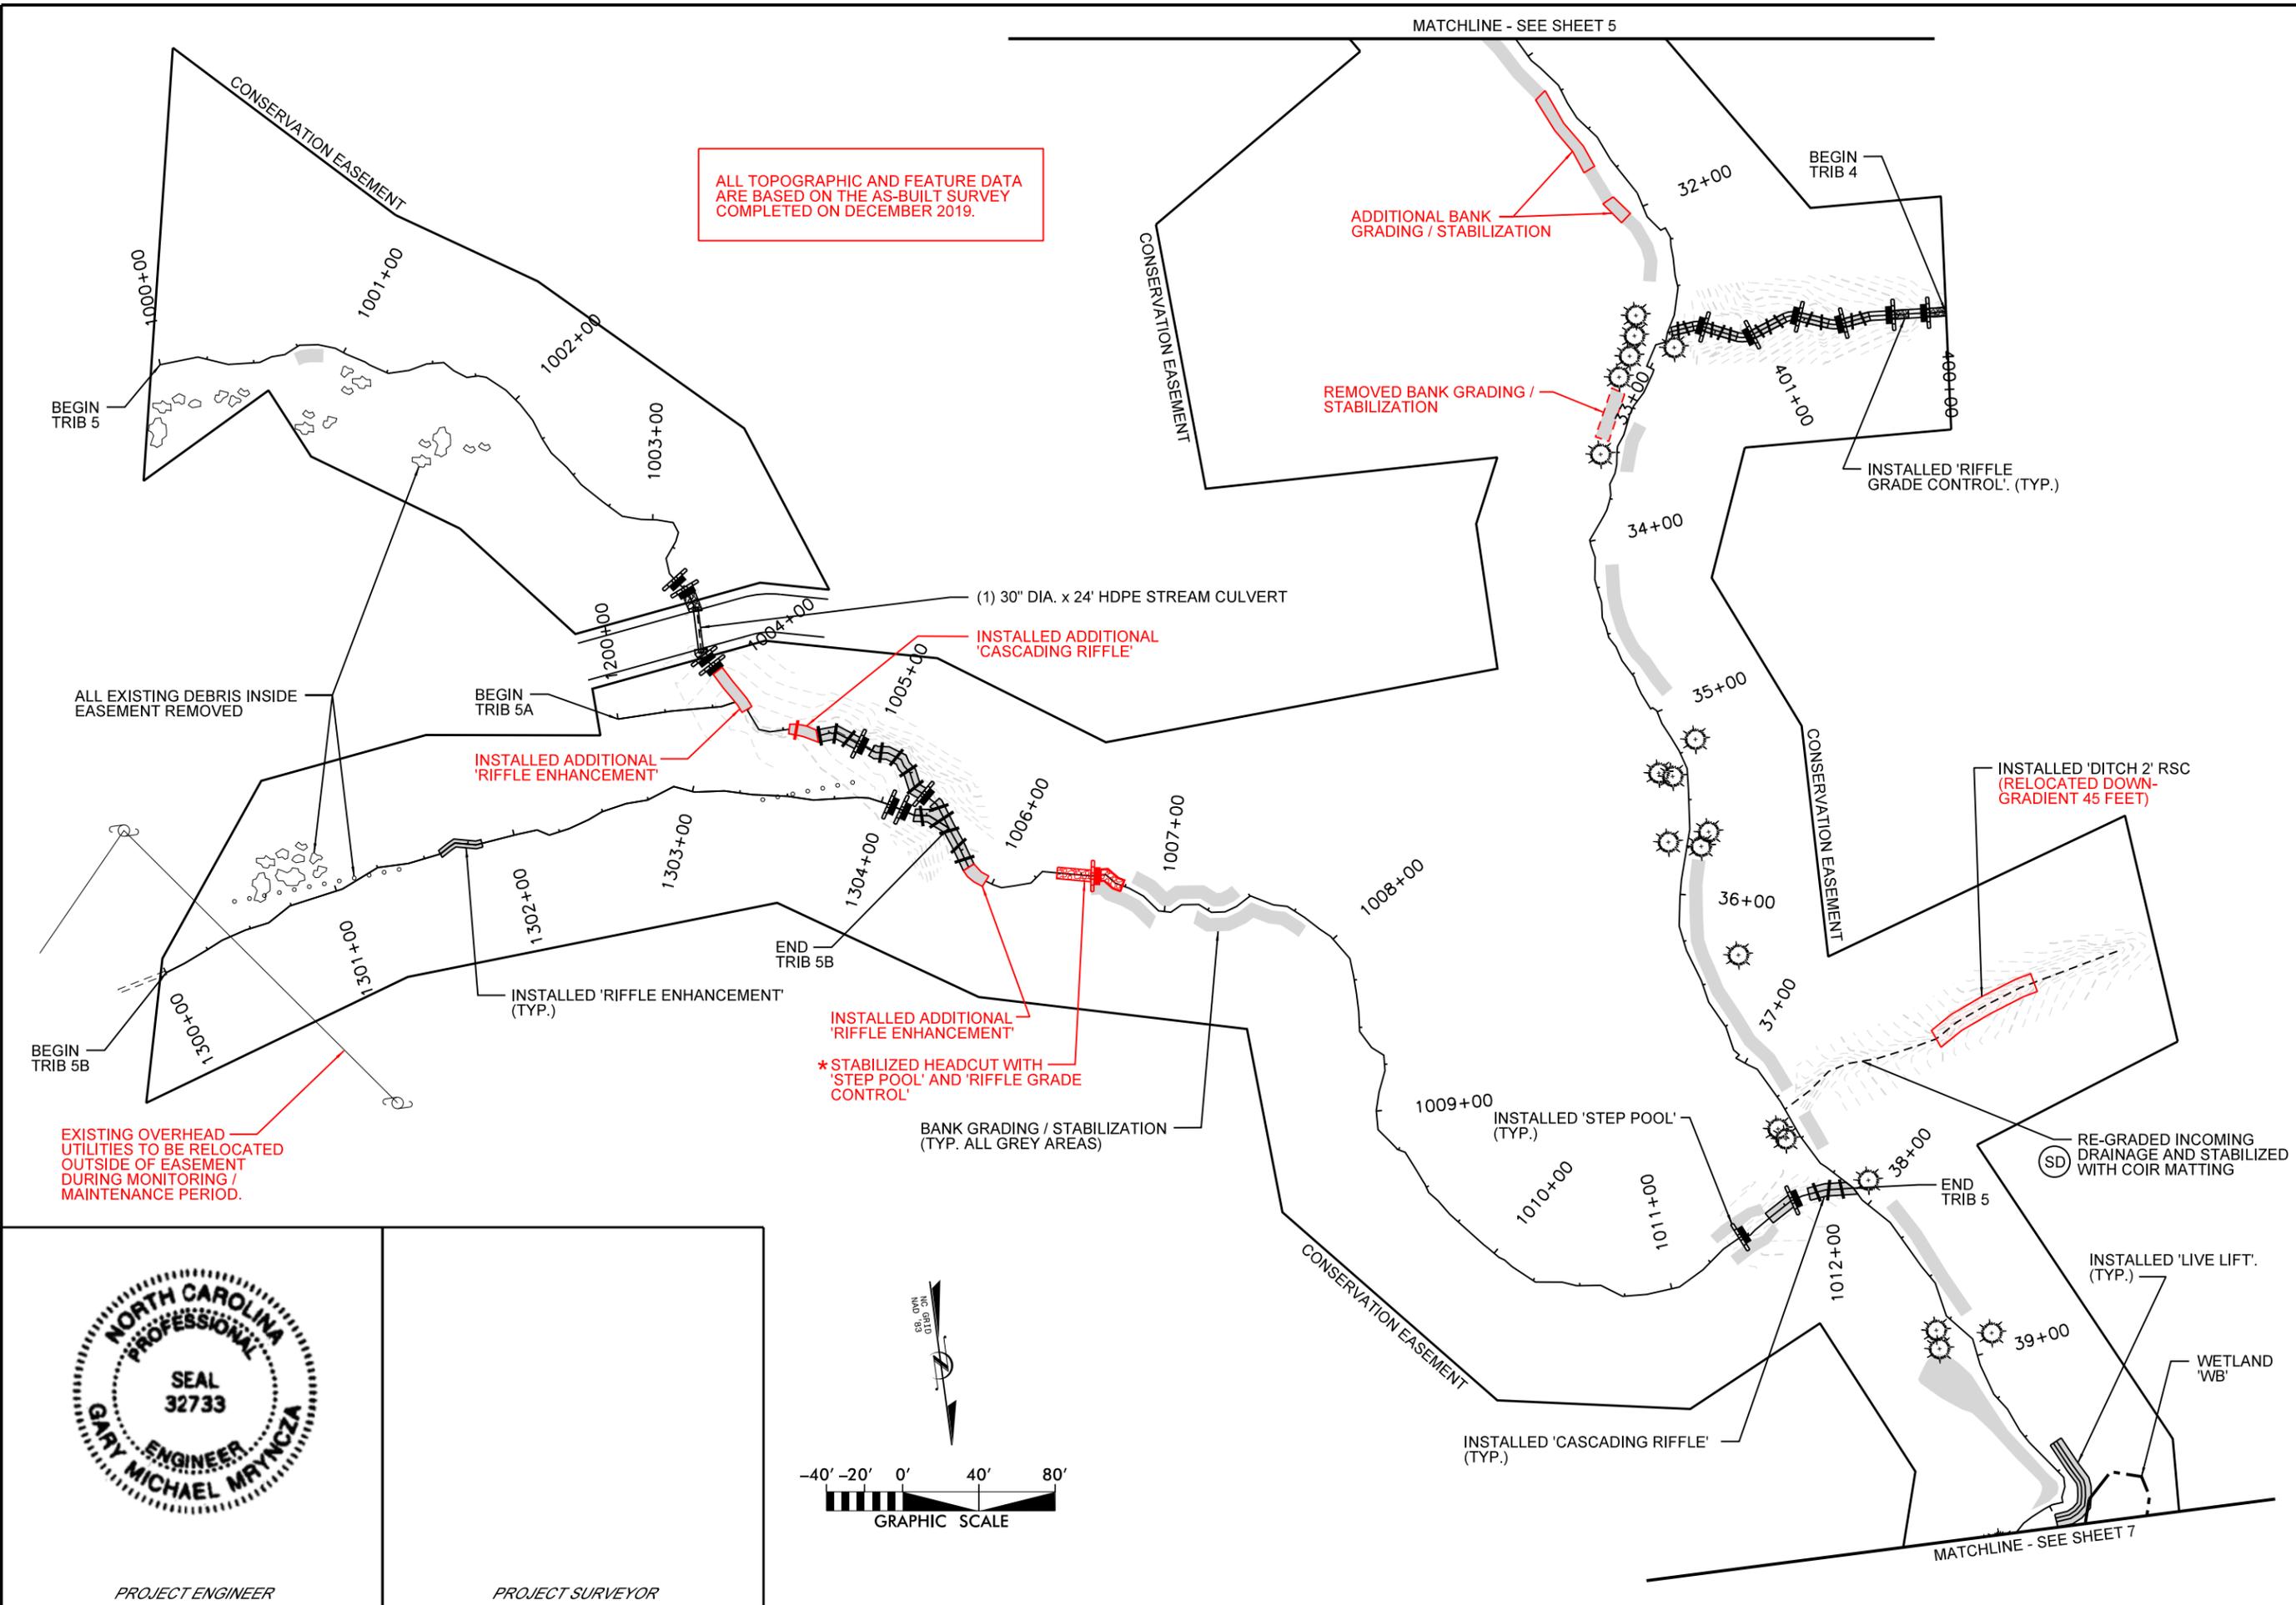
DATE: APRIL 2020
SCALE: GRAPHIC
SITE PLAN
REACH: T4, T5, T5A, T5B & UTHC
SHEET 6 OF 14

**MILL DAM CREEK  
STREAM RESTORATION SITE**  
YADKIN COUNTY, NORTH CAROLINA

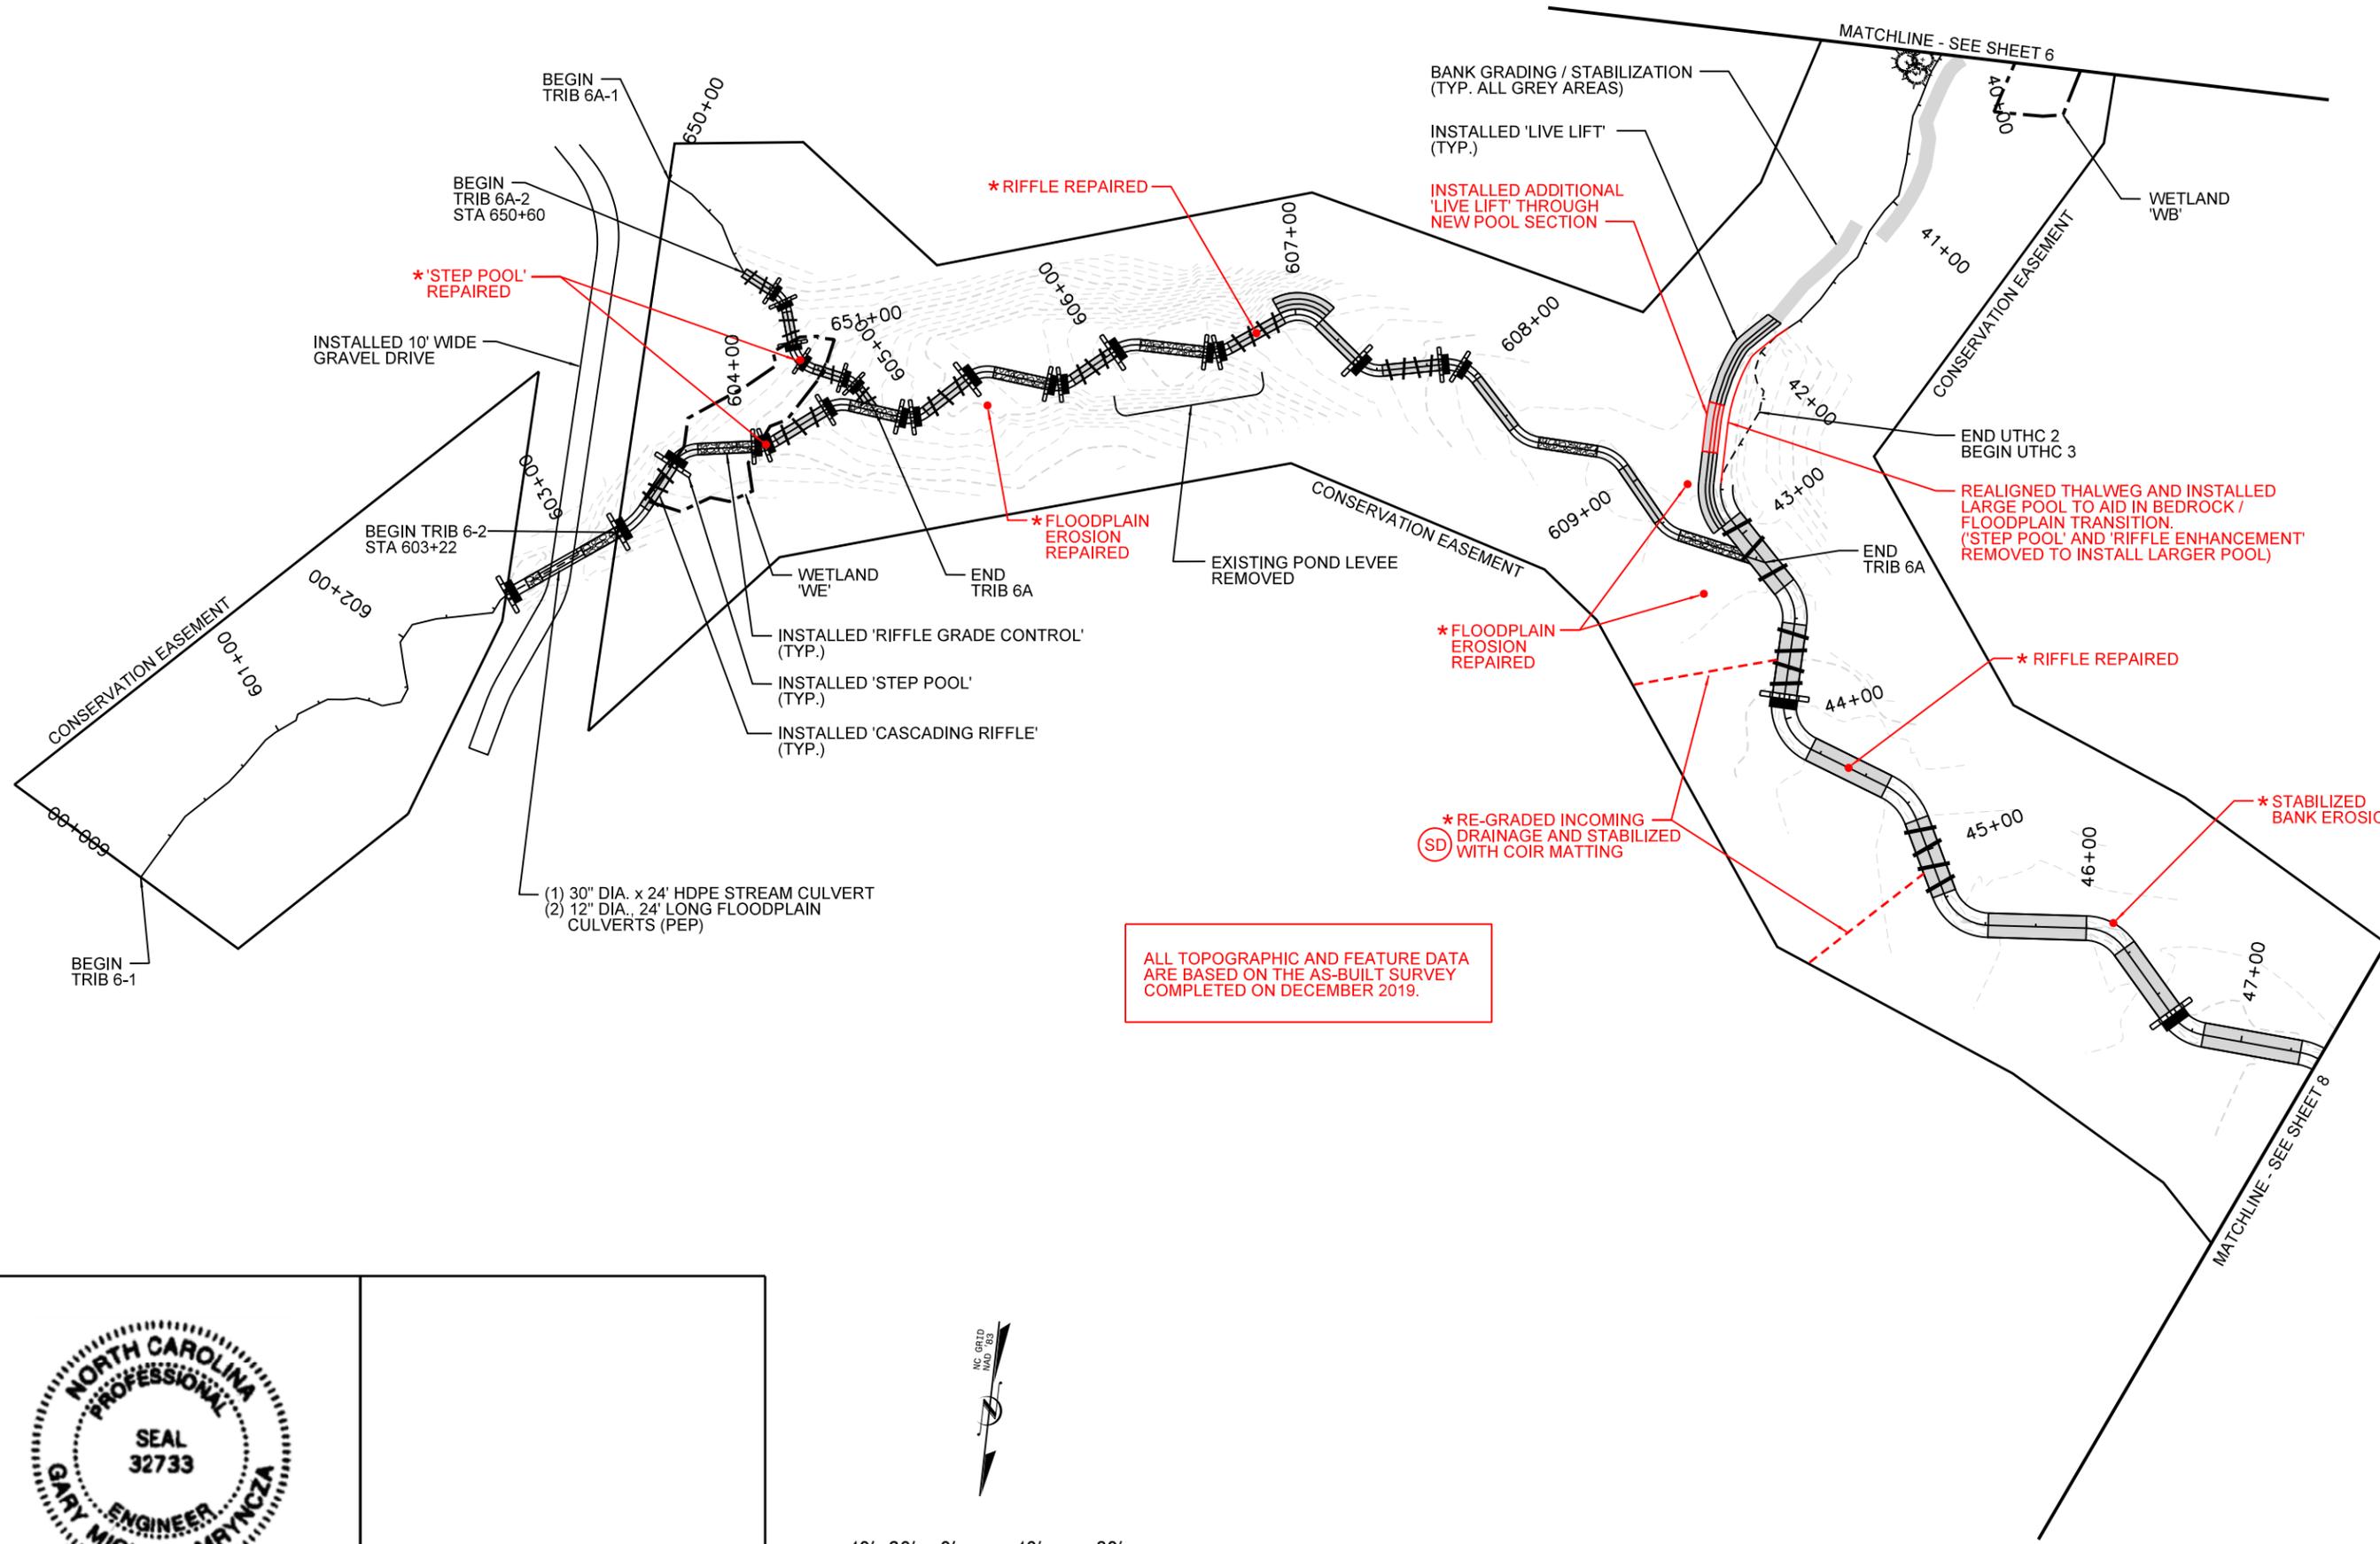
DATE: APRIL 2020
SCALE: GRAPHIC
SITE PLAN
REACH: T6, T6A & UTHC
SHEET 7 OF 14

MILL DAM CREEK  
STREAM RESTORATION SITE  
YADKIN COUNTY, NORTH CAROLINA

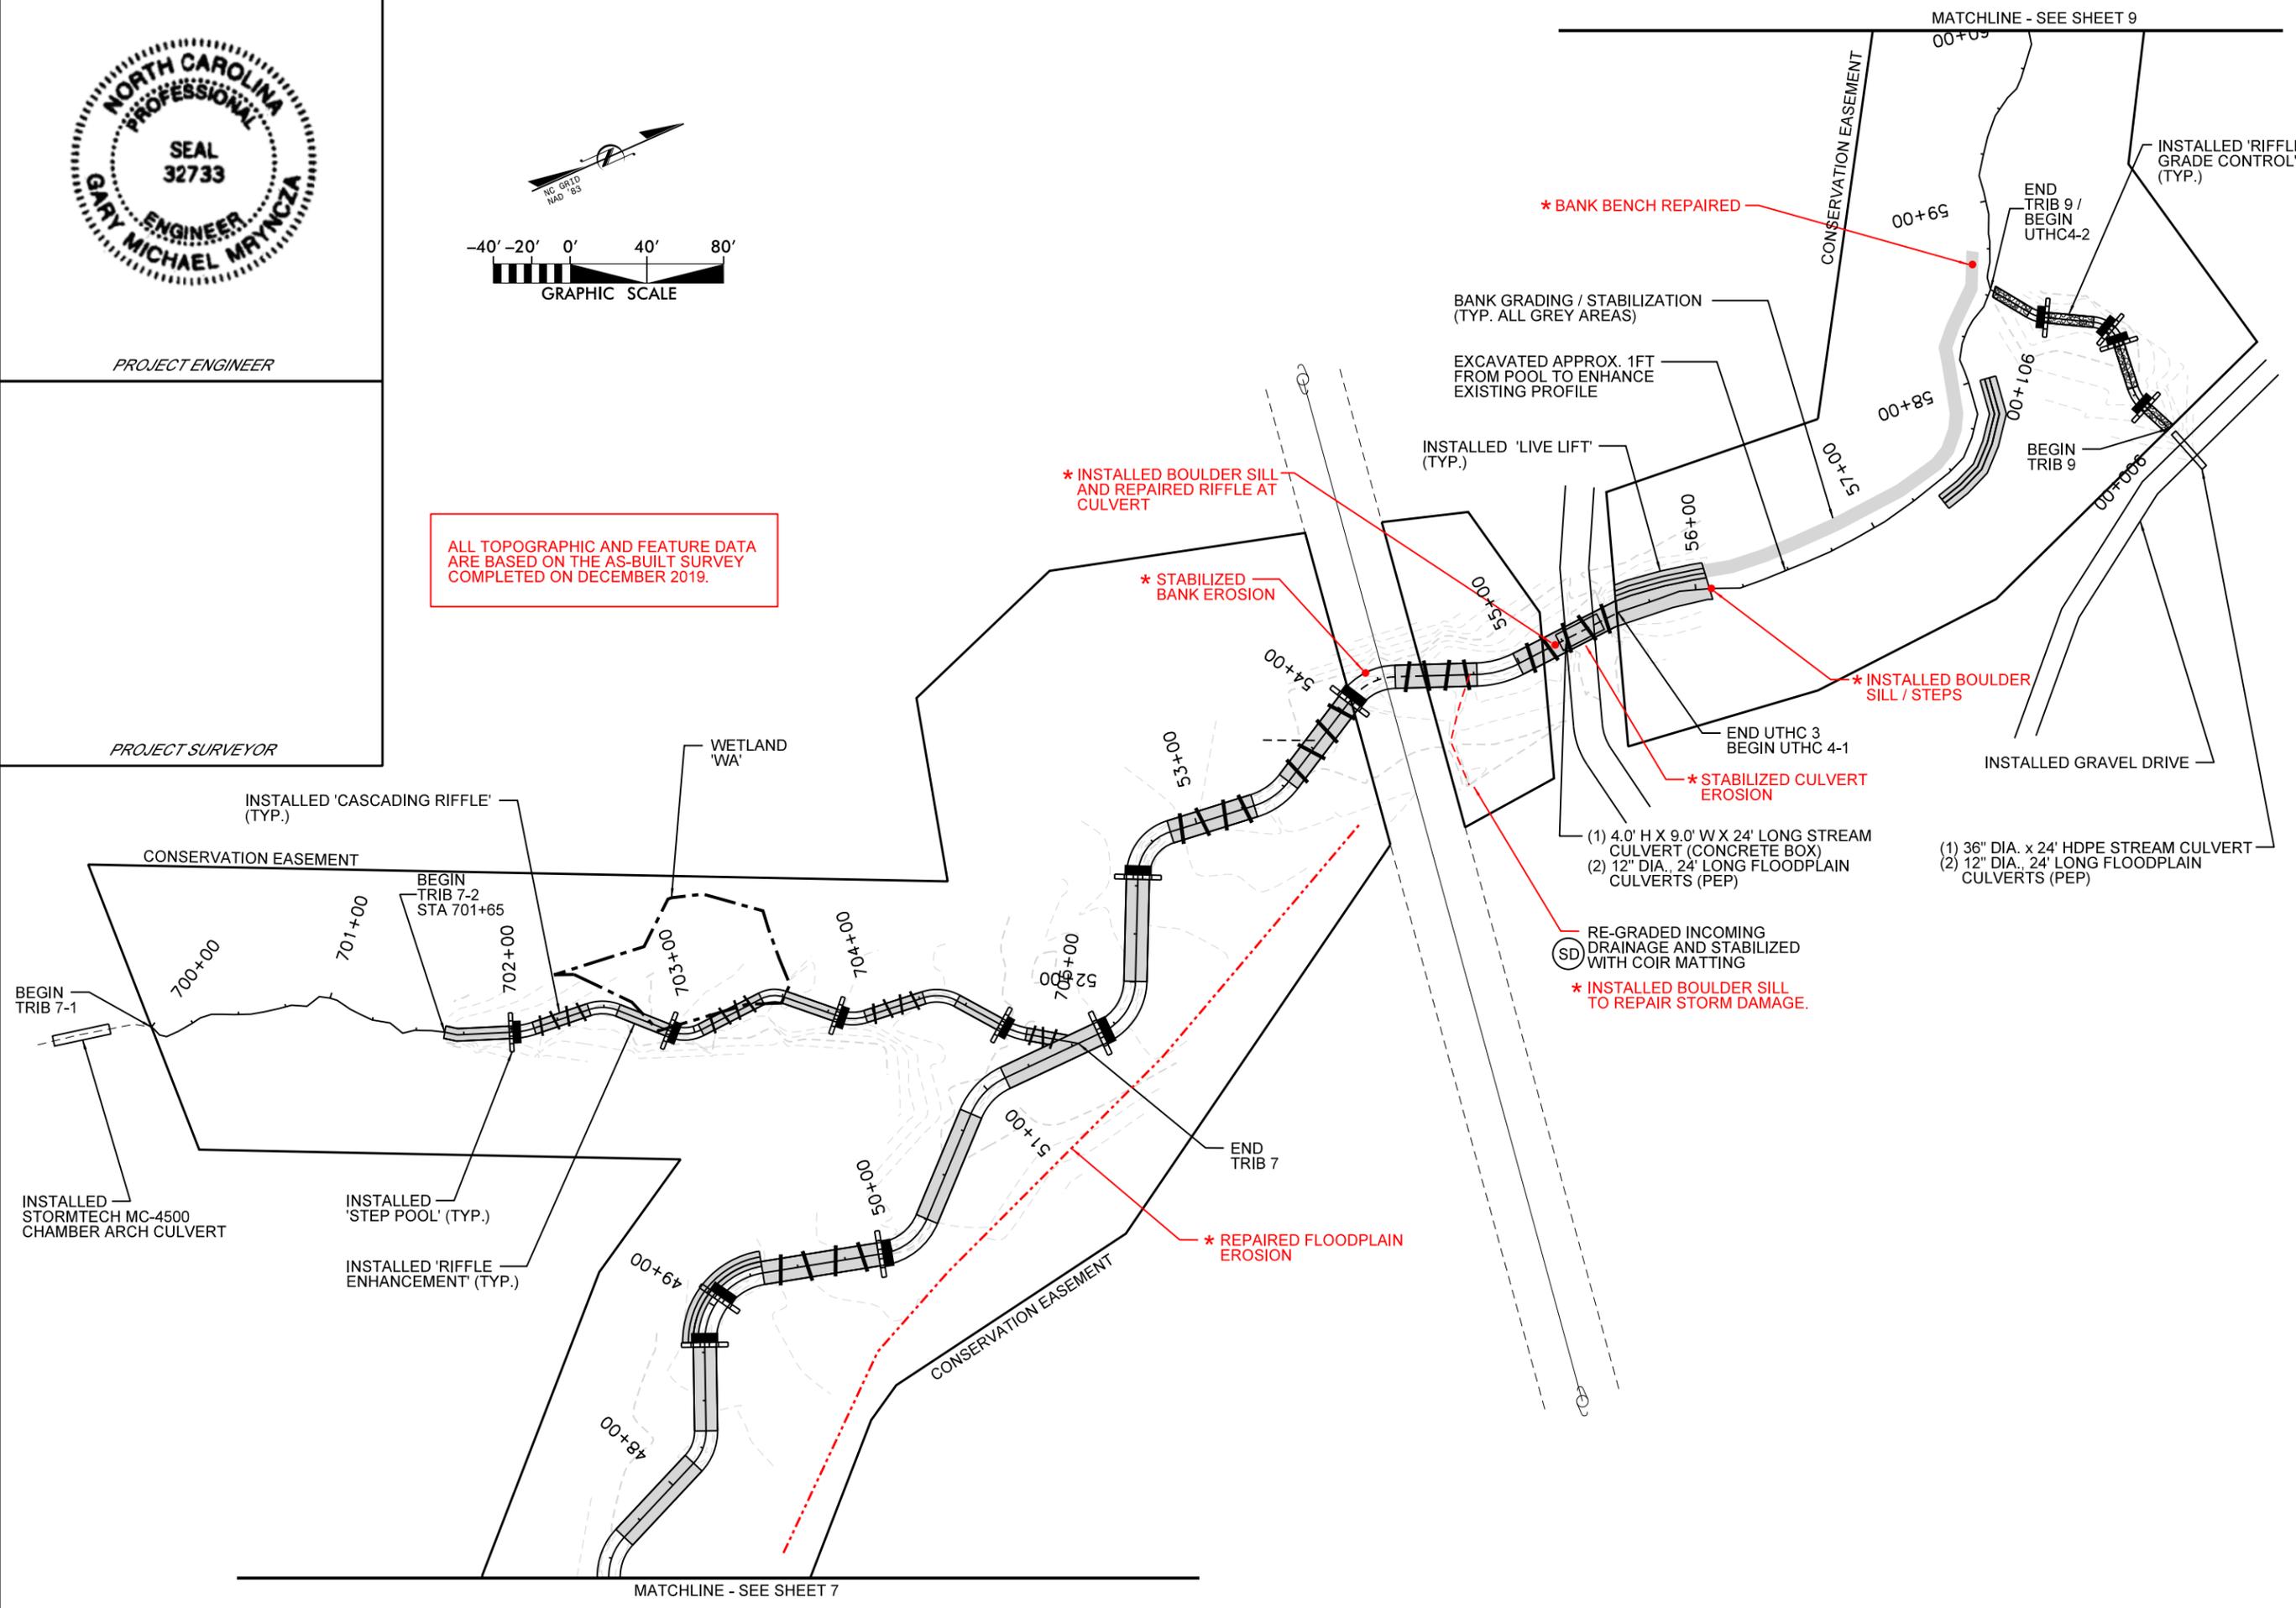
DATE: APRIL 2020  
SCALE: GRAPHIC  
SITE PLAN  
REACH:  
T7, T9  
& UTHC  
SHEET 8 OF 14

MILL DAM CREEK  
STREAM RESTORATION SITE  
YADKIN COUNTY, NORTH CAROLINA

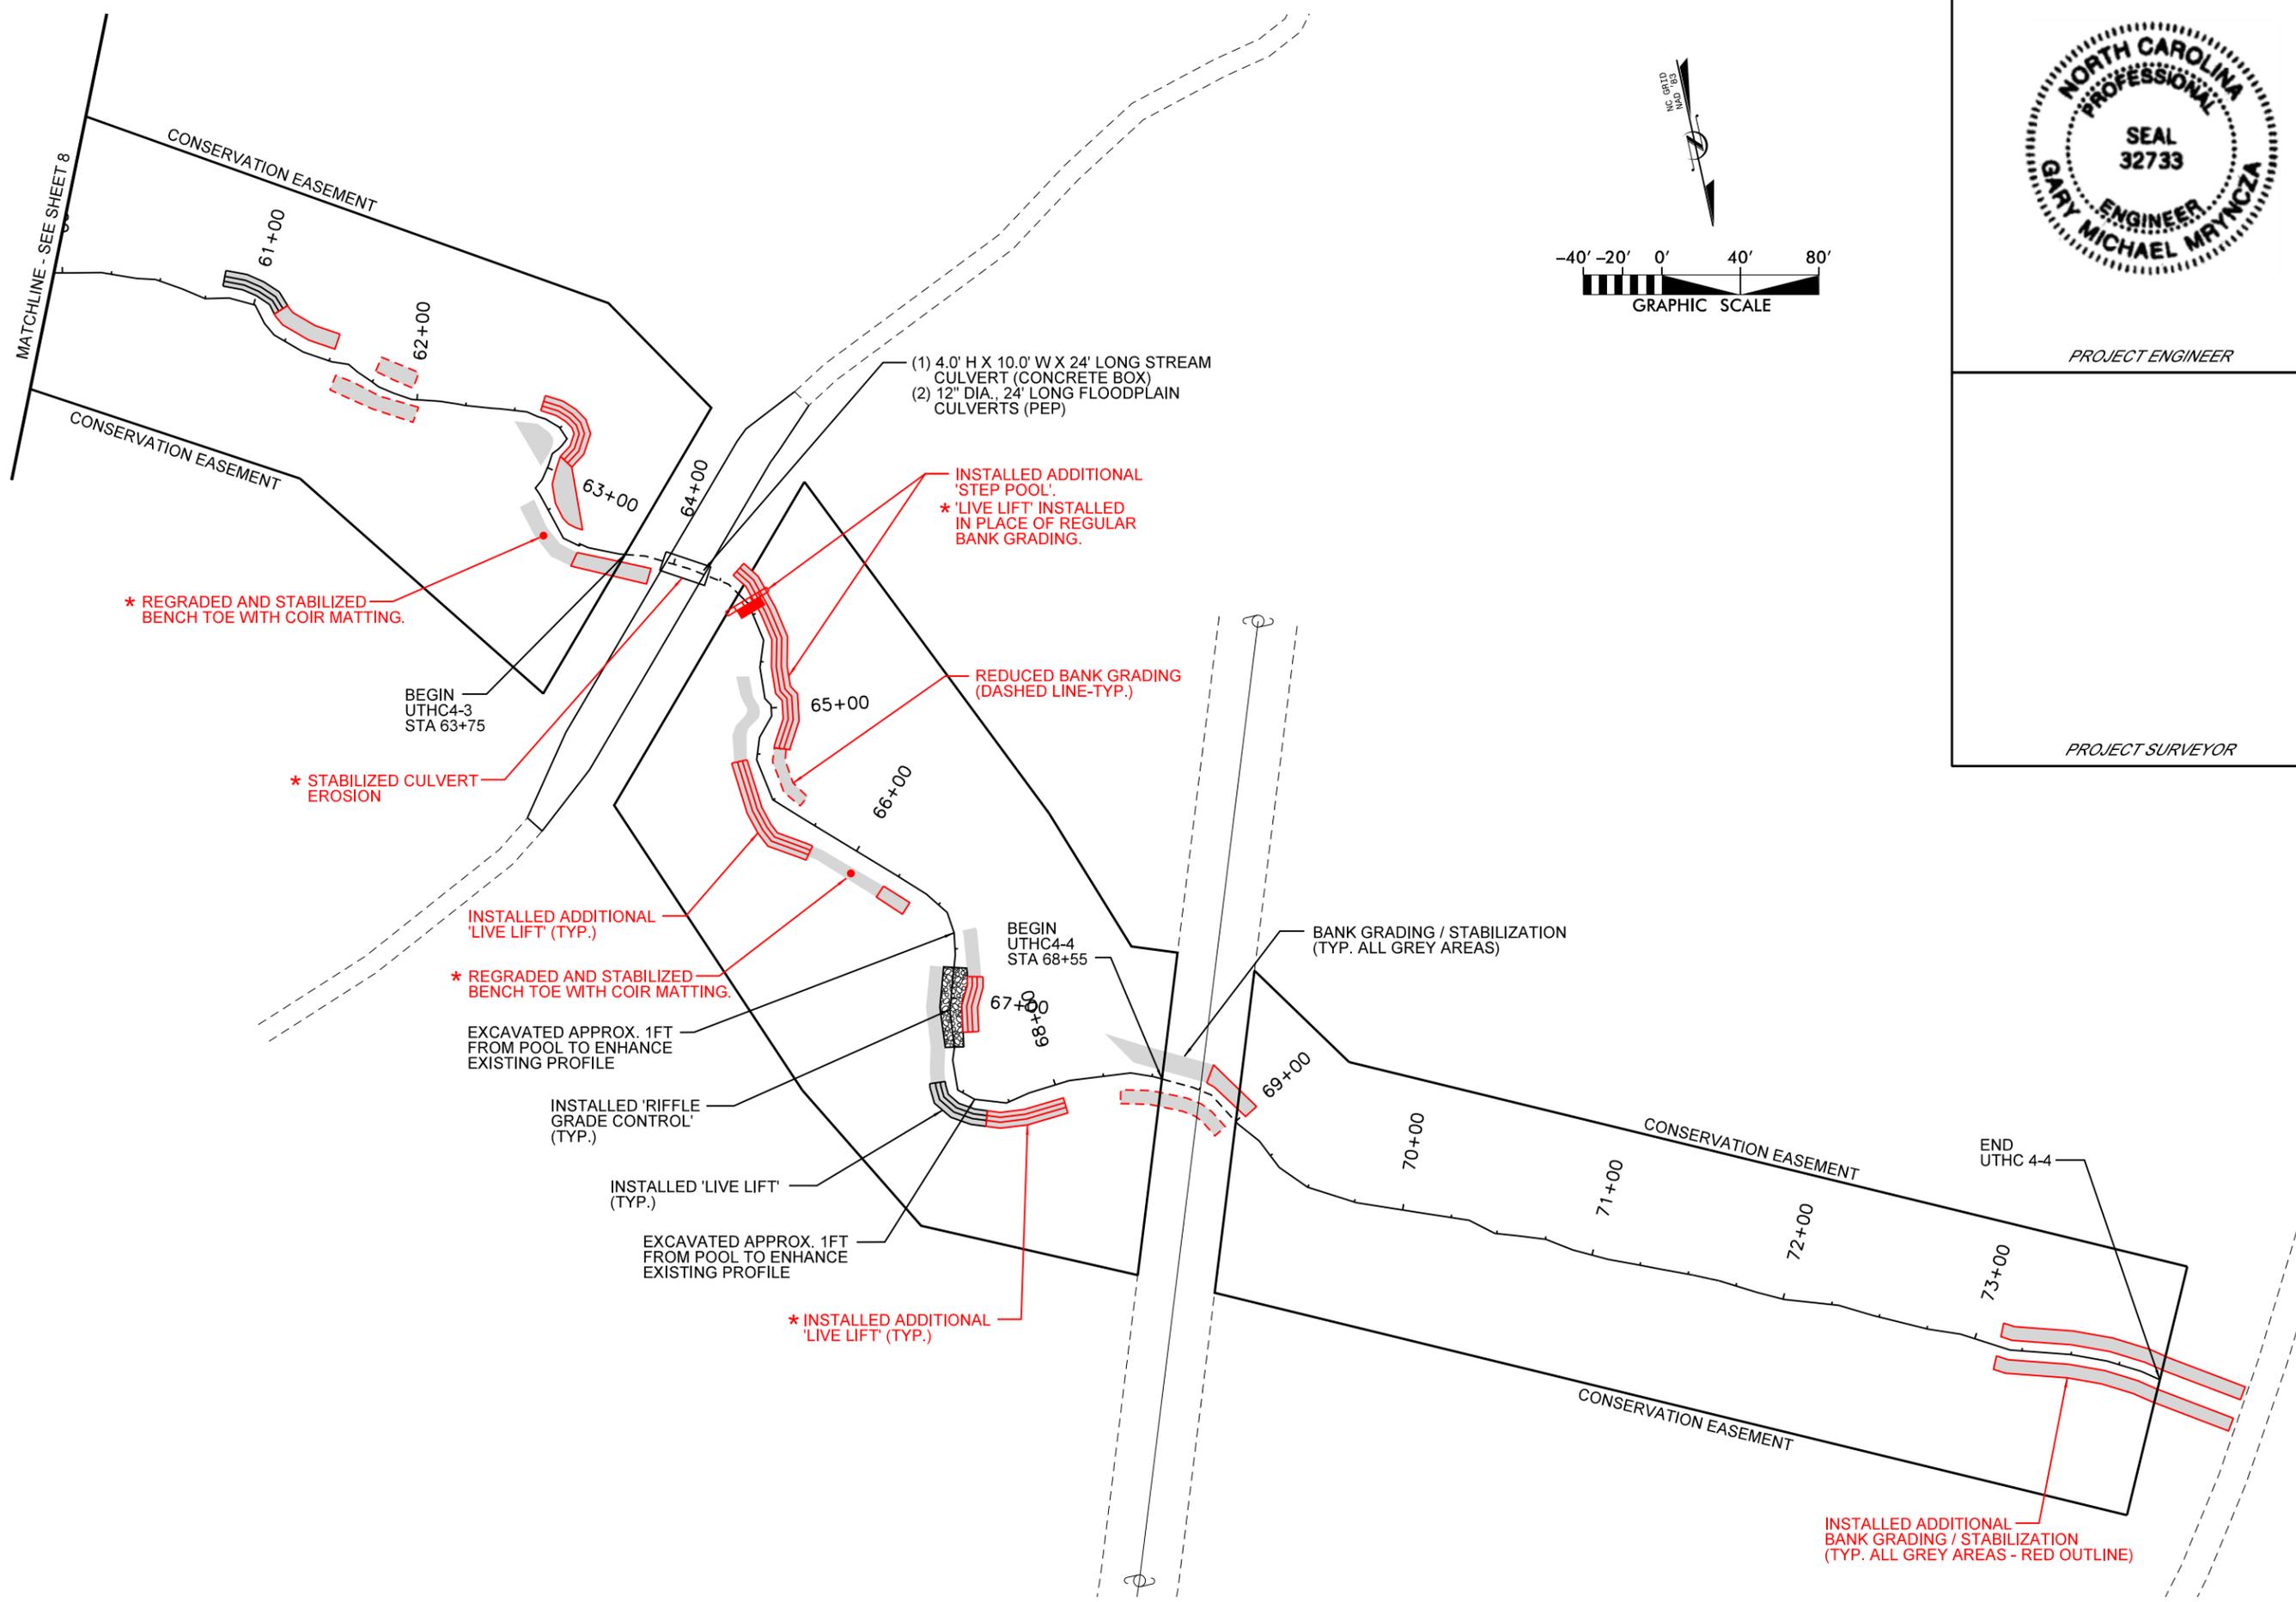
DATE: APRIL 2020  
SCALE: GRAPHIC  
SITE PLAN  
REACH: UTHC  
SHEET 9 OF 14

MILL DAM CREEK  
STREAM RESTORATION SITE  
YADKIN COUNTY, NORTH CAROLINA
