# **As-built Baseline Monitoring Report**

**Mill Dam Creek Restoration Site  
Yadkin River Basin - 03040101  
Monitoring Year 00  
DEQ Contract 6898  
DMS Project Number 97136**

**DWR #: 18-1349  
USACE Action ID: 2016-01335  
Yadkin County, North Carolina**

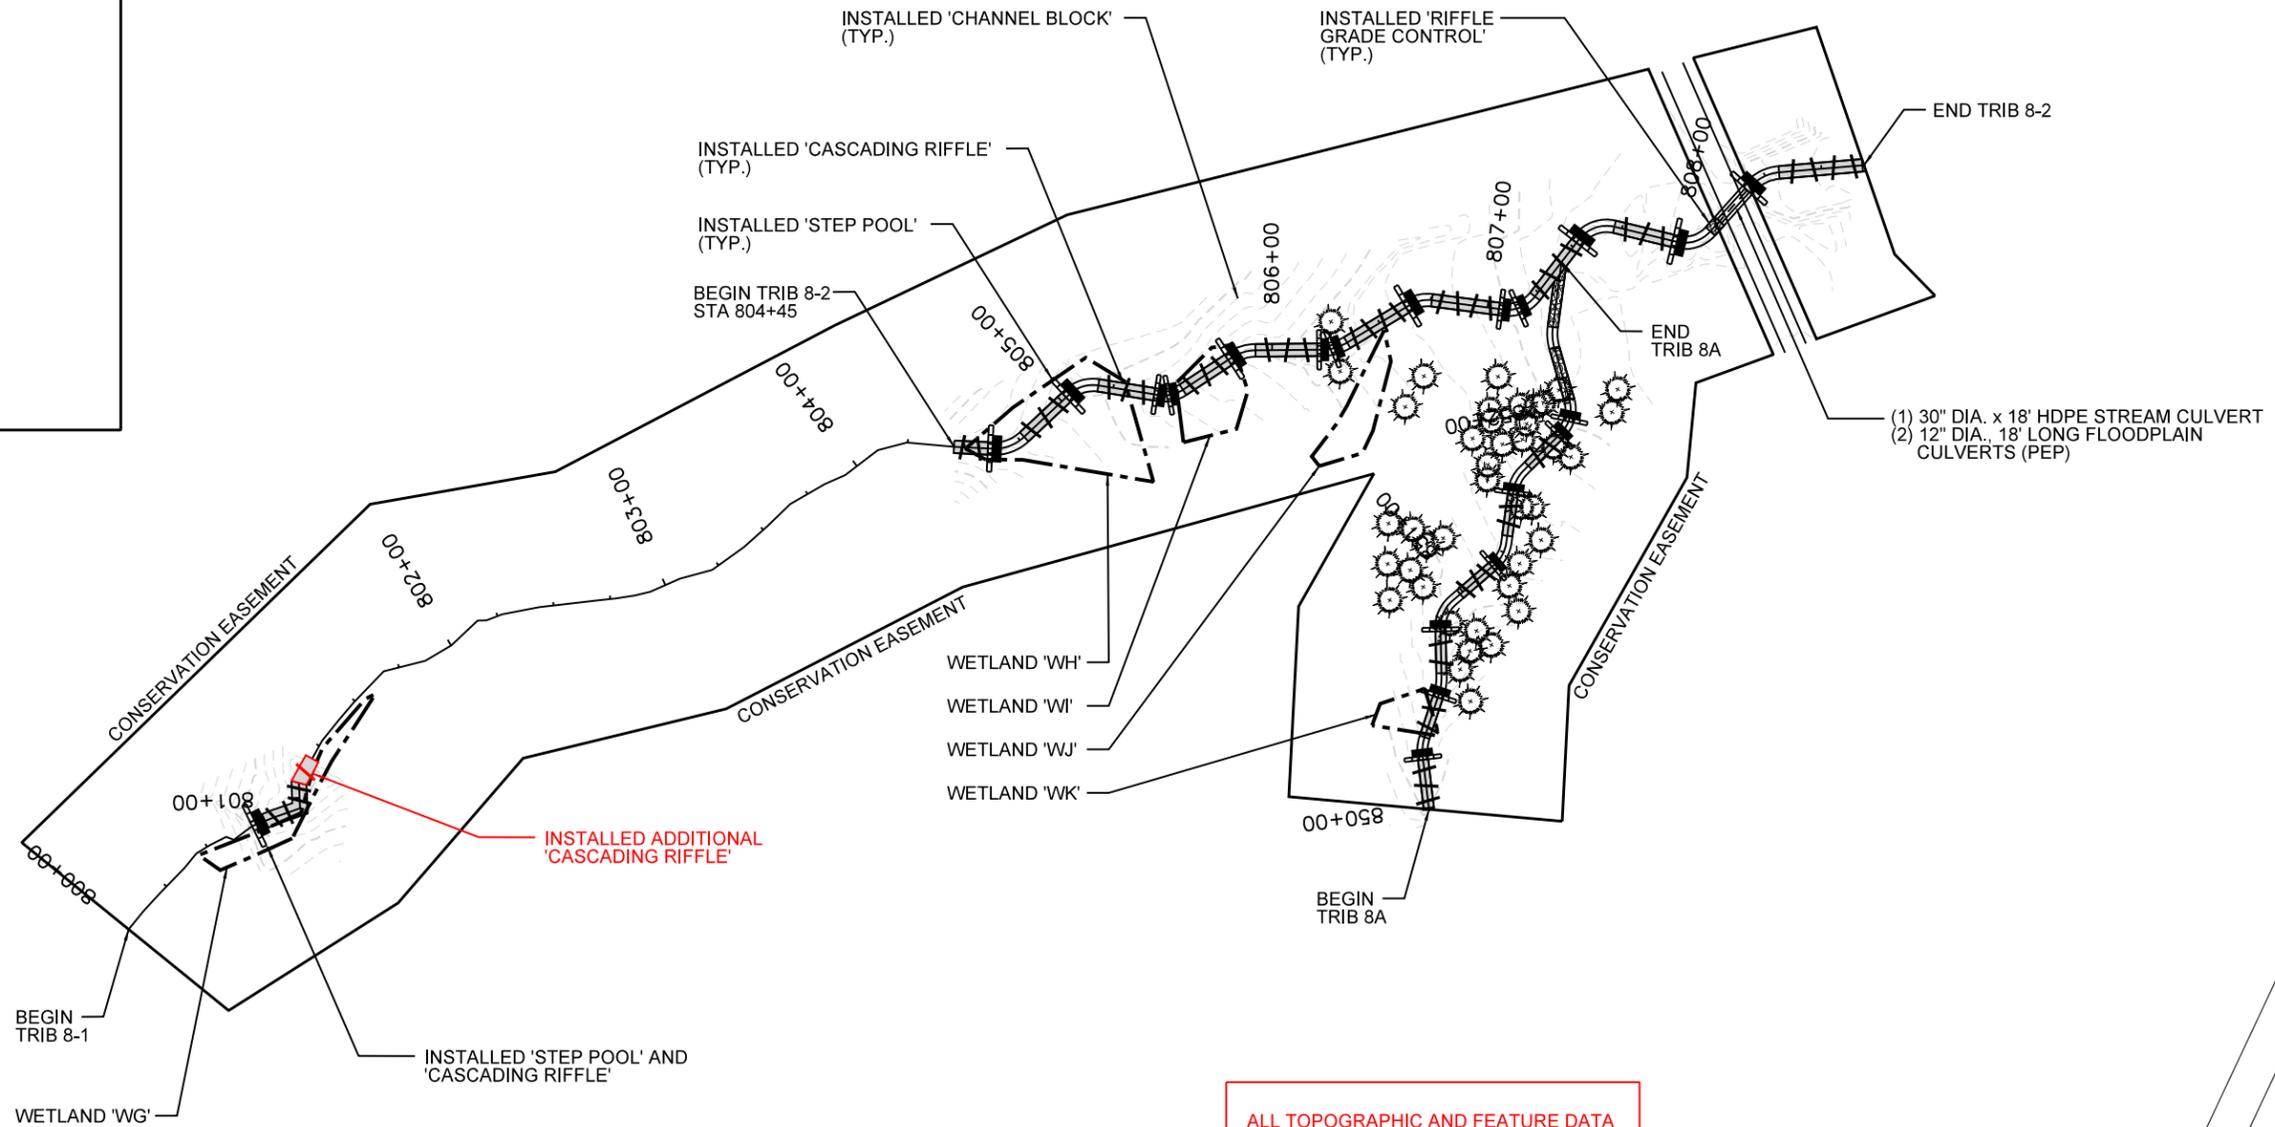
(1) 30" DIA. x 18' HDPE STREAM CULVERT  
 (2) 12" DIA., 18' LONG FLOODPLAIN CULVERTS (PEP)

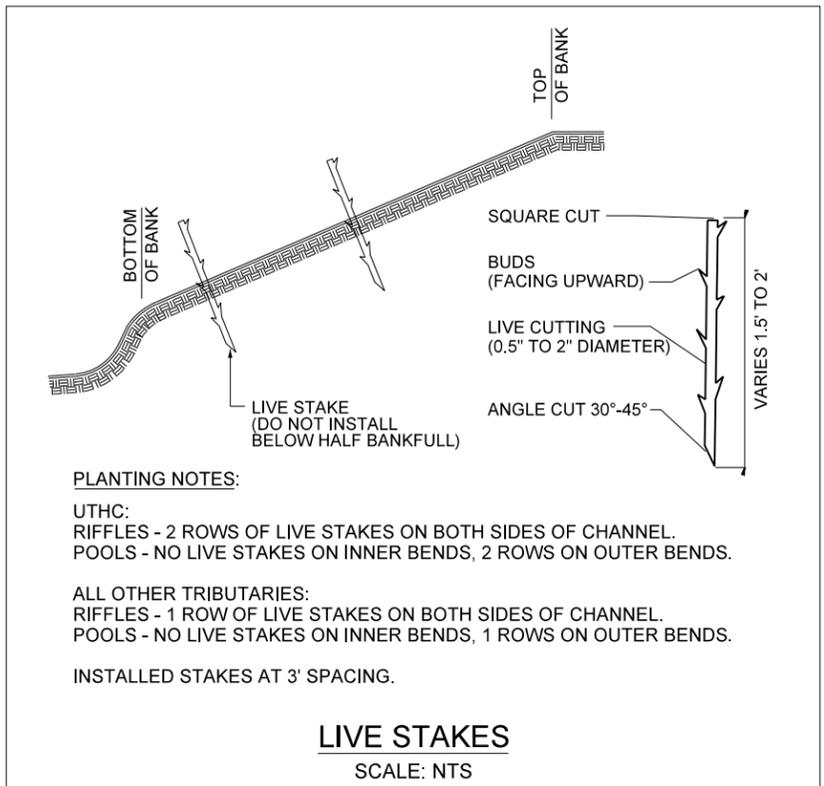
**LIVE STAKES**  
 SCALE: NTS

**PLANTING NOTES:**  
 UTHC:  
 RIFFLES - 2 ROWS OF LIVE STAKES ON BOTH SIDES OF CHANNEL.  
 POOLS - NO LIVE STAKES ON INNER BENDS, 2 ROWS ON OUTER BENDS.  
 ALL OTHER TRIBUTARIES:  
 RIFFLES - 1 ROW OF LIVE STAKES ON BOTH SIDES OF CHANNEL.  
 POOLS - NO LIVE STAKES ON INNER BENDS, 1 ROWS ON OUTER BENDS.  
 INSTALLED STAKES AT 3' SPACING.
