UT to Barnes Creek Restoration Project Mitigation Report Montgomery County, North Carolina

Design Report Prepared by Buck Engineering, A Unit of Michael Baker

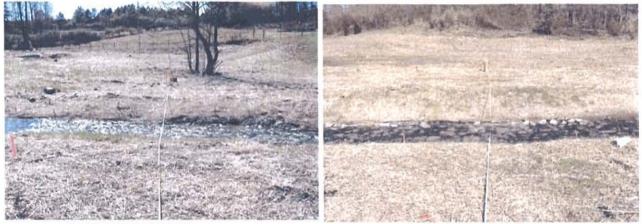
(As-Built Data - collected Mar. 2006)

Looking at the Left Bank

Looking at the Right Bank

For monitoring stream success criteria, 8 permanent cross sections, one rain gauge, and three crest gauges were installed. The permanent cross sections will be used to monitor channel dimension and bank erosion over time. The rain gauge and crest gauges will be used to document the occurrence of bankfull events. In addition, a longitudinal survey was completed for the restored stream channels to provide a base-line for evaluating changes in bed conditions over time. The longitudinal profiles included the elevations of all grade control structures. The permanent cross sections and longitudinal data are provided in Appendix 2. The location of the permanent cross sections, rain gauge, and the stream gauges are shown on the as-built plan sheets in Appendix 3.

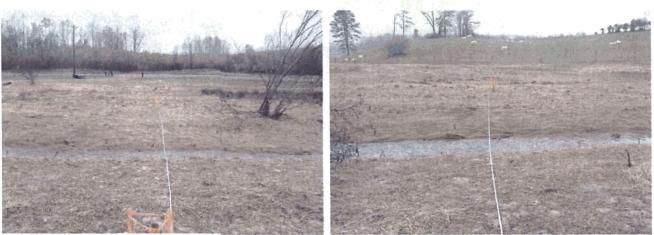
Permanent Cross Section X4 (As-Built Data - collected Mar. 2006)

Looking at the Left Bank

Looking at the Right Bank

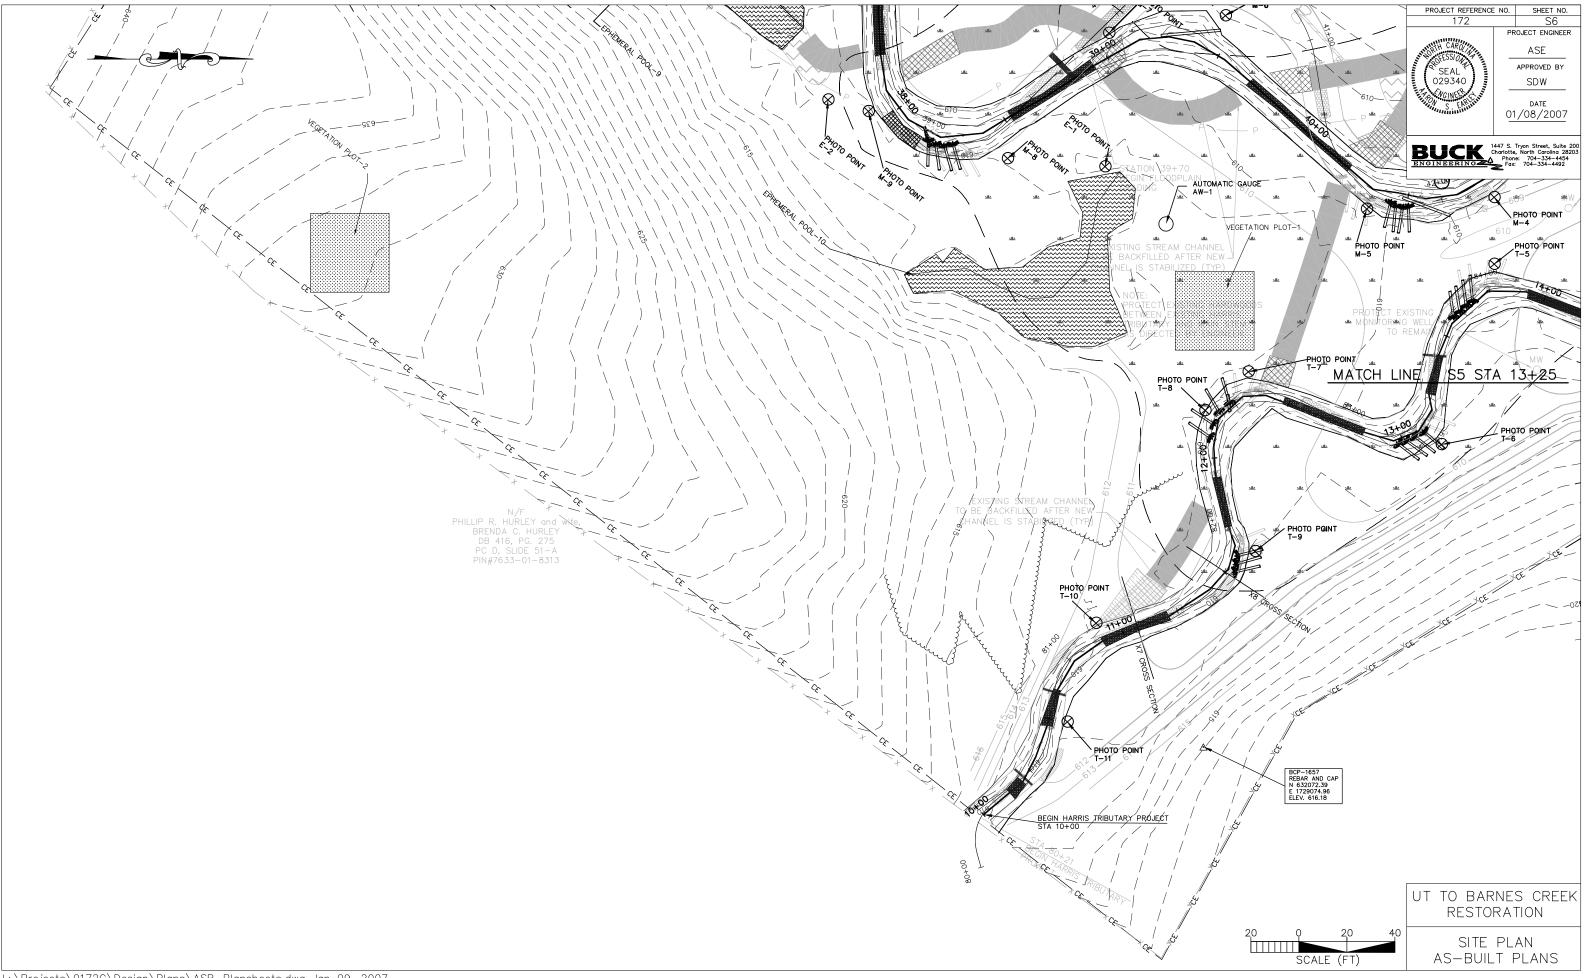
17+00 +	AS-BUILT STREAM ALIGNMENT
10+00 +	DESIGN ALIGNMENT
	AS-BUILT TOP OF BANK
CE CE	CONSERVATION EASEMENT
	NCDOT RIGHT OF WAY
	PROPERTY LIMITS
COE

These changes are documented in the attached as-built drawings.

See Attached Plan Set S1-S6
