BASELINE MONITORING DOCUMENT AND AS-BUILT BASELINE REPORT

BIG HARRIS CREEK MITIGATION SITE

Cleveland County, NC
DEQ Contract No. 6256
DMS Project No. 739
USACE Action ID No. SAW-2009-0475
DWR No. 10-0811
Broad River Basin
HUC 03050105

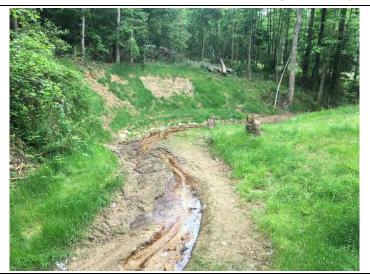
Elliott Creek Photo Point 77 – view upstream (05/15/2018)

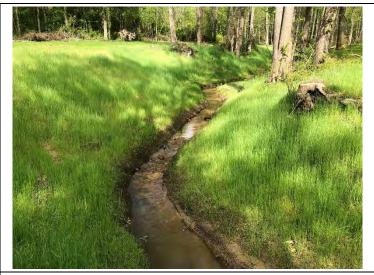
Elliott Creek Photo Point 77 – view downstream (05/15/2018)

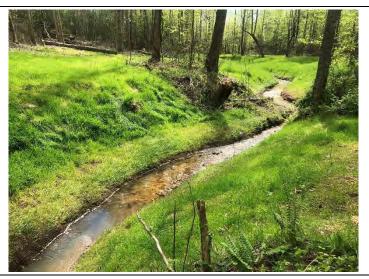
Elliott Creek Photo Point 78 - view upstream (04/25/2018)

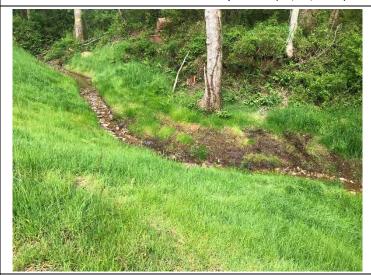
Elliott Creek Photo Point 78 – view downstream (04/25/2018)

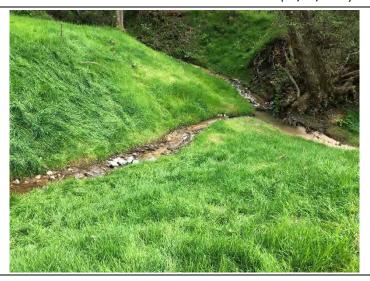
Elliott Creek UT1 Photo Point 79 – view upstream (04/25/2018)

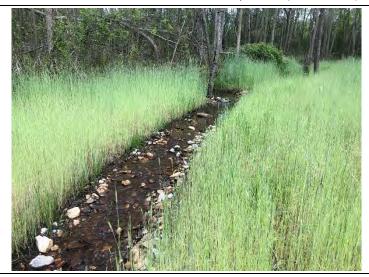
Elliott Creek UT1 Photo Point 79 – view downstream

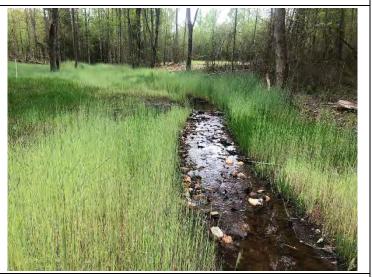
Bridges Creek R1 Photo Point 80 – view upstream (04/26/2018)

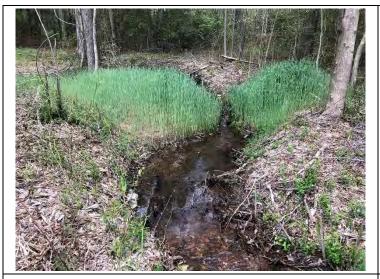
Bridges Creek R1 Photo Point 80 – view downstream

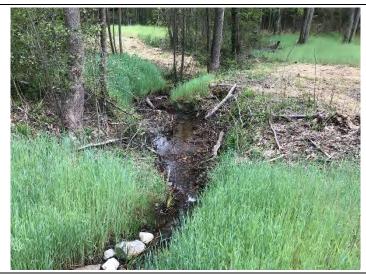
Bridges Creek R2 Photo Point 81 – view upstream (04/26/2018)

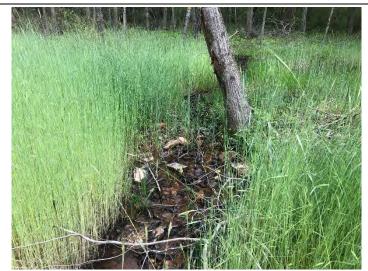
Bridges Crk R2 Photo Point 81 – view downstream (04/26/2018)

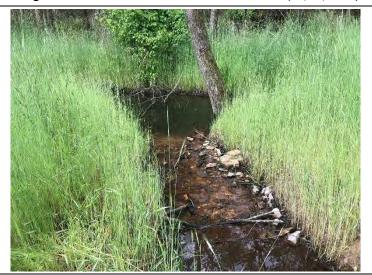
Bridges Creek UT1 Photo Point 82 – view upstream (04/25/2018)

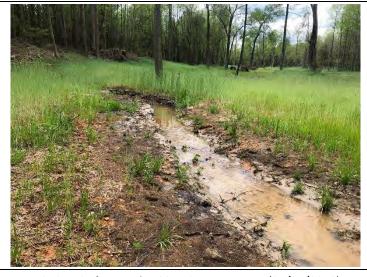
Bridges Crk UT1 Photo Point 82 – view downstream (04/25/2018)

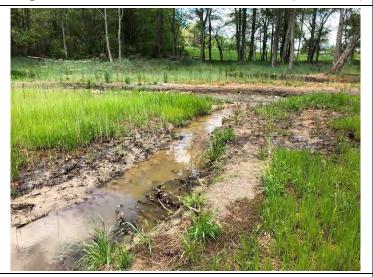
USEC UT2 Photo Point 83 – view upstream (04/25/2018)

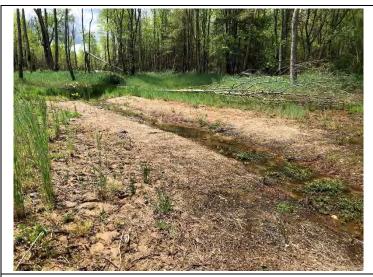
USEC UT2 Photo Point 83 – view downstream (04/25/2018)

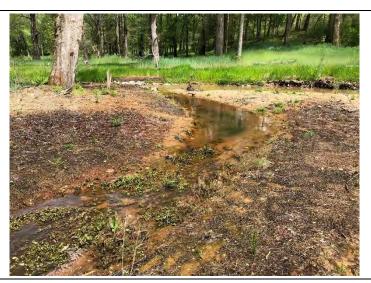
USEC UT3 Photo Point 84 – view upstream (04/25/2018)

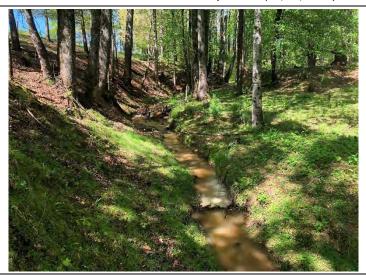
USEC UT3 Photo Point 84 – view downstream (04/25/2018)

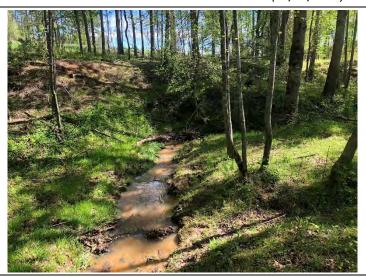
UFC R1 Photo Point 85 – view upstream (04/25/2018)

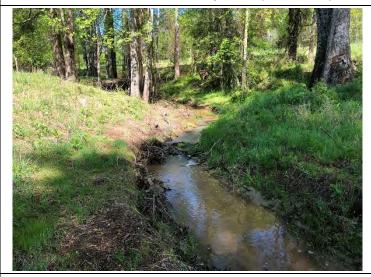
UFC R1 Photo Point 85 – view downstream (04/25/2018)

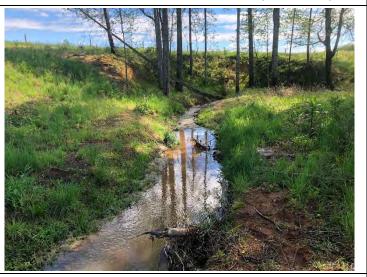
UFC R1 Photo Point 86 – view upstream (04/25/2018)

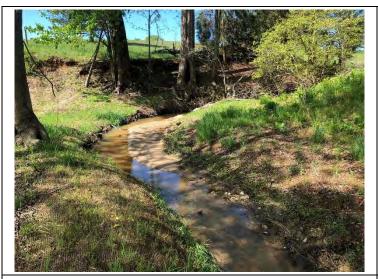
UFC R1 Photo Point 86 – view downstream (04/25/2018)

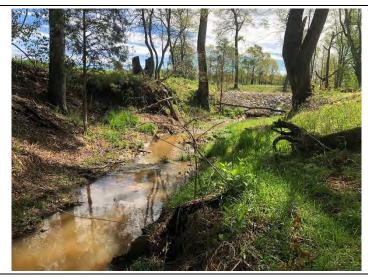
UFC R1 Photo Point 87 – view upstream (04/25/2018)

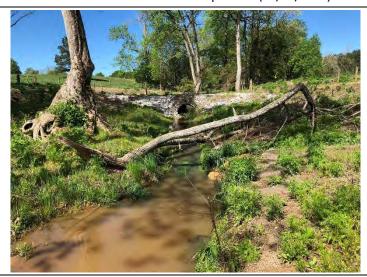
UFC R1 Photo Point 87 – view downstream (04/25/2018)

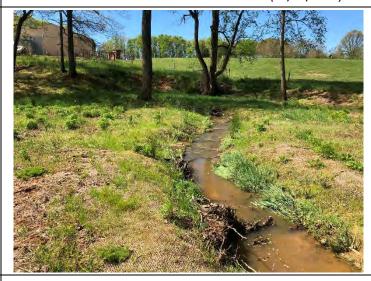
UFC R2 Photo Point 88 – view upstream (04/25/2018)

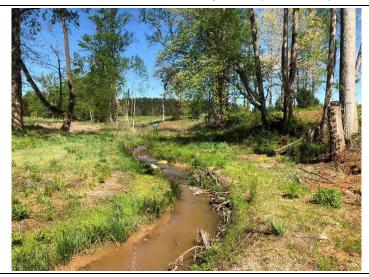
UFC R2 Photo Point 88 – view downstream (04/25/2018)

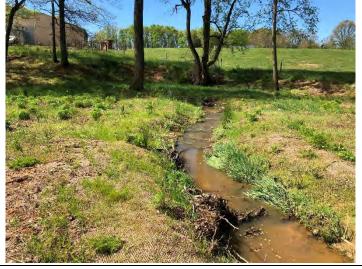
UFC R2 Photo Point 89 – view upstream (04/25/2018)

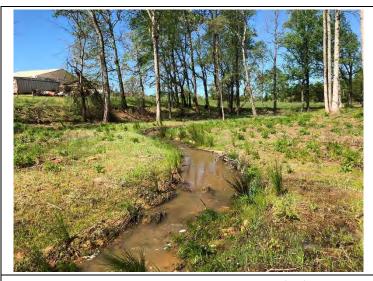
UFC R2 Photo Point 89 – view downstream (04/25/2018)

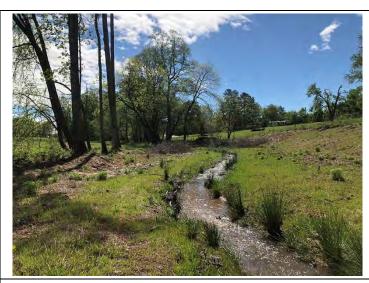
UFC R2 Photo Point 90 - view upstream (04/25/2018)

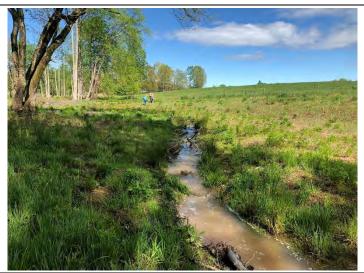
UFC R2 Photo Point 90 – view downstream (04/25/2018)

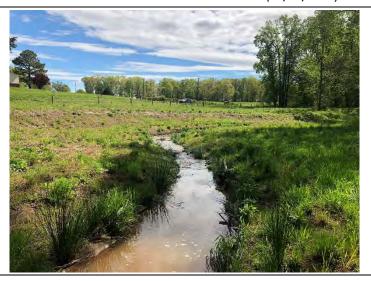
UFC R2 Photo Point 91 – view upstream (04/25/2018)

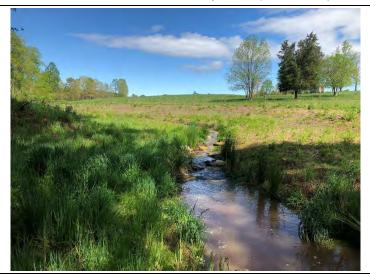
UFC R2 Photo Point 91 – view downstream (04/25/2018)

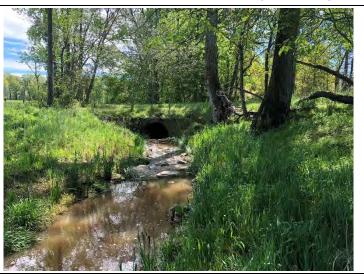
UFC R2 Photo Point 92 – view upstream (04/25/2018)

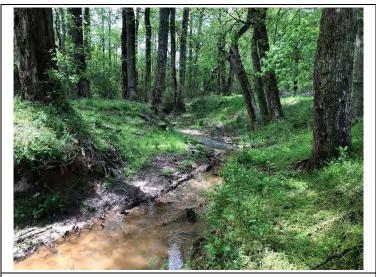
UFC R2 Photo Point 92 – view downstream (04/25/2018)

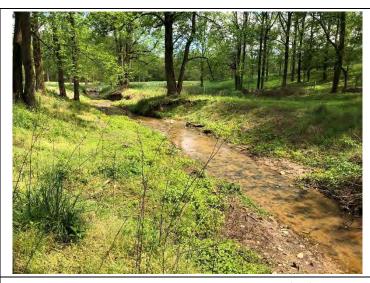
LFC R1 Photo Point 93 - view upstream (04/26/2018)

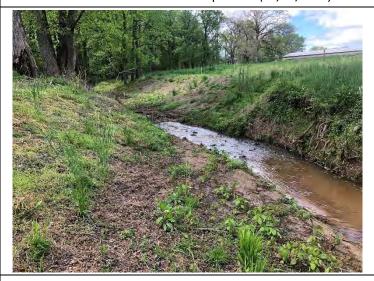
LFC R1 Photo Point 93 – view downstream (04/26/2018)

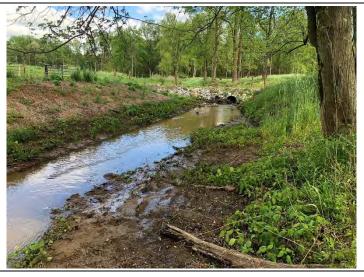
LFC R1 Photo Point 94 – view upstream (04/26/2018)

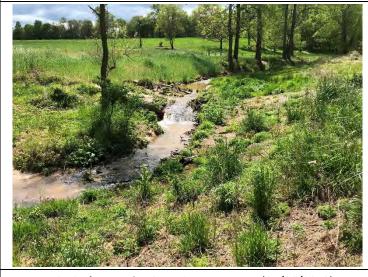
LFC R1 Photo Point 94 – view downstream (04/26/2018)

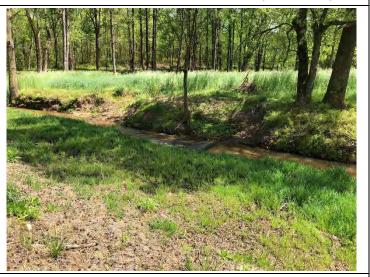
LFC R2 Photo Point 95 – view upstream (04/26/2018)

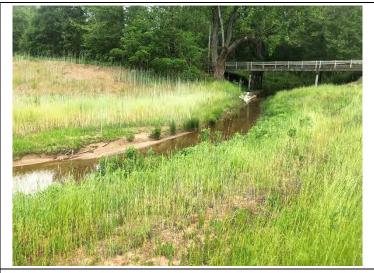
LBHC R1A Photo Point 96 – view upstream (05/14/2018)

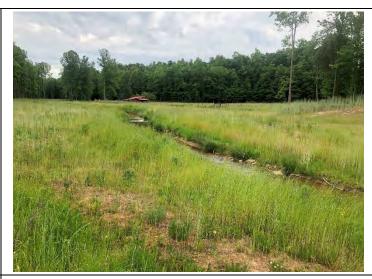
LBHC R1A Photo Point 96 – view downstream (05/14/2018)

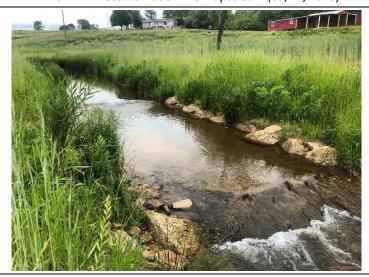
LBHC R1A Photo Point 97 – view upstream (05/14/2018)
