CALDWELL STATION CREEK AND ASSOCIATED FLOODPLAIN WETLANDS RESTORATION PLAN

60% RESTORATION PLAN

**MECKLENBURG COUNTY
NORTH CAROLINA**

HDR Engineering, Inc.
of the Carolinas

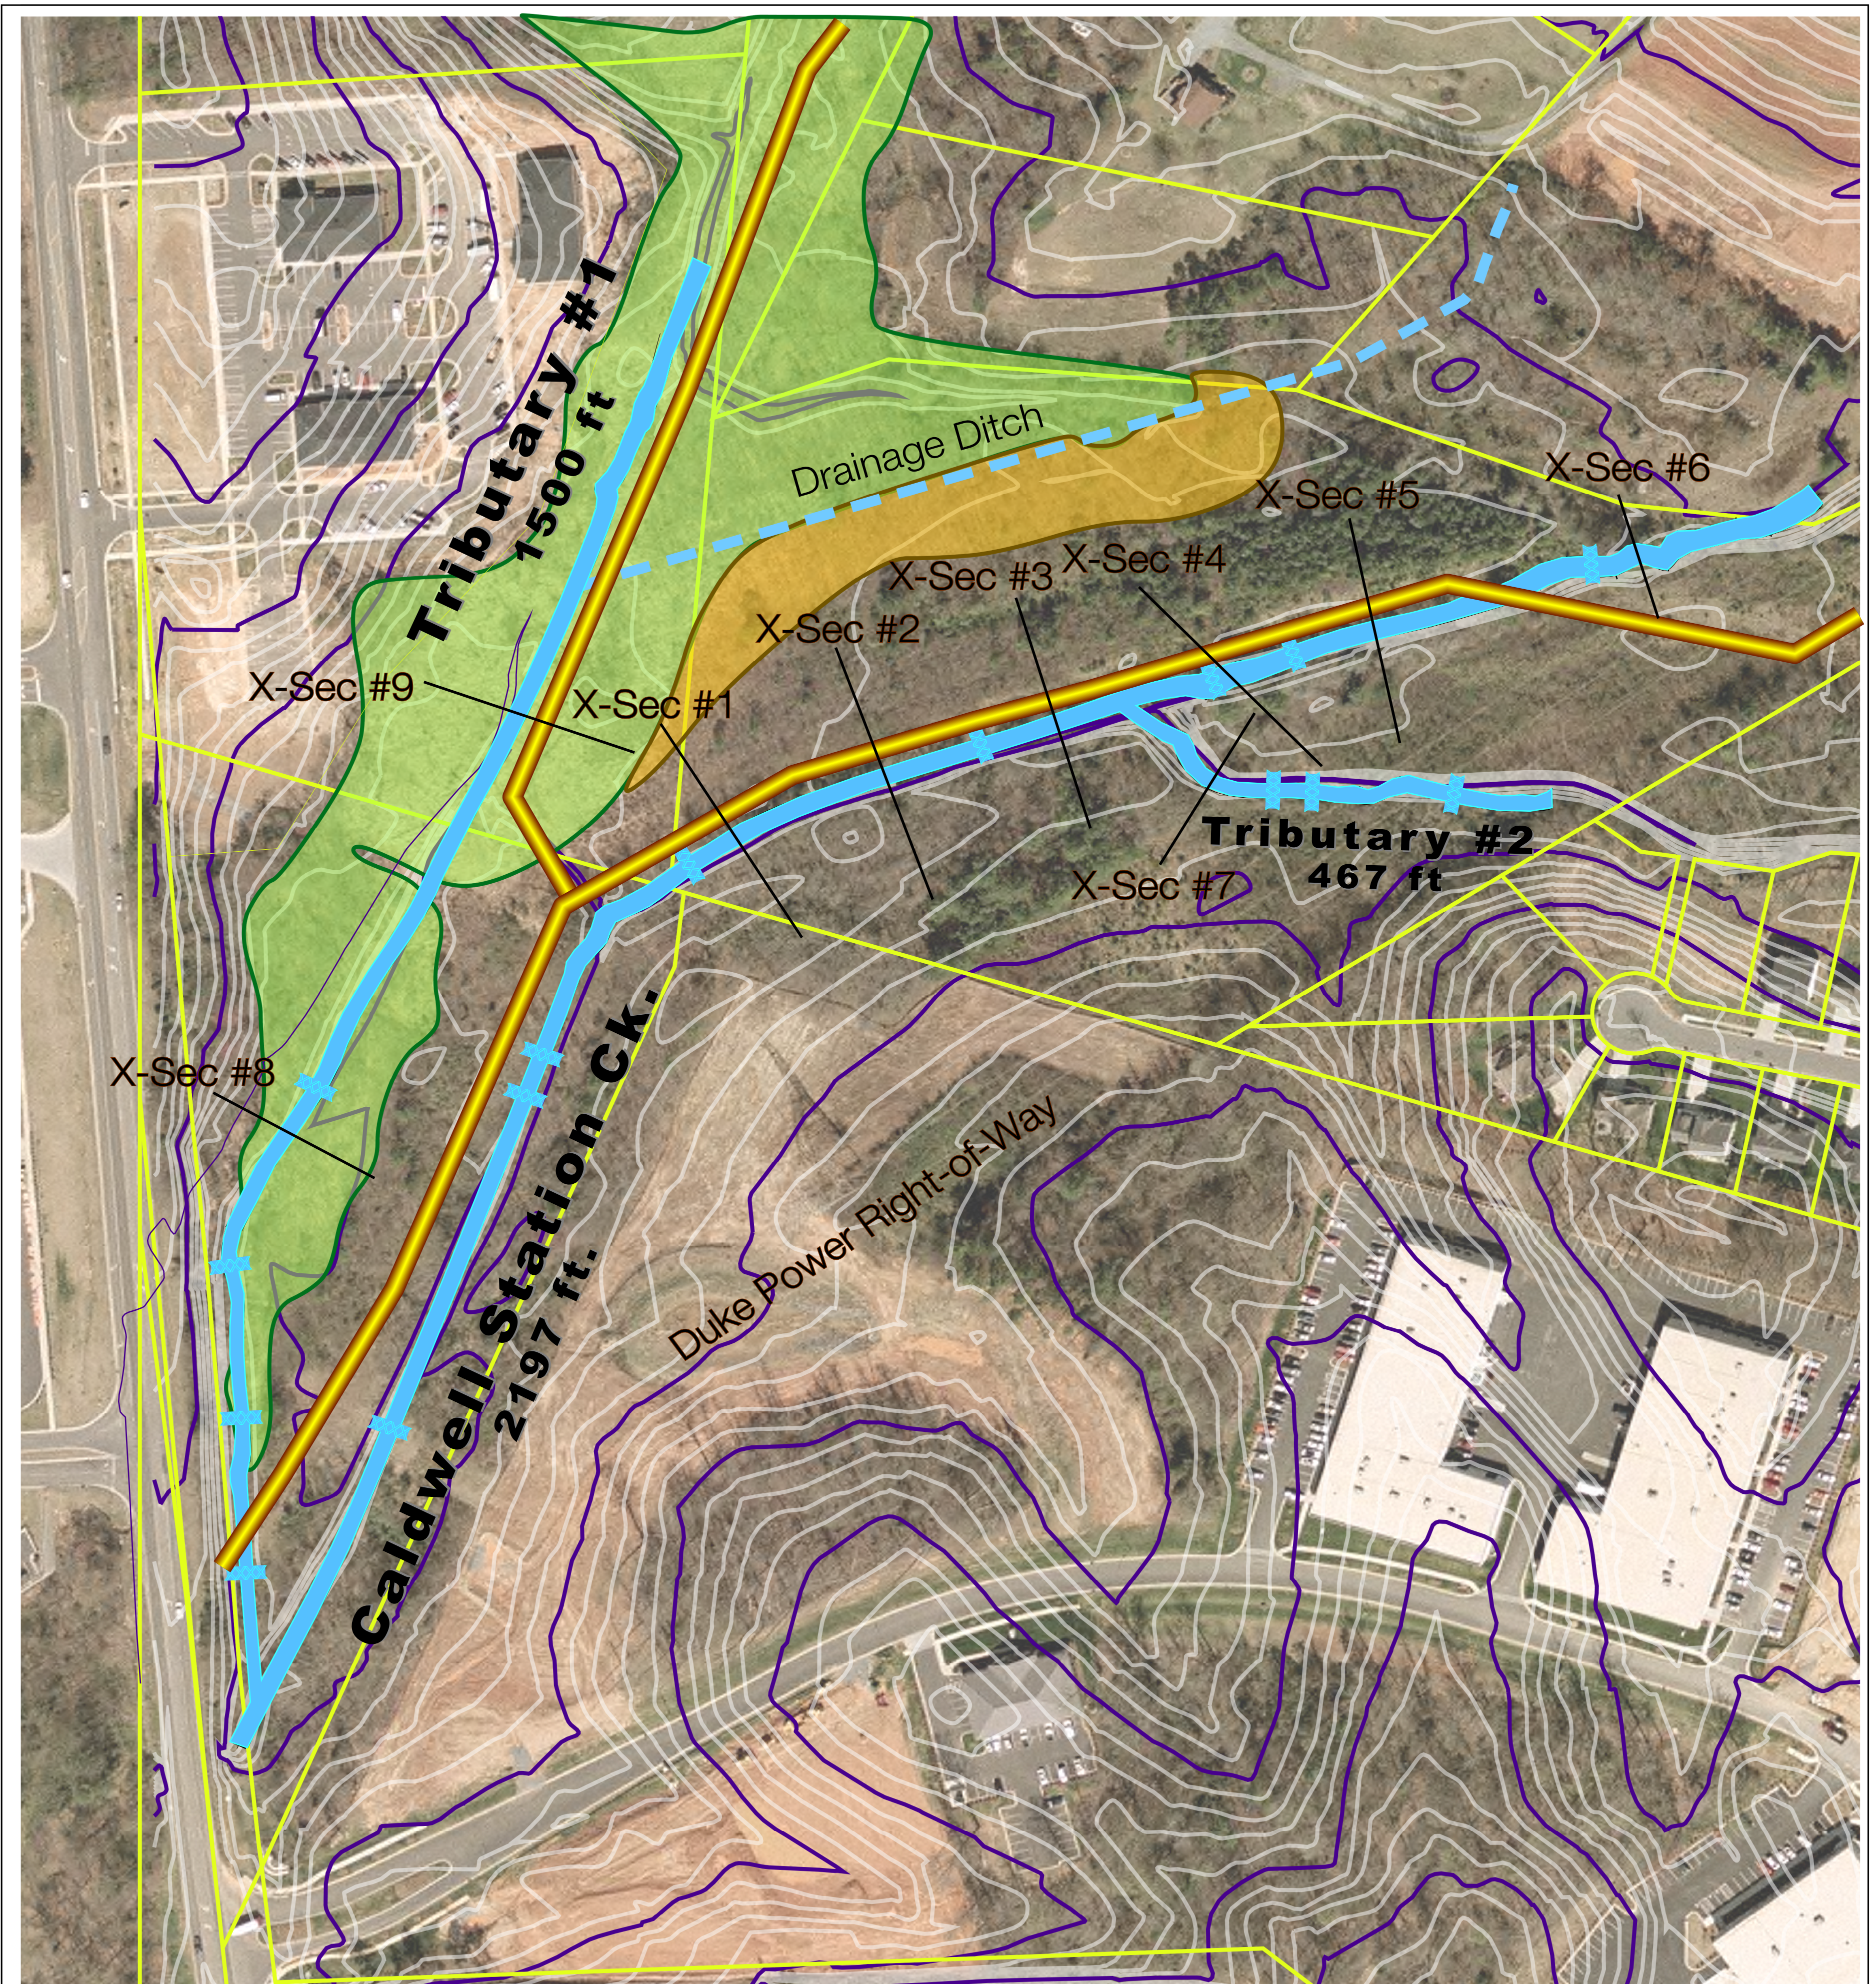
**Figure 13. Planform View of Existing
Stream Channels and Wetlands***

Existing Channels
 Debris Blockage
 Existing Wetlands*
 Existing Transitional Wetlands

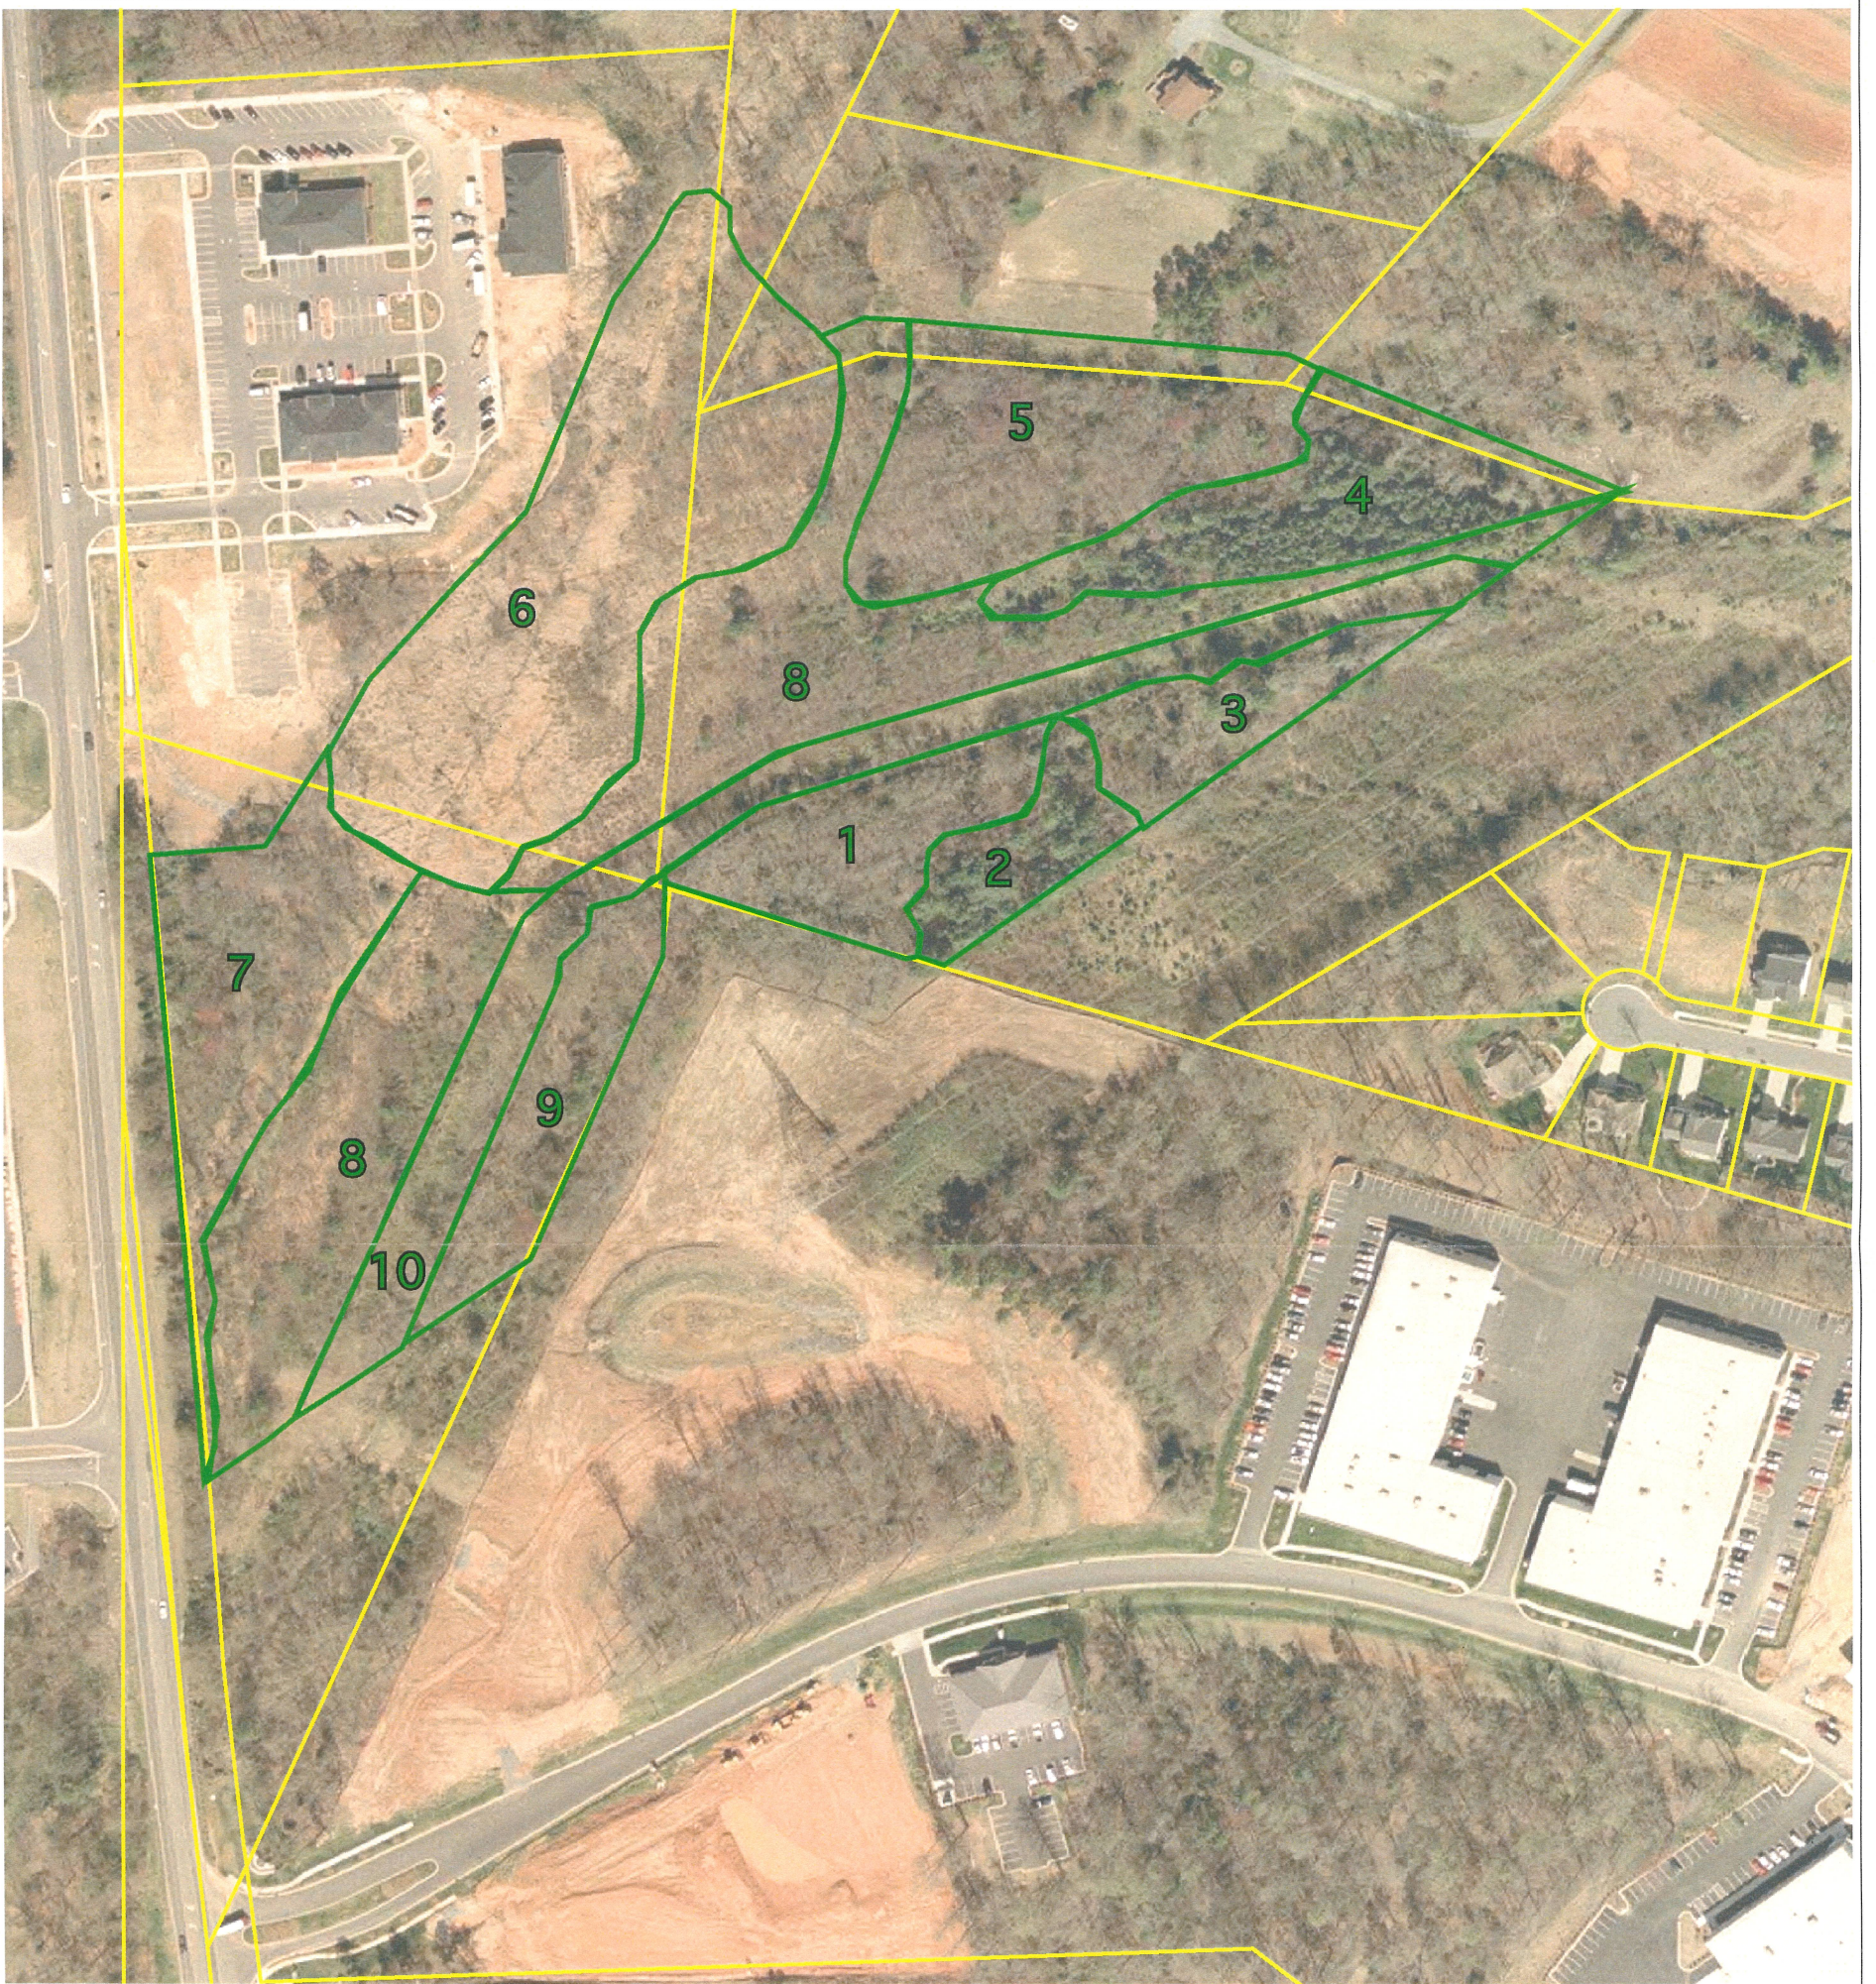
- 1 Mixed Hardwoods Uplands
- 2 Pine & Mixed Hardwoods Upland
- 3 Bottomland Hardwoods & Pine Floodplain
- 4 Loblolly Pine Planting Floodplain
- 5 Bottomland Hardwood Floodplain & Potential Wetland Inclusions
- 6 Former Beaver Pond & Potential Wetland Inclusions
- 7 Mixed Bottomland Hardwoods Floodplain & Wetlands
- 8 Mixed Bottomland Hardwoods Floodplain & Potential Wetland Inclusions
- 9 Mixed Bottomland Hardwoods Floodplain
- 10 Sewer right-of-way

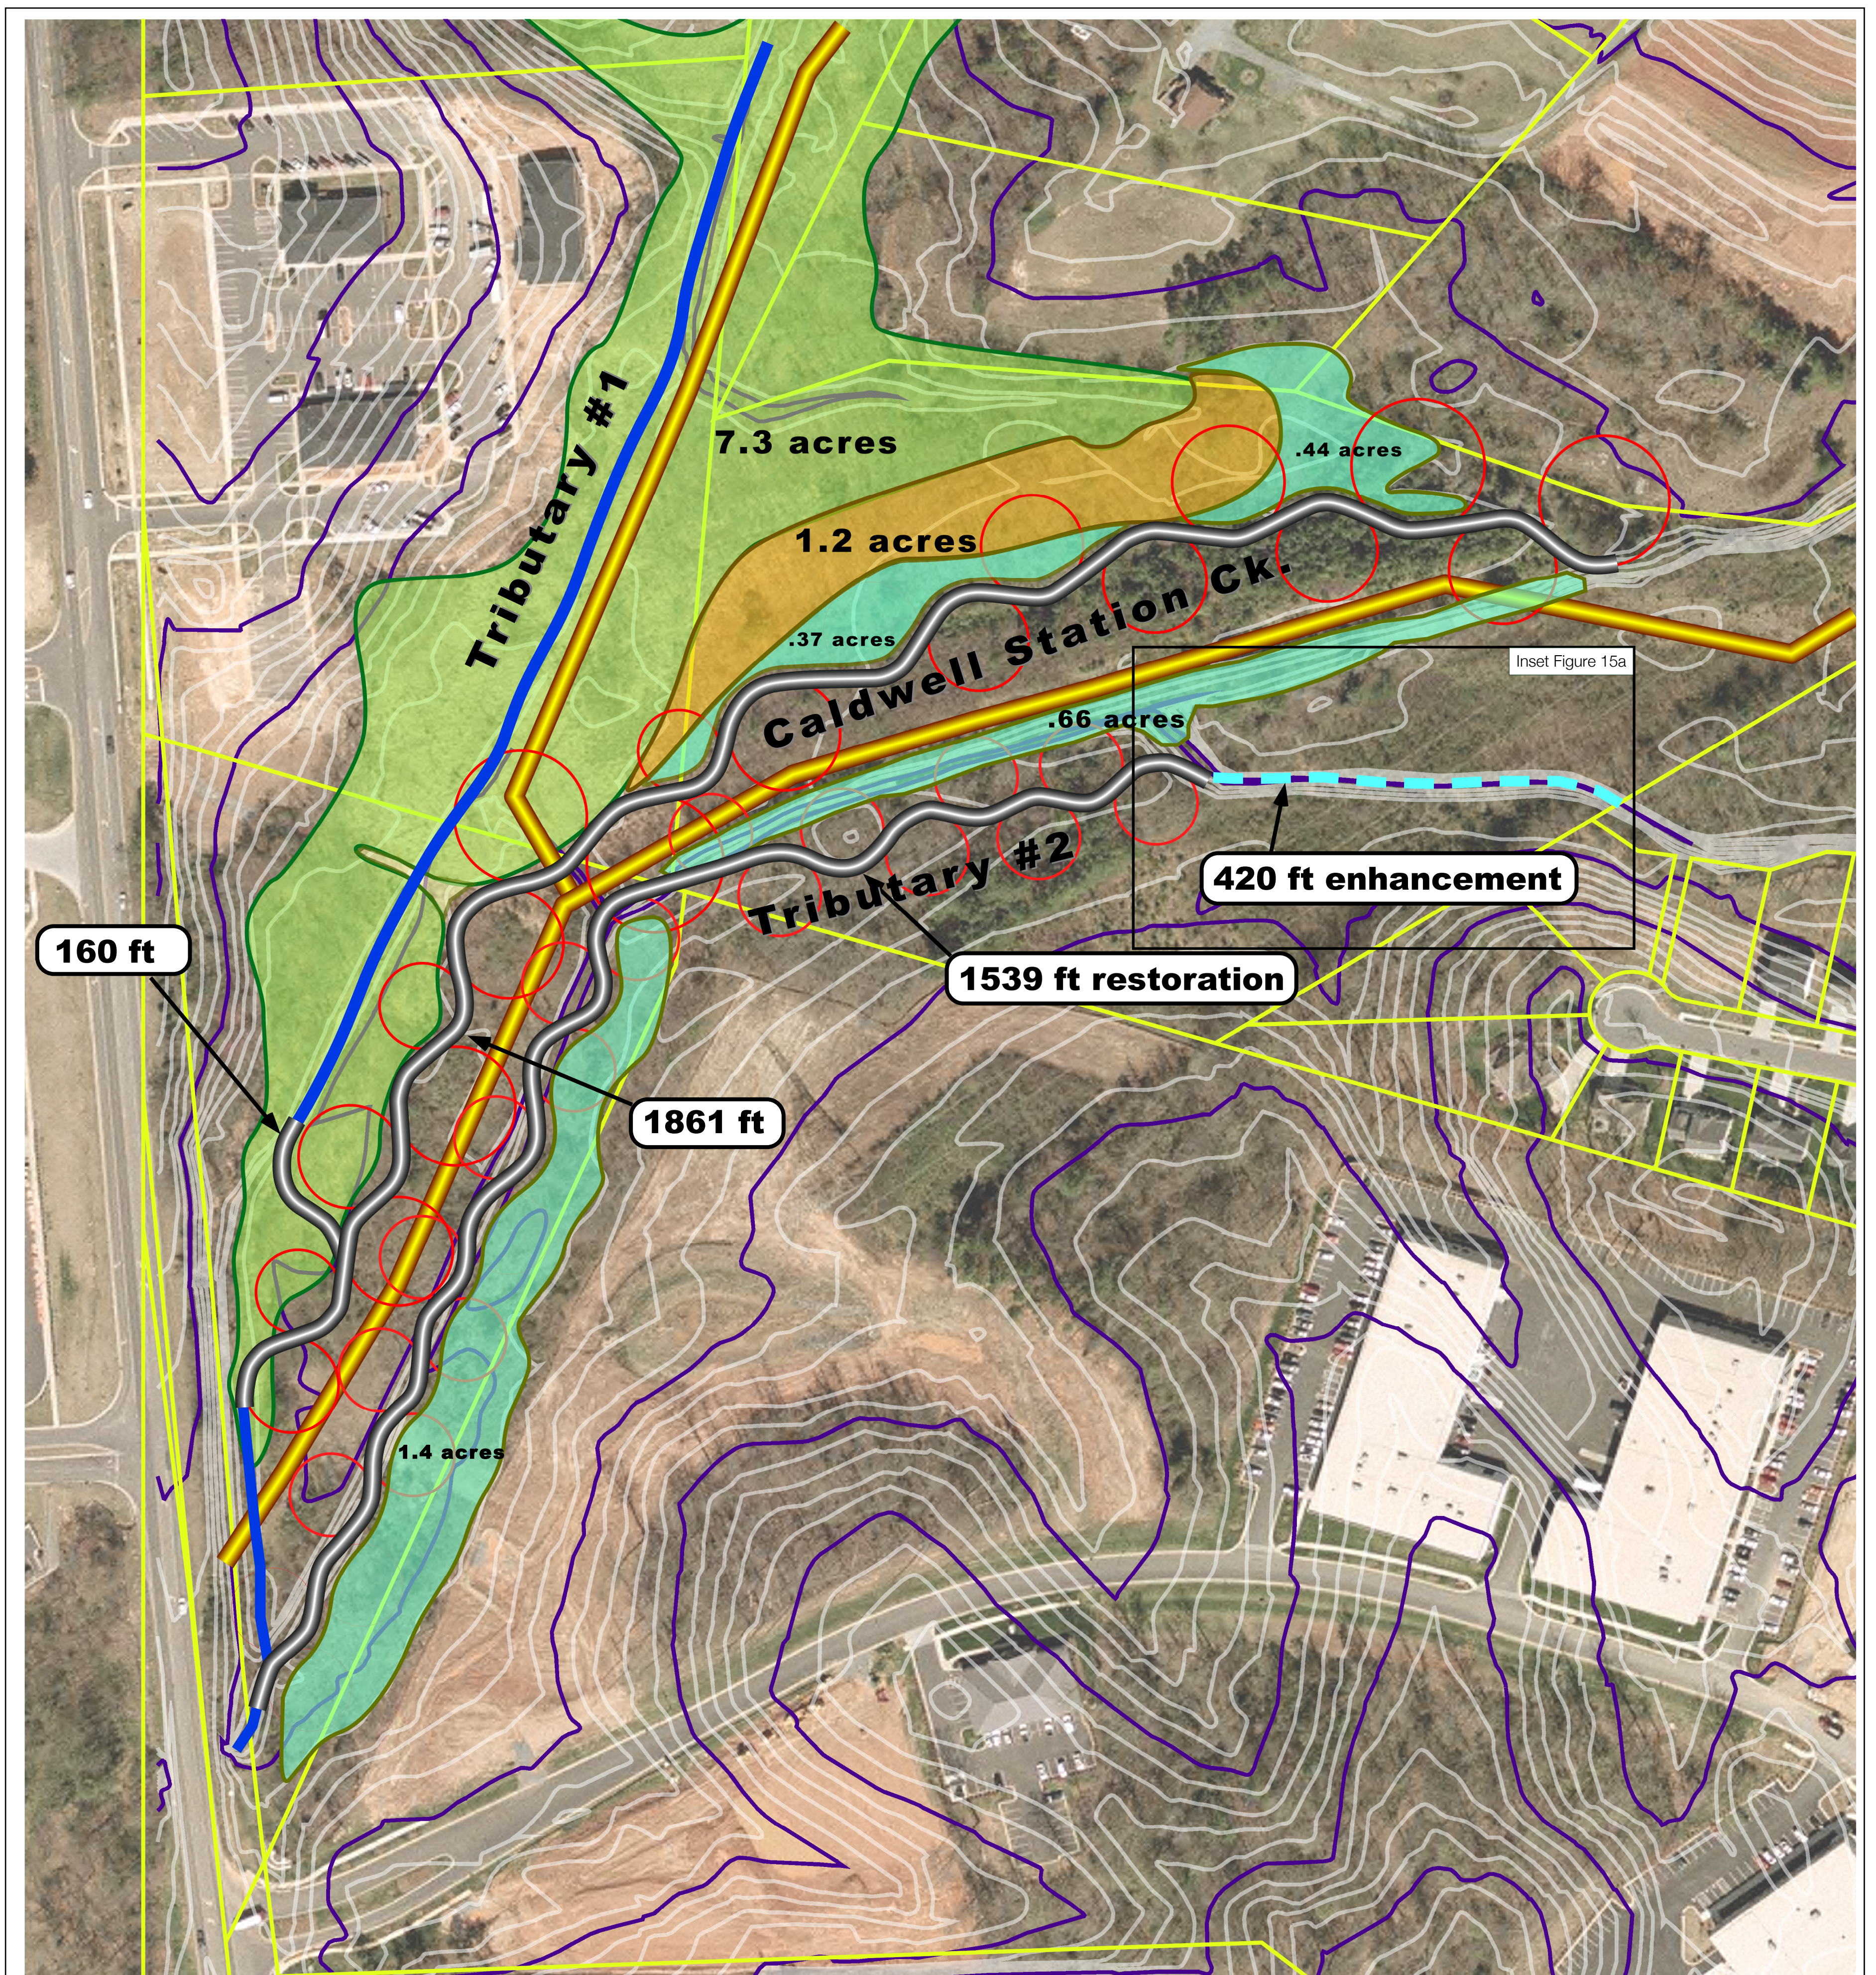
| | Restored New Wetlands | | Parcel Boundaries |

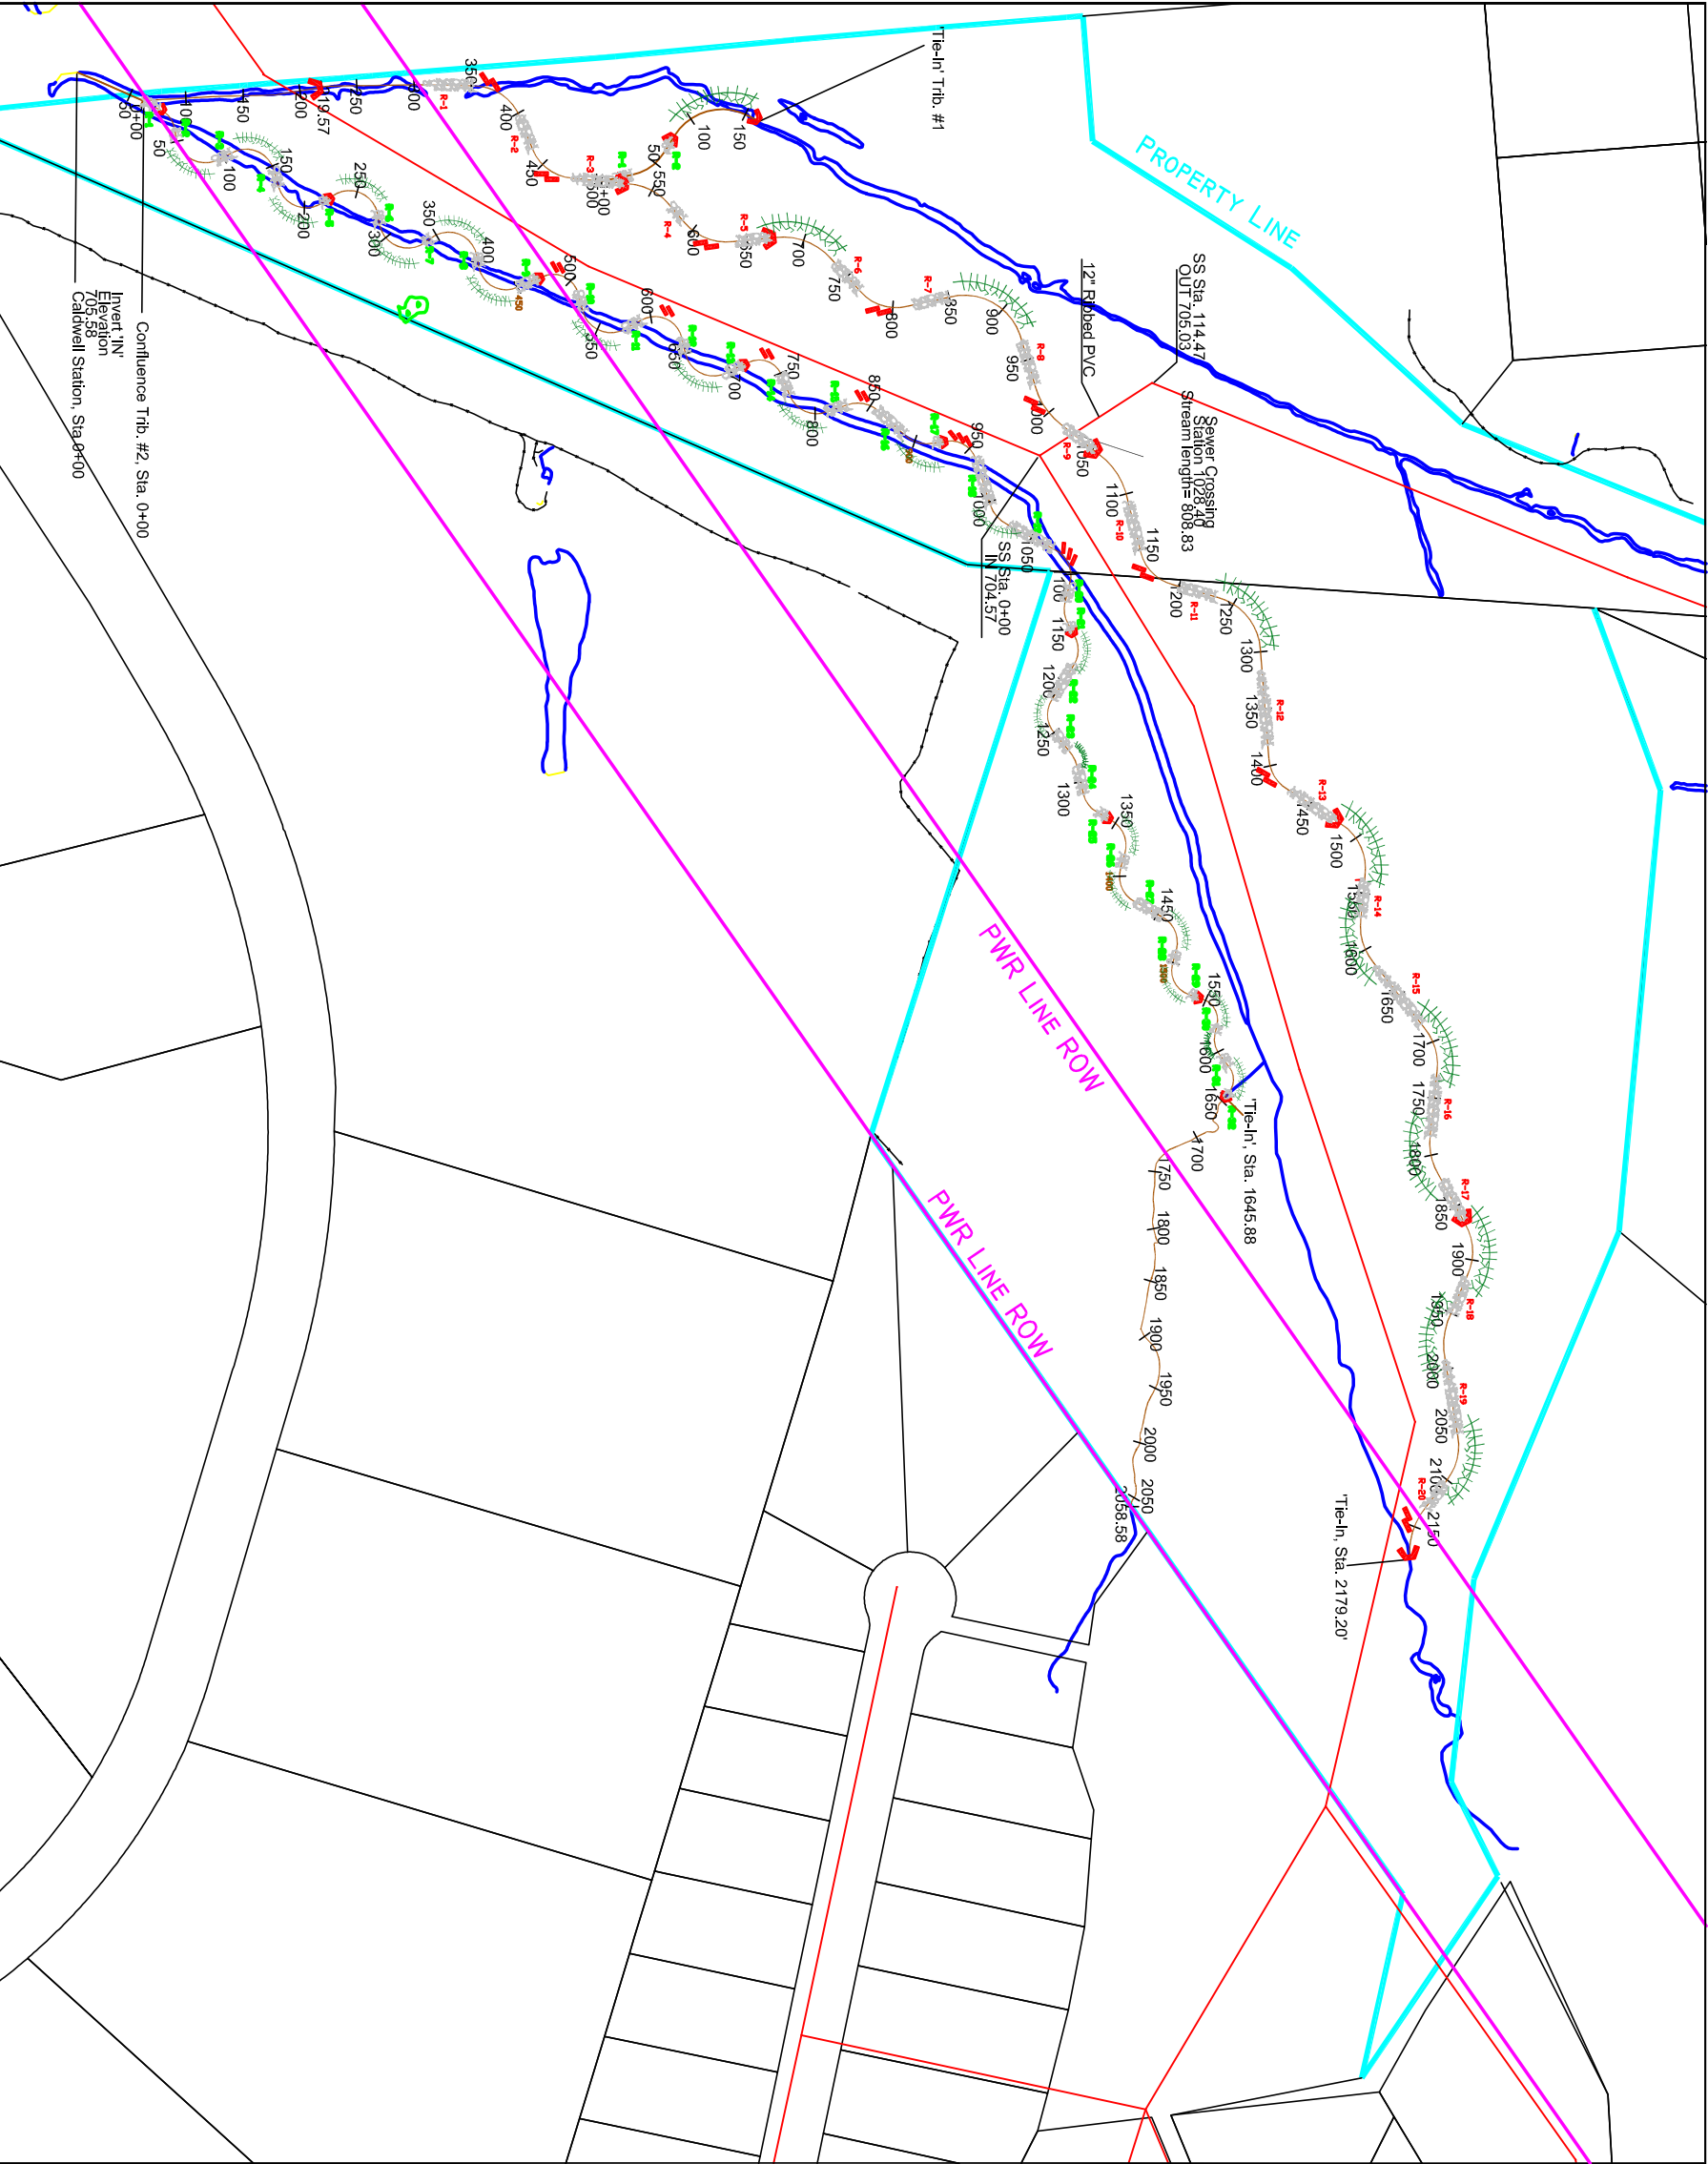
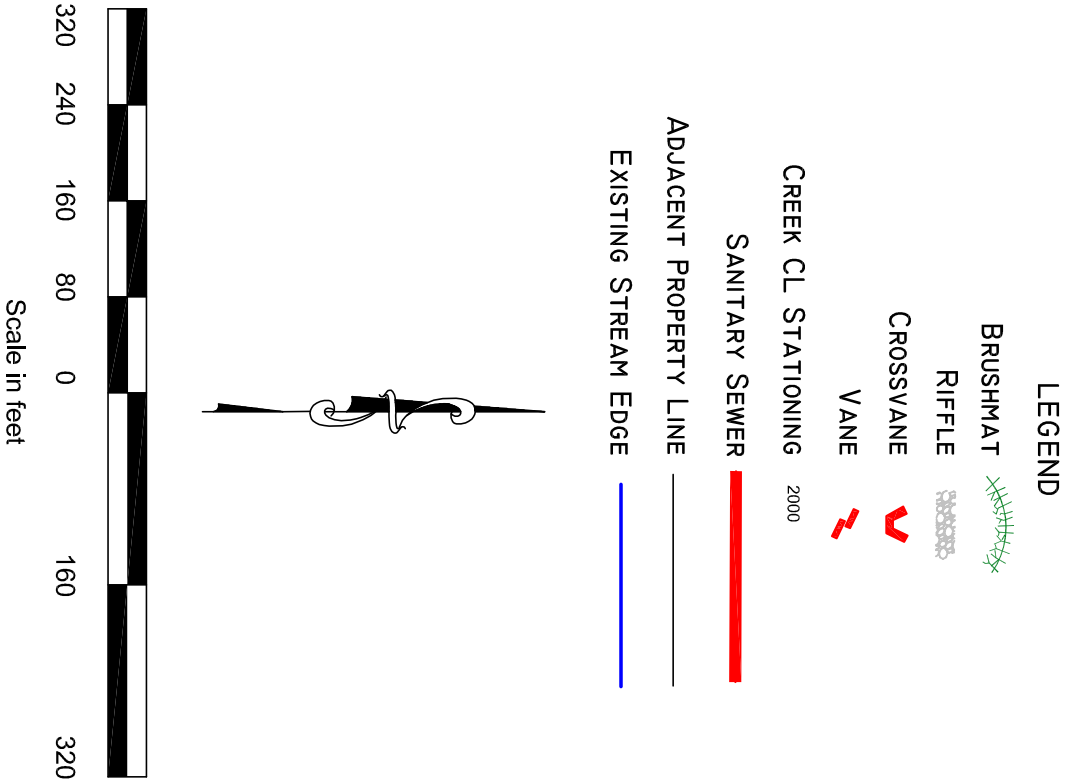
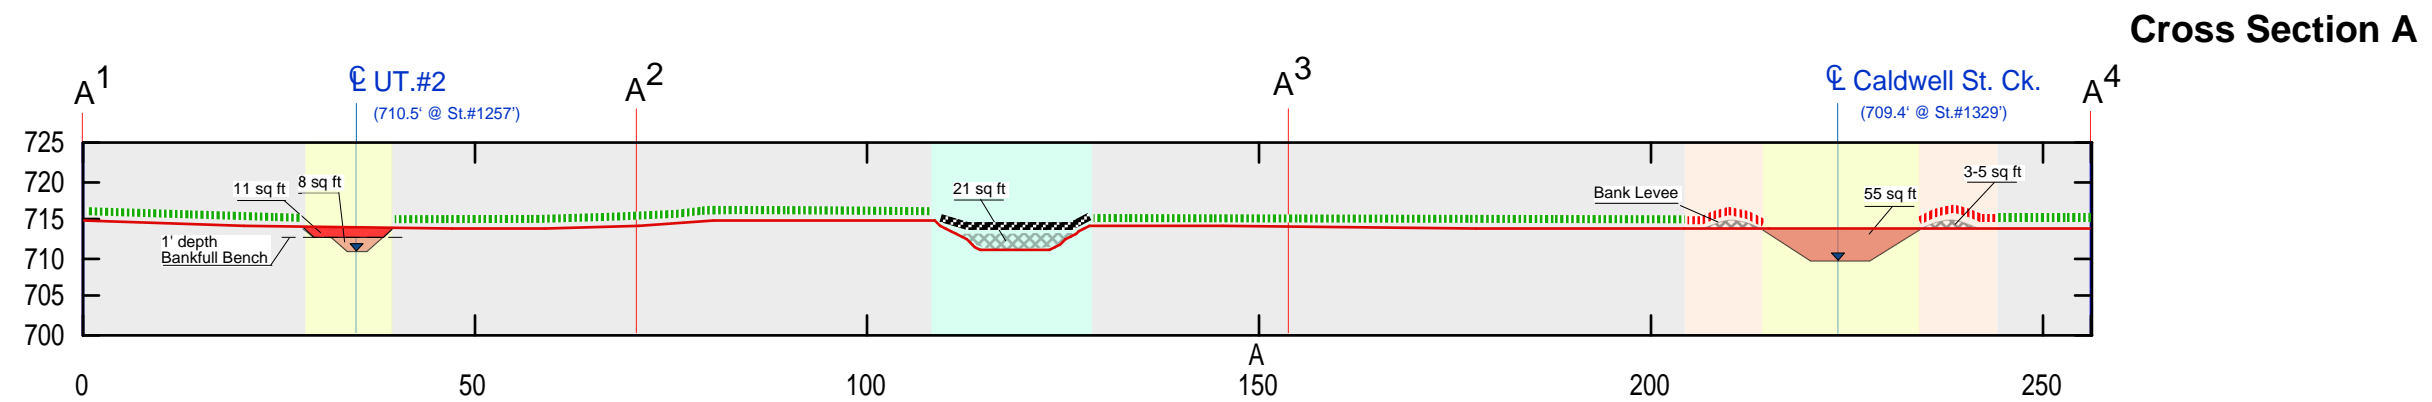
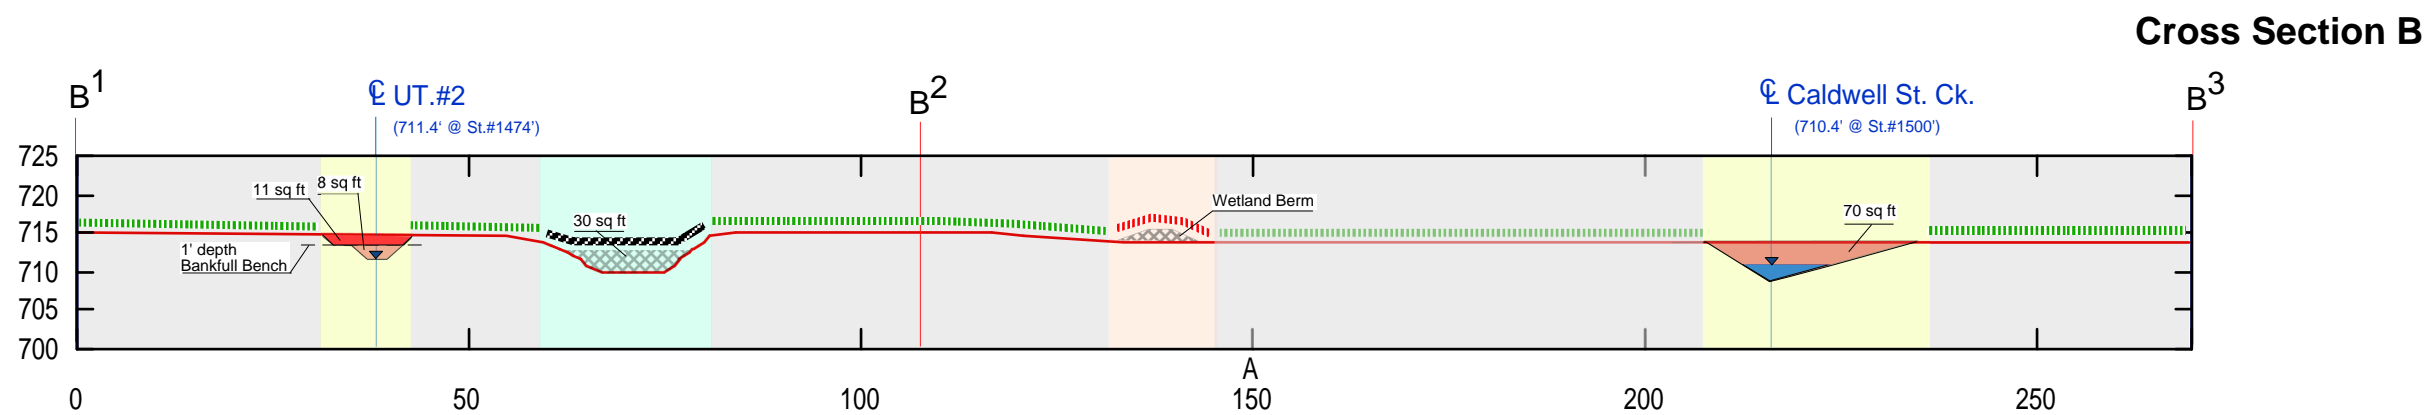
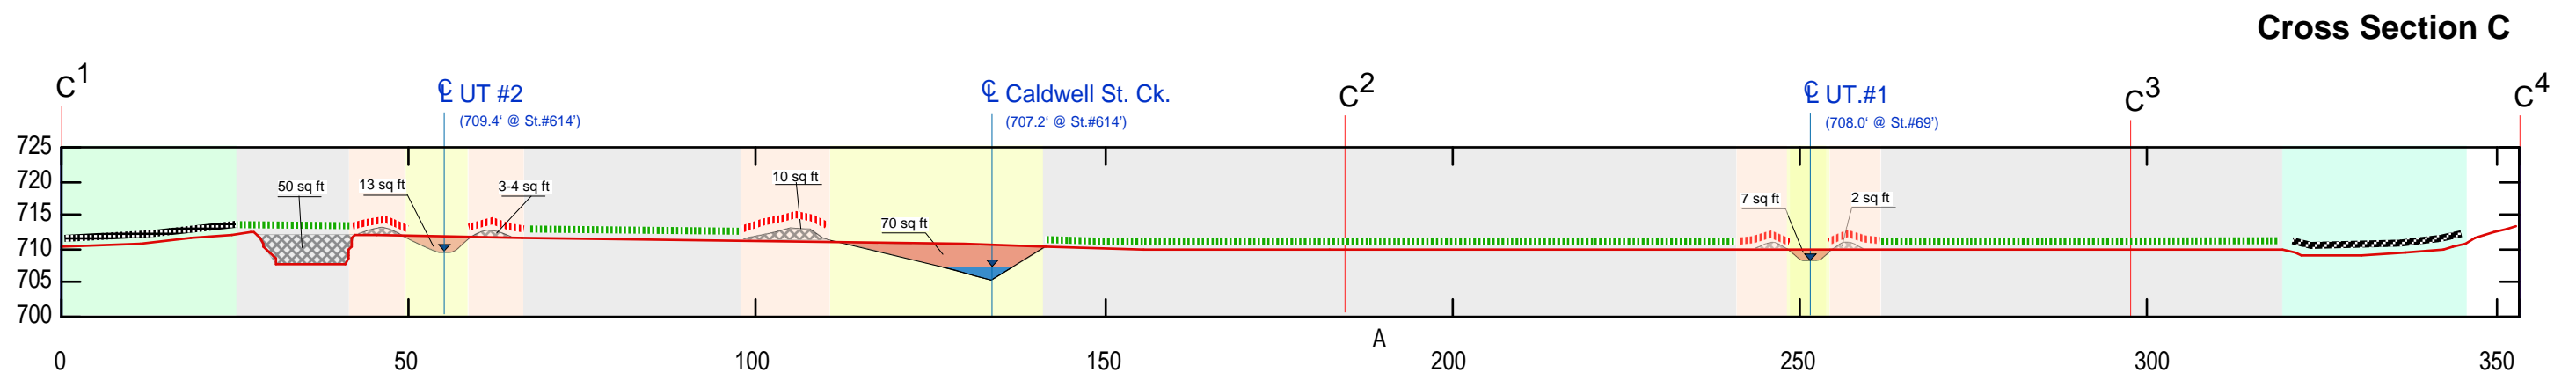
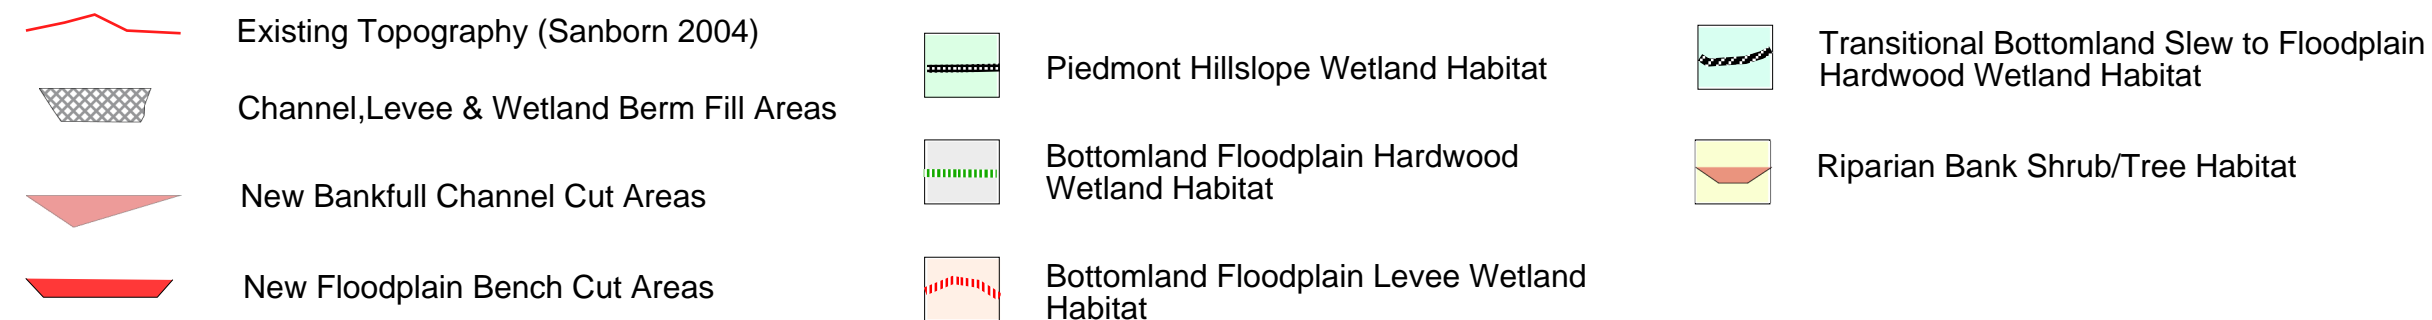
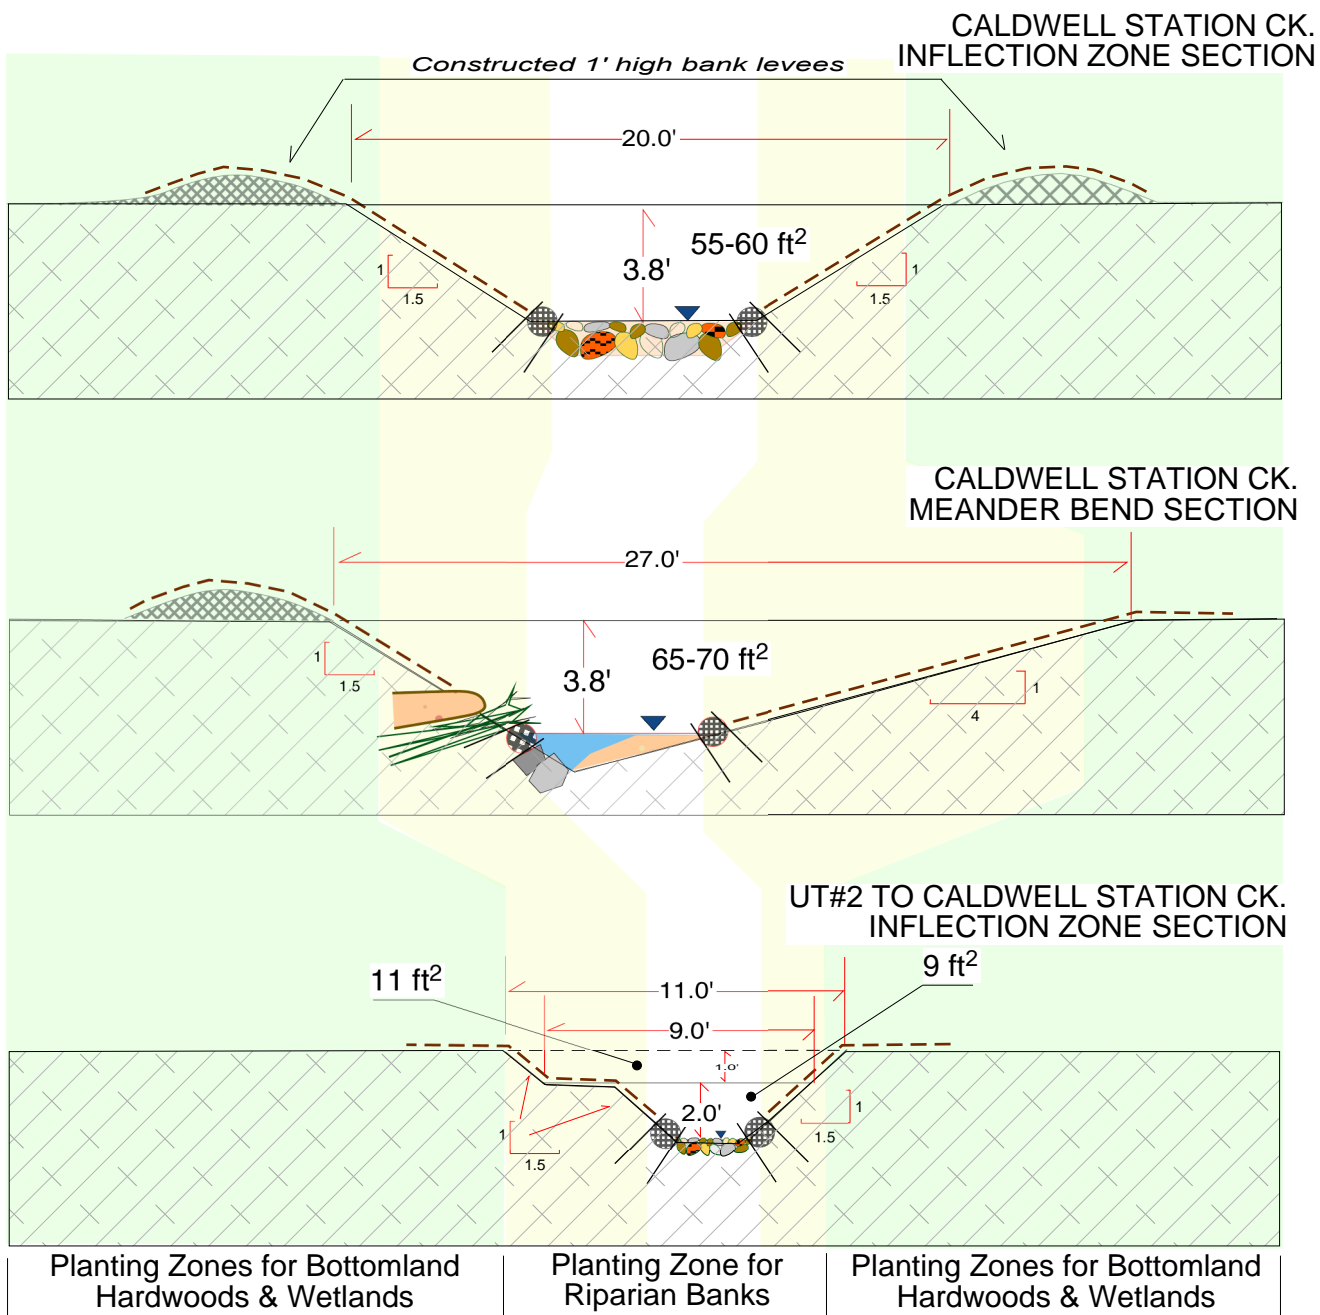
**Figure 15a. Proposed stream enhance-
ment along 420' reach of UT to Caldwell
Station Creek (Trib.#2)**

- Stapled matting (e.g. SC150)
- 12" Coir fiber logs, staked into cohesive channel substrate
- Riffle zones augmented with river cobble (D₈₄; sized for immobility)
- 12" soil lift wrapped in coconut-straw matting (e.g. SC150)
- Brush mattress laid 3' into bank, see planting table for species
- Footer stones to be used under coir fiber logs along outer meanders

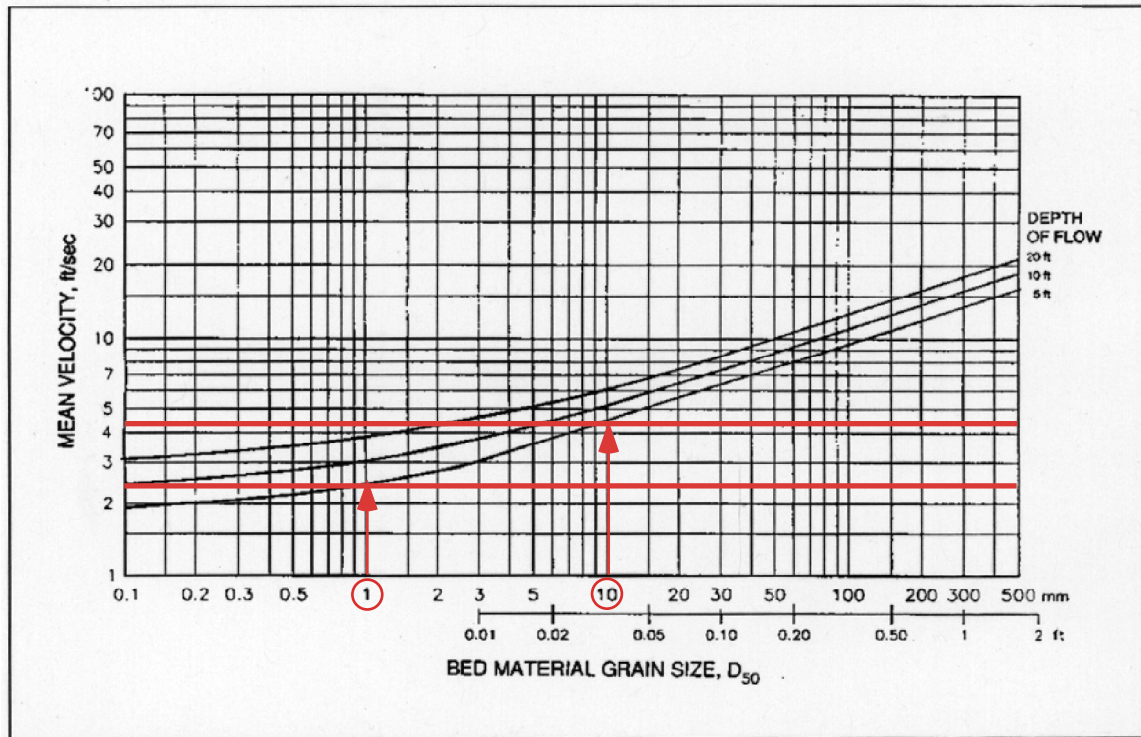
Range of estimated velocities for Caldwell Station and UT#2 bankfull storm plotted on the Mean Velocity vs Bed Material Size (D_{50}) chart from the USACOE 1994 guide to stream stabilization.
