CALDWELL STATION CREEK AND ASSOCIATED FLOODPLAIN WETLANDS RESTORATION PLAN

60% RESTORATION PLAN

**MECKLENBURG COUNTY
NORTH CAROLINA**

HDR Engineering, Inc.
of the Carolinas

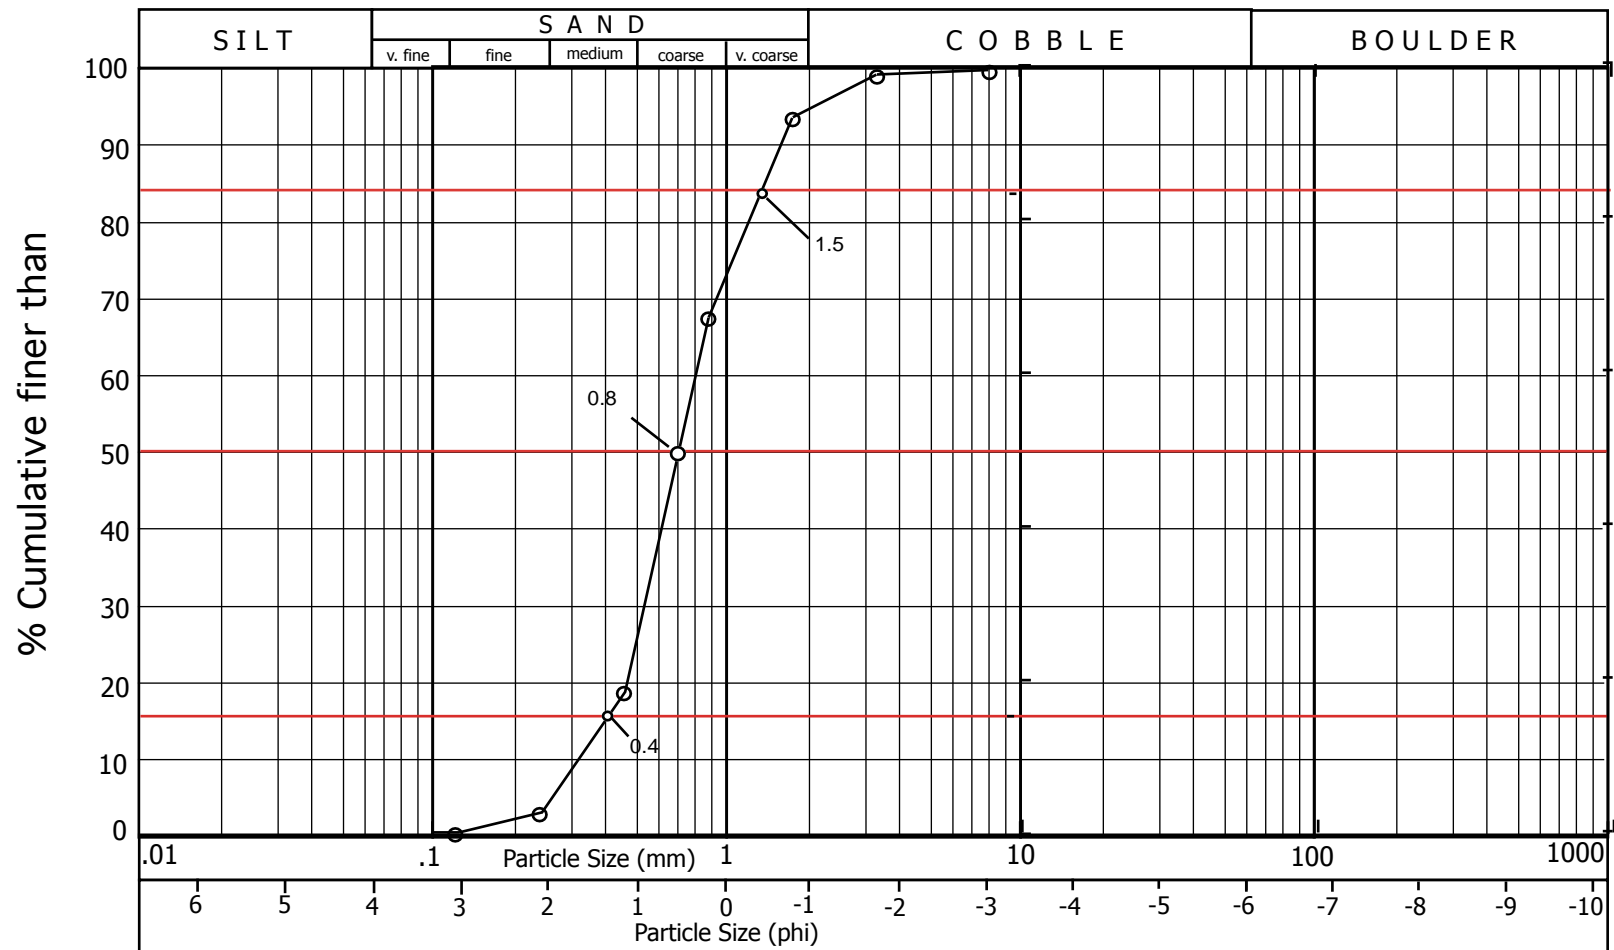
Sample CS-BA

$D_{84(min)}$ 0.4 mm

D_{50} 0.8 mm

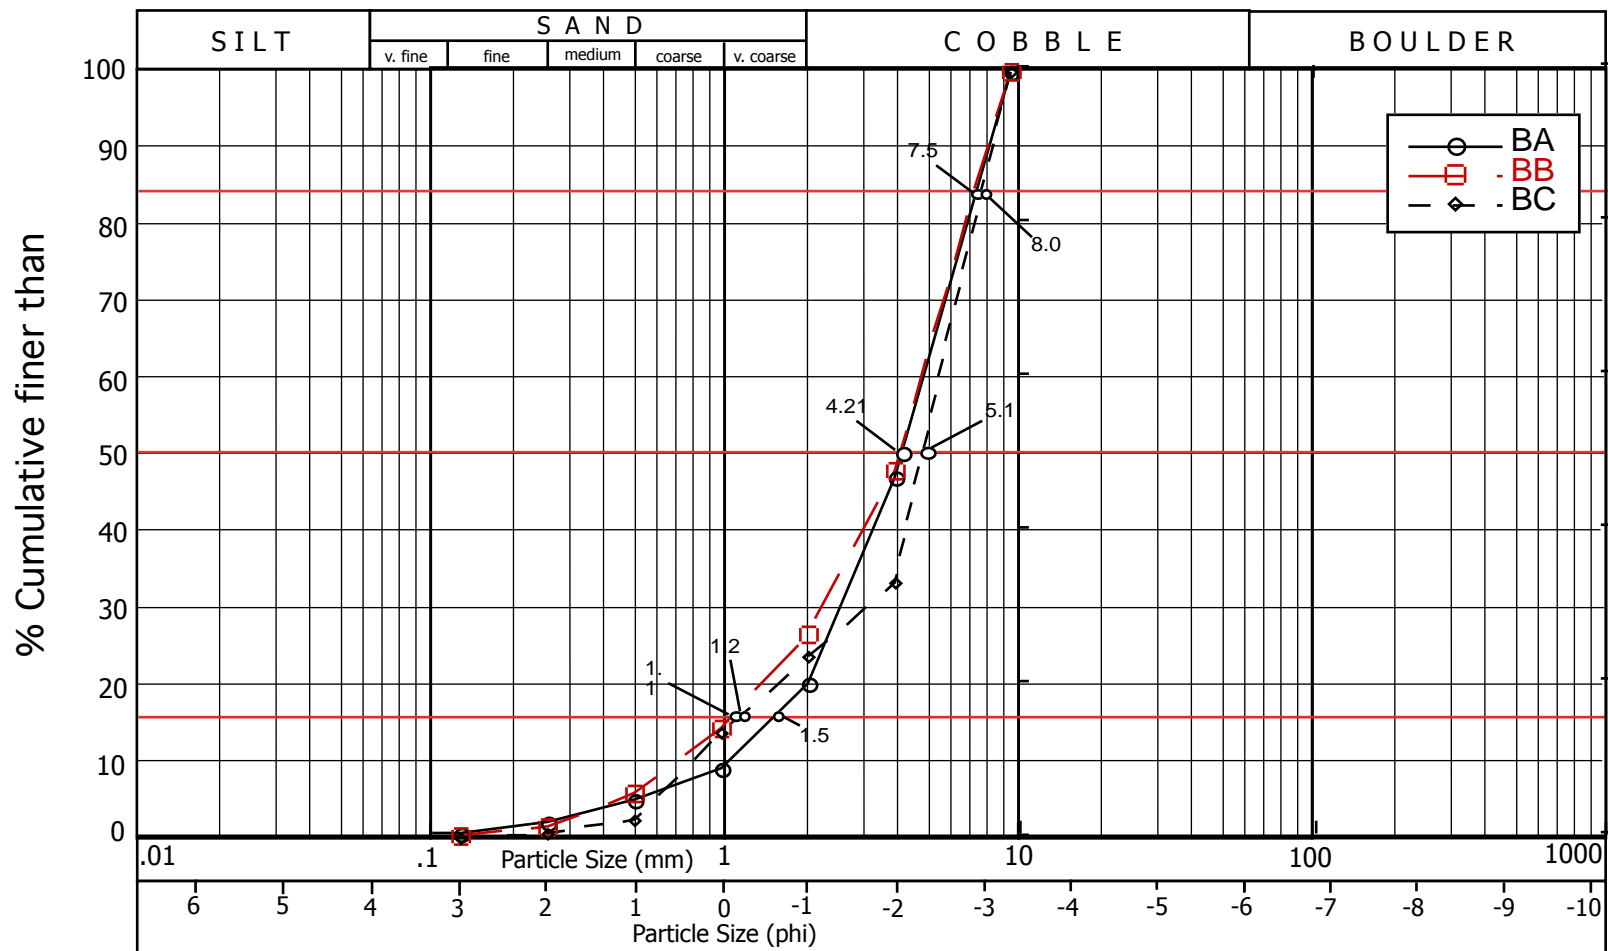
Samples CSR-BA, CSR-BB, & CSR-BC

$D_{84(min)}$ 1.26 mm

D_{50} 4.5 mm

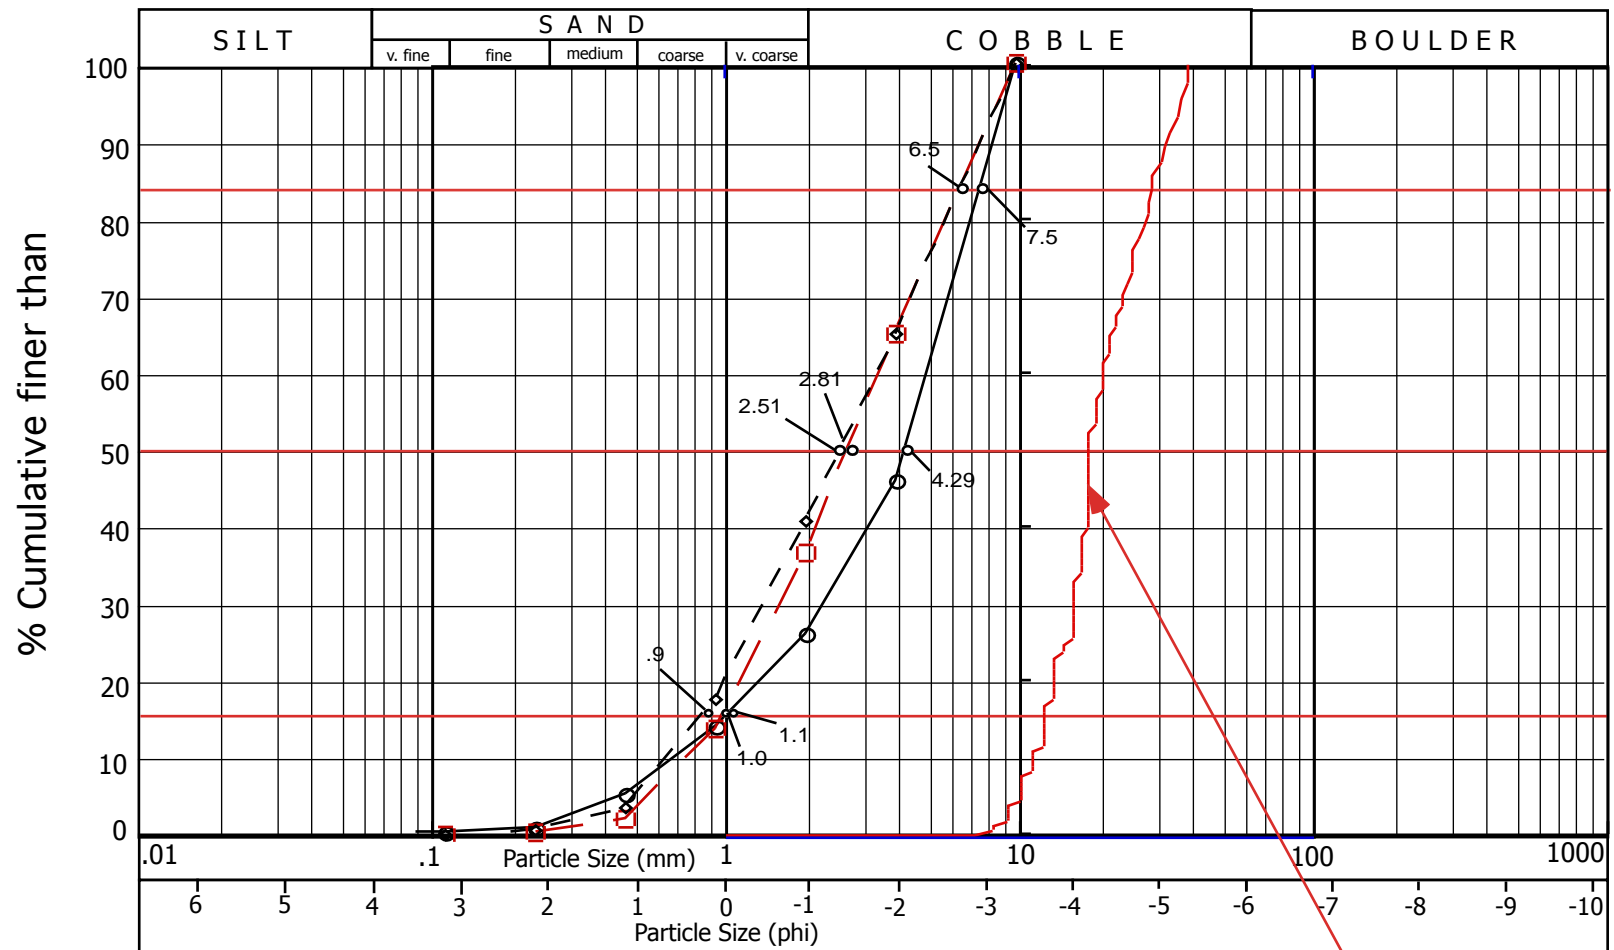
SITE Samples CSR-RA, CSR-RB, & CSR-RC

LOCALITY Caldwell Station Reference Reach - Riffle Substrate Grain Size Samples

$D_{84(\min)}$ 1.0 mm

D_{50} 3.17 mm

$D_{84(\max)}$ 6.8 mm

Riffle Armor
 D_{50} : 17 mm
 $D_{84(\max)}$: 28 mm

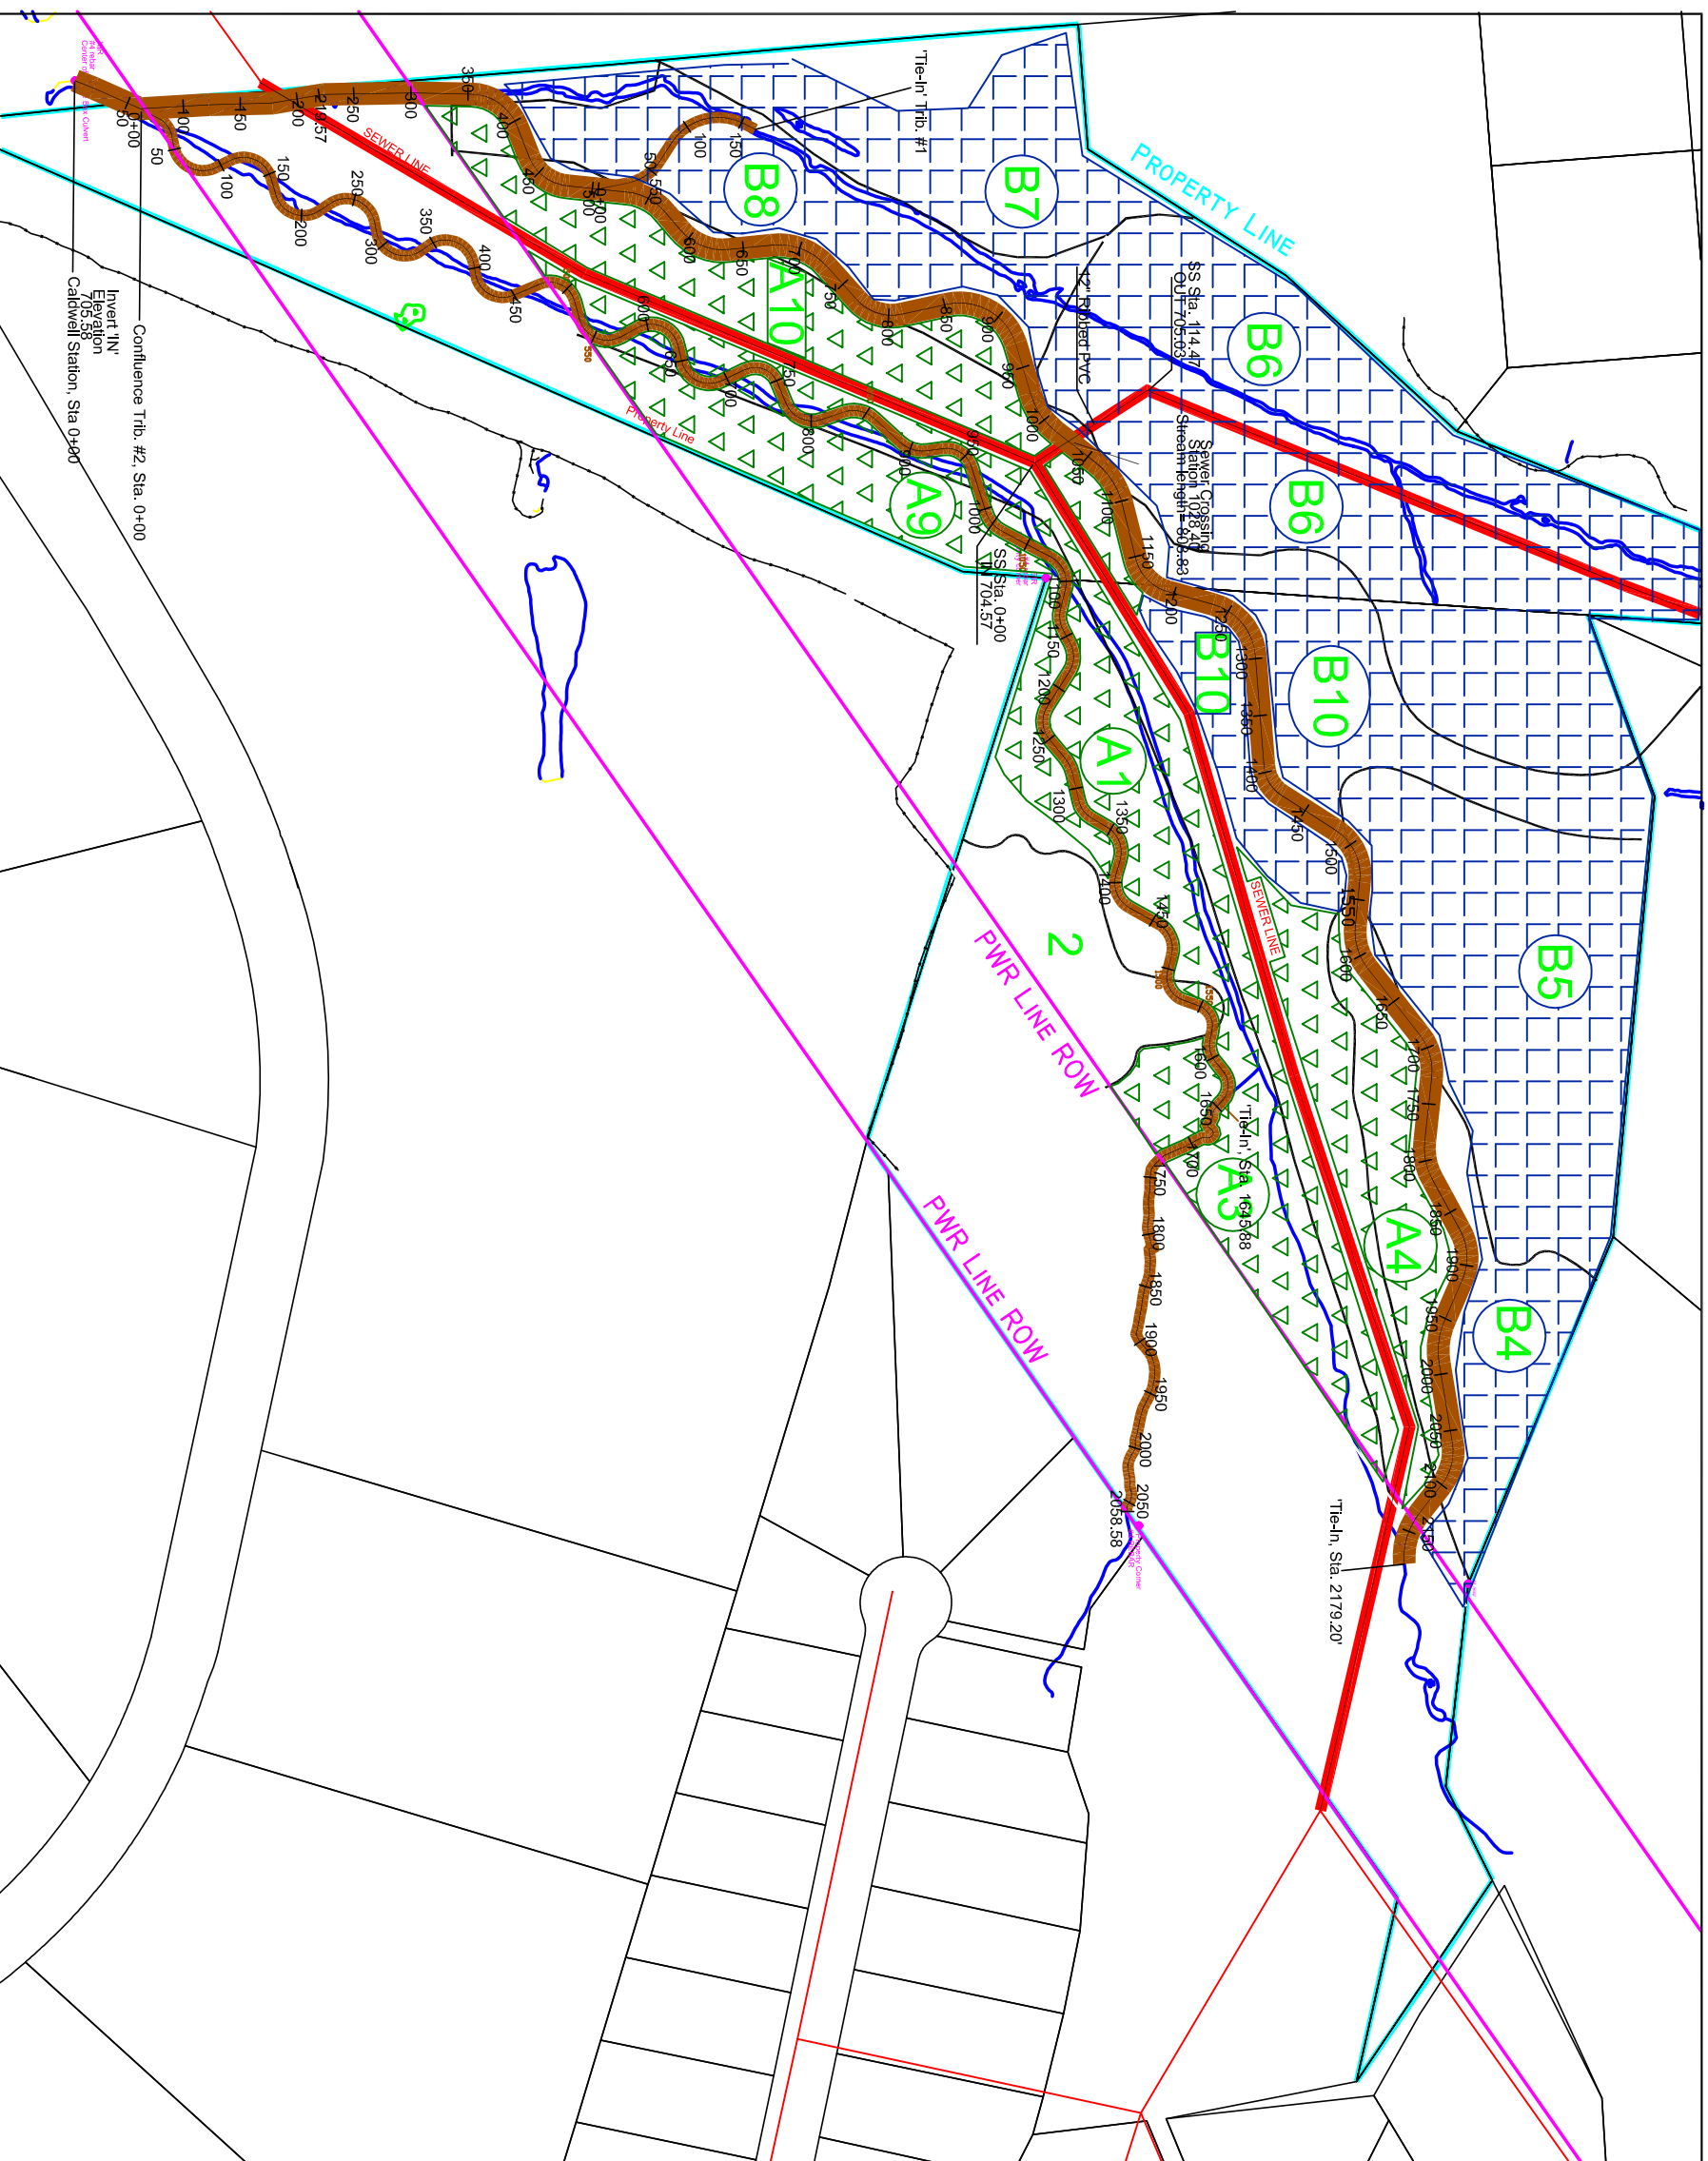
Existing Communities

- 1 Mixed Hardwood Upland
- 2 Pine and Mixed Hardwood Upland
- 3 Bottomland Hardwoods w/ Pine Flood Plain
- 4 Loblolly Pine Planting Flood Plain
- 5 Bottomland Hardwoods Flood Plain w/ Potential Wetlands
- 6 Former Beaver Pond w/ Potential Wetlands
- 7 Mixed Bottomland Hardwoods Flood Plain w/ Wetlands
- 8 Mixed Bottomland Hardwoods Flood Plain w/ Potential Wetlands
- 9 Mixed Bottomland Hardwoods Flood Plain
- 10 Mixed Bottomland Hardwoods Flood Plain w/ Potential Wetlands

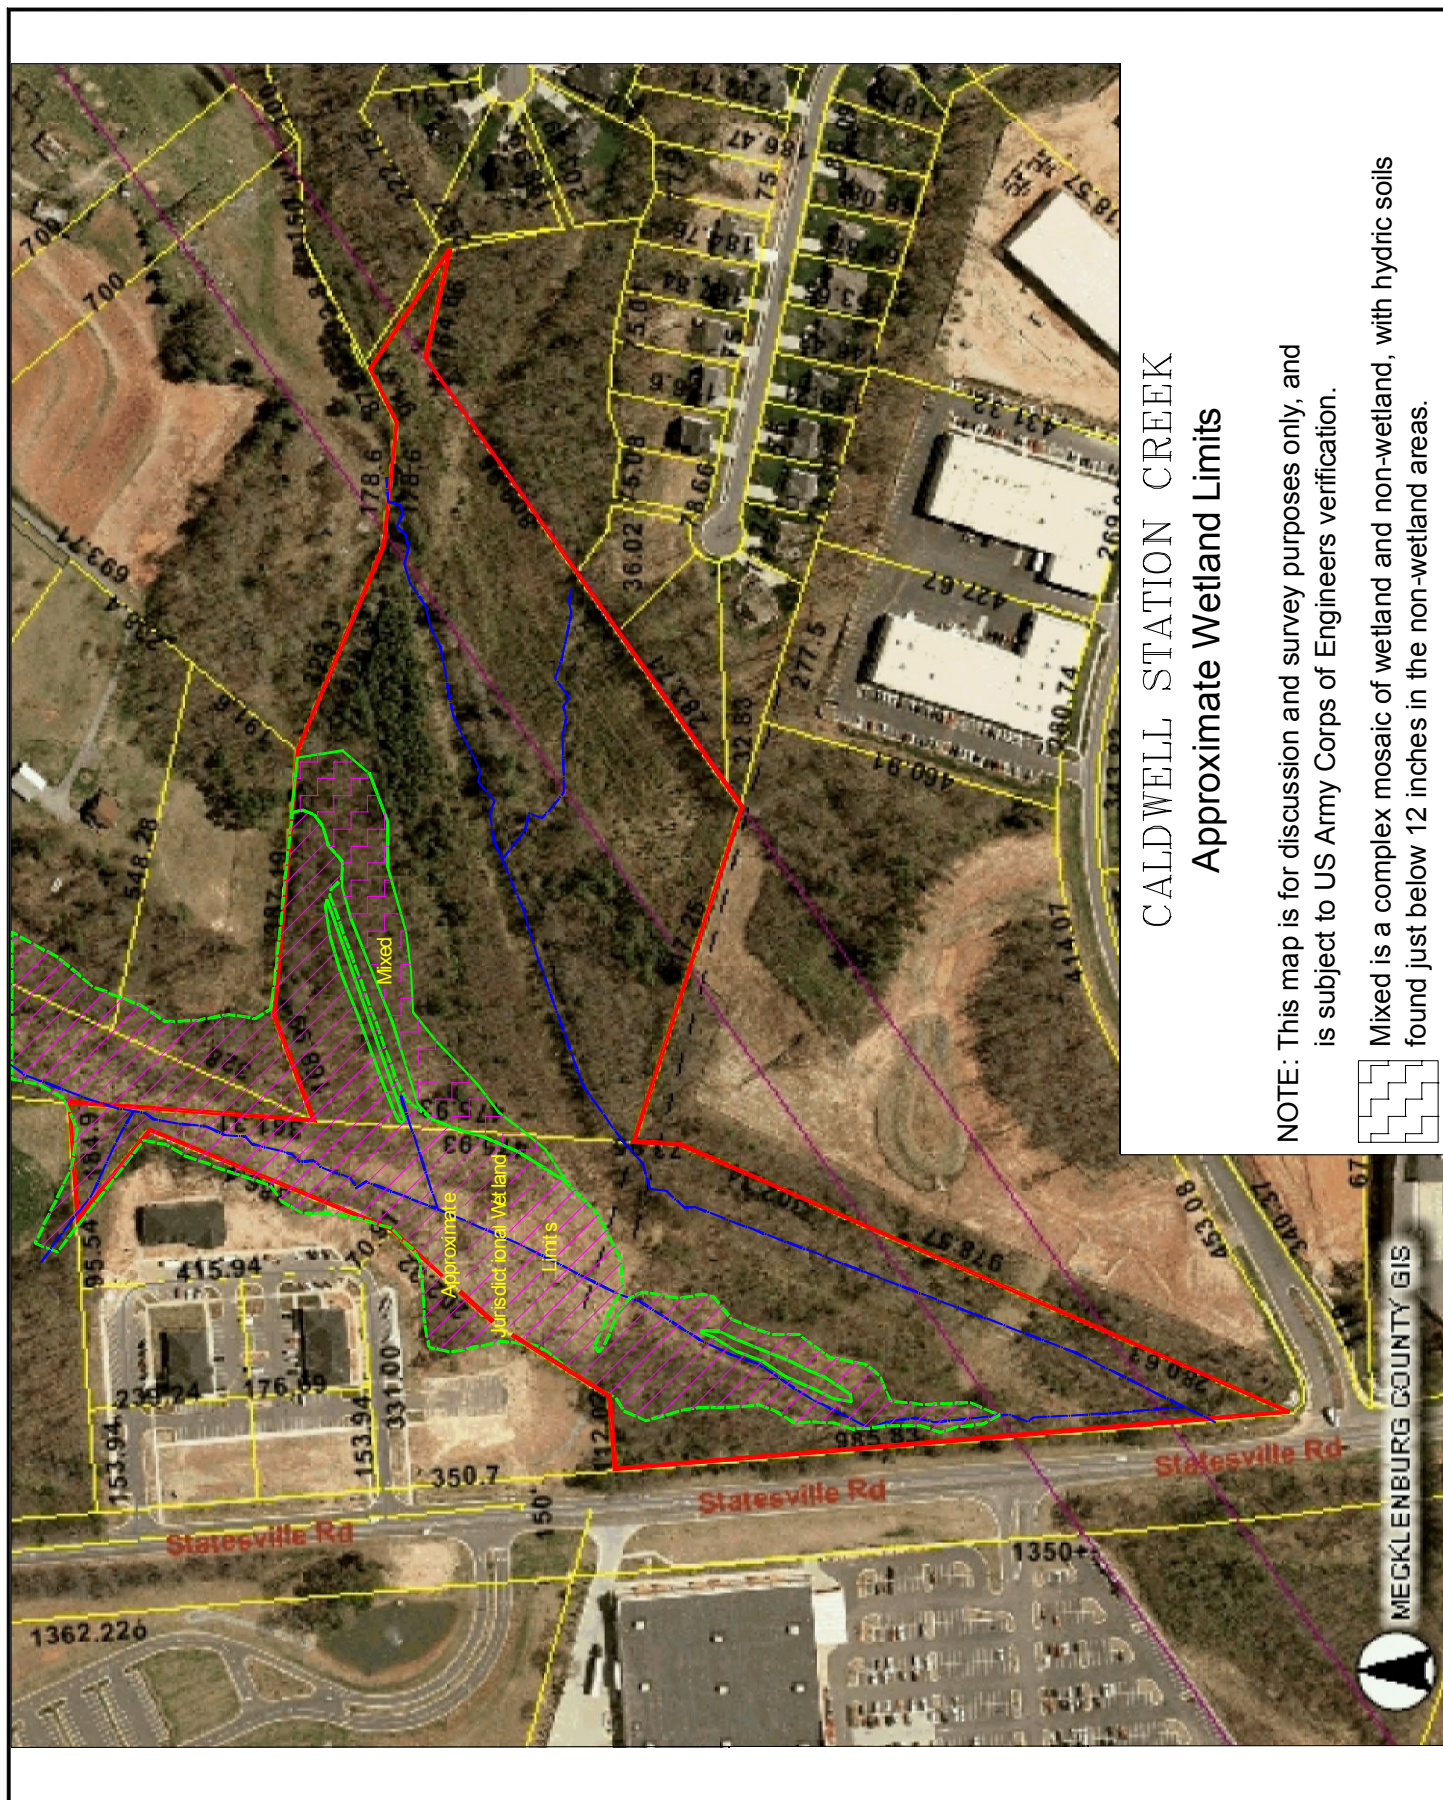
Figure A12

Map of Approximate Jurisdictional Wetland Areas

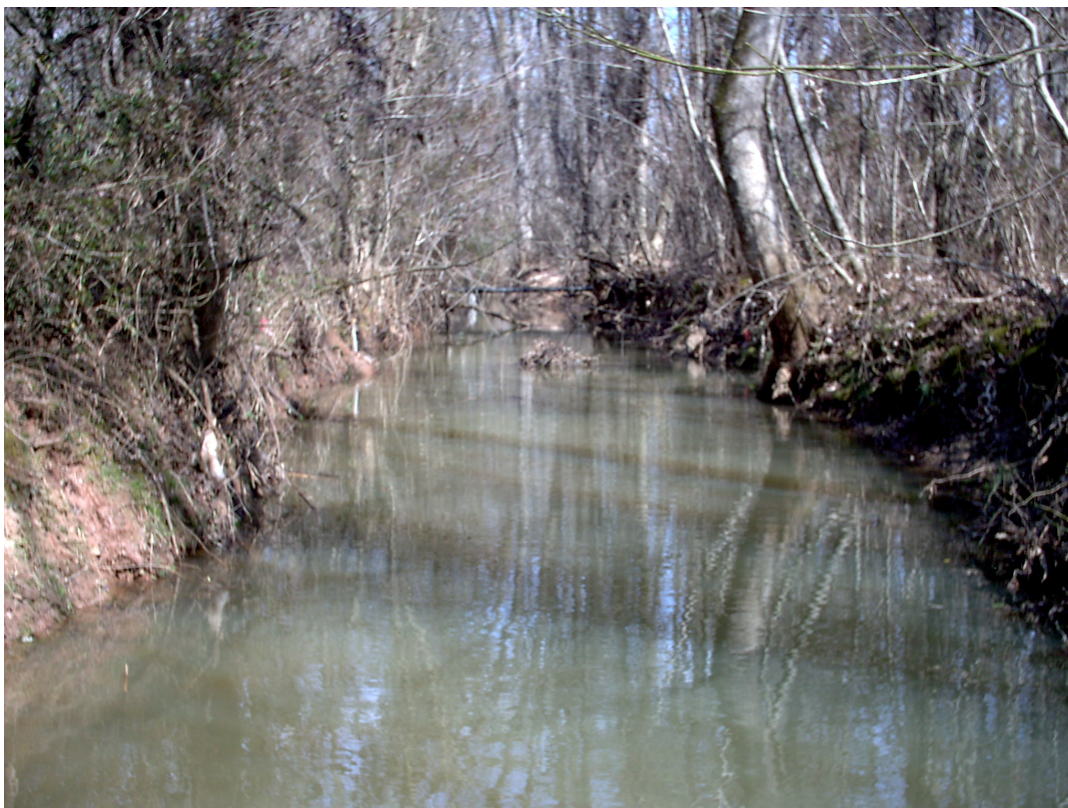
Caldwell Station Main Reach between I-77 and Interstate 21 looking upstream

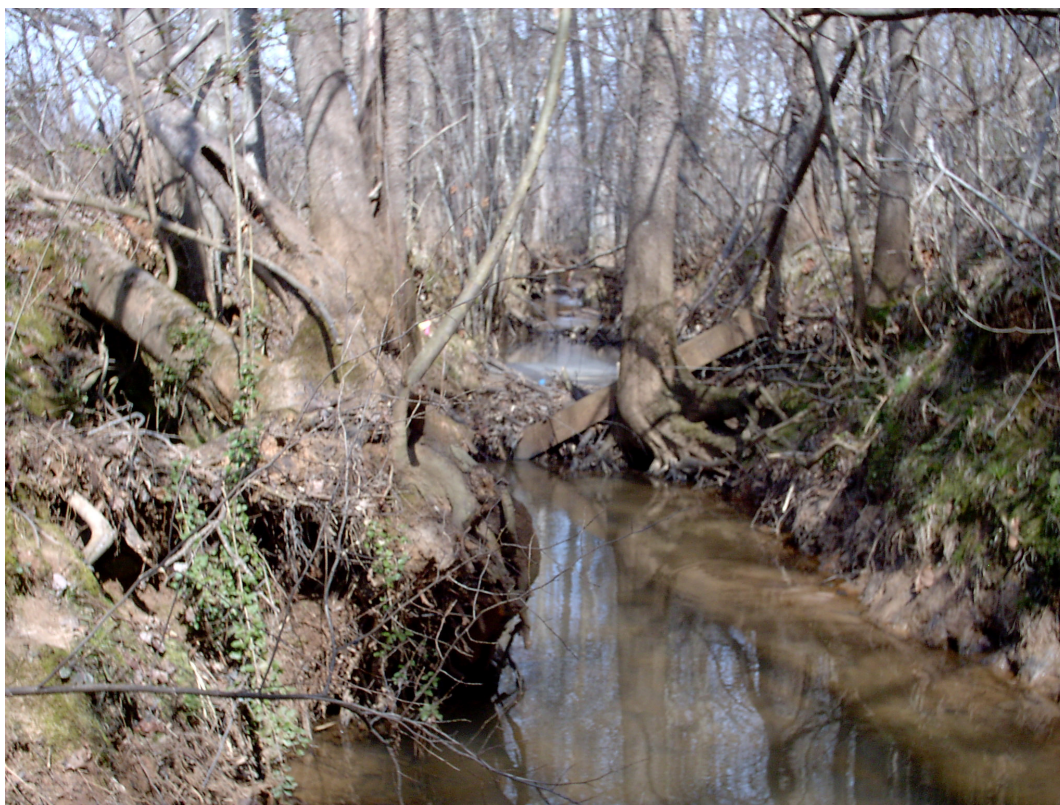
Caldwell Station Main Reach -- 550 ft upstream of Interstate 21 culvert looking upstream

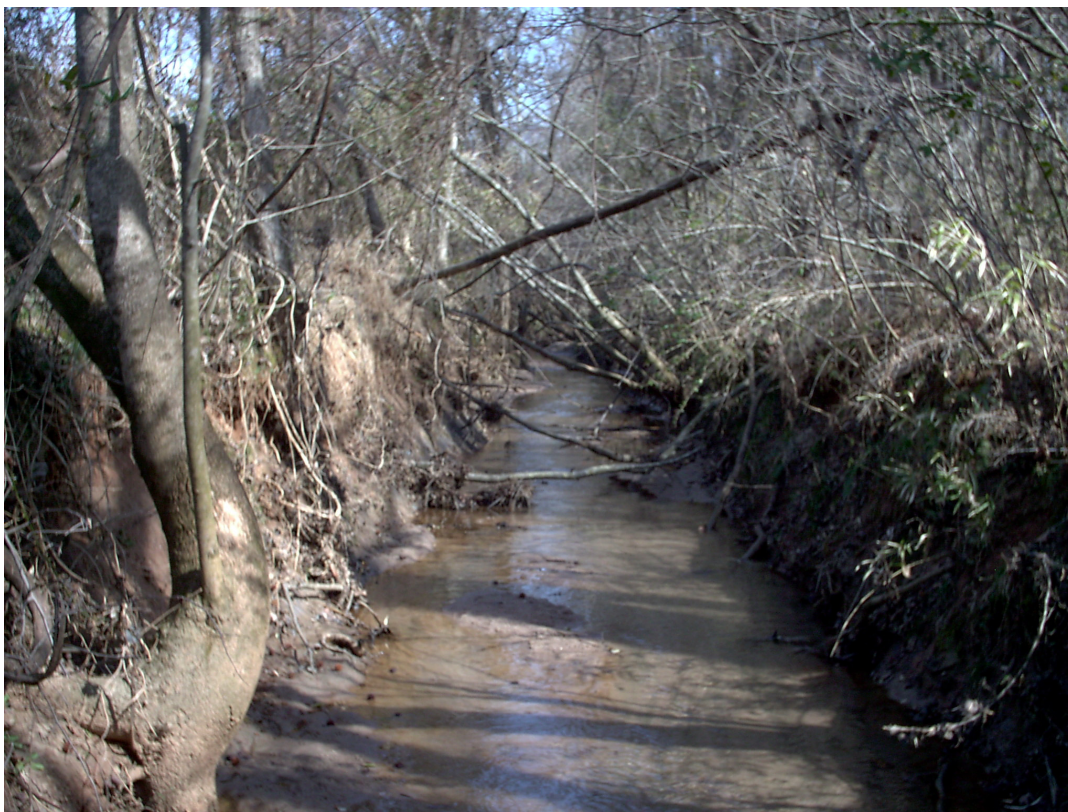
Caldwell Station Main Reach – 1000 ft upstream of Interstate 21 culvert looking upstream

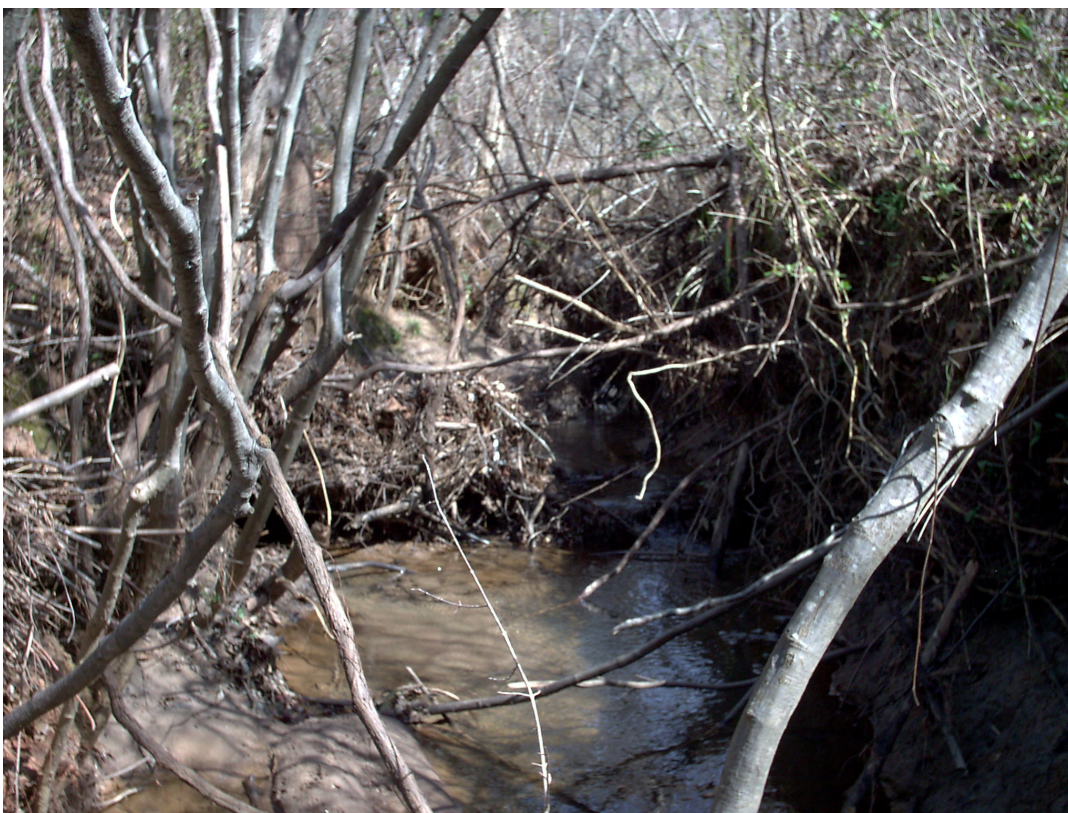
Caldwell Station Main Reach – 1700 ft upstream of Interstate 21 culvert looking upstream

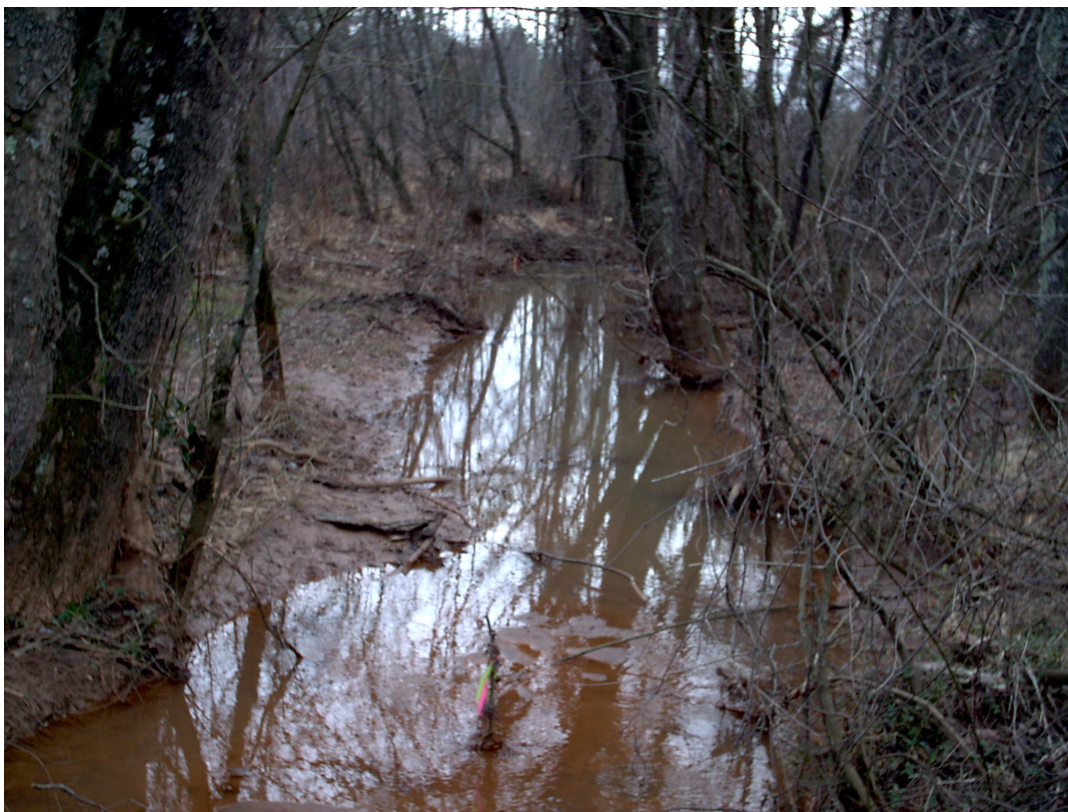
Caldwell Station Tributary #1 – 375 ft upstream of confluence with Caldwell Station looking downstream

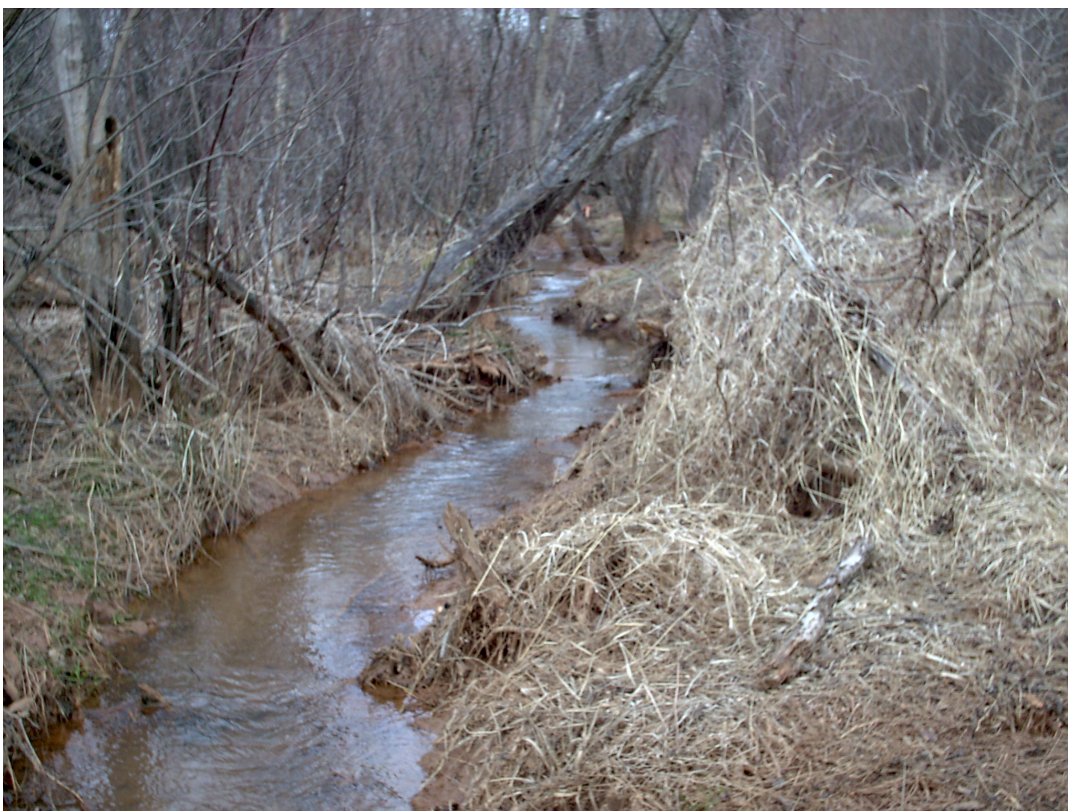
Caldwell Station Tributary #1 – 1200 ft upstream of confluence with Caldwell Station looking upstream

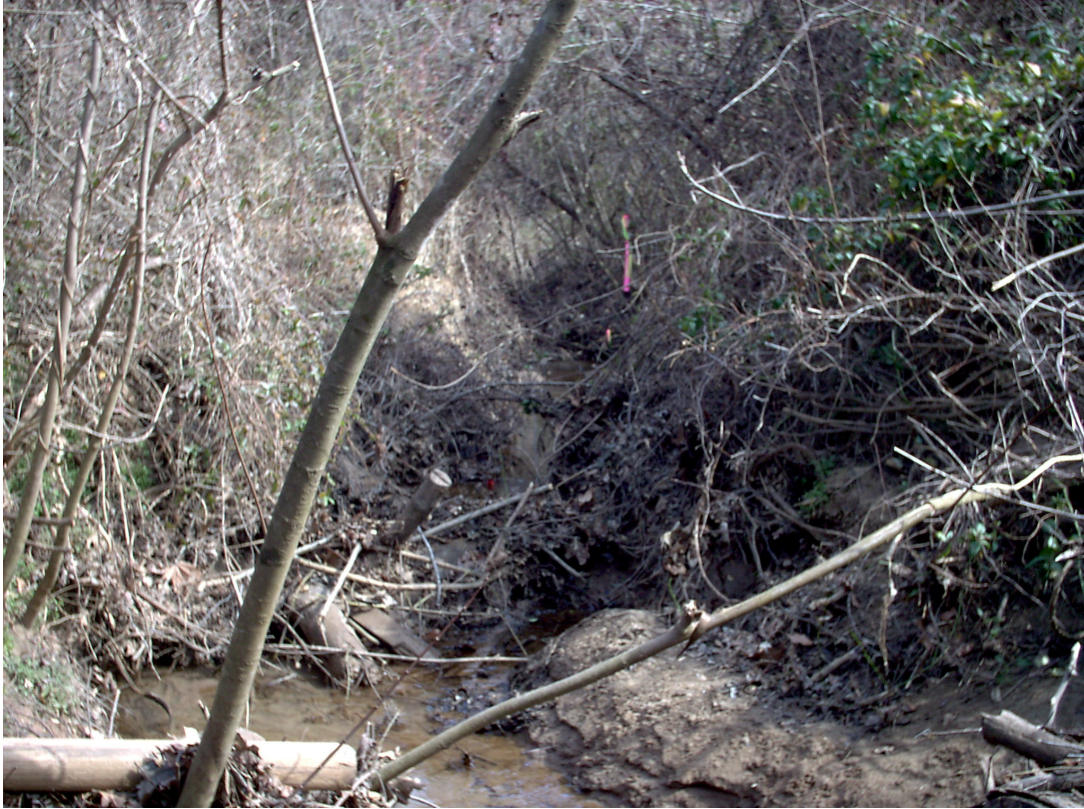
Caldwell Station Tributary #2 – 200 ft upstream of confluence with Caldwell Station looking upstream

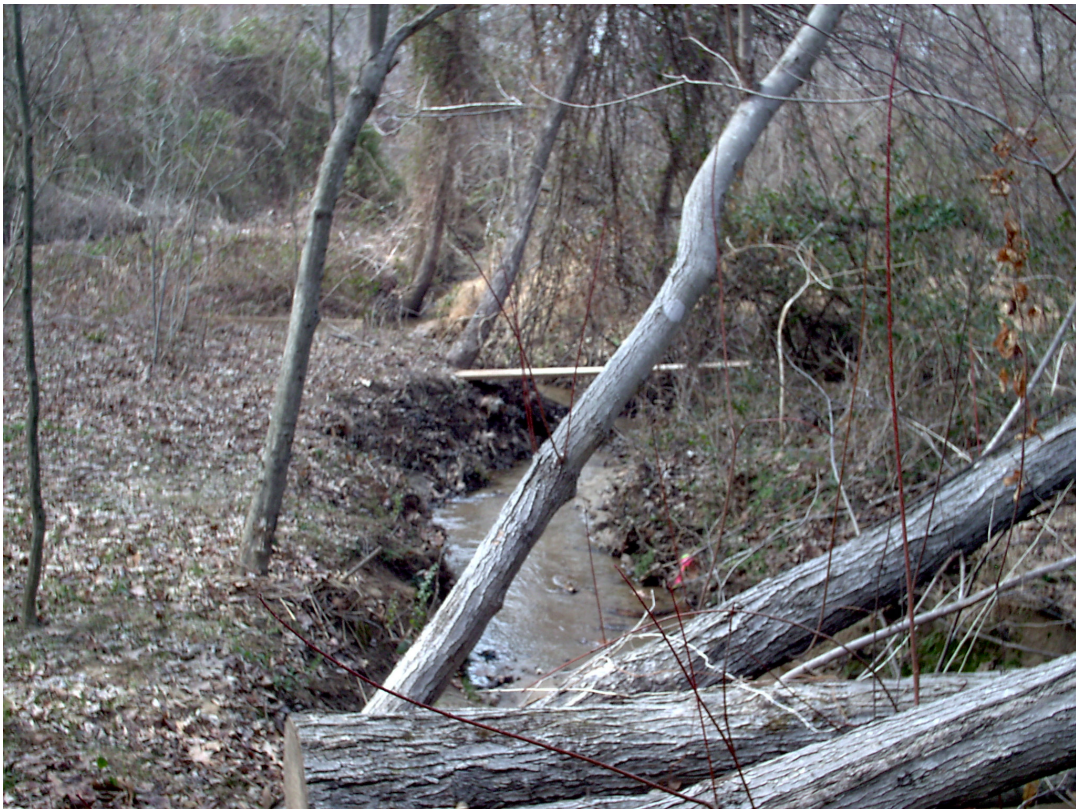
Caldwell Station Tributary #2 – 475 ft upstream of confluence with Caldwell Station looking downstream

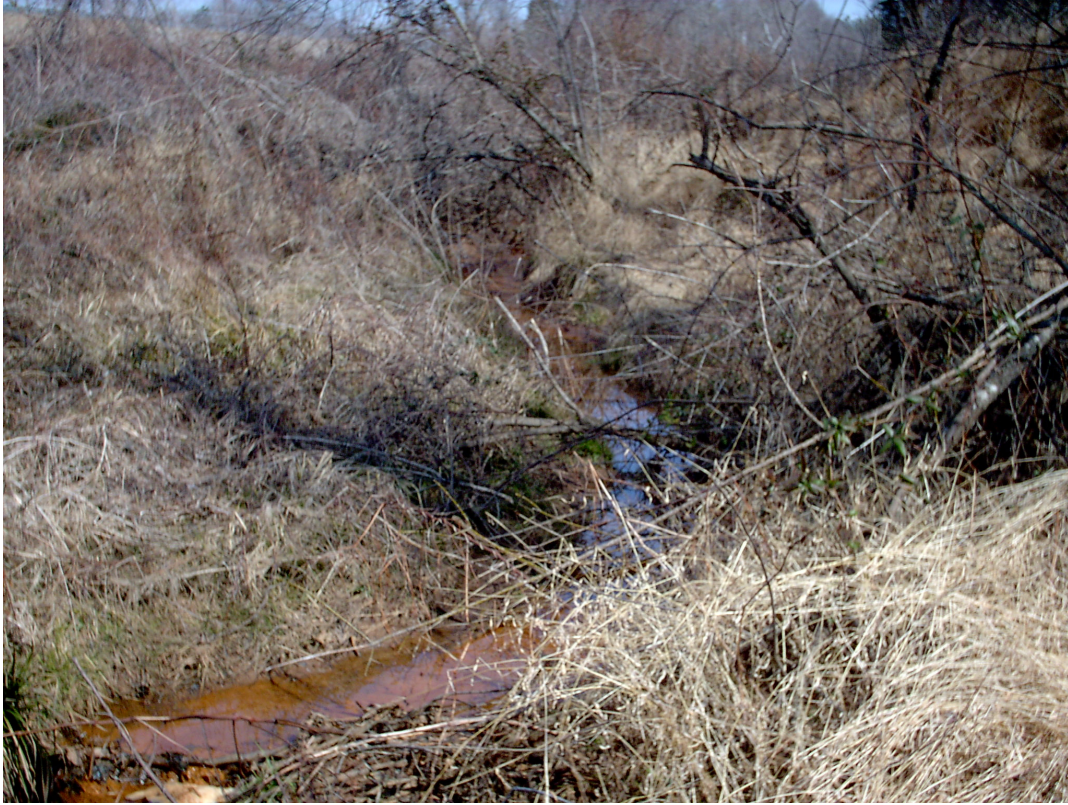
Caldwell Station Tributary #1 Relic, between I-77 and Interstate 21 looking upstream

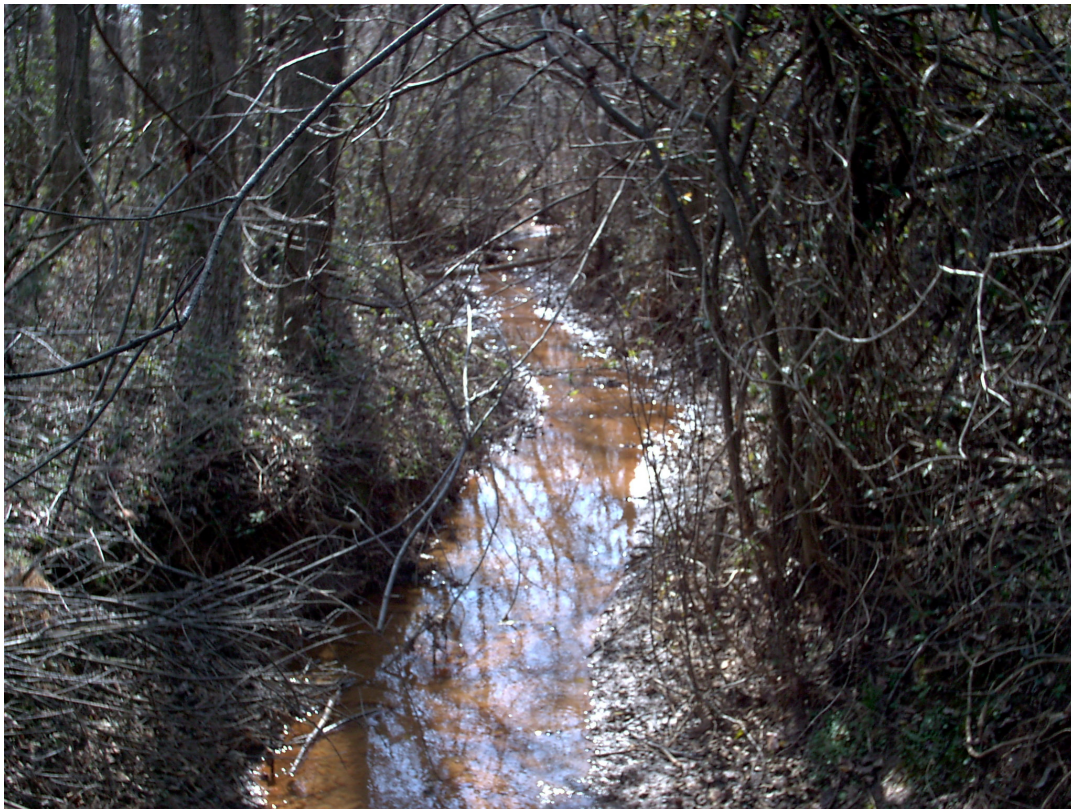
Caldwell Station Tributary #1 Relic, between I-77 and Interstate 21 looking downstream

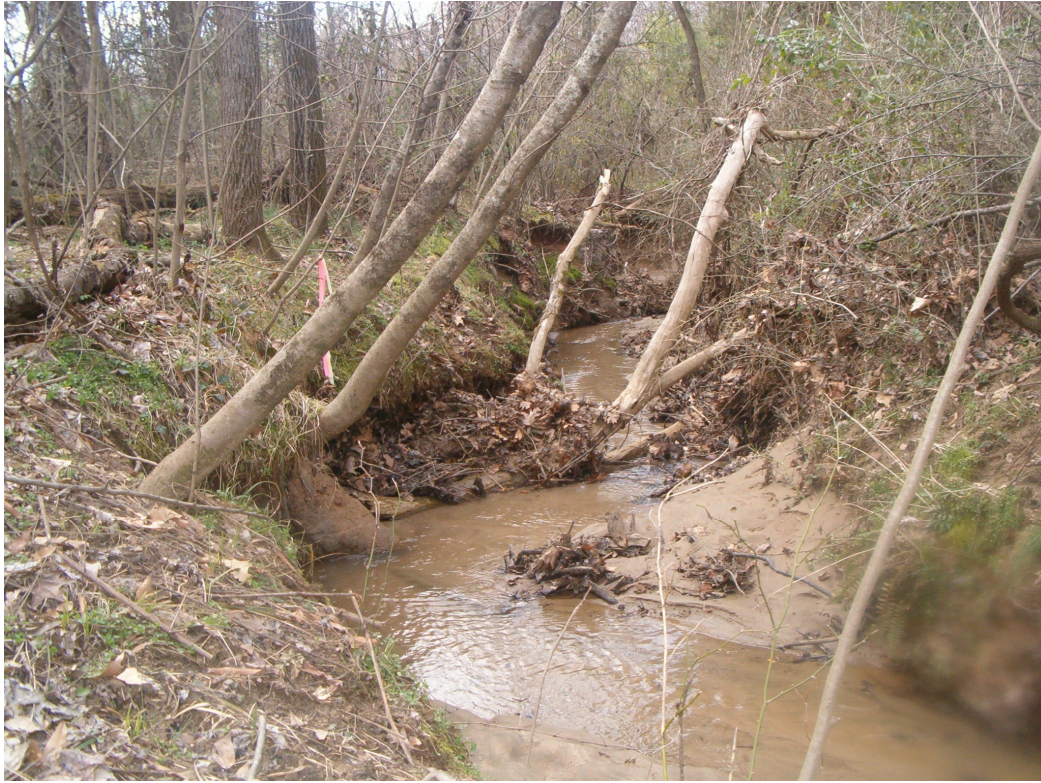
Photo T2-1, South UT to Caldwell Station Crk. Looking downstream to confluence

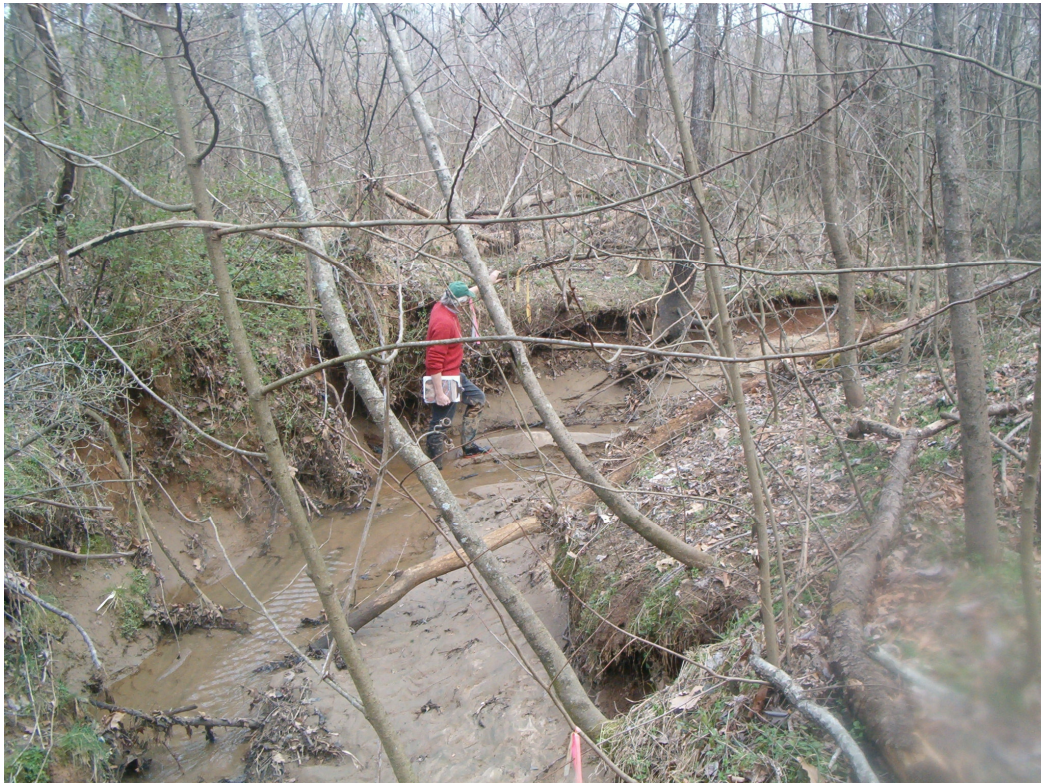
Photo T2-2, South UT to Caldwell Station Crk. Looking upstream.

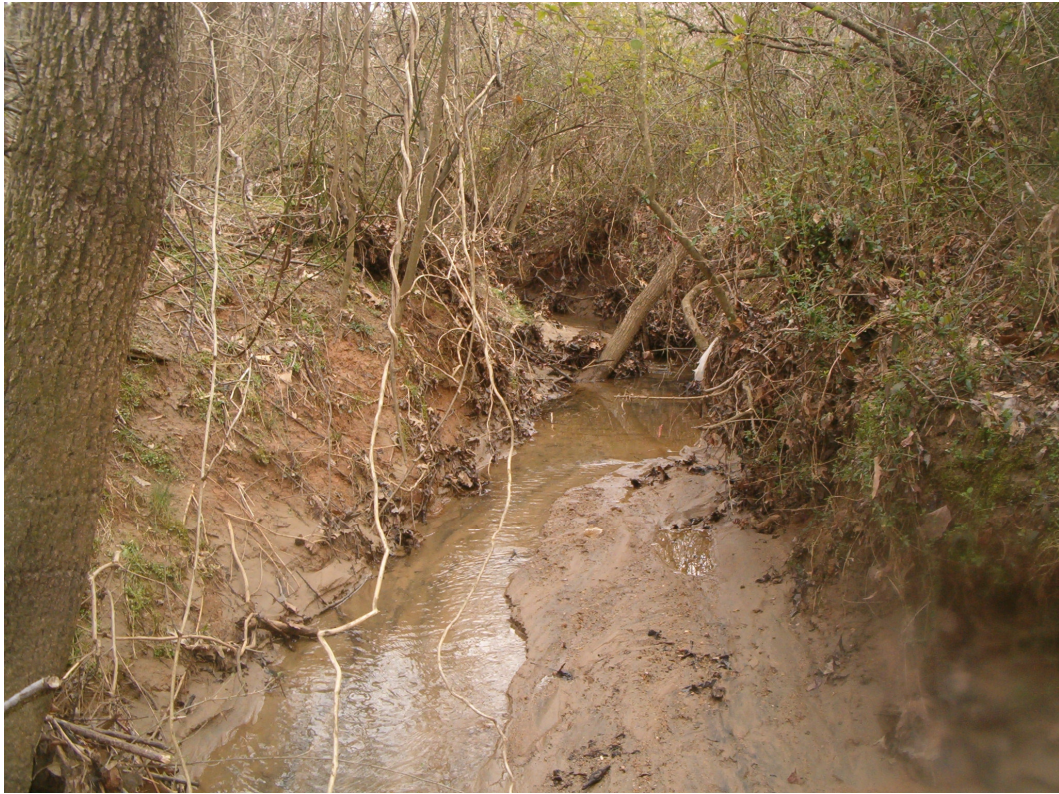
Photo T2-3, South UT to Caldwell Station Crk. Looking upstream.
