CALDWELL STATION CREEK AND ASSOCIATED FLOODPLAIN WETLANDS RESTORATION PLAN

60% RESTORATION PLAN

**MECKLENBURG COUNTY
NORTH CAROLINA**

HDR Engineering, Inc.
of the Carolinas

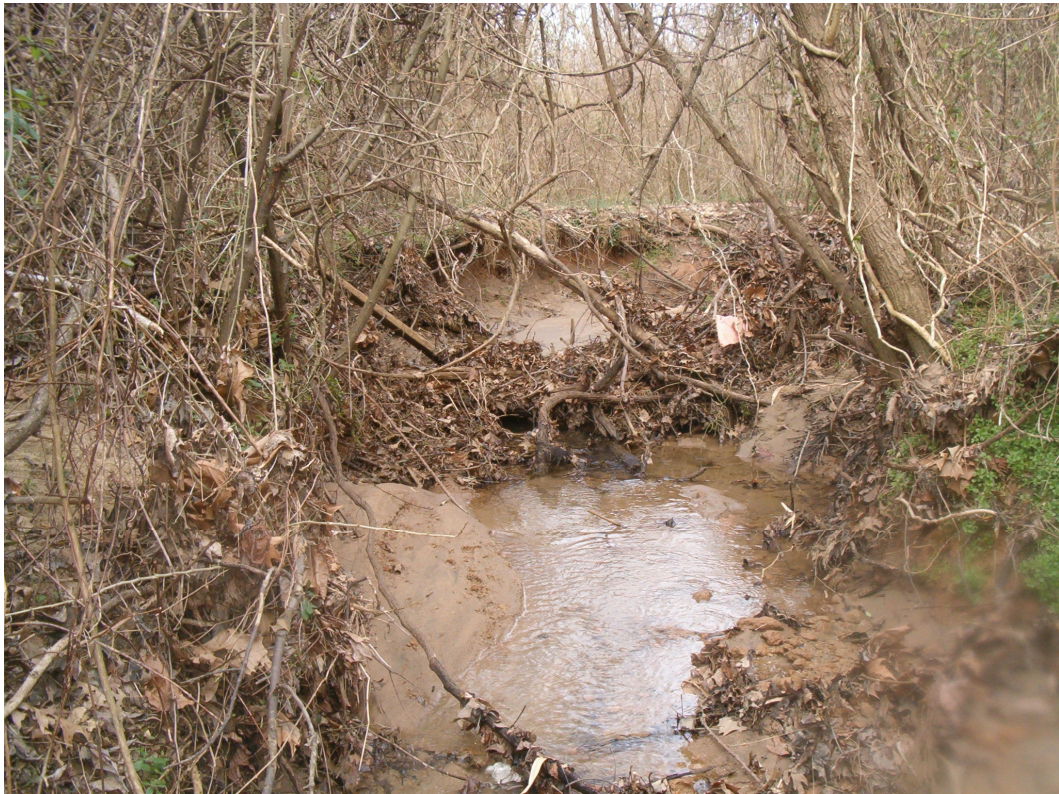
Photo T2-4, South UT to Caldwell Station Crk. Looking upstream at debris jam.

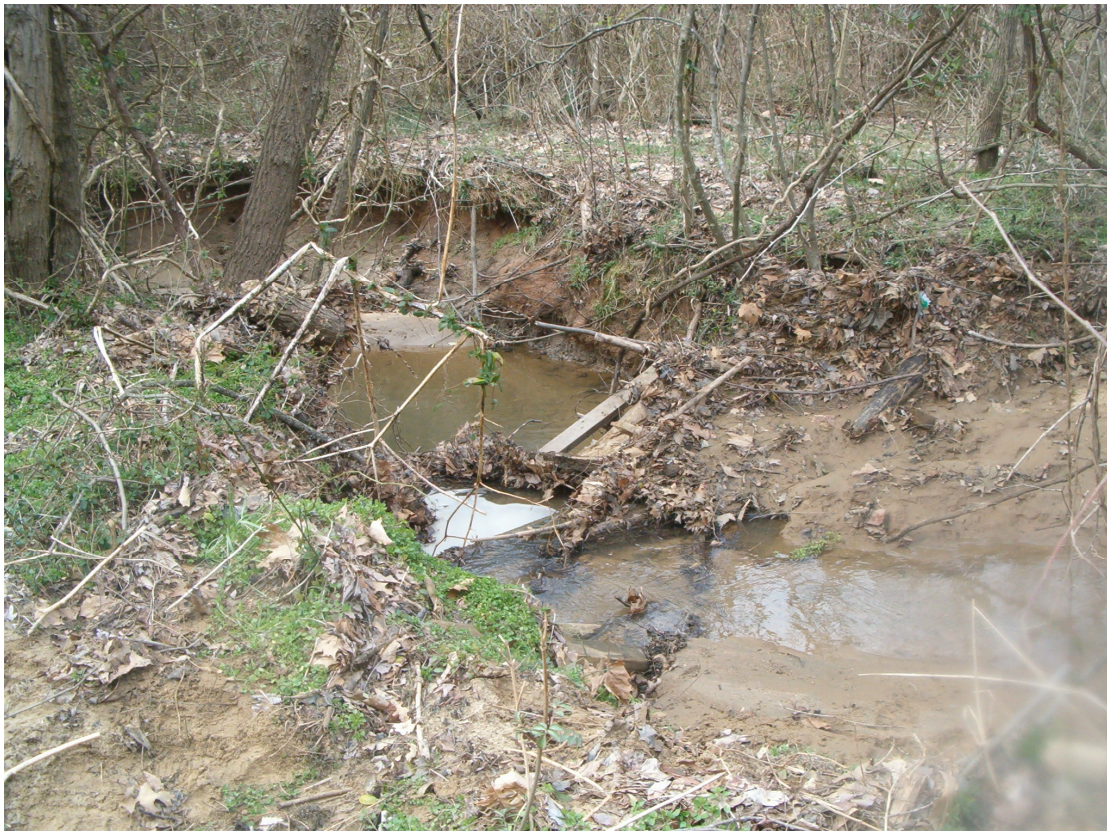
Photo T2-5, South UT to Caldwell Station Crk. Looking downstream at debris jam.

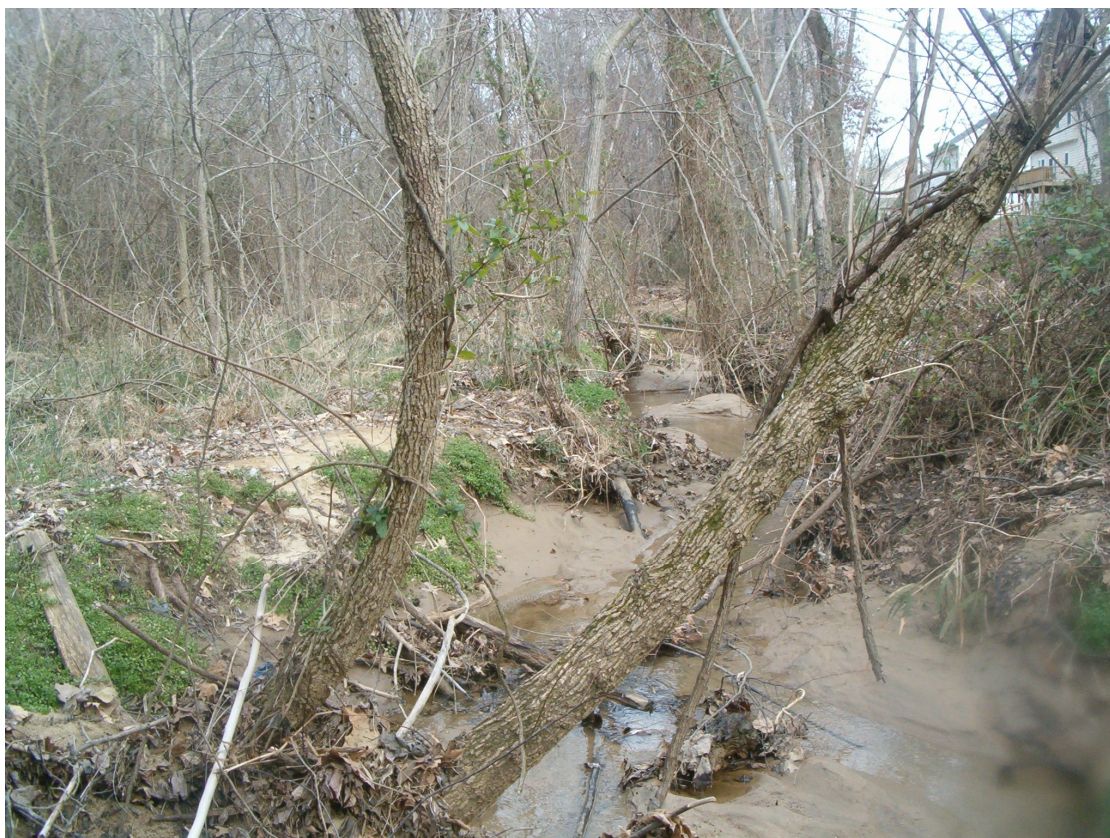
Photo T2-6, South UT to Caldwell Station Crk. Looking upstream to property line.

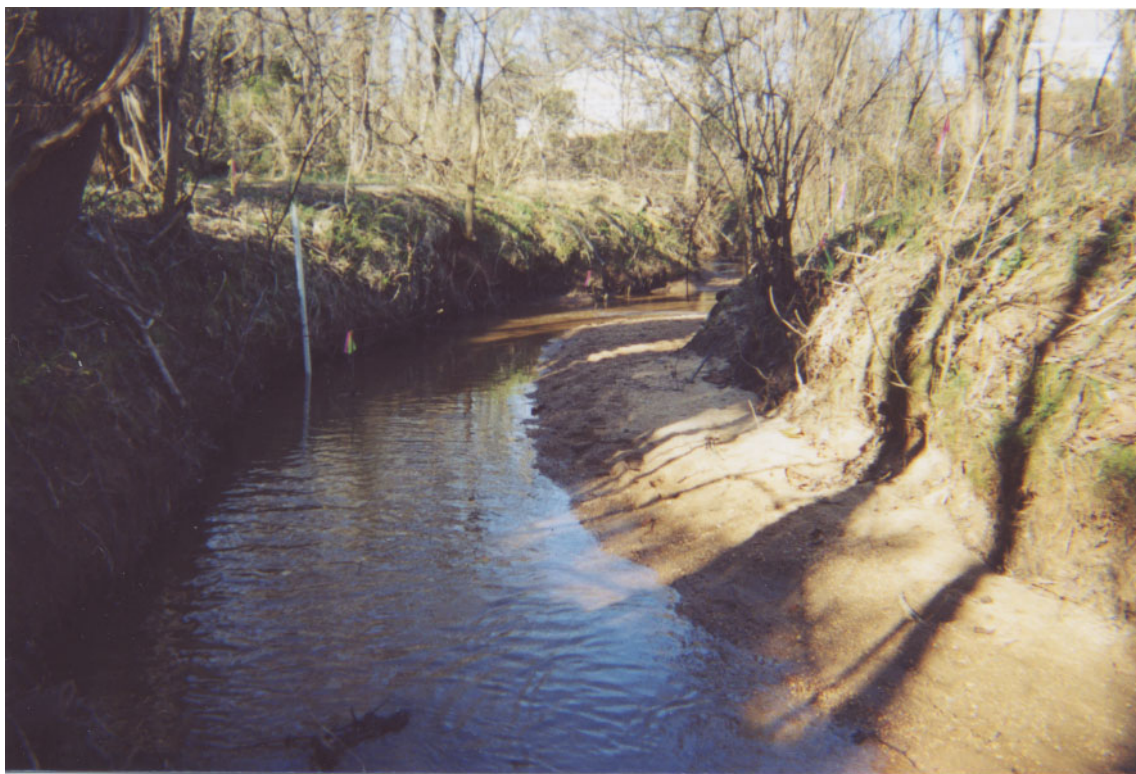
Reed's Creek West Fork Meander X-Section 1 (Fore) and Inflection X-Section 2 (Back)
looking upstream

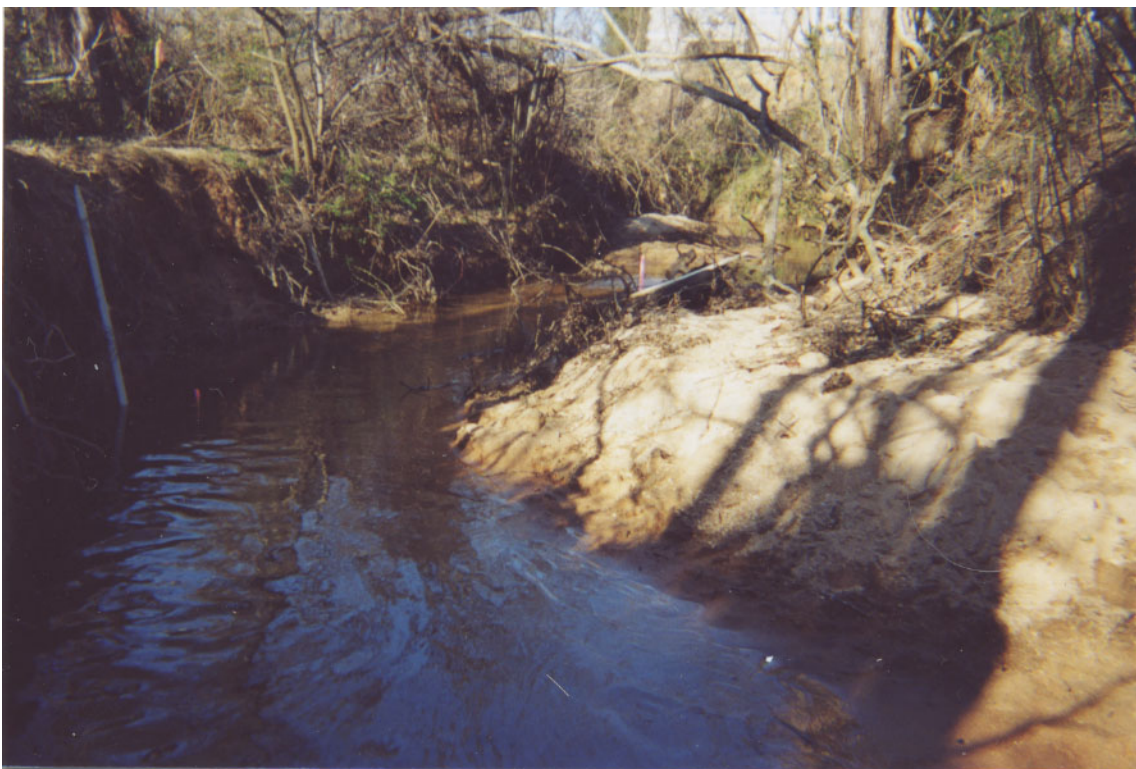
Reed's Creek West Fork Meander X-Section 3 (Fore) and Inflection X-Section 4 (Back)
looking upstream

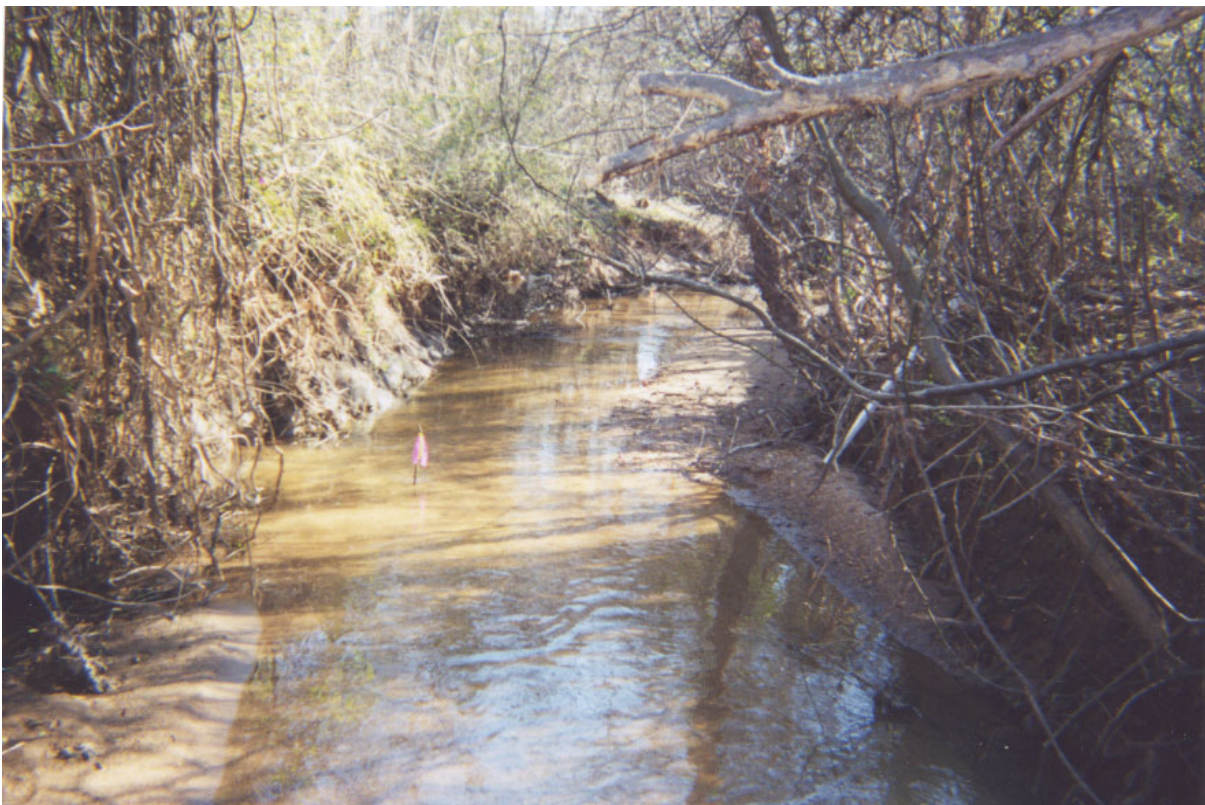
Reed's Creek West Fork Meander X-Section 5 looking downstream

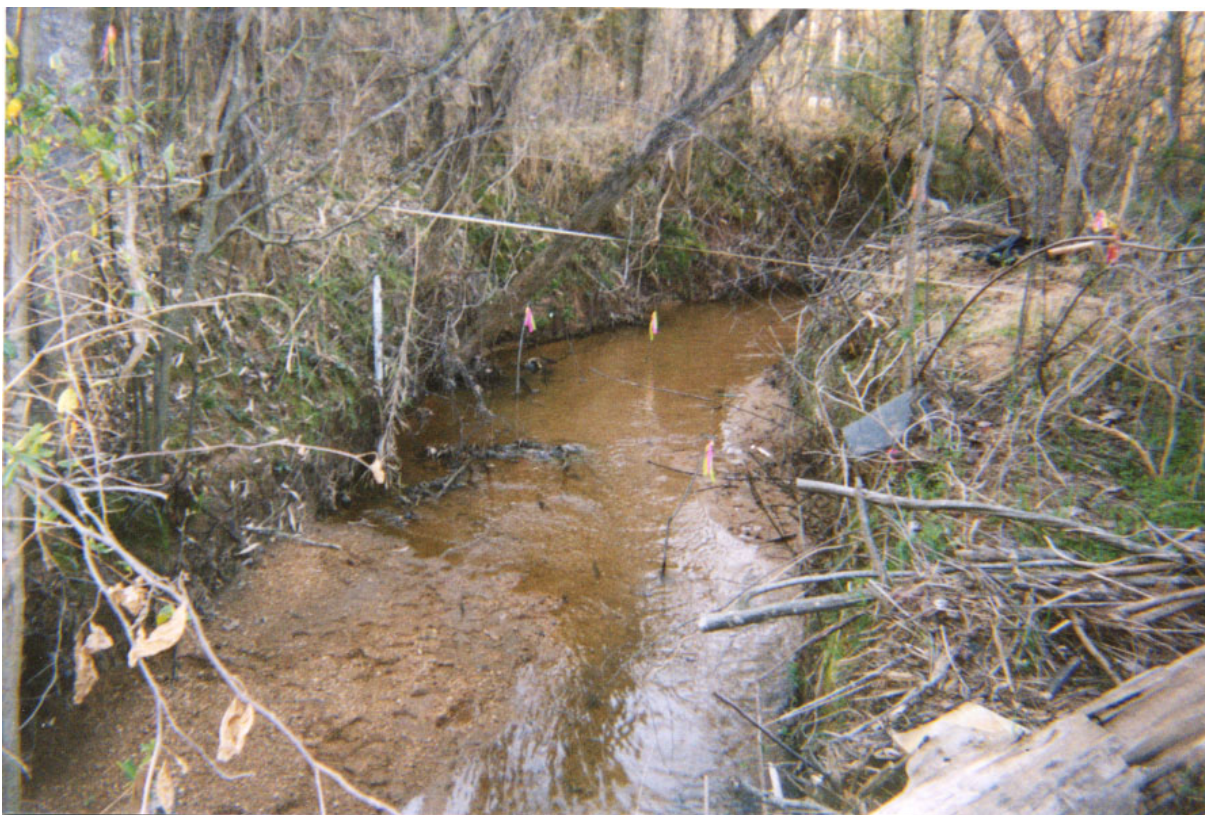
Reed's Creek West Fork Inflection X-Section 6 looking upstream

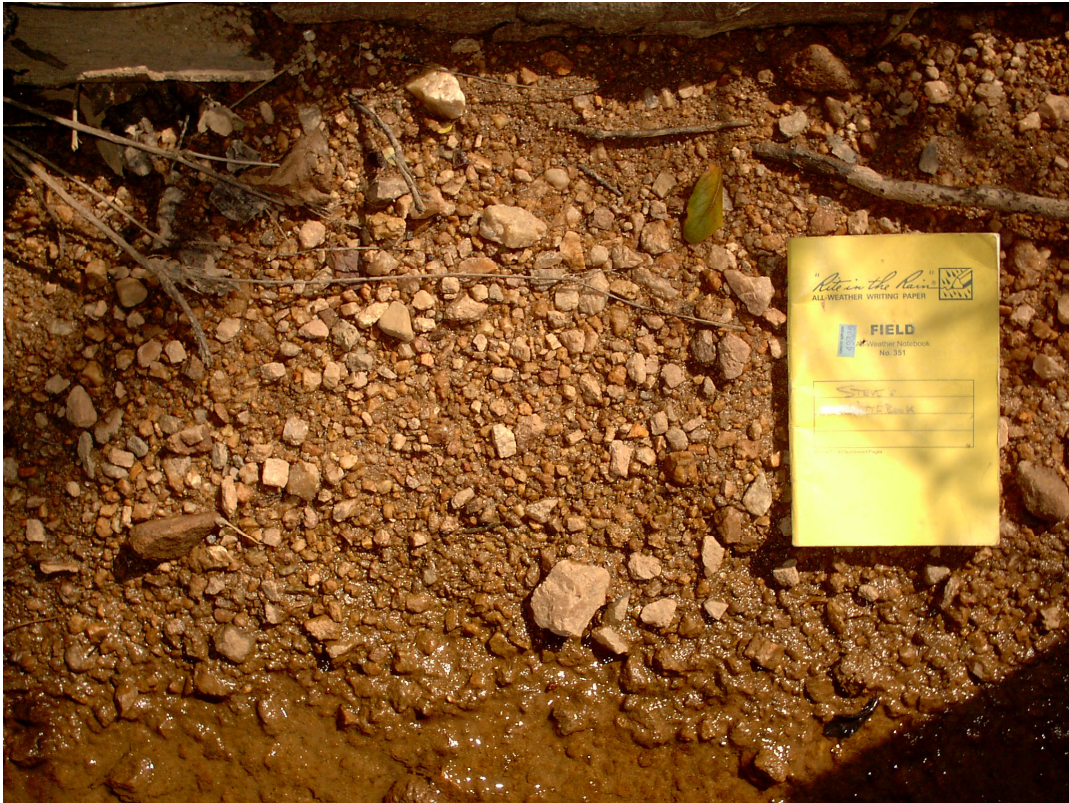
Reed's Creek West Fork Riffle Point A at approximately 233 feet on the Longitudinal

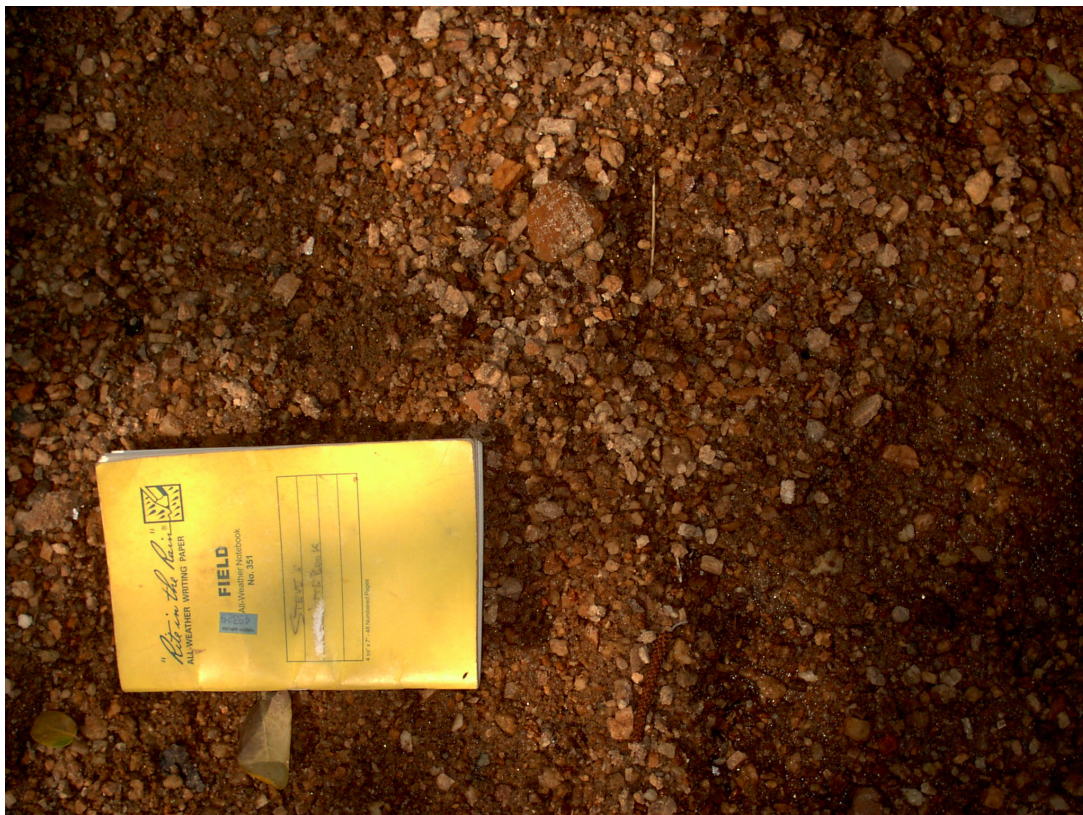
Reed's Creek West Fork Riffle Point B at approximately 545 feet on the Longitudinal

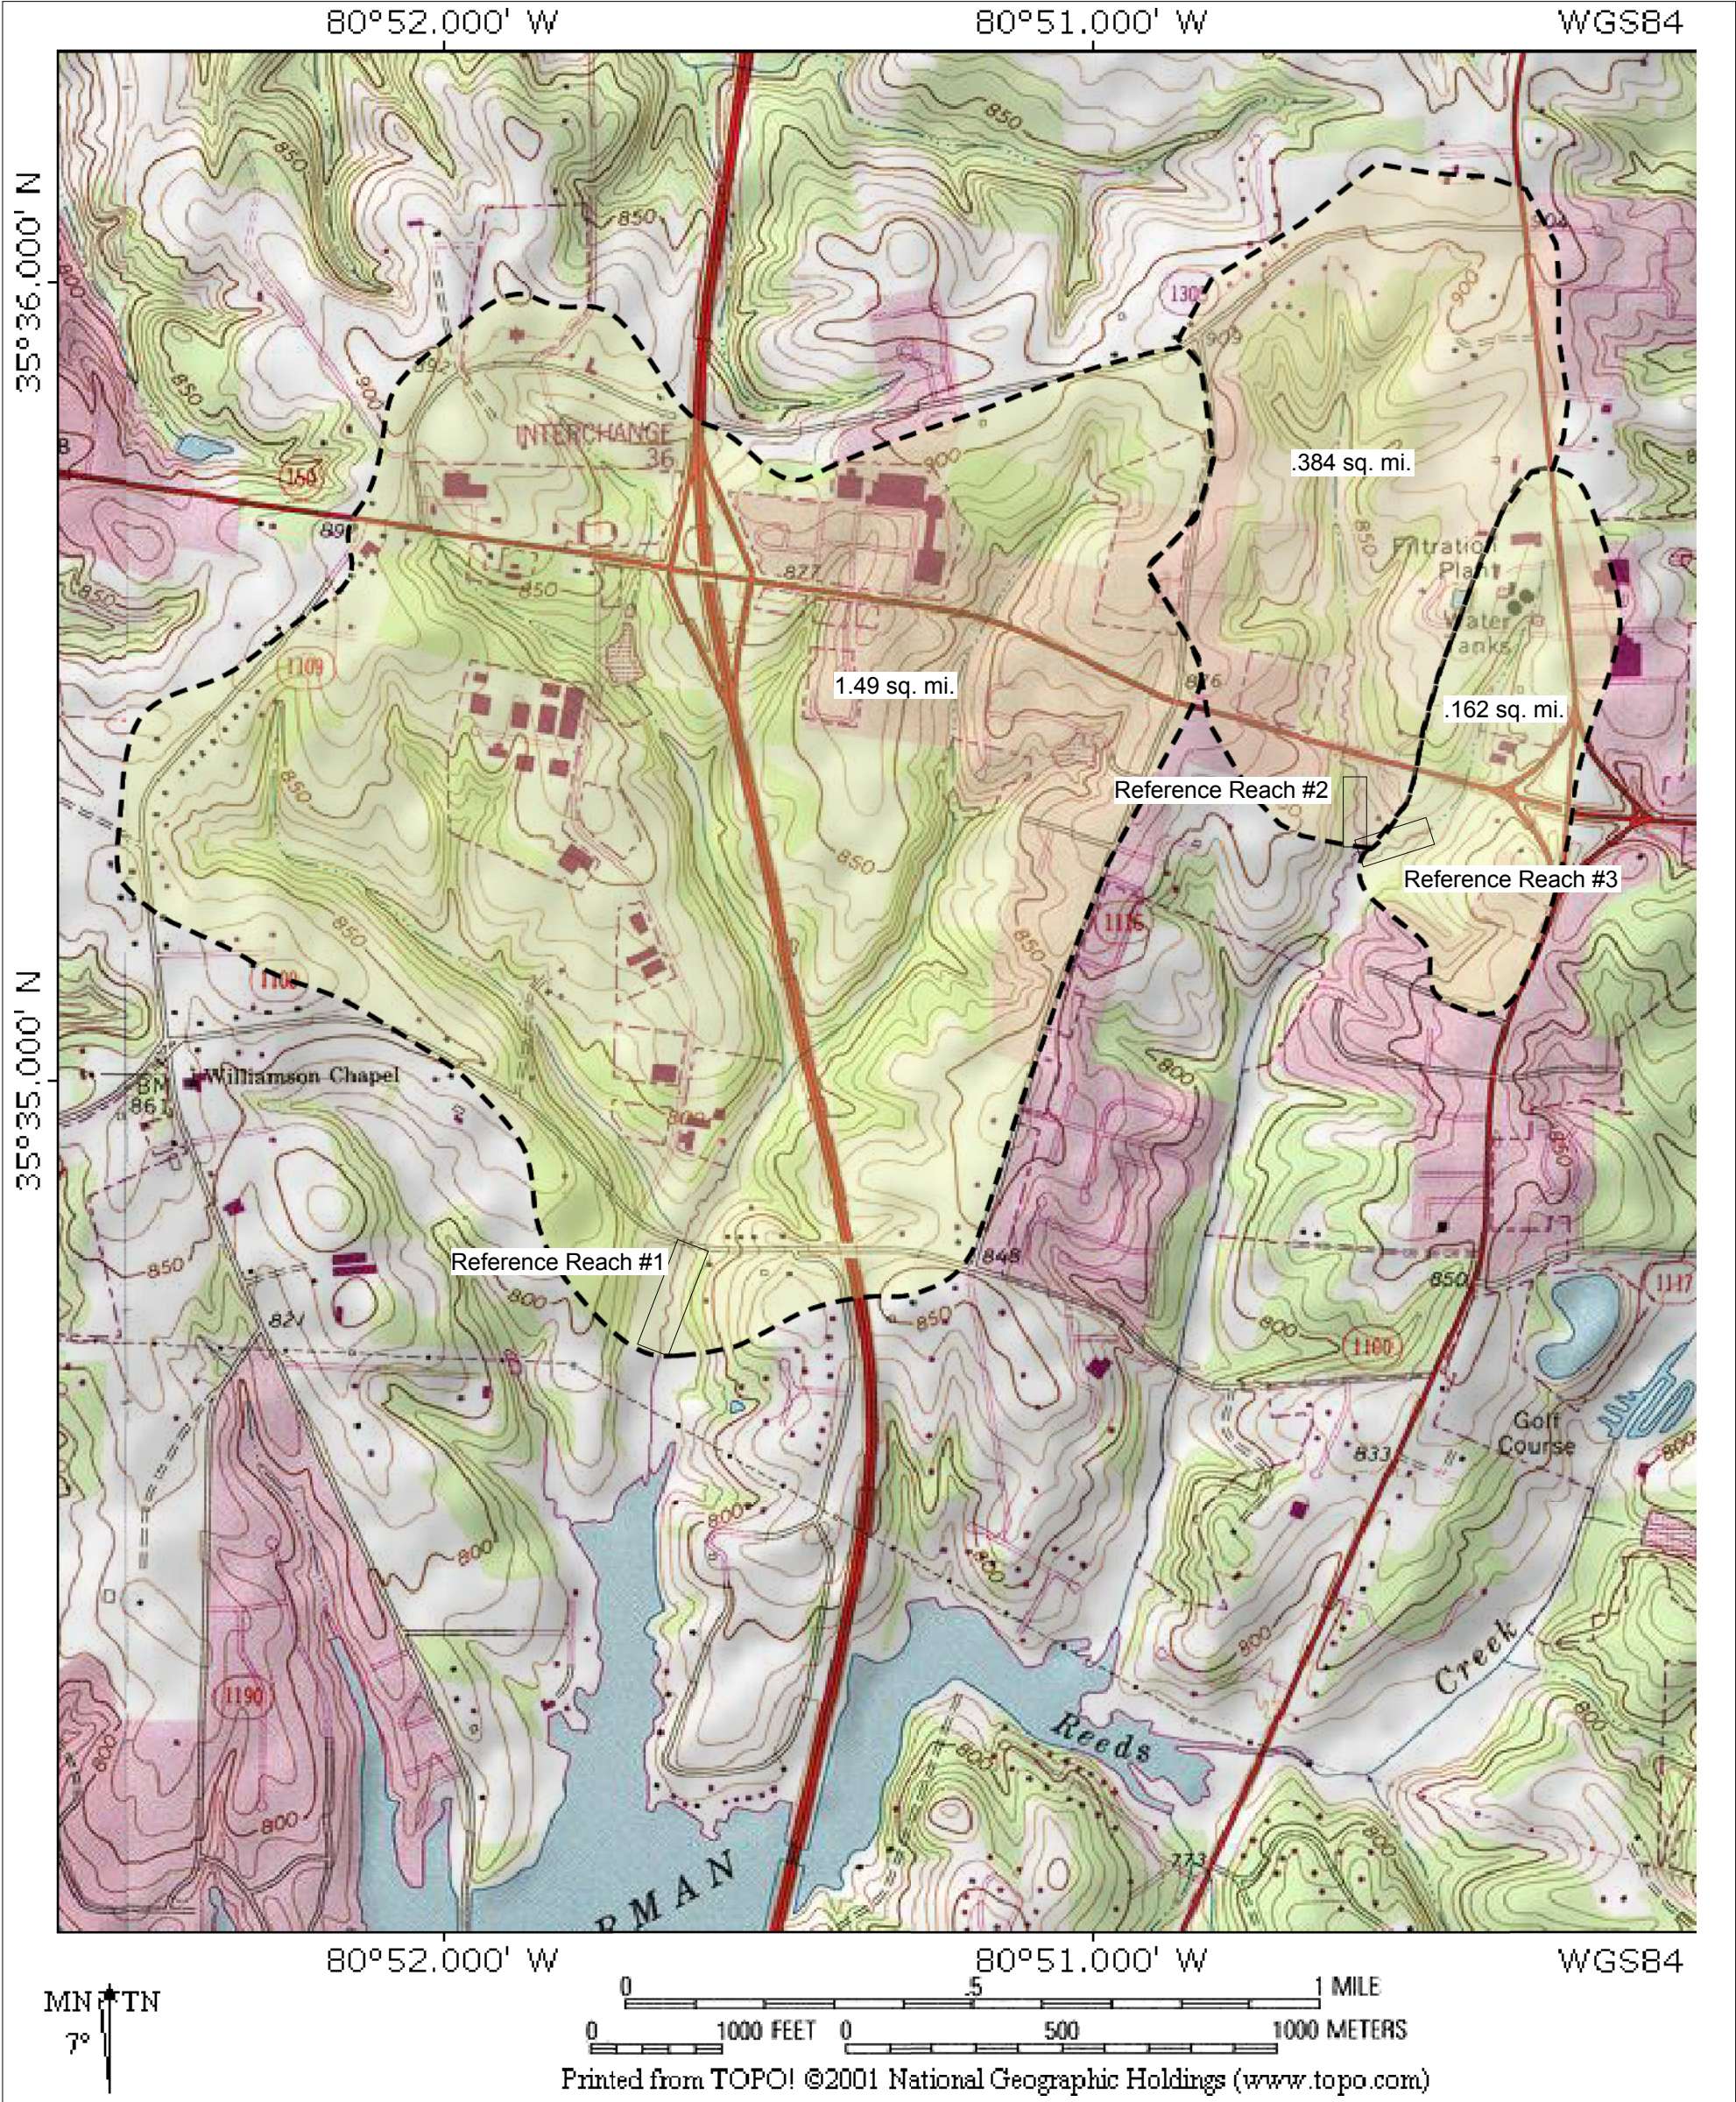
Figure D1. Reference Reach Sites, Un-named
Tributaries to Reeds Creek Cove, Lake Norman,
Iredell Co. N.C.

Reed's Creek West Fork Riffle Point C 15 feet beyond the Longitudinal Profile

NCEP Stream Restoration Project:
Caldwell Station Ck., Mecklenburg, CO., NC

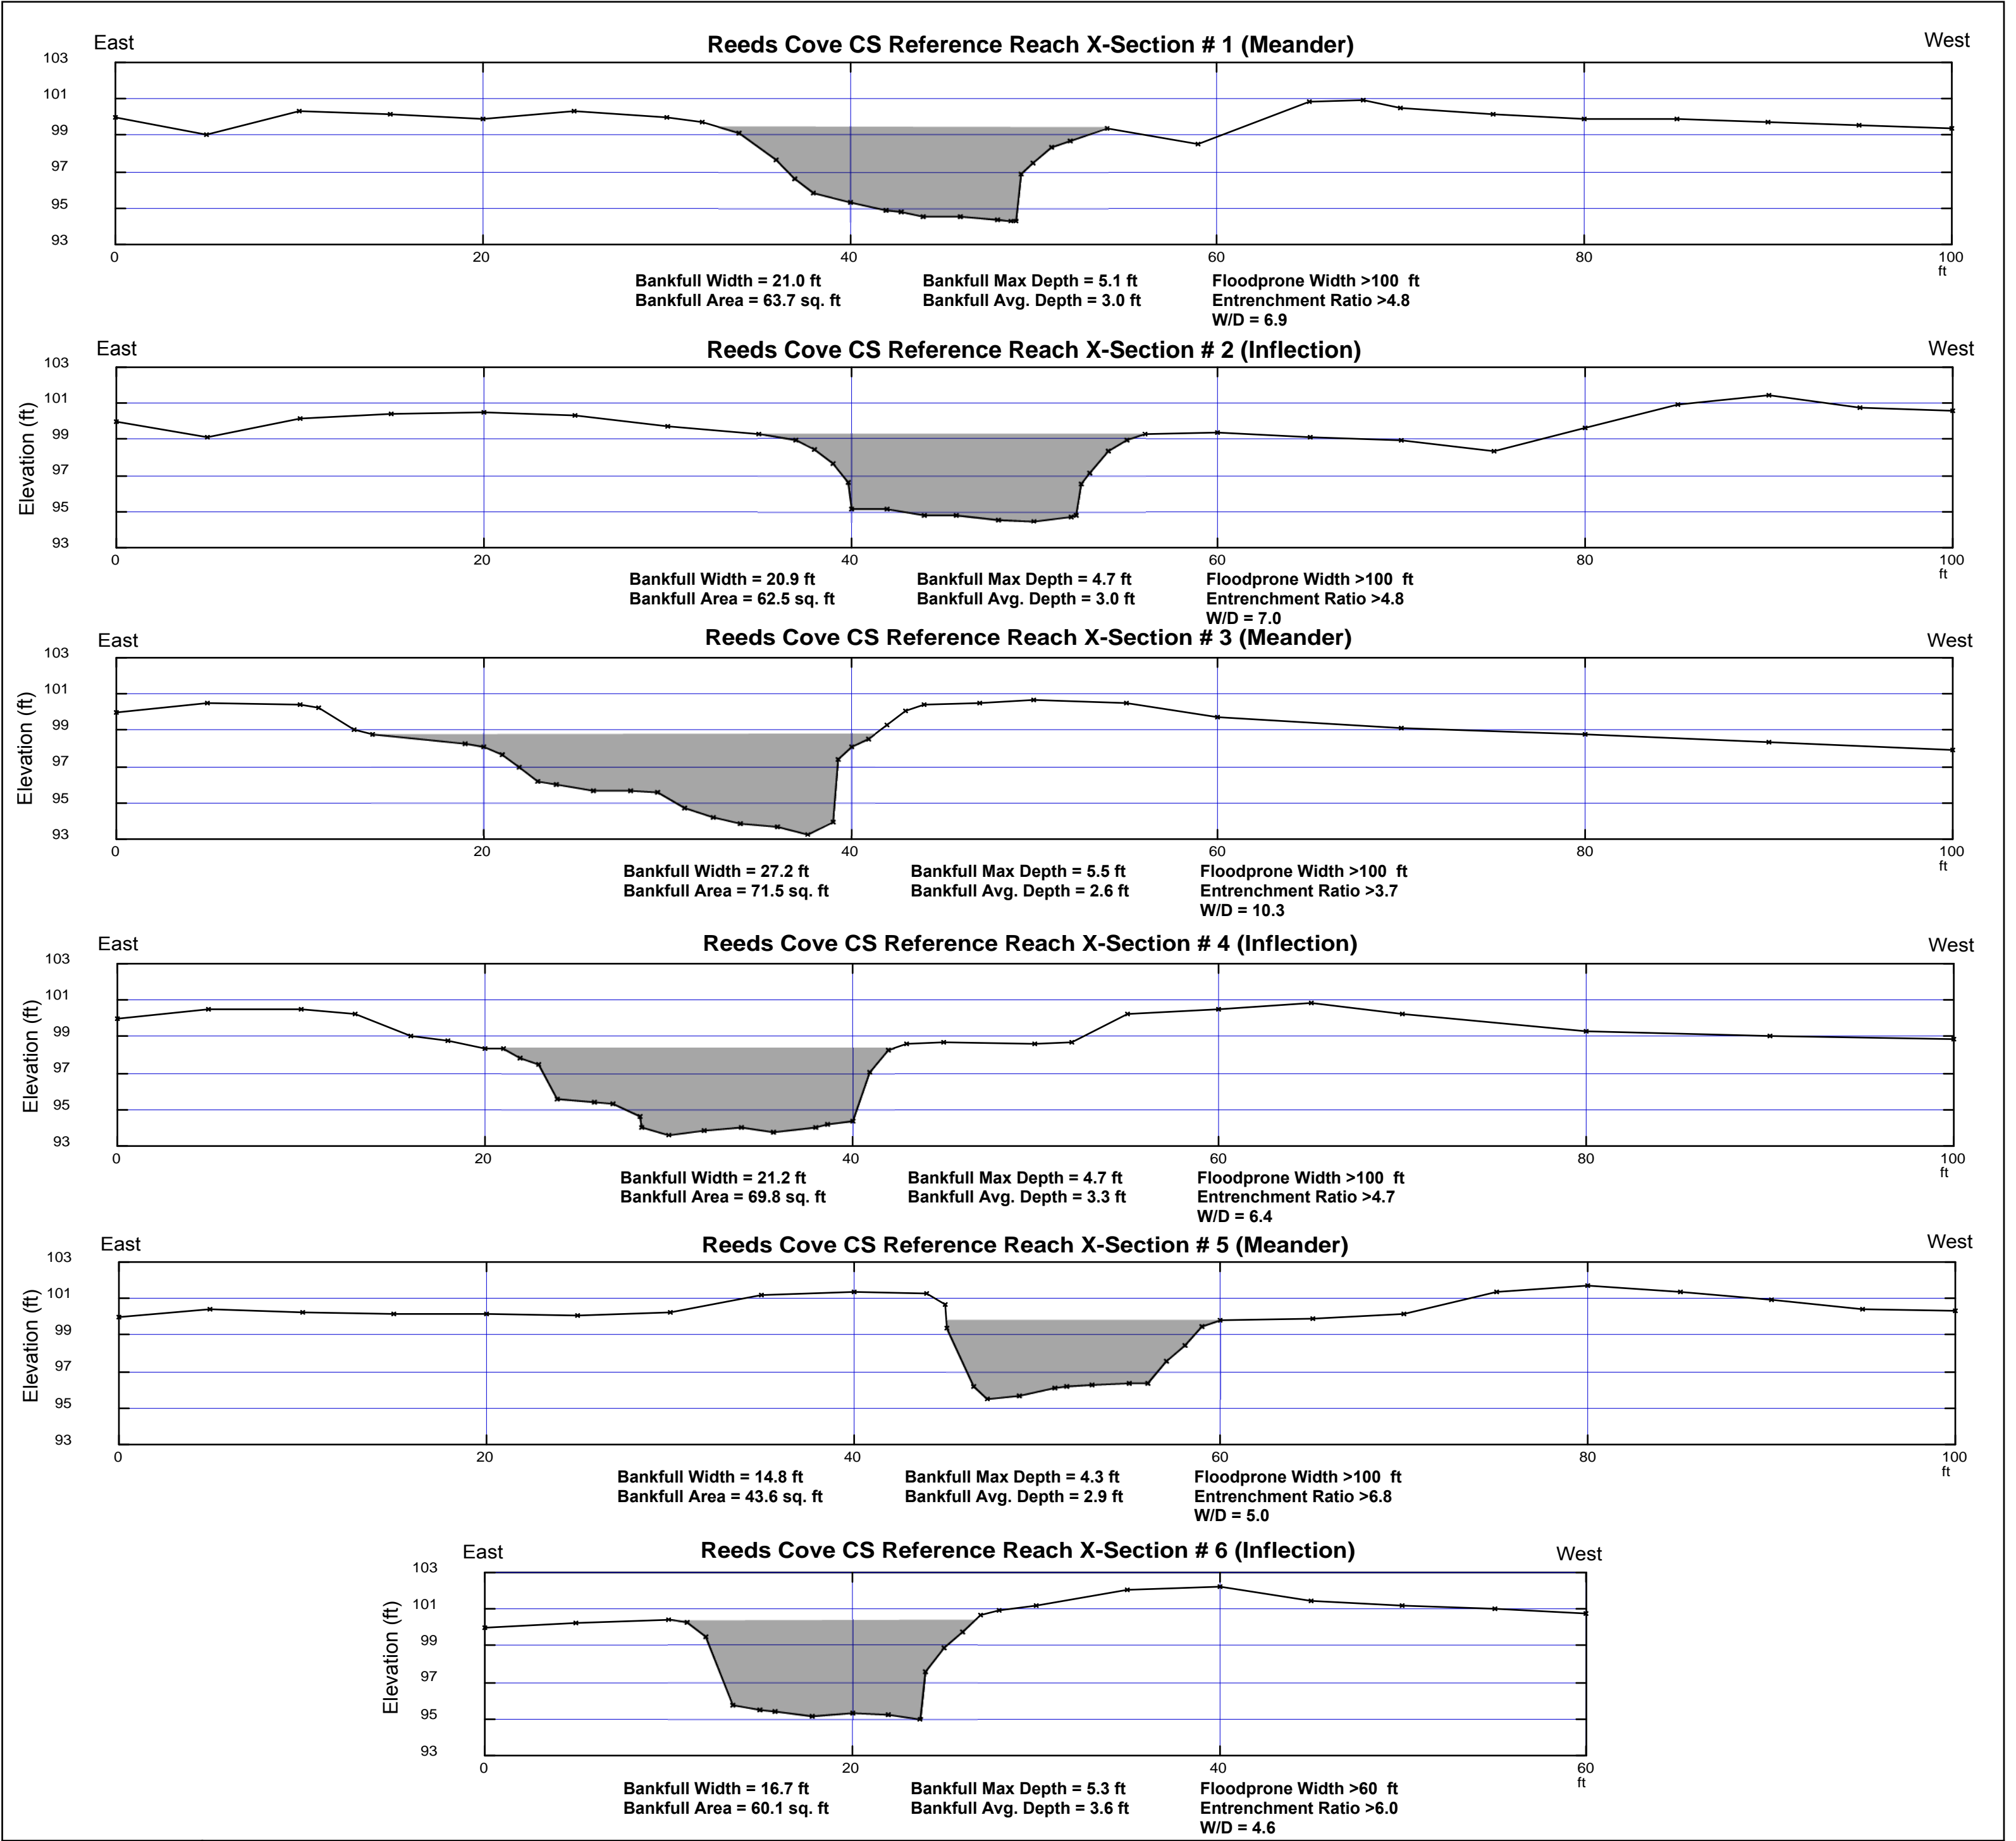
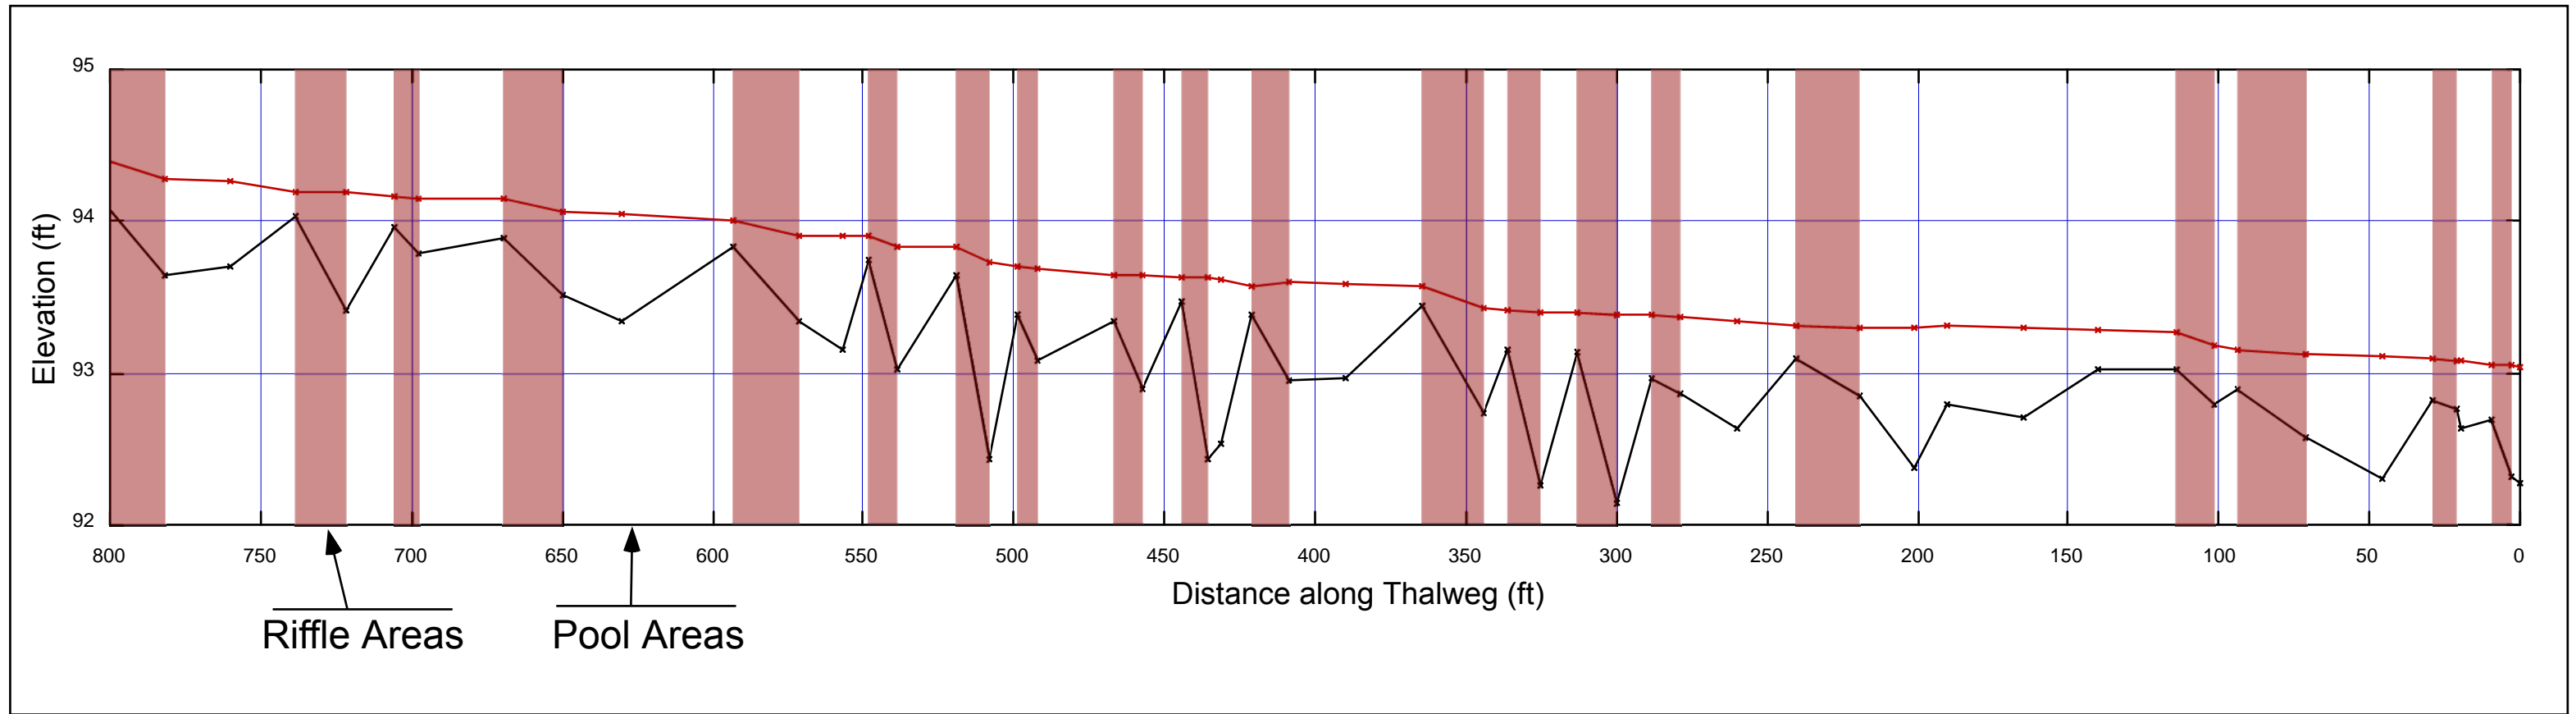
Figure D4. West Fork Reeds Creek Reference Reach Longitudinal Profile

NCEP Caldwell Station Creek
Restoration Site, Mecklenburg Co., NC
