Cane Creek Tributary Site Stream Restoration Plan

Person County, North Carolina

State Contract No. D06002

DECEMBER 2007

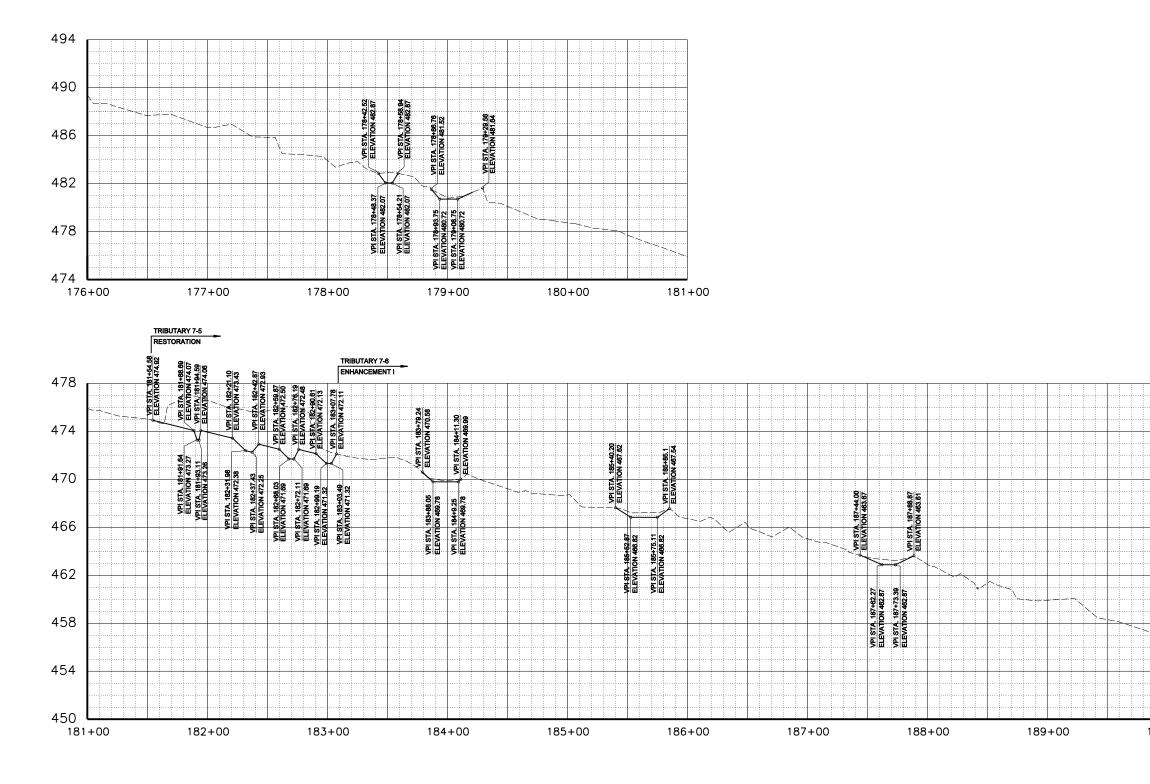
ł			
SH	SCAL	DAT			N N	SUBMITTED WITH RESTORATION PLAN	DEC 2007	
EET				,				
PR	"=4	DEC	TECHNOLOGIES					
PLA AN OF	0'		FNGINFFRS • PLANNERS • SCIENTISTS					
D				Honeretam				
			4601SIX FORKS ROAD	R nhoncement	SYM.	DESCRIPTION	DATE	APPROVED
38		T7-4, T7-5, T7-6: STATION 176+51 TO STATION 189+38	RALEIGH, NURTH CARCEINA 21000			REVISIONS

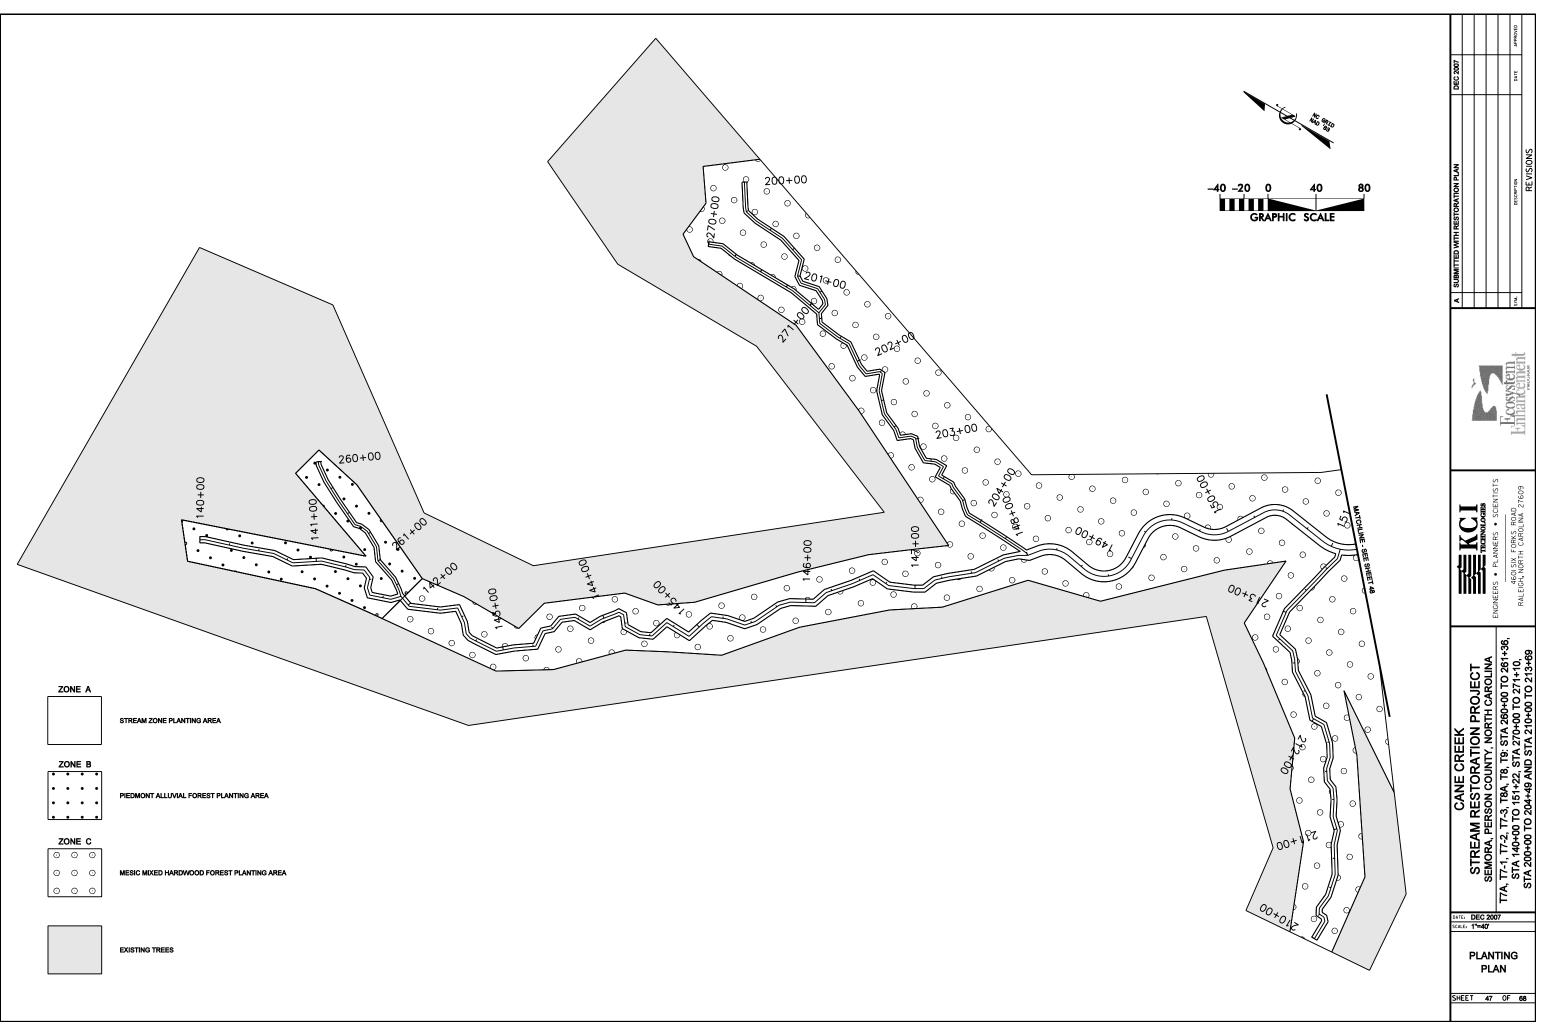
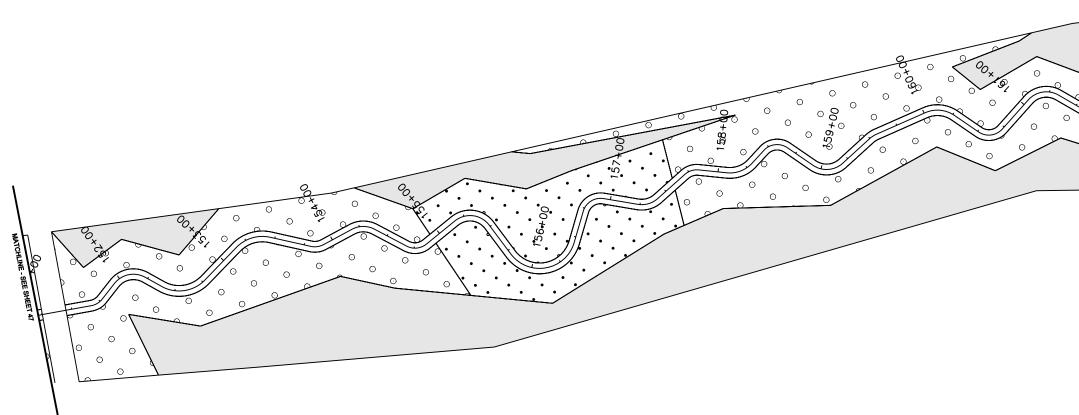
Image: state of the state			
Image: Section of the section of th		2	APPROVED
ABA A A A A A A A A A A A A A A A A A A A		DEC 200	DATE
			0650
BUILTURE BUILTURE SEMORA, PERSON COUNTY, NORTH CAROLINA T7-3: STATION 151+22 TO STATION 163+79		2	Hcosystem
BUILTURE SEMORA, PERSON COUNTY, NORTH CAROLINA T7-3: STATION 151+22 TO STATION 163+79		KCI	TECHNOLOGIES NNERS • SCIENTISTS FORKS ROAD H CAROLINA 27609
DATE: DEC 2007 SCALE: 1=40 PLANTING PLAN	80		ENGINEERS - PLA 4601 SIX RALEIGH, NORT
PLANTING PLAN		CANE CREEK	STREAM RESTORATION PROJECT SEMORA, PERSON COUNTY, NORTH CAROLINA T7-3: STATION 151+22 TO STATION 163+79
PLAN			
		P SHEET	LANTING PLAN 48 OF 68

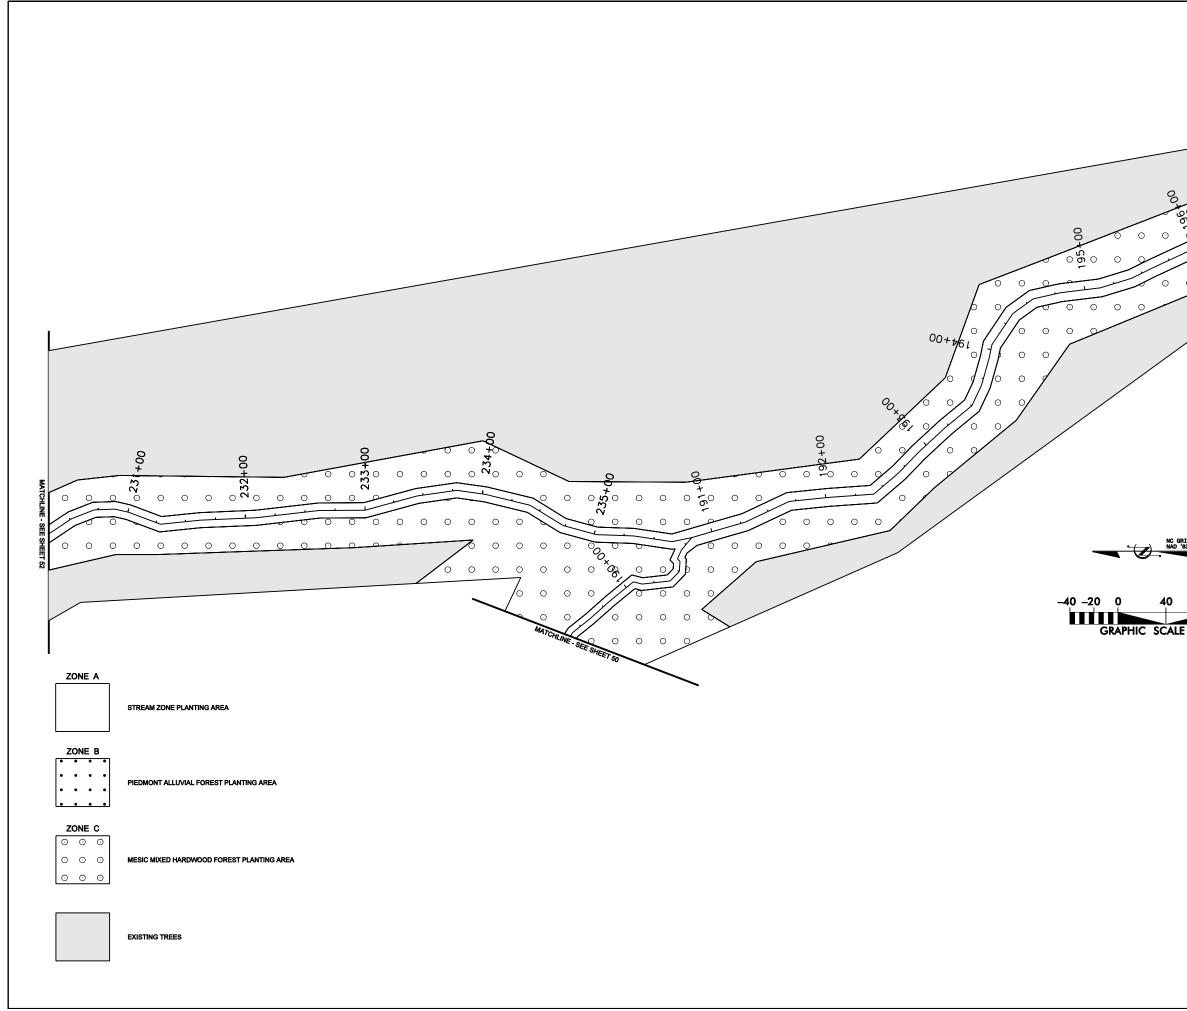
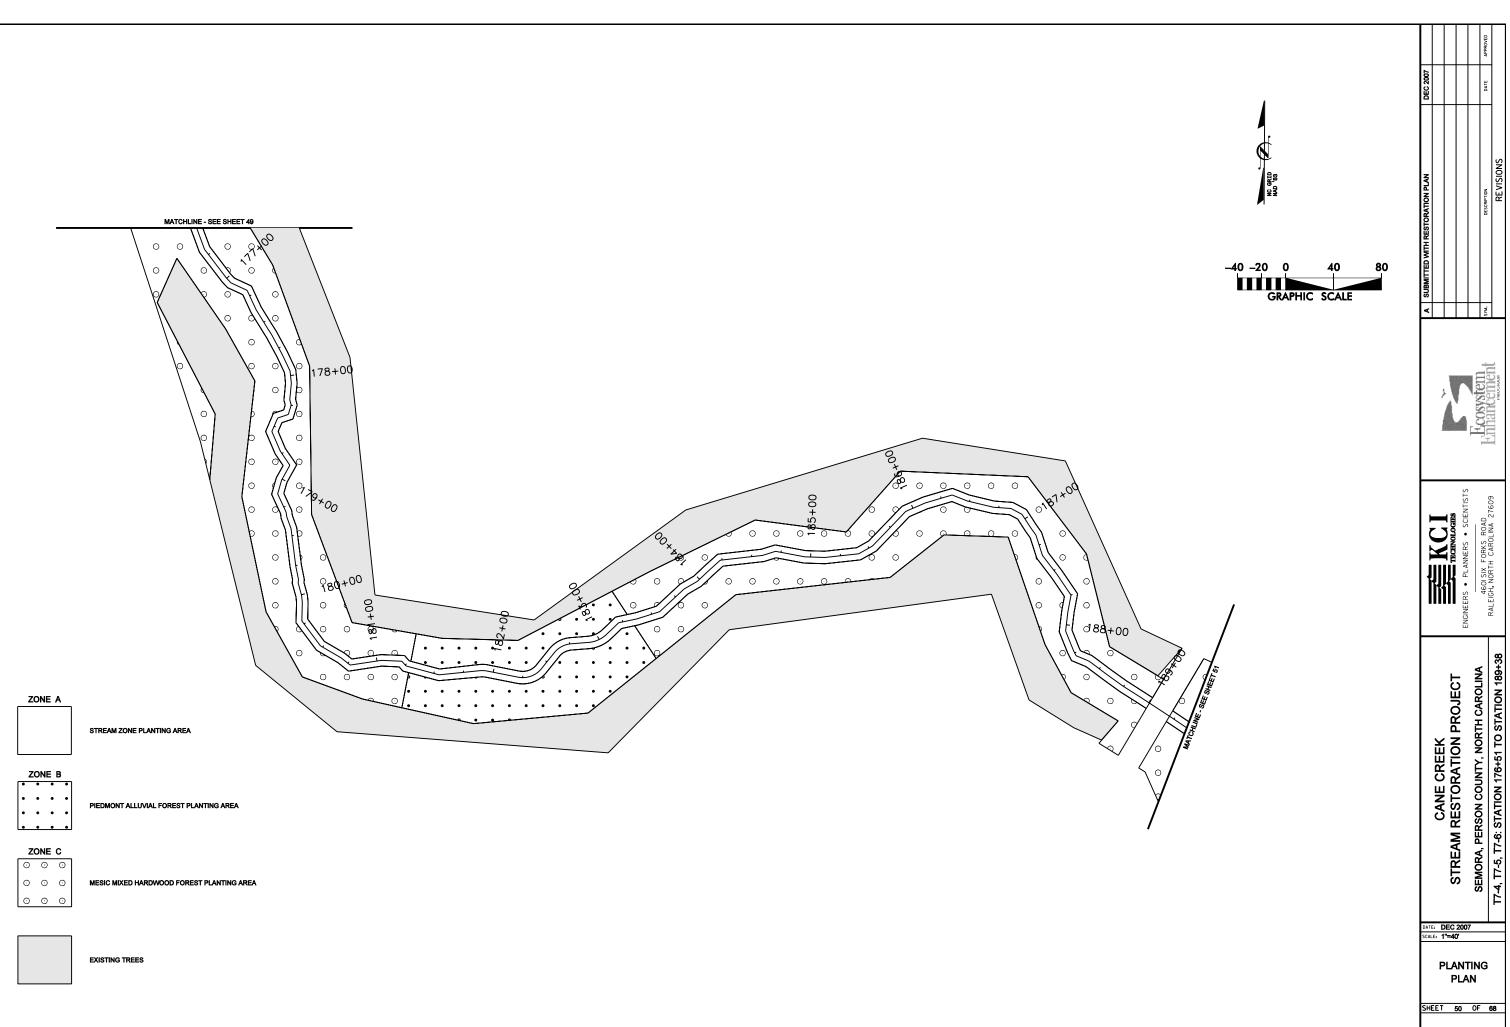
APPROVED	
	DEC 2007	
	SUBMITTED WITH RESTORATION PLAN	RF VISIONS
DATE: DEC 2007 SCALE: 1"=40" PLANTING PLAN	ENGINEERS • PLANNERS • SCIENTISTS RALEGH, NORTH CARGINA 27609	
PLANTING PLAN	OJECT CAROLINA	TATION 235+82
PLANTING PLAN	CANE CREEK STREAM RESTORATION PR SEMORA, PERSON COUNTY, NORTH	T10-1, T10-2: STATION 230+29 TO S
		I T10-1, T10-2: STATION 230+29 TO S
	DATE: DEC 2007 SCALE: 1"=40" PLANTING	T10-1, T10-2: STATION 230+29 TO S
