Cane Creek Stream Restoration Site

Mitigation Plan

Contract # D06002

May 2009

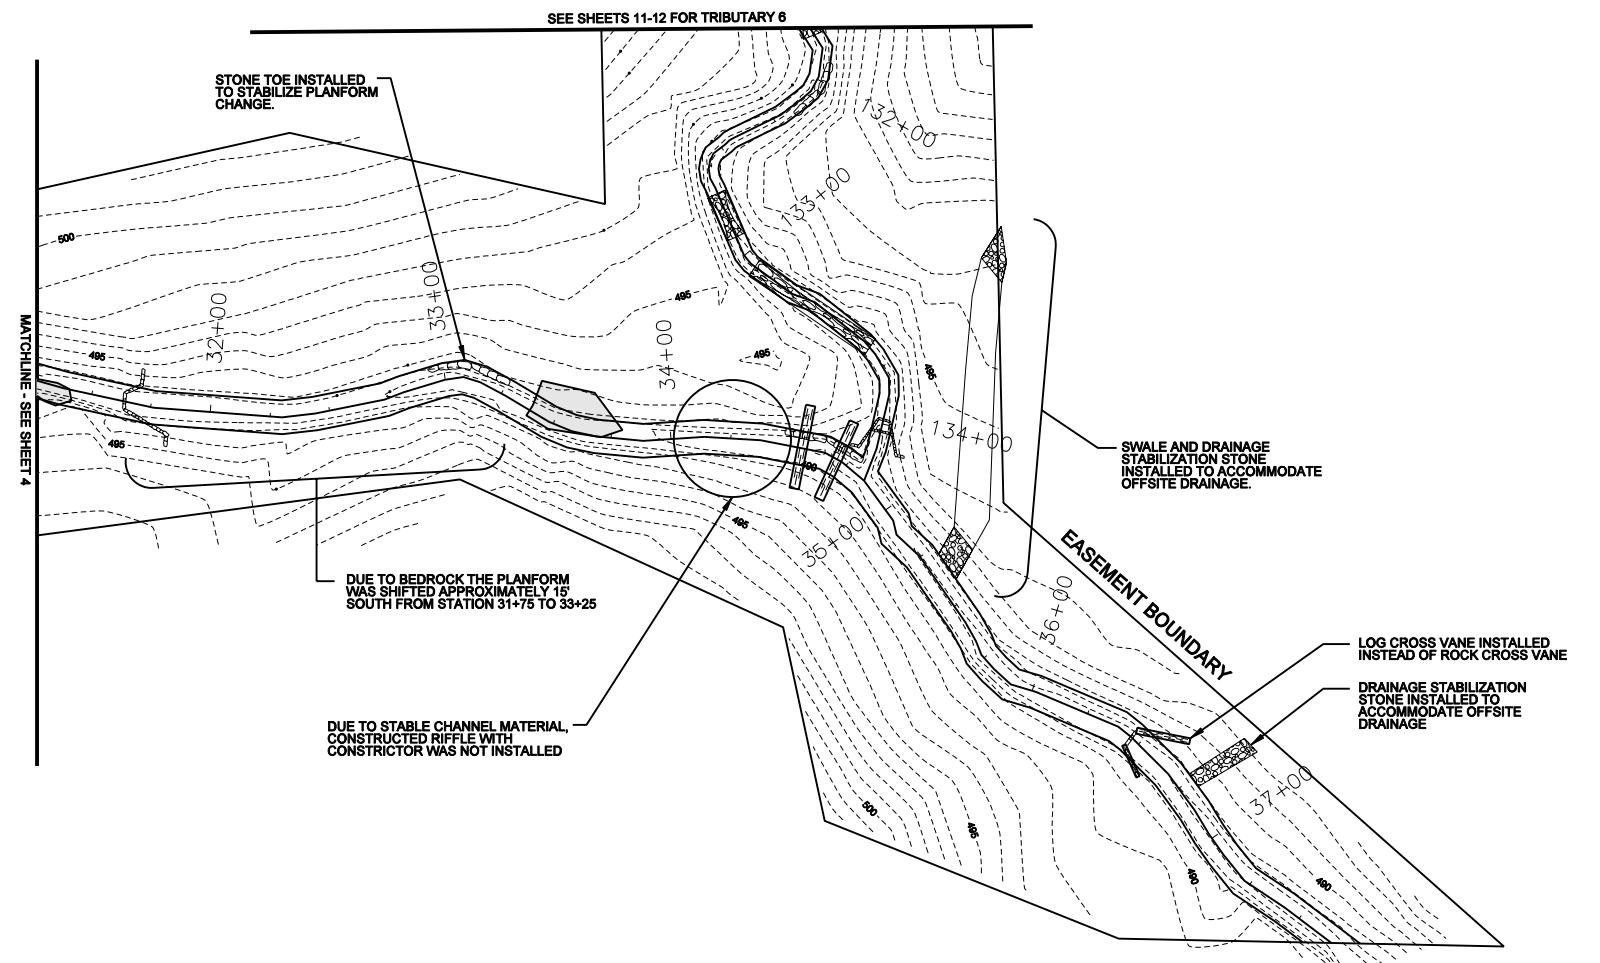
**CANE CREEK
STREAM RESTORATION PROJECT**
SEMOREA, PERSON COUNTY, NORTH CAROLINA
T14, T15: STATION 31+26 TO STATION 37+67

AS-BUILT
SITE PLAN

T1 was restored from Station 21+50 until it ends at the property boundary. There are three separate reaches in this section of T1: T1-3 from Station 21+50 to 24+76 where T4 enters; T1-4 from Station 24+76 to 34+85 where T6 flows into T1, and T1-5 from Station 34+85 to 37+67. These three lower reaches of T1 were restored using a Priority 3 approach. Along this section of T1, the restoration established riffle and pool features and a new stable planform, while also utilizing existing bedrock as grade control.

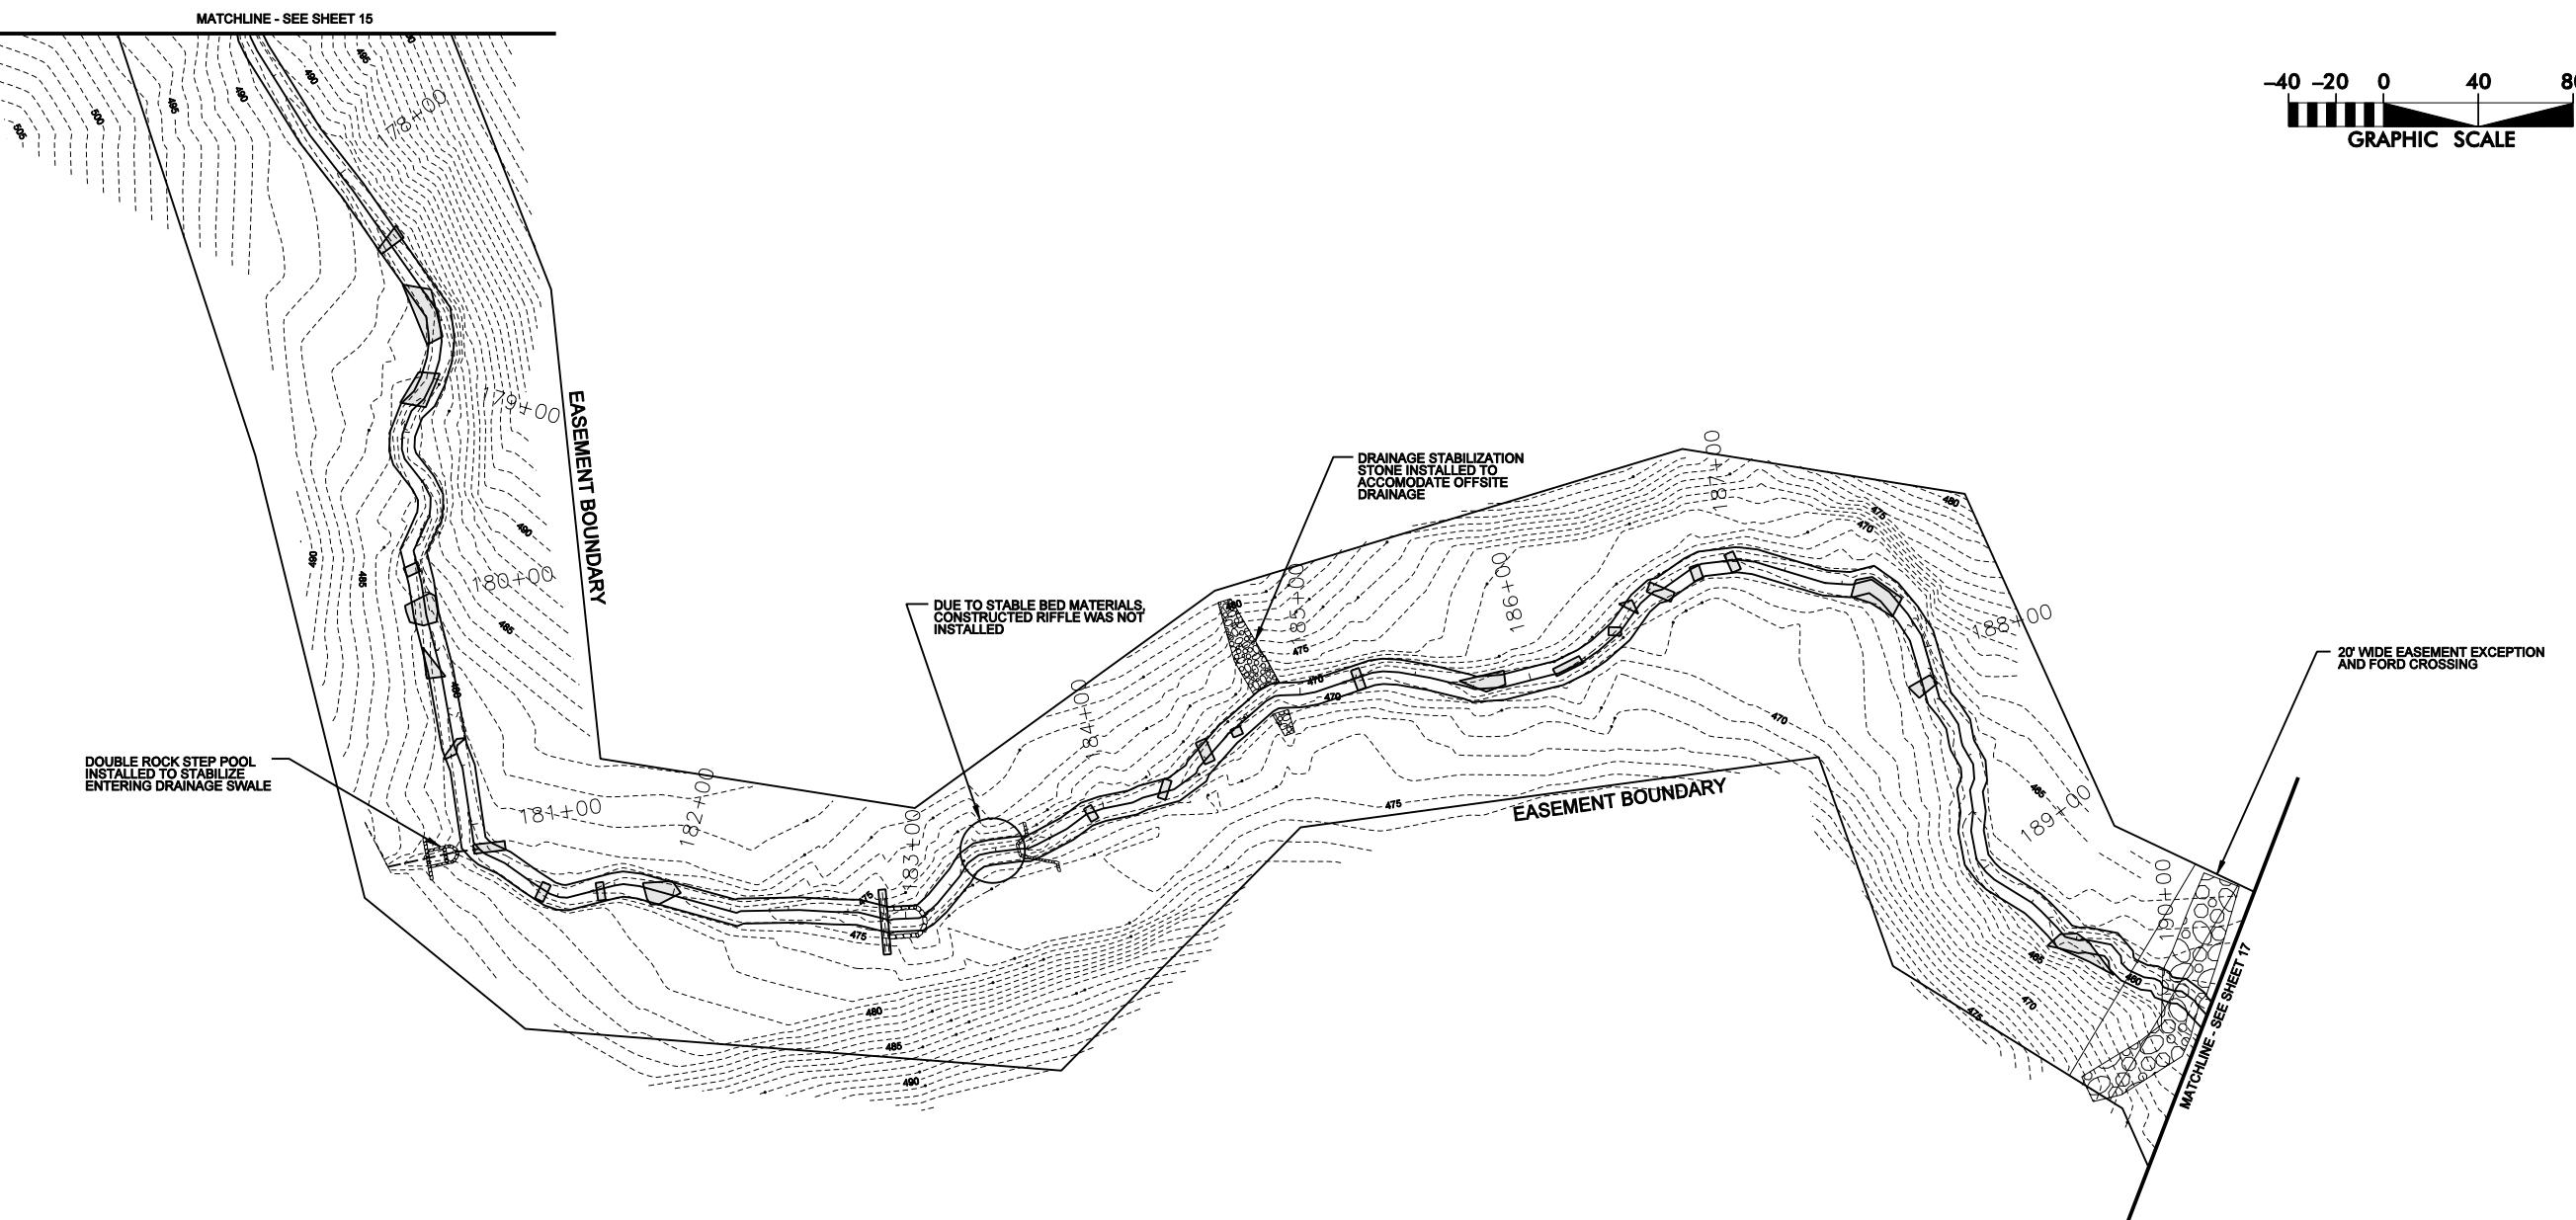
CANE CREEK
STREAM RESTORATION PROJECT
SEMORA, PERSON COUNTY, NORTH CAROLINA
T7.4, T7.5, T7.6: STATION 177+29 TO STATION 190+18

DATE: MAR 2009
SCALE: 1"=80'
AS-BUILT
SITE PLAN
SHEET 16 OF 35

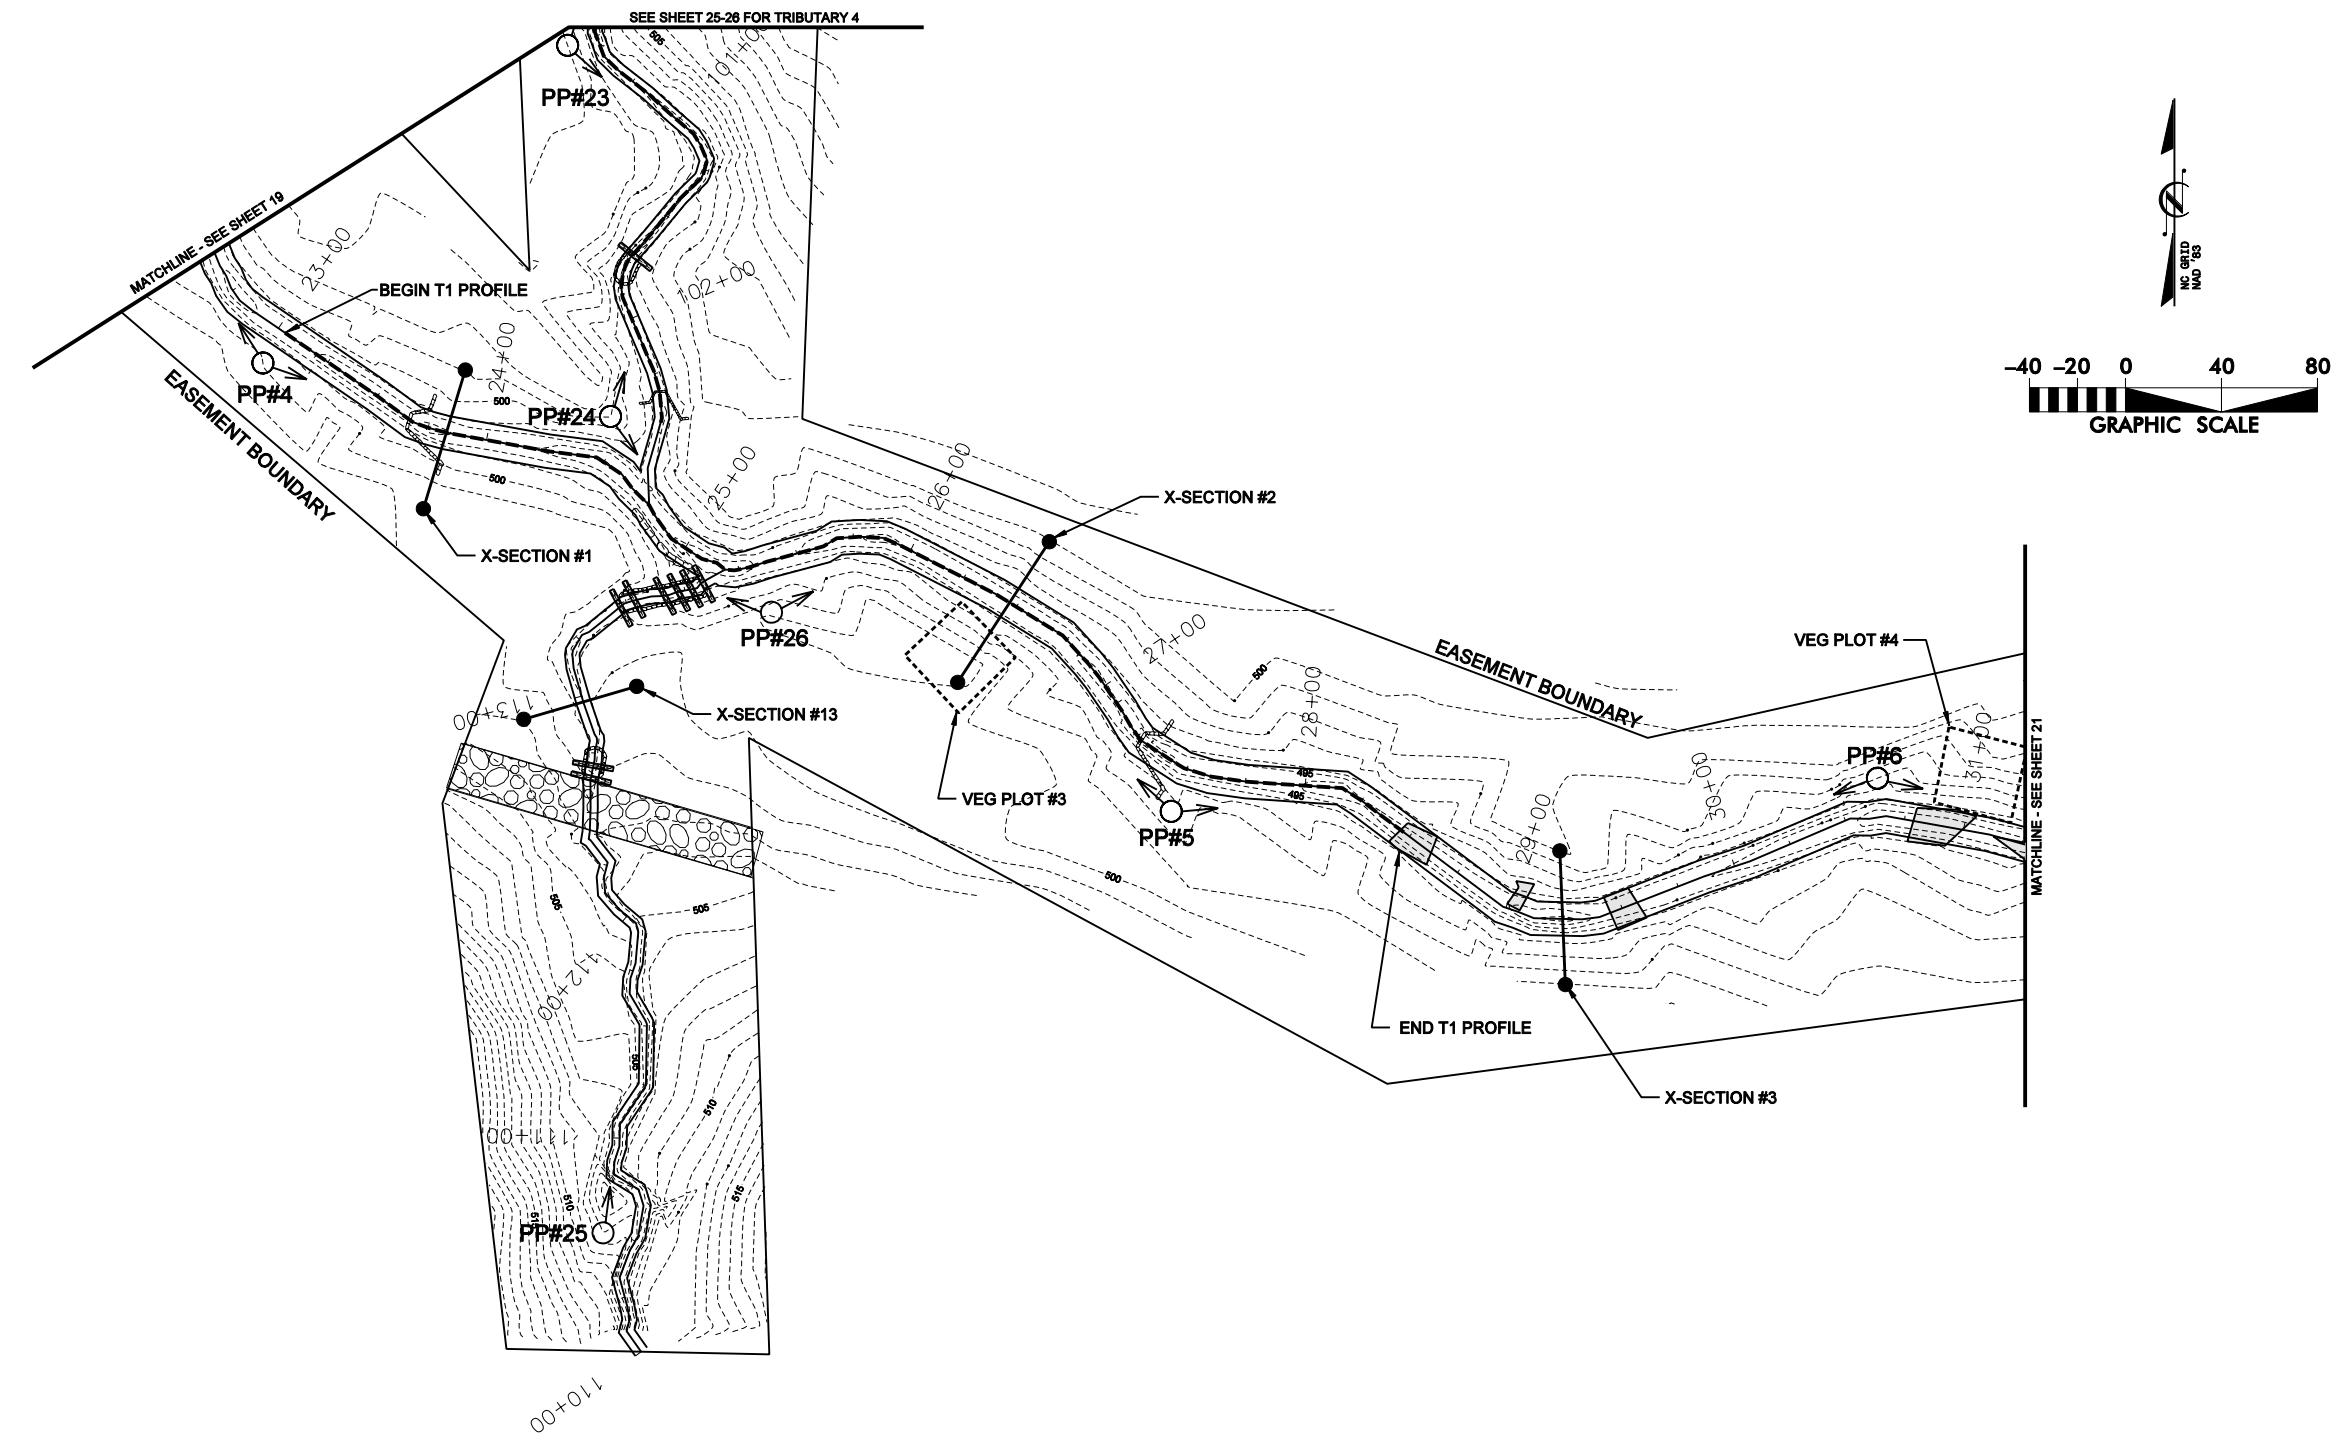
**CANE CREEK
STREAM RESTORATION PROJECT
SEMORA, PERSON COUNTY, NORTH CAROLINA
T1-3,T1-4: STATION 22+57 TO STATION 31+**

MONITORING
PLAN VIEW

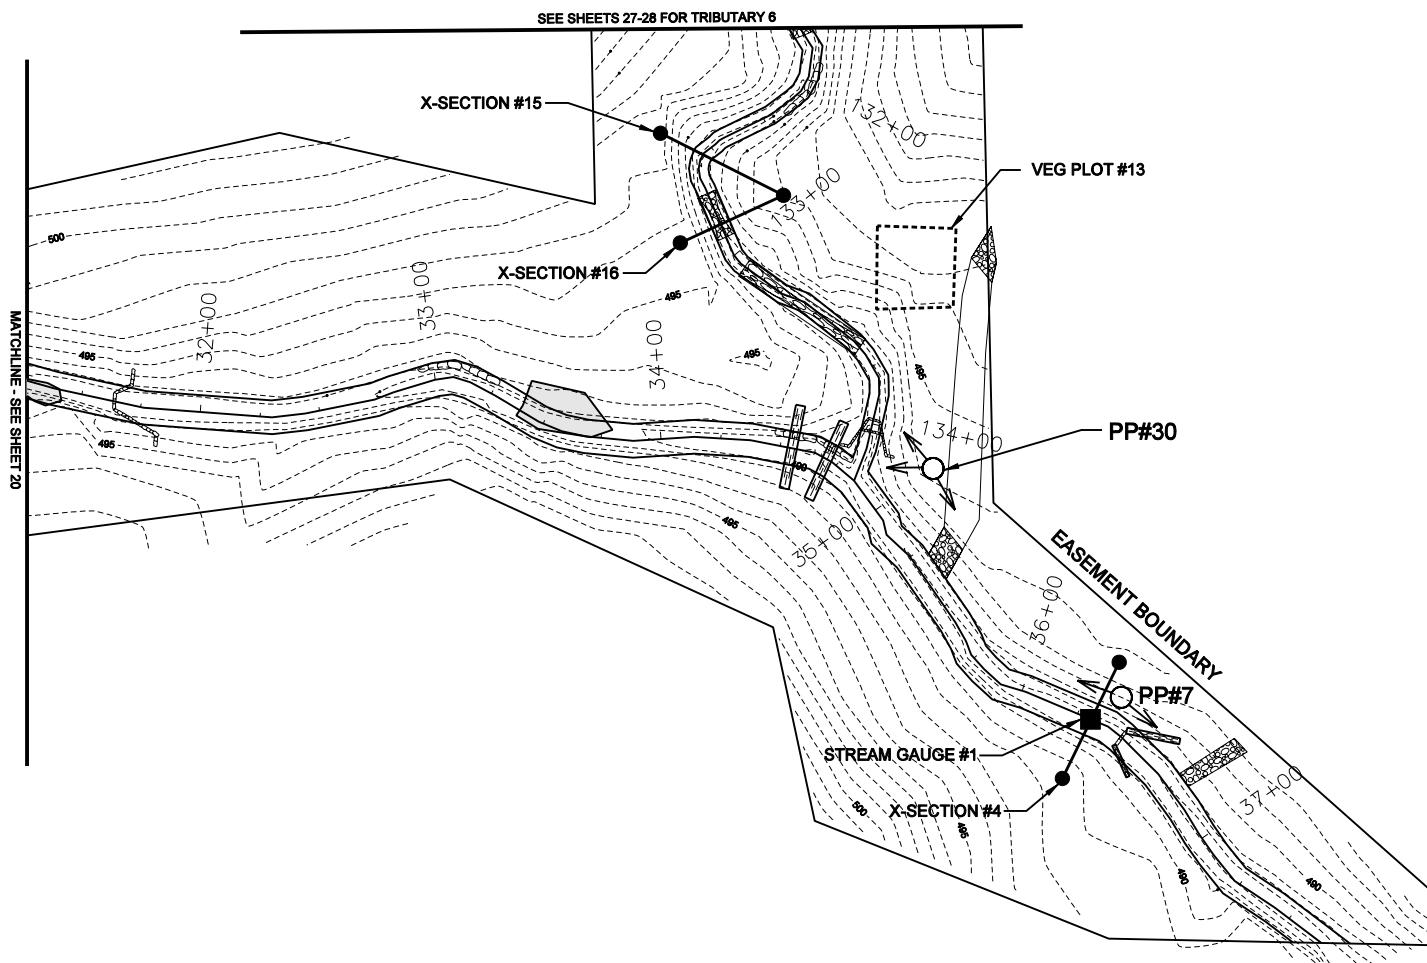
**CANE CREEK
STREAM RESTORATION PROJECT**
SEMOREA, PERSON COUNTY, NORTH CAROLINA
T1-4, T1-5: STATION 31+26 TO STATION 37+67

MONITORING
PLAN VIEW

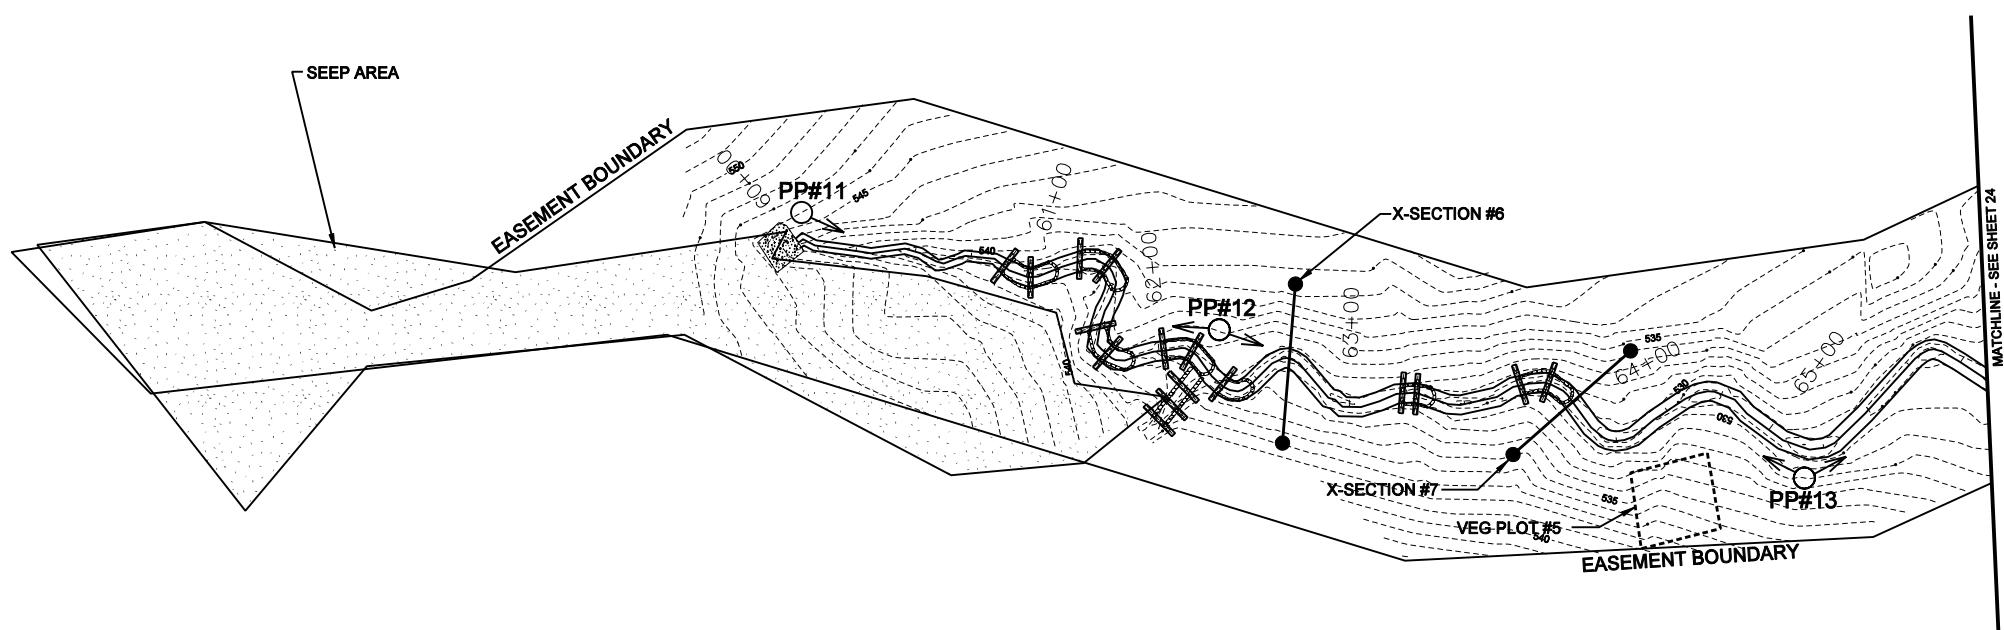
CANE CREEK
STREAM RESTORATION PROJECT
SEMORA, PERSON COUNTY, NORTH CAROLINA
T3-1, T3-2: STATION 60+00 TO STATION 66+13

DATE: MAR 2009
SCALE: 1"=80'
MONITORING PLAN VIEW
SHEET 23 OF 35

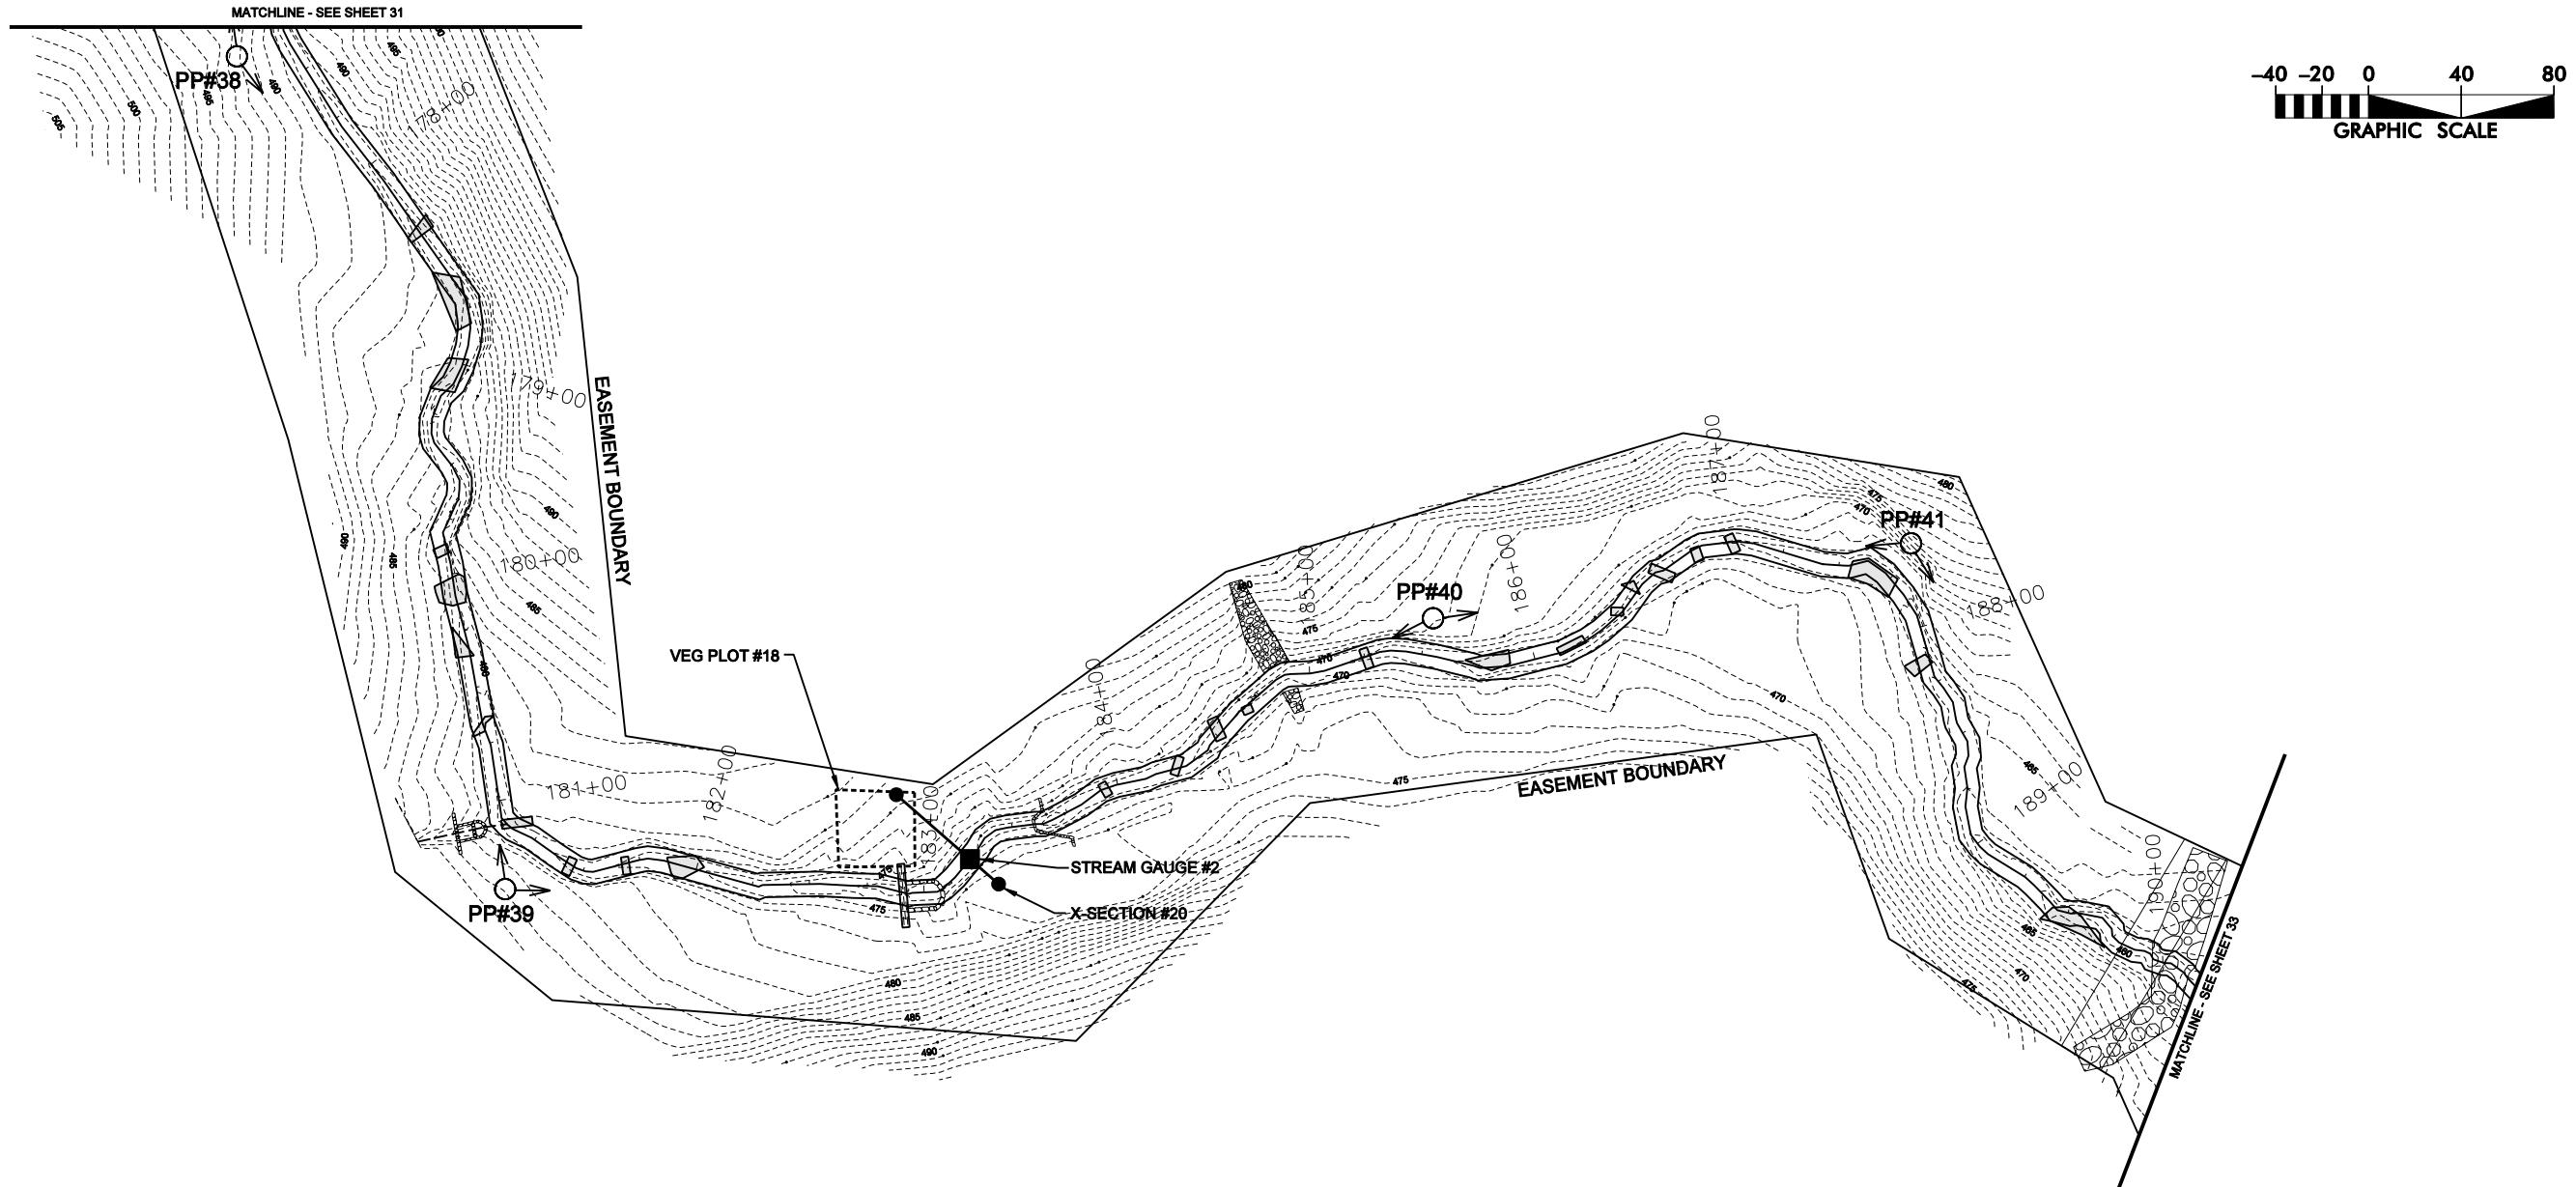
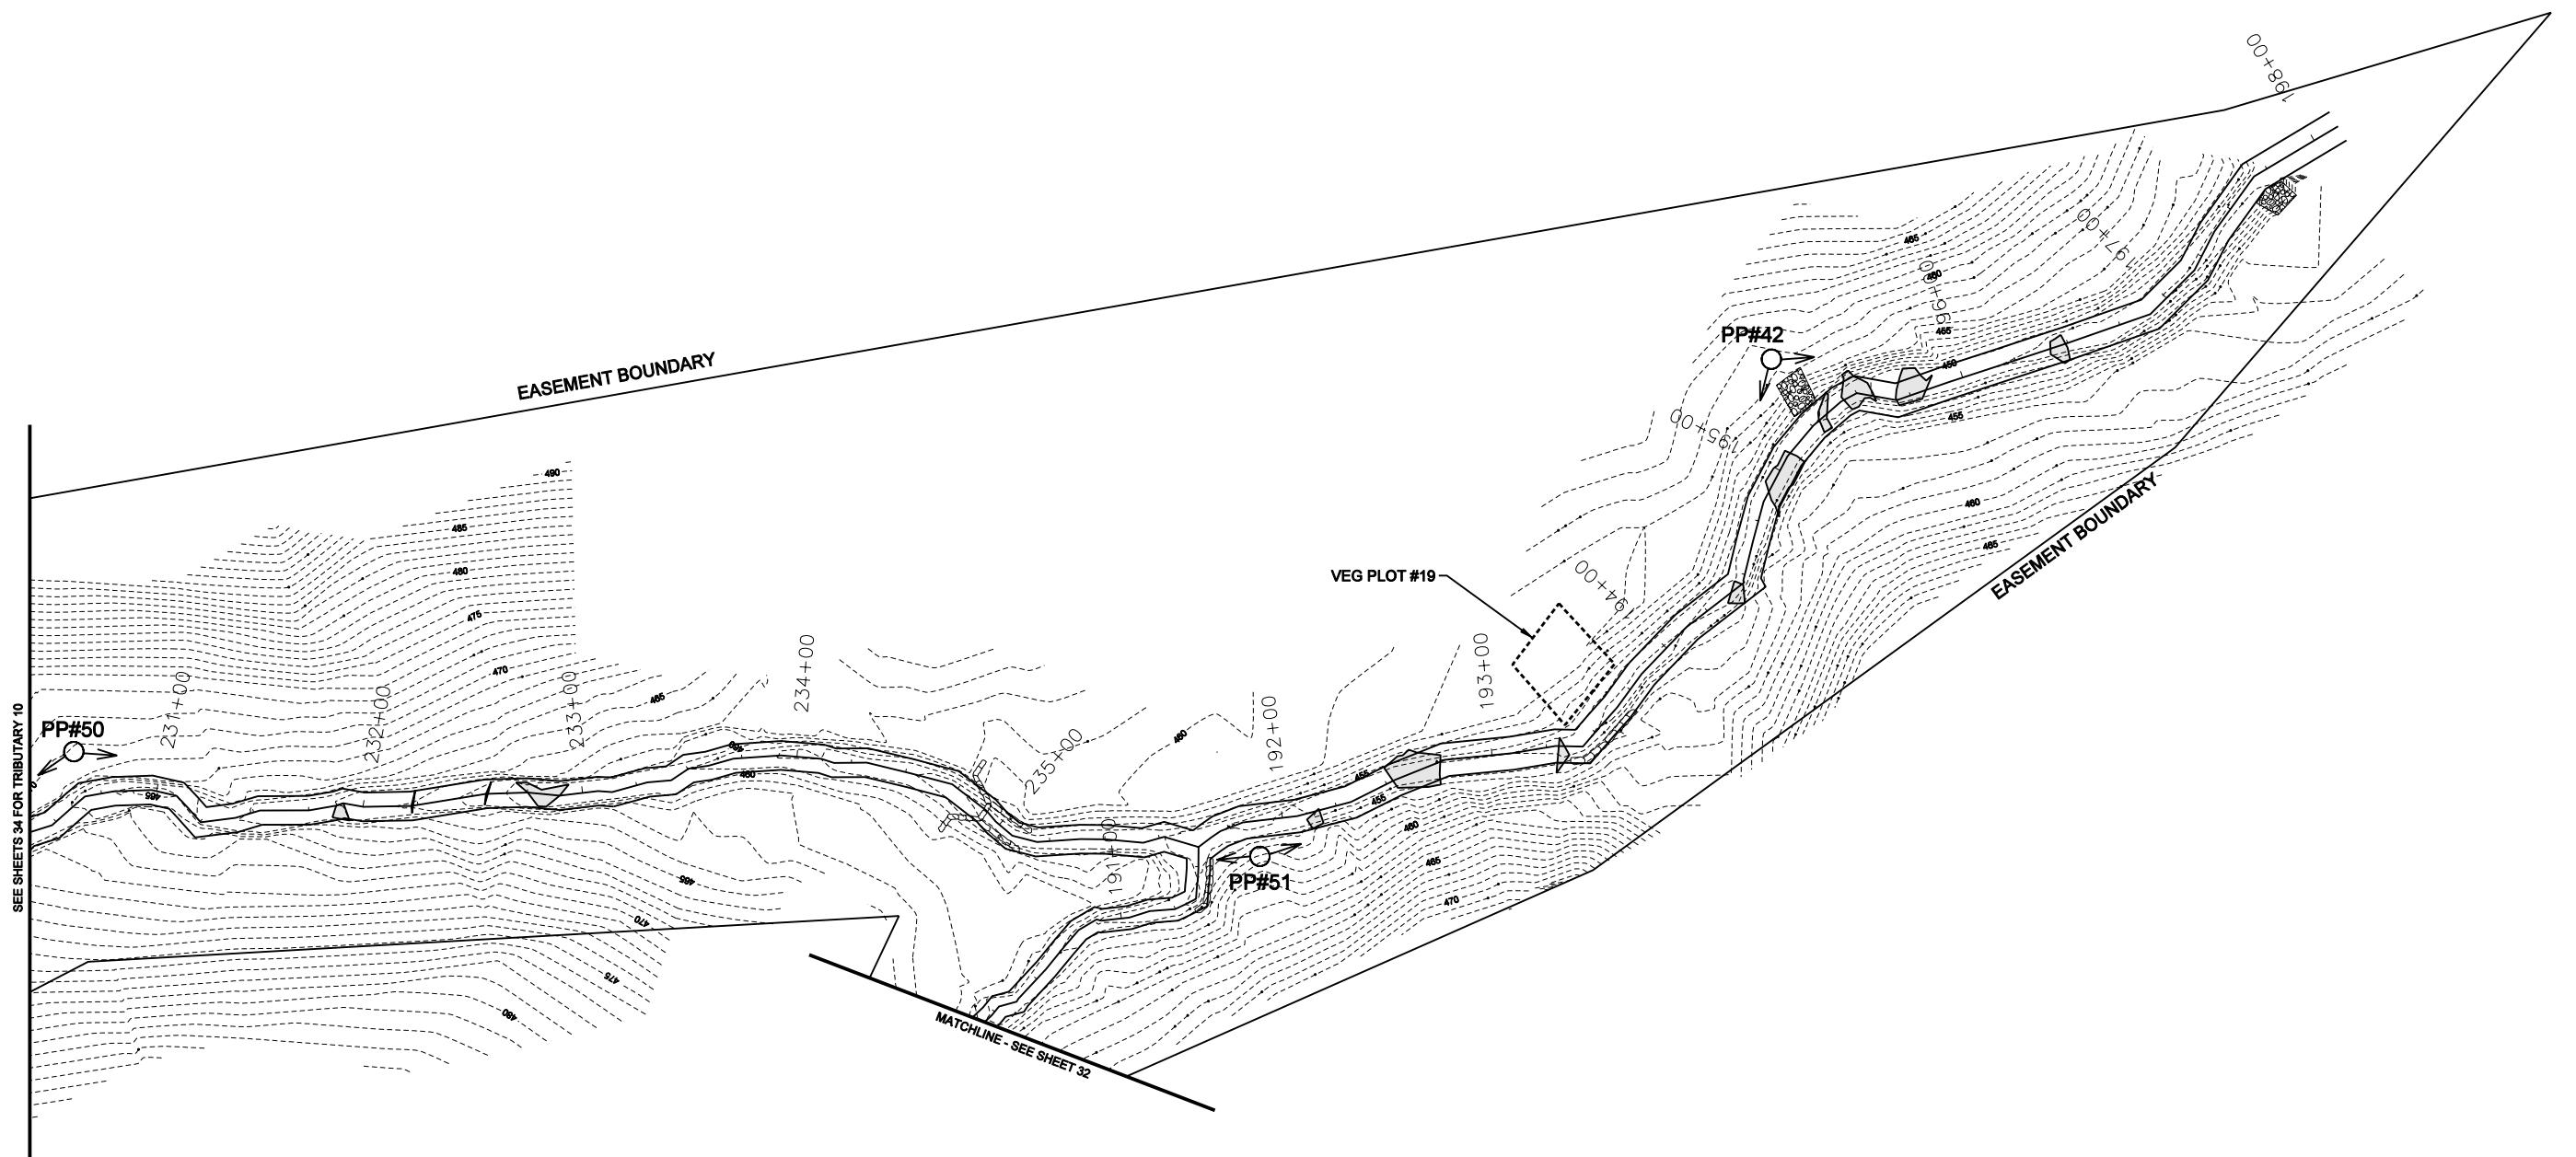
MONITORING
PLAN VIEW

**STREAM RESTORATION PROJECT
CANE CREEK
SEOMORA, PERSON COUNTY, NORTH CAROLINA**

THE AS-BUILT SITE PLAN (SHEETS 3-18) DEPICTS THE AS-BUILT CONDITIONS. ANY DEVIATIONS FROM THE DESIGN PLANS ARE SPECIFICALLY CALLED OUT WITH NOTES. IF THERE ARE NOT ASSOCIATED NOTES WITH A SPECIFIC SECTION THEN THAT SECTION WAS BUILT AS DESIGNED.

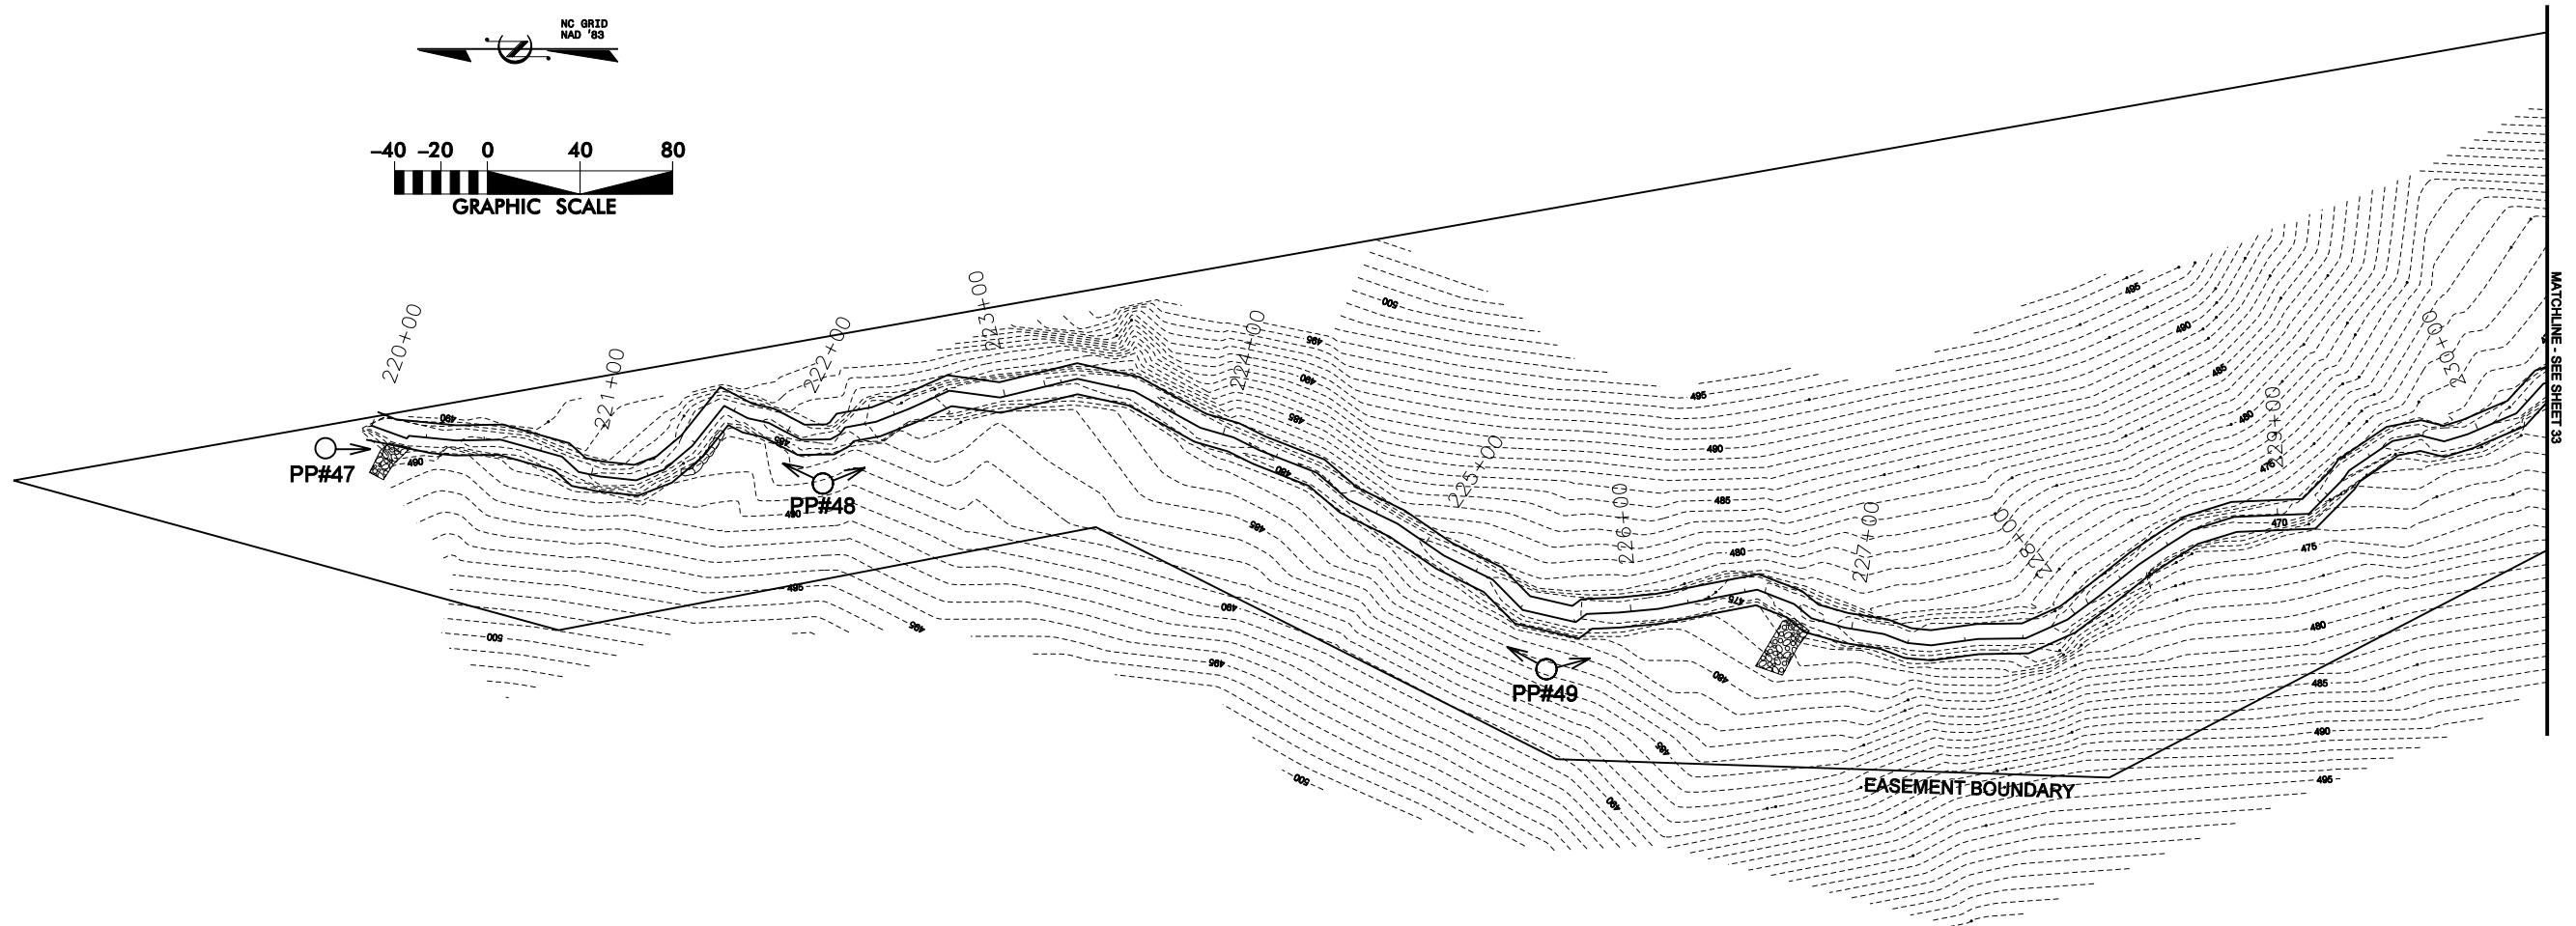
MONITORING
PLAN VIEW

SEE SHEETS 34 FOR TRIBUTARY 10

**CANE CREEK
STREAM RESTORATION PROJECT**
SEMOREA, PERSON COUNTY, NORTH CAROLINA
T10: STATION 220+00 TO STATION 230+37

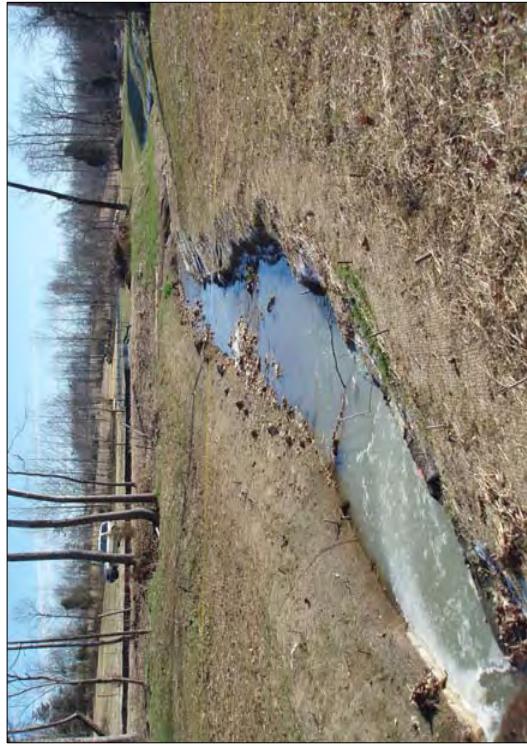
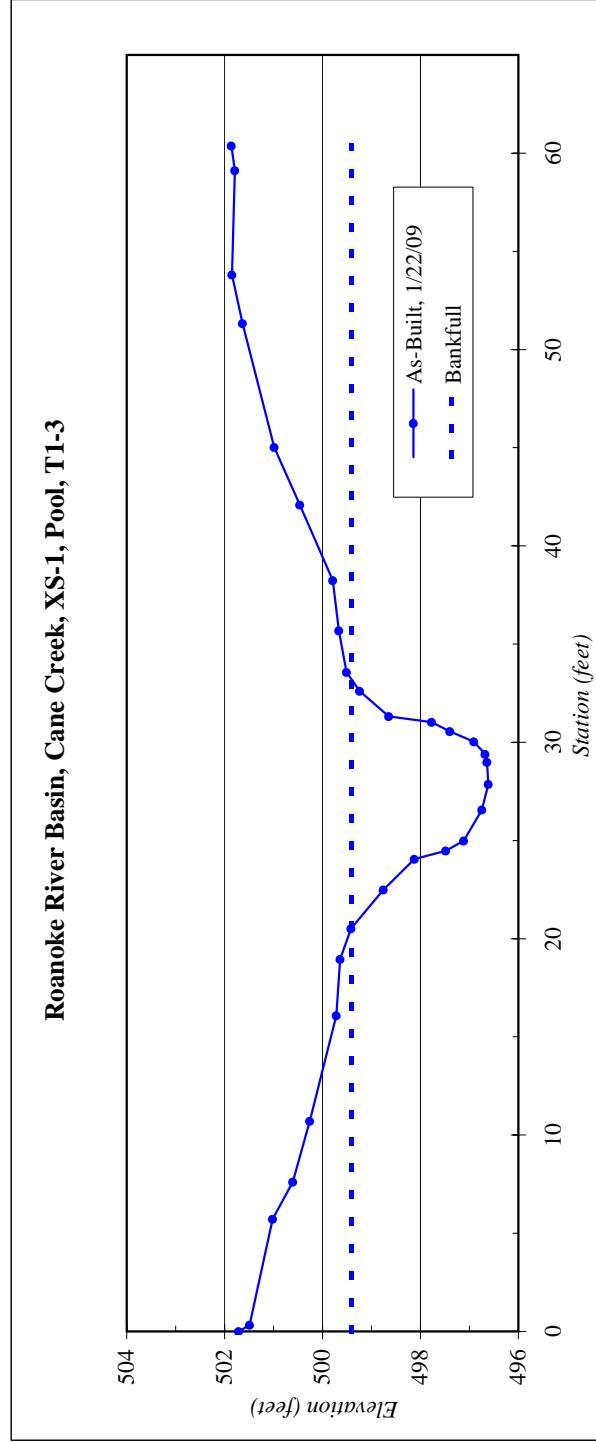
Roanoke River Basin, Cane Creek, XS-1, Pool, T1-3

River Basin:	Roanoke
Watershed:	Cane Creek
XS ID	XS-1, Pool, T1-3
Drainage Area (sq mi):	0.49
Date:	1/22/2009
Field Crew:	B. Roberts, A. Davis

Station	Elevation
0.0	501.71
0.3	501.49
5.7	501.02
7.6	500.61
10.7	500.26
16.1	499.72
18.9	499.64
20.5	499.42
22.5	498.76
24.1	498.12
24.5	497.48
25.0	497.12
26.6	496.74
27.9	496.62
29.0	496.64
29.4	496.68
30.0	496.91
30.5	497.40
31.0	497.77
31.3	498.64
32.6	499.24
33.6	499.51
35.7	499.67
38.3	499.79
42.1	500.46
45.0	500.99
51.3	501.63
53.8	501.85
59.1	501.79
60.4	501.86

Stream Type C/B4

Cross-section measurements should show little or no change from the as-built cross-sections. Annual measurements of the longitudinal profile should indicate a stable bedform with little change from the as-built survey. Sediment transport should remain relatively unchanged with respect to aggradation and deposition of sediments. Any observed variation in the annual monitoring of the cross-sections and longitudinal profiles will be evaluated to determine whether they are minor adjustments associated with normal sediment transport and increasing stability or whether they indicate movement toward an unstable condition. If any changes occur, they will be discussed within the yearly monitoring reports.

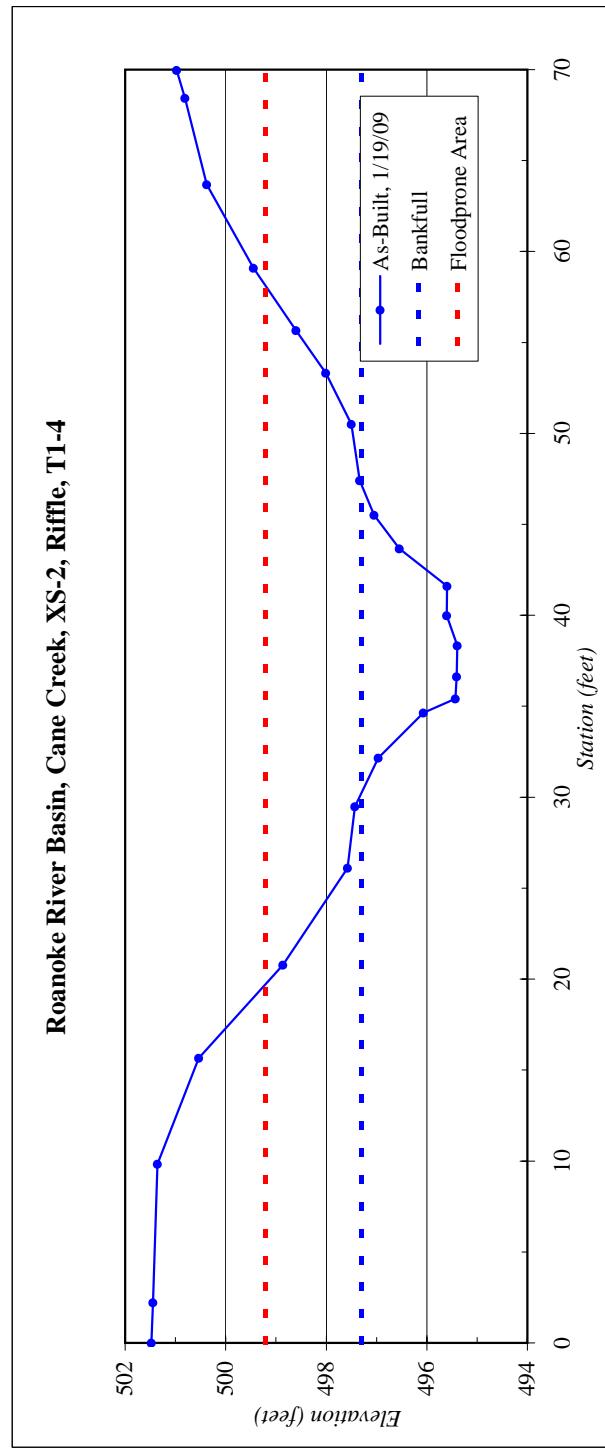
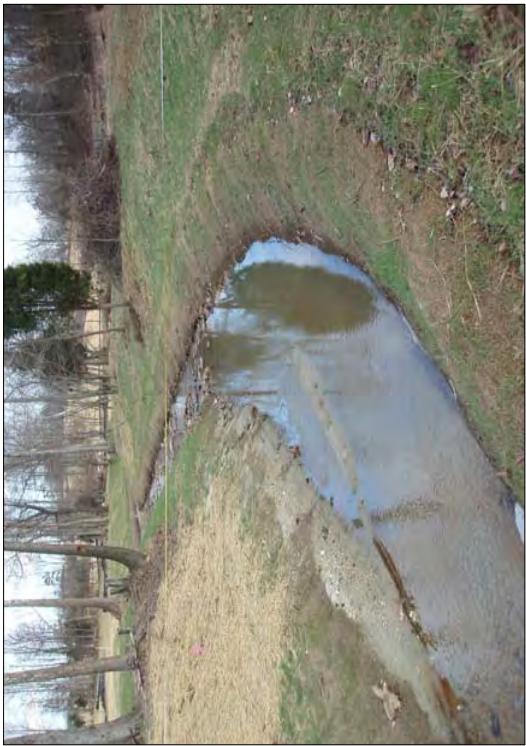
Roanoke River Basin, Cane Creek, XS-2, Riffle, T1-4

River Basin:	Roanoke
Watershed:	Cane Creek
XS ID	XS-2, Riffle, T1-4
Drainage Area (sq mi):	0.62
Date:	1/19/2009
Field Crew:	B. Roberts, A. Davis

Stream Type C/B4
