Cane Creek Stream Restoration Site

Mitigation Plan

Contract # D06002

May 2009

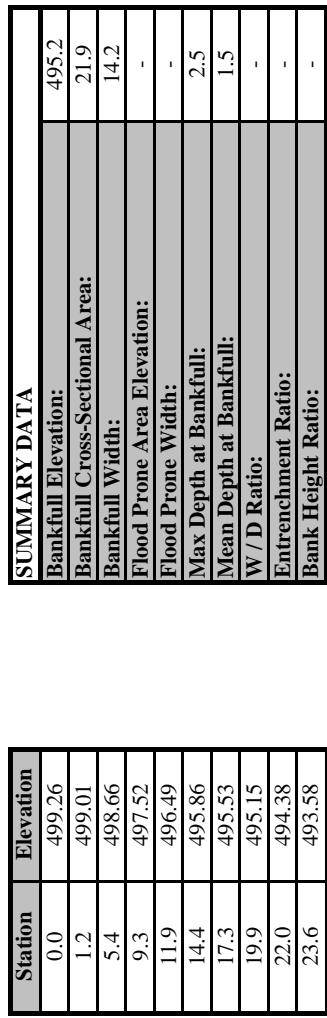
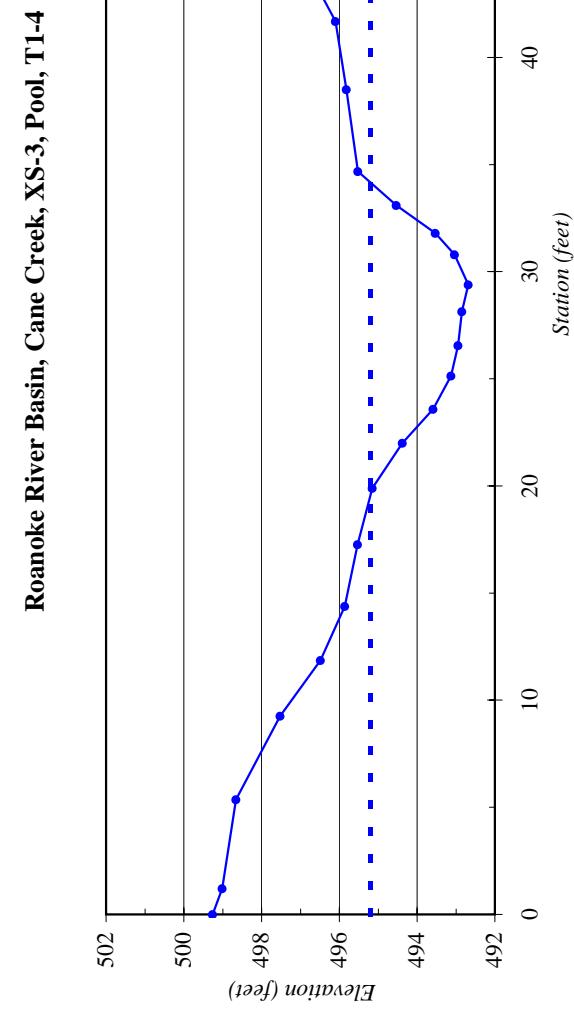
River Basin:	Roanoke
Watershed:	Cane Creek
XS ID	XS-3, Pool, T1-4
Drainage Area (sq mi):	0.62
Date:	1/19/2009
Field Crew:	B. Roberts, A. Davis

Stream Type C/B4

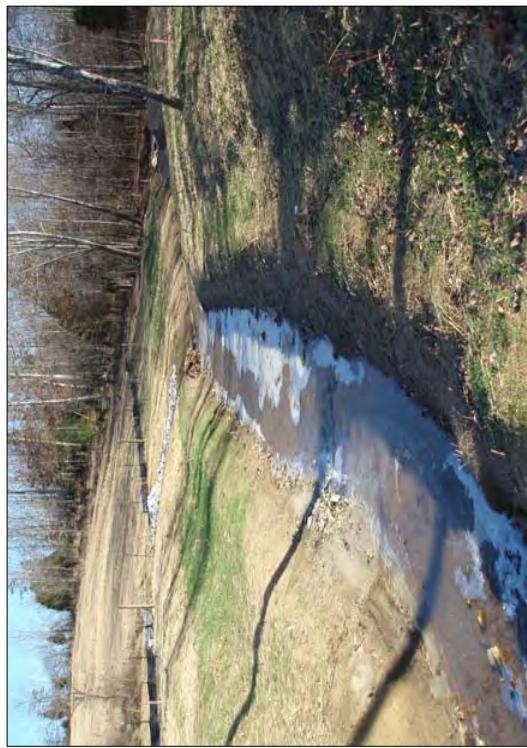
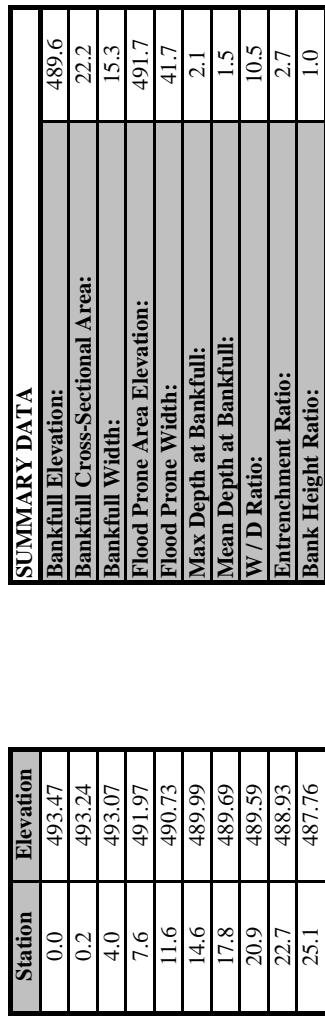
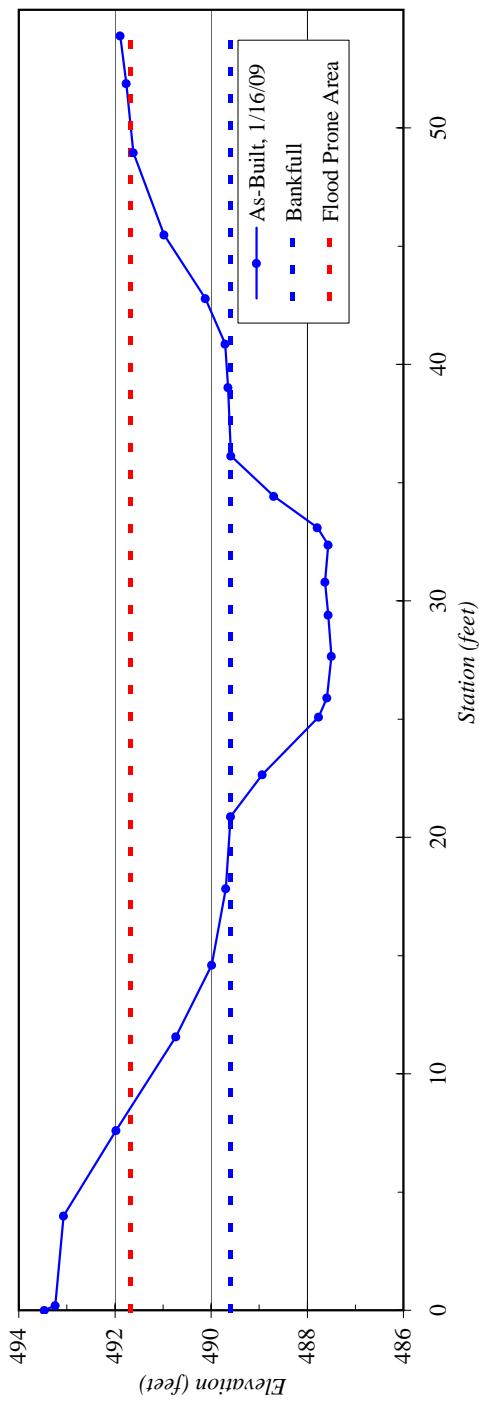
Roanoke River Basin, Cane Creek, XS-4, Riffle, T1-5

River Basin:	Roanoke
Watershed:	Cane Creek
XS ID	XS-4, Riffle, T1-5
Drainage Area (sq mi):	0.70
Date:	1/16/2009
Field Crew:	B. Roberts, M. Stokes

Stream Type C/B4

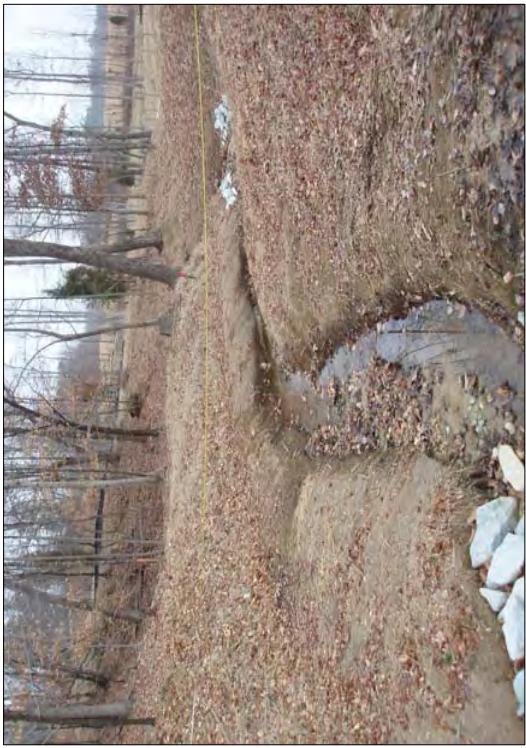
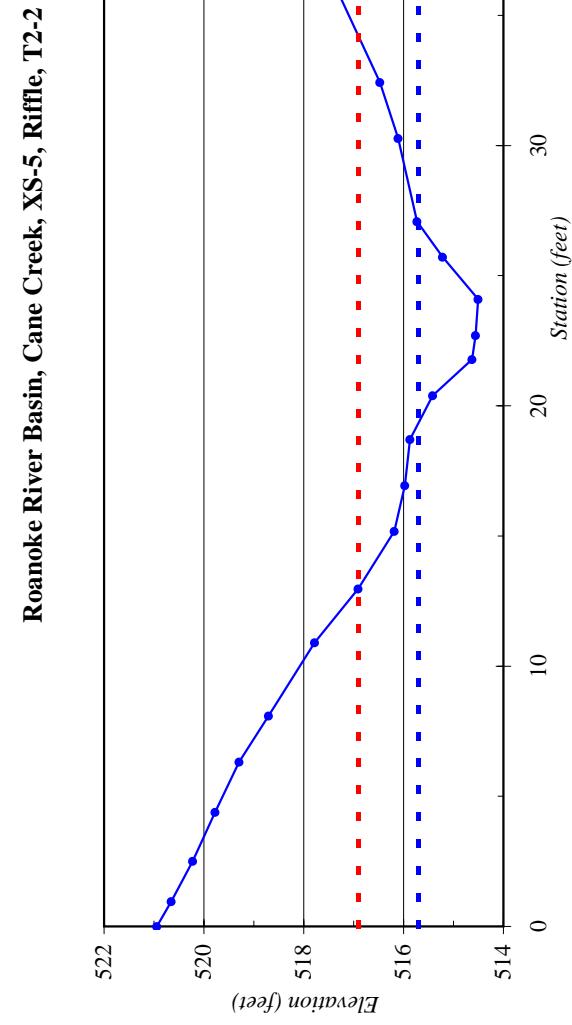
River Basin:	Roanoke
Watershed:	Cane Creek
XS ID	XS-5, Riffle, T2-2
Drainage Area (sq mi):	0.11
Date:	1/19/2009
Field Crew:	B. Roberts, A. Davis

Station	Elevation
0.0	520.94
1.0	520.65
2.5	520.22
4.4	519.78
6.3	519.29
8.1	518.71
10.9	517.78
13.0	516.91
15.2	516.19
16.9	515.97
18.7	515.87
20.4	515.42
21.8	514.63
22.7	514.56
24.1	514.50
25.7	515.22
27.1	515.73
30.3	516.11
32.4	516.48
37.6	517.74
42.6	519.03
45.9	519.91
47.1	520.21

Stream Type C/E4

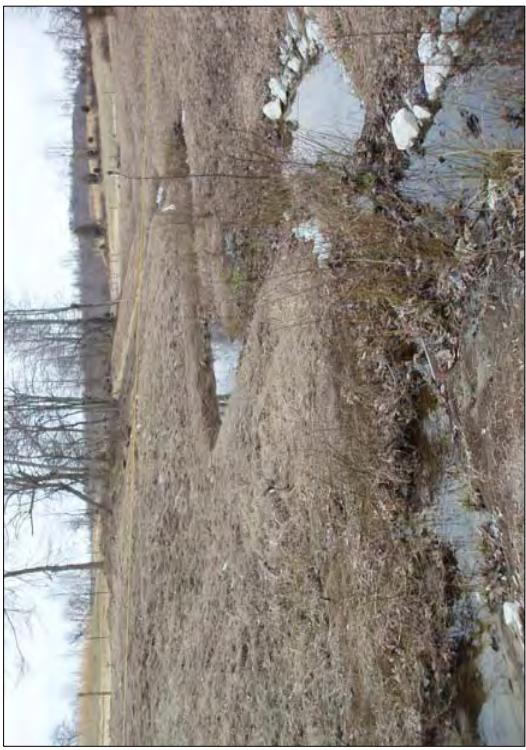
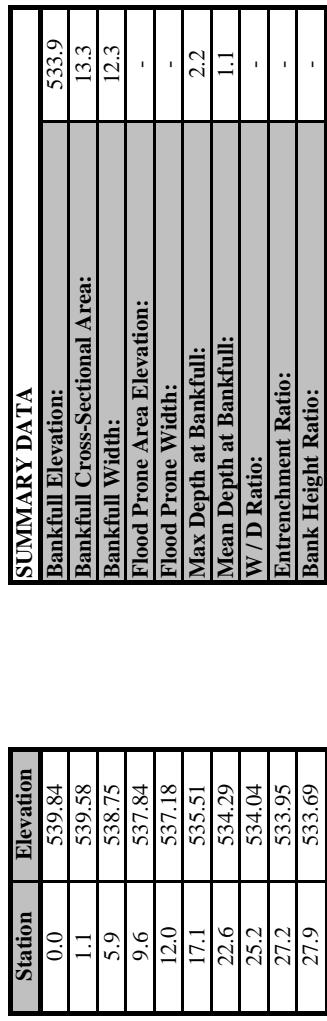
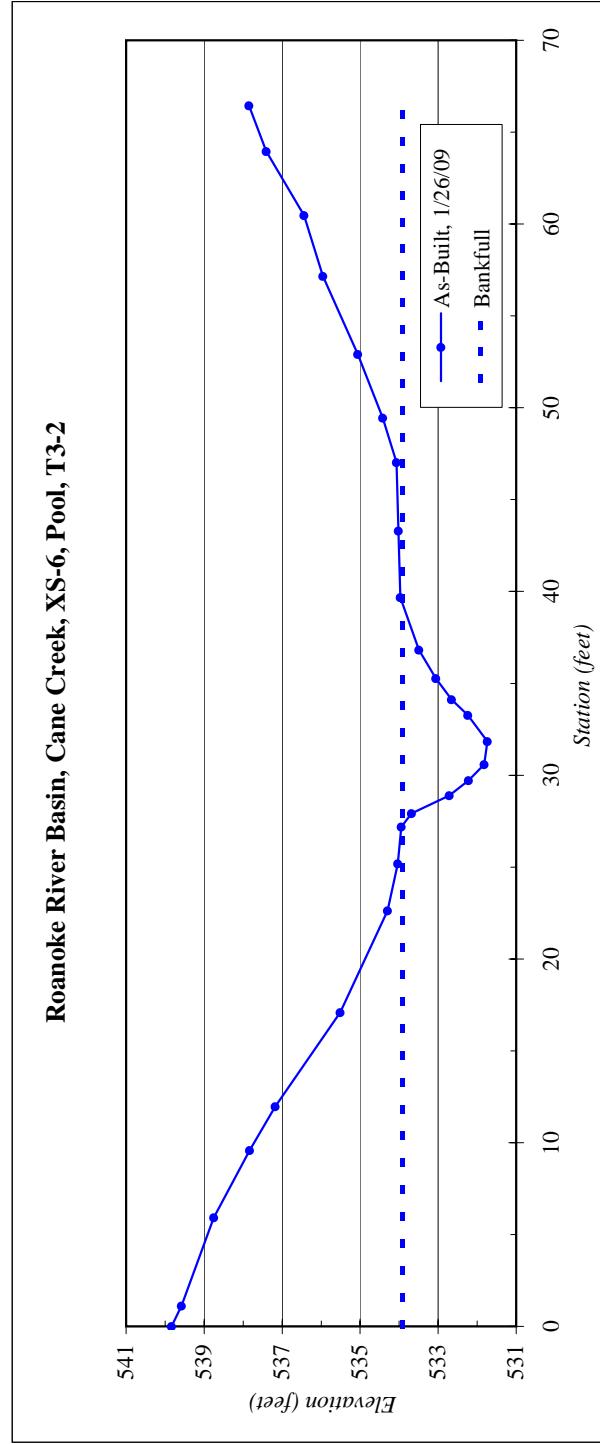
River Basin:	Roanoke
Watershed:	Cane Creek
XS ID	XS-6, Pool, T3-2
Drainage Area (sq mi):	0.08
Date:	1/26/2009
Field Crew:	B. Roberts, M. Stokes

Stream Type B4

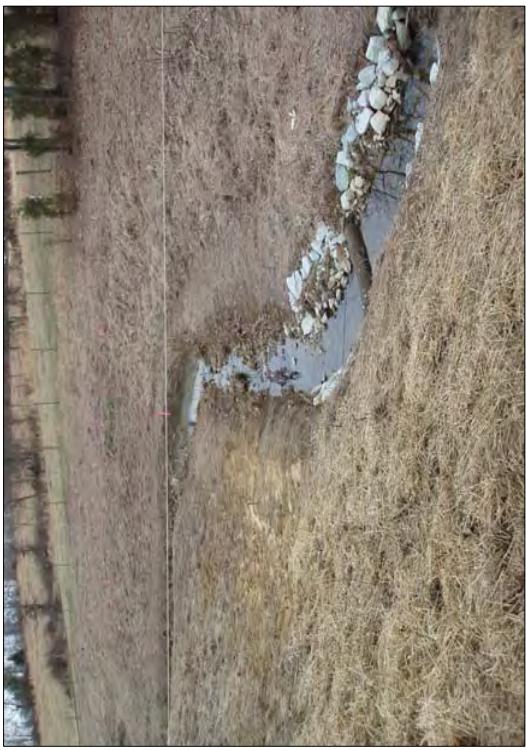
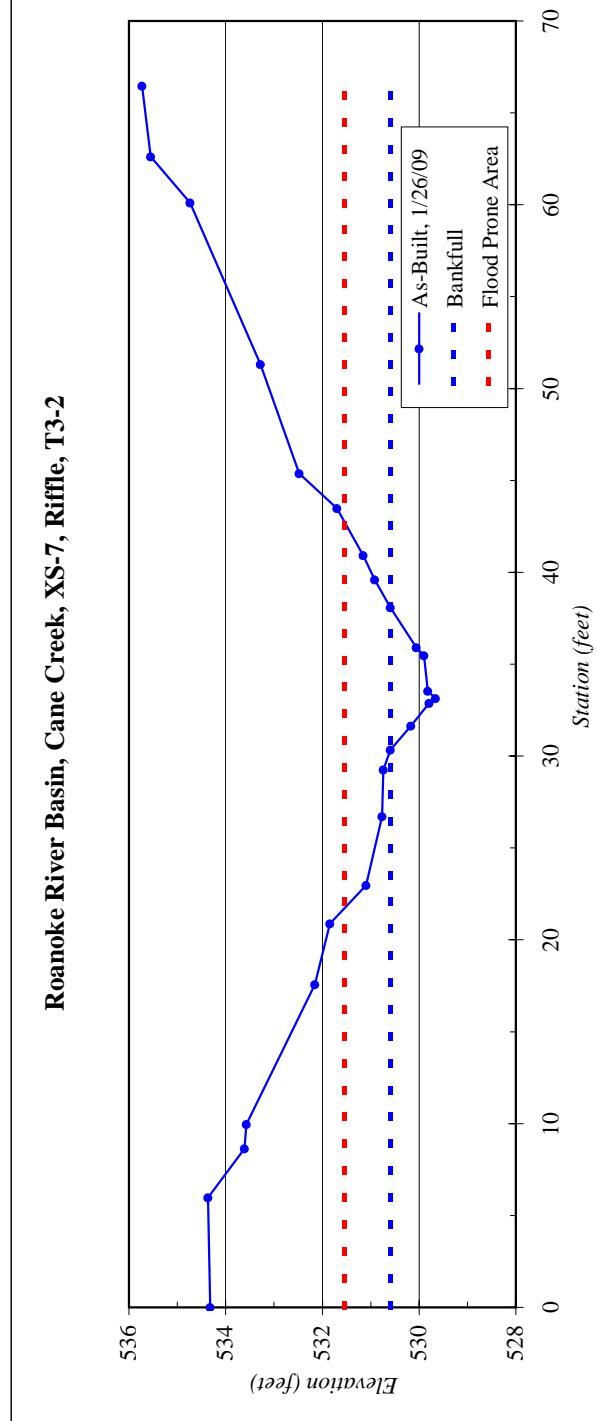
Roanoke River Basin, Cane Creek, XS-7, Riffle, T3-2

River Basin:	Roanoke
Watershed:	Cane Creek
XS ID	XS-7, Riffle, T3-2
Drainage Area (sq mi):	0.08
Date:	1/26/2009
Field Crew:	B. Roberts, M. Stokes

Station	Elevation	Stream Type
0.0	534.32	
6.0	534.36	
8.6	533.61	
10.0	533.57	
17.6	532.16	
20.9	531.85	
23.0	531.10	
26.7	530.76	
29.2	530.74	
30.3	530.60	
31.6	530.17	
32.9	529.80	
33.1	529.66	
33.5	529.82	
35.5	529.90	
35.9	530.06	
38.1	530.59	
39.6	530.92	
40.9	531.16	
43.5	531.70	
45.4	532.48	
51.3	533.28	
60.1	534.74	
62.6	535.55	
66.5	535.73

Stream Type B4

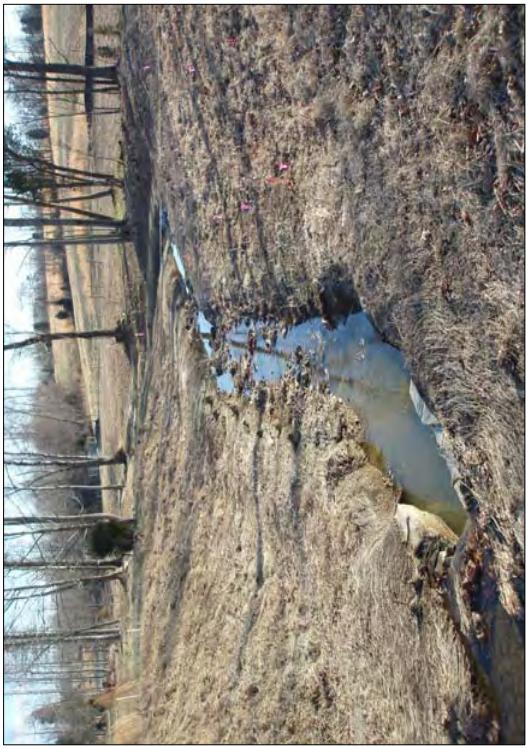
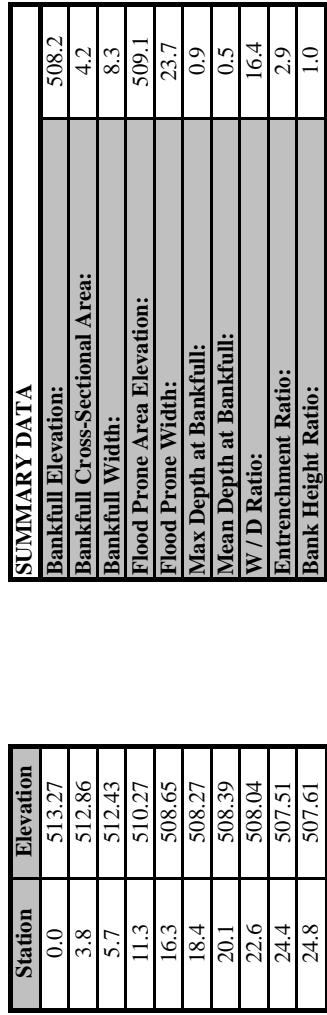
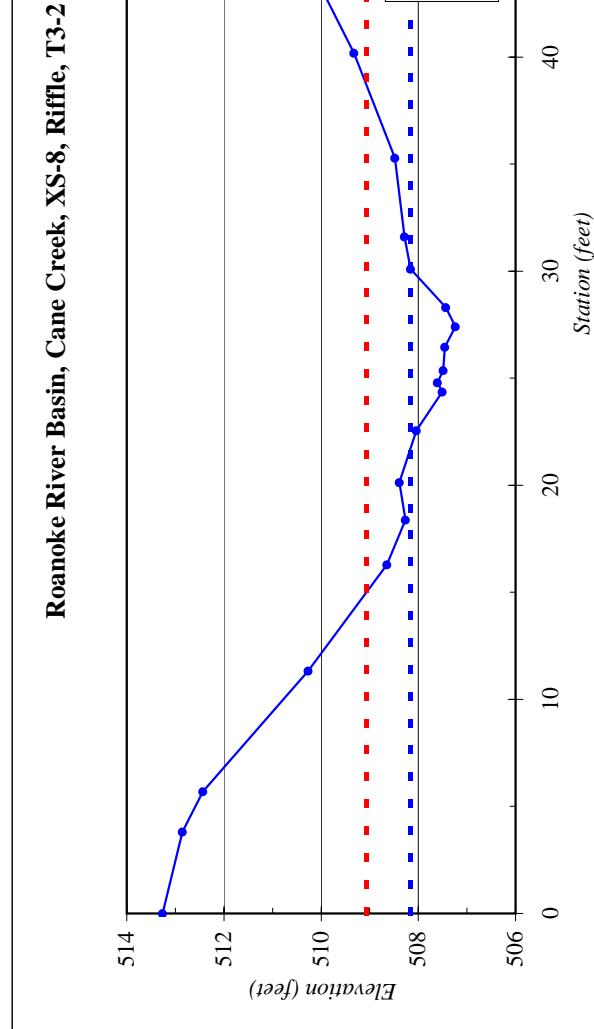
River Basin:	Roanoke
Watershed:	Cane Creek
XS ID	XS-8, Riffle, T3-2
Drainage Area (sq mi):	0.08
Date:	1/23/2009
Field Crew:	B. Roberts, A. Davis

Stream Type B4

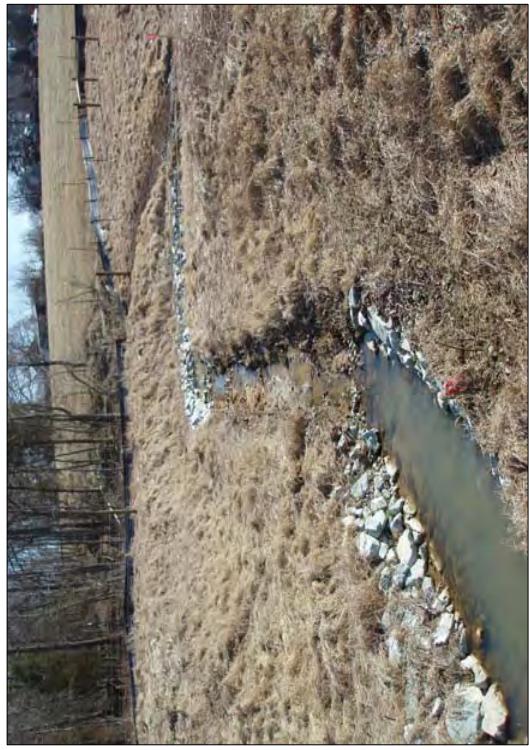
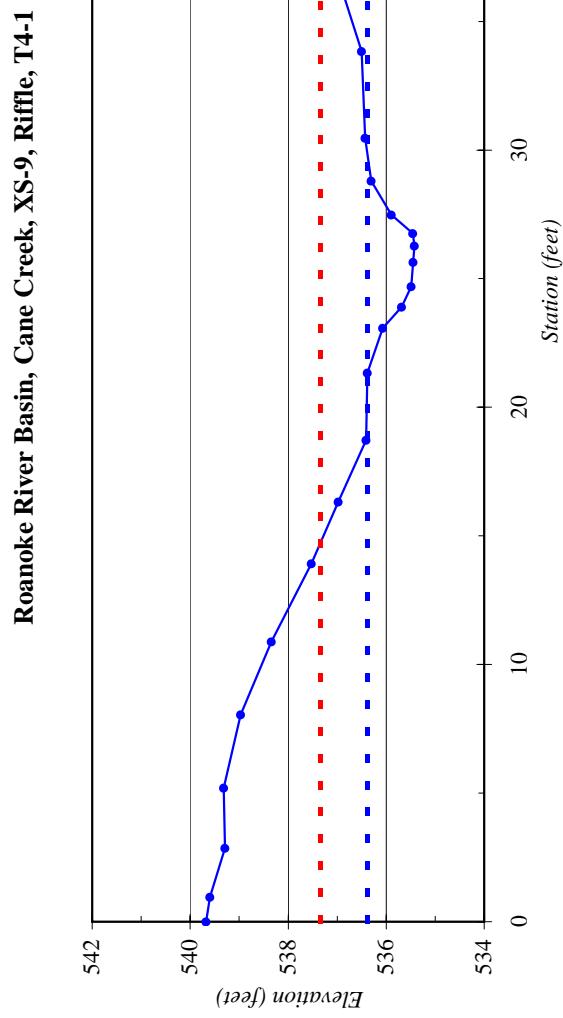
River Basin:	Roanoke
Watershed:	Cane Creek
XS ID	XS-9, Riffle, T4-1
Drainage Area (sq mi):	0.10
Date:	1/23/2009
Field Crew:	B. Roberts, A. Davis

Station	Elevation	SUMMARY DATA
0.0	539.67	Bankfull Elevation:
1.0	539.60	536.4
2.9	539.29	Bankfull Cross-Sectional Area:
5.2	539.32	4.1
8.0	538.97	Bankfull Width:
10.9	538.34	Flood Prone Area Elevation:
13.9	537.53	537.3
16.3	536.98	Flood Prone Width:
18.7	536.41	23.8
21.3	536.38	Max Depth at Bankfull:
23.1	536.07	1.0
23.9	535.69	Mean Depth at Bankfull:
24.7	535.49	0.5
25.6	535.45	W / D Ratio:
26.3	535.43	17.6
26.8	535.46	Entrenchment Ratio:
27.5	535.89	2.8
28.8	536.30	Bank Height Ratio:
30.5	536.43	1.0
33.8	536.50	
36.3	536.91	
38.5	537.32	
41.9	538.01	
45.1	538.29	
46.3	538.49

Stream Type B4

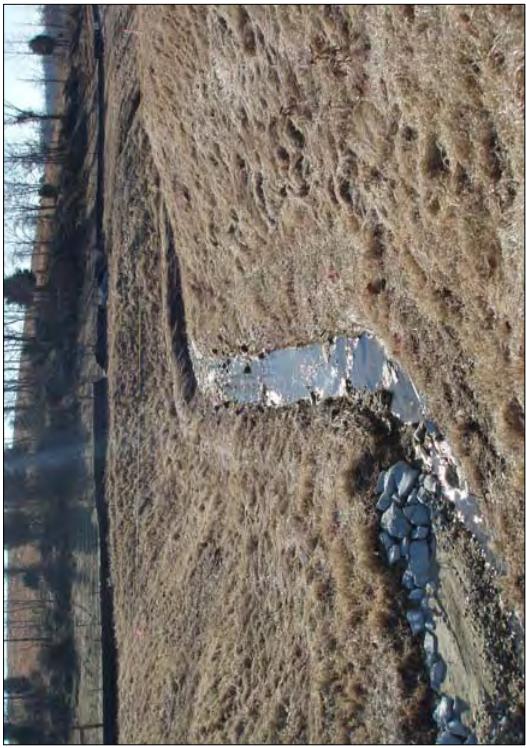
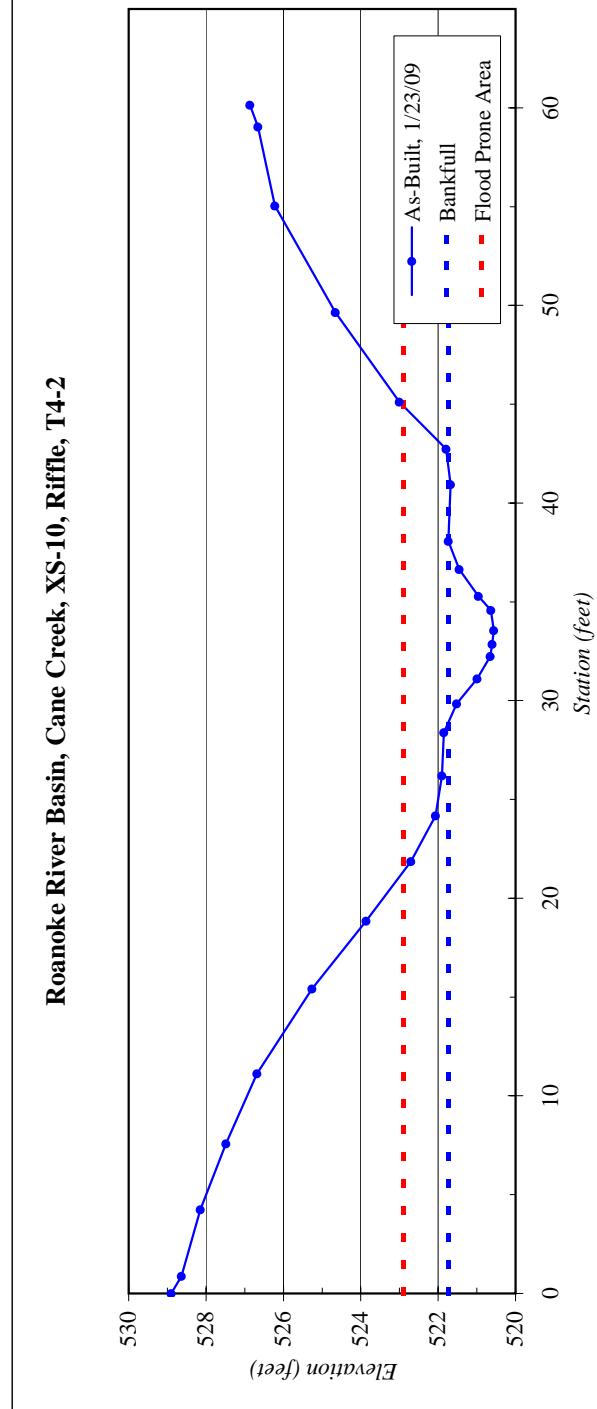
Roanoke River Basin, Cane Creek, XS-10, Riffle, T4-2

River Basin:	Roanoke
Watershed:	Cane Creek
XS ID	XS-10, Riffle, T4-2
Drainage Area (sq mi):	0.10
Date:	1/23/2009
Field Crew:	B. Roberts, A. Davis

Station	Elevation	SUMMARY DATA
0.0	528.90	Bankfull Elevation: 521.7
0.9	528.64	Bankfull Cross-Sectional Area: 5.9
4.3	528.15	Bankfull Width: 9.1
7.6	527.49	Flood Prone Area Elevation: 522.9
11.1	526.68	Flood Prone Width: 23.6
15.4	525.26	Max Depth at Bankfull: 1.2
18.8	523.86	Mean Depth at Bankfull: 0.6
21.9	522.70	W / D Ratio: 14.0
24.2	522.07	Entrenchment Ratio: 2.6
26.2	521.91	Bank Height Ratio: 1.0
28.4	521.85	
29.8	521.53	
31.1	520.99	
32.2	520.65	
32.9	520.61	
33.6	520.56	
34.6	520.63	
35.3	520.96	
36.7	521.45	
38.1	521.74	
40.9	521.68	
42.7	521.80	
45.1	523.00	
49.7	524.65	
55.0	526.22	
59.0	526.66	
60.1	526.87

Stream Type B4

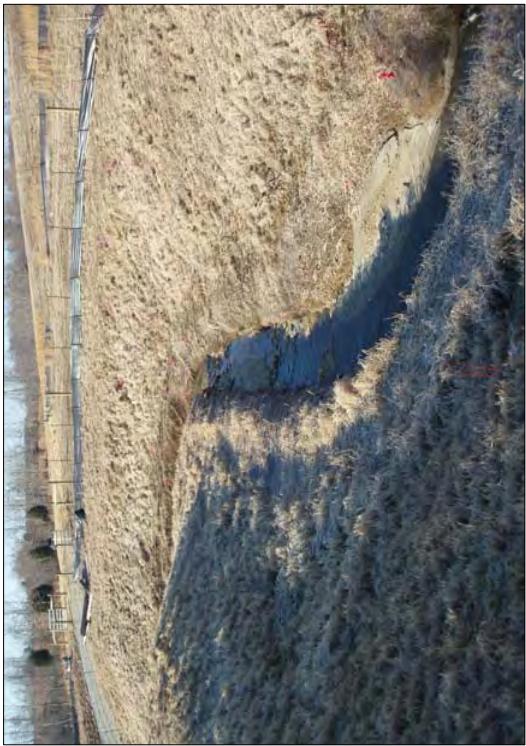
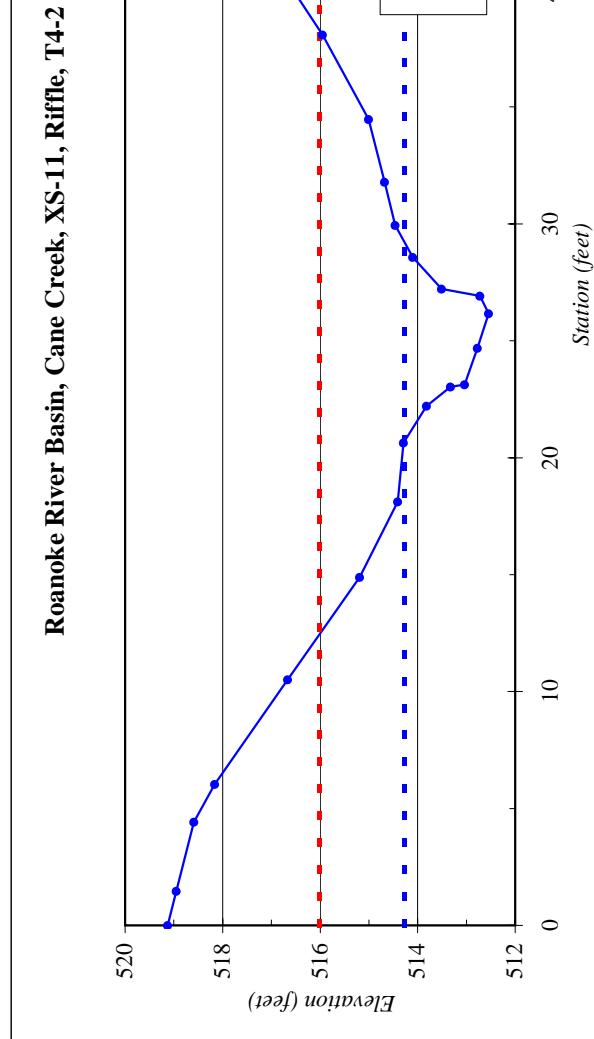
River Basin:	Roanoke
Watershed:	Cane Creek
XS ID	XS-11, Riffle, T4-2
Drainage Area (sq mi):	0.10
Date:	1/22/2009
Field Crew:	B. Roberts, A. Davis

Station	Elevation	SUMMARY DATA
0.0	519.12	Bankfull Elevation:
1.5	518.95	514.3
4.4	518.59	Bankfull Cross-Sectional Area:
6.0	518.16	7.9
10.5	516.66	Bankfull Width:
14.9	515.19	Flood Prone Area Elevation:
18.1	514.41	516.0
20.6	514.29	Flood Prone Width:
22.2	513.82	26
23.0	513.33	Max Depth at Bankfull:
23.1	513.04	1.7
24.7	512.78	Mean Depth at Bankfull:
26.2	512.55	0.9
26.9	512.72	W / D Ratio:
27.2	513.51	9.4
28.6	514.10	Entrenchment Ratio:
29.9	514.46	3.0
31.8	514.68	Bank Height Ratio:
34.5	515.01	1.0
38.1	515.95	
44.6	518.02	
49.1	518.93	
52.9	519.68	
53.5	519.83

Stream Type B4

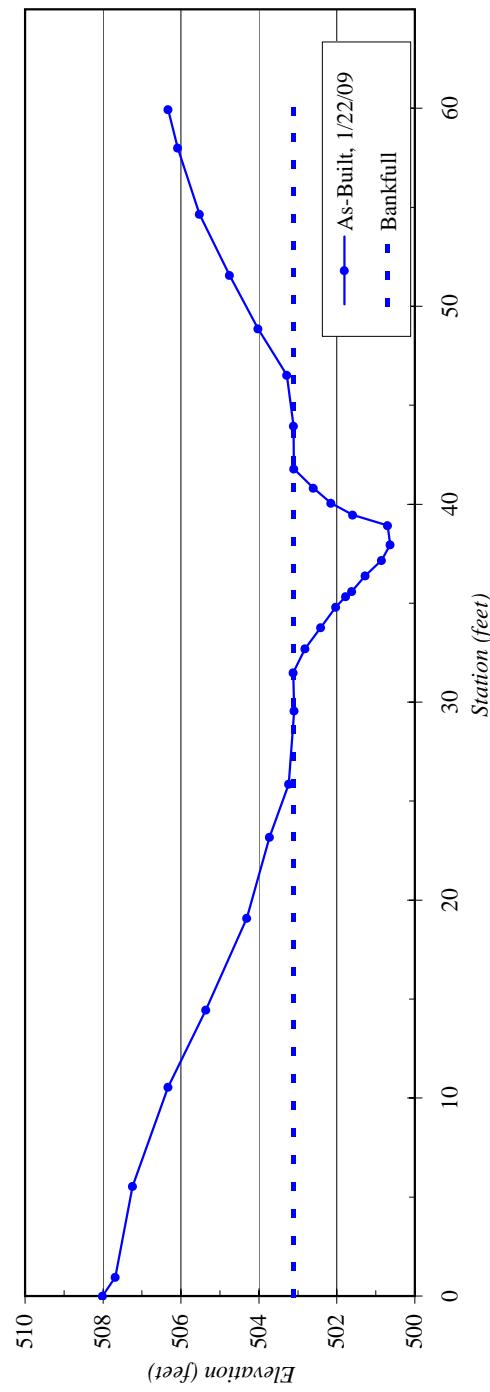
Roanoke River Basin, Cane Creek, XS-12, Pool, T4-2

River Basin:	Roanoke
Watershed:	Cane Creek
XS ID	XS-12, Pool, T4-2
Drainage Area (sq mi):	0.10
Date:	1/22/2009
Field Crew:	B. Roberts, A. Davis

Stream Type B4

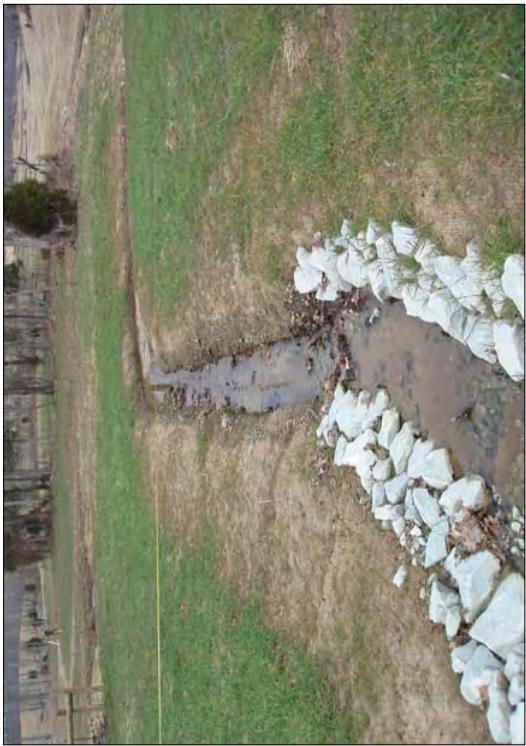
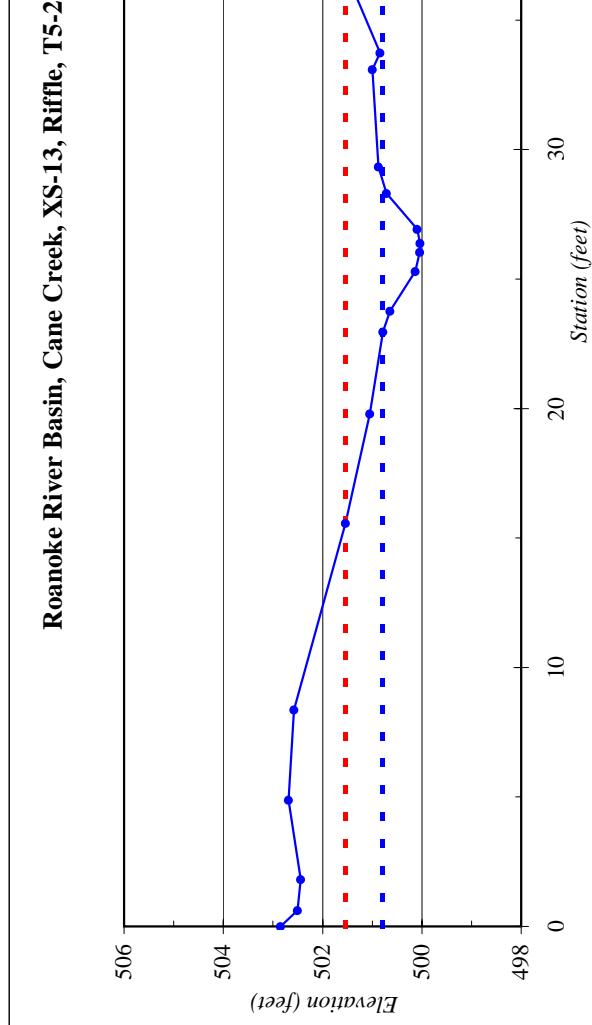
River Basin:	Roanoke
Watershed:	Cane Creek
XS ID	XS-13, Riffle, T5-2
Drainage Area (sq mi):	0.02
Date:	1/19/2009
Field Crew:	B. Roberts, A. Davis

SUMMARY DATA	
Bankfull Elevation:	500.8
Bankfull Cross-Sectional Area:	2.4
Bankfull Width:	5.9
Flood Prone Area Elevation:	501.5
Flood Prone Width:	21.0
Max Depth at Bankfull:	0.8
Mean Depth at Bankfull:	0.4
W / D Ratio:	14.5
Entrenchment Ratio:	3.6
Bank Height Ratio:	1.0
26.0	500.04
26.4	500.04
26.9	500.09
28.3	500.71
29.3	500.87
33.1	501.00
33.7	501.84
36.3	501.42
39.1	501.72
44.6	501.94
48.9	501.80
49.1	501.91

Stream Type B4

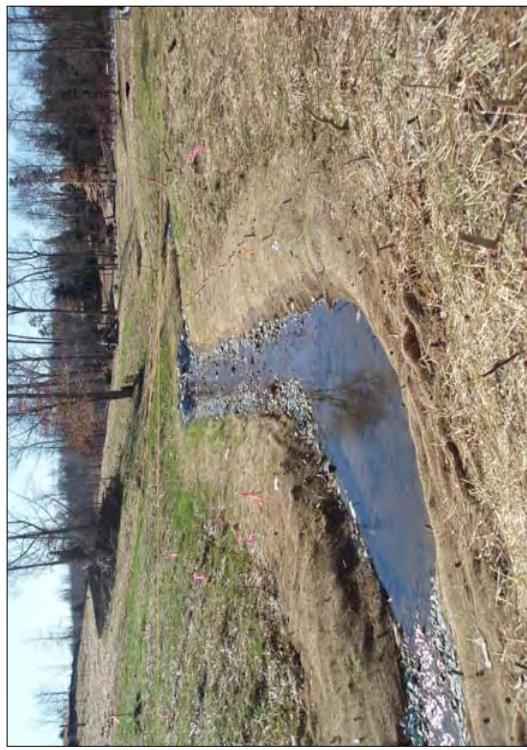
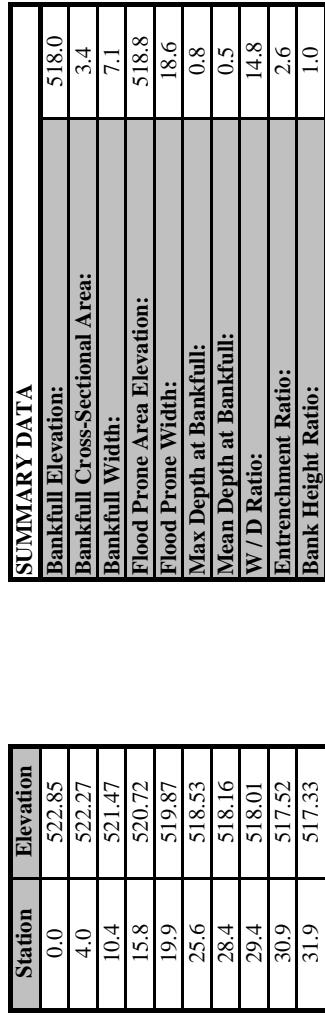
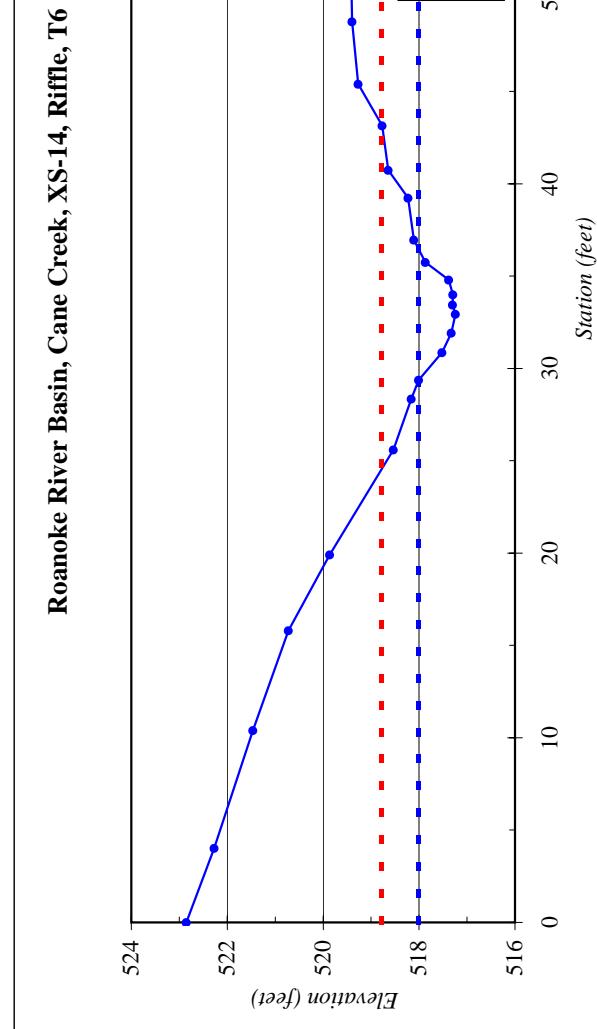
River Basin:	Roanoke
Watershed:	Cane Creek
XS ID	XS-14, Riffle, T6
Drainage Area (sq mi):	0.07
Date:	1/16/2009
Field Crew:	B. Roberts, M. Stokes

Stream Type B4

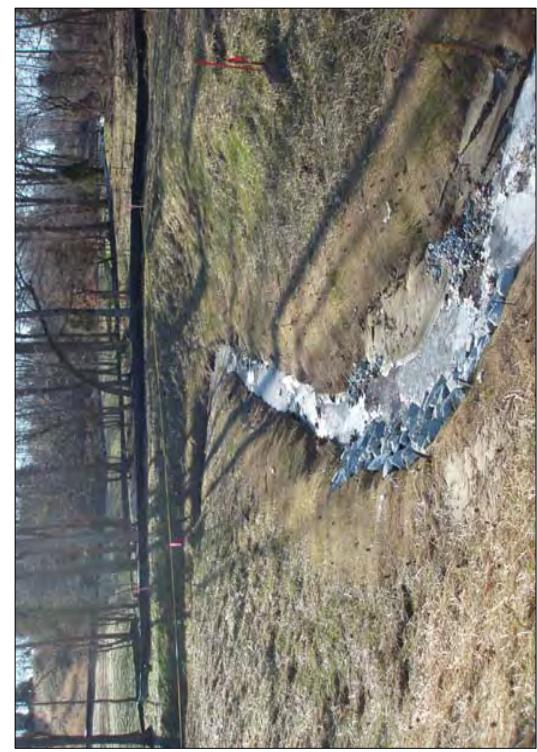
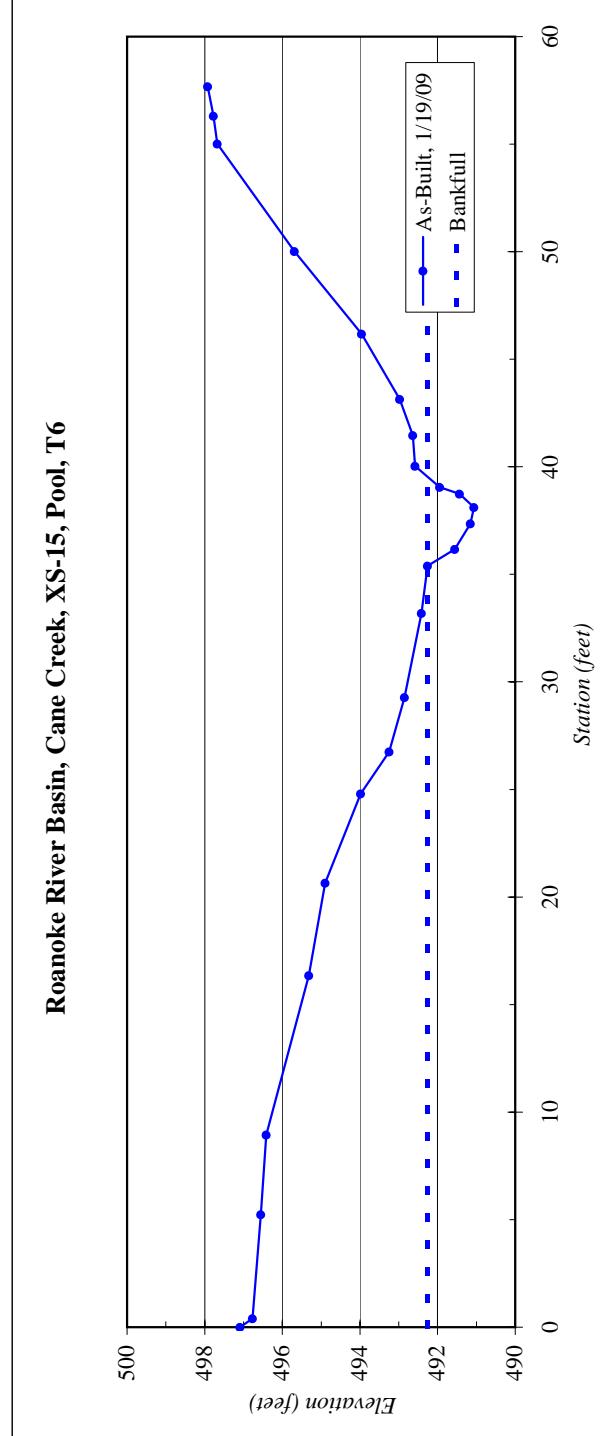
Roanoke River Basin, Cane Creek, XS-15, Pool, T6

River Basin:	Roanoke
Watershed:	Cane Creek
XS ID	XS-15, Pool, T6
Drainage Area (sq mi):	0.07
Date:	1/16/2009
Field Crew:	B. Roberts, M. Stokes

Station	Elevation	SUMMARY DATA
0.0	497.09	Bankfull Elevation:
0.4	496.77	Bankfull Cross-Sectional Area:
5.2	496.56	Bankfull Width:
8.9	496.41	Flood Prone Area Elevation:
16.4	495.32	Flood Prone Width:
20.7	494.90	Max Depth at Bankfull:
24.8	493.98	Mean Depth at Bankfull:
26.7	493.25	W / D Ratio:
29.3	492.85	Entrenchment Ratio:
33.2	492.41	Bank Height Ratio:
35.4	492.26	-
36.2	491.56	-
37.4	491.15	-
38.1	491.06	-
38.7	491.44	-
39.1	491.95	-
40.0	492.58	-
41.5	492.64	-
43.1	492.98	-
46.2	493.96	-
50.0	495.68	-
55.0	497.67	-
56.3	497.78	-
57.7	497.93	-

Stream Type B4

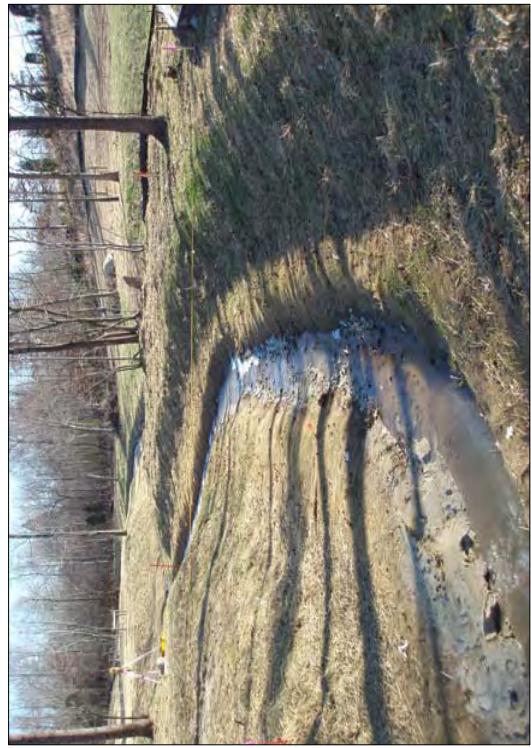
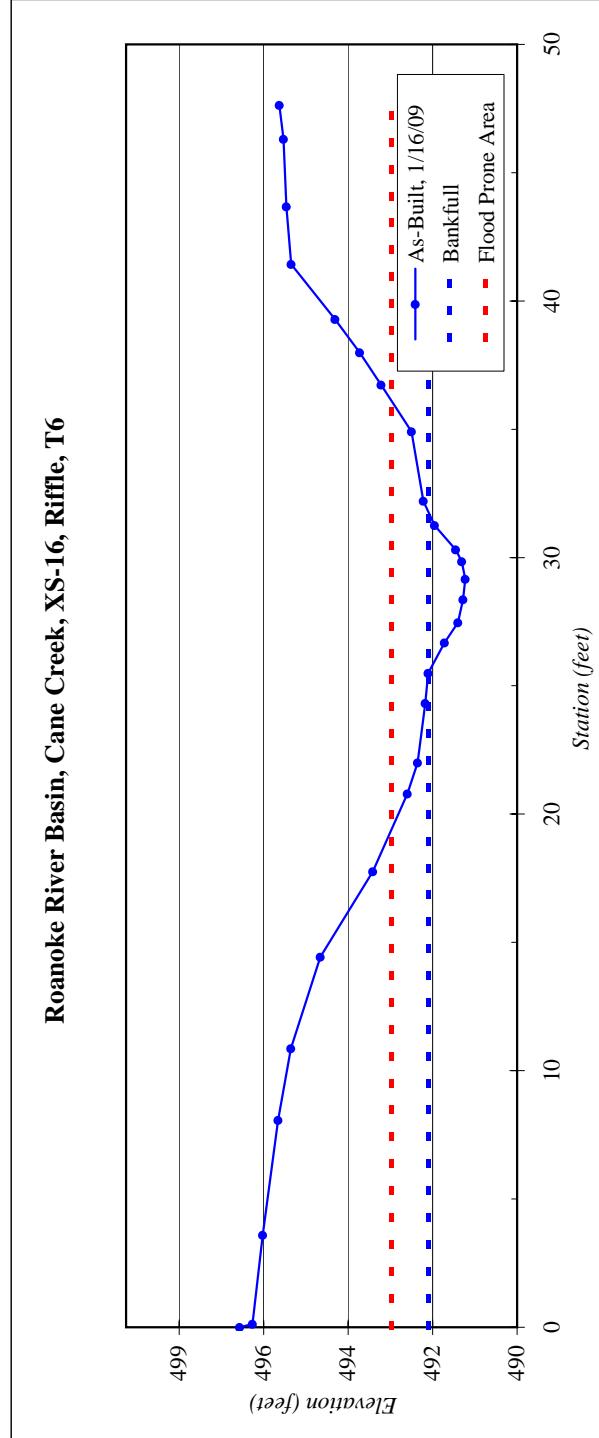
Roanoke River Basin, Cane Creek, XS-16, Riffle, T6

River Basin:	Roanoke
Watershed:	Cane Creek
XS ID	XS-16, Riffle, T6
Drainage Area (sq mi):	0.07
Date:	1/16/2009
Field Crew:	B. Roberts, M. Stokes

Station	Elevation	Stream Type
0.0	497.10	
0.1	496.77	
3.6	496.50	
8.1	496.11	
10.9	495.79	
14.4	495.03	
17.8	493.69	
20.8	492.80	
22.0	492.55	
24.3	492.35	
25.5	492.27	
26.7	491.86	B4
27.5	491.52	
28.4	491.38	
29.2	491.33	
29.8	491.42	
30.3	491.57	
31.3	492.11	
32.2	492.39	
34.9	492.70	
36.7	493.48	
38.0	494.03	
39.3	494.66	
41.4	495.78	
43.7	495.90	
46.3	495.98	
47.6	496.08

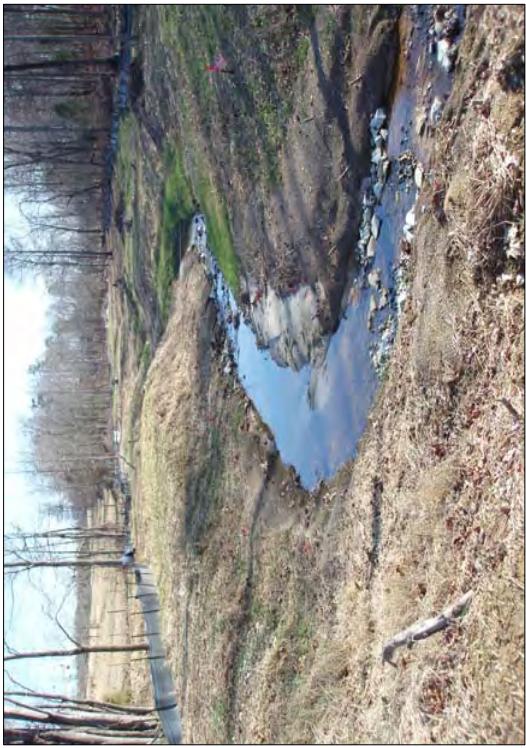
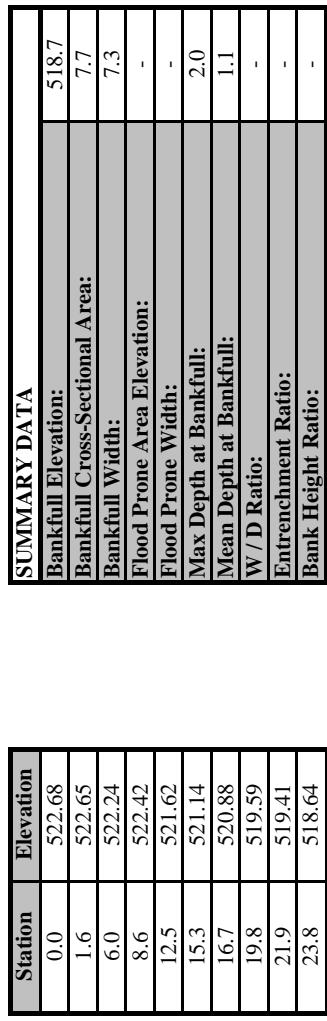
River Basin:	Roanoke
Watershed:	Cane Creek
XS ID	XS-17, Pool, T7-3
Drainage Area (sq mi):	0.18
Date:	1/12/2009
Field Crew:	B. Roberts, M. Stokes

Stream Type B4c

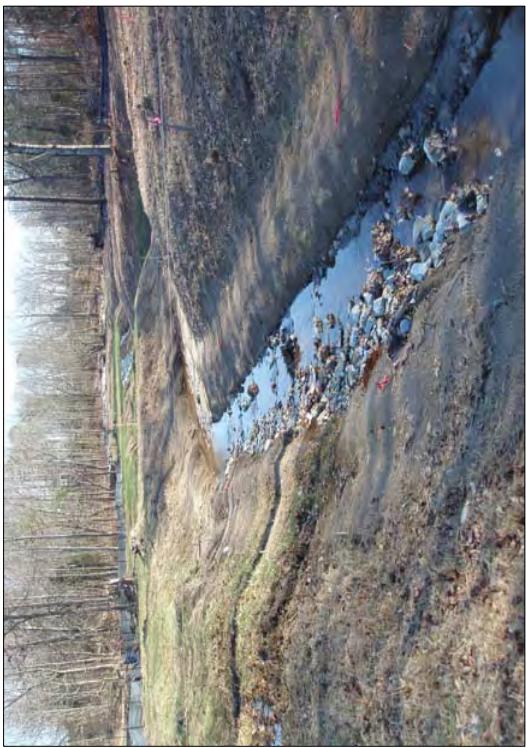
River Basin:	Roanoke
Watershed:	Cane Creek
XS ID	XS-18, Riffle, T7-3
Drainage Area (sq mi):	0.18
Date:	1/12/2009
Field Crew:	B. Roberts, M. Stokes

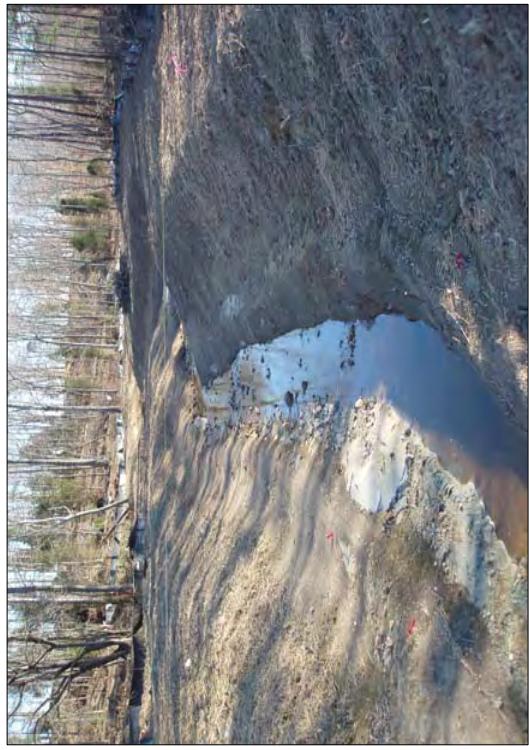
River Basin:	Roanoke
Watershed:	Cane Creek
XS ID	XS-19, Riffle, T7-3
Drainage Area (sq mi):	0.18
Date:	1/12/2009
Field Crew:	B. Roberts, M. Stokes

Station	Elevation
0.0	512.51
2.0	512.05
6.5	511.86
8.6	512.27
14.0	512.08
18.8	511.65
22.1	509.95
25.3	508.05
26.0	507.93
27.5	507.78
29.1	507.04
29.8	506.88
30.4	506.85
31.1	506.89
32.0	506.83
32.7	506.91
34.2	506.87
34.7	506.90
35.7	507.40
36.9	507.95
38.2	508.10
41.0	509.42
43.2	510.51
46.2	512.26
47.7	512.55
54.3	512.57
59.8	512.40
60.9	512.59

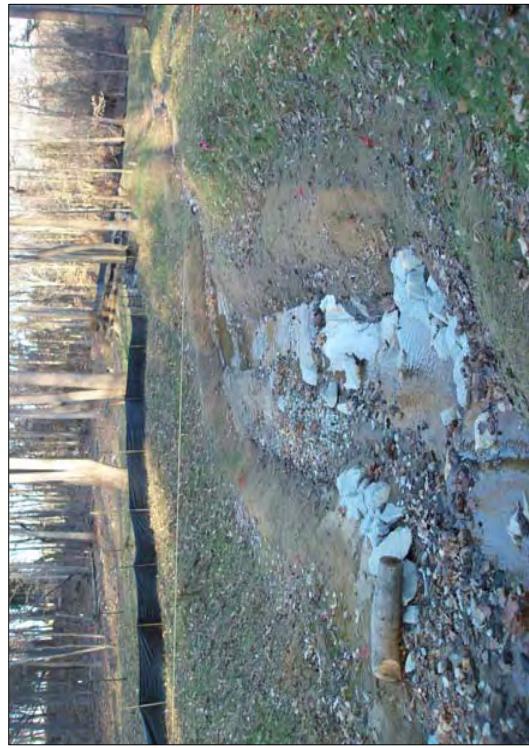
River Basin:	Roanoke
Watershed:	Cane Creek
XS ID	XS-20, Riffle, T7-5
Drainage Area (sq mi):	0.26
Date:	1/12/2009
Field Crew:	B. Roberts, M. Stokes
