Cane Creek Stream Restoration Site

Mitigation Plan

Contract # D06002

May 2009

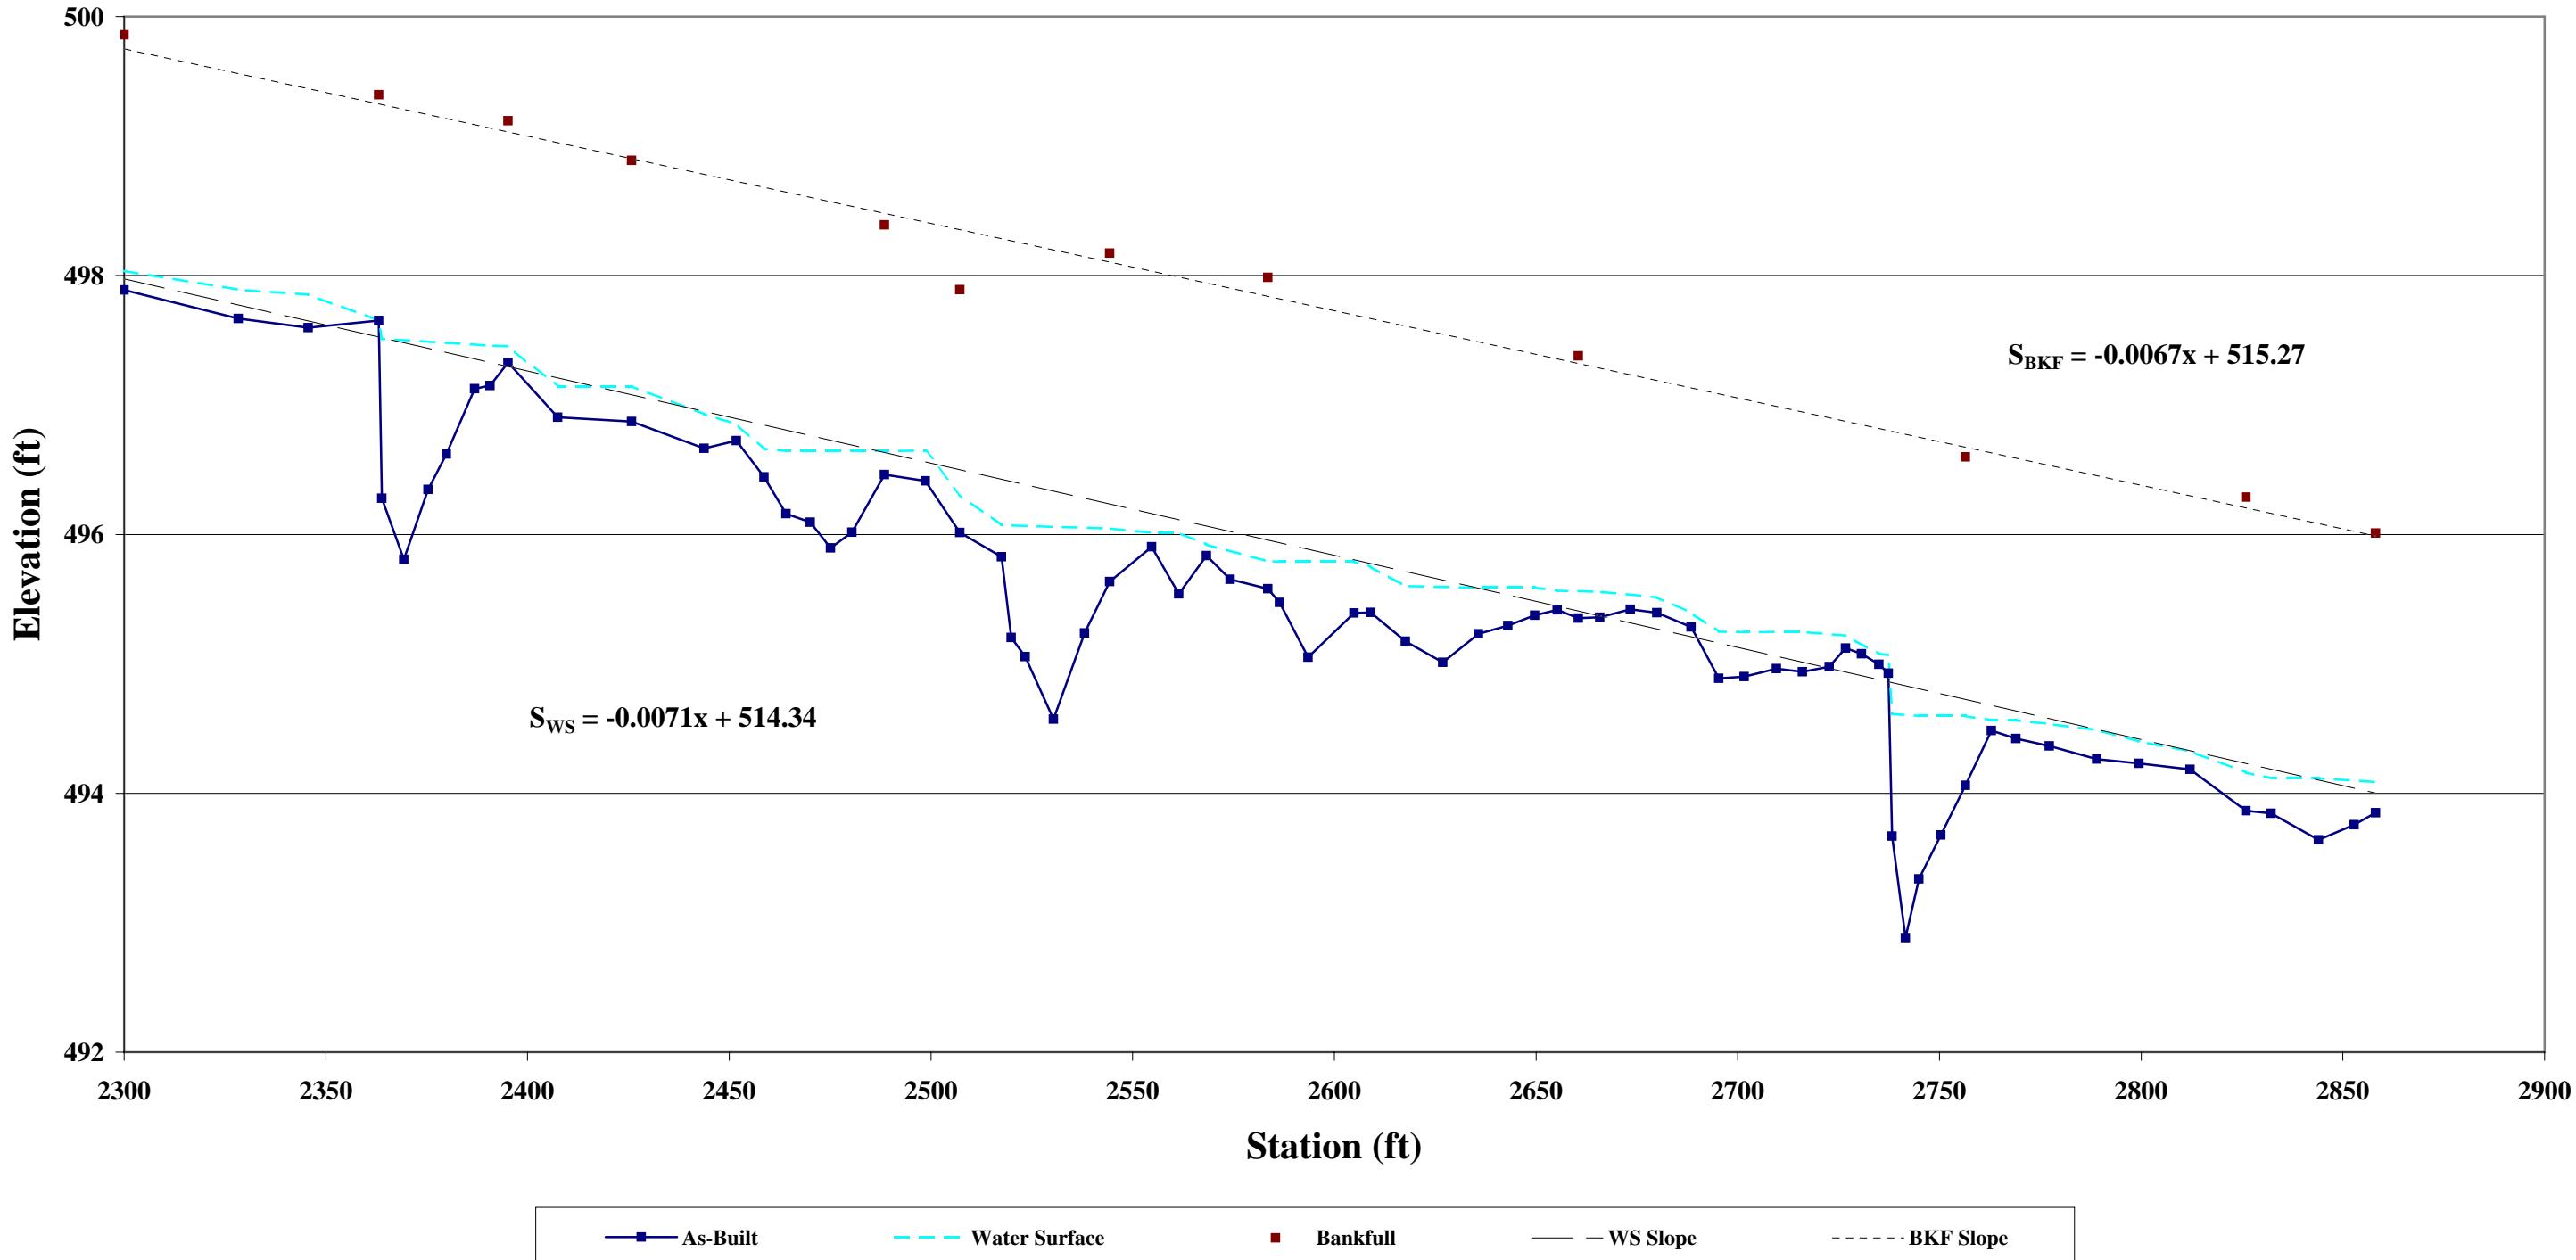
Cane Creek Tributary Site
Longitudinal Profile
Tributary 1, As-Built
Stations 23+00 - 28+58

Cross-section measurements should show little or no change from the as-built cross-sections. Annual measurements of the longitudinal profile should indicate a stable bedform with little change from the as-built survey. Sediment transport should remain relatively unchanged with respect to aggradation and deposition of sediments. Any observed variation in the annual monitoring of the cross-sections and longitudinal profiles will be evaluated to determine whether they are minor adjustments associated with normal sediment transport and increasing stability or whether they indicate movement toward an unstable condition. If any changes occur, they will be discussed within the yearly monitoring reports.

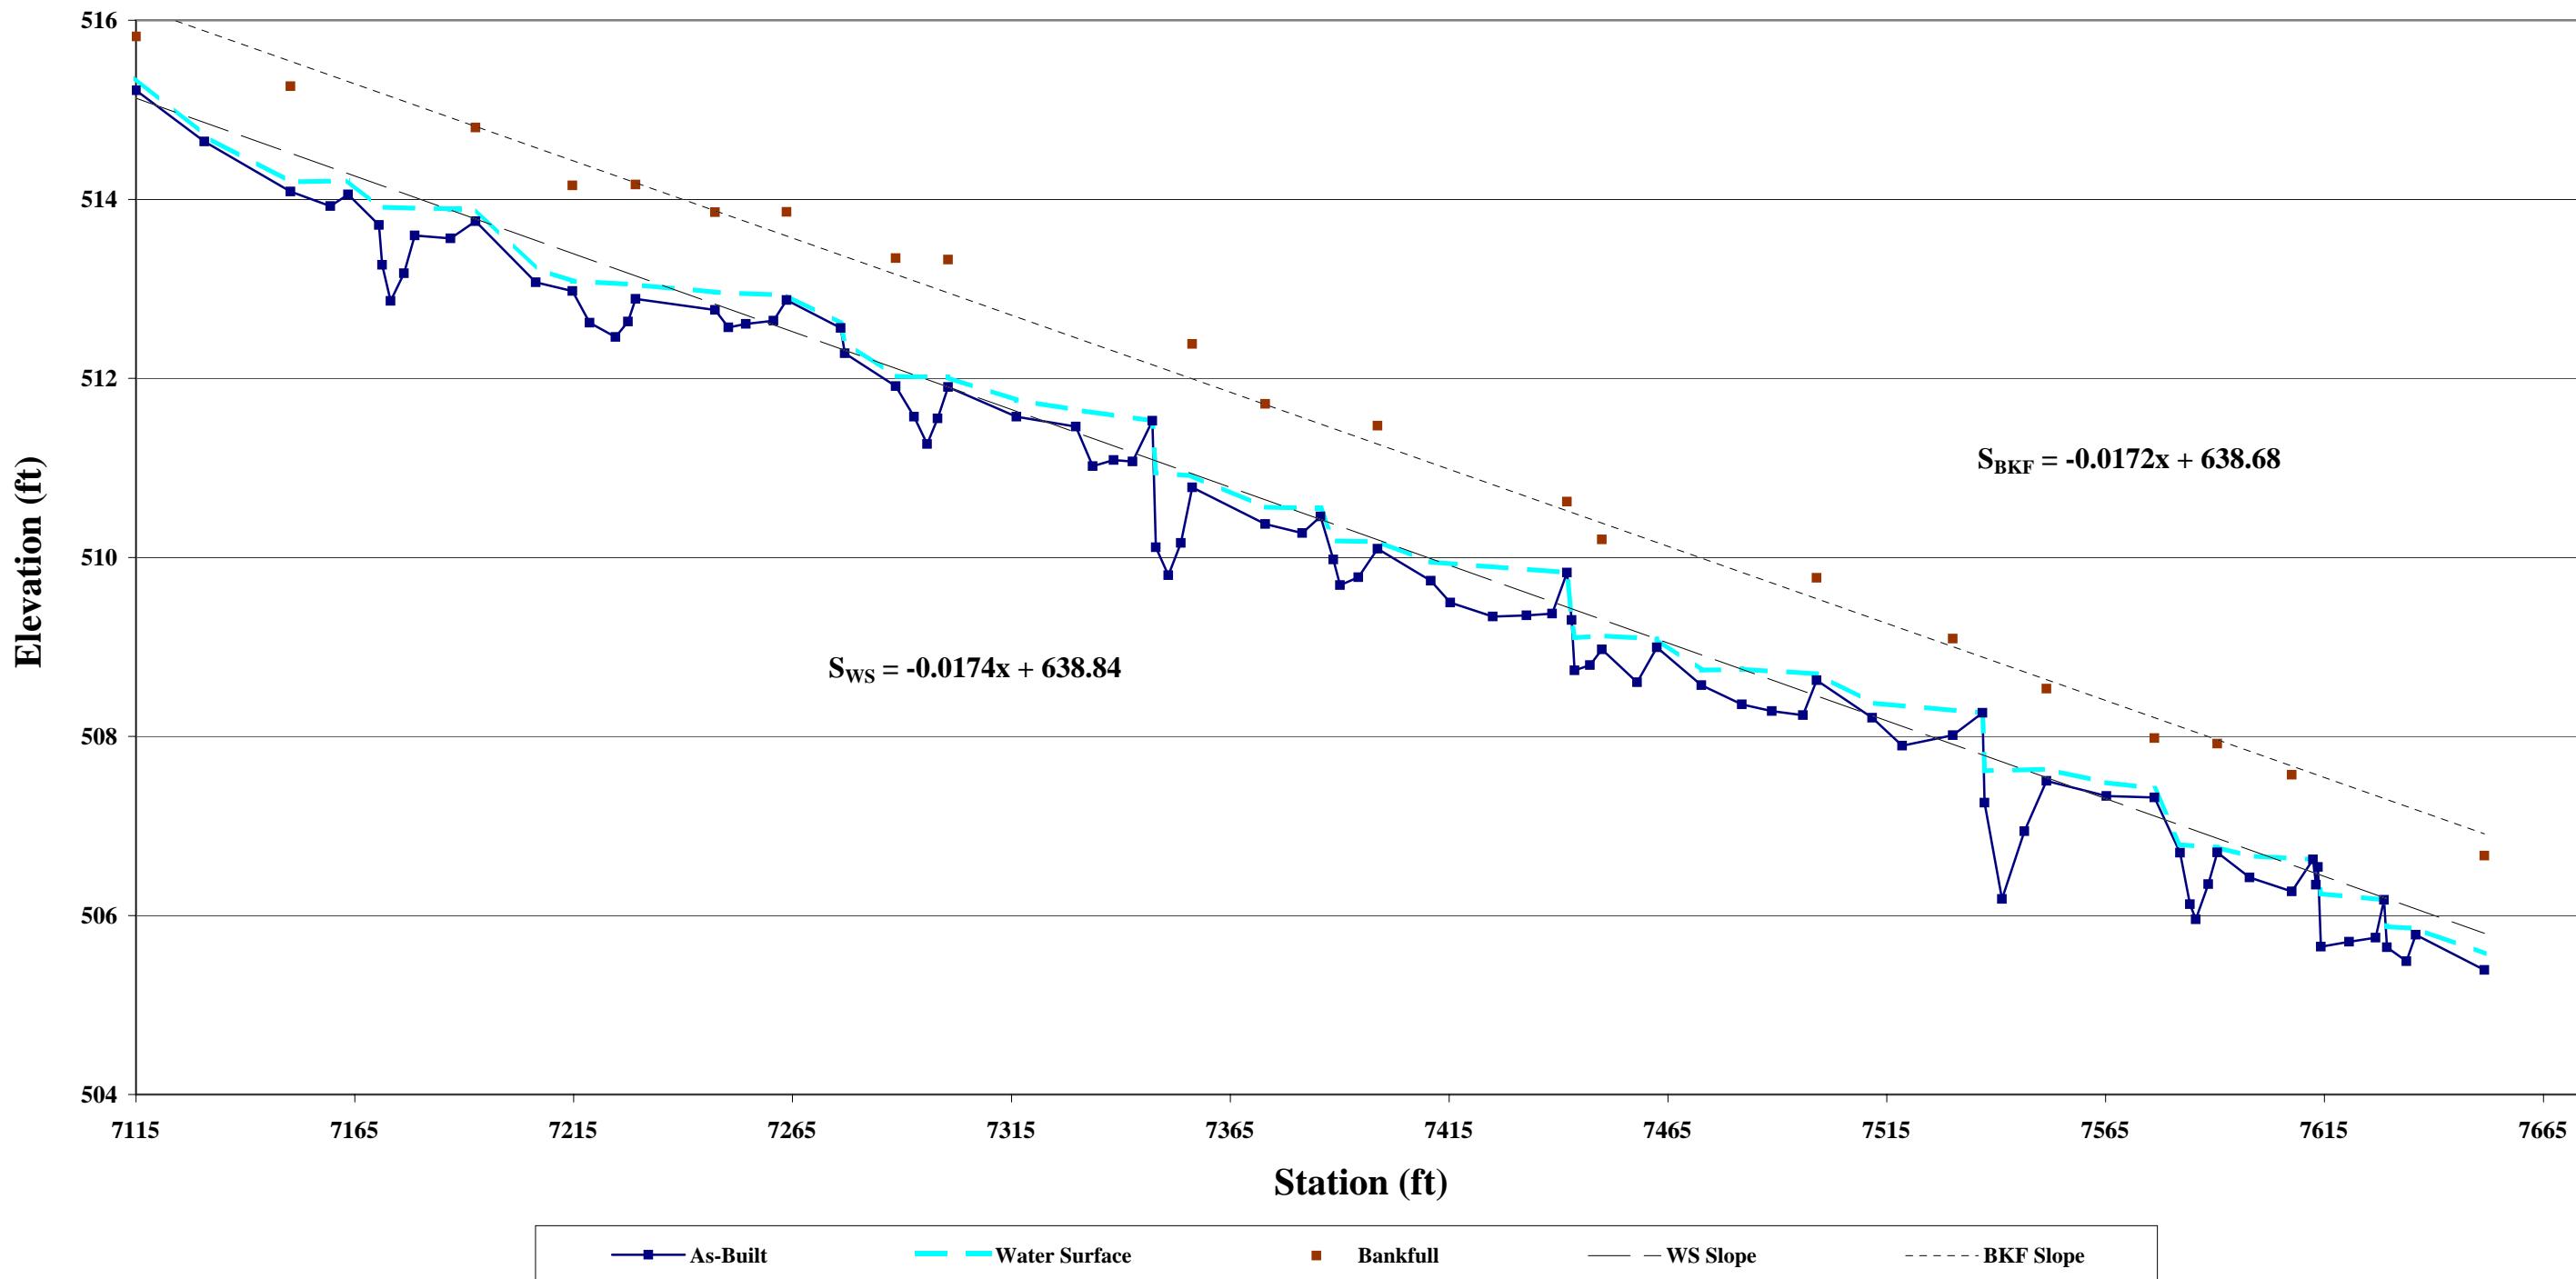
Cane Creek Tributary Site
Longitudinal Profile
Tributary 3, As-Built
Stations 71+15 - 76+51

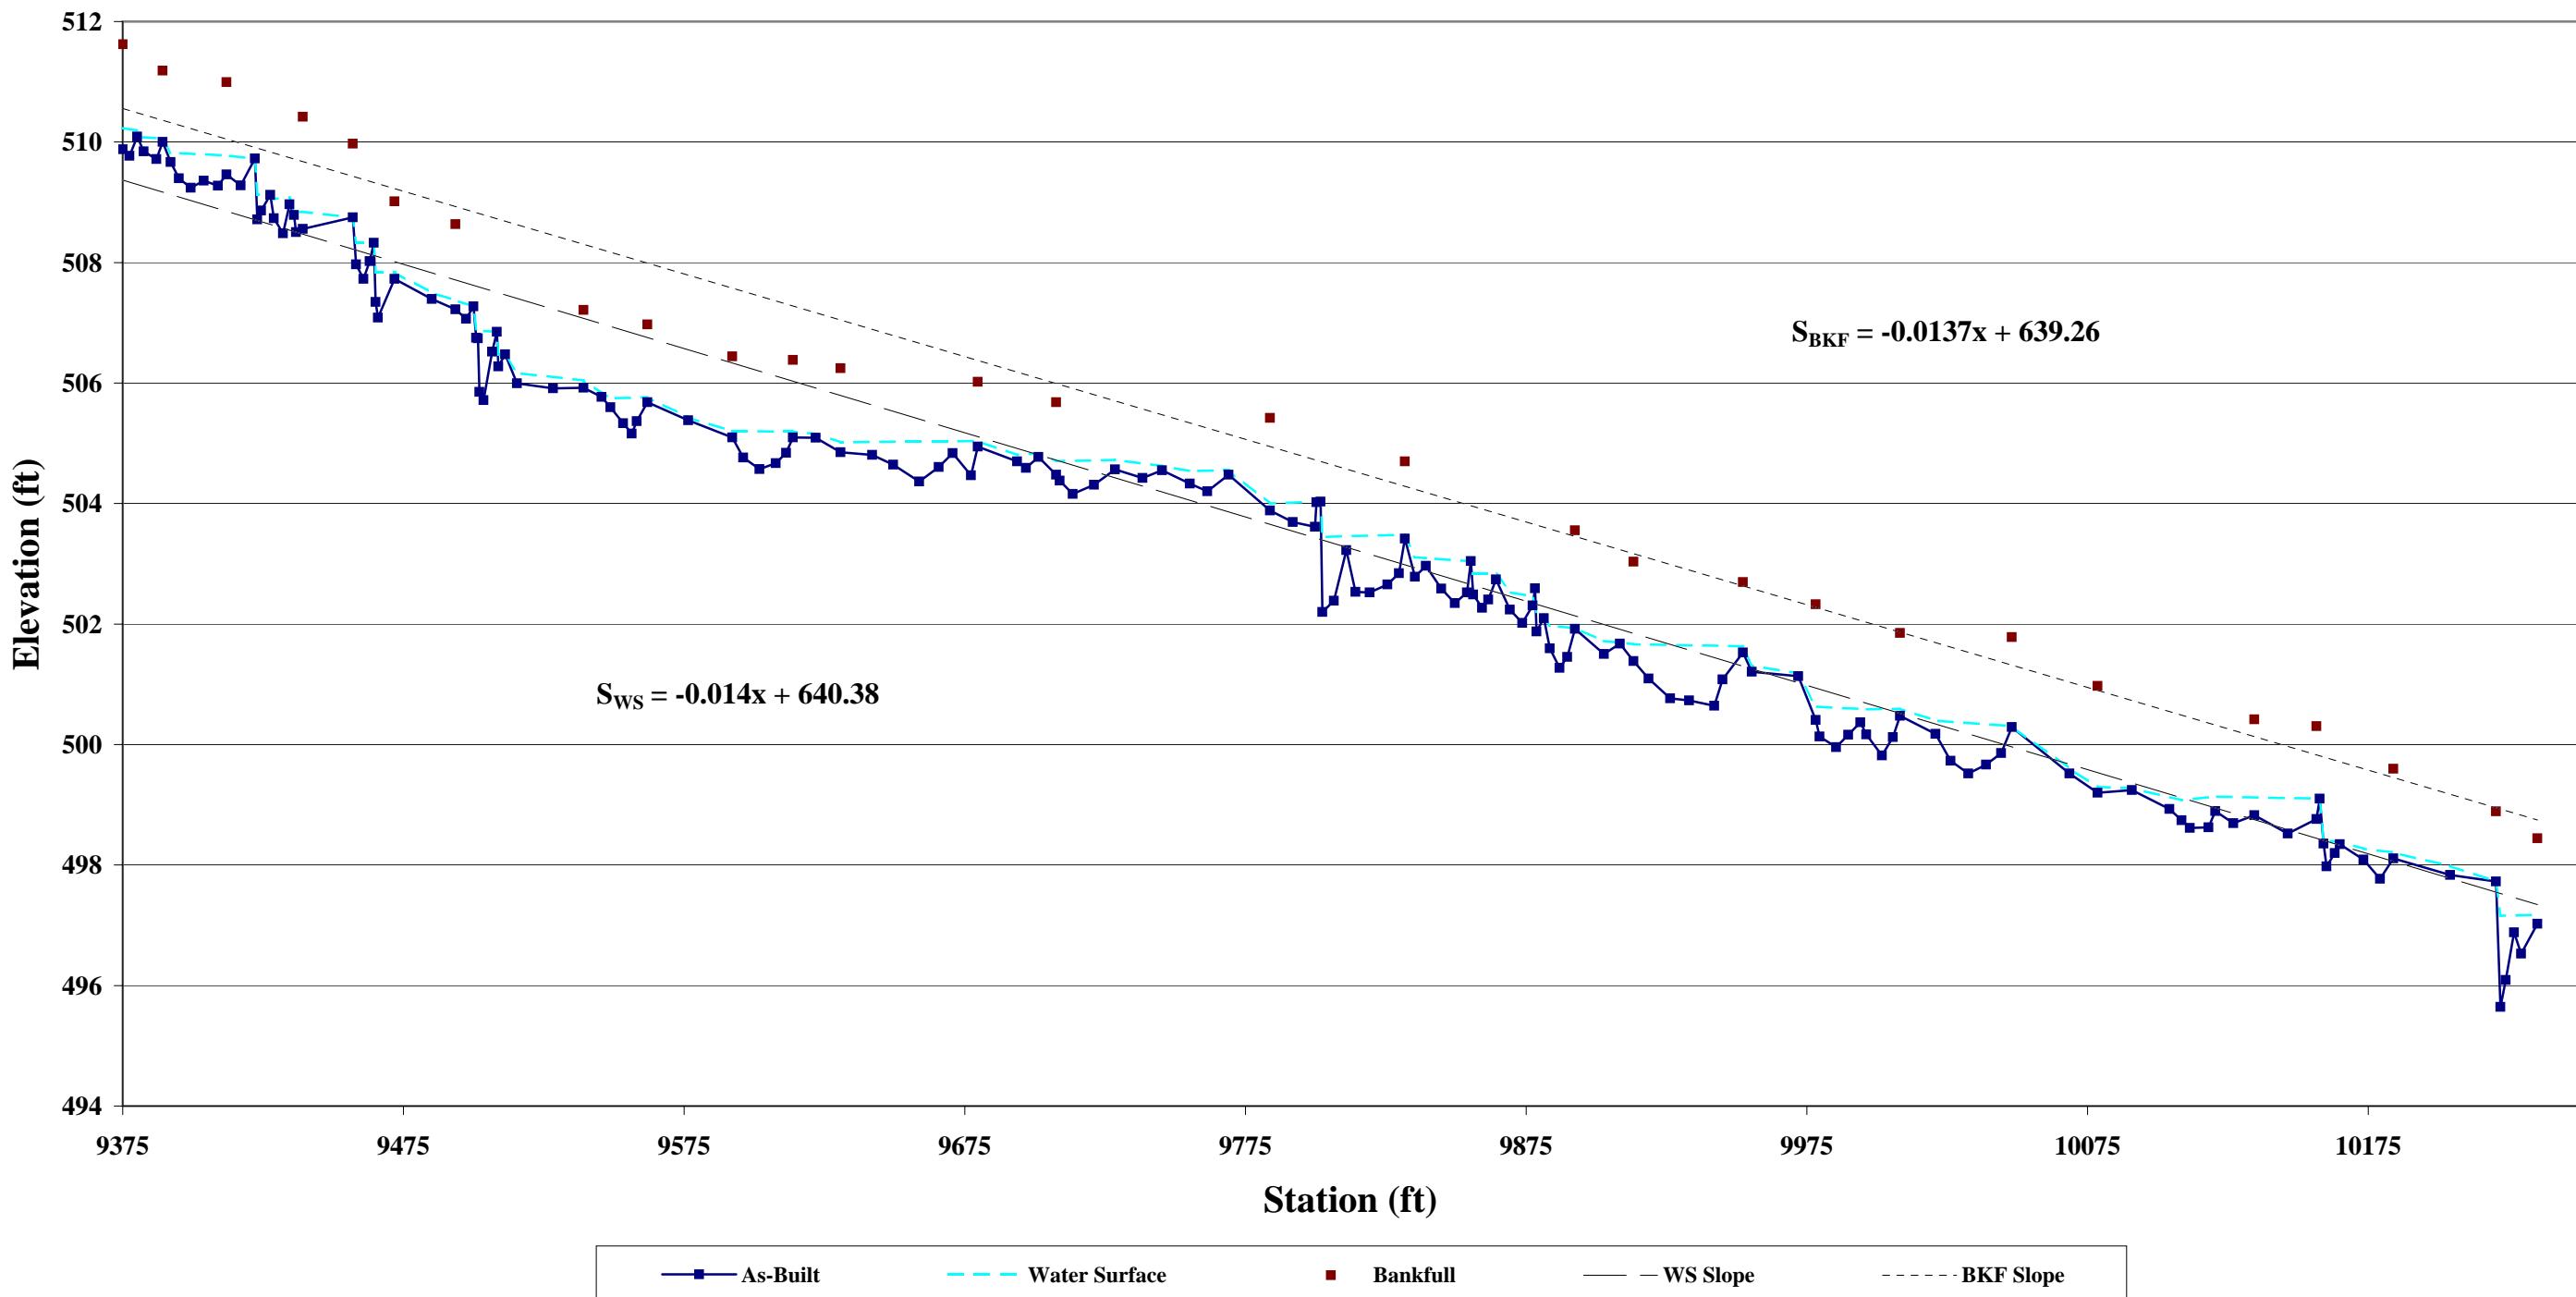
Cane Creek Tributary Site
Longitudinal Profile
Tributary 4, As-Built
Stations 93+75 - 102+35

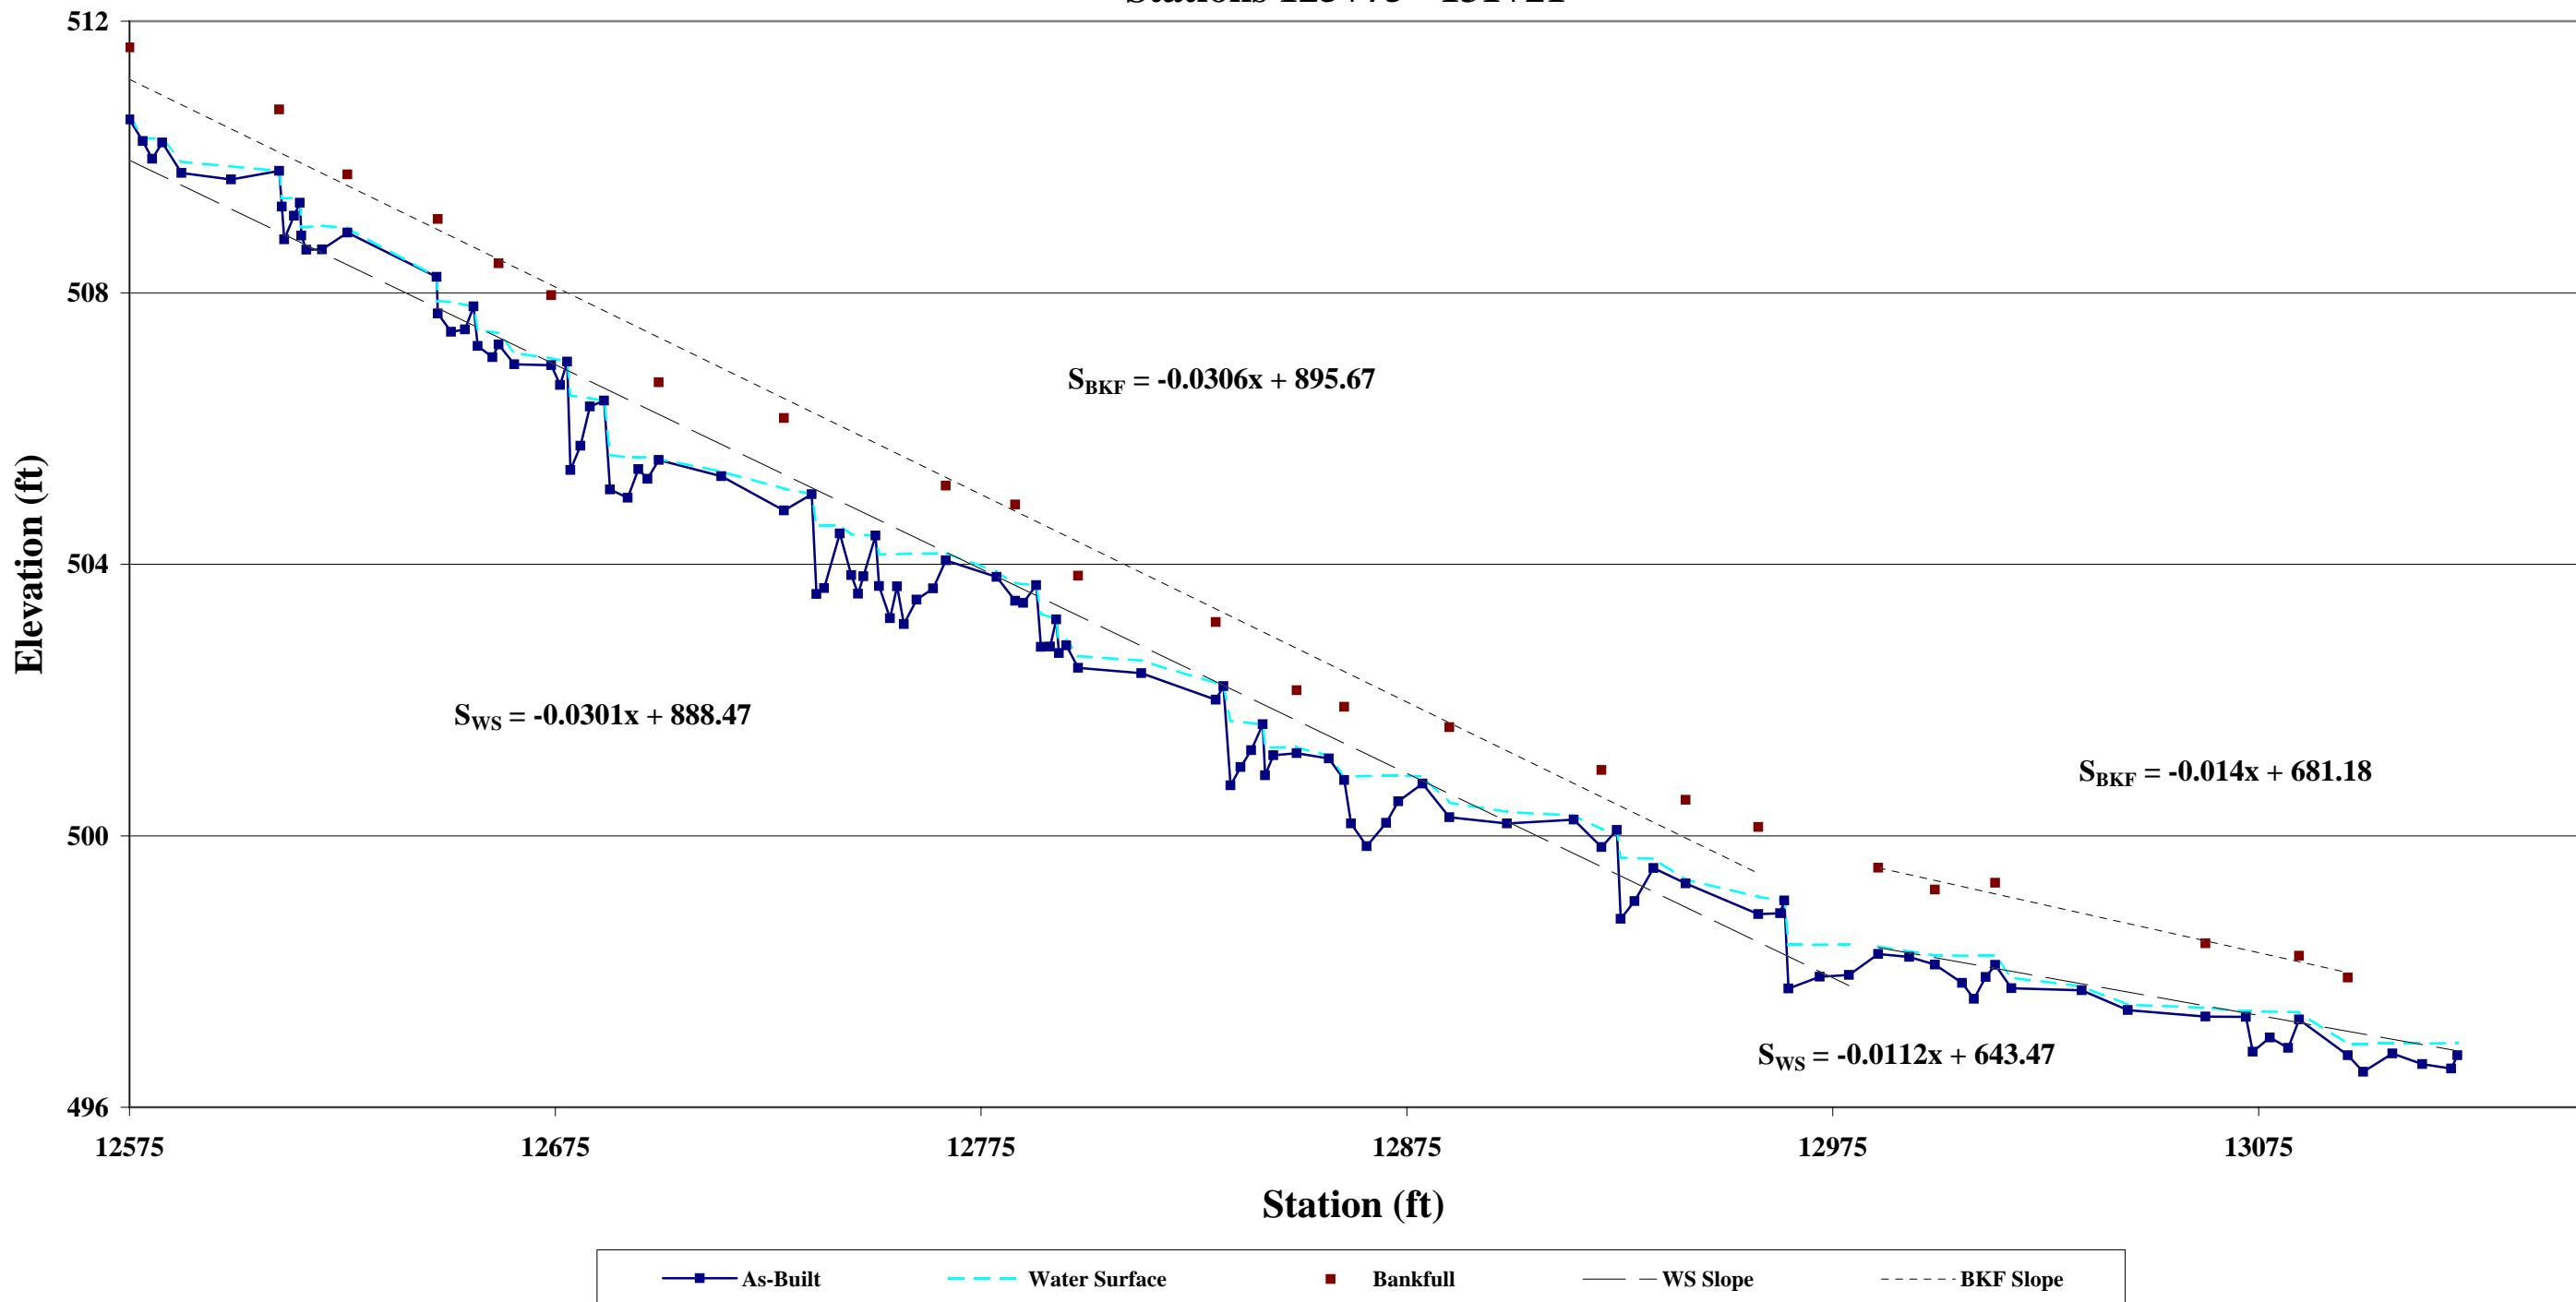
Cane Creek Tributary Site
Longitudinal Profile
Tributary 6, As-Built
Stations 125+75 - 131+21

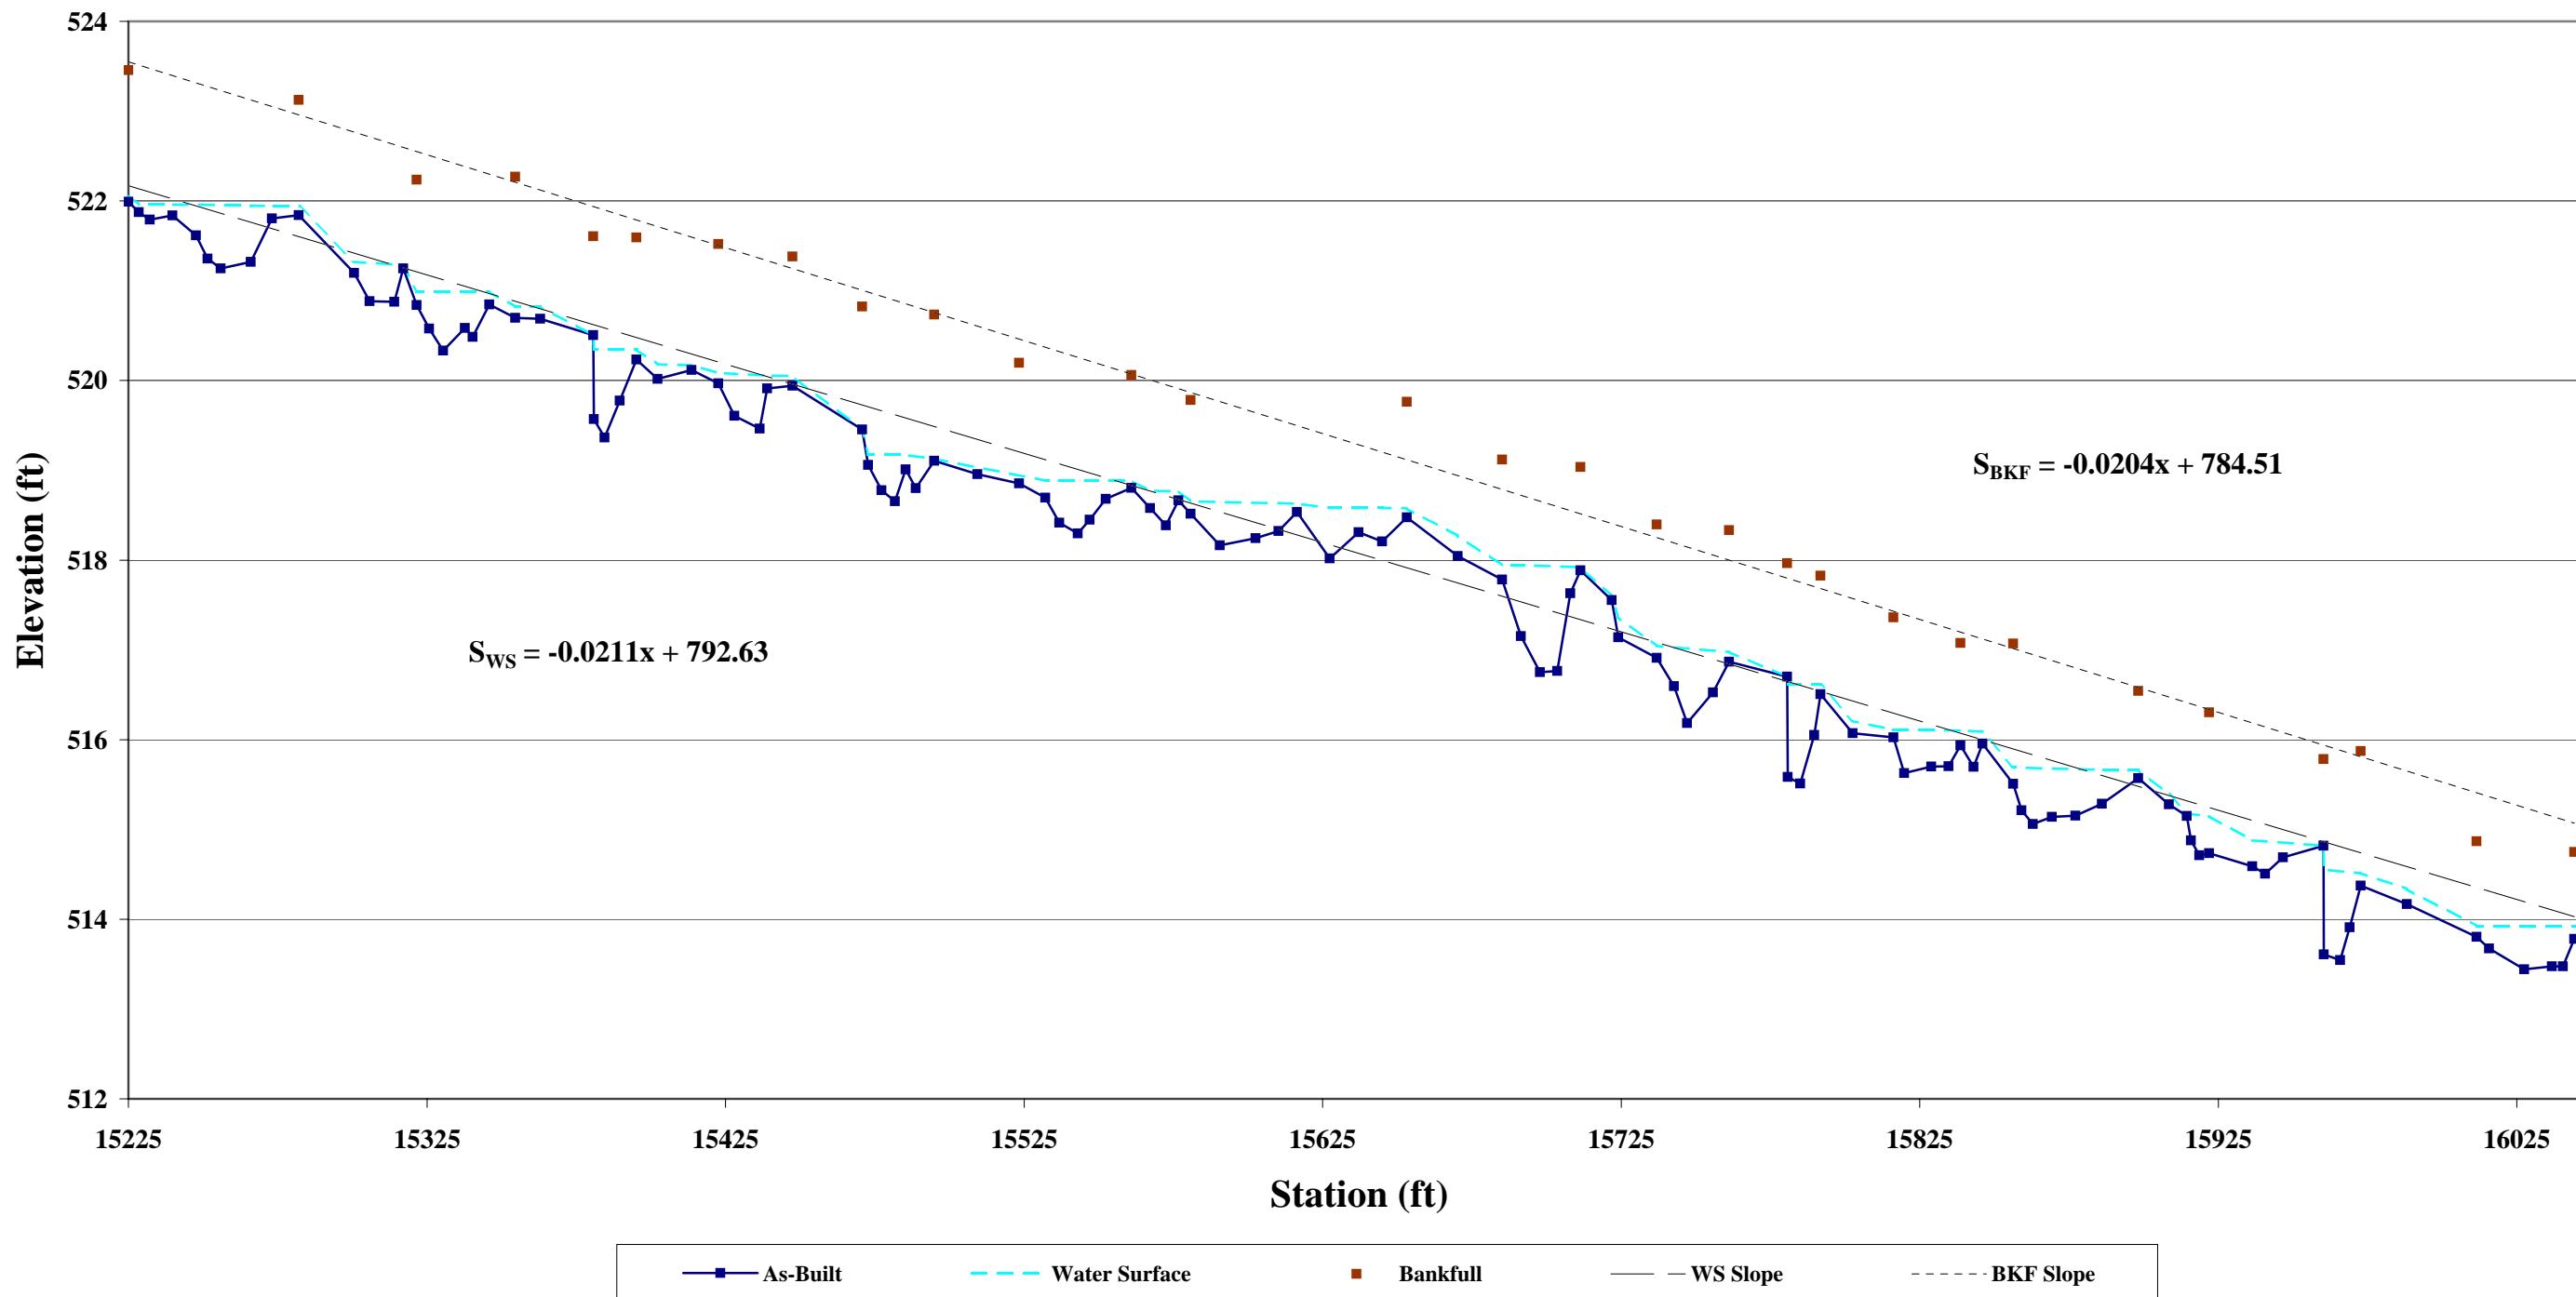
Cane Creek Tributary Site
Longitudinal Profile
Tributary 7, As-Built
Stations 152+25 - 160+44

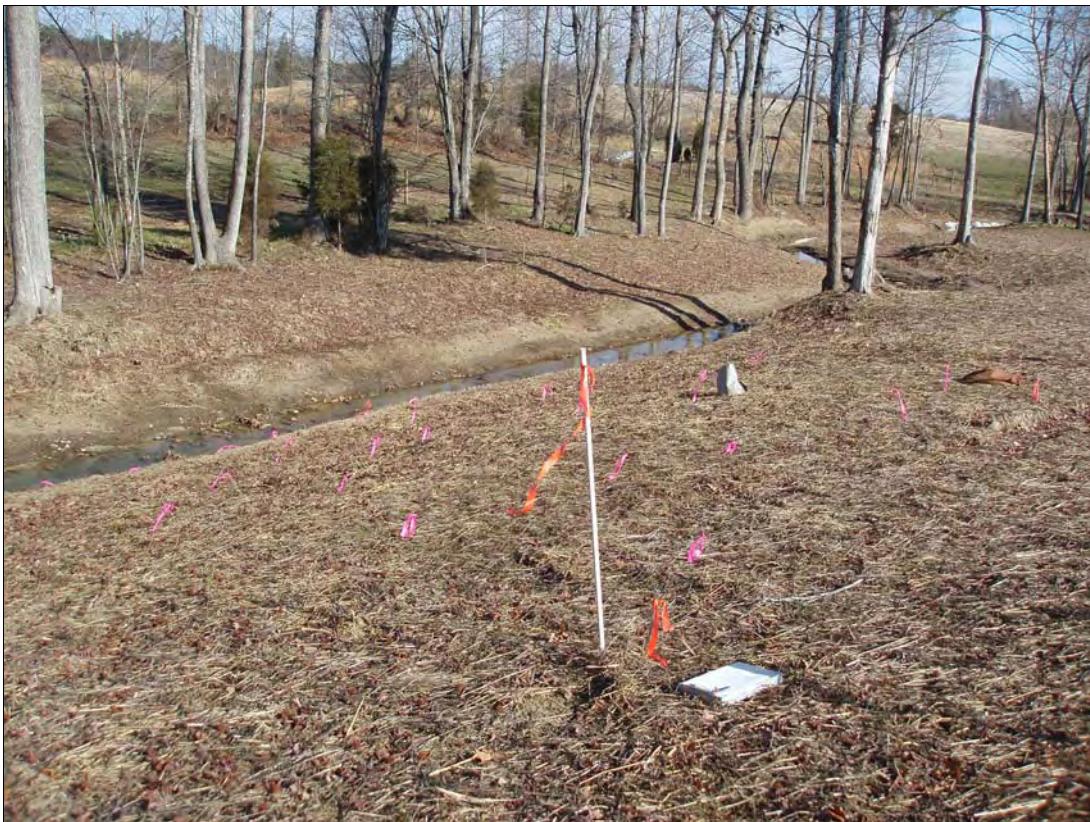
Vegetation Plot 1: View looking toward plot center from origin corner. 1/12/09 – As-Built

Baseline vegetation monitoring data from the 20 vegetation plots were collected in January 2009. The vegetation monitoring follows the CVS/EEP vegetation monitoring protocol. Plot photos from all the vegetation plots can be found in Appendix D.

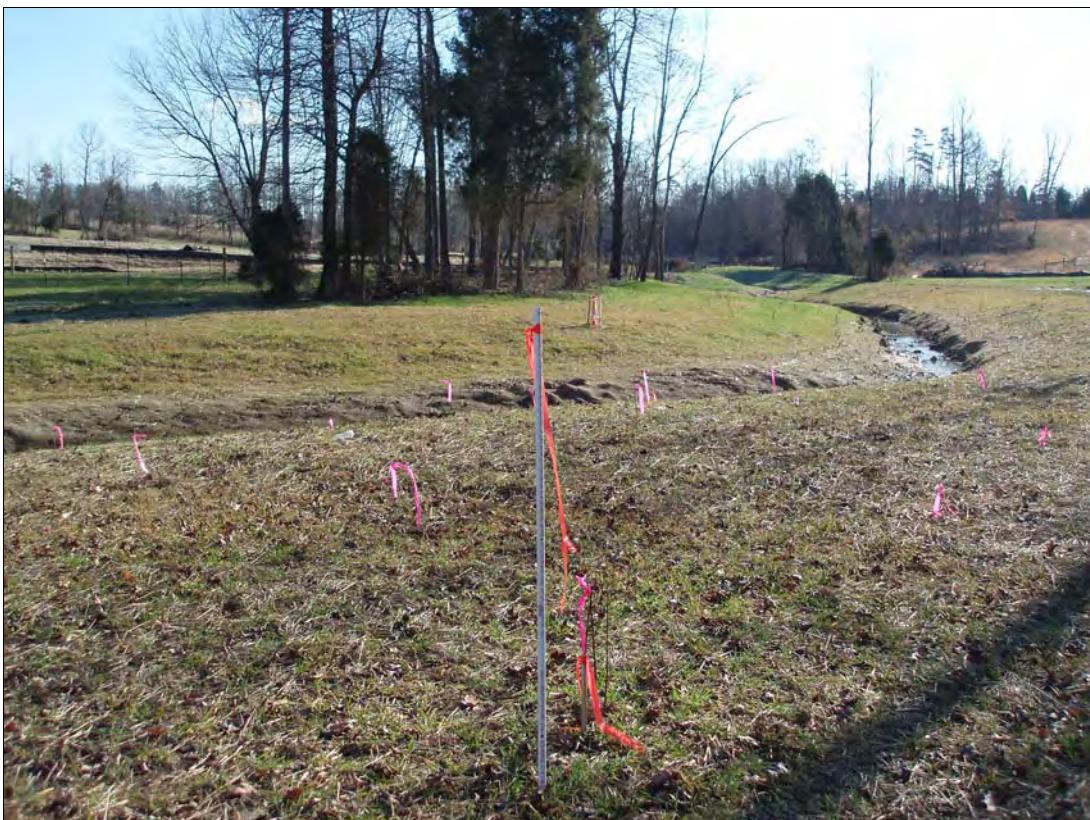
Vegetation Plot 2: View looking toward plot center from origin corner. 1/12/09 – As-Built

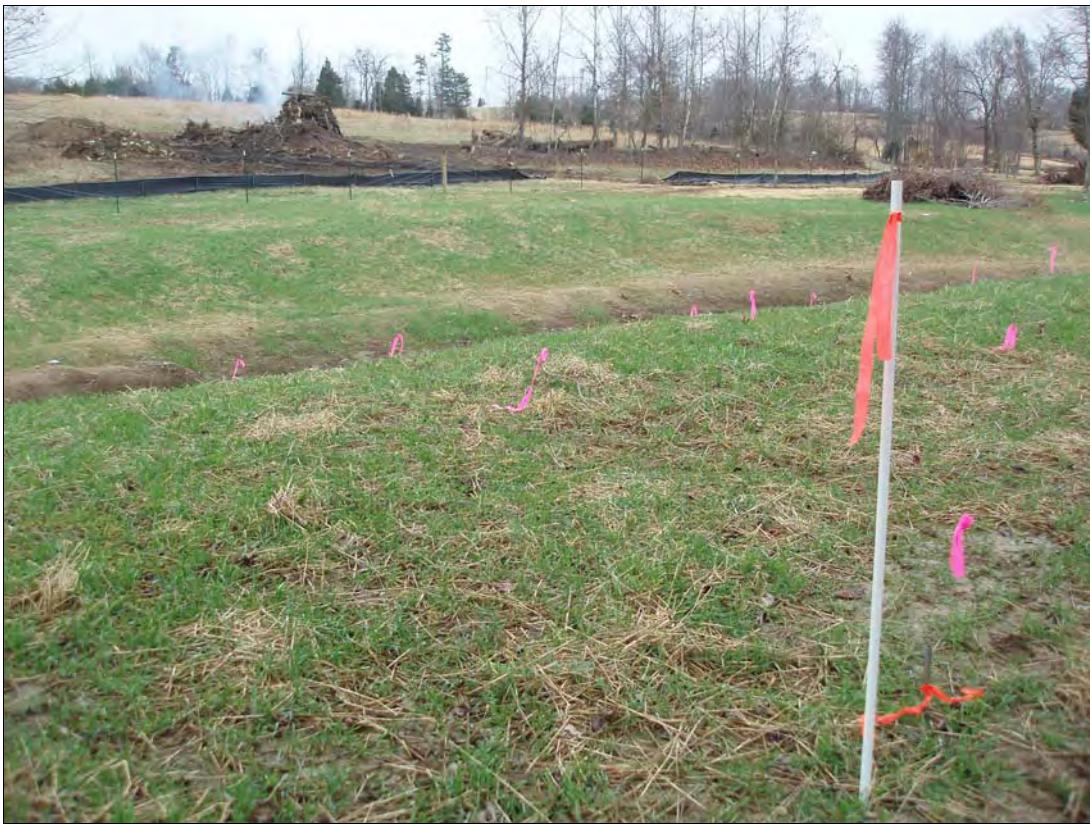
Vegetation Plot 3: View looking toward plot center from origin corner. 1/5/09 – As-Built

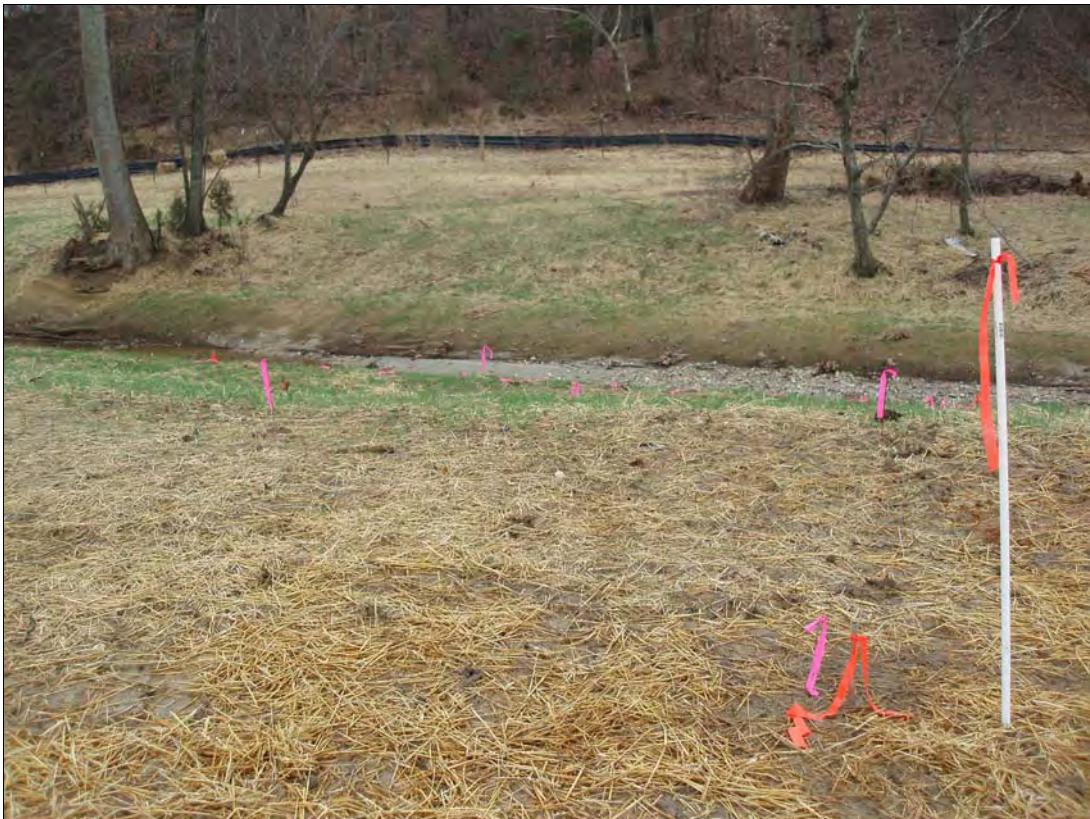
Vegetation Plot 4: View looking toward plot center from origin corner. 1/5/09 – As-Built

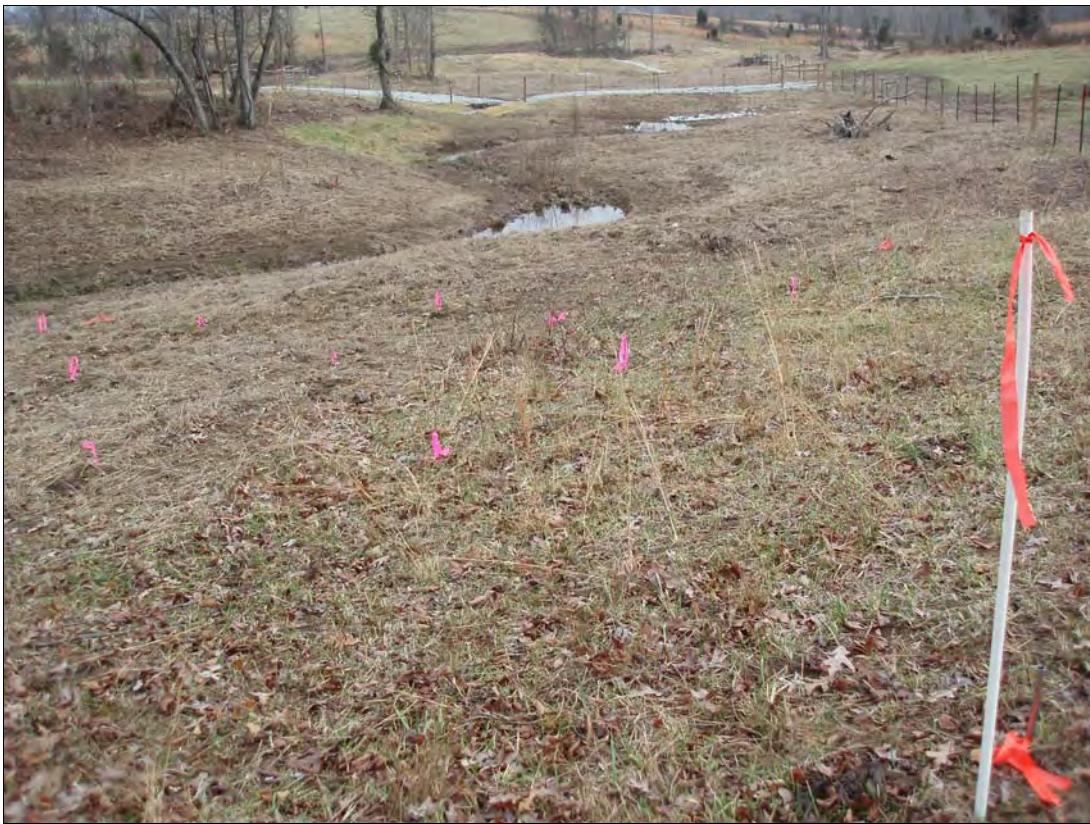
Vegetation Plot 5: View looking toward plot center from origin corner. 1/5/09 – As-Built

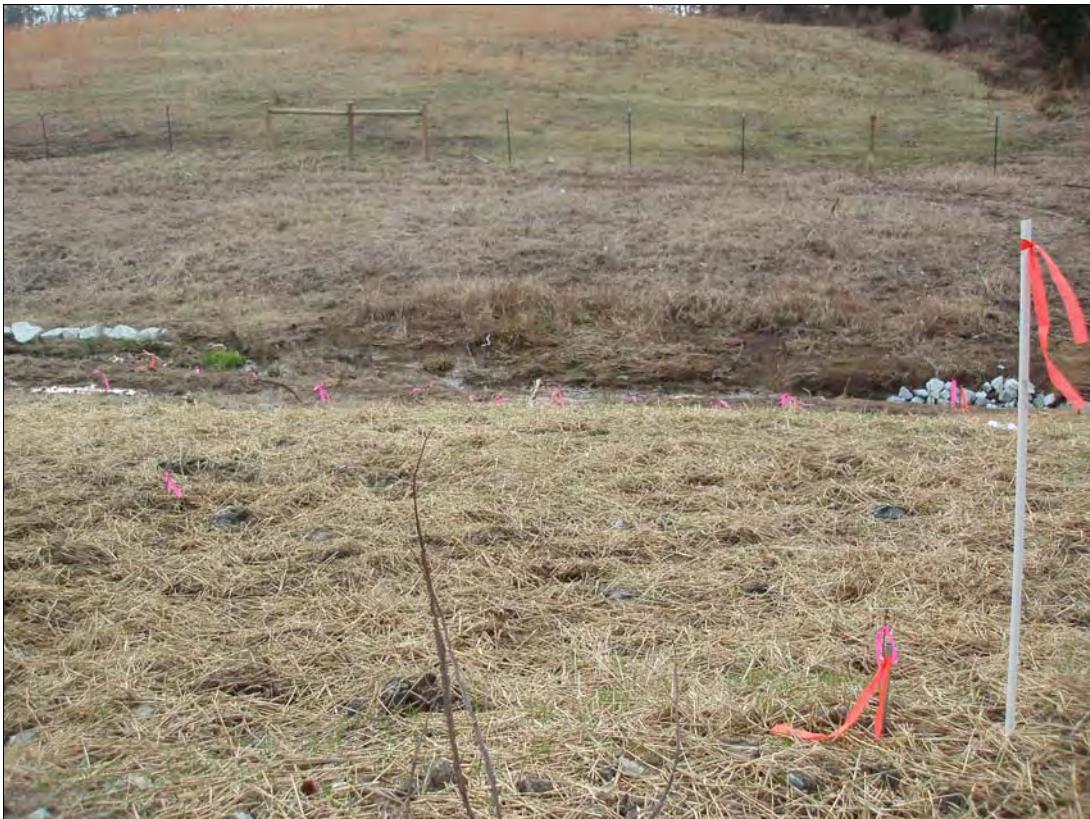
Vegetation Plot 6: View looking toward plot center from origin corner. 1/5/09 – As-Built
