Cane Creek Stream Restoration Site

Mitigation Plan

Contract # D06002

May 2009

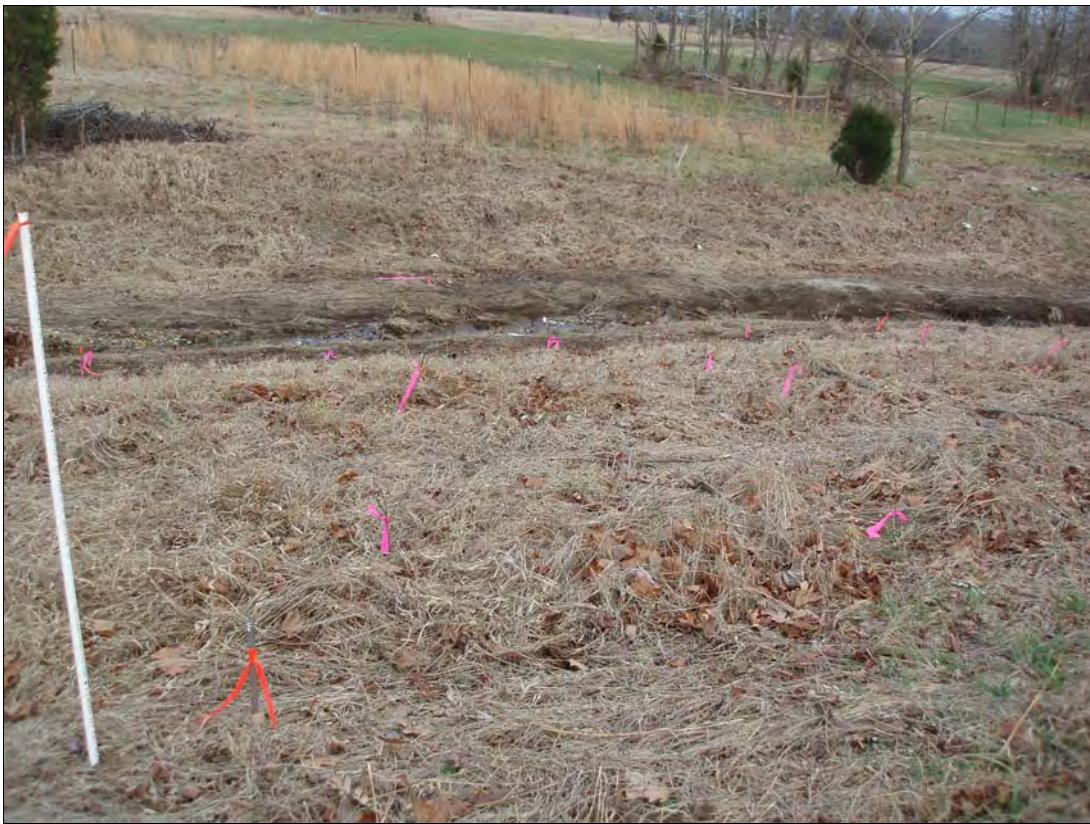
Vegetation Plot 7: View looking toward plot center from origin corner. 1/5/09 – As-Built

Baseline vegetation monitoring data from the 20 vegetation plots were collected in January 2009. The vegetation monitoring follows the CVS/EEP vegetation monitoring protocol. Plot photos from all the vegetation plots can be found in Appendix D.

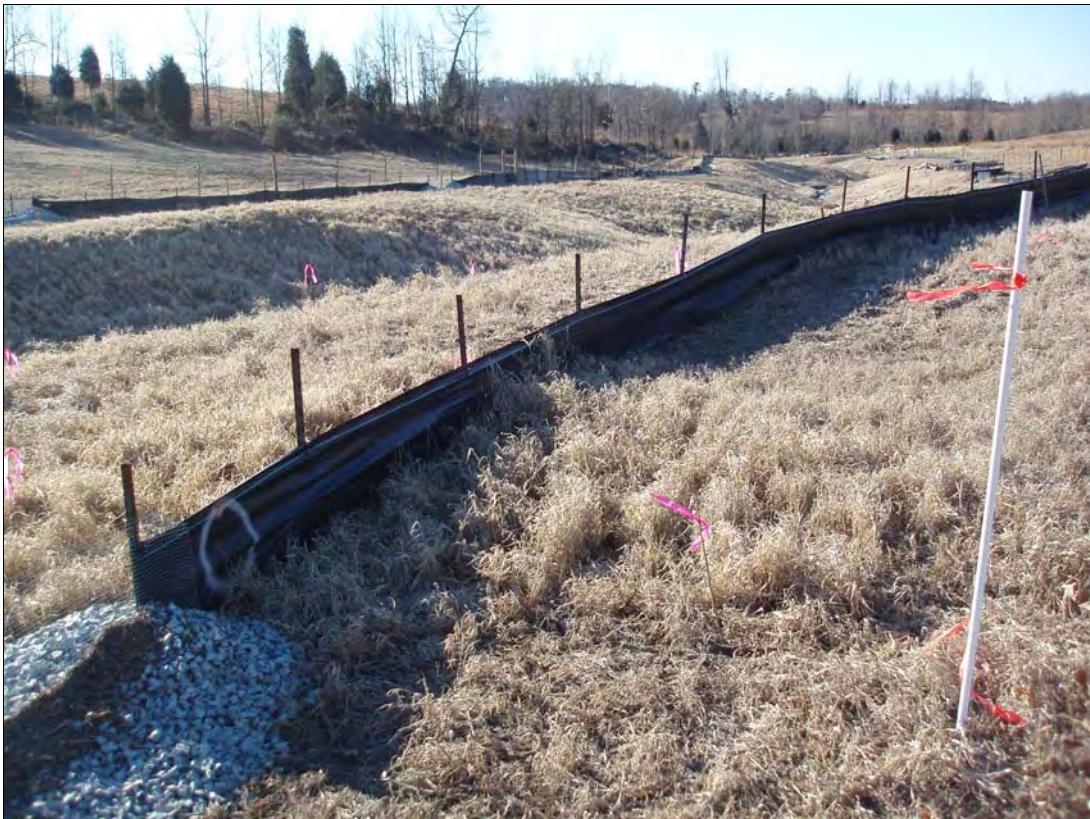
Vegetation Plot 8: View looking toward plot center from origin corner. 1/16/09 – As-Built

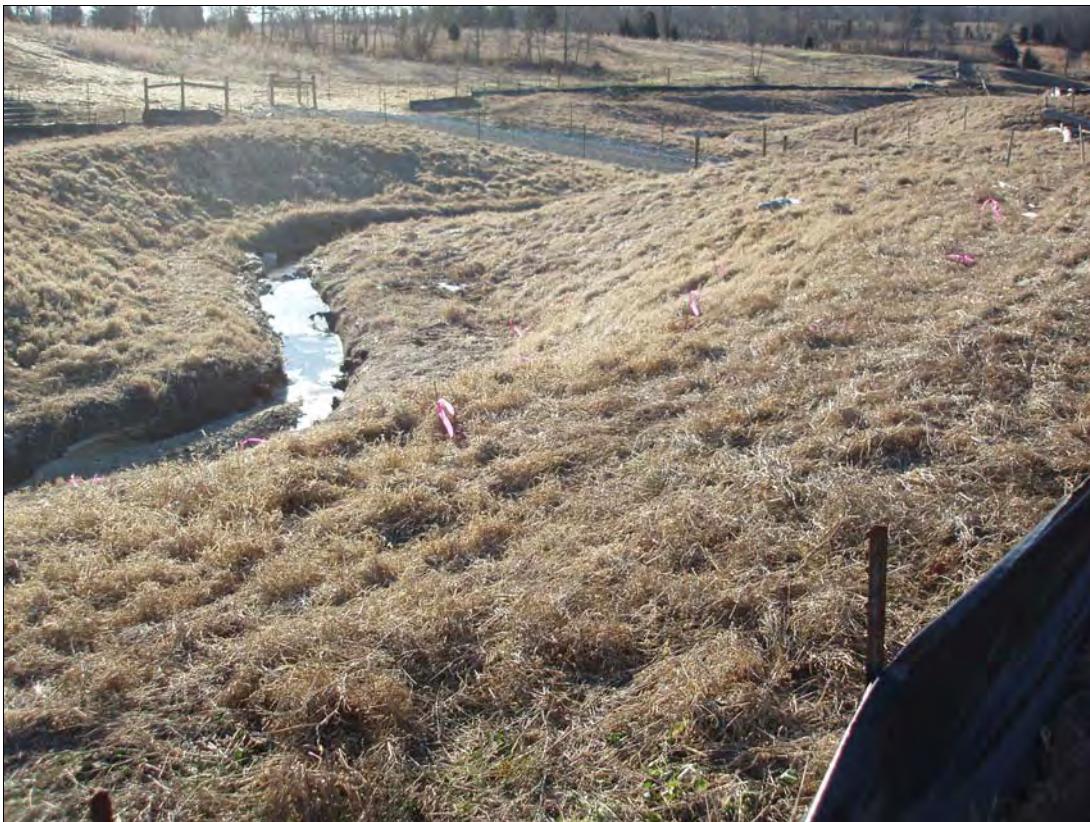
Vegetation Plot 9: View looking toward plot center from origin corner. 1/16/09 – As-Built

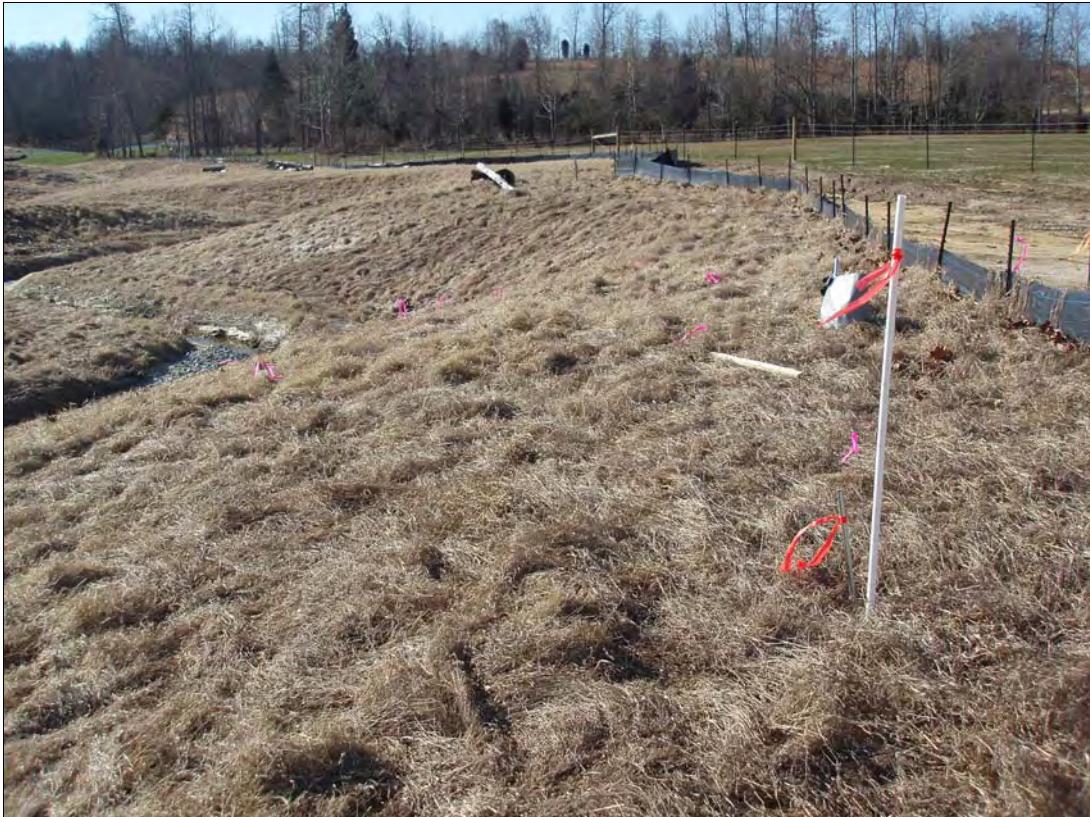
Vegetation Plot 10: View looking toward plot center from origin corner. 1/12/09 – As-Built

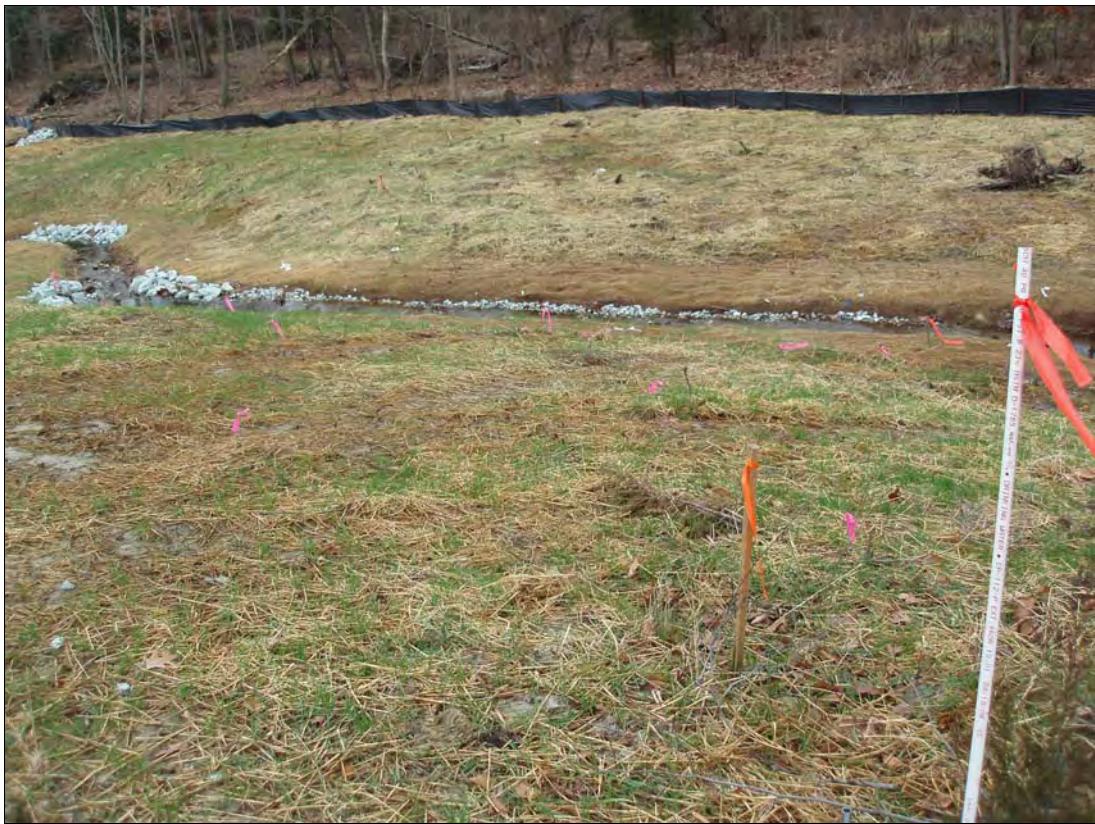
Vegetation Plot 11: View looking toward plot center from origin corner. 1/5/09 – As-Built

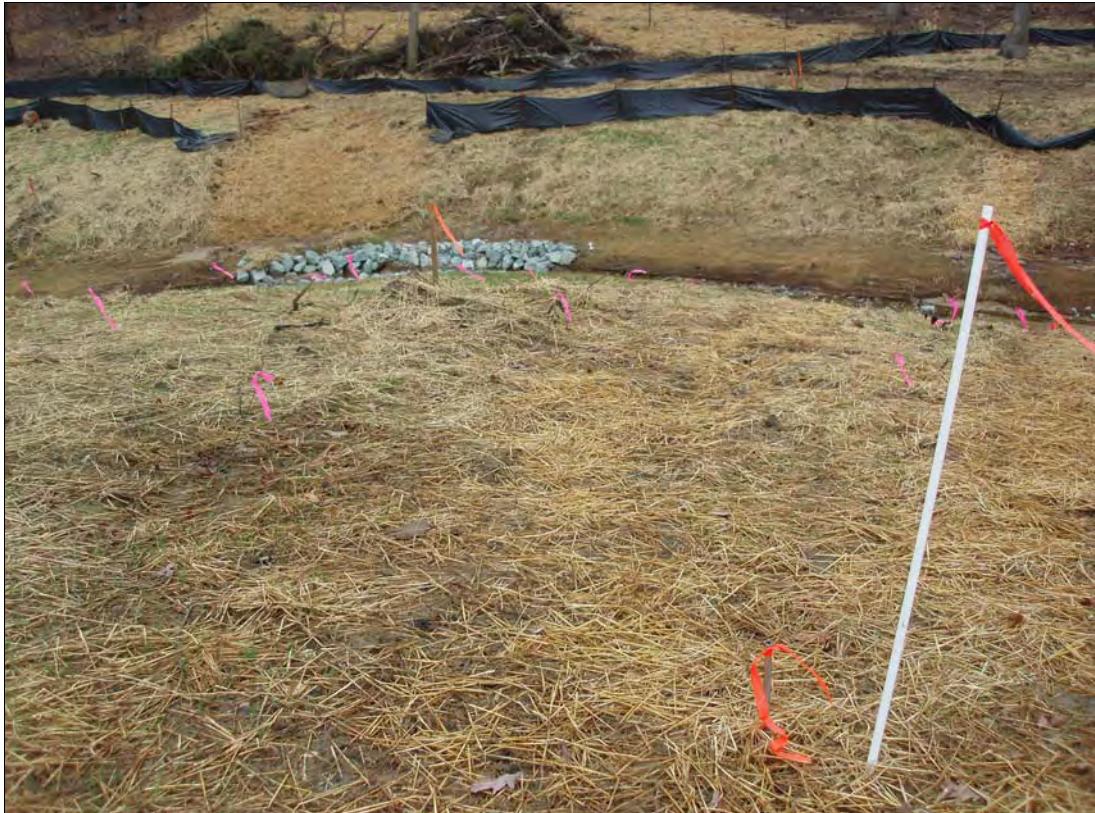
Vegetation Plot 12: View looking toward plot center from origin corner. 1/5/09 – As-Built

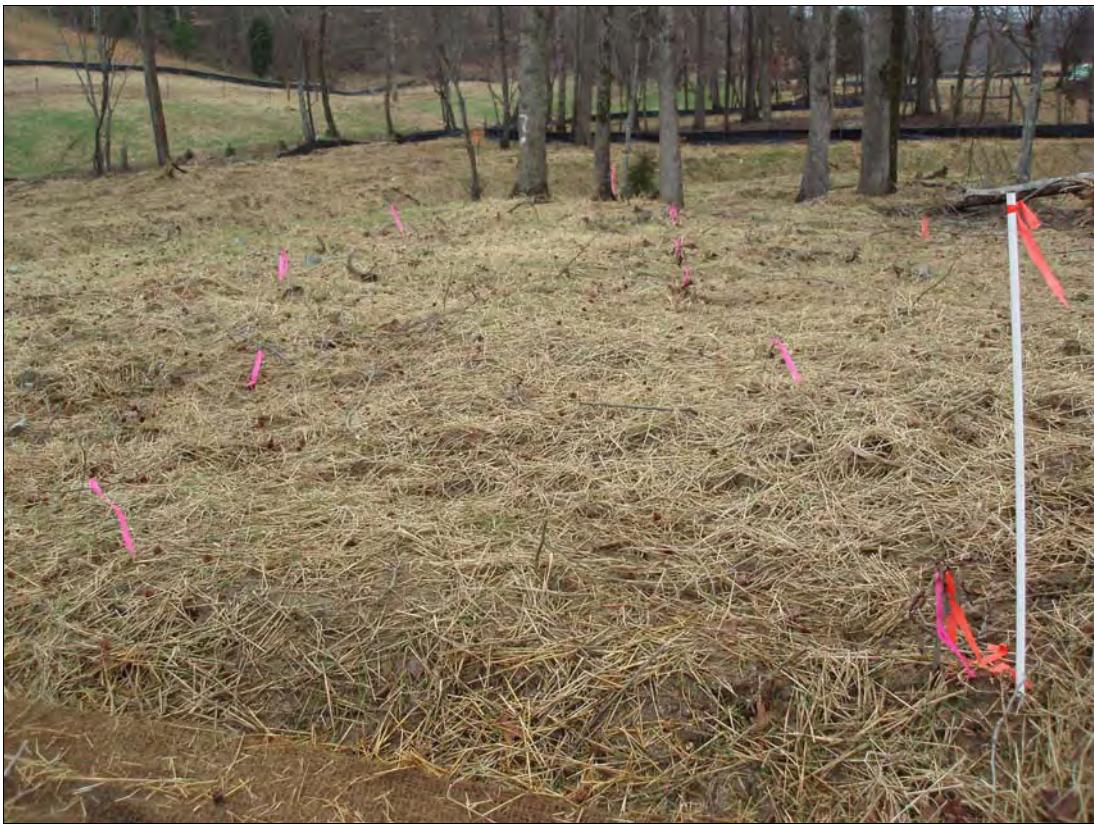
Vegetation Plot 13: View looking toward plot center from origin corner. 1/5/09 – As-Built

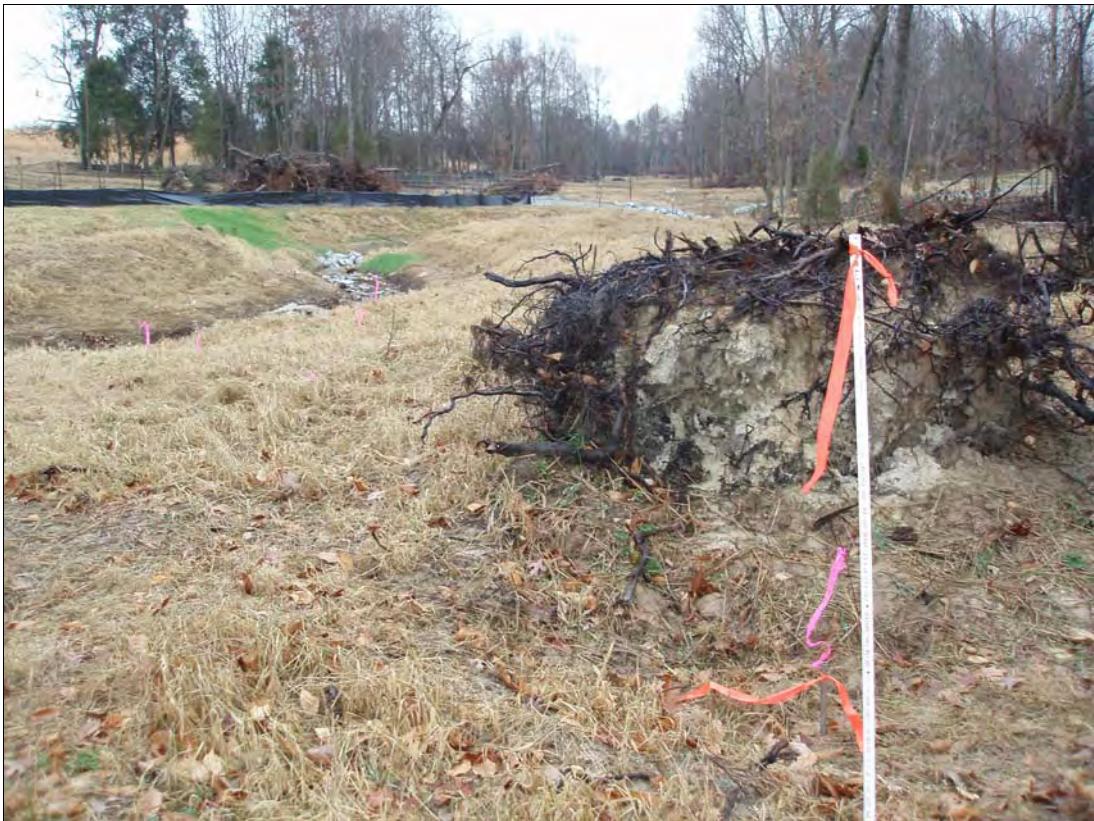
Vegetation Plot 14: View looking toward plot center from origin corner. 1/5/09 – As-Built

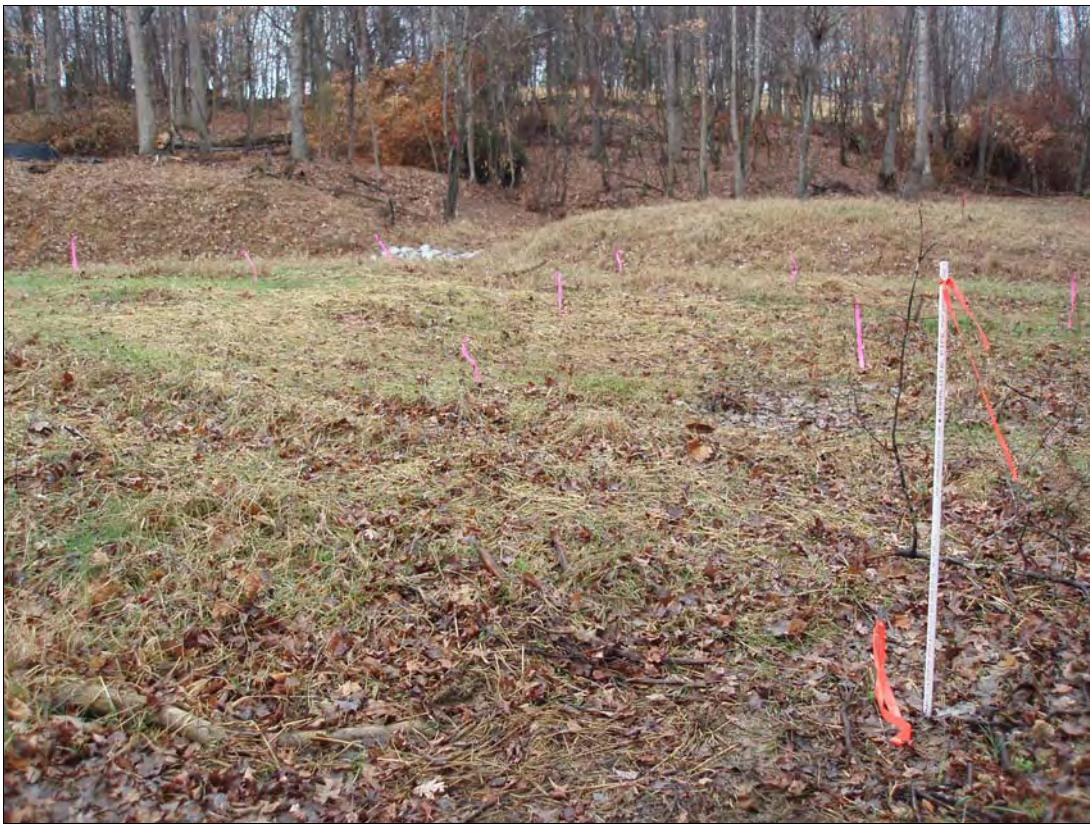
Vegetation Plot 15: View looking toward plot center from origin corner. 1/2/09 – As-Built

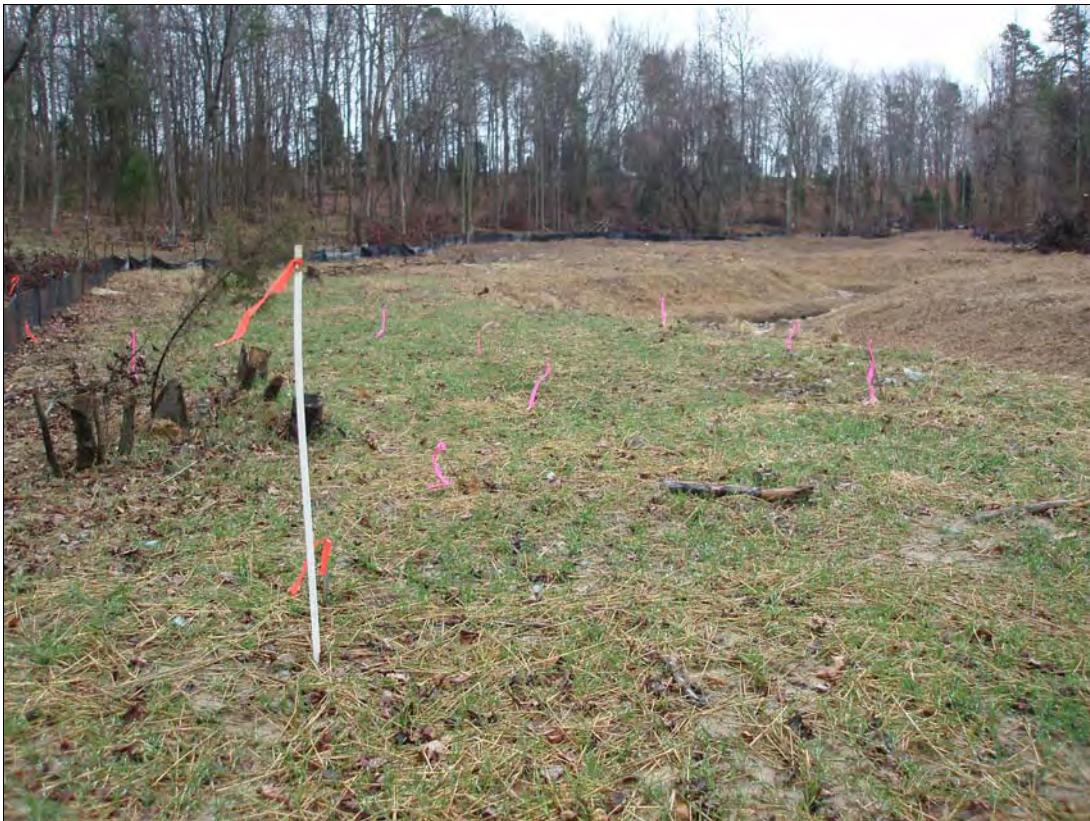
Vegetation Plot 16: View looking toward plot center from origin corner. 1/2/09 – As-Built

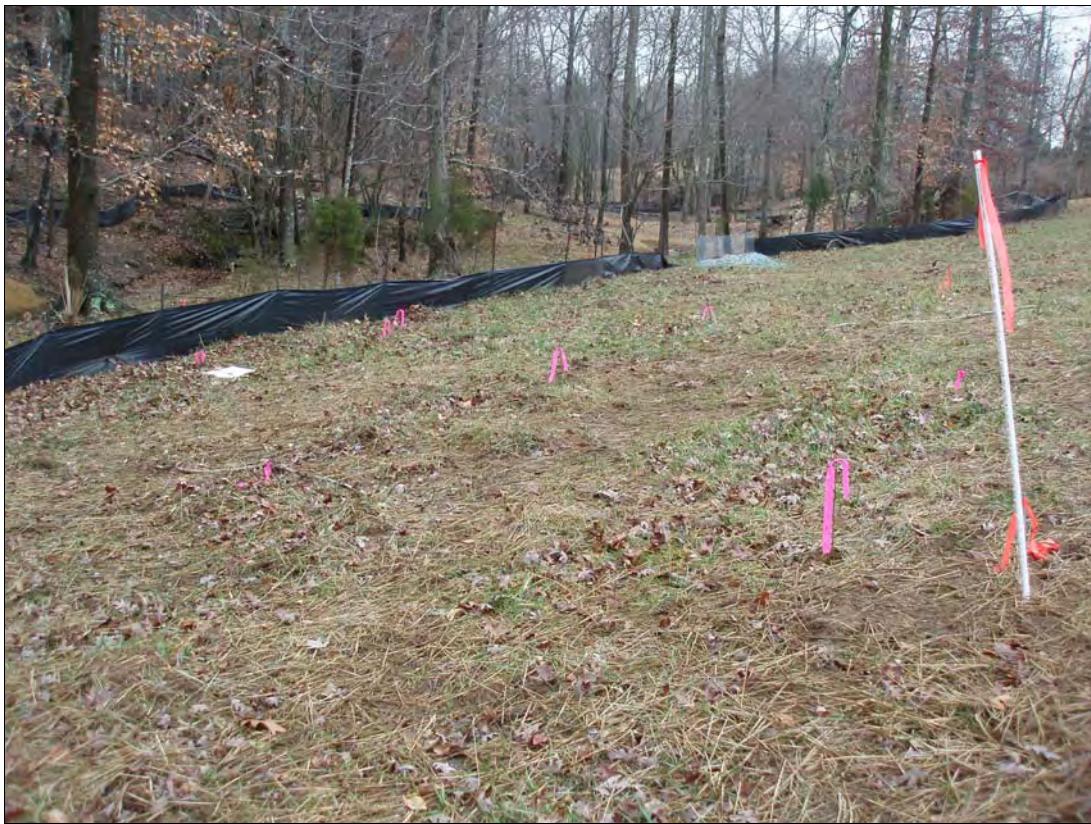
Vegetation Plot 17: View looking toward plot center from origin corner. 1/5/09 – As-Built

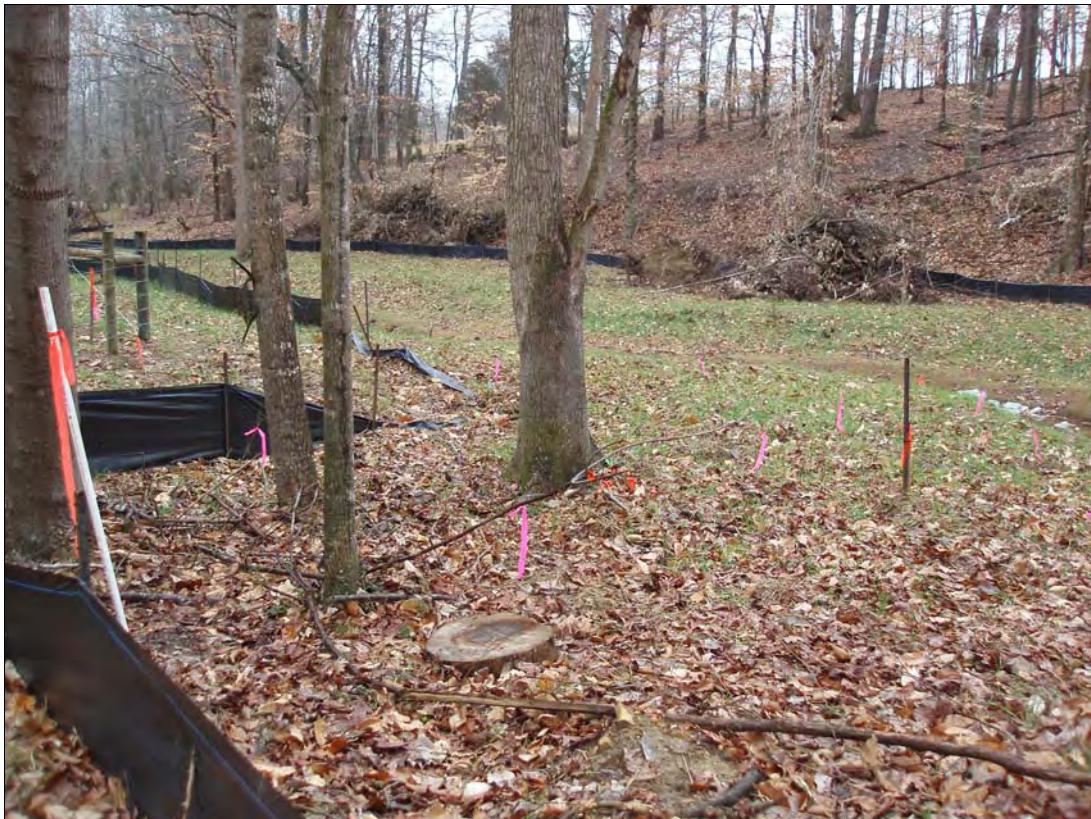
Vegetation Plot 18: View looking toward plot center from origin corner. 1/2/09 – As-Built

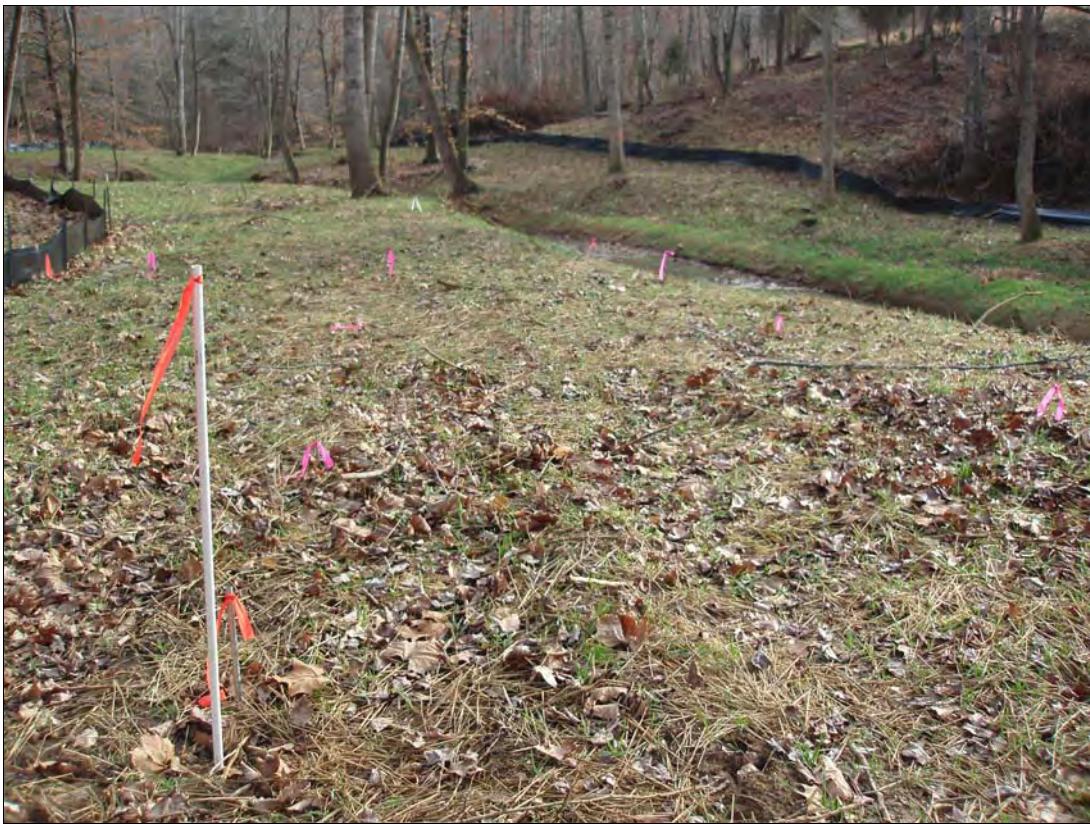
Vegetation Plot 19: View looking toward plot center from origin corner. 1/2/09 – As-Built

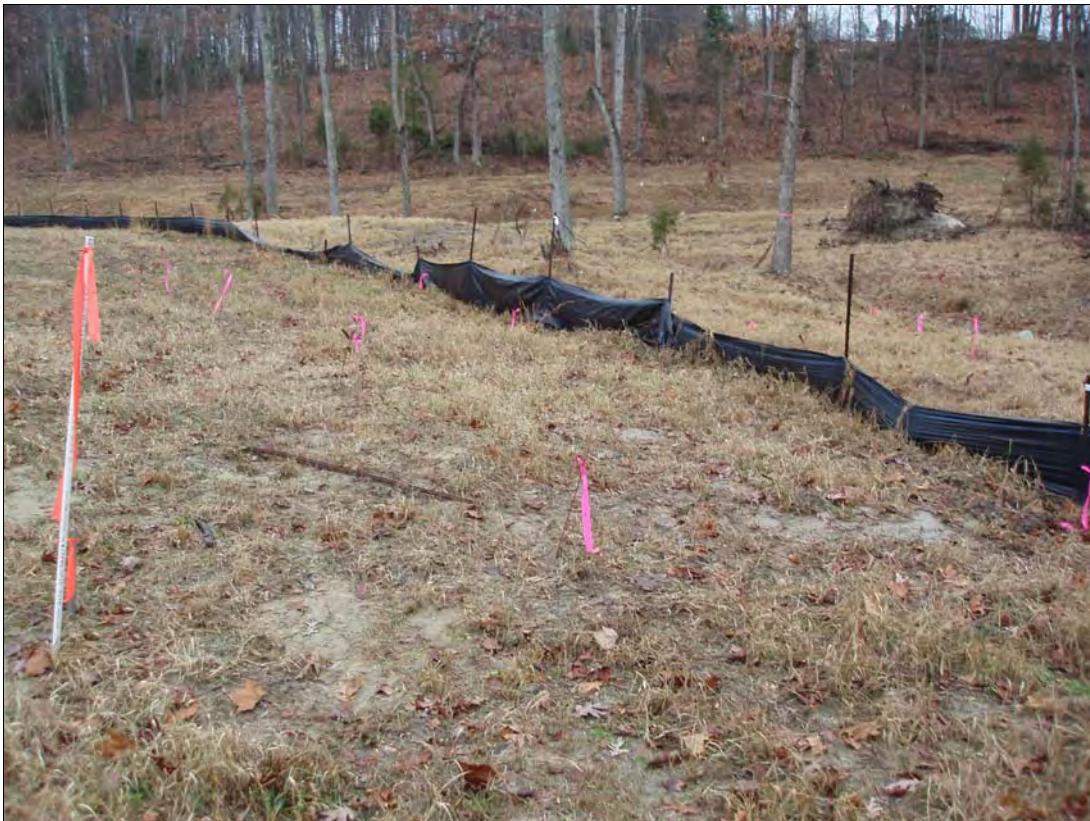
Vegetation Plot 20: View looking toward plot center from origin corner. 1/2/09 – As-Built
