# **As-built Baseline Monitoring Report**FINAL

Cedar Branch Restoration Site Monitoring Year 00 DMS Contract 6598 DMS Project Number 97009

DWR #: 20150904 USACE Action ID: 2003-21395 Randolph County, North Carolina

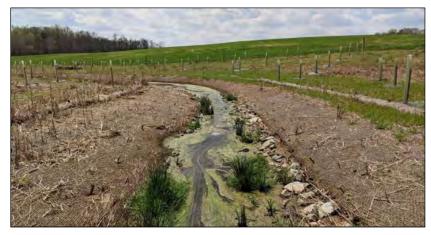
River Basin:	Yadkin River
Site:	Cedar Branch
XS ID	XS14
Drainage Area (sq mi):	0.41
Date:	4/11/2018
Field Crew:	T. Seelinger, A. French

Station	Elevation
0.00	638.73
0.45	638.16
4.90	638.10
8.89	638.07
12.26	638.01
15.72	637.46
17.55	637.05
18.61	636.49
20.75	636.27
23.13	636.69
25.34	637.39
26.67	637.60
28.03	637.94
31.89	638.08
36.50	638.16
40.18	638.19
43.05	638.25
43.57	638.85

SUMMARY DATA	
Current Bankfull Elevation:	637.94
Bankfull Cross-Sectional Area:	12.8
Total Cross-Sectional Area:	12.8
Bankfull Width:	15.3
Flood Prone Area Elevation:	639.6
Flood Prone Width:	43.6
Max Depth at Bankfull:	1.7
Mean Depth at Bankfull:	0.8
W / D Ratio:	18.3
Entrenchment Ratio:	2.8
Bank Height Ratio:	1.0

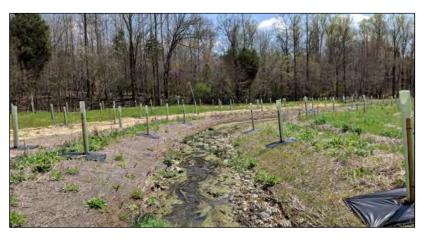
River Basin:	Yadkin River
Site:	Cedar Branch
XS ID	XS15
Drainage Area (sq mi):	0.41
Date:	4/11/2018
Field Crew:	T. Seelinger, A. French

Station	Elevation
0.00	637.83
0.77	637.30
5.14	637.38
9.98	637.39
12.97	637.43
14.77	636.62
16.19	635.79
17.80	634.77
19.46	634.02
21.99	634.67
23.75	635.10
25.58	635.47
26.92	635.78
30.17	636.53
32.51	637.02
35.98	637.49
40.44	637.47
45.11	637.65
48.73	637.57
49.36	638.04

SUMMARY DATA	
Current Bankfull Elevation:	637.43
Bankfull Cross-Sectional Area:	35.8
Total Cross-Sectional Area:	35.8
Bankfull Width:	22.5
Flood Prone Area Elevation:	
Flood Prone Width:	
Max Depth at Bankfull:	3.4
Mean Depth at Bankfull:	1.6
W / D Ratio:	
Entrenchment Ratio:	
Bank Height Ratio:
