Davis Branch and Unnamed Tributary Mitigation Plan

Union County North Carolina NC EEP Project Number: D06054-F

Mitigation Plan – Davis Branch and Unnamed Tributary EEP Contract # D06054-F

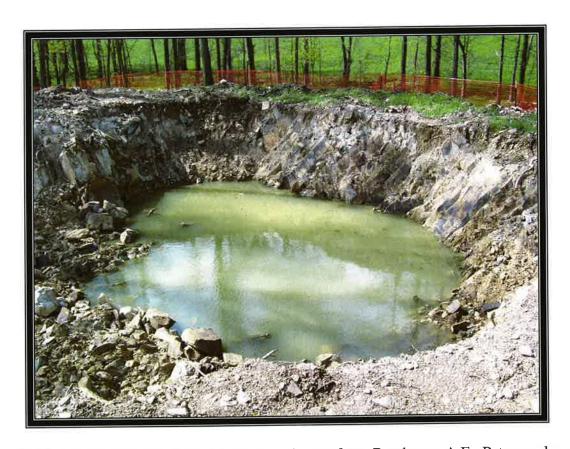
eye), moderately to steeply dipping, fractured, medium to thick bedded slate. The following photograph shows typical bedrock streambed conditions on the upper section of the mainstem Enhancement Level I reach. The following photograph shows the onsite quarry (now reclaimed, seeded and stabilized) utilized as a source for instream structure stone during construction of the project stream reaches. Note the steeply dipping bedding planes and rock cleavage in the thick bedded slate bedrock of the McManus Formation.

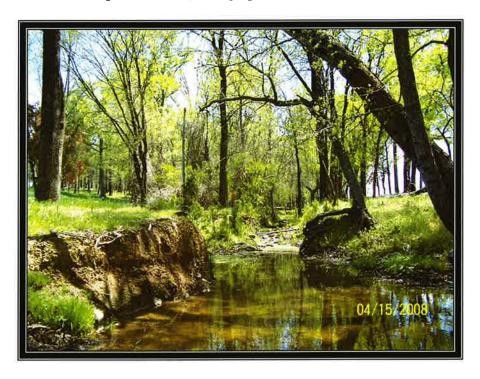
The predominant soil type mapped on the Davis Branch mainstem is the Cid channery silt loam, 1 to 5 percent slopes. This map unit consists mainly of moderately deep, moderately well drained and somewhat poorly drained, nearly level and gently sloping Cid and similar soils on flats, on ridges in the uplands, in depressions and in headwater drainageways. Typically, the surface layer is light brownish gray channery silt loam 4 inches thick. The subsurface layer is a pale yellow channery silt loam 5 inches thick. The subsoil is 18 inches thick. In the upper part, it is light olive brown silty clay that has light brownish gray mottles. In the lower part, it is mottled grayish brown and light olive brown channery silty clay. Weathered, fractured slate bedrock is encountered at a depth of about 27 inches. Hard, fractured slate bedrock is encountered at a depth of about 32 inches. Permeability is slow in the Cid soil. Average water capacity is low or moderate. The shrink-swell potential is moderate. A seasonal high water table is perched between 1.5 to 2.5 feet below ground surface from December through May. The depth to hard bedrock ranges from 20 to 40 inches. The hazard of erosion is moderate on construction sites if the ground cover is removed. This map unit is used mainly as cropland, hay, pasture or woodland. The following photograph shows the entire Cid pedon section, exposed to erosion along the east (river right) bank of Davis Branch, taken on April 15, 2008, facing upstream.

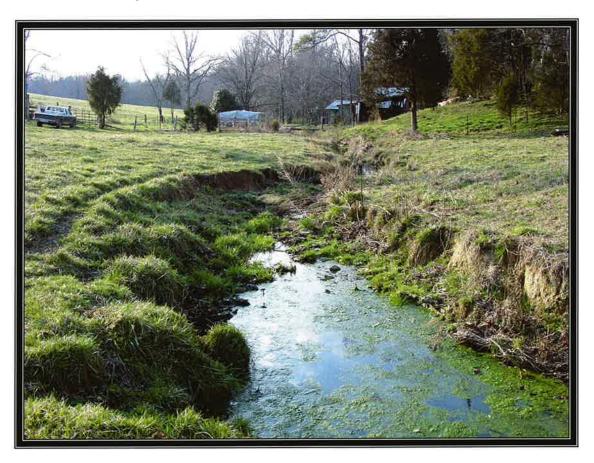
The next photograph, taken at the bottom of the mainstem reach on March 9, 2006, shows the Cid pedon section, with nutrient laden water, as evidenced by prolific algae bloom, attributed to agricultural runoff exacerbated by livestock intrusion, and hoof-shear streambank destabilization leading to streambank failure and erosion.

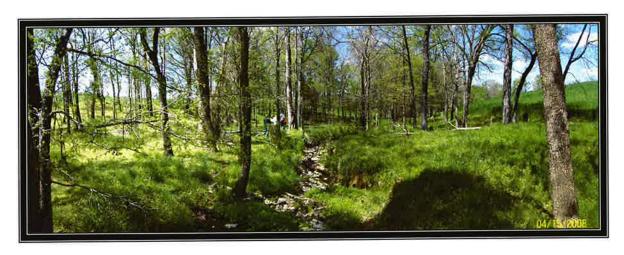
An area of Badin channery silty clay loam, 2 to 8 percent, eroded (map symbol - BdC2) is present along the lower Enhancement Level 1 mainstem reach on Davis Branch. The soil taxonomy is essentially identical to the BaB map unit described in the preceding paragraph. Some primary differences are the BdC2 map unit is poorly suited to cultivated crops because of slope constraints and the eroded surface layer. The hazard of further erosion is very severe. Weathered, fractured slate bedrock is encountered at a depth of about 29 inches. Hard, fractured slate bedrock is encountered at a depth of about 41 inches. The following photograph, taken on April 15, 2008 looking upstream on Davis Branch mainstem Enhancement Level 1 reach, shows the erodible nature of the Badin, BdC2 soil pedon on site, with streambank sloughing in the foreground and vertical, denuded streambanks upstream attributed to cattle intrusion.

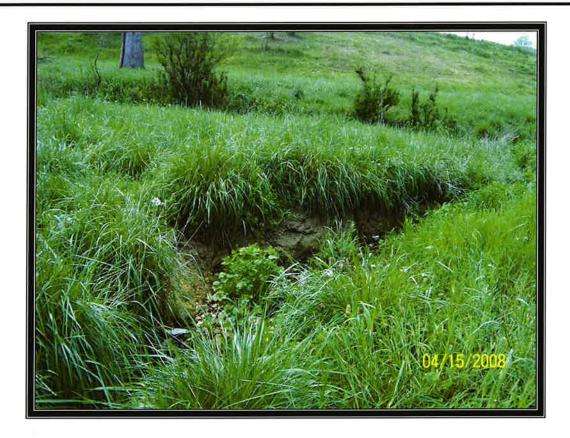
The Goldston soil is well drained to excessively drained and is shallow over bedrock. Typically, the surface layer of the Goldston soil is brown very channery silt loam 5 inches thick. The subsoil is light yellow brown very channery silt loam 11 inches thick. Weathered, fractured slate bedrock is typically encountered at a depth of 16 inches. Hard, fractured slate bedrock is encountered at approximately 27 inches below ground surface In some places bedrock is exposed at ground surface, resulting in narrow, scattered bands of weathered slate outcrops. In other areas, flagstones are in and on the surface layer. Other than shallower accumulated soil thickness attributed to hill slope landform geomorphologic processes associated with steeper land surface slope, as described above, with the GsB component containing a proportionately higher composition of Goldston soil based on slope position, the GsB pedon is otherwise identical to the GsC pedon. The following photograph shows soil conditions near the mouth of UT-1, partially obscured to vegetation on April 15, 2008, characteristic of the onsite GsB soil pedon section.

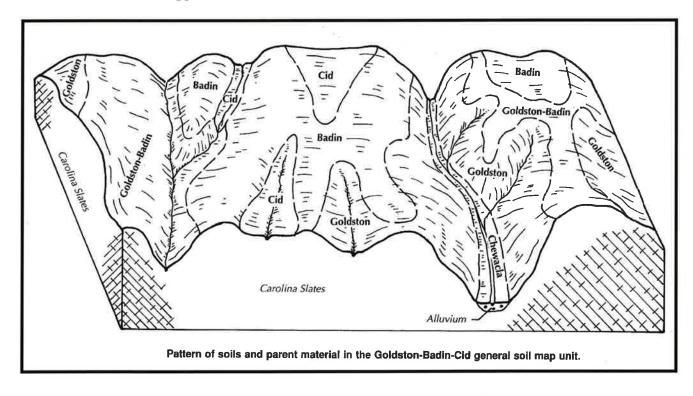
The following block diagram, from the cited Soil Survey of Union County, is representative of the occurrence of mapped Goldston-Badin-Cid soils on site.

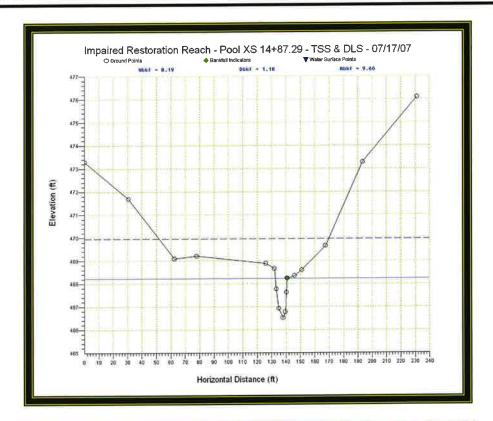
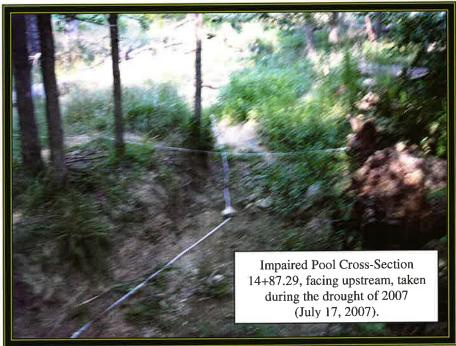
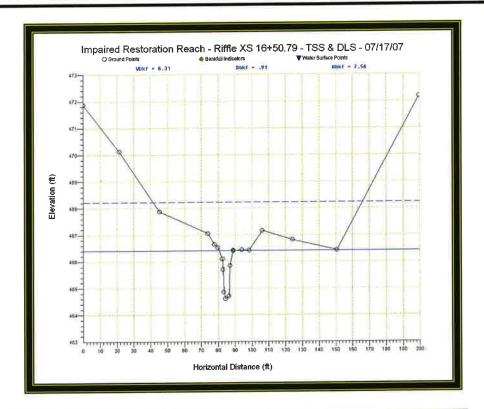
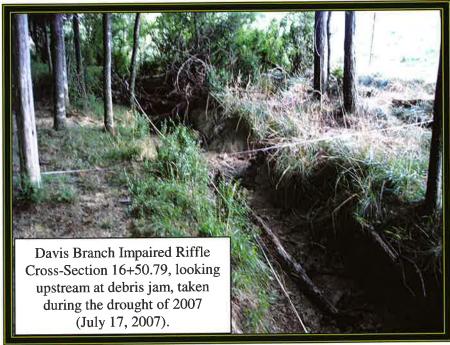
A number of anthropogenic factors impacted the stream channel and riparian corridor along the impaired upper mainstem restoration reach, resulting in its pre-restoration unstable, moderately incised and braided condition. Bank height ratios (BHR) calculated at impaired pool cross-section 14+87.29 and impaired riffle cross-section 16+50.79, located 706 feet and 870 feet downstream from the top of the mainstem preservation reach on the Griffin property, are 1.38 and 1.41, respectively (BHR = Low Bank Height/Bankfull Maximum Depth). Deep channel incision was attributed to uncontrolled cattle intrusion (herbaceous groundcover grazing, shrub vegetation browsing and streambank hoof shear) resulting in a denuded riparian landscape and destabilized, eroding streambanks. Multiple thread channels, created by breaches that rerouted the mainstem channel around woody debris jams (avulsions) were present at a number of locations throughout the reach. (Degree of Channel Incision, *River Stability Field Guide*, David L. Rosgen, Ph.D., P.H. and Hilton Lee Silvey, 2008).

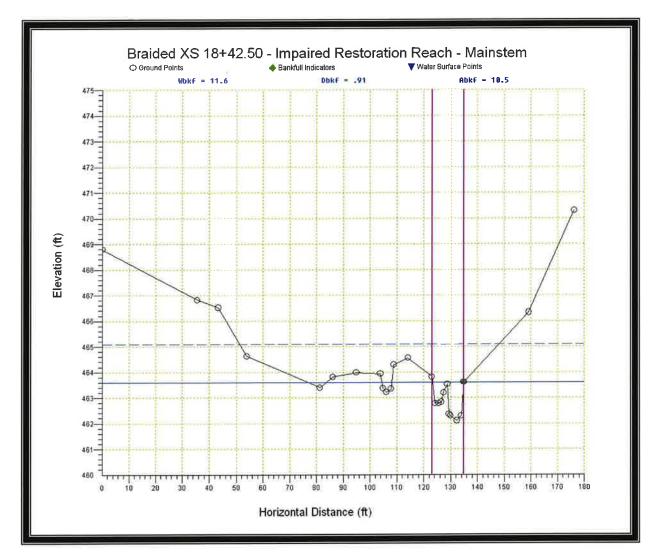
under incised conditions along the reach. In addition to cattle intrusion, channelization (impaired conditions sinussity = 1.12), and an average channel slope of 1.58 percent increased critical shear stress acting on the streambed and banks during bankfull flows (Qbkf = 24.8 cfs with a mean velocity of 5.26 ft/sec under impaired conditions) and greater flows. The following impaired conditions cross-section 18+42.50 graphically shows the multithread, braided stream channels characteristic of Davis Branch prior to restoration.

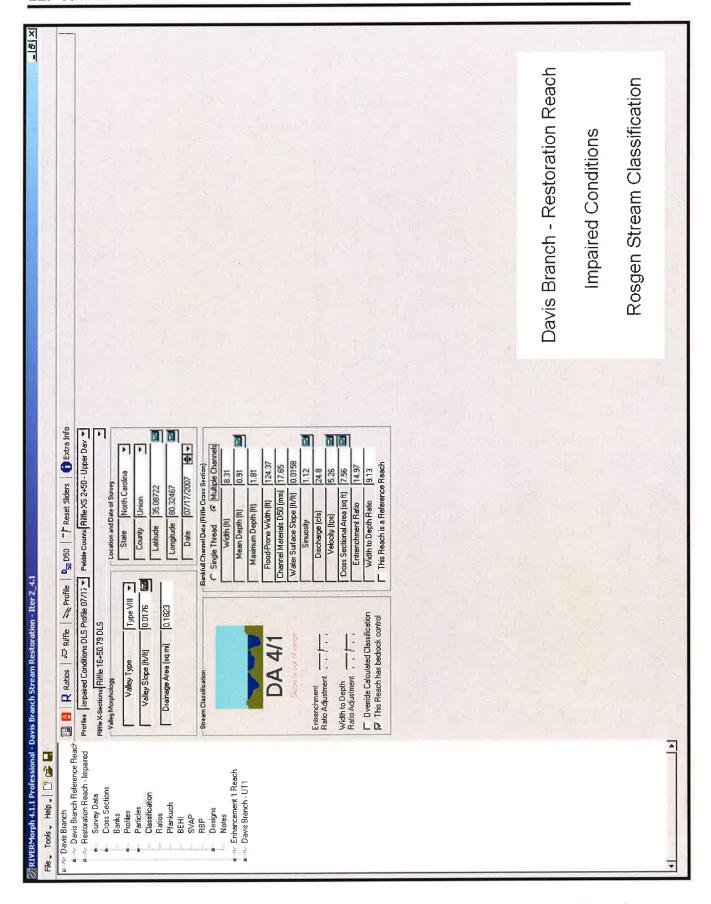
Table 2a provides baseline morphologic and hydraulic summaries for regional curve, reference reach, existing, proposed and As-Built channel dimension, pattern, profile and substrate, along with additional reach parameters for upper Davis Branch. The following screenshot from RiverMorph v. 4.1.1, shows impaired project reach Rosgen stream channel classification, dominant substrate materials readily available to the stream, geomorphologic and hydraulic conditions on the Davis Branch mainstem restoration reach. The impaired mainstem restoration reach longitudinal profile is presented following the Rosgen Classification screen capture. Supporting impaired conditions documentation is included with the information in Appendix 3 of the Davis Branch and Unnamed Tributary Restoration Plan (EMH&T, June 2008).

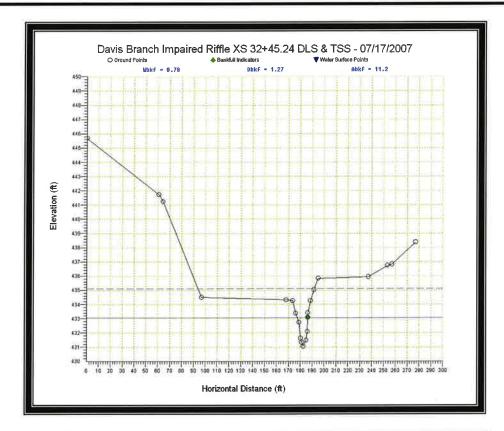
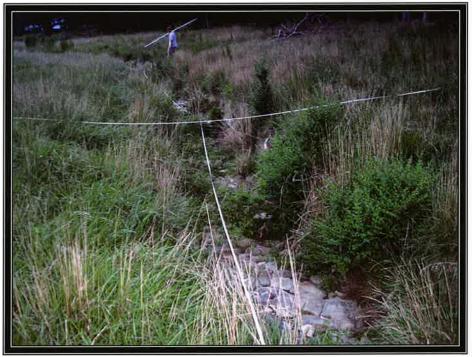
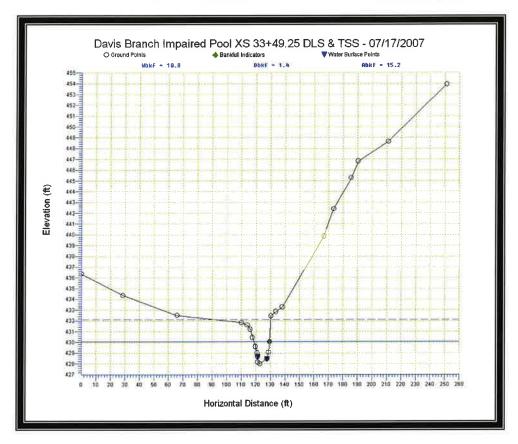
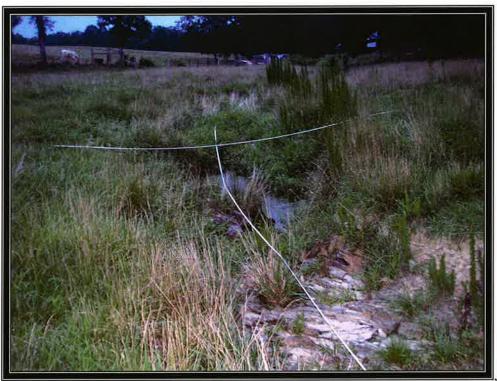
Priority Level I/II restoration approach was initially proposed as the preferred mitigation approach to restore stable boundary conditions on the lower mainstem reach. Based on a field meeting held on April 15, 2008 between EEP and EMH&T, during the design phase of the project, the mitigation approach was modified from full-scale restoration Enhancement Level I restoration along the final 1,289 l.f. Davis Branch mainstem reach, under which only profile and channel dimension would be restored. The design approach included sizing the channel based on reference reach boundary conditions and the construction of riffles and step-pools to dissipate energy and reduce bankfull flow velocities. EEP approved Priority Level I/II offline restoration approach for the 1,562 l.f. impaired mainstem reach located in a wooded corridor immediately upstream from the EI 1,289 l.f. mainstem reach located in an open meadow. Differential level survey cross-sections plots and impaired conditions photographs taken at the line of section that follow, were taken during the impaired conditions geomorphologic survey on August 17, 2007.

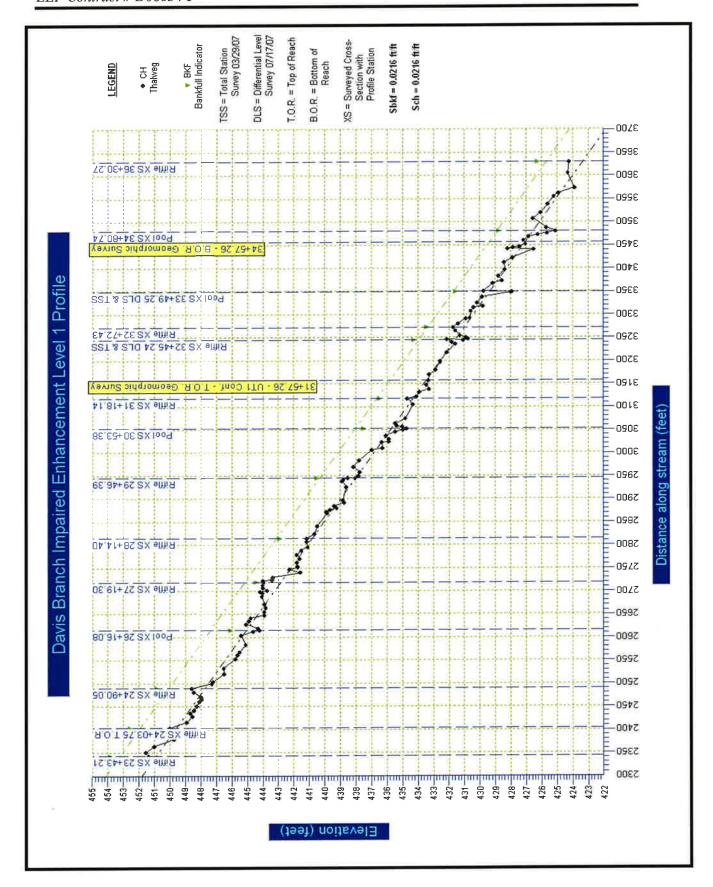
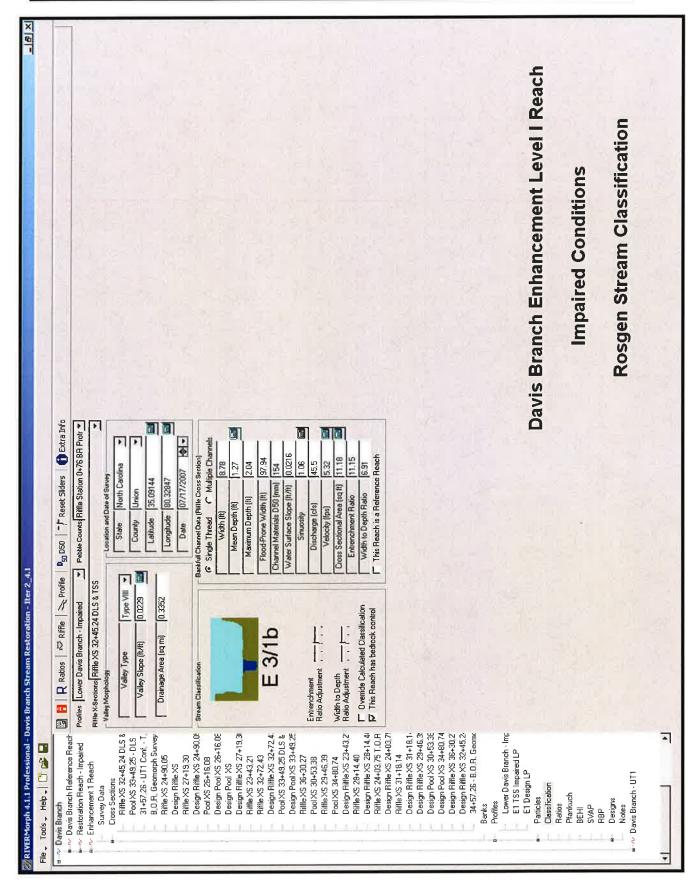
The following longitudinal profile, analyzed using RiverMorph v. 4.1.1, shows the impaired EI mainstem project reach, with locations of impaired conditions cross-sections shown on the profile. Following the impaired conditions longitudinal profile, the impaired conditions Rosgen stream channel classification, dominant substrate materials, geomorphologic parameters and hydraulic geometries from representative impaired riffle cross-section 32+45.24, surveyed in the field on July 17, 2007 are presented. Supporting impaired conditions geomorphologic and hydraulic assessment documentation is included with the information in **Appendix 3** of the Davis Branch and Unnamed Tributary Restoration Plan (EMH&T, June 2008) incorporated herein by reference.

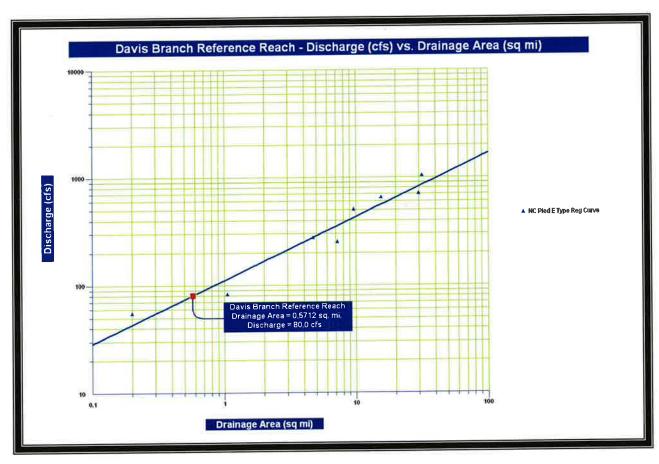
The calculated discharge, using carefully delineated reference reach drainage area, quantified reference bankfull riffle geometry, profile slope, and bed roughness yielded a bankfull discharge of 77.6 cubic feet per second (cfs). The following Discharge versus Drainage Area, Rural Piedmont Regional Curve, stratified by Rosgen E stream type analysis predicts Q_{bkf} = 80.0 cfs and validates quantified bankfull discharge calculations for the Davis Branch Reference Reach.

Since the quantitatively derived bankfull discharge of 77.6 cfs, based on carefully measured field parameters, closely matches the empirical relationships between drainage area and bankfull discharge estimates from the stratified Rosgen E stream type Rural Piedmont Regional Curve dataset, the quantitatively derived bankfull discharge was carried forward into the design, proportionally adjusted for individual project reach drainage areas. Refer to Table 2a through

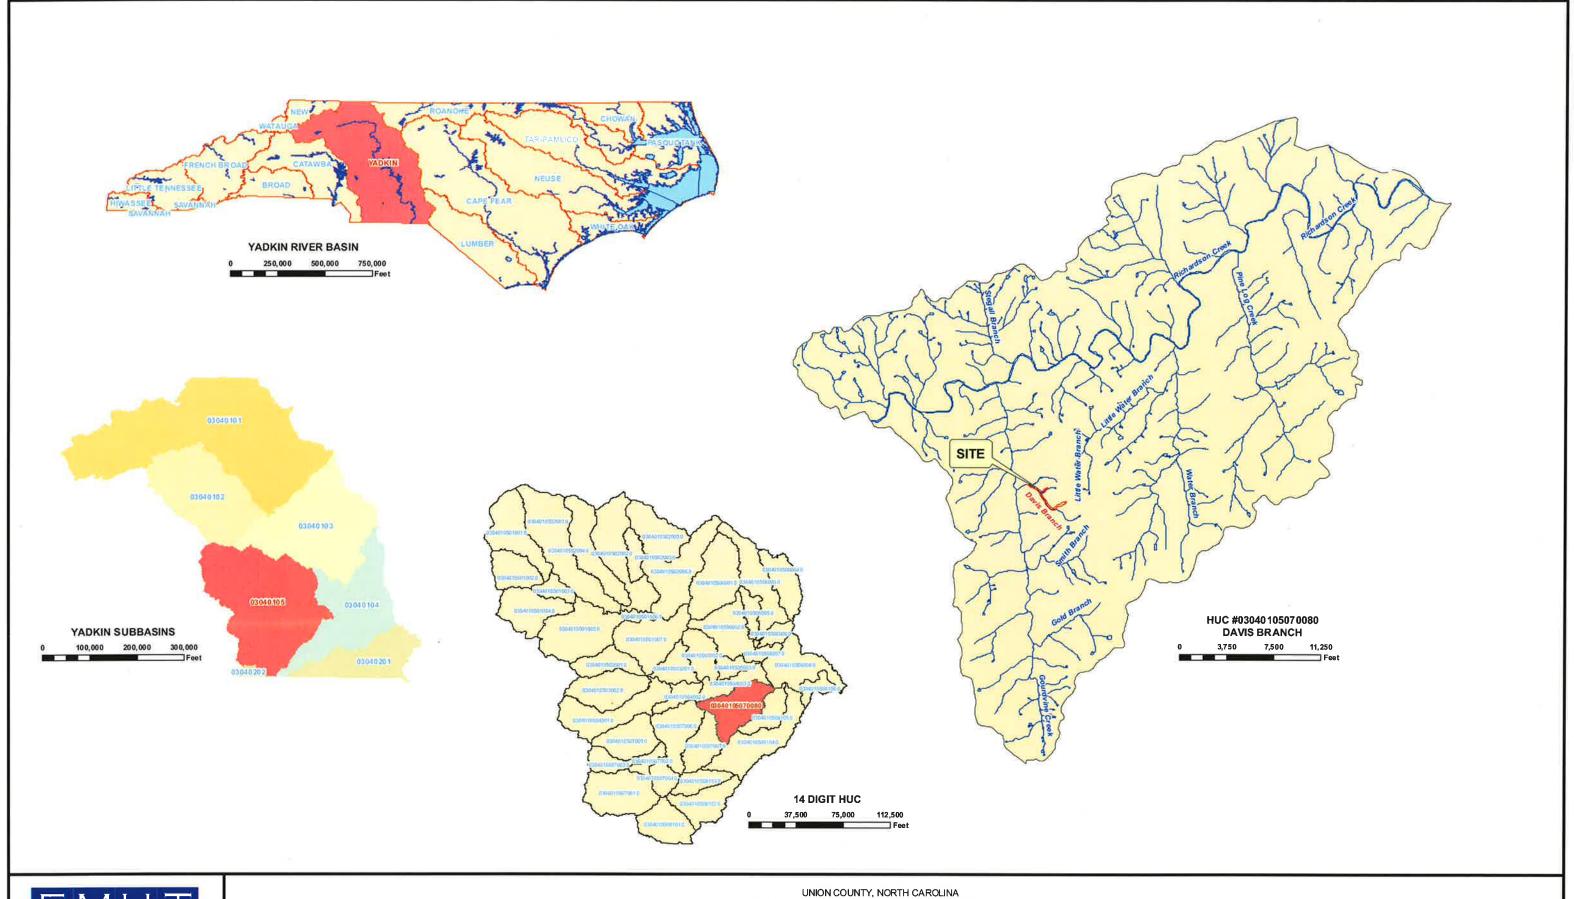
DAVIS BRANCH & UNNAMED TRIBUTARY TARGETED LOCAL WATERSHED SUBBASIN MAP FIGURE 2

- Hydrology subbasin data obtained from North Carolina Center for Geographic Information and Analysis

The Davis Branch watershed is located within the USGS 14-digit HUC watershed 03040105070080. Davis Branch is a tributary to Gourdvine Creek, to Richardson Creek to the Rocky River in the Lower Yadkin-Pee Dee River Subbasin 03-07-14, as shown on **Figure 2**. The project is not located within a North Carolina Wetland Restoration Program (WRP) targeted watershed; however, it is located immediately north of Beaverdam Creek WRP Targeted Watershed 81030. The project stream reaches are mapped on North Carolina Department of Transportation, Light Detection and Ranging (LiDAR) March 2005 coverage for Union County, North Carolina as shown on **Figure 3**.

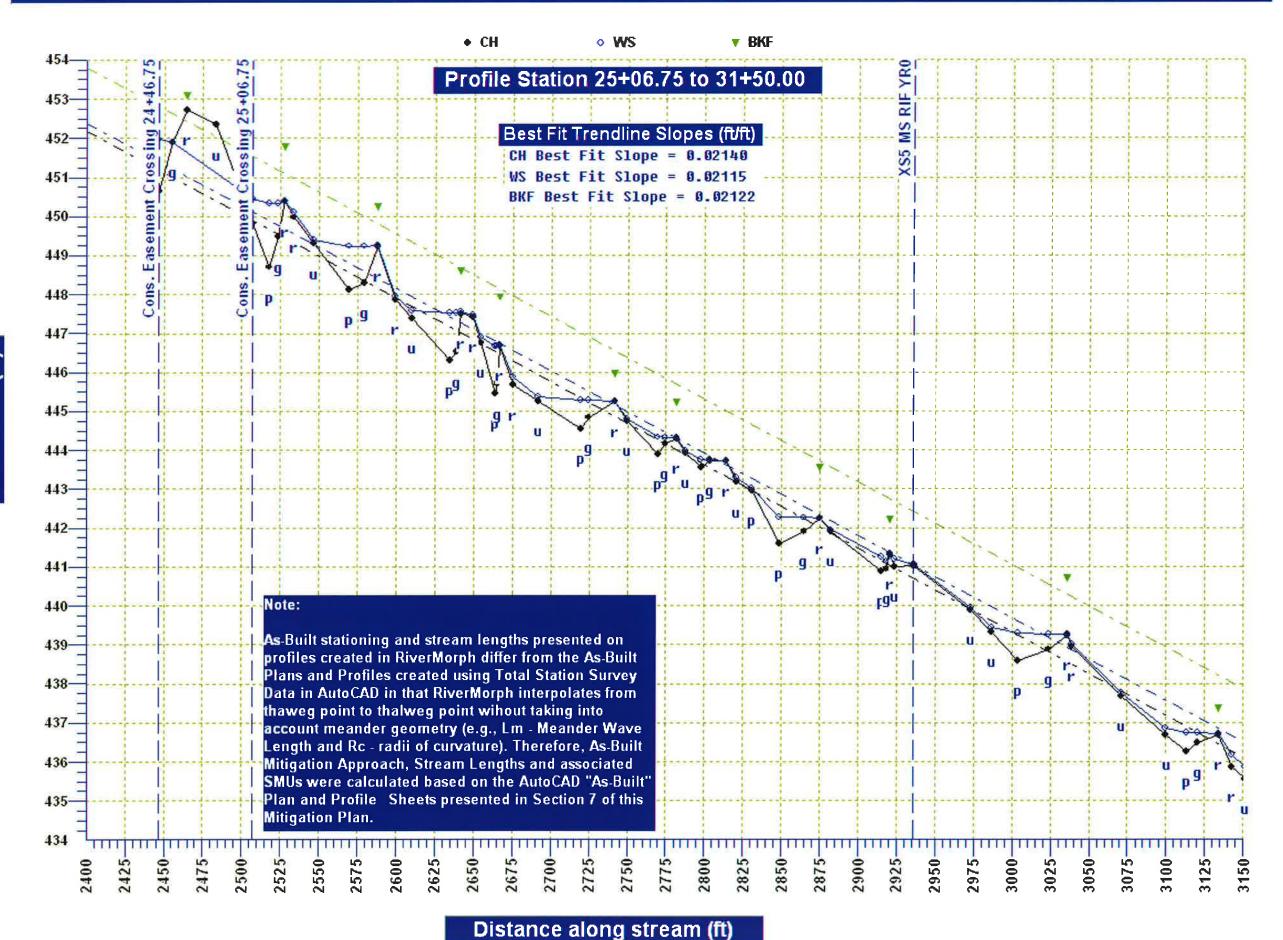
Davis Branch Mainstem - Enhancement Level 1 Reach "As-Built" - May 5, 2009

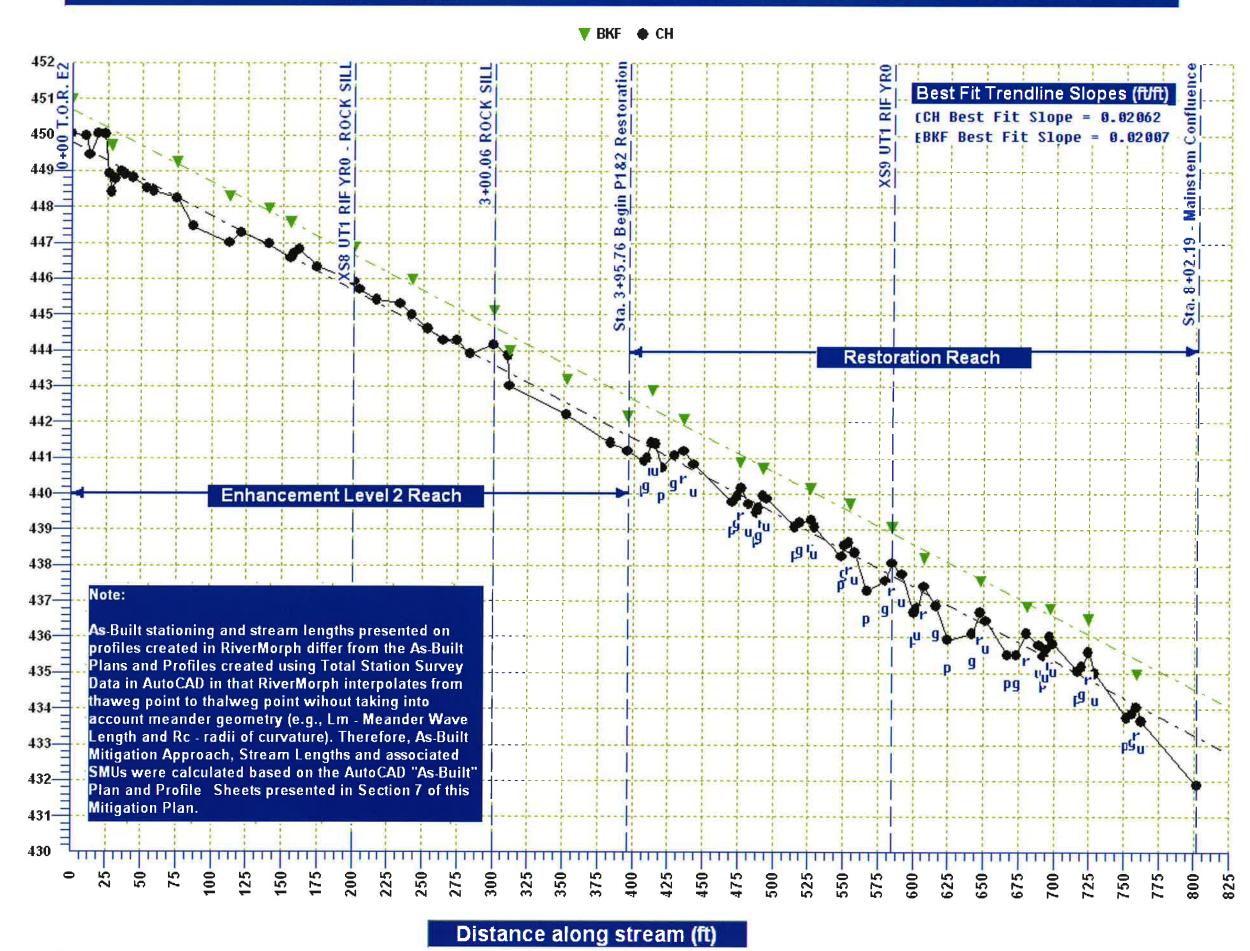
Davis Branch UT1 - As-Built Longitudinal Profile - May 5, 2009

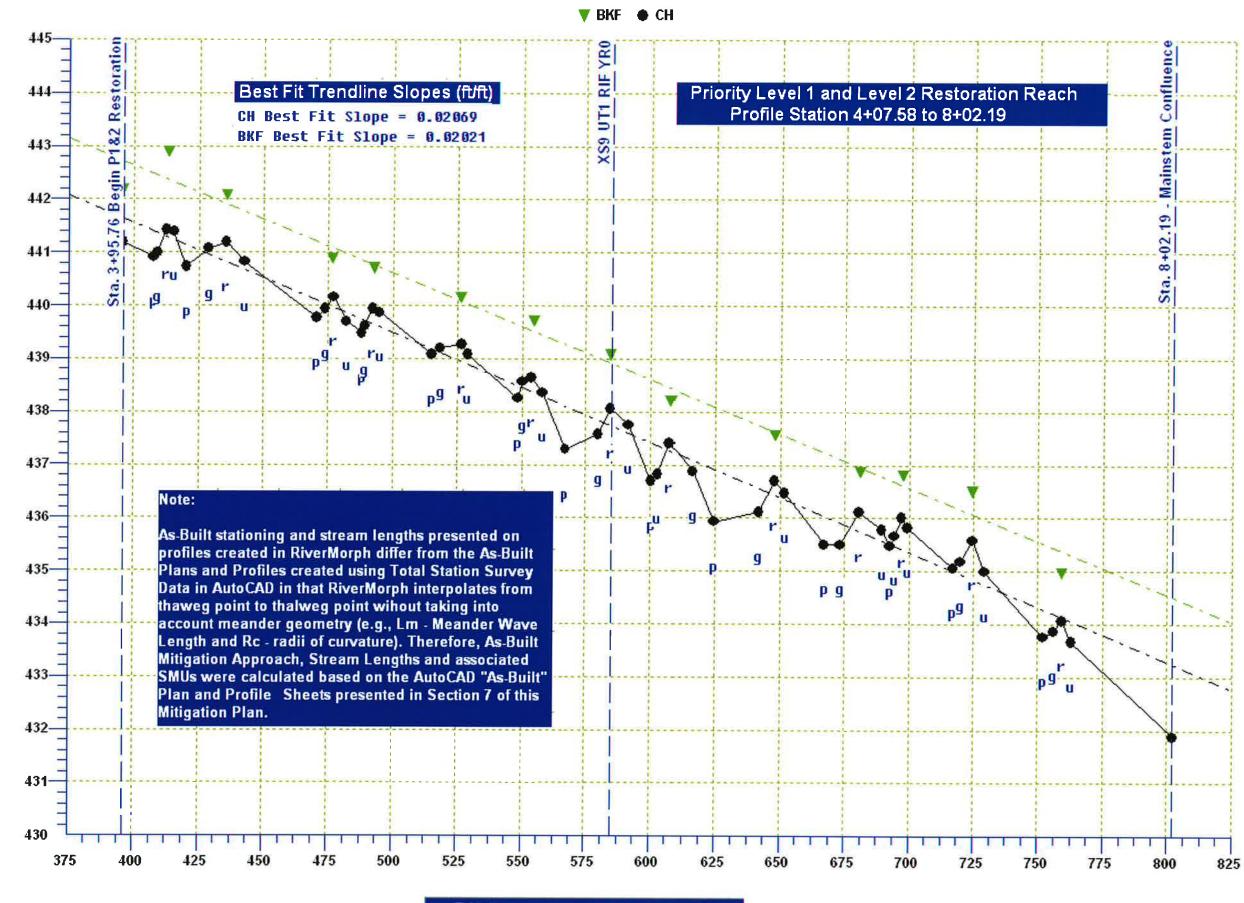
Davis Branch UT1 - As-Built Longitudinal Profile - May 5, 2009

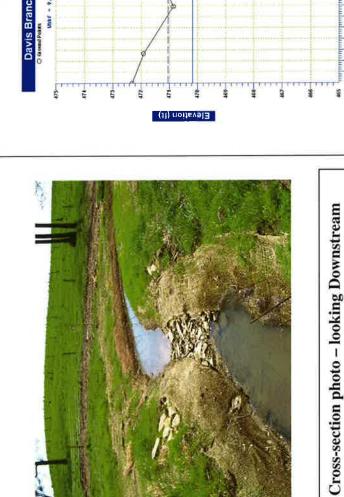
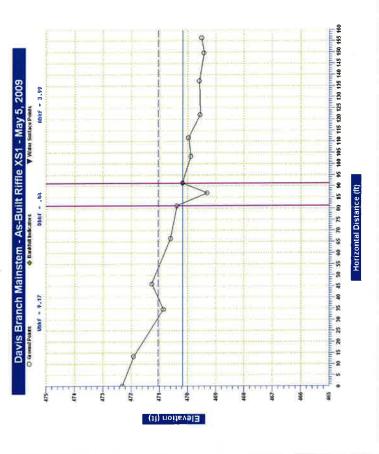
Davis Branch D06054-F 0-YEAR Riffle PROJECT Cross-Section Davis Branch CROSS SECTION: **FEATURE**: 5/5/09 REACH TASK DATE 3.99 ft² 9.17 ft 0.44 ft 0.87 ft 20.84 12.3 C4 All dimensions in feet. Entrenchment Ratio Width/Depth Ratio Maximum Depth Summary Data Bankfull Width Bankfull Area Classification Mean Depth

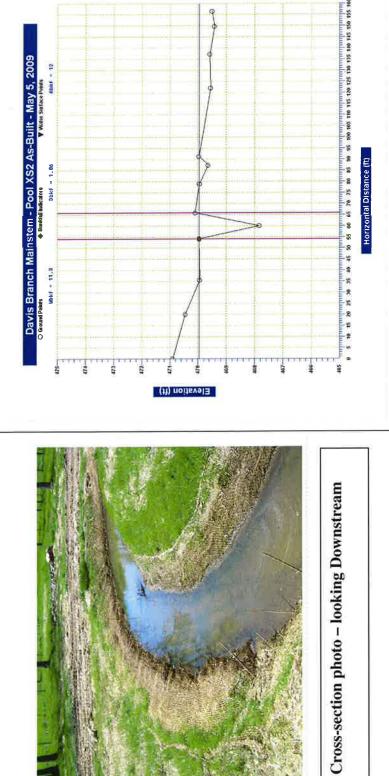
Davis Branch D06054-F 0-YEAR Pool PROJECT **Cross-Section** Davis Branch CROSS SECTION: FEATURE: 2/5/09 REACH DATE TASK 11.97 ft² 11.34 ft 1.06 ft 2.11 ft 10.7 13.8 E5 All dimensions in feet. Mean Depth Maximum Depth Width/Depth Ratio Entrenchment Ratio Summary Data Bankfull Width Bankfull Area Classification

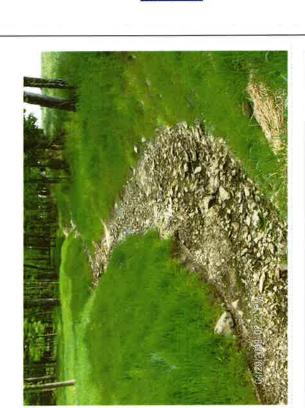
Cummony Doto			PROJECT	PROJECT Davis Branch	
Summary Data All dimensions in feet				D06054-F	
				0-YEAR	
Bankfull Area	9.98 ft^2	TASK	Cross-Section		
Bankfull Width	13.38 ft	REACH	Davis Branch		
Mean Depth	0.75 ft	DATE	5/5/09		
Maximum Depth	1.62 ft				
Width/Depth Ratio	17.84	,		9	
Entrenchment Ratio	4.71	V	SECTION:	m	
Classification	C4	Ecosystem	FEATURE	Riffle	
		Emhancement

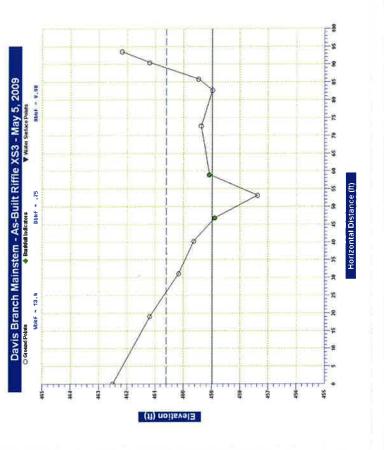
Davis Branch D06054-F 0-YEAR Pool **PROJECT Cross-Section** Davis Branch CROSS SECTION: FEATURE: 5/5/09 REACH DATE TASK 18.64 ft² 21.38 ft 0.87 ft 2.24 ft 24.57 3.15 C4 All dimensions in feet.

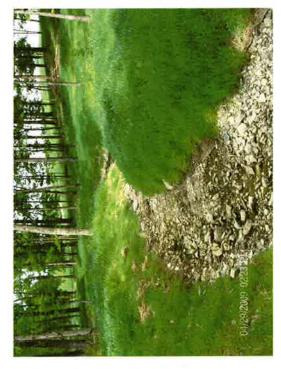
Cummont Doto			PROJECT	PROJECT Davis Branch
Summary Data All dimensions in feet				D06054-F
				0-YEAR
Bankfull Area	10.3 ft^2	TASK	Cross-Section	
Bankfull Width	17.38 ft	REACH	Davis Branch	
Mean Depth	0.59 ft	DATE	5/2/08	
Maximum Depth	1.22 ft			
Width/Depth Ratio	29.46	,		
Entrenchment Ratio	3.67	V	SECTION:	2
Classification	C4b/1	Froevetern	EE ATI IDE.	9,910
		Emhancement

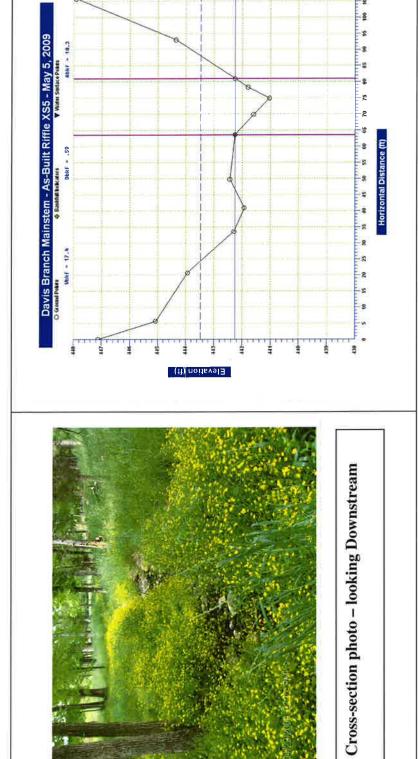
PROJECT CROSS SECTION: Cross-Section Davis Branch FEATURE: 2/5/09 REACH TASK DATE 16.75 ft² 11.81 ft 1.42 ft 2.28 ft 8.32 7.16 E4b/1 All dimensions in feet. Entrenchment Ratio Width/Depth Ratio Maximum Depth Summary Data Bankfull Width Bankfull Area Classification Mean Depth

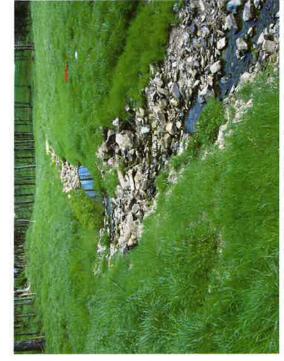
Cross-section photo - looking Upstream

Cummony Doto			PROJECT	PROJECT Davis Branch
Summary Data All dimensions in feet				D06054-F
				0-YEAR
Bankfull Area	5.45 ft ²	TASK	Cross-Section	
Bankfull Width	12.58 ft	REACH	Unnamed Trib. 1	
Mean Depth	0.43 ft	DATE	2/2/09	
Maximum Depth	0.95 ft			
Width/Depth Ratio	29.26	1		į
Entrenchment Ratio	4.01	V	CHOSS SECTION:	20
Classification	C4b	Fcosystem	FEATURE:	Riffle
		Hanancement

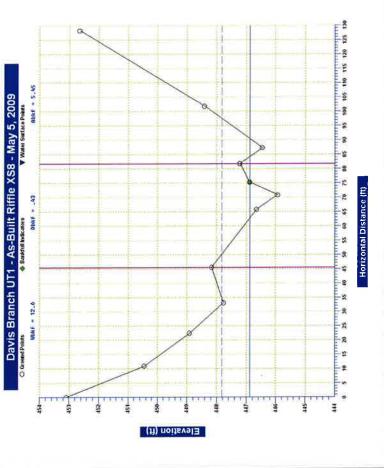
Davis Branch D06054-F 0-YEAR Riffle PROJECT CROSS SECTION: Unnamed Trib. 1 Cross-Section **FEATURE**: 2/5/09 REACH DATE TASK 5.14 ft² 12.18 ft 0.42 ft 1.02 ft 29.0 4.74 C4b All dimensions in feet. Entrenchment Ratio Maximum Depth Width/Depth Ratio Summary Data Bankfull Area Bankfull Width Classification Mean Depth

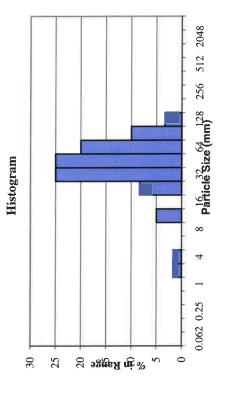
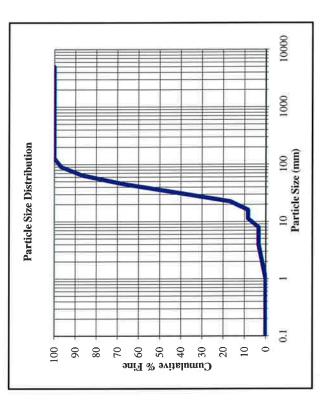
Branch &	Davis Branch & Unnamed Tributary - EEP Project No. D06054-F	- EEP Project No.	D06054-F
Reach	Mainstem	X Sec	1
Date	04/08/2009	Sta No.	12+31.44

Particle Distribution - Riffle XS-1: Sta. 12+31.44 (D50 = 36.3 mm; D84 = 61.5 mm)	Riffle XS-1: Sta. 12-	+31.44 (D	50 = 36.3 mm;	D84 = 61.5 mm
Material	Particle Size (mm)	Count	% in Range	% Cumulative
Silt/Clay	<0.062	0	0	0
Very Fine Sand	0.062-0.125	0	0	0
Fine Sand	0.125-0.25	0	0	0
Medium Sand	0.25-0.5	0	0	0
Coarse Sand	0.5-1.0	0	0	0
Very Coarse Sand	1.0-2.0	1	2	2
Very Fine Gravel	2.0-4.0	1	2	3
Fine Gravel	4.0-5.7	0	0	3
Fine Gravel	5.7-8.0	0	0	3
Medium Gravel	8.0-11.3	3	5	8
Medium Gravel	11.3-16.0	0	0	8
Coarse Gravel	16.0-22.6	5	8	17
Coarse Gravel	22.6-32	15	25	42
Very Coarse Gravel	32-45	15	25	<i>L</i> 9
Very Coarse Gravel	45-64	12	20	87
Small Cobble	64-90	9	10	26
Small Cobble	90-128	2	3	100
Large Cobble	128-180	0	0	100
Large Cobble	180-256	0	0	100
Small Boulder	256-362	0	0	100
Small Boulder	362-512	0	0	100
Medium Boulder	512-1024	0	0	100
Large Boulder	1024-2048	0	0	100
Bedrock	>2048	0	0	100
Totals	s	09	100	100

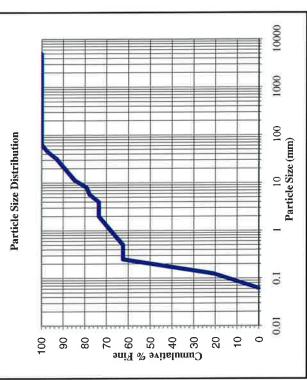
Davis Branch &	Davis Branch & Unnamed Tributary - EEP Project No. D06054-F	- EEP Project No.	. D06054-F
Reach	Mainstem	X Sec	2
Date	04/08/2009	Sta No.	12+66.55

Pebble Count - P	Pebble Count - Pool XS-2: Sta. 12+66.55 (D50 = 0.21 mm; D84	.55 (D50 = 0).21 mm; D84	= 10.9 mm)	
Material	Particle Size (mm)	Count	% in Range	% Cumulative	
Silt/Clay	<0.062	0	0	0	
Very Fine Sand	0.062-0.125	15	21	21	
Fine Sand	0.125-0.25	30	42	63	
Medium Sand	0.25-0.5	0	0	63	
Coarse Sand	0.5-1.0	4	9	89	
Very Coarse Sand	1.0-2.0	4	9	74	
Very Fine Gravel	2.0-4.0	0	0	74	
Fine Gravel	4.0-5.7	3	4	78	
Fine Gravel	5.7-8.0	1	1	62	
Medium Gravel	8.0-11.3	4	9	85	
Medium Gravel	11.3-16.0	2	3	88	
Coarse Gravel	16.0-22.6	2	3	06	L
Coarse Gravel	22.6-32	2	3	93	
Very Coarse Gravel	32-45	3	4	16	
Very Coarse Gravel	45-64	2	3	100	
Small Cobble	64-90	0	0	100	
Small Cobble	90-128	0	0	100	
Large Cobble	128-180	0	$\bar{0}$	100	
Large Cobble	180-256	0	0	100	
Small Boulder	256-362	0	0	100	
Small Boulder	362-512	0	0	100	
Medium Boulder	512-1024	0	0	100	
Large Boulder	1024-2048	0	0	100	
Bedrock	>2048	0	0	100	
Totals	als	72	100	100

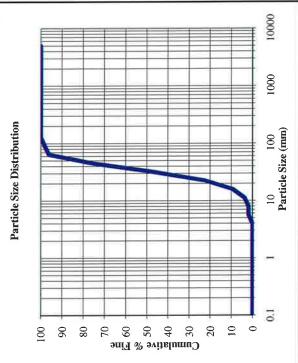
Davis Branch	Davis Branch & Unnamed Tributary - EEP Project No. D06054-F	- EEP Project No.	. D06054-F
Reach	Mainstem	X Sec	3
Date	04/08/2009	Sta No.	21+61.52

Particle Distribution -	Particle Distribution - Riffle XS-3; Sta. 21+61.52 (D50	51.52 (D50	= 33.3 mm; D	33.3 mm; D84 = 52.8 mm)	Davi
Material	Particle Size (mm)	Count	% in Range	% Cumulative	
Silt/Clay	<0.062	0	0	0	
Very Fine Sand	0.062-0.125	0	0	0	
Fine Sand	0.125-0.25	0	0	0	30
Medium Sand	0.25-0.5	0	0	0	8
Coarse Sand	0.5-1.0	0	0	0	C7 S
Very Coarse Sand	1.0-2.0	0	0	0	ge 20
Very Fine Gravel	2.0-4.0	0	0	0	Rank
Fine Gravel	4.0-5.7	1	2	2	₽ %
Fine Gravel	5.7-8.0	0	0	2	5
Medium Gravel	8.0-11.3	1	2	4	0
Medium Gravel	11.3-16.0	3	9	6	
Coarse Gravel	16.0-22.6	7	13	23	L
Coarse Gravel	22.6-32	13	25	47	
Very Coarse Gravel	32-45	15	28	75	
Very Coarse Gravel	45-64	11	21	96	
Small Cobble	64-90	1	2	86	
Small Cobble	90-128	1	2	100	ət
Large Cobble	128-180	0	0	100	ıi∄ %
Large Cobble	180-256	0	0	100	eviti
Small Boulder	256-362	0	0	100	3[nwi
Small Boulder	362-512	0	0	100	r)
Medium Boulder	512-1024	0	0	100	
Large Boulder	1024-2048	0	0	100

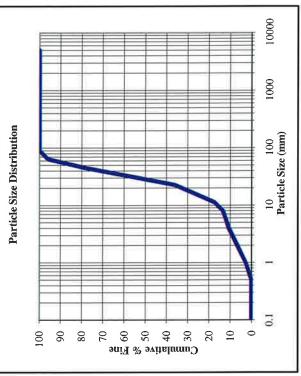
Davis Branch	Davis Branch & Unnamed Tributary - EEP Project No. D06054-F	- EEP Project No.	. D06054-F
Reach	Mainstem	X Sec	4
Date	04/08/2009	Sta No.	21+85.85

Particle Distribution - Pool XS-4: Sta. 21+85.85 (D50 = 28.8 mm; D84 = 50.8 mm)	- Pool XS-4: Sta. 21+	85.85 (D50	= 28.8 mm; D	84 = 50.8 mm
Material	Particle Size (mm)	Count	% in Range	% Cumulative
Silt/Clay	<0.062	0	0	0
Very Fine Sand	0.062-0.125	0	0	0
Fine Sand	0.125-0.25	0	0	0
Medium Sand	0.25-0.5	0	0	0
Coarse Sand	0.5-1.0	2	3	3
Very Coarse Sand	1.0-2.0	3	4	7
Very Fine Gravel	2.0-4.0	3	4	11
Fine Gravel	4.0-5.7	1	1	12
Fine Gravel	5.7-8.0	1	1	13
Medium Gravel	8.0-11.3	3	4	17
Medium Gravel	11.3-16.0	7	6	27
Coarse Gravel	16.0-22.6	7	6	36
Coarse Gravel	22.6-32	16	21	57
Very Coarse Gravel	32-45	16	21	62
Very Coarse Gravel	45-64	13	17	96
Small Cobble	64-90	3	4	001
Small Cobble	90-128	0	0	100
Large Cobble	128-180	0	0	100
Large Cobble	180-256	0	0	100
Small Boulder	256-362	0	0	100
Small Boulder	362-512	0	0	100
Medium Boulder	512-1024	0	0	100
Large Boulder	1024-2048	0	0	100
Bedrock	>2048	0	0	100
Totals	als	75	100	100

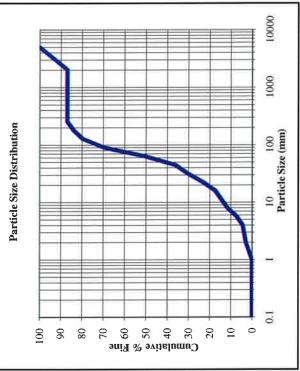
Davis Branch	Davis Branch & Unnamed Tributary - EEP Project No. D06054-F	- EEP Project No.	D06054-F
Reach	Mainstem	X Sec	5
Date	04/08/2009	Sta No.	29+36.09

Particle Distribution	Particle Distribution - Riffle XS-5: Sta. $29+36.09$ ($\overline{D50} = 63.1$ mm; $\overline{D84} = 179.3$ mm)	86.09 (D50	= 63.1 mm; D8	4 = 179.3 mm)	Davis
Material	Particle Size (mm)	Count	% in Range	% Cumulative	Ä
Silt/Clay	<0.062	0	0	0	
Very Fine Sand	0.062-0.125	0	0	0	
Fine Sand	0.125-0.25	0	0	0	ć
Medium Sand	0.25-0.5	0	0	0	07 81
Coarse Sand	0.5-1.0	0	0	0	16
Very Coarse Sand	1.0-2.0	2	3	3	4 3)
Very Fine Gravel	2.0-4.0	1	1	4	र् <mark>ध</mark> ार
Fine Gravel	4.0-5.7	2	3	7	oni.e%
Fine Gravel	5.7-8.0	3	4	12	4 0
Medium Gravel	8.0-11.3	2	3	14	0 7
Medium Gravel	11.3-16.0	2	3	17	
Coarse Gravel	16.0-22.6	4	9	23	Į
Coarse Gravel	22.6-32	5	7	30	
Very Coarse Gravel	32-45	4	9	36	
Very Coarse Gravel	45-64	10	14	51	
Small Cobble	64-90	13	19	70	
Small Cobble	90-128	7	10	80	
Large Cobble	128-180	3	4	84	
Large Cobble	180-256	2	3	87	
Small Boulder	256-362	0	0	87	
Small Boulder	362-512	0	0	87	
Medium Boulder	512-1024	0	0	87

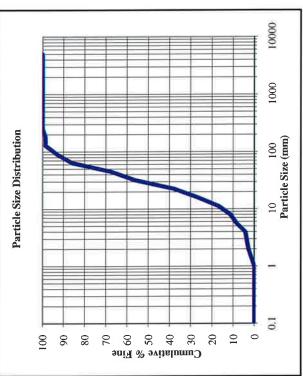
Davis Branch	Davis Branch & Unnamed Tributary - EEP Project No. D06054-F	- EEP Project No.	. D06054-F
Reach	UT-1	X Sec	8
Date	04/08/2009	Sta No.	2+00.10

Particle Distribu	Particle Distribution - Riffle XS-8: Sta. $2+00.10 \text{ (D50} = 28.8 \text{ mm; D84} = 62.0 \text{ mm})$	2+00.10 (D50	= 28.8 mm; D84	= 62.0 mm)	Davis Branc
Material	Particle Size (mm)	Count	% in Range	% Cumulative	Reach
Silt/Clay	<0.062	0	0	0	Date
Very Fine Sand	0.062-0.125	0	0	0	j.
Fine Sand	0.125-0.25	0	0	0	00
Medium Sand	0.25-0.5	0	0	0	18
Coarse Sand	0.5-1.0	0	0	0	16
Very Coarse Sand	1.0-2.0	2	3	3	. 3s
Very Fine Gravel	2.0-4.0	1	1	4	Ran
Fine Gravel	4.0-5.7	3	4	8	uj.%
Fine Gravel	5.7-8.0	2	3	111	4 6
Medium Gravel	8.0-11.3	4	9	17	0
Medium Gravel	11.3-16.0	7	10	27	0.062 0.
Coarse Gravel	16.0-22.6	8	11	38	
Coarse Gravel	22.6-32	13	18	56	
Very Coarse Gravel	32-45	8	11	89	<u> </u>
Very Coarse Gravel	45-64	13	18	98	8 8
Small Cobble	64-90	2	7	93	08
Small Cobble	90-128	4	9	66	- 0 <i>L</i> "
Large Cobble	128-180	0	0	66	Fine 6
Large Cobble	180-256	1	1	100	% 9vi
Small Boulder	256-362	0	0	100	tislun 6

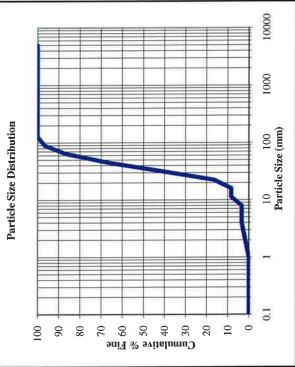
Davis Branch &	Davis Branch & Unnamed Tributary - EEP Project No. D06054-F	- EEP Project No.	D06054-F	
Reach	UT-1	X Sec	6	
Date	04/08/2009	Sta No.	5+84.56

Particle Distrib	Particle Distribution - Riffle XS-9; Sta. 5+84.56 (D50 = 38.5 mm; D84 = 91.0 mm)	. 5+84.56 (D	50 = 38.5 mm; D	84 = 91.0 mm)	Davis Branch	Davis Branch & Unnamed Tributa
Material	Particle Size (mm)	Count	% in Range	% Cumulative	Reach	UT-1
Silt/Clay	<0.062	0	0	0	Date	04/08/2009
Very Fine Sand	0.062-0.125	0	0	0		
Fine Sand	0.125-0.25	0	0	0	30	His
Medium Sand	0.25-0.5	0	0	0	OC :	
Coarse Sand	0.5-1.0	0	0	0	25	
Very Coarse Sand	1.0-2.0	1	2	2	£ 50	
Very Fine Gravel	2.0-4.0	3	5	9	इक्तस्थ	
Fine Gravel	4.0-5.7	0	0	9	uP%	
Fine Gravel	5.7-8.0	7	11	18	% ·~	
Medium Gravel	8.0-11.3	9	10	27		
Medium Gravel	11.3-16.0	4	9	34	0.062 0.25	1 4 8 16
Coarse Gravel	16.0-22.6	2	3	37		-
Coarse Gravel	22.6-32	5	8	45		Particle Size
Very Coarse Gravel	32-45	9	10	55	001	
Very Coarse Gravel	45-64	13	21	92	06	
Small Cobble	64-90	5	8	84	08	
Small Cobble	90-128	3	5	68	6 70	
Large Cobble	128-180	7	11	100	ni'I &	
Large Cobble	180-256	0	0	100	S svil
