**Dog Bite Stream Restoration Site
Monitoring Report – MY02
Mitchell County, NC
Basin 06010108 - Contract # D06056-A**

December 2011

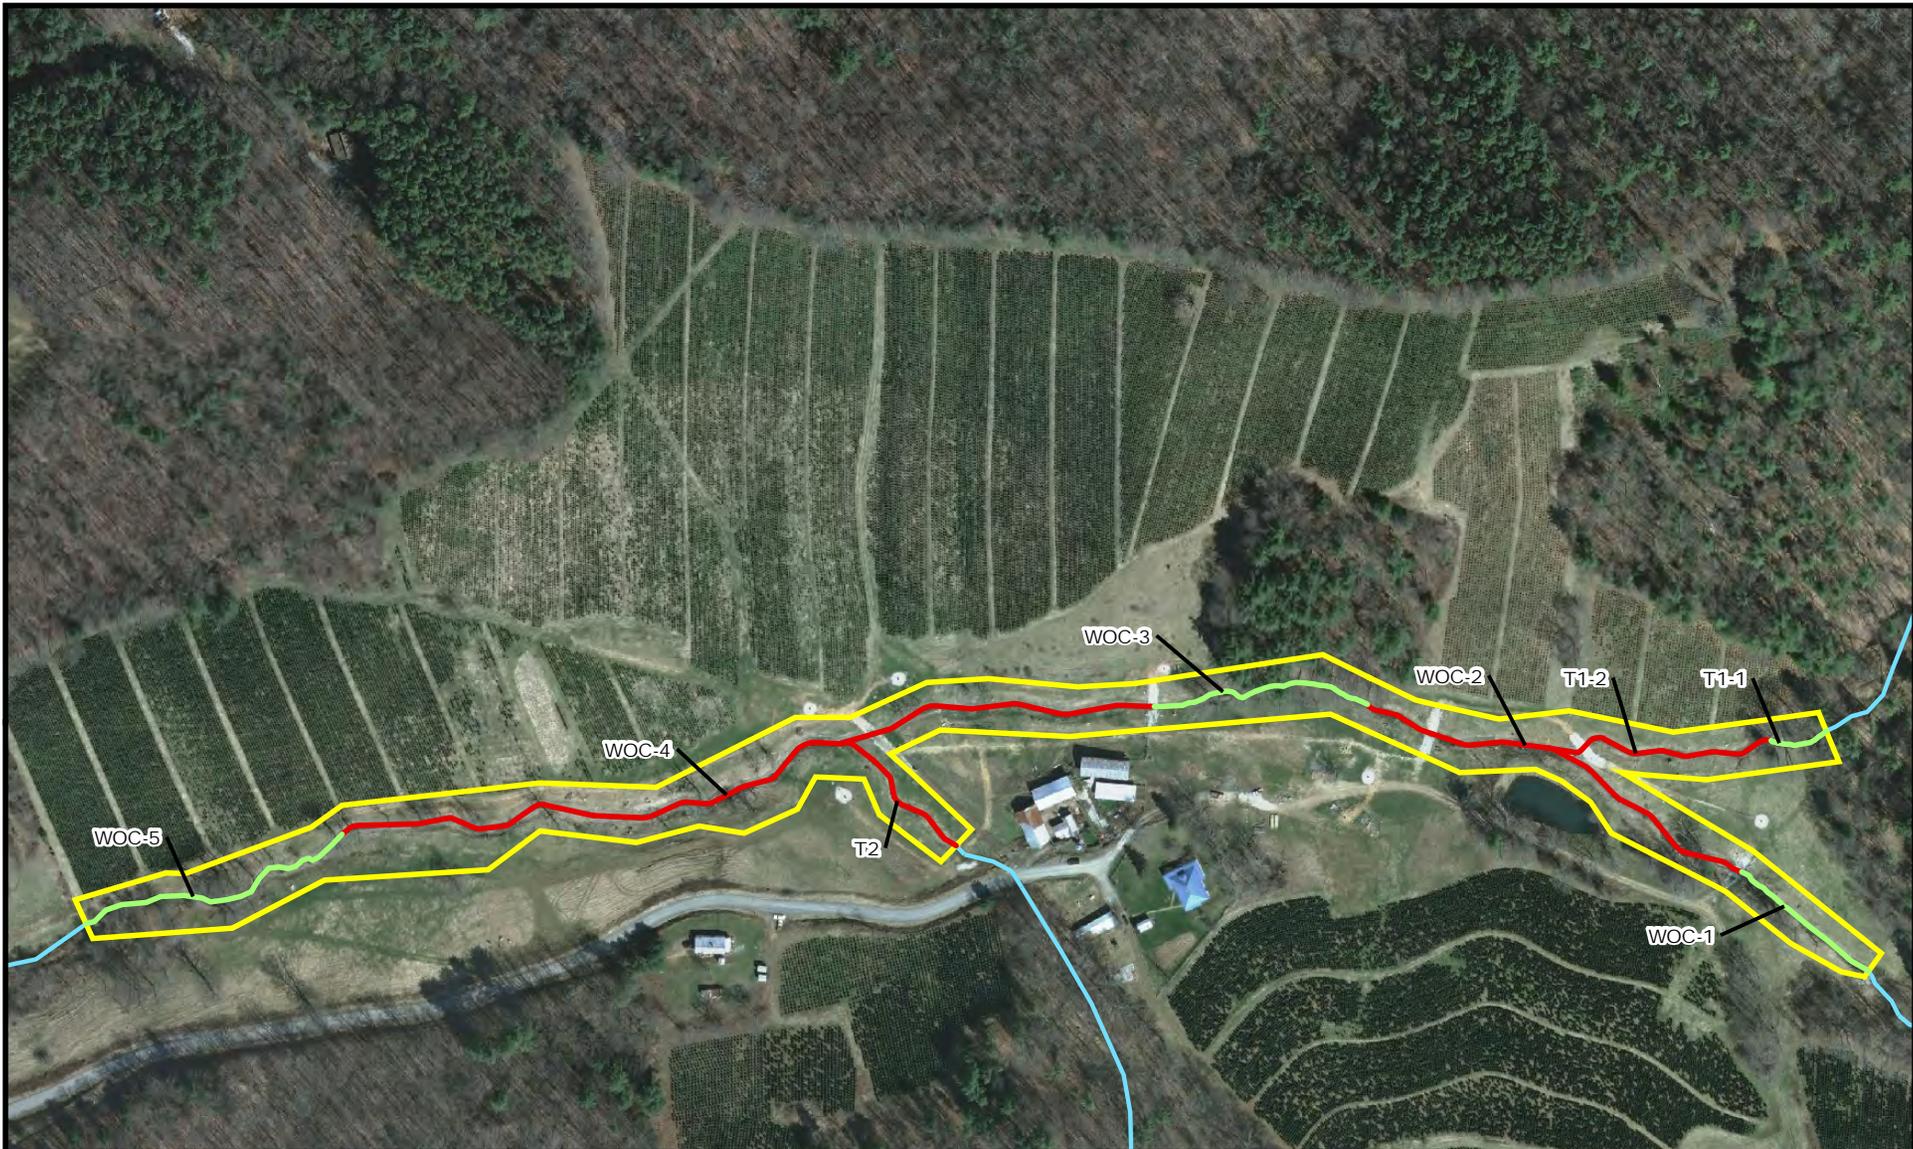
Figure 2. Site Map

Project Easement Boundary
-

Enhancement I Reach
-

Restoration Reach
-

Other Streams

The Dog Bite Site is located at the end of Wilson Dairy Road in central Mitchell County, North Carolina (Figure 1). The project is centered at approximately 35.9956 degrees north and -82.1302 degrees west (WGS84). To reach the site from Raleigh, begin by proceeding west on I-40 for approximately 200 miles. Then take Exit 86 for NC-226 toward Shelby/Marion. Take a right onto NC-226, traveling north. Follow NC-226 through Marion and Spruce Pine. Just before reaching Bakersville, make a right onto White Oak Road. Follow White Oak Road for approximately 1.5 miles and then make a left onto Wilson Dairy Road. The road will dead end at the Wilson property and the site is on the left. Due to the close proximity of the landowner's residence to the property, the landowner has asked to be contacted before any site visits are made.

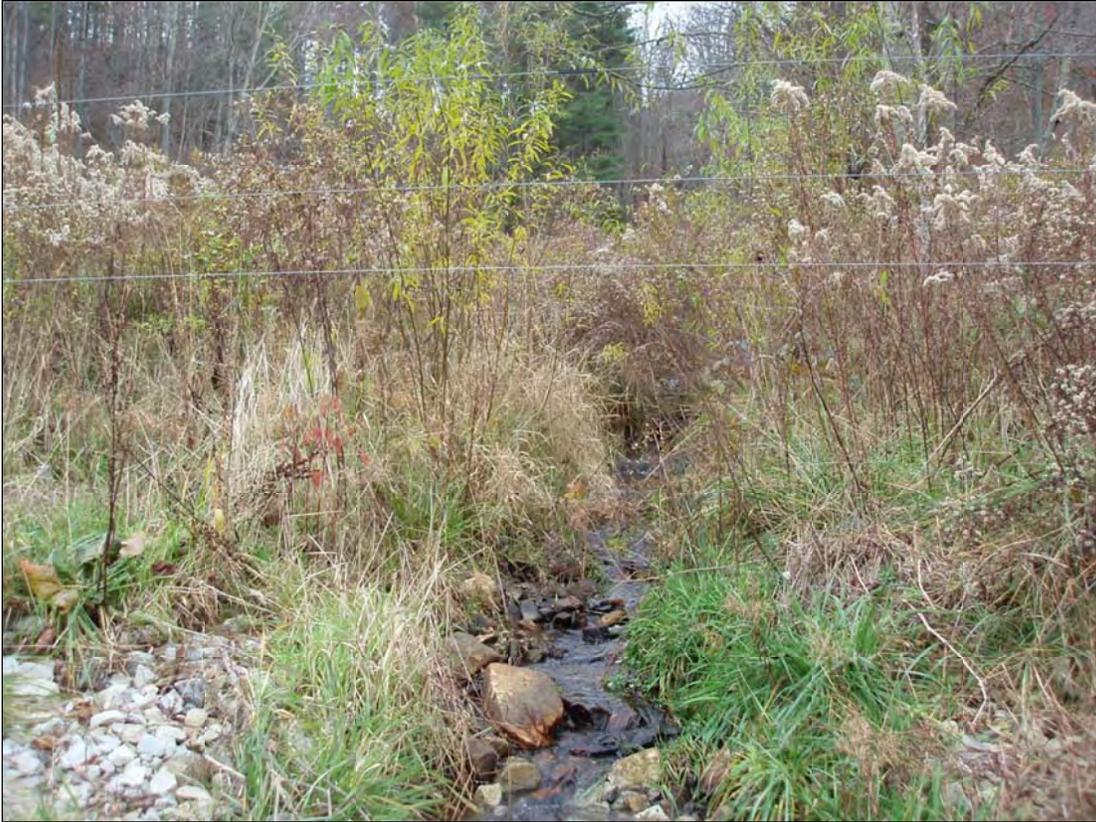
Photo Point 1: View looking upstream, from ford crossing near Station 12+50. 11/9/11 – MY02

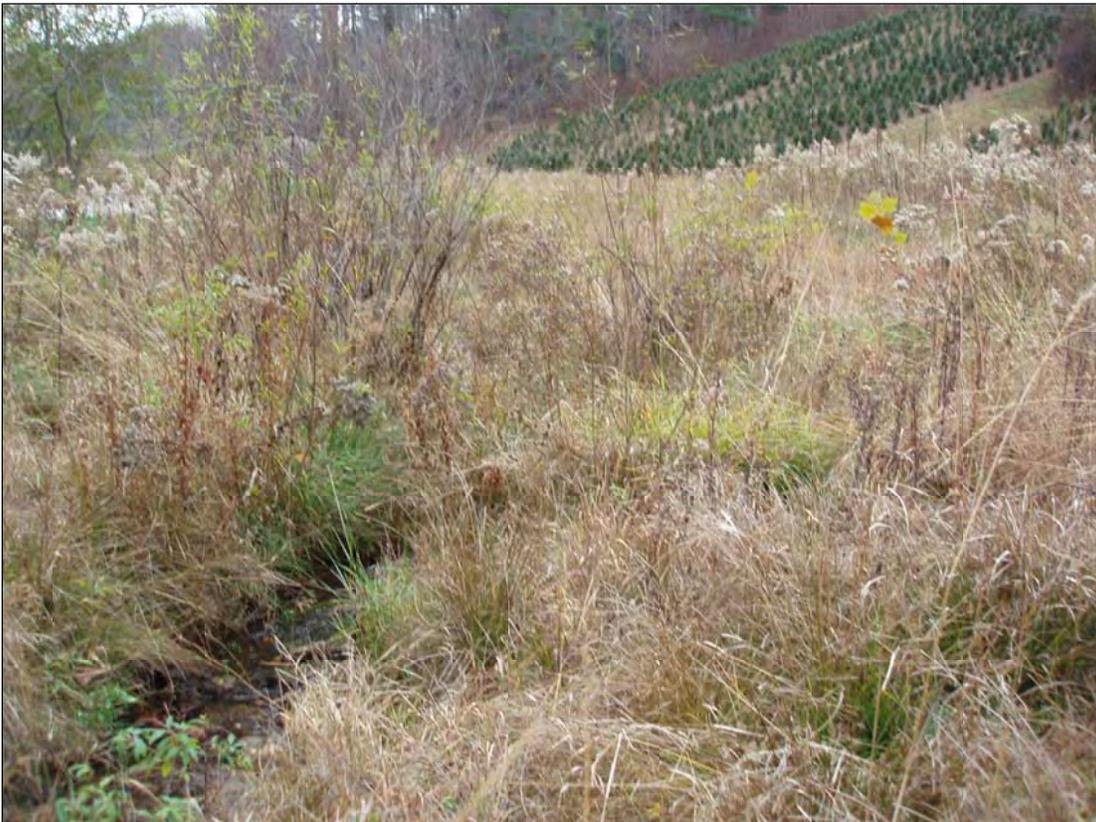
Photo Point 2: View looking downstream, near Station 14+00. 11/9/11 – MY02

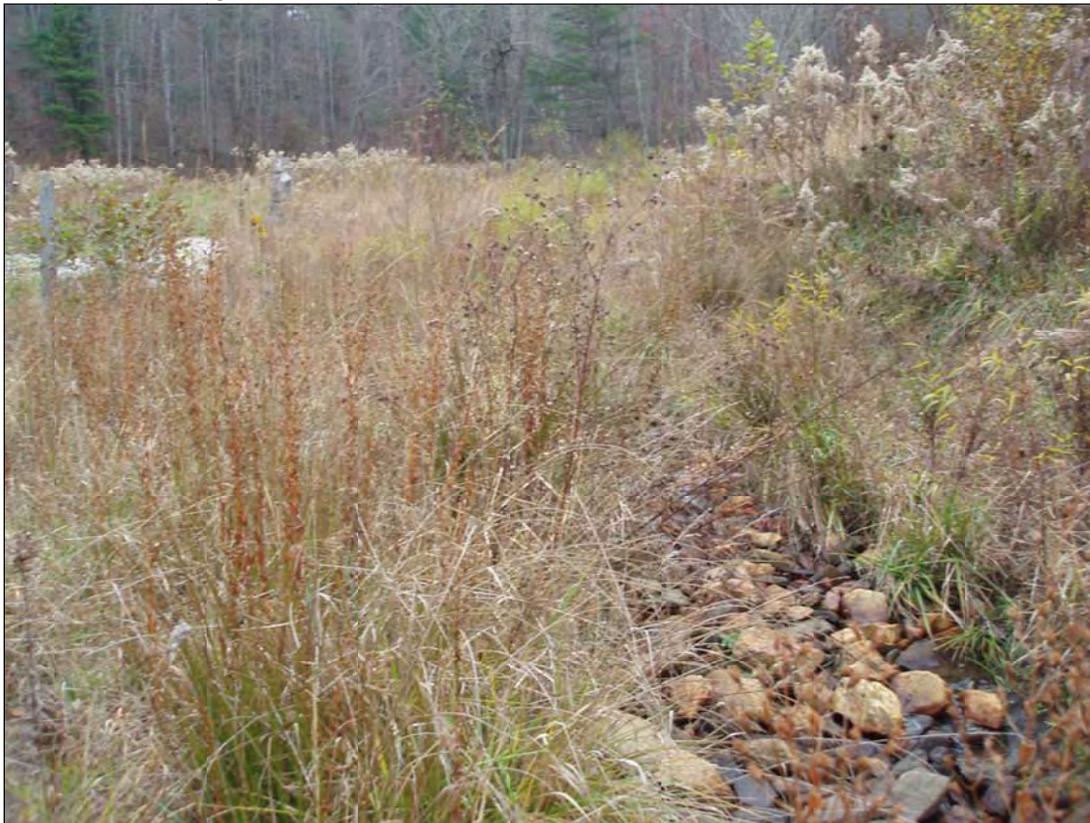
Photo Point 3: View looking upstream at the confluence of WOC and T1. 11/9/11 – MY02

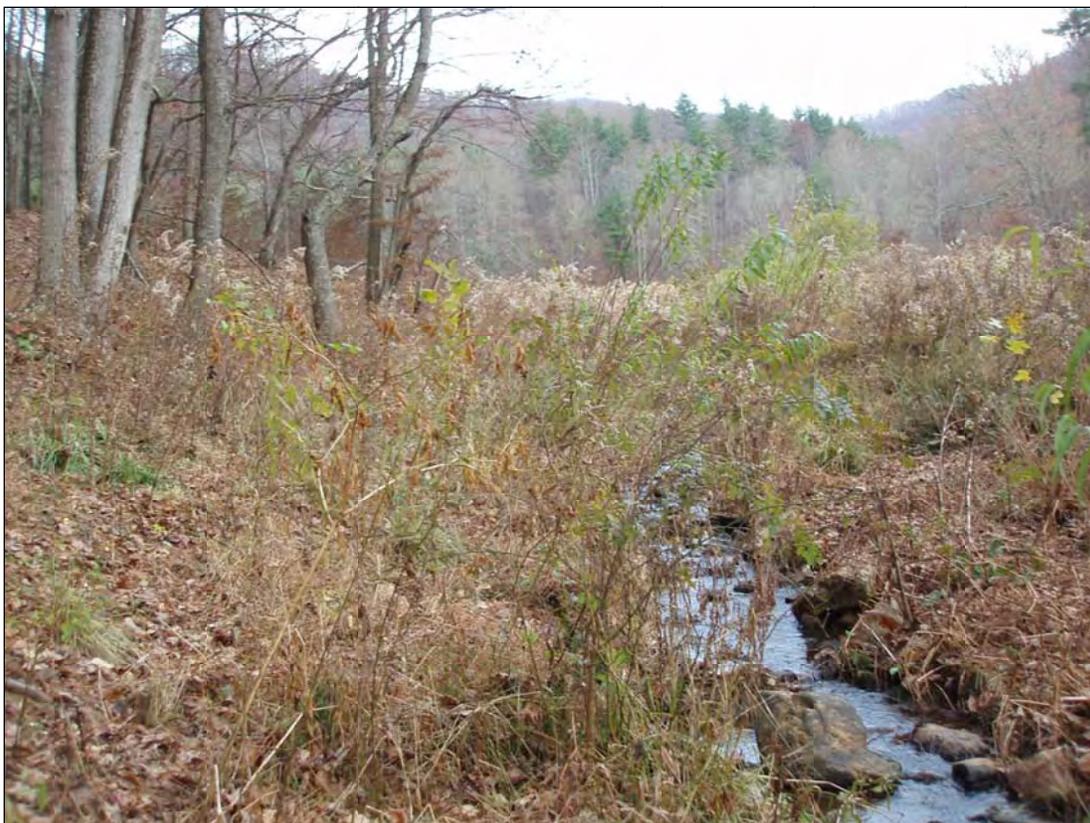
Photo Point 4: View looking upstream taken near Station 20+50. 11/9/11 – MY02

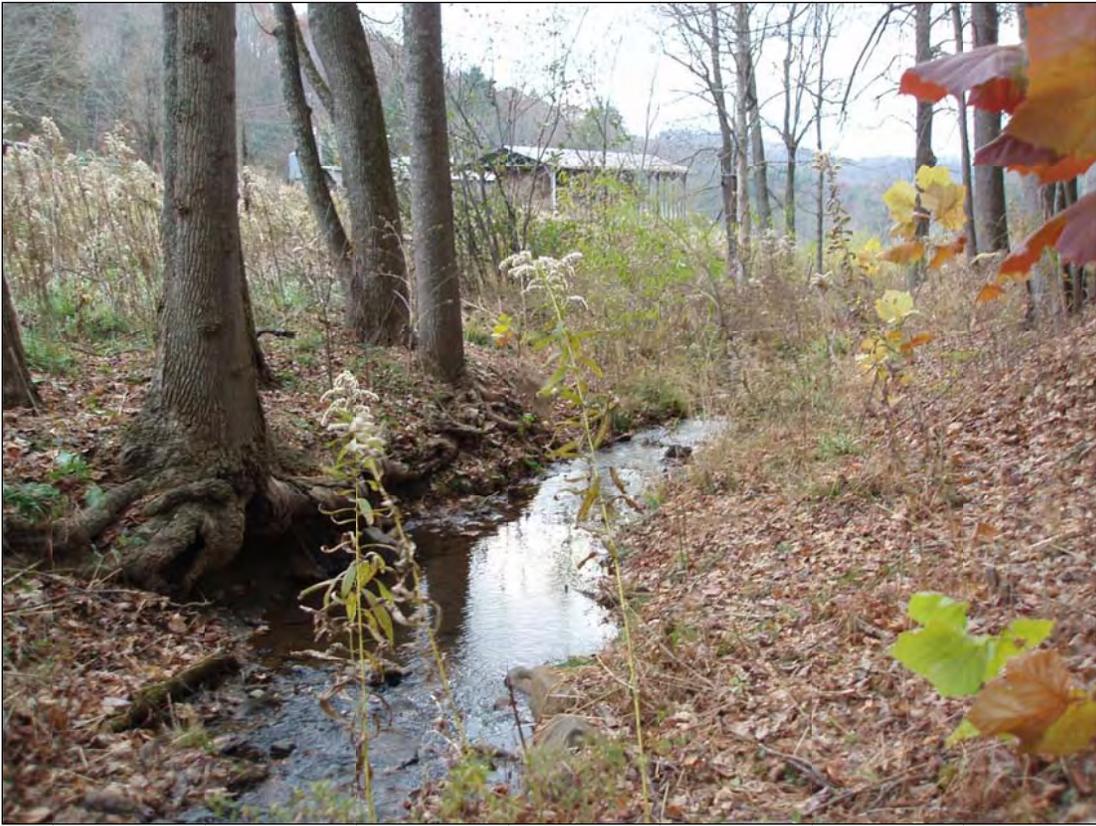
Photo Point 4: View looking downstream near Station 20+50. 11/9/11 – MY02

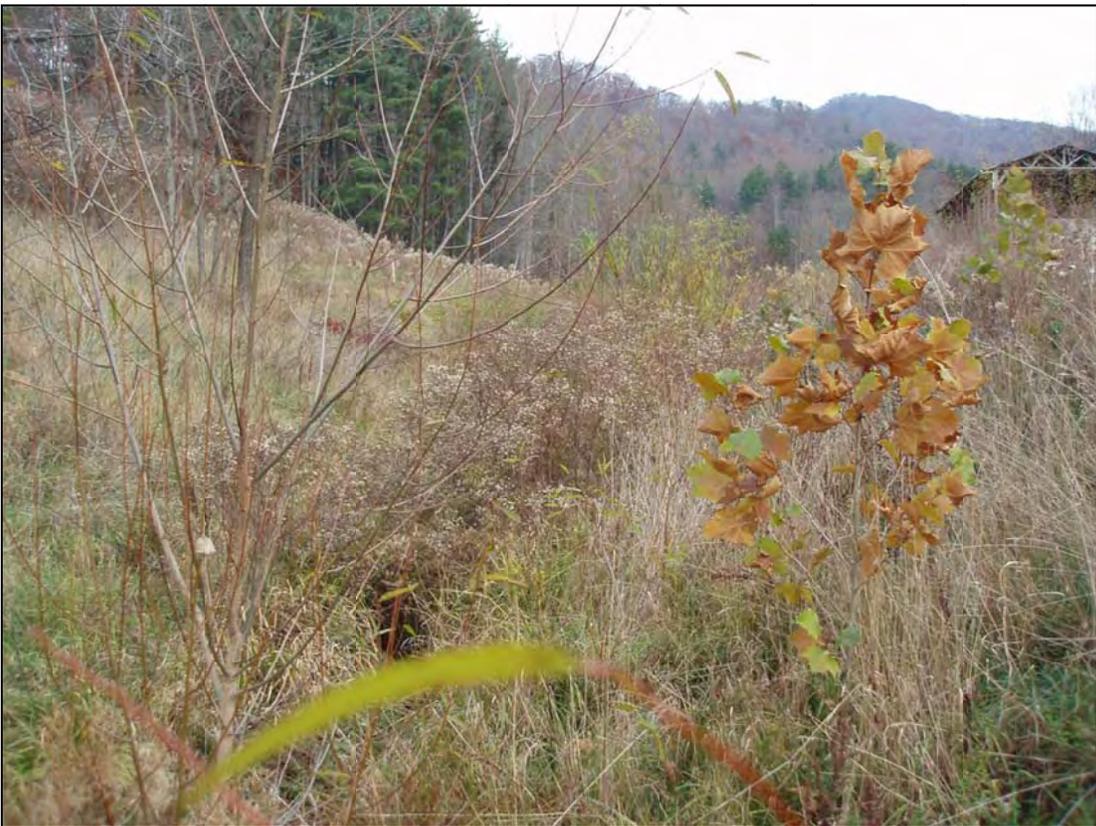
Photo Point 5: View looking upstream at WOC, near Station 26+25. 11/9/11 – MY02

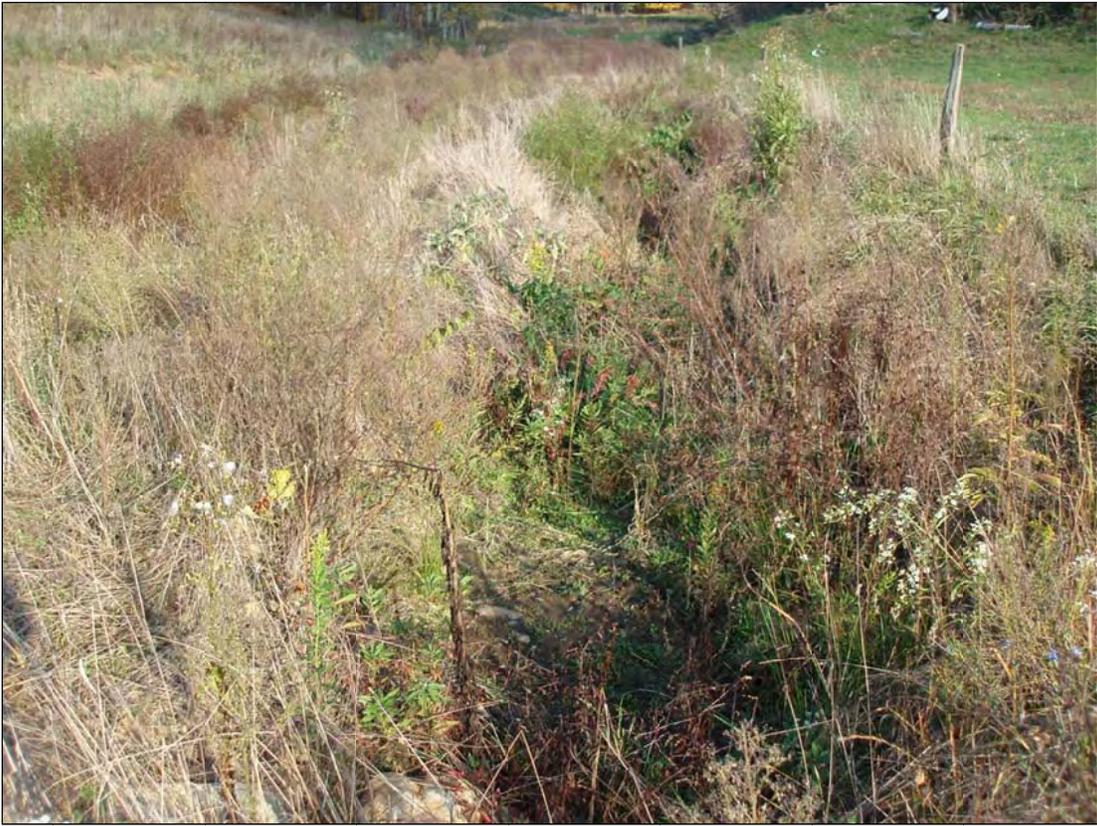
Photo Point 5: View looking at water treatment pool, near Station 26+25. 11/9/11 – MY02

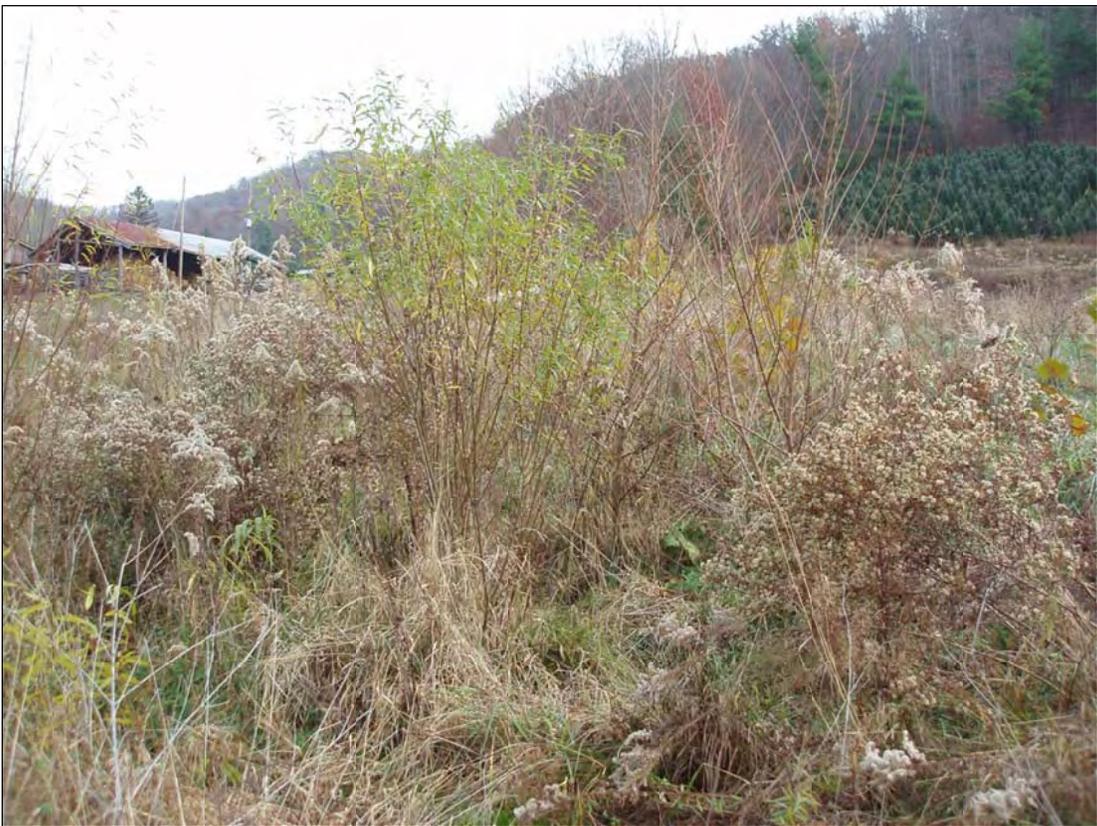
Photo Point 6: View looking upstream at T2, near Station 27+75. 11/9/11 – MY02

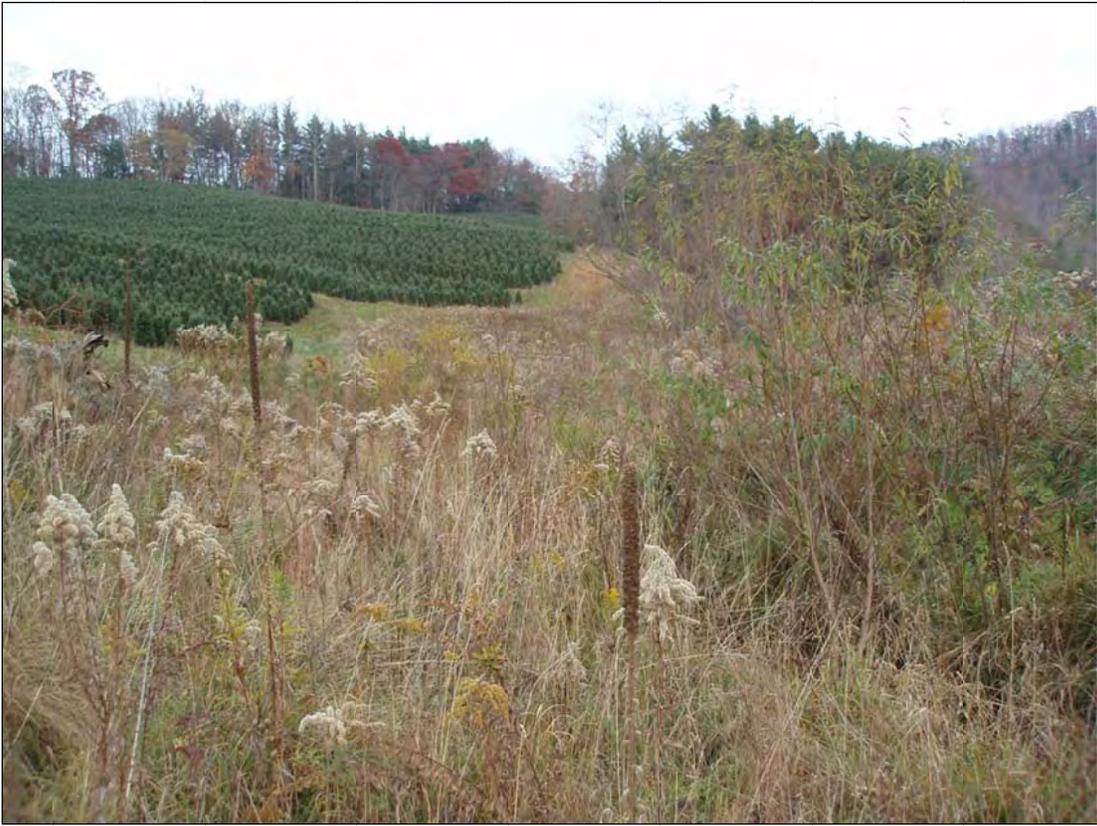
Photo Point 7: View looking upstream near Station 29+25. 11/9/11 – MY02

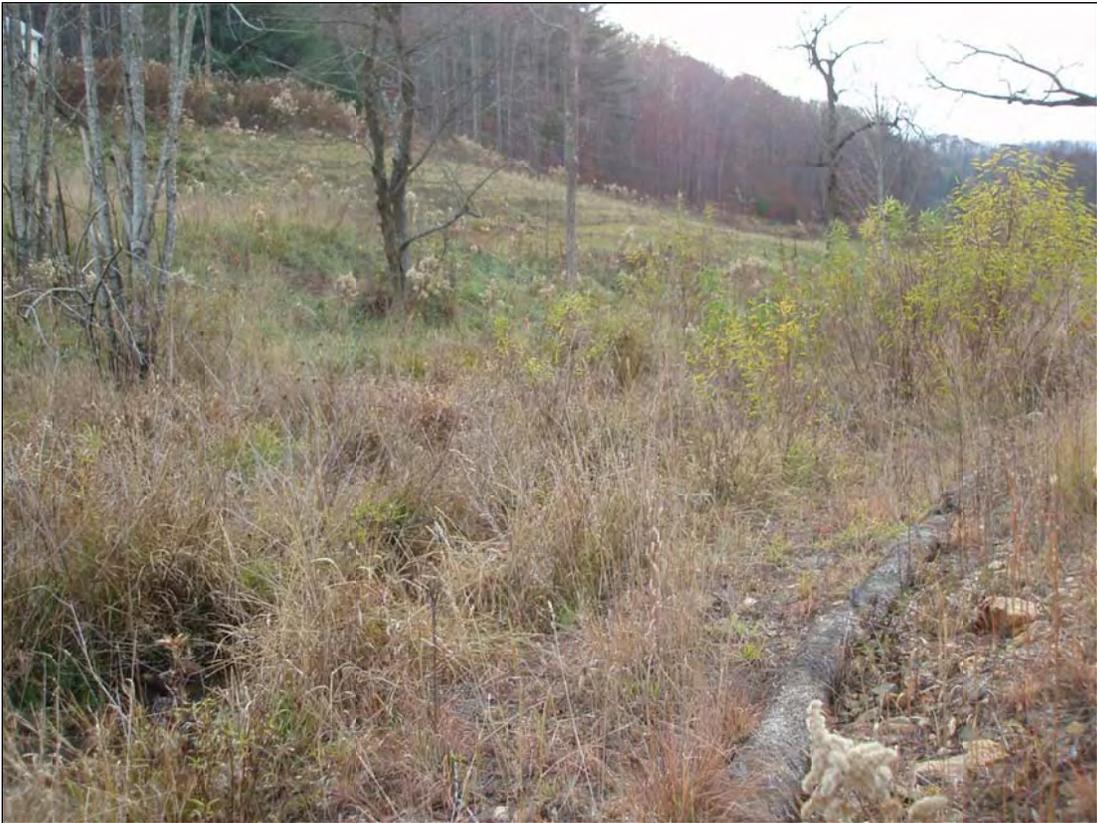
Photo Point 7: View looking downstream near Station 29+25. 11/9/11 – MY02

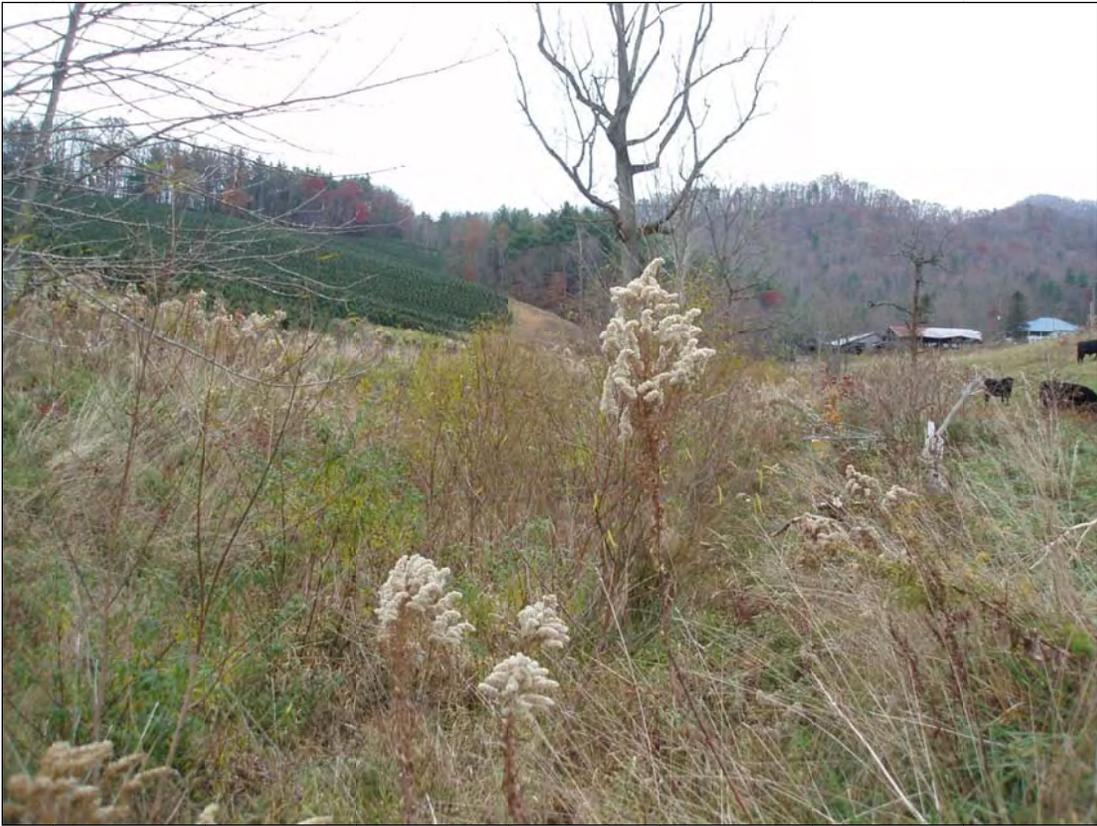
Photo Point 8: View looking upstream near Station 34+00. 11/9/11 – MY02

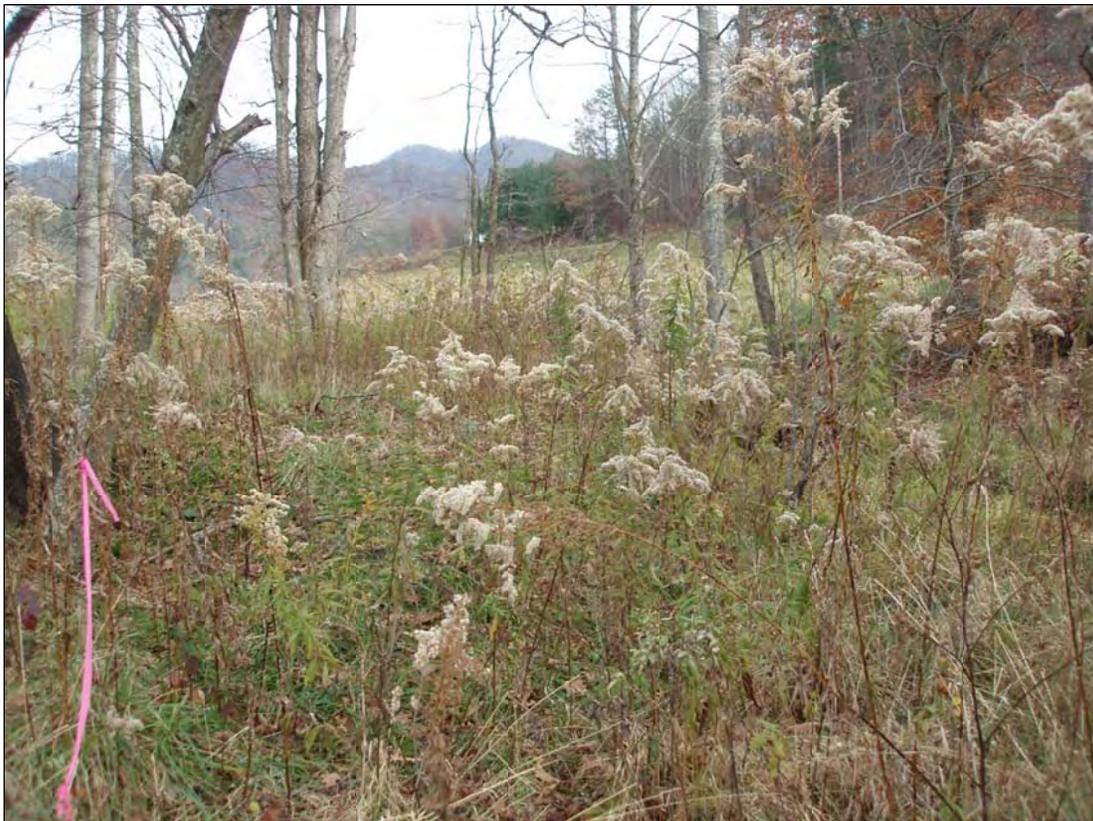
Photo Point 9: View looking upstream near Station 39+25. 11/9/11 – MY02

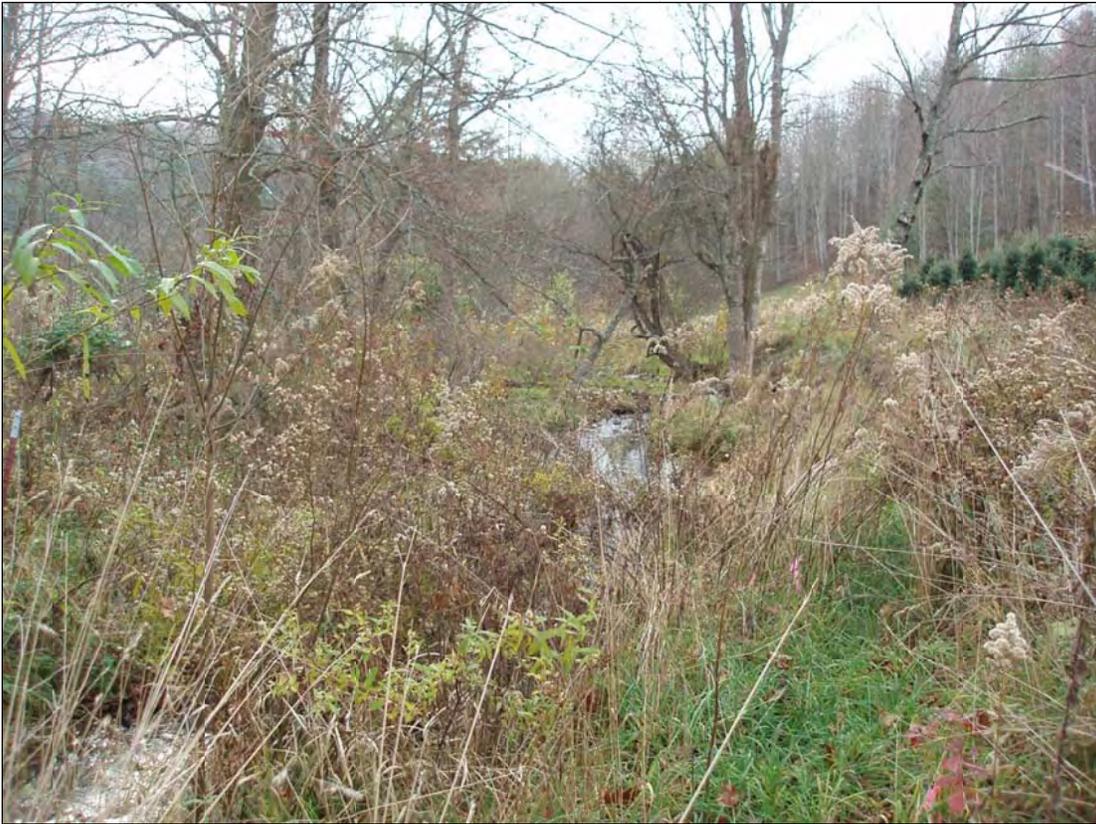
Photo Point 9: View looking downstream near Station 34+00. 11/9/11 – MY02

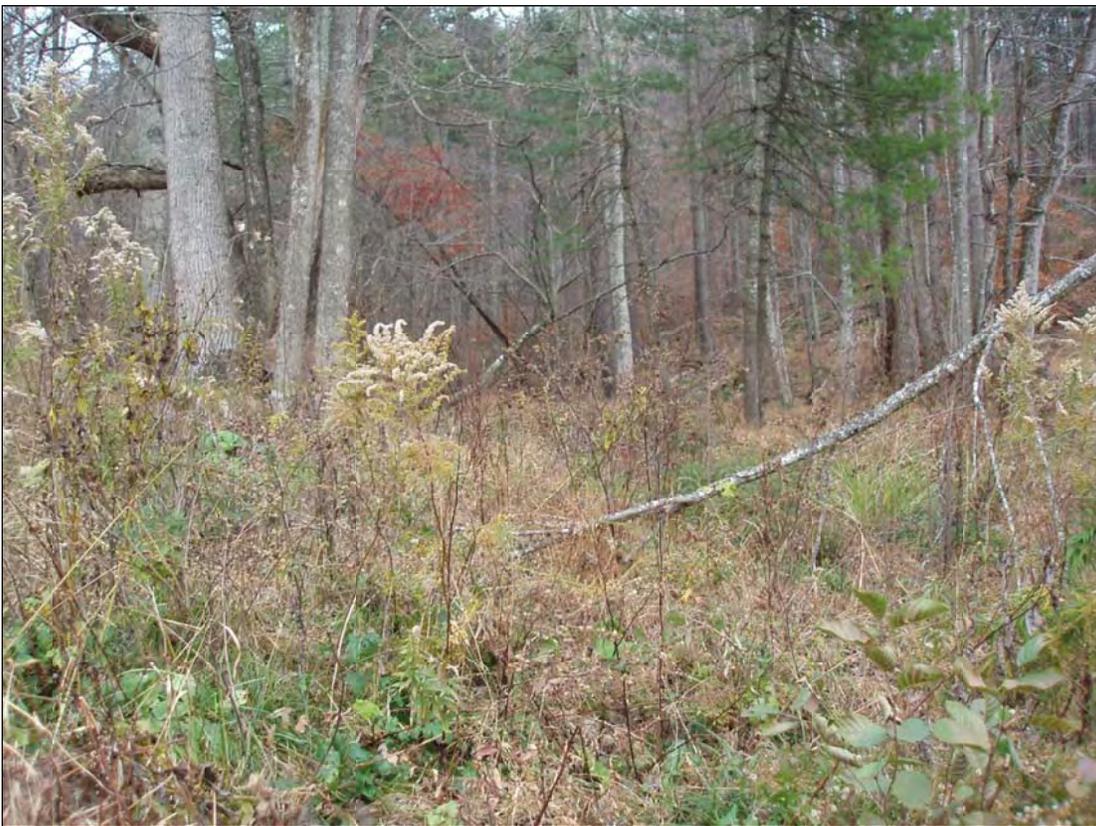
Photo Point 10: View looking upstream on T1 near Station 51+00. 11/9/11 – MY02

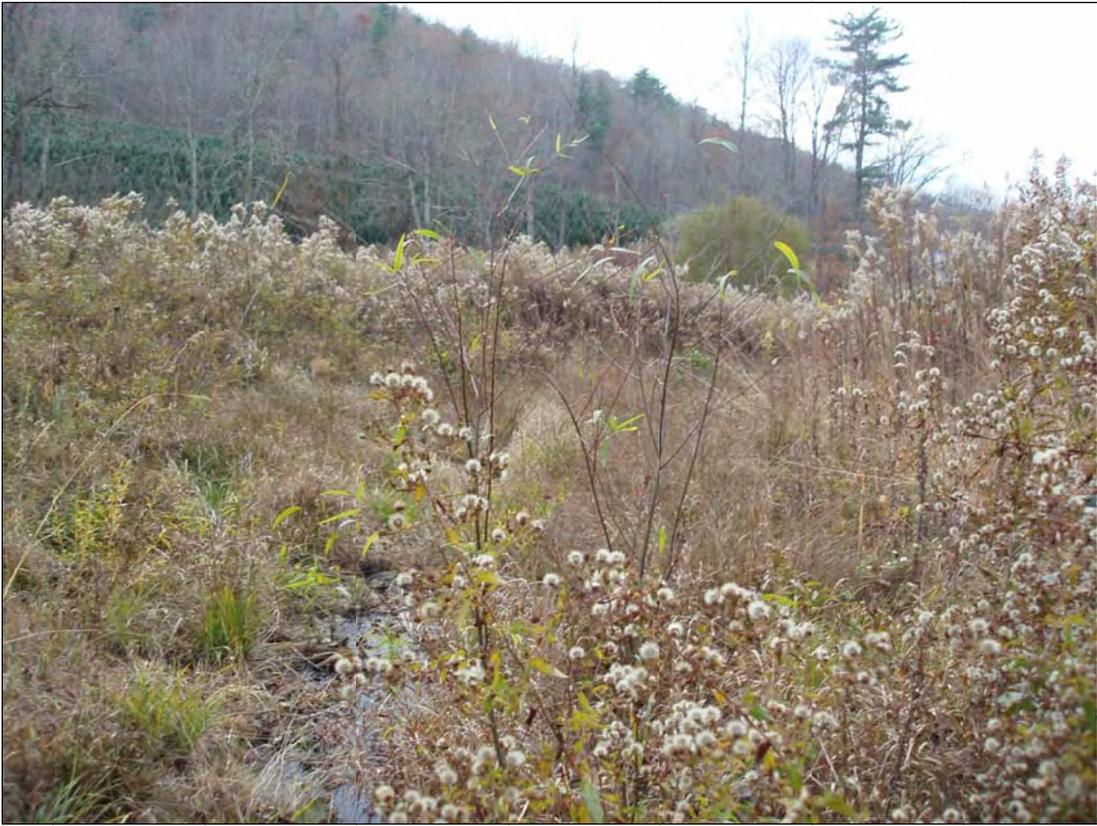
Photo Point 10: View looking downstream on T1 near Station 51+00. 11/9/11 – MY02

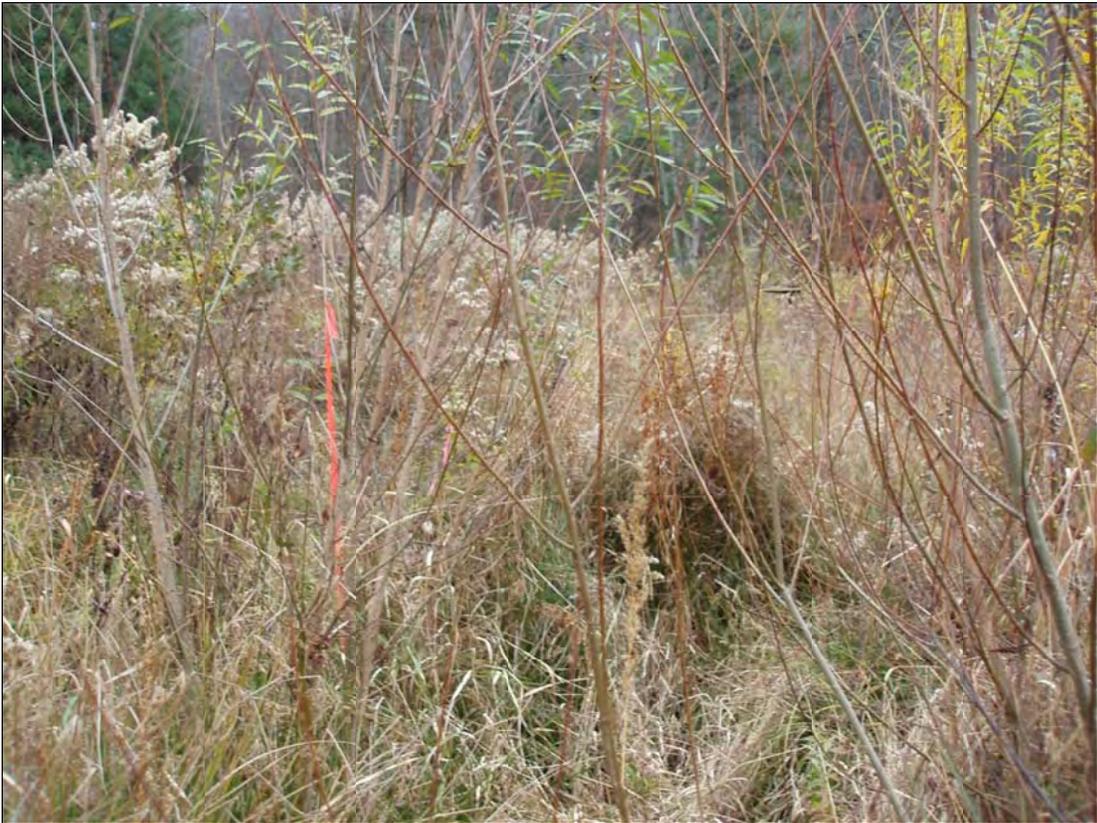
Photo Point 11: View looking upstream on T1 near Station 52+50. 11/9/11 – MY02

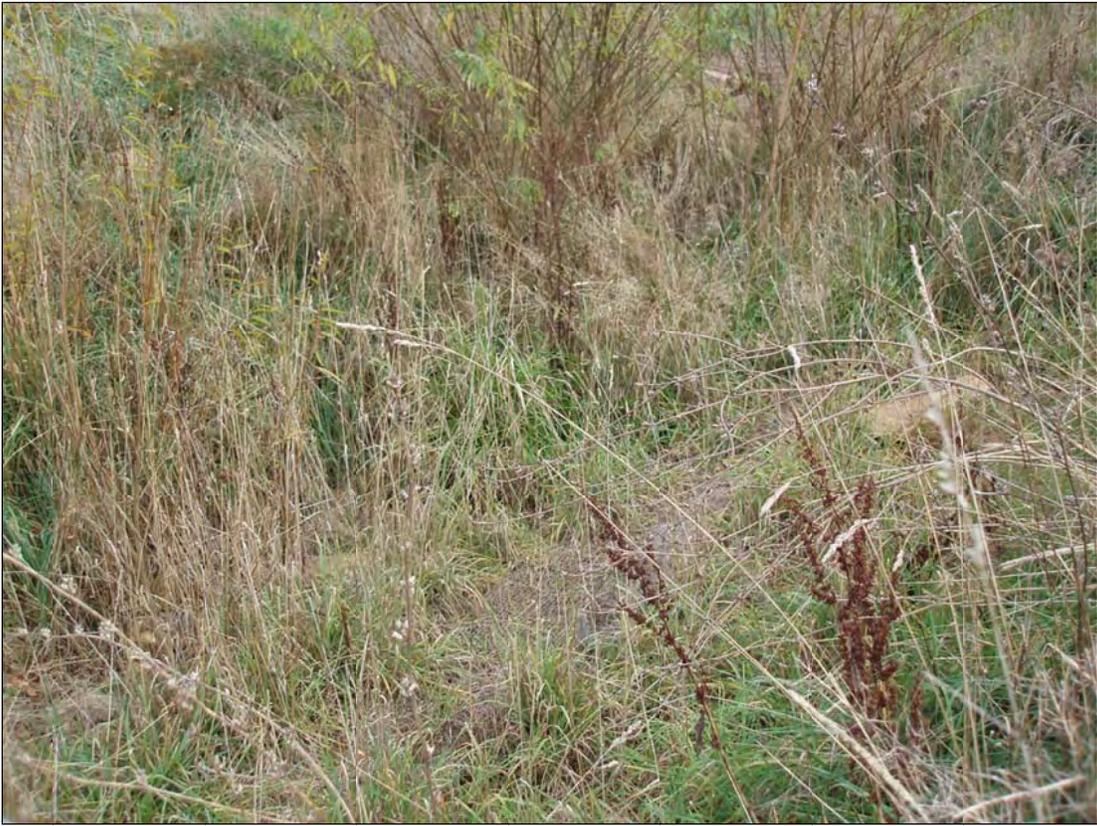
Photo Point 12: View looking upstream on T2 near Station 60+50. 11/9/11 – MY02

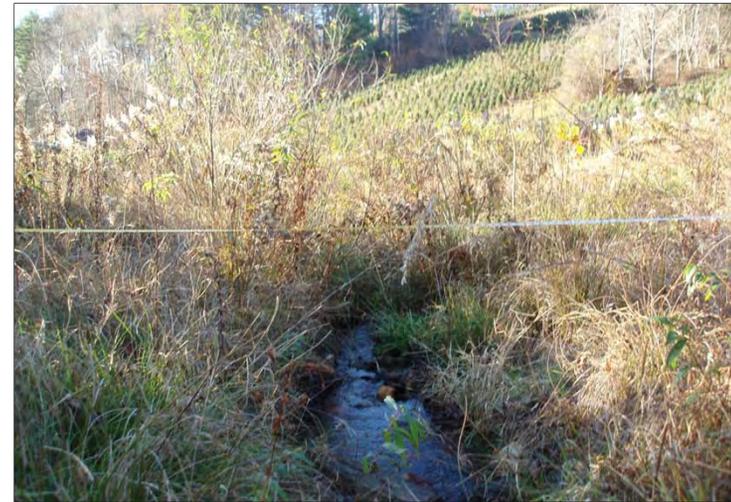
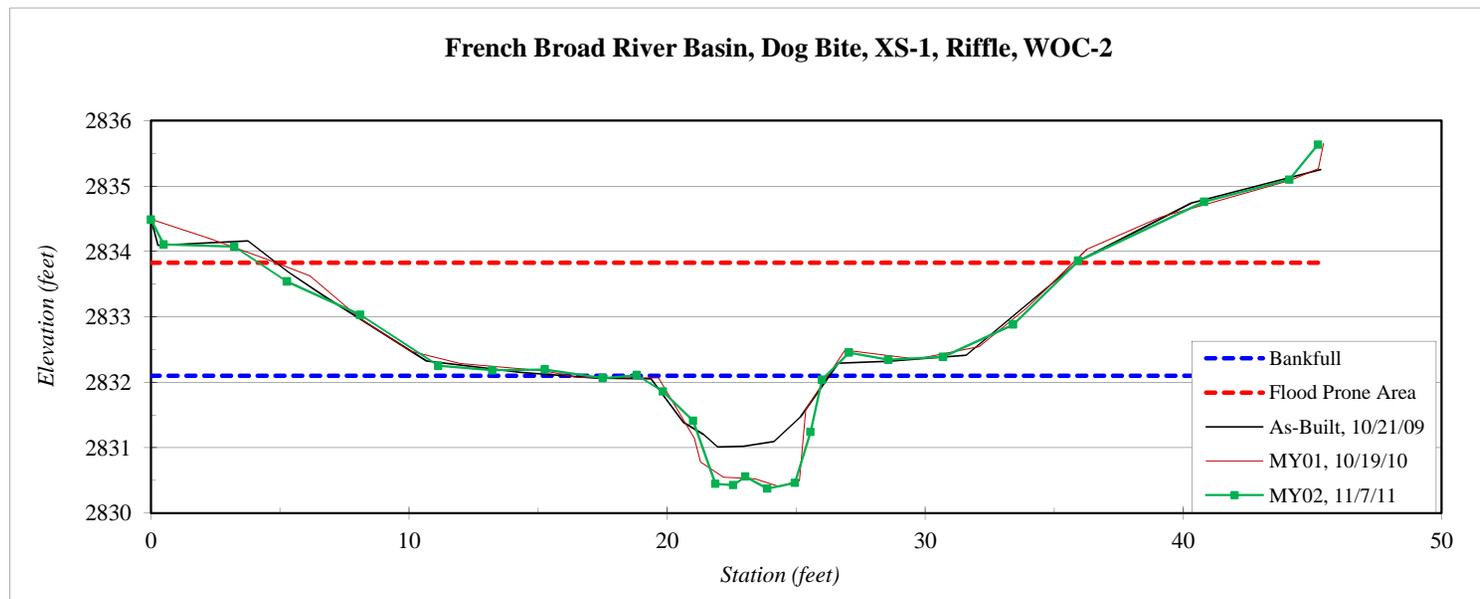
Station	Elevation
0.0	2834.49
0.5	2834.11
3.2	2834.07
5.3	2833.54
8.1	2833.03
11.1	2832.25
13.2	2832.18
15.3	2832.20
17.5	2832.06
18.8	2832.11
19.8	2831.86
21.0	2831.41
21.9	2830.45
22.6	2830.43
23.0	2830.56
23.9	2830.37
25.0	2830.46
25.6	2831.24
26.0	2832.04
27.0	2832.45
28.6	2832.34
30.7	2832.39
33.4	2832.88
35.9	2833.86
40.8	2834.76
44.1	2835.10
45.2	2835.64

SUMMARY DATA	
Bankfull Elevation:	2832.1
Bankfull Cross-Sectional Area:	7.7
Bankfull Width:	7.3
Flood Prone Area Elevation:	2833.8
Flood Prone Width:	30
Max Depth at Bankfull:	1.7
Mean Depth at Bankfull:	1.1
W / D Ratio:	6.9
Entrenchment Ratio:	4.1
Bank Height Ratio:	1.0

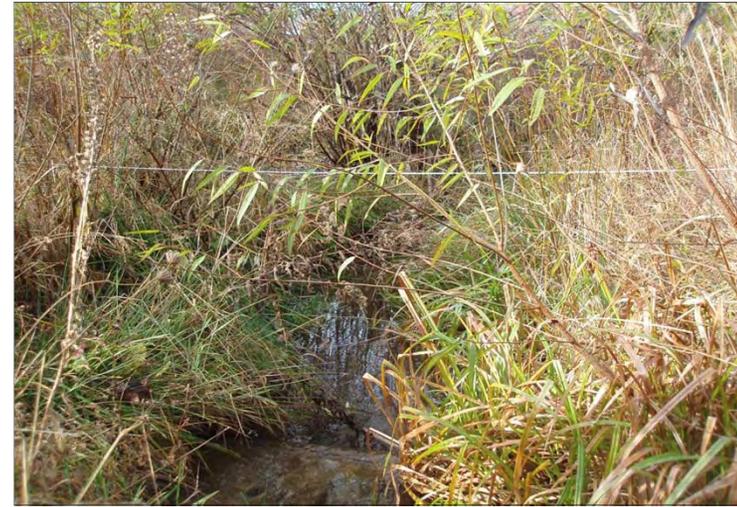
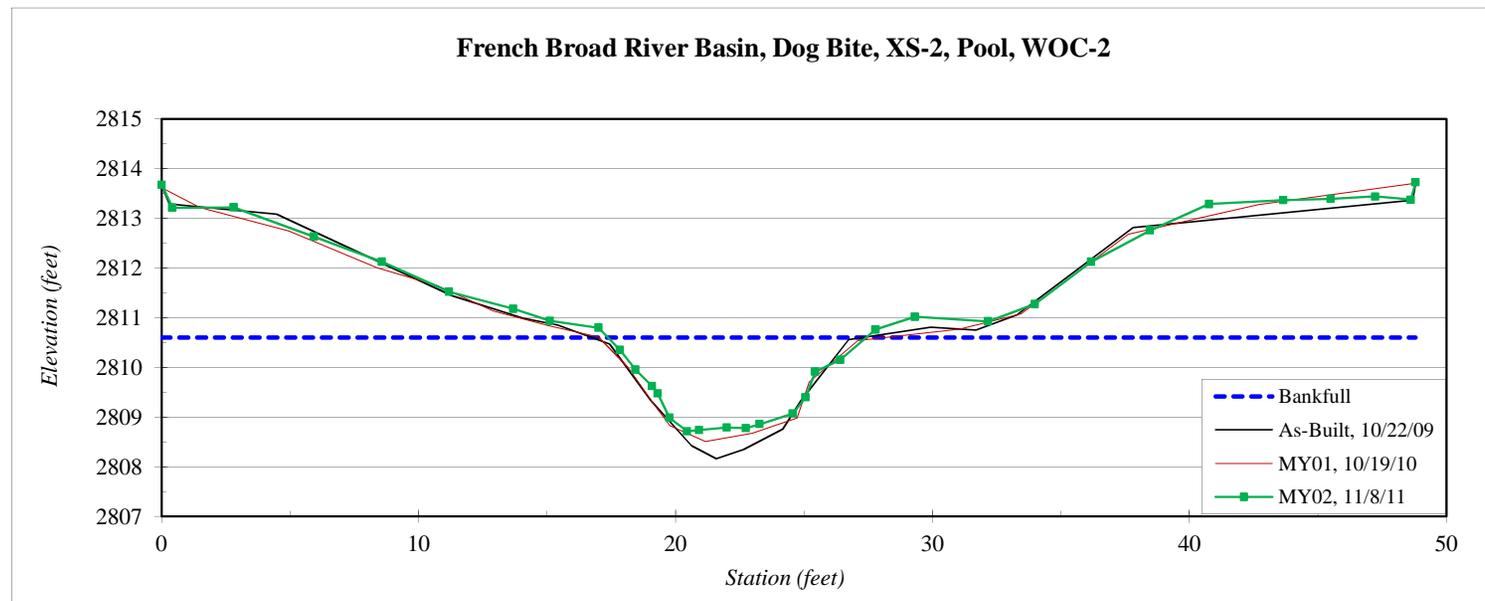
River Basin:	French Broad
Watershed:	Dog Bite
XS ID	XS-2, Pool, WOC-2
Drainage Area (sq mi):	0.36
Date:	11/8/2011
Field Crew:	A. French, A. Helms

Station	Elevation
0.0	2813.67
0.4	2813.21
2.8	2813.22
5.9	2812.63
8.6	2812.12
11.2	2811.52
13.7	2811.18
15.1	2810.93
17.0	2810.79
17.8	2810.35
18.4	2809.95
19.1	2809.62
19.3	2809.47
19.8	2808.98
20.5	2808.71
20.9	2808.73
22.0	2808.79
22.7	2808.77
23.3	2808.85
24.6	2809.07
25.1	2809.40
25.4	2809.91
26.4	2810.15
27.8	2810.76
29.3	2811.02
32.2	2810.92
34.0	2811.27
36.2	2812.12
38.5	2812.76
40.8	2813.29
43.7	2813.37
45.5	2813.39
47.2	2813.44
48.6	2813.38
48.8	2813.73

SUMMARY DATA	
Bankfull Elevation:	2810.6
Bankfull Cross-Sectional Area:	12.0
Bankfull Width:	10.1
Flood Prone Area Elevation:	-
Flood Prone Width:	-
Max Depth at Bankfull:	1.9
Mean Depth at Bankfull:	1.2
W / D Ratio:	-
Entrenchment Ratio:	-
Bank Height Ratio:	-

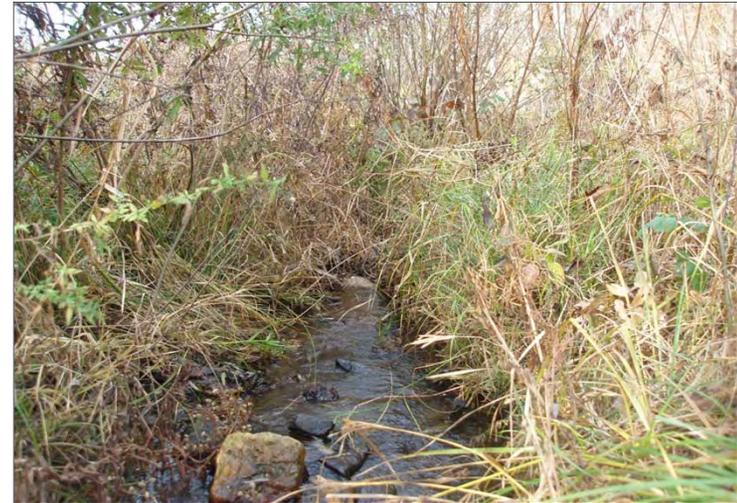
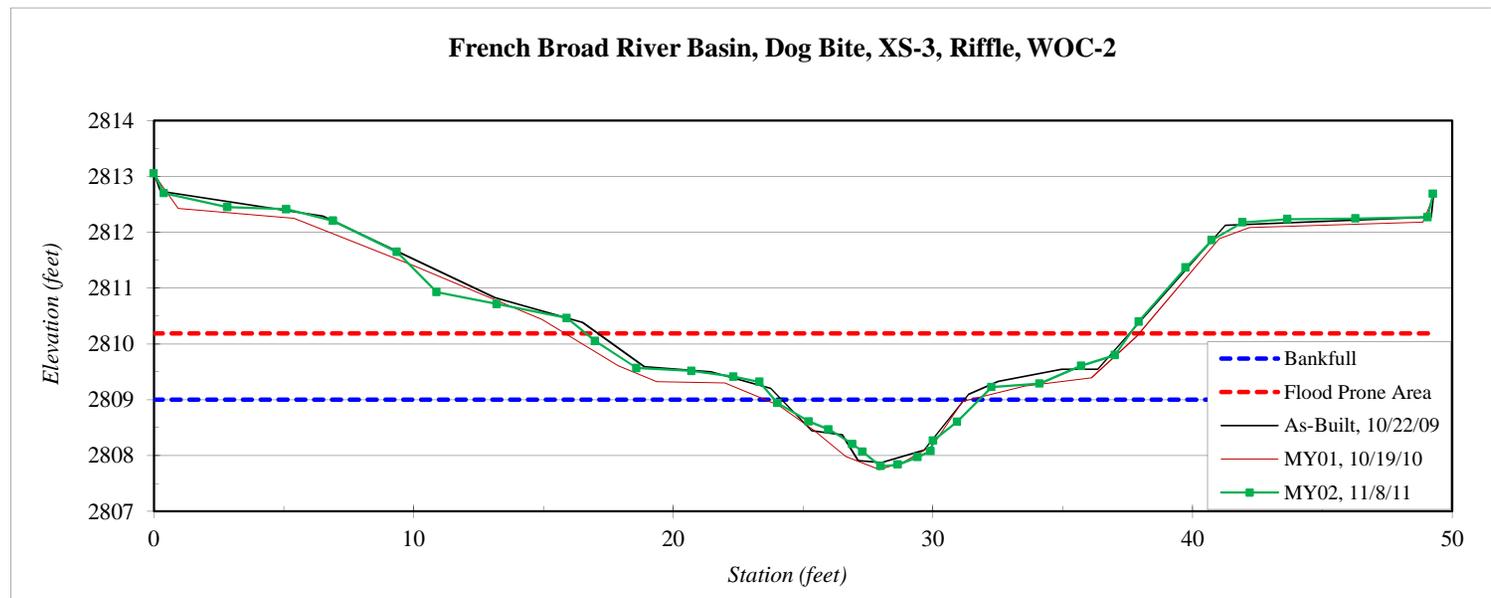
River Basin:	French Broad
Watershed:	Dog Bite
XS ID	XS-3, Riffle, WOC-2
Drainage Area (sq mi):	0.36
Date:	11/8/2011
Field Crew:	A. French, A. Helms

Station	Elevation
0.0	2813.06
0.4	2812.70
2.8	2812.45
5.1	2812.42
6.9	2812.21
9.4	2811.65
10.9	2810.93
13.2	2810.71
15.9	2810.46
17.0	2810.05
18.6	2809.57
20.7	2809.52
22.3	2809.41
23.3	2809.32
24.0	2808.94
25.2	2808.61
26.0	2808.47
26.9	2808.21
27.3	2808.07
28.0	2807.81
28.7	2807.84
29.4	2807.97
29.9	2808.08
30.0	2808.27
30.9	2808.60
32.3	2809.23
34.1	2809.29
35.7	2809.61
37.0	2809.80
37.9	2810.40
39.7	2811.37
40.7	2811.86
41.9	2812.18
43.7	2812.23

SUMMARY DATA	
Bankfull Elevation:	2809.0
Bankfull Cross-Sectional Area:	5.2
Bankfull Width:	7.9
Flood Prone Area Elevation:	2810.2
Flood Prone Width:	21
Max Depth at Bankfull:	1.2
Mean Depth at Bankfull:	0.7
W / D Ratio:	12.0
Entrenchment Ratio:	2.7
Bank Height Ratio:	1.0
