**Dog Bite Stream Restoration Site
Monitoring Report – MY02
Mitchell County, NC
Basin 06010108 - Contract # D06056-A**

December 2011

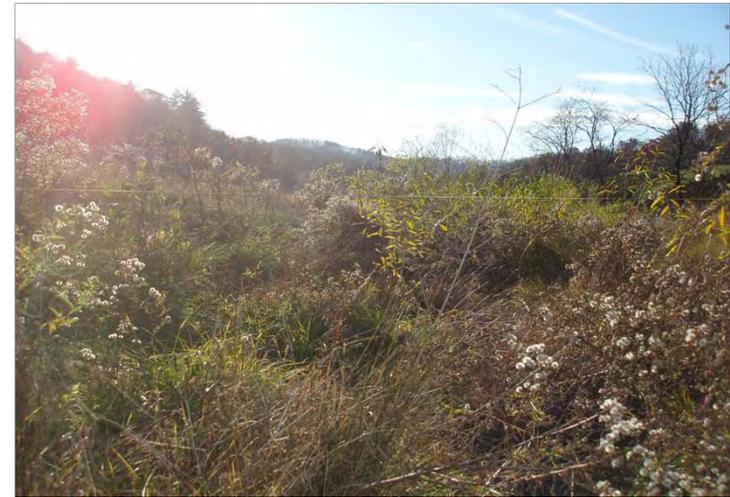
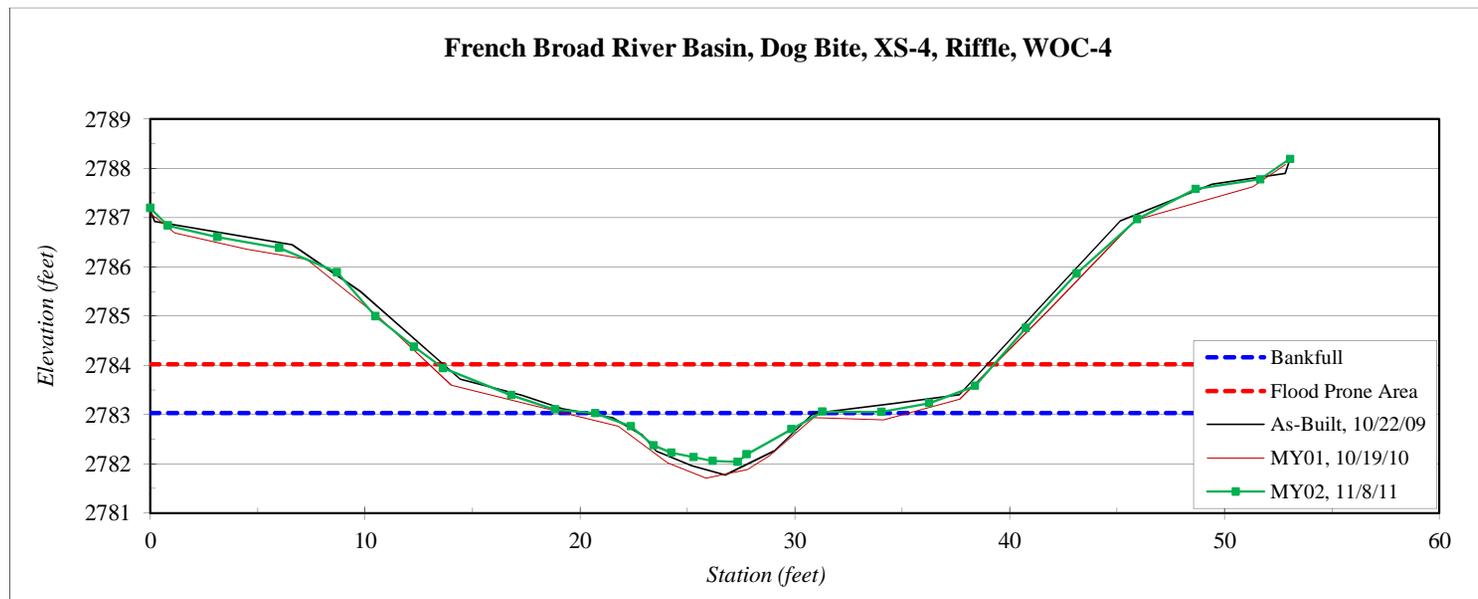
French Broad River Basin, Dog Bite, XS-4, Riffle, WOC-4

River Basin:	French Broad
Watershed:	Dog Bite
XS ID	XS-4, Riffle, WOC-4
Drainage Area (sq mi):	0.54
Date:	11/8/2011
Field Crew:	A. French, A. Helms

Station	Elevation
0.0	2787.19
0.8	2786.84
3.1	2786.60
6.0	2786.38
8.7	2785.89
10.5	2785.00
12.3	2784.38
13.6	2783.95
16.8	2783.39
18.8	2783.10
20.7	2783.03
22.4	2782.76
23.4	2782.37
24.2	2782.23
25.3	2782.13
26.2	2782.06
27.3	2782.04
27.8	2782.19
29.8	2782.70
31.3	2783.06
34.0	2783.05
36.3	2783.23
38.4	2783.58
40.8	2784.76
43.1	2785.86
45.9	2786.96
48.7	2787.58
51.7	2787.78
53.1	2788.19

SUMMARY DATA	
Bankfull Elevation:	2783.0
Bankfull Cross-Sectional Area:	6.0
Bankfull Width:	10.6
Flood Prone Area Elevation:	2784.0
Flood Prone Width:	26
Max Depth at Bankfull:	1.0
Mean Depth at Bankfull:	0.6
W / D Ratio:	18.7
Entrenchment Ratio:	2.5
Bank Height Ratio:	1.0

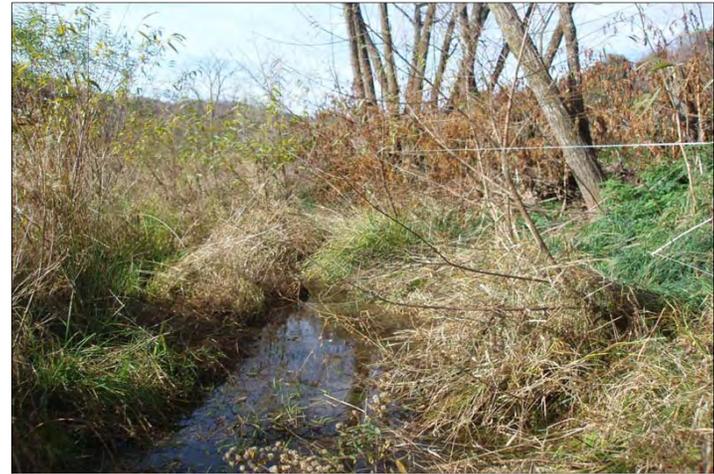
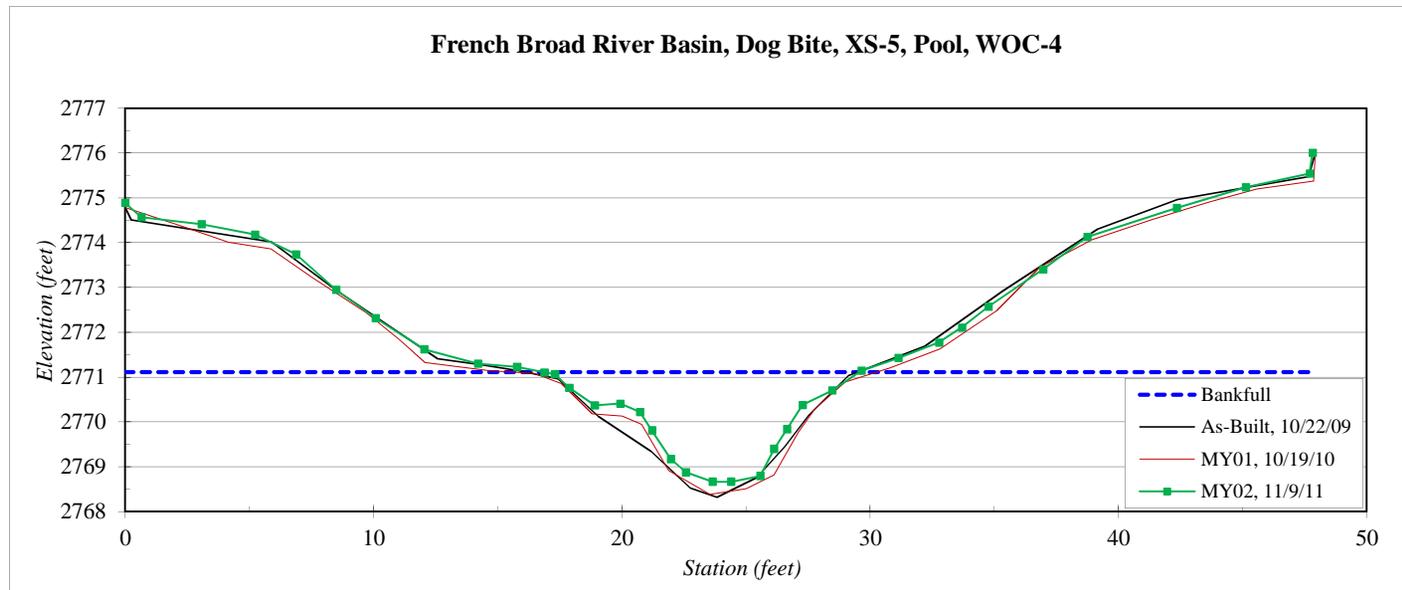
River Basin:	French Broad
Watershed:	Dog Bite
XS ID	XS-5, Pool, WOC-4
Drainage Area (sq mi):	0.54
Date:	11/9/2011
Field Crew:	A. French, A. Helms

Station	Elevation
0.0	2774.89
0.6	2774.57
3.1	2774.41
5.2	2774.18
6.9	2773.74
8.5	2772.95
10.1	2772.32
12.0	2771.62
14.2	2771.30
15.8	2771.23
16.9	2771.11
17.3	2771.06
17.9	2770.76
18.9	2770.37
19.9	2770.41
20.7	2770.22
21.2	2769.81
22.0	2769.17
22.6	2768.87
23.7	2768.67
24.4	2768.67
25.6	2768.79
26.1	2769.40
26.7	2769.84
27.3	2770.38
28.5	2770.70
29.7	2771.15
31.1	2771.43
32.8	2771.77
33.7	2772.11
34.8	2772.57
37.0	2773.41
38.8	2774.13
42.4	2774.78
45.1	2775.24
47.7	2775.54
47.8	2776.01

SUMMARY DATA	
Bankfull Elevation:	2771.1
Bankfull Cross-Sectional Area:	15.6
Bankfull Width:	12.7
Flood Prone Area Elevation:	-
Flood Prone Width:	-
Max Depth at Bankfull:	2.4
Mean Depth at Bankfull:	1.2
W / D Ratio:	-
Entrenchment Ratio:	-
Bank Height Ratio:	-

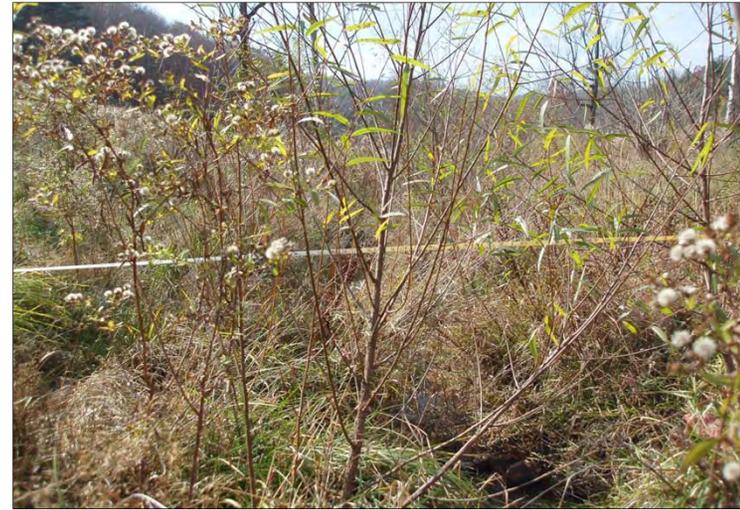
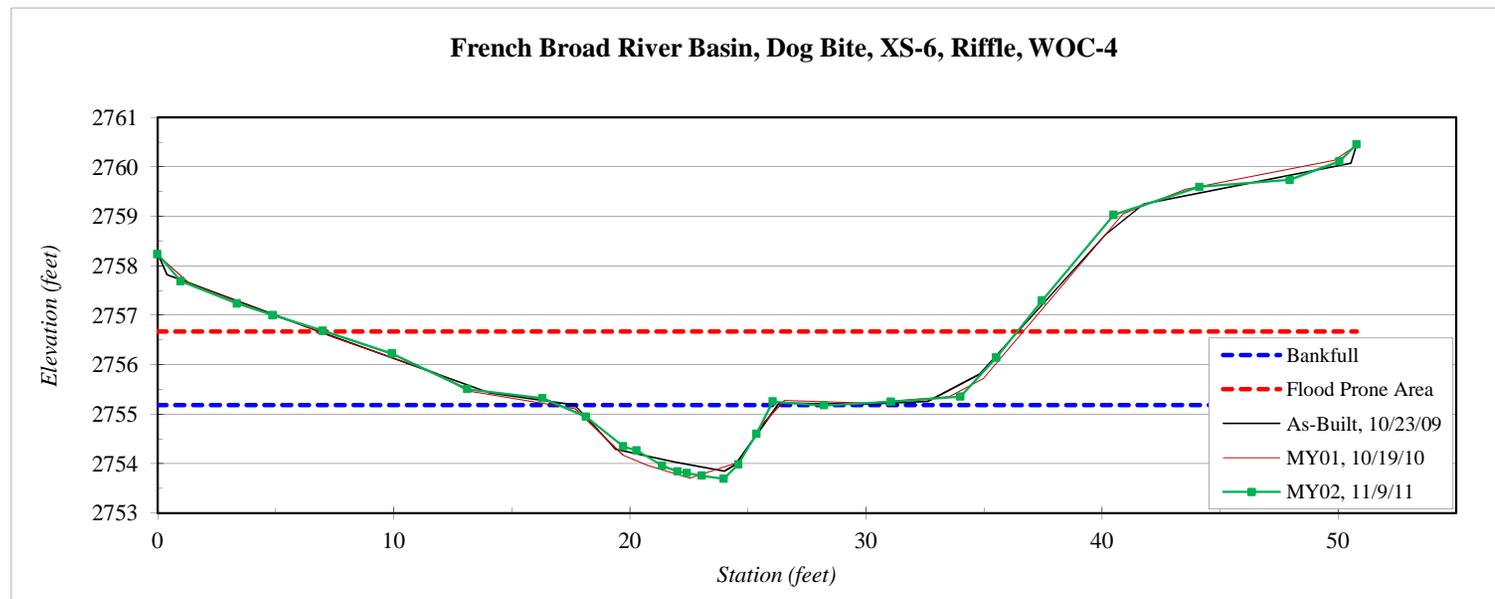
Station	Elevation
0.0	2758.24
1.0	2757.69
3.4	2757.24
4.9	2757.00
7.0	2756.69
9.9	2756.23
13.1	2755.50
16.3	2755.32
18.2	2754.95
19.7	2754.35
20.3	2754.27
21.4	2753.96
22.0	2753.84
22.4	2753.81
23.1	2753.75
24.0	2753.69
24.6	2753.98
25.4	2754.60
26.1	2755.25
28.2	2755.18
31.1	2755.25
34.0	2755.35
35.5	2756.15
37.5	2757.30
40.5	2759.03
44.1	2759.59
48.0	2759.74
50.1	2760.11
50.8	2760.46

SUMMARY DATA	
Bankfull Elevation:	2755.2
Bankfull Cross-Sectional Area:	7.9
Bankfull Width:	9.2
Flood Prone Area Elevation:	2756.7
Flood Prone Width:	30
Max Depth at Bankfull:	1.5
Mean Depth at Bankfull:	0.9
W / D Ratio:	10.7
Entrenchment Ratio:	3.3
Bank Height Ratio:	1.0

Stream Type	C3b
--------------------	-----

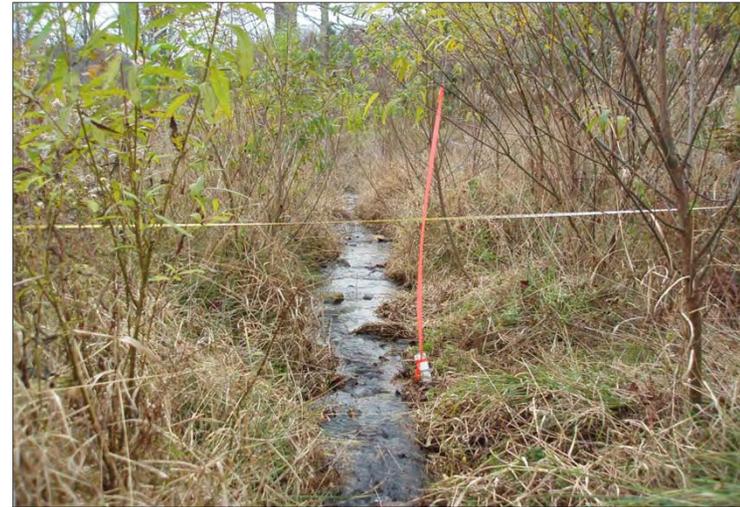
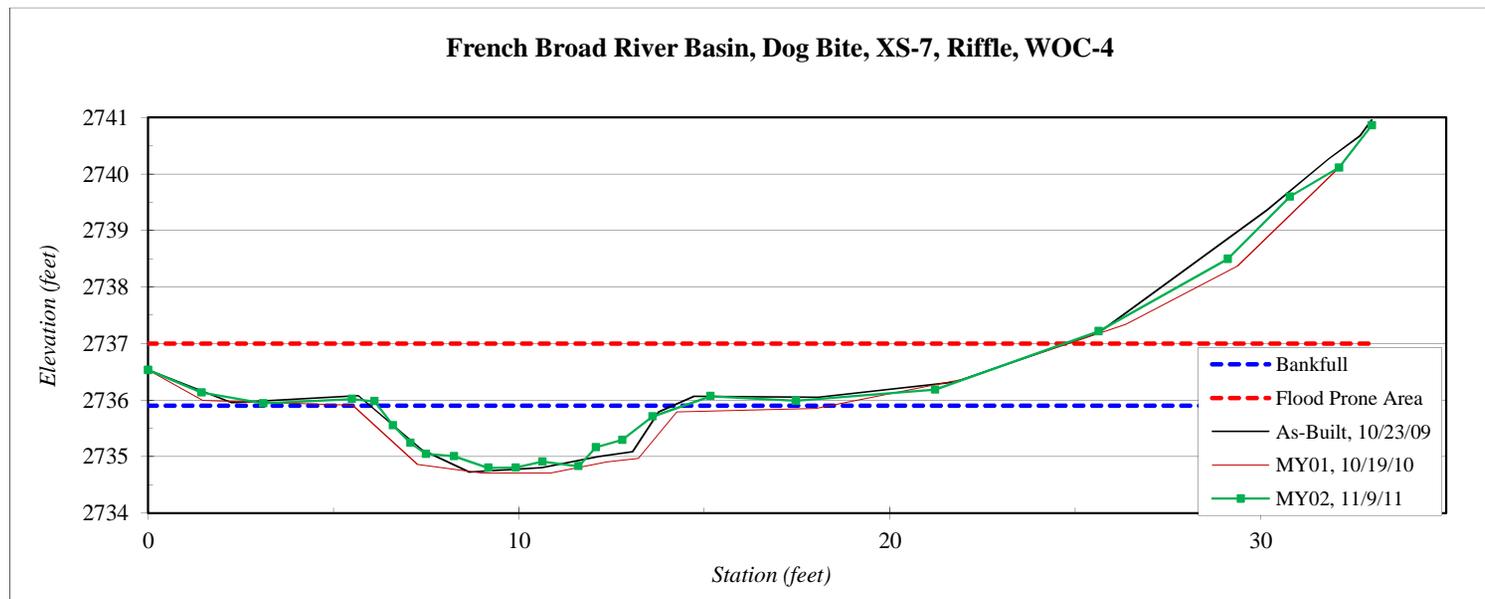
River Basin:	French Broad
Watershed:	Dog Bite
XS ID	XS-7, Riffle, WOC-4
Drainage Area (sq mi):	0.54
Date:	11/9/2011
Field Crew:	A. French, A. Helms

Station	Elevation
0.0	2736.53
1.4	2736.13
3.1	2735.94
5.5	2736.02
6.1	2735.98
6.6	2735.55
7.1	2735.24
7.5	2735.05
8.2	2735.00
9.2	2734.80
9.9	2734.80
10.6	2734.91
11.6	2734.83
12.1	2735.16
12.8	2735.29
13.6	2735.71
15.2	2736.07
17.5	2735.99
21.2	2736.18
25.6	2737.22
29.1	2738.50
30.8	2739.60
32.1	2740.11
33.0	2740.86

SUMMARY DATA	
Bankfull Elevation:	2735.9
Bankfull Cross-Sectional Area:	6.1
Bankfull Width:	8.2
Flood Prone Area Elevation:	2737.0
Flood Prone Width:	>25
Max Depth at Bankfull:	1.1
Mean Depth at Bankfull:	0.7
W / D Ratio:	11.0
Entrenchment Ratio:	3.0
Bank Height Ratio:	1.0

Stream Type	C3b
--------------------	-----

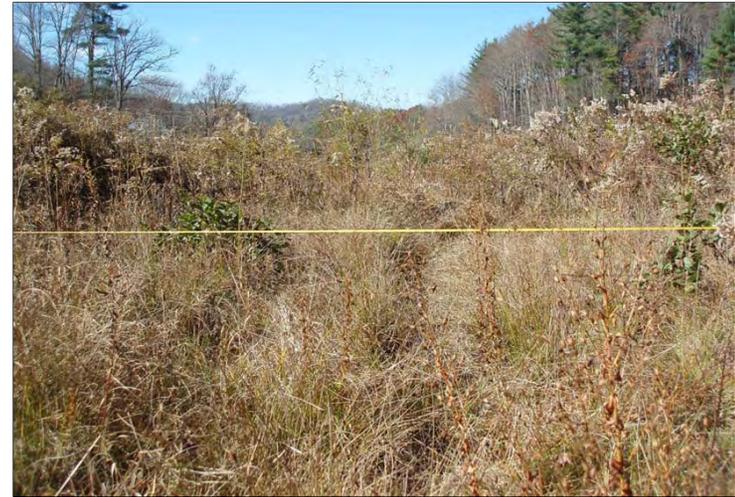
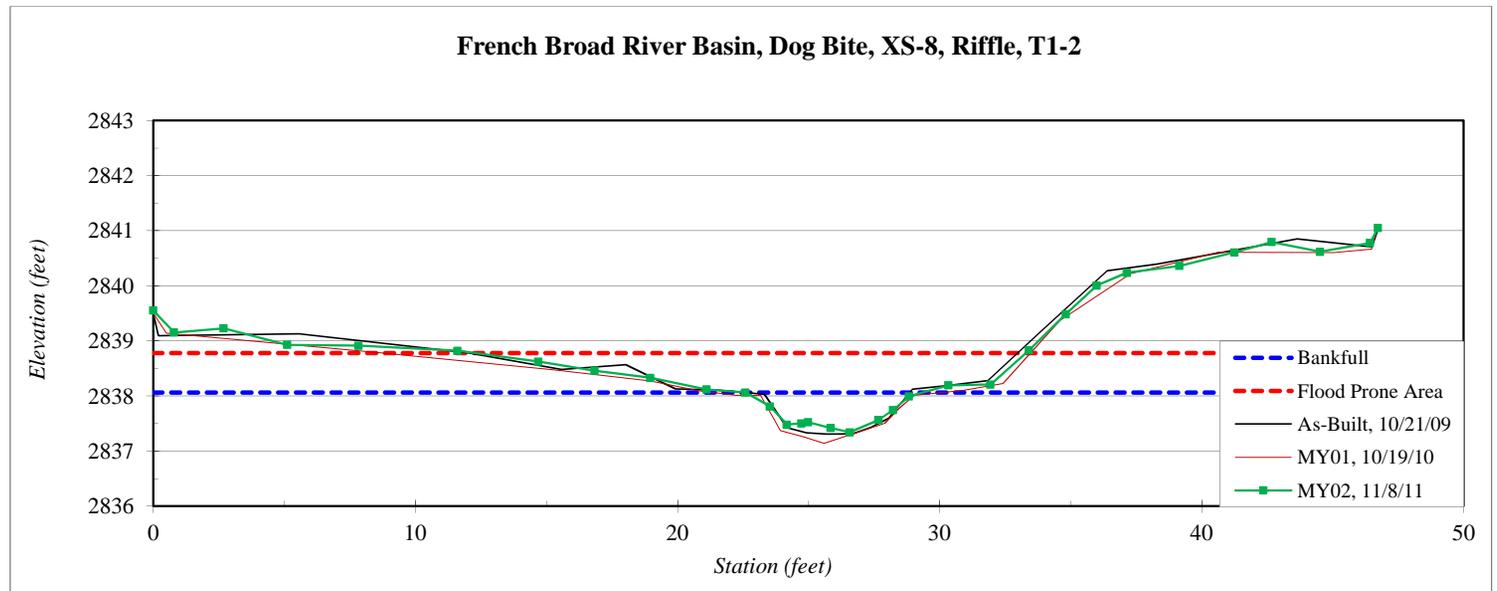
River Basin:	French Broad
Watershed:	Dog Bite
XS ID	XS-8, Riffle, T1-2
Drainage Area (sq mi):	0.08
Date:	11/8/2011
Field Crew:	A. French, A. Helms

Station	Elevation
0.0	2839.55
0.8	2839.15
2.7	2839.23
5.1	2838.93
7.8	2838.91
11.6	2838.82
14.7	2838.62
16.8	2838.46
19.0	2838.33
21.1	2838.12
22.6	2838.06
23.5	2837.81
24.2	2837.48
24.7	2837.50
25.0	2837.52
25.9	2837.42
26.6	2837.34
27.7	2837.57
28.2	2837.74
28.8	2837.99
30.3	2838.20
31.9	2838.21
33.4	2838.83
34.8	2839.48
36.0	2840.00
37.1	2840.24
39.2	2840.36
41.3	2840.61
42.7	2840.80
44.5	2840.62
46.4	2840.78
46.7	2841.05

SUMMARY DATA	
Bankfull Elevation:	2838.1
Bankfull Cross-Sectional Area:	2.9
Bankfull Width:	6.7
Flood Prone Area Elevation:	2838.8
Flood Prone Width:	21
Max Depth at Bankfull:	0.7
Mean Depth at Bankfull:	0.4
W / D Ratio:	15.5
Entrenchment Ratio:	3.1
Bank Height Ratio:	1.0

Stream Type	C3b
--------------------	-----

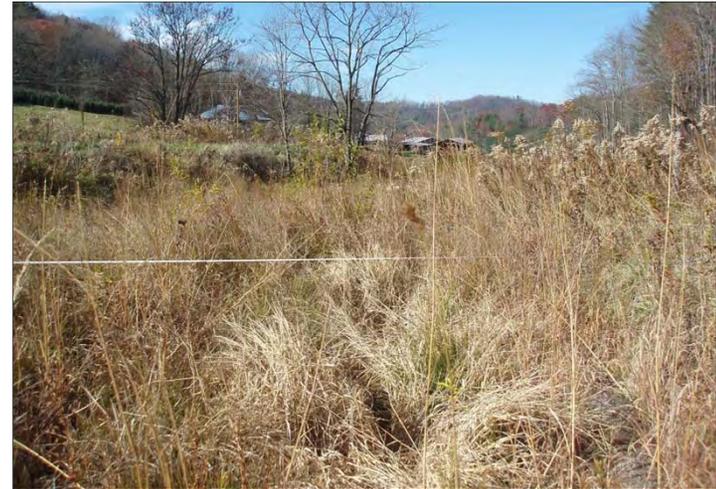
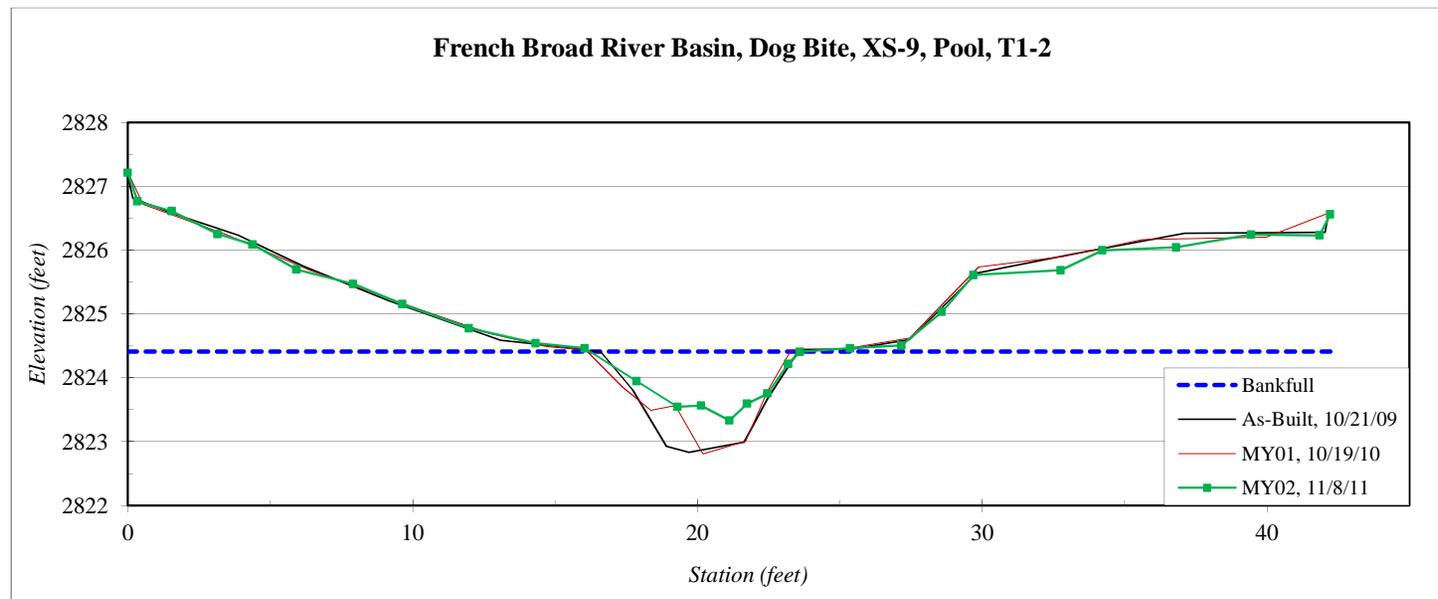
River Basin:	French Broad
Watershed:	Dog Bite
XS ID	XS-9, Pool, T1-2
Drainage Area (sq mi):	0.08
Date:	11/8/2011
Field Crew:	A. French, A. Helms

Station	Elevation
0.0	2827.21
0.3	2826.76
1.5	2826.61
3.2	2826.25
4.4	2826.09
5.9	2825.70
7.9	2825.47
9.6	2825.15
12.0	2824.78
14.3	2824.54
16.0	2824.46
17.9	2823.95
19.3	2823.54
20.1	2823.56
21.1	2823.33
21.7	2823.60
22.5	2823.75
23.2	2824.22
23.6	2824.41
25.4	2824.46
27.2	2824.51
28.6	2825.03
29.7	2825.61
32.8	2825.68
34.2	2825.99
36.8	2826.04
39.4	2826.24
41.8	2826.23
42.2	2826.56

SUMMARY DATA	
Bankfull Elevation:	2824.4
Bankfull Cross-Sectional Area:	4.5
Bankfull Width:	7.4
Flood Prone Area Elevation:	-
Flood Prone Width:	-
Max Depth at Bankfull:	1.1
Mean Depth at Bankfull:	0.6
W / D Ratio:	-
Entrenchment Ratio:	-
Bank Height Ratio:	-

Stream Type	C3b
--------------------	-----

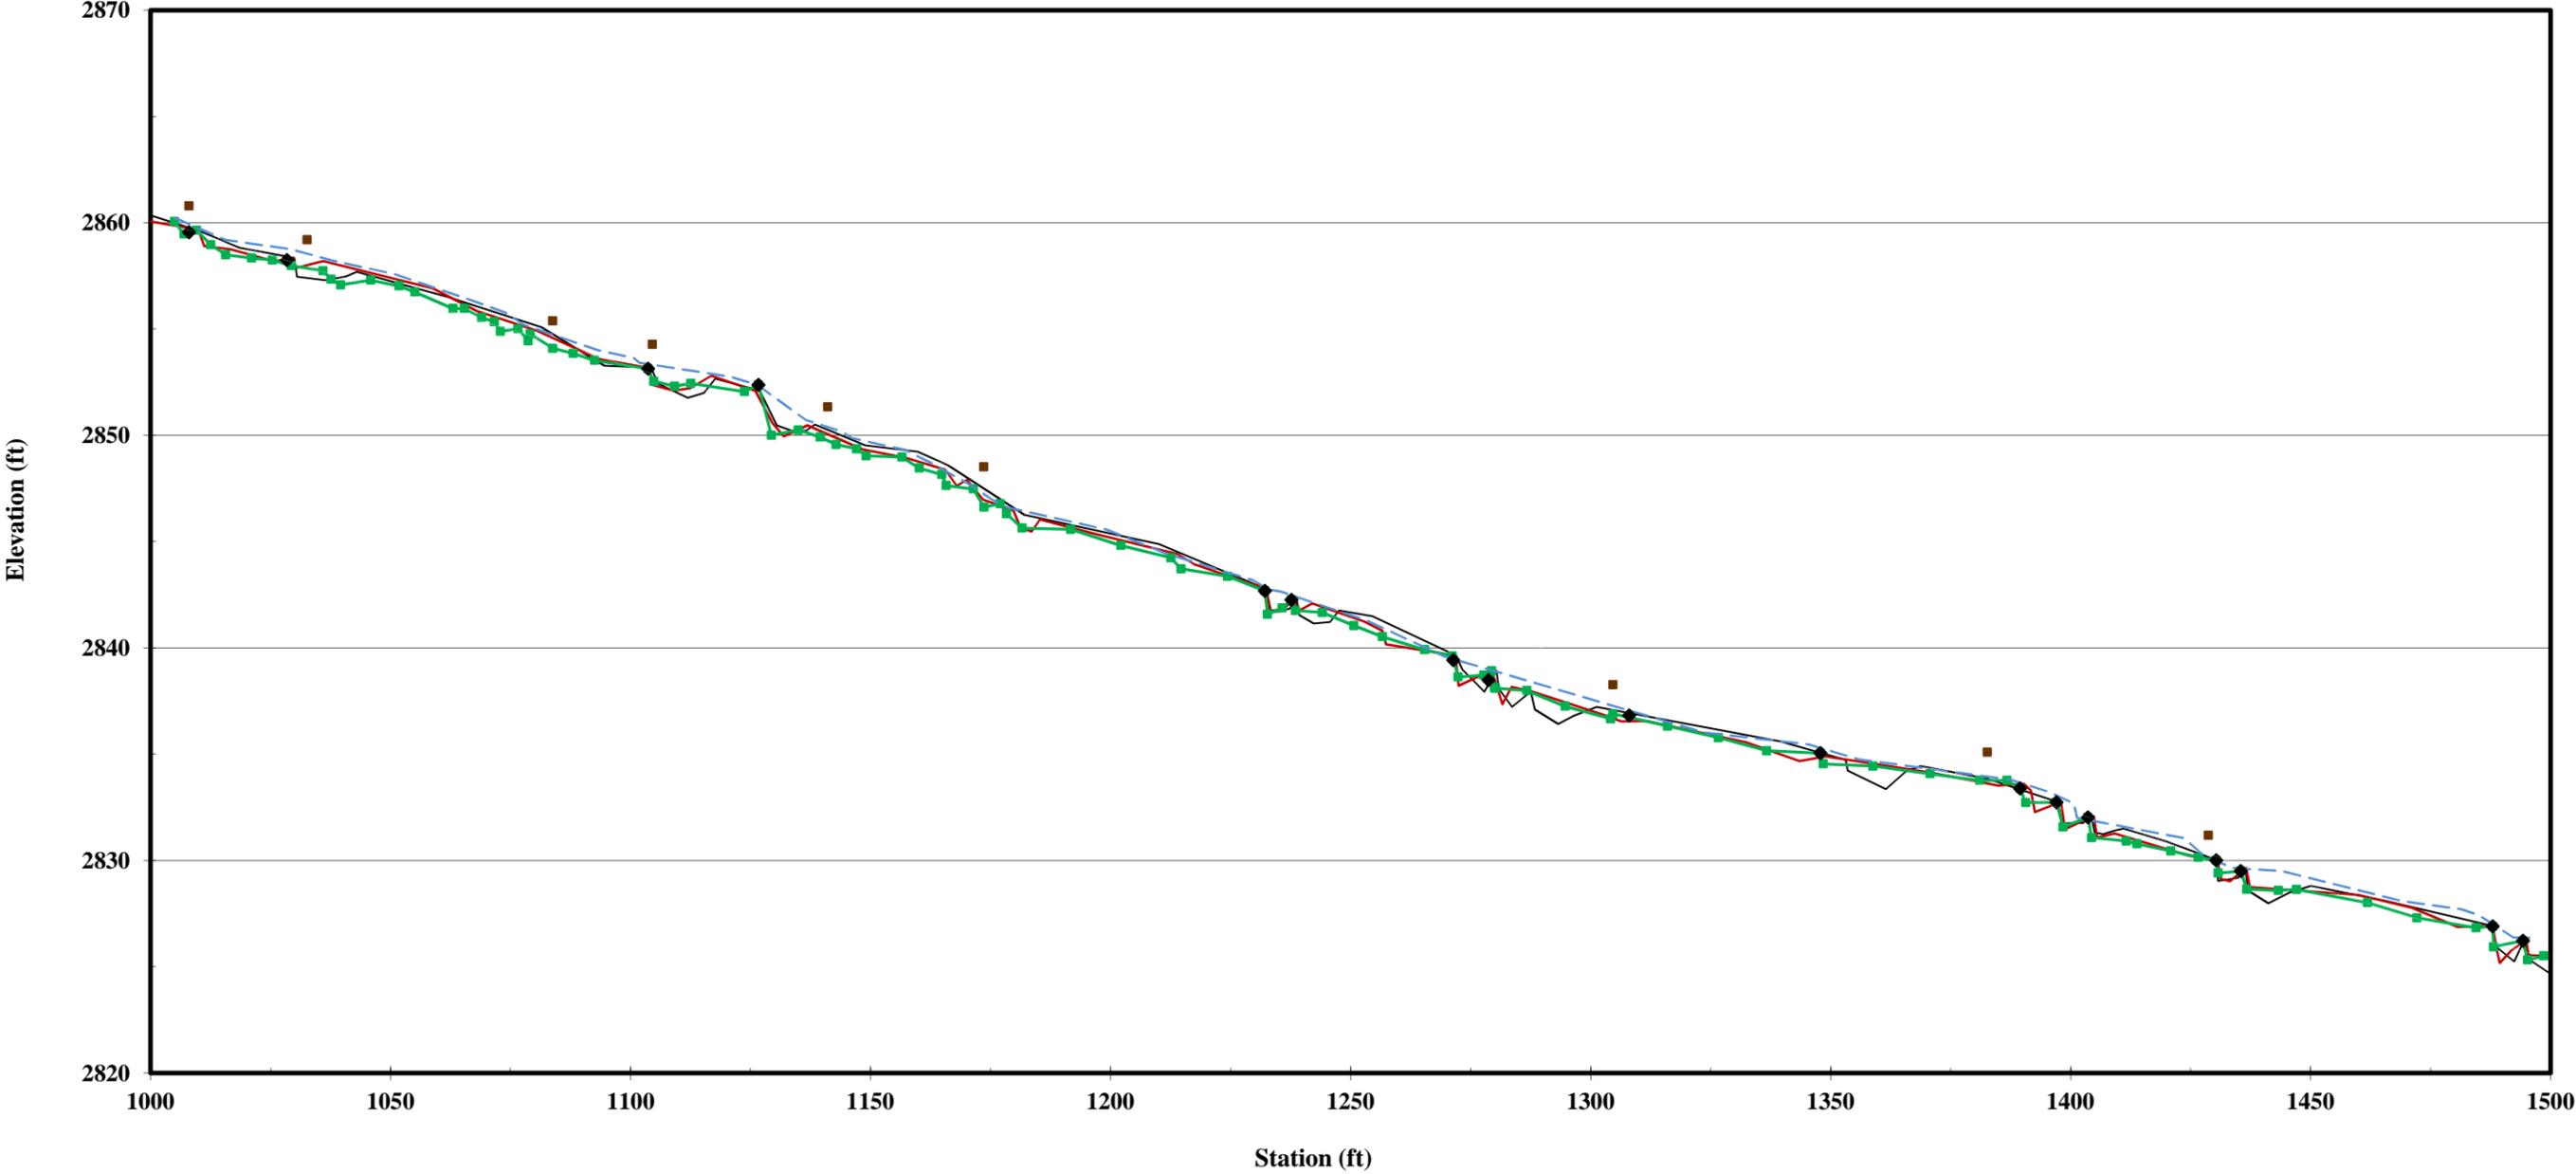
**Dog Bite Site
Longitudinal Profile
White Oak Creek, MY02
Stations 10+00 - 15+00**

— MY00, 10/22/09 — MY01, 10/19/10 —■— MY02, 11/8/11 - - - Water Surface ■ Bankfull ◆ Grade Control Structures

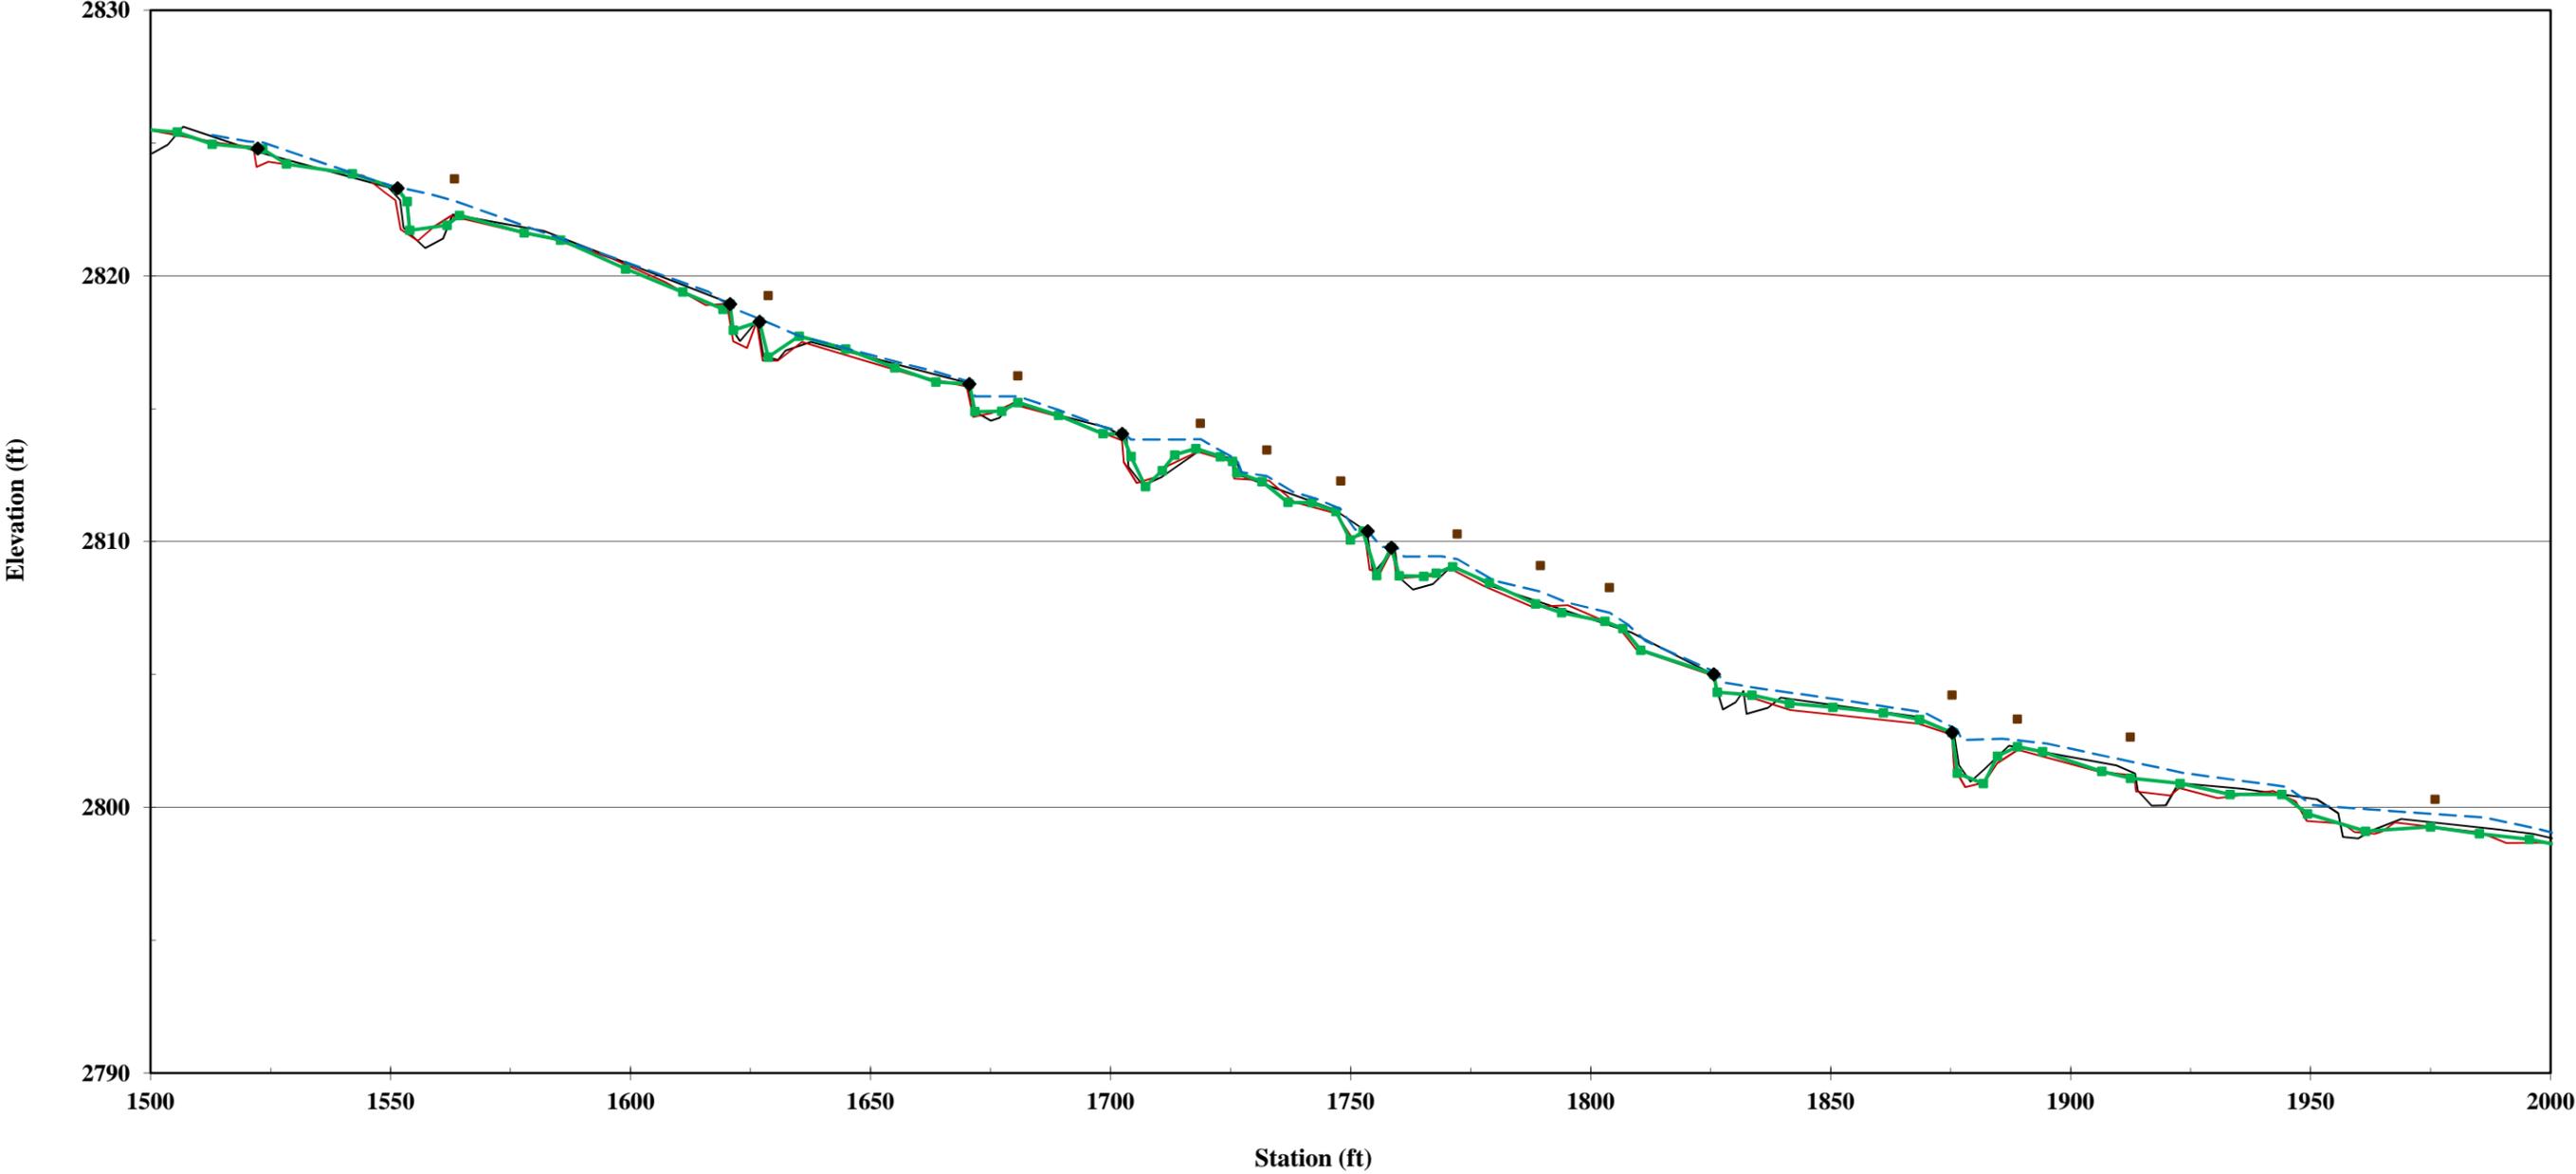
**Dog Bite Site
Longitudinal Profile
White Oak Creek, MY02
Stations 15+00 - 20+00**

— MY00, 10/22/09 — MY01, 10/19/10 —■ MY02, 11/8/11 ■ Bankfull

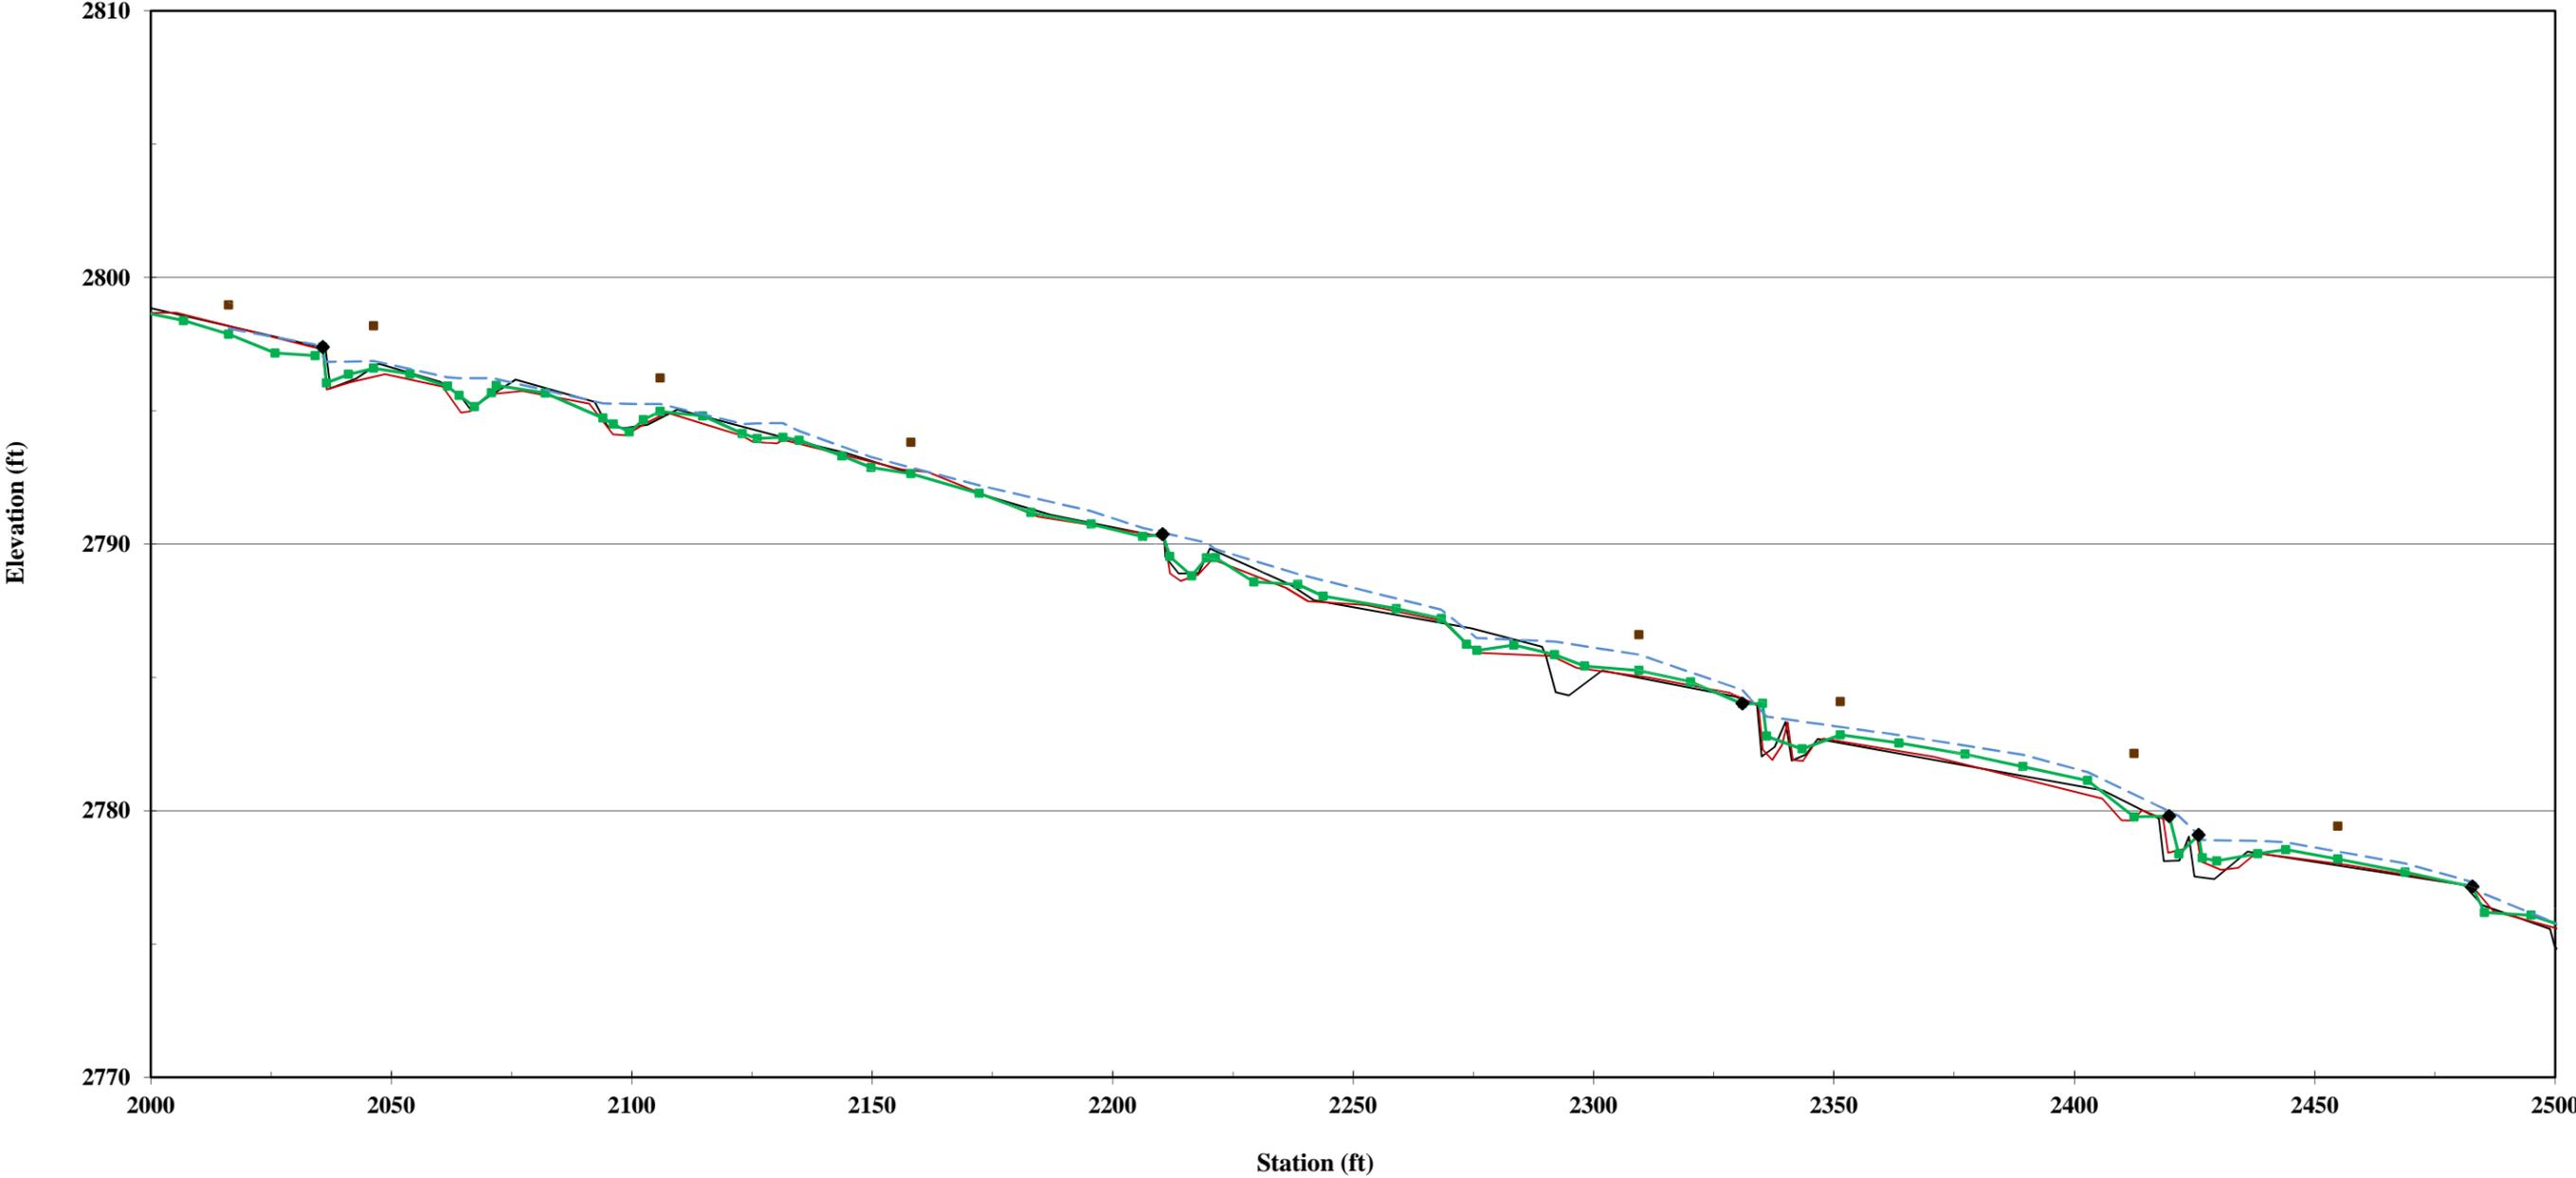
**Dog Bite Site
Longitudinal Profile
White Oak Creek, MY02
Stations 20+00 - 25+00**

— MY00, 10/22/09 — MY01, 10/19/10 —■— MY02, 11/8/11 - - - Water Surface

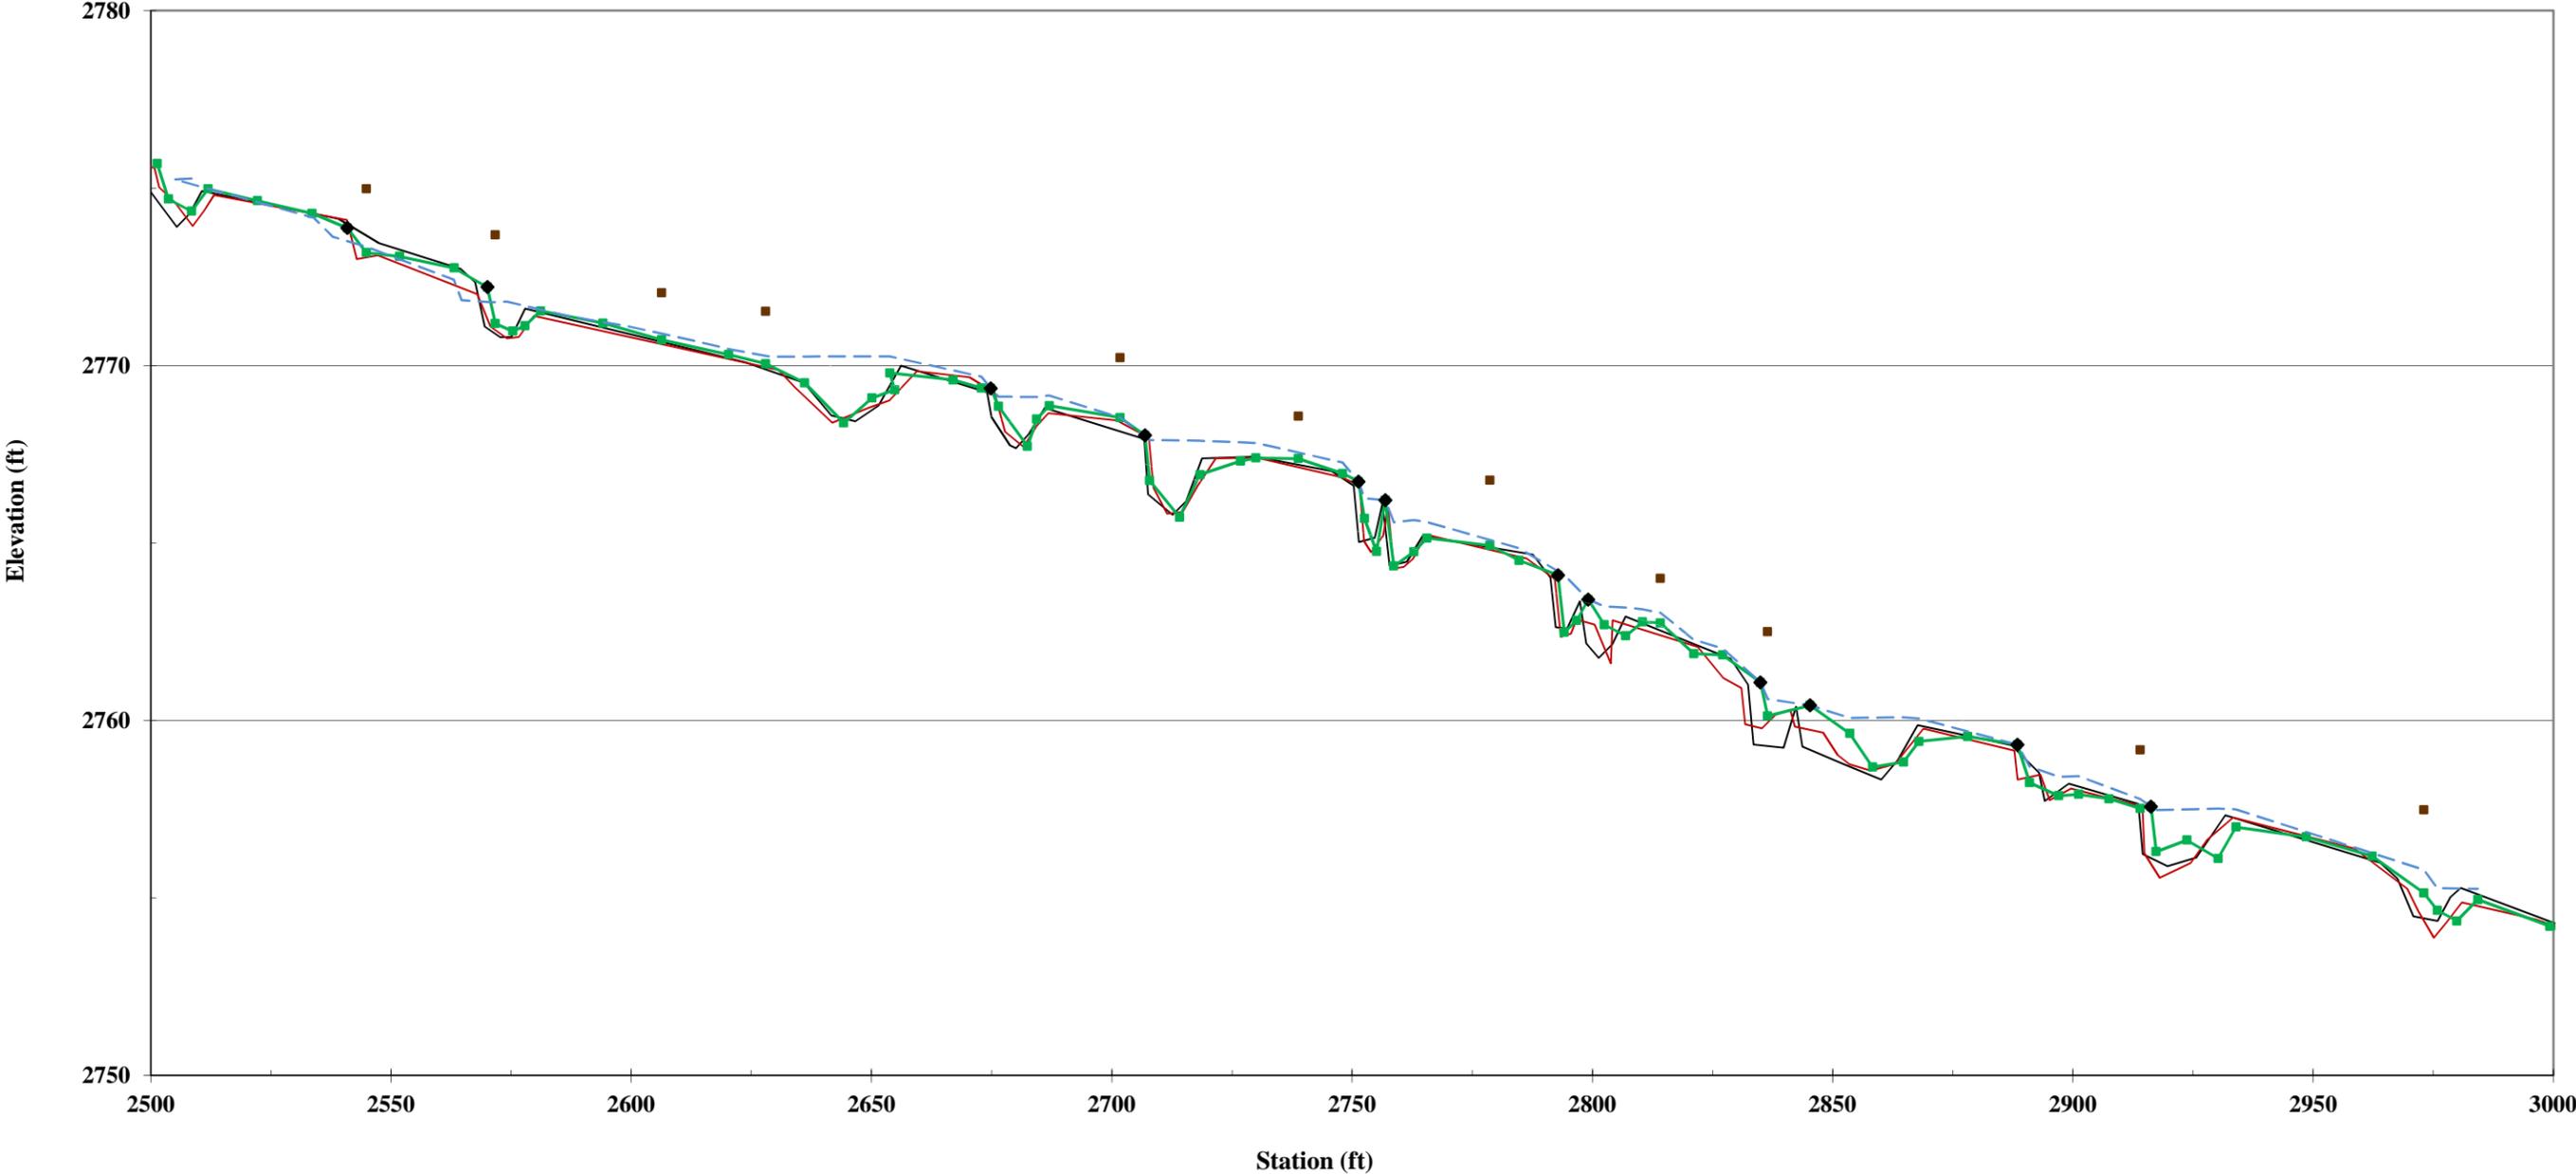
**Dog Bite Site
Longitudinal Profile
White Oak Creek, MY02
Stations 25+00 - 30+00**

— MY00, 10/22/09 — MY01, 10/22/10 —■— MY02, 11/8/11 - - - Water Surface ■ Bankfull ◆ Grade Control Structures
