**Dog Bite Stream Restoration Site
Monitoring Report – MY02
Mitchell County, NC
Basin 06010108 - Contract # D06056-A**

December 2011

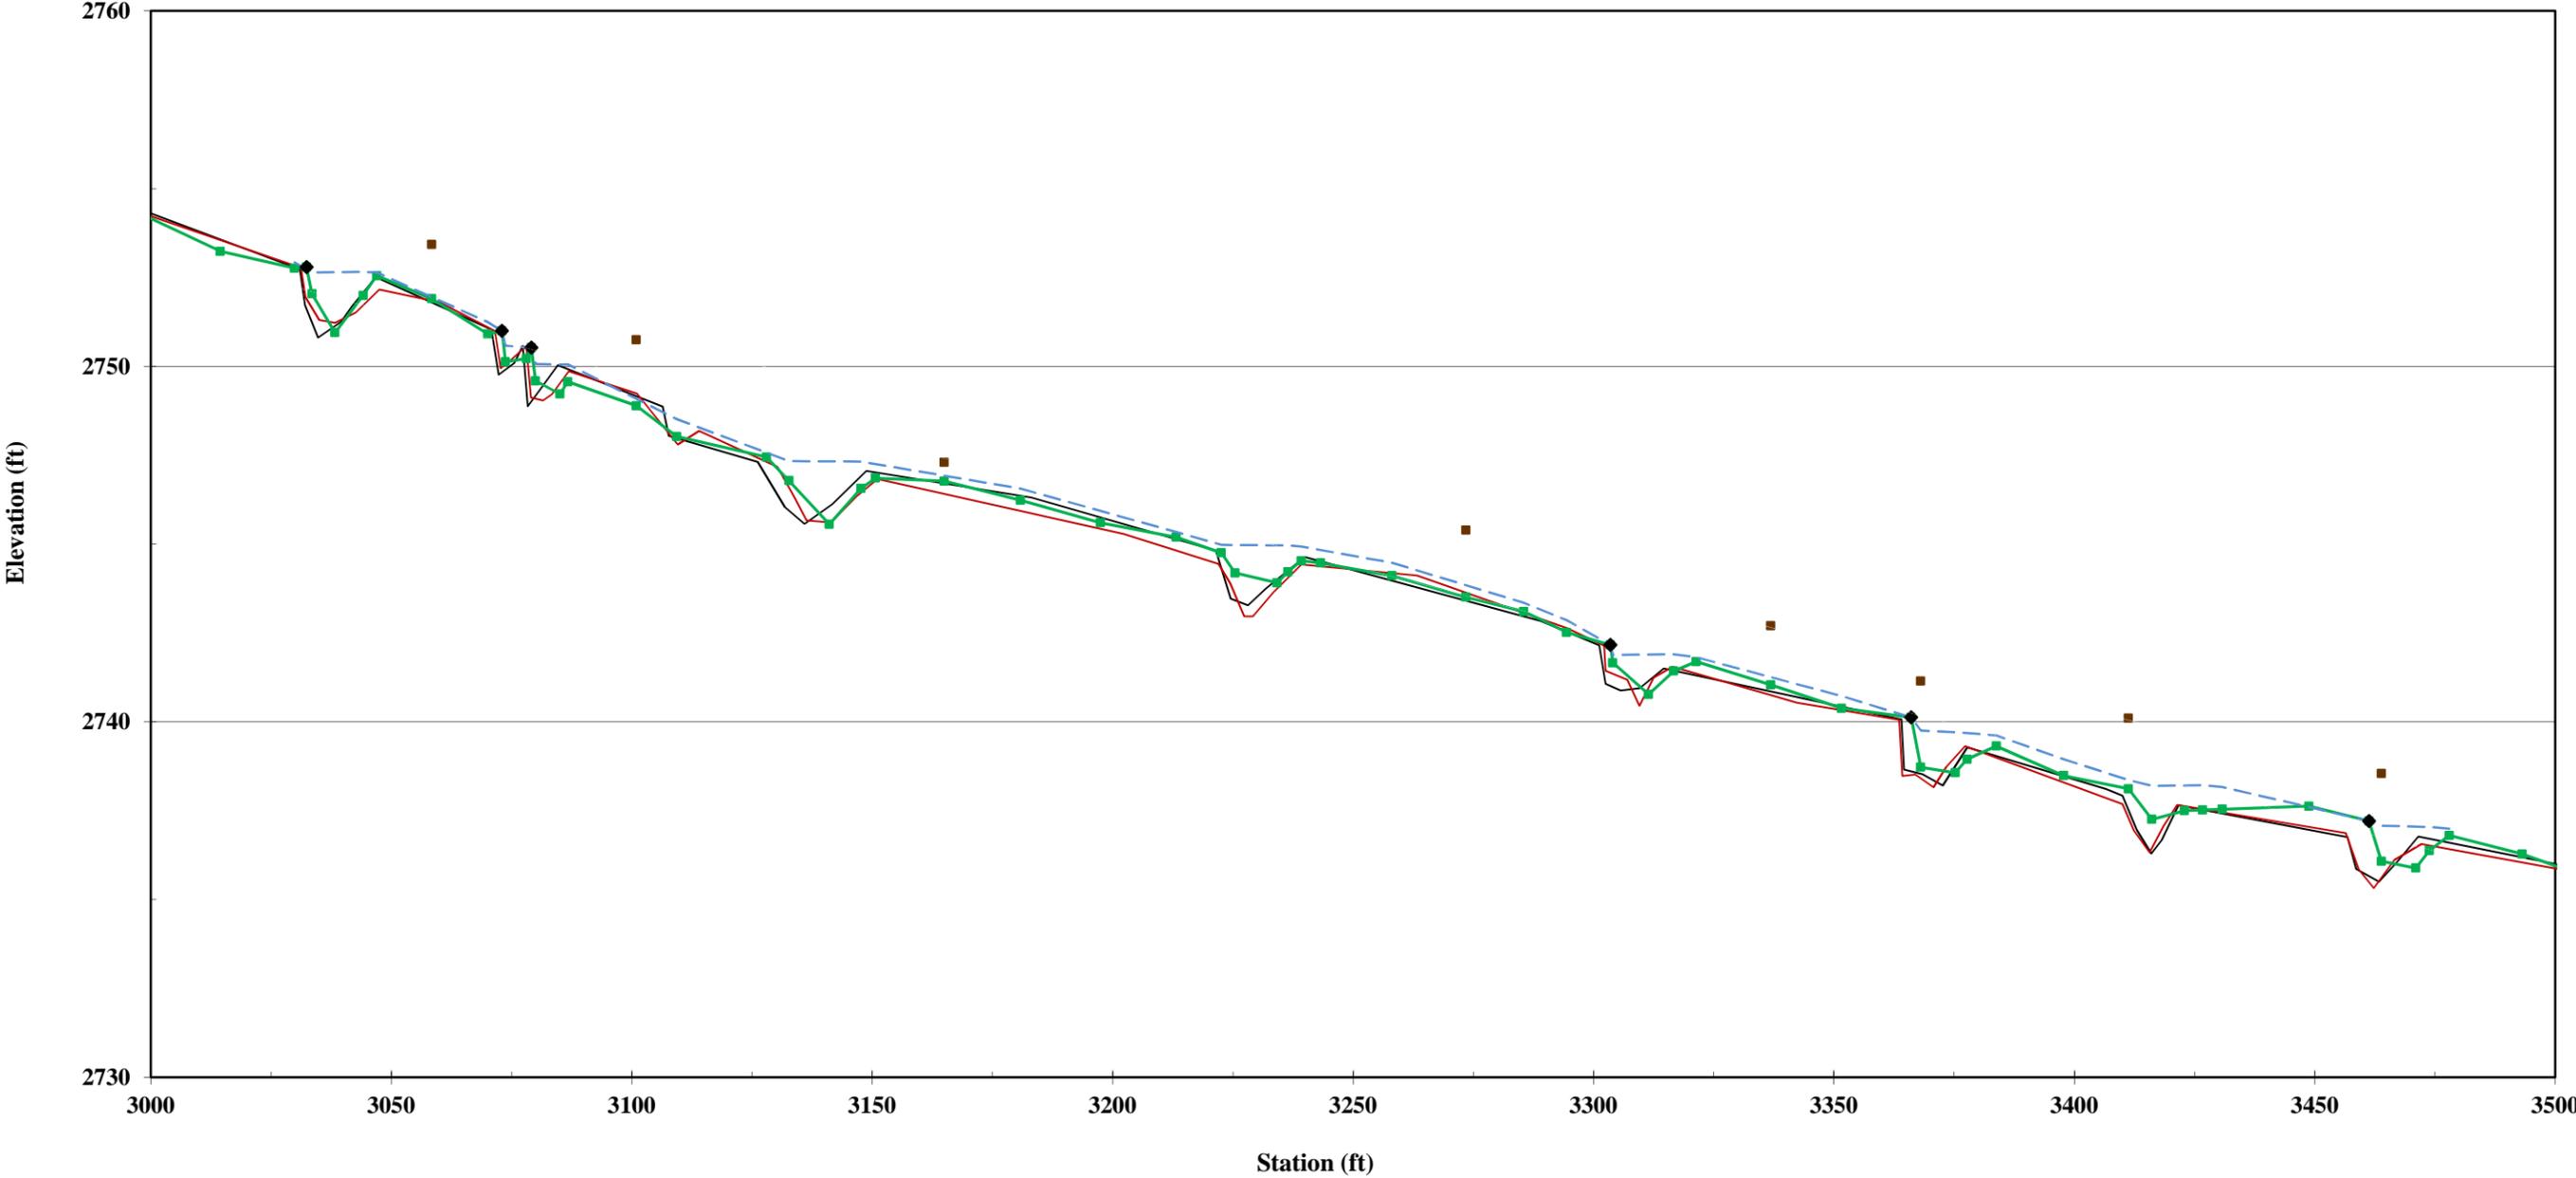
**Dog Bite Site
Longitudinal Profile
White Oak Creek, MY02
Stations 30+00 - 35+00**

— MY00, 10/22/09 — MY01, 10/19/10 —■— MY02, 11/8/11 - - - Water Surface ■ Bankfull ◆ Grade Control Structures

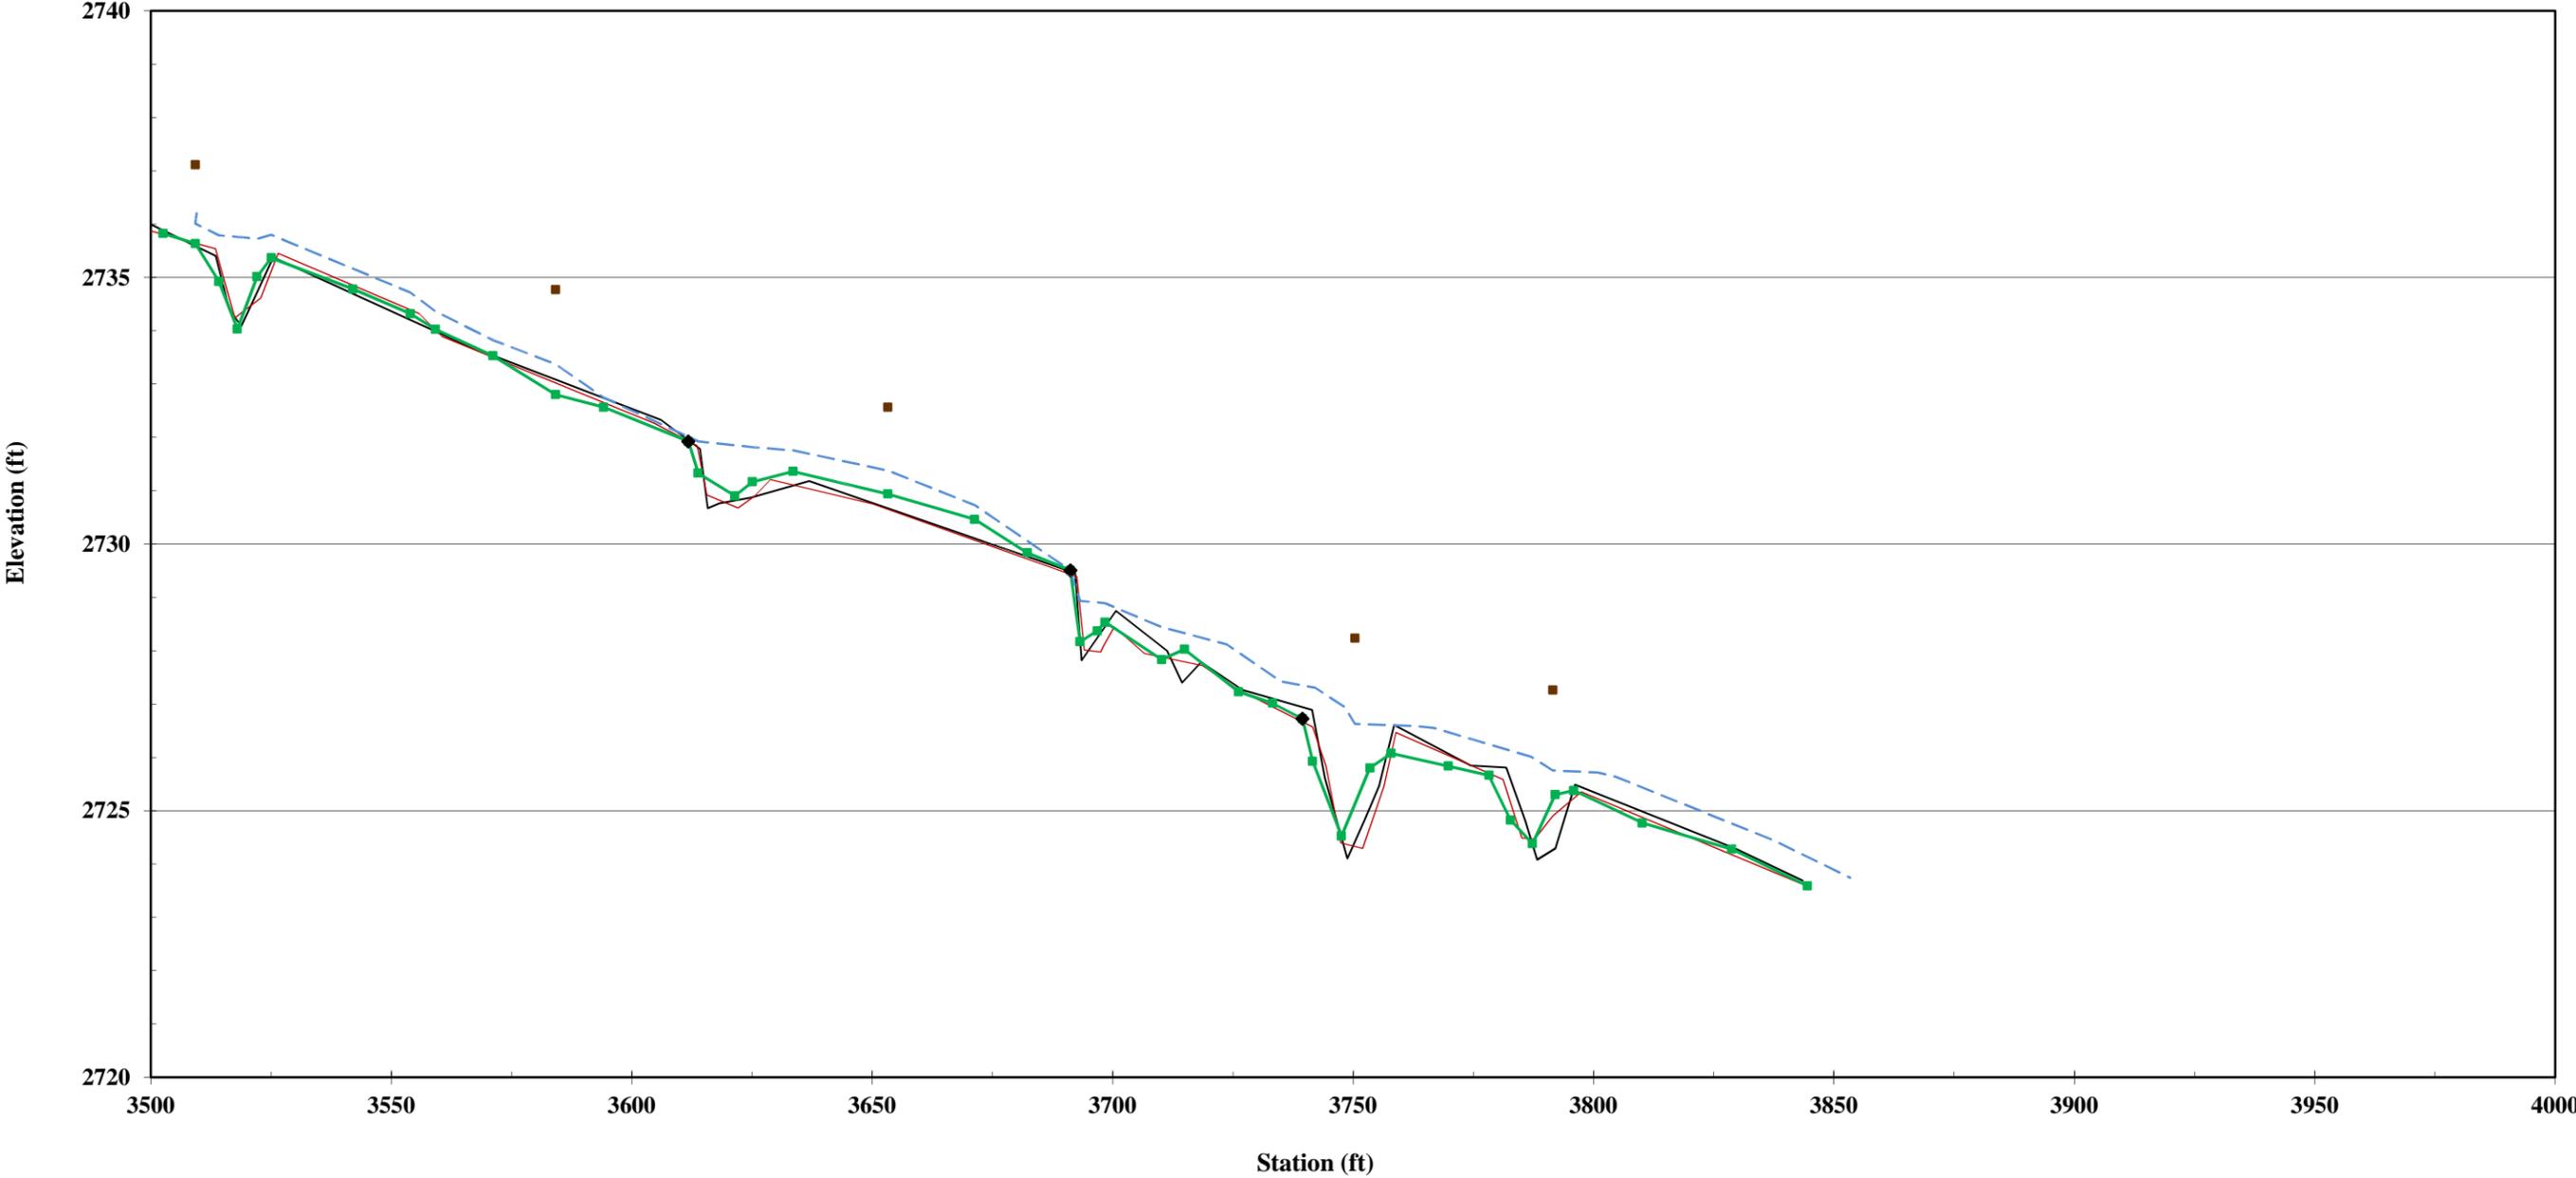
**Dog Bite Site
Longitudinal Profile
White Oak Creek, MY02
Stations 35+00 - 40+00**

— MY00, 10/22/09 — MY01, 10/19/10 —■— MY02, 11/8/11 - - - Water Surface ■ Bankfull ◆ Grade Control Structures

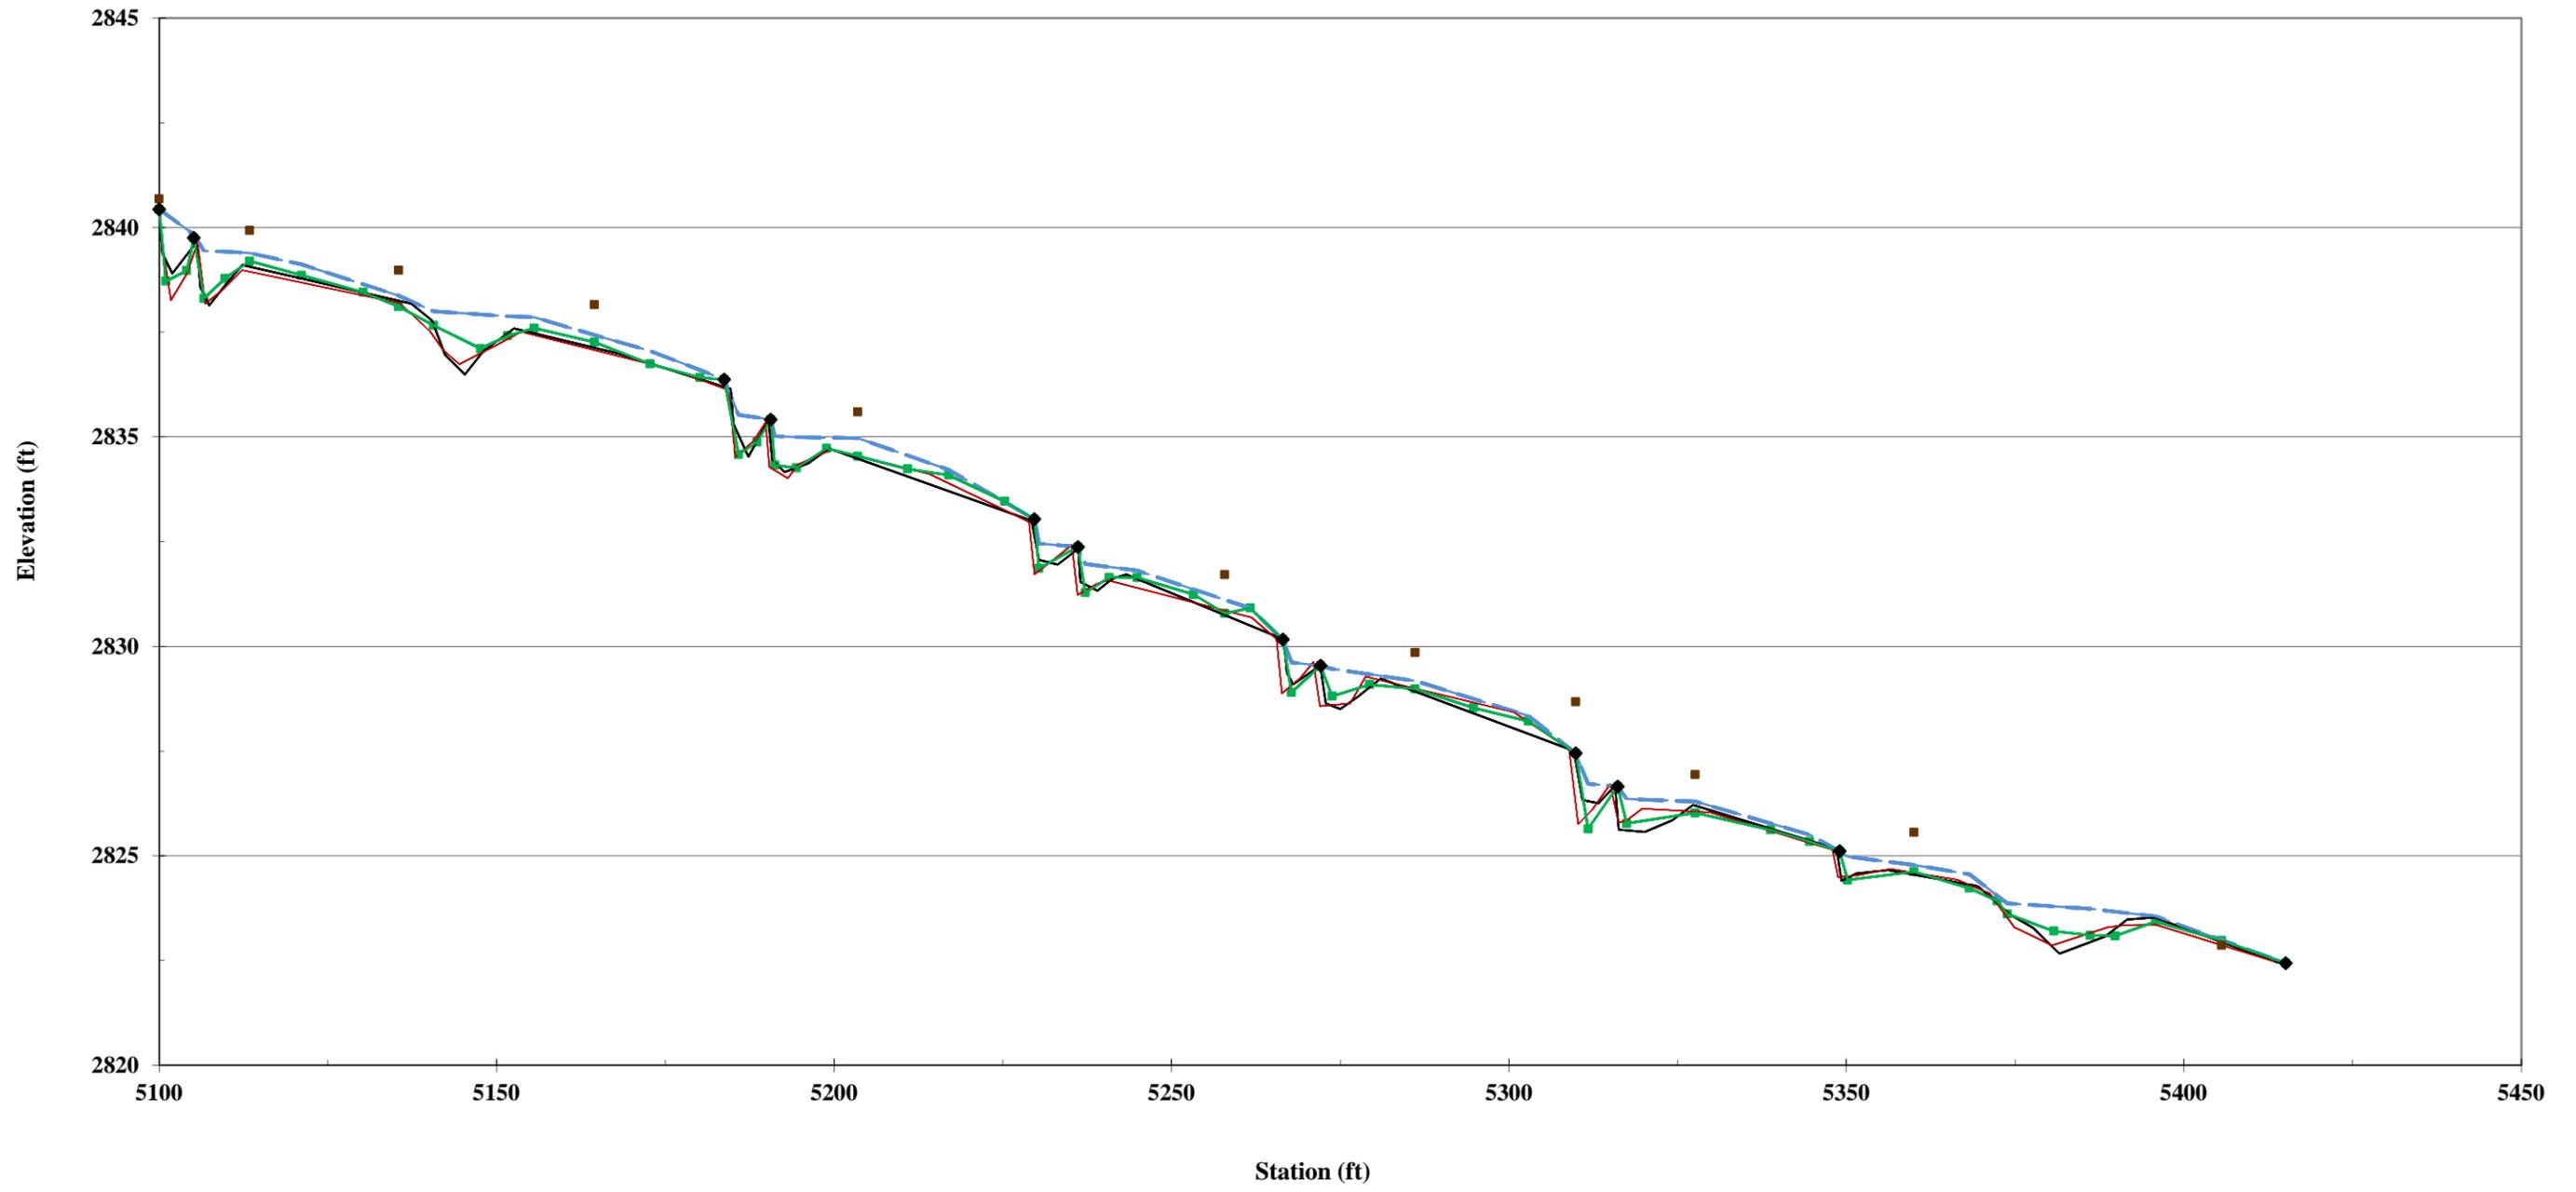
**Dog Bite Site
Longitudinal Profile
T1, MY02
Stations 51+00 - 54+15**

— MY00, 10/22/09 — MY01, 10/19/10 —■— MY02, 11/8/11 - - - Water Surface ■ Bankfull ◆ Grade Control Structures

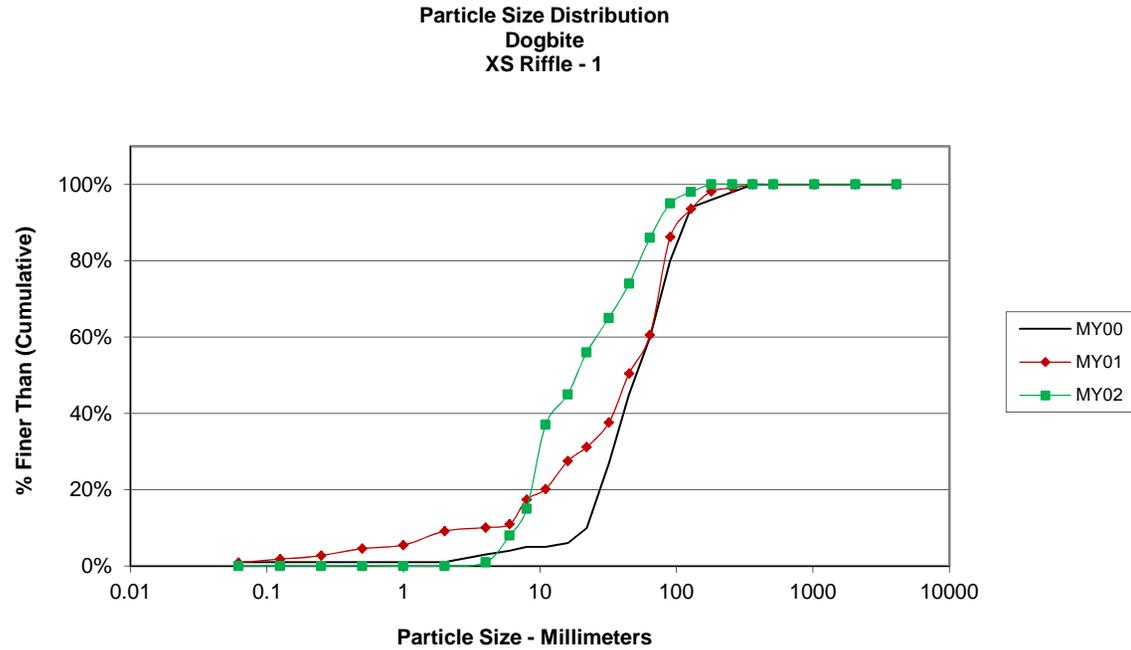
Cross-Section Riffle 1 - MY02			
Particle	Millimeter		Count
Silt/Clay	< 0.062	S/C	
Very Fine	.062 - .125	S	
Fine	.125 - .25	A	
Medium	.25 - .50	N	
Coarse	.50 - 1	D	
Very Coarse	1 - 2	S	
Very Fine	2 - 4		1
Fine	4 - 5.7	G	7
Fine	5.7 - 8	R	7
Medium	8 - 11.3	A	22
Medium	11.3 - 16	V	8
Coarse	16 - 22.6	E	11
Coarse	22.6 - 32	L	9
Very Coarse	32 - 45	S	9
Very Coarse	45 - 64		12
Small	64 - 90	C	9
Small	90 - 128	O	3
Large	128 - 180	B	2
Large	180 - 256	L	
Small	256 - 362	B	
Small	362 - 512	L	
Medium	512 - 1024	D	
Lrg- Very Lrg	1024 - 2048	R	
Bedrock	>2048	BDRK	
		Total	100
Note:

Size (mm)	
D16	8.1
D35	11
D50	18
D65	32
D84	60
D95	90

Size Distribution	
mean	22.0
dispersion	2.8
skewness	0.09

Type	
silt/clay	0%
sand	0%
gravel	86%
cobble	14%
boulder	0%
bedrock	0%
hardpan	0%
wood/det	0%
artificial	0%

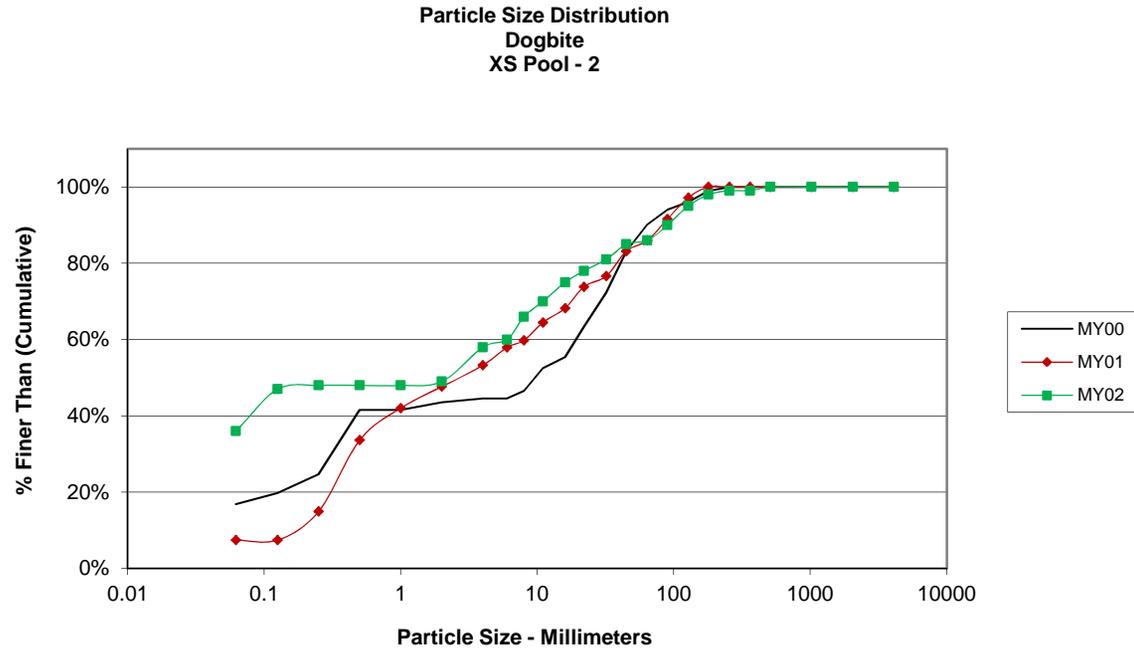
Cross-Section Pool 2 - MY02			
Particle	Millimeter		Count
Silt/Clay	< 0.062	S/C	36
Very Fine	.062 - .125	S	11
Fine	.125 - .25	A	1
Medium	.25 - .50	N	
Coarse	.50 - 1	D	
Very Coarse	1 - 2	S	1
Very Fine	2 - 4		9
Fine	4 - 5.7	G	2
Fine	5.7 - 8	R	6
Medium	8 - 11.3	A	4
Medium	11.3 - 16	V	5
Coarse	16 - 22.6	E	3
Coarse	22.6 - 32	L	3
Very Coarse	32 - 45	S	4
Very Coarse	45 - 64		1
Small	64 - 90	C	4
Small	90 - 128	O	5
Large	128 - 180	B	3
Large	180 - 256	L	1
Small	256 - 362	B	
Small	362 - 512	L	1
Medium	512 - 1024	D	
Lrg- Very Lrg	1024 - 2048	R	
Bedrock	>2048	BDRK	
		Total	100
Note:

Size (mm)	
D16	0.062
D35	0.062
D50	2.2
D65	7.6
D84	41
D95	130

Size Distribution	
mean	1.6
dispersion	27.1
skewness	-0.08

Type	
silt/clay	36%
sand	13%
gravel	37%
cobble	13%
boulder	1%
bedrock	0%
hardpan	0%
wood/det	0%
artificial	0%

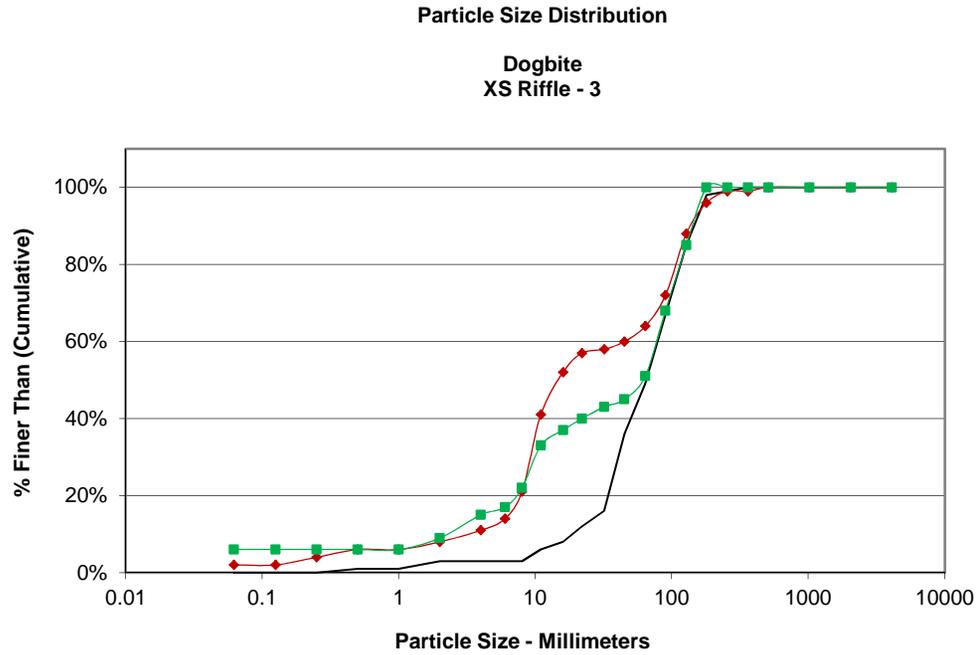
Cross-Section Riffle 3 - MY02			
Particle	Millimeter		Count
Silt/Clay	< 0.062	S/C	6
Very Fine	.062 - .125	S	
Fine	.125 - .25	A	
Medium	.25 - .50	N	
Coarse	.50 - 1	D	
Very Coarse	1 - 2	S	3
Very Fine	2 - 4		6
Fine	4 - 5.7	G	2
Fine	5.7 - 8	R	5
Medium	8 - 11.3	A	11
Medium	11.3 - 16	V	4
Coarse	16 - 22.6	E	3
Coarse	22.6 - 32	L	3
Very Coarse	32 - 45	S	2
Very Coarse	45 - 64		6
Small	64 - 90	C	17
Small	90 - 128	O	17
Large	128 - 180	B	15
Large	180 - 256	L	
Small	256 - 362	B	
Small	362 - 512	L	
Medium	512 - 1024	D	
Lrg- Very Lrg	1024 - 2048	R	
Bedrock	>2048	BDRK	
		Total	100
Note:

Size (mm)	
D16	4.9
D35	13
D50	60
D65	85
D84	130
D95	160

Size Distribution	
mean	25.2
dispersion	7.2
skewness	-0.32

Type	
silt/clay	6%
sand	3%
gravel	42%
cobble	49%
boulder	0%
bedrock	0%
hardpan	0%
wood/det	0%
artificial	0%

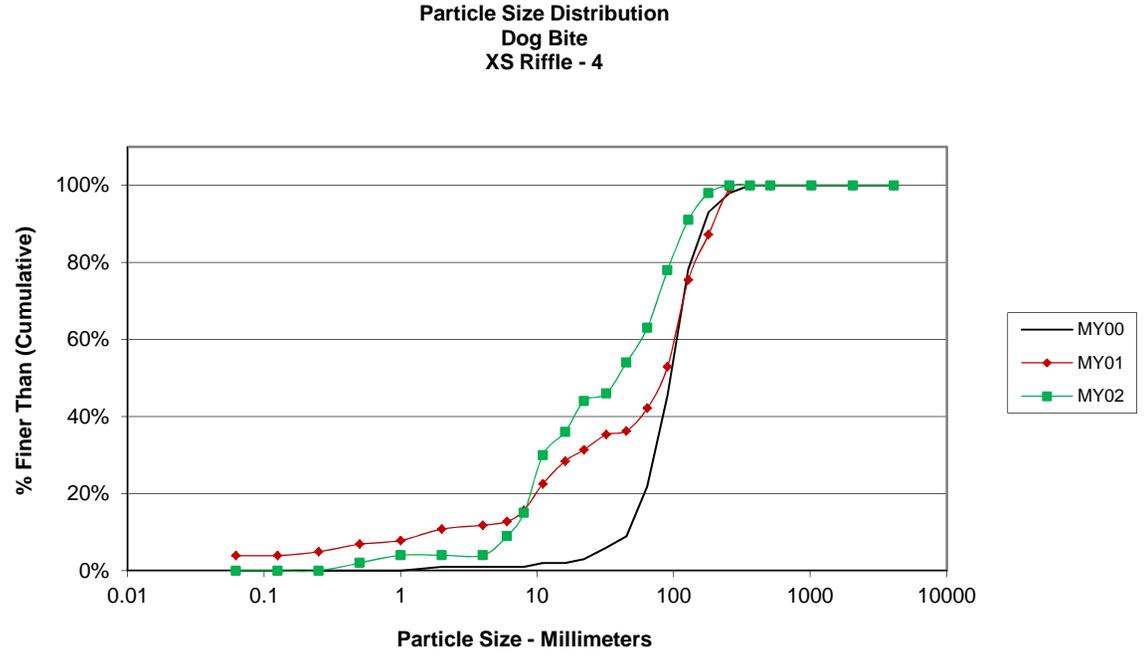
Cross-Section Riffle 4 - MY02			
Particle	Millimeter		Count
Silt/Clay	< 0.062	S/C	
Very Fine	.062 - .125	S	
Fine	.125 - .25	A	
Medium	.25 - .50	N	2
Coarse	.50 - 1	D	2
Very Coarse	1 - 2	S	
Very Fine	2 - 4		
Fine	4 - 5.7	G	5
Fine	5.7 - 8	R	6
Medium	8 - 11.3	A	15
Medium	11.3 - 16	V	6
Coarse	16 - 22.6	E	8
Coarse	22.6 - 32	L	2
Very Coarse	32 - 45	S	8
Very Coarse	45 - 64		9
Small	64 - 90	C	15
Small	90 - 128	O	13
Large	128 - 180	B	7
Large	180 - 256	L	2
Small	256 - 362	B	
Small	362 - 512	L	
Medium	512 - 1024	D	
Lrg- Very Lrg	1024 - 2048	R	
Bedrock	>2048	BDRK	
		Total	100
Note:

Size (mm)	
D16	8.2
D35	15
D50	38
D65	67
D84	110
D95	160

Size Distribution	
mean	30.0
dispersion	3.8
skewness	-0.10

Type	
silt/clay	0%
sand	4%
gravel	59%
cobble	37%
boulder	0%
bedrock	0%
hardpan	0%
wood/det	0%
artificial	0%

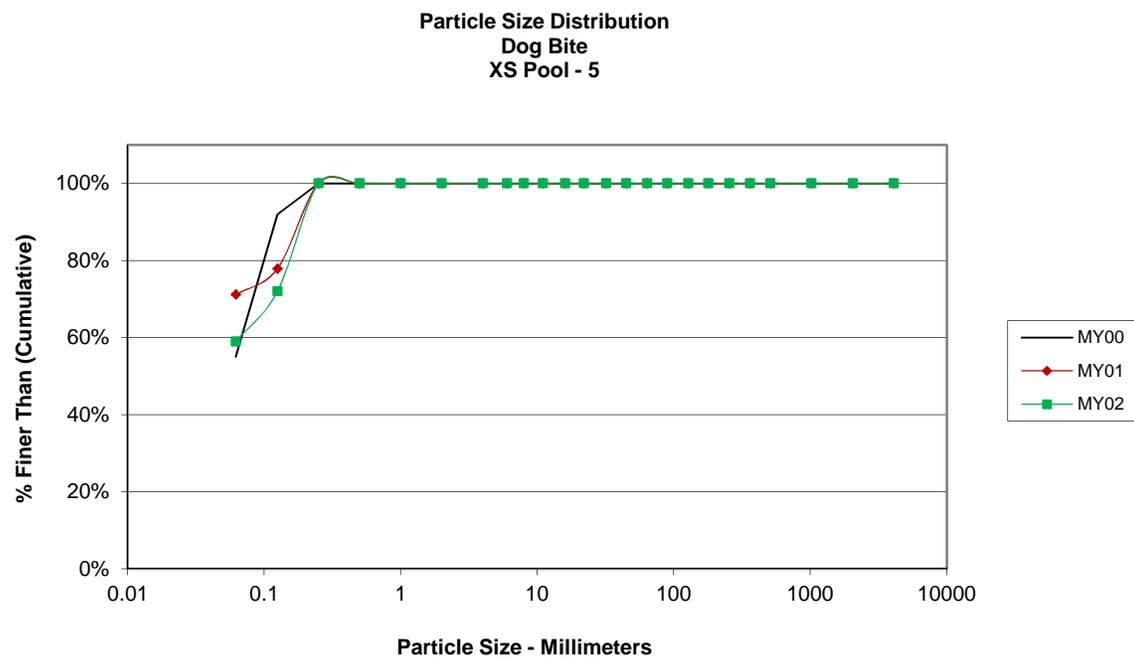
Cross-Section Pool 5 - MY02			
Particle	Millimeter		Count
Silt/Clay	< 0.062	S/C	59
Very Fine	.062 - .125	S	13
Fine	.125 - .25	A	28
Medium	.25 - .50	N	
Coarse	.50 - 1	D	
Very Coarse	1 - 2	S	
Very Fine	2 - 4		
Fine	4 - 5.7	G	
Fine	5.7 - 8	R	
Medium	8 - 11.3	A	
Medium	11.3 - 16	V	
Coarse	16 - 22.6	E	
Coarse	22.6 - 32	L	
Very Coarse	32 - 45	S	
Very Coarse	45 - 64		
Small	64 - 90	C	
Small	90 - 128	O	
Large	128 - 180	B	
Large	180 - 256	L	
Small	256 - 362	B	
Small	362 - 512	L	
Medium	512 - 1024	D	
Lrg- Very Lrg	1024 - 2048	R	
Bedrock	>2048	BDRK	
		Total	100
Note:

Size (mm)	
D16	0.062
D35	0.062
D50	0.062
D65	0.086
D84	0.17
D95	0.22

Size Distribution	
mean	0.1
dispersion	1.9
skewness	0.33

Type	
silt/clay	59%
sand	41%
gravel	0%
cobble	0%
boulder	0%
bedrock	0%
hardpan	0%
wood/det	0%
artificial	0%

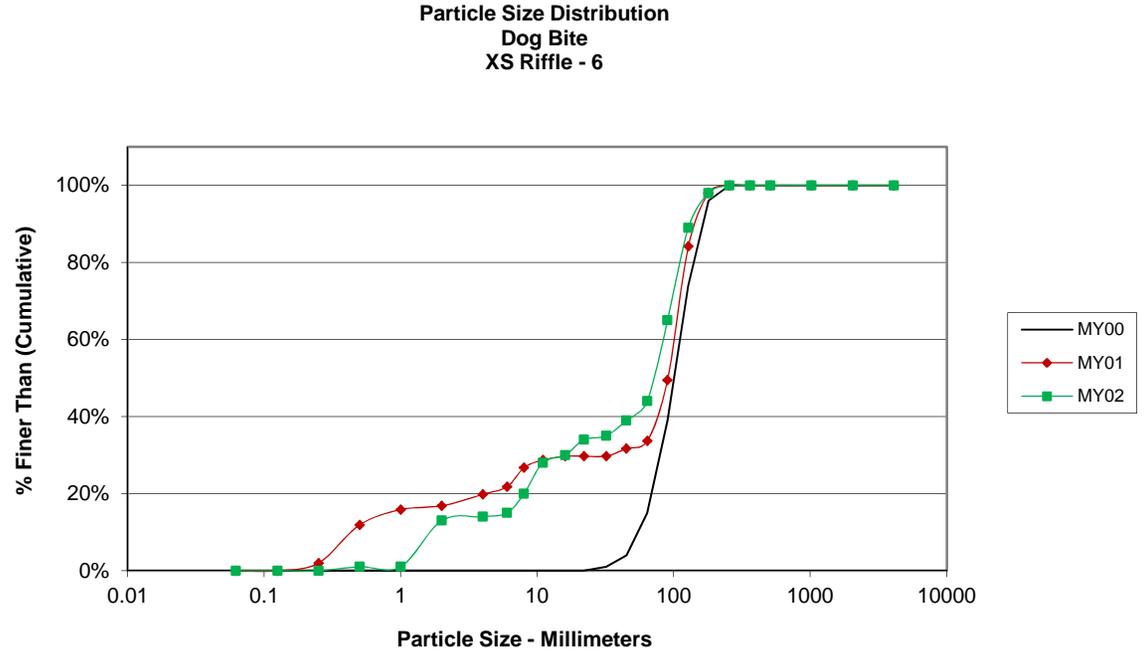
Cross-Section Riffle 6 - MY02			
Particle	Millimeter		Count
Silt/Clay	< 0.062	S/C	
Very Fine	.062 - .125	S	
Fine	.125 - .25	A	
Medium	.25 - .50	N	1
Coarse	.50 - 1	D	
Very Coarse	1 - 2	S	12
Very Fine	2 - 4		1
Fine	4 - 5.7	G	1
Fine	5.7 - 8	R	5
Medium	8 - 11.3	A	8
Medium	11.3 - 16	V	2
Coarse	16 - 22.6	E	4
Coarse	22.6 - 32	L	1
Very Coarse	32 - 45	S	4
Very Coarse	45 - 64		5
Small	64 - 90	C	21
Small	90 - 128	O	24
Large	128 - 180	B	9
Large	180 - 256	L	2
Small	256 - 362	B	
Small	362 - 512	L	
Medium	512 - 1024	D	
Lrg- Very Lrg	1024 - 2048	R	
Bedrock	>2048	BDRK	
		Total	100
Note:

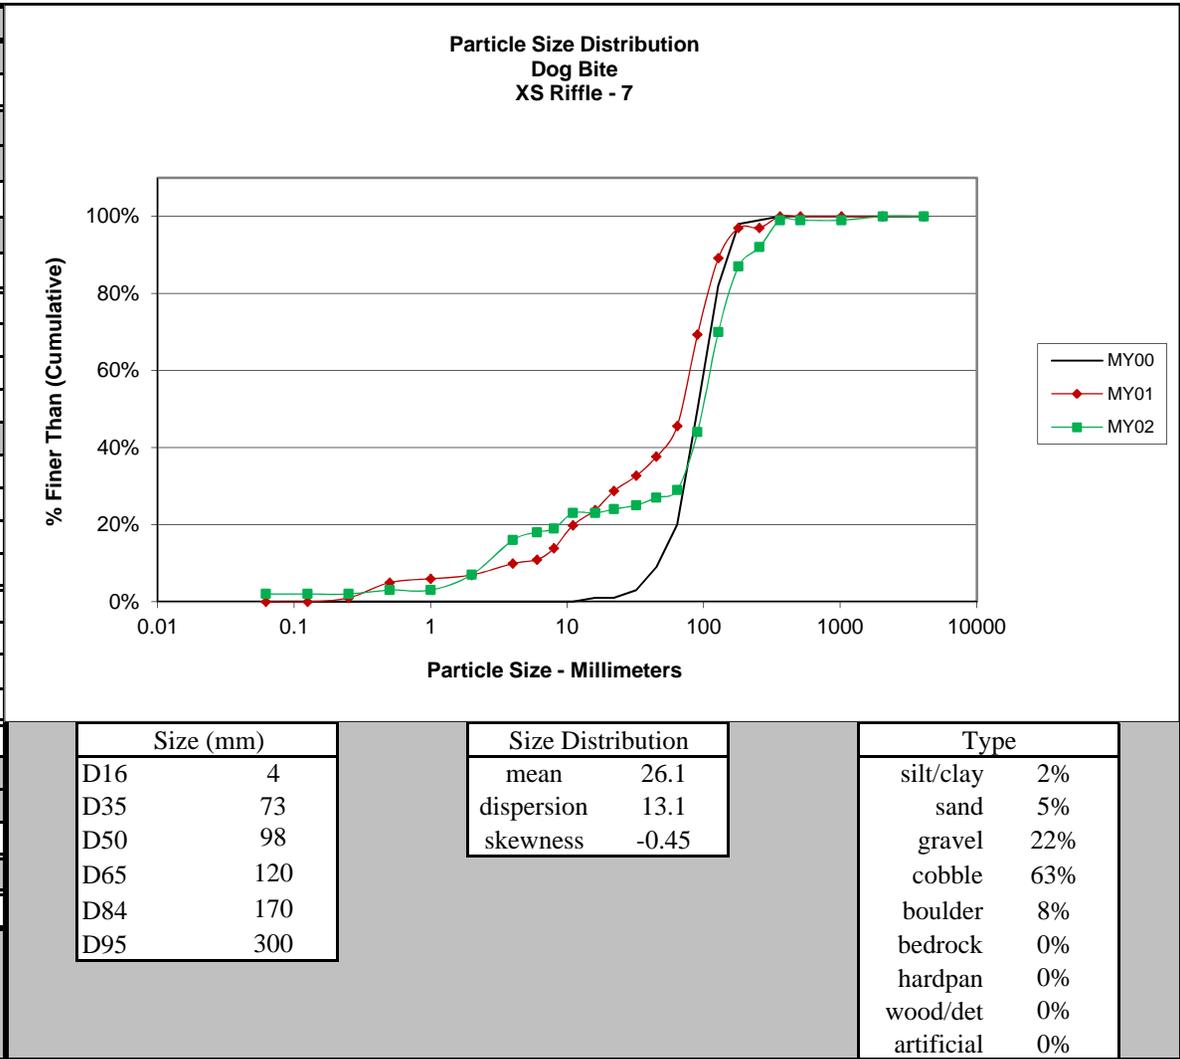
Cross-Section Riffle 7 - MY02			
Particle	Millimeter		Count
Silt/Clay	< 0.062	S/C	2
Very Fine	.062 - .125	S	
Fine	.125 - .25	A	
Medium	.25 - .50	N	1
Coarse	.50 - 1	D	
Very Coarse	1 - 2	S	4
Very Fine	2 - 4		9
Fine	4 - 5.7	G	2
Fine	5.7 - 8	R	1
Medium	8 - 11.3	A	4
Medium	11.3 - 16	V	
Coarse	16 - 22.6	E	1
Coarse	22.6 - 32	L	1
Very Coarse	32 - 45	S	2
Very Coarse	45 - 64		2
Small	64 - 90	C	15
Small	90 - 128	O	26
Large	128 - 180	B	17
Large	180 - 256	L	5
Small	256 - 362	B	7
Small	362 - 512	L	
Medium	512 - 1024	D	
Lrg- Very Lrg	1024 - 2048	R	1
Bedrock	>2048	BDRK	
		Total	100
Note:

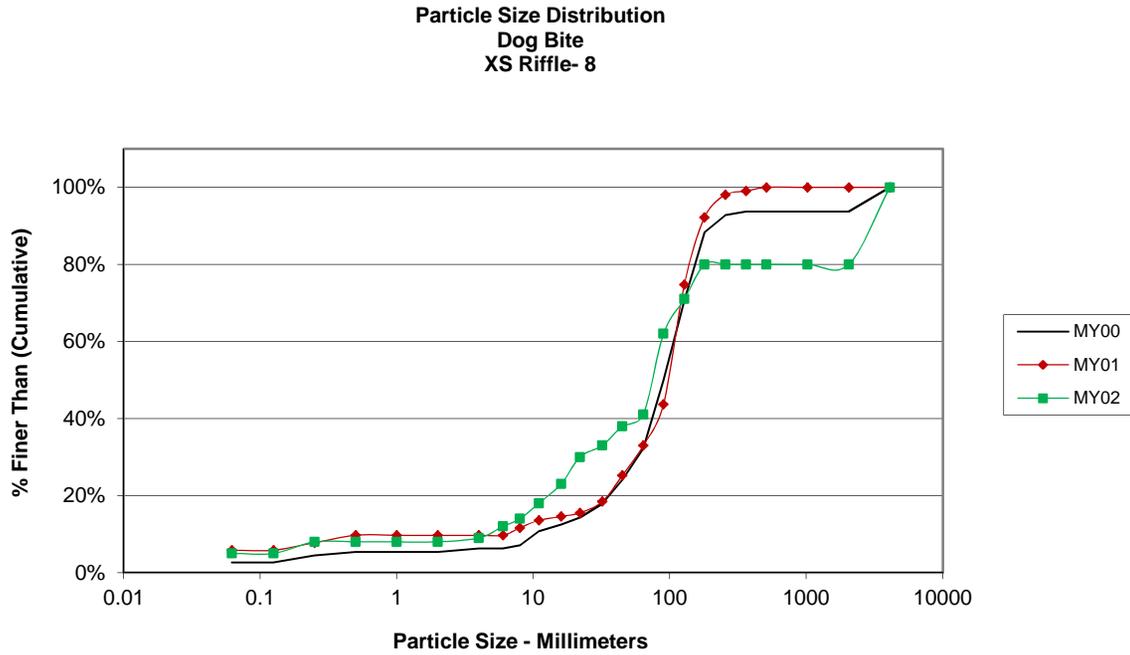
Cross-Section Riffle 8 - MY02			
Particle	Millimeter		Count
Silt/Clay	< 0.062	S/C	5
Very Fine	.062 - .125	S	
Fine	.125 - .25	A	3
Medium	.25 - .50	N	
Coarse	.50 - 1	D	
Very Coarse	1 - 2	S	
Very Fine	2 - 4		1
Fine	4 - 5.7	G	3
Fine	5.7 - 8	R	2
Medium	8 - 11.3	A	4
Medium	11.3 - 16	V	5
Coarse	16 - 22.6	E	7
Coarse	22.6 - 32	L	3
Very Coarse	32 - 45	S	5
Very Coarse	45 - 64		3
Small	64 - 90	C	21
Small	90 - 128	O	9
Large	128 - 180	B	9
Large	180 - 256	L	
Small	256 - 362	B	
Small	362 - 512	L	
Medium	512 - 1024	D	
Lrg- Very Lrg	1024 - 2048	R	
Bedrock	>2048	BDRK	20
		Total	100
Note:

Size (mm)	
D16	9.4
D35	37
D50	74
D65	100
D84	2400
D95	3400

Size Distribution	
mean	150.2
dispersion	20.2
skewness	0.20

Type	
silt/clay	5%
sand	3%
gravel	33%
cobble	39%
boulder	20%
bedrock	0%
hardpan	0%
wood/det	0%
artificial	0%

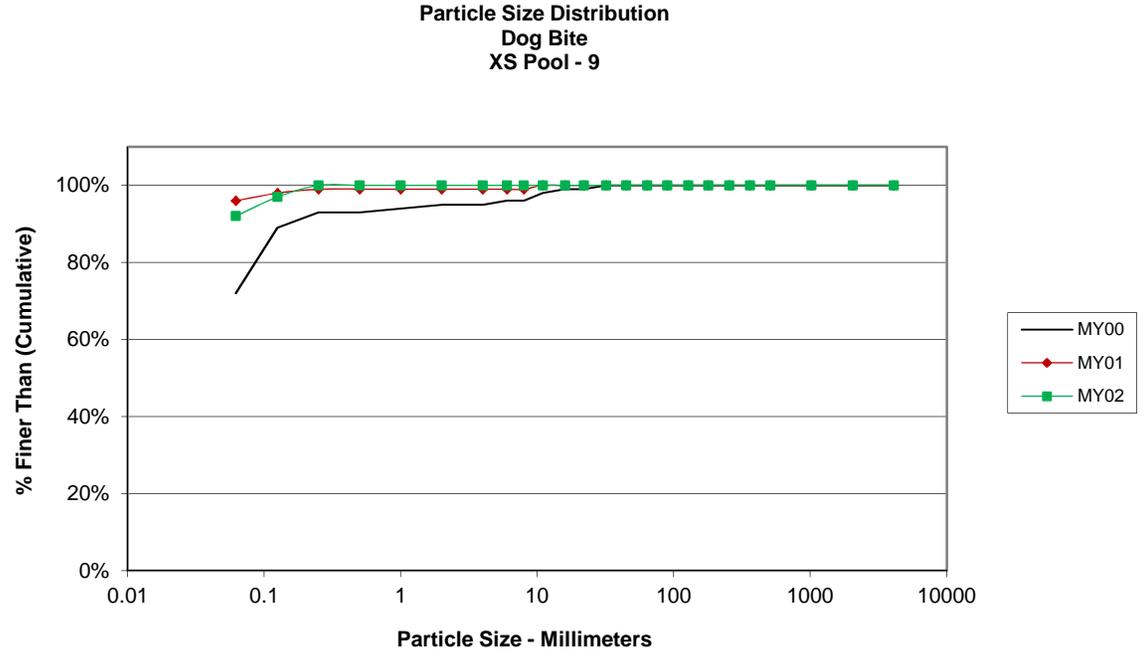
Cross-Section Pool 9 - MY02			
Particle	Millimeter		Count
Silt/Clay	< 0.062	S/C	92
Very Fine	.062 - .125	S	5
Fine	.125 - .25	A	3
Medium	.25 - .50	N	
Coarse	.50 - 1	D	
Very Coarse	1 - 2	S	
Very Fine	2 - 4		
Fine	4 - 5.7	G	
Fine	5.7 - 8	R	
Medium	8 - 11.3	A	
Medium	11.3 - 16	V	
Coarse	16 - 22.6	E	
Coarse	22.6 - 32	L	
Very Coarse	32 - 45	S	
Very Coarse	45 - 64		
Small	64 - 90	C	
Small	90 - 128	O	
Large	128 - 180	B	
Large	180 - 256	L	
Small	256 - 362	B	
Small	362 - 512	L	
Medium	512 - 1024	D	
Lrg- Very Lrg	1024 - 2048	R	
Bedrock	>2048	BDRK	
		Total	100
Note:

Size (mm)	
D16	0.062
D35	0.062
D50	0.062
D65	0.062
D84	0.062
D95	0.094

Size Distribution	
mean	0.1
dispersion	1.0
skewness	---

Type	
silt/clay	92%
sand	8%
gravel	0%
cobble	0%
boulder	0%
bedrock	0%
hardpan	0%
wood/det	0%
artificial	0%

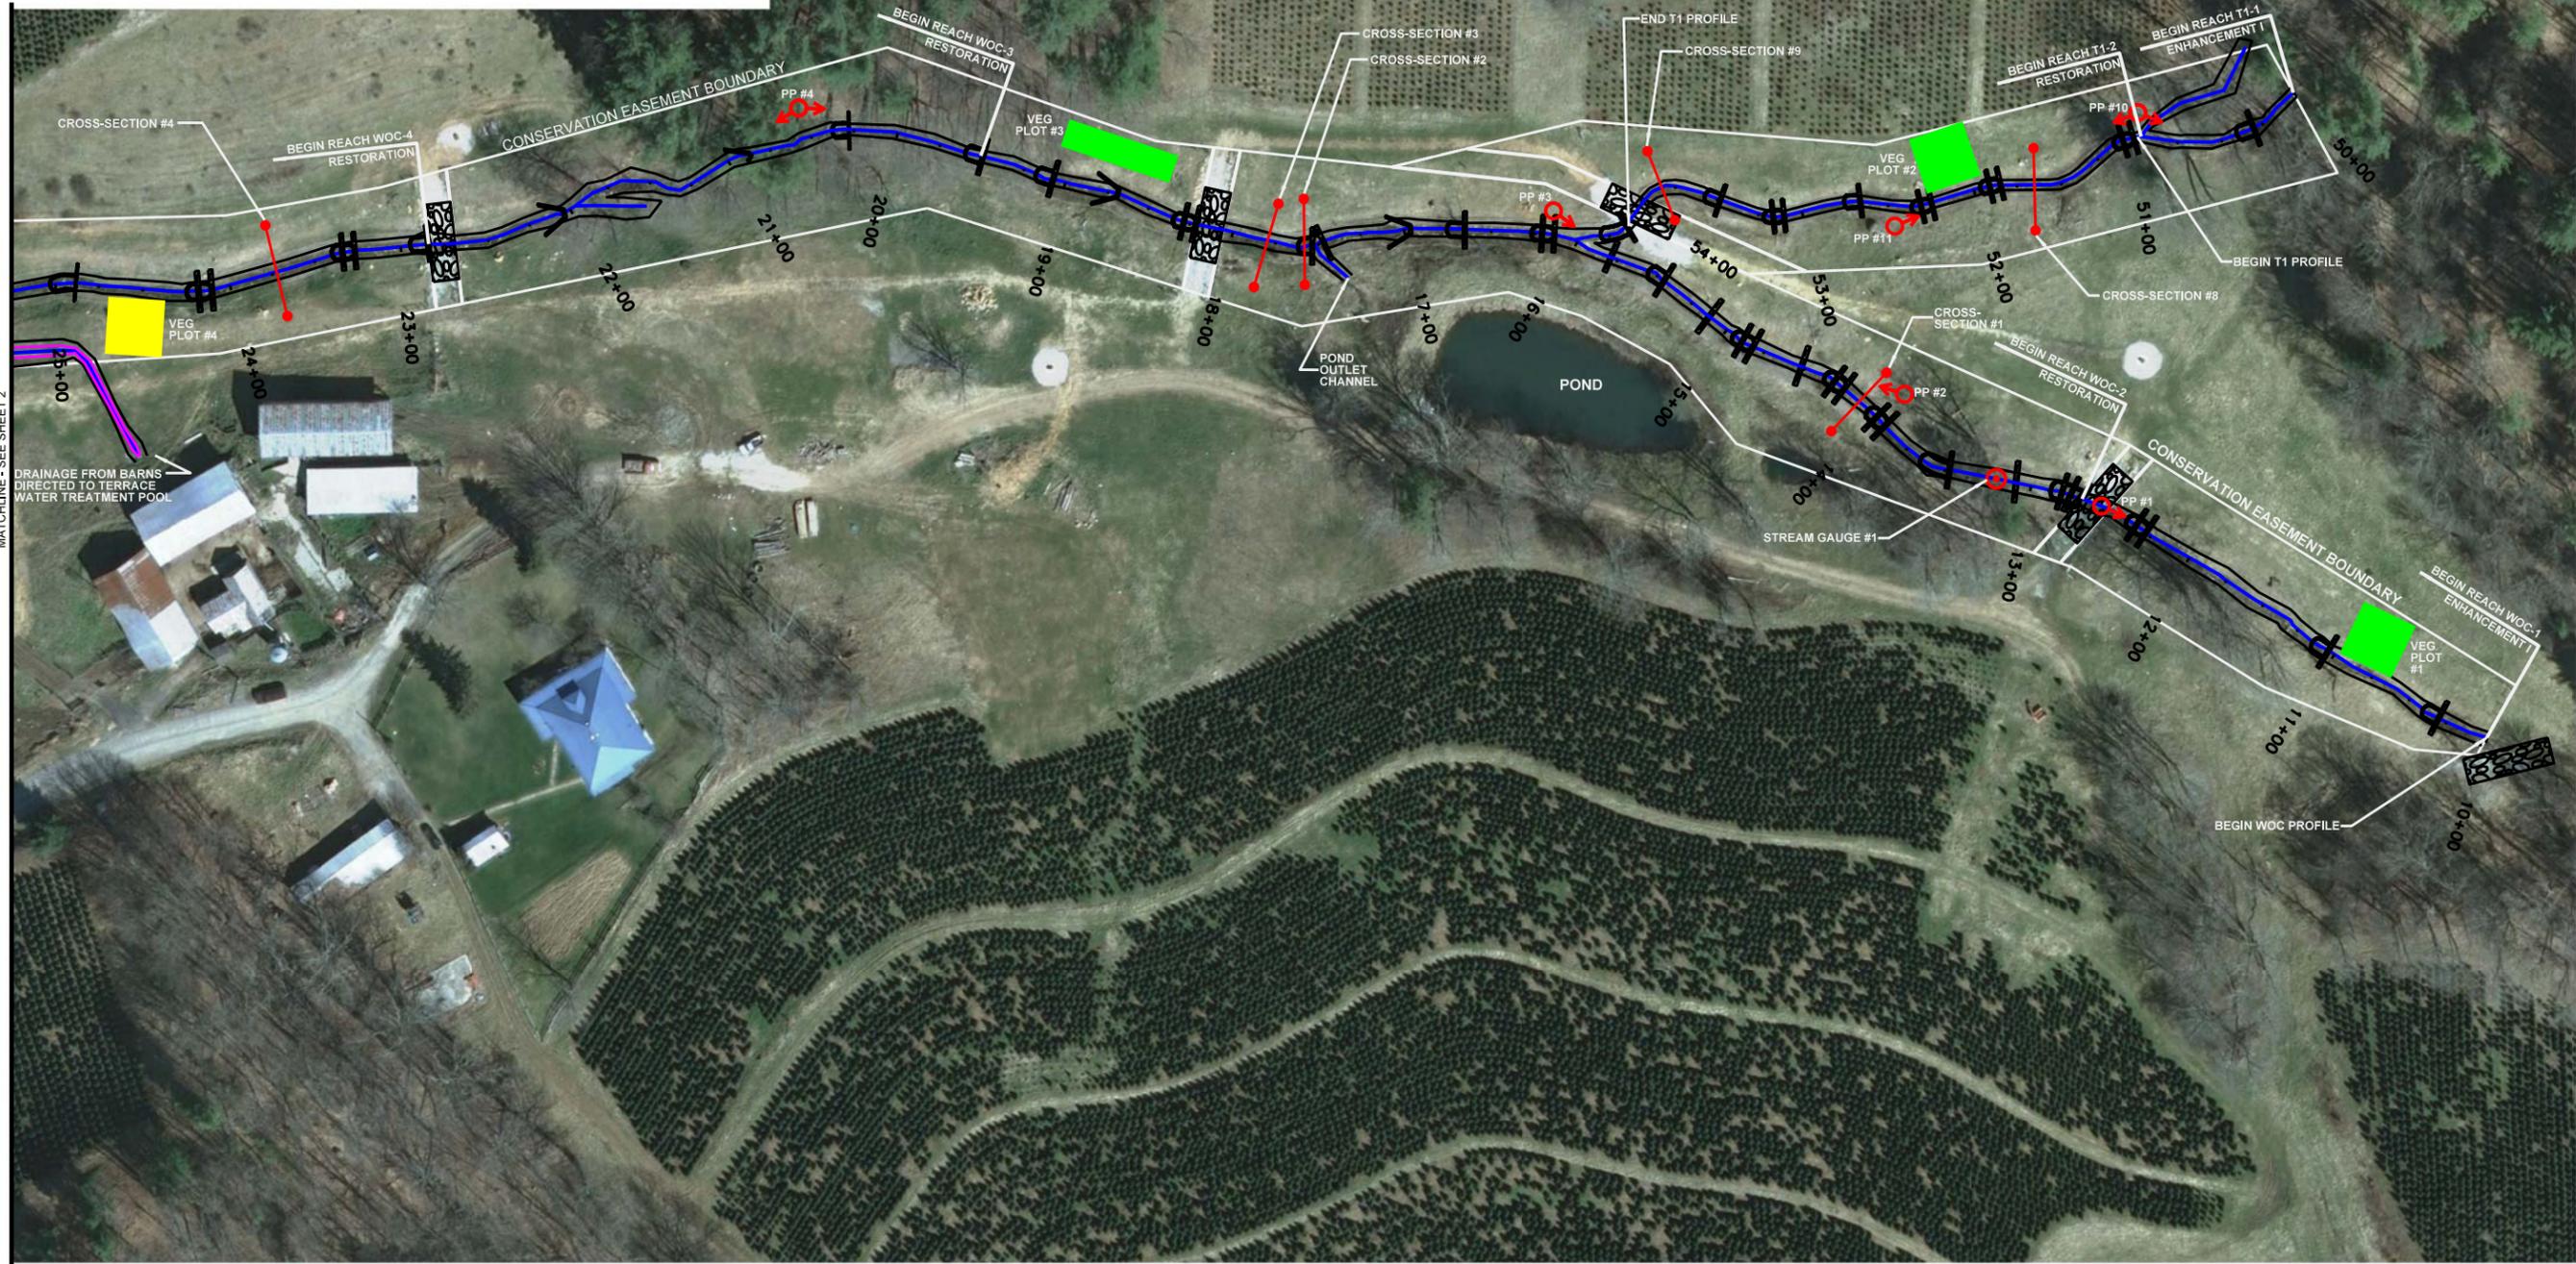
DATE: DECEMBER 2011
SCALE: 1" = 100'
CURRENT
CONDITION
PLAN VIEW
MY 2 OF 5
SHEET 1 OF 2

- VEG PLOT ACHIEVING DENSITY ABOVE 320 STEMS/ACRE..... [Symbol: Green square]
- VEG PLOT WITH DENSITY BELOW 320 STEMS/ACRE..... [Symbol: Yellow square]

DOG BITE
STREAM RESTORATION PROJECT
BAKERSVILLE, MITCHELL COUNTY, NORTH CAROLINA
WOC STATION 10+00 TO STATION 25+25; T1

Additional stream assessment data can be found in Appendix B and the Current Condition Plan View in Appendix C.
