**Dog Bite Stream Restoration Site
Monitoring Report – MY02
Mitchell County, NC
Basin 06010108 - Contract # D06056-A**

December 2011

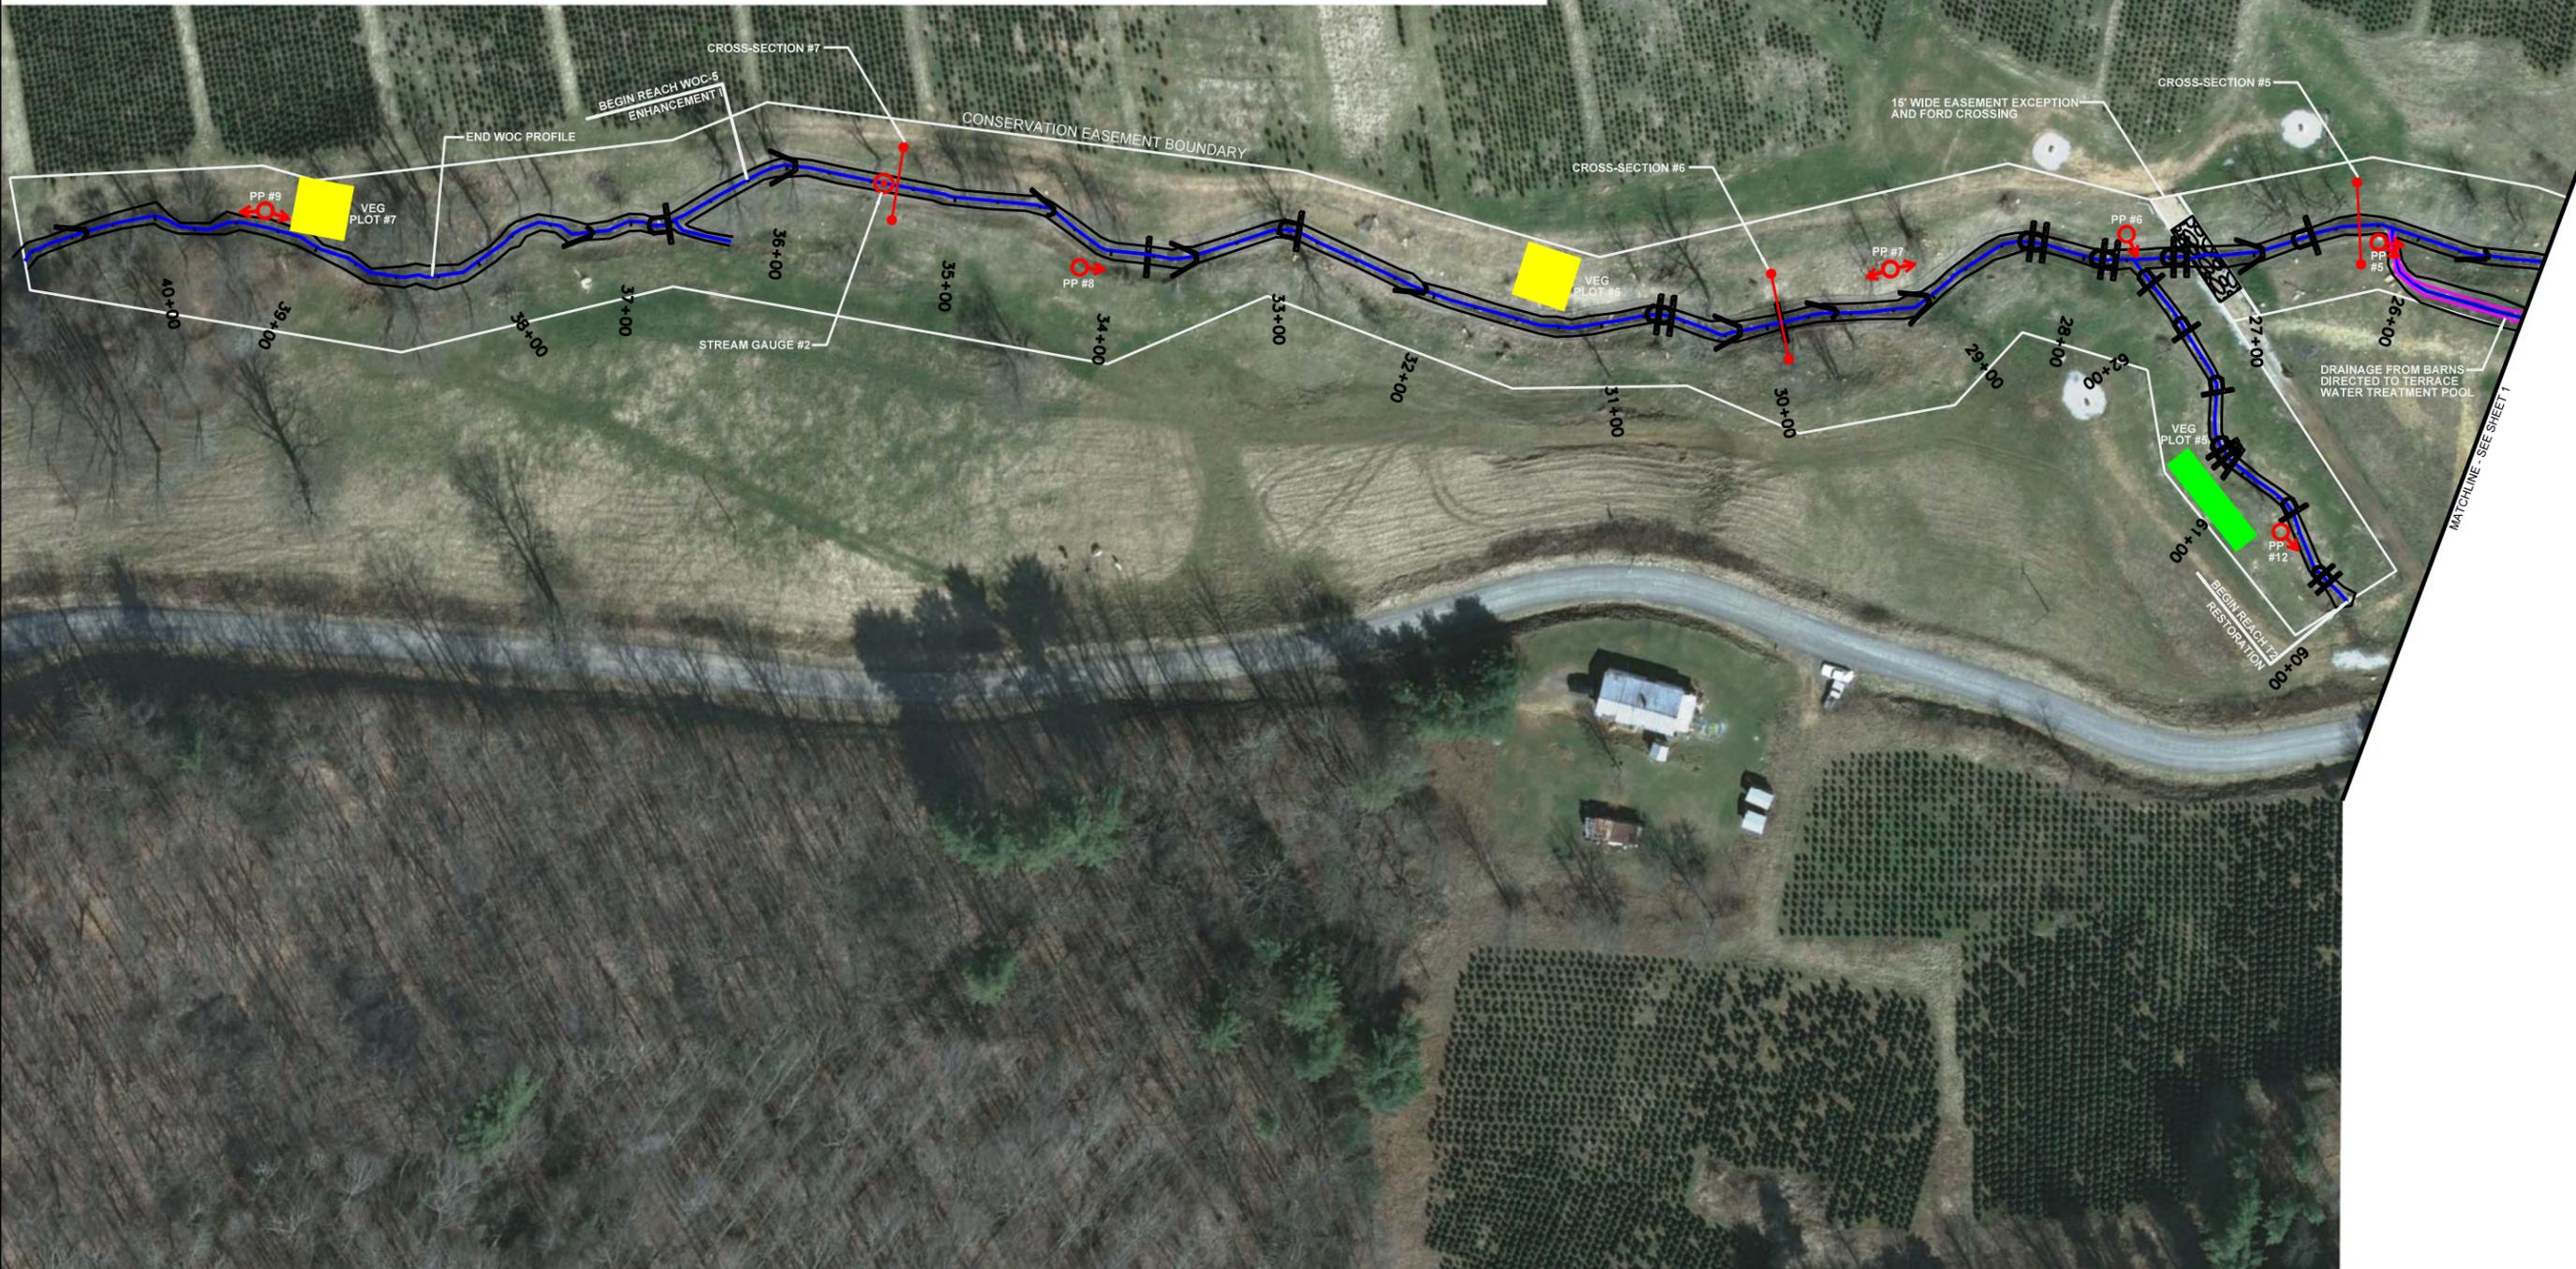
DATE: DECEMBER 2011
SCALE: 1" = 100'
CURRENT
CONDITION
PLAN VIEW
MY 2 OF 5
SHEET 2 OF 2

- VEG PLOT ACHIEVING DENSITY ABOVE 320 STEMS/ACRE.....
- VEG PLOT WITH DENSITY BELOW 320 STEMS/ACRE.....
