Farrar Dairy Stream and Wetland Restoration Site

Mitigation Plan

Contract # D06002

August 2009

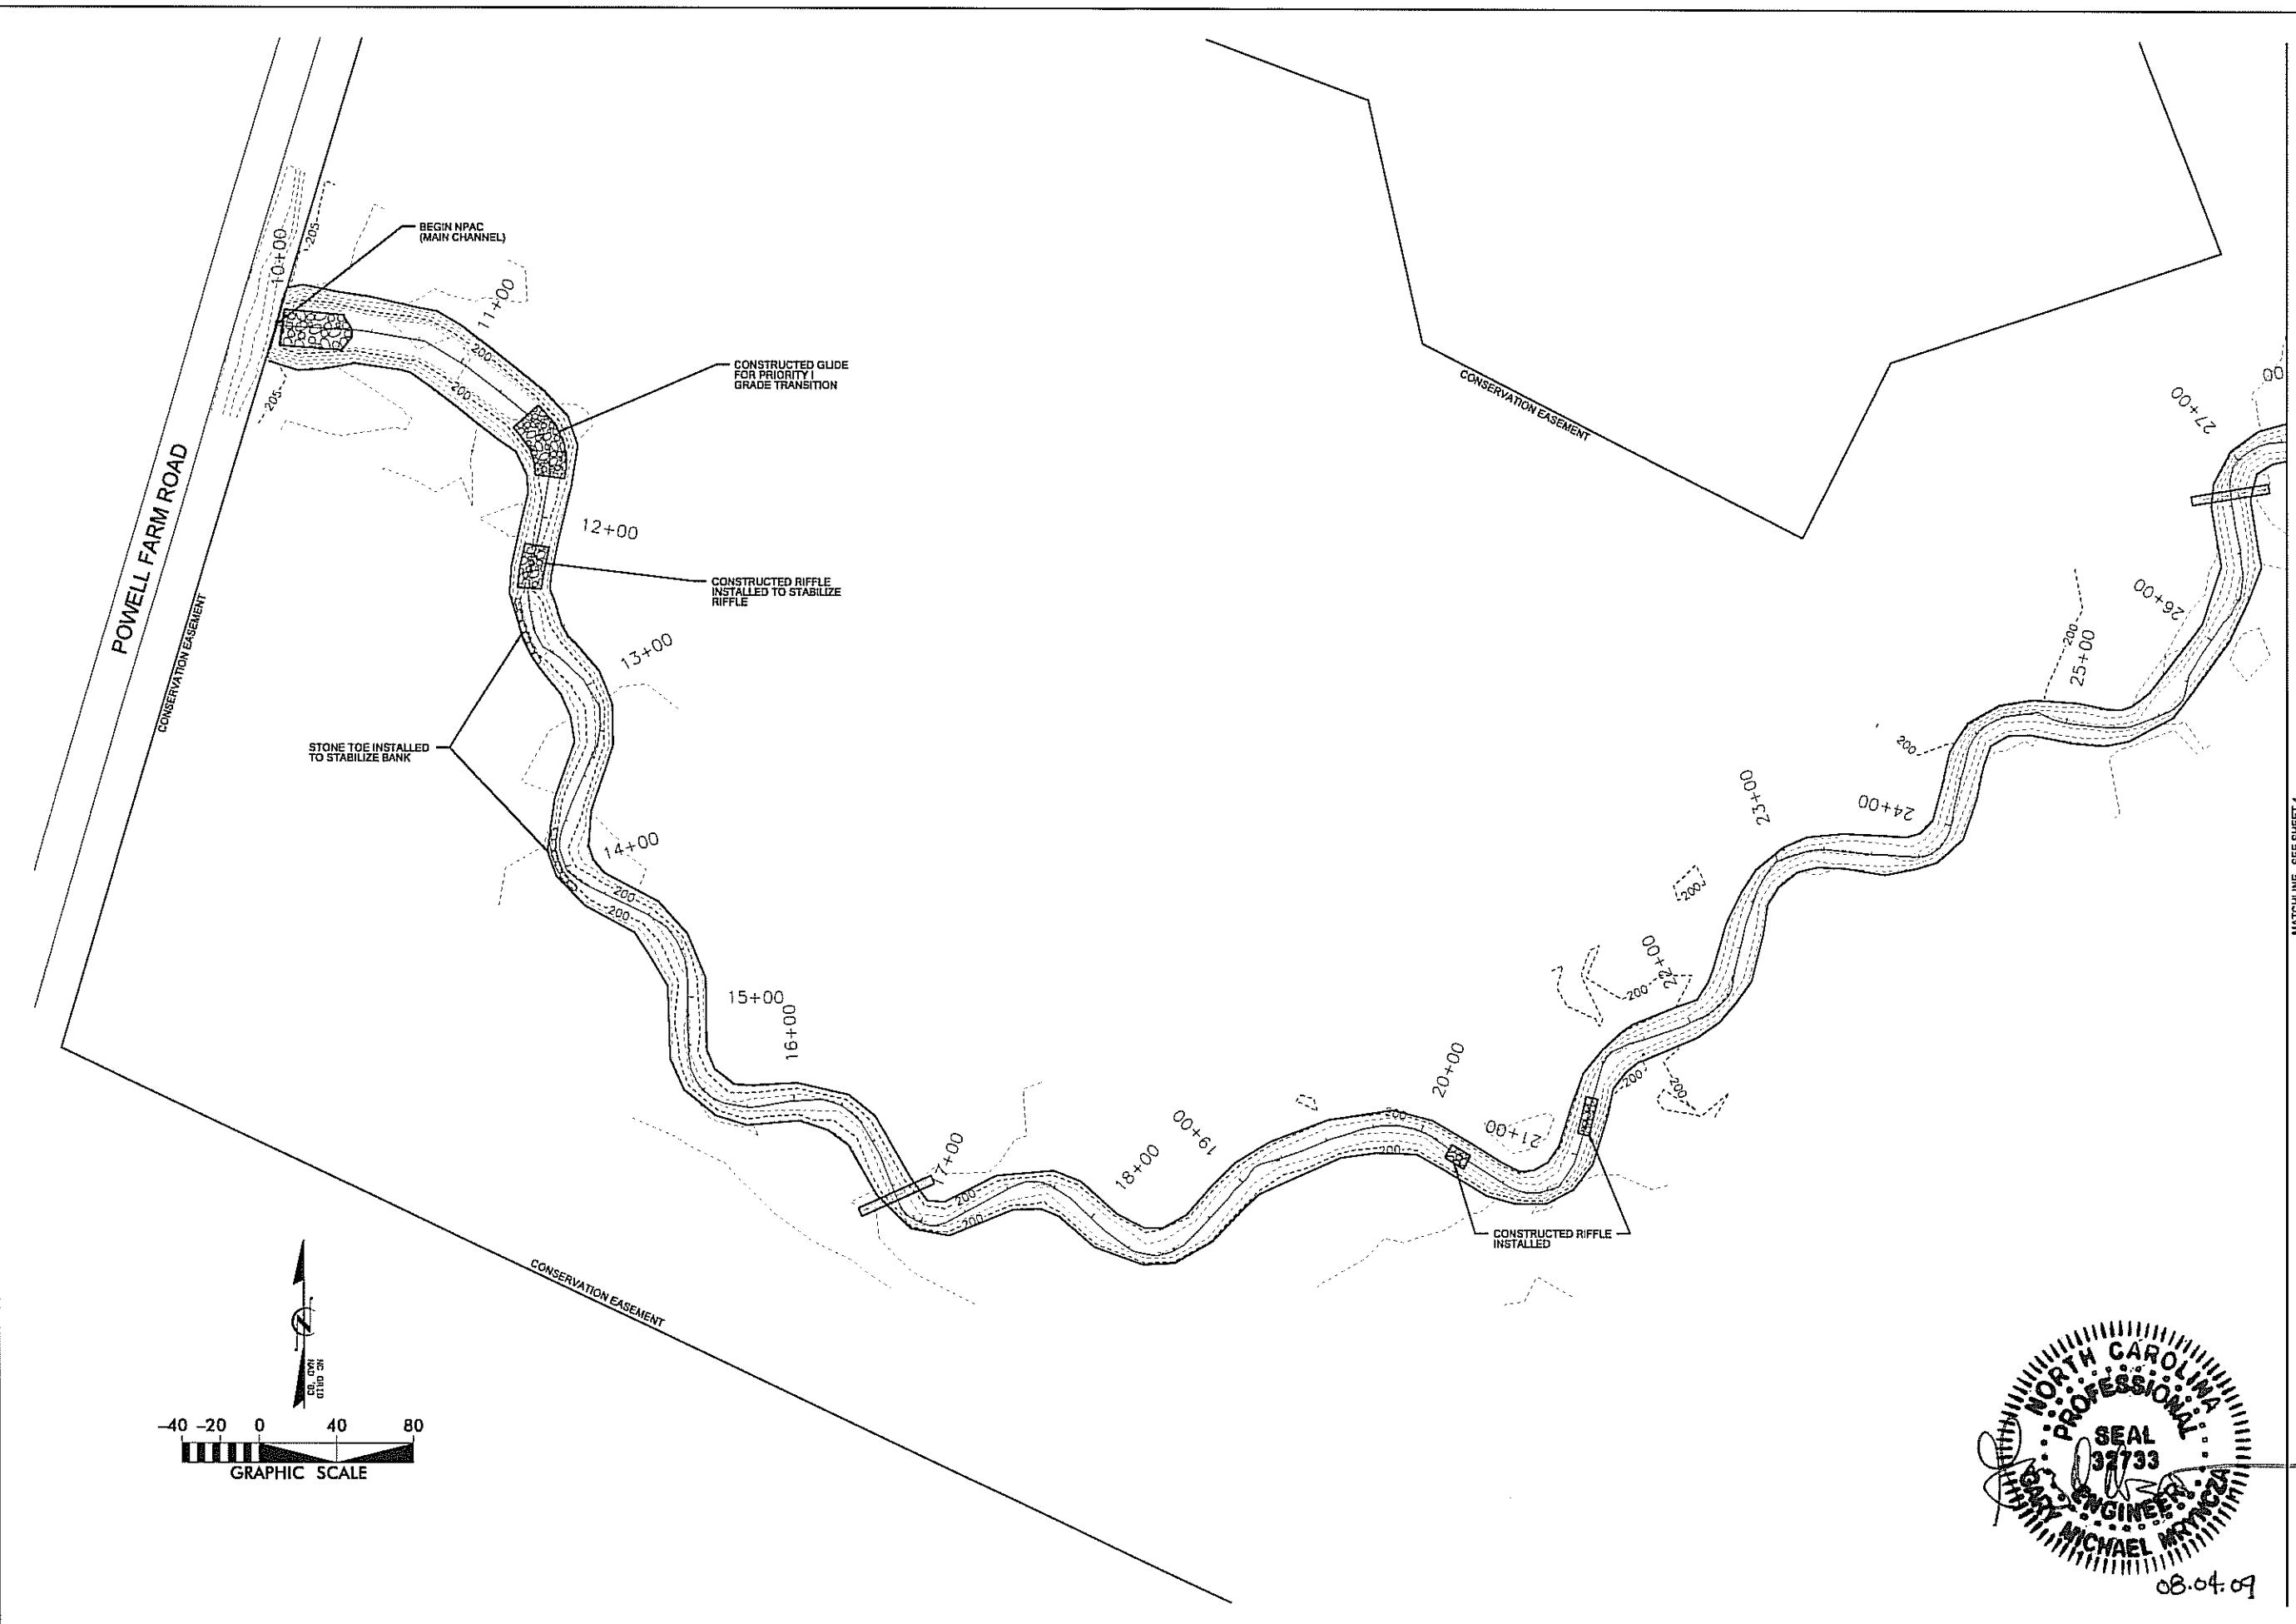
SHEET 2 OF 31

EASEMENT EXCEPTION
WITH 10' WIDE GRAVEL
ROAD AND FORD CROSSING

AS-BUILT
SITE PLAN

Baseline stream monitoring data were collected throughout April and May 2009. Any changes made to the design during construction are documented on the As-Built Site Plan in Appendix A. Most of the project was constructed as designed, but field conditions caused small adjustments to be made. Large rain events during construction caused small instabilities in isolated portions of the stream bed and banks. These areas were stabilized with structures, which are indicated on the As-Built Plan.

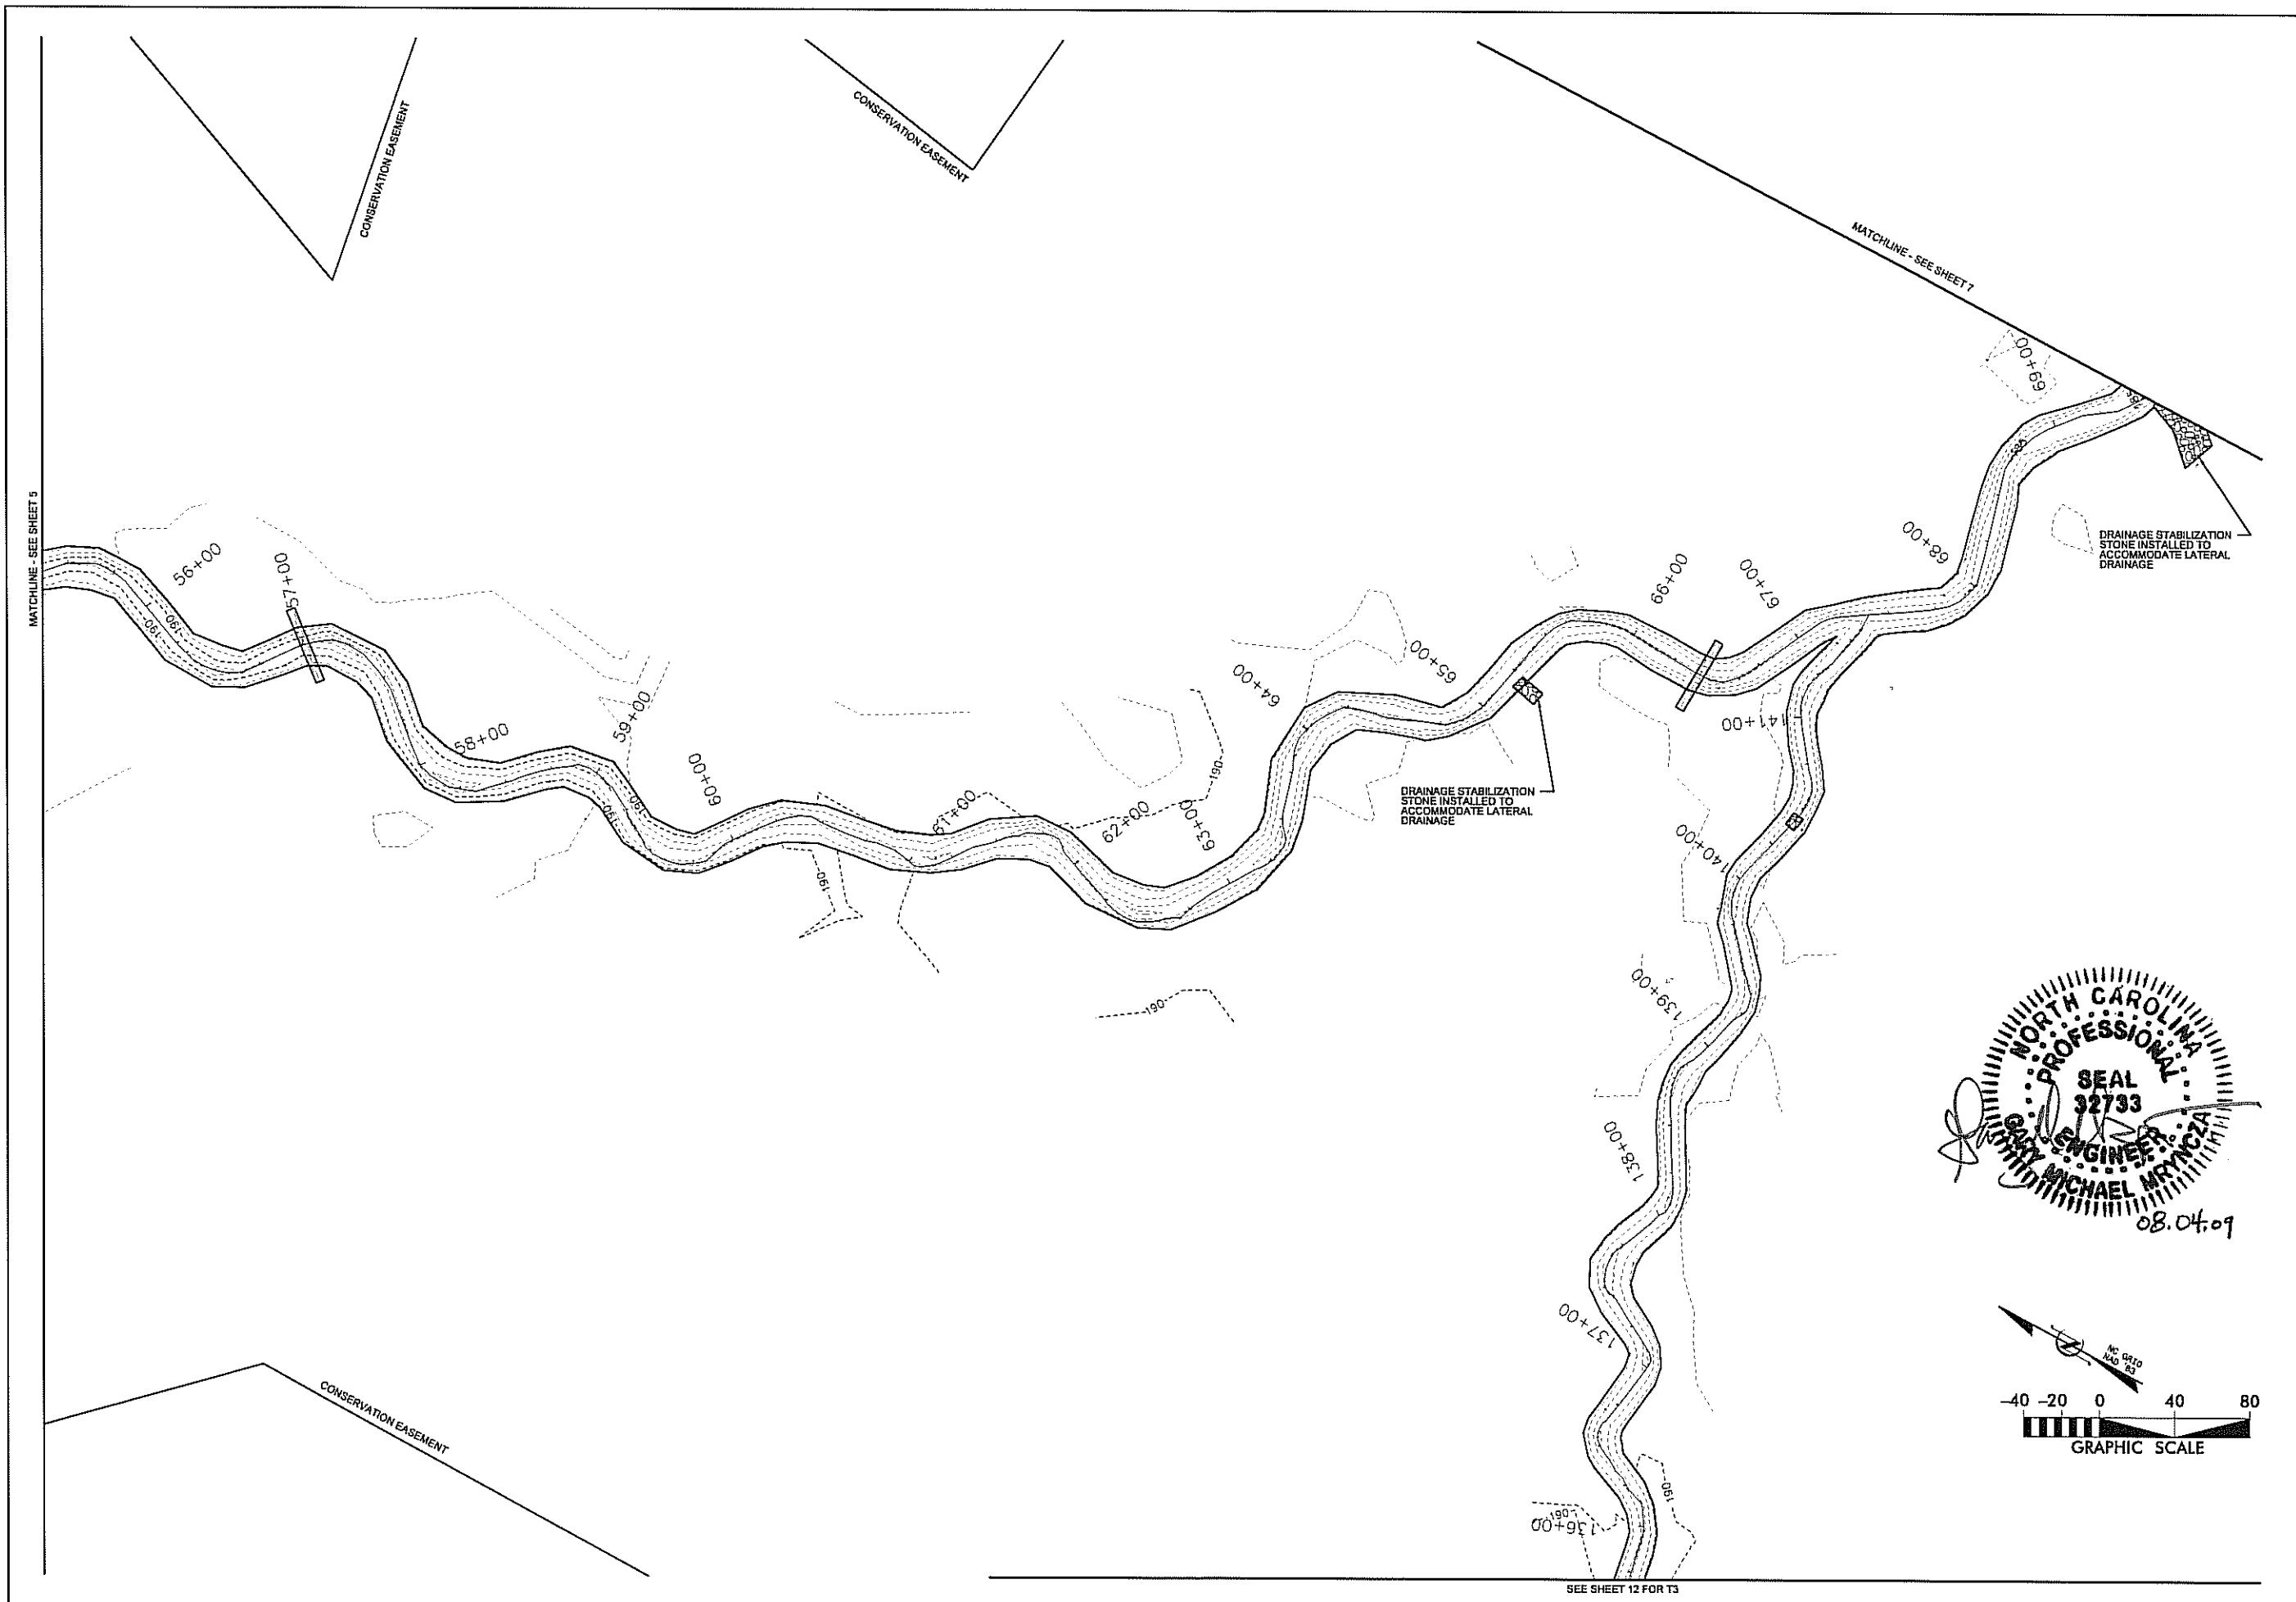
FARRAR DAIRY		A SUBMITTED WITH MITIGATION PLAN		JUNE 2009
STREAM AND WETLAND MITIGATION				
LILLINGTON, HARNETT COUNTY, NORTH CAROLINA				
NPAC - STATION 55+39 TO STATION 69+51				
DATE:	JUNE 2009			
SCALE:	1"=40'			
AS-BUILT SITE PLAN				
SHEET	6	OF	31	
KCI		ENGINEERS • PLANNERS • SCIENTISTS

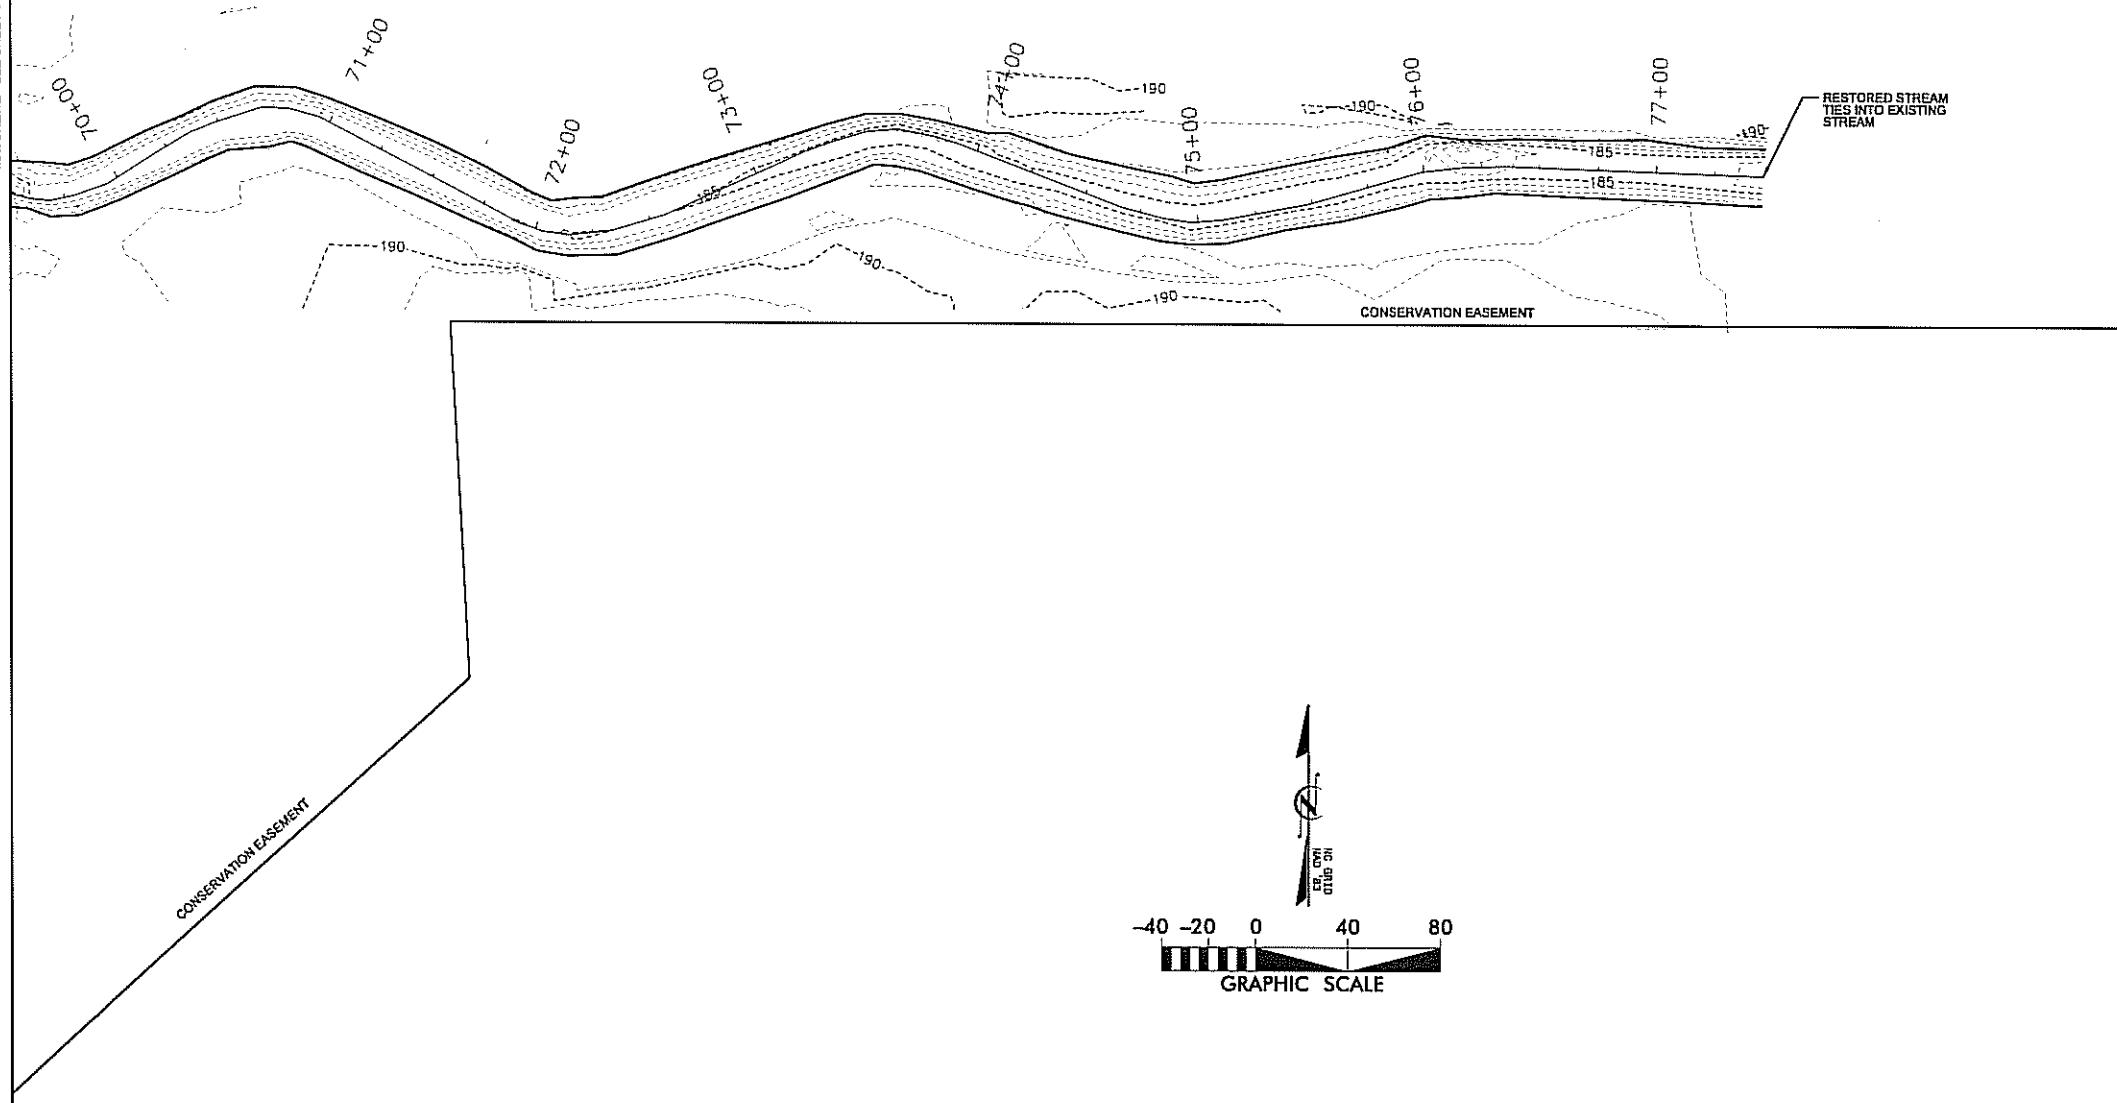
FARRAR DAIRY STREAM AND WETLAND MITIGATION		KCI ASSOCIATES INC. ENGINEERS • PLANNERS • SCIENTISTS 460 SIX FORKS ROAD RALEIGH, NORTH CAROLINA 27609	A SUBMITTED WITH MITIGATION PLAN B REVISED MAIN CHANNEL ENDING PROFILE	JUNE 2008 DEC 2008
LILLINGTON, HARNETT COUNTY, NORTH CAROLINA			URL DESCRIPTION	DATE APPROVED
NPAC - STATION 60+51 TO STATION 77+46				REVISIONS
AS-BUILT SITE PLAN				
DATE: JUNE 2008 SCALE: 1"=40'				
SHEET 7 OF 31

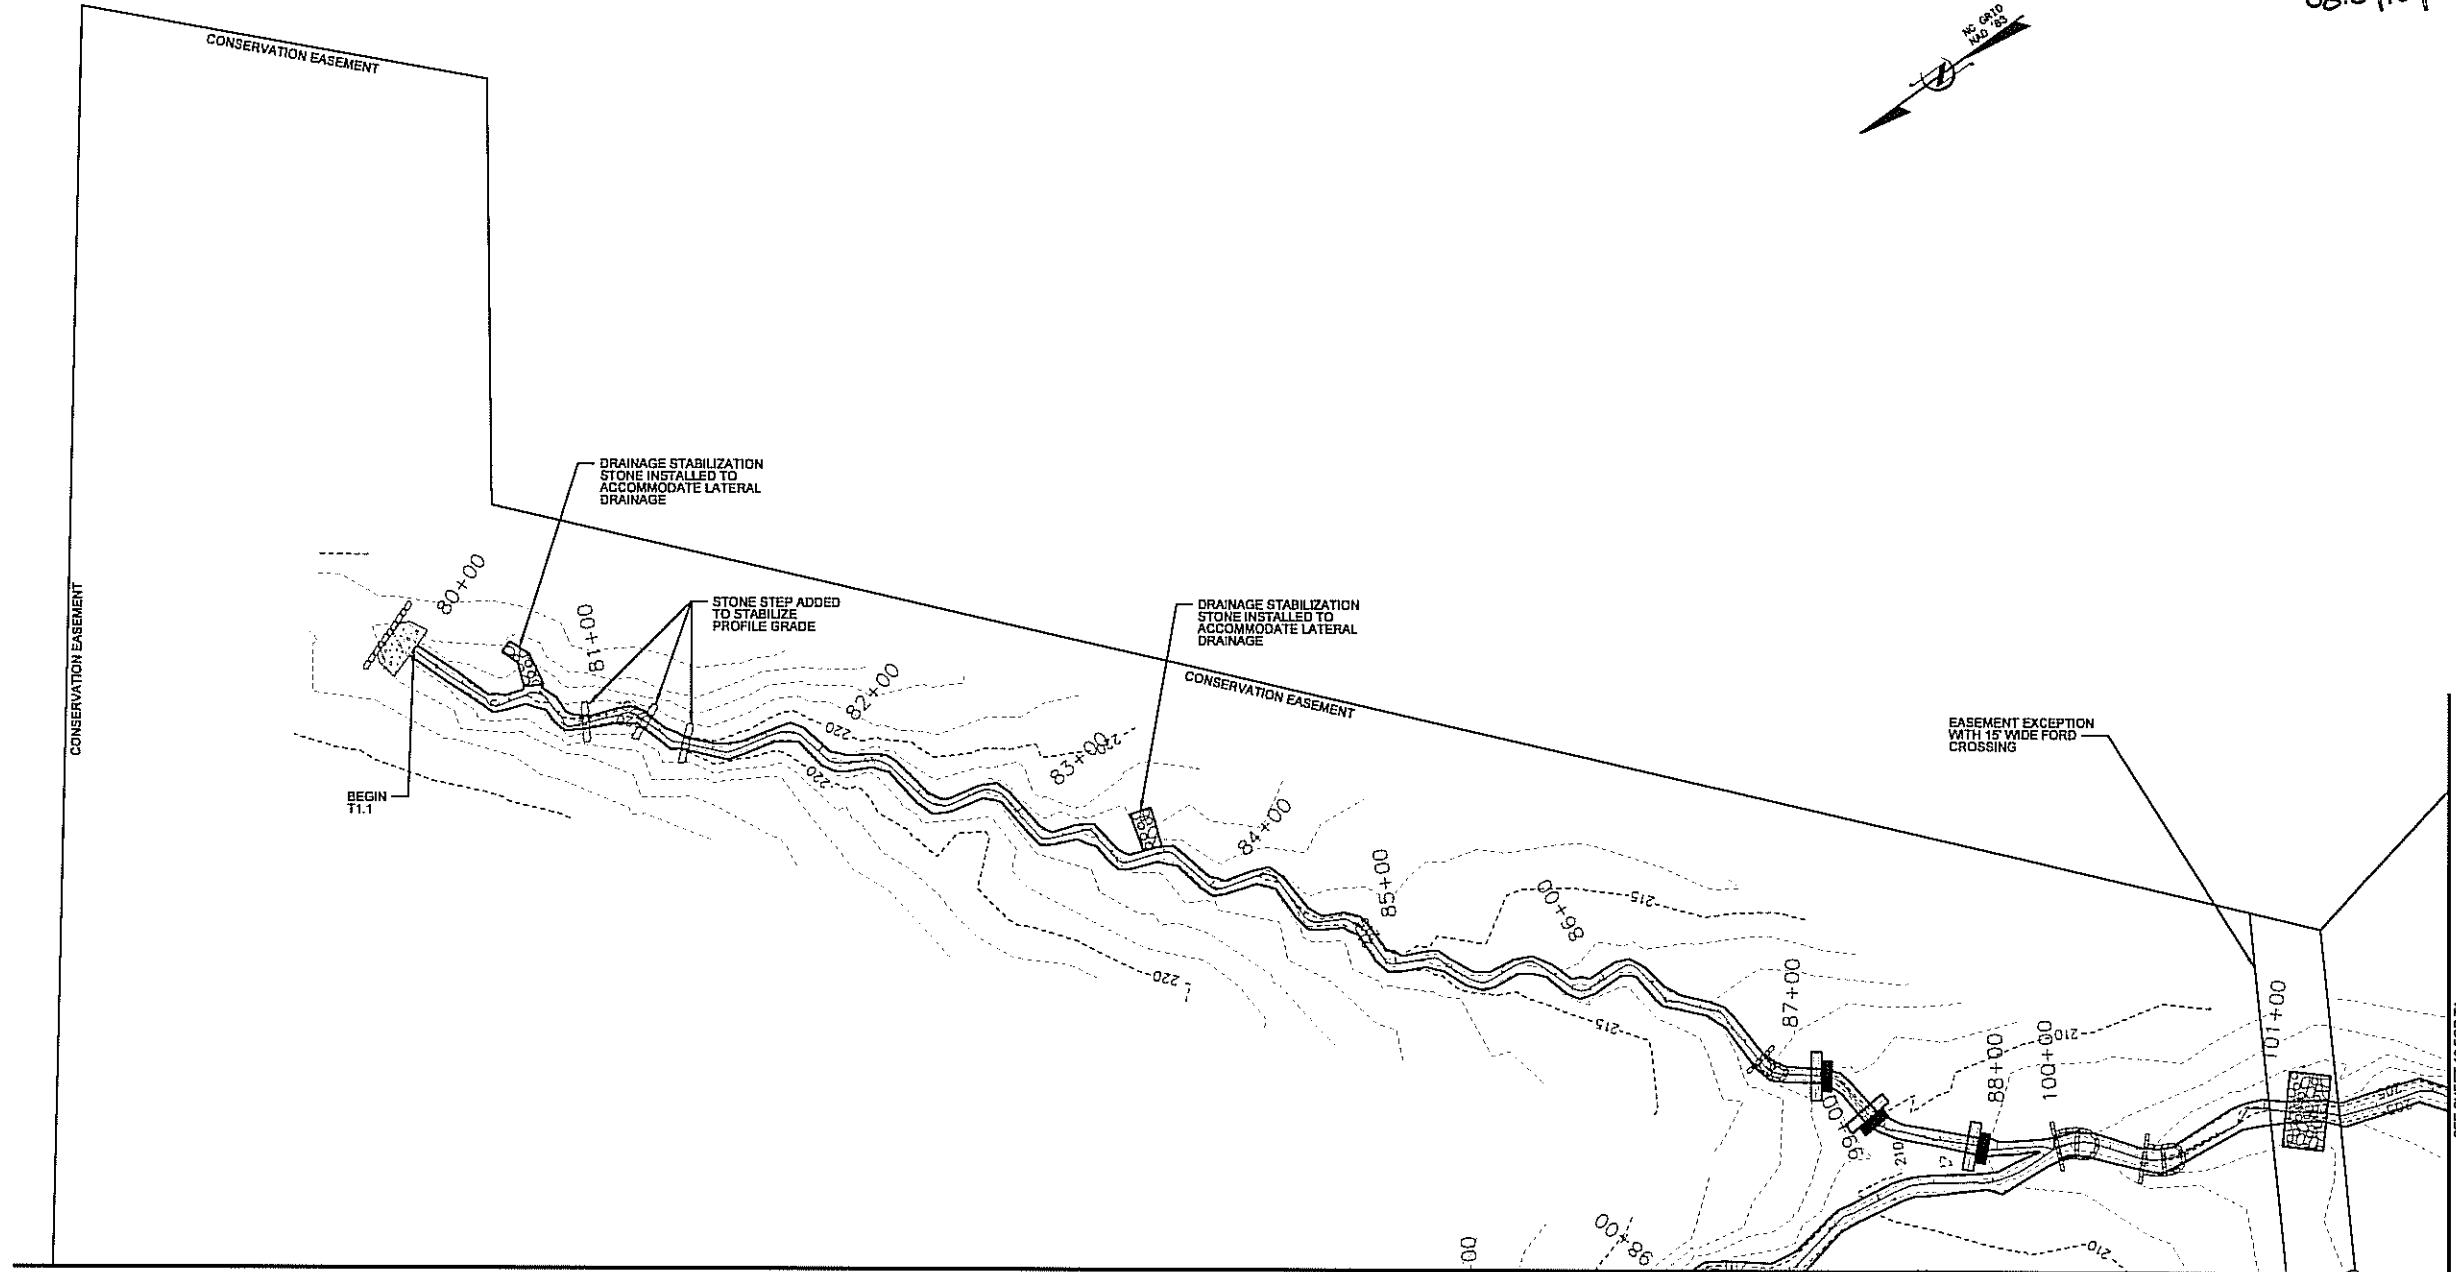
FARRAR DAIRY STREAM AND WETLAND MITIGATION		LILLINGTON, HARNETT COUNTY, NORTH CAROLINA	
T1.1 - STATION 80+00 TO STATION 88+25		REVISIONS	
DATE: JUNE 2009	SCALE: 1"=40'	SHEET 8 OF 31	APPROVED
KCI ASSOCIATES INC ENGINEERS • PLANNERS • SCIENTISTS 460 SIX FORKS ROAD RALEIGH, NORTH CAROLINA 27609	FARRAR DAIRY STREAM AND WETLAND MITIGATION	SEE SHEET 10 FOR T1

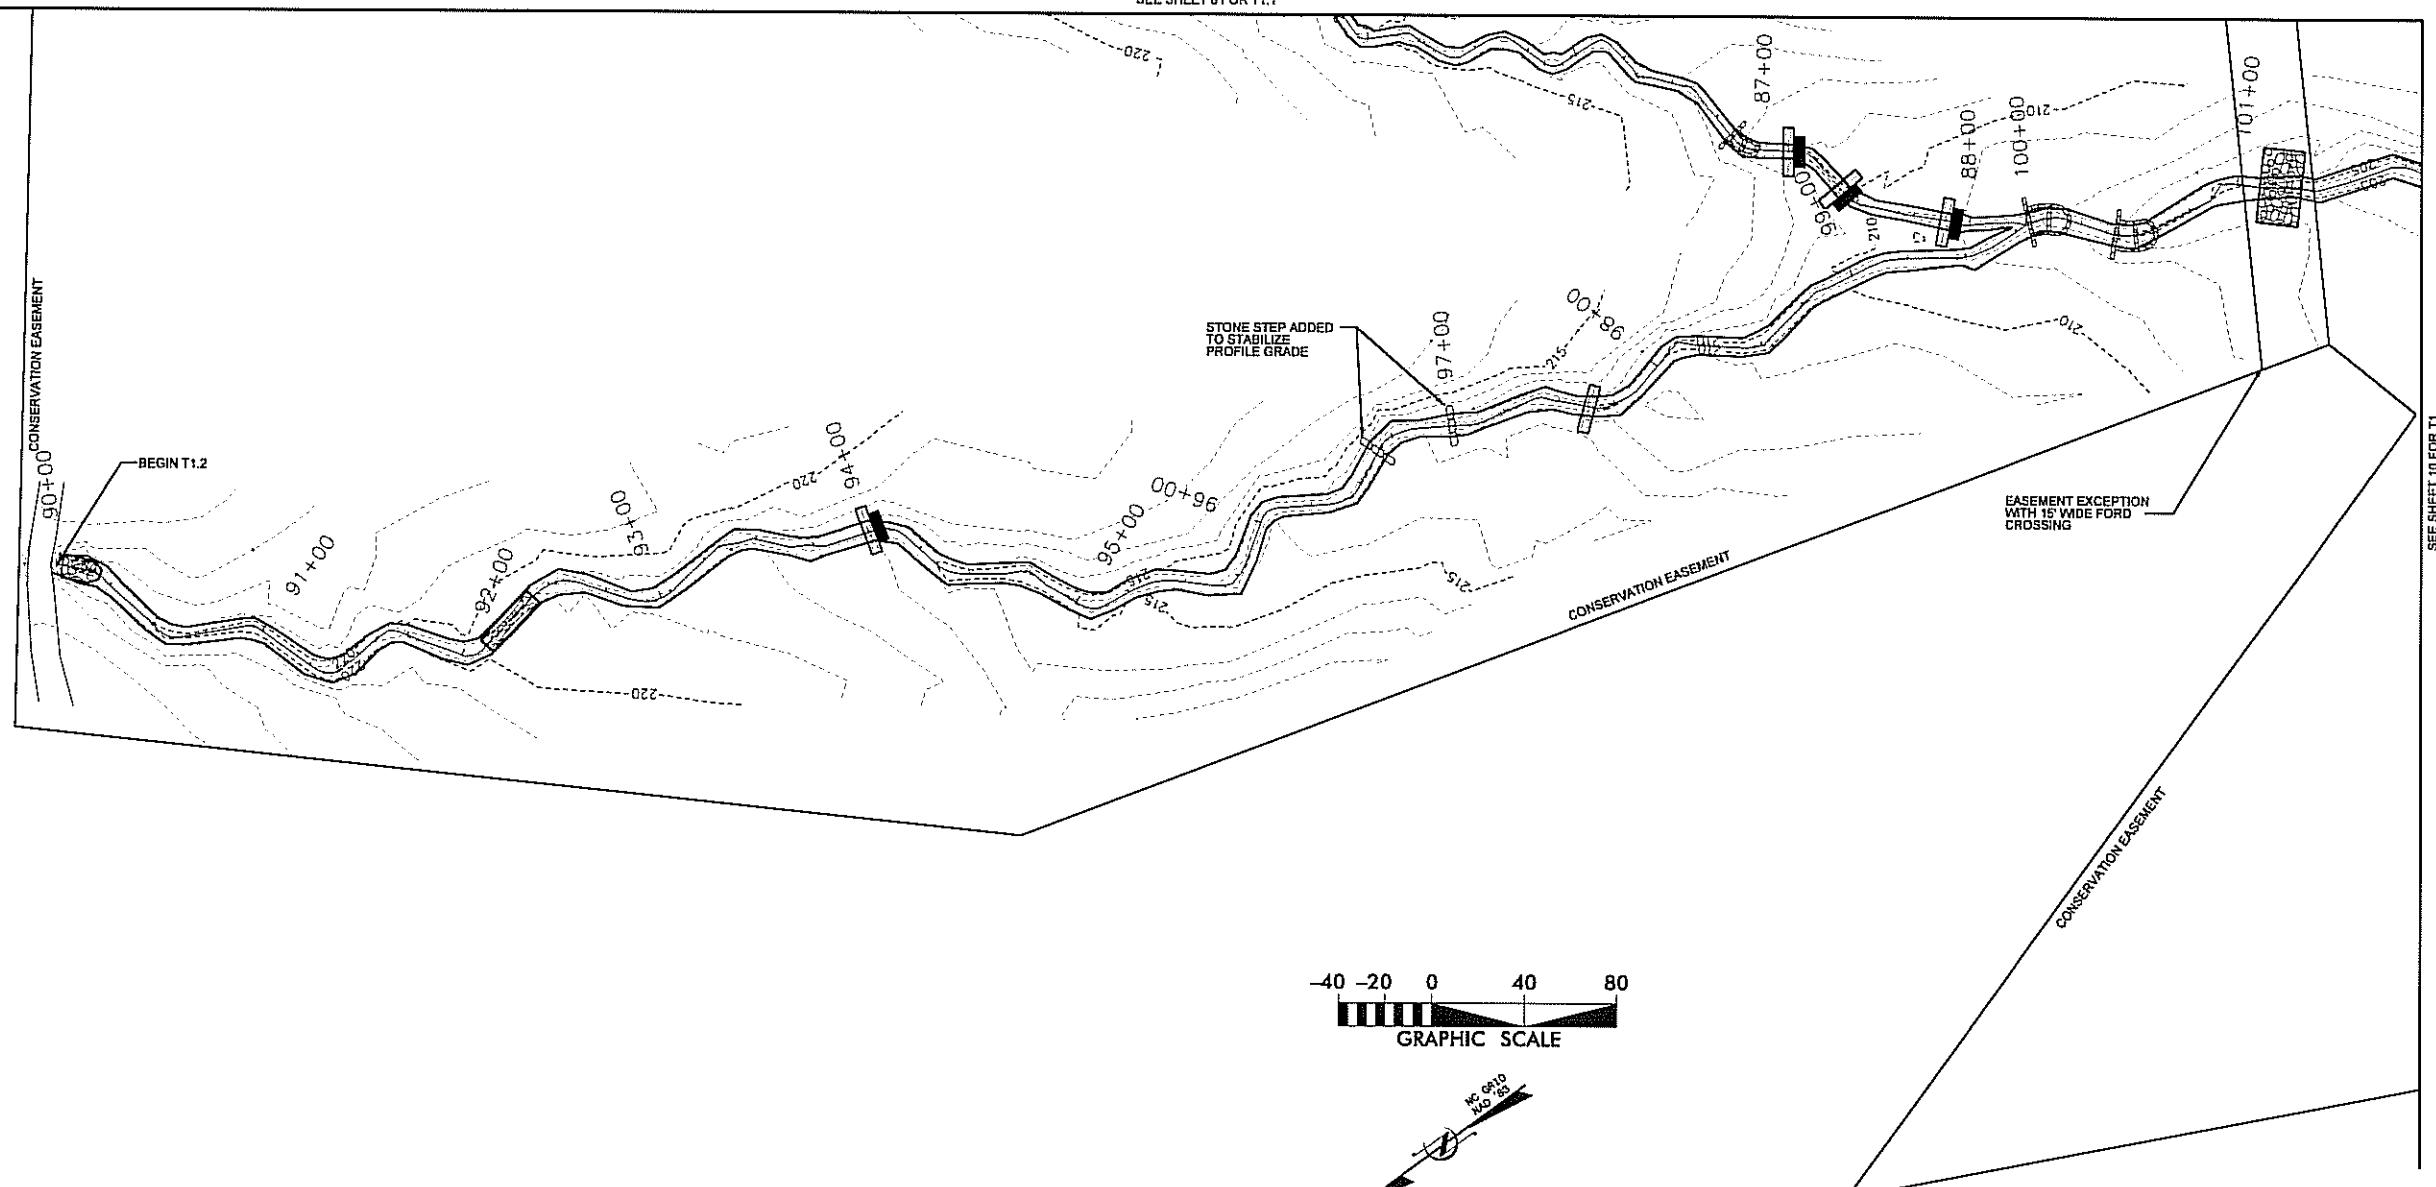
A	SUBMITTED WITH MITIGATION PLAN	JUNE 2000
STL.	DESCRIPTION	DATE APPROVED
KCI ASSOCIATES INC	FARRAR DAIRY STREAM AND WETLAND MITIGATION	
ENGINEERS • PLANNERS • SCIENTISTS	LILLINGTON, HARNETT COUNTY, NORTH CAROLINA	
460 SIX FORKS ROAD		
RALEIGH, NORTH CAROLINA 27609		
T1.2 - STATION 90+00 TO STATION 99+80		
AS-BUILT SITE PLAN		
SHEET 9 OF 31

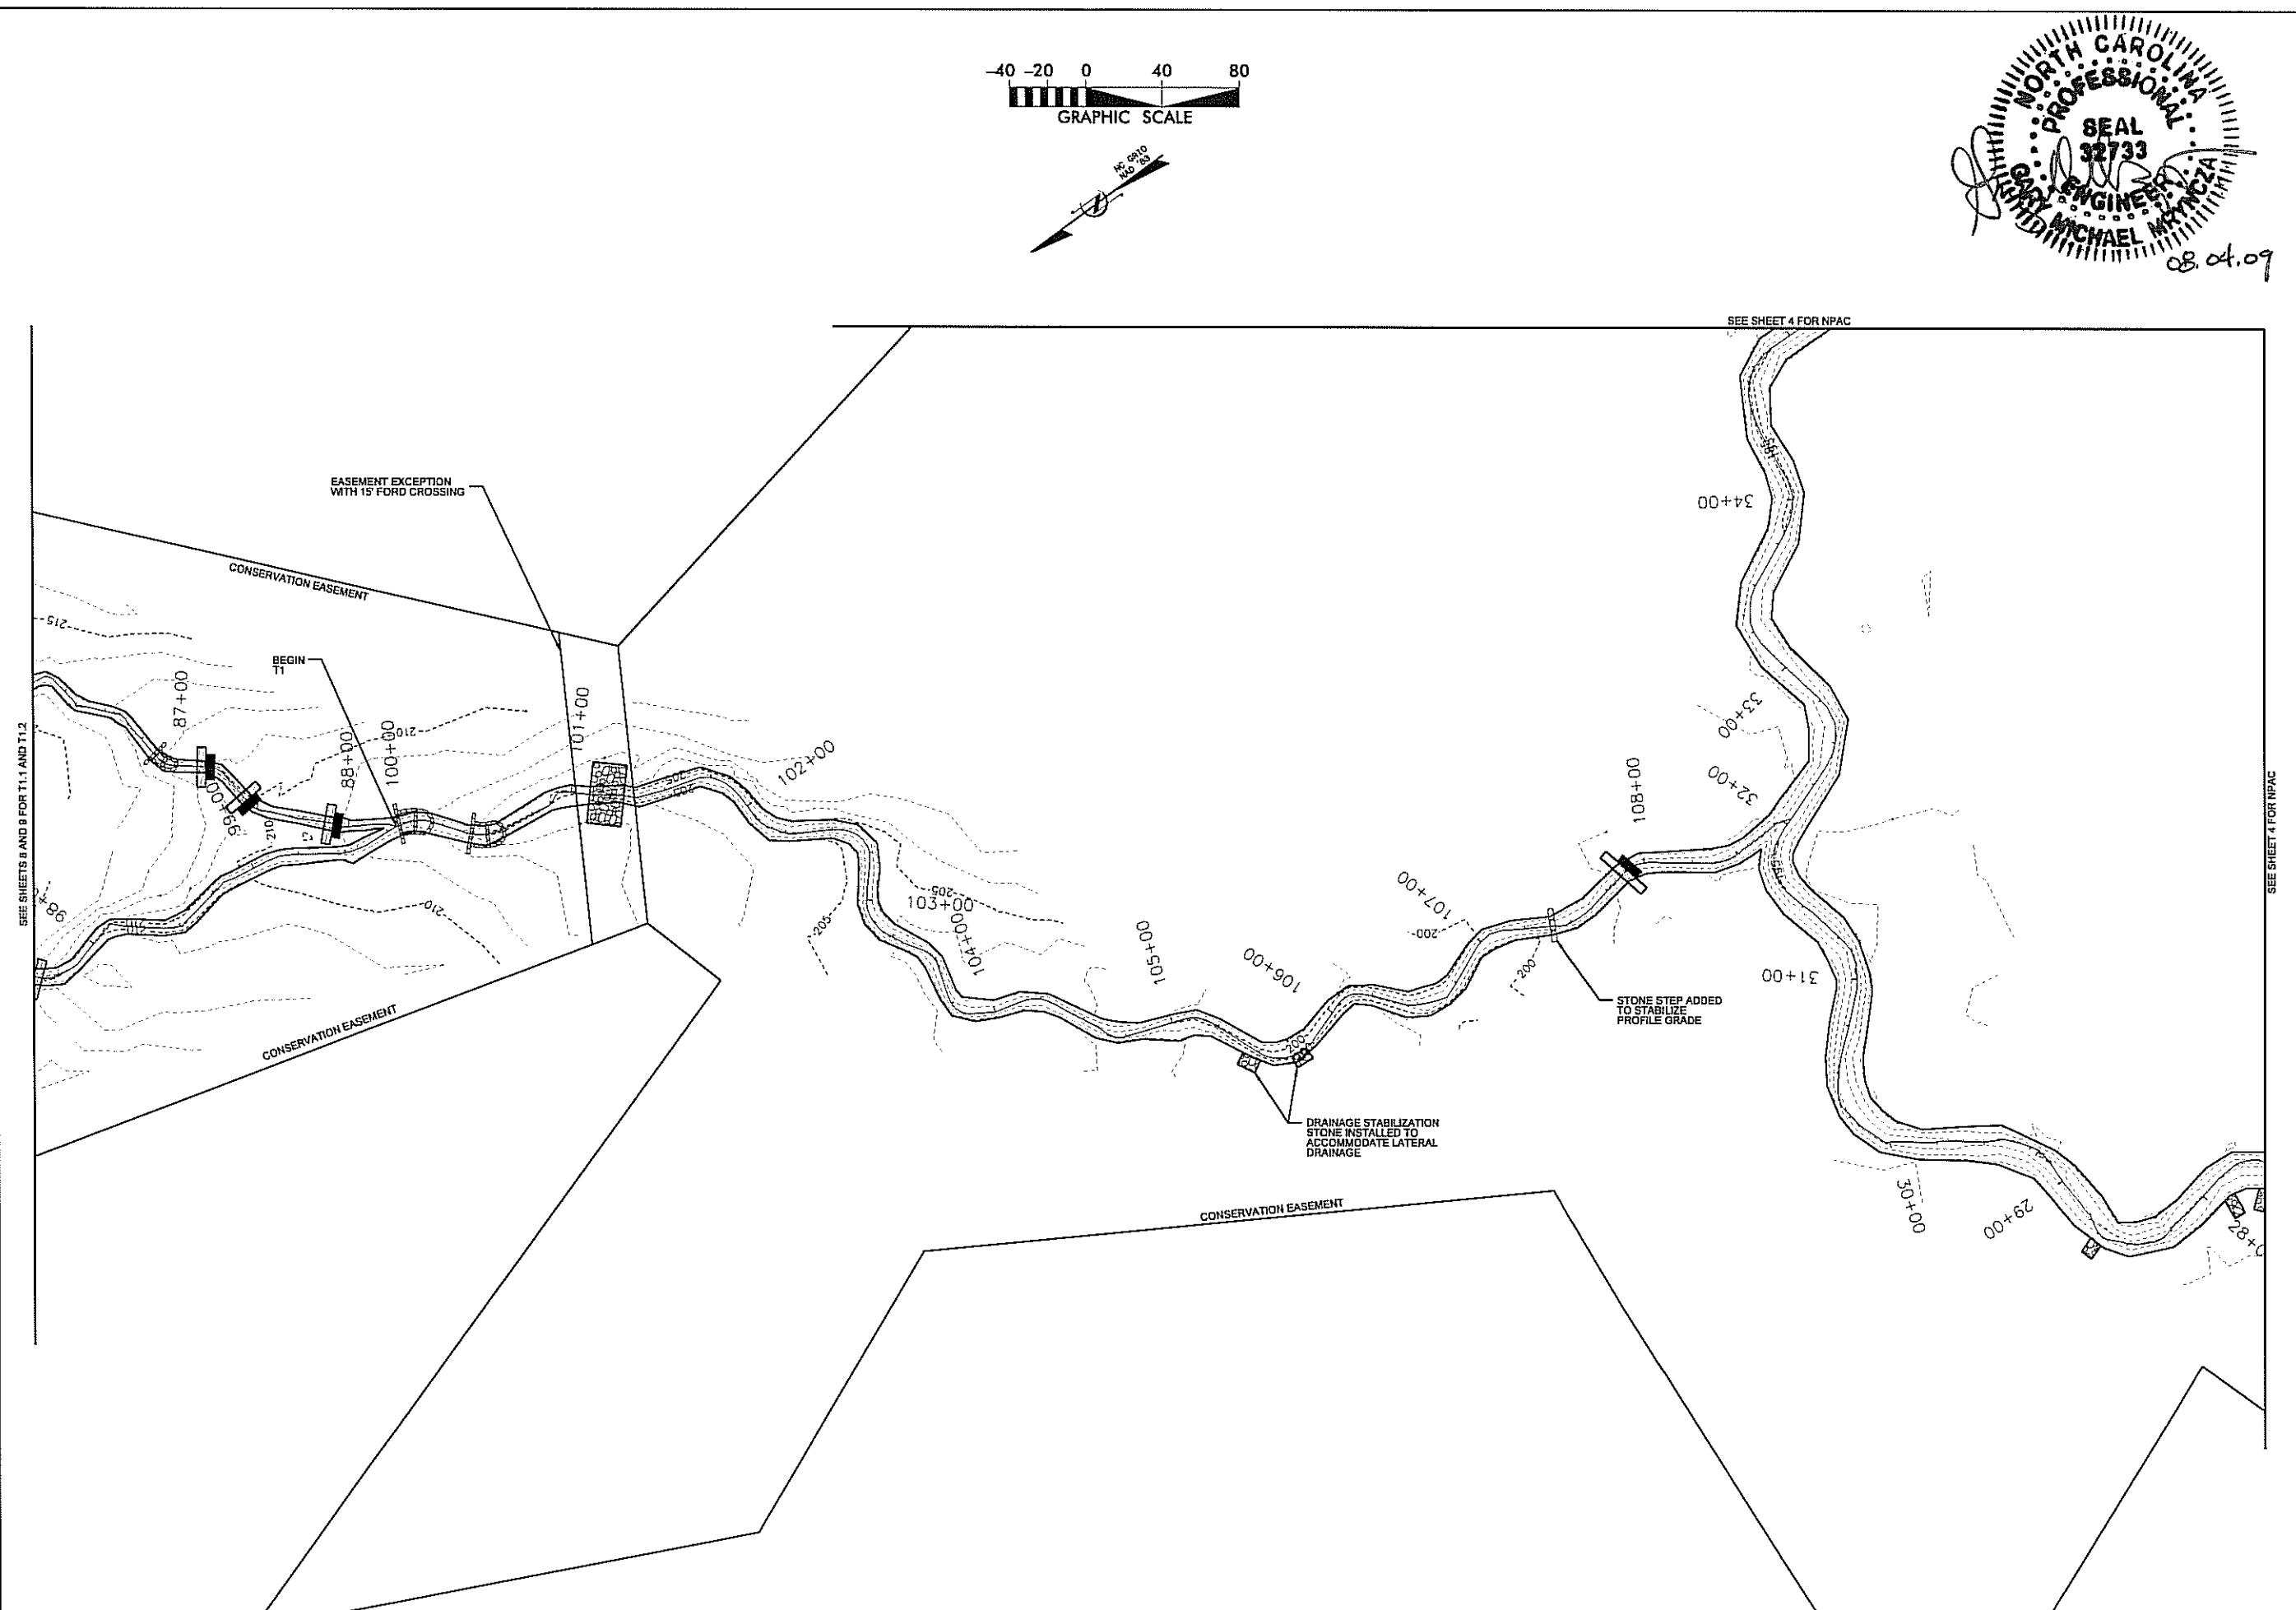
FARRAR DAIRY STREAM AND WETLAND MITIGATION		A SUBMITTED WITH MITIGATION PLAN	JUNE 2009
LILLINGTON, HARNETT COUNTY, NORTH CAROLINA			
T1 - STATION 100+00 TO STATION 108+84			
AS-BUILT SITE PLAN			
SHEET	10	OF	31

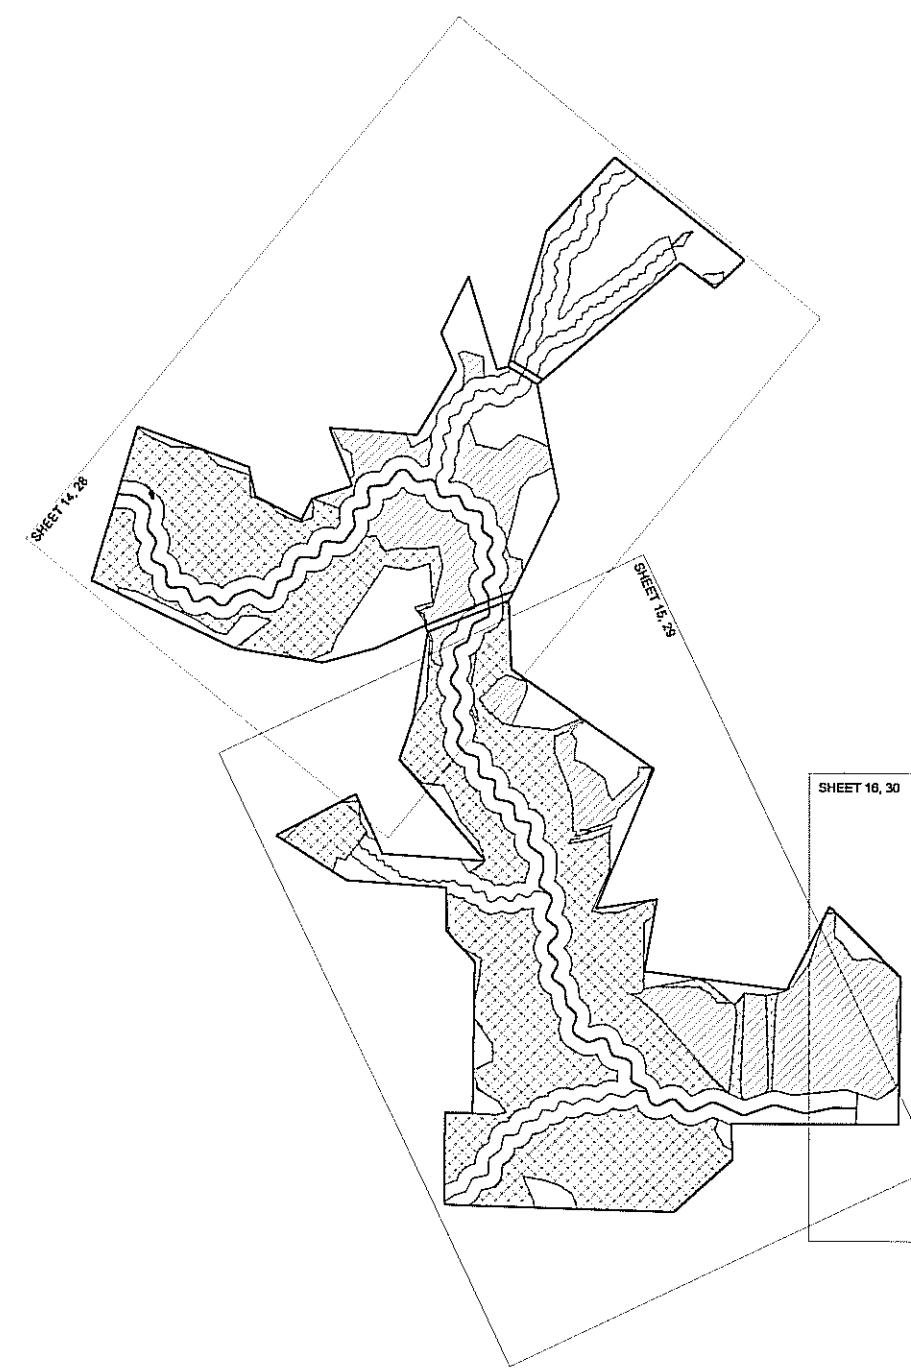
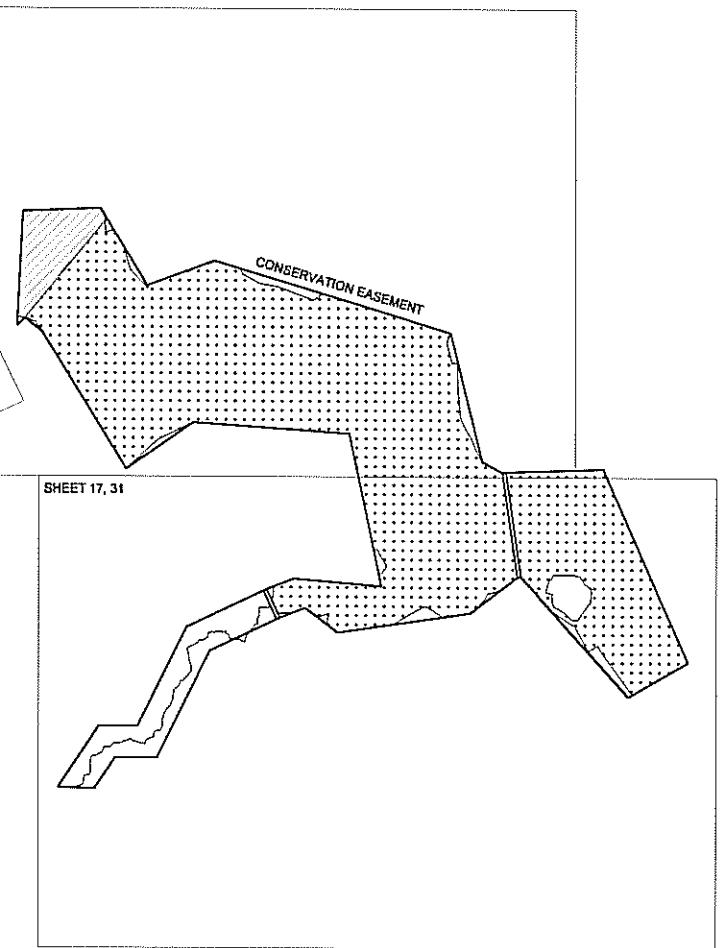
SHEET 13 OF 3

AS-BUILT
WETLAND
OVERVIEW
