Farrar Dairy Stream and Wetland Restoration Site

Mitigation Plan

Contract # D06002

August 2009

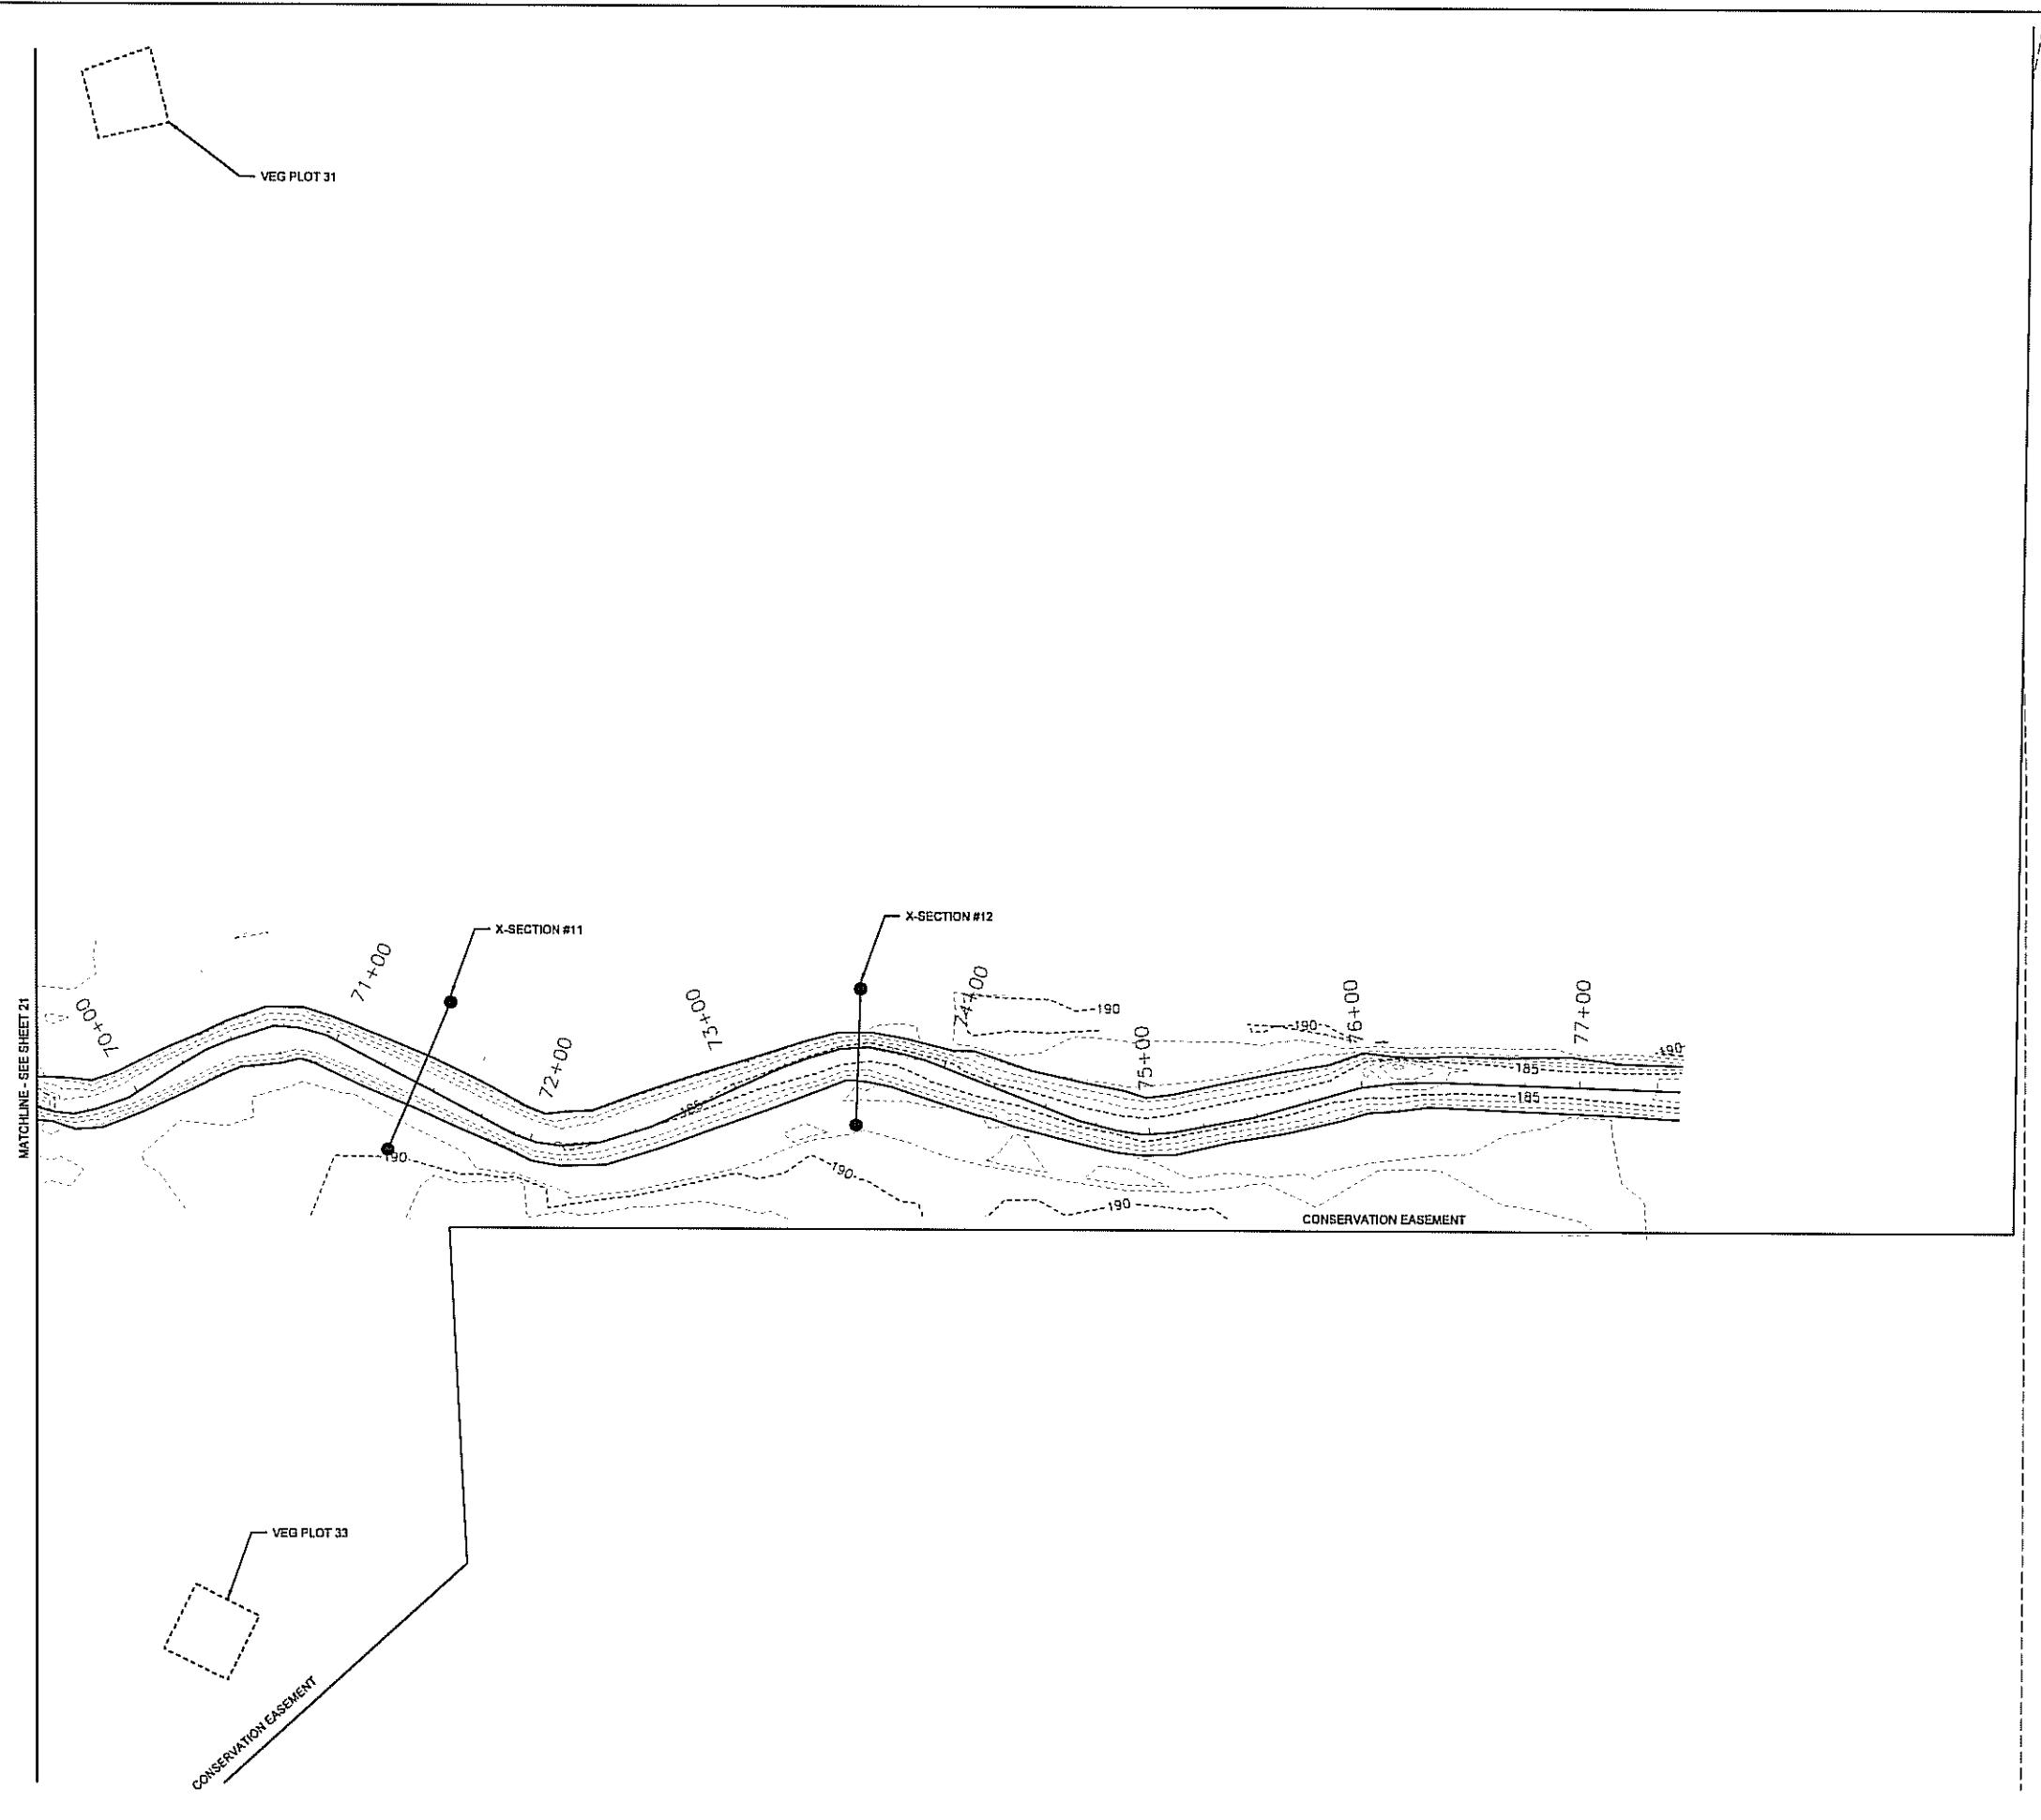
FARRAR DAIRY		A SUBMITTED WITH MITIGATED PLAN	JUNE 2009
STREAM AND WETLAND MITIGATION		B REVISED MAIN CHANNEL CROSSING PROFILE	
LILLINGTON, HARNETT COUNTY, NORTH CAROLINA		SITE	APPROVED
NPAC - STATION 69+51 TO STATION 77+46		DESIGNER	
		DATE	
		SCALE	
		MONITORING PLAN VIEW	
		SHEET 22 OF 31

MONITORING PLAN VIEW

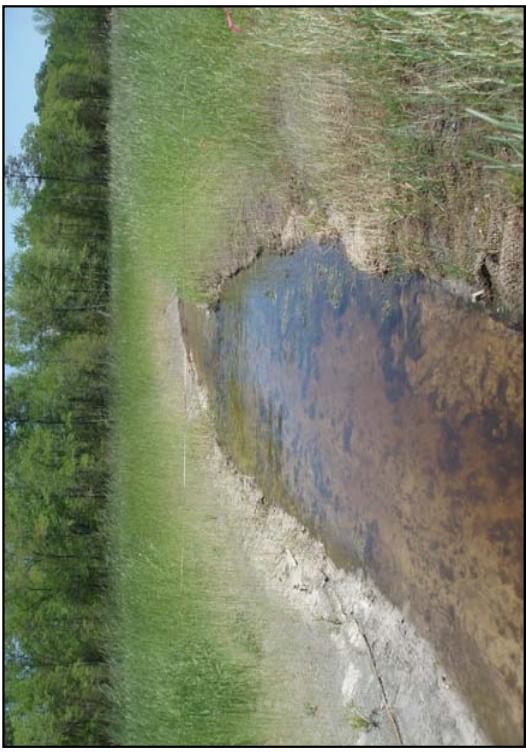
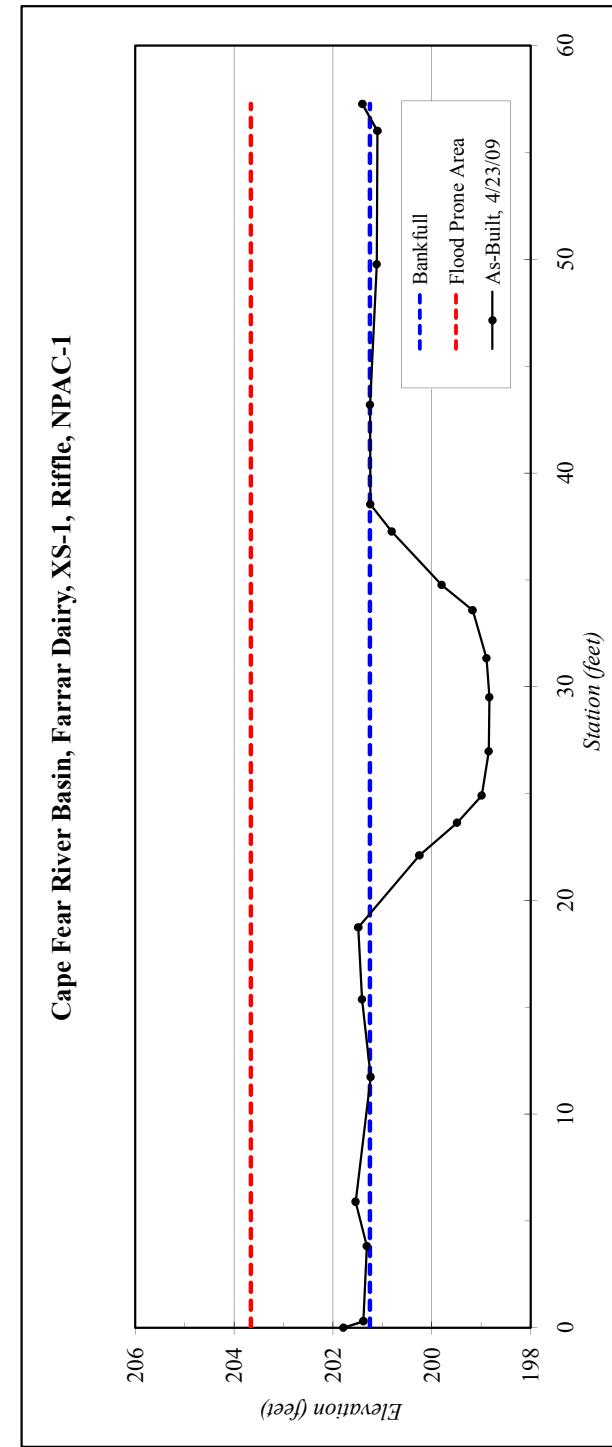
Cape Fear River Basin, Farrar Dairy, XS-1, Riffle, NPAC-1

River Basin:	Cape Fear
Watershed:	Farrar Dairy
XS ID	XS-1, Riffle, NPAC-1
Drainage Area (sq mi):	3.92
Date:	4/23/2009
Field Crew:	A. French, B. Roberts

Station	Elevation	Stream Type
0.0	201.79	
0.3	201.38	
3.8	201.32	
5.9	201.54	
11.7	201.24	
15.4	201.42	
18.7	201.49	C5
22.1	200.25	
23.6	199.49	
24.9	198.99	
27.0	198.85	
29.5	198.84	
31.3	198.89	
33.6	199.18	
34.8	199.80	
37.3	200.81	
38.5	201.25	
43.2	201.25	
49.8	201.11	
56.0	201.10	
57.3	201.40

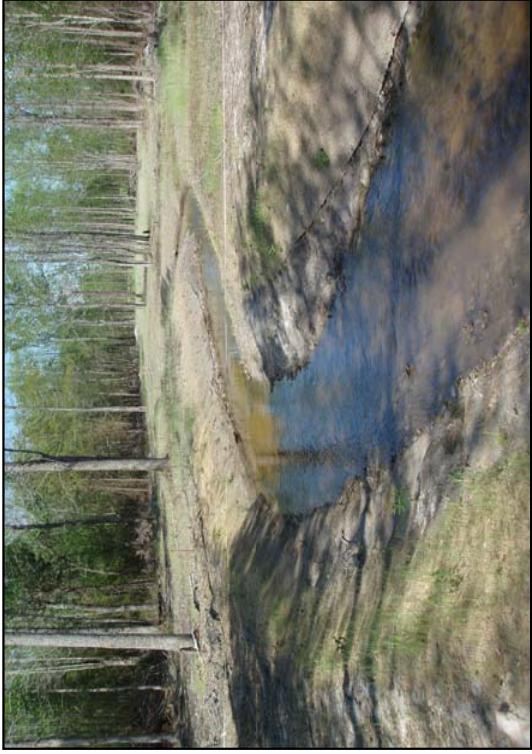
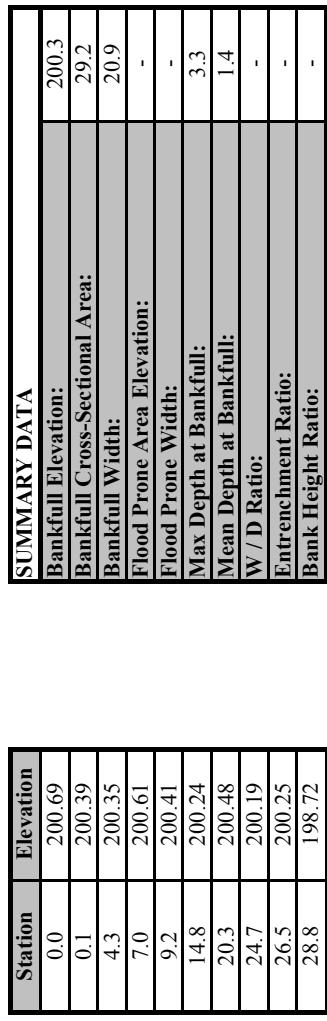
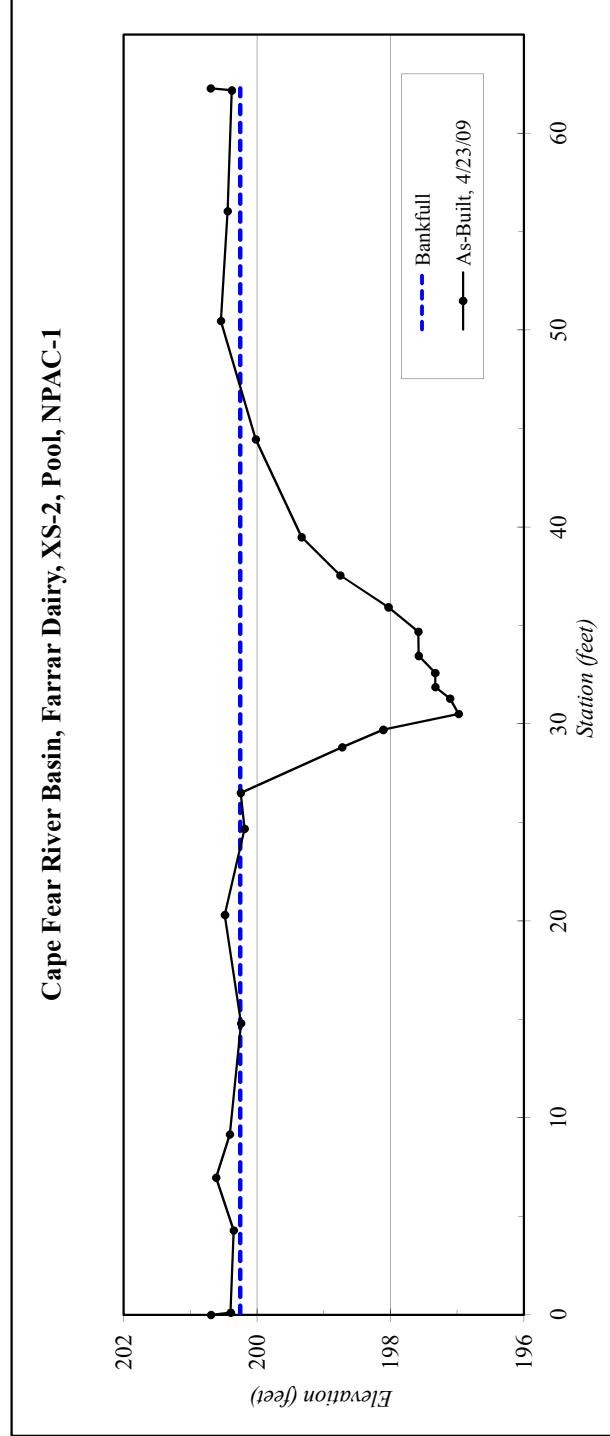
Cape Fear River Basin, Farrar Dairy, XS-2, Pool, NPAC-1

River Basin:	Cape Fear
Watershed:	Farrar Dairy
XS ID	XS2, Pool, NPAC-1
Drainage Area (sq mi):	3.92
Date:	4/23/2009
Field Crew:	A. French, B. Roberts

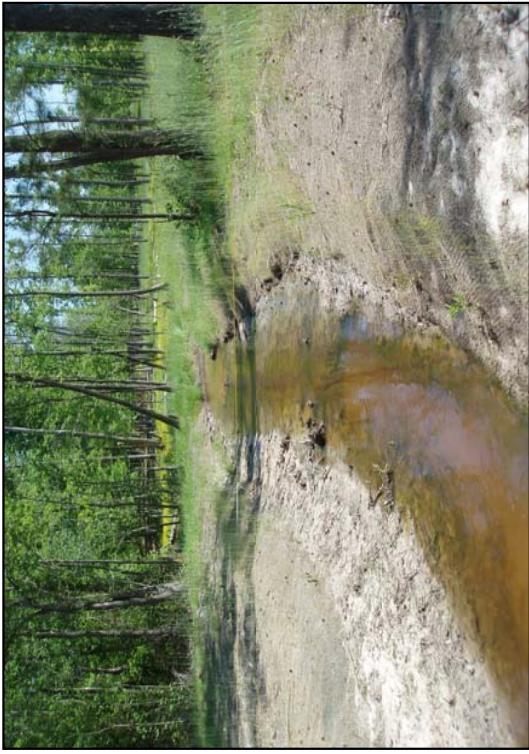
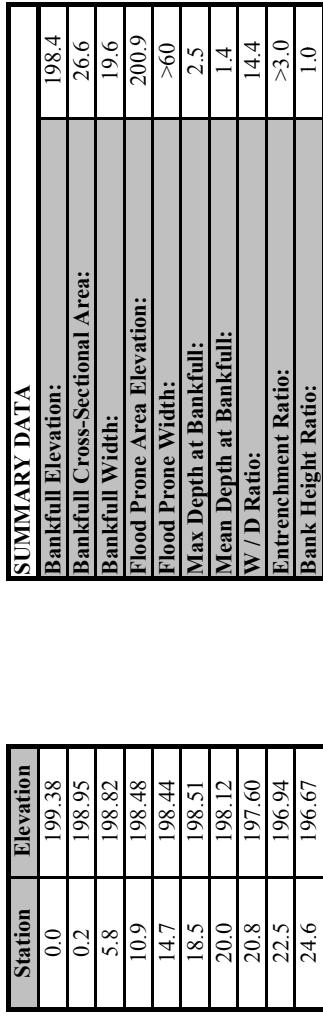
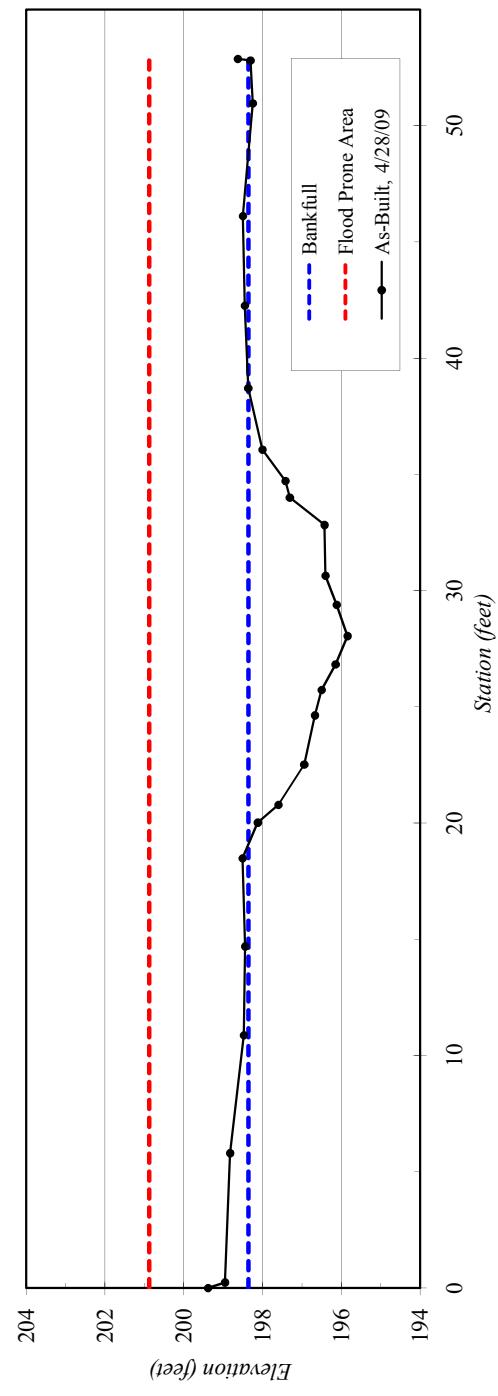
Cape Fear River Basin, Farrar Dairy, XS-3, Riffle, NPAC-1

River Basin:	Cape Fear
Watershed:	Farrar Dairy
XS ID	XS-3, Riffle, NPAC-1
Drainage Area (sq mi):	3.92
Date:	4/28/2009
Field Crew:	B. Roberts, A. Davis

Stream Type C5

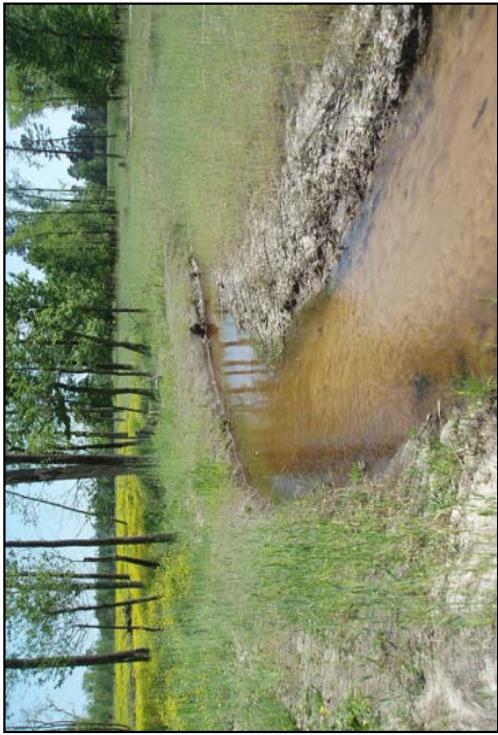
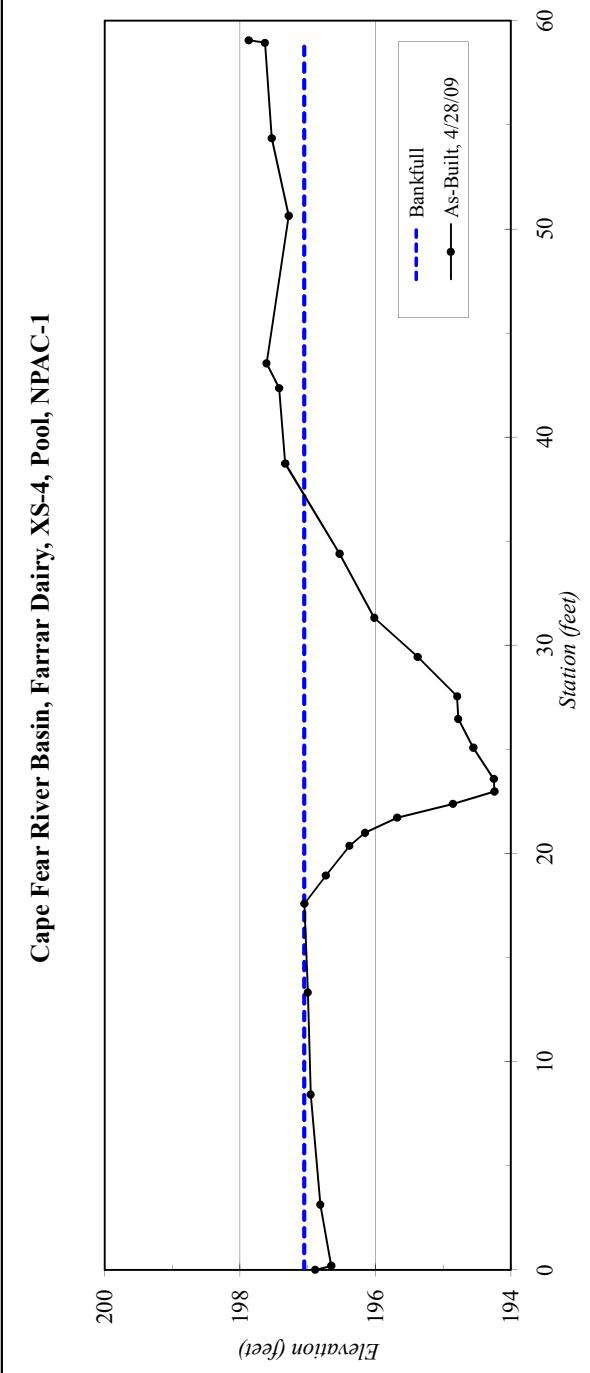
Cape Fear River Basin, Farrar Dairy, XS-4, Pool, NPAC-1

River-Basin:	Cape Fear
Watershed:	Farrar Dairy
XS ID:	XS-4, Pool, NPAC-1
Drainage Area (sq mi):	4.10
Date:	4/28/2009
Field Crew:	B. Roberts, A. Davis

SUMMARY DATA	
Bankfull Elevation:	197.1
Bankfull Cross-Sectional Area:	24.7
Bankfull Width:	18.9
Flood Prone Area Elevation:	-
Flood Prone Width:	-
Max Depth at Bankfull:	2.8
Mean Depth at Bankfull:	1.3
W / D Ratio:	-
Entrenchment Ratio:	-
Bank Height Ratio:	-

27.6	194.80
26.5	194.78
25.1	194.56
23.6	194.26
23.0	194.24
22.4	194.86
21.7	195.68
21.0	196.15
20.4	196.38
18.9	196.73
17.6	197.05
13.3	197.00
8.4	196.96
3.1	196.81
0.2	196.65
0.0	196.89

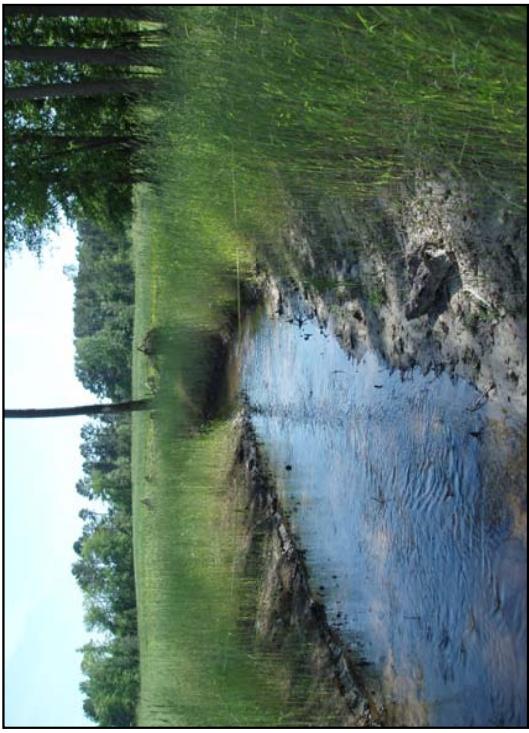
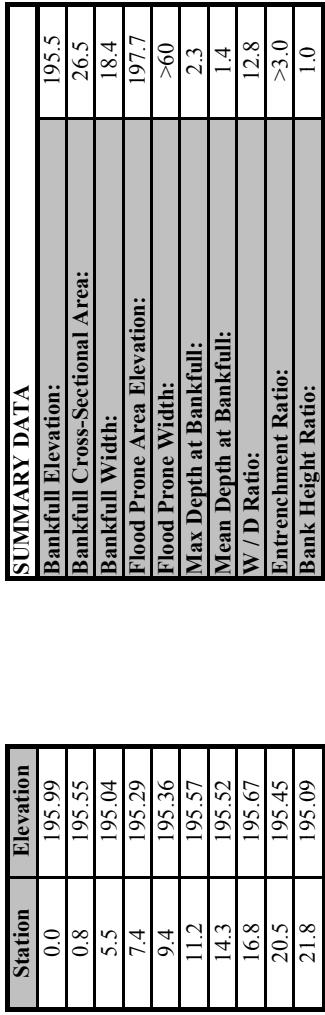
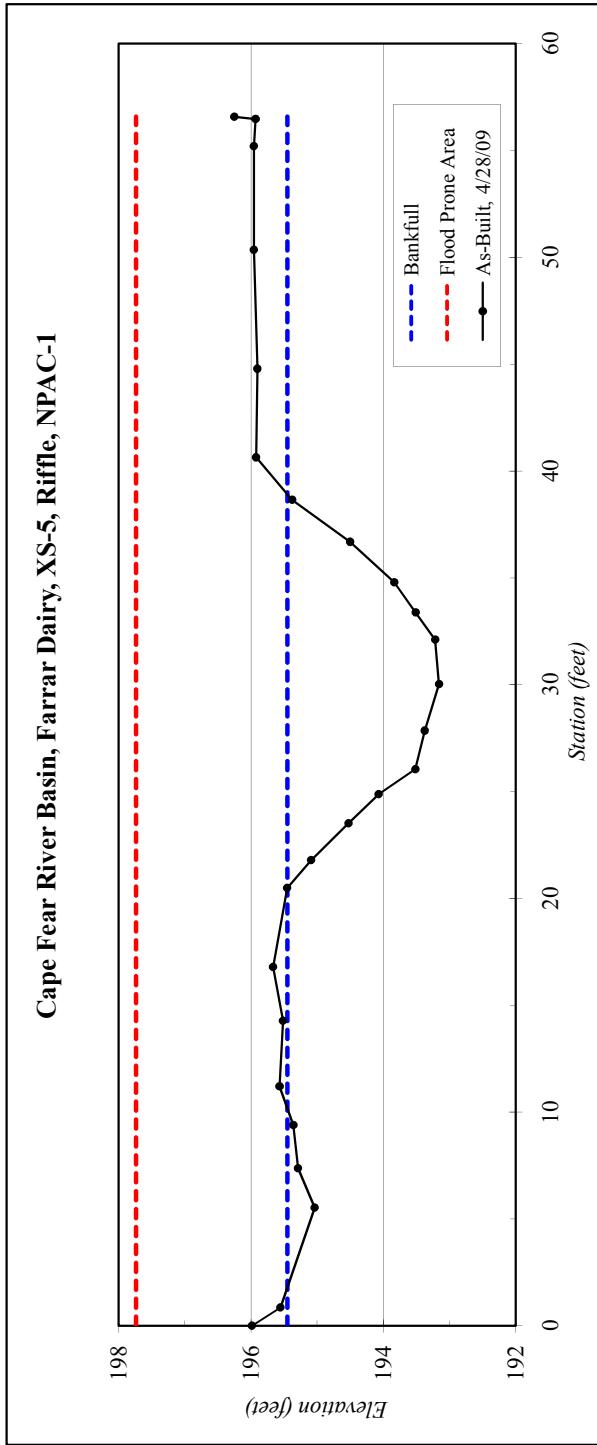
Cape Fear River Basin, Farrar Dairy, XS-5, Riffle, NPAC-1

River Basin:	Cape Fear
Watershed:	Farrar Dairy
XS ID	XS-5, Riffle, NPAC-1
Drainage Area (sq mi):	4.10
Date:	4/28/2009
Field Crew:	B. Roberts, A. Davis

Stream Type C5

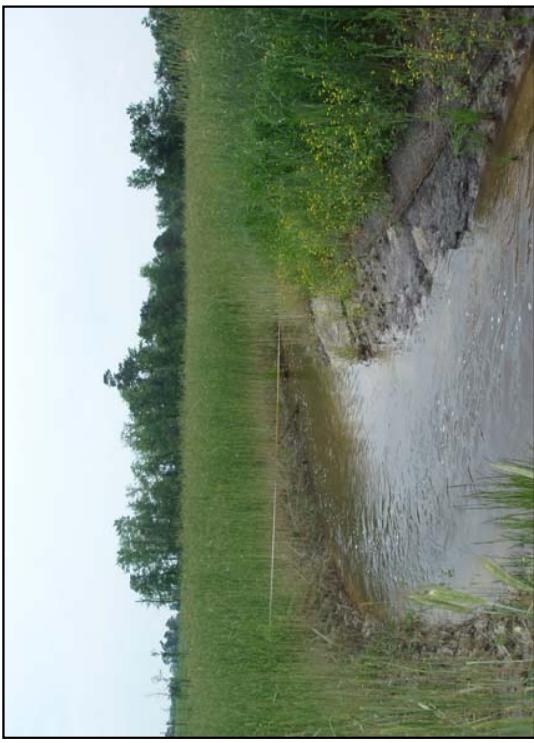
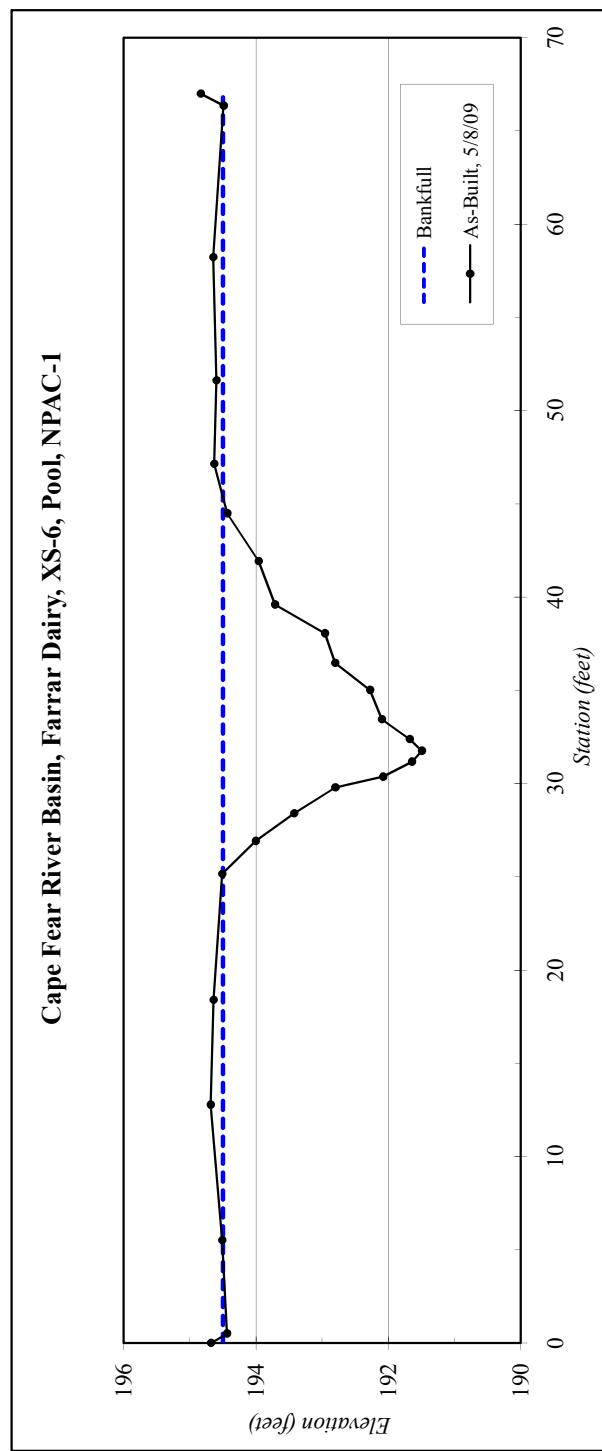
River Basin:	Cape Fear
Watershed:	Farrar Dairy
XS ID	XS-6, Pool, NPAC-1
Drainage Area (sq mi):	4.1
Date:	5/8/2009
Field Crew:	A. French, K. O'Briant

SUMMARY DATA	
Bankfull Elevation:	194.5
Bankfull Cross-Sectional Area:	26.6
Bankfull Width:	20.4
Flood Prone Area Elevation:	-
Flood Prone Width:	-
Max Depth at Bankfull:	3.0
Mean Depth at Bankfull:	1.3
W / D Ratio:	-
Entrenchment Ratio:	-
Bank Height Ratio:	-

Stream Type C5

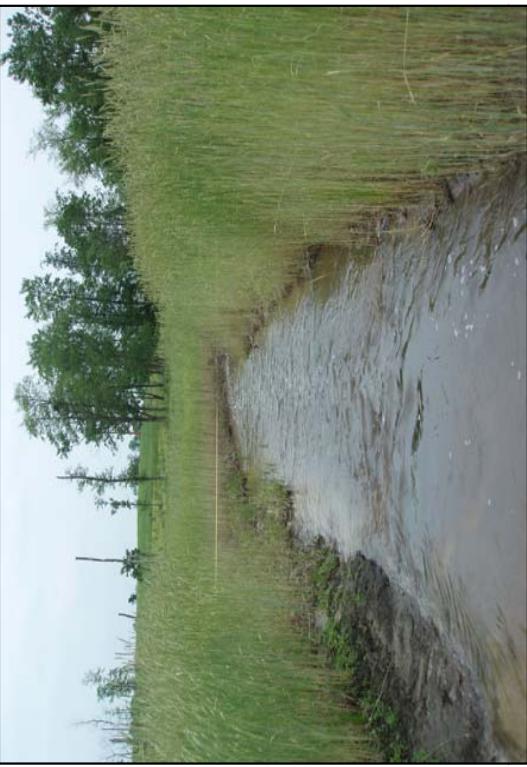
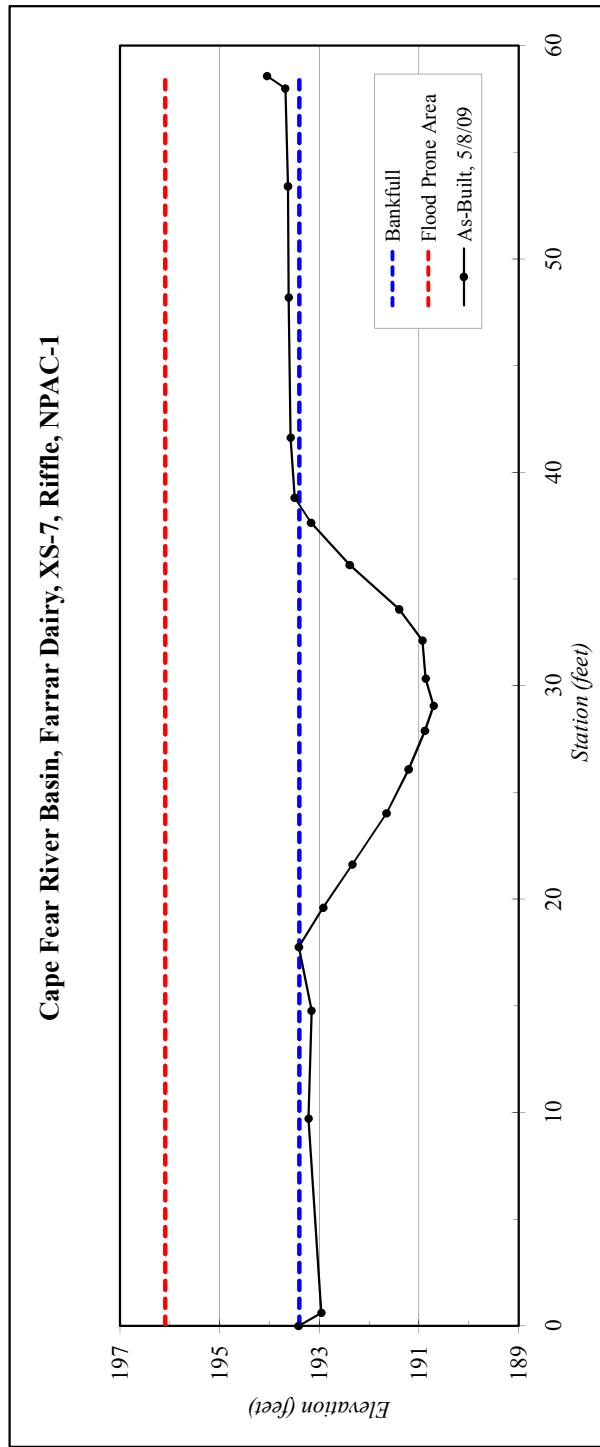
River Basin:	Cape Fear
Watershed:	Farrar Dairy
XS ID	XS-7, Riffle, NPAC-1
Drainage Area (sq mi):	4.1
Date:	5/8/2009
Field Crew:	A. French, K. O'Briant

SUMMARY DATA	
Bankfull Elevation:	193.4
Bankfull Cross-Sectional Area:	32.2
Bankfull Width:	20.7
Flood Prone Area Elevation:	196.1
Flood Prone Width:	>60
Max Depth at Bankfull:	2.7
Mean Depth at Bankfull:	1.6
W / D Ratio:	13.3
Entrenchment Ratio:	>3.0
Bank Height Ratio:	1.0

Station	Elevation
0.0	193.42
0.6	192.96
9.7	193.22
14.8	193.16
17.8	193.41
19.6	192.92
21.6	192.34
24.0	191.65
26.1	191.21
27.9	190.88
29.1	190.71
30.3	190.86
32.1	190.93
33.6	191.40
35.7	192.39
37.6	193.17
38.8	193.49
41.6	193.58
48.2	193.61
53.4	193.63
58.0	193.68
58.6	194.05

Stream Type C5

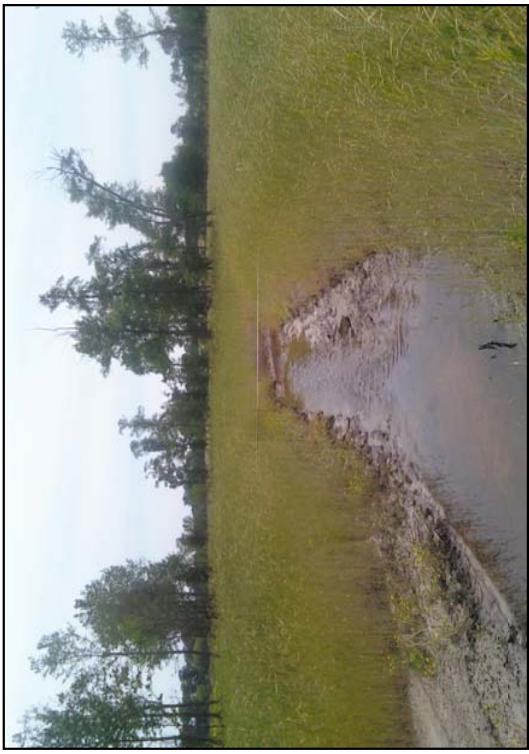
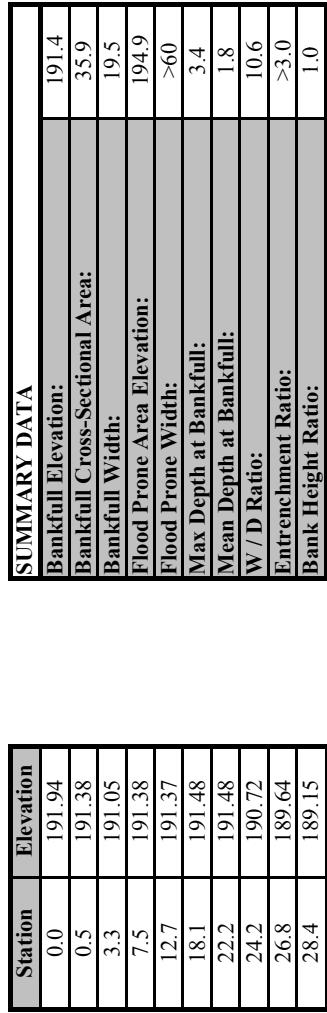
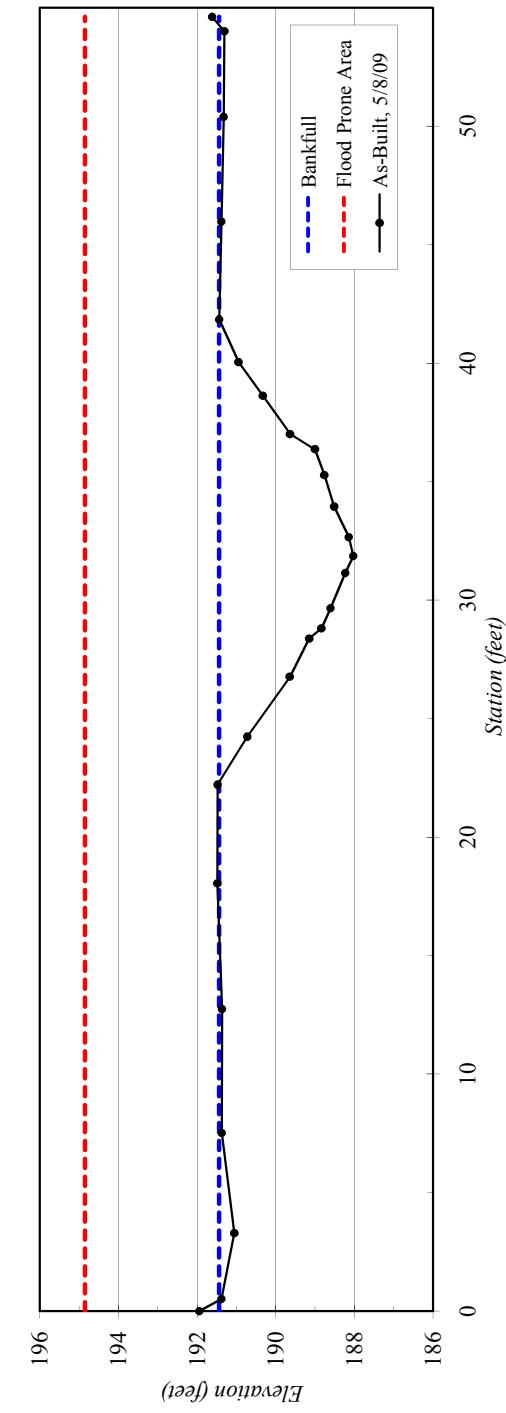
Cape Fear River Basin, Farrar Dairy, XS-8, Riffle, NPAC-2

River Basin:	Cape Fear
Watershed:	Farrar Dairy
XS ID	XS-8, Riffle, NPAC-2
Drainage Area (sq mi):	4.1
Date:	5/8/2009
Field Crew:	A. French, K. O'Briant

Stream Type C5

Bankfull
Flood Prone Area
As-Built, 5/8/09

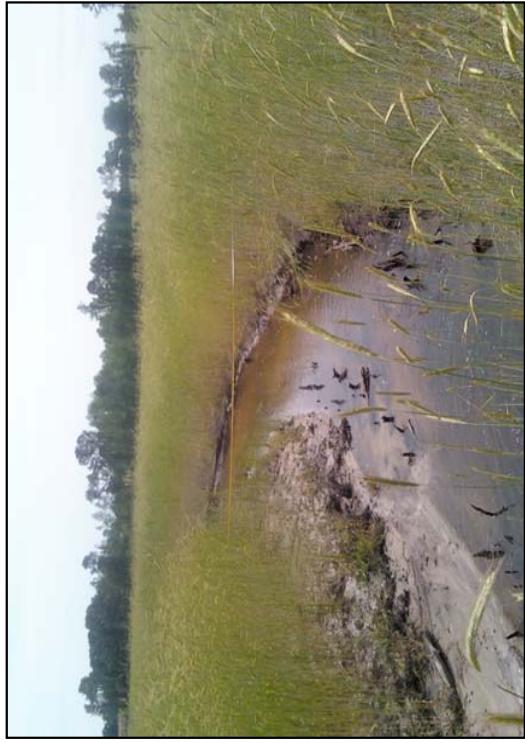
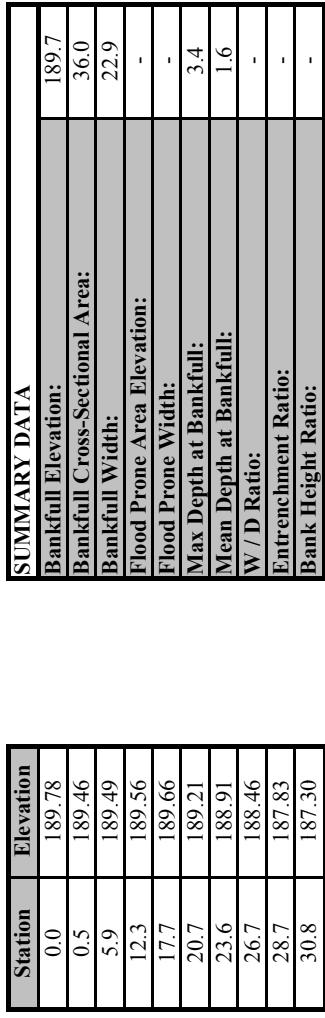
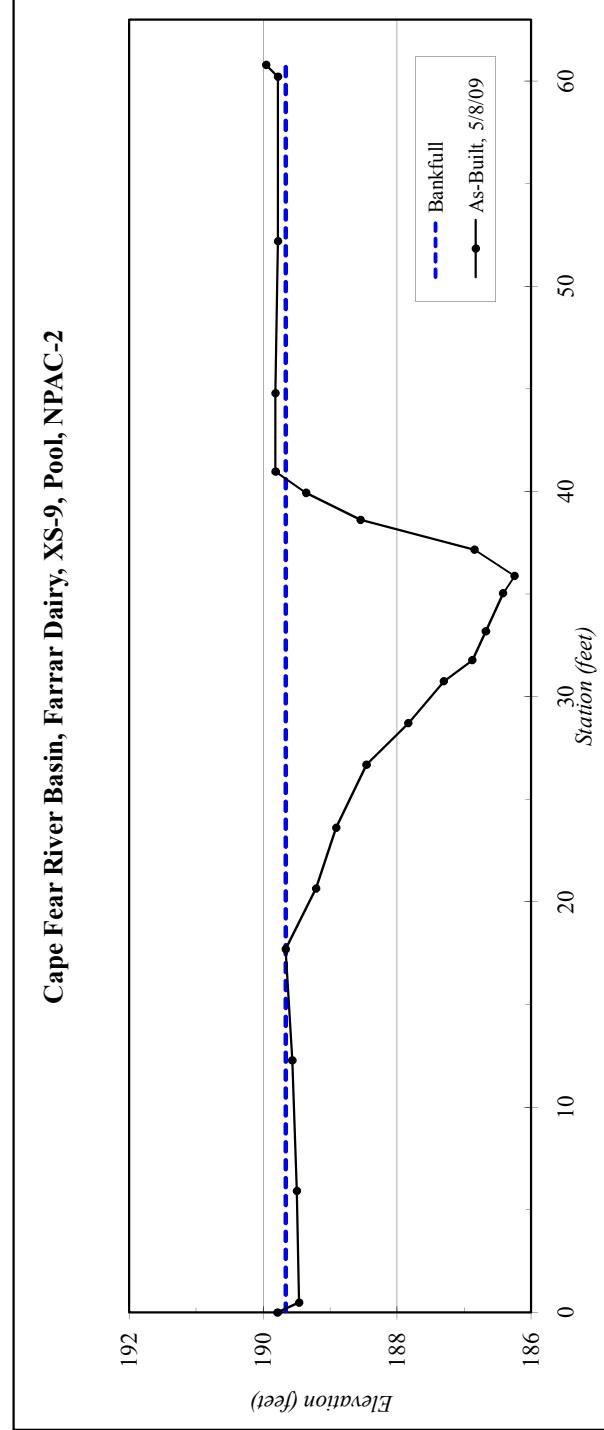
Cape Fear River Basin, Farrar Dairy, XS-9, Pool, NPAC-2

River Basin:	Cape Fear
Watershed:	Farrar Dairy
XS ID	XS-9, Pool, NPAC-2
Drainage Area (sq mi):	4.65
Date:	5/8/2009
Field Crew:	A. French, K. O'Briant

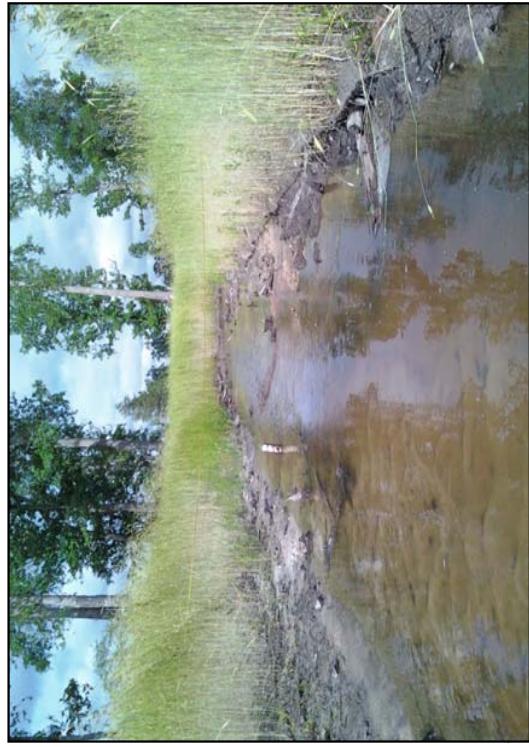
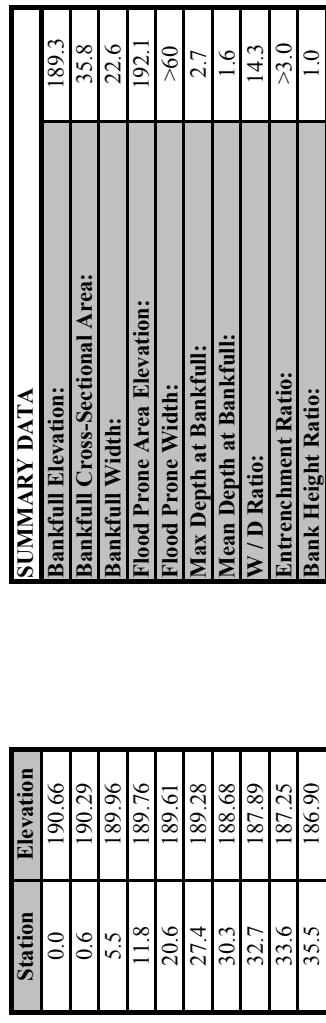
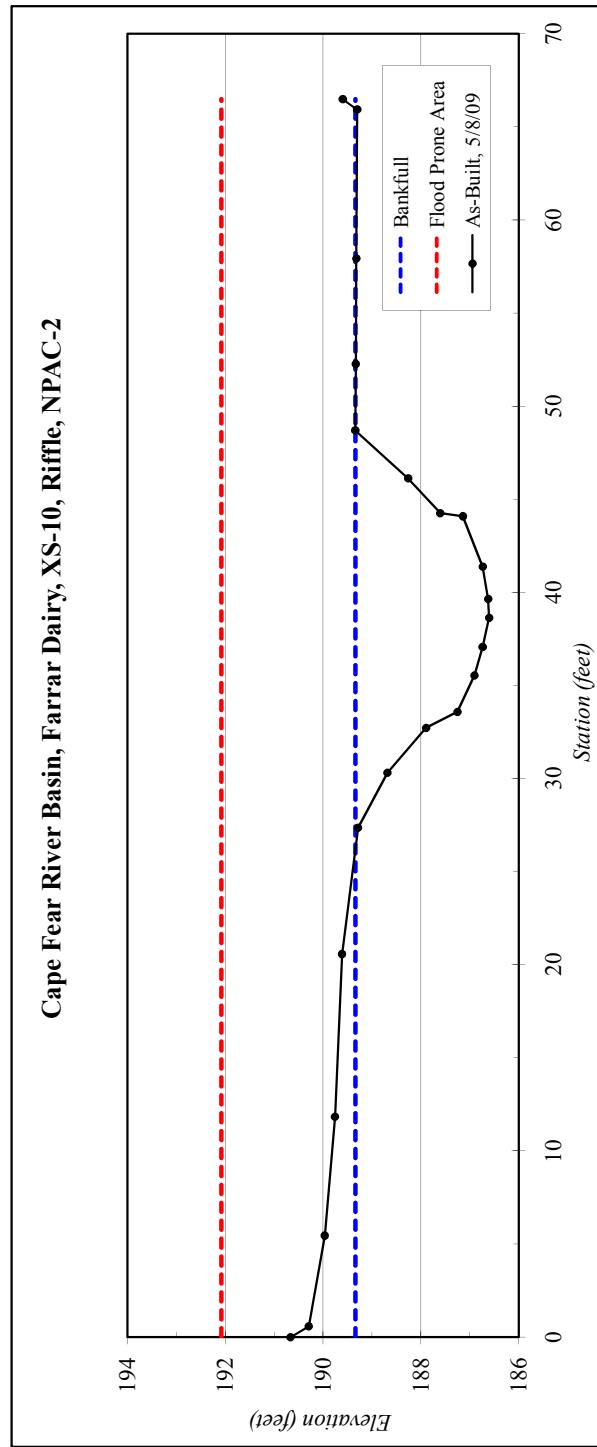
River Basin:	Cape Fear
Watershed:	Farrar Dairy
XS ID	XS-10, Riffle, NPAC-2
Drainage Area (sq mi):	4.65
Date:	5/8/2009
Field Crew:	A. French, K. O'Briant

Stream Type C5

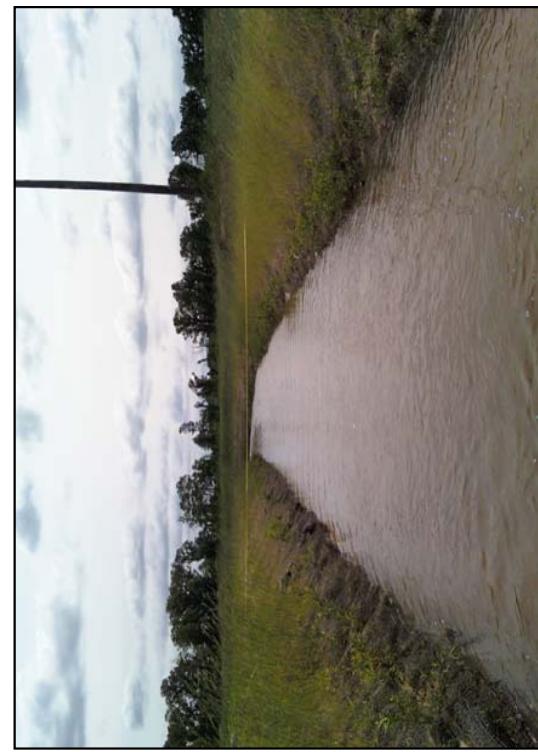
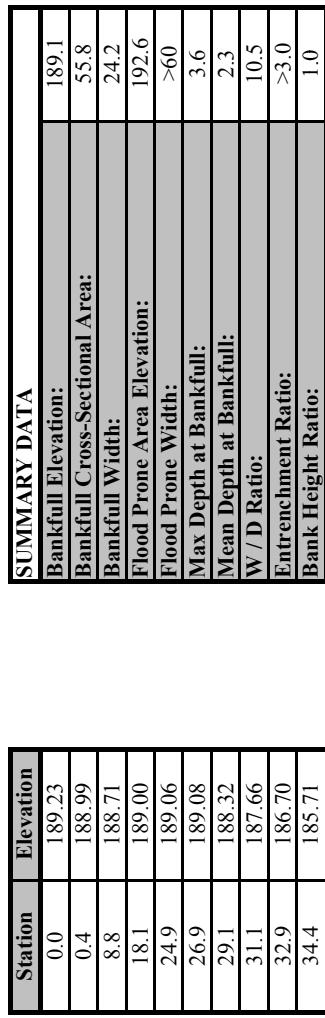
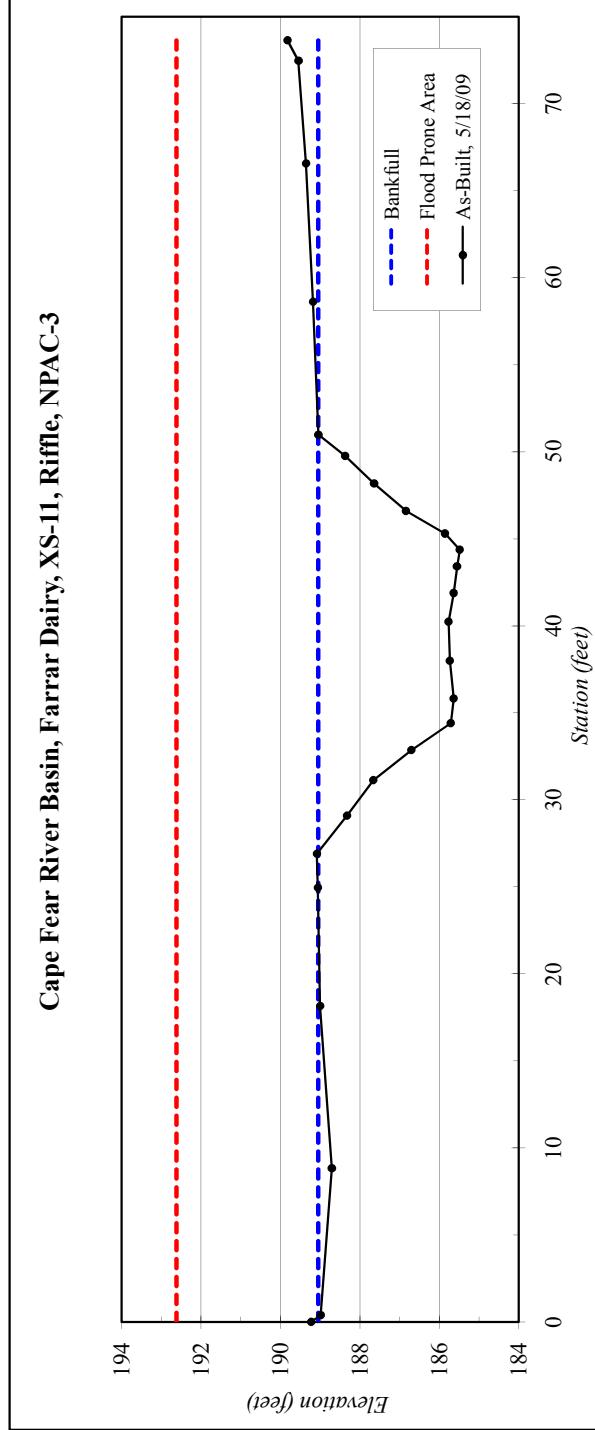
Cape Fear River Basin, Farrar Dairy, XS-11, Riffle, NPAC-3

River Basin:	Cape Fear
Watershed:	Farrar Dairy
XS ID	XS-11, Riffle, NPAC-3
Drainage Area (sq mi):	4.82
Date:	5/18/2009
Field Crew:	A. French, K. O'Briant

Stream Type C5

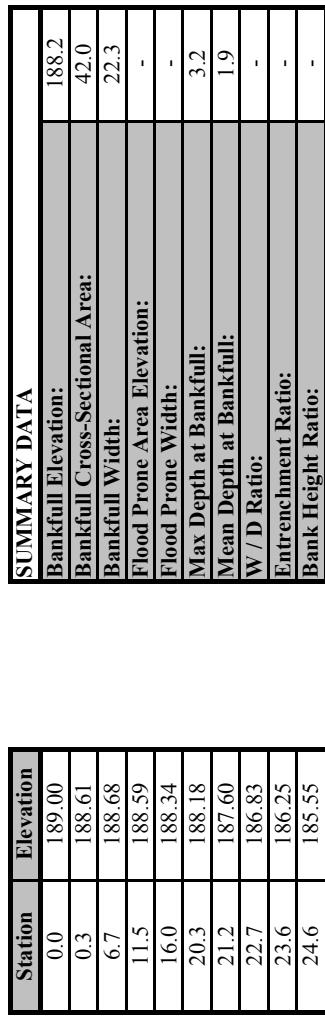
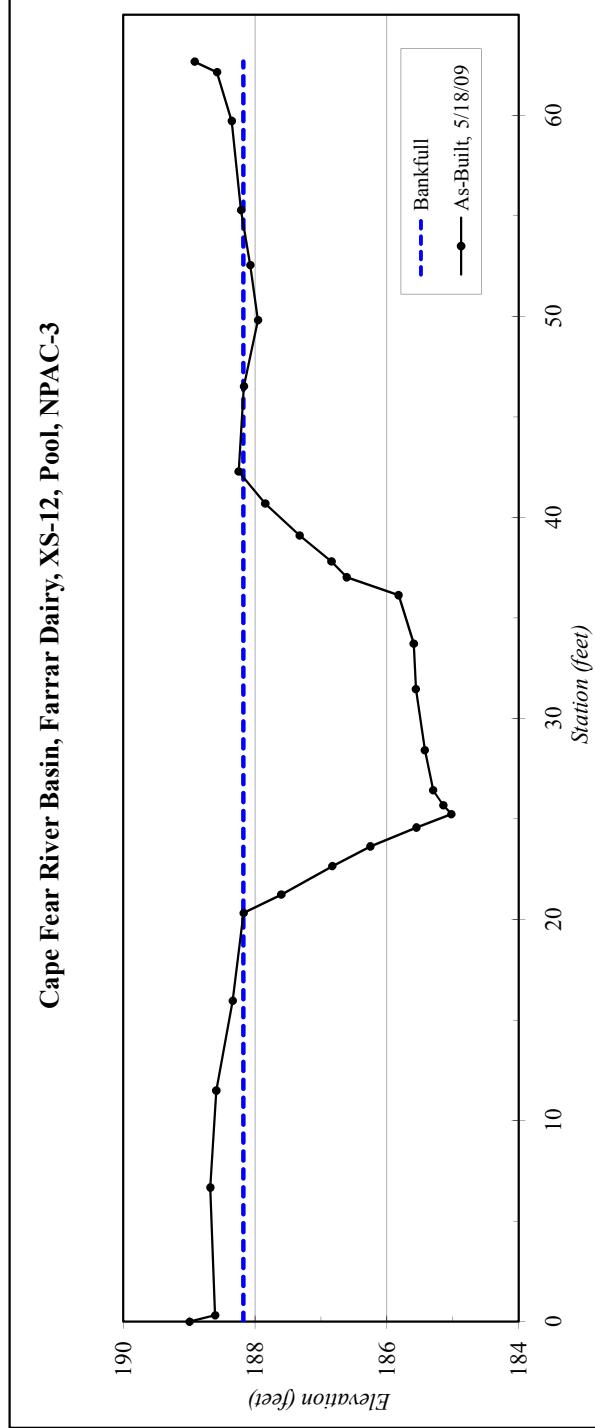
Cape Fear River Basin, Farrar Dairy, XS-12, Pool, NPAC-3

River Basin:	Cape Fear
Watershed:	Farrar Dairy
XS ID	XS-12, Pool, NPAC-3
Drainage Area (sq mi):	4.82
Date:	5/18/2009
Field Crew:	A. French, K. O'Briant

Stream Type C5
