Farrar Dairy Stream and Wetland Restoration Site

Mitigation Plan

Contract # D06002

August 2009

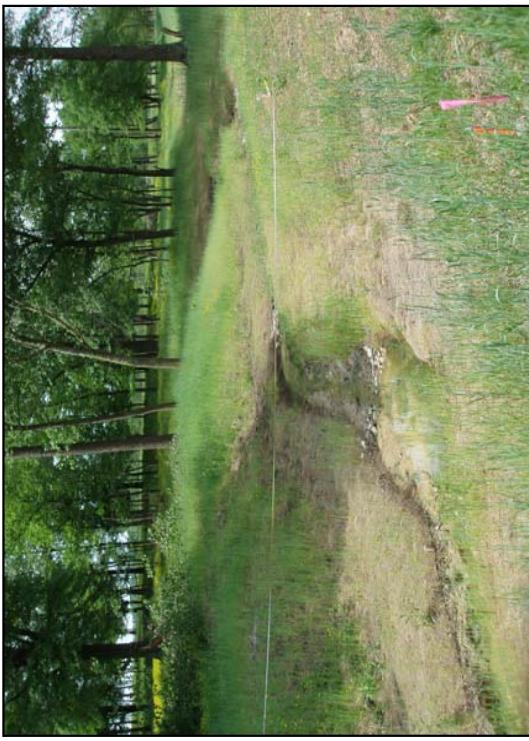
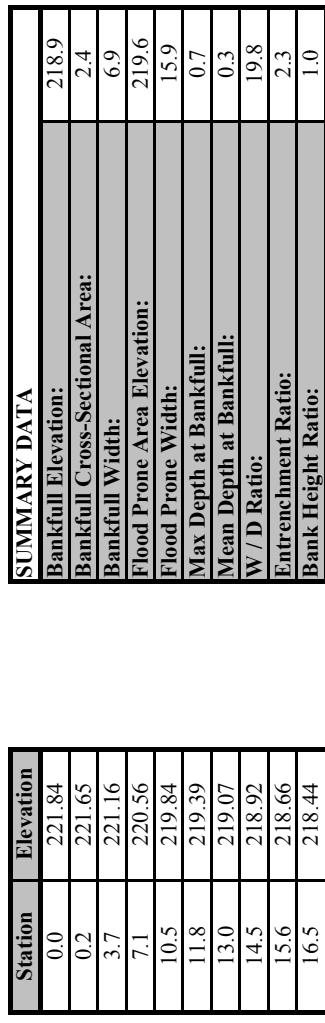
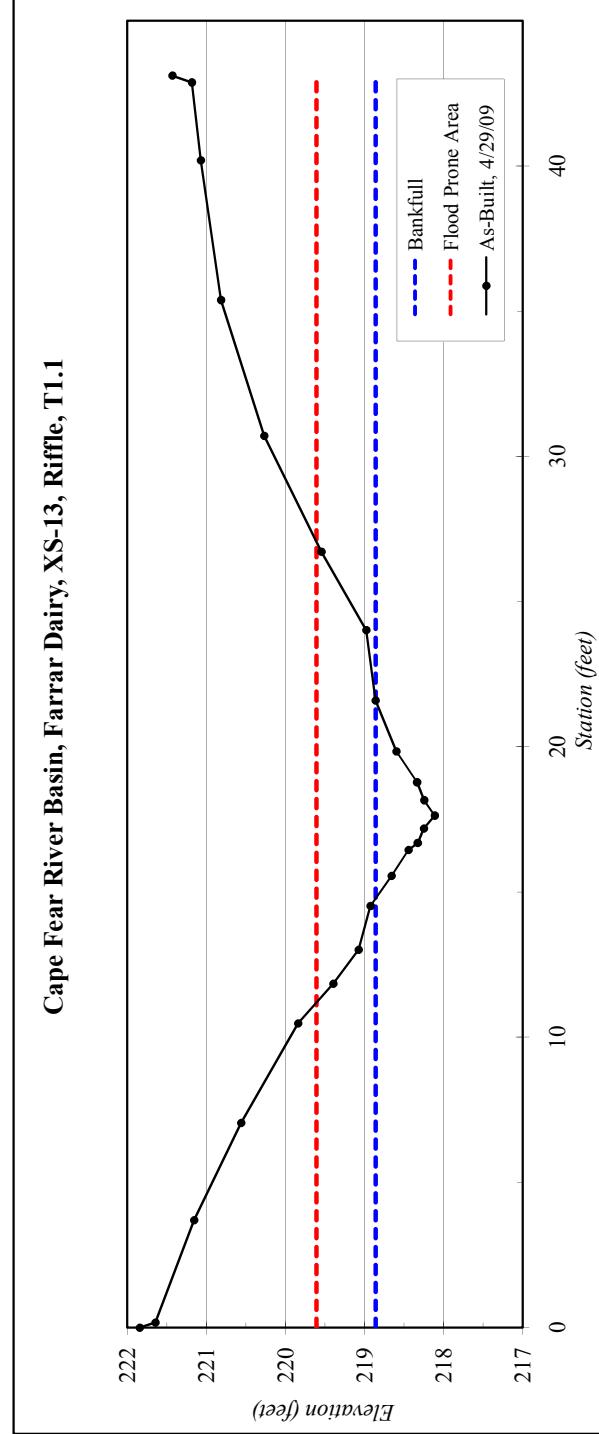
Cape Fear River Basin, Farrar Dairy, XS-13, Riffle, T1.1

River Basin:	Cape Fear
Watershed:	Farrar Dairy
XS ID	XS-13, Riffle, T1.1
Drainage Area (sq mi):	0.02
Date:	4/29/2009
Field Crew:	A. French, B. Roberts

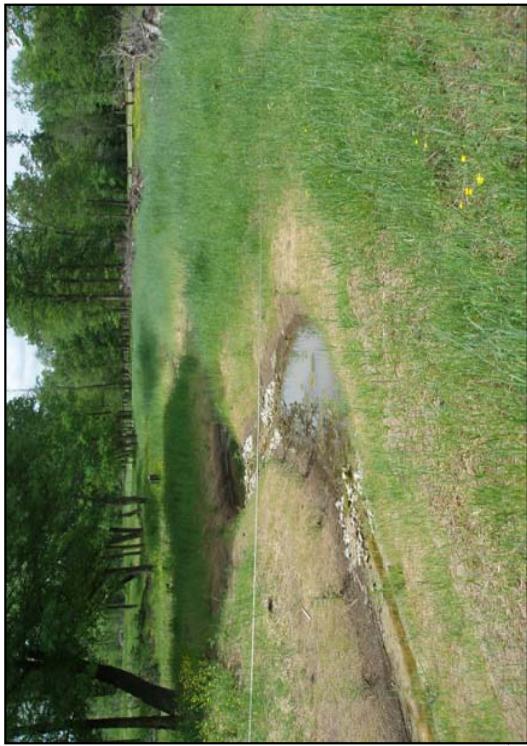
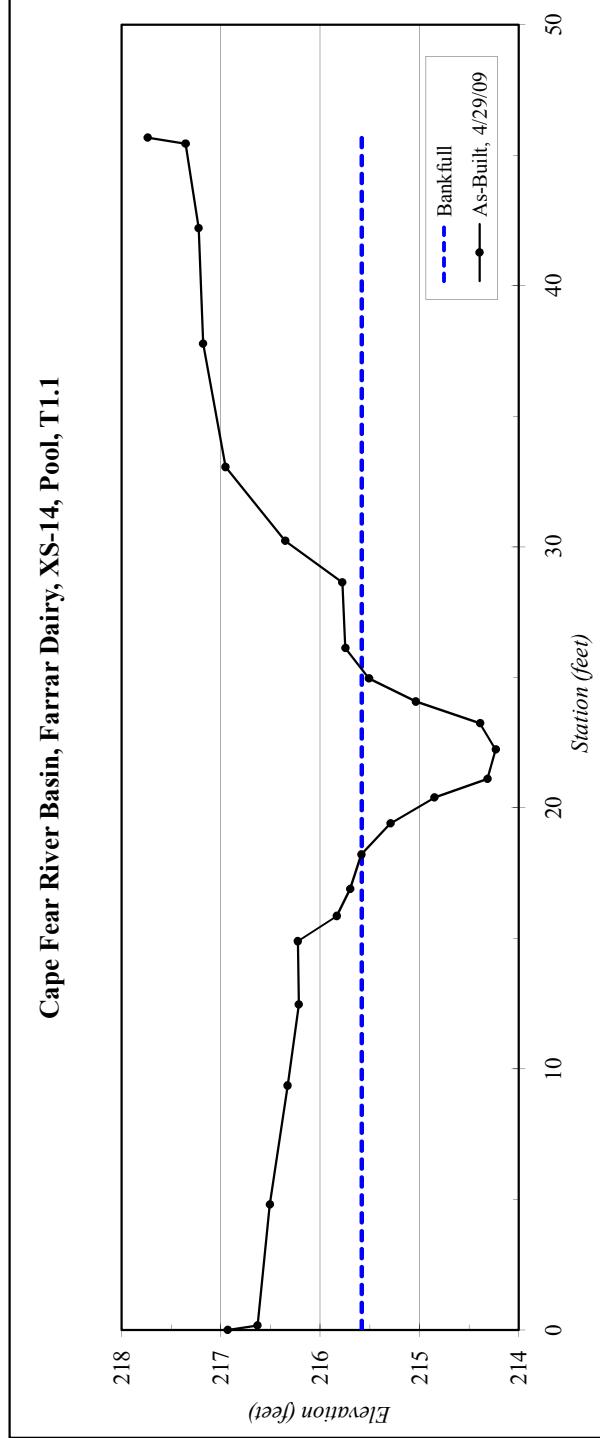
Cape Fear River Basin, Farrar Dairy, XS-14, Pool, T1.1

River Basin:	Cape Fear
Watershed:	Farrar Dairy
XS ID	XS-14, Pool, T1.1
Drainage Area (sq mi):	0.02
Date:	4/29/2009
Field Crew:	A. French, B. Roberts

Station	Elevation	SUMMARY DATA
0.0	216.93	Bankfull Elevation:
0.2	216.63	Bankfull Cross-Sectional Area:
4.8	216.51	Bankfull Width:
9.4	216.33	Flood Prone Area Elevation:
12.5	216.22	Flood Prone Width:
14.9	216.23	Max Depth at Bankfull:
15.9	215.83	Mean Depth at Bankfull:
16.9	215.70	W / D Ratio:
18.2	215.59	Entrenchment Ratio:
19.4	215.29	Bank Height Ratio:
20.4	214.85	-
21.1	214.31	-
22.2	214.23	-
23.2	214.39	-
24.1	215.04	-
25.0	215.51	-
26.1	215.75	-
28.6	215.78	-
30.2	216.35	-
33.1	216.95	-
37.8	217.18	-
42.2	217.23	-
45.4	217.36	-
45.7	217.74	-

Stream Type C5

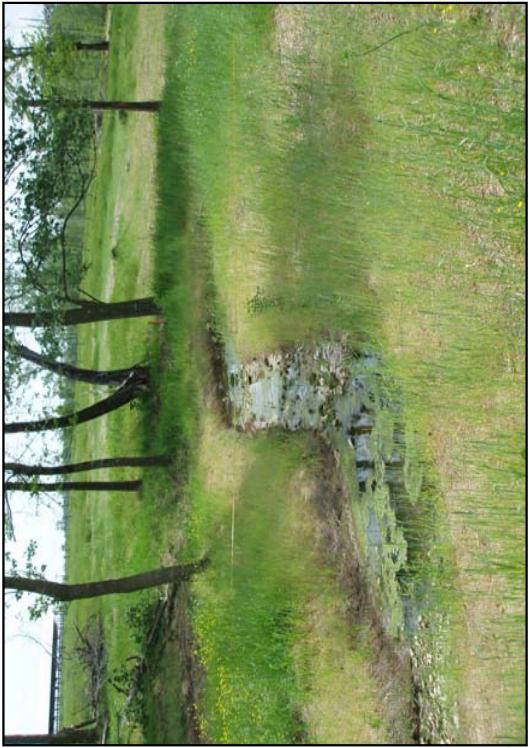
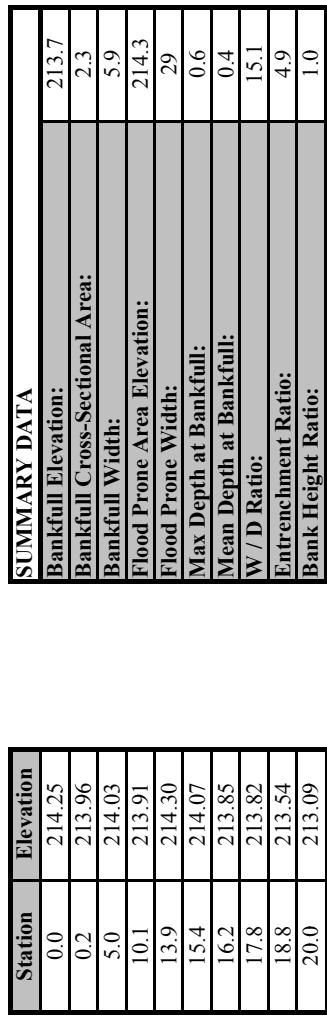
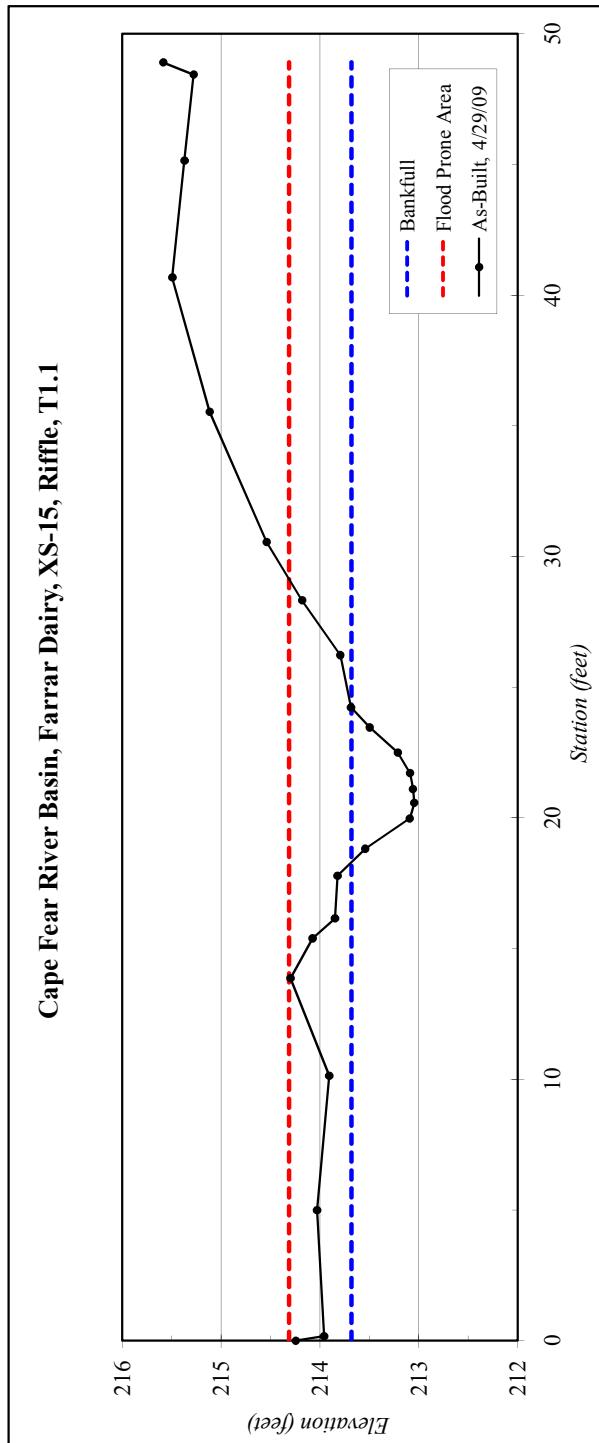
Cape Fear River Basin, Farrar Dairy, XS-15, Riffle, T1.1

River Basin:	Cape Fear
Watershed:	Farrar Dairy
XS ID	XS-15, Riffle, T1.1
Drainage Area (sq mi):	0.02
Date:	4/29/2009
Field Crew:	A. French, B. Roberts

Stream Type: C5

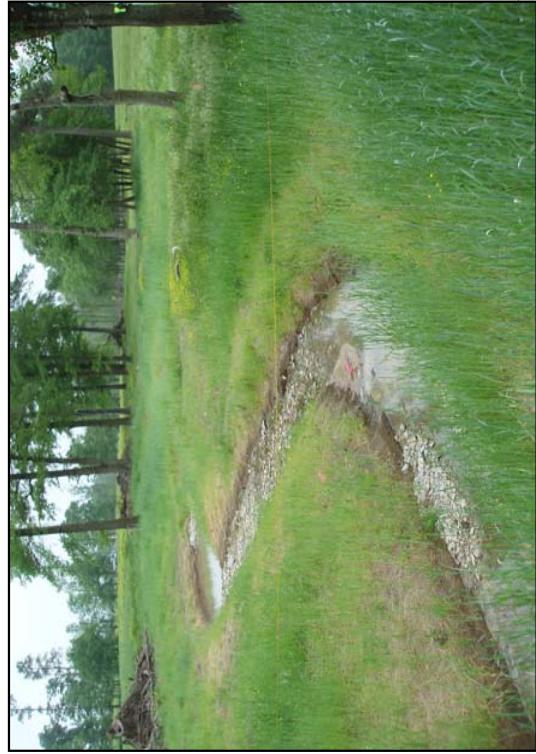
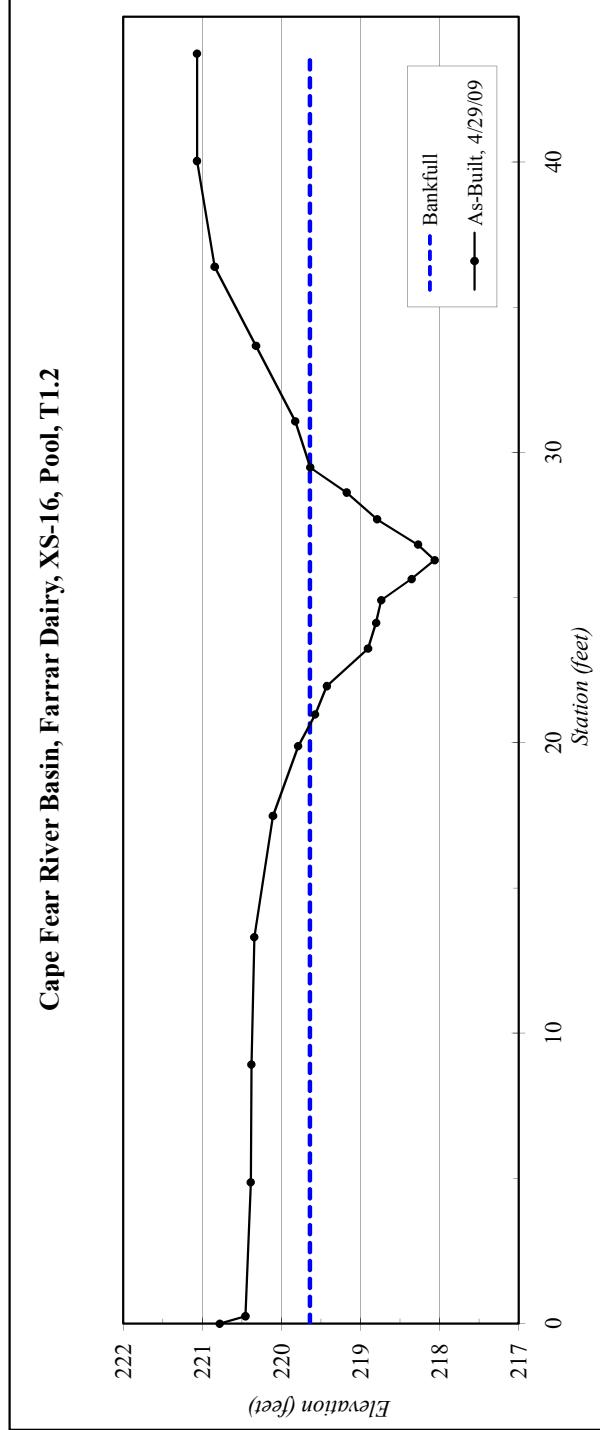
Cape Fear River Basin, Farrar Dairy, XS-16, Pool, T1.2

River Basin:	Cape Fear
Watershed:	Farrar Dairy
XS ID	XS-16, Pool, T1.2
Drainage Area (sq mi):	0.10
Date:	4/29/2009
Field Crew:	A. French, B. Roberts

Station	Elevation	SUMMARY DATA
0.0	220.78	Bankfull Elevation:
0.3	220.46	Bankfull Cross-Sectional Area:
4.9	220.39	Bankfull Width:
8.9	220.38	Flood Prone Area Elevation:
13.3	220.34	Flood Prone Width:
17.5	220.11	Max Depth at Bankfull:
19.9	219.79	Mean Depth at Bankfull:
21.0	219.57	W / D Ratio:
21.9	219.43	Entrenchment Ratio:
23.2	218.91	Bank Height Ratio:
24.1	218.80	-
24.9	218.74	-
25.6	218.36	-
26.3	218.06	-
26.8	218.27	-
27.7	218.79	-
28.6	219.18	-
29.5	219.64	-
31.1	219.83	-
33.7	220.32	-
36.4	220.84	-
40.0	221.07	-
43.7	221.07	-

Stream Type C5

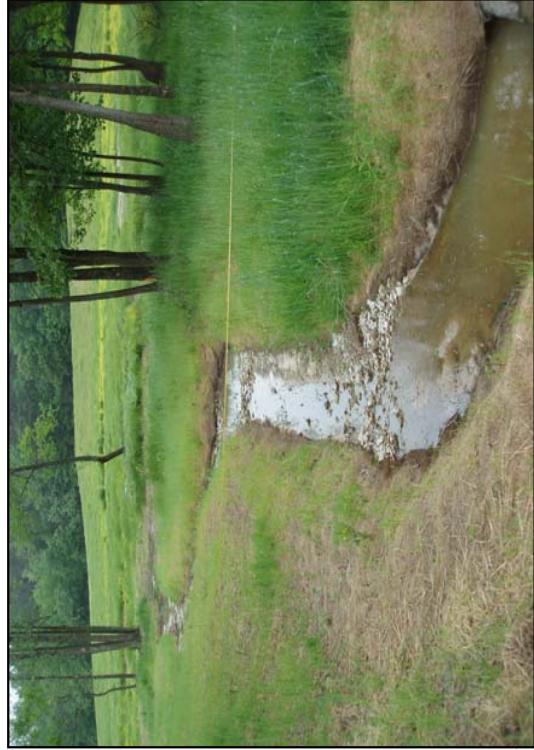
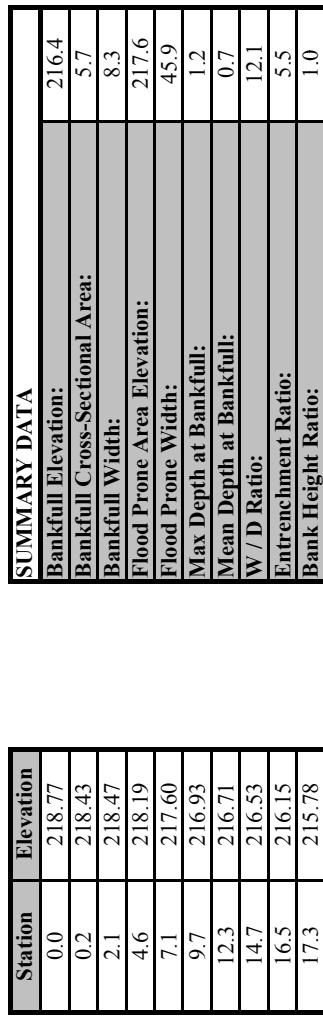
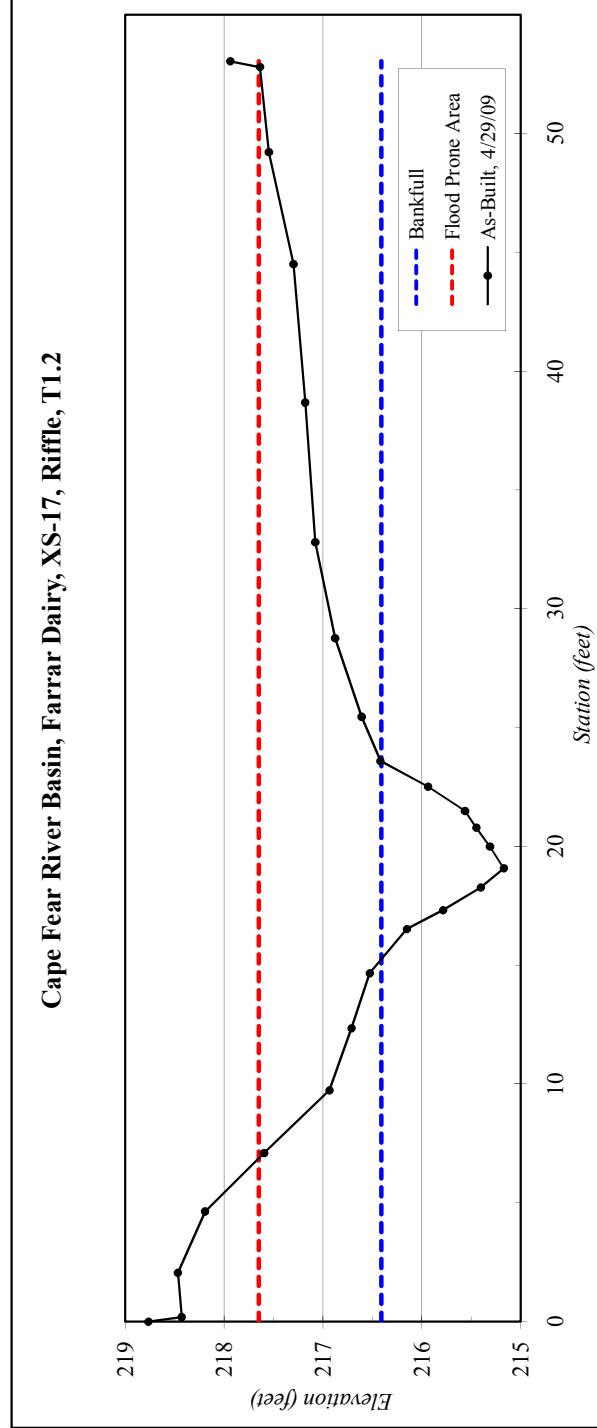
Cape Fear River Basin, Farrar Dairy, XS-17, Riffle, T1.2

River Basin:	Cape Fear
Watershed:	Farrar Dairy
XS ID	XS-17, Riffle, T1.2
Drainage Area (sq mi):	0.10
Date:	4/29/2009
Field Crew:	A. French, B. Roberts

Stream Type C5

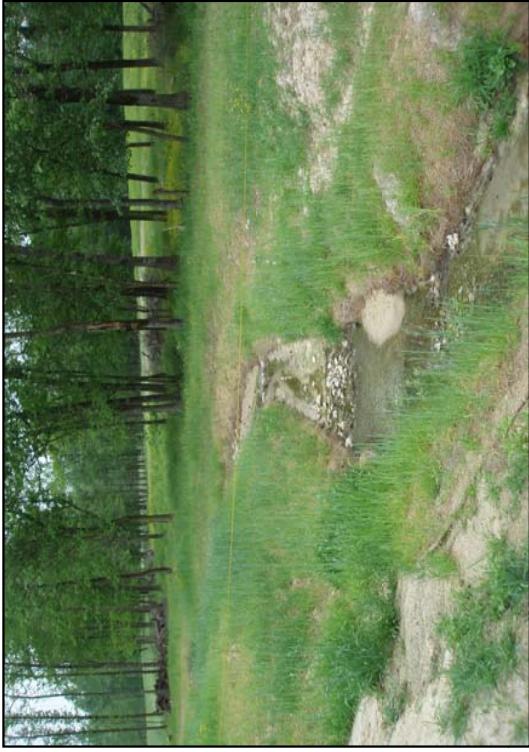
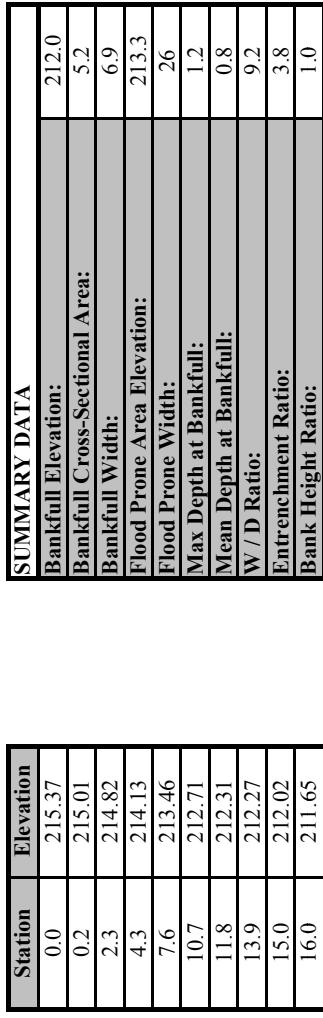
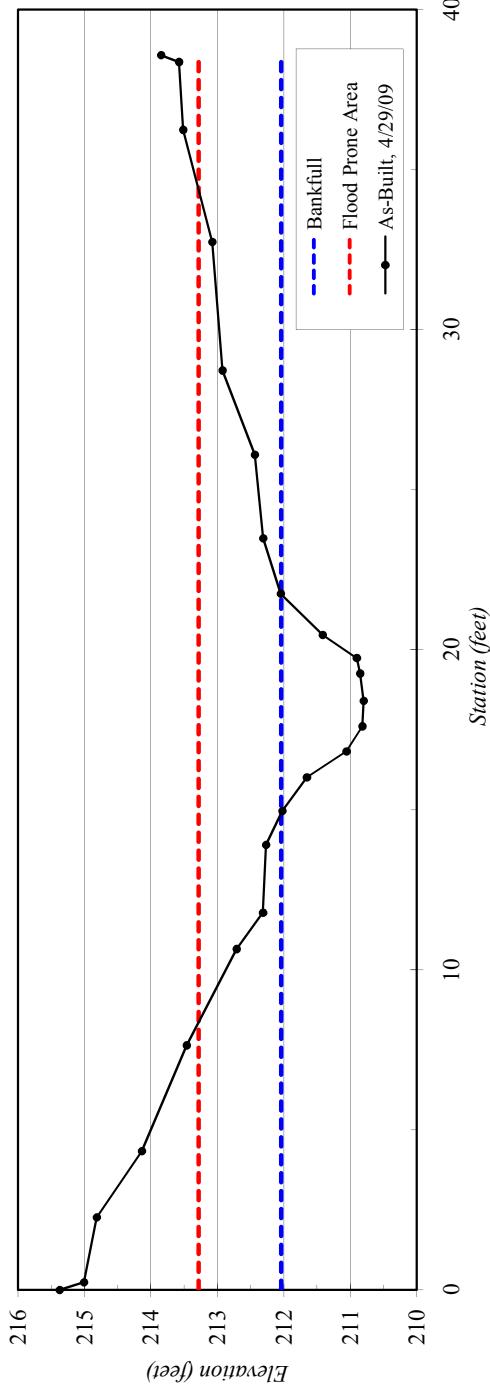
Cape Fear River Basin, Farrar Dairy, XS-18, Riffle, T1.2

River Basin:	Cape Fear
Watershed:	Farrar Dairy
XS ID	XS-18, Riffle, T1.2
Drainage Area (sq mi):	0.10
Date:	4/29/2009
Field Crew:	A. French, B. Roberts

Stream Type E5

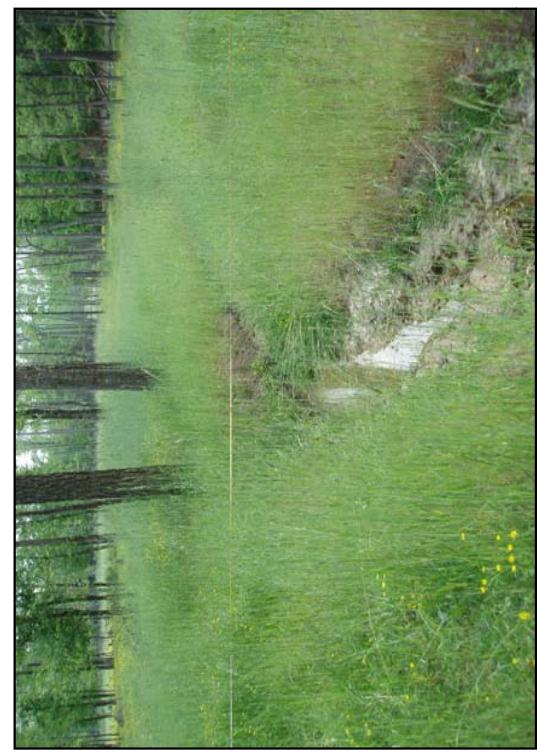
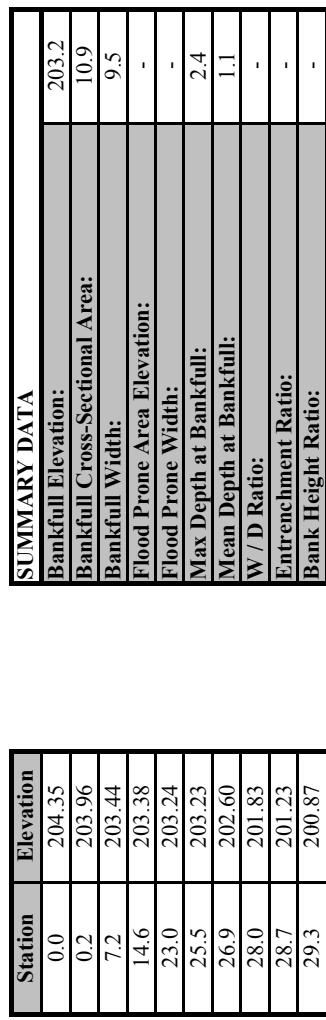
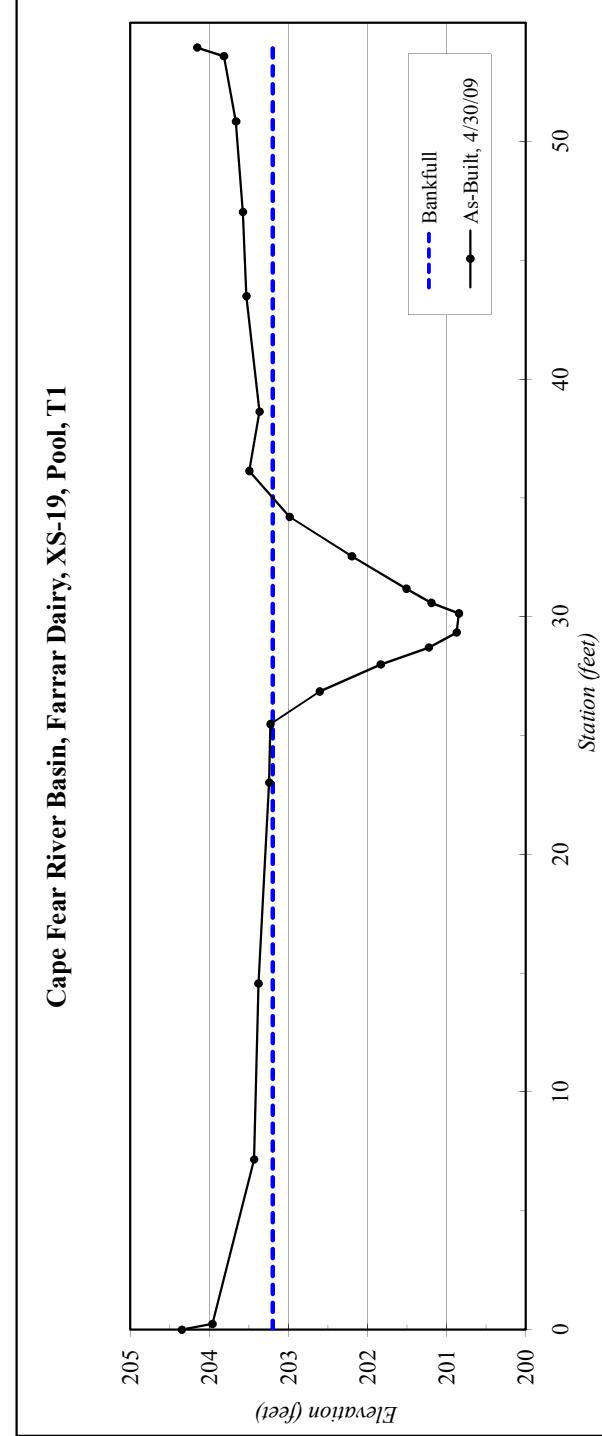
Cape Fear River Basin, Farrar Dairy, XS-19, Pool, T1

River Basin:	Cape Fear
Watershed:	Farrar Dairy
XS ID	XS-19, Pool, T1
Drainage Area (sq mi):	0.18
Date:	4/30/2009
Field Crew:	A. French, B. Roberts

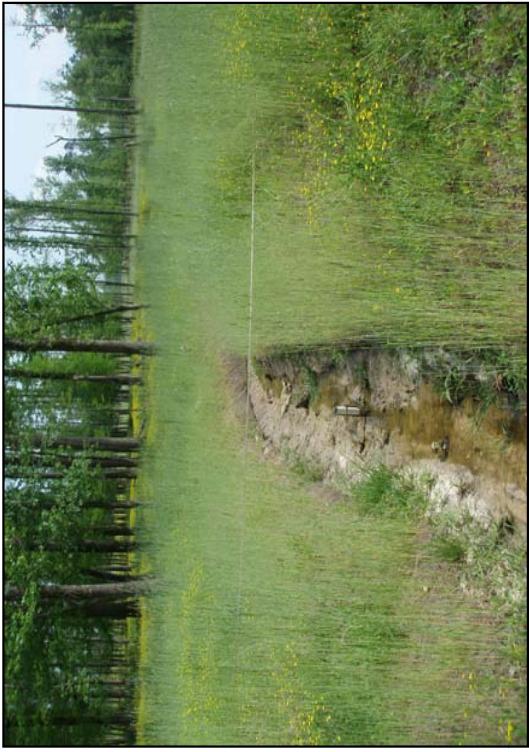
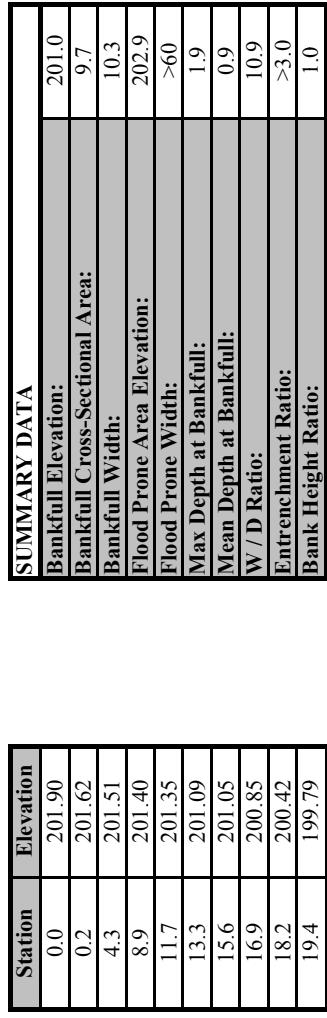
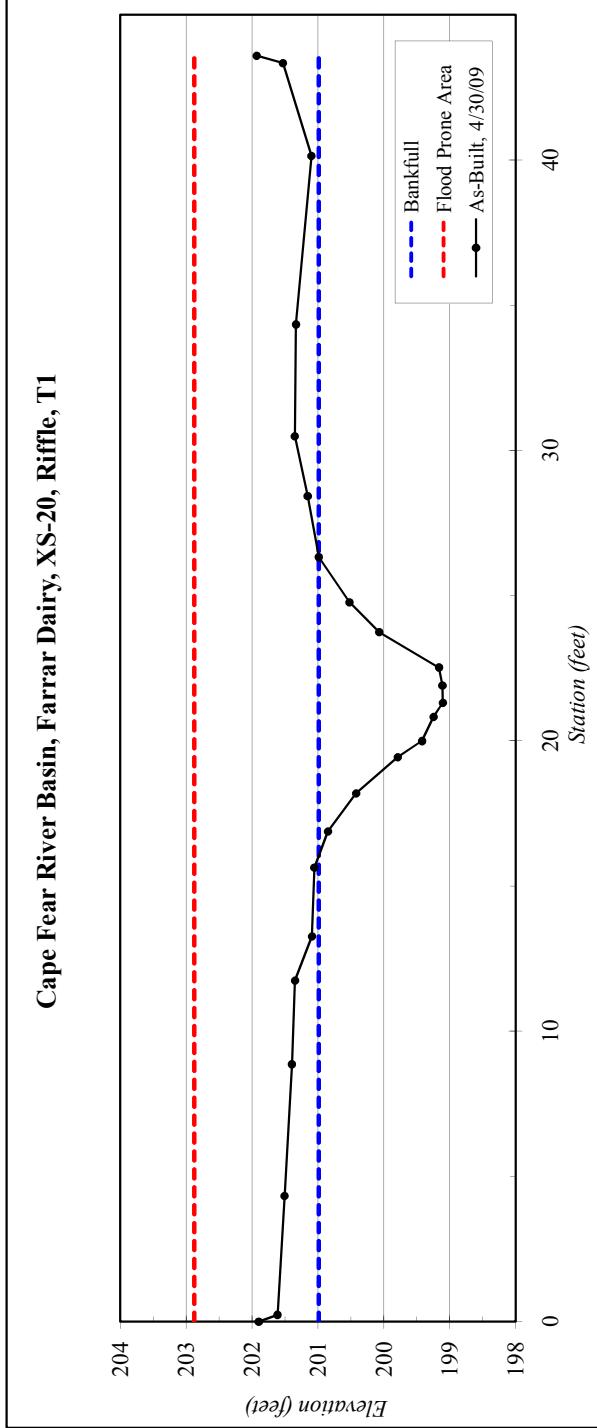
Cape Fear River Basin, Farrar Dairy, XS-20, Riffle, T1

River Basin:	Cape Fear
Watershed:	Farrar Dairy
XS ID	XS-20, Riffle, T1
Drainage Area (sq mi):	0.18
Date:	4/30/2009
Field Crew:	A. French, B. Roberts

Stream Type E5

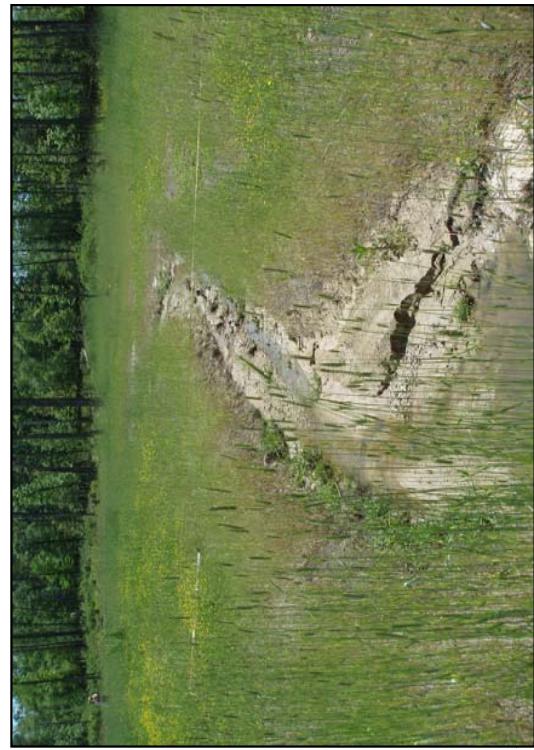
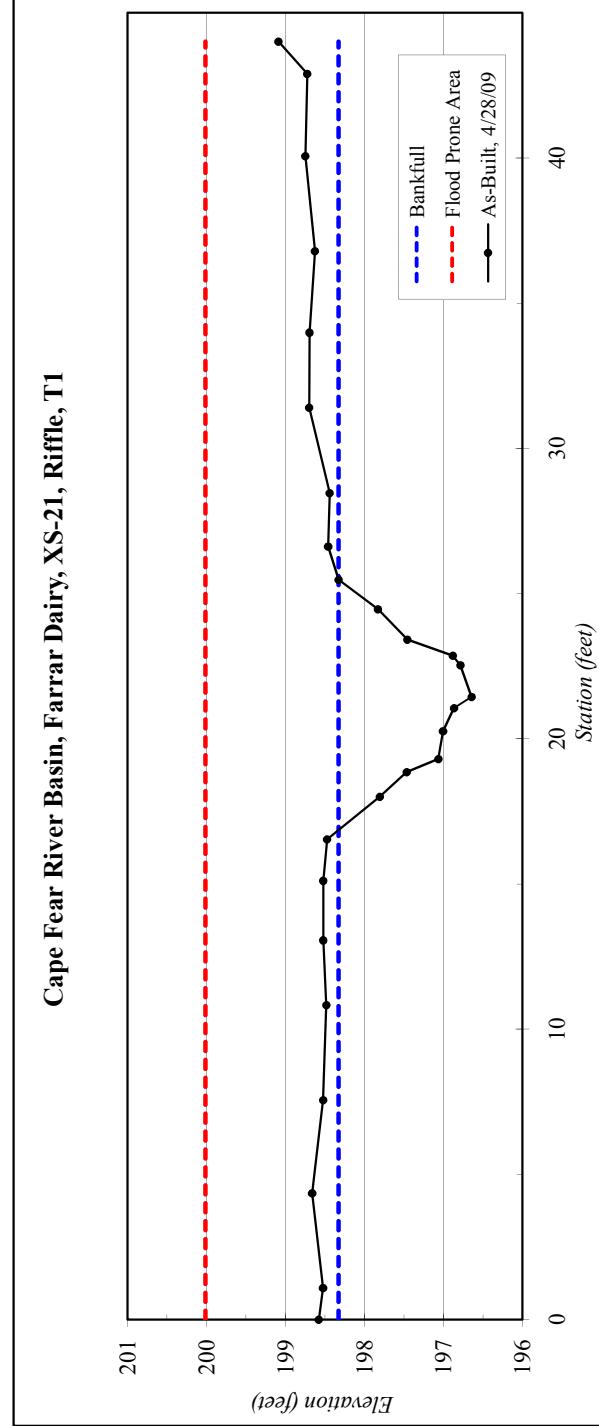
Cape Fear River Basin, Farrar Dairy, XS-21, Riffle, T1

River Basin:	Cape Fear
Watershed:	Farrar Dairy
XS ID	XS-21, Riffle, T1
Drainage Area (sq mi):	0.18
Date:	4/28/2009
Field Crew:	B. Roberts, A. Davis

Station	Elevation	SUMMARY DATA
0.0	198.58	Bankfull Elevation:
1.1	198.53	Bankfull Cross-Sectional Area:
4.4	198.66	Bankfull Width:
7.6	198.52	Flood Prone Area Elevation:
10.8	198.48	Flood Prone Width:
13.1	198.52	Max Depth at Bankfull:
15.1	198.52	Mean Depth at Bankfull:
16.5	198.47	W / D Ratio:
18.0	197.81	Entrenchment Ratio:
18.8	197.47	Bank Height Ratio:
19.3	197.06	
20.3	197.01	
21.1	196.87	
21.4	196.64	
22.5	196.79	
22.9	196.88	
23.4	197.46	
24.5	197.83	
25.5	198.33	
26.6	198.46	
28.5	198.44	
31.4	198.70	
34.0	198.70	
36.8	198.63	
40.1	198.75	
42.9	198.73	
44.0	199.09

Stream Type E5

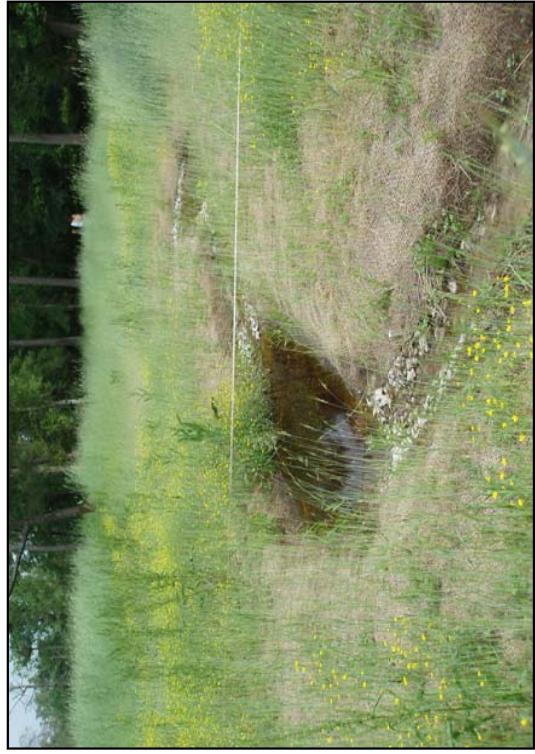
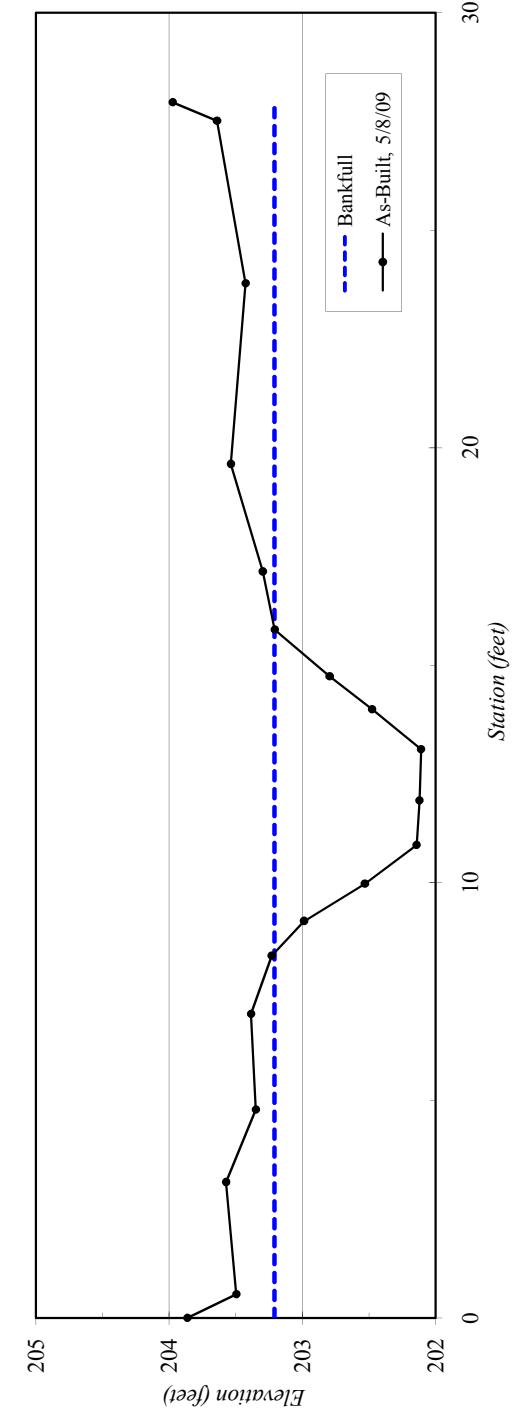
Cape Fear River Basin, Farrar Dairy, XS-22, Pool, T2A

River Basin:	Cape Fear
Watershed:	Farrar Dairy
XS ID	XS-22, Pool, T2A
Drainage Area (sq mi):	0.04
Date:	5/8/2009
Field Crew:	A. French, K. O'Briant

Bankfull Elevation:	203.2
Bankfull Cross-Sectional Area:	5.1
Bankfull Width:	7.5
Flood Prone Area Elevation:	-
Flood Prone Width:	-
Max Depth at Bankfull:	1.1
Mean Depth at Bankfull:	0.7
W / D Ratio:	-
Entrenchment Ratio:	-
Bank Height Ratio:	-
Station	Elevation
0.0	203.86
0.5	203.49
3.1	203.57
4.8	203.35
7.0	203.38
8.3	203.23
9.1	202.99
10.0	202.53
10.9	202.14
11.9	202.12
13.1	202.11
14.0	202.48
14.7	202.79
15.8	203.21
17.2	203.30
19.6	203.54
23.8	203.43
27.5	203.64
27.9	203.97

Stream Type E5

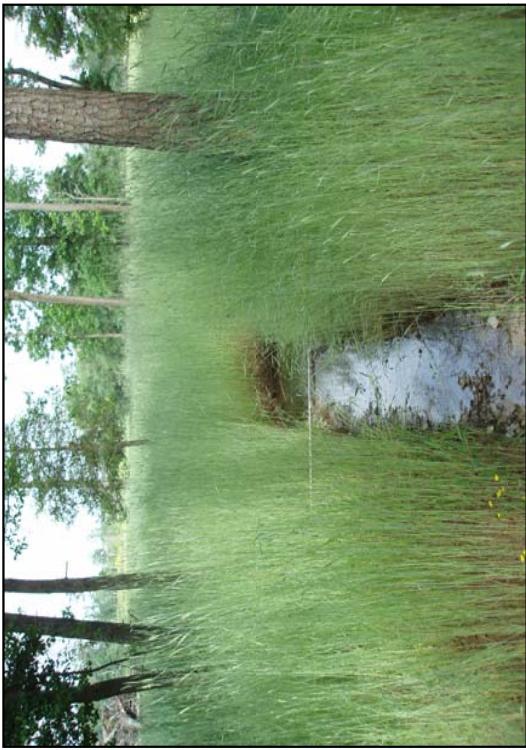
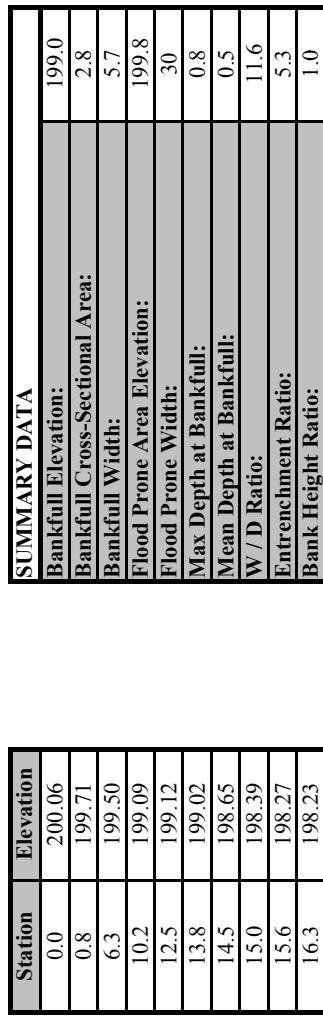
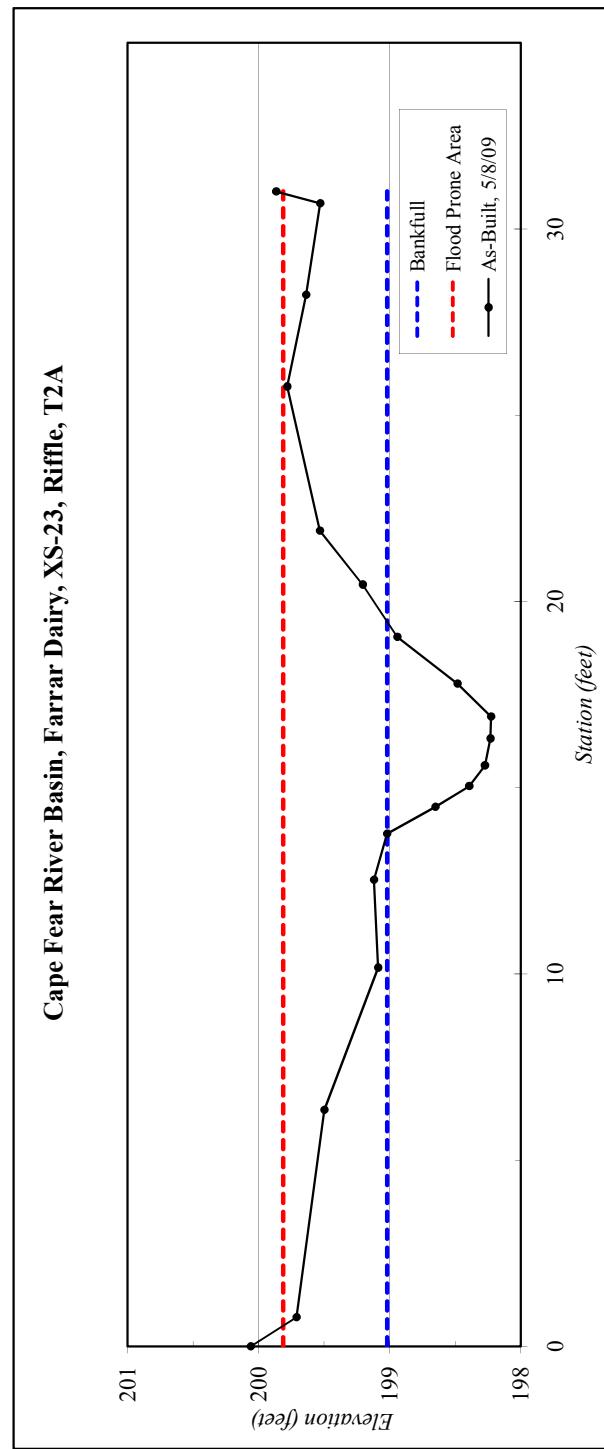
River Basin:	Cape Fear
Watershed:	Farrar Dairy
XS ID	XS-23, Riffle, T2A
Drainage Area (sq mi):	0.04
Date:	5/8/2009
Field Crew:	A. French, K. O'Briant

Stream Type E5

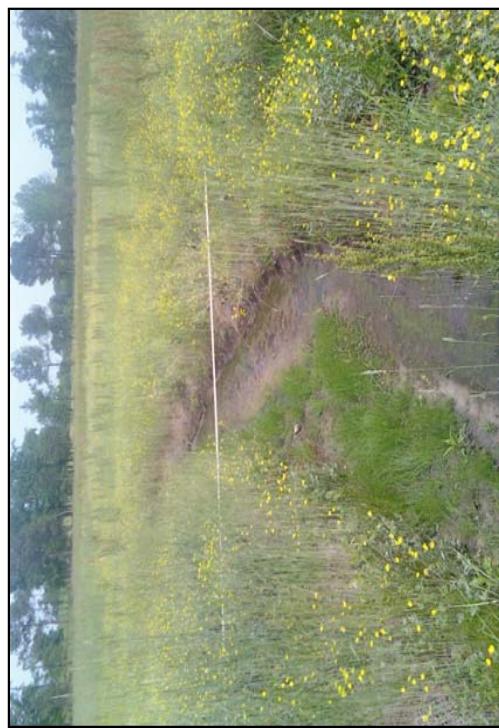
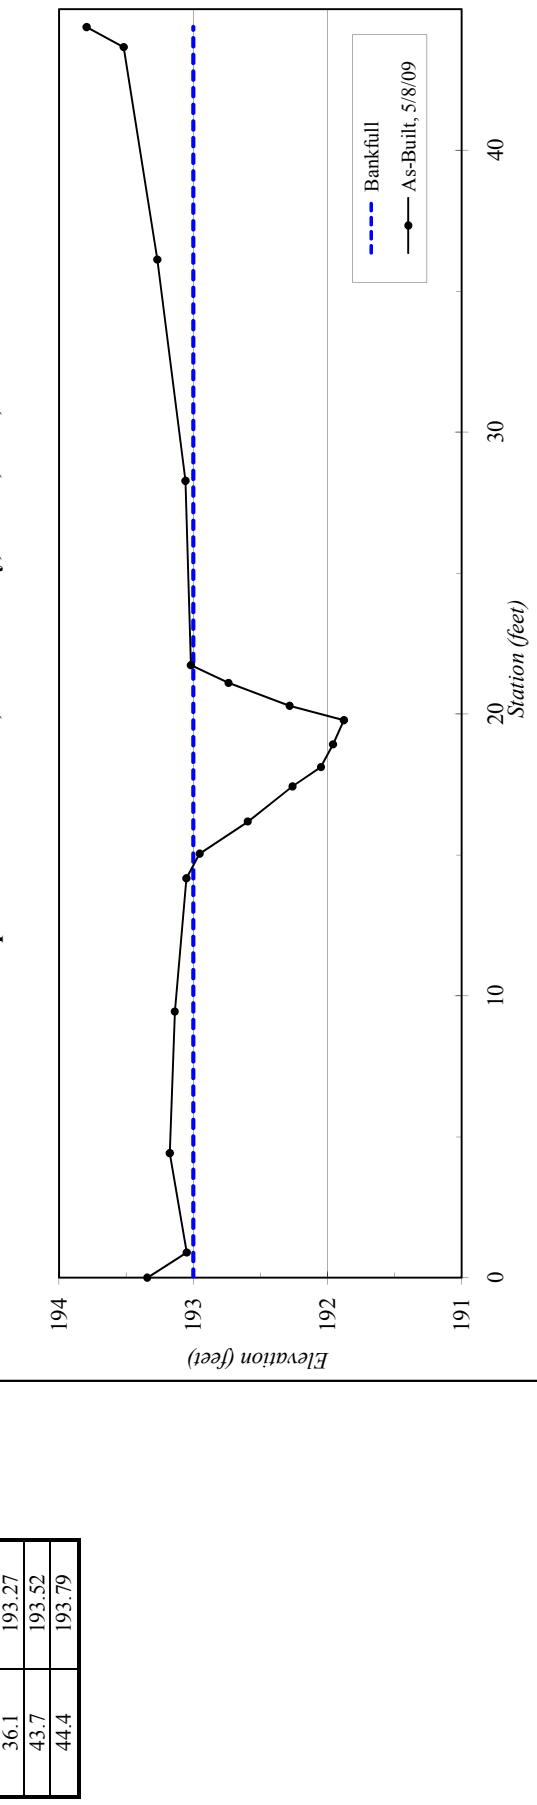
Cape Fear River Basin, Farrar Dairy, XS-24, Pool, T2B

River-Basin:	Cape Fear
Watershed:	Farrat Dairy
XS ID	XS-24, Pool, T2B
Drainage Area (sq mi):	0.04
Date:	5/8/2009
Field Crew:	A. French, K. O'Briant

Station	Elevation
0.0	193.34
0.9	193.05
4.4	193.17
9.4	193.14
14.2	193.05
15.0	192.95
16.2	192.59
17.4	192.26
18.1	192.05
18.9	191.96
19.8	191.88
20.3	192.28
21.1	192.74
21.7	193.02
28.3	193.06
26.1	193.27
43.7	193.52
44.4	193.79

E5

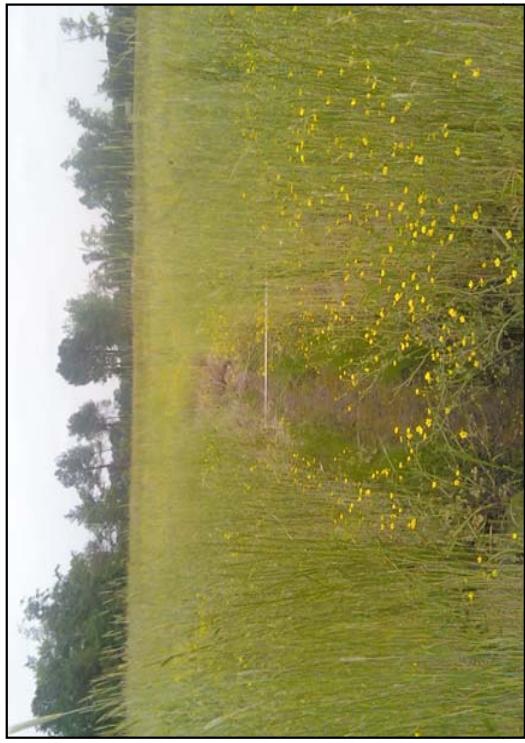
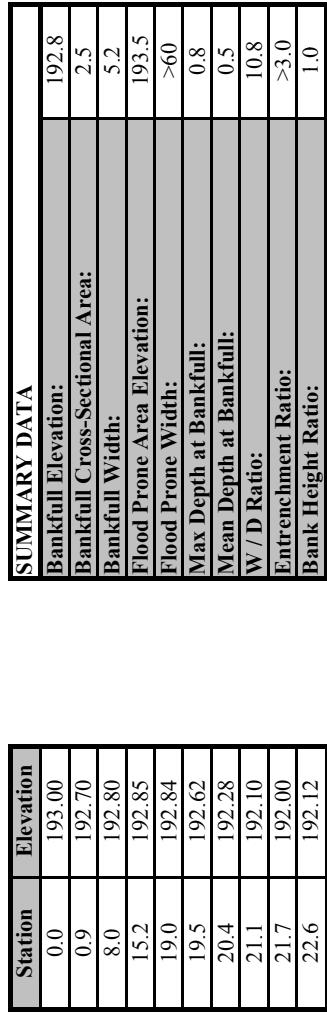
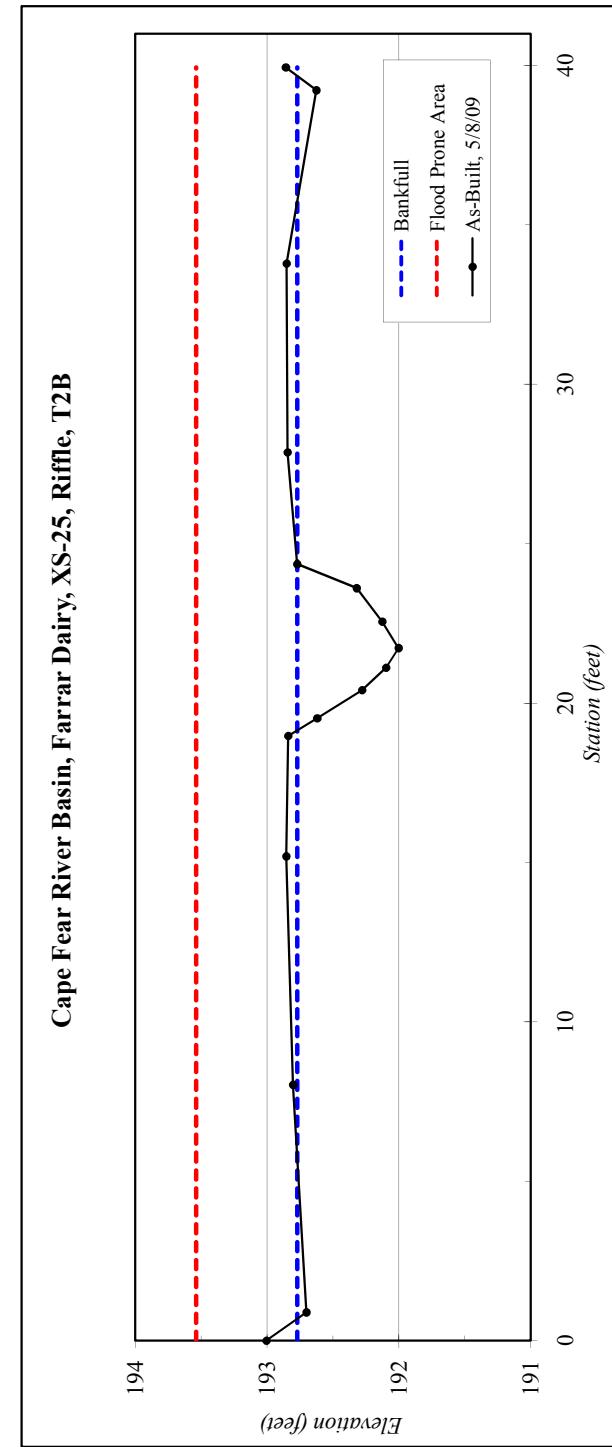
Cape Fear River Basin, Farrar Dairy, XS-25, Riffle, T2B

River Basin:	Cape Fear
Watershed:	Farrar Dairy
XS ID	XS-25, Riffle, T2B
Drainage Area (sq mi):	0.04
Date:	5/8/2009
Field Crew:	A. French, K. O'Briant

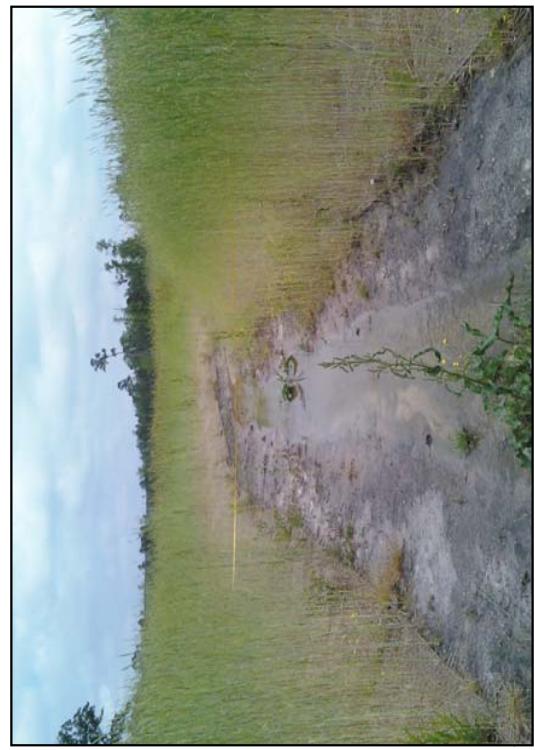
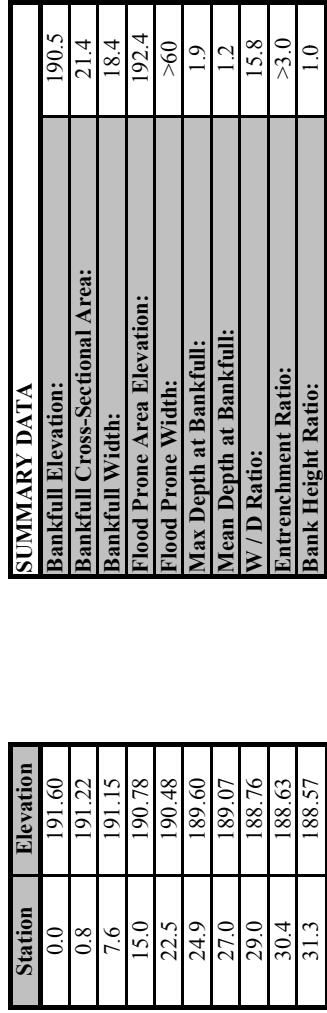
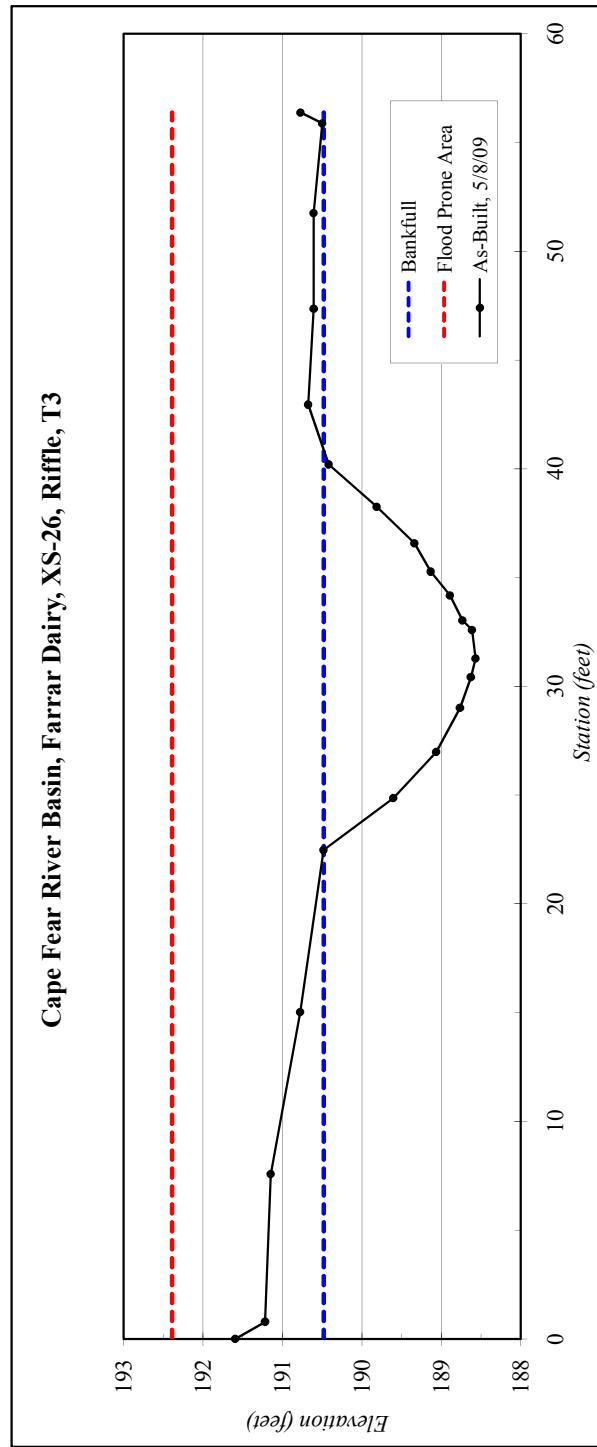
Cape Fear River Basin, Farrar Dairy, XS-26, Riffle, T3

River Basin:	Cape Fear
Watershed:	Farrar Dairy
XS ID	XS-26, Riffle, T3
Drainage Area (sq mi):	0.39
Date:	5/8/2009
Field Crew:	A. French, K. O'Briant

Stream Type C5
