Farrar Dairy Stream and Wetland Restoration Site

Mitigation Plan

Contract # D06002

August 2009

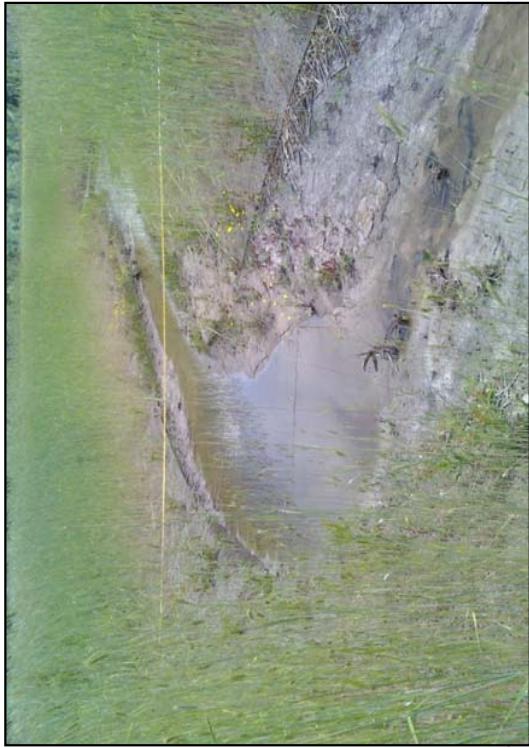
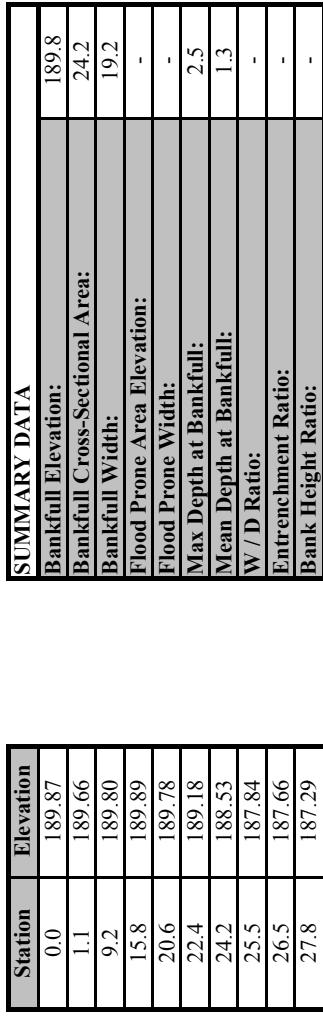
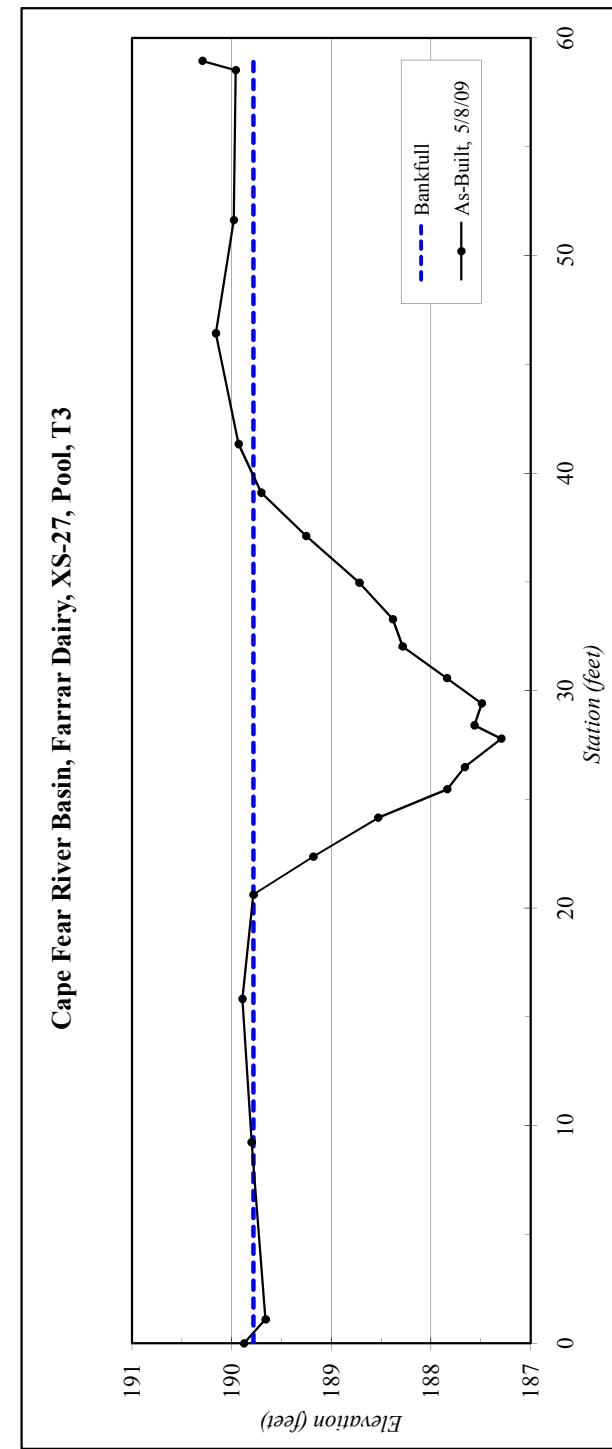
Cape Fear River Basin, Farrar Dairy, XS-27, Pool, T3

River Basin:	Cape Fear
Watershed:	Farrar Dairy
XS ID	XS-27, Pool, T3
Drainage Area (sq mi):	0.39
Date:	5/8/2009
Field Crew:	A. French, K. O'Briant

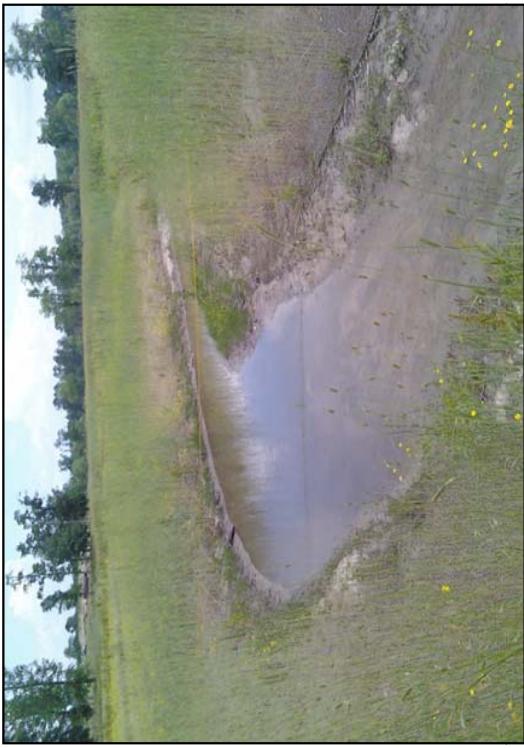
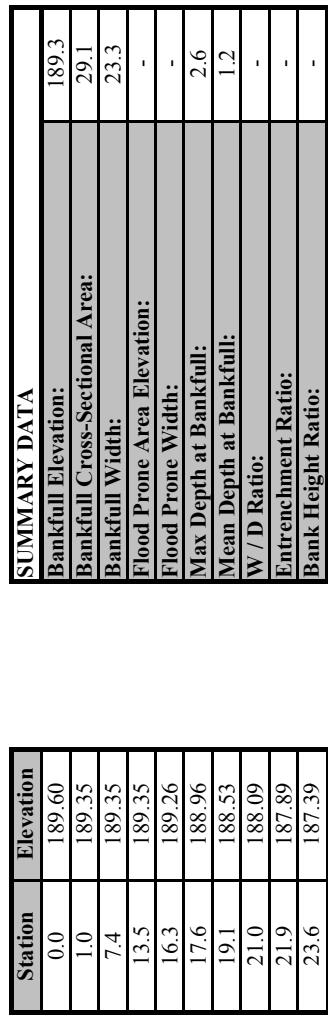
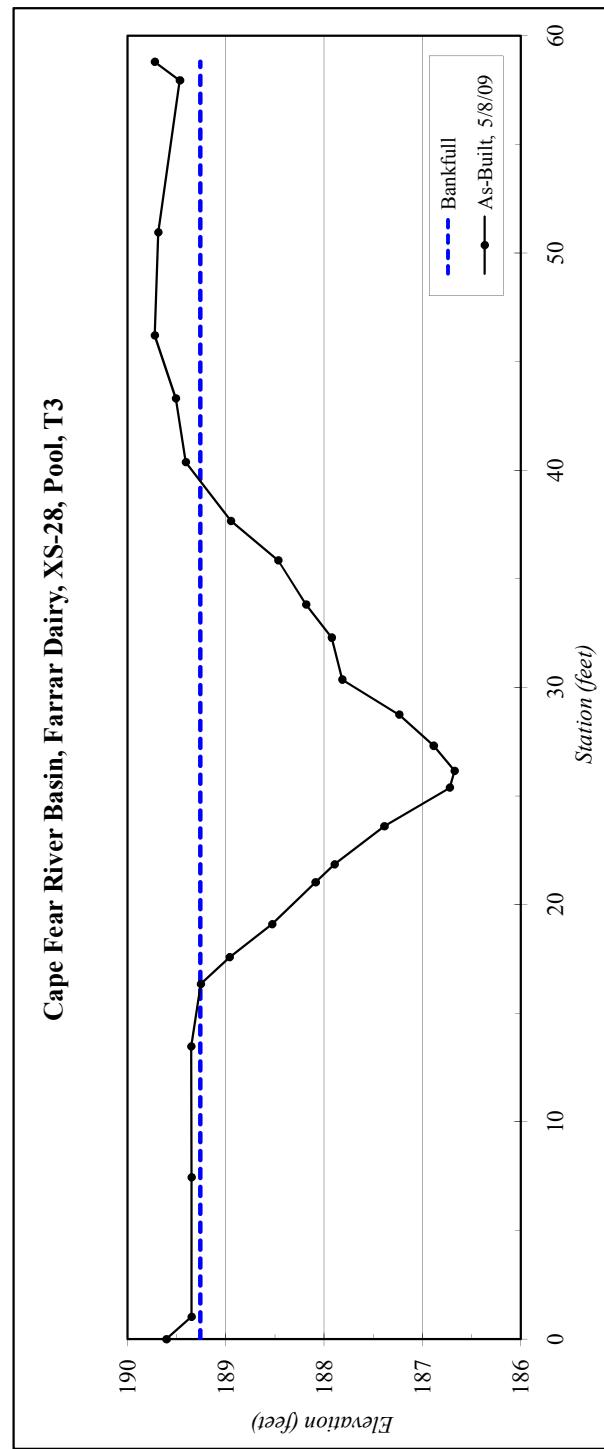
River Basin:	Cape Fear
Watershed:	Farrar Dairy
XS ID	XS-28, Pool, T3
Drainage Area (sq mi):	0.39
Date:	5/8/2009
Field Crew:	A. French, K. O'Briant

Stream Type: C5

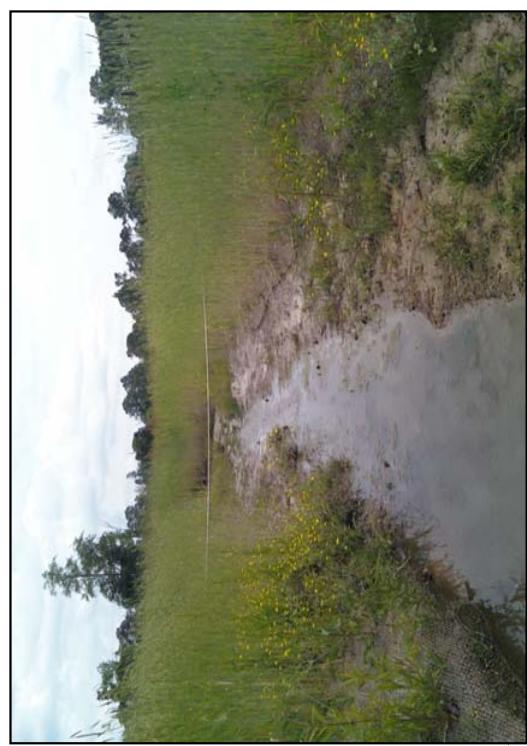
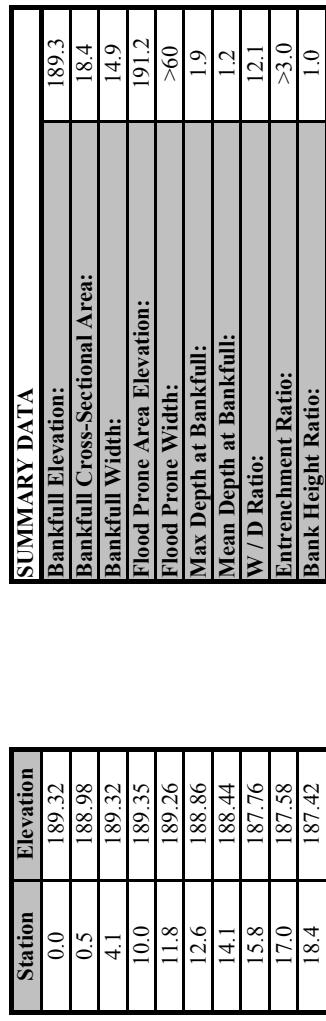
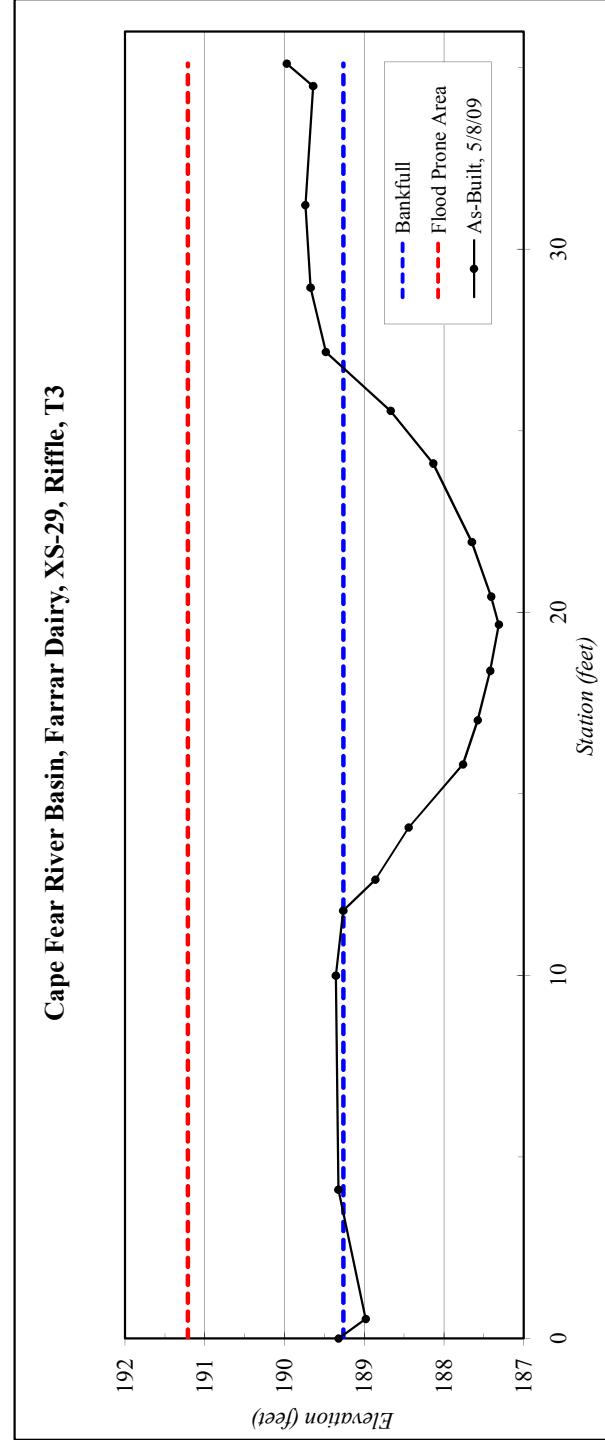
Cape Fear River Basin, Farrar Dairy, XS-29, Riffle, T3

River Basin:	Cape Fear
Watershed:	Farrar Dairy
XS ID	XS-29, Riffle, T3
Drainage Area (sq mi):	0.39
Date:	5/8/2009
Field Crew:	A. French, K. O'Briant

Stream Type C5

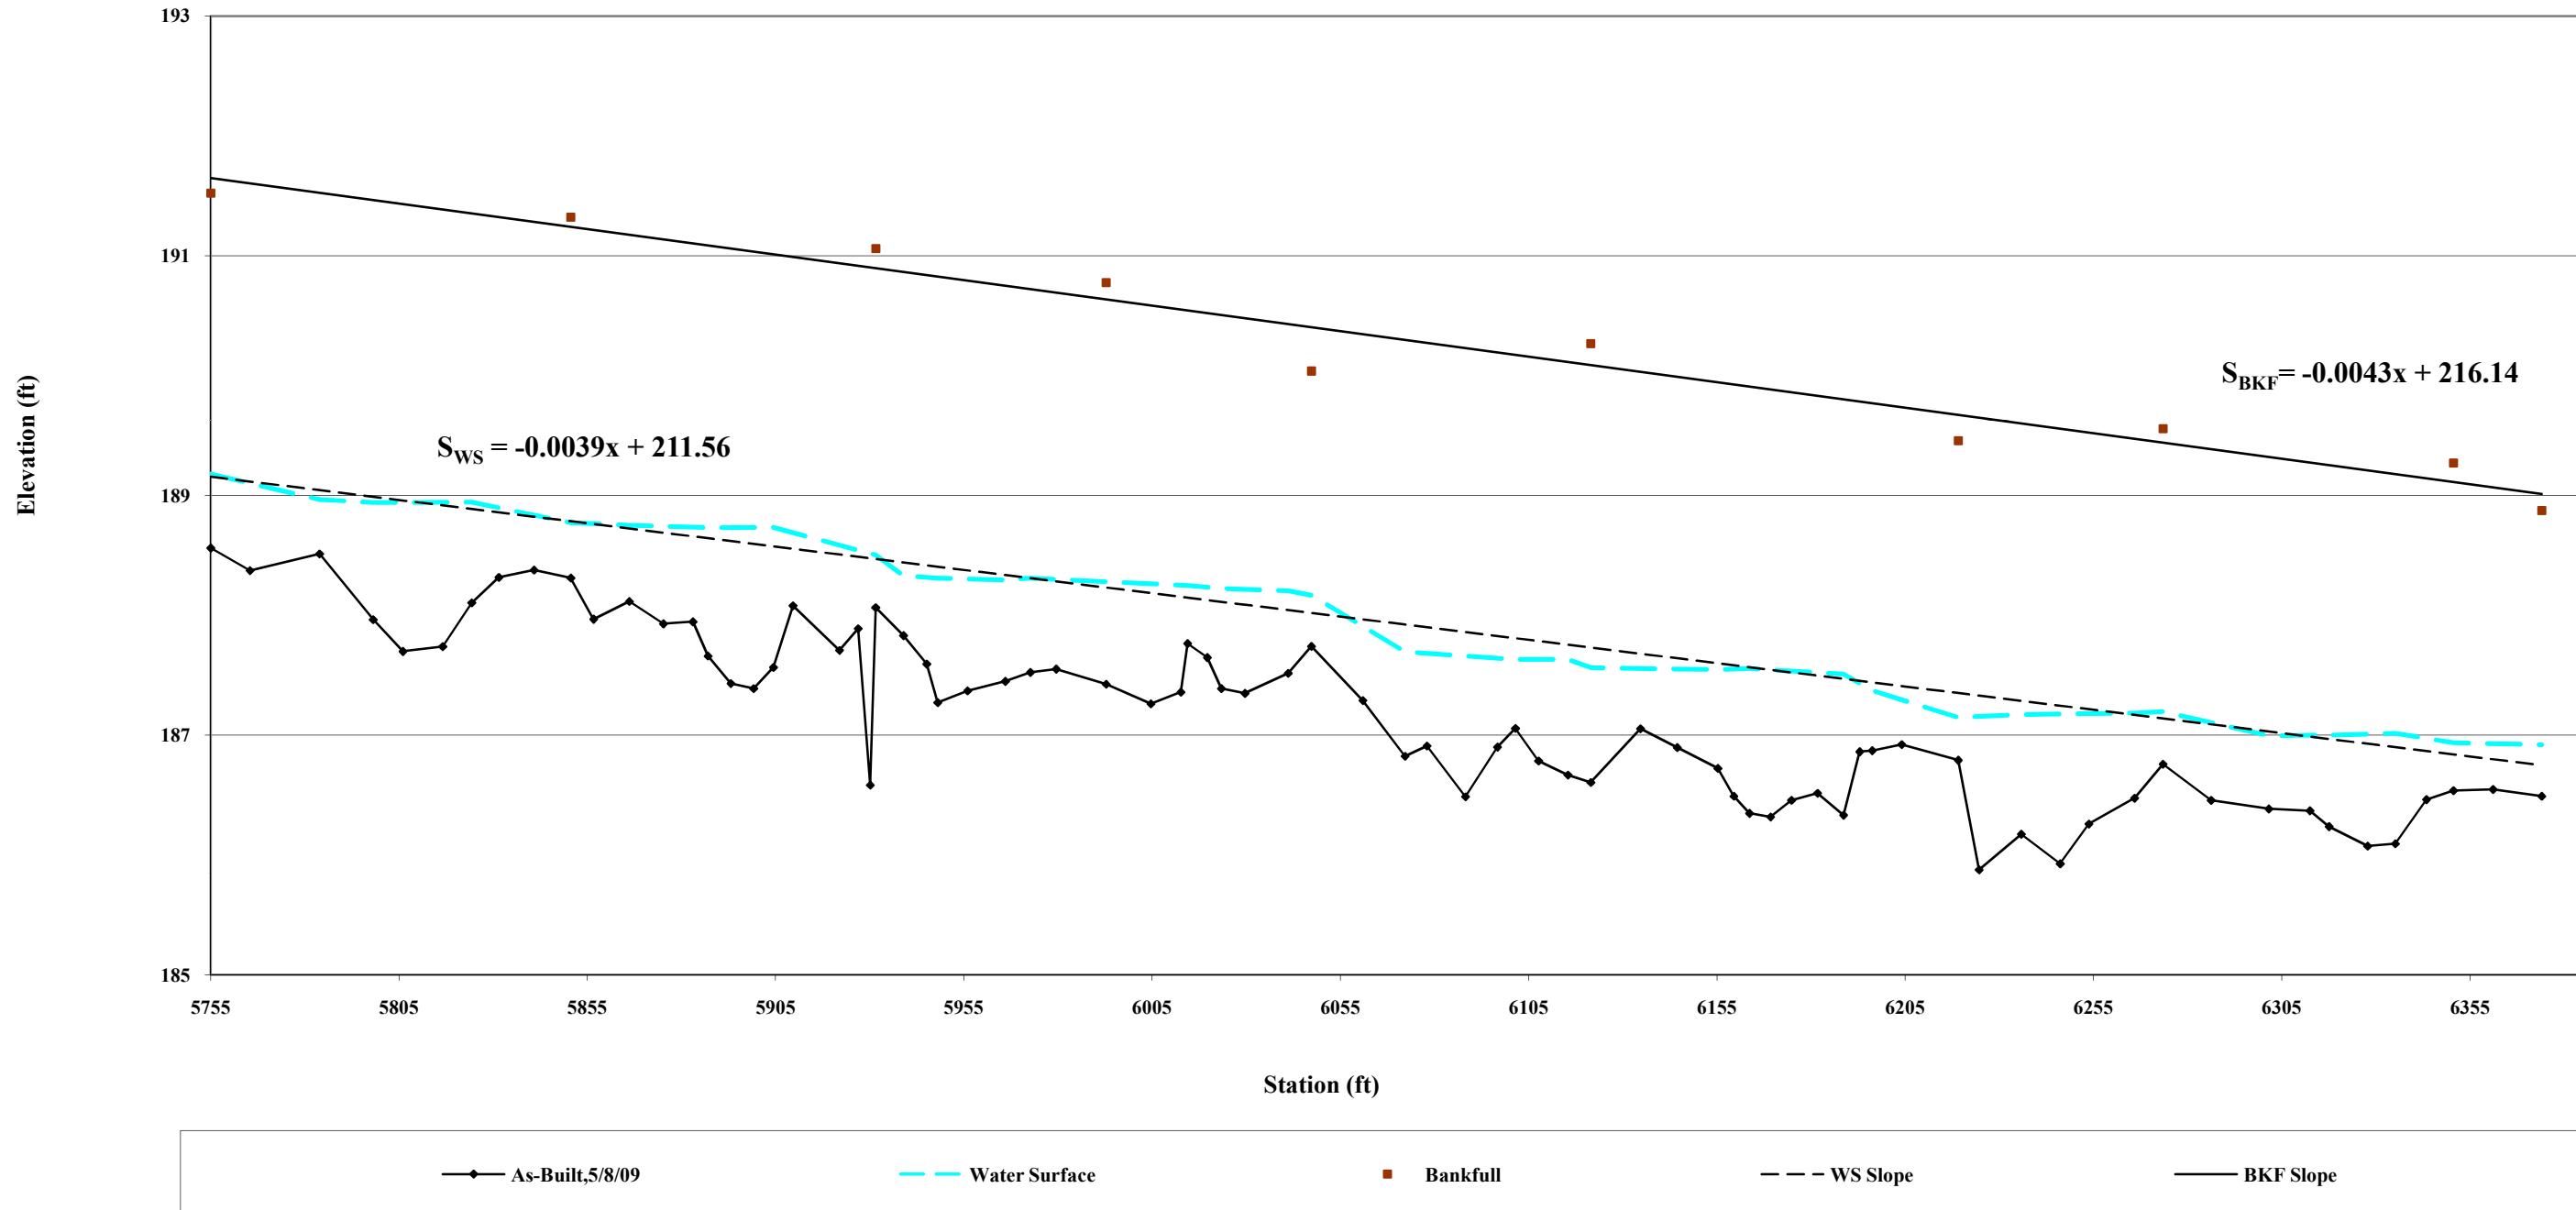
Farrar Dairy Longitudinal Profile
NPAC-2, As-Built
Stations 57+55 - 63+77

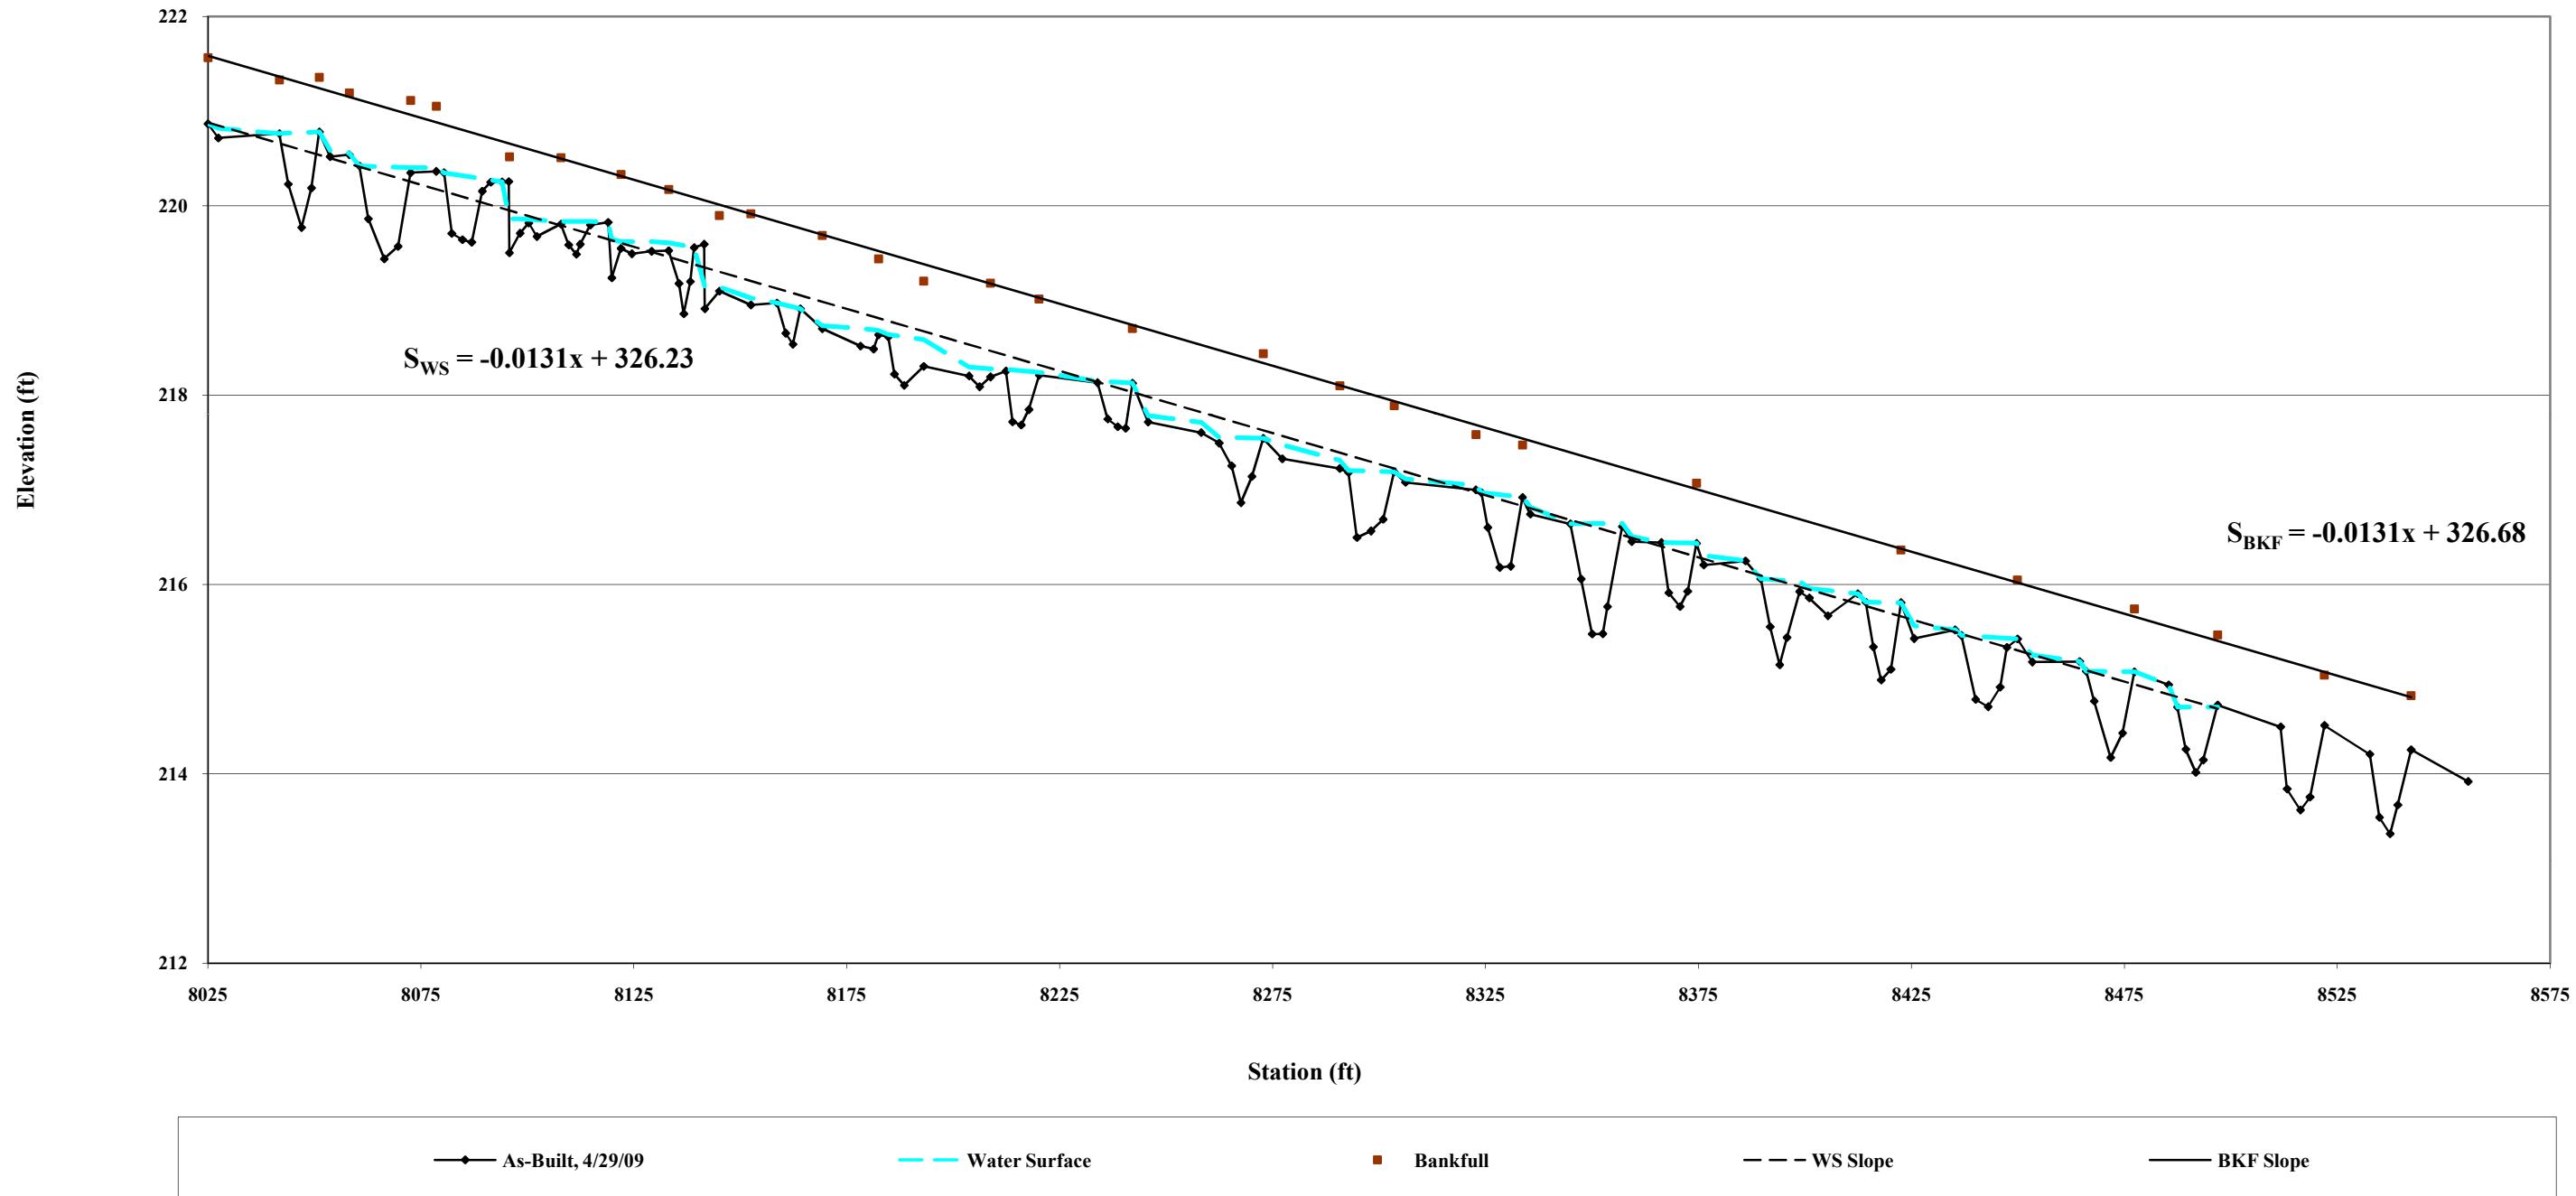
Farrar Dairy Longitudinal Profile
Tributary 1.1, As-Built
Stations 80+25 - 85+75

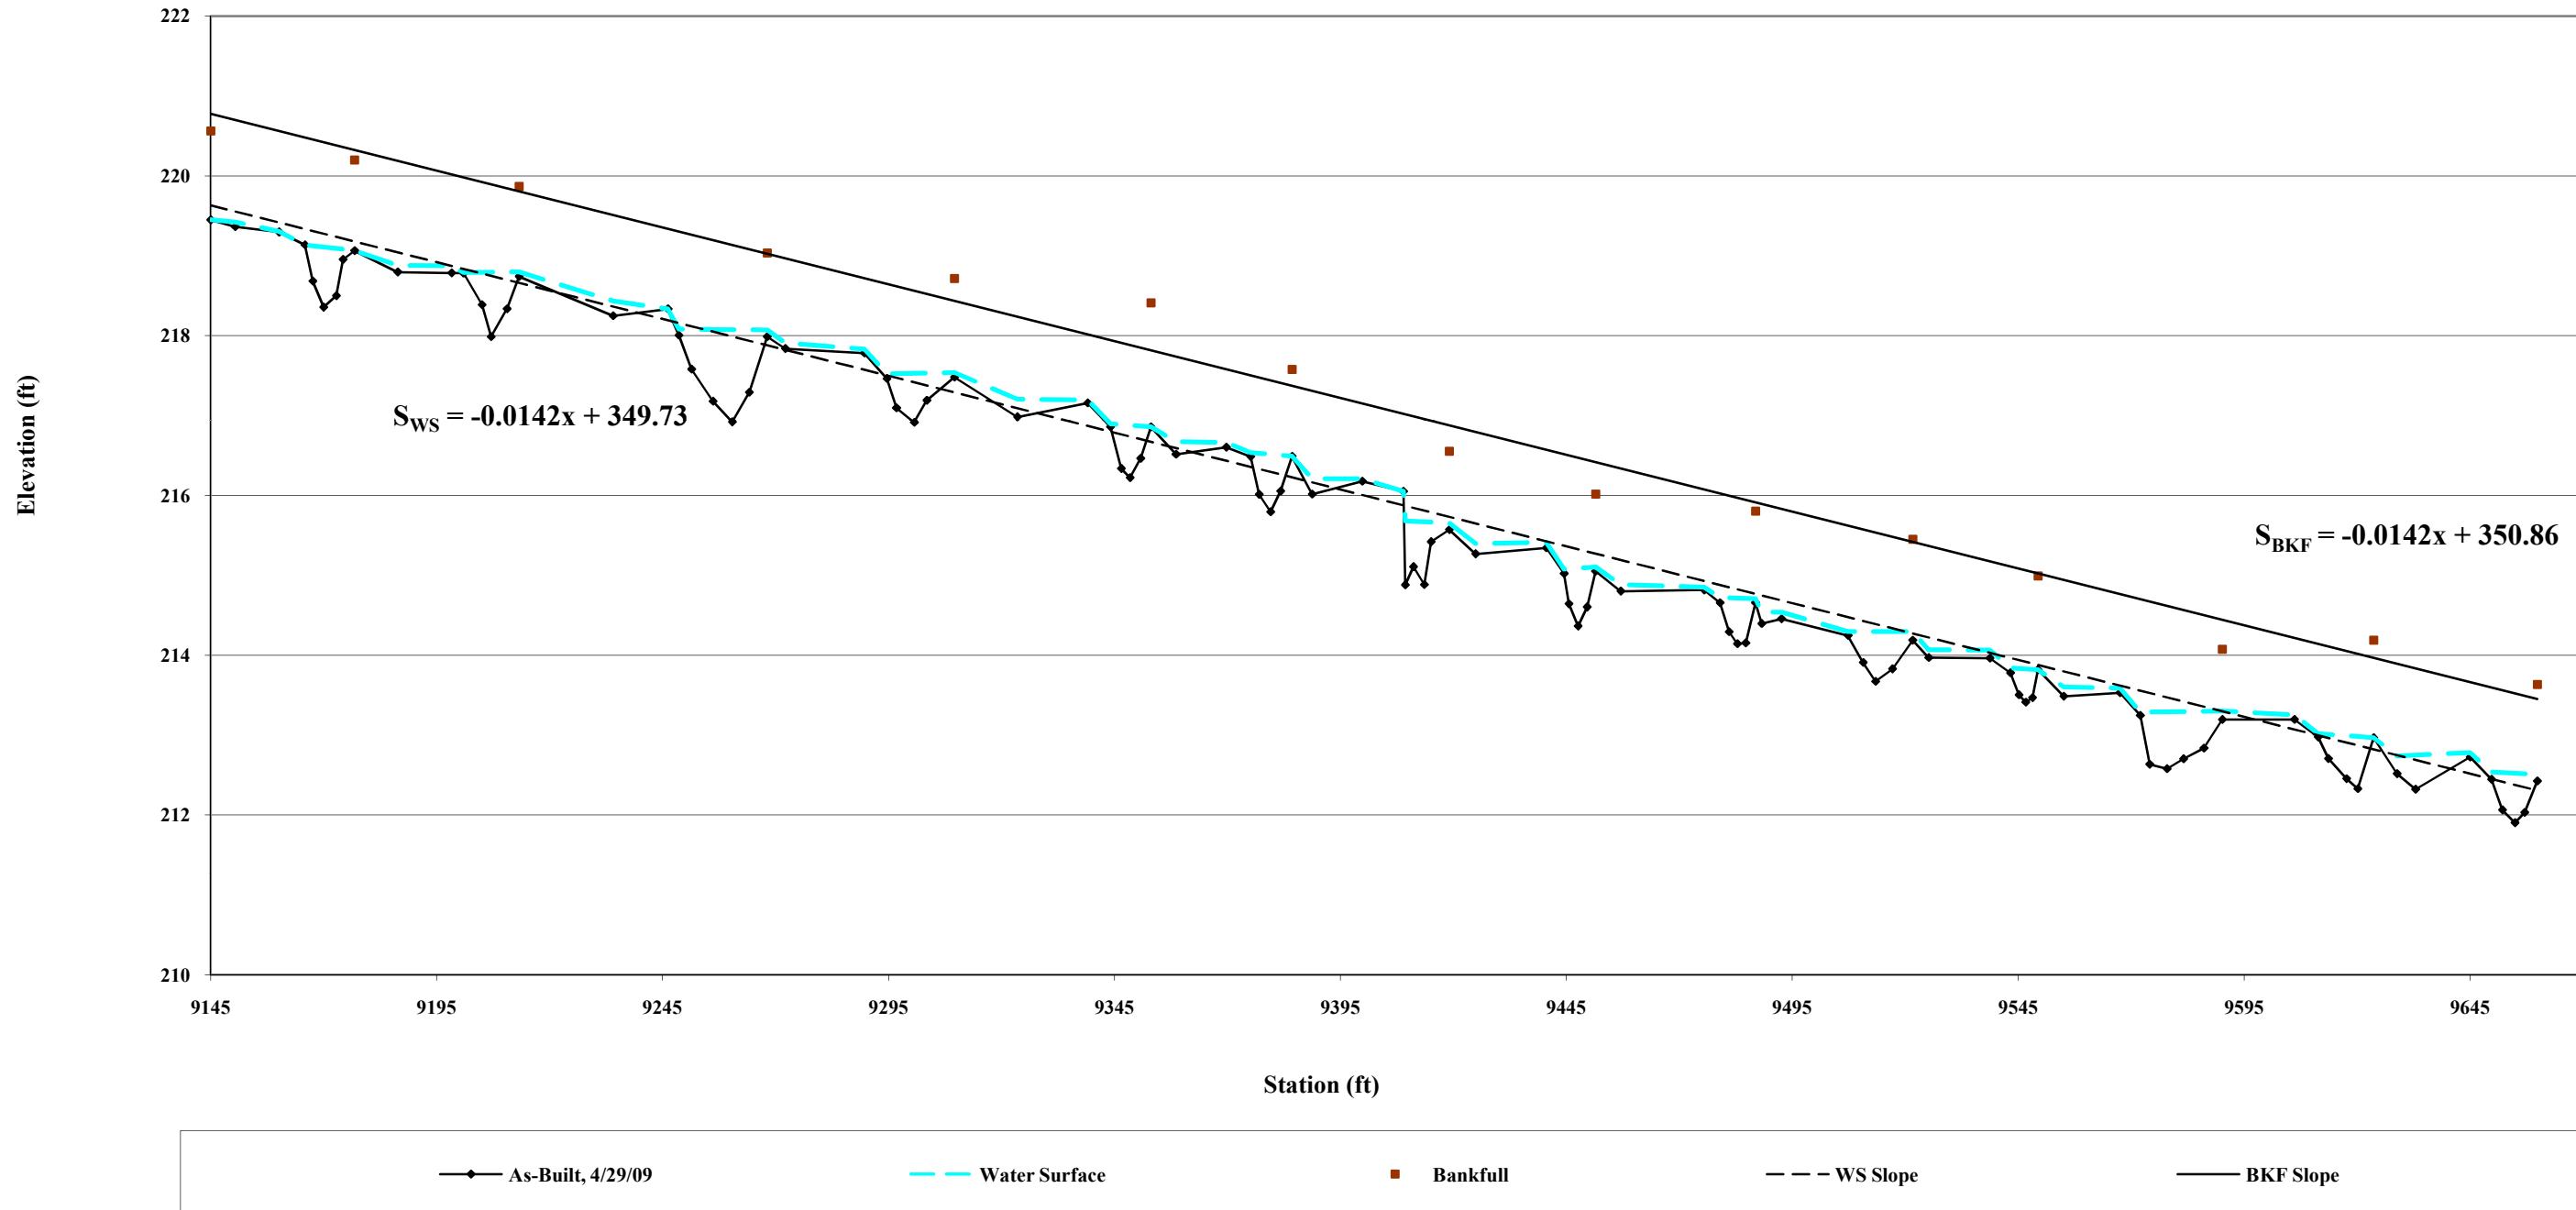
Farrar Dairy Longitudinal Profile
Tributary 1.2, As-Built
Stations 91+45 - 96+70

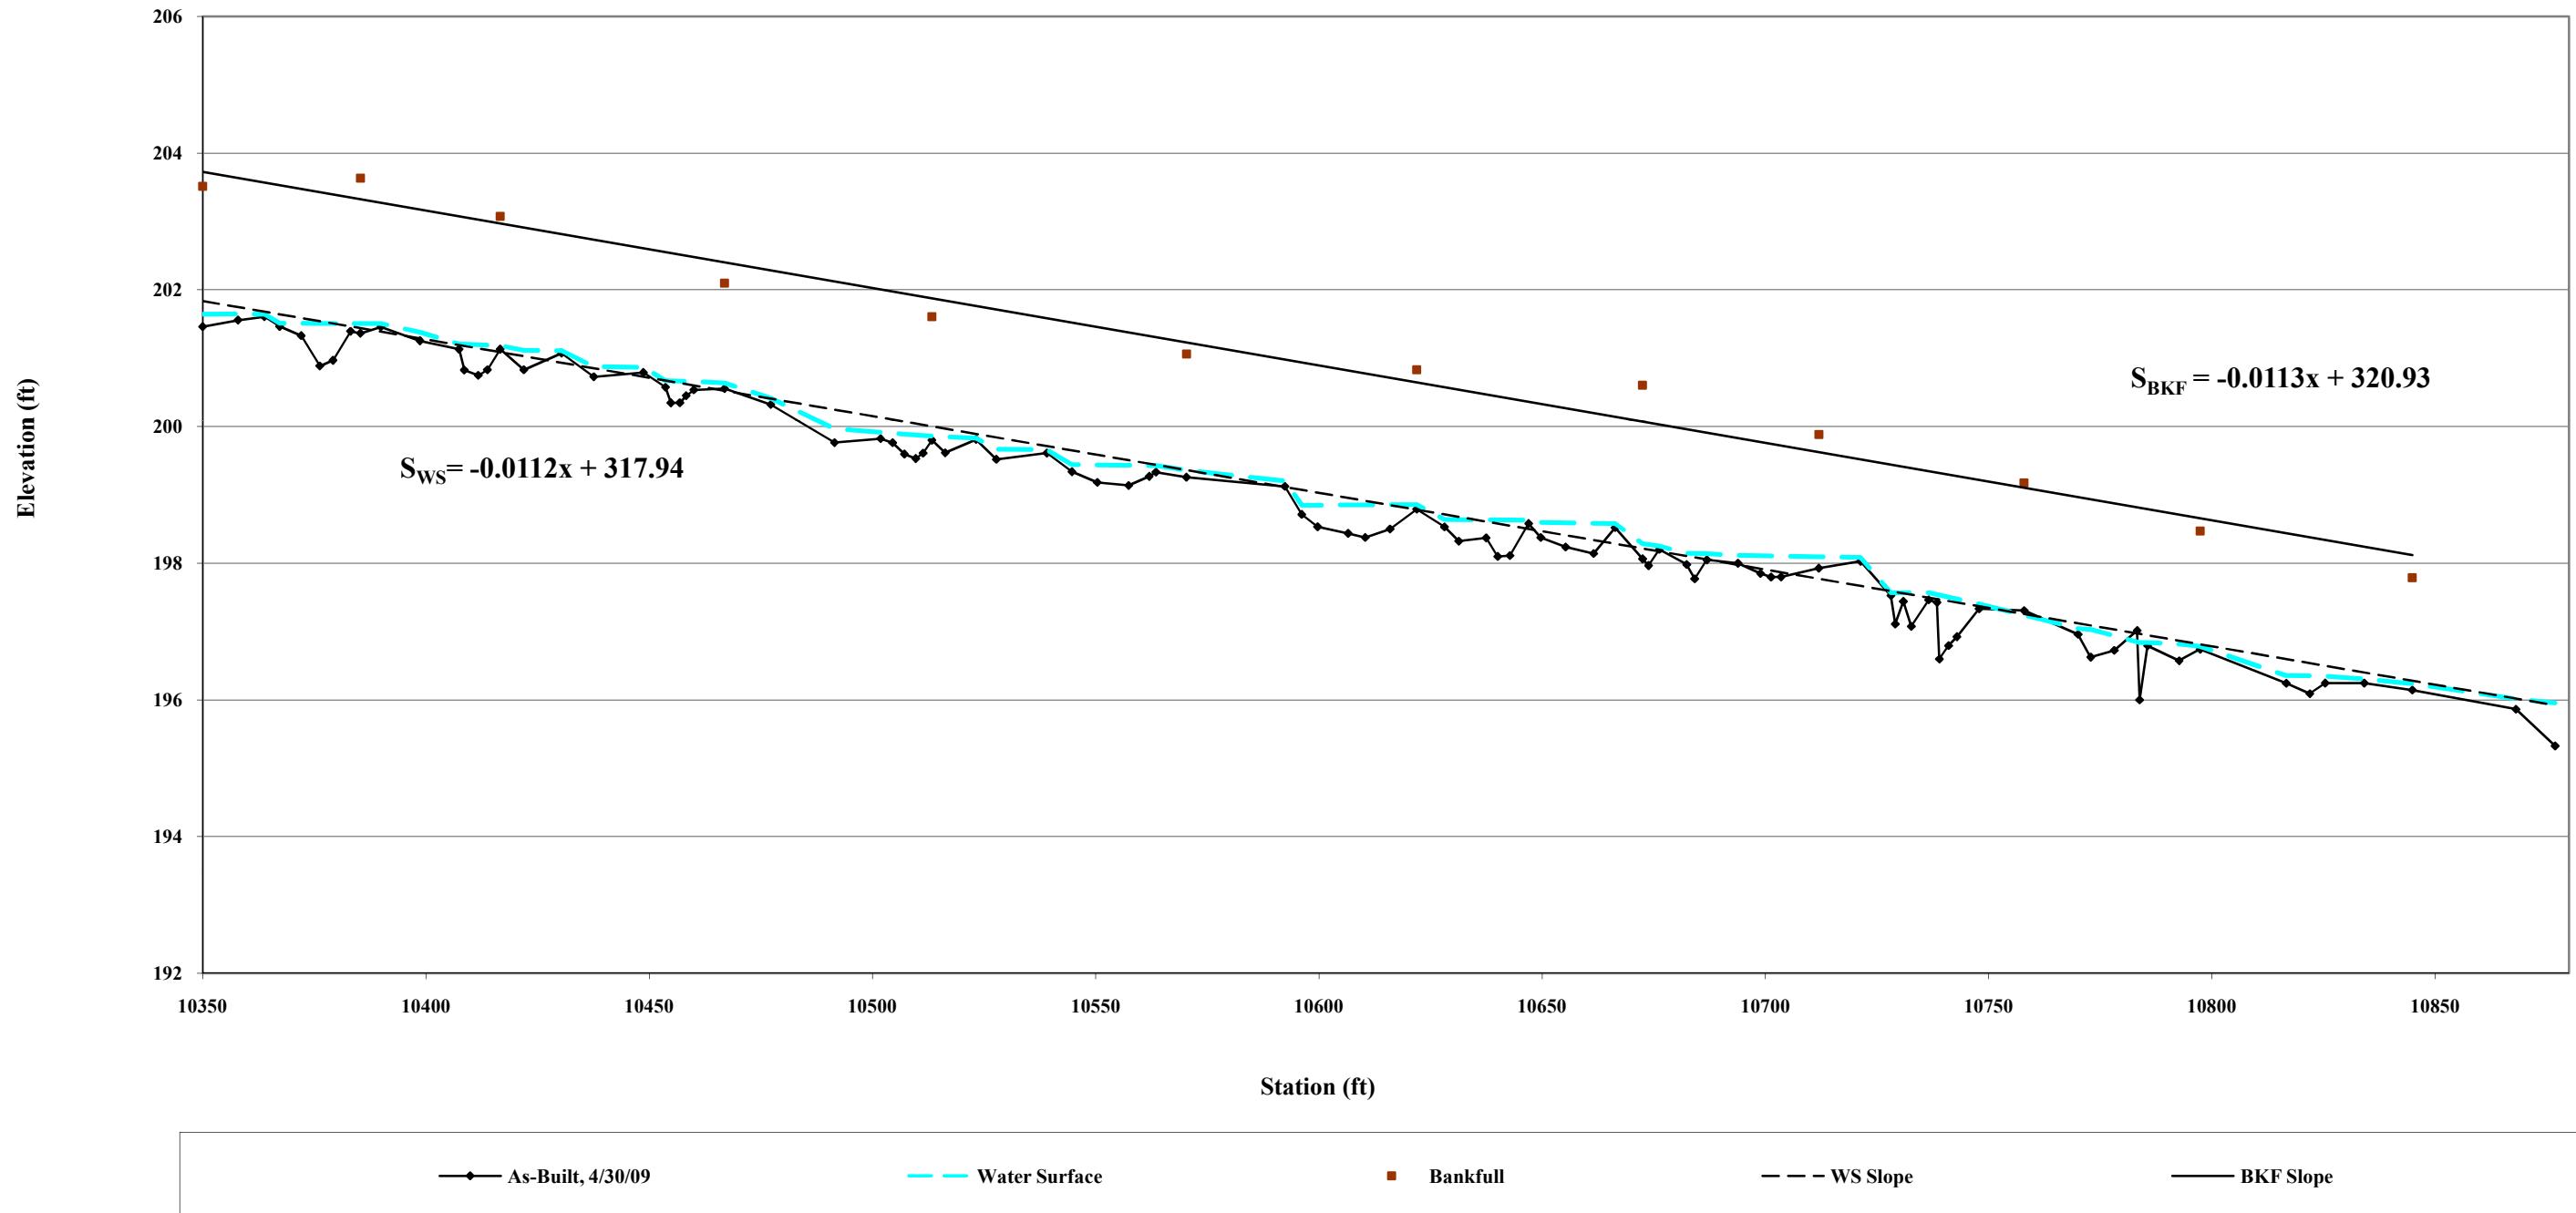
**Longitudinal Profile
Tributary 1, As-Built
Stations 103+50 - 108+77**

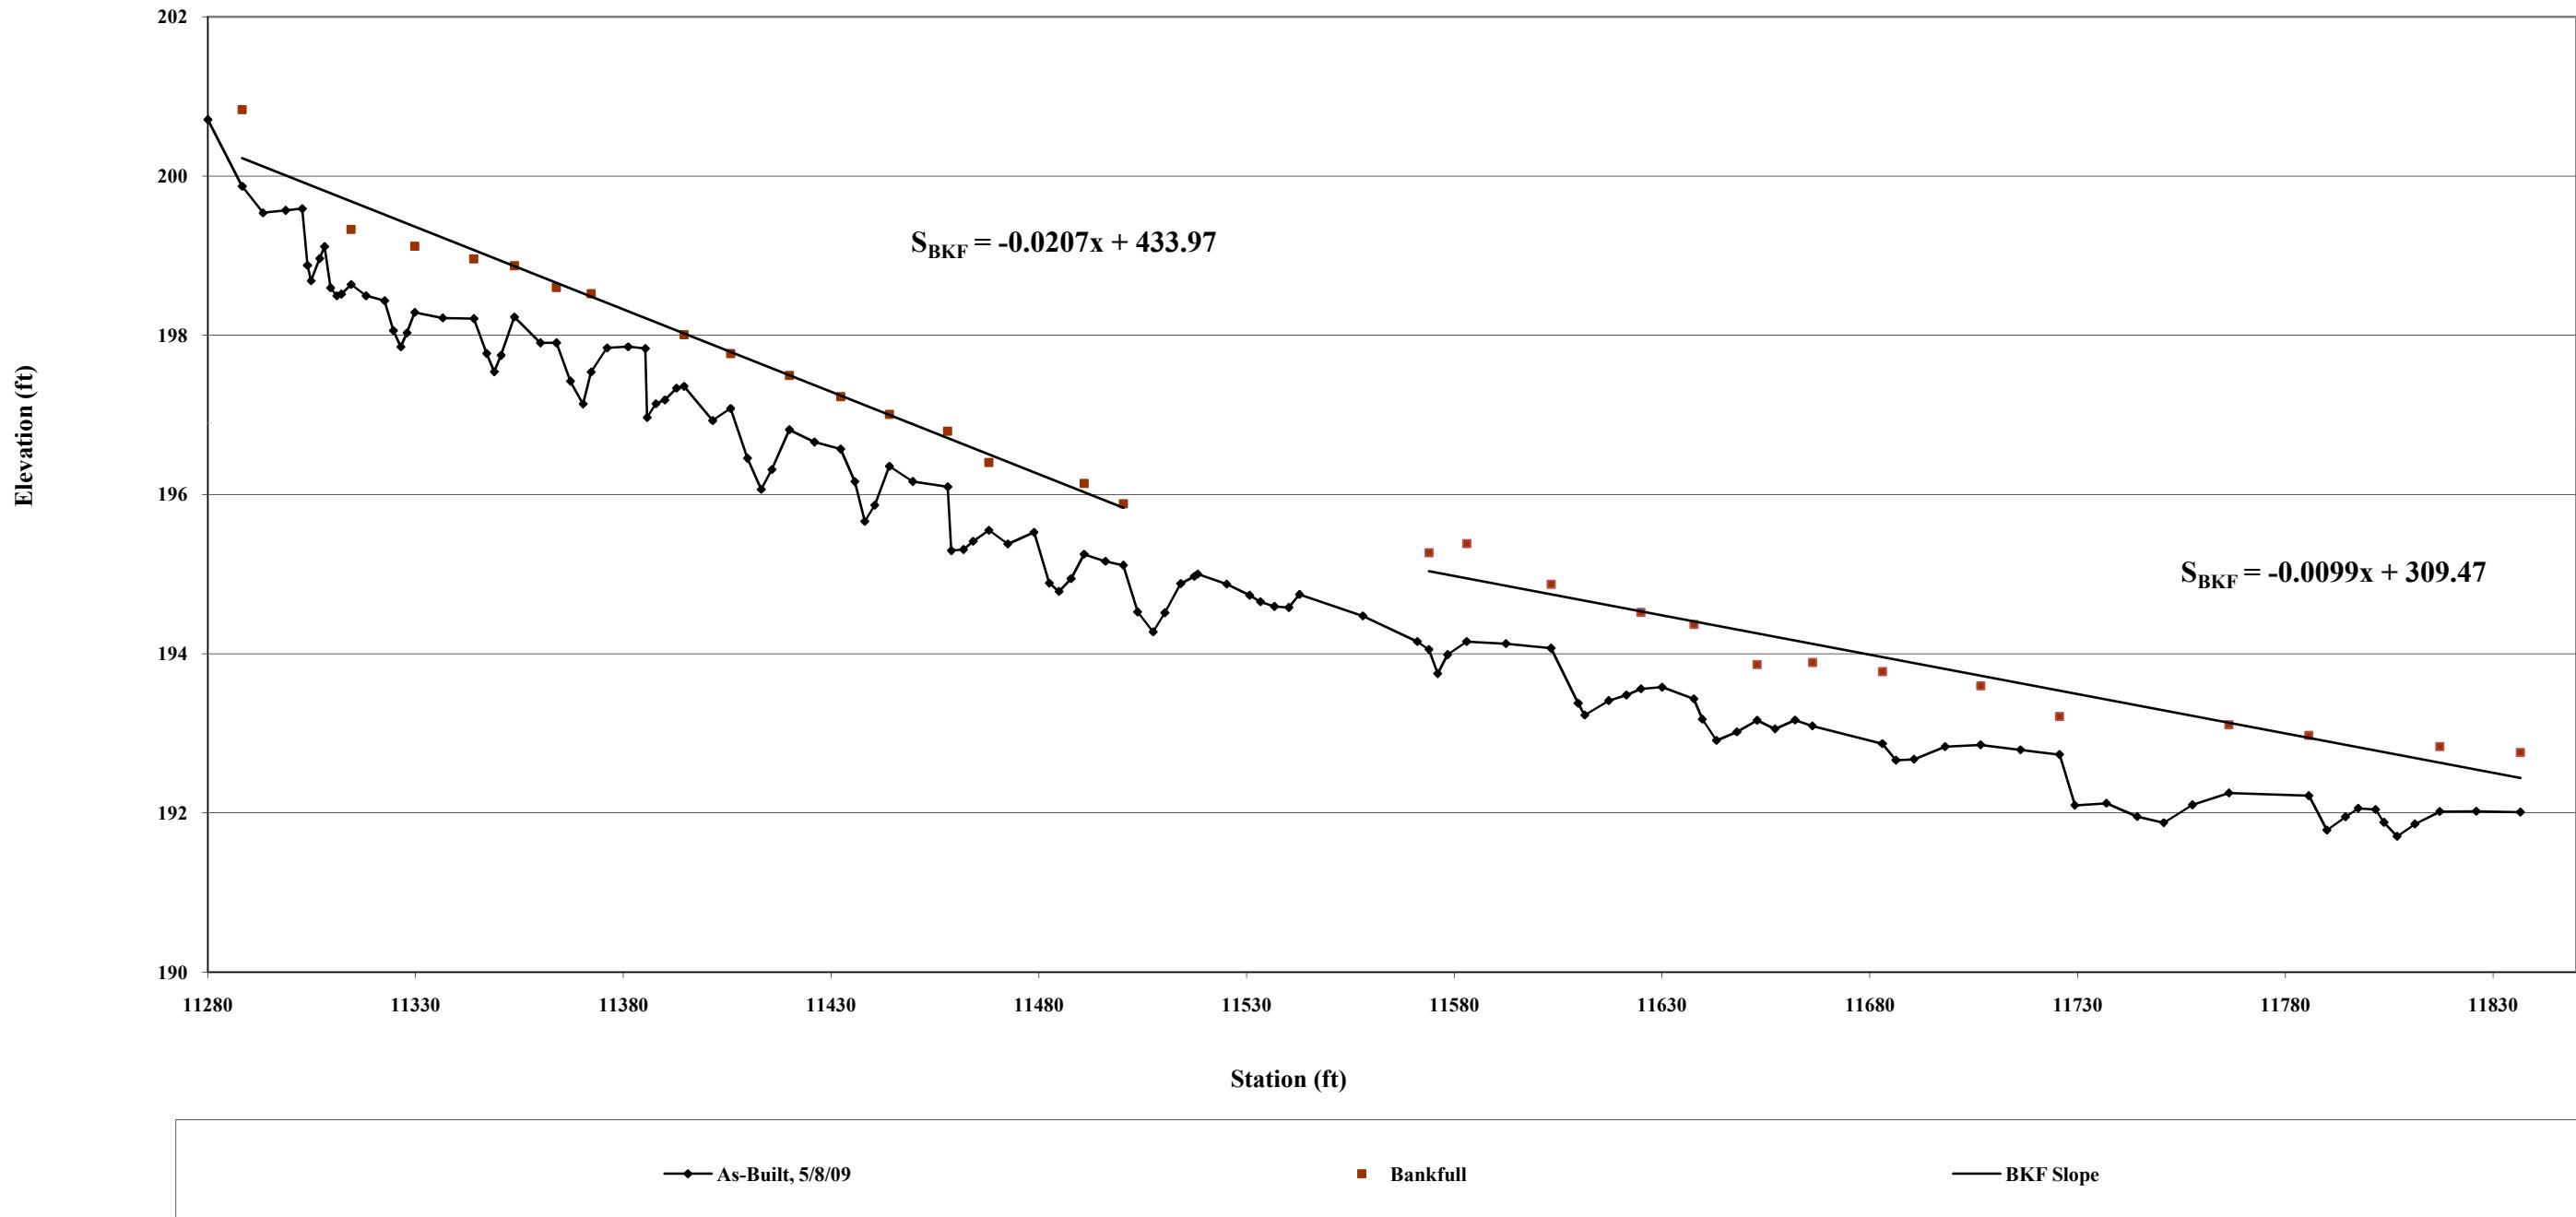
**Longitudinal Profile
Tributary 2, As-Built
Stations 112+80 - 118+37**

*No WS due to no flow in channel during survey.
