Farrar Dairy Stream and Wetland Restoration Site

Mitigation Plan

Contract # D06002

August 2009

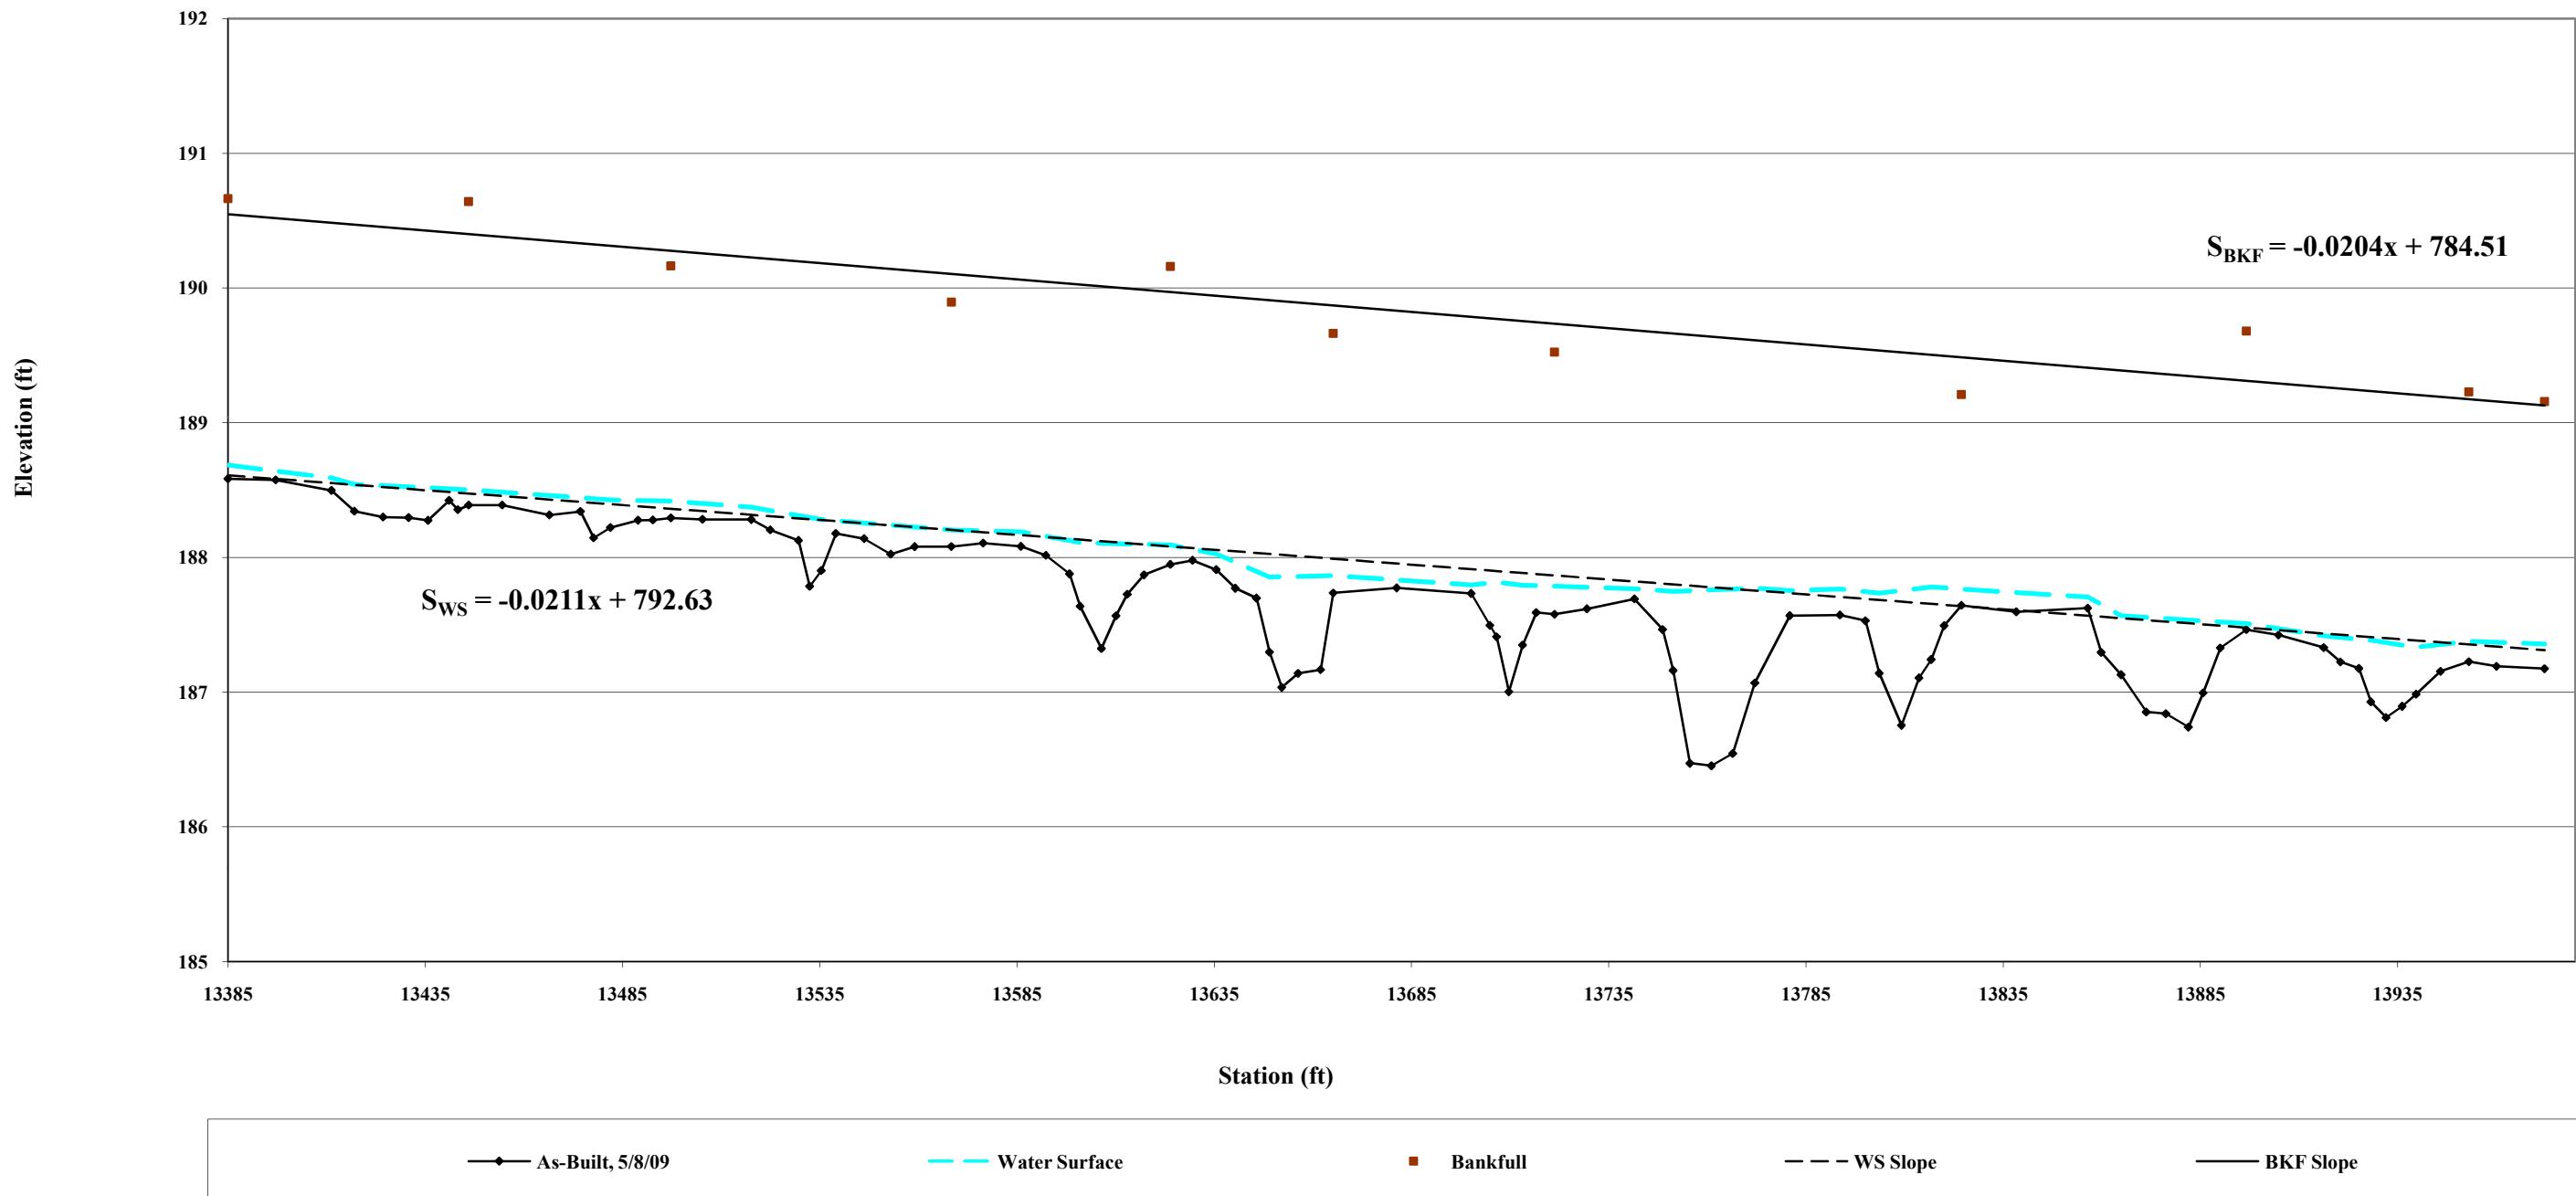
**Longitudinal Profile
Tributary 3, As-Built
Stations 133+85 - 139+73**
