# **Fletcher Stream and Wetland Mitigation Site**

## **Annual Monitoring Report**

**Monitoring Year 1 of 7**

Fletcher Stream and Wetland Mitigation Site

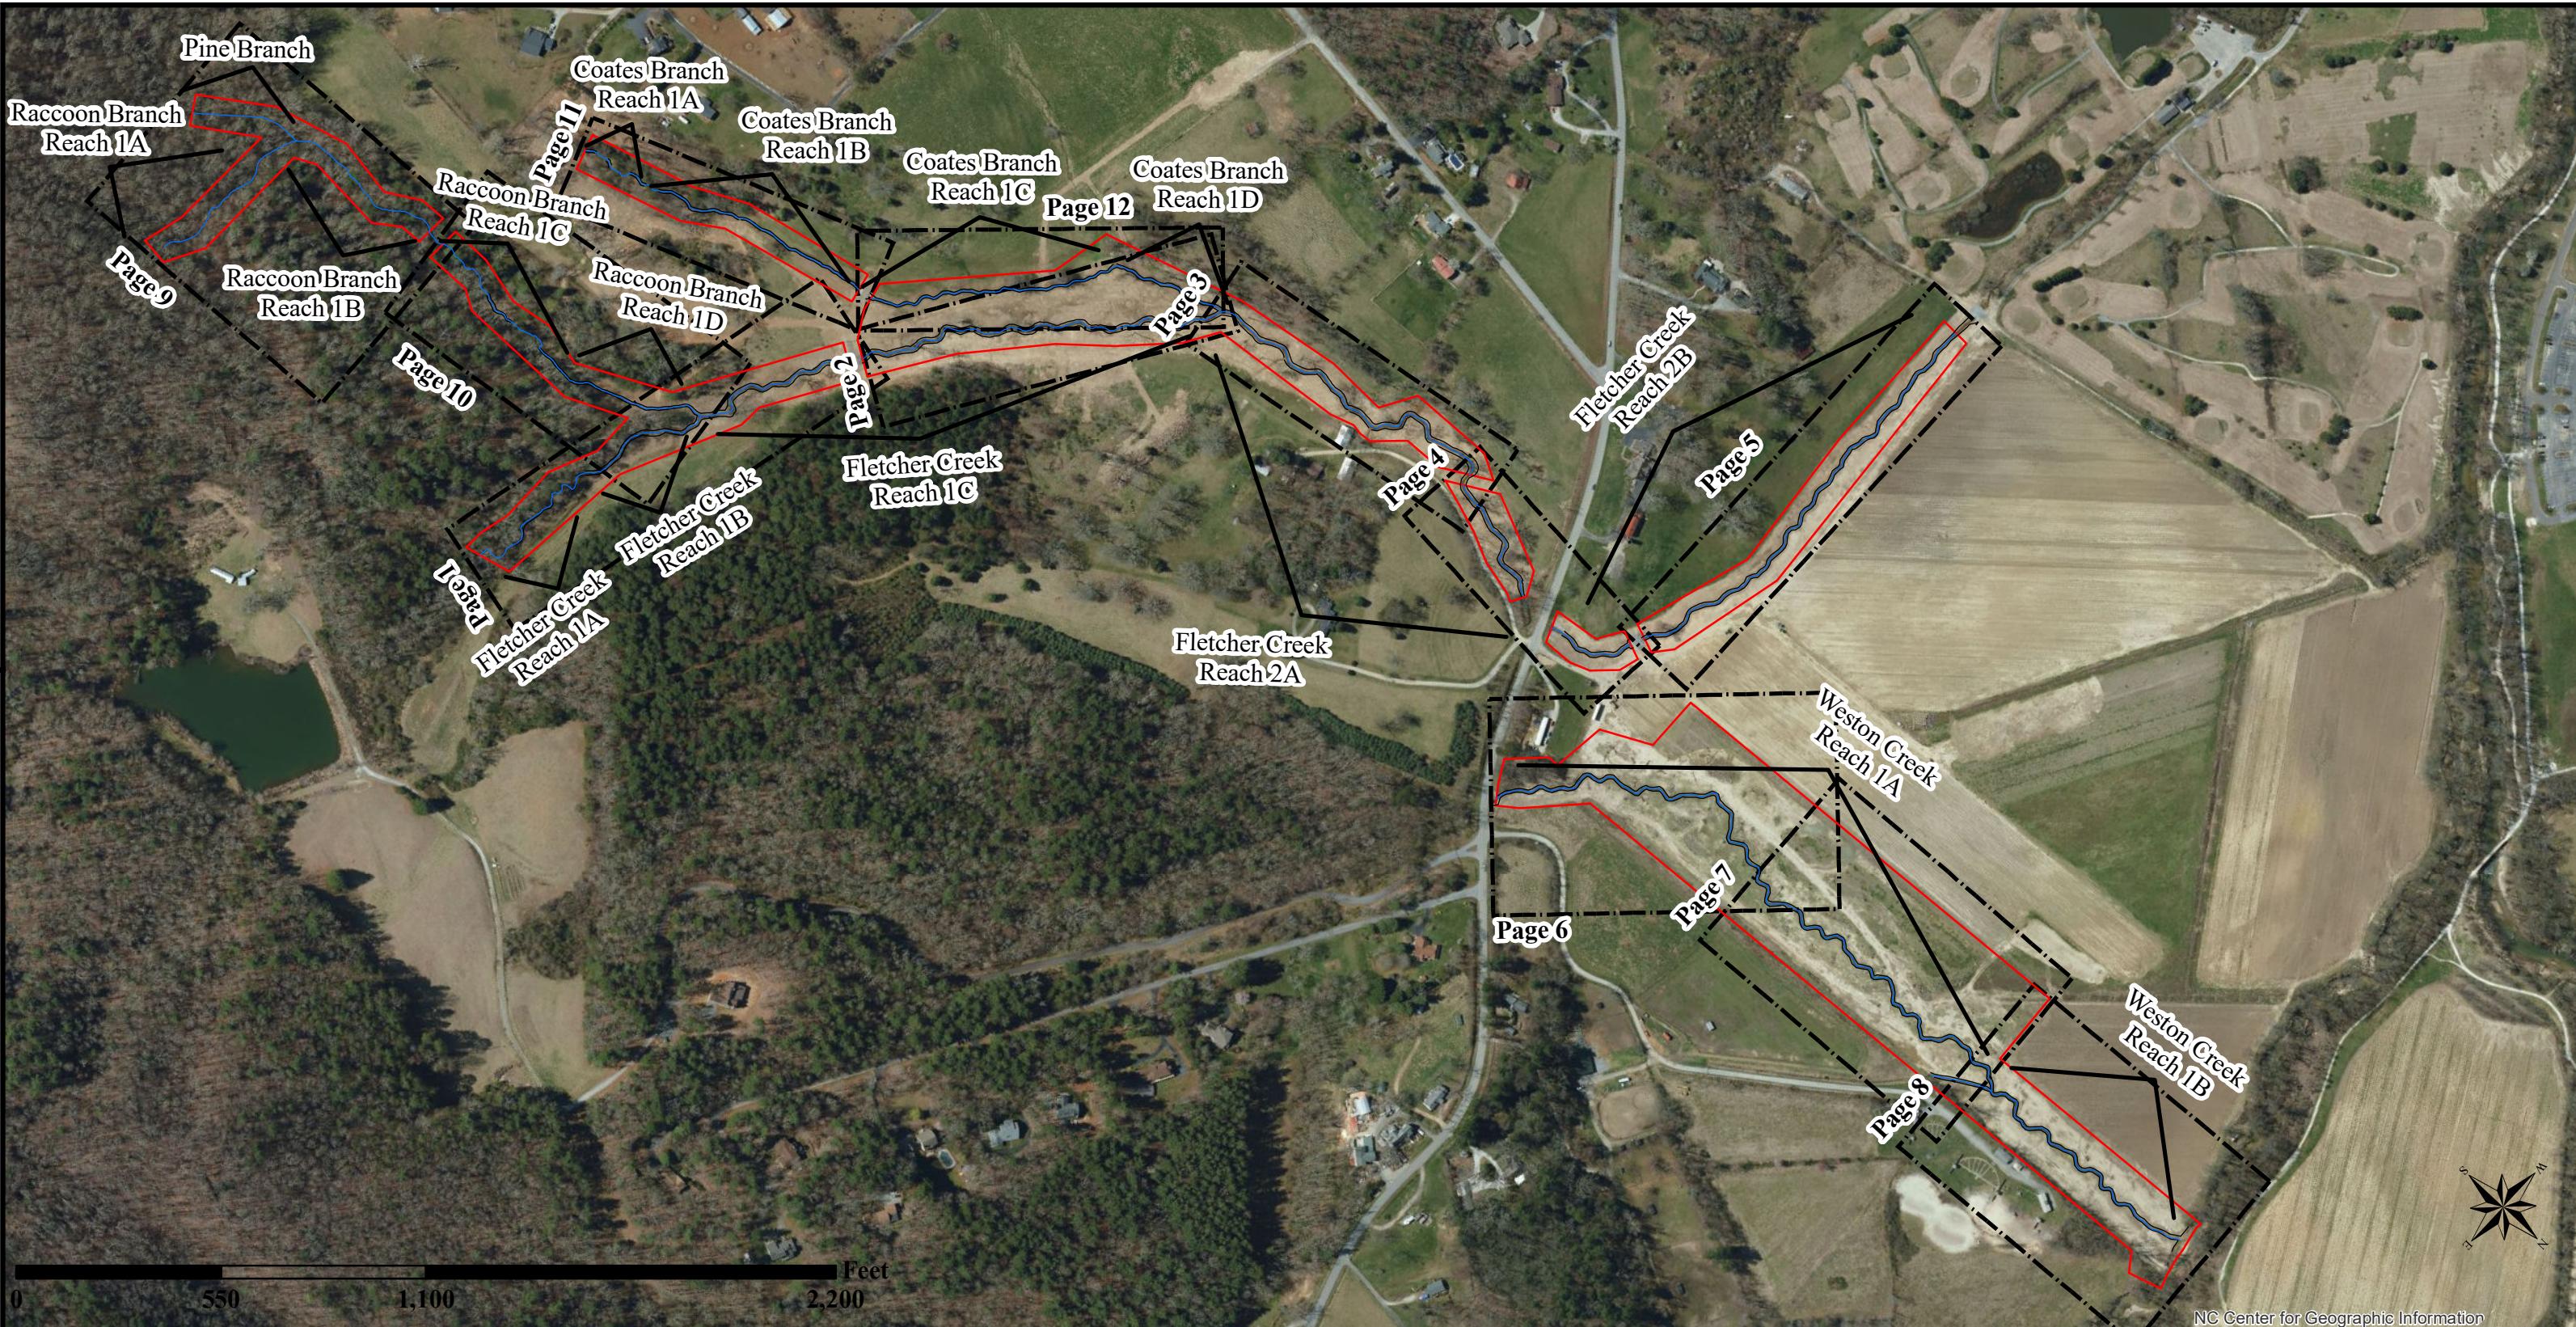
Current Condition Plan View  
Fletcher Mitigation Site  
Monitoring Year 1  
Henderson County, NC  
NCDMS Contract No.: 006997  
NCDMS Project No.: 100004  
December 2020  
Overview

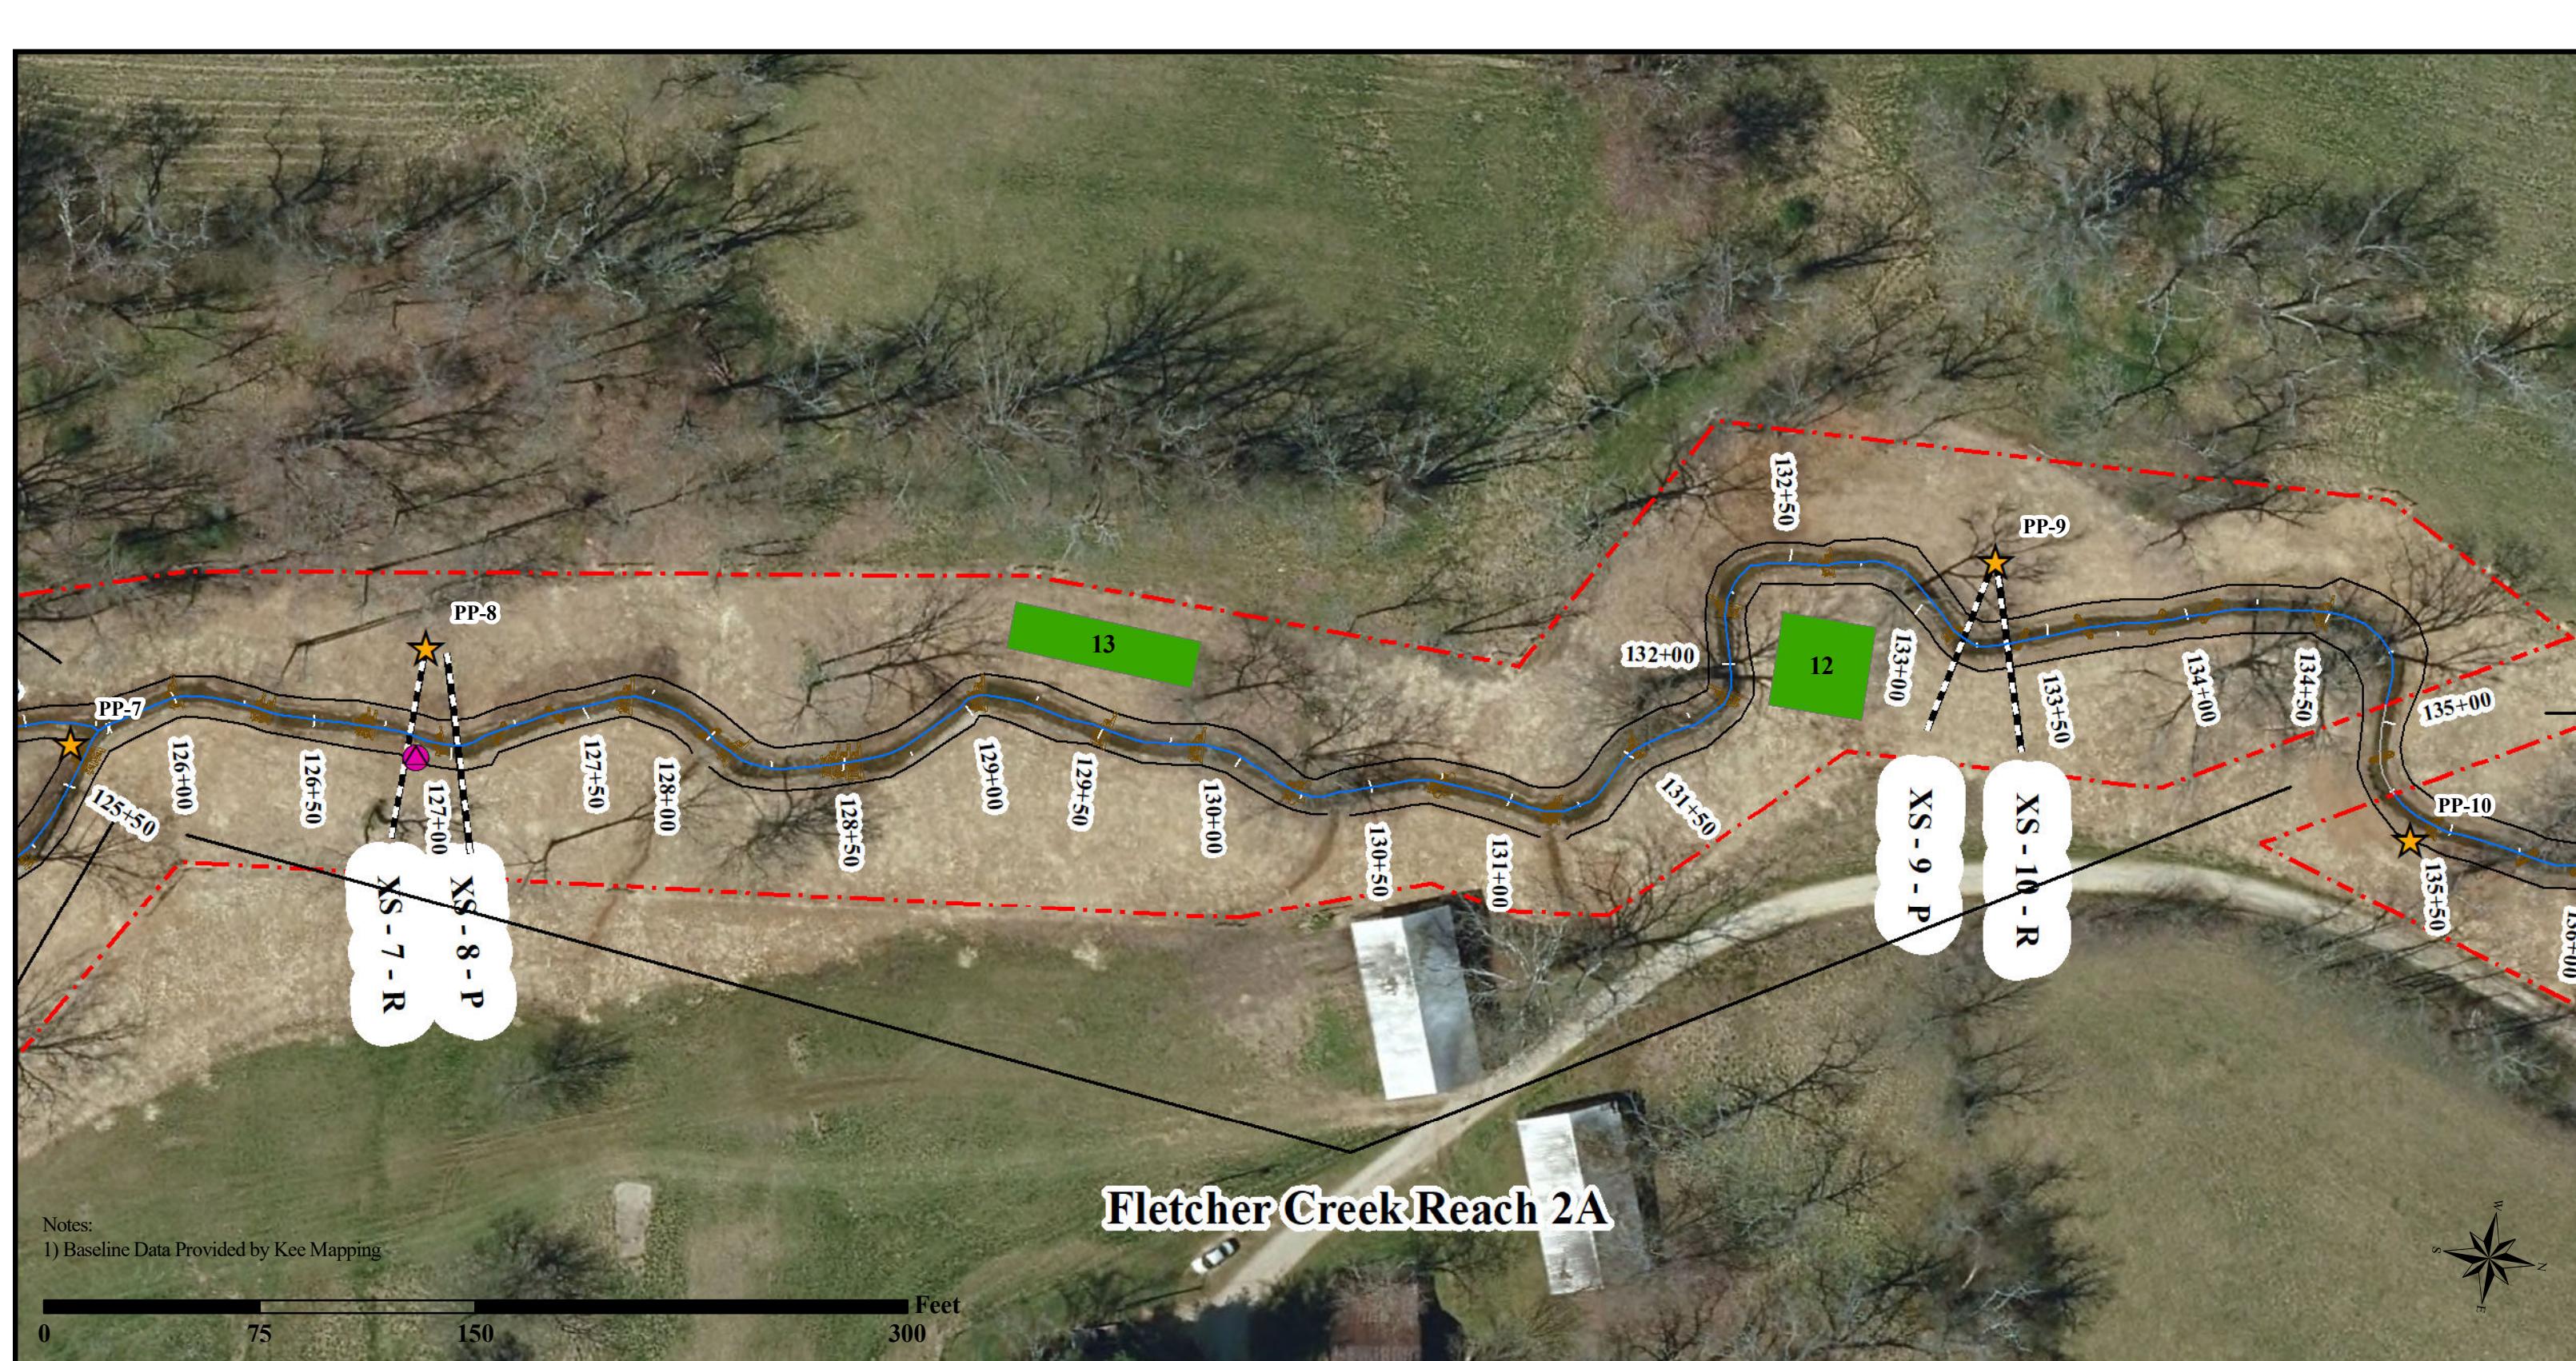
CCPV  
Fletcher Mitigation Site  
Monitoring Year 1  
Henderson County, NC  
NCDMS Contract No.: 006997  
NCDMS Project No.: 100004  
December 2020  
Sheet 3 of 12

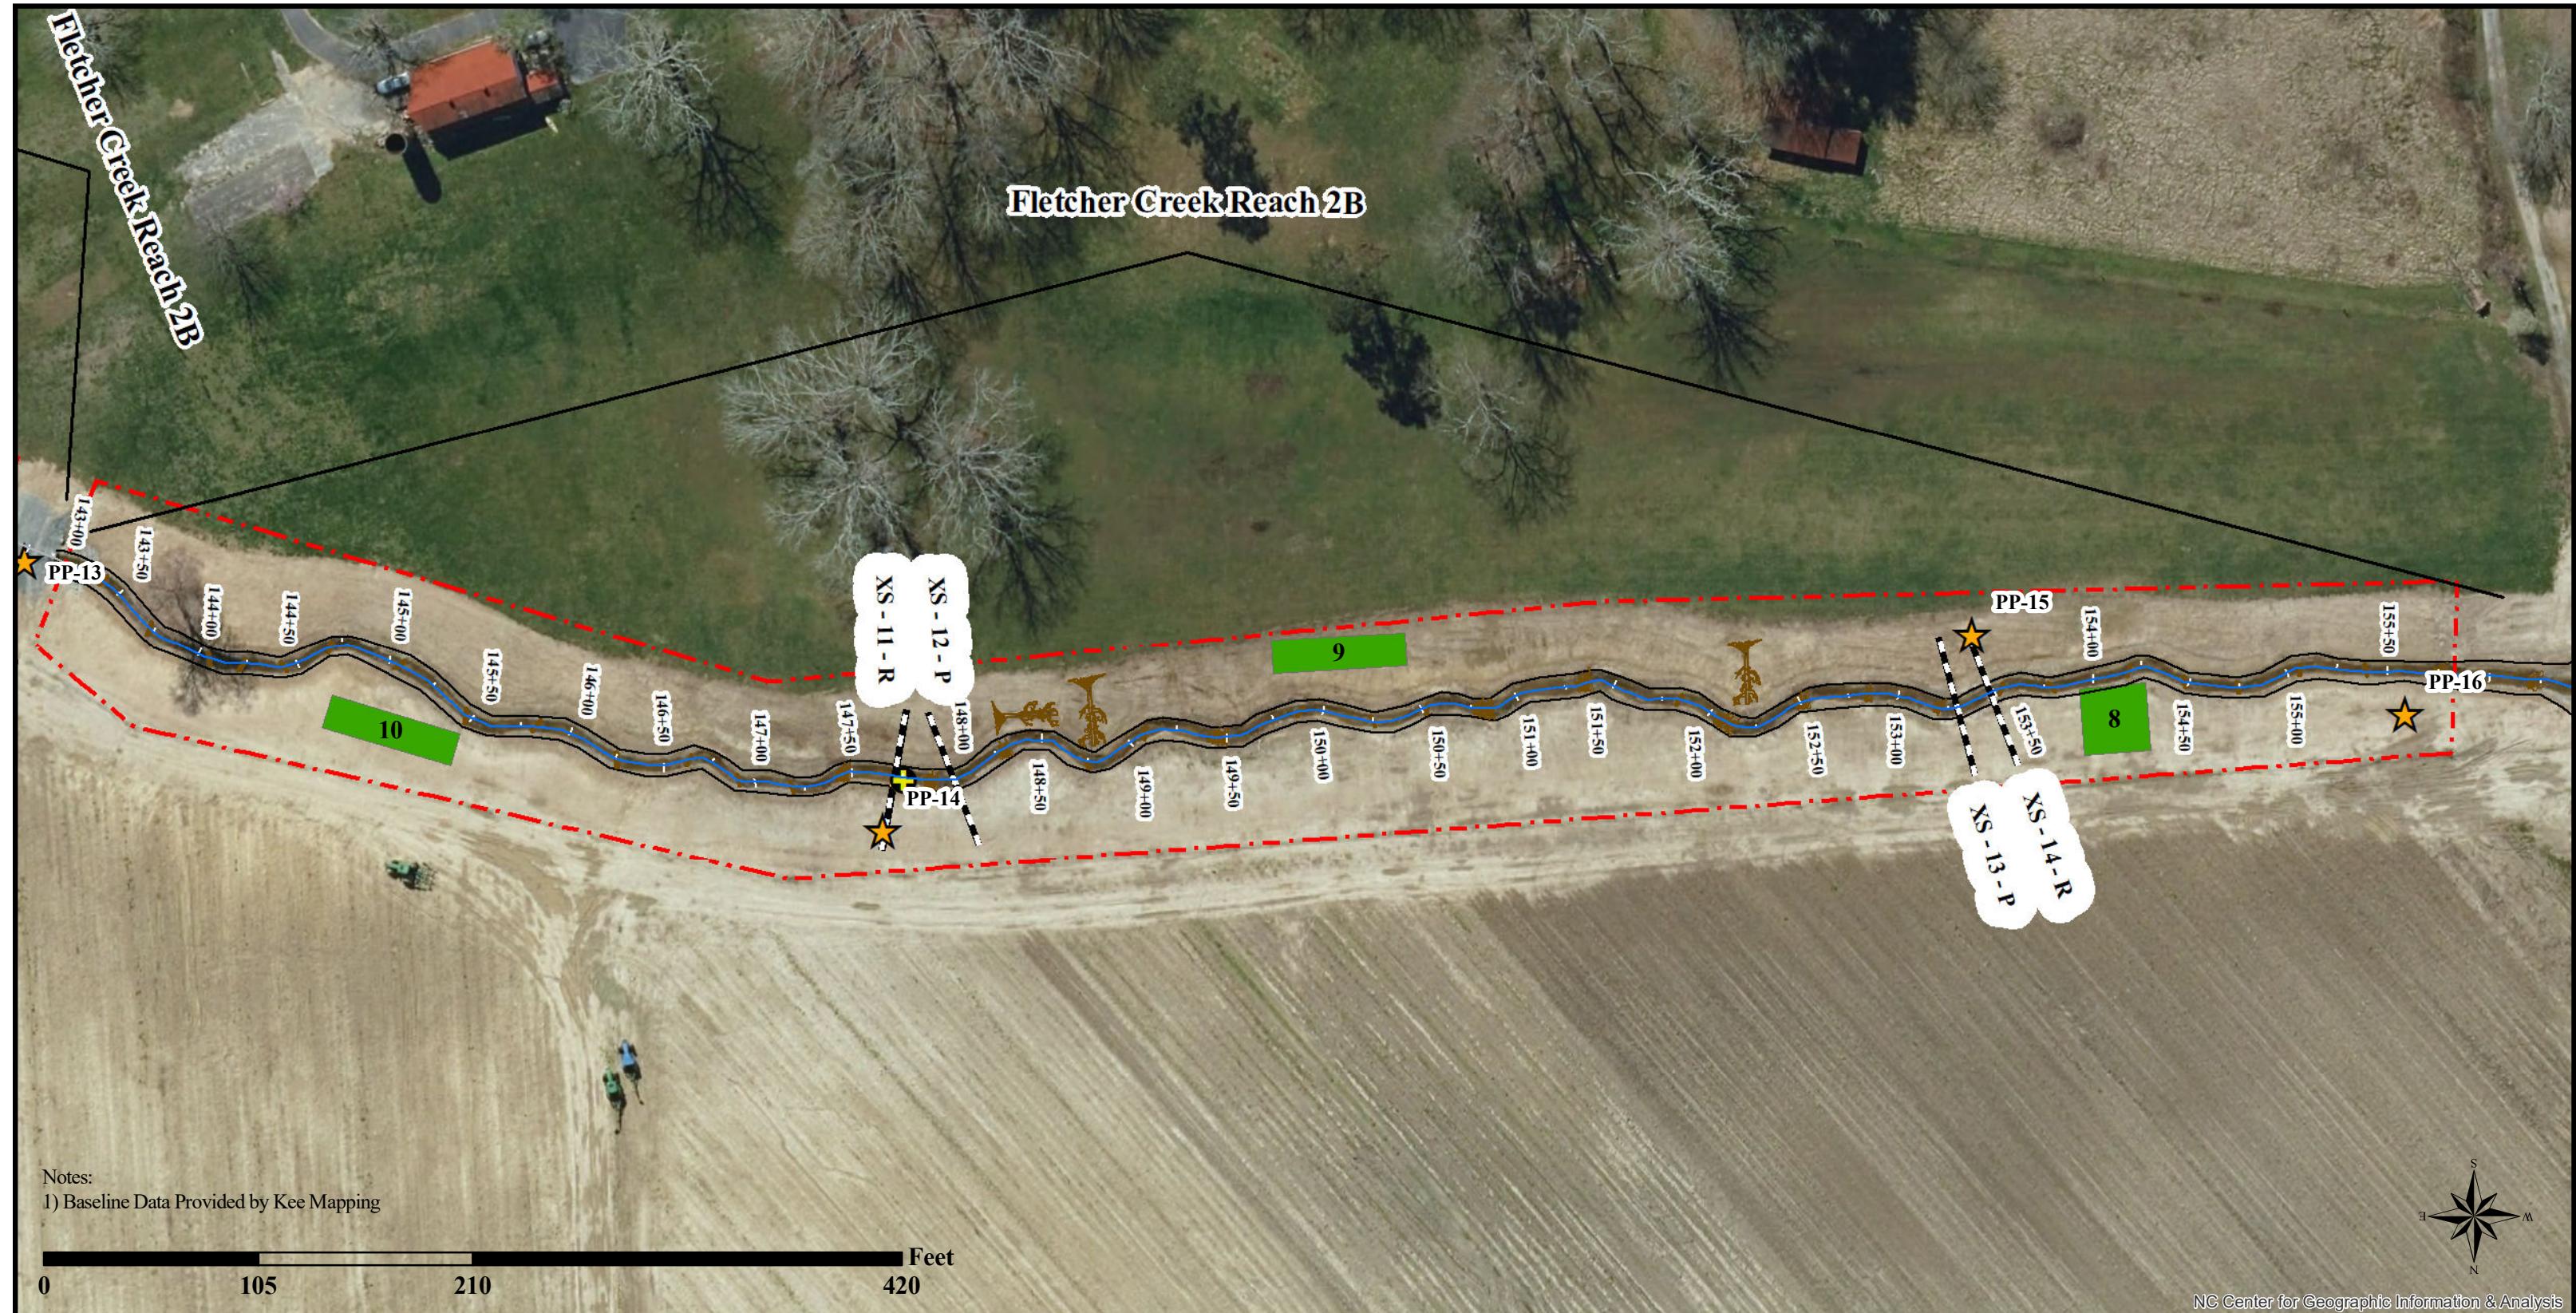
CCPV  
Fletcher Mitigation Site  
Monitoring Year 1  
Henderson County, NC  
NCDMS Contract No.: 006997  
NCDMS Project No.: 100004  
December 2020  
Sheet 5 of 12

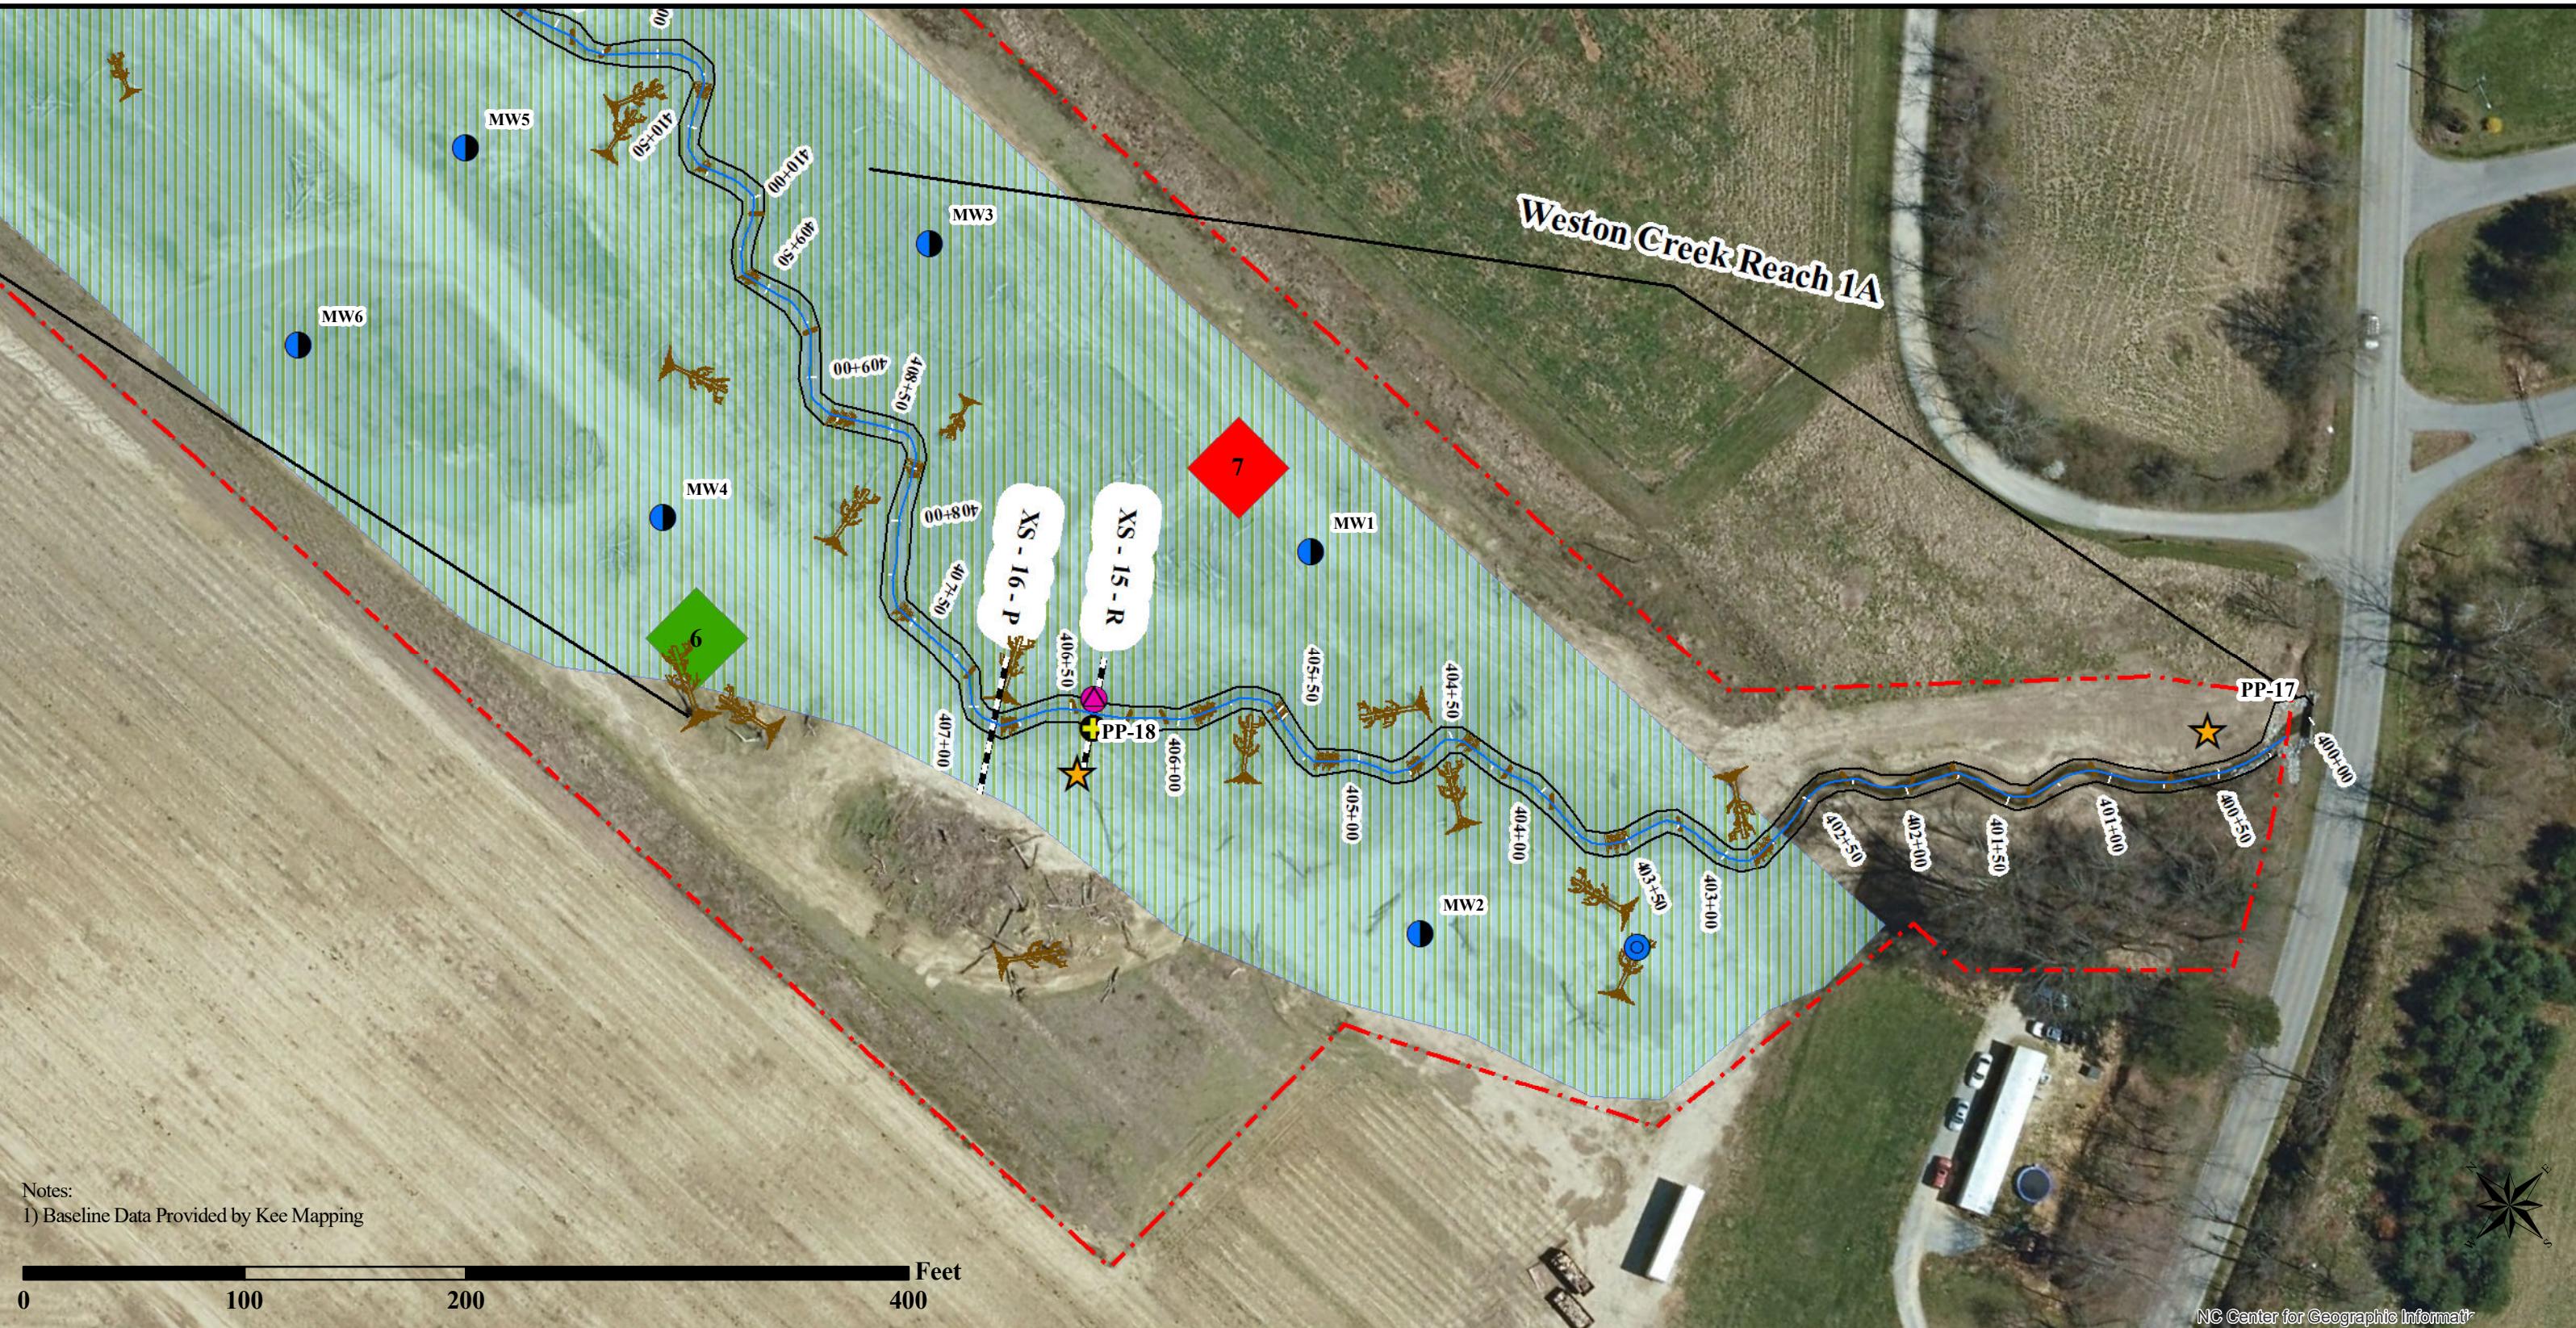
CCPV  
Fletcher Mitigation Site  
Monitoring Year 1  
Henderson County, NC  
NCDMS Contract No.: 006997  
NCDMS Project No.: 100004  
December 2020  
Sheet 6 of 12

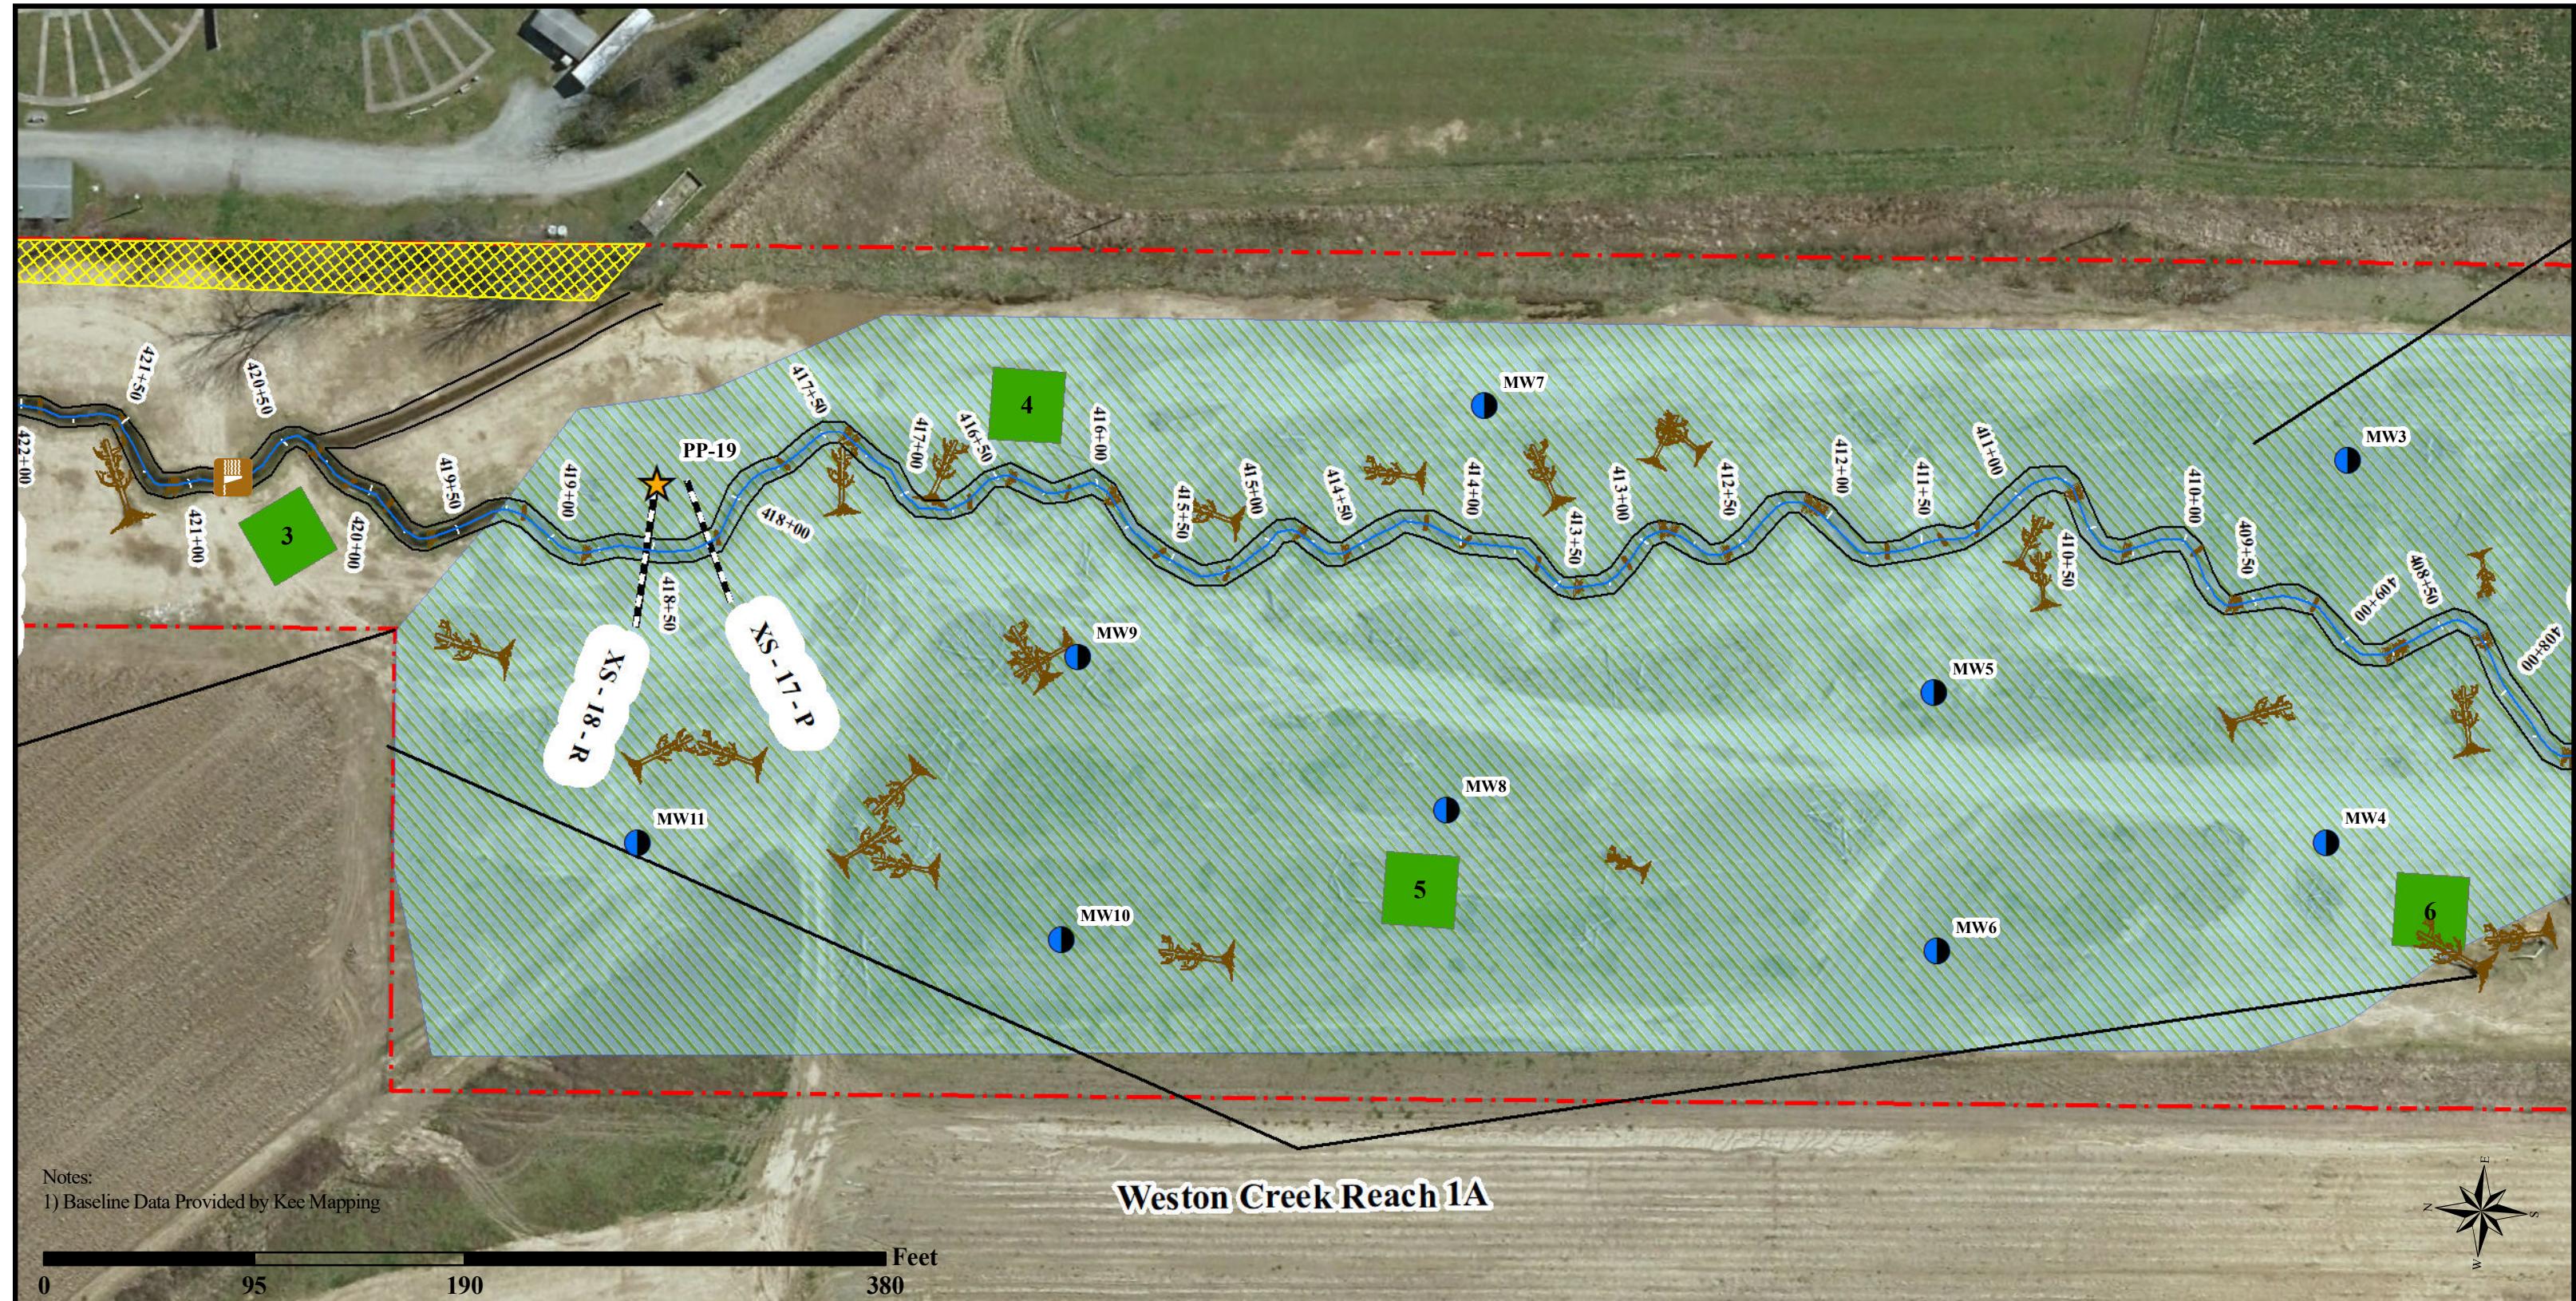
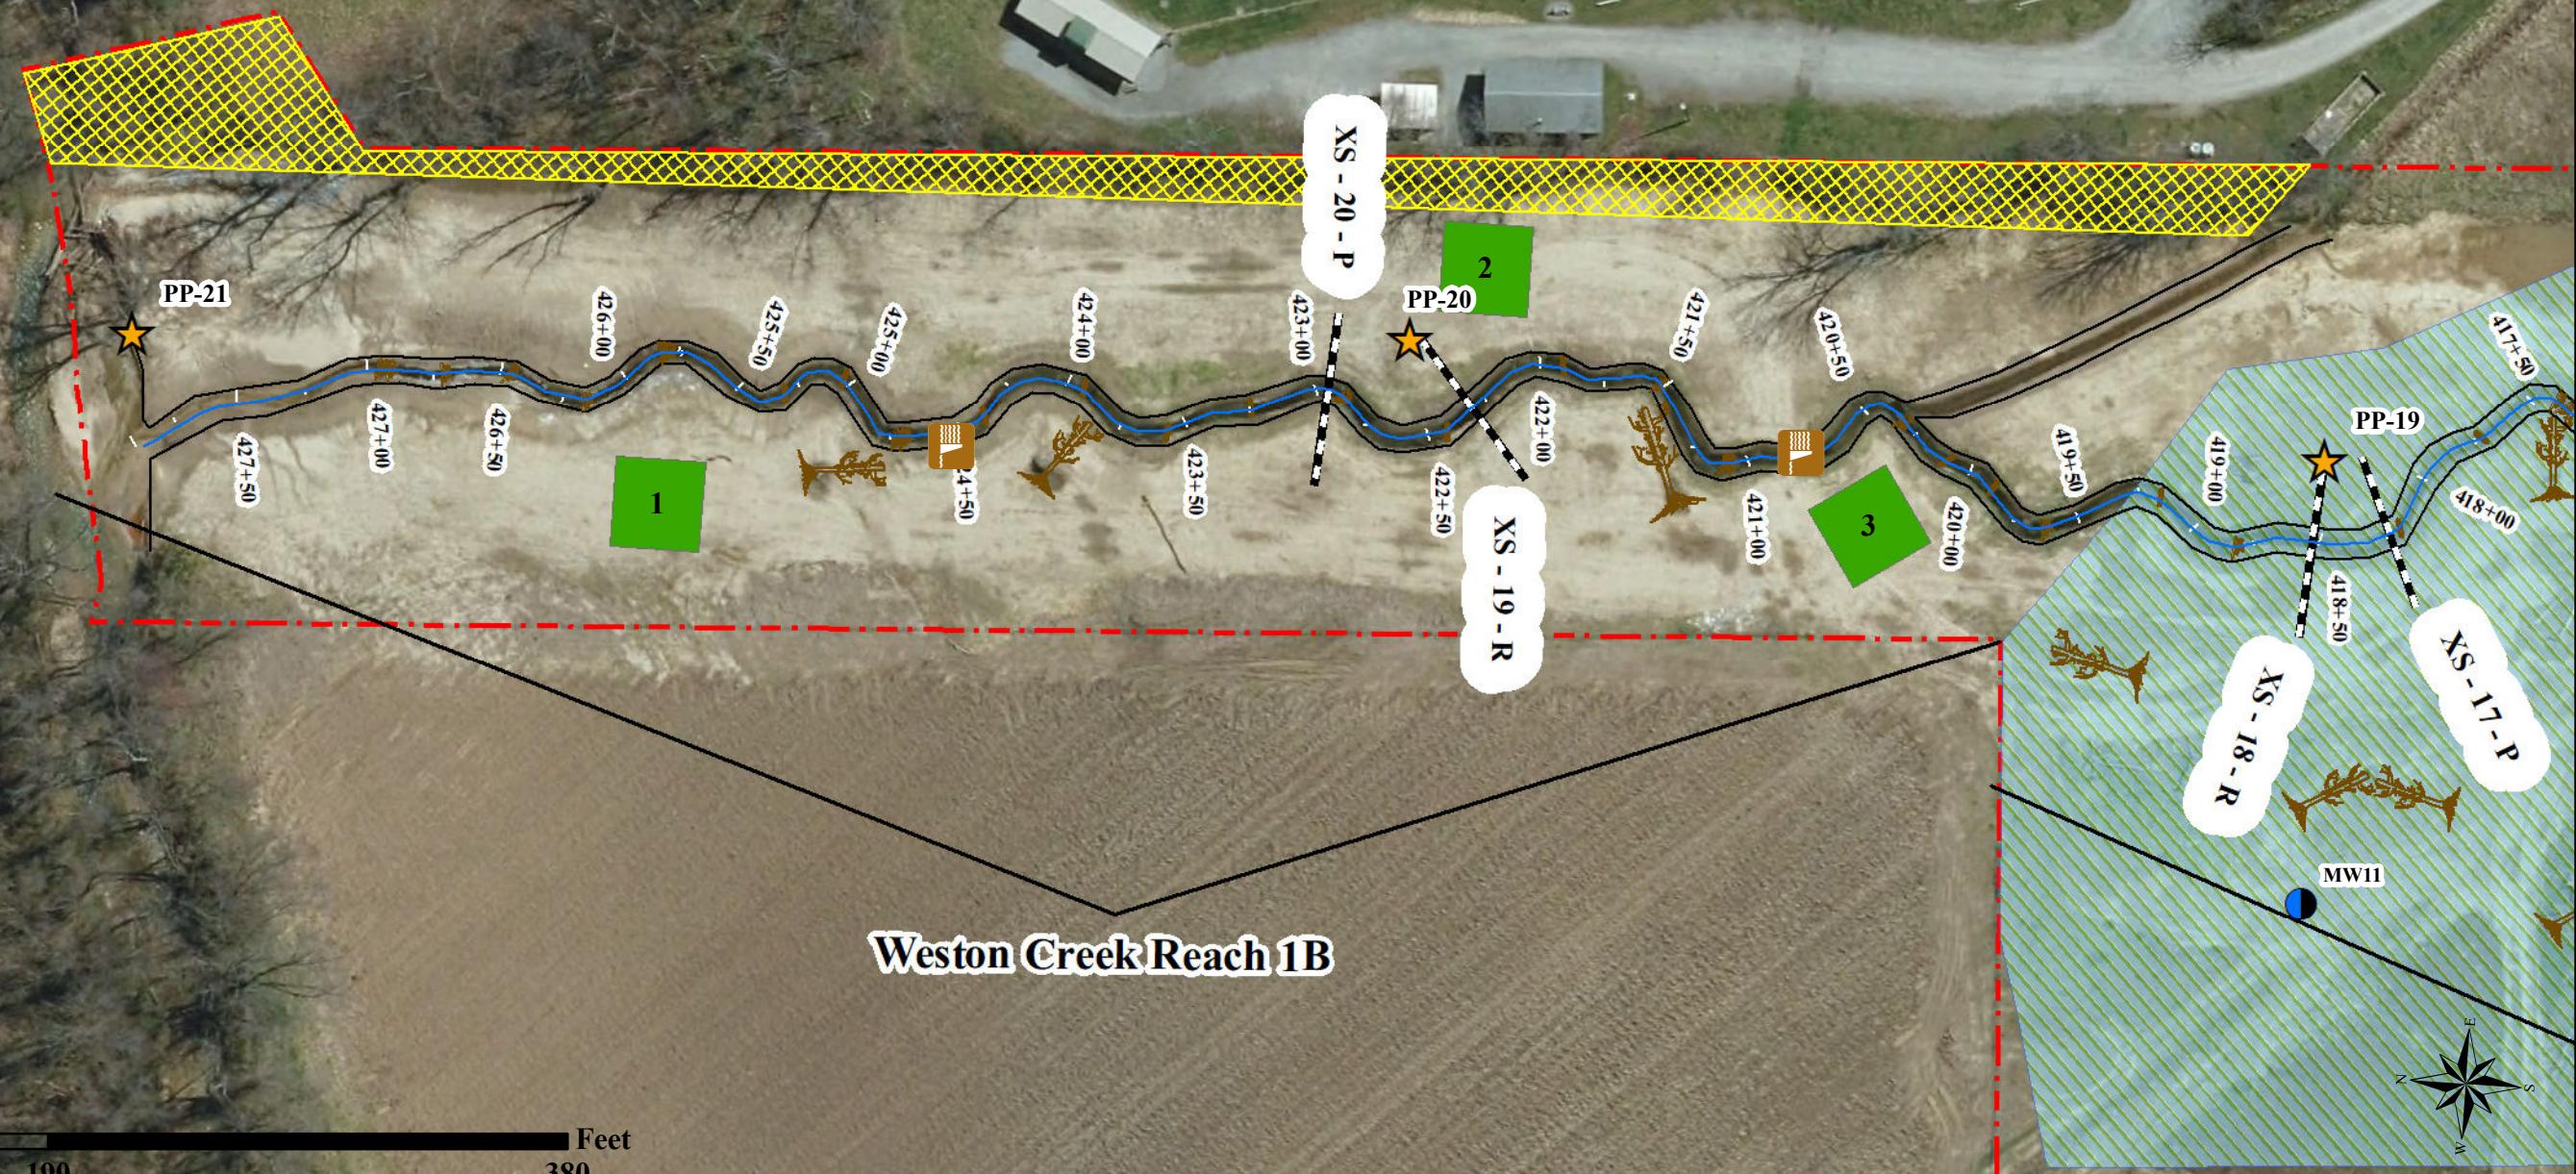
CCPV  
Fletcher Mitigation Site  
Monitoring Year 1  
Henderson County, NC  
NCDMS Contract No.: 006997  
NCDMS Project No.: 100004  
December 2020  
Sheet 8 of 12
