# **Fletcher Stream and Wetland Mitigation Site**

## **Annual Monitoring Report**

**Monitoring Year 1 of 7**

Fletcher Stream and Wetland Mitigation Site

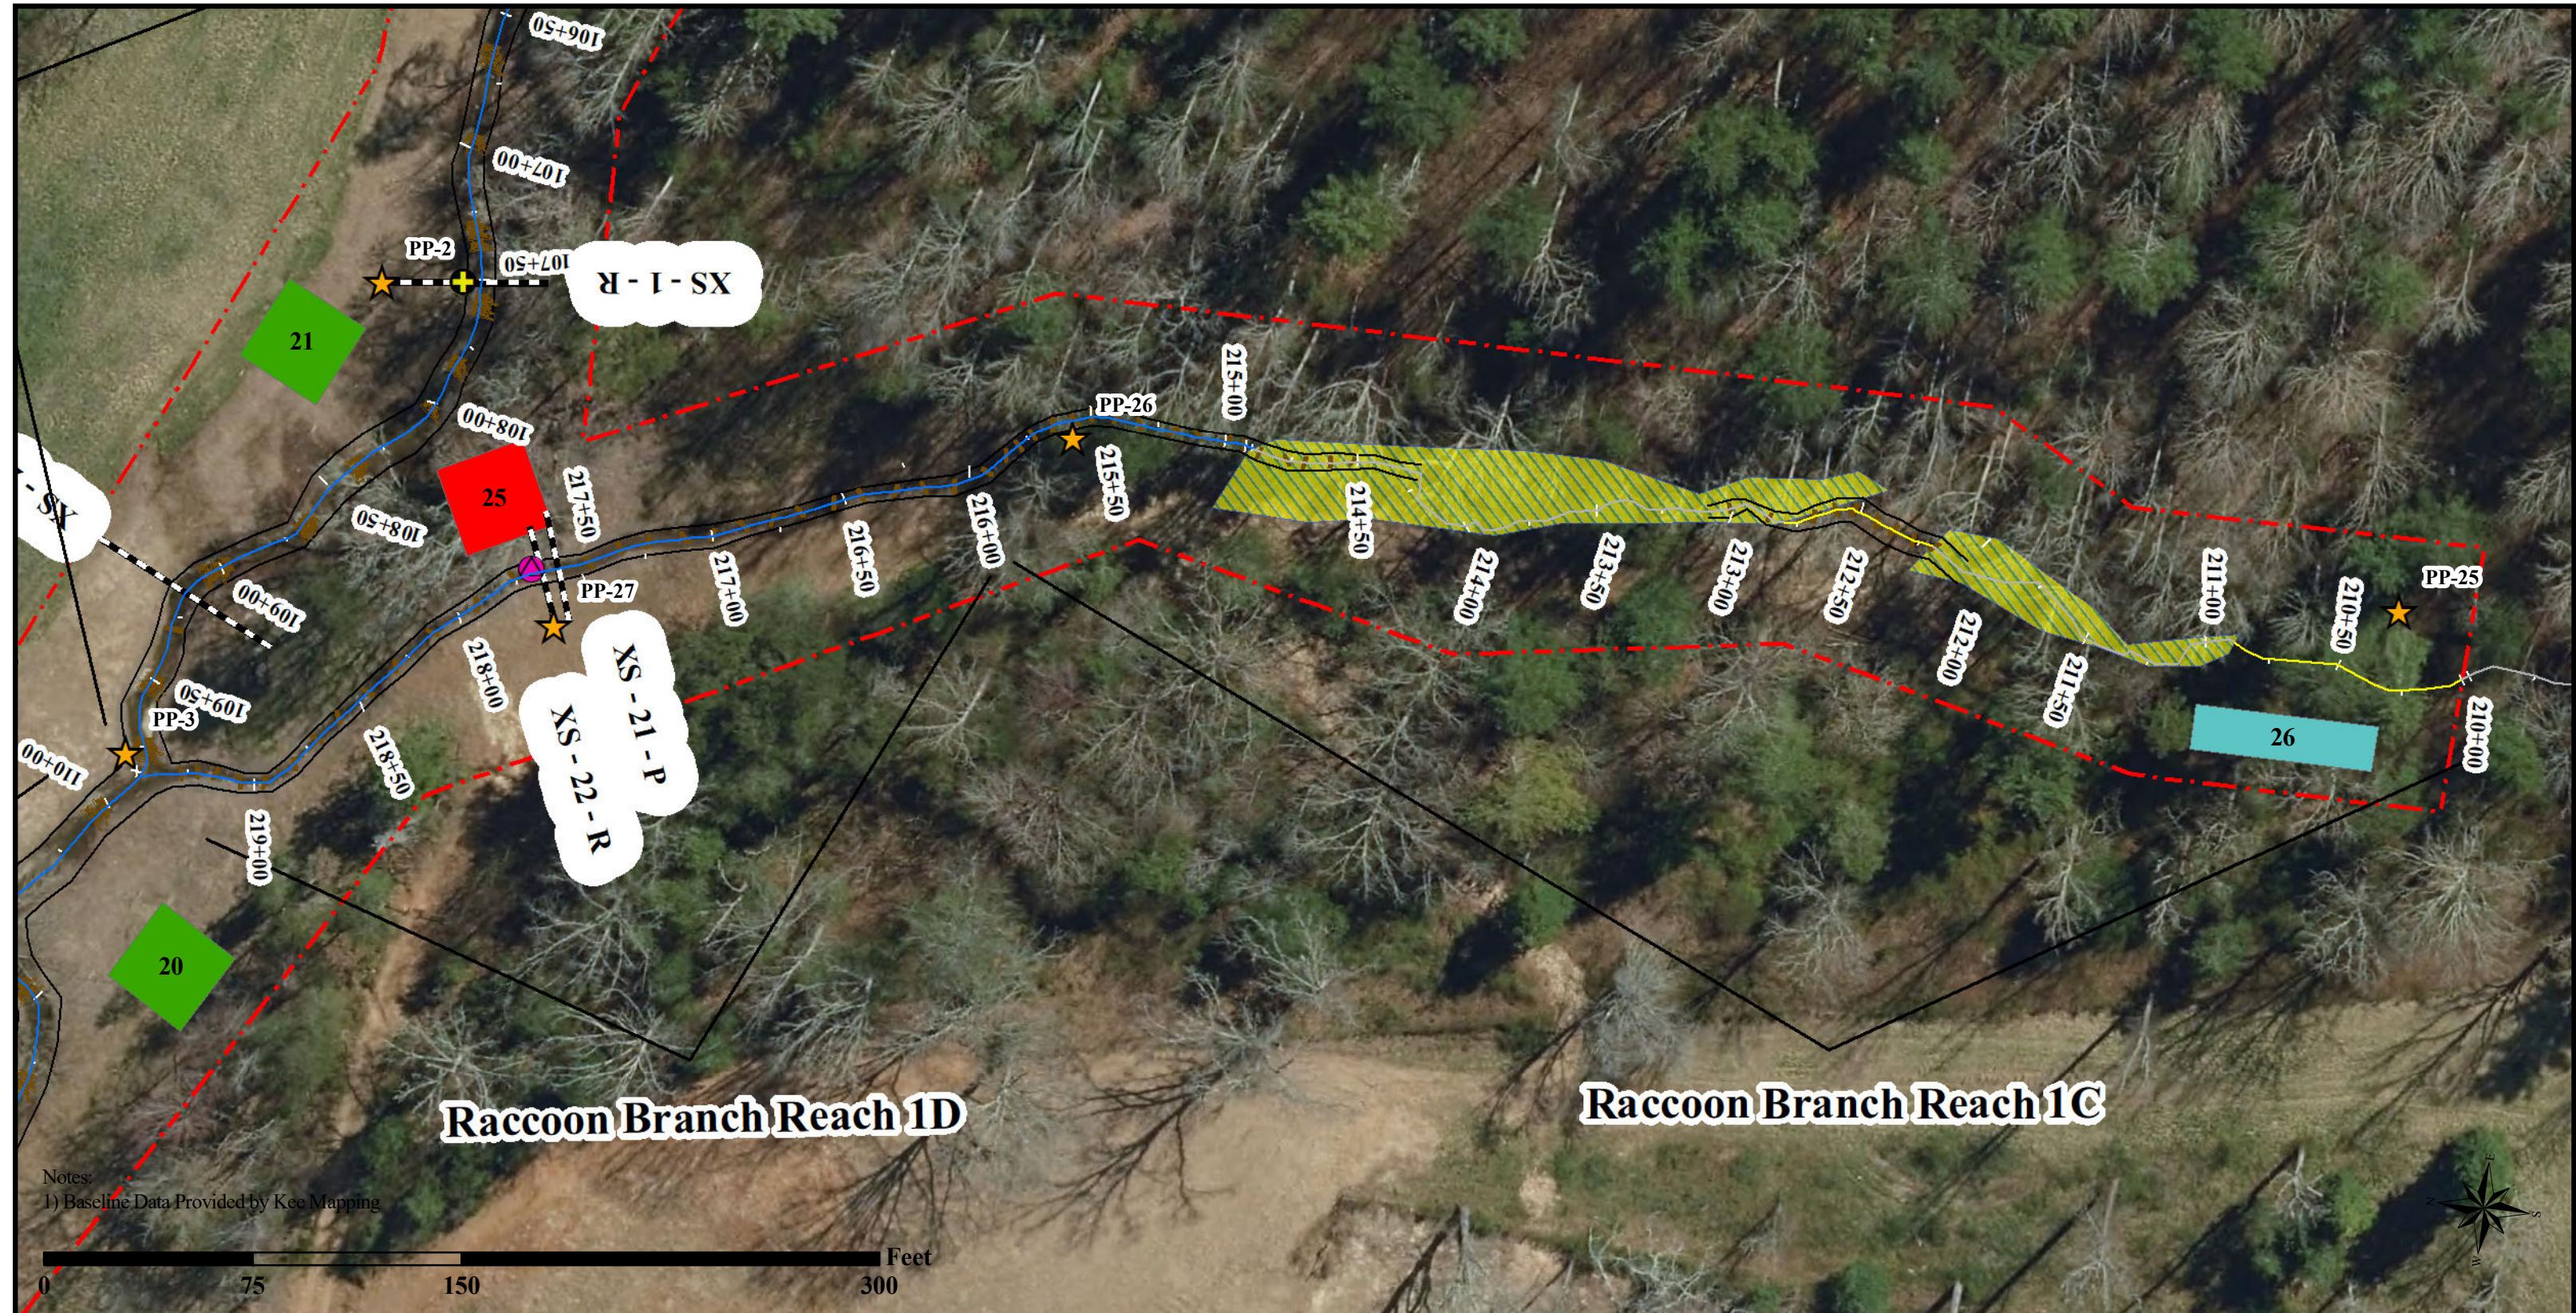
CCPV  
Fletcher Mitigation Site  
Monitoring Year 1  
Henderson County, NC  
NCDMS Contract No.: 006997  
NCDMS Project No.: 100004  
December 2020  
Sheet 10 of 12

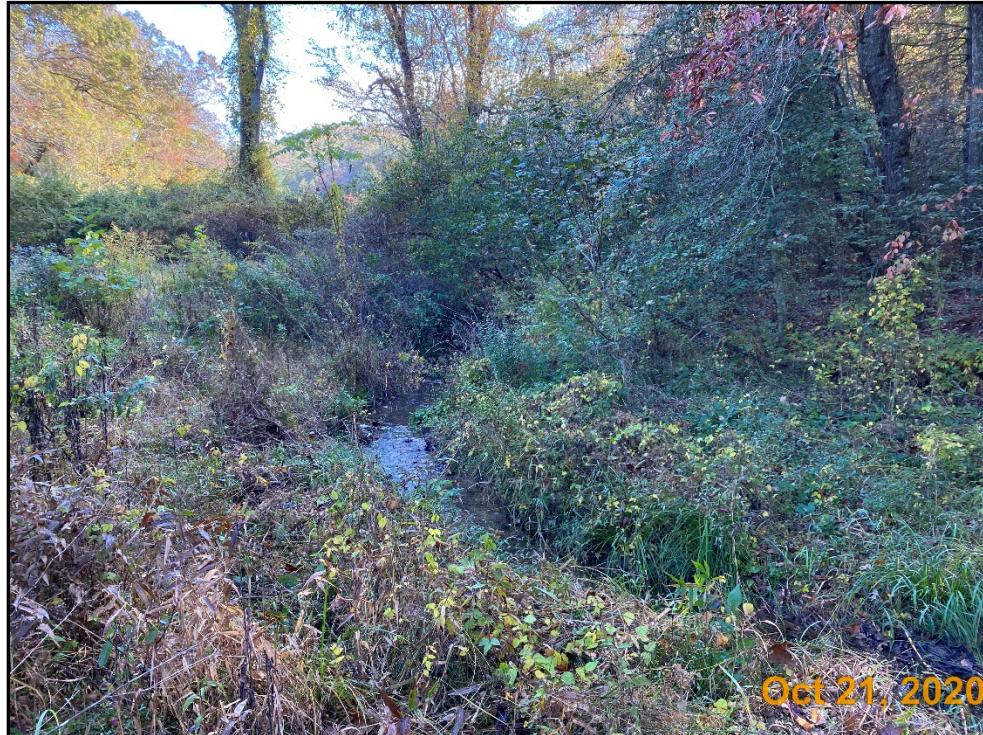
Fletcher Creek 1A – Permanent Photo Station 1  
Looking Upstream

The visual assessment of the project was performed at the beginning and end of each monitoring year. Permanent photo station photos were taken during the initial visual assessment when leaf-off conditions exist. Additional photos of vegetation or stream problem areas were taken as needed.

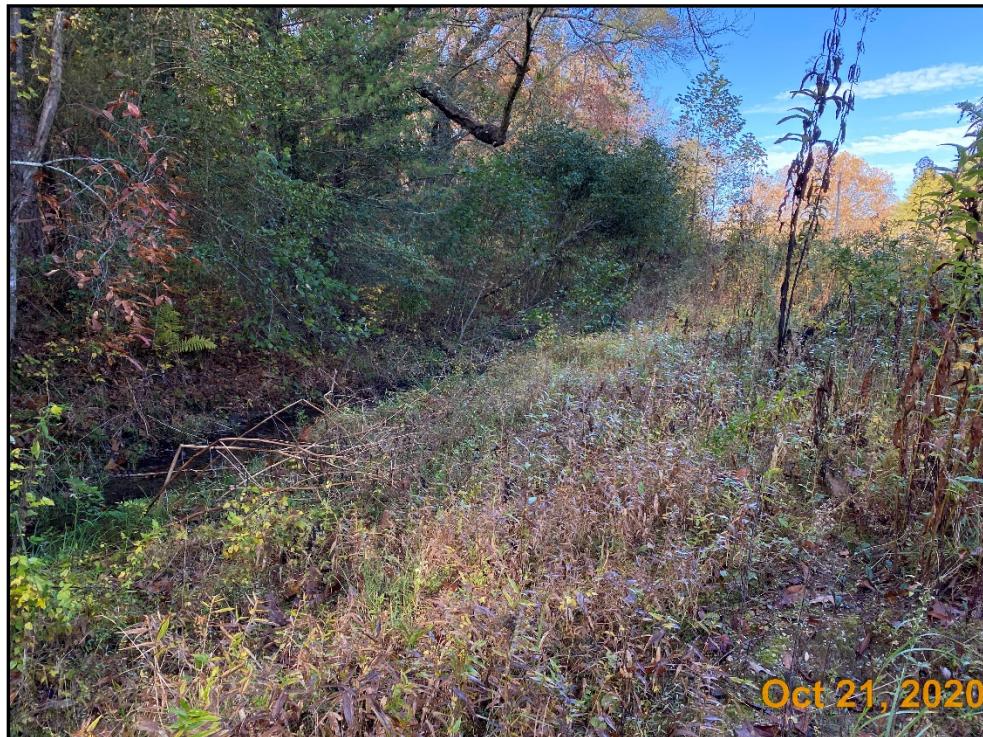
Fletcher Creek 1A – Permanent Photo Station 1  
Looking Downstream

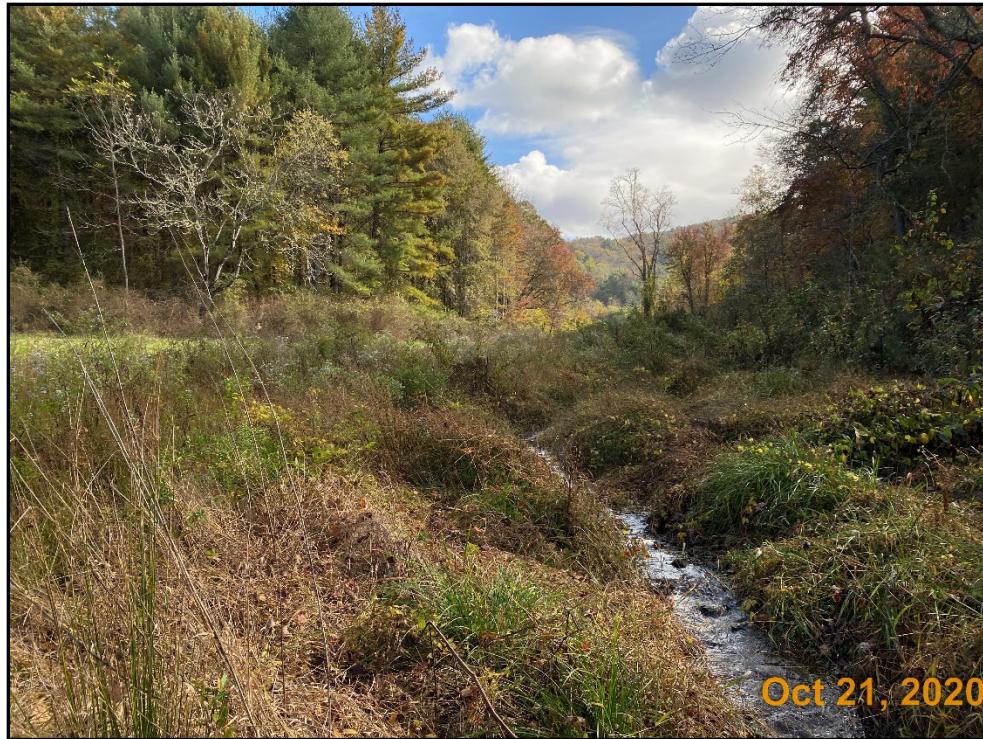
Fletcher Creek 1B – Permanent Photo Station 2  
Looking Upstream

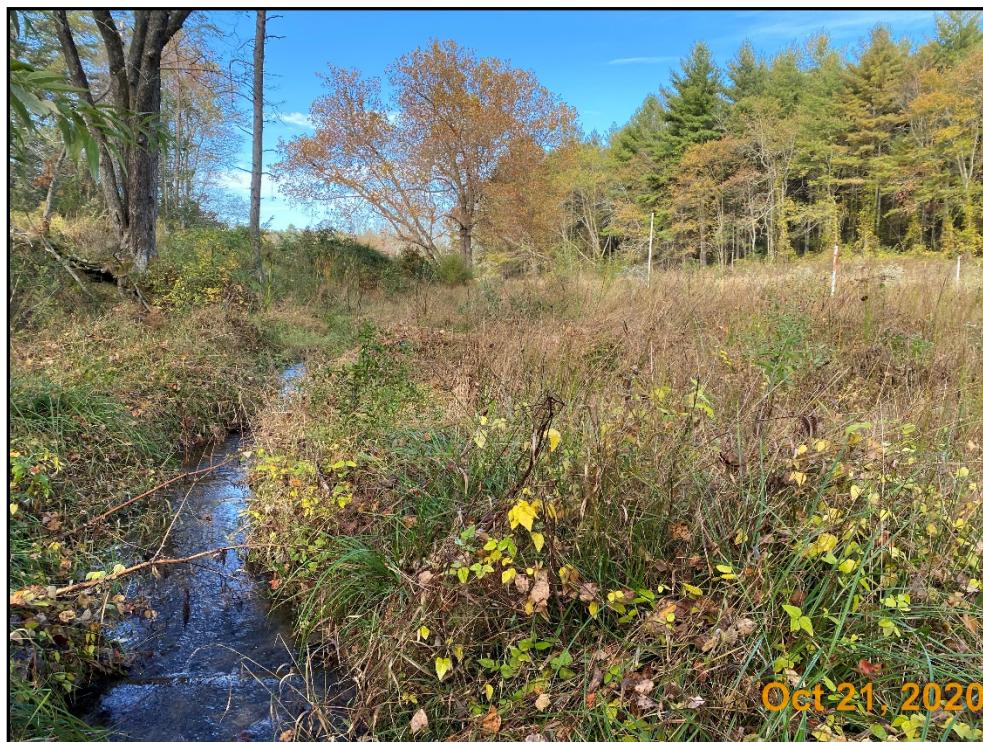
Fletcher Creek 1B – Permanent Photo Station 2  
Looking Downstream

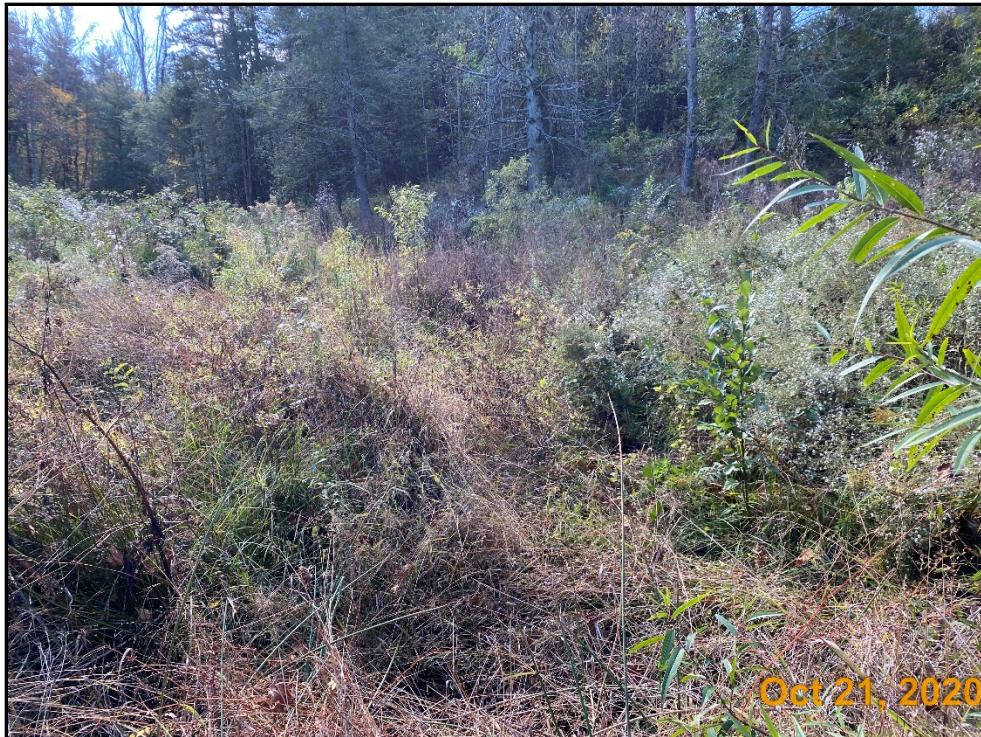
Fletcher Creek 1B – Permanent Photo Station 3  
Looking Upstream

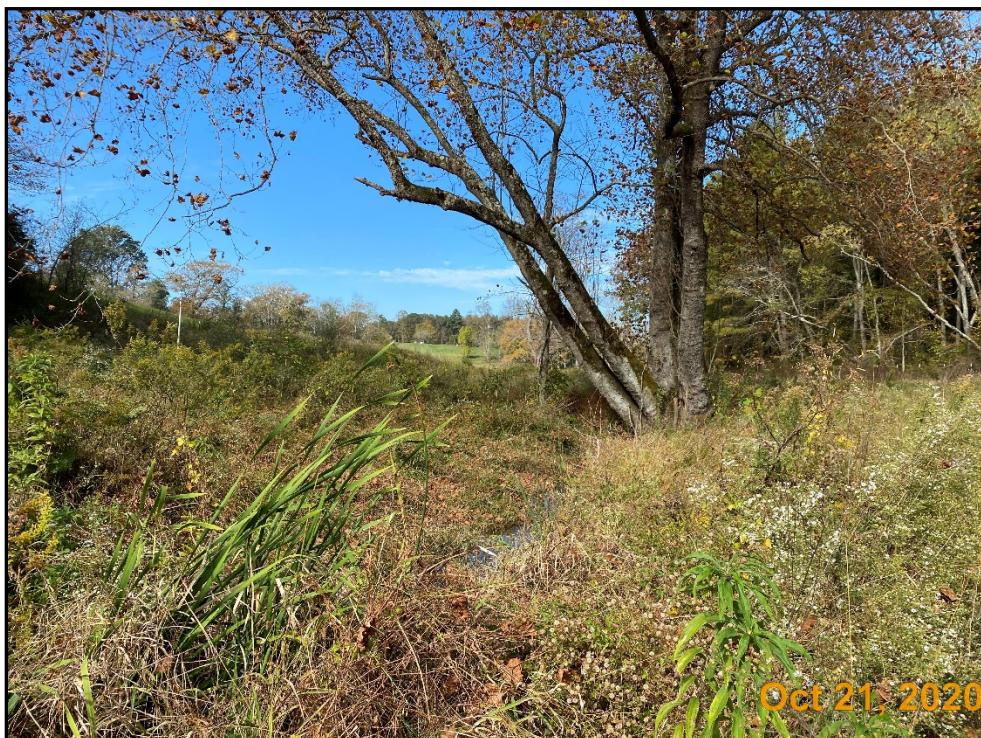
Fletcher Creek 1C – Permanent Photo Station 3  
Looking Downstream

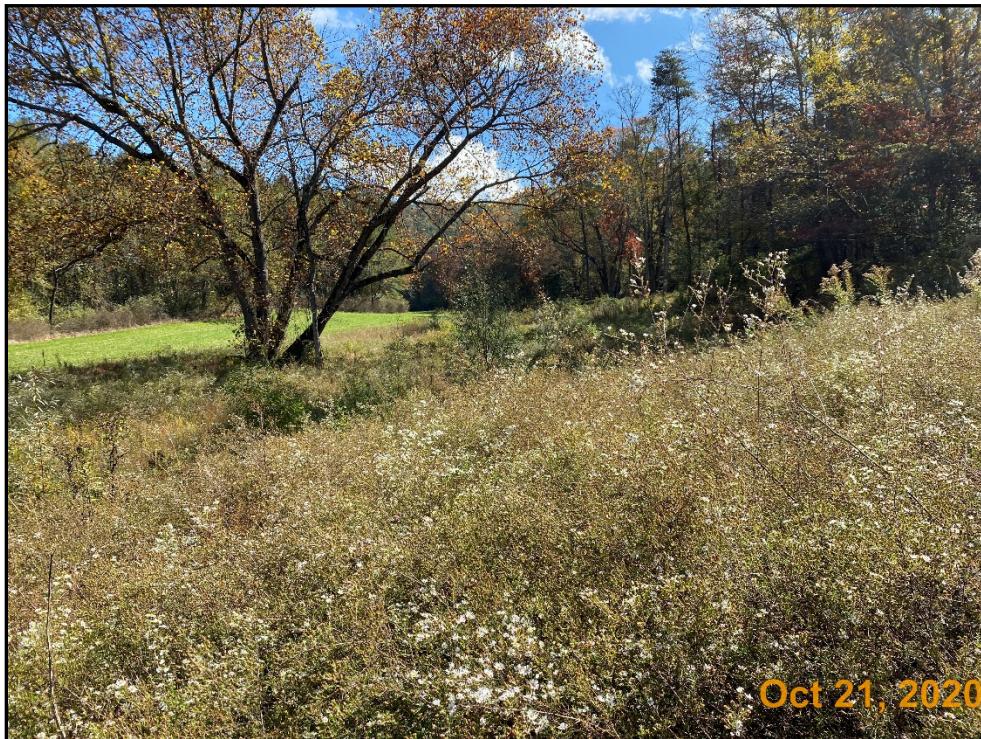
Fletcher Creek 1C – Permanent Photo Station 4  
Looking Upstream

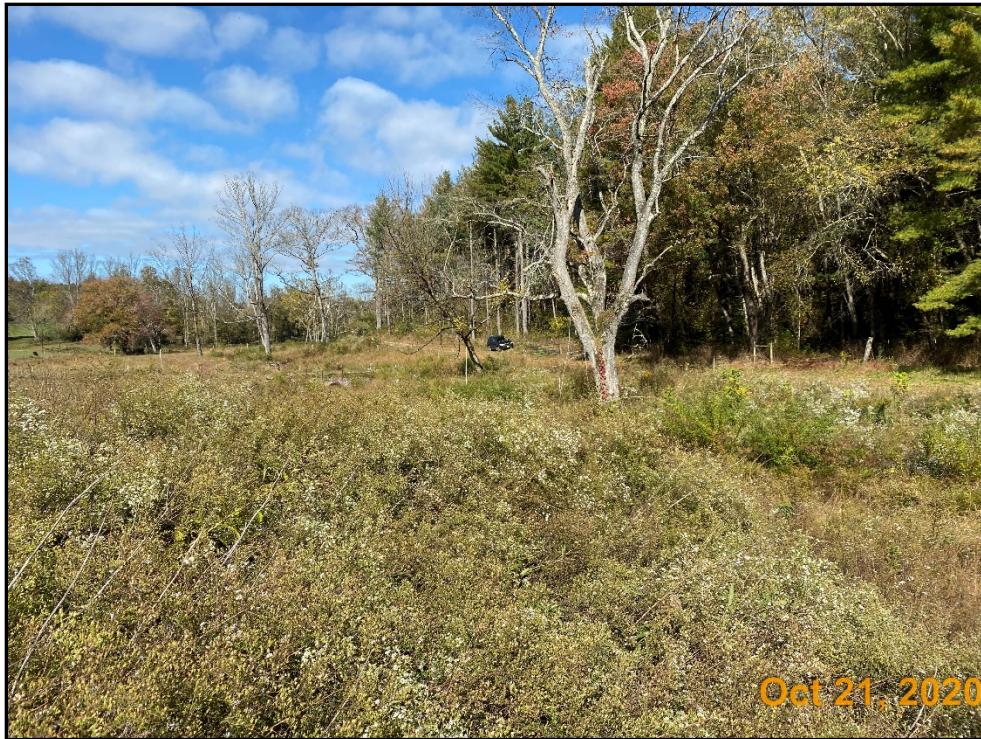
Fletcher Creek 1C – Permanent Photo Station 4  
Looking Downstream

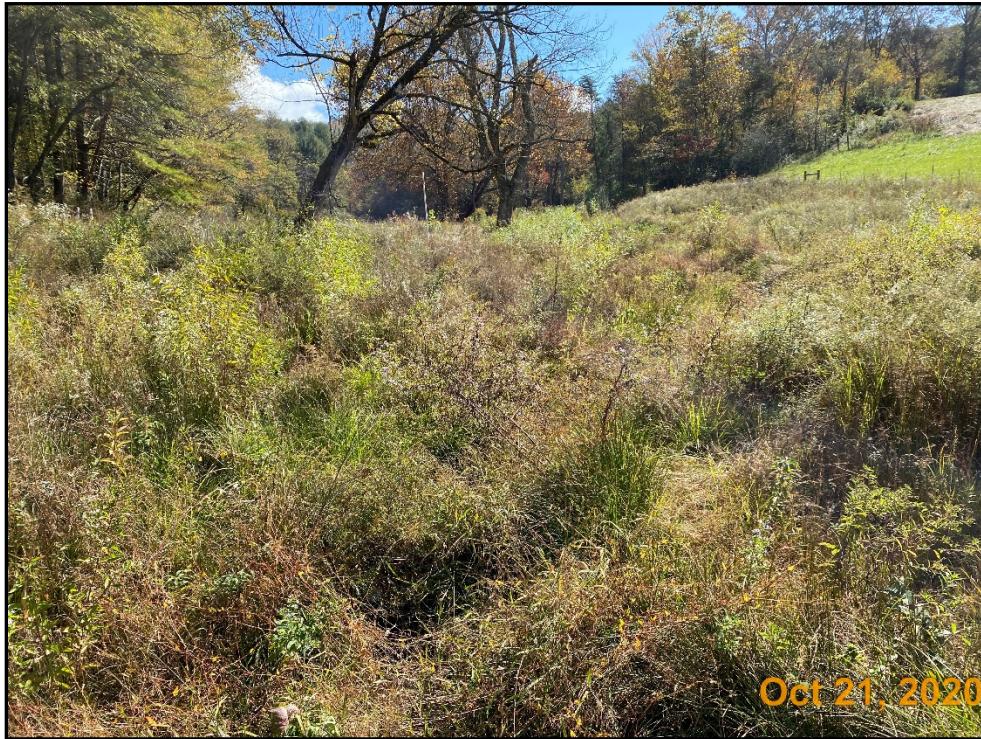
Fletcher Creek 1C – Permanent Photo Station 5  
Looking Upstream from Crossing

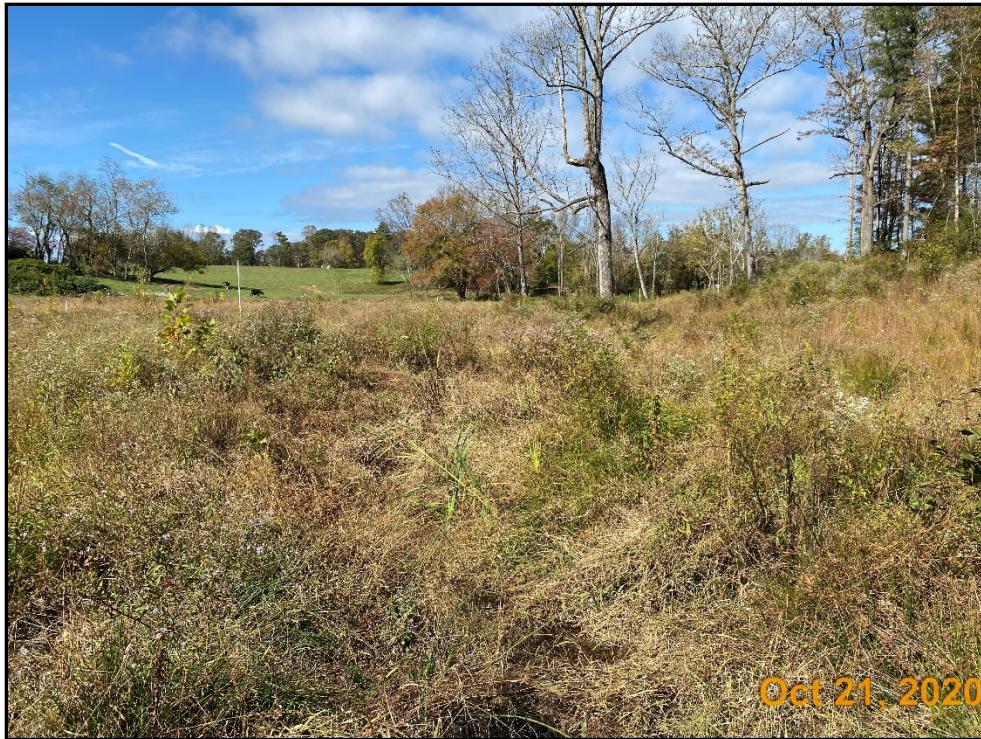
Fletcher Creek 1C – Permanent Photo Station 5  
Looking Downstream from Crossing

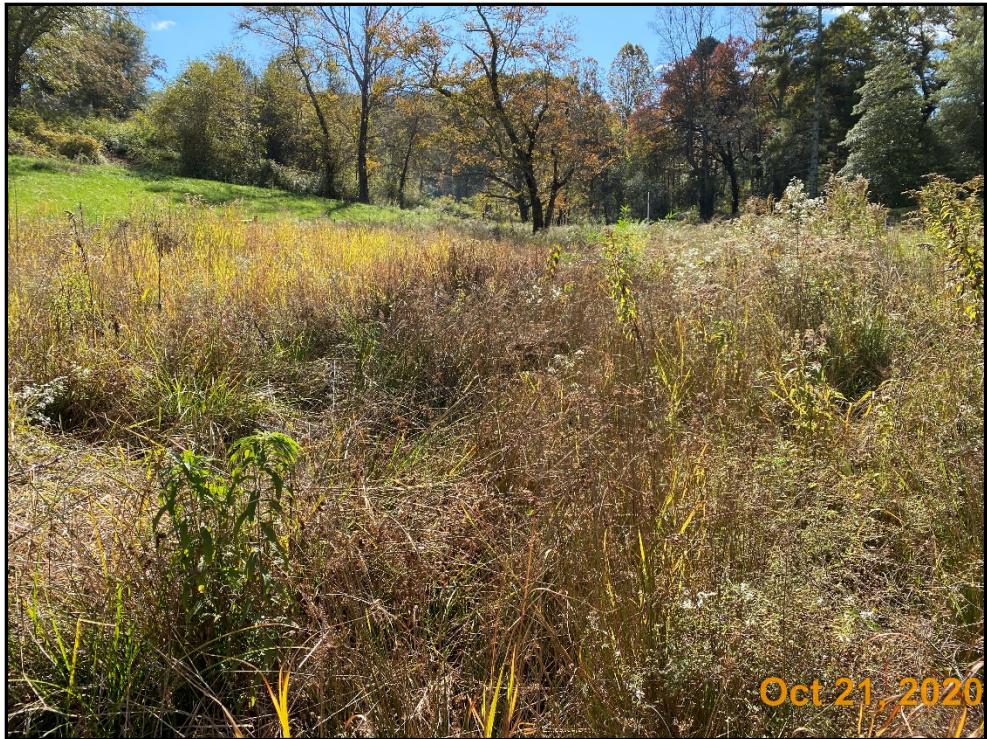
Coates Branch 1B – Permanent Photo Station 29  
Looking Downstream

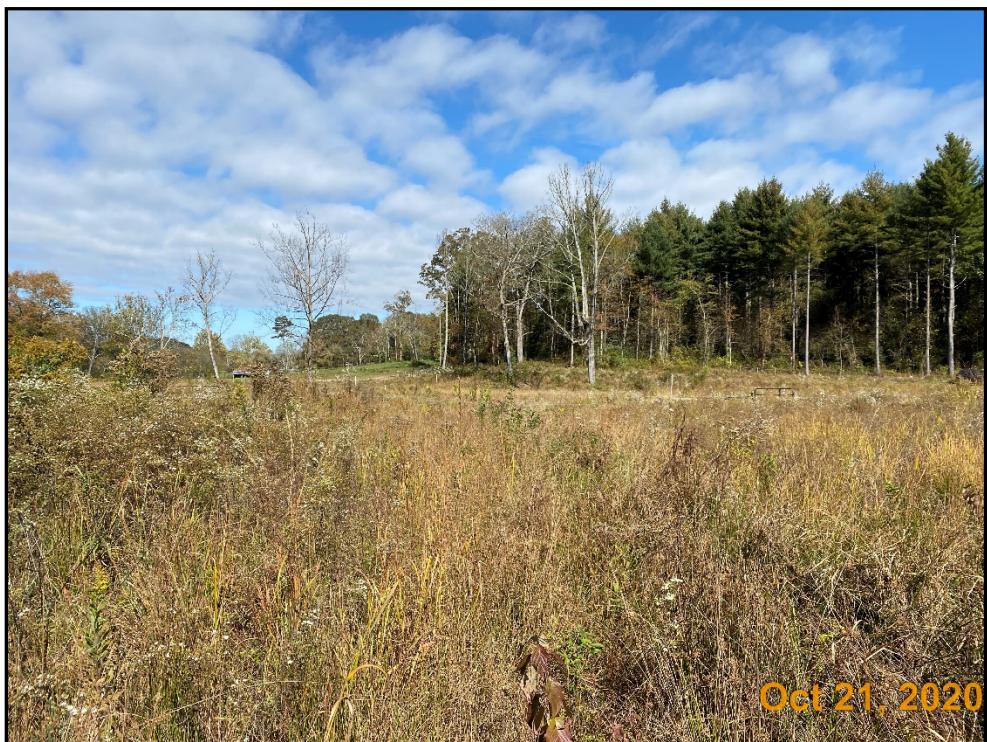
Coates Branch 1B – Permanent Photo Station 30  
Looking Upstream

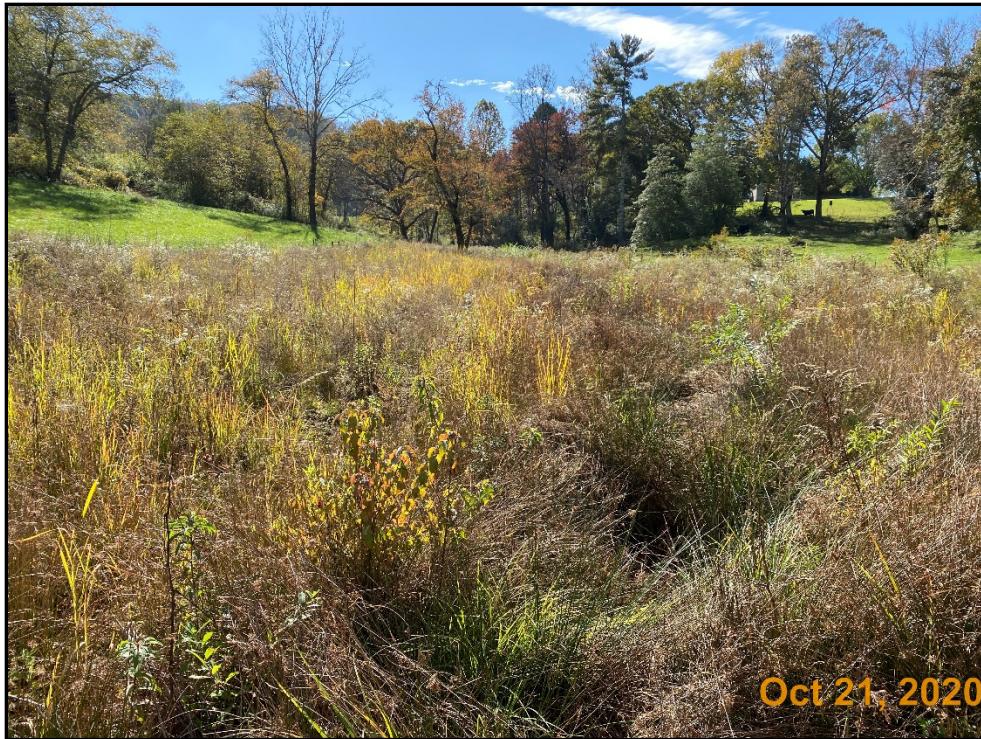
Coates Branch 1B – Permanent Photo Station 30  
Looking Downstream

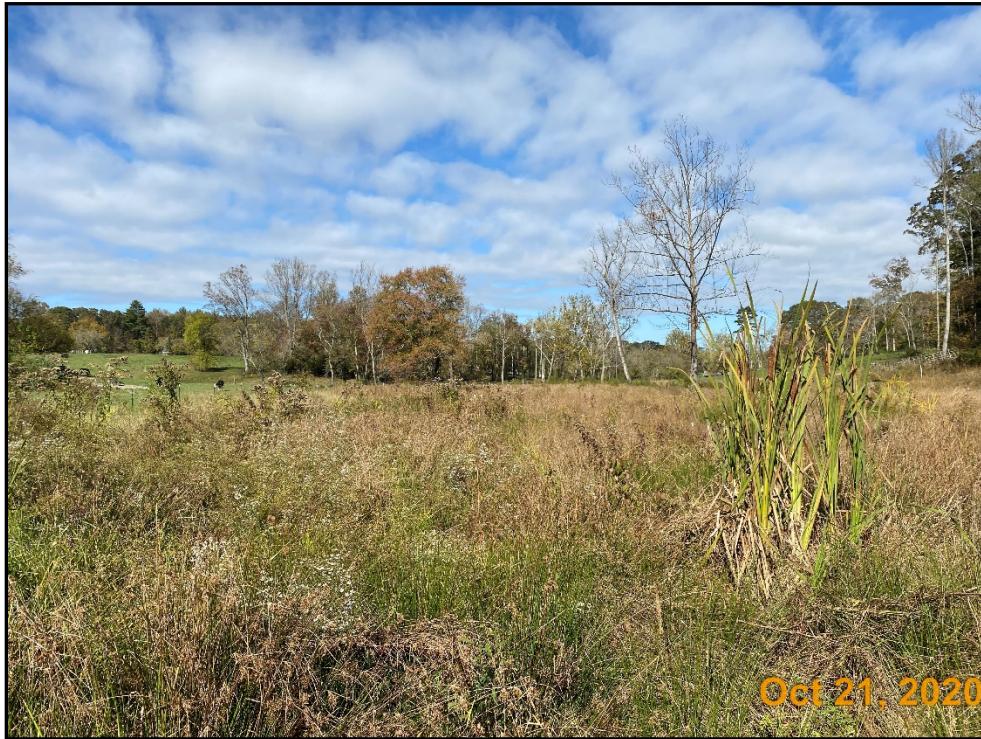
Coates Branch 1B – Permanent Photo Station 31  
Looking Upstream from Crossing

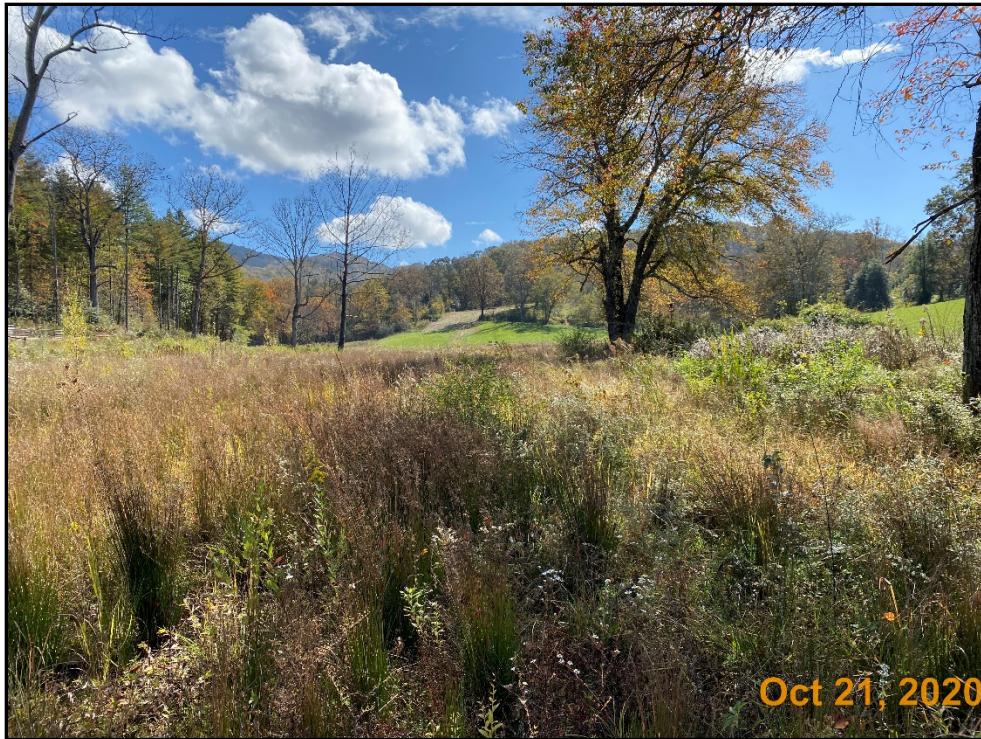
Coates Branch 1C – Permanent Photo Station 31  
Looking Downstream from Crossing

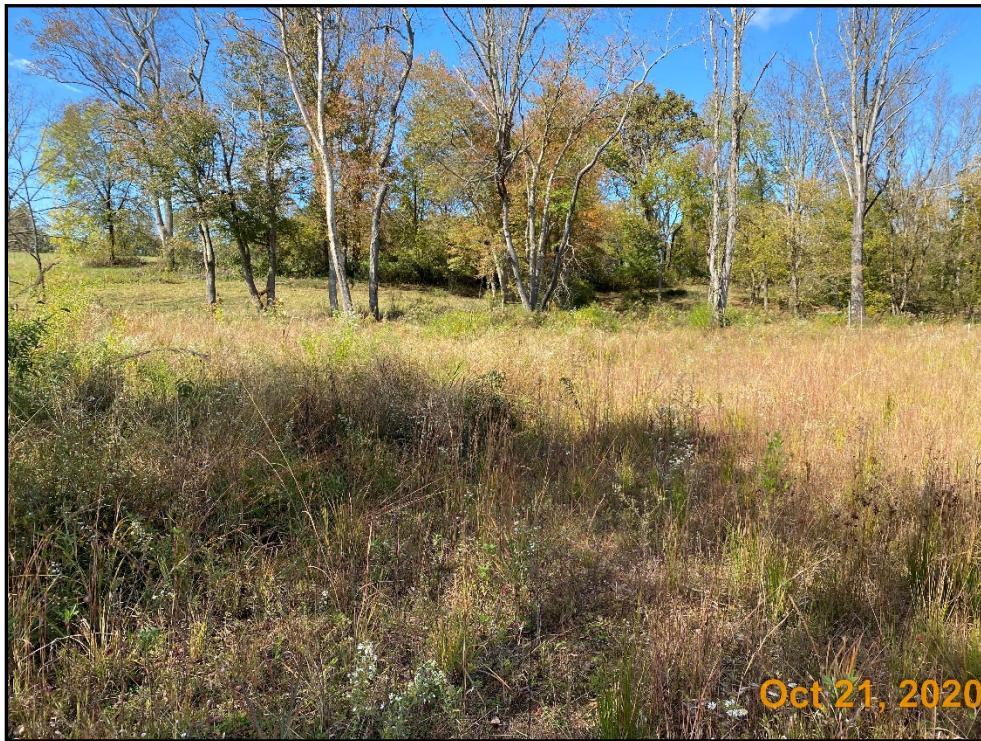
Coates Branch 1C – Permanent Photo Station 32  
Looking Upstream

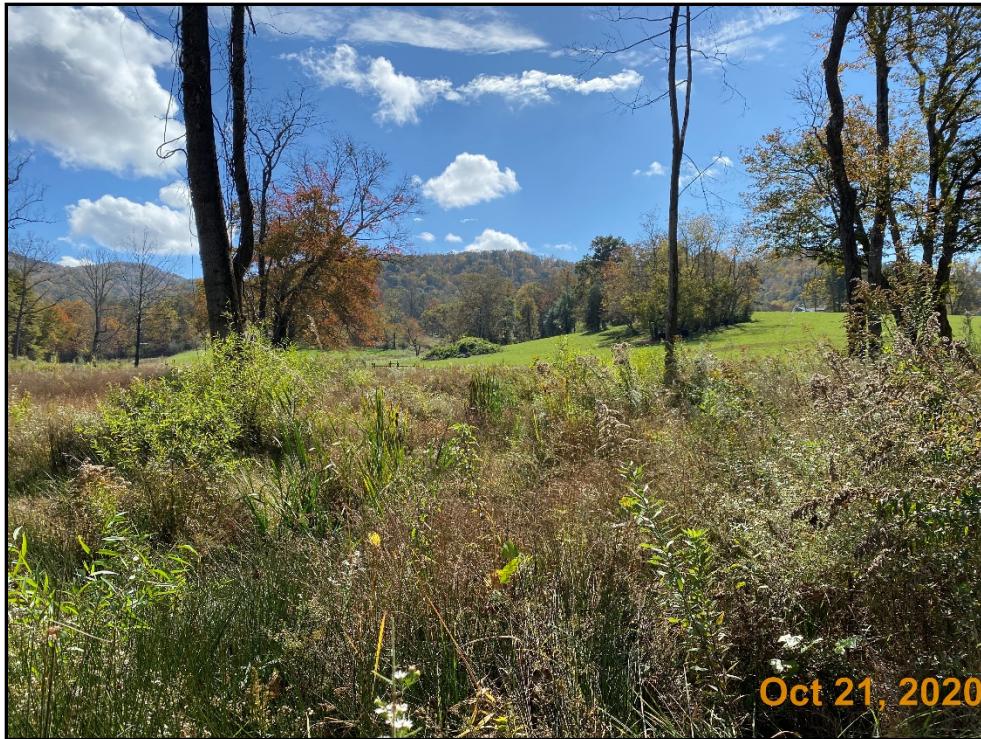
Coates Branch 1C – Permanent Photo Station 32  
Looking Downstream

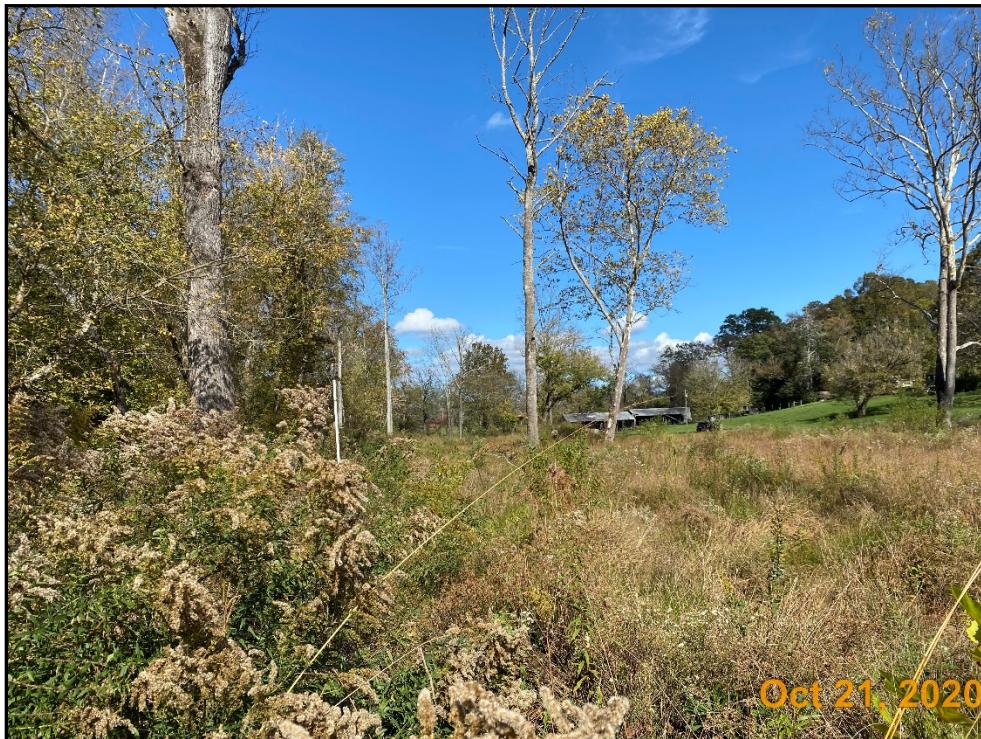
Coates Branch 1D – Permanent Photo Station 33  
Looking Upstream

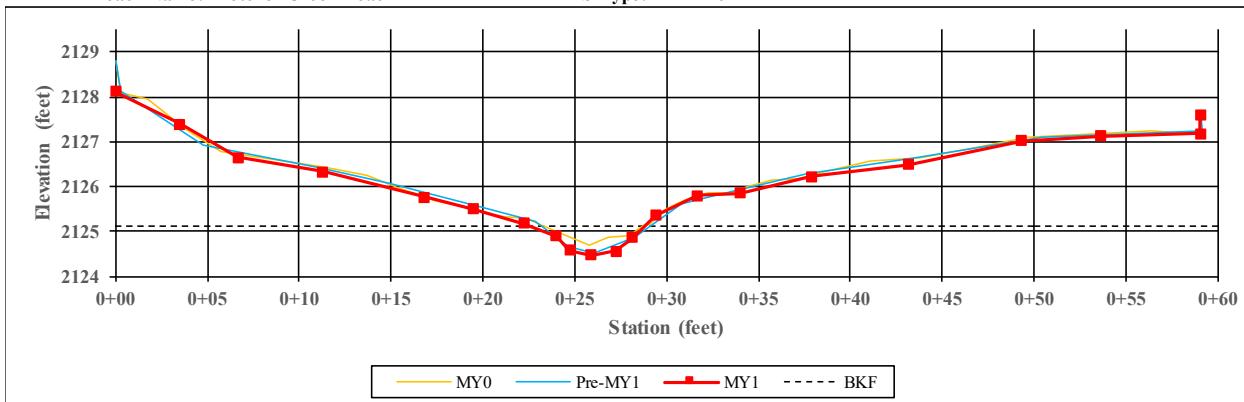
XS Number: 1  
XS Type: Riffle

Station: 107+51

Geomorphic data for MY1 was collected during October 2020. Summary tables and cross-section data plots related to stream morphology are located in Appendix D. Cross-sectional dimensions remained relatively stable between baseline conditions and MY1 monitoring efforts. The most substantial changes took place at cross-section 9. Cross-section 9 has shown some aggradation in the Pre-MY1 survey. This had cleared by the MY1 monitoring period, reverting to near as-built condition (Appendix D, cross-section graphics and Table 11a). Riffle dimensions for each reach also remained relatively similar between baseline conditions and MY1 monitoring (Appendix D, Table 11b).

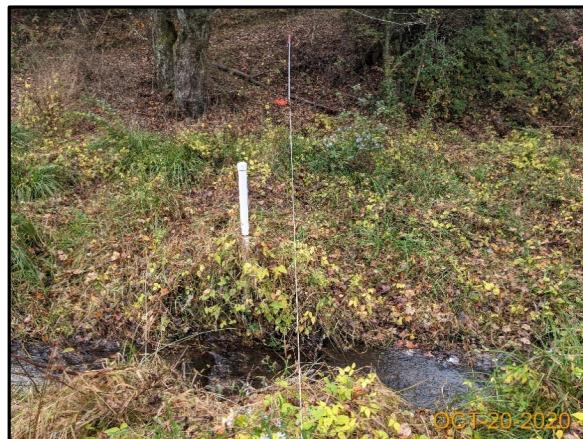
Left Descending Bank

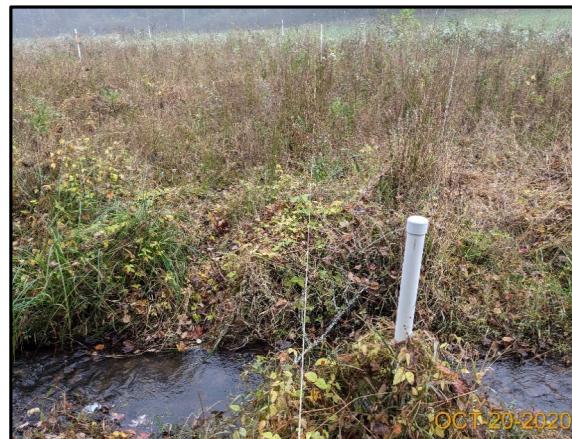
Right Descending Bank

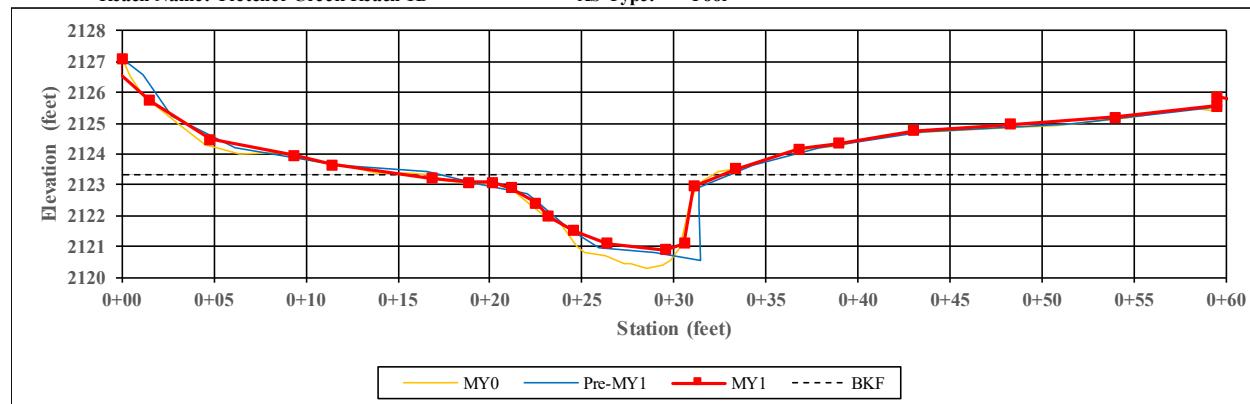
XS Number: 2  
XS Type: Pool

Station: 109+16

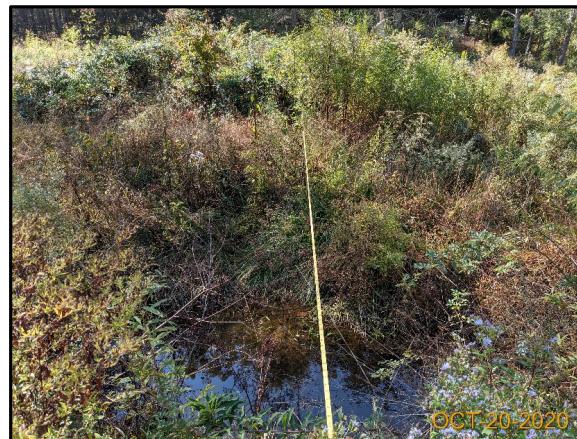
Left Descending Bank

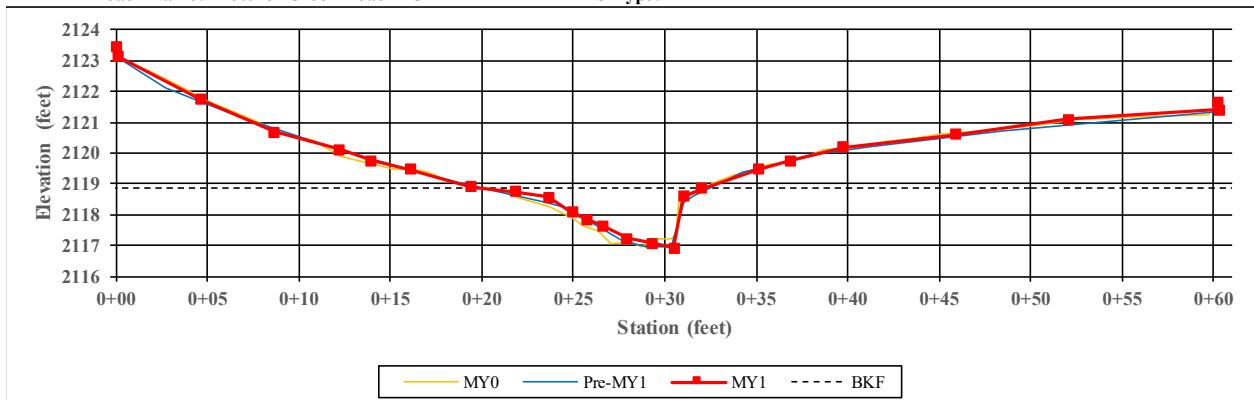
XS Number: 3  
XS Type: P

Station: 112+04

| CHANNEL DIMENSIONS SUMMARY | MY0 | *Pre-MY1 | MY1 | MY2 | MY3 | MY4 | MY5 | MY6 |
| Bankfull Width (ft) | 10.9 | 7.5 | 12.2 | - | - | - | - | - |
| Entrenchment Ratio | 3.7 | 5.3 | 3.3 | - | - | - | - | - |
| Bank Height Ratio | 1.0 | 0.8 | 0.8 | - | - | - | - | - |

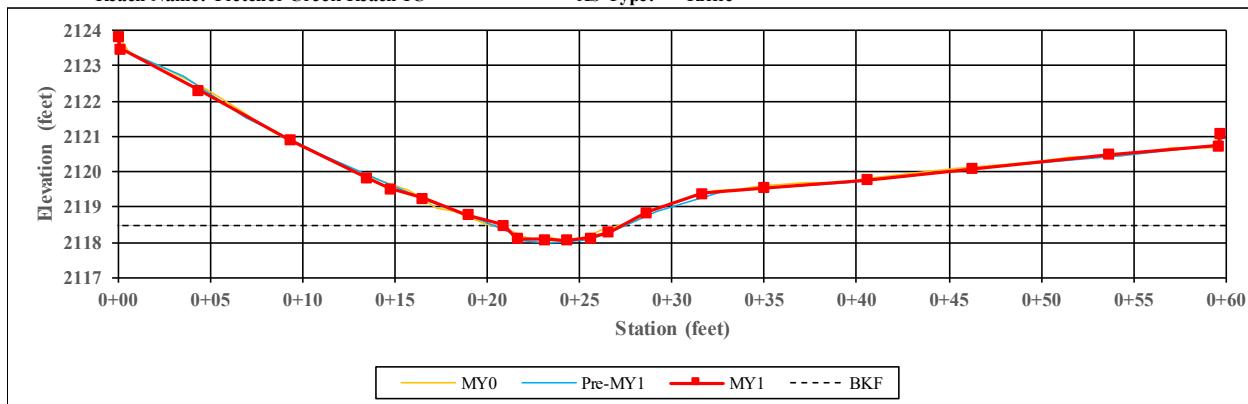
XS Number: 4  
XS Type: Riffle

Station: 112+24

| CHANNEL DIMENSIONS SUMMARY | MY0 | *Pre-MY1 | MY1 | MY2 | MY3 | MY4 | MY5 | MY6 |
| Bankful Width (ft) | 7.6 | 6.1 | 6.5 | - | - | - | - | - |
| Entrenchment Ratio | 1.3 | 1.6 | 1.5 | - | - | - | - | - |
| Bank Height Ratio | 1.0 | 1.4 | 1.3 | - | - | - | - | - |

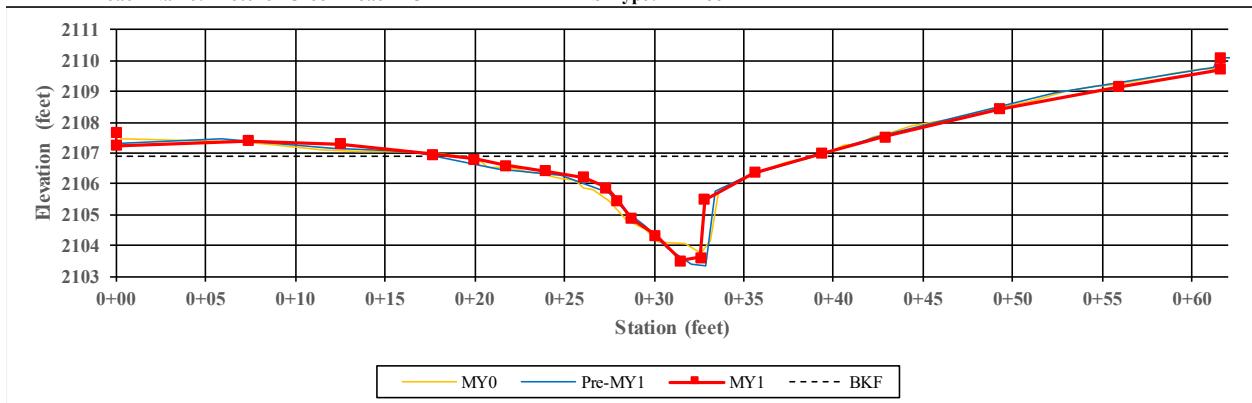
XS Number: 5  
XS Type: Pool

Station: 122+51

| CHANNEL DIMENSIONS SUMMARY | MY0 | *Pre-MY1 | MY1 | MY2 | MY3 | MY4 | MY5 | MY6 |
| Bankfull Width (ft) | 16.6 | 14.0 | 18.7 | - | - | - | - | - |
| Entrenchment Ratio | 3.6 | 4.3 | 3.2 | - | - | - | - | - |
| Bank Height Ratio | 1.0 | 0.8 | 0.8 | - | - | - | - | - |

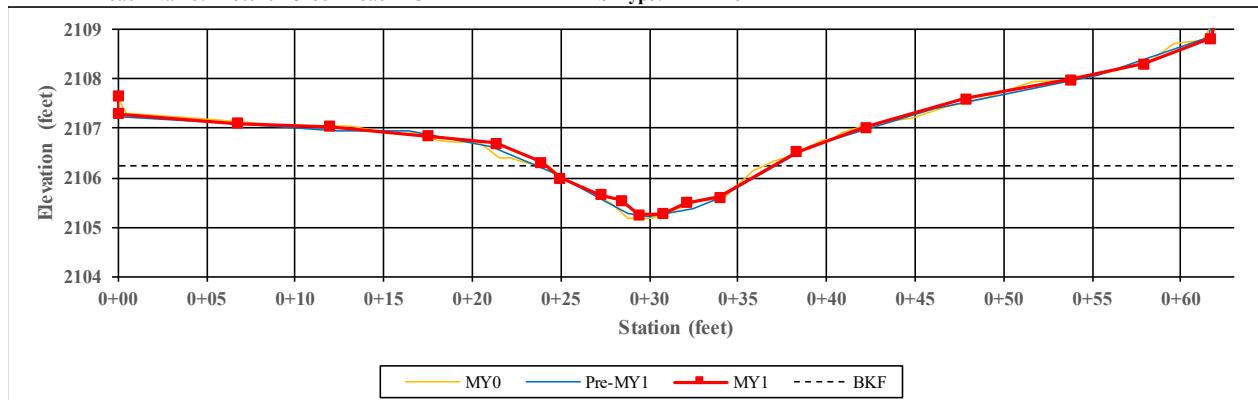
XS Number: 6  
XS Type: Riffle

Station: 122+74

| CHANNEL DIMENSIONS SUMMARY | MY0 | *Pre-MY1 | MY1 | MY2 | MY3 | MY4 | MY5 | MY6 |
| Bankfull Width (ft) | 12.0 | 12.9 | 13.0 | - | - | - | - | - |
| Entrenchment Ratio | 4.2 | 3.9 | 3.9 | - | - | - | - | - |
| Bank Height Ratio | 1.0 | 1.4 | 1.4 | - | - | - | - | - |

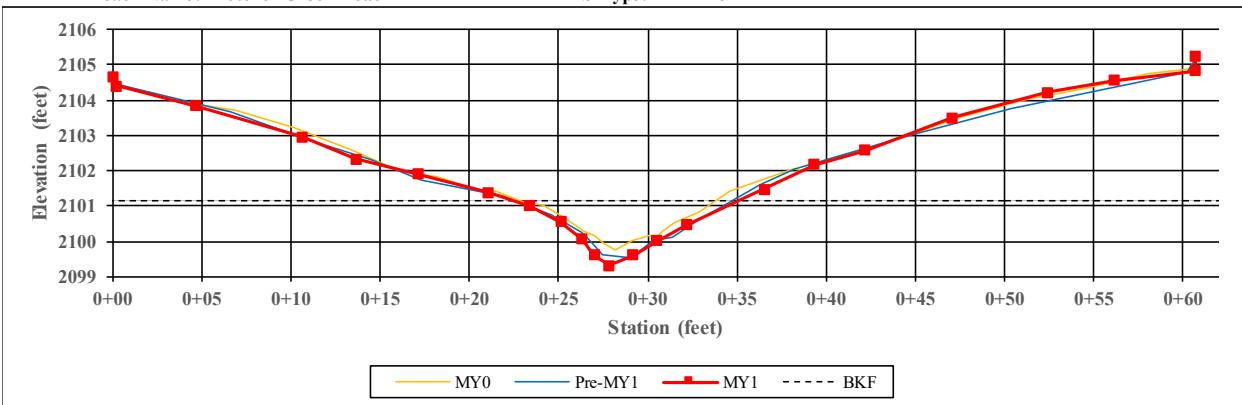
XS Number: 7  
XS Type: Riffle

Station: 127+03

| CHANNEL DIMENSIONS SUMMARY | MY0 | *Pre-MY1 | MY1 | MY2 | MY3 | MY4 | MY5 | MY6 |
| Bankful Width (ft) | 13.1 | 10.6 | 11.7 | - | - | - | - | - |
| Entrenchment Ratio | 2.7 | 3.3 | 3.0 | - | - | - | - | - |
| Bank Height Ratio | 1.0 | 1.0 | 0.9 | - | - | - | - | - |

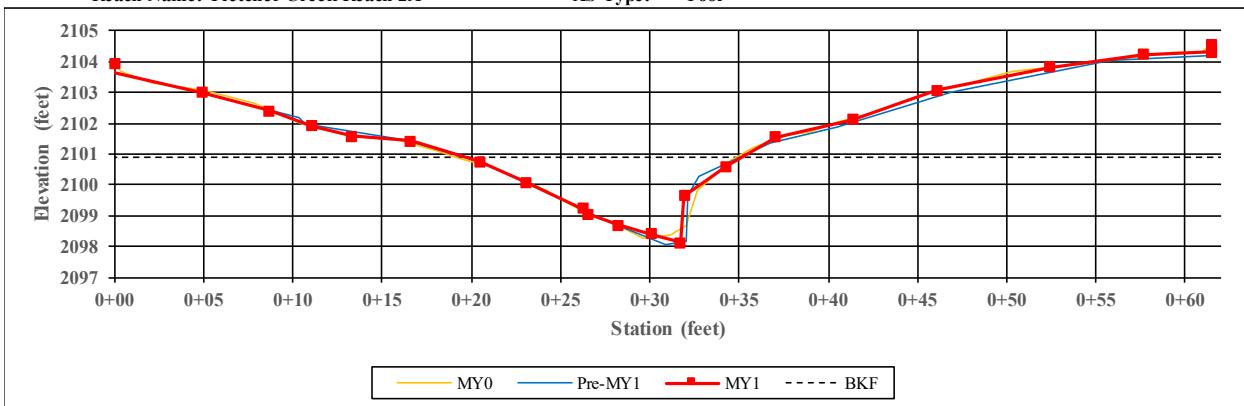
XS Number: 8  
XS Type: Pool

Station: 133+19

| CHANNEL DIMENSIONS SUMMARY | MY0 | *Pre-MY1 | MY1 | MY2 | MY3 | MY4 | MY5 | MY6 |
| Bankful Width (ft) | 15.3 | 15.0 | 15.7 | - | - | - | - | - |
| Entrenchment Ratio | 3.3 | 3.3 | 3.2 | - | - | - | - | - |
| Bank Height Ratio | 1.0 | 0.8 | 0.9 | - | - | - | - | - |
