# **Fletcher Stream and Wetland Mitigation Site**

## **Annual Monitoring Report**

**Monitoring Year 1 of 7**

Fletcher Stream and Wetland Mitigation Site

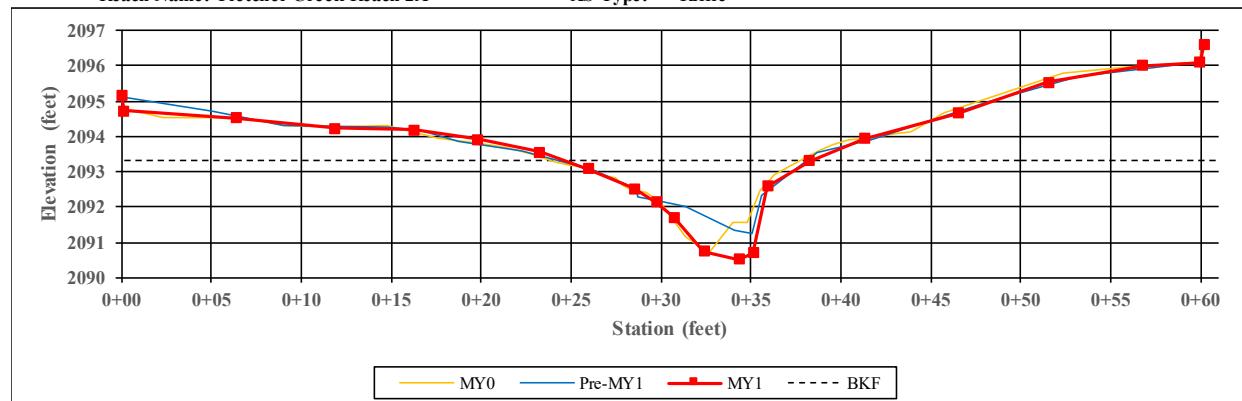
XS Number: 9  
XS Type: Riffle

Station: 133+19

| CHANNEL DIMENSIONS SUMMARY | MY0 | *Pre-MY1 | MY1 | MY2 | MY3 | MY4 | MY5 | MY6 |
| Bankfull Width (ft) | 15.5 | 16.1 | 13.6 | - | - | - | - | - |
| Entrenchment Ratio | 3.9 | 3.7 | 4.4 | - | - | - | - | - |
| Bank Height Ratio | 1.0 | 1.0 | 0.7 | - | - | - | - | - |

Geomorphic data for MY1 was collected during October 2020. Summary tables and cross-section data plots related to stream morphology are located in Appendix D. Cross-sectional dimensions remained relatively stable between baseline conditions and MY1 monitoring efforts. The most substantial changes took place at cross-section 9. Cross-section 9 has shown some aggradation in the Pre-MY1 survey. This had cleared by the MY1 monitoring period, reverting to near as-built condition (Appendix D, cross-section graphics and Table 11a). Riffle dimensions for each reach also remained relatively similar between baseline conditions and MY1 monitoring (Appendix D, Table 11b).

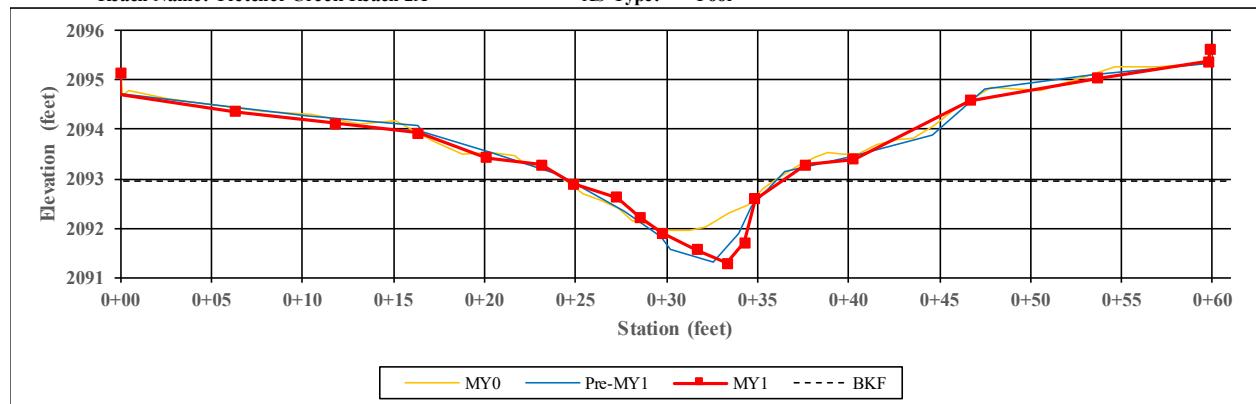
XS Number: 10  
XS Type: Pool

Station: 133+36

| CHANNEL DIMENSIONS SUMMARY | MY0 | *Pre-MY1 | MY1 | MY2 | MY3 | MY4 | MY5 | MY6 |
| Bankful Width (ft) | 12.6 | 11.0 | 11.8 | - | - | - | - | - |
| Entrenchment Ratio | 4.0 | 4.6 | 4.3 | - | - | - | - | - |
| Bank Height Ratio | 1.0 | 1.1 | 1.2 | - | - | - | - | - |

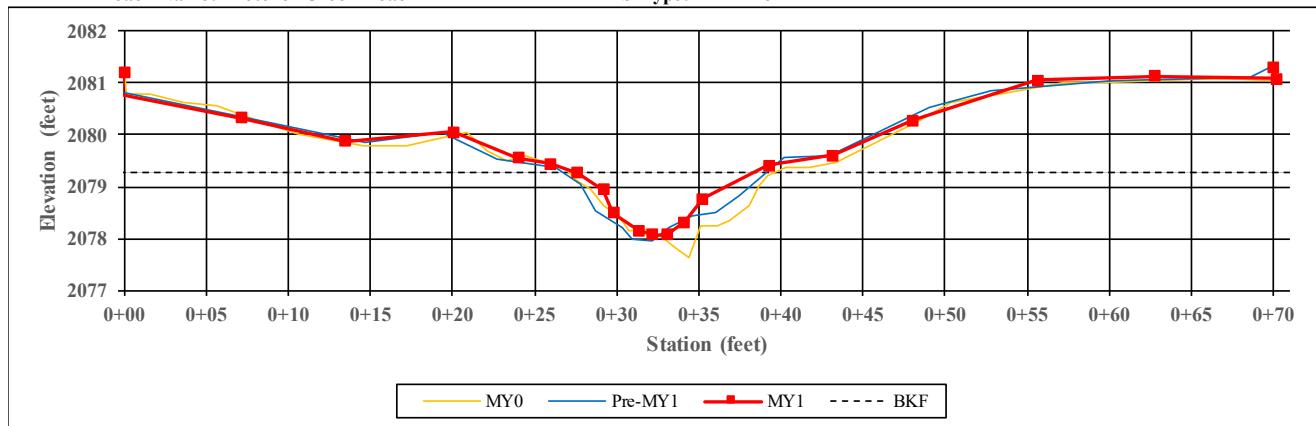
XS Number: 11  
XS Type: Riffle

Station: 147+71

| CHANNEL DIMENSIONS SUMMARY | MY0 | *Pre-MY1 | MY1 | MY2 | MY3 | MY4 | MY5 | MY6 |
| Bankfull Width (ft) | 10.2 | 9.6 | 11.2 | - | - | - | - | - |
| Entrenchment Ratio | 3.9 | 4.2 | 3.6 | - | - | - | - | - |
| Bank Height Ratio | 1.0 | 1.1 | 1.0 | - | - | - | - | - |

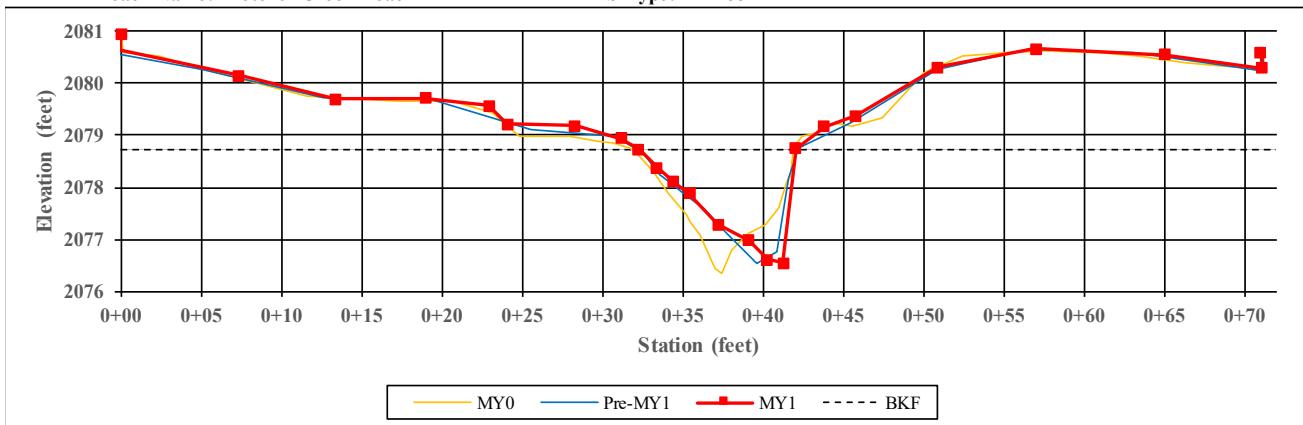
XS Number: 12  
XS Type: Pool

Station: 148+00

| CHANNEL DIMENSIONS SUMMARY | MY0 | *Pre-MY1 | MY1 | MY2 | MY3 | MY4 | MY5 | MY6 |
| Bankfull Width (ft) | 9.7 | 10.0 | 9.7 | - | - | - | - | - |
| Entrenchment Ratio | 7.2 | 7.0 | 7.2 | - | - | - | - | - |
| Bank Height Ratio | 1.0 | 1.0 | 1.0 | - | - | - | - | - |

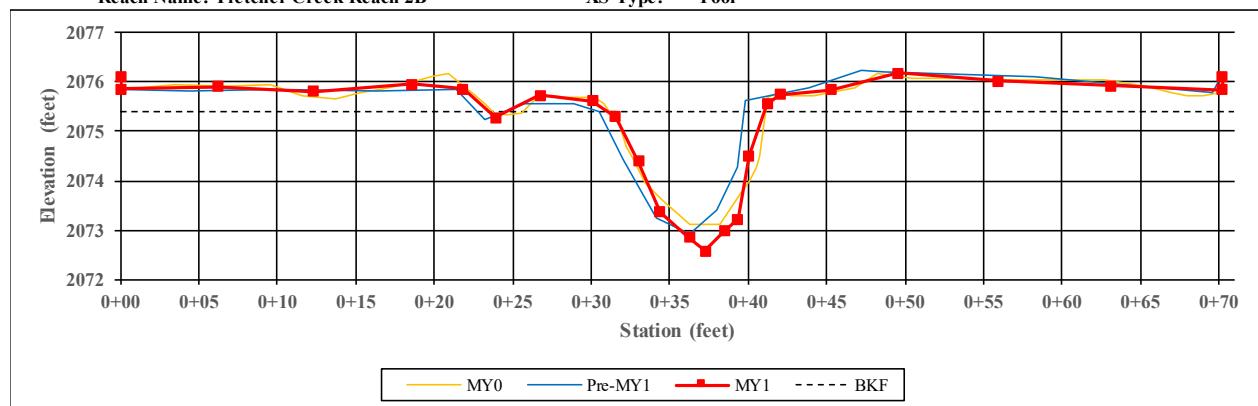
XS Number: 13  
XS Type: Pool

Station: 153+30

| CHANNEL DIMENSIONS SUMMARY | MY0 | *Pre-MY1 | MY1 | MY2 | MY3 | MY4 | MY5 | MY6 |
| Bankfull Width (ft) | 10.1 | 13.1 | 9.9 | - | - | - | - | - |
| Entrenchment Ratio | 6.9 | 5.3 | 7.1 | - | - | - | - | - |
| Bank Height Ratio | 1.0 | 1.0 | 1.1 | - | - | - | - | - |

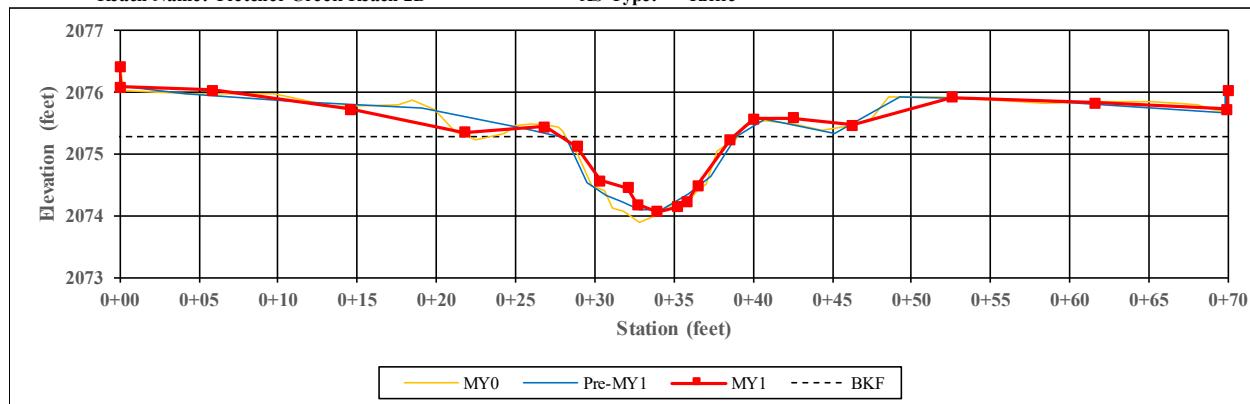
XS Number: 14  
XS Type: Riffle

Station: 153+48

| CHANNEL DIMENSIONS SUMMARY | MY0 | *Pre-MY1 | MY1 | MY2 | MY3 | MY4 | MY5 | MY6 |
| Bankful Width (ft) | 9.8 | 10.3 | 9.7 | - | - | - | - | - |
| Entrenchment Ratio | 7.1 | 6.8 | 7.2 | - | - | - | - | - |
| Bank Height Ratio | 1.0 | 1.1 | 1.1 | - | - | - | - | - |

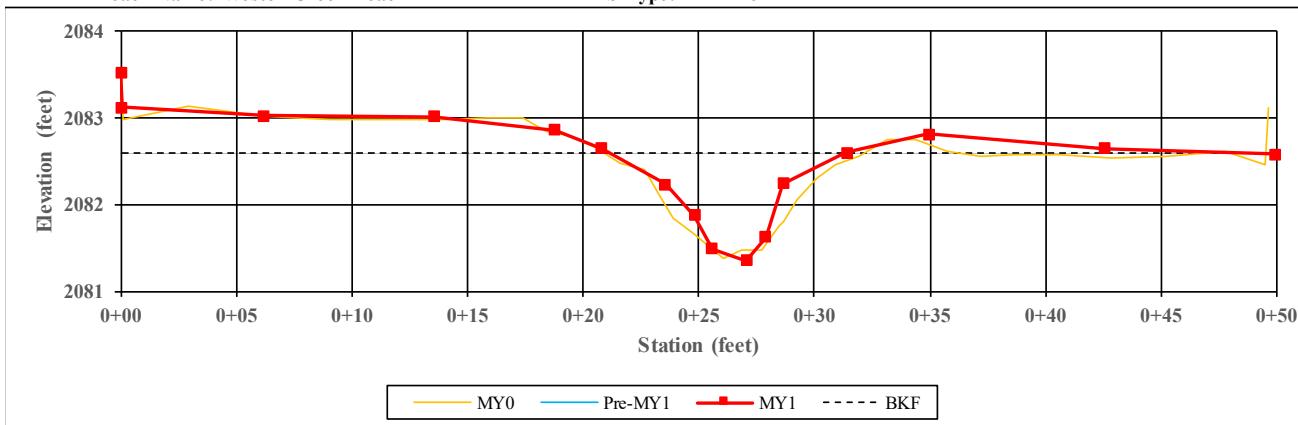
Reach Name: Weston Creek Reach 1A

XS Type: Riffle

| CHANNEL DIMENSIONS SUMMARY | MY0 | *Pre-MY1 | MY1 | MY2 | MY3 | MY4 | MY5 | MY6 |
| Bankfull Width (ft) | 9.1 | - | 10.8 | - | - | - | - | - |
| Entrenchment Ratio | 5.5 | - | 4.6 | - | - | - | - | - |
| Bank Height Ratio | 1.0 | - | 1.2 | - | - | - | - | - |

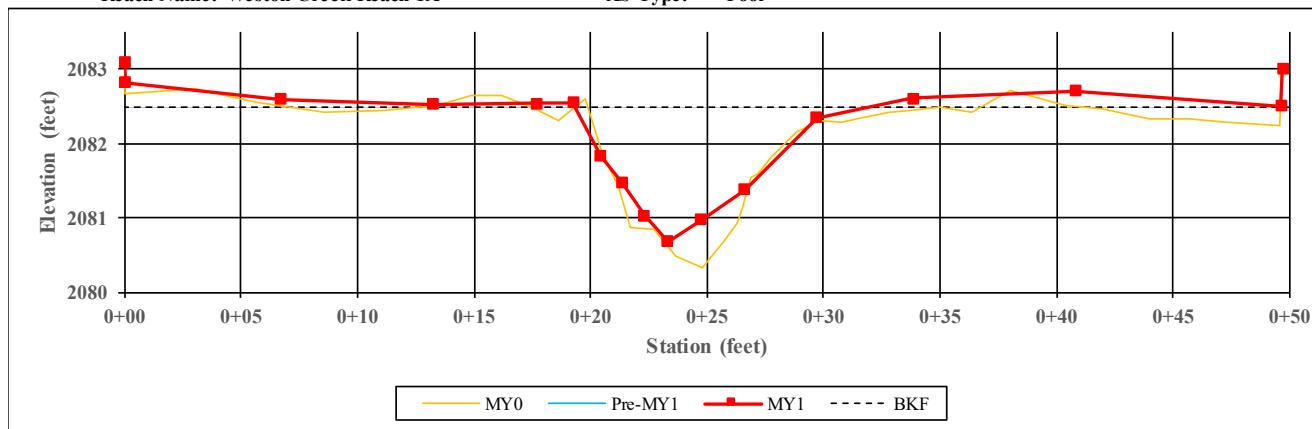
XS Number: 16  
XS Type: Pool

Station: 406+87

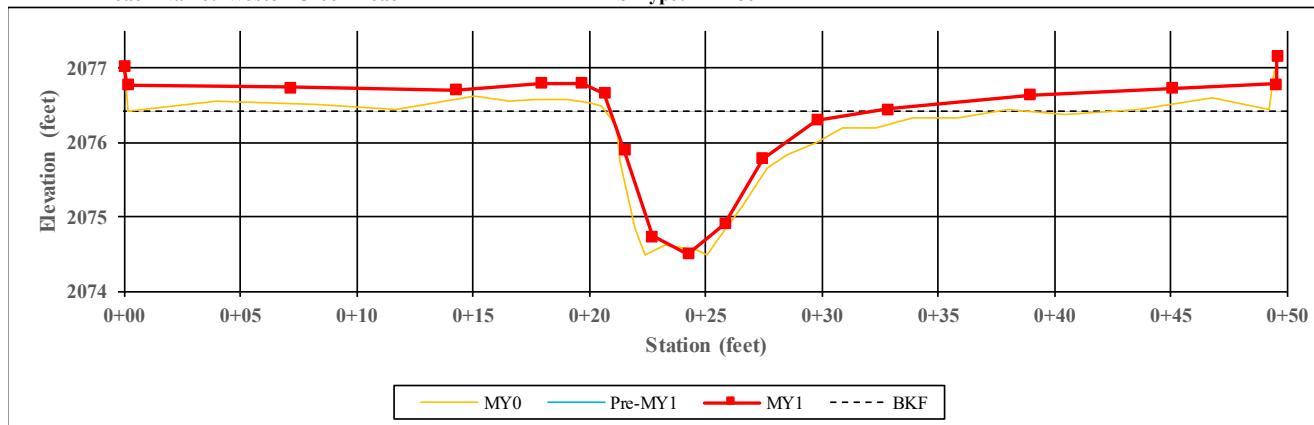
XS Number: 17  
XS Type: Pool

Station: 418+23

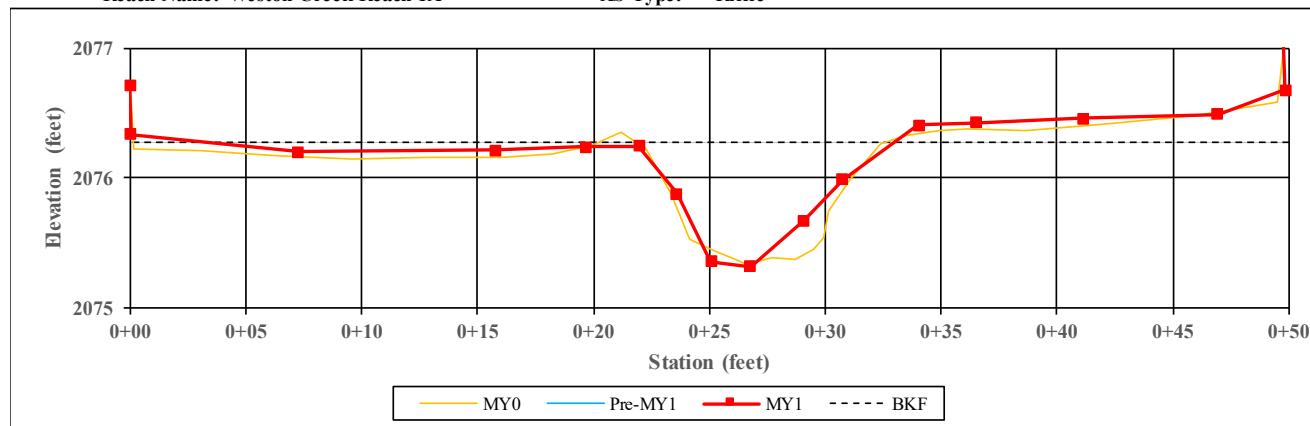
XS Number: 18  
XS Type: Riffle

Station: 418+53

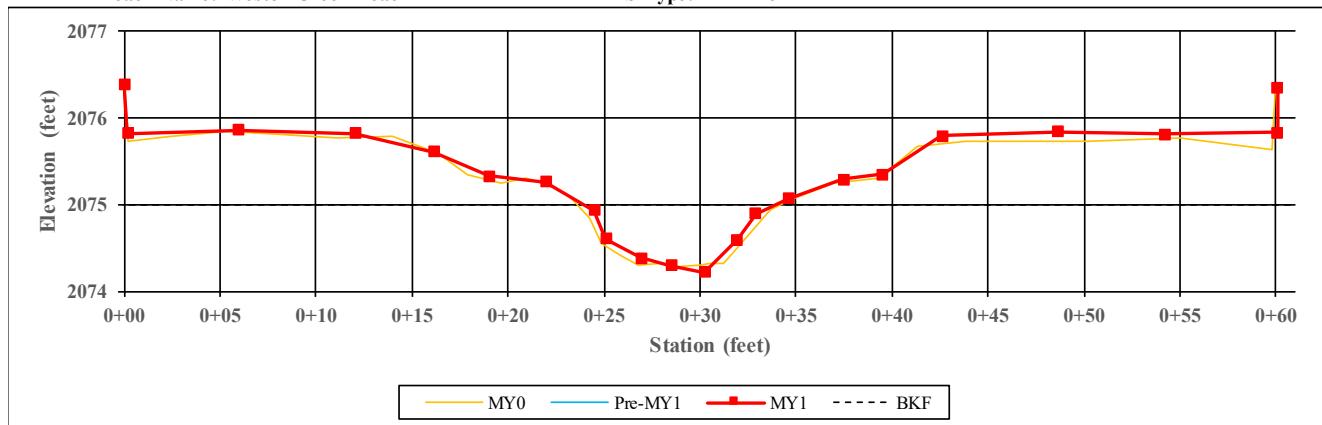
XS Number: 19  
XS Type: Riffle

Station: 422+31

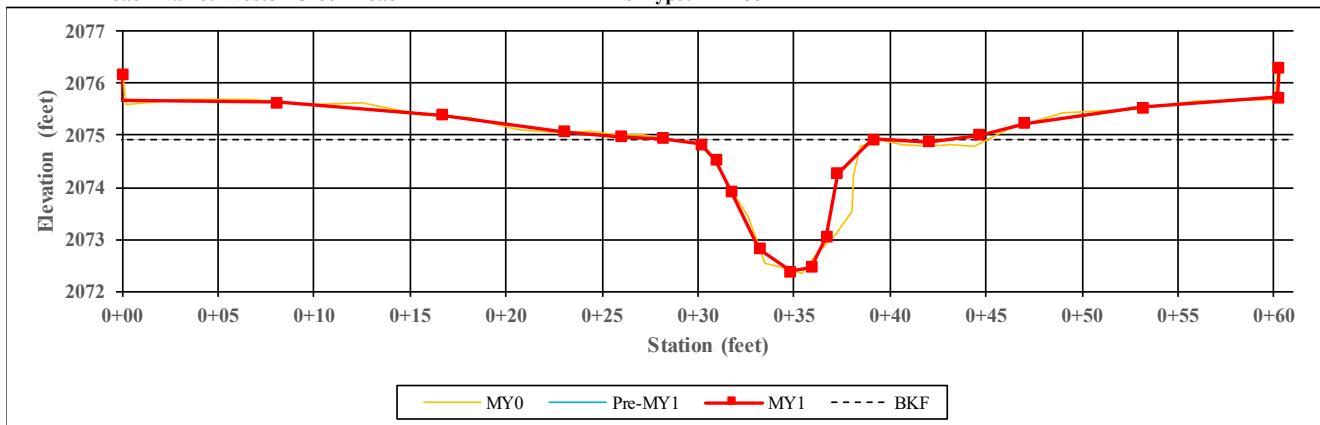
XS Number: 20  
XS Type: Pool

Station: 422+95

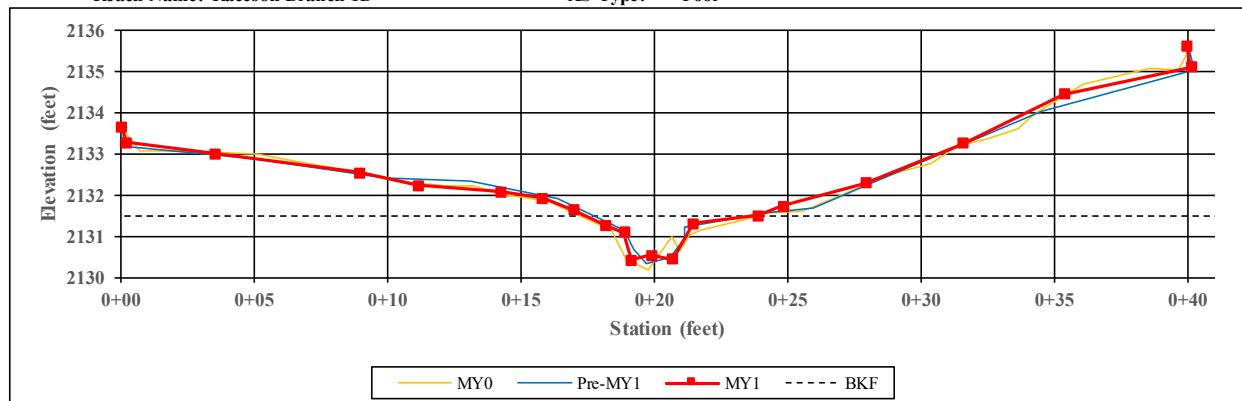
Reach Name: Raccoon Branch 1D

XS Type: Pool

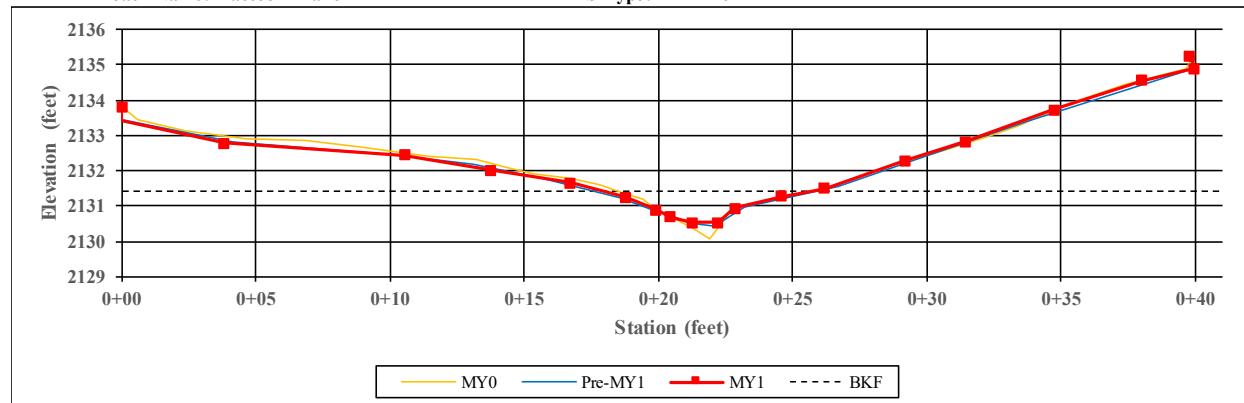
Reach Name: Raccoon Branch 1D

XS Type: Riffle

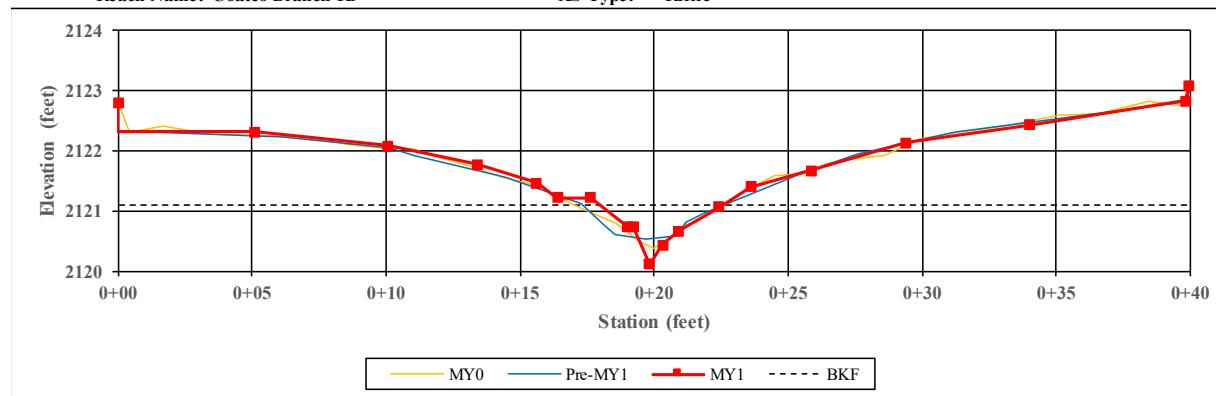
XS Number: 23  
XS Type: Riffle

Station: 307+87

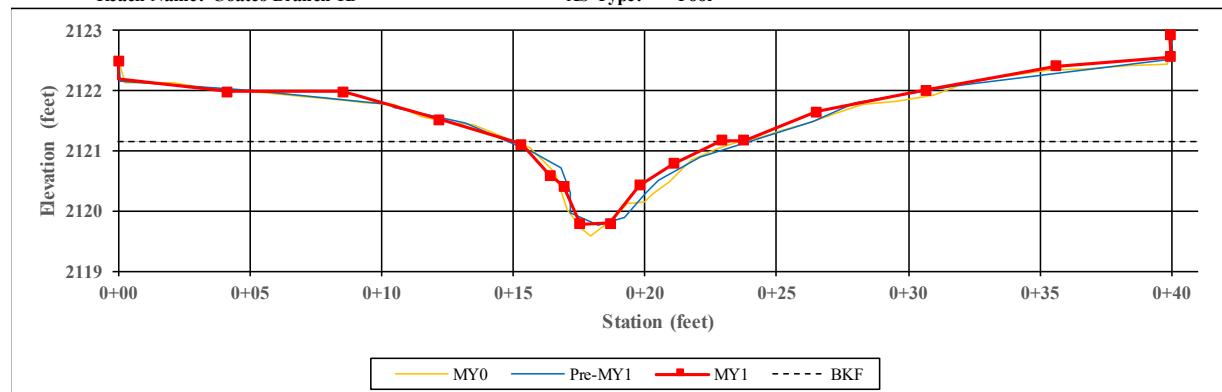
XS Number: 24  
XS Type: Pool

Station: 307+95

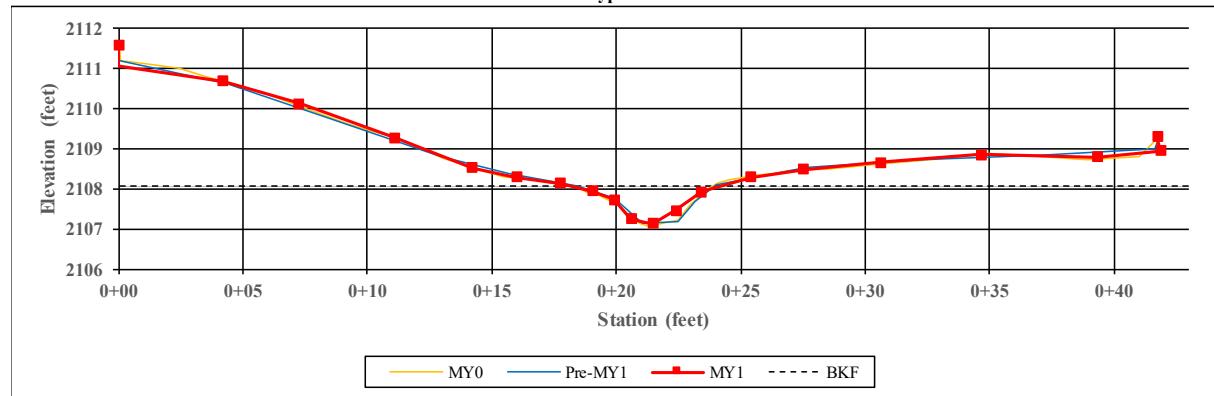
XS Number: 25  
XS Type: Pool

Station: 315+12

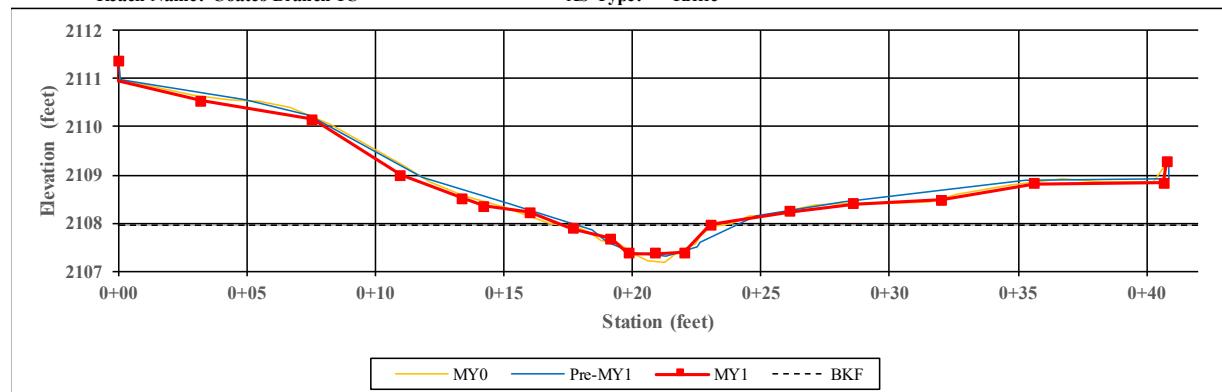
XS Number: 26  
XS Type: Riffle

Station: 315+20

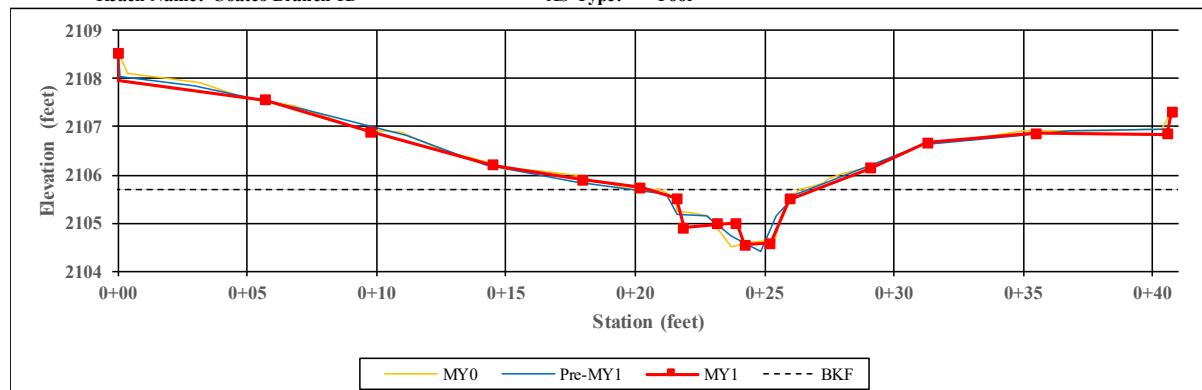
XS Number: 27  
XS Type: Pool

Station: 317+35

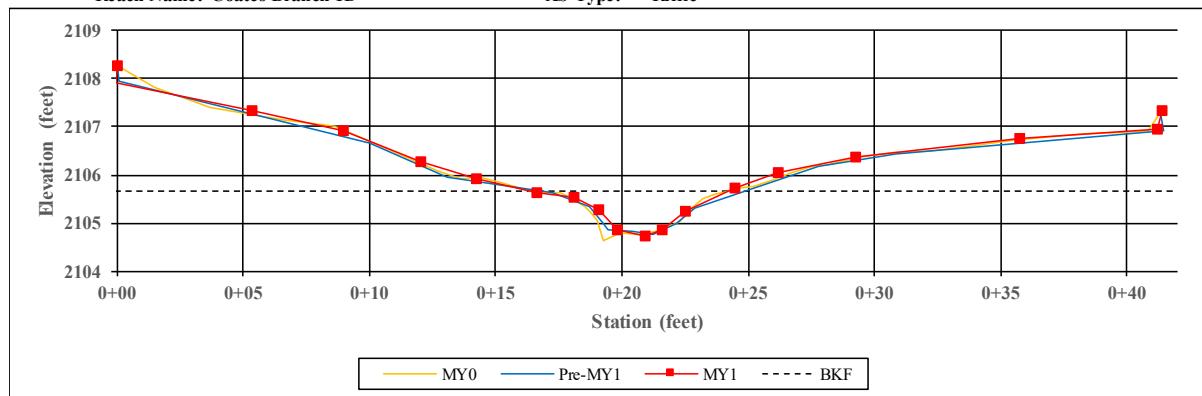
Reach Name: Coates Branch 1D

XS Type: Riffle

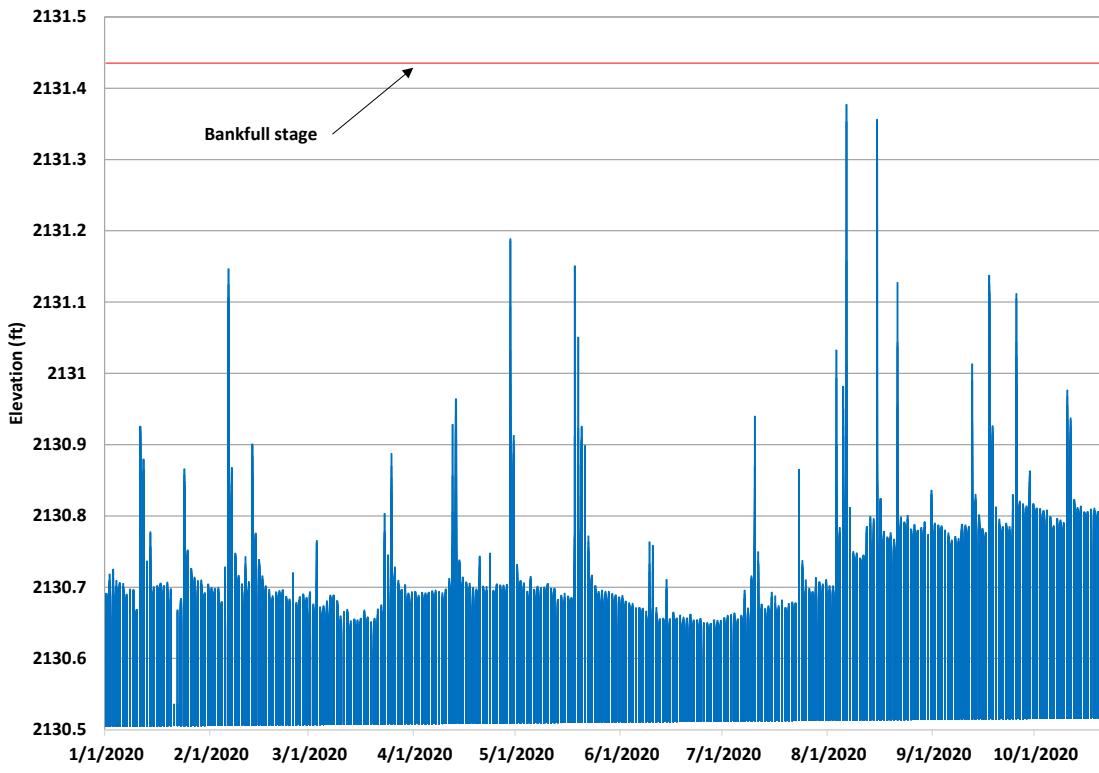
### Raccoon XS22 Stage

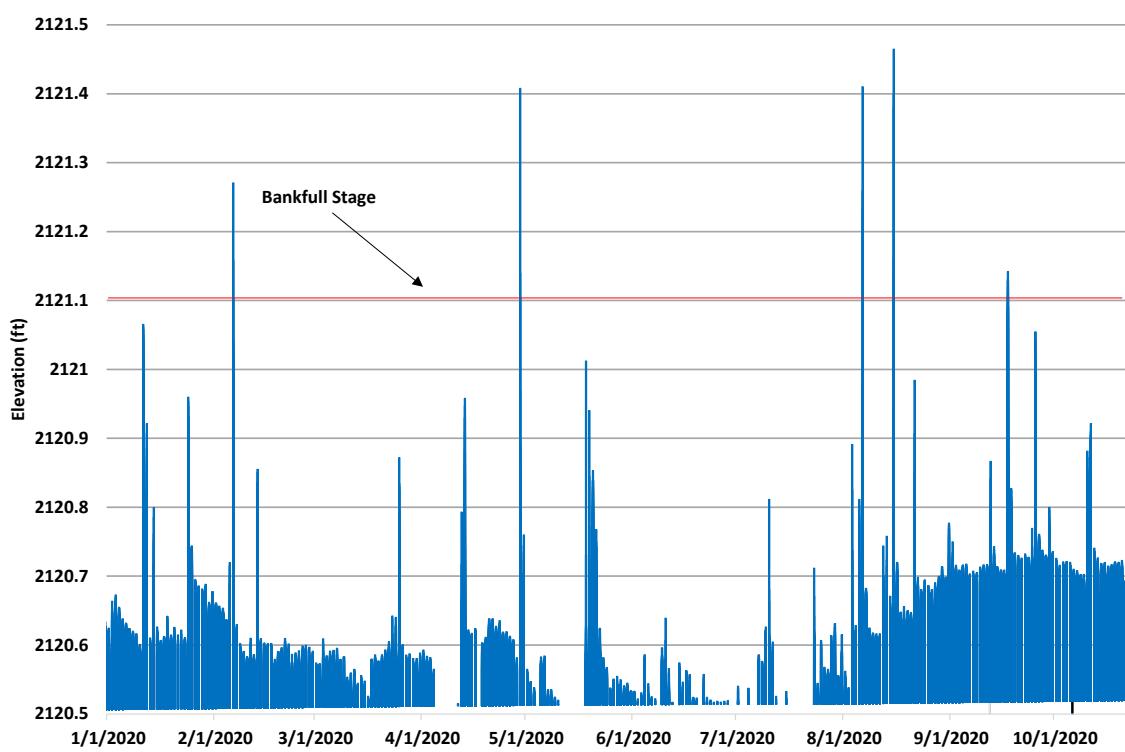
### Coates XS23 Stage MY1 (2020)
