BASELINE MONITORING DOCUMENT AND AS-BUILT BASELINE REPORT

FOUST CREEK MITIGATION SITE

Alamance County, NC DENR Contract 004954 NCDMS Project Number 95715

Wildlands Engineering, Inc. 312 West Millbrook Road, Suite 225 Raleigh, NC 27609

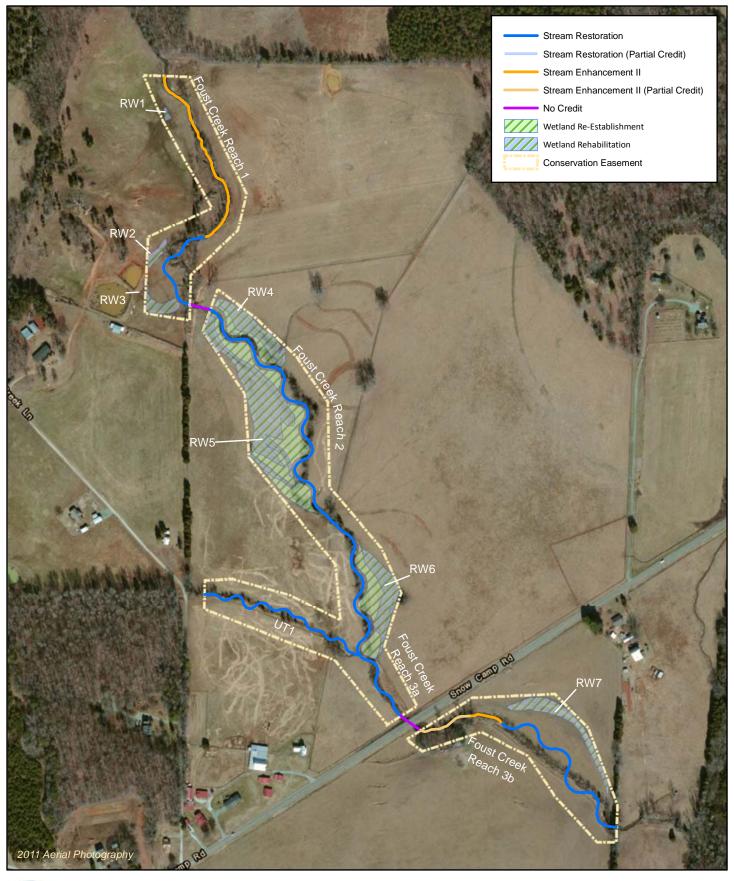
Figure 2 Project Component/ Asset Map Foust Creek Mitigation Site NCDMS Project No. 95715 Monitoring Year 0 - 2015 Alamance County, NC

The project is anticipated to provide 4,770 stream mitigation units (SMUs) and 4.0 wetland mitigation units (WMUs). Please refer to Figure 2 for the project component/asset map for the stream and wetland restoration feature exhibits and Table 1 for the project component and mitigation credit information for the Site.

The design streams were restored to the appropriate type based on the surrounding landscape, climate, and natural vegetation communities but also with strong consideration to existing watershed conditions and trajectory. The Site consists of stream restoration and enhancement, as well as wetland reestablishment and rehabilitation (Figure 2). The specific proposed stream types are described below.

The wetlands proposed for rehabilitation and re-establishment are located within the Foust Creek floodplain and are shown in Figure 2. Photographs of the project site are included in Appendix 2.

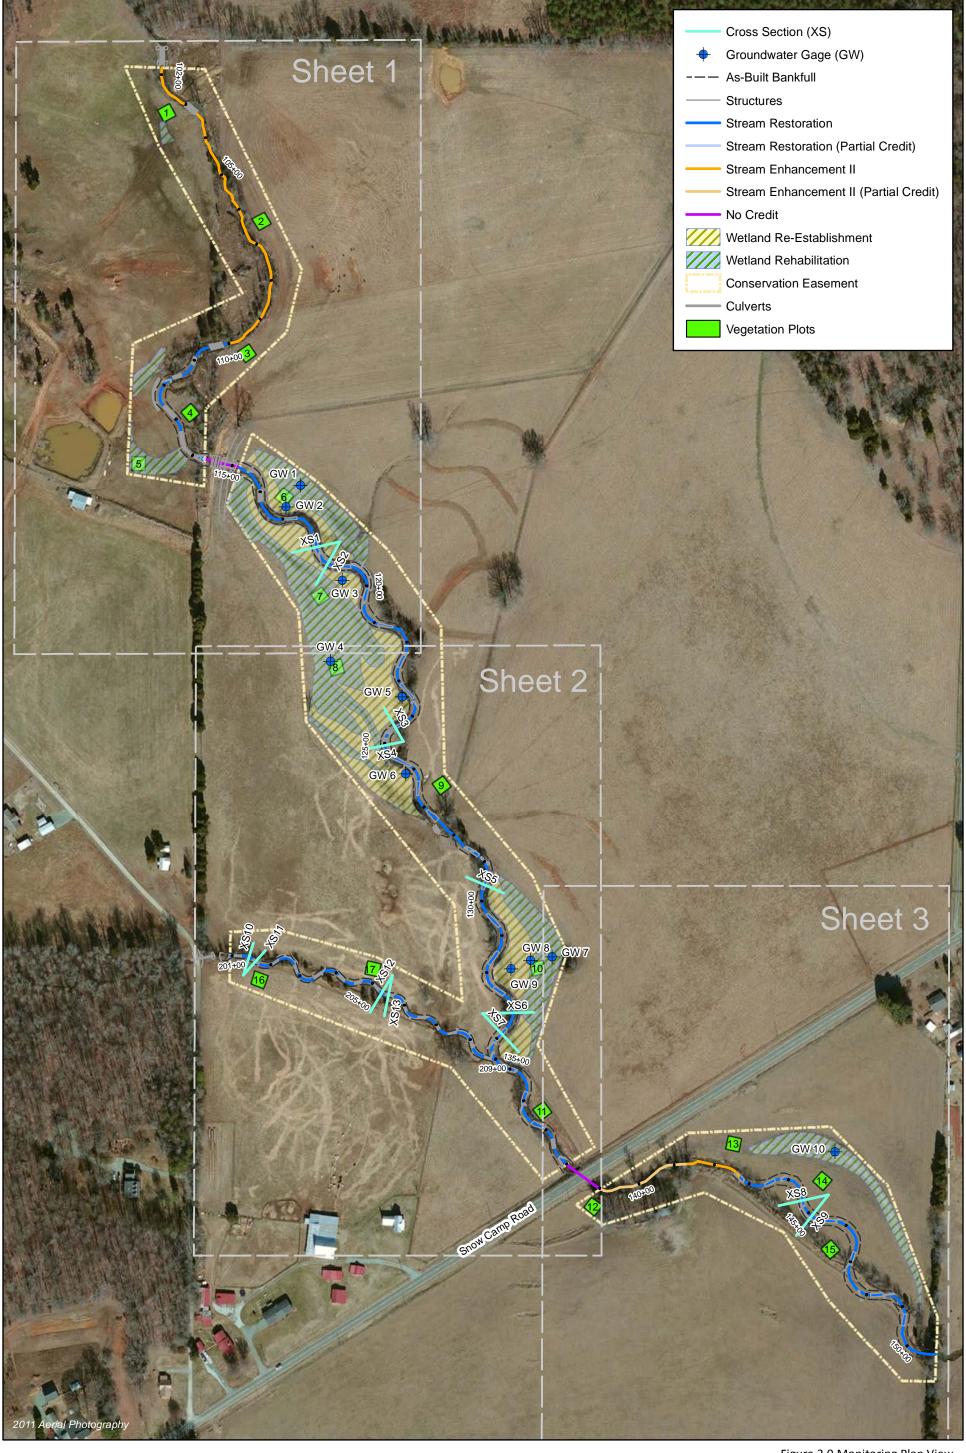
Figure 3.0 Monitoring Plan View (Key) Foust Creek Stream Restoration Site NCDMS Project No. 95715 Monitoring Year 0 - 2015

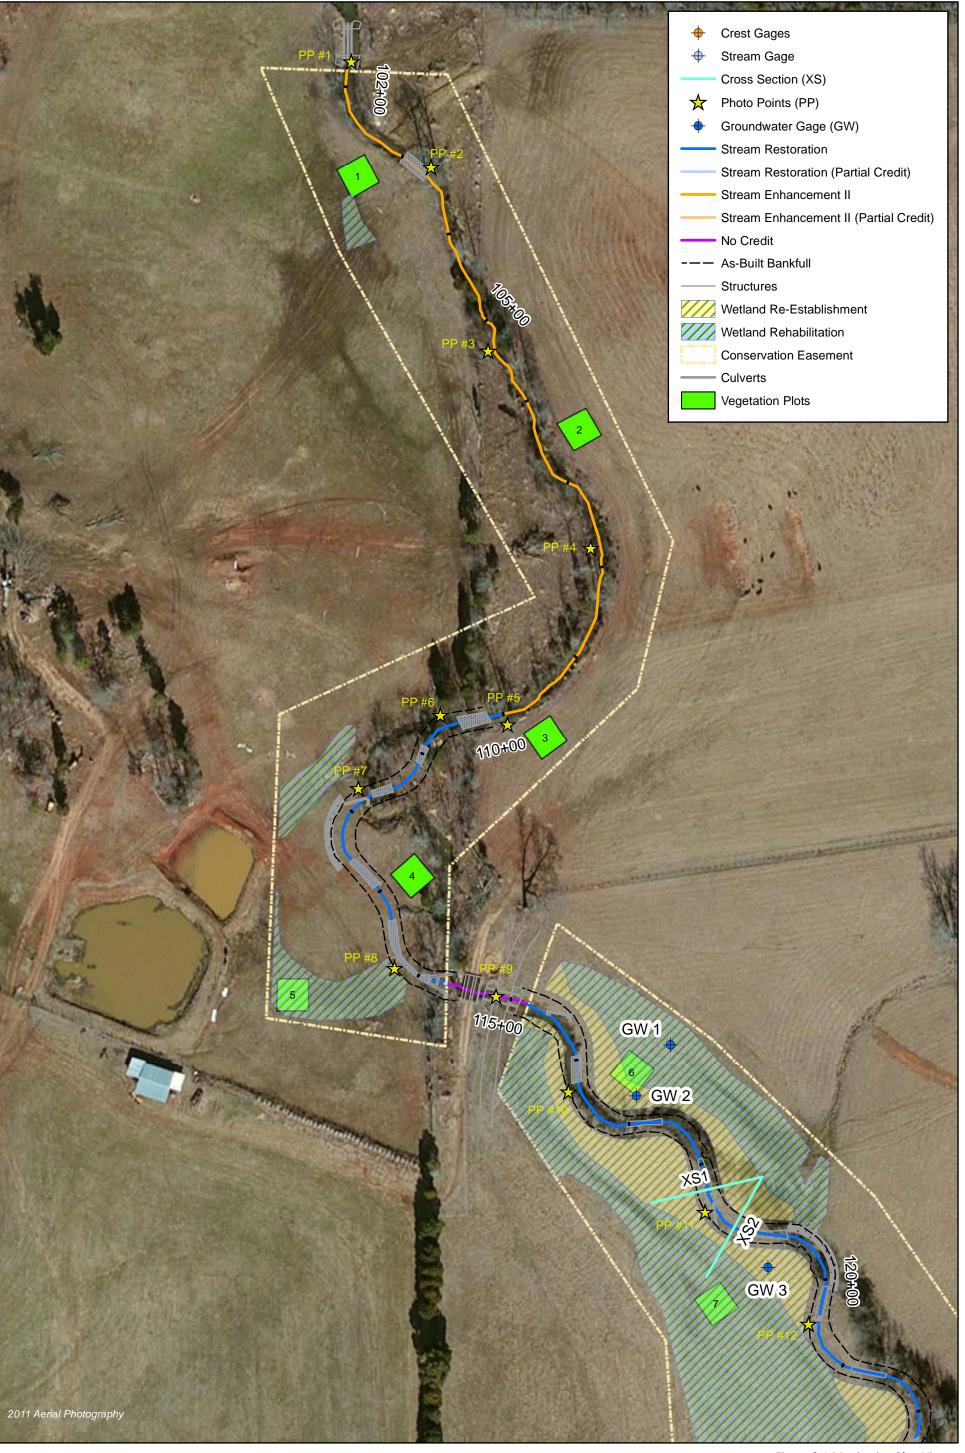
Figure 3.1 Monitoring Plan View (Sheet 1 of 3) Foust Creek Stream Restoration Site NCDMS Project No. 95715 Monitoring Year 0 - 2015

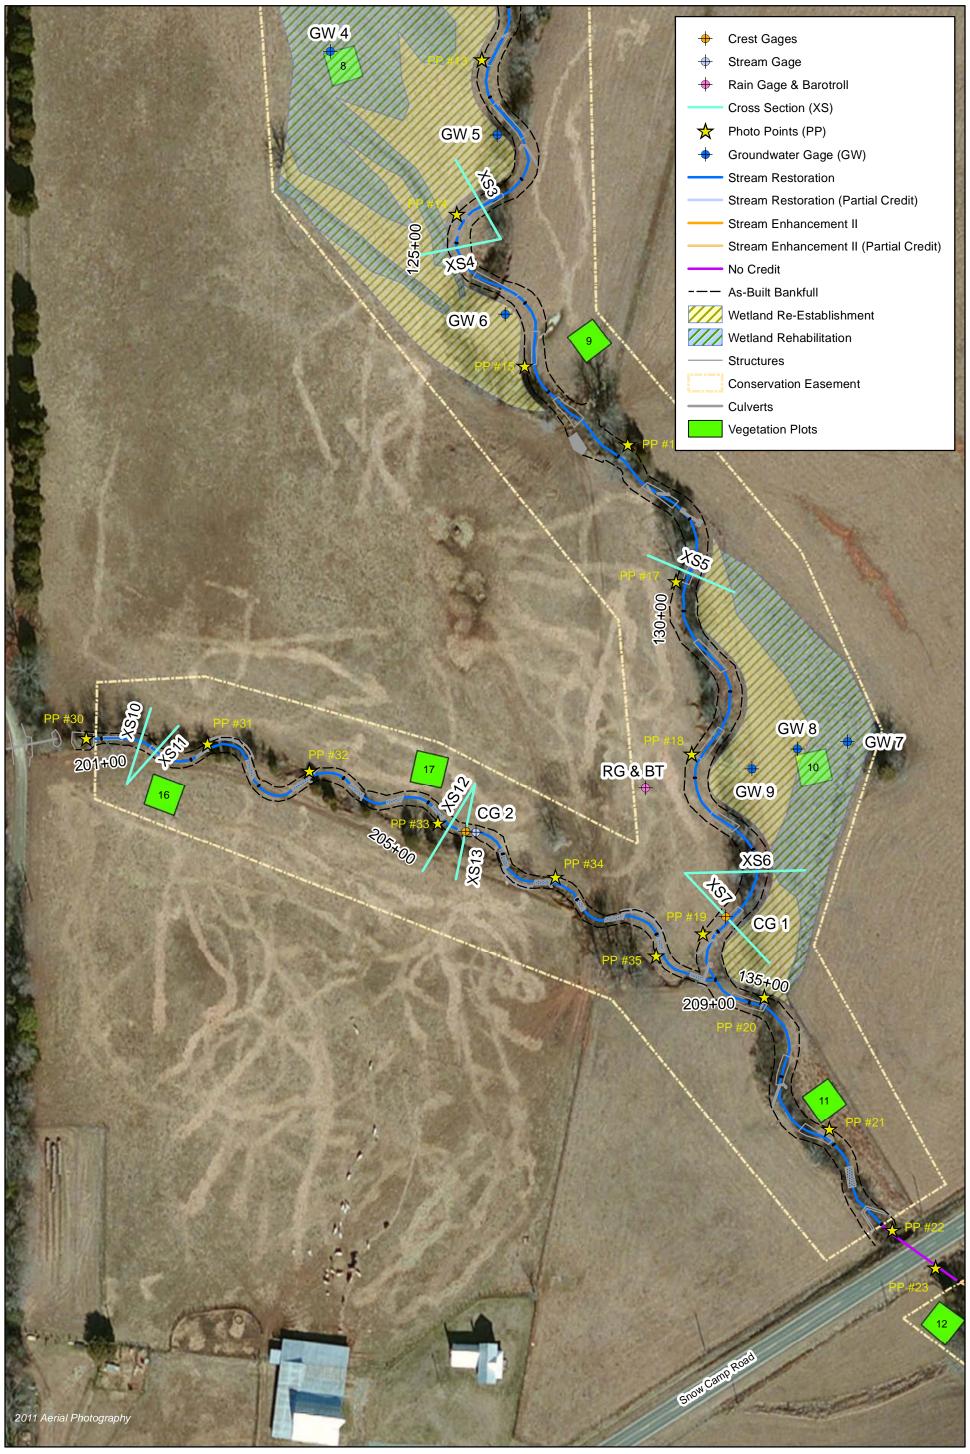
Figure 3.2 Monitoring Plan View (Sheet 2 of 3) Foust Creek Stream Restoration Site NCDMS Project No. 95715 Monitoring Year 0 - 2015

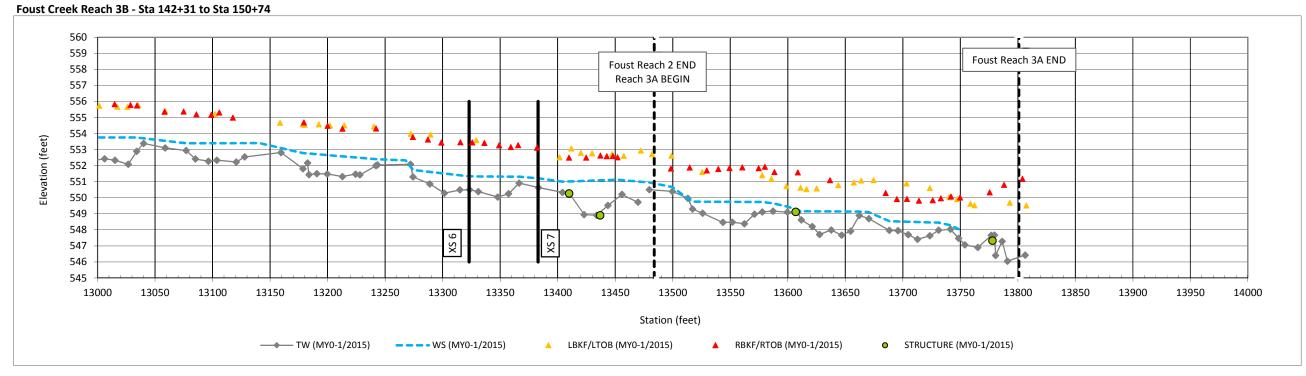
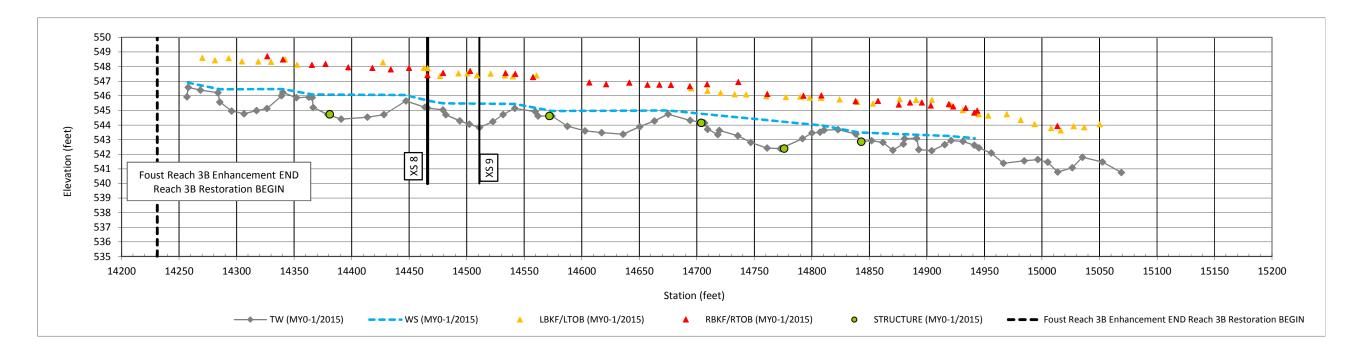
Foust Creek Reach 2 - Sta 109+96 to Sta 134+84
Foust Creek Reach 3A - Sta 134+84 to Sta 138+01

Longitudinal Profile Plots

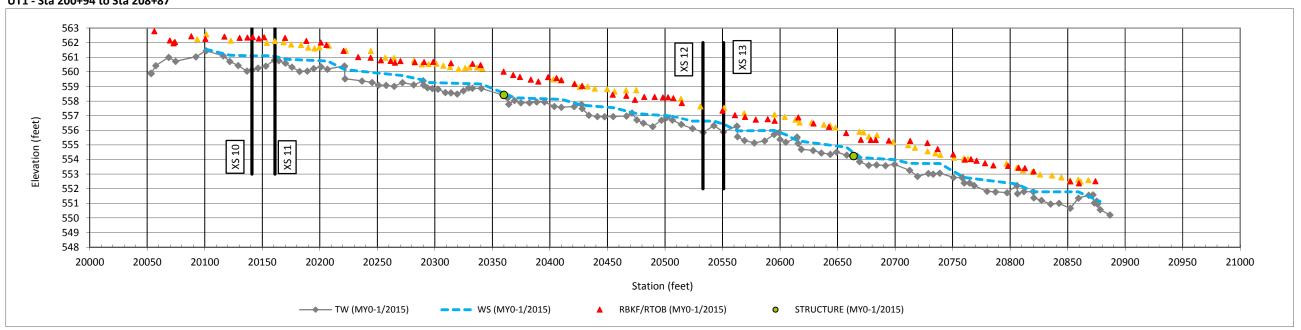
UT1 - Sta 200+94 to Sta 208+87

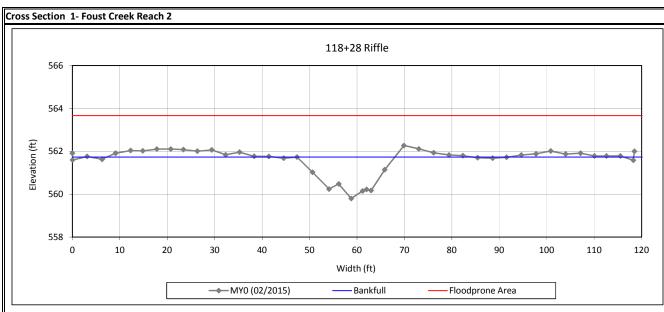
Bankfull Dimensions

- 22.7 x-section area (ft.sq.)
- 20.6 width (ft)
- 1.1 mean depth (ft)
- 1.9 max depth (ft)
- 21.1 wetted parimeter (ft)
- 1.1 hyd radi (ft)
- 18.8 width-depth ratio
- 150.0 W flood prone area (ft)
- 7.3 entrenchment ratio
- 1.0 low bank height ratio

The MYO dimension numbers closely match the design parameters with some minor variability for all reaches. Summary data and cross section plots of each project reach can be found in Appendix 2.

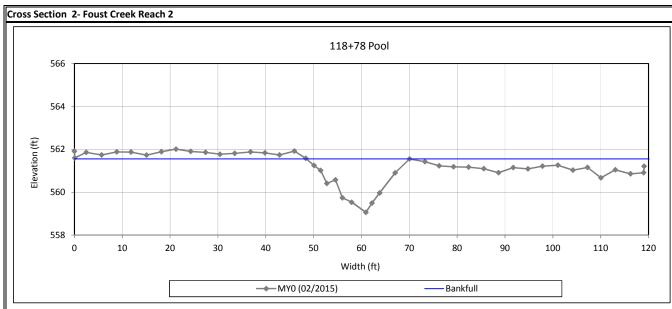
Bankfull Dimensions

26.7 x-section area (ft.sq.)

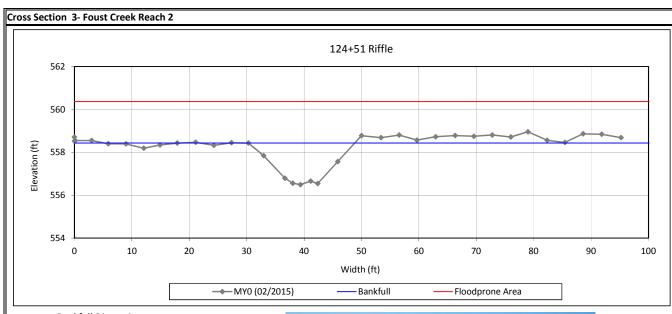
Bankfull Dimensions

- 21.5 x-section area (ft.sq.)
- 18.5 width (ft)
- 1.2 mean depth (ft)
- 1.9 max depth (ft)
- 19.0 wetted parimeter (ft)
- 1.1 hyd radi (ft)
- 16.0 width-depth ratio
- 150.0 W flood prone area (ft)
- 8.1 entrenchment ratio
- 1.0 low bank height ratio

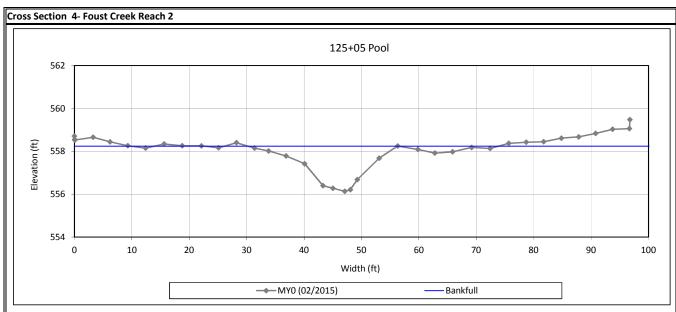
Bankfull Dimensions

24.4 x-section area (ft.sq.)

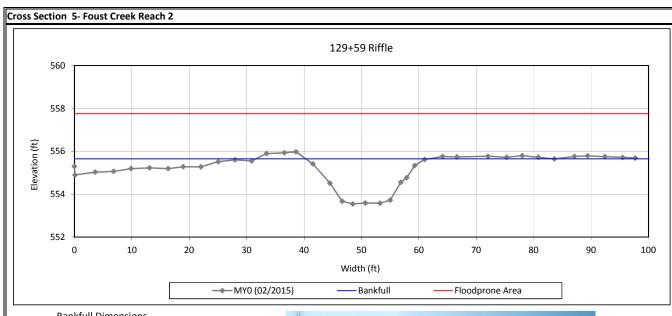
Bankfull Dimensions

- x-section area (ft.sq.) 27.6
- 20.7 width (ft)
- 1.3 mean depth (ft)
- 2.1 max depth (ft)
- wetted parimeter (ft) 21.4
- 1.3 hyd radi (ft)
- width-depth ratio 15.5
- 150.0 W flood prone area (ft)
- 7.2 entrenchment ratio
- 1.0 low bank height ratio

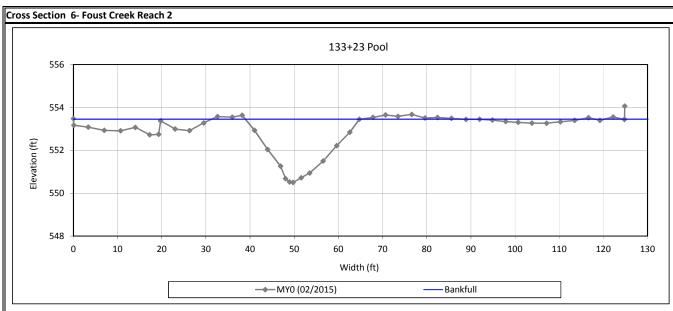
Bankfull Dimensions

41.7 x-section area (ft.sq.)

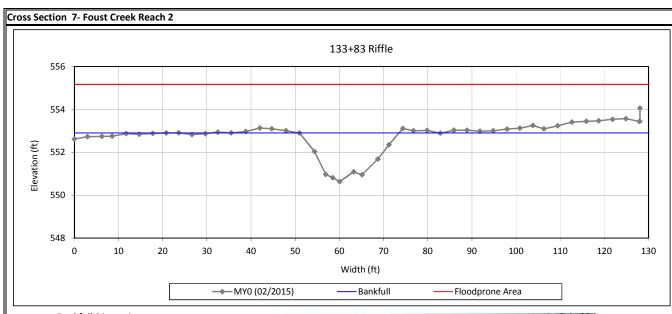
Bankfull Dimensions

- 30.2 x-section area (ft.sq.)
- 22.5 width (ft)
- 1.3 mean depth (ft)
- 2.3 max depth (ft)
- 23.1 wetted parimeter (ft)
- 1.3 hyd radi (ft)
- 16.8 width-depth ratio
- 150.0 W flood prone area (ft)
- 6.7 entrenchment ratio
- 1.0 low bank height ratio

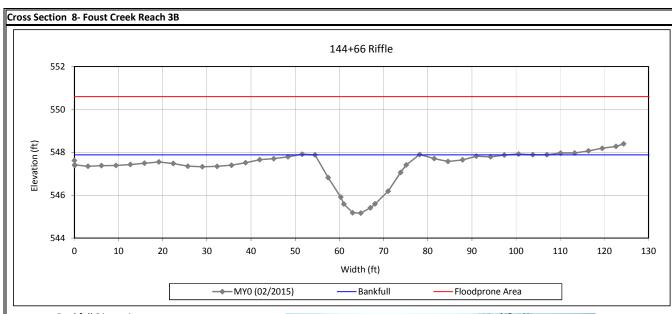
Bankfull Dimensions

- 36.5 x-section area (ft.sq.)
- 23.6 width (ft)
- 1.5 mean depth (ft)
- 2.7 max depth (ft)
- 24.3 wetted parimeter (ft)
- 1.5 hyd radi (ft)
- 15.2 width-depth ratio
- 150.0 W flood prone area (ft)
- 6.4 entrenchment ratio
- 1.0 low bank height ratio

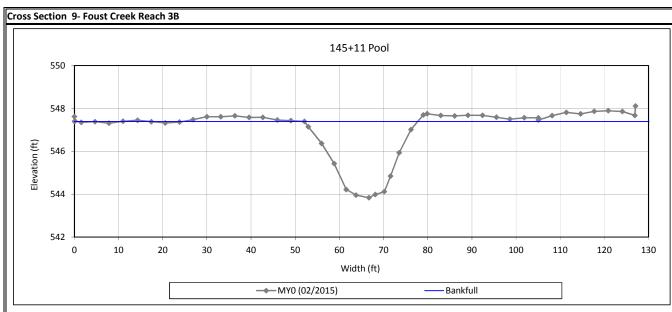
Bankfull Dimensions

53.5 x-section area (ft.sq.)

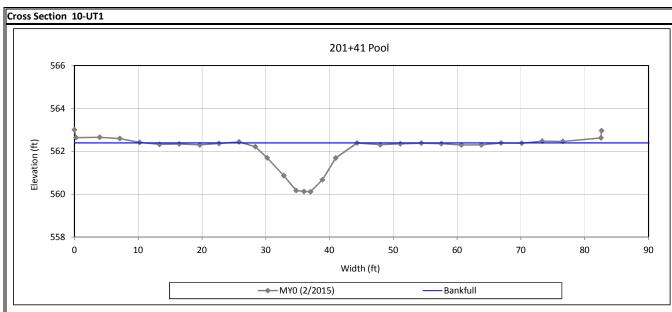
Bankfull Dimensions

20.0 x-section area (ft.sq.)

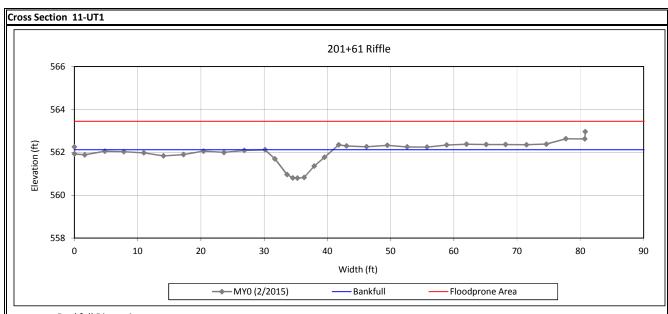
Bankfull Dimensions

- 8.1 x-section area (ft.sq.)
- 10.8 width (ft)
- 0.8 mean depth (ft)
- 1.3 max depth (ft)
- 11.1 wetted parimeter (ft)
- 0.7 hyd radi (ft)
 - .2 width-depth ratio
- 150.0 W flood prone area (ft)
- 13.9 entrenchment ratio
- 1.0 low bank height ratio

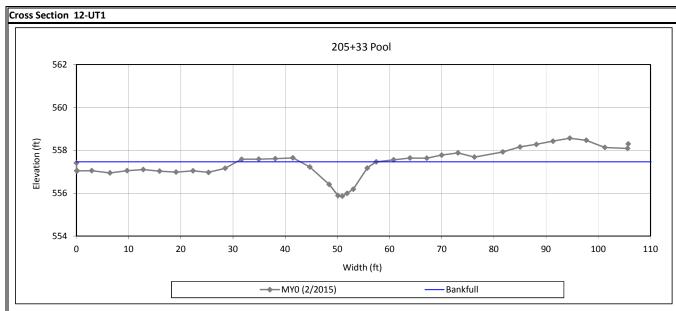
Bankfull Dimensions

11.5 x-section area (ft.sq.)

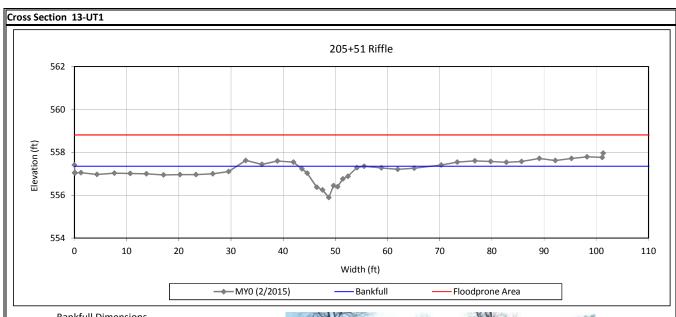
Bankfull Dimensions

- x-section area (ft.sq.) 7.7
- width (ft) 12.6
- 0.6 mean depth (ft)
- 1.5 max depth (ft)
- wetted parimeter (ft) 13.0
- 0.6 hyd radi (ft)
 - width-depth ratio
- 150.0 W flood prone area (ft)
- 11.9 entrenchment ratio
- 1.0 low bank height ratio

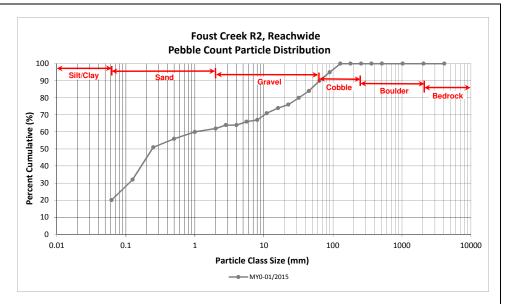
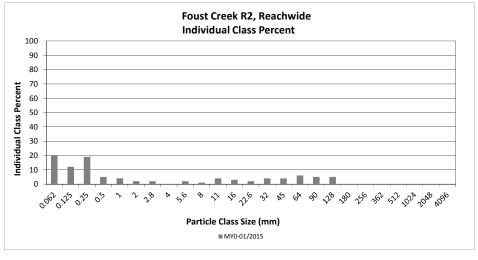
Diame	ter (mm)	Pa	rticle Co	unt	Reach S	ummary
Particle Class		min	max	Riffle	Pool	Total	Class Percentage	Percent Cumulative
SILT/CLAY	Silt/Clay	0.000	0.062		20	20	20	20
	Very fine	0.062	0.125	2	10	12	12	32
	Fine	0.125	0.250	4	15	19	19	51
SAND	Medium	0.25	0.50		5	5	5	56
יכ	Coarse	0.5	1.0	1	3	4	4	60
	Very Coarse	1.0	2.0		2	2	2	62
	Very Fine	2.0	2.8		2	2	2	64
	Very Fine	2.8	4.0					64
	Fine	4.0	5.6		2	2	2	66
	Fine	5.6	8.0	1		1	1	67
36	Medium	8.0	11.0	3	1	4	4	71
GRAVEL	Medium	11.0	16.0	3		3	3	74
	Coarse	16.0	22.6	2		2	2	76
	Coarse	22.6	32	4		4	4	80
	Very Coarse	32	45	4		4	4	84
	Very Coarse	45	64	6		6	6	90
	Small	64	90	5		5	5	95
ale	Small	90	128	5		5	5	100
CORRIE	Large	128	180					100
	Large	180	256					100
ROUTER TO	Small	256	362					100
	Small	362	512					100
	Medium	512	1024	•				100
*	Large/Very Large	1024	2048					100
BEDROCK	Bedrock	2048	>2048					100
·			Total	40	60	100	100	100

Reachwide						
Chann	Channel materials (mm)					
D ₁₆ =	Silt/Clay					
D ₃₅ =	0.14					
D ₅₀ =	0.2					
D ₈₄ =	45.0					
D ₉₅ =	90.0					
D ₁₀₀ =	128.0

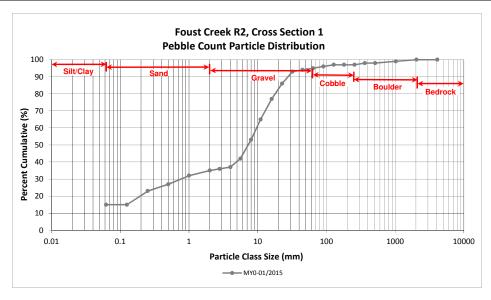
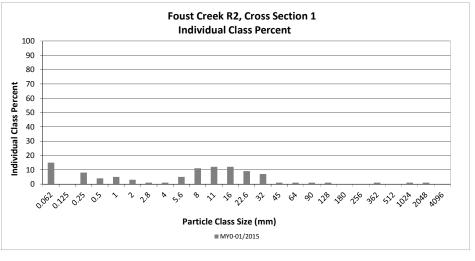
Particle Class		ter (mm)	Riffle 100-	Sum	mary
Par			max	Count	Class	Percent Cumulative
SILT/CLAY Silt/Clay		min 0.000	0.062	15	Percentage 15	15
SILT/CLAT	***			13	13	
	Very fine	0.062	0.125		_	15
v0	Fine	0.125	0.250	8	8	23
SAND	Medium	0.25	0.50	4	4	27
	Coarse	0.5	1.0	5	5	32
	Very Coarse	1.0	2.0	3	3	35
	Very Fine	2.0	2.8	1	1	36
	Very Fine	2.8	4.0	1	1	37
	Fine	4.0	5.6	5	5	42
	Fine	5.6	8.0	11	11	53
JE	Medium	8.0	11.0	12	12	65
GRAVEL	Medium	11.0	16.0	12	12	77
	Coarse	16.0	22.6	9	9	86
	Coarse	22.6	32	7	7	93
	Very Coarse	32	45	1	1	94
	Very Coarse	45	64	1	1	95
	Small	64	90	1	1	96
COBBLE	Small	90	128	1	1	97
COST	Large	128	180			97
	Large	180	256			97
	Small	256	362	1	1	98
	Small	362	512			98
ao ^{oy}	Medium	512	1024	1	1	99
¥	Large/Very Large	1024	2048	1	1	100
BEDROCK	Bedrock	2048	>2048			100
			Total	100	100	100

Cross Section 1					
Ch	annel materials (mm)				
D ₁₆ =	0.14				
D ₃₅ =	2.00				
D ₅₀ =	7.3				
D ₈₄ =	20.9				
D ₉₅ =	64.0				
D ₁₀₀ =	2048.0

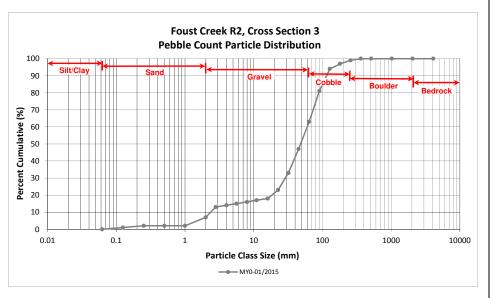
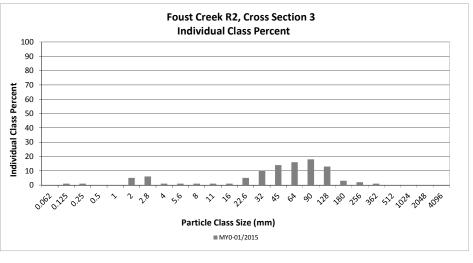
Diame	ter (mm)	Riffle 100-	Sum	mary
Particle Class		min	max	Count	Class Percentage	Percent Cumulative
SILT/CLAY	Silt/Clay	0.000	0.062			0
	Very fine	0.062	0.125	1	1	1
_	Fine	0.125	0.250	1	1	2
SAND	Medium	0.25	0.50			2
۵,	Coarse	0.5	1.0			2
	Very Coarse	1.0	2.0	5	5	7
	Very Fine	2.0	2.8	6	6	13
	Very Fine	2.8	4.0	1	1	14
	Fine	4.0	5.6	1	1	15
	Fine	5.6	8.0	1	1	16
36	Medium	8.0	11.0	1	1	17
GRAVEL	Medium	11.0	16.0	1	1	18
	Coarse	16.0	22.6	5	5	23
	Coarse	22.6	32	10	10	33
	Very Coarse	32	45	14	14	47
	Very Coarse	45	64	16	16	63
	Small	64	90	18	18	81
COBBLE	Small	90	128	13	13	94
CORY	Large	128	180	3	3	97
	Large	180	256	2	2	99
_	Small	256	362	1	1	100
RONDER	Small	362	512			100
wy.	Medium	512	1024	-		100
~	Large/Very Large	1024	2048			100
BEDROCK	Bedrock	2048	>2048			100
			Total	100	100	100

Cross Section 3						
Ch	Channel materials (mm)					
D ₁₆ =	8.00					
D ₃₅ =	33.60					
D ₅₀ =	48.1					
D ₈₄ =	97.6					
D ₉₅ =	143.4					
D ₁₀₀ =	362.0

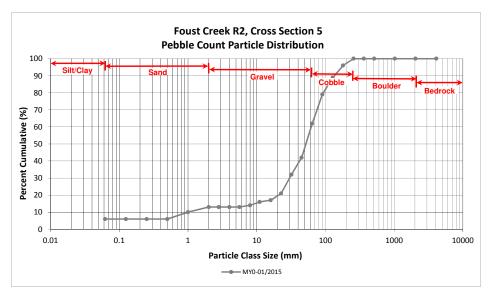
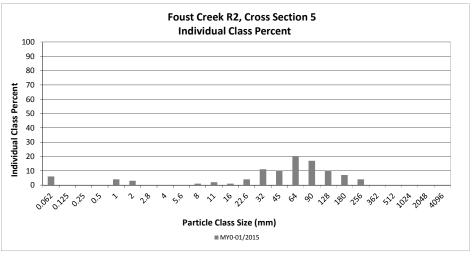
Particle Class		Diame	ter (mm)	Riffle 100-	Sum	mary
		min	max	Count	Class Percentage	Percent Cumulative
SILT/CLAY	Silt/Clay	0.000	0.062	6	6	6
	Very fine	0.062	0.125			6
_	Fine	0.125	0.250			6
SAND	Medium	0.25	0.50			6
יל	Coarse	0.5	1.0	4	4	10
	Very Coarse	1.0	2.0	3	3	13
	Very Fine	2.0	2.8			13
	Very Fine	2.8	4.0			13
	Fine	4.0	5.6			13
	Fine	5.6	8.0	1	1	14
GRAVEL	Medium	8.0	11.0	2	2	16
Gar.	Medium	11.0	16.0	1	1	17
	Coarse	16.0	22.6	4	4	21
	Coarse	22.6	32	11	11	32
	Very Coarse	32	45	10	10	42
	Very Coarse	45	64	20	20	62
	Small	64	90	17	17	79
COBBLE	Small	90	128	10	10	89
COBL	Large	128	180	7	7	96
	Large	180	256	4	4	100
	Small	256	362			100
*ONDE	Small	362	512			100
	Medium	512	1024	-		100
V	Large/Very Large	1024	2048			100
BEDROCK	Bedrock	2048	>2048			100
			Total	100	100	100

Cross Section 5						
Ch	annel materials (mm)					
D ₁₆ =	11.00					
D ₃₅ =	35.45					
D ₅₀ =	51.8					
D ₈₄ =	107.3					
D ₉₅ =	171.4					
D ₁₀₀ =	256.0

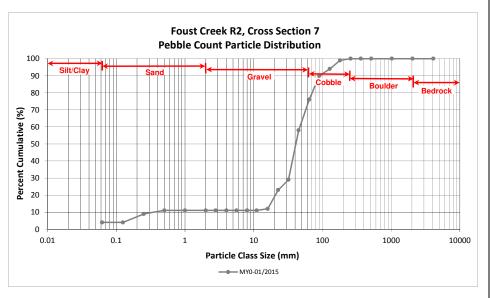
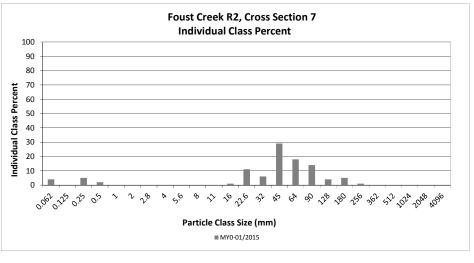
Diame	ter (mm)	Riffle 100-	Sum	mary
Part	Particle Class			Count	Class	Percent
		min max			Percentage	Cumulative
SILT/CLAY	Silt/Clay	0.000	0.062	4	4	4
	Very fine	0.062	0.125			4
_	Fine	0.125	0.250	5	5	9
SAND	Medium	0.25	0.50	2	2	11
7	Coarse	0.5	1.0			11
	Very Coarse	1.0	2.0			11
	Very Fine	2.0	2.8			11
	Very Fine	2.8	4.0			11
	Fine	4.0	5.6			11
	Fine	5.6	8.0			11
J&	Medium	8.0	11.0			11
GRAVEL	Medium	11.0	16.0	1	1	12
	Coarse	16.0	22.6	11	11	23
	Coarse	22.6	32	6	6	29
	Very Coarse	32	45	29	29	58
	Very Coarse	45	64	18	18	76
	Small	64	90	14	14	90
COBBLE	Small	90	128	4	4	94
CORT	Large	128	180	5	5	99
	Large	180	256	1	1	100
	Small	256	362			100
SOUDIE	Small	362	512			100
"O),	Medium	512	1024			100
· ·	Large/Very Large	1024	2048			100
BEDROCK	Bedrock	2048	>2048			100
			Total	100	100	100

Cross Section 7						
Ch	annel materials (mm)						
D ₁₆ =	18.14						
D ₃₅ =	34.34						
D ₅₀ =	41.0						
D ₈₄ =	77.8						
D ₉₅ =	137.0						
D ₁₀₀ =	256.0

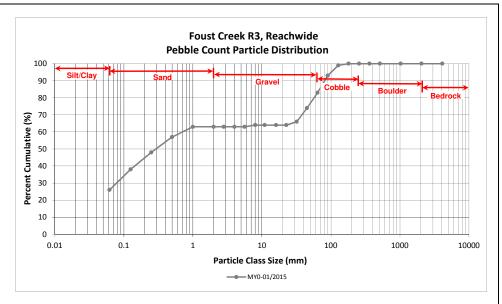
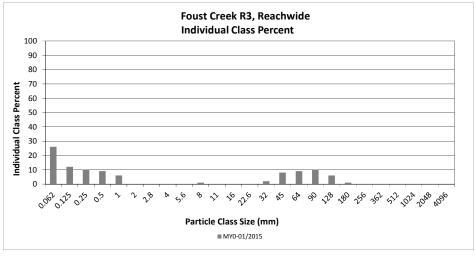
Par SILT/CLAY	ticle Class				Diameter (mm) Particle Count			Reach Summary	
SILT/CLAY							Class	Percent	
SILT/CLAY		min	max	Riffle	Pool	Total	Percentage	Cumulative	
	Silt/Clay	0.000	0.062	3	23	26	26	26	
	Very fine	0.062	0.125		12	12	12	38	
_	Fine	0.125	0.250		10	10	10	48	
SAND	Medium	0.25	0.50		9	9	9	57	
٦'	Coarse	0.5	1.0		6	6	6	63	
	Very Coarse	1.0	2.0					63	
	Very Fine	2.0	2.8					63	
	Very Fine	2.8	4.0					63	
	Fine	4.0	5.6					63	
	Fine	5.6	8.0	1		1	1	64	
Jer	Medium	8.0	11.0					64	
GRANEL	Medium	11.0	16.0					64	
	Coarse	16.0	22.6					64	
	Coarse	22.6	32	2		2	2	66	
	Very Coarse	32	45	8		8	8	74	
	Very Coarse	45	64	9		9	9	83	
	Small	64	90	10		10	10	93	
COBBLE	Small	90	128	6		6	6	99	
COBL	Large	128	180	1		1	1	100	
	Large	180	256					100	
*onione	Small	256	362					100	
	Small	362	512					100	
	Medium	512	1024					100	
	Large/Very Large	1024	2048					100	
BEDROCK	Bedrock	2048	>2048					100

Reachwide						
Chann	Channel materials (mm)						
D ₁₆ =	Silt/Clay						
D ₃₅ =	0.10						
D ₅₀ =	0.3						
D ₈₄ =	66.2						
D ₉₅ =	101.2						
D ₁₀₀ =	180.0

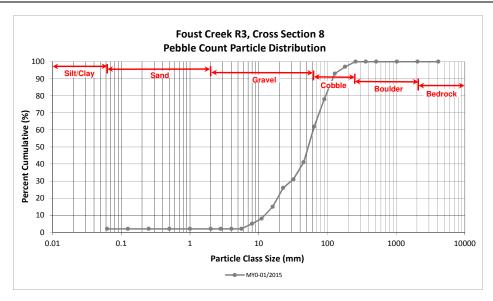
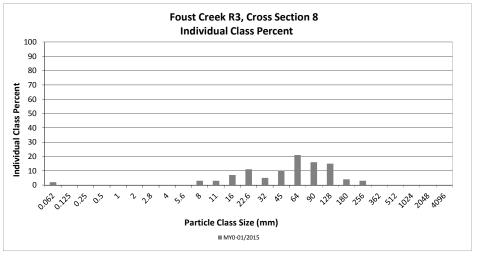
Particle Class		Diameter (mm)		Riffle 100-	Summary	
		min	max	Count	Class Percentage	Percent Cumulative
SILT/CLAY	Silt/Clay	0.000	0.062	2	2	2
	Very fine	0.062	0.125			2
	Fine	0.125	0.250			2
SAND	Medium	0.25	0.50			2
۵,	Coarse	0.5	1.0			2
	Very Coarse	1.0	2.0			2
	Very Fine	2.0	2.8			2
	Very Fine	2.8	4.0			2
	Fine	4.0	5.6			2
	Fine	5.6	8.0	3	3	5
36	Medium	8.0	11.0	3	3	8
GRAVEL	Medium	11.0	16.0	7	7	15
	Coarse	16.0	22.6	11	11	26
	Coarse	22.6	32	5	5	31
	Very Coarse	32	45	10	10	41
	Very Coarse	45	64	21	21	62
	Small	64	90	16	16	78
COBBLE	Small	90	128	15	15	93
CORE	Large	128	180	4	4	97
•	Large	180	256	3	3	100
	Small	256	362			100
ROTOES.	Small	362	512			100
	Medium	512	1024	-		100
	Large/Very Large	1024	2048			100
BEDROCK	Bedrock	2048	>2048			100
			Total	100	100	100

Cross Section 8				
Channel materials (mm)				
D ₁₆ =	16.51			
D ₃₅ =	36.68			
D ₅₀ =	52.3			
D ₈₄ =	103.6			
D ₉₅ =	151.8			
D ₁₀₀ =	256.0

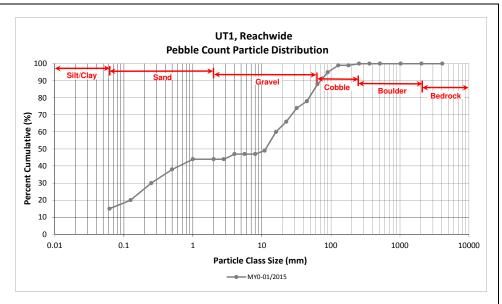
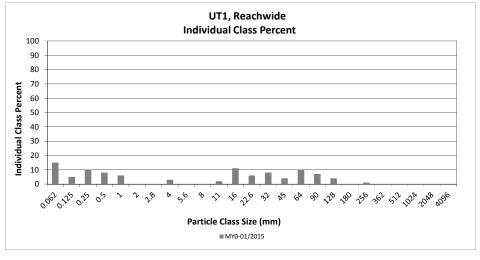
Particle Class		Diameter (mm)		Particle Count			Reach Summary	
		min	max	Riffle	Pool	Total	Class Percentage	Percent Cumulative
SILT/CLAY	Silt/Clay	0.000	0.062	3	12	15	15	15
	Very fine	0.062	0.125	1	4	5	5	20
	Fine	0.125	0.250	1	9	10	10	30
SAND	Medium	0.25	0.50		8	8	8	38
יכ	Coarse	0.5	1.0	1	5	6	6	44
	Very Coarse	1.0	2.0					44
	Very Fine	2.0	2.8					44
	Very Fine	2.8	4.0		3	3	3	47
	Fine	4.0	5.6					47
GRAVEL	Fine	5.6	8.0					47
	Medium	8.0	11.0		2	2	2	49
	Medium	11.0	16.0	7	4	11	11	60
	Coarse	16.0	22.6	5	1	6	6	66
	Coarse	22.6	32	7	1	8	8	74
	Very Coarse	32	45	4		4	4	78
	Very Coarse	45	64	9	1	10	10	88
	Small	64	90	7		7	7	95
COBBLE	Small	90	128	4		4	4	99
Ogr	Large	128	180					99
-	Large	180	256	1		1	1	100
BOHOLE	Small	256	362					100
	Small	362	512					100
	Medium	512	1024					100
	Large/Very Large	1024	2048					100
BEDROCK	Bedrock	2048	>2048					100
			Total	50	50	100	100	100

Reachwide				
Channel materials (mm)				
D ₁₆ =	0.07			
D ₃₅ =	0.39			
D ₅₀ =	11.4			
D ₈₄ =	55.6			
D ₉₅ =	90.0			
D ₁₀₀ =	256.0

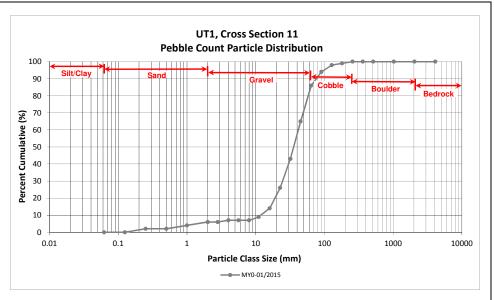
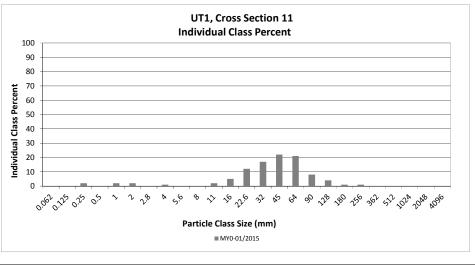
Particle Class		Diameter (mm)		Riffle 100-	Summary	
		min		Count	Class	Percent
			max		Percentage	Cumulative
SILT/CLAY	Silt/Clay	0.000	0.062			0
	Very fine	0.062	0.125			0
	Fine	0.125	0.250	2	2	2
SAND	Medium	0.25	0.50			2
,	Coarse	0.5	1.0	2	2	4
	Very Coarse	1.0	2.0	2	2	6
	Very Fine	2.0	2.8			6
	Very Fine	2.8	4.0	1	1	7
	Fine	4.0	5.6			7
	Fine	5.6	8.0			7
Jer	Medium	8.0	11.0	2	2	9
GRAVEL	Medium	11.0	16.0	5	5	14
	Coarse	16.0	22.6	12	12	26
	Coarse	22.6	32	17	17	43
	Very Coarse	32	45	22	22	65
	Very Coarse	45	64	21	21	86
	Small	64	90	8	8	94
COBBLE	Small	90	128	4	4	98
COBY	Large	128	180	1	1	99
-	Large	180	256	1	1	100
	Small	256	362			100
	Small	362	512			100
బ్యా	Medium	512	1024			100
70	Large/Very Large	1024	2048			100
BEDROCK	Bedrock	2048	>2048			100
			Total	100	100	100

Cross Section 11				
Channel materials (mm)				
D ₁₆ =	16.95			
D ₃₅ =	27.17			
D ₅₀ =	35.7			
D ₈₄ =	61.9			
D ₉₅ =	98.3			
D ₁₀₀ =	256.0

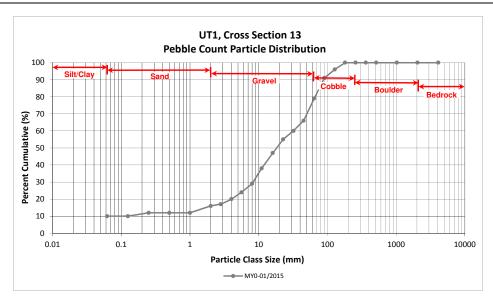
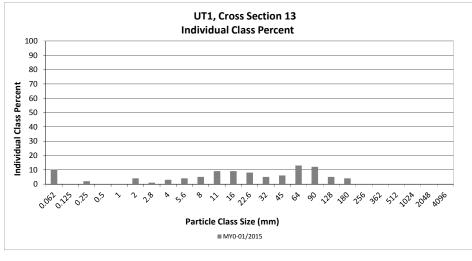
Particle Class		Diameter (mm)		Riffle 100-	Summary	
		min	Count		Class	Percent
	_		max		Percentage	Cumulative
SILT/CLAY	Silt/Clay	0.000	0.062	10	10	10
	Very fine	0.062	0.125			10
_	Fine	0.125	0.250	2	2	12
SAND	Medium	0.25	0.50			12
7	Coarse	0.5	1.0			12
	Very Coarse	1.0	2.0	4	4	16
	Very Fine	2.0	2.8	1	1	17
	Very Fine	2.8	4.0	3	3	20
	Fine	4.0	5.6	4	4	24
	Fine	5.6	8.0	5	5	29
365	Medium	8.0	11.0	9	9	38
GRAVEL	Medium	11.0	16.0	9	9	47
	Coarse	16.0	22.6	8	8	55
	Coarse	22.6	32	5	5	60
	Very Coarse	32	45	6	6	66
	Very Coarse	45	64	13	13	79
	Small	64	90	12	12	91
COBBLE	Small	90	128	5	5	96
OBL	Large	128	180	4	4	100
•	Large	180	256			100
goliates.	Small	256	362			100
	Small	362	512			100
	Medium	512	1024			100
v	Large/Very Large	1024	2048			100
BEDROCK	Bedrock	2048	>2048			100
			Total	100	100	100

Cross Section 13				
Channel materials (mm)				
D ₁₆ =	2.00			
D ₃₅ =	9.89			
D ₅₀ =	18.2			
D ₈₄ =	73.8			
D ₉₅ =	119.3			
D ₁₀₀ =	180.0

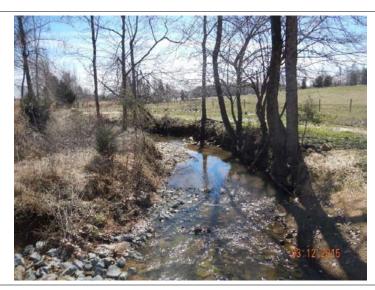
PHOTO POINT 1 – looking downstream (03/12/2015)

Photographs should illustrate the site's vegetation and morphological stability on an annual basis. Cross section photos should demonstrate no excessive erosion or degradation of the banks. Longitudinal photos should indicate the absence of persistent bars within the channel or vertical incision. Grade control structures should remain stable. Deposition of sediment on the bank side of vane arms is preferable. Maintenance of scour pools on the channel side of vane arms is expected.

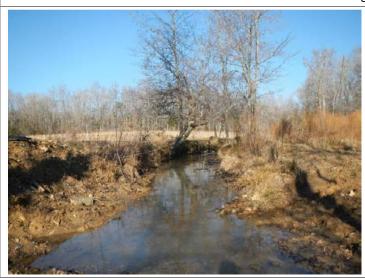
PHOTO POINT 2 – looking upstream (02/12/2015)

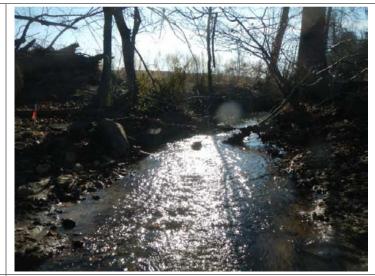
PHOTO POINT 2 – looking downstream (02/12/2015)

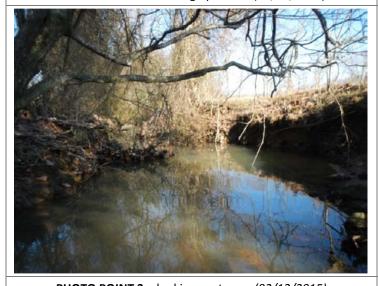
PHOTO POINT 3 – looking upstream (02/12/2015)

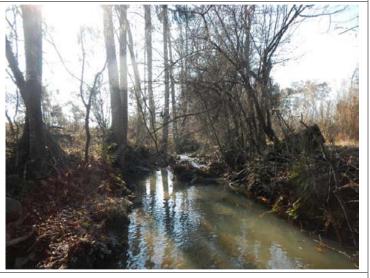
PHOTO POINT 3 – looking downstream (02/12/2015)

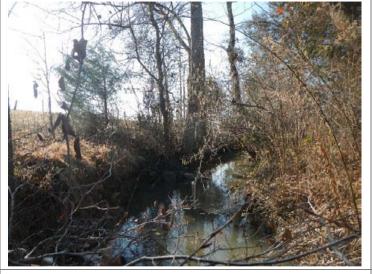
PHOTO POINT 4 – looking upstream (02/12/2015)

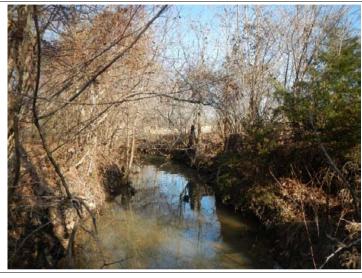
PHOTO POINT 4 – looking downstream (02/12/2015)

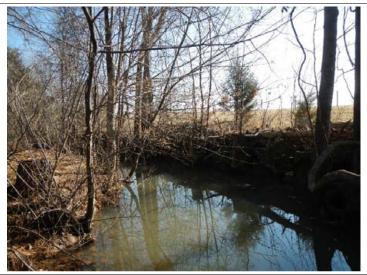
PHOTO POINT 5 – looking upstream (02/12/2015)

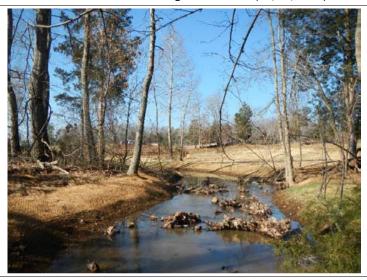
PHOTO POINT 5 – looking downstream (02/12/2015)

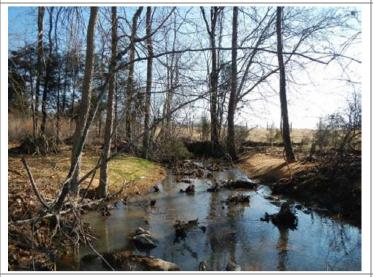
PHOTO POINT 6 – looking upstream (02/12/2015)

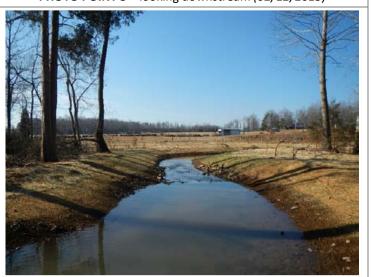
PHOTO POINT 6 - looking downstream (02/12/2015)

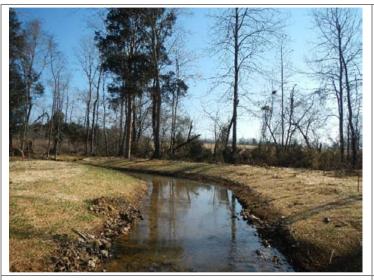
PHOTO POINT 7 – looking upstream (02/12/2015)

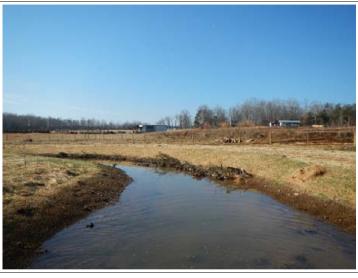
PHOTO POINT 7 – looking downstream (02/12/2015)

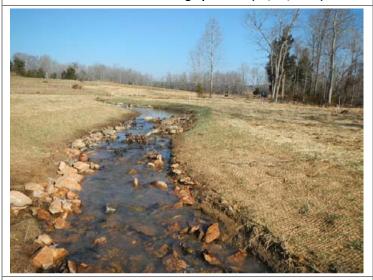
PHOTO POINT 8 – looking upstream (02/12/2015)

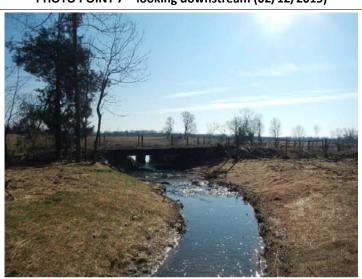
PHOTO POINT 8 – looking downstream (02/12/2015)

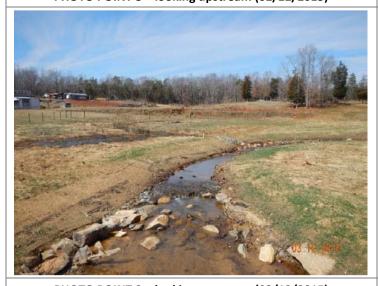
PHOTO POINT 9 – looking upstream (03/12/2015)

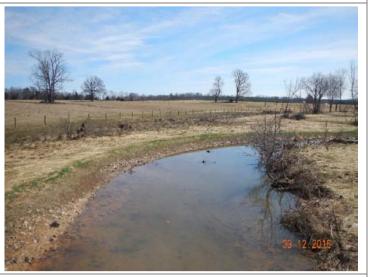
PHOTO POINT 9 - looking downstream (03/12/2015)

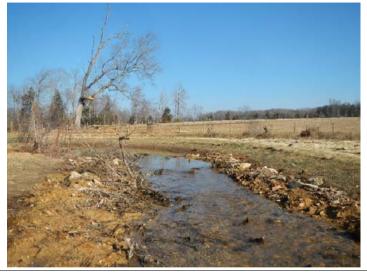
PHOTO POINT 10 – looking upstream (02/12/2015)

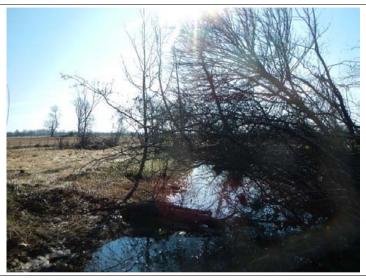
PHOTO POINT 10 – looking downstream (02/12/2015)

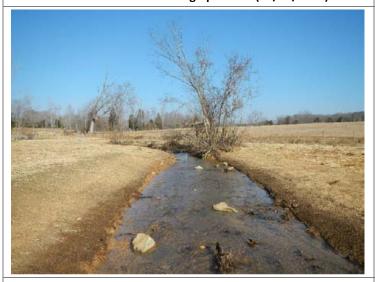
PHOTO POINT 11 – looking upstream (02/12/2015)

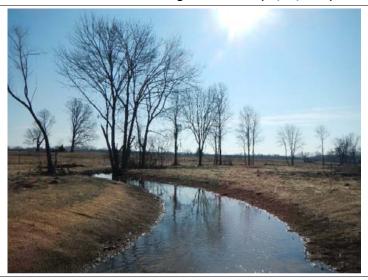
PHOTO POINT 11 – looking downstream (02/12/2015)

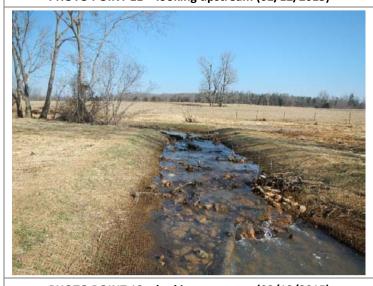
PHOTO POINT 12 – looking upstream (02/12/2015)

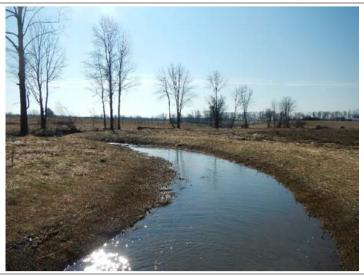
PHOTO POINT 12 – looking downstream (02/12/2015)

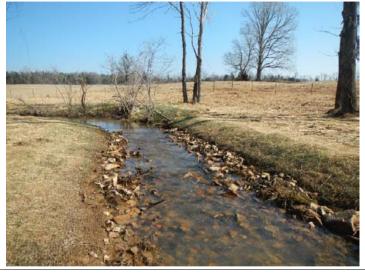
PHOTO POINT 13 – looking upstream (02/12/2015)

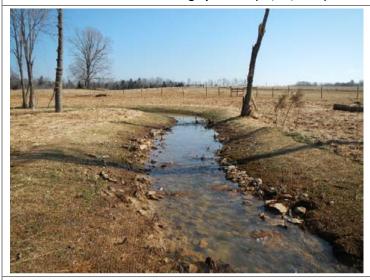
PHOTO POINT 13 – looking downstream (02/12/2015)

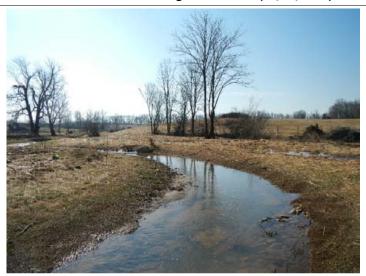
PHOTO POINT 14 - looking downstream (02/12/2015)

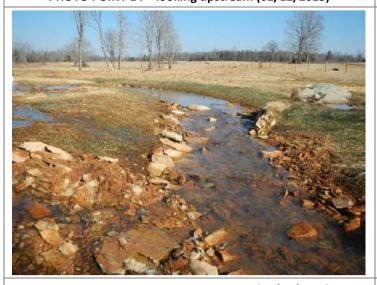
PHOTO POINT 15 – looking upstream (02/12/2015)

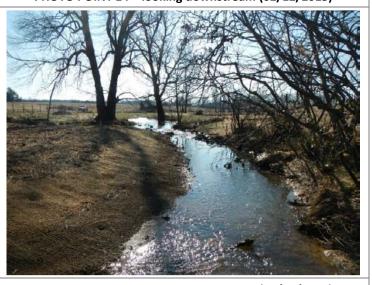
PHOTO POINT 15 - looking downstream (02/12/2015)

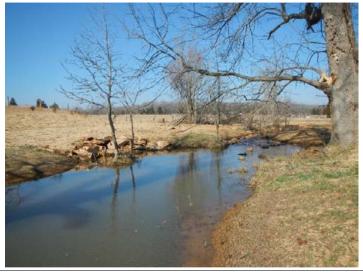
PHOTO POINT 16 – looking upstream (02/12/2015)

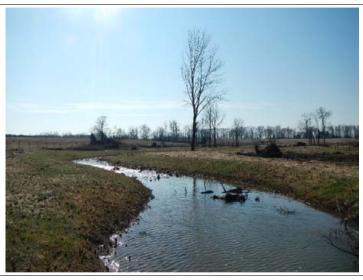
PHOTO POINT 16 – looking downstream (02/12/2015)

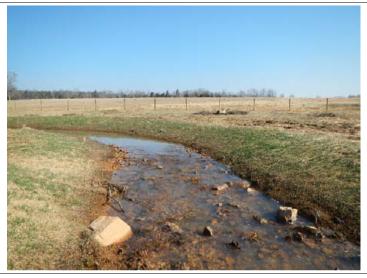
PHOTO POINT17 – looking upstream (02/12/2015)

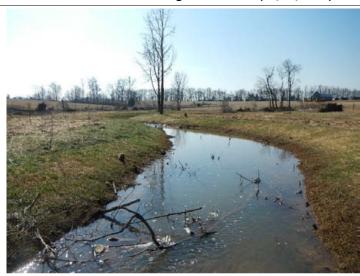
PHOTO POINT 17 – looking downstream (02/12/2015)

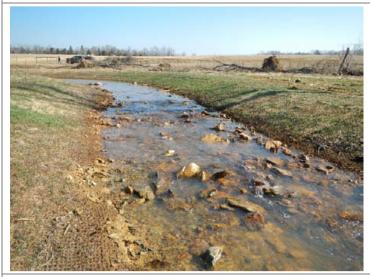
PHOTO POINT 18 - looking upstream (02/12/2015)

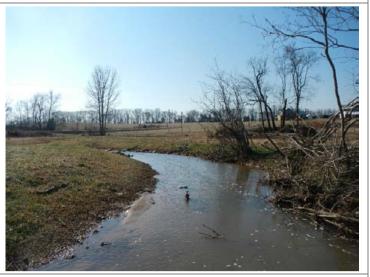
PHOTO POINT 18 - looking downstream (02/12/2015)
