BASELINE MONITORING DOCUMENT AND AS-BUILT BASELINE REPORT

FOUST CREEK MITIGATION SITE

Alamance County, NC DENR Contract 004954 NCDMS Project Number 95715

Wildlands Engineering, Inc. 312 West Millbrook Road, Suite 225 Raleigh, NC 27609

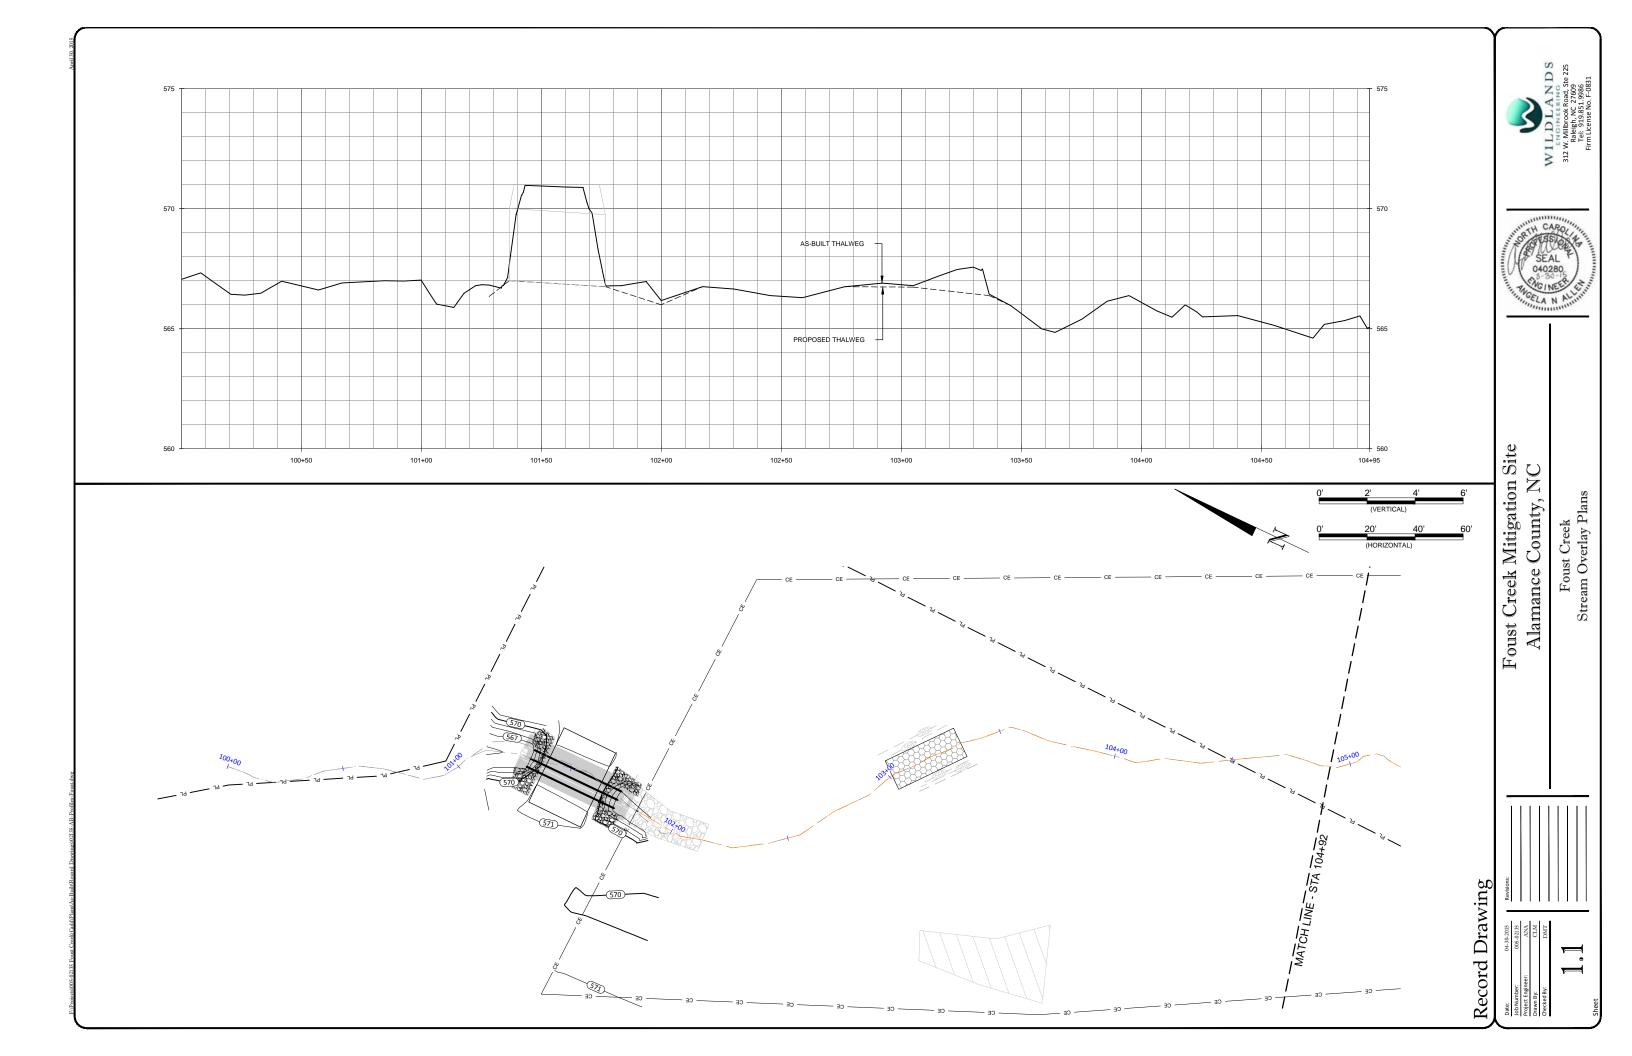
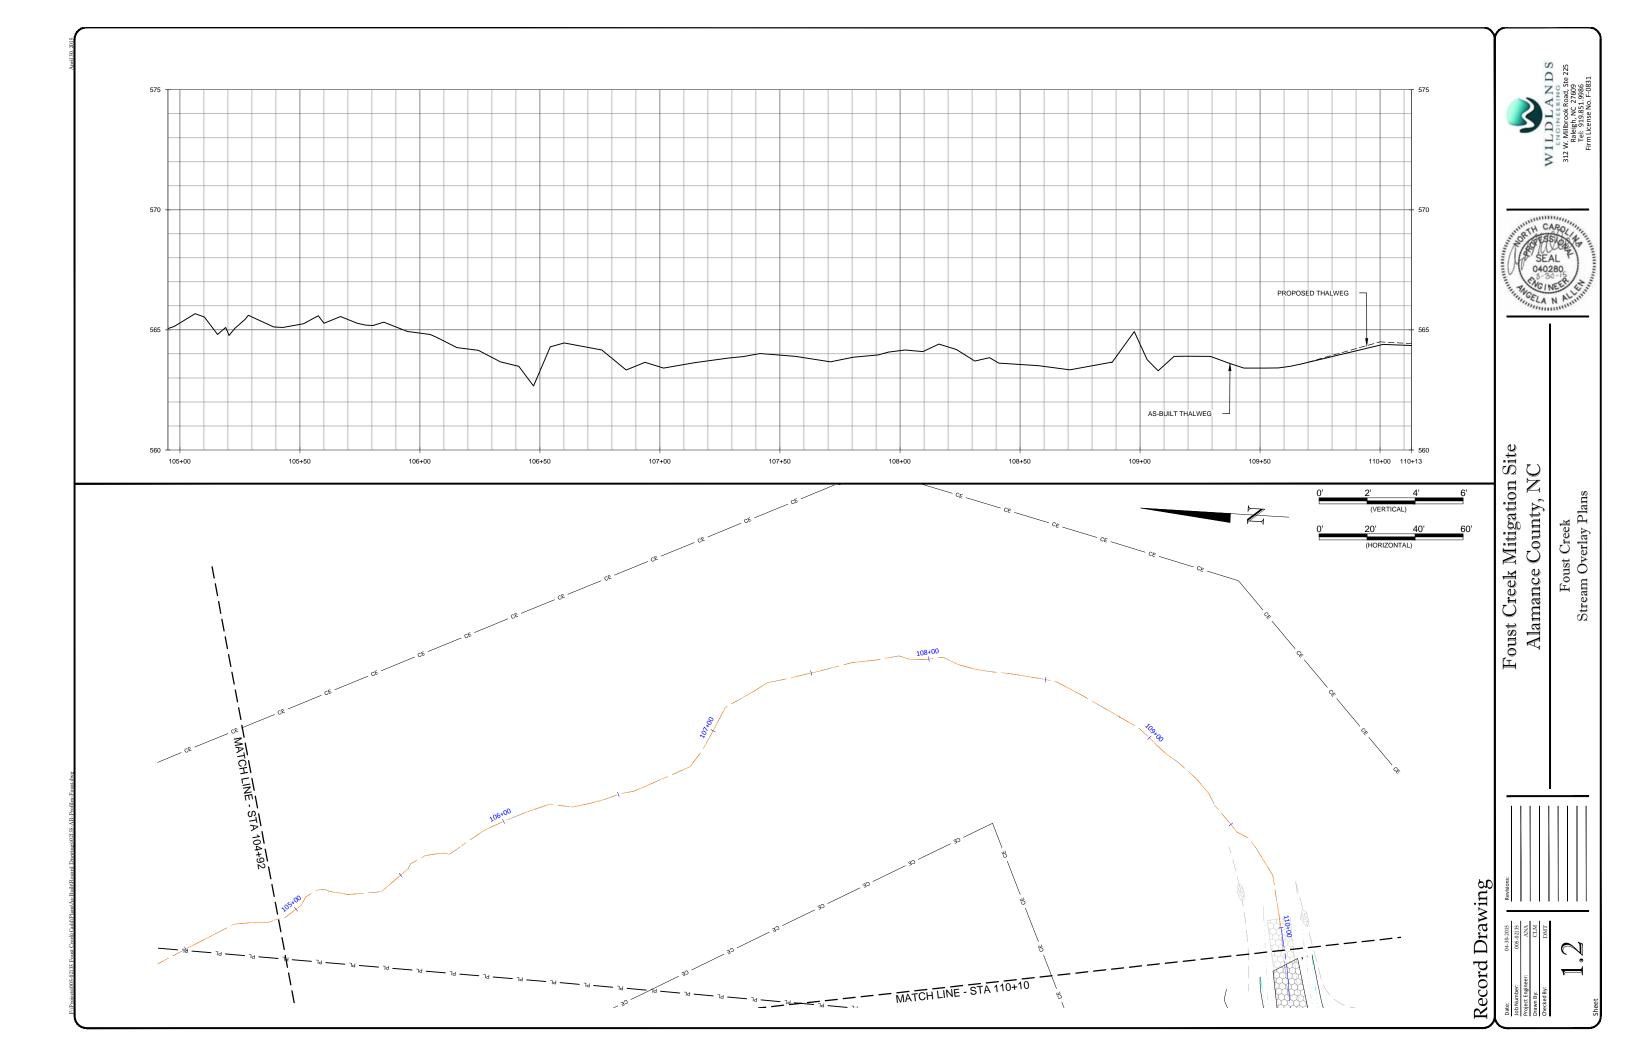
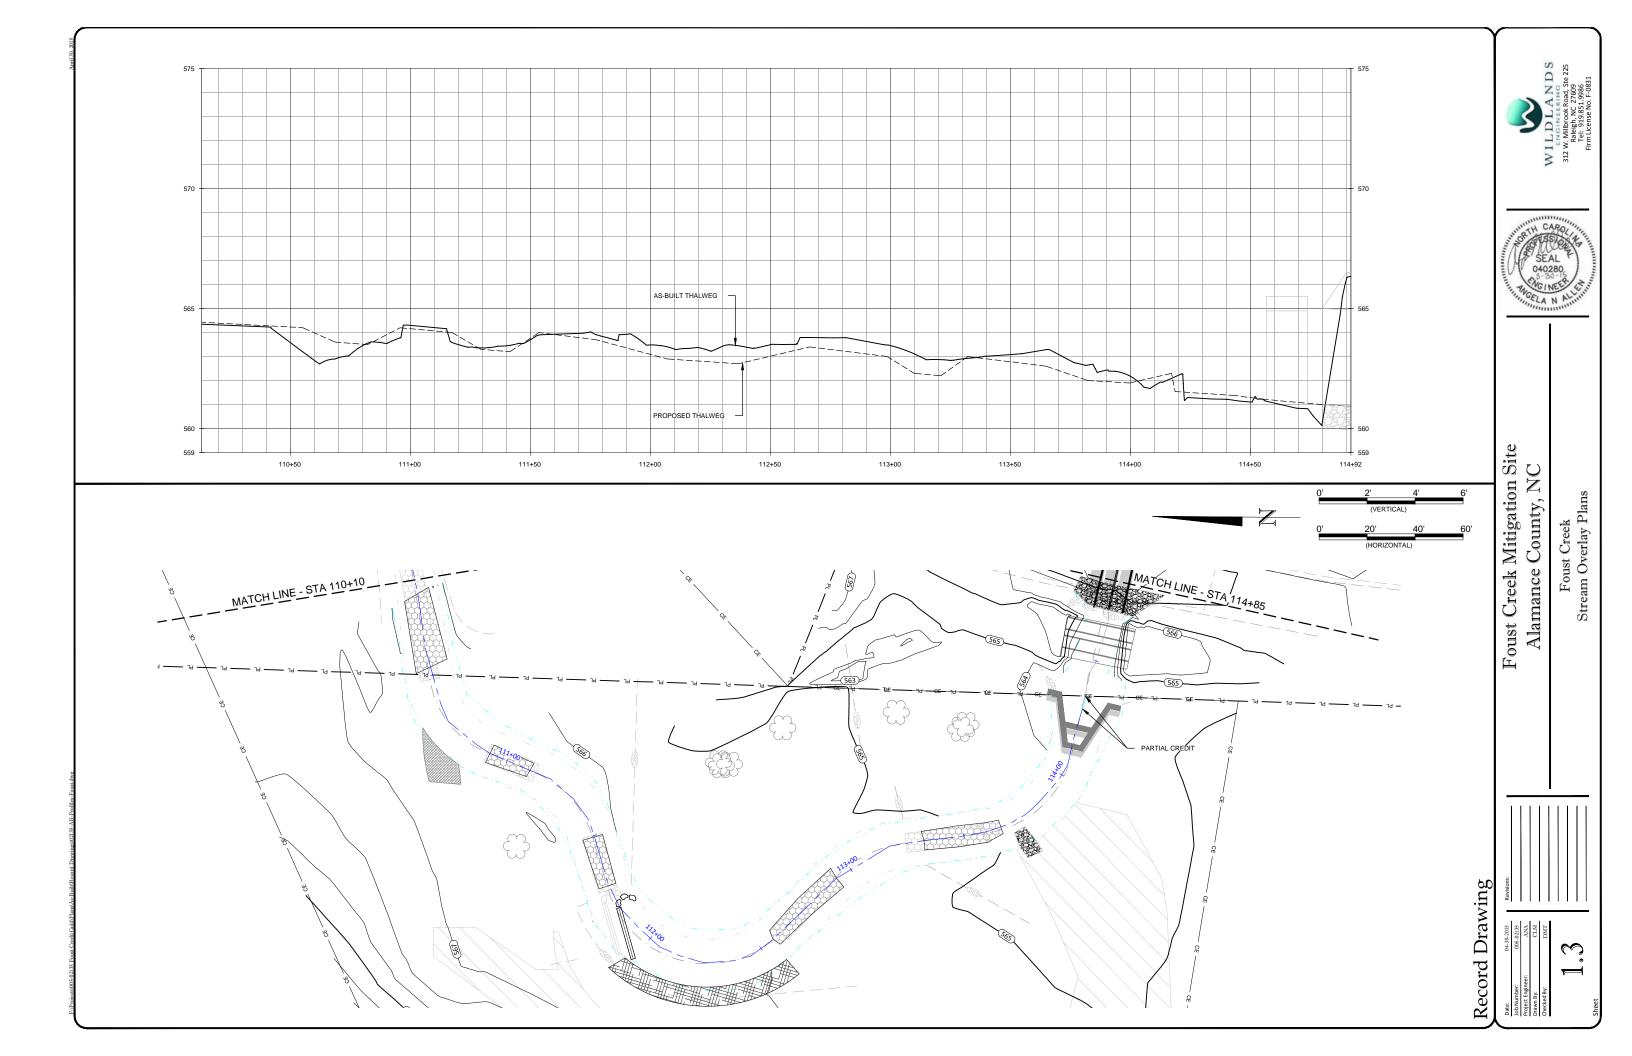
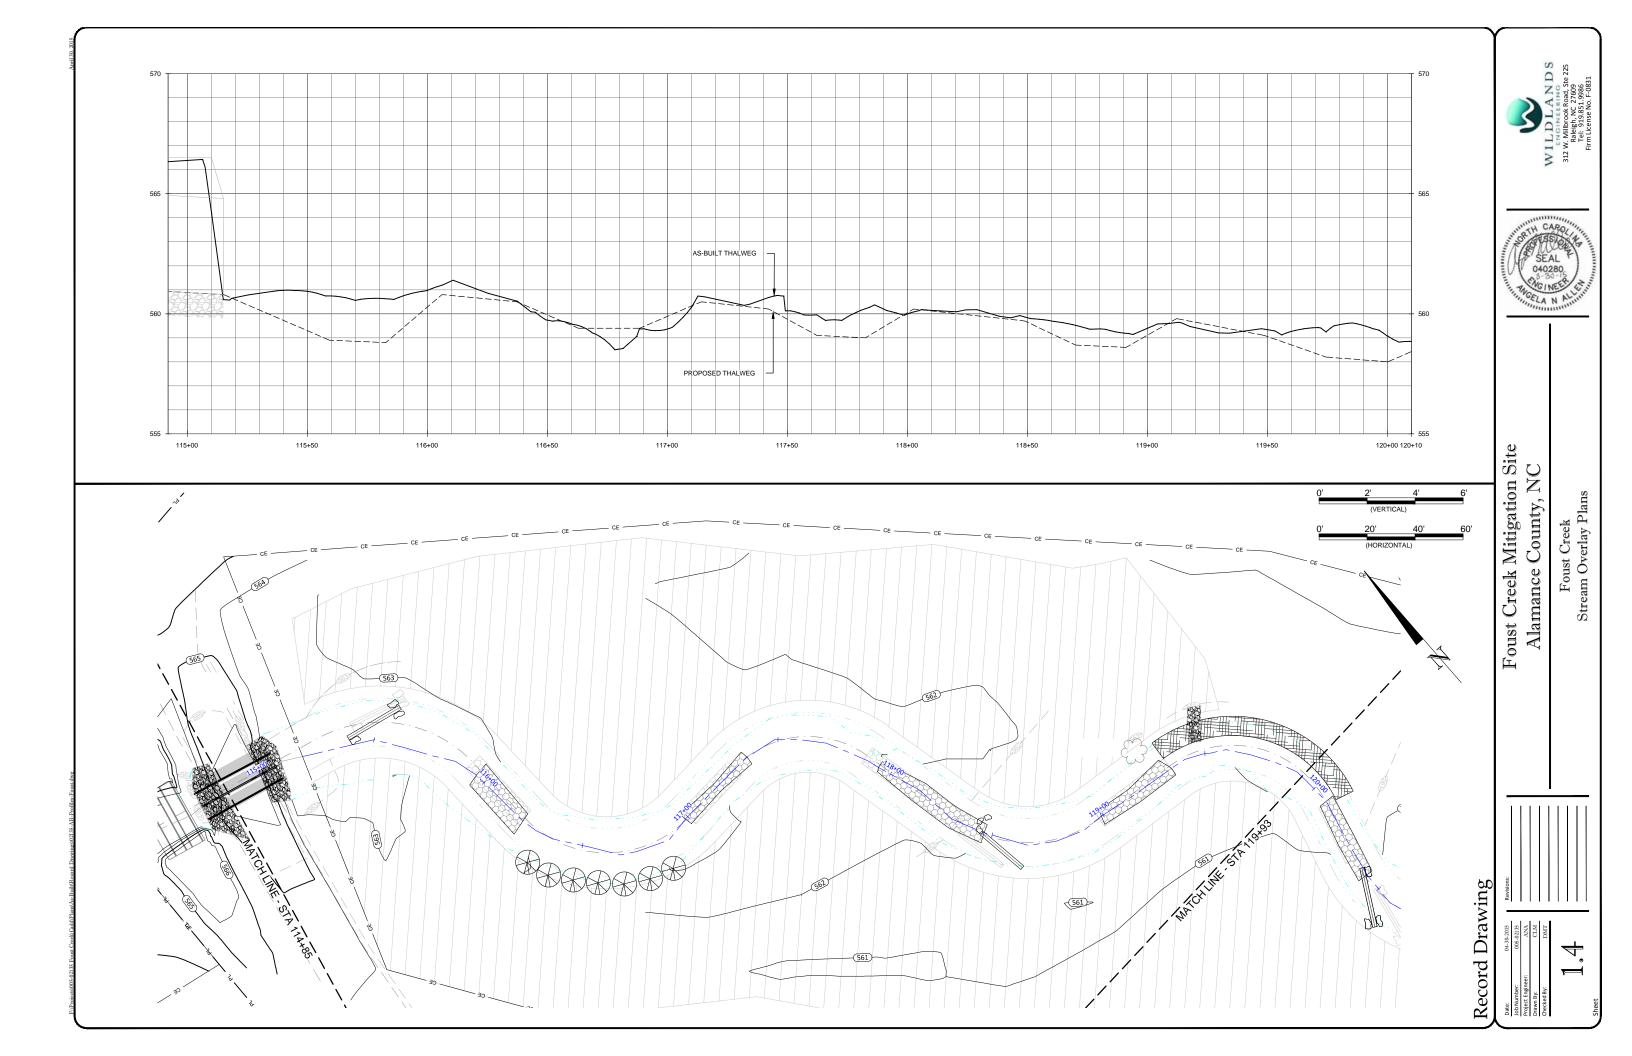
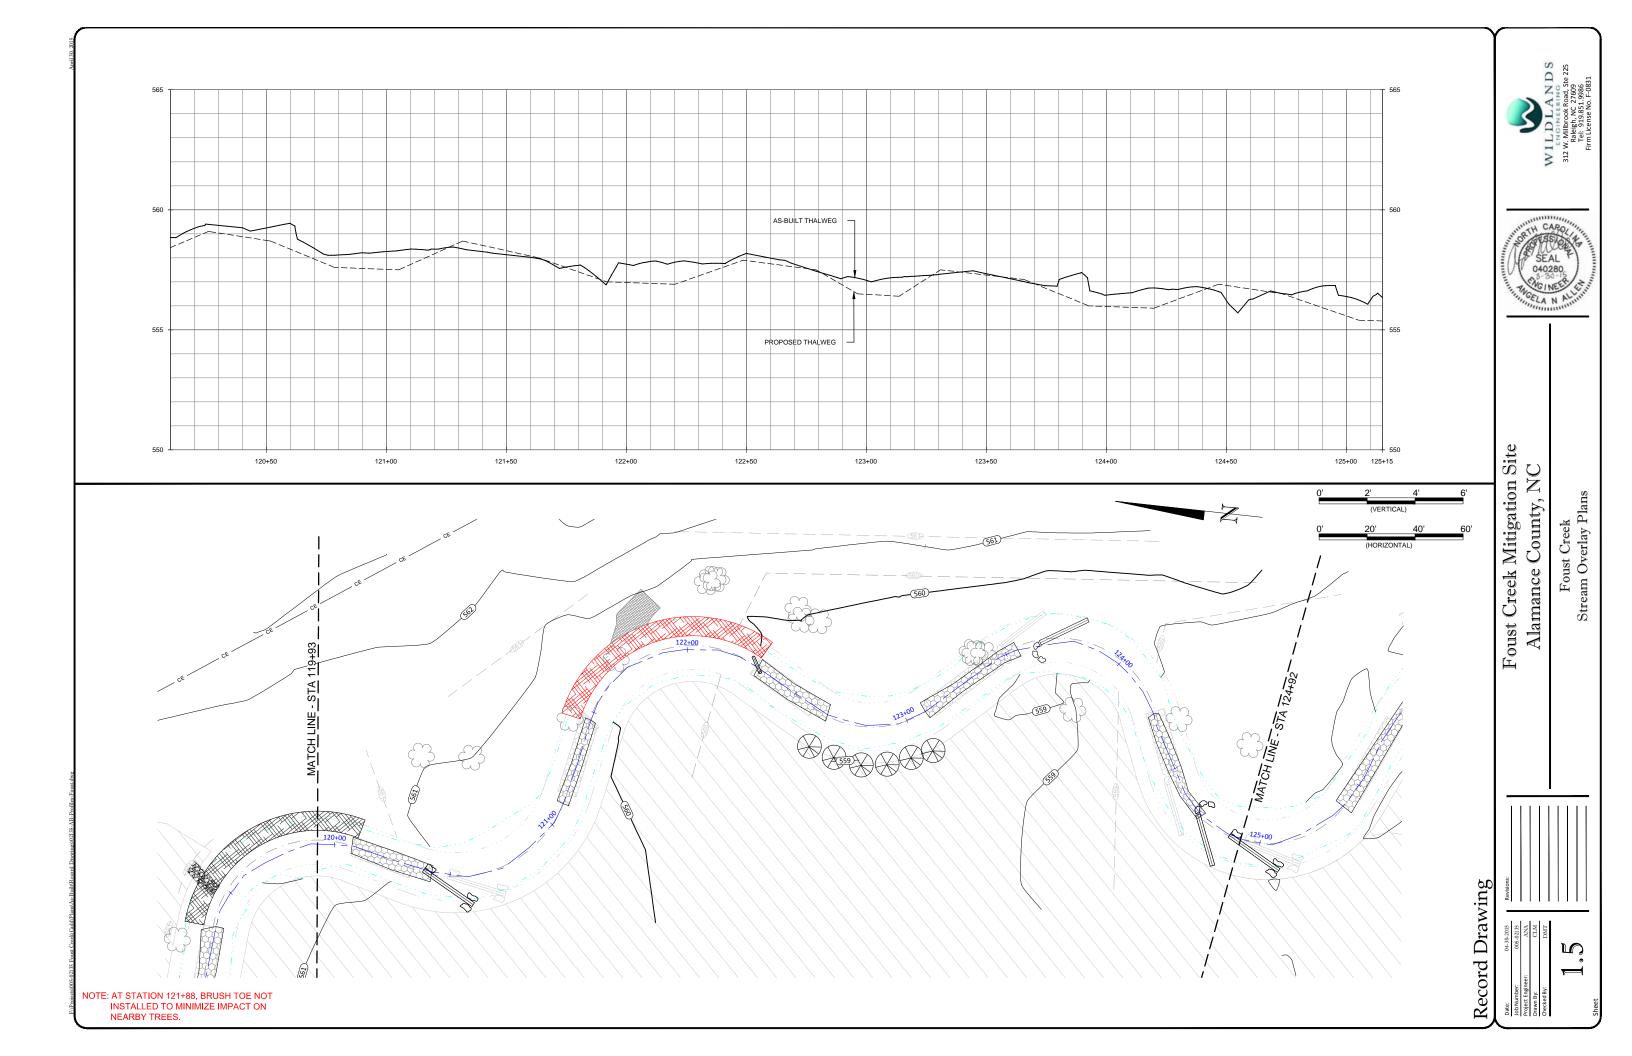
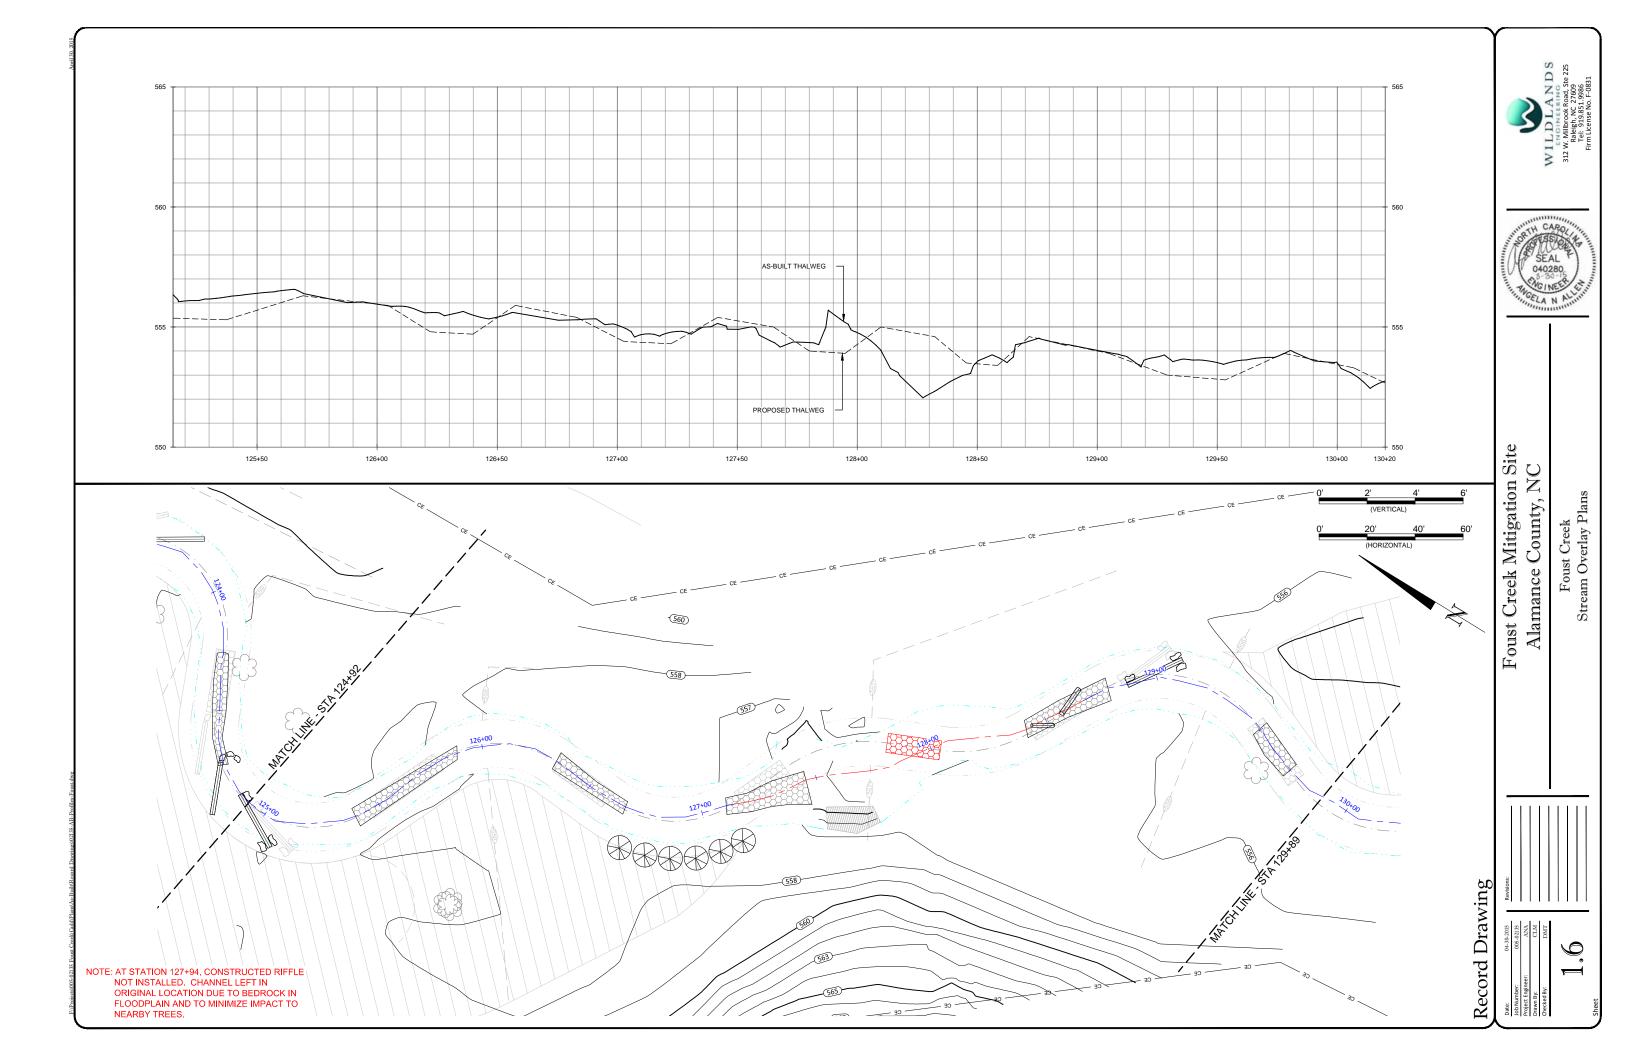
Foust Creek Mitigation Site Alamance County, NC

NOTE: FEATURES IN RED INDICATE DEVIATION FROM FINAL CONSTRUCTION PLANS.
