ANNUAL MONITORING REPORT YEAR 1 (2010)

FOX RUN RIPARIAN BUFFER MITIGATION SITE PITT COUNTY, NORTH CAROLINA

(EEP Contract No. 002281)

November 2010

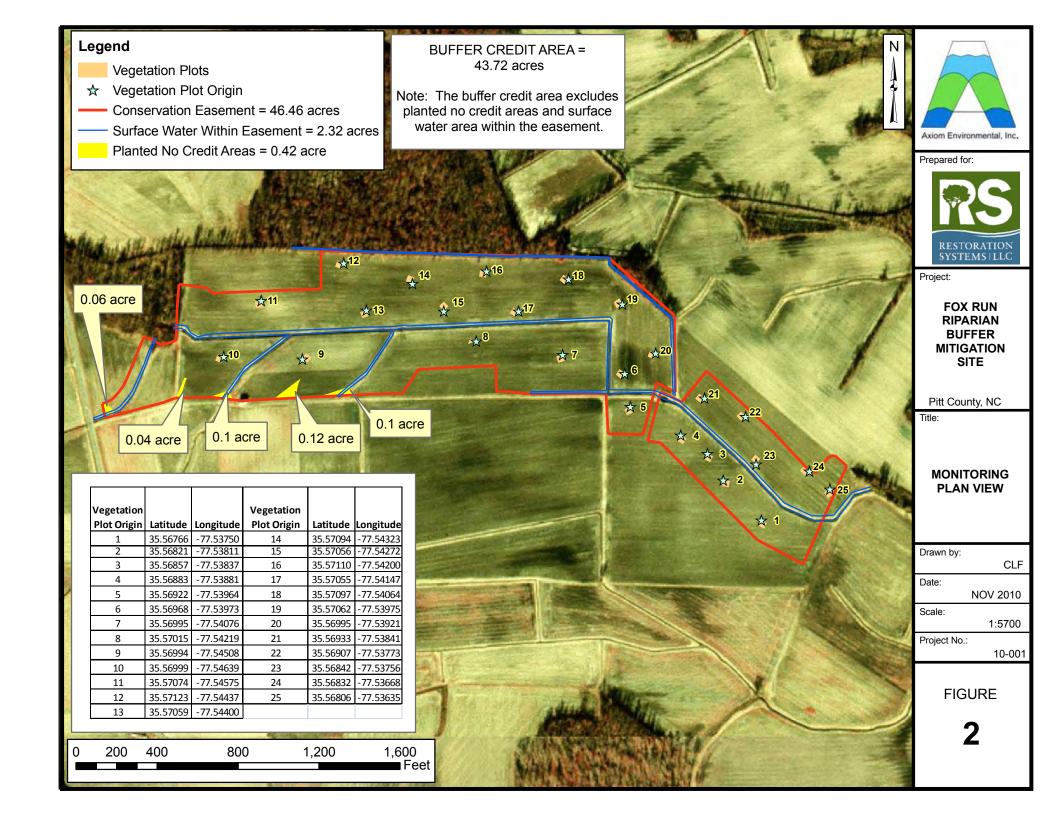
Figure 1. Site Location Figure 2. Monitoring Plan View

As constructed, Site activities restored historic riparian buffer functions by planting the entire 46.46-acre Site with native riparian vegetation. This resulted in 43.72 Riparian Buffer Mitigation Units (Table 1, Appendix B and Figure 2, Appendix A). Approximately 2.32 acres of the Site is surface water associated with Site ditches and 0.42 acres of the Site exist outside of the 200-foot buffer area or within areas of nondiffuse flow. The target natural community consisted of Coastal Plain Bottomland Hardwood Forest (Schafale and Weakley 1990). Table 5 (Appendix C) outlines woody species planted within the Site. Completed project activities, reporting history, completion dates, project contacts, and background information are summarized in Tables 2-4 (Appendix B).

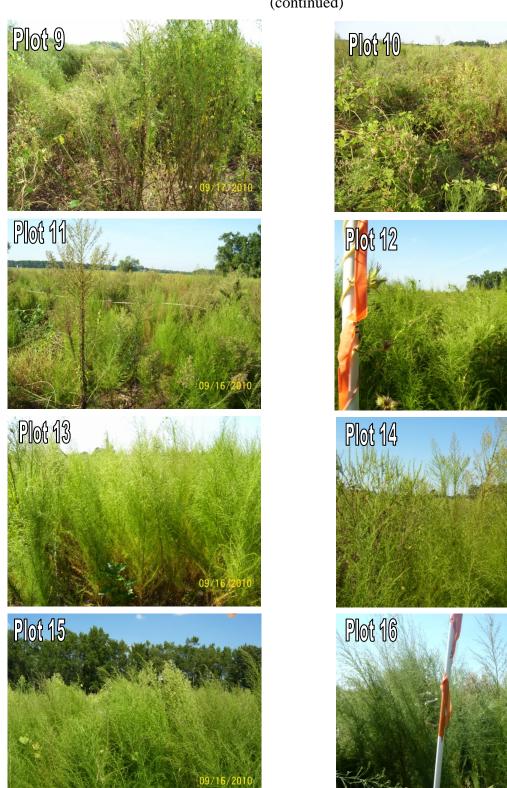
Fox Run **Year 1 (2010) Vegetation Monitoring Plot Photos Taken September 16-17, 2010**
