Baseline Monitoring Document and As-Built Report Final Glade Creek Stream Restoration Site

NCEEP Project Number: 854 Alleghany County, North Carolina

Ecosystem Enhancement Program
North Carolina Department of Environment and Natural Resources
December 2011

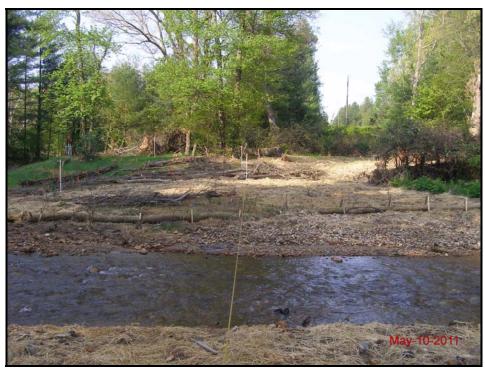
Glade Creek – Cross-Section 1 – Riffle (Looking at Left Bank Descending) Baseline – May 10, 2011

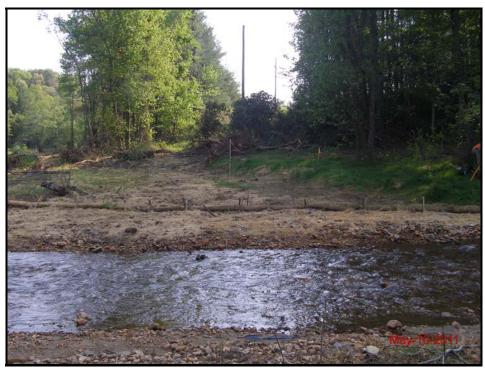
Glade Creek – Cross-Section 1 – Riffle (Looking at Right Bank Descending) Baseline – May 10, 2011

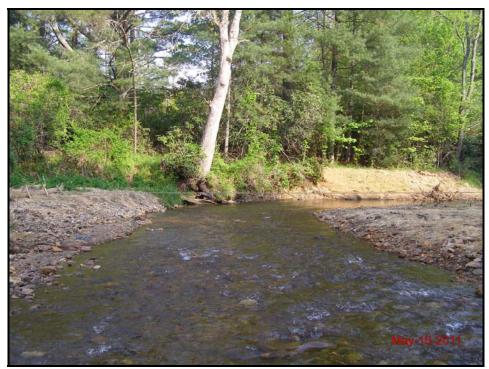
Glade Creek – Cross-Section 1 – Riffle (Looking Downstream) Baseline – May 10, 2011

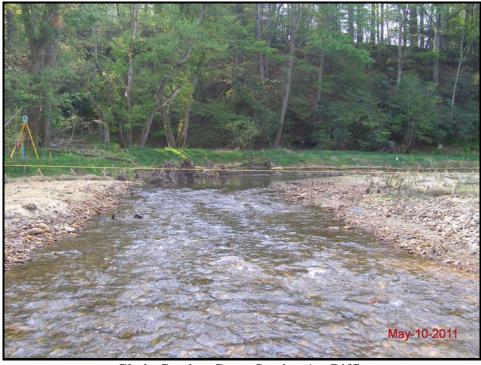
Glade Creek – Cross-Section 1 – Riffle (Looking Upstream) Baseline – May 10, 2011

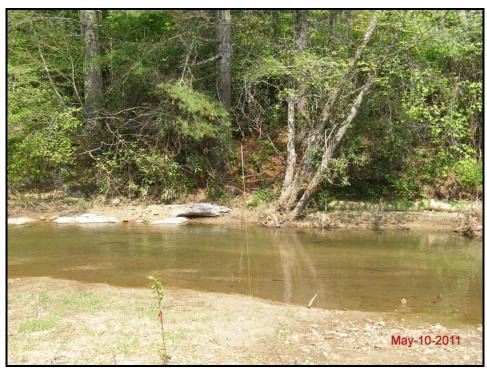
Glade Creek – Cross-Section 2 – Pool (Looking at Left Bank Descending) Baseline – May 10, 2011

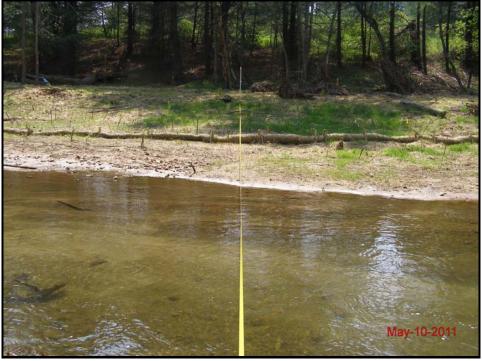
Glade Creek – Cross-Section 2 – Pool (Looking at Right Bank Descending) Baseline – May 10, 2011

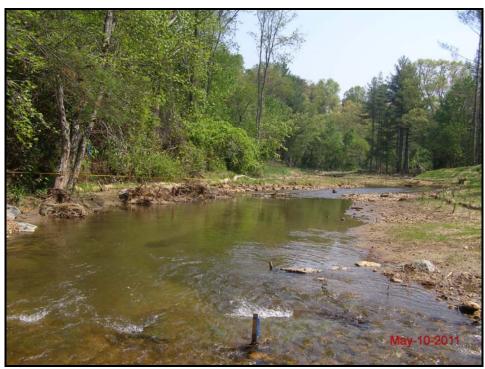
Glade Creek – Cross-Section 2 – Pool (Looking Downstream) Baseline – May 10, 2011

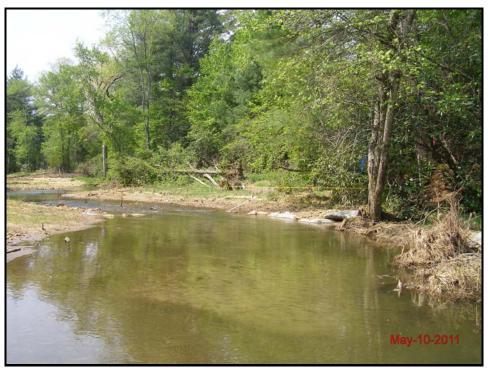
Glade Creek – Cross-Section 2 – Pool (Looking Upstream) Baseline – May 10, 2011

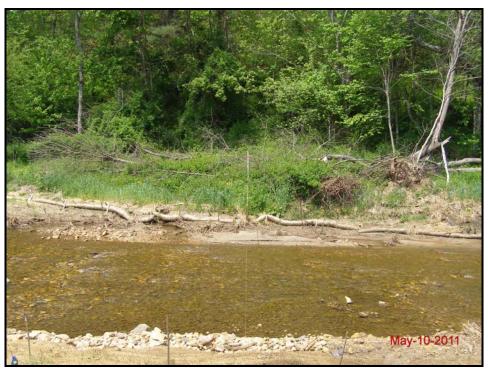
Glade Creek – Cross-Section 3 – Riffle (Looking at Left Bank Descending) Baseline – May 10, 2011

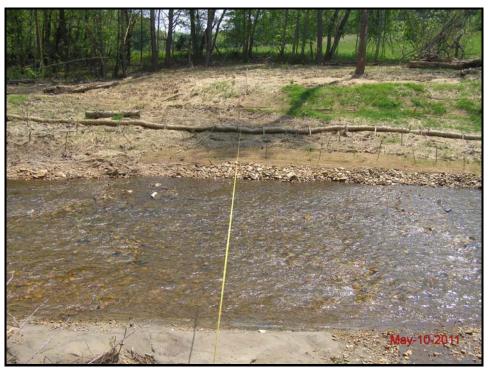
Glade Creek – Cross-Section 3 – Riffle (Looking at Right Bank Descending)
Baseline – May 10, 2011

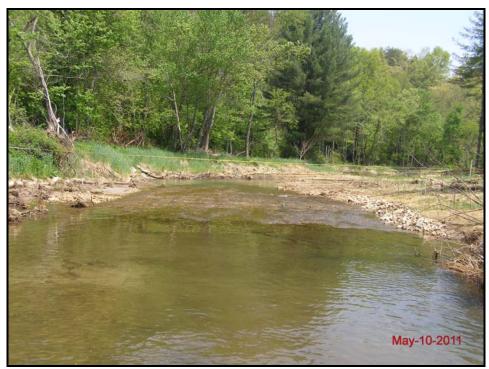
Glade Creek – Cross-Section 3 – Riffle (Looking Downstream) Baseline – May 10, 2011

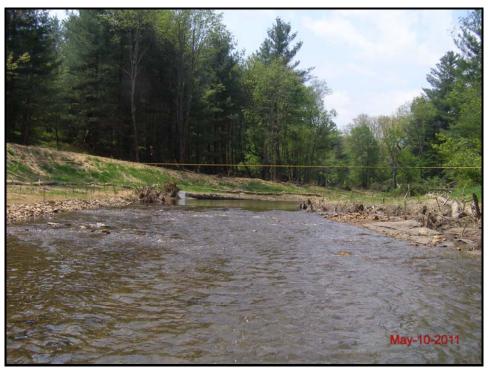
Glade Creek – Cross-Section 3 – Riffle (Looking Upstream) Baseline – May 10, 2011

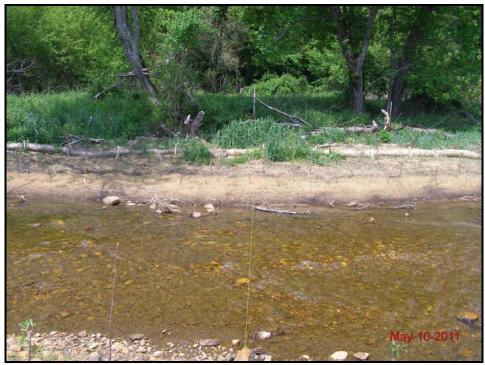
Glade Creek – Cross-Section 4 – Riffle (Looking at Left Bank Descending) Baseline –May 10, 2011

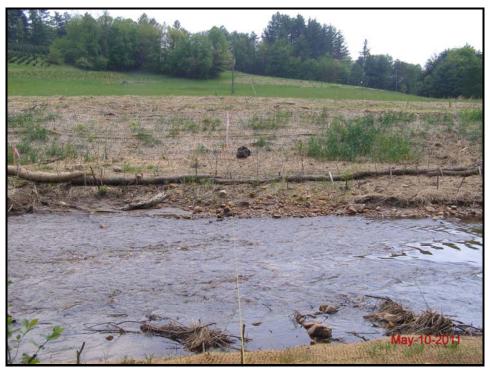
Glade Creek – Cross-Section 4 – Riffle (Looking at Right Bank Descending)
Baseline – May 10, 2011

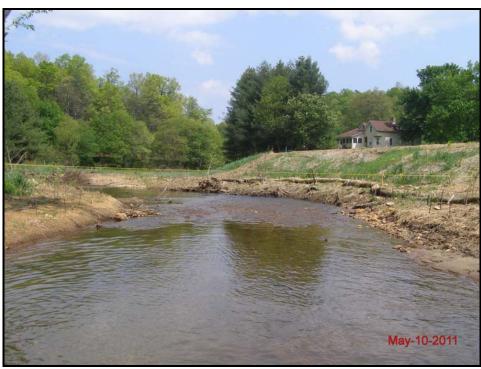
Glade Creek – Cross-Section 4 – Riffle (Looking Downstream) Baseline – May 10, 2011

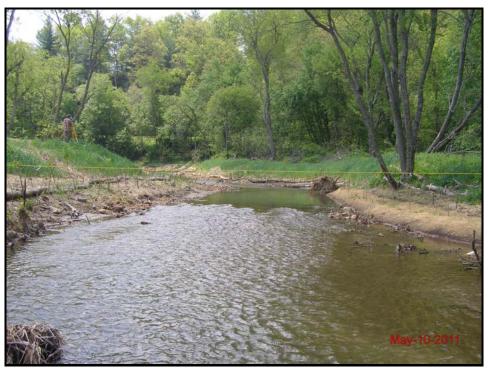
Glade Creek – Cross-Section 4 – Riffle (Looking Upstream) Baseline – May 10, 2011

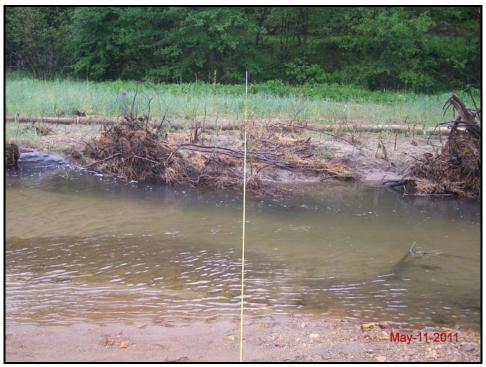
Glade Creek – Cross-Section 5 – Pool (Looking at Left Bank Descending) Baseline – May 11, 2011

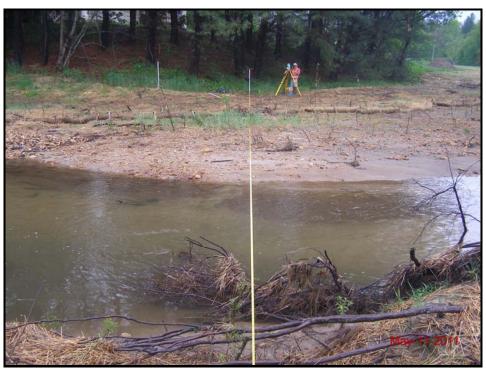
Glade Creek – Cross-Section 5 – Pool (Looking at Right Bank Descending) Baseline – May 11, 2011

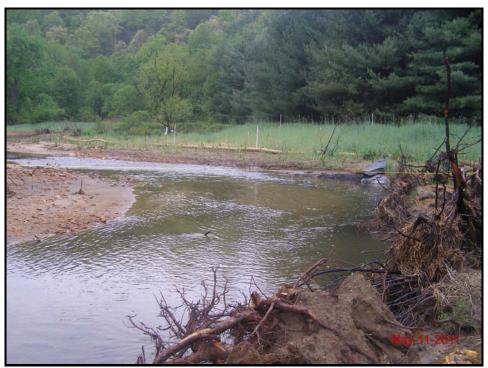
Glade Creek – Cross-Section 5 – Pool (Looking Downstream) Baseline – May 11, 2011

Permanent photo stations were established at each cross-section to digitally document annual conditions. Each vegetation monitoring plot includes a photo station taken diagonally from the origin towards the opposite plot corner. Additionally, seven permanent photo stations were established throughout the project area to provide representative digital documentation of stream features and vegetation conditions. Permanent photo stations were marked with rebar, labeled wooden stakes, and red flagging tape.

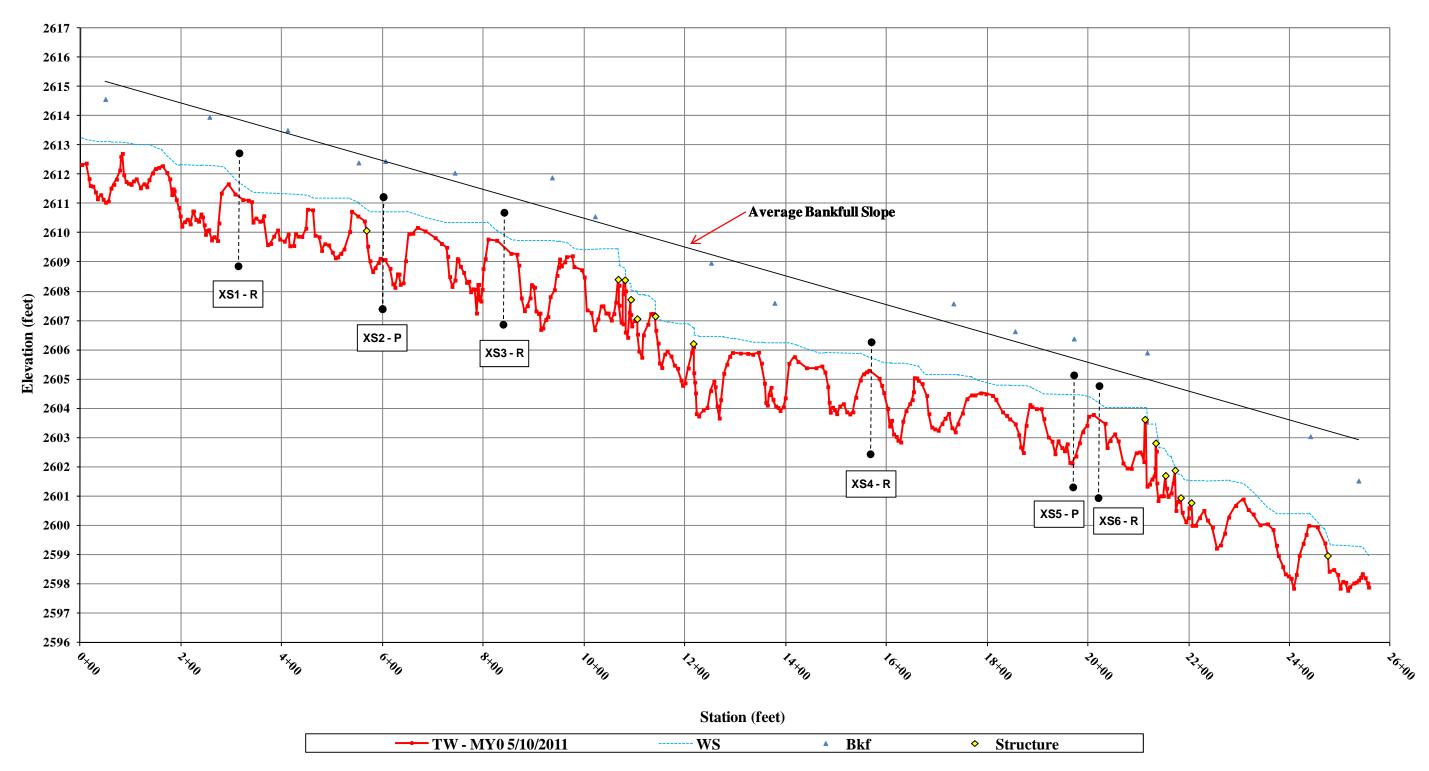
Longitudinal Profile Plots

Longitudinal profile monitoring reaches were established for the majority of the restoration reaches and included a total of 2,811 linear feet. The Glade Creek profile reach included a total of 2,548 linear feet while the Unnamed Tributary reach included a total of 263 linear feet. The beginning and ending locations of the longitudinal profile reaches were marked on both banks with rebar and PVC conduit with blue flagging tape. Annual measurements will be compared with as-built conditions to document trends in the stream profile occurring throughout the monitoring period. A total station will be used to collect annual cross-sectional and longitudinal profile data. Visual monitoring will be conducted for all additional stream segments.

Baseline stream monitoring data were collected in May 2011. Data are summarized in Tables 5 and 6, while cross-section and longitudinal profile graphics are located in Appendices C and D. In general, the restored and enhanced stream pattern was similar to the proposed design. The design Rosgen classification was a C4 for the Glade Creek and unnamed tributary reaches. Based on the as-built conditions, the restored reaches classify as C stream types.

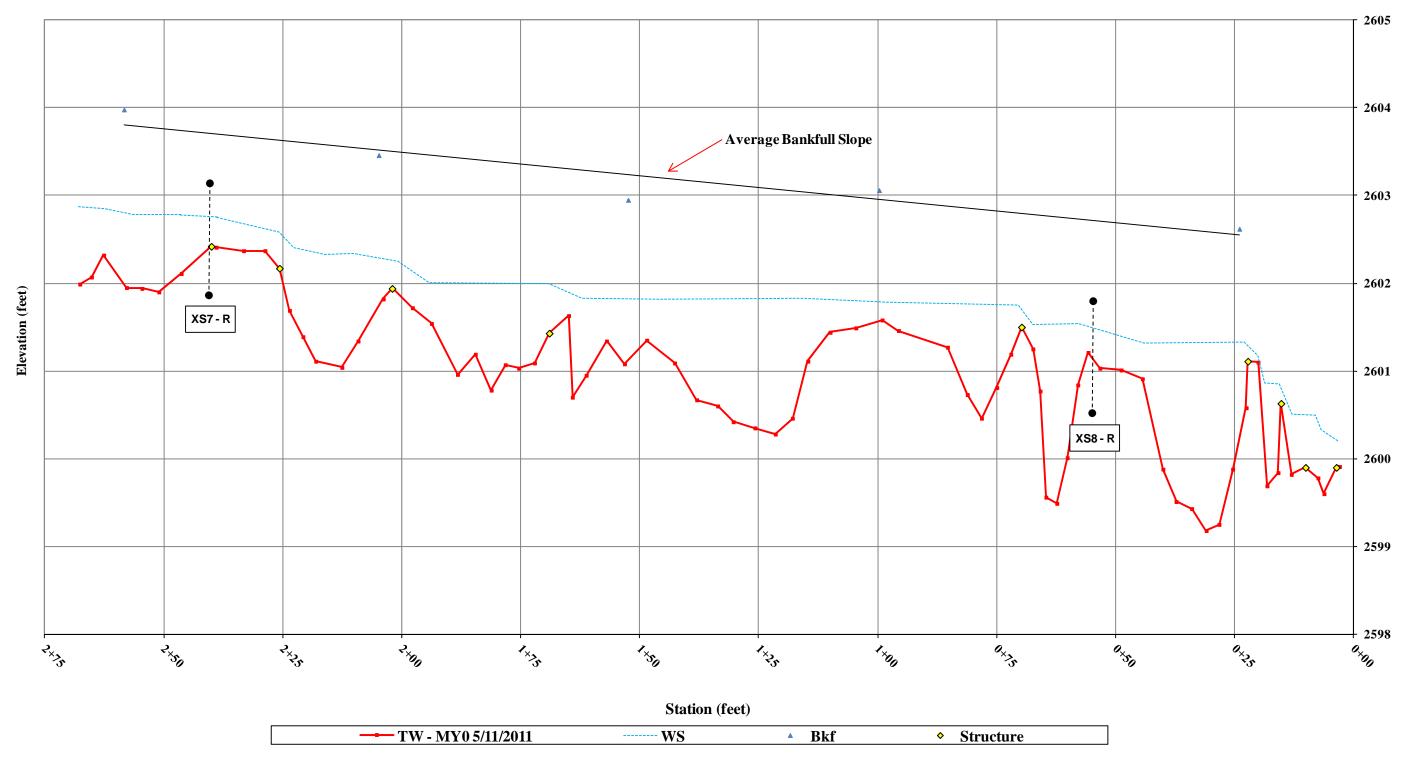
Longitudinal Profile Plots

Stationing for this reach was established from downstream to upstream.

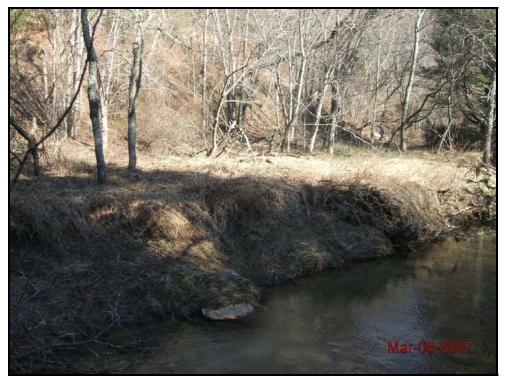
Glade Creek
Pre-construction conditions in proximity to Photo Station 1

Photos were collected during April 2011 at the seven permanent photo stations established throughout the project area to provide representative digital documentation of baseline stream and vegetation conditions (Appendix F – Permanent Photo Station Photos). Representative preconstruction photos are included in Appendix F.

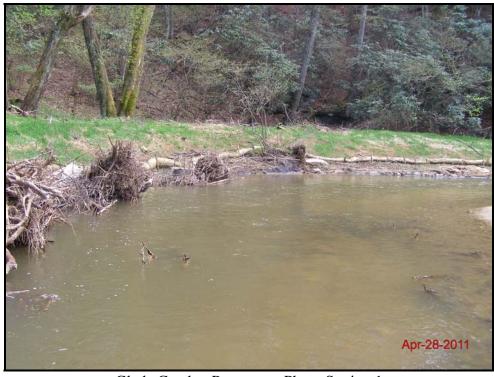
Glade Creek – Permanent Photo Station 1 Looking Upstream – April 28, 2011

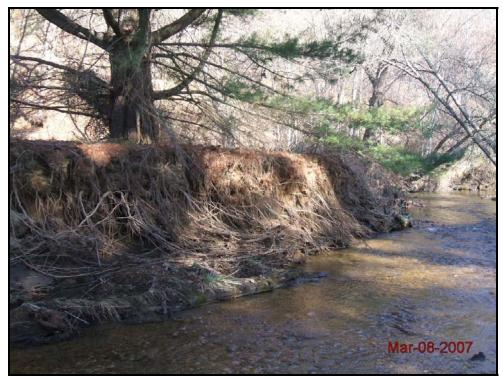
Glade Creek
Pre-construction conditions in proximity to Photo Station 2

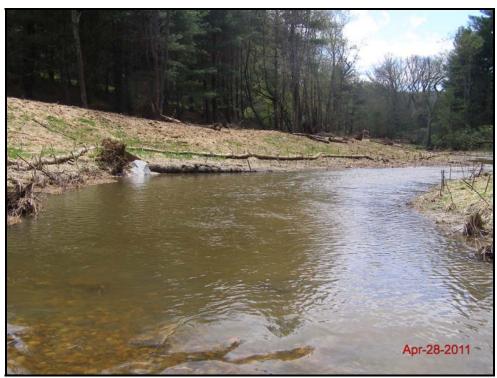
Glade Creek – Permanent Photo Station 2 Looking Upstream – April 28, 2011

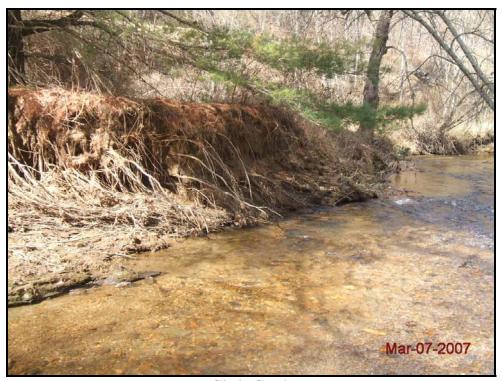
Glade Creek
Pre-construction conditions in proximity to Photo Station 3

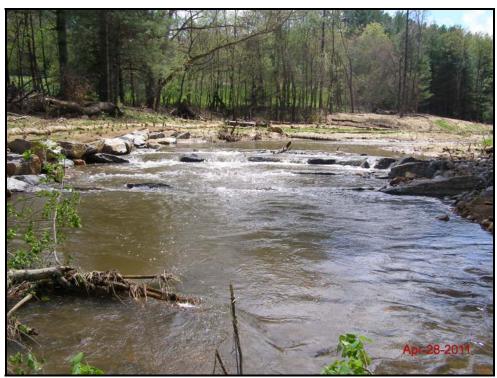
Glade Creek – Permanent Photo Station 3 Looking Upstream – April 28, 2011

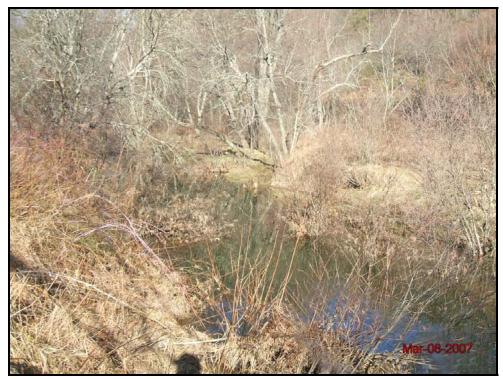
Glade Creek
Pre-construction conditions in proximity to Photo Station 4

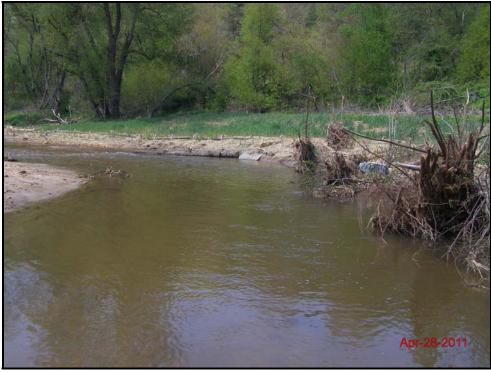
Glade Creek – Permanent Photo Station 4 Looking Upstream – April 28, 2011

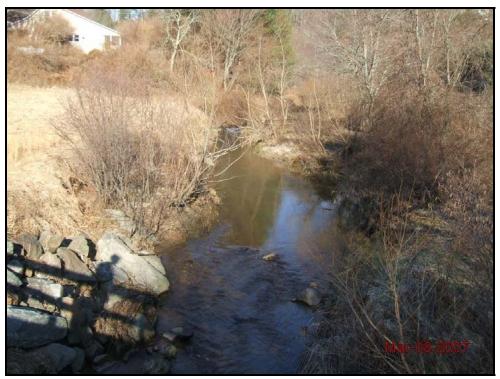
Glade Creek
Pre-construction conditions looking upstream from Photo Station 5

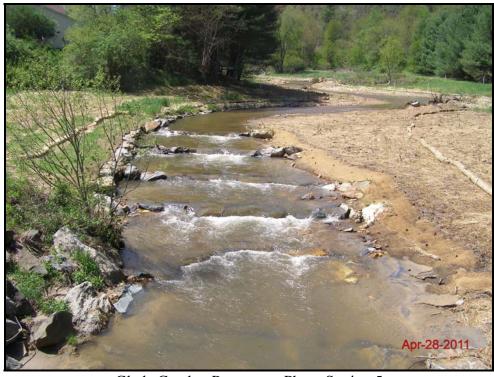
Glade Creek – Permanent Photo Station 5 Looking Upstream – April 28, 2011

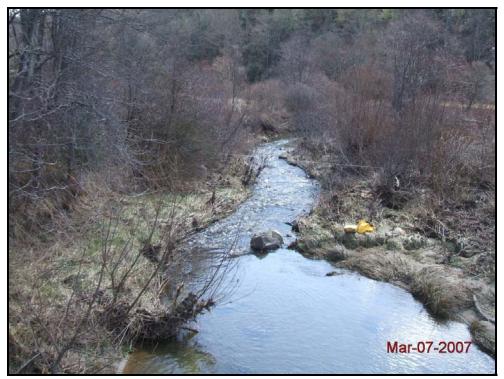
Glade Creek
Pre-construction conditions looking downstream from Photo Station 5

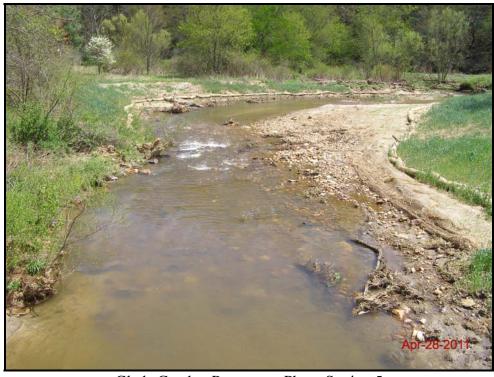
Glade Creek – Permanent Photo Station 5 Looking Downstream – April 28, 2011

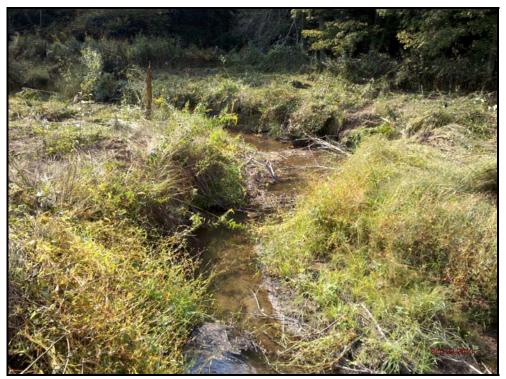
Unnamed Tributary Lower
Pre-construction conditions in proximity to Photo Station 6

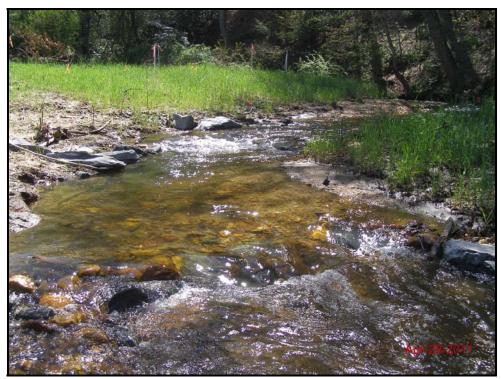
Unnamed Tributary Lower – Permanent Photo Station 6 Looking Upstream – April 28, 2011

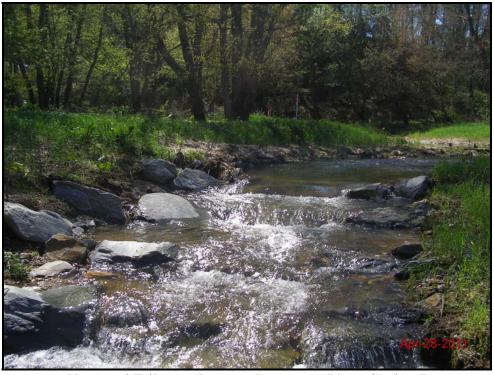
Unnamed Tributary Lower – Permanent Photo Station 7 Looking Upstream – April 28, 2011
