Harrell Farm Stream/Wetland Restoration Mitigation Plan Contract # D05025-1

March 2008

TYPE OF WORK: STREAM AND WETLAND RESTORATION

AS-BUILT PLAN

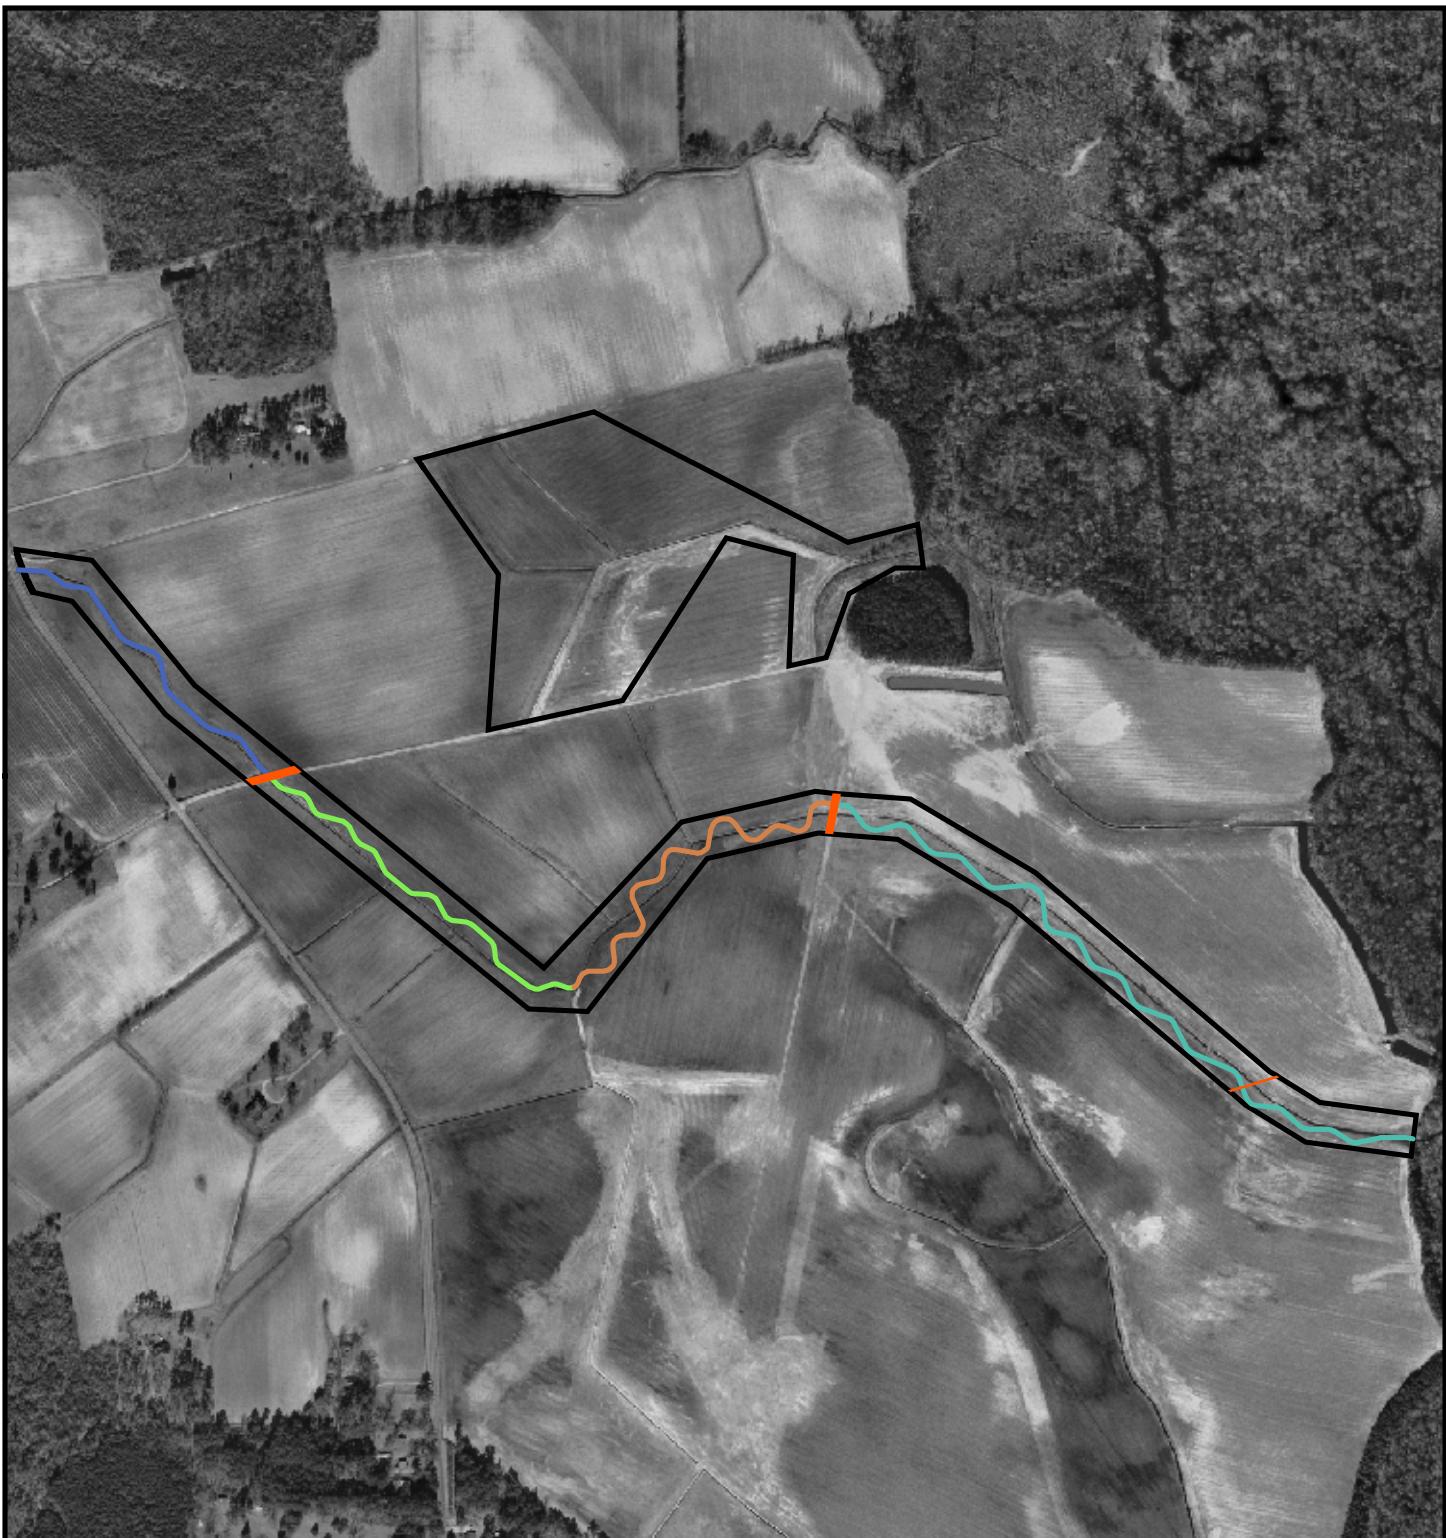
Figure 2. Project Reaches

- Reach 1 ■ Easement Exception
- Reach 2 □ Project Site Boundary
- Reach 3
- Reach 4

The project stream had been channelized and straightened since at least 1948. The entire site was under agricultural production, with the fields directly bordering the stream. There were no remaining vegetated buffers or in-stream features in the channel and the banks were nearly vertical. The channel was characterized as having poor streambed variability and habitat diversity. Restoration of 6,808 linear feet of channel was accomplished utilizing a combination of Priority Levels 2 and 3 (Table 1). Reach 1 (Station 10+00 to 22+26) was restored using a Priority Level 3 approach. The restoration of a B5c channel with a sinuosity of 1.06 was accomplished by building a bankfull channel with a higher width/depth ratio than the existing stream, creating distinct bed features by adding pools and riffles to the profile, and grading back the upper slopes to create an appropriate valley for the stream. Reaches 2, 3, and 4 (Stations 22+26 to 36+91, 36+91 to 51+82, and 51+82 to 78+80, respectively) were restored to a C5 channel with a Priority Level 2 restoration. The restoration established a bankfull channel with a new floodplain where the designed bankfull stage equals the new floodplain elevation (bank height ratio=1.0). Reaches 2, 3, and 4 have sinuosity values of 1.07, 1.23, and 1.10, respectively. The four different reaches are shown in Figure 2.

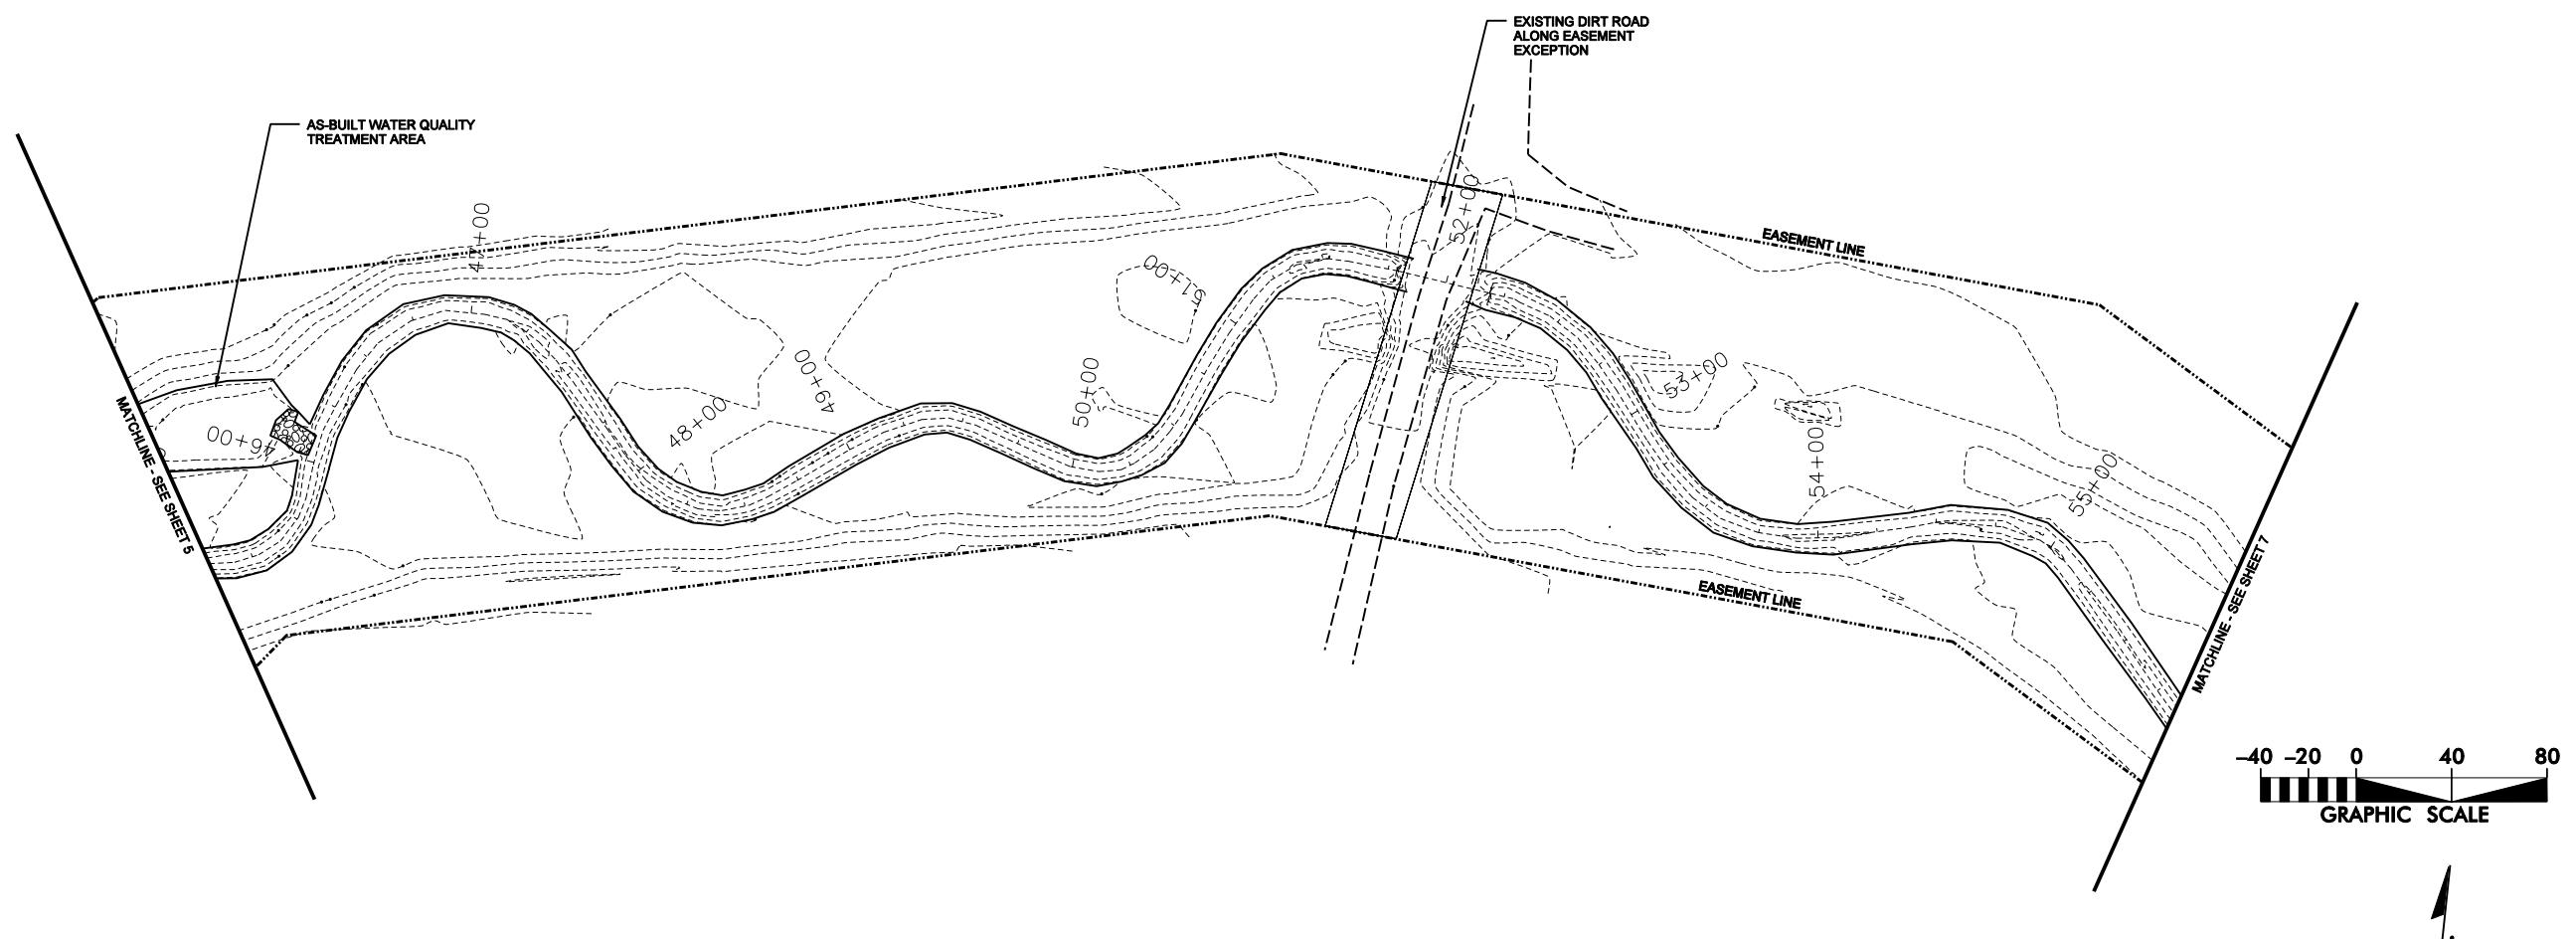
HARRELL SITE
STREAM AND WETLAND RESTORATION
EDGECOMBE CO., NORTH CAROLINA
STATION 45+31 TO STATION 55+86

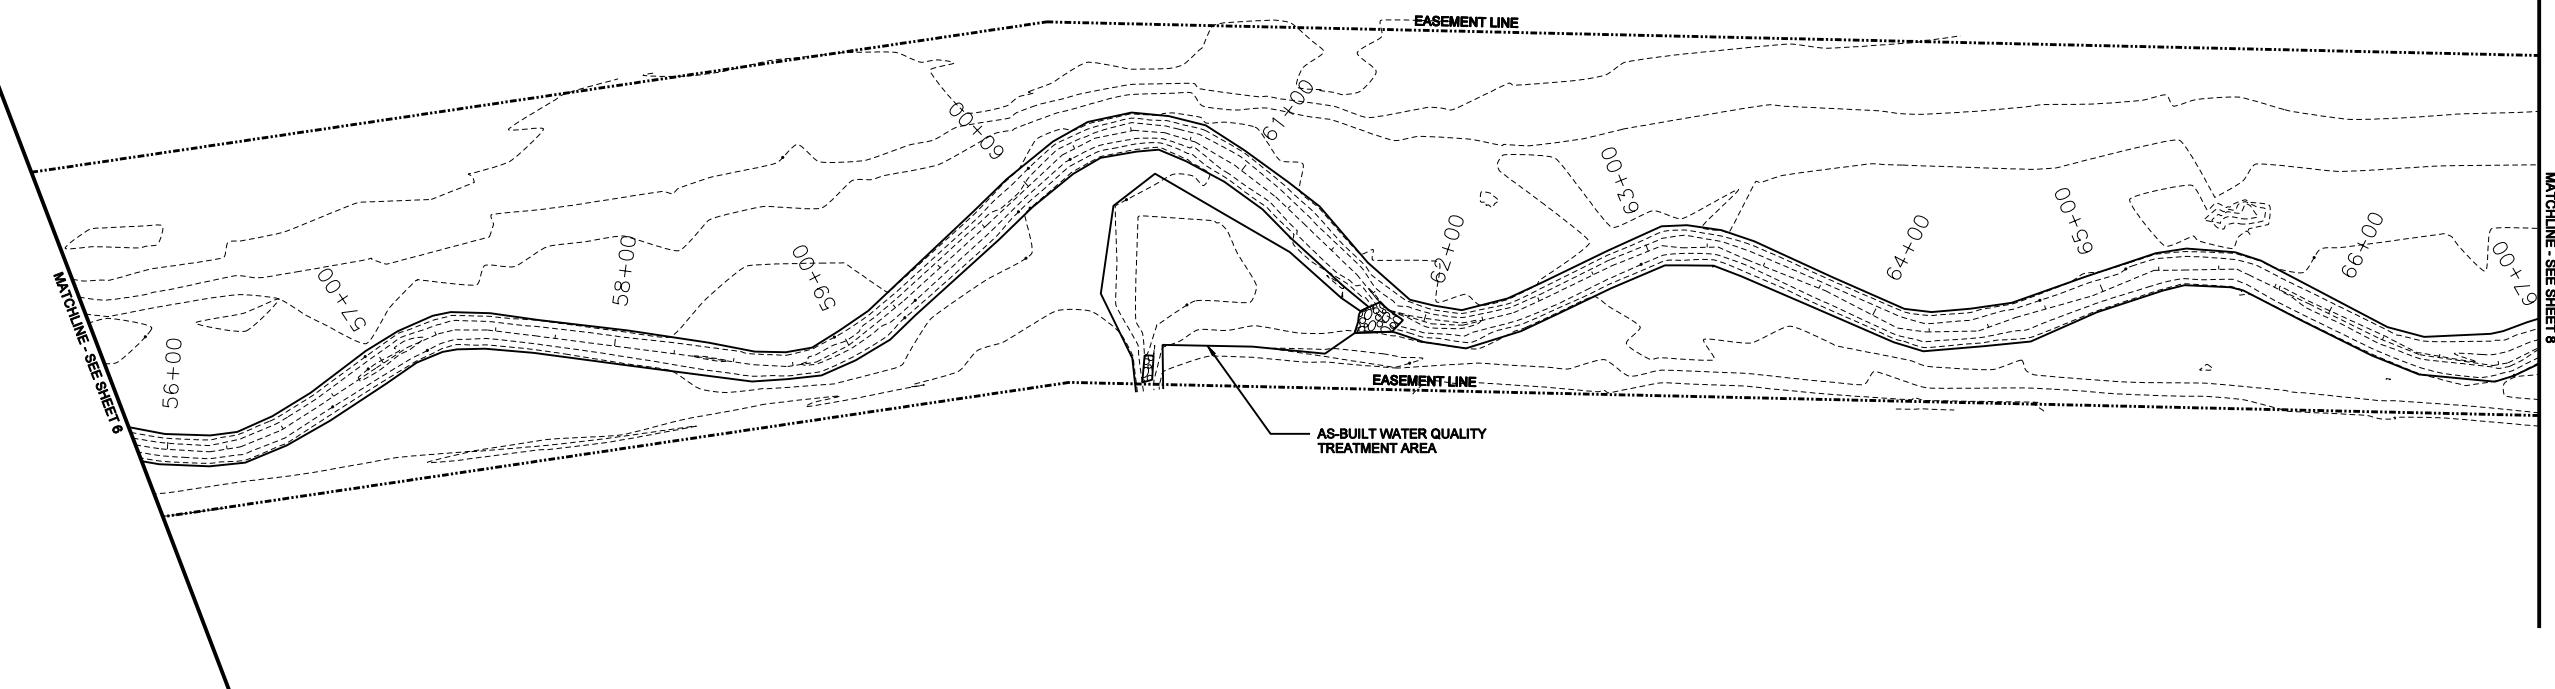
HARRELL SITE
STREAM AND WETLAND RESTORATION
EDGECOMBE CO., NORTH CAROLINA
STATION 55+86 TO STATION 66+94

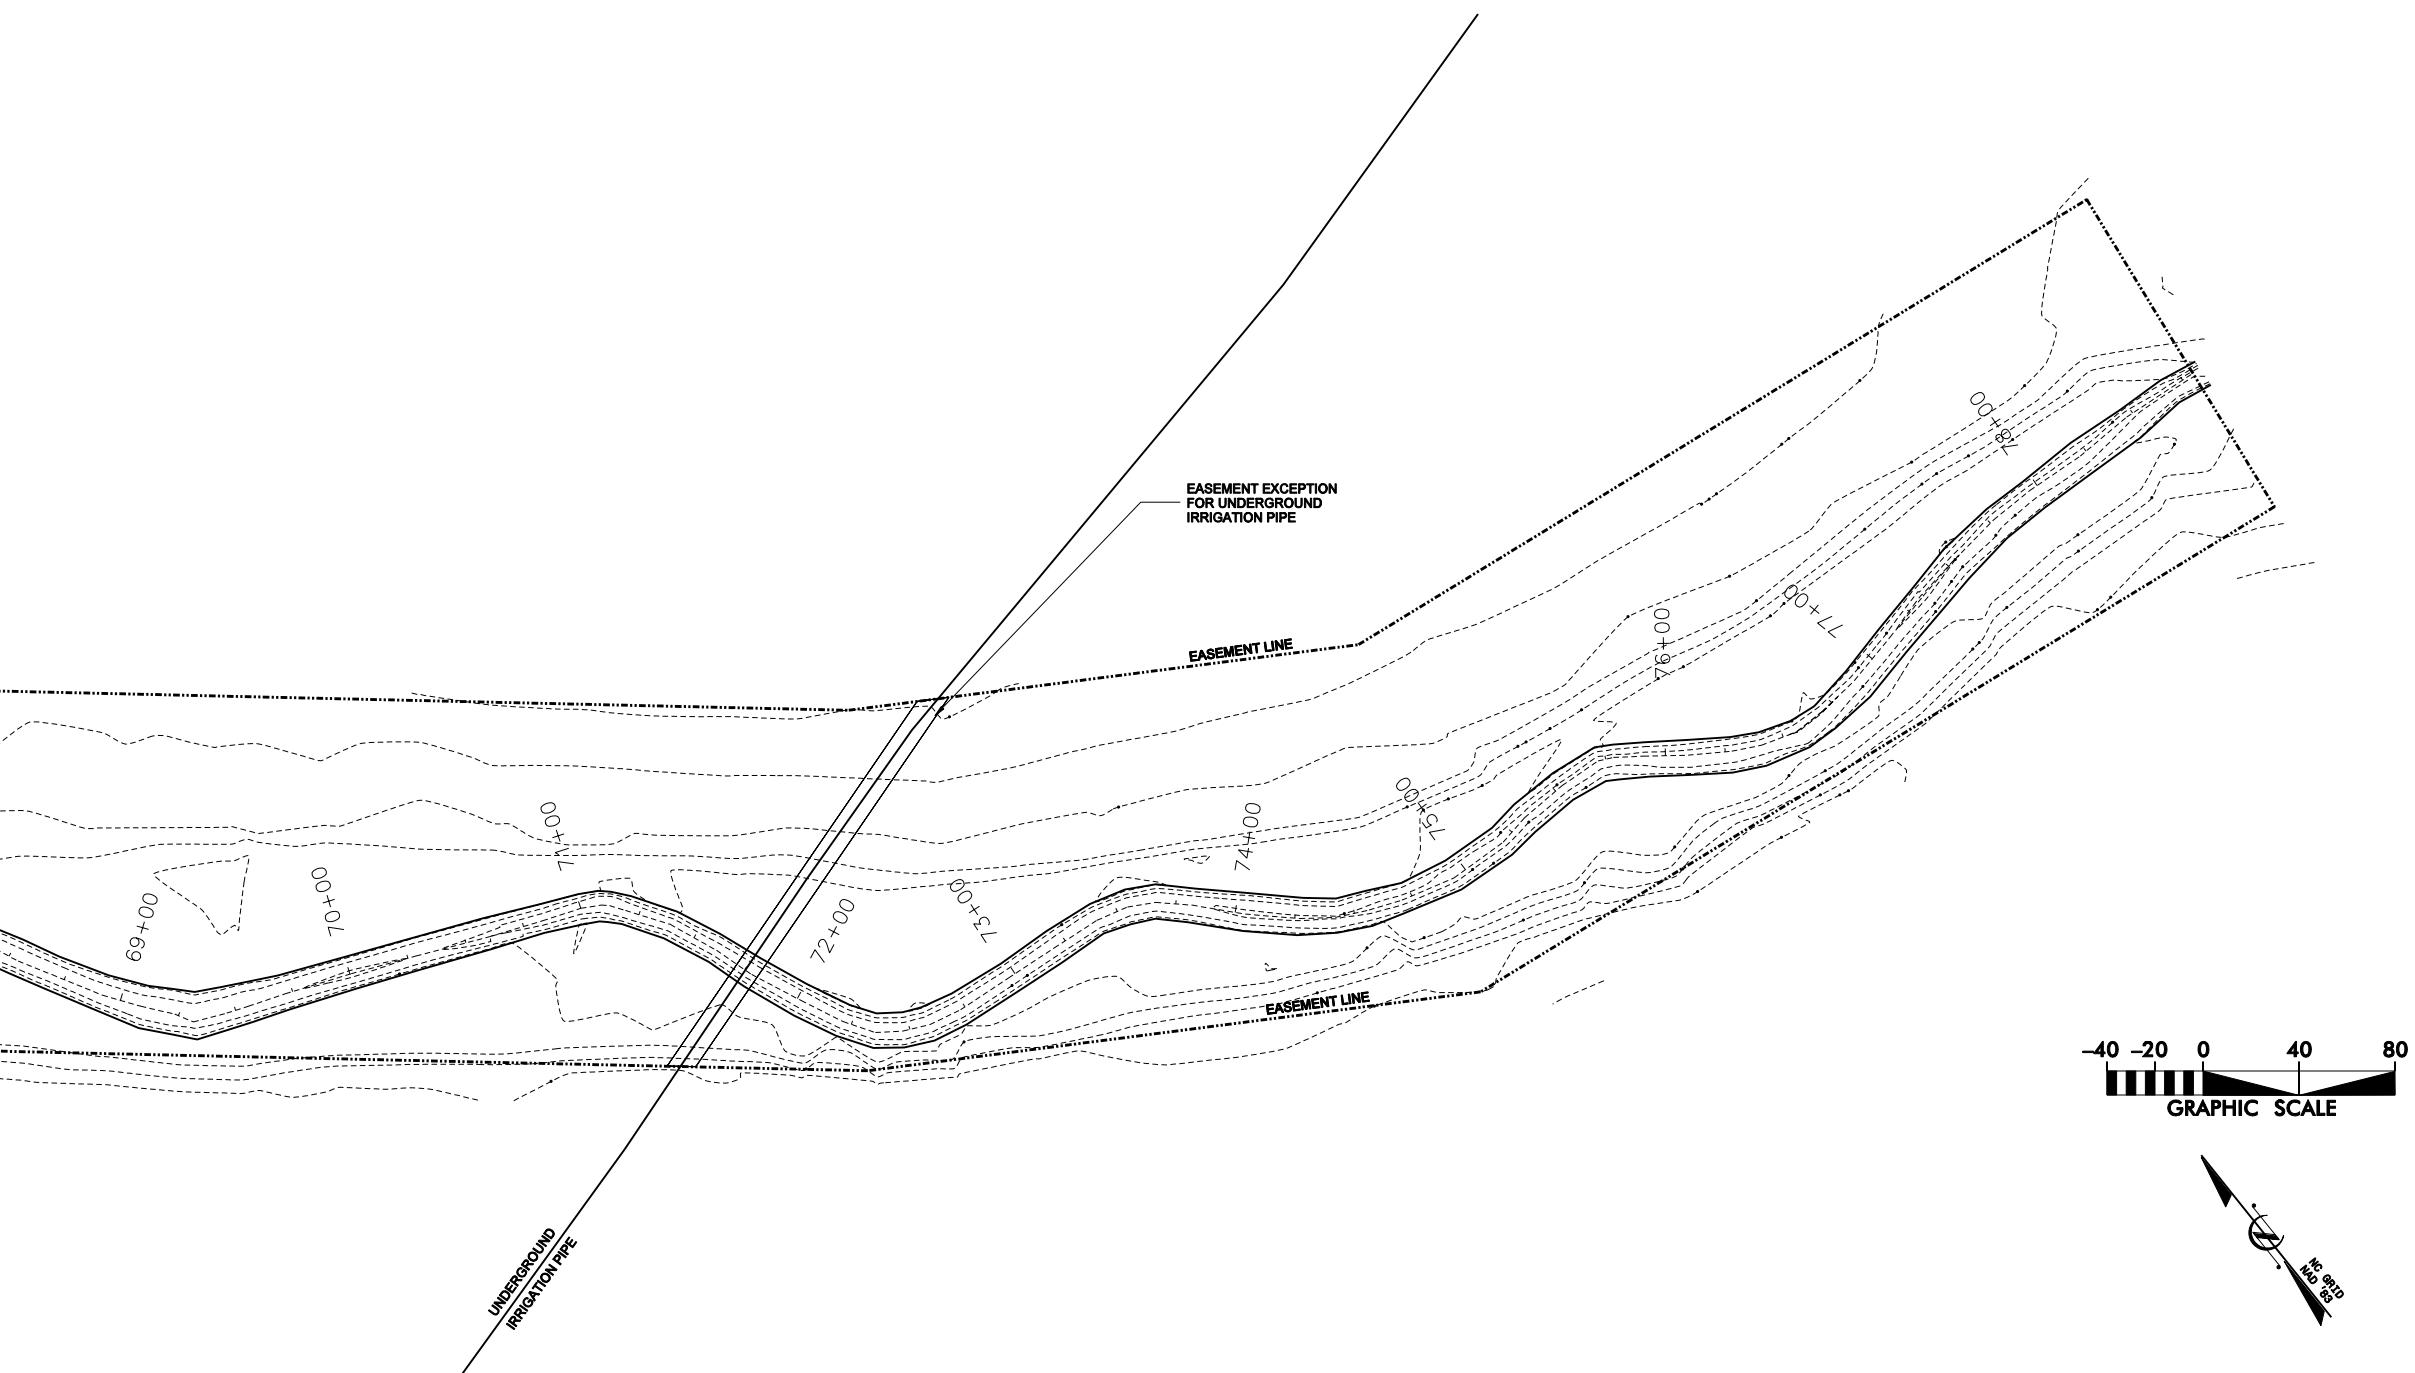
HARRELL SITE
STREAM AND WETLAND RESTORATION
EDGECOMBE CO., NORTH CAROLINA
STATION 66+94 TO STATION 78+80

DATE: FEB 2008
SCALE: 1"=80'
STREAM
AS-BUILT
SHEET 8 OF 22

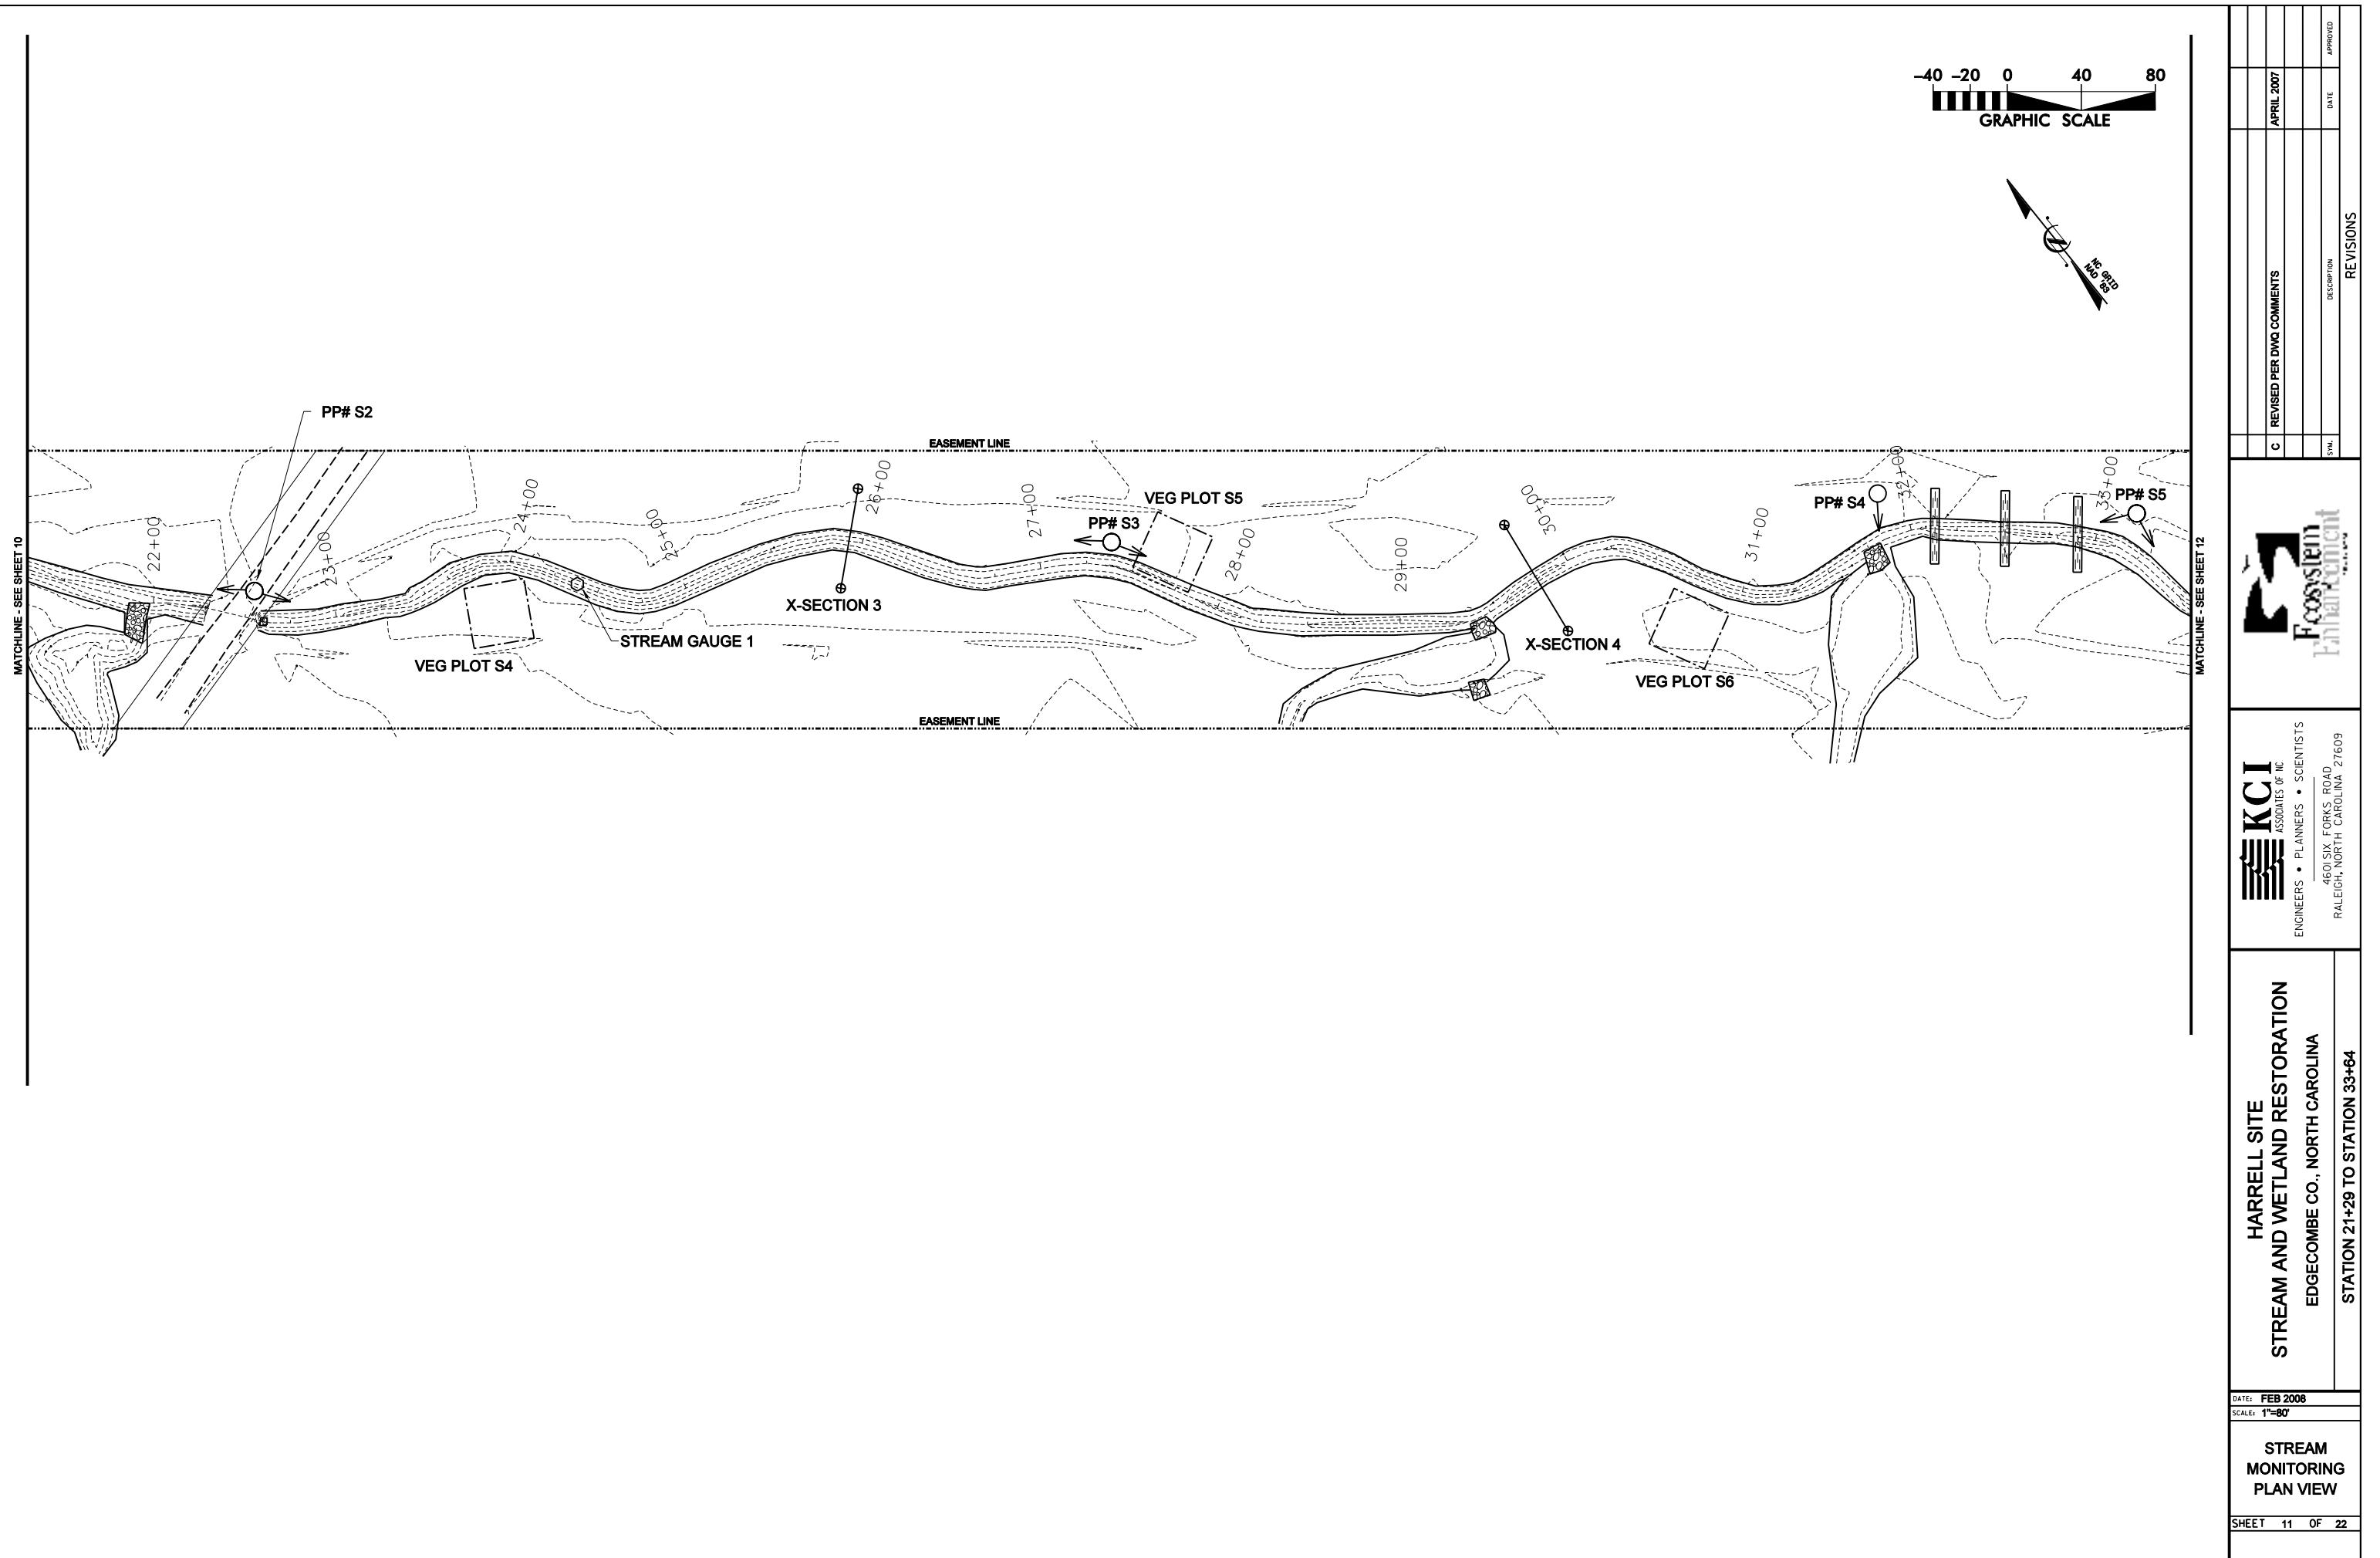
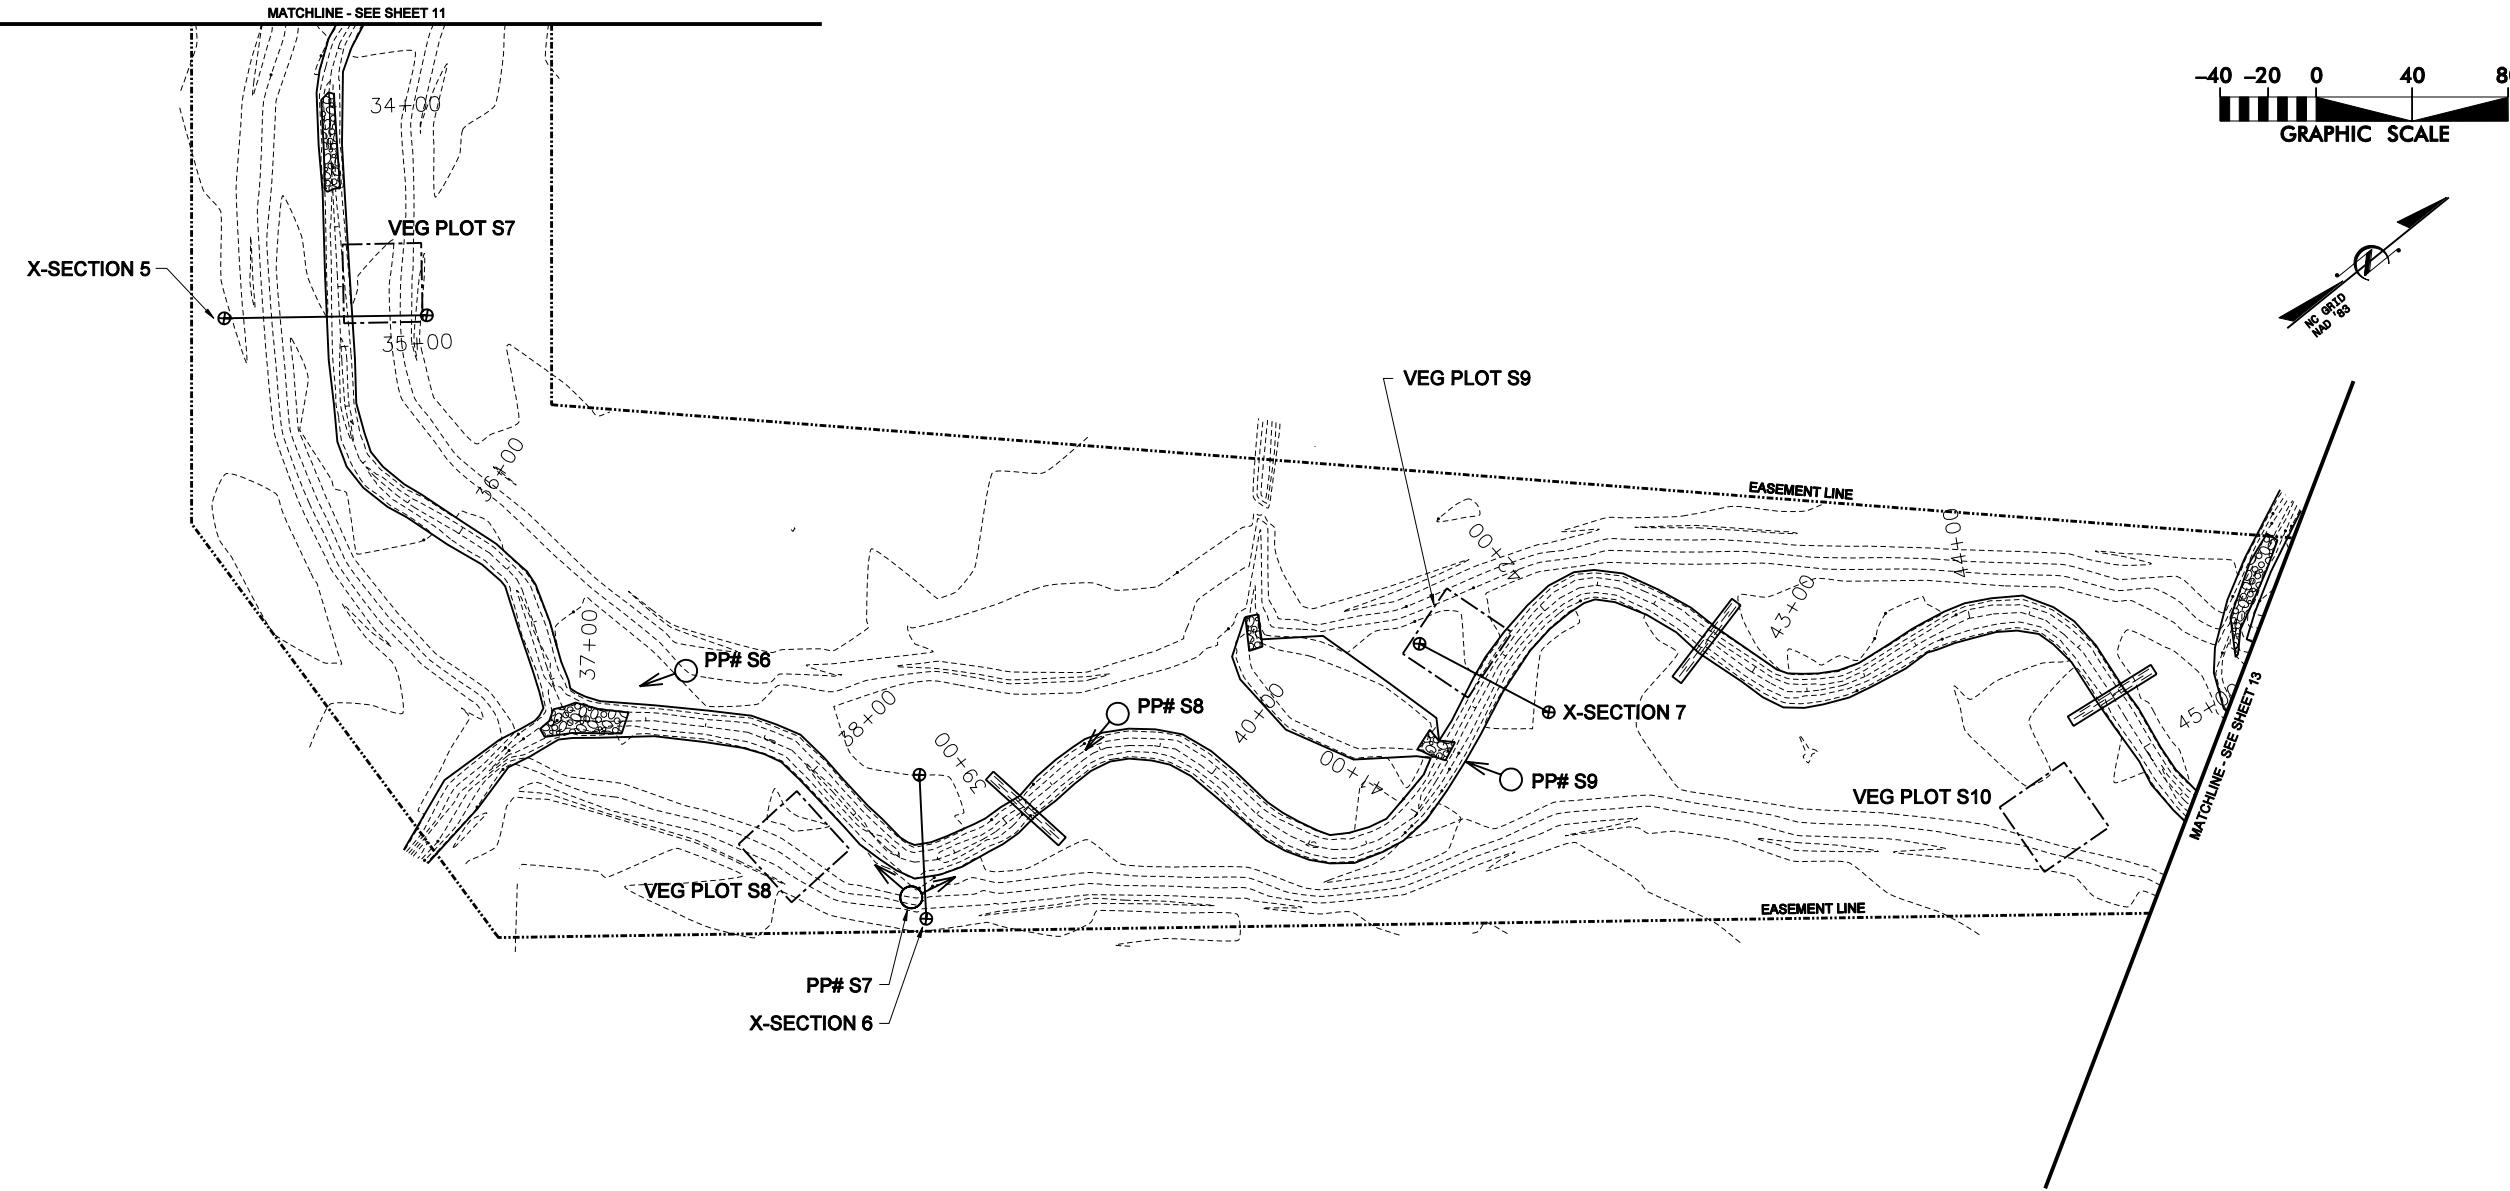
**HARRELL SITE
STREAM AND WETLAND RESTORATION
EDGECOMBE CO., NORTH CAROLINA**

STATION 33+64 TO STATION 45+31

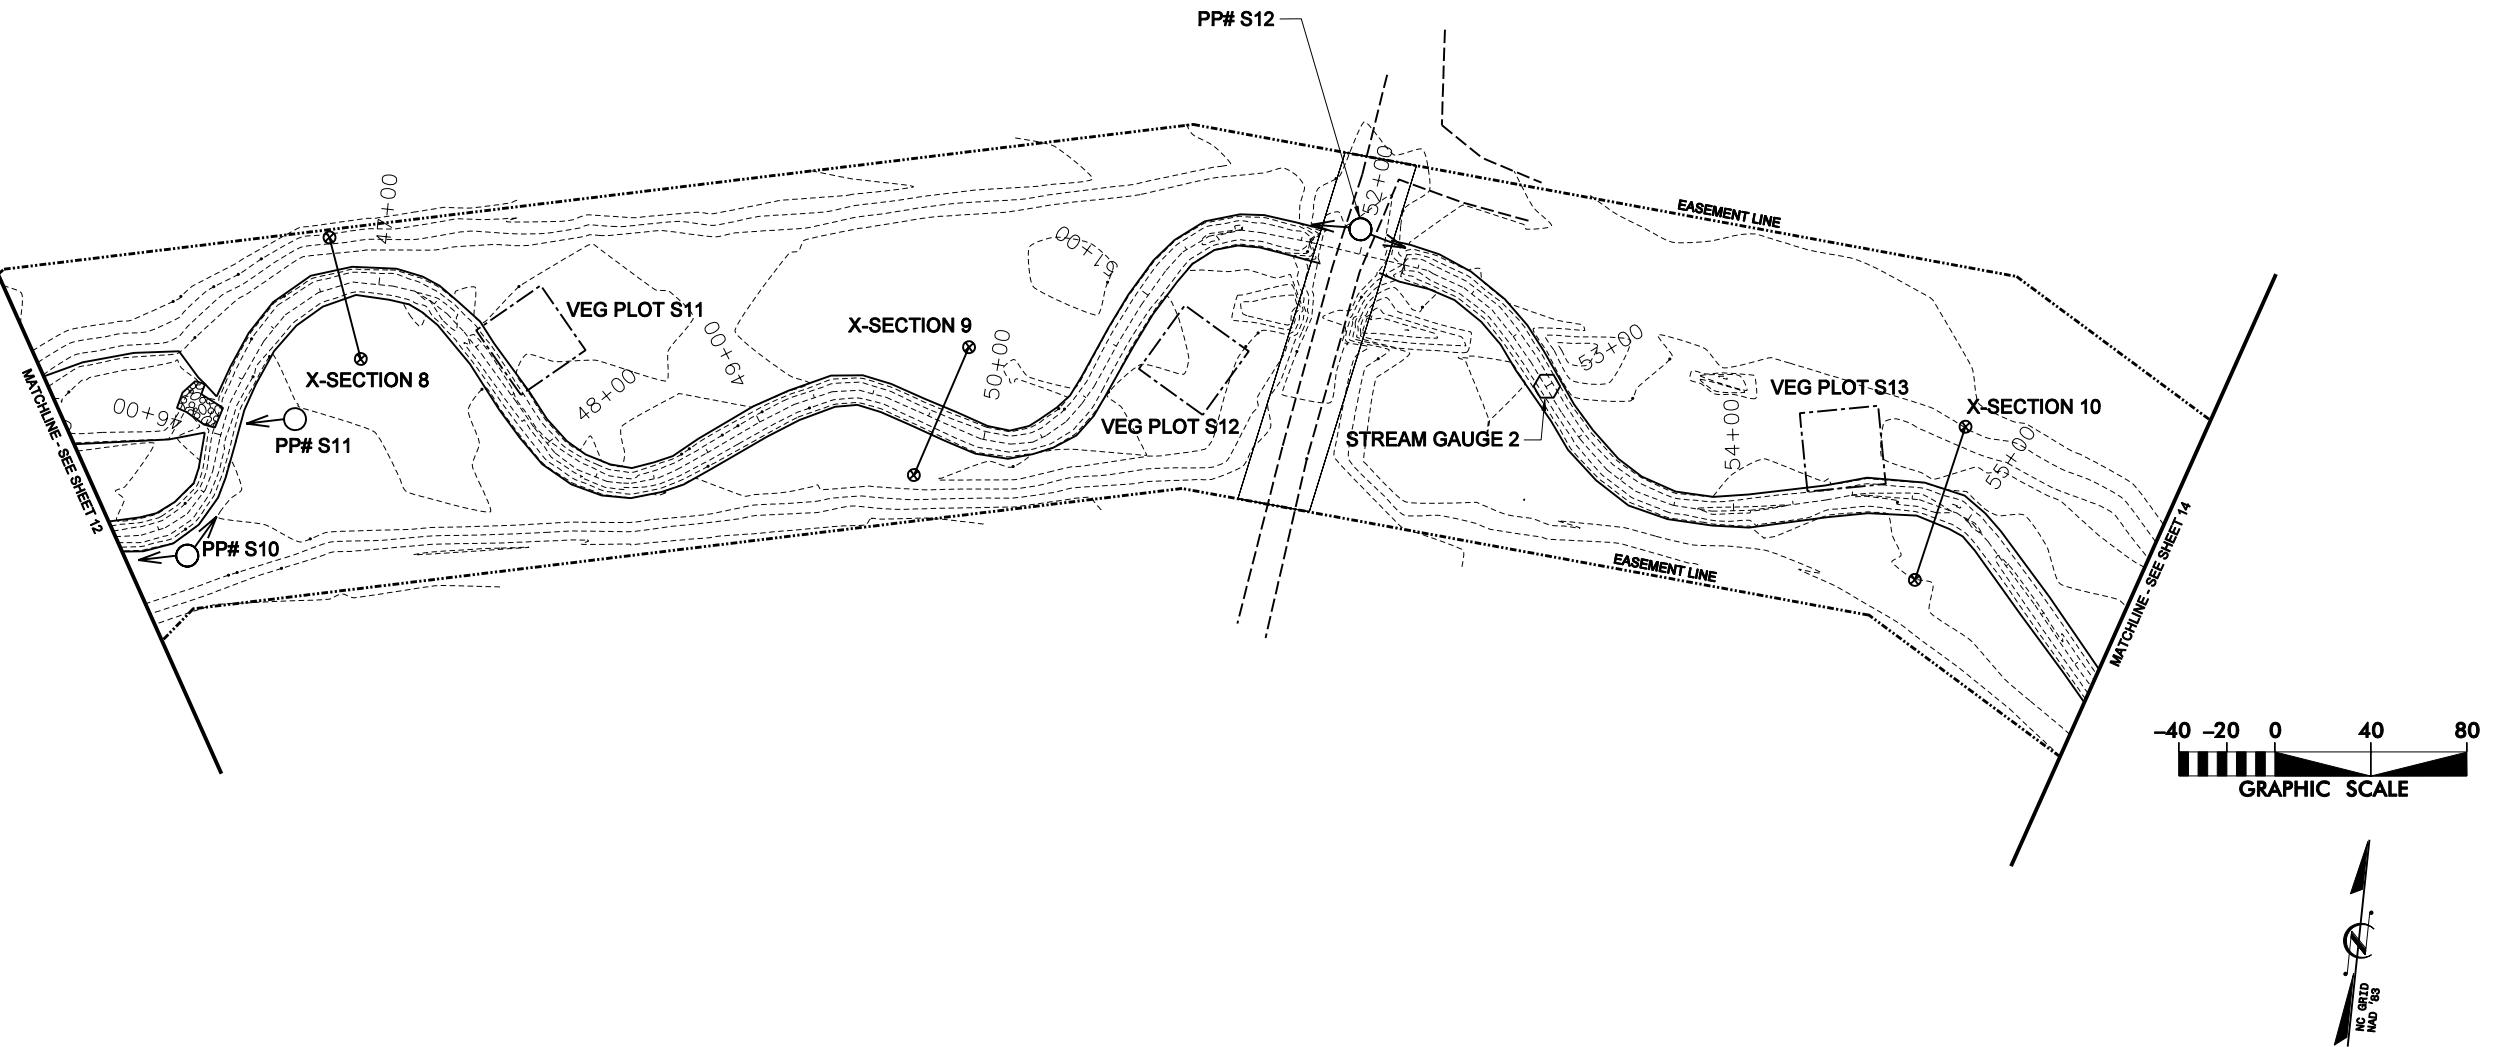
HARRELL SITE
STREAM AND WETLAND RESTORATION
EDGECOMBE CO., NORTH CAROLINA

STATION 45+31 TO STATION 55+86

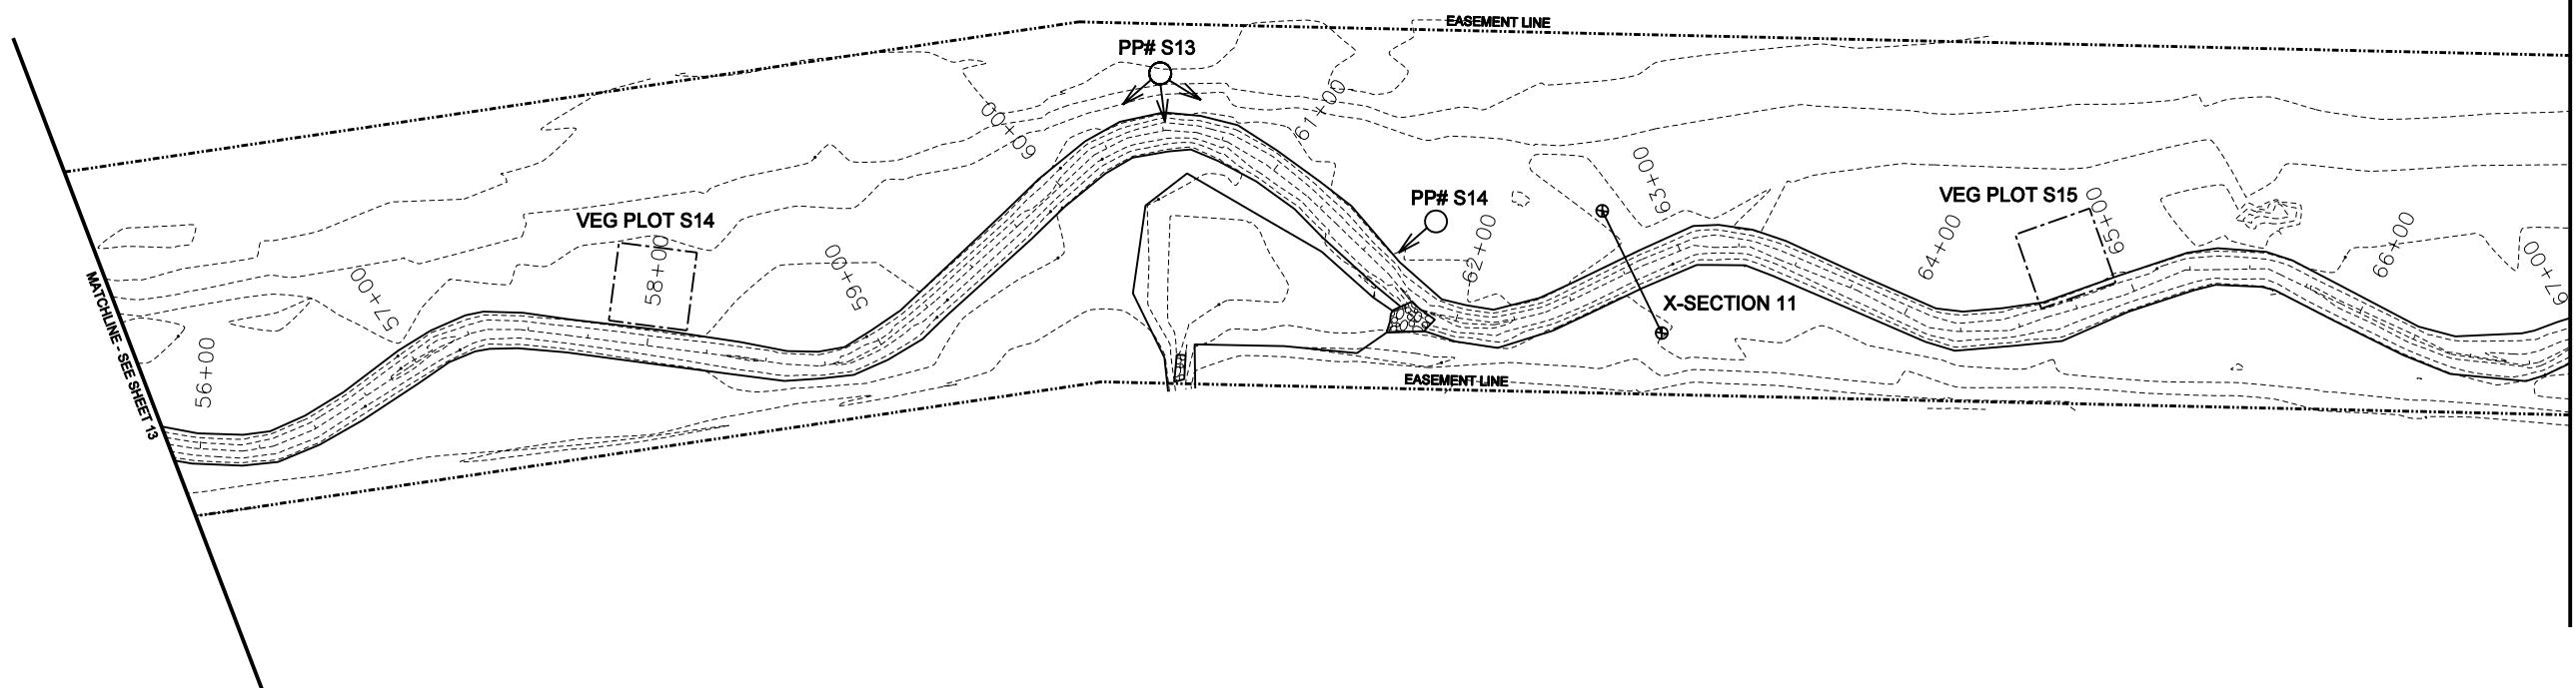
HARRELL SITE
STREAM AND WETLAND RESTORATION
EDGECOMBE CO., NORTH CAROLINA
STATION 55+86 TO STATION 66+94
