Harrell Farm Stream/Wetland Restoration Mitigation Plan Contract # D05025-1

March 2008

TYPE OF WORK: STREAM AND WETLAND RESTORATION

AS-BUILT PLAN

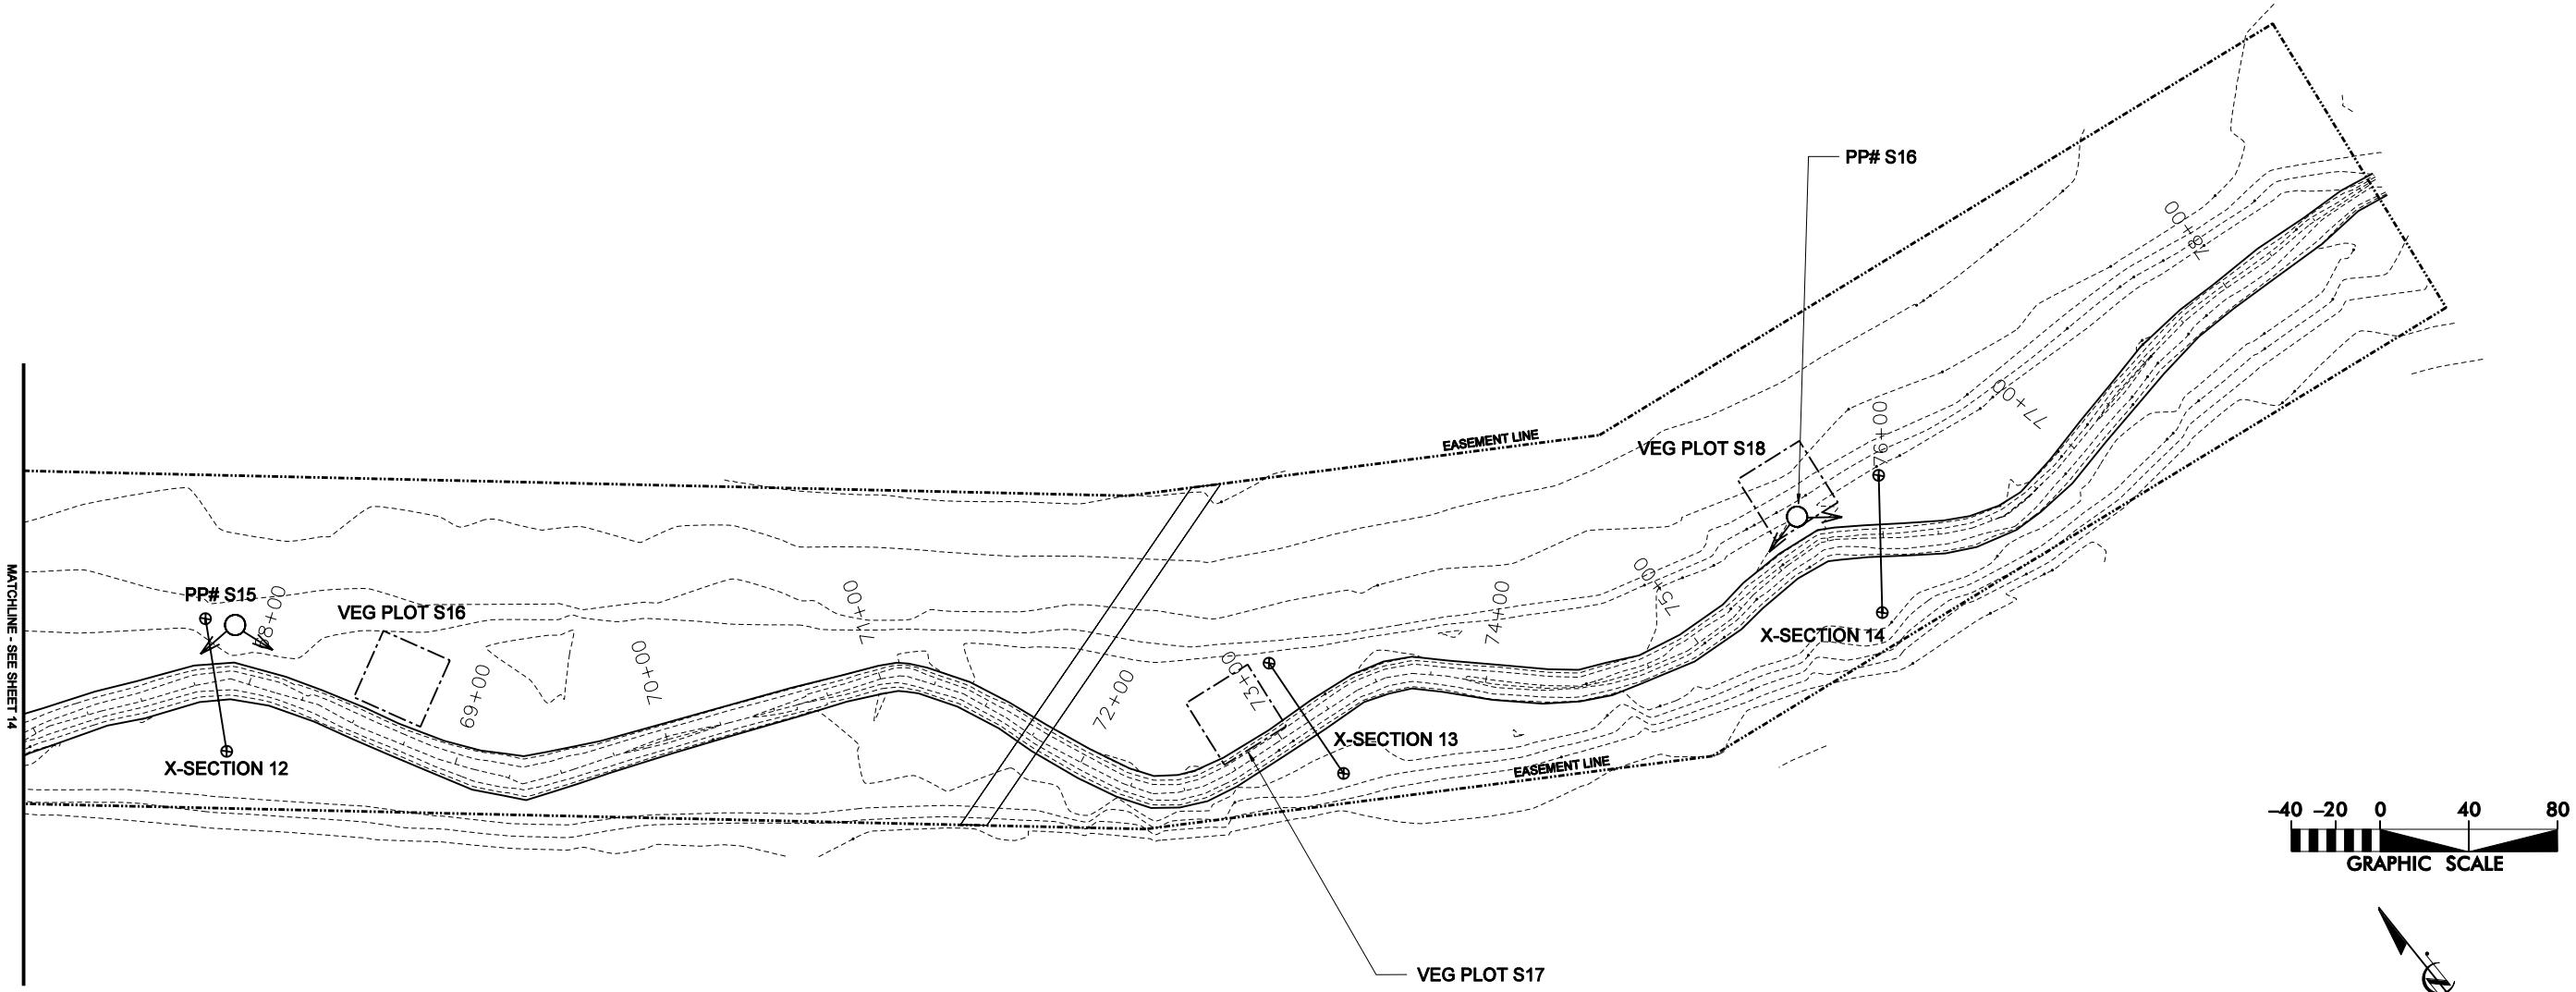
HARRELL SITE
STREAM AND WETLAND RESTORATION
EDGECOMBE CO., NORTH CAROLINA
STATION 66+94 TO STATION 78+80

DATE: FEB 2008
SCALE: 1"=80'
STREAM
MONITORING
PLAN VIEW
SHEET 16 OF 22

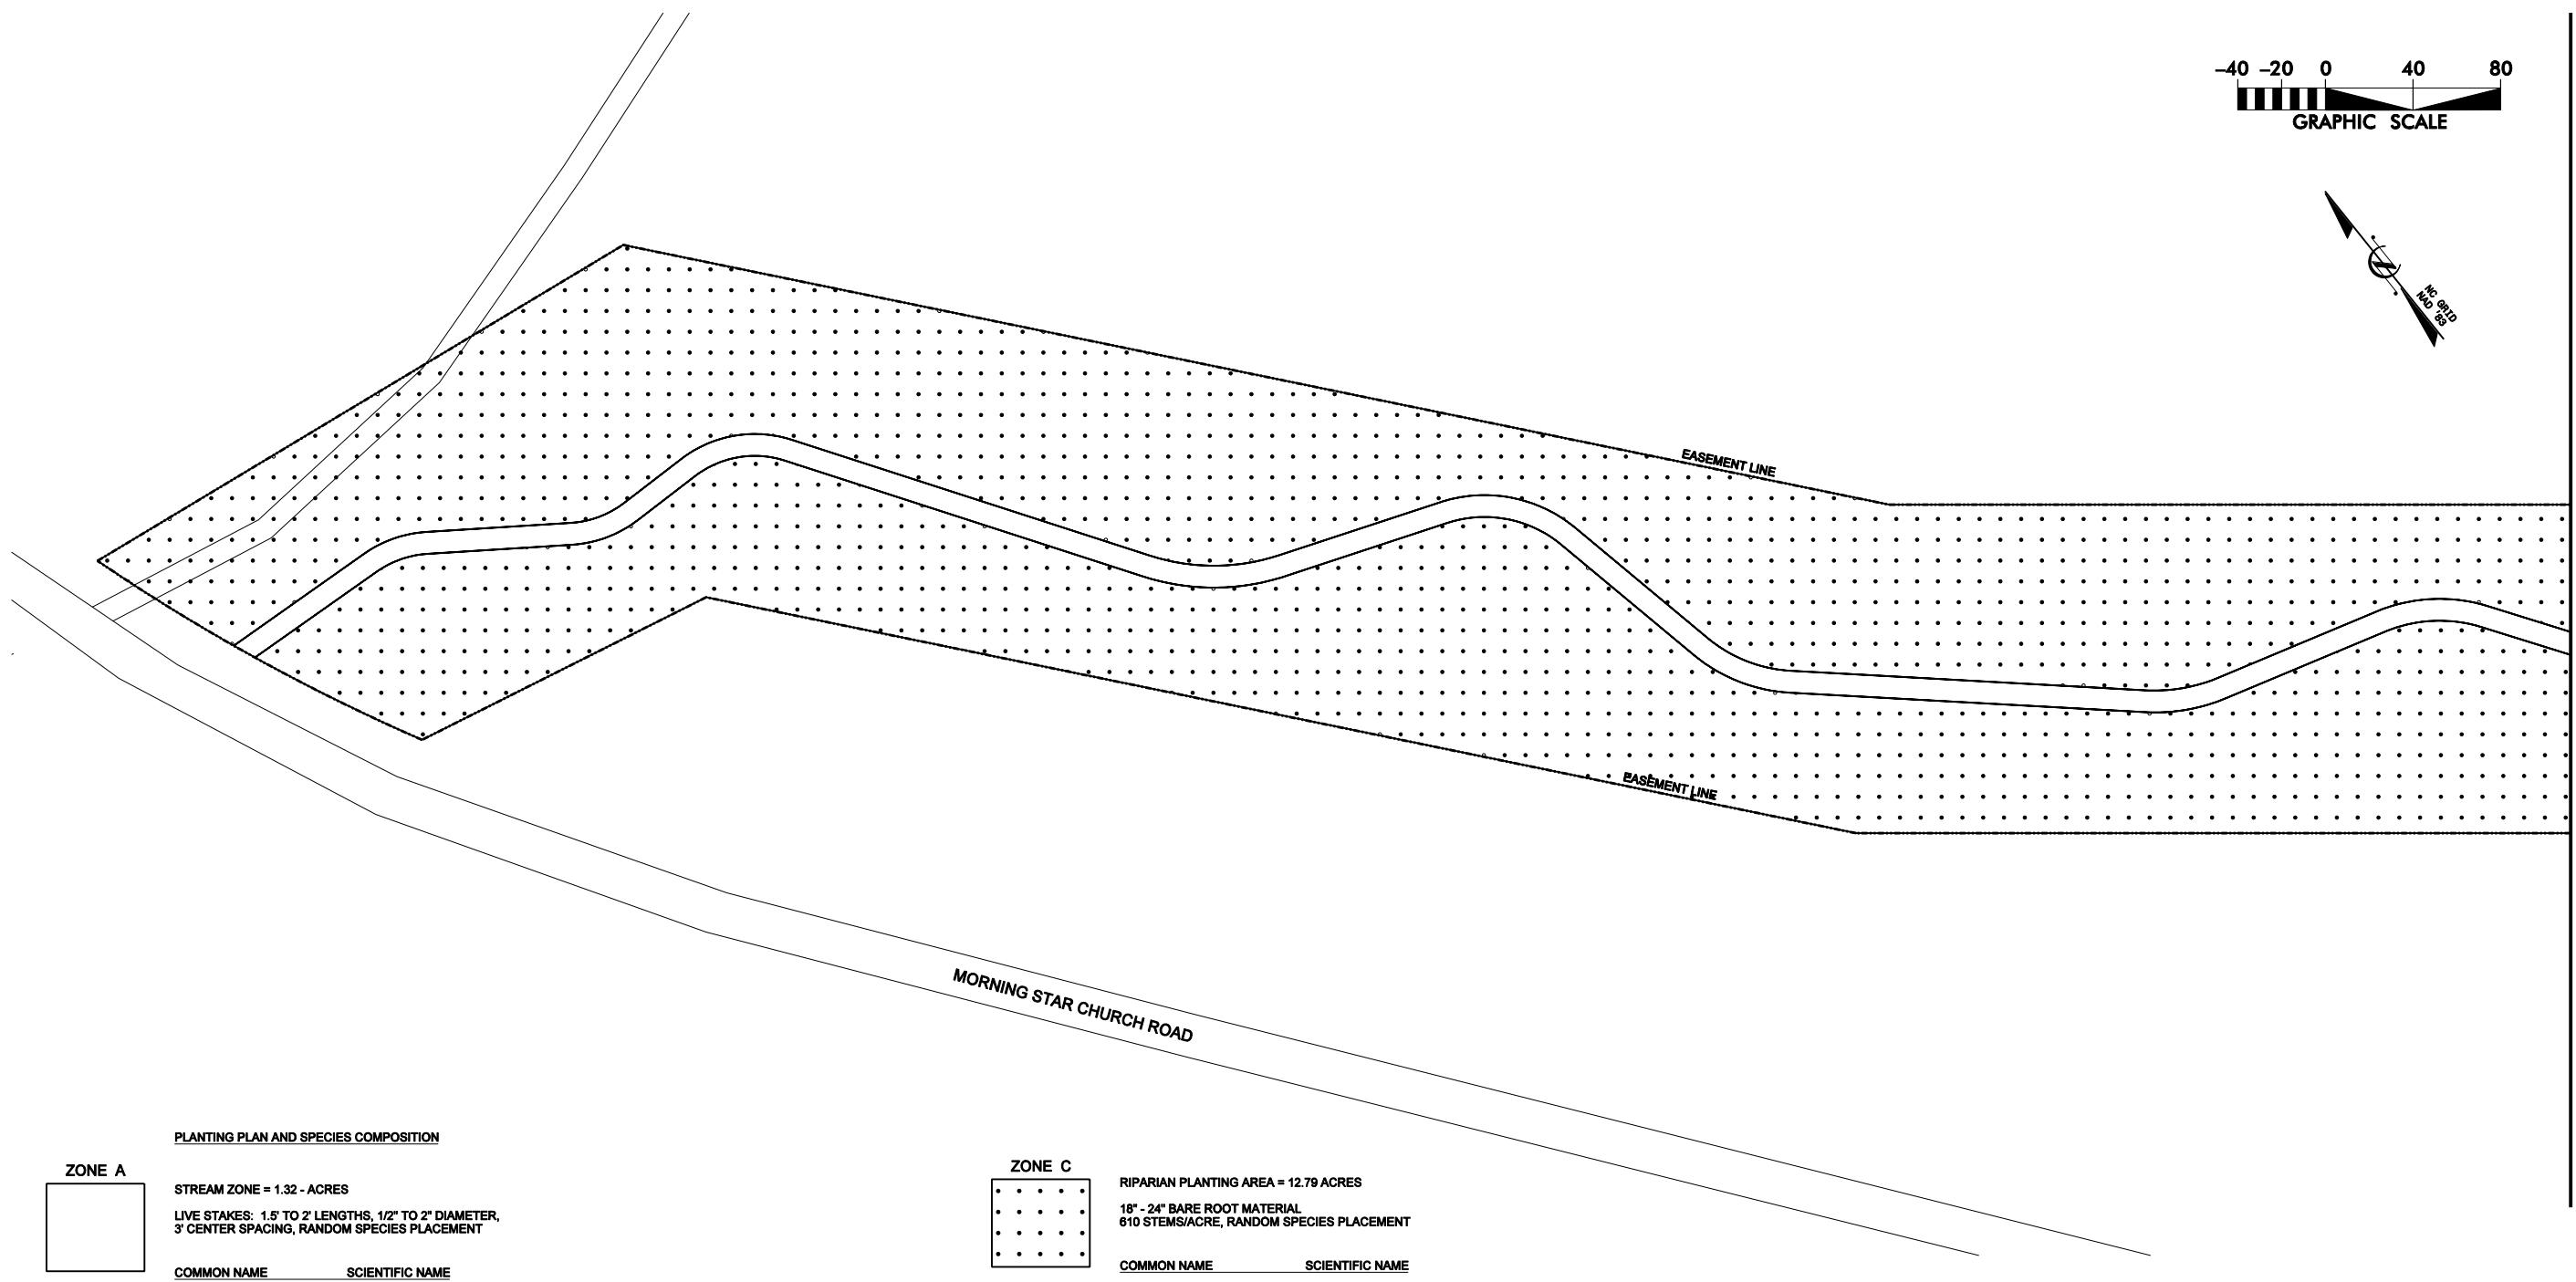
PLANTING PLAN AND SPECIES COMPOSITION

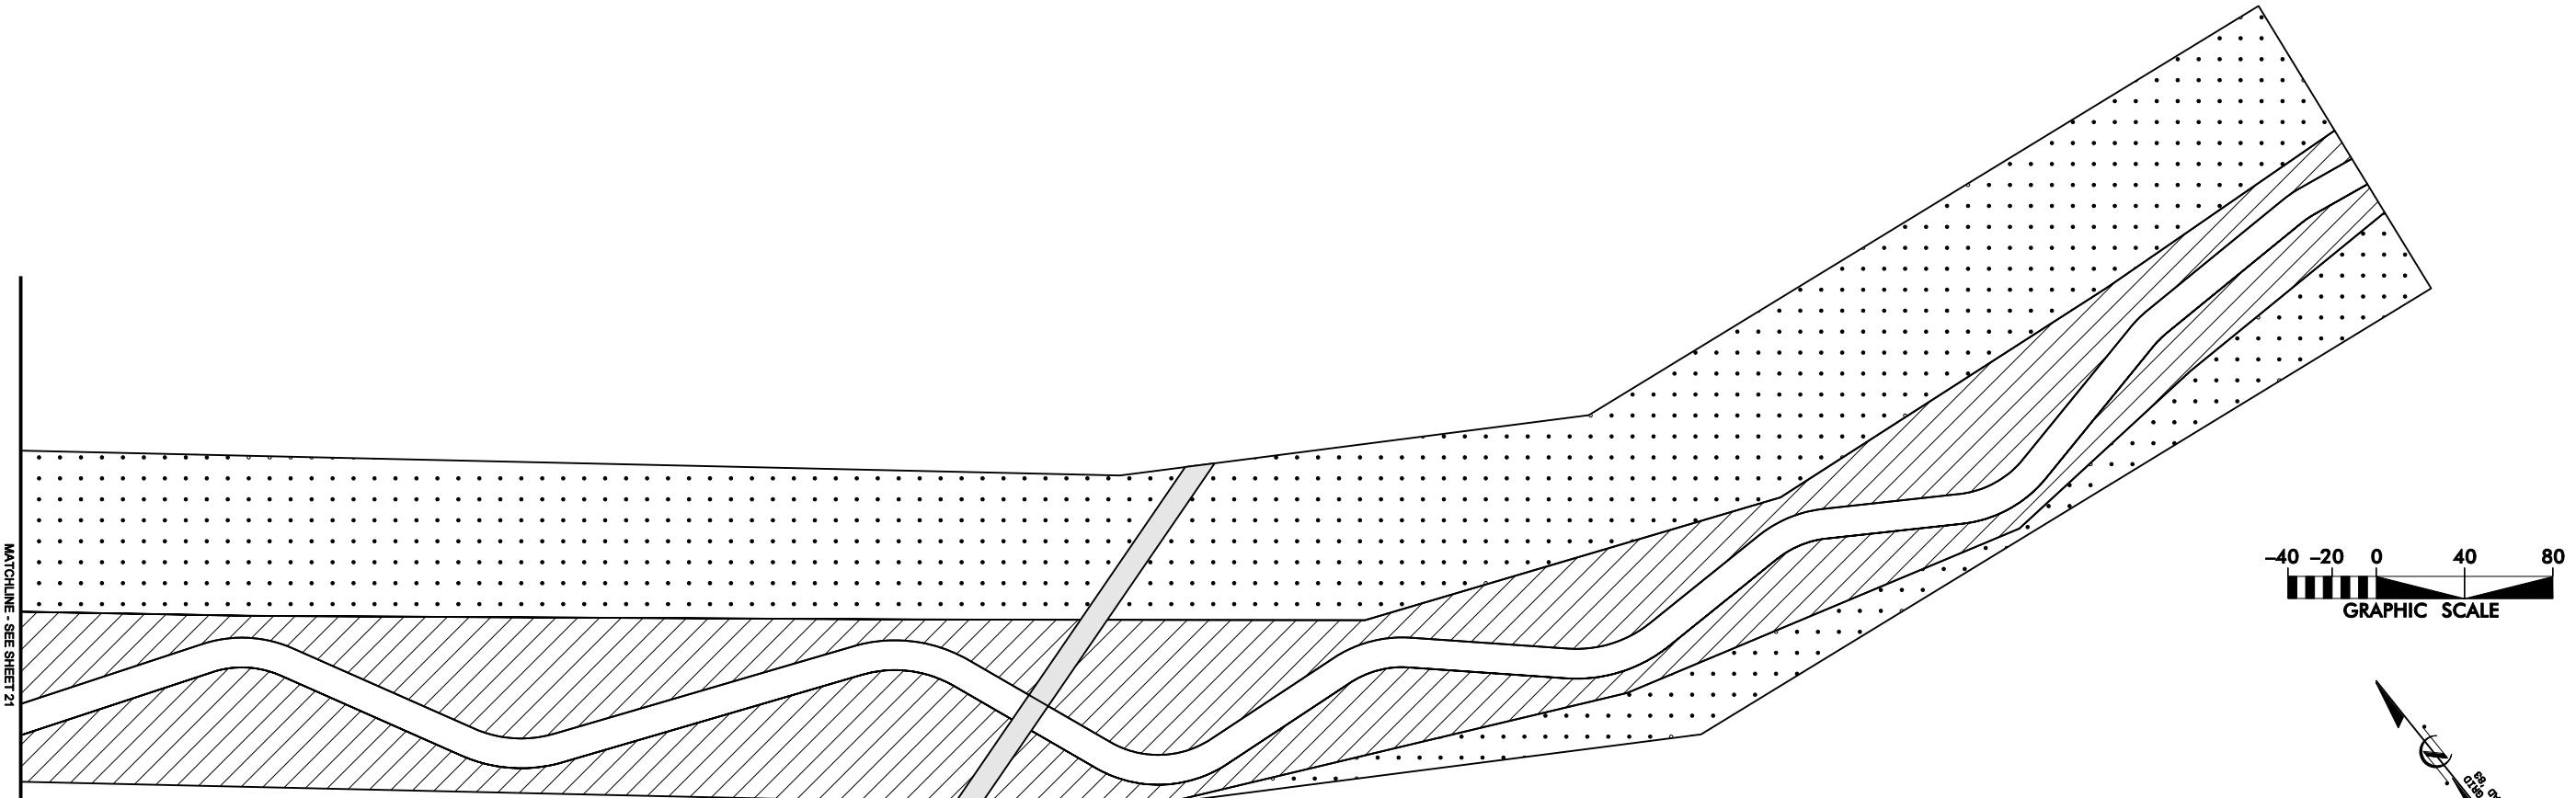
HARRELL SITE
STREAM AND WETLAND RESTORATION
EDGECOMBE CO., NORTH CAROLINA
STATION 66+94 TO STATION 78+80

DATE: FEB 2008
SCALE: 1"=80'
STREAM AS-BUILT PLANTING PLAN
SHEET 22 OF 22

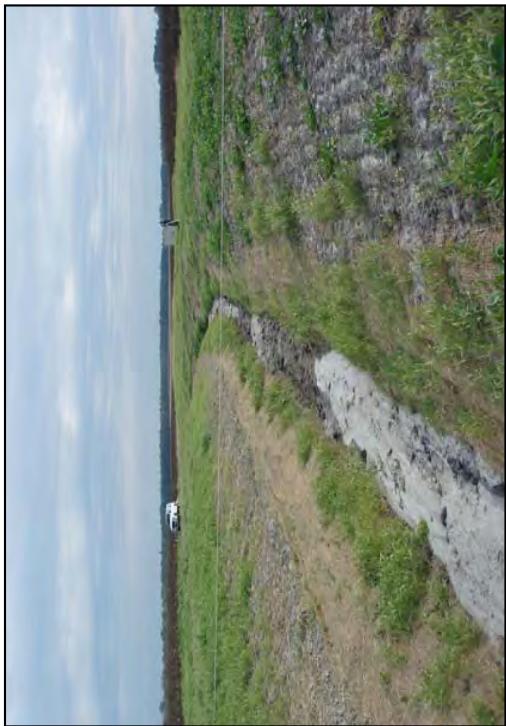
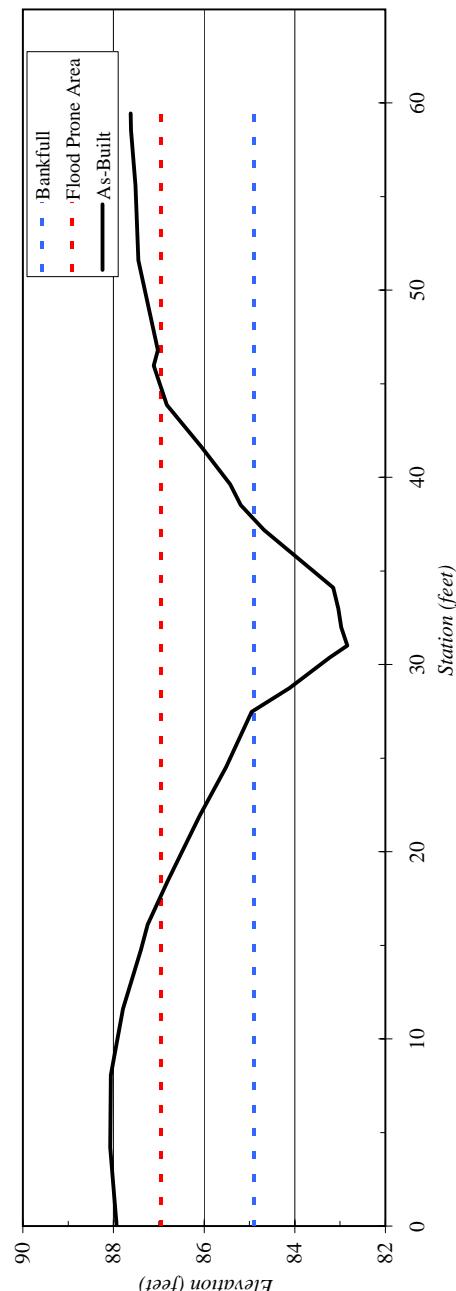
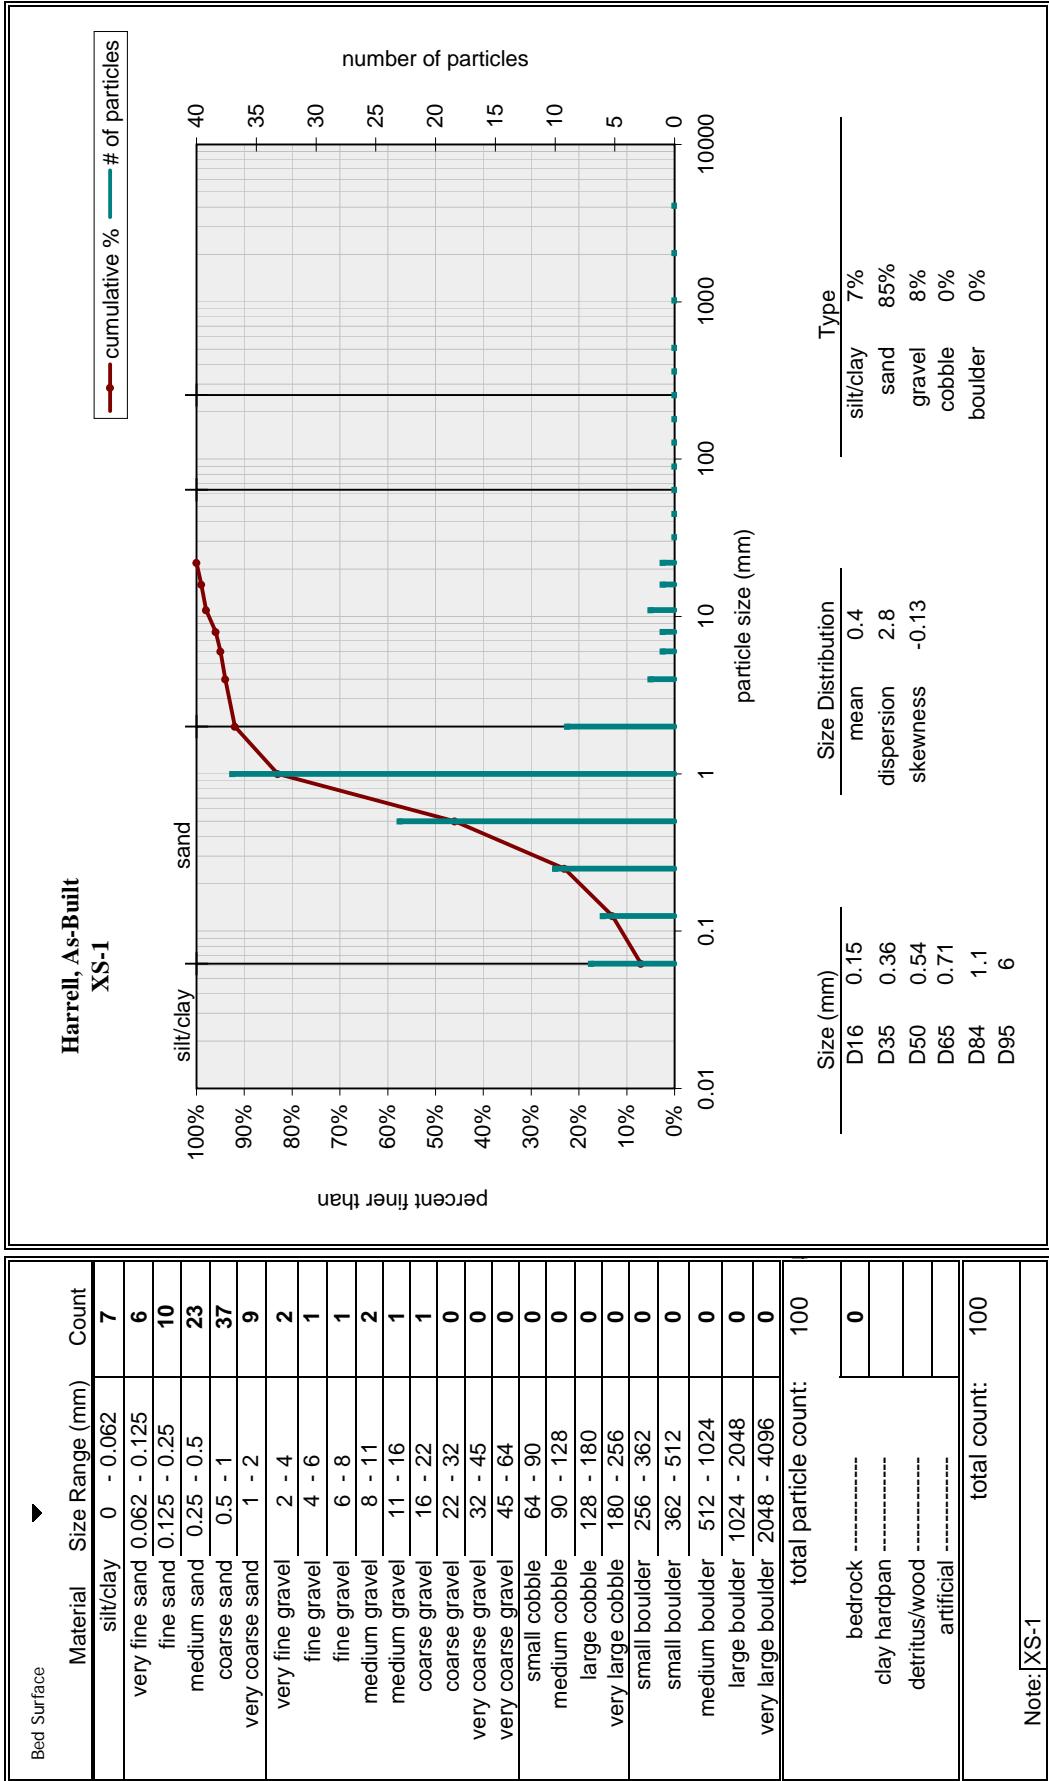
Tar-Pamlico River Basin, Harrell, As-Built, XS - 1

River Basin:	Tar-Pamlico
Watershed:	Harrell, As-Built
XS ID	XS - 1
Drainage Area (sq mi):	0.20
Date:	11/7/2007
Field Crew:	B. Roberts, T. King

SUMMARY DATA	
Bankfull Elevation:	84.9
Bankfull Cross-Sectional Area:	12.6
Bankfull Width:	10.2
Flood Prone Area Elevation:	87.0
Flood Prone Width:	27
Max Depth at Bankfull:	2.1
Mean Depth at Bankfull:	1.2
W / D Ratio:	8.3
Entrenchment Ratio:	2.7
Bank Height Ratio:	1.0

Stream Type	B5c

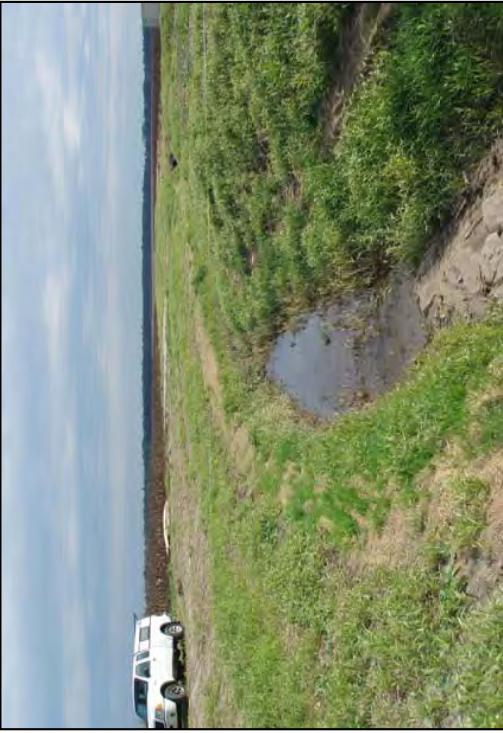
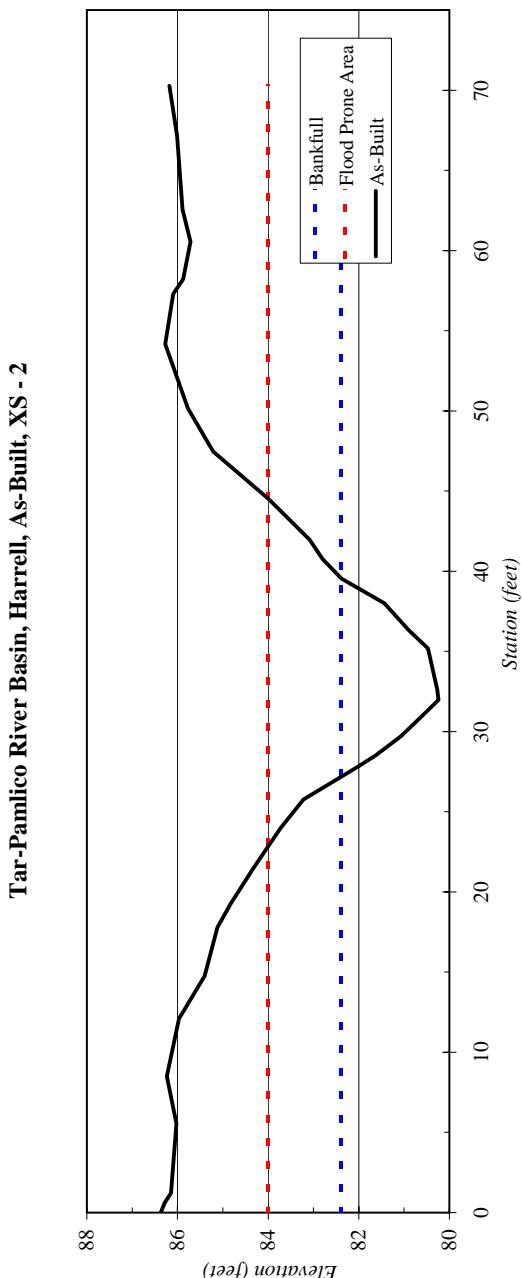
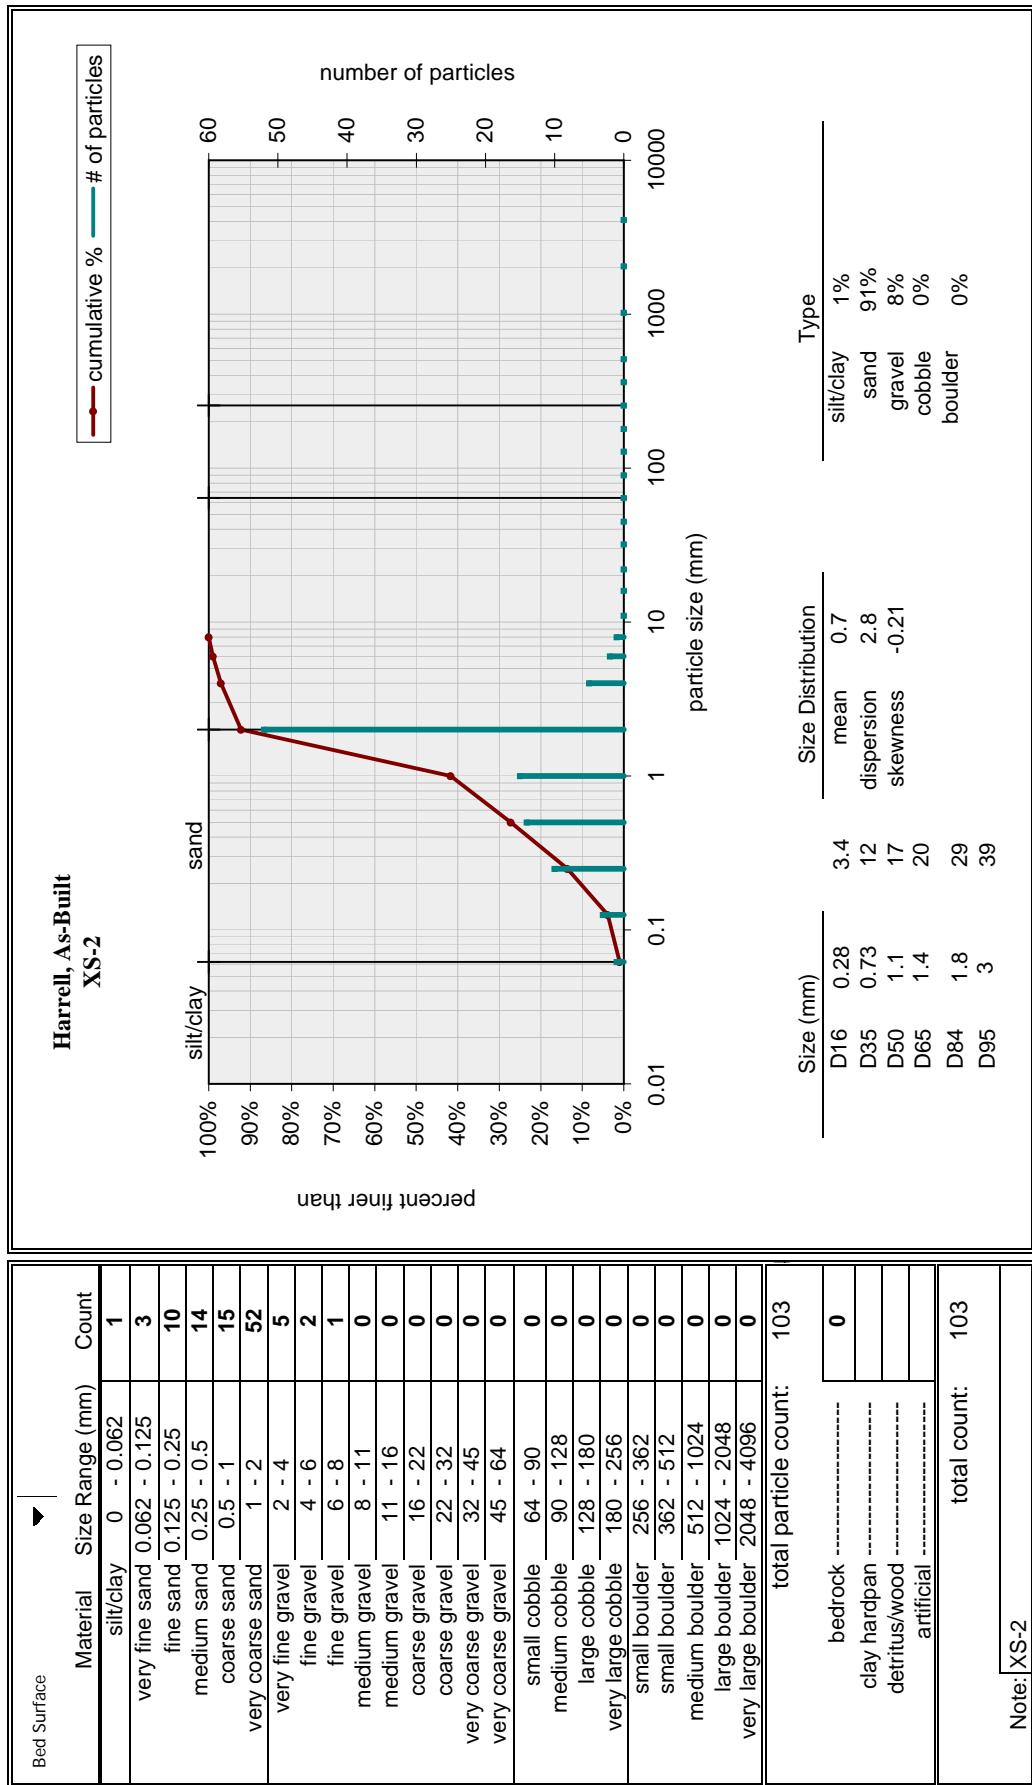
Tar-Pamlico River Basin, Harrell, As-Built, XS - 2

River Basin:	Tar-Pamlico
Watershed:	Harrell, As-Built
XS ID	XS - 2
Drainage Area (sq mi):	0.20
Date:	11/7/2007
Field Crew:	B. Roberts, T. King

SUMMARY DATA	
Bankfull Elevation:	82.4
Bankfull Cross-Sectional Area:	17.1
Bankfull Width:	12.4
Flood Prone Area Elevation:	84.0
Flood Prone Width:	25
Max Depth at Bankfull:	2.2
Mean Depth at Bankfull:	1.4
W/D Ratio:	9.0
Entrenchment Ratio:	2.8
Bank Height Ratio:	1.0

Stream Type: B5c

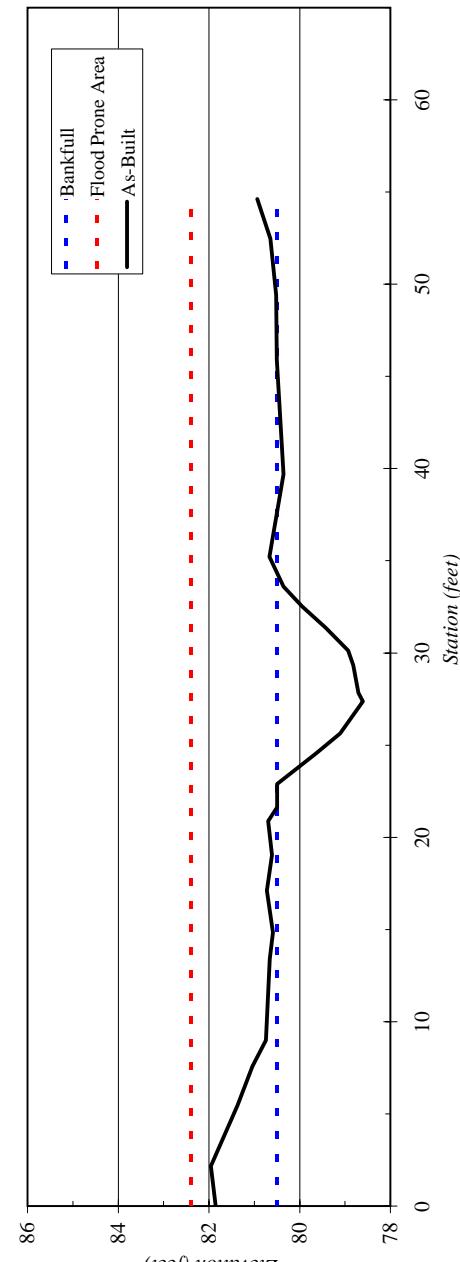
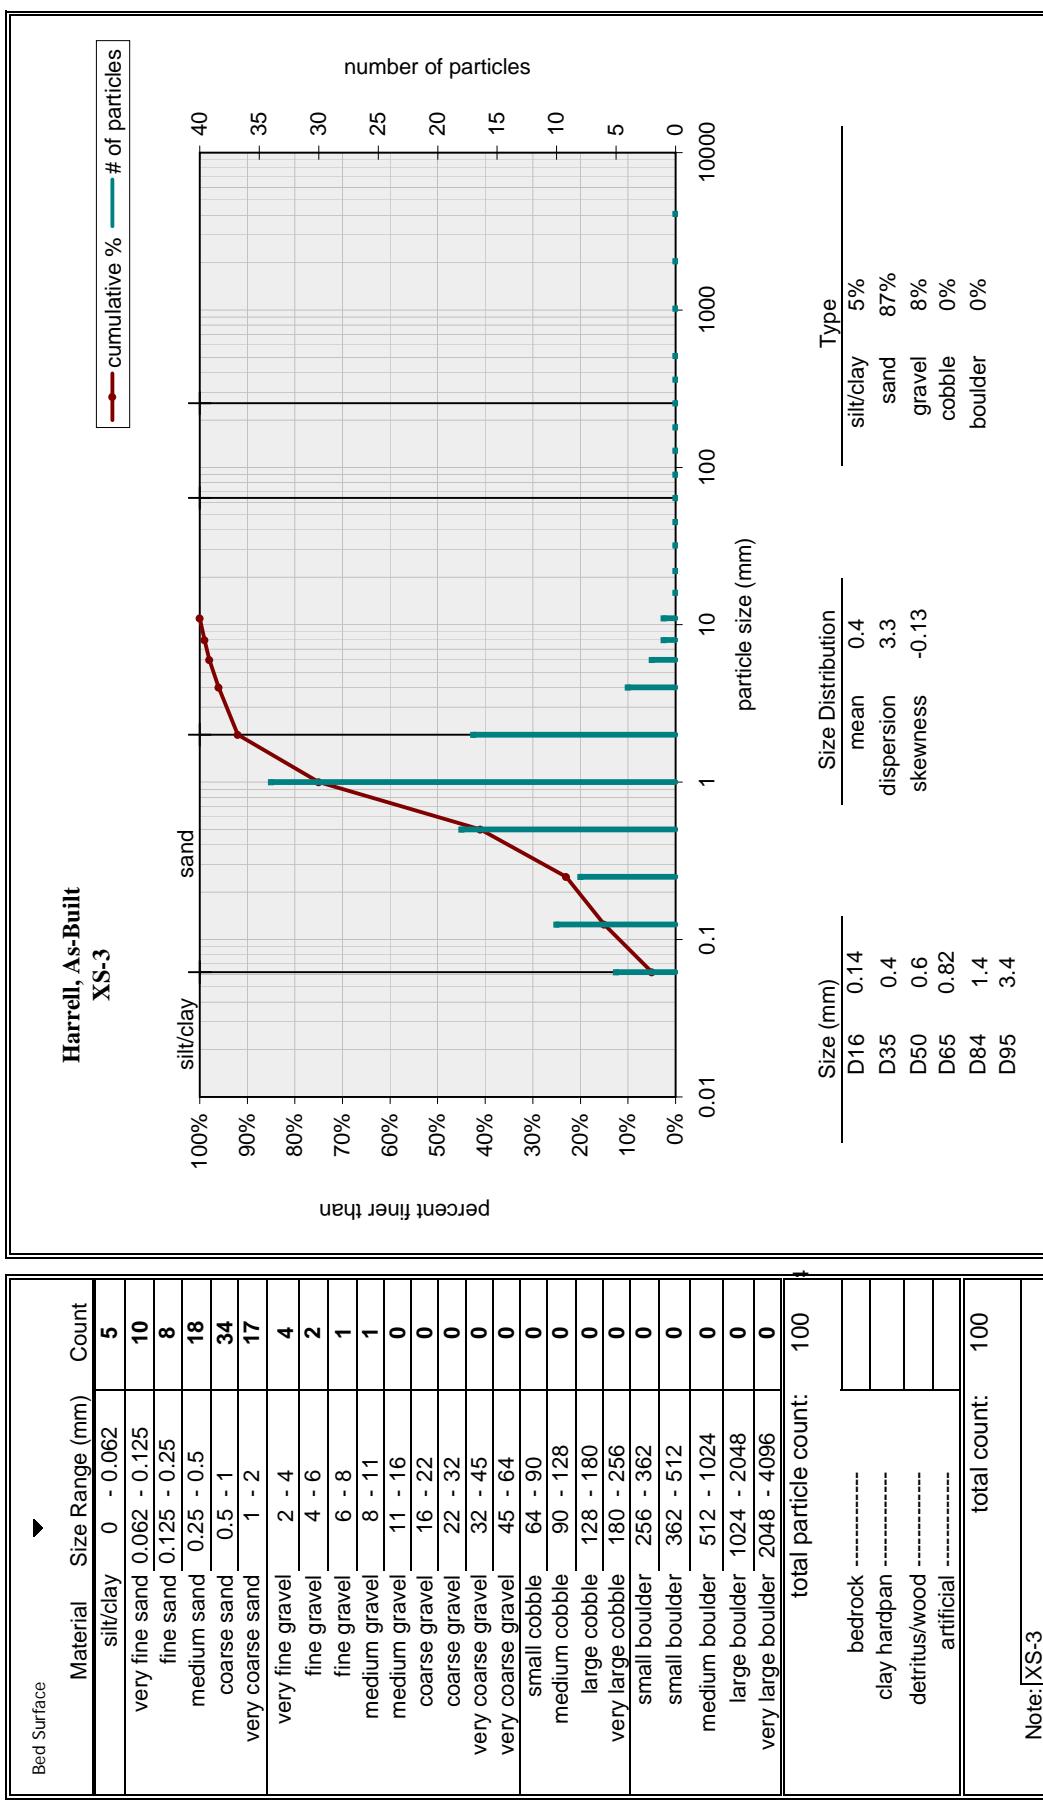
Tar-Pamlico River Basin, Harrell, As-Built, XS - 3

River Basin:	Tar-Pamlico
Watershed:	Harrell, As-Built
XS ID	XS - 3
Drainage Area (sq mi):	0.23
Date:	11/7/2007
Field Crew:	B. Roberts, T. King

SUMMARY DATA	
Bankfull Elevation:	80.5
Bankfull Cross-Sectional Area:	12.5
Bankfull Width:	11.5
Flood Prone Area Elevation:	82.4
Flood Prone Width:	>55
Max Depth at Bankfull:	1.9
Mean Depth at Bankfull:	1.1
W / D Ratio:	10.6
Entrenchment Ratio:	4.8
Bank Height Ratio:	1.0

Stream Type	C5

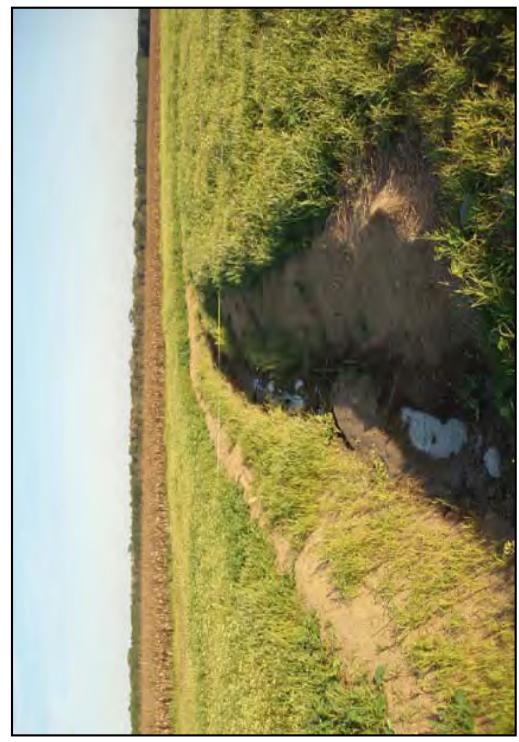
River Basin:	Tar-Pamlico
Watershed:	Harrell, As-Built
XS ID	XS - 4
Drainage Area (sq mi):	0.23
Date:	11/7/2007
Field Crew:	B. Roberts, T. King

SUMMARY DATA	
Bankfull Elevation:	79.7
Bankfull Cross-Sectional Area:	10.3
Bankfull Width:	9.8
Flood Prone Area Elevation:	81.4
Flood Prone Width:	>67
Max Depth at Bankfull:	1.7
Mean Depth at Bankfull:	1.1
W / D Ratio:	9.3
Entrenchment Ratio:	6.8
Bank Height Ratio:	1.0

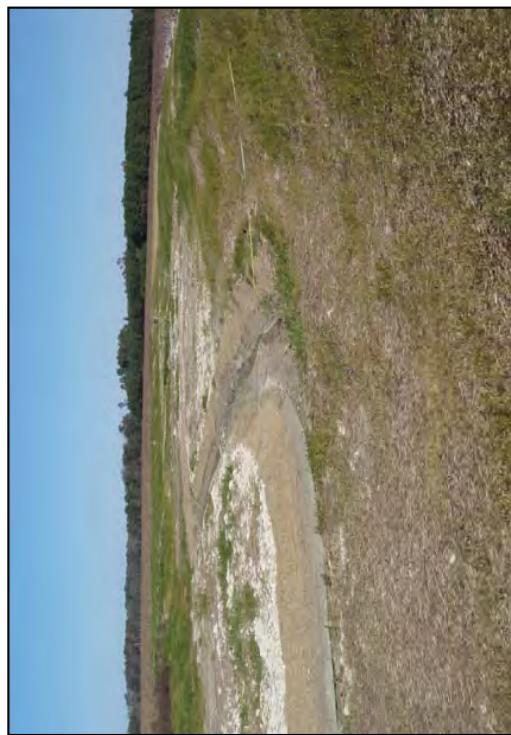
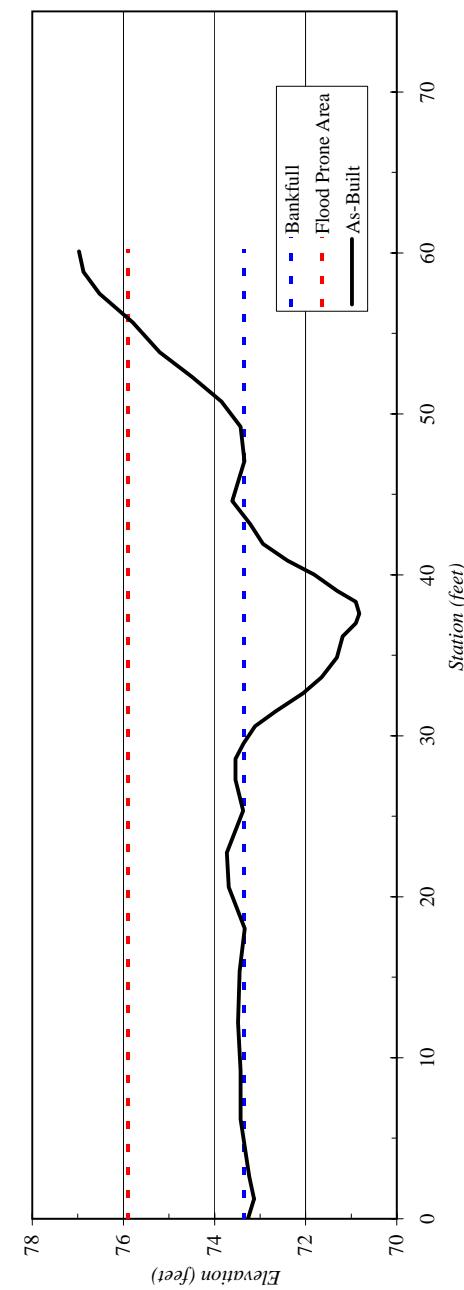
Tar-Pamlico River Basin, Harrell, As-Built, XS - 6

River Basin:	Tar-Pamlico
Watershed:	Harrell, As-Built
XS ID	XS - 6
Drainage Area (sq mi):	0.42
Date:	11/7/2007
Field Crew:	B. Roberts, T. King

SUMMARY DATA	
Bankfull Elevation:	73.4
Bankfull Cross-Sectional Area:	19.1
Bankfull Width:	14.1
Flood Prone Area Elevation:	75.9
Flood Prone Width:	>60
Max Depth at Bankfull:	2.5
Mean Depth at Bankfull:	1.4
W / D Ratio:	10.4
Entrenchment Ratio:	4.3
Bank Height Ratio:	1.0

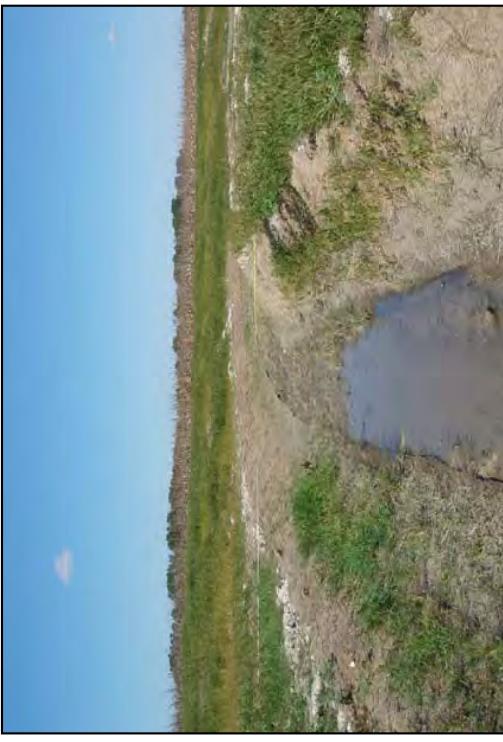
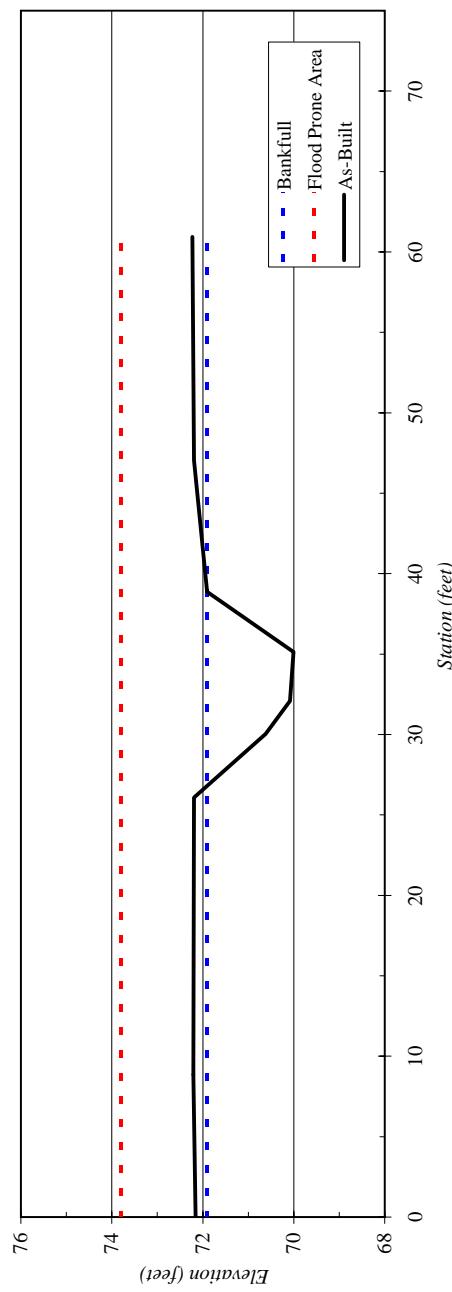
Tar-Pamlico River Basin, Harrell, As-Built, XS - 7

River Basin:	Tar-Pamlico
Watershed:	Harrell, As-Built
XS ID	XS - 7
Drainage Area (sq mi):	0.42
Date:	11/7/2007
Field Crew:	B. Roberts, T. King

Bankfull Elevation:	71.9
Bankfull Cross-Sectional Area:	14.4
Bankfull Width:	12.1
Flood Prone Area Elevation:	73.8
Flood Prone Width:	>61
Max Depth at Bankfull:	1.9
Mean Depth at Bankfull:	1.2
W / D Ratio:	10.2
Entrenchment Ratio:	5.0
Bank Height Ratio:	1.0

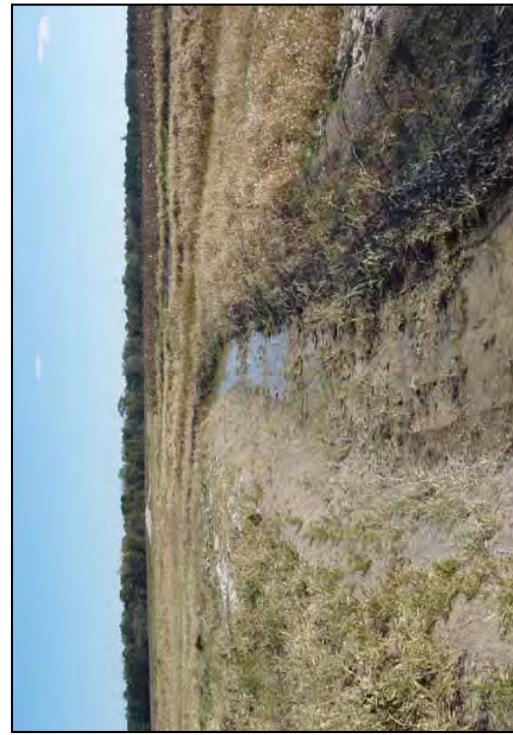
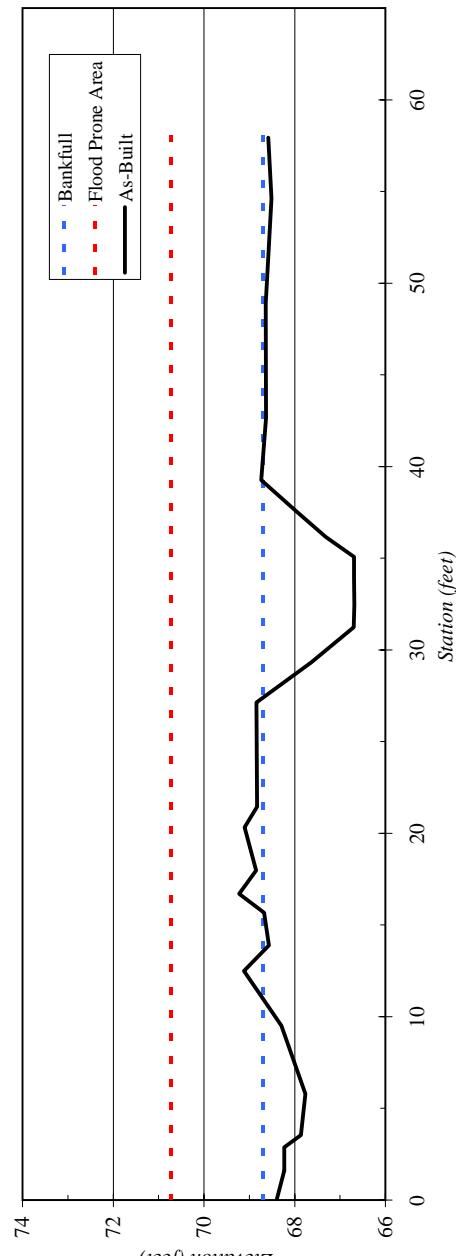
Tar-Pamlico River Basin, Harrell, As-Built, XS - 9

River Basin:	Tar-Pamlico
Watershed:	Harrell, As-Built
XS ID	XS - 9
Drainage Area (sq mi):	0.42
Date:	11/7/2007
Field Crew:	B. Roberts, T. King

SUMMARY DATA	
Bankfull Elevation:	68.7
Bankfull Cross-Sectional Area:	15.6
Bankfull Width:	11.8
Flood Prone Area Elevation:	70.7
Flood Prone Width:	>58
Max Depth at Bankfull:	2.0
Mean Depth at Bankfull:	1.3
W / D Ratio:	8.9
Entrenchment Ratio:	4.9
Bank Height Ratio:	1.0

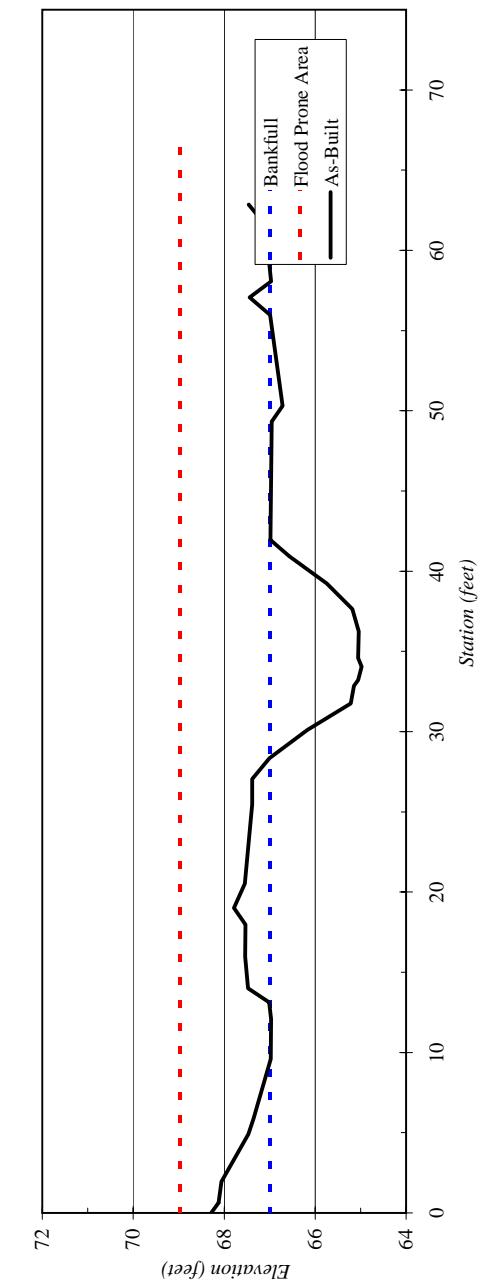
Tar-Pamlico River Basin, Harrell, As-Built, XS - 10

River Basin:	Tar-Pamlico
Watershed:	Harrell, As-Built
XS ID	XS - 10
Drainage Area (sq mi):	0.61
Date:	11/7/2007
Field Crew:	B. Roberts, T. King

SUMMARY DATA	
Bankfull Elevation:	67.0
Bankfull Cross-Sectional Area:	17.9
Bankfull Width:	13.5
Flood Prone Area Elevation:	69.0
Flood Prone Width:	>67
Max Depth at Bankfull:	2.0
Mean Depth at Bankfull:	1.3
W/D Ratio:	10.2
Entrenchment Ratio:	5.0
Bank Height Ratio:	1.0

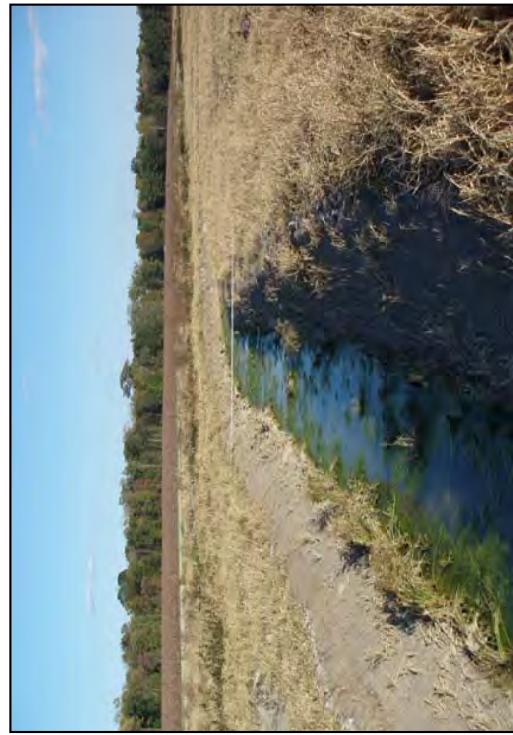
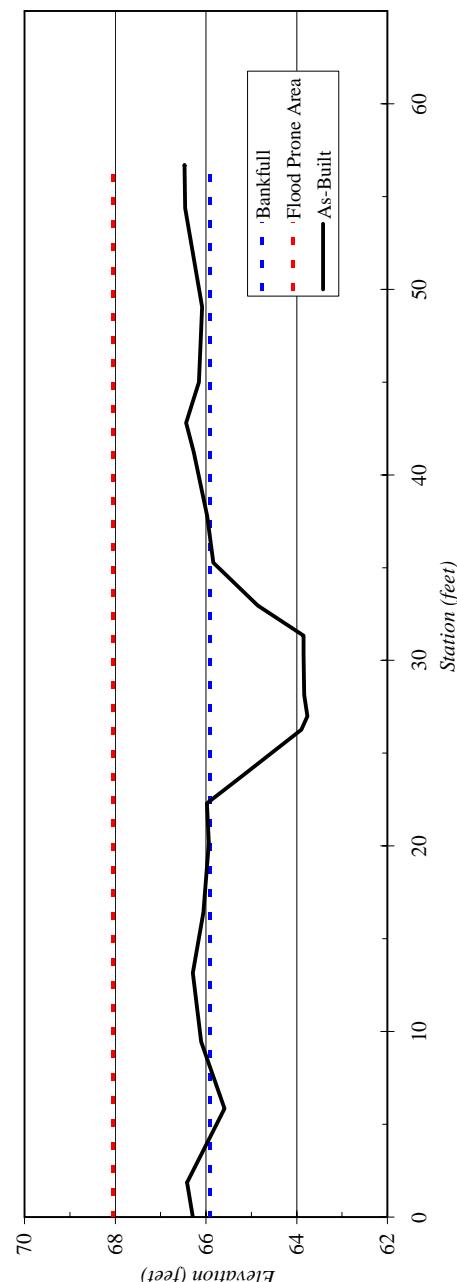
Tar-Pamlico River Basin, Harrell, As-Built, XS - 11

River Basin:	Tar-Pamlico
Watershed:	Harrell, As-Built
XS ID	XS - 11
Drainage Area (sq mi):	0.61
Date:	11/7/2007
Field Crew:	B. Roberts, T. King

SUMMARY DATA	
Bankfull Elevation:	65.9
Bankfull Cross-Sectional Area:	18.2
Bankfull Width:	14.0
Flood Prone Area Elevation:	68.0
Flood Prone Width:	>57
Max Depth at Bankfull:	2.1
Mean Depth at Bankfull:	1.3
W / D Ratio:	10.8
Entrenchment Ratio:	4.1
Bank Height Ratio:	1.0

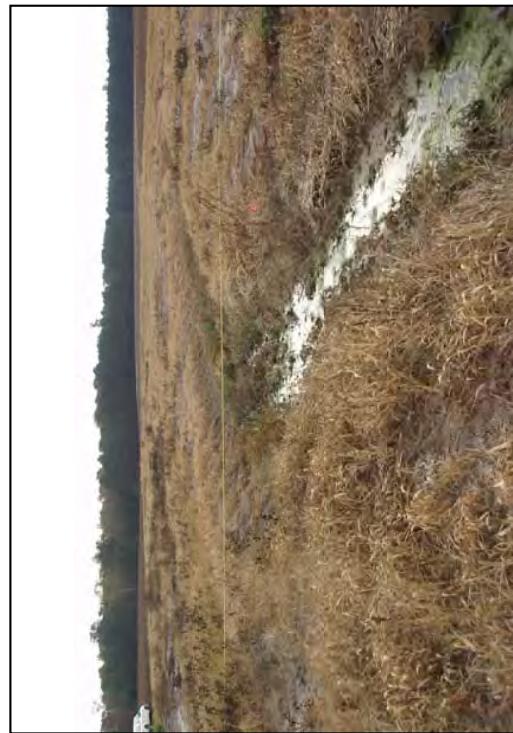
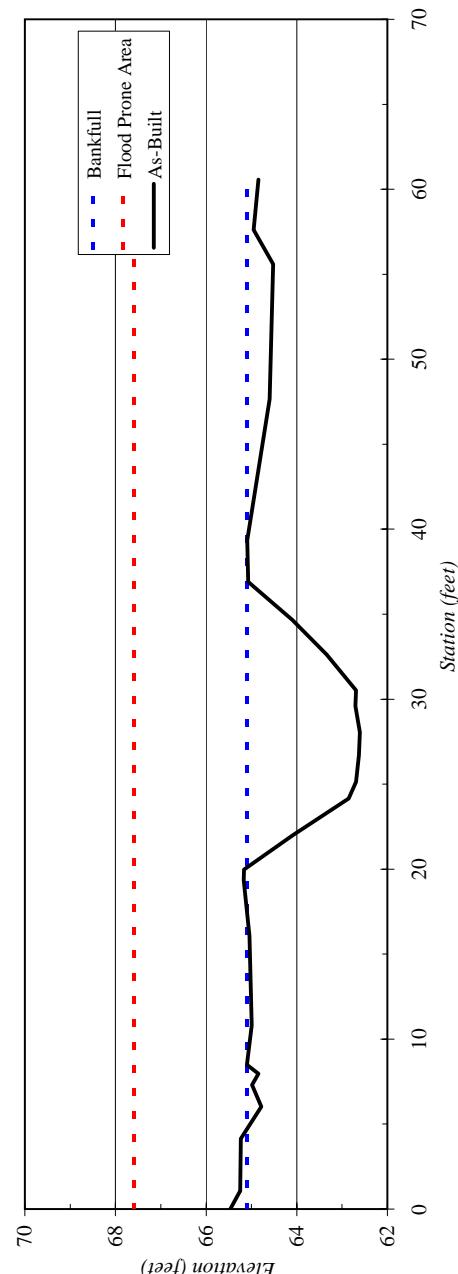
Tar-Pamlico River Basin, Harrell, As-Built, XS - 12

River Basin:	Tar-Pamlico
Watershed:	Harrell, As-Built
XS ID	XS - 12
Drainage Area (sq mi):	0.61
Date:	11/7/2007
Field Crew:	B. Roberts, T. King

Bankfull Elevation:	65.1
Bankfull Cross-Sectional Area:	28.2
Bankfull Width:	16.8
Flood Prone Area Elevation:	67.6
Flood Prone Width:	>61
Max Depth at Bankfull:	2.5
Mean Depth at Bankfull:	1.7
W / D Ratio:	10.0
Entrenchment Ratio:	3.6
Bank Height Ratio:	1.0
