Harrell Farm Stream/Wetland Restoration Mitigation Plan Contract # D05025-1

March 2008

TYPE OF WORK: STREAM AND WETLAND RESTORATION

AS-BUILT PLAN

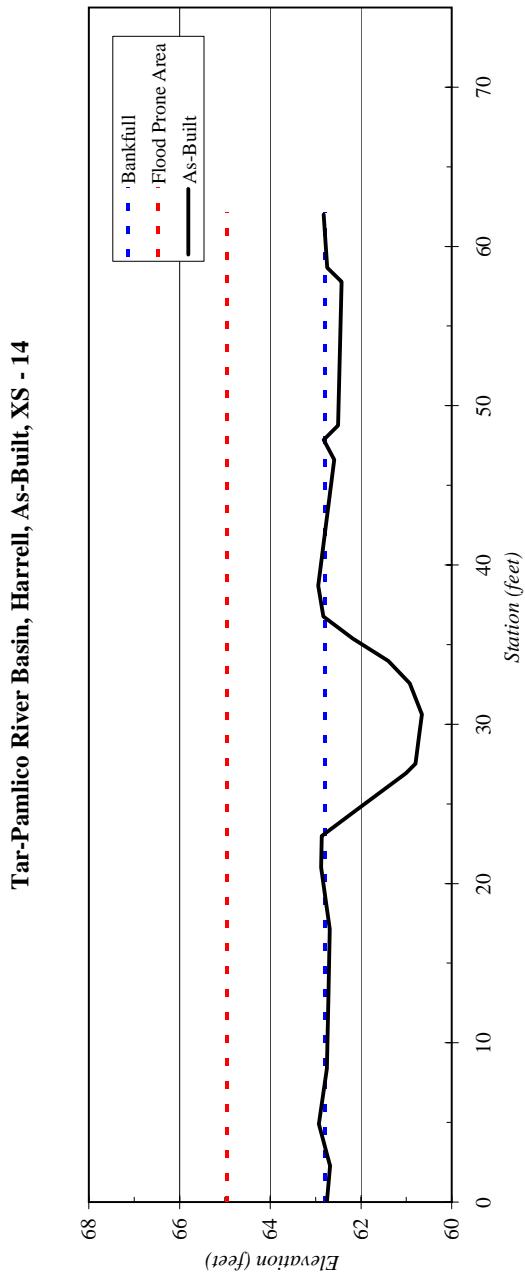
River Basin:	Tar-Pamlico
Watershed:	Harrell, As-Built
XS ID	XS - 14
Drainage Area (sq mi):	0.61
Date:	11/7/2007
Field Crew:	B. Roberts, T. King

Station	Elevation	SUMMARY DATA
0.0	62.75	Bankfull Elevation:
2.3	62.68	Bankfull Cross-Sectional Area:
4.9	62.93	Bankfull Width:
8.4	62.75	Flood Prone Area Elevation:
13.0	62.72	Flood Prone Width:
17.1	62.69	>62
21.0	62.88	Max Depth at Bankfull:
23.0	62.86	Mean Depth at Bankfull:
24.4	62.21	W / D Ratio:
26.9	61.01	Entrenchment Ratio:
27.5	60.79	Bank Height Ratio:
29.2	60.72	
30.6	60.65	
32.6	60.93	
34.0	61.39	
35.4	62.18	
36.8	62.83	
38.7	62.94	
46.6	62.59	
47.9	62.82	
48.8	62.51	
57.8	62.43	
58.7	62.74	
62.0	62.82

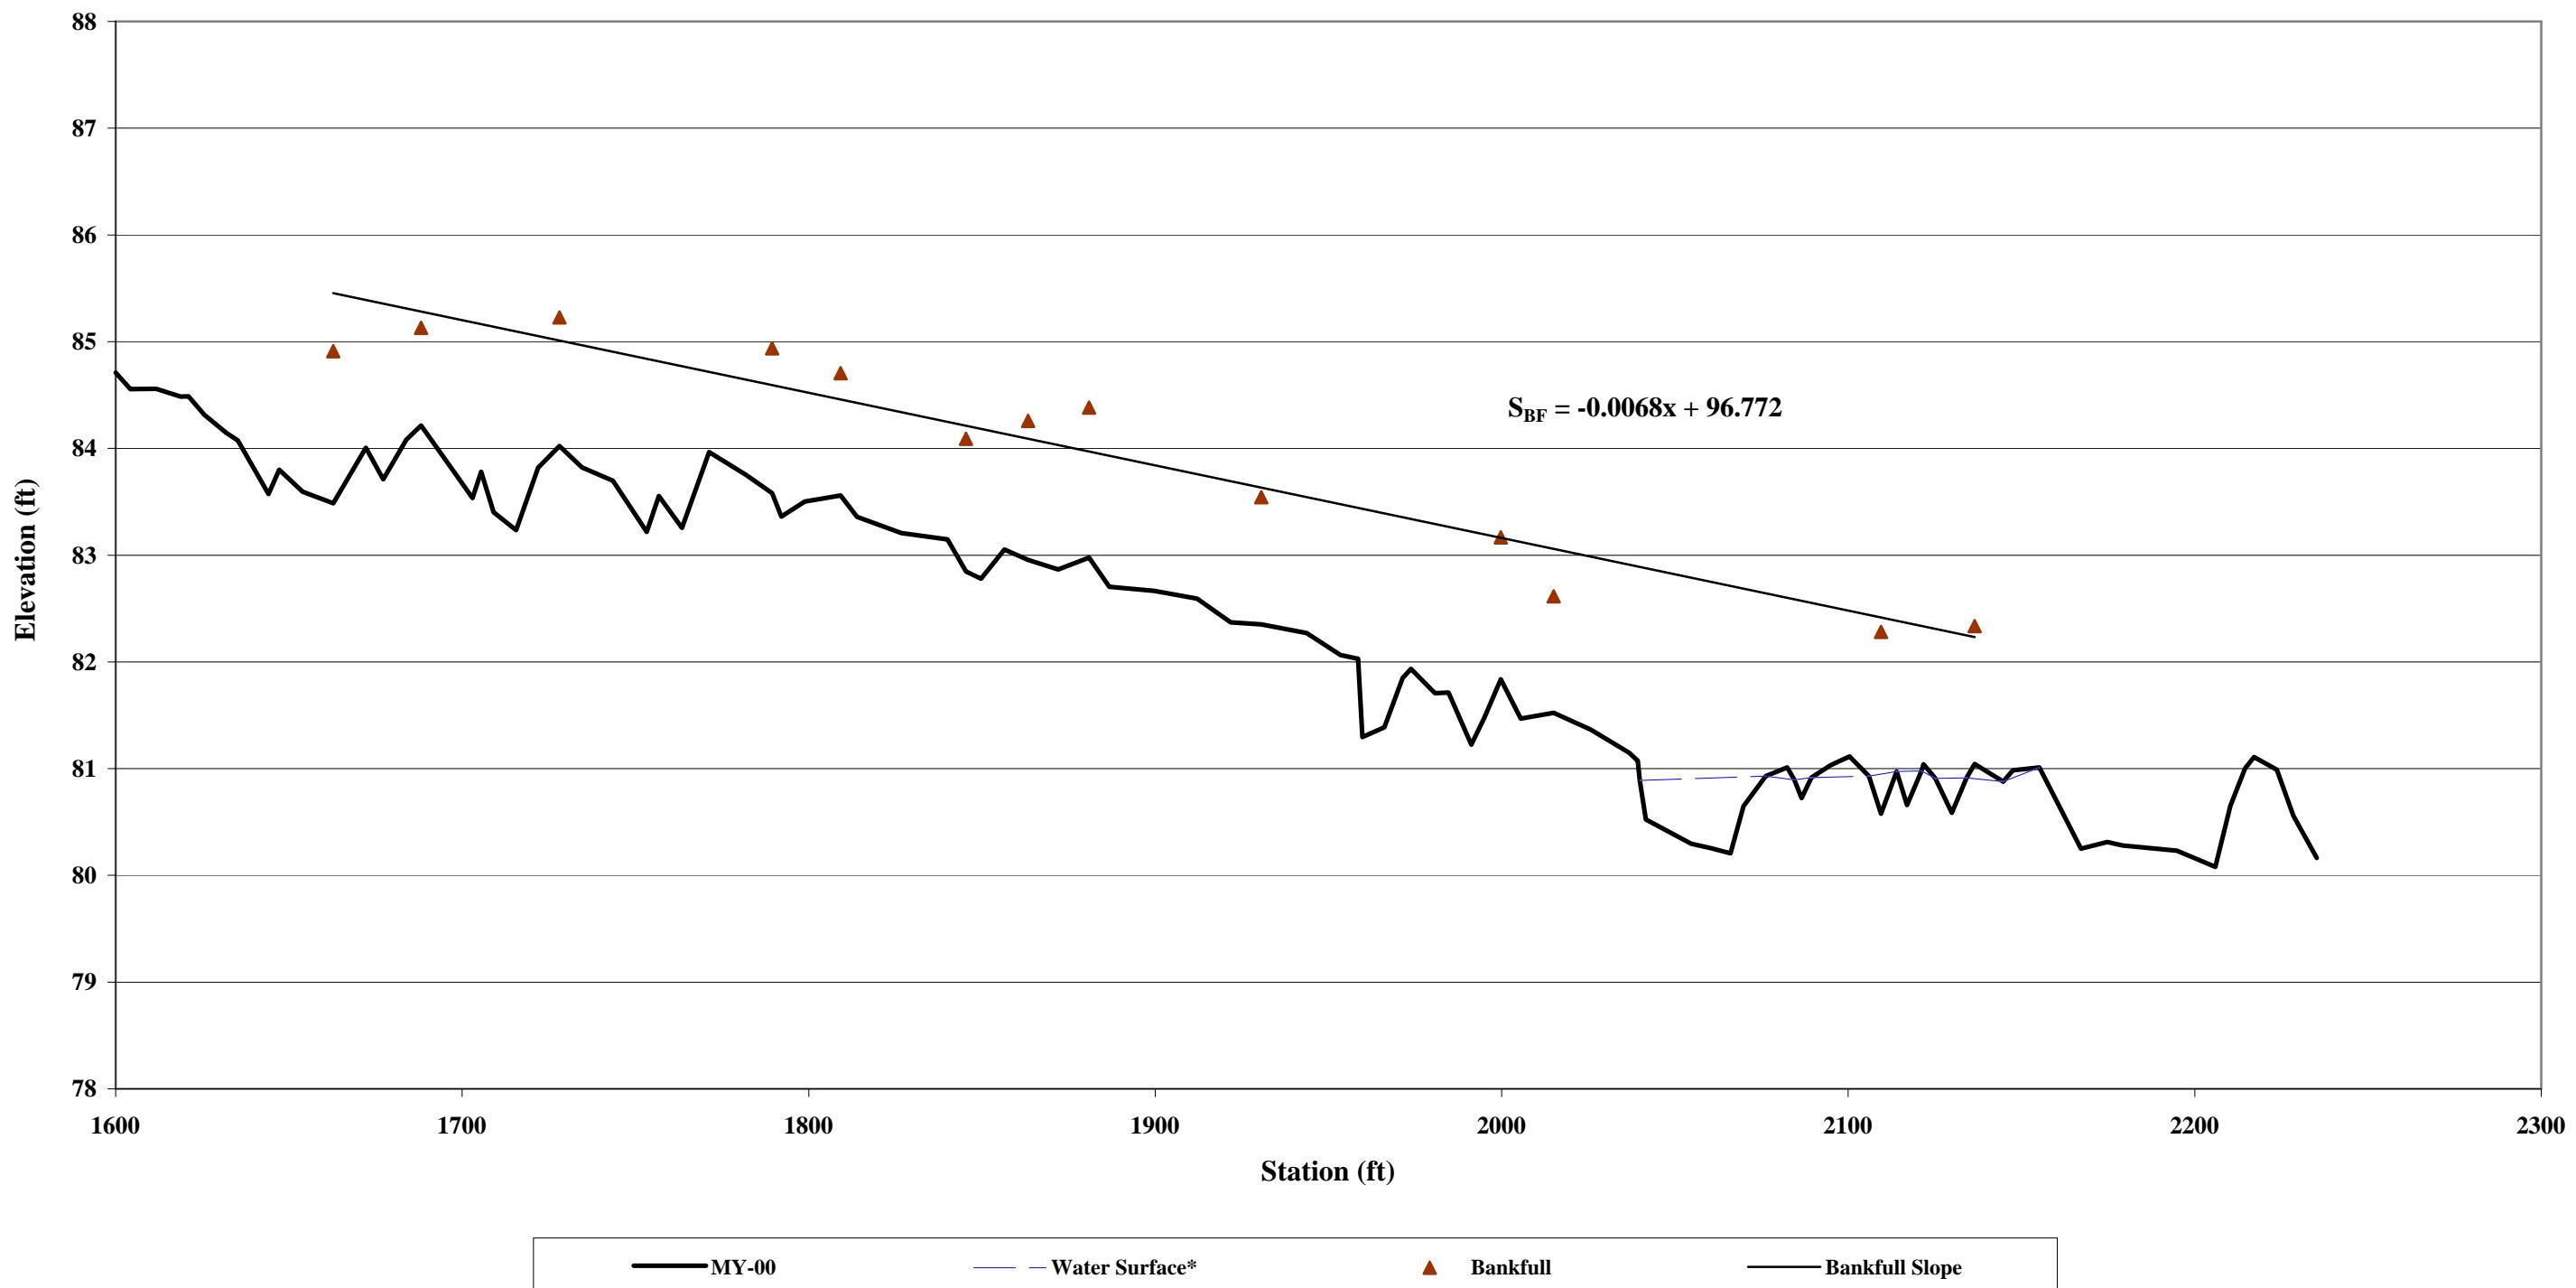
Longitudinal Profile
Harrell Stream Restoration
Reach 1 - Station 16+00 - 22+35

*Due to drought conditions many portions of the stream were dry.

When comparing the designed stream to the as-built conditions, there are minor variations, particularly in Reach 1. This reach was constructed as a Bc stream type due to the relatively steep grade (for the Coastal Plain) that was held between two culverts. The existing stream was also ditched and although it had a floodplain area in the adjacent agricultural field, it rarely accessed it with a bank height ratio of 2.7. For the post-restoration conditions, Cross-Section 1 shows that the stream was constructed deeper than designed in that section of Reach 1 with its as-built maximum depth 2.1 feet compared to the designed maximum depth of 1.4. The entrenchment ratio at this as-built cross-section is 2.7. Although this entrenchment ratio is smaller than the pre-restoration conditions, the stream has a bank height ratio of 1.0 and will experience bankfull events more frequently than the former channel. This restored system will allow for the stable maintenance of incoming sand material and promote bed diversity. The pre-restoration channel had little habitat with its vertical banks and a homogenous profile that flushed out entering sediment. Although there were variations from the design in Reach 1, these changes are not expected to affect the performance of the restored channel.

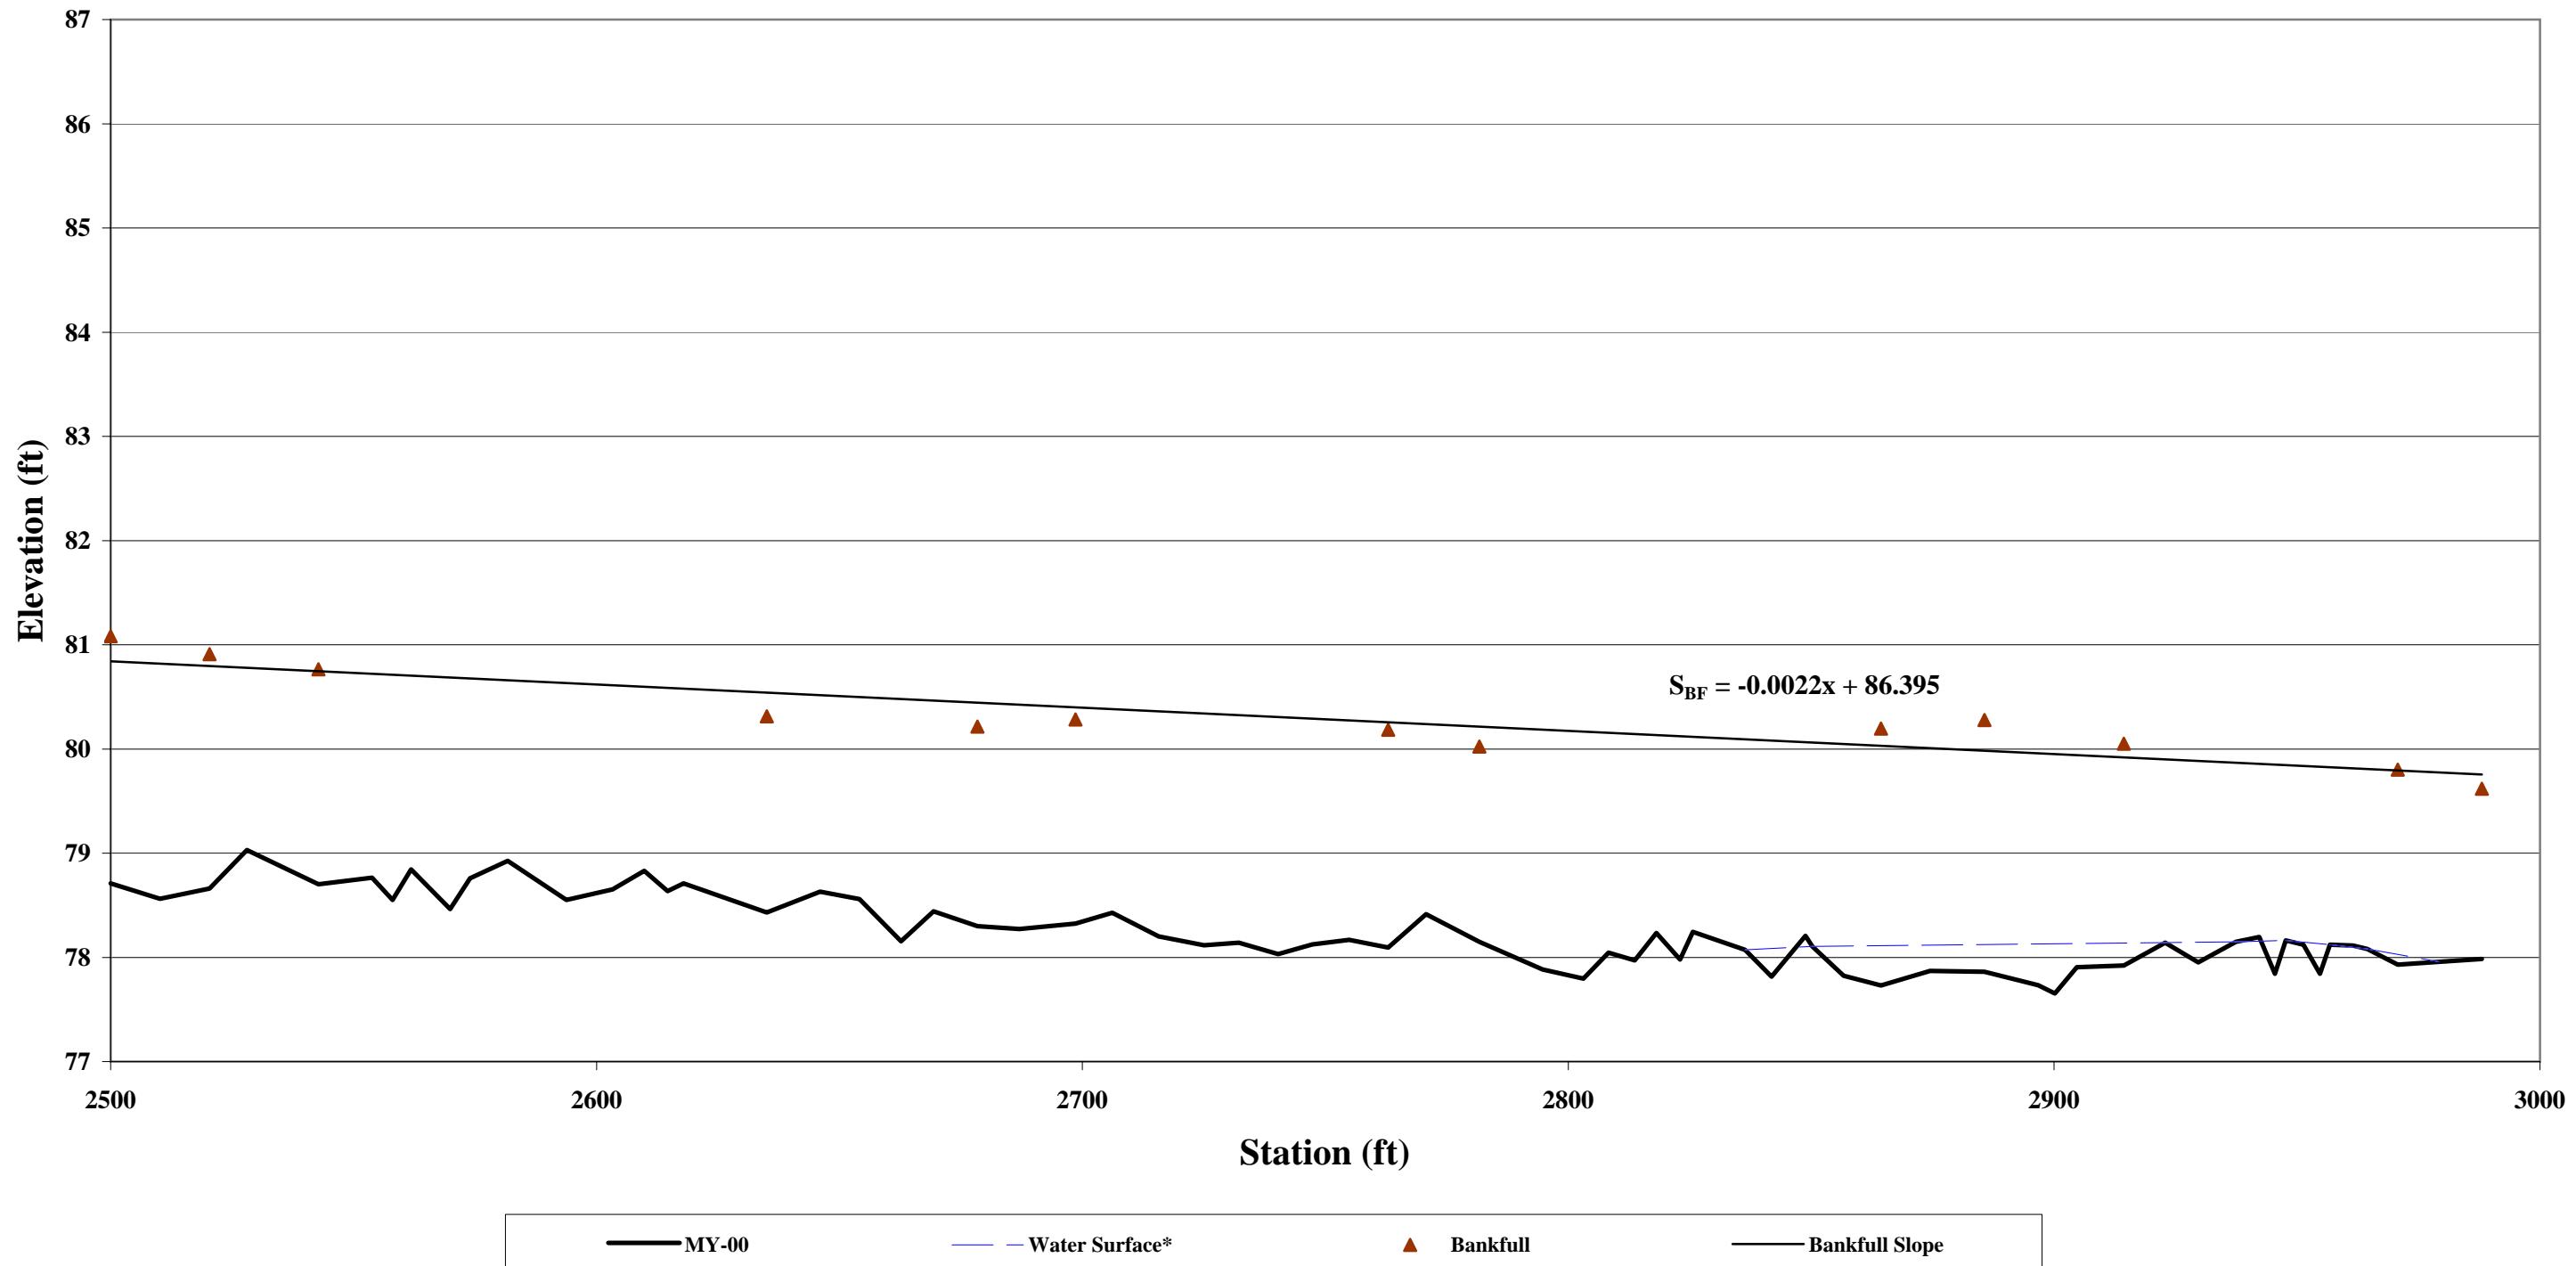
**Longitudinal Profile
Harrell Stream Restoration
Reach 2 - Station 25+00 - 29+90**

*Due to drought conditions many portions of the stream were dry.

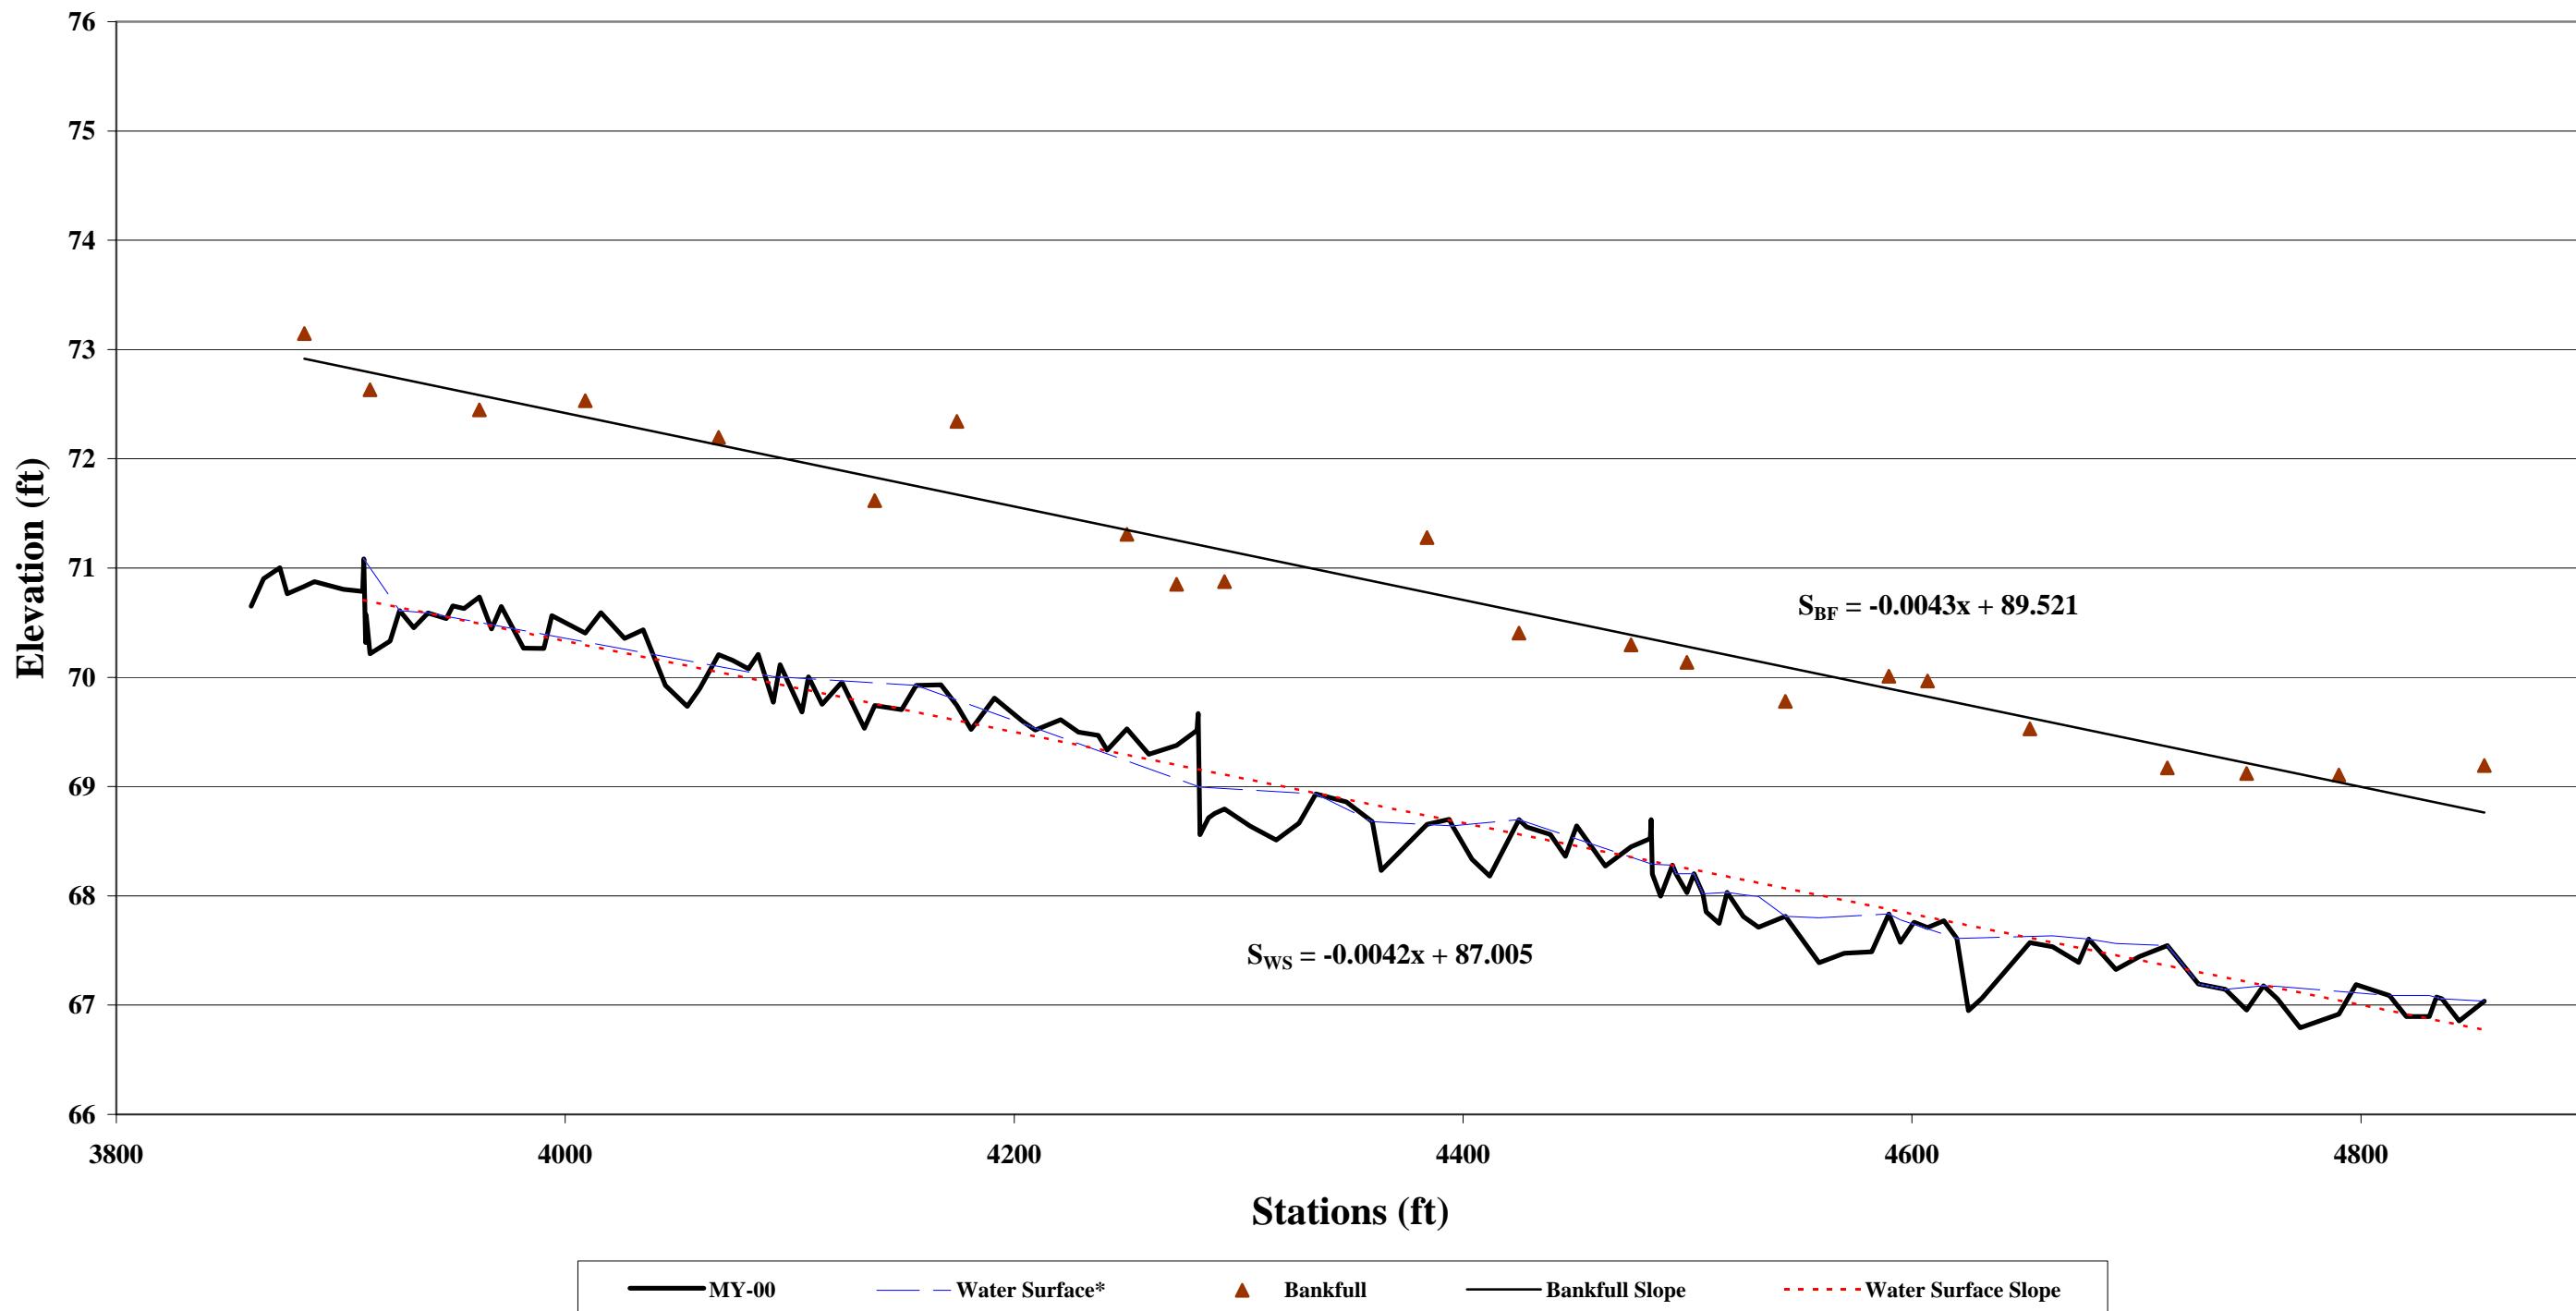
Longitudinal Profile
Harrell Stream Restoration
Reach 3 - Station 38+60 - 48+50

*Due to drought conditions many portions of the stream were dry.

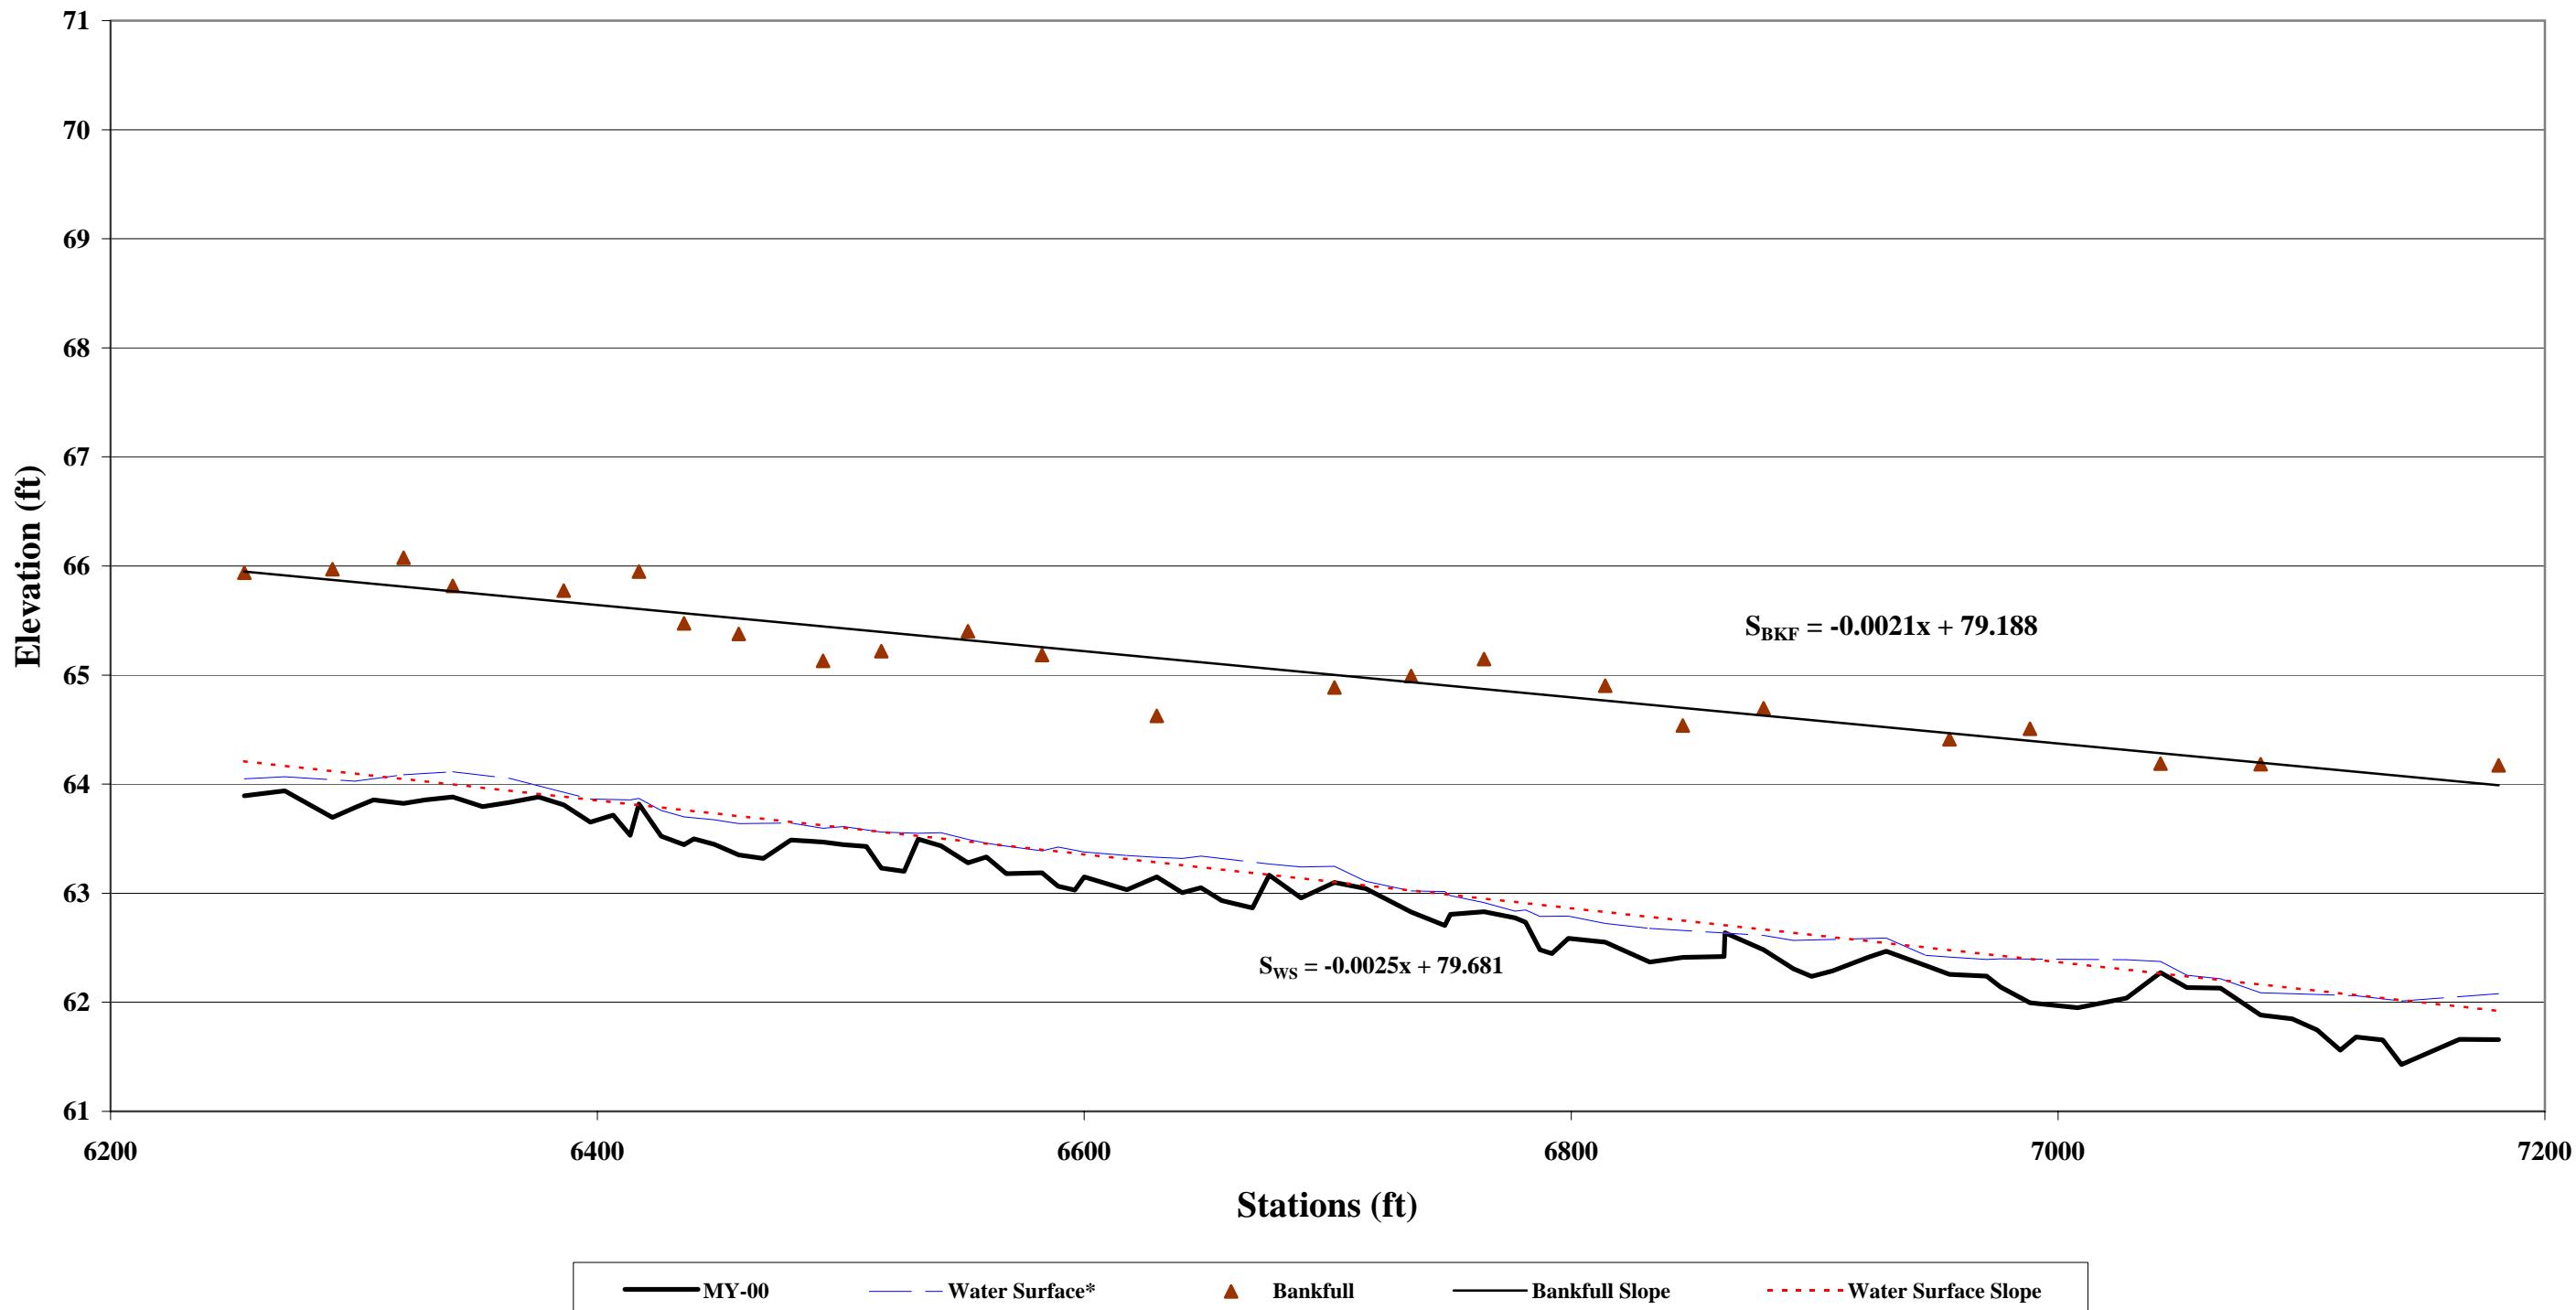
Longitudinal Profile
Harrell Stream Restoration
Reach 4 - Station 62+50 - 71+80

*Due to drought conditions many portions of the stream were dry.

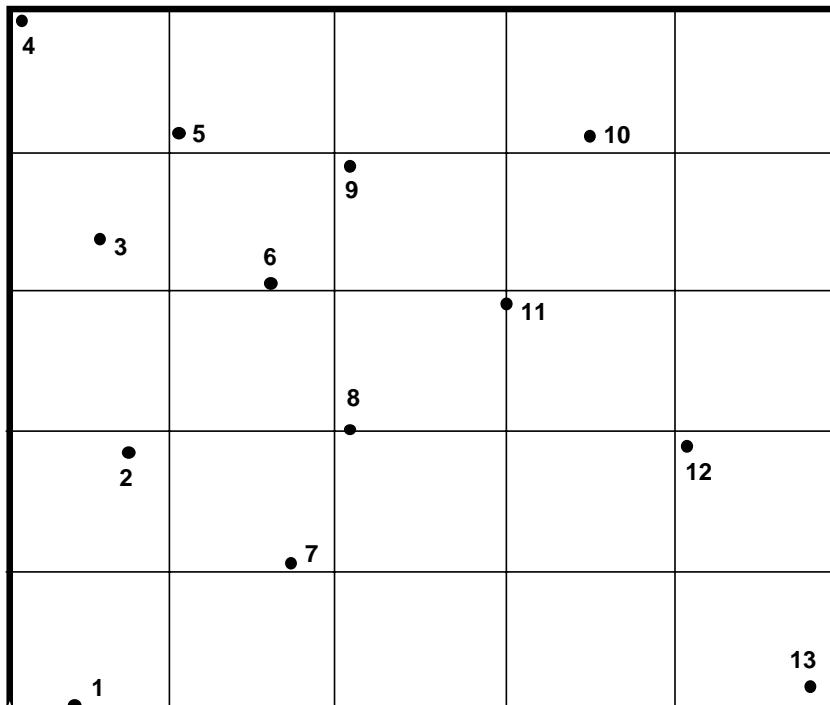
Plot Map

Site: Harrell **Plot:** W1 **Date:** 6/19/2007

Baseline vegetation monitoring data were collected in the wetland in June 2007 and in the riparian buffer in February 2008. Within each monitoring plot, stem height and vigor were recorded. Plot photos from all the vegetation plots can be found in Appendix D.

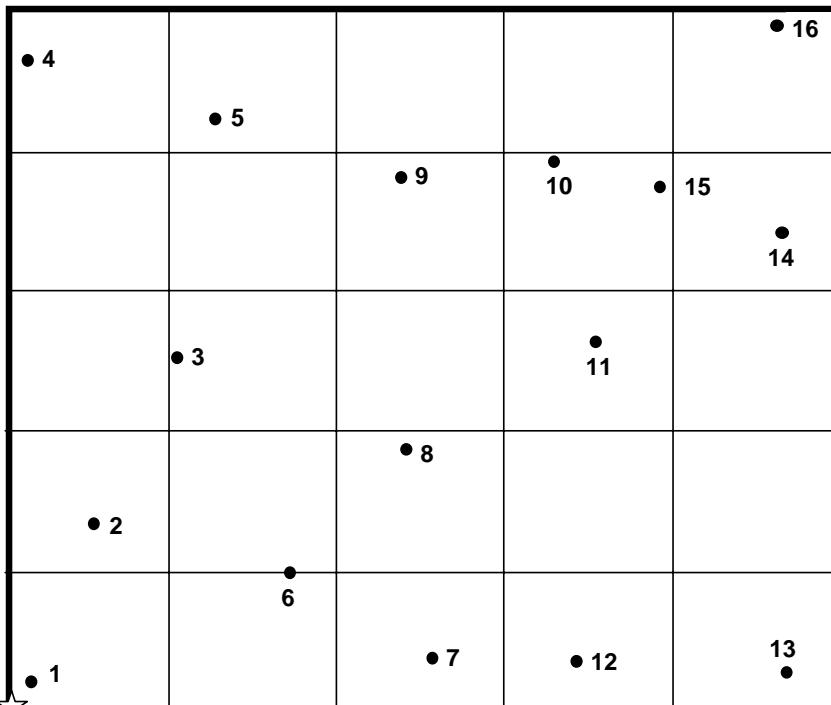
Plot Map

Site: Harrell **Plot:** W2 **Date:** 6/14/2007

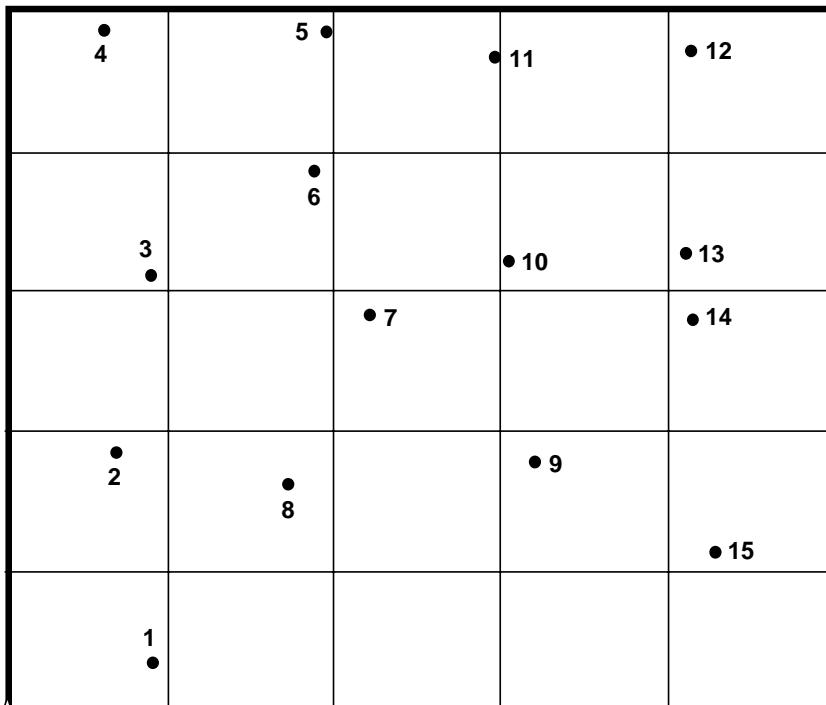
Plot Map

Plot: W3

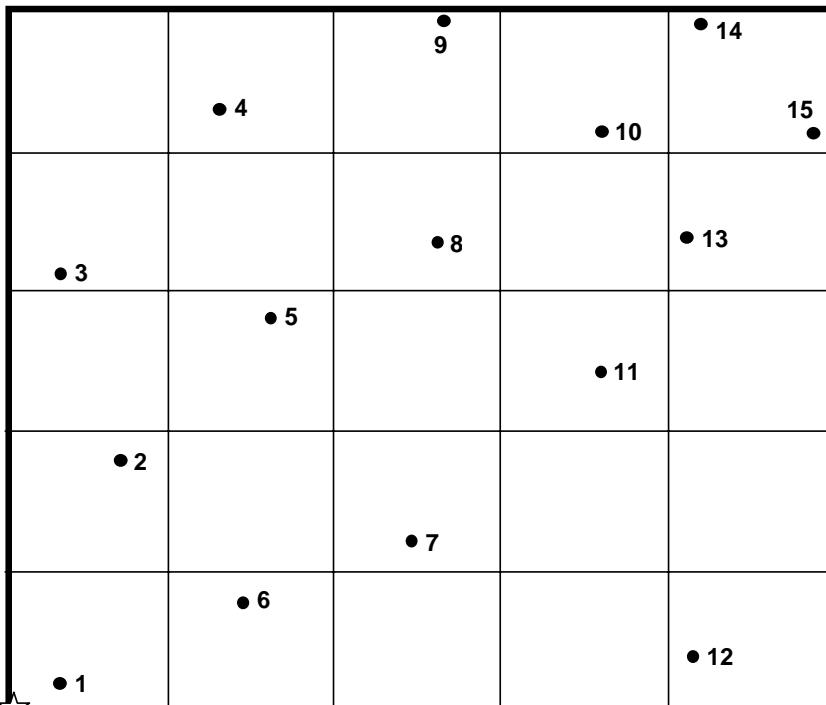
Plot Map

Plot: W5

Species	Percent of Total
Bald Cypress (<i>Taxodium distichum</i>)	26.7%
Green Ash (<i>Fraxinus pennsylvanica</i>)	26.7%
Cherrybark Oak (<i>Quercus pagoda</i>)	6.7%
Swamp Chestnut Oak (<i>Quercus michauxii</i>)	33.3%
Beautyberry (<i>Callicarpa americana</i>)	6.7%

$$\text{Total Number of Trees} \quad \underline{\underline{15}} \quad / \quad 0.025 \text{ acres} \quad = \quad \underline{\underline{640}} \quad \text{trees / acre}$$

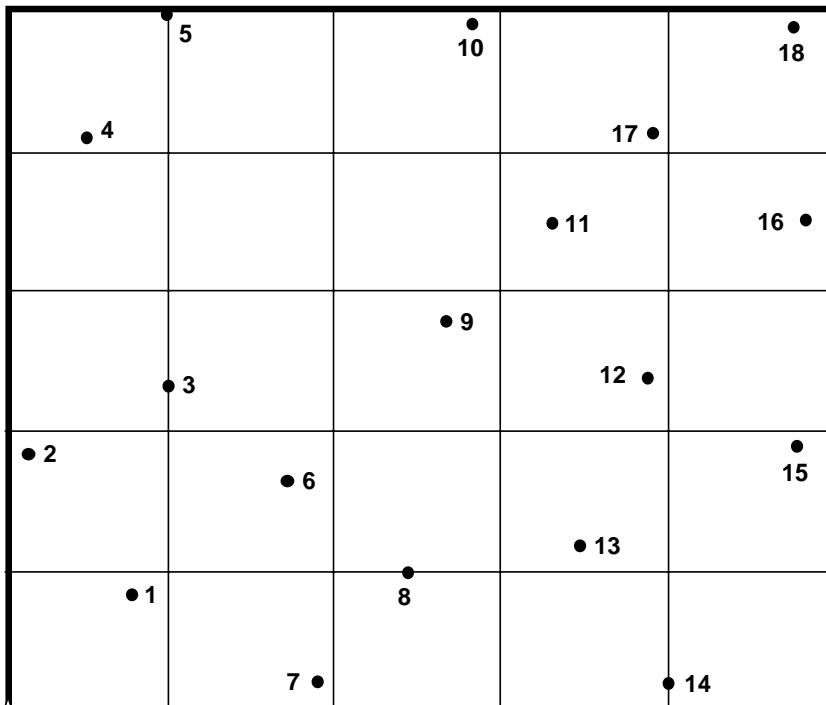
Plot Map

Plot: W6

Species	Percent of Total
Bald Cypress (<i>Taxodium distichum</i>)	16.7%
Possumhaw (<i>Viburnum nudum</i>)	5.6%
Willow Oak (<i>Quercus phellos</i>)	27.8%
Laurel Oak (<i>Quercus laurifolia</i>)	16.7%
Swamp Chestnut Oak (<i>Quercus michauxii</i>)	5.6%
Buttonbush (<i>Cephalanthus occidentalis</i>)	27.8%

$$\text{Total Number of Trees} \quad \underline{\underline{18}} \quad / \quad 0.025 \text{ acres} \quad = \quad \underline{\underline{720}} \quad \text{trees / acre}$$

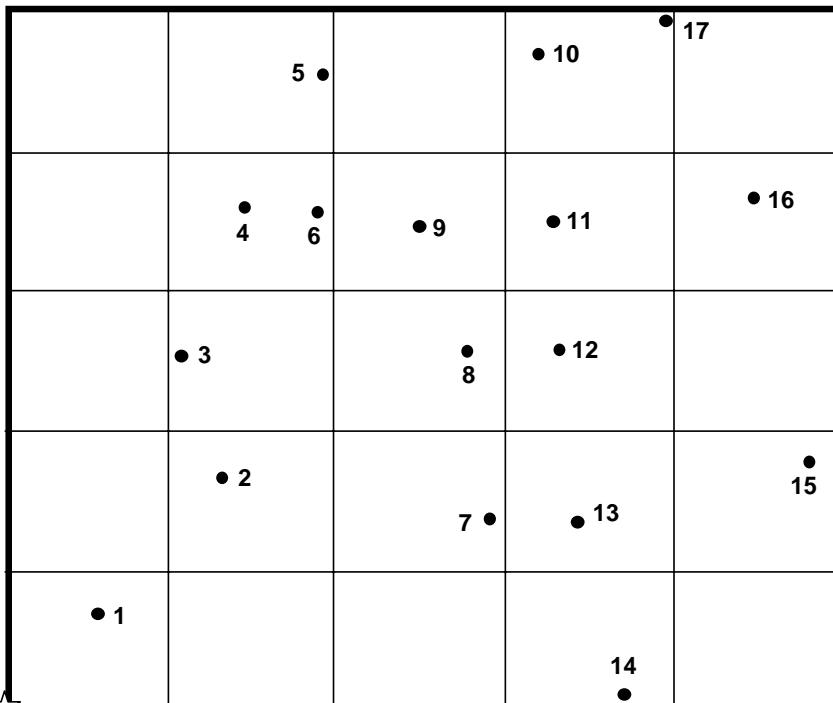
Plot Map

Site: Harrell **Plot:** W7 **Date:** 6/14/2007

Species	Percent of Total
Willow Oak (<i>Quercus phellos</i>)	23.5%
Swamp Chestnut Oak (<i>Quercus michauxii</i>)	17.6%
Water Hickory (<i>Carya aquatica</i>)	5.9%
Cherrybark Oak (<i>Quercus pagoda</i>)	5.9%
Buttonbush (<i>Cephalanthus occidentalis</i>)	5.9%
Unknown	41.2%

$$\text{Total Number of Trees} \quad \underline{\underline{17}} \quad / \quad 0.025 \text{ acres} \quad = \quad \underline{\underline{680}} \quad \text{trees / acre}$$

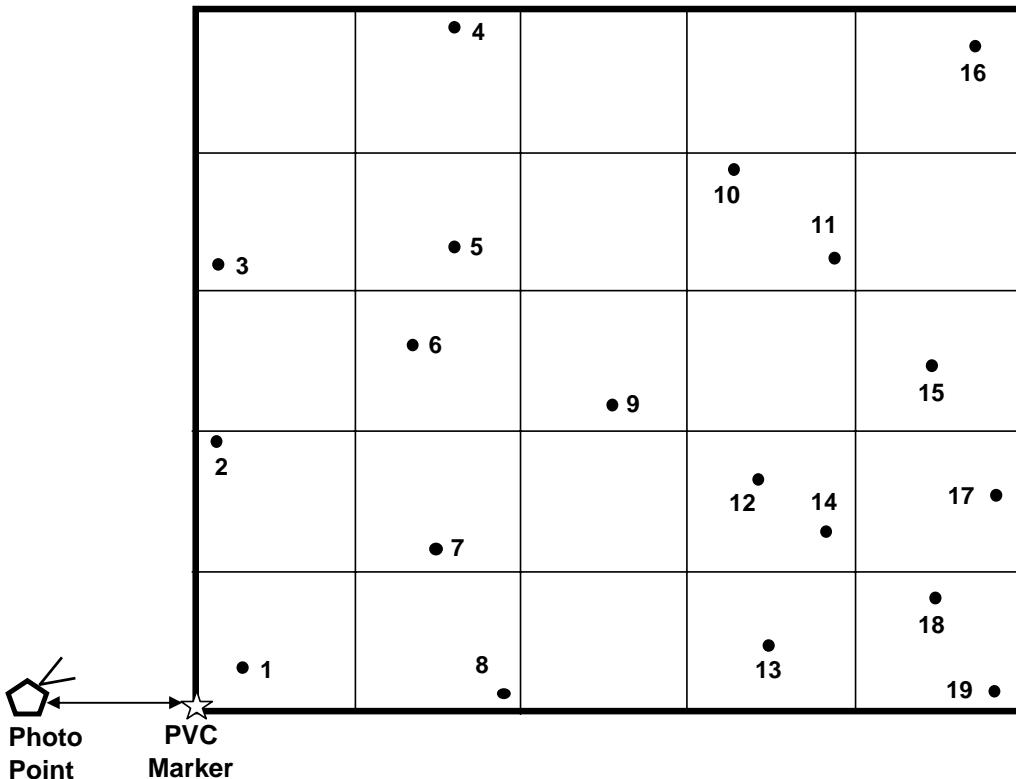
Plot Map

Site: Harrell **Plot:** W8 **Date:** 6/14/2007

Species	Percent of Total
Water Hickory (<i>Carya aquatica</i>)	42.1%
Bald Cypress (<i>Taxodium distichum</i>)	21.1%
Buttonbush (<i>Cephalanthus occidentalis</i>)	21.1%
Beautyberry (<i>Callicarpa americana</i>)	5.3%
Unknown	10.5%

$$\text{Total Number of Trees} \quad \underline{\underline{19}} \quad / \quad 0.025 \text{ acres} \quad = \quad \underline{\underline{760}} \quad \text{trees / acre}$$

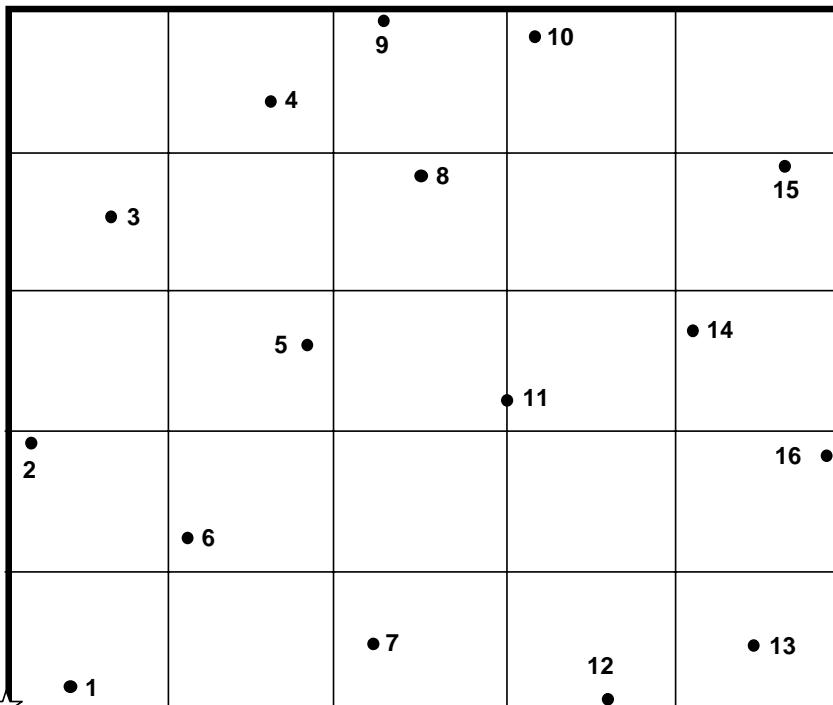
Plot Map

Plot: W9

Species	Percent of Total
Green Ash (<i>Fraxinus pennsylvanica</i>)	12.5%
Laurel Oak (<i>Quercus laurifolia</i>)	18.8%
Willow Oak (<i>Quercus phellos</i>)	6.3%
Cherrybark Oak (<i>Quercus pagoda</i>)	25.0%
Swamp Chestnut Oak (<i>Quercus michauxii</i>)	6.3%
Bald Cypress (<i>Taxodium distichum</i>)	6.3%
Buttonbush (<i>Cephalanthus occidentalis</i>)	6.3%
Beautyberry (<i>Callicarpa americana</i>)	12.5%
Unknown	6.3%

$$\text{Total Number of Trees} \quad \underline{\underline{16}} \quad / \quad 0.025 \text{ acres} \quad = \quad \underline{\underline{640}} \quad \text{trees / acre}$$

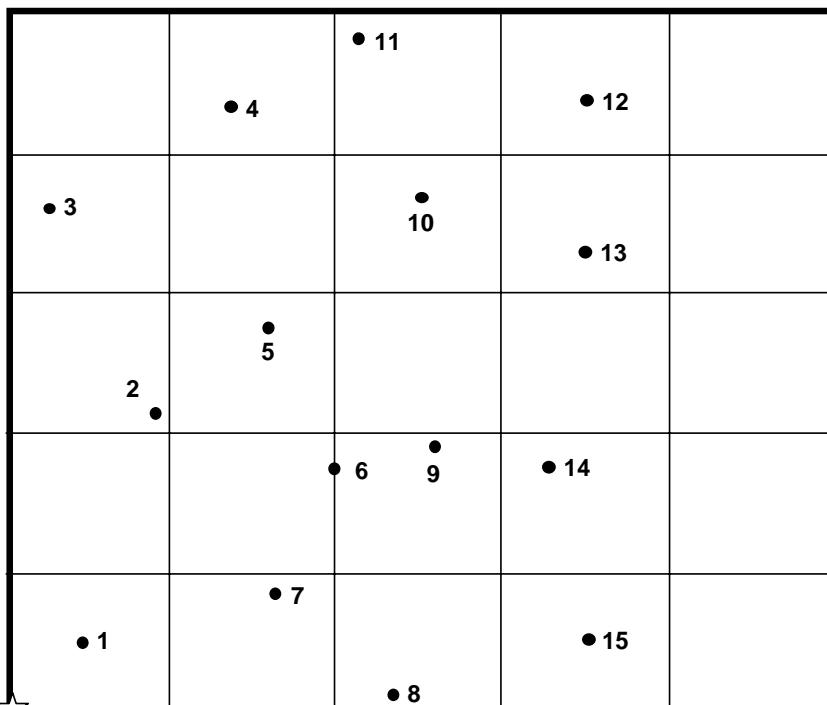
Plot Map

Site: Harrell **Plot:** W10 **Date:** 6/14/2007

Species	Percent of Total
Laurel Oak (<i>Quercus laurifolia</i>)	33.3%
Bald Cypress (<i>Taxodium distichum</i>)	6.7%
Green Ash (<i>Fraxinus pennsylvanica</i>)	20.0%
Buttonbush (<i>Cephaelanthus occidentalis</i>)	20.0%
Beautyberry (<i>Callicarpa americana</i>)	6.7%
Cherrybark Oak (<i>Quercus pagoda</i>)	13.3%

$$\text{Total Number of Trees} \quad \underline{\underline{15}} \quad / \quad 0.025 \text{ acres} \quad = \quad \underline{\underline{600}} \quad \text{trees / acre}$$

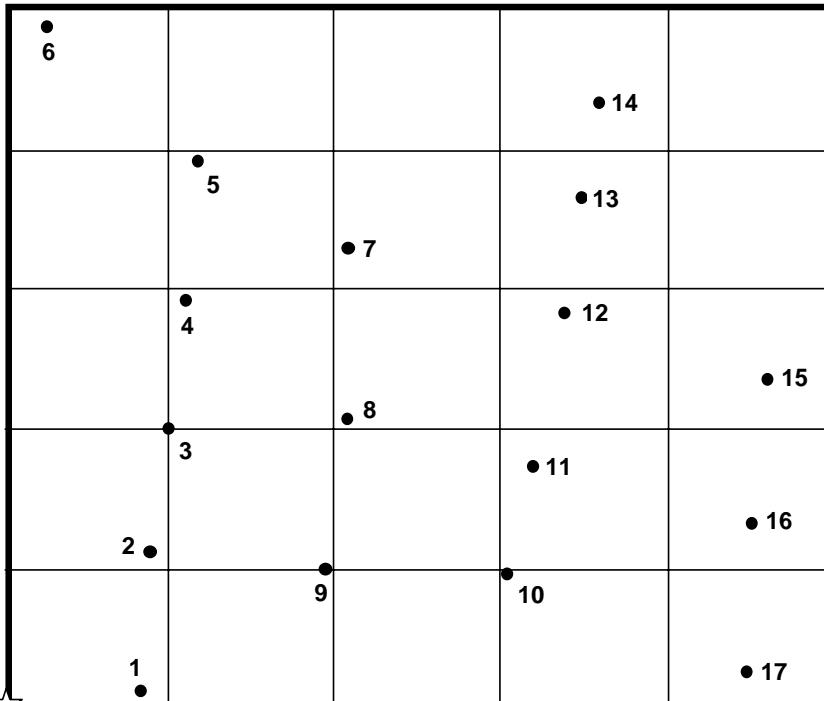
Plot Map

Site: Harrell **Plot:** W11 **Date:** 6/14/2007

Species	Percent of Total
Bald Cypress (<i>Taxodium distichum</i>)	47.1%
Water Hickory (<i>Carya aquatica</i>)	17.6%
Buttonbush (<i>Cephalanthus occidentalis</i>)	23.5%
Beautyberry (<i>Callicarpa americana</i>)	5.9%
Unknown	5.9%

$$\text{Total Number of Trees} \quad \underline{\underline{17}} \quad / \quad 0.025 \text{ acres} \quad = \quad \underline{\underline{680}} \quad \text{trees / acre}$$

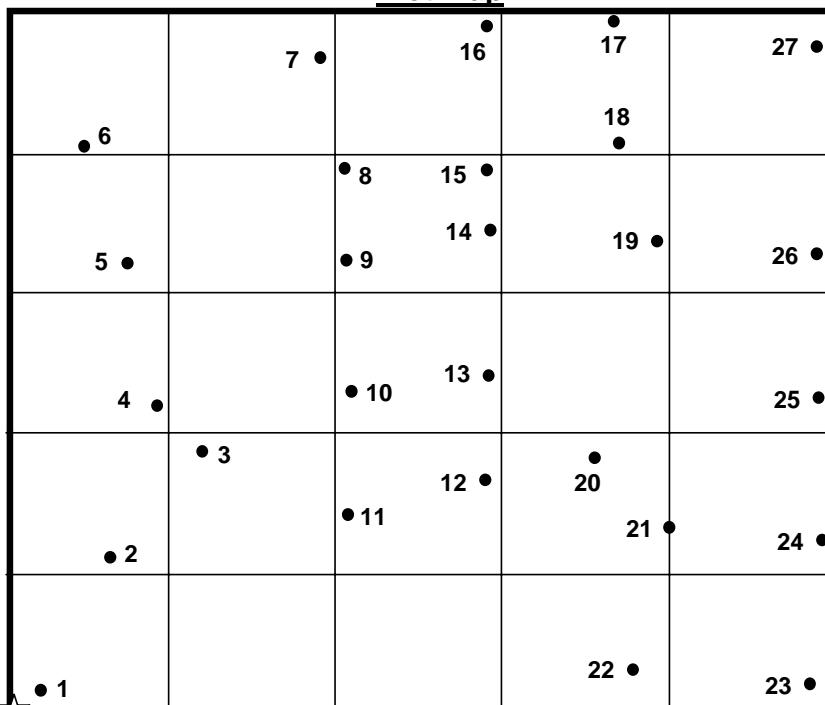
Plot Map

Site: Harrell Plot: W12 Date: 6/14/2007

ID	Species	Height (m)	Vigor	Comment
1	Water Hickory (<i>Carya aquatica</i>)	0.75	4	
2	Bald Cypress (<i>Taxodium distichum</i>)	0.92	4	
3	Buttonbush (<i>Cephalanthus occidentalis</i>)	0.57	3	Browsed
4	Bald Cypress (<i>Taxodium distichum</i>)	0.69	2	
5	Bald Cypress (<i>Taxodium distichum</i>)	0.87	3	
6	Bald Cypress (<i>Taxodium distichum</i>)	0.77	4	
7	Beautyberry (<i>Callicarpa americana</i>)	0.65	2	
8	Buttonbush (<i>Cephalanthus occidentalis</i>)	0.56	2	Browsed
9	Buttonbush (<i>Cephalanthus occidentalis</i>)	0.41	3	
10	Buttonbush (<i>Cephalanthus occidentalis</i>)	0.31	2	Browsed
11	Buttonbush (<i>Cephalanthus occidentalis</i>)	0.38	3	
12	Buttonbush (<i>Cephalanthus occidentalis</i>)	0.42	3	
13	Unknown	0.29	3	
14	Buttonbush (<i>Cephalanthus occidentalis</i>)	0.43	3	
15	Buttonbush (<i>Cephalanthus occidentalis</i>)	0.51	3	Browsed
16	Water Hickory (<i>Carya aquatica</i>)	0.63	4	
17	Water Hickory (<i>Carya aquatica</i>)	0.65	3	Browsed

Species	Percent of Total
Water Hickory (<i>Carya aquatica</i>)	14.8%
Bald Cypress (<i>Taxodium distichum</i>)	33.3%
Buttonbush (<i>Cephalanthus occidentalis</i>)	44.4%
Unknown	3.7%
Beautyberry (<i>Callicarpa americana</i>)	3.7%

$$\text{Total Number of Trees} \quad \underline{\underline{27}} \quad / \quad 0.025 \text{ acres} \quad = \quad \underline{\underline{1080}} \quad \text{trees / acre}$$
