Harrell Farm Stream/Wetland Restoration Mitigation Plan Contract # D05025-1

March 2008

TYPE OF WORK: STREAM AND WETLAND RESTORATION

AS-BUILT PLAN

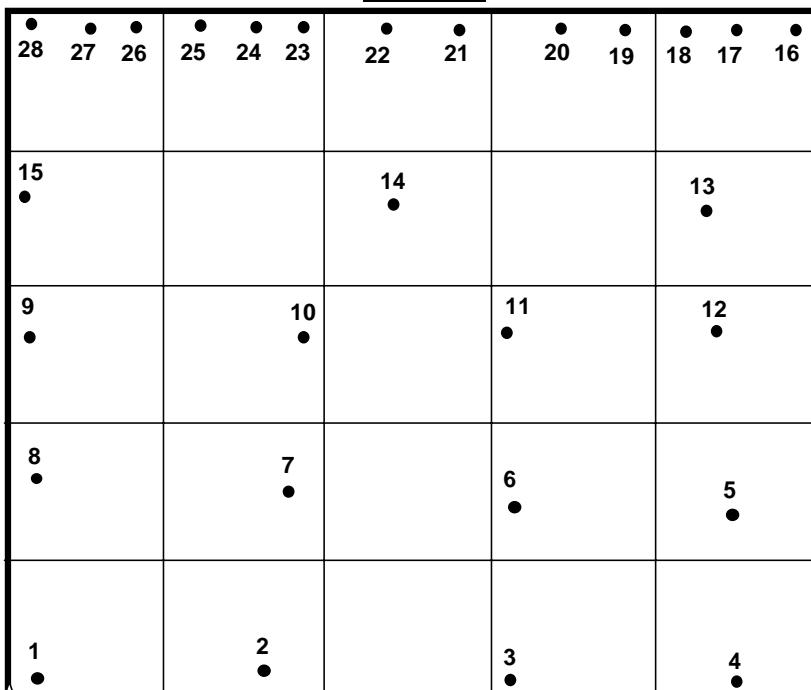
Plot Map

Site: Harrell Plot: S1 Date: 1/30/2008

ID	Species	Height (m)	Vigor	Comment
1	Unknown	0.42	4	
2	Unknown	0.29	4	
3	Southern Red Oak (<i>Quercus falcata</i>)	0.47	4	
4	Southern Red Oak (<i>Quercus falcata</i>)	0.40	4	
5	Southern Red Oak (<i>Quercus falcata</i>)	0.40	4	
6	Unknown	0.56	4	
7	Unknown	0.20	4	
8	Unknown	0.27	4	
9	Unknown	0.35	4	
10	Willow Oak (<i>Quercus phellos</i>)	0.54	4	
11	Willow Oak (<i>Quercus phellos</i>)	0.51	4	
12	Unknown	0.36	4	
13	Southern Red Oak (<i>Quercus falcata</i>)	0.33	4	
14	Southern Red Oak (<i>Quercus falcata</i>)	0.37	4	
15	Southern Red Oak (<i>Quercus falcata</i>)		4	
16	Silky Dogwood (<i>Cornus amomum</i>)		4	Live Stake
17	Silky Dogwood (<i>Cornus amomum</i>)		4	Live Stake
18	Silky Dogwood (<i>Cornus amomum</i>)		4	Live Stake
19	Silky Dogwood (<i>Cornus amomum</i>)		4	Live Stake
20	Silky Dogwood (<i>Cornus amomum</i>)		4	Live Stake
21	Elderberry (<i>Sambucus canadensis</i>)		4	Live Stake
22	Silky Dogwood (<i>Cornus amomum</i>)		4	Live Stake

Species	Percent of Total
Silky Dogwood (<i>Cornus amomum</i>)	28.6%
Southern Red Oak (<i>Quercus falcata</i>)	21.4%
Elderberry (<i>Sambucus canadensis</i>)	17.9%
Willow Oak (<i>Quercus phellos</i>)	7.1%
Unknown	25.0%

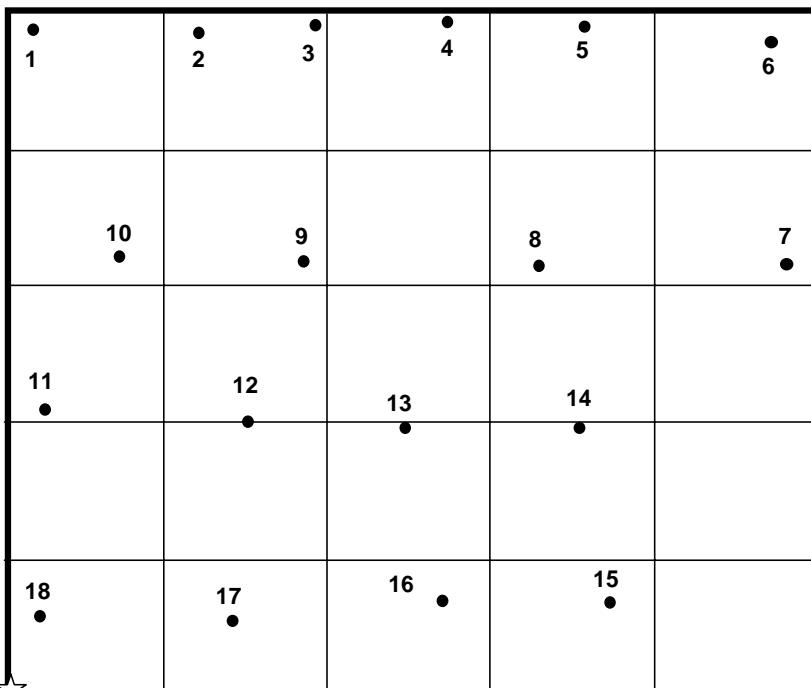
Plot Map

Site: Harrell Plot: S2 Date: 1/30/2008

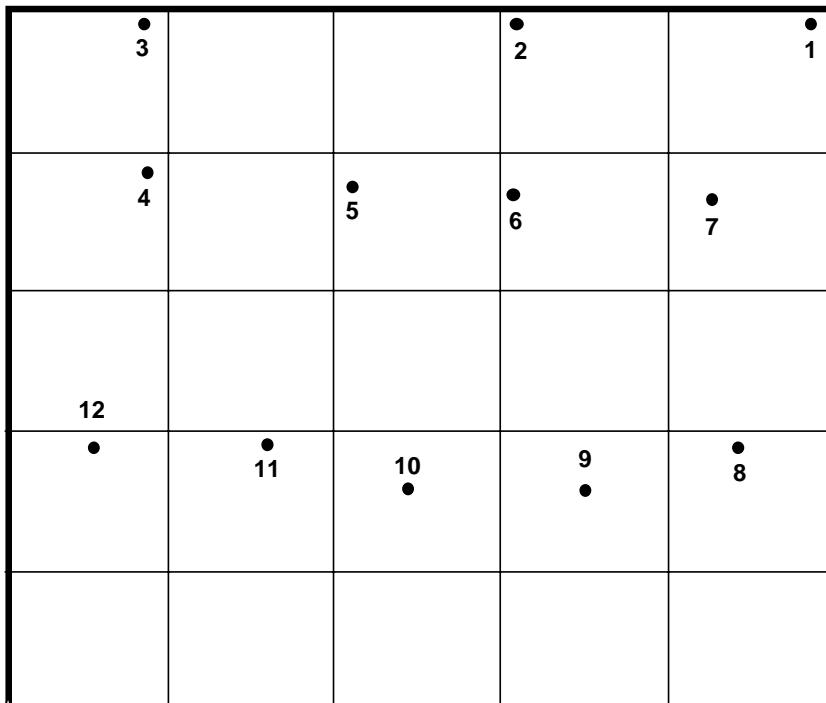
Plot Map

Site: Harrell **Plot:** S6 **Date:** 1/30/2008

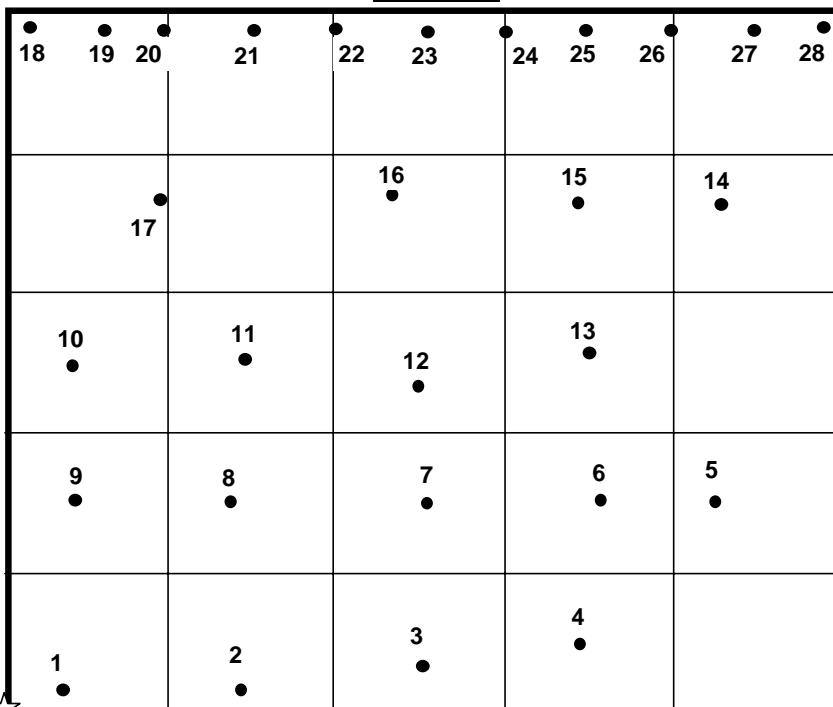
Plot Map

Site: Harrell Plot: S7 Date: 1/30/2008

ID	Species	Height (m)	Vigor	Comment
1	Unknown	0.26	4	
2	Unknown	0.40	4	
3	Unknown	0.30	4	
4	Unknown	0.47	4	
5	Unknown	0.36	4	
6	Unknown	0.42	4	
7	Unknown	0.38	4	
8	Unknown	0.49	4	
9	Unknown	0.29	4	
10	Unknown	0.50	4	
11	Unknown	0.22	4	
12	Unknown	0.42	4	
13	Unknown	0.47	4	
14	Unknown	0.52	4	
15	Unknown	0.54	4	
16	Unknown	0.30	4	
17	Unknown	0.51	4	
18	Silky Dogwood (<i>Cornus amomum</i>)		4	Live Stake
19	Silky Dogwood (<i>Cornus amomum</i>)		4	Live Stake
20	Silky Dogwood (<i>Cornus amomum</i>)		4	Live Stake
21	Silky Dogwood (<i>Cornus amomum</i>)		4	Live Stake
22	Silky Dogwood (<i>Cornus amomum</i>)		4	Live Stake
23	Silky Dogwood (<i>Cornus amomum</i>)		4	Live Stake
24	Silky Dogwood (<i>Cornus amomum</i>)		4	Live Stake
25	Silky Dogwood (<i>Cornus amomum</i>)		4	Live Stake
26	Elderberry (<i>Sambucus canadensis</i>)		4	Live Stake
27	Elderberry (<i>Sambucus canadensis</i>)		4	Live Stake
28	Elderberry (<i>Sambucus canadensis</i>)		4	Live Stake

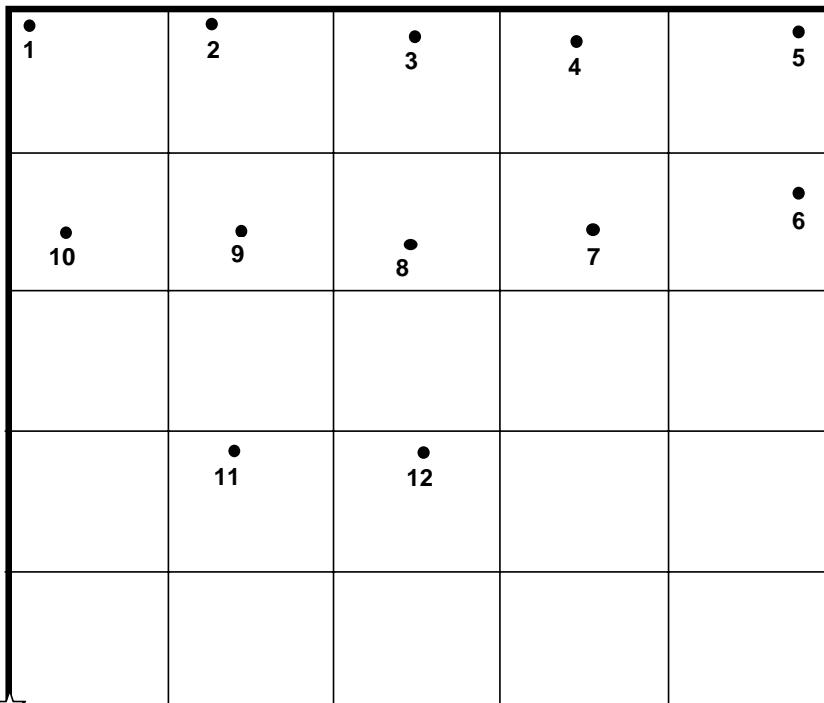
Plot Map

Site: Harrell **Plot:** S8 **Date:** 1/30/2008

Species	Percent of Total
Unknown	100.0%

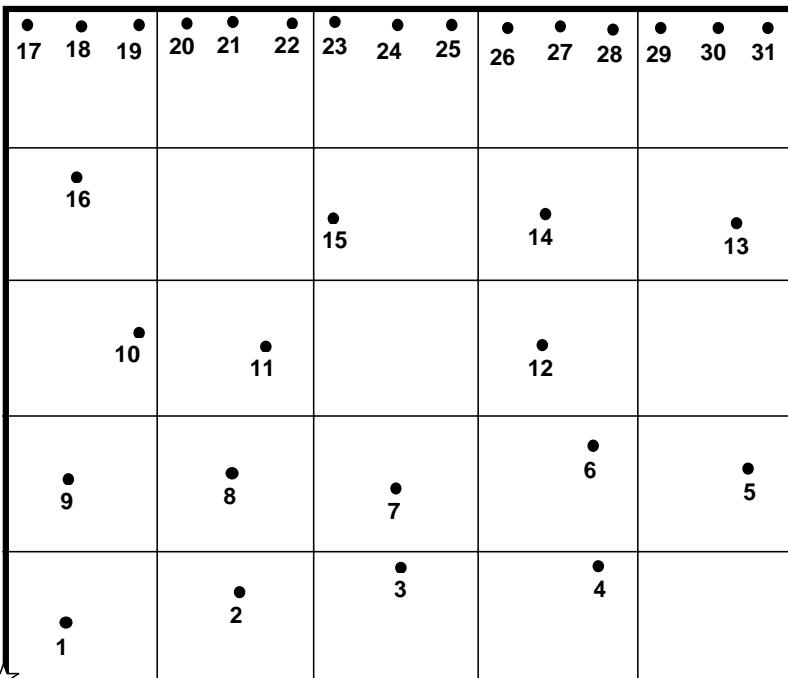
Plot Map

Site: Harrell Plot: S9 Date: 1/31/2008

ID	Species	Height (m)	Vigor	Comment
1	Unknown	0.35	4	
2	Unknown	0.57	4	
3	Unknown	0.59	4	
4	Unknown	0.63	4	
5	Willow Oak (<i>Quercus phellos</i>)	0.57	4	
6	Unknown	0.30	4	
7	Unknown	0.41	4	
8	River Birch (<i>Betula nigra</i>)	0.48	4	
9	River Birch (<i>Betula nigra</i>)	0.49	4	
10	Unknown	0.78	4	
11	Willow Oak (<i>Quercus phellos</i>)	0.50	4	
12	Unknown	0.55	4	
13	Swamp Chestnut Oak (<i>Quercus michauxii</i>)	0.55	4	
14	Unknown	0.29	4	
15	River Birch (<i>Betula nigra</i>)	0.50	4	
16	River Birch (<i>Betula nigra</i>)	0.42	4	
17	Silky Dogwood (<i>Cornus amomum</i>)		4	Live Stake
18	Silky Dogwood (<i>Cornus amomum</i>)		4	Live Stake
19	Silky Dogwood (<i>Cornus amomum</i>)		4	Live Stake
20	Elderberry (<i>Sambucus canadensis</i>)		4	Live Stake
21	Black Willow (<i>Salix nigra</i>)		4	Live Stake
22	Silky Dogwood (<i>Cornus amomum</i>)		4	Live Stake
23	Silky Dogwood (<i>Cornus amomum</i>)		4	Live Stake
24	Silky Dogwood (<i>Cornus amomum</i>)		4	Live Stake

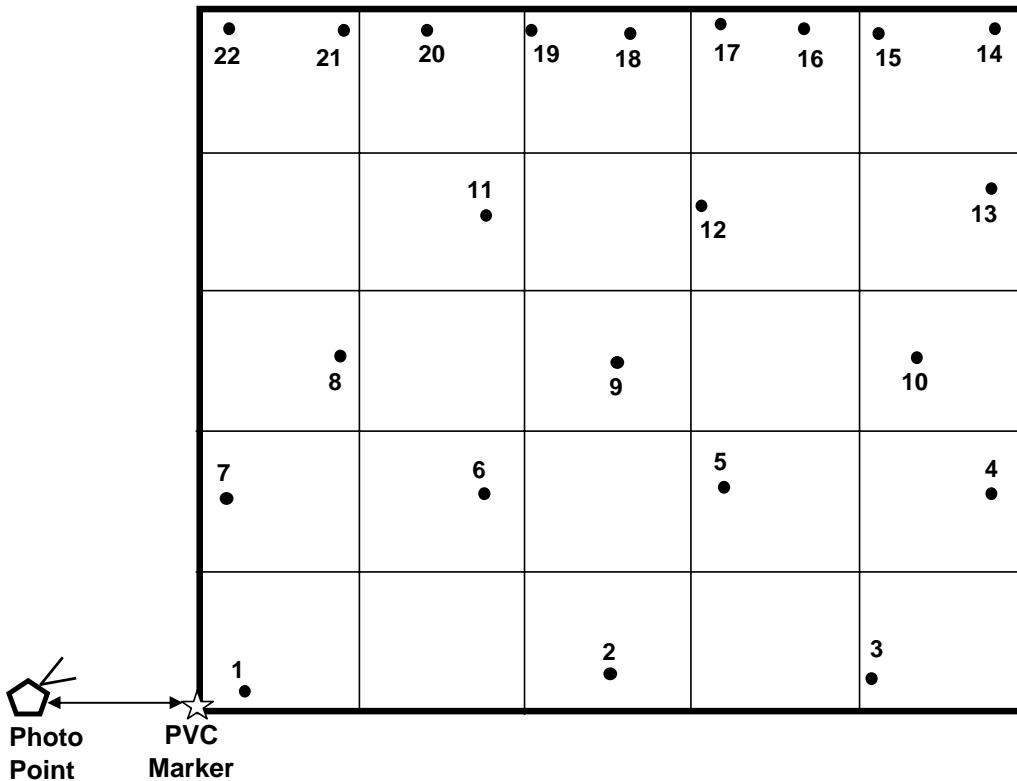
Plot Map

Site: Harrell Plot: S11 Date: 1/31/2008

ID	Species	Height (m)	Vigor	Comment
1	Unknown	0.57	4	
2	Unknown	0.45	4	
3	Unknown	0.50	4	
4	Unknown	0.55	4	
5	Unknown	0.70	4	
6	Unknown	0.34	4	
7	Unknown	0.56	4	
8	Unknown	0.35	4	
9	Unknown	0.49	4	
10	Unknown	0.57	4	
11	Unknown	0.51	4	
12	Unknown	0.40	4	
13	Unknown	0.60	4	
14	Elderberry (<i>Sambucus canadensis</i>)		4	Live Stake
15	Silky Dogwood (<i>Cornus amomum</i>)		4	Live Stake
16	Silky Dogwood (<i>Cornus amomum</i>)		4	Live Stake
17	Silky Dogwood (<i>Cornus amomum</i>)		4	Live Stake
18	Silky Dogwood (<i>Cornus amomum</i>)		4	Live Stake
19	Silky Dogwood (<i>Cornus amomum</i>)		4	Live Stake
20	Silky Dogwood (<i>Cornus amomum</i>)		4	Live Stake
21	Elderberry (<i>Sambucus canadensis</i>)		4	Live Stake
22	Black Willow (<i>Salix nigra</i>)		4	Live Stake

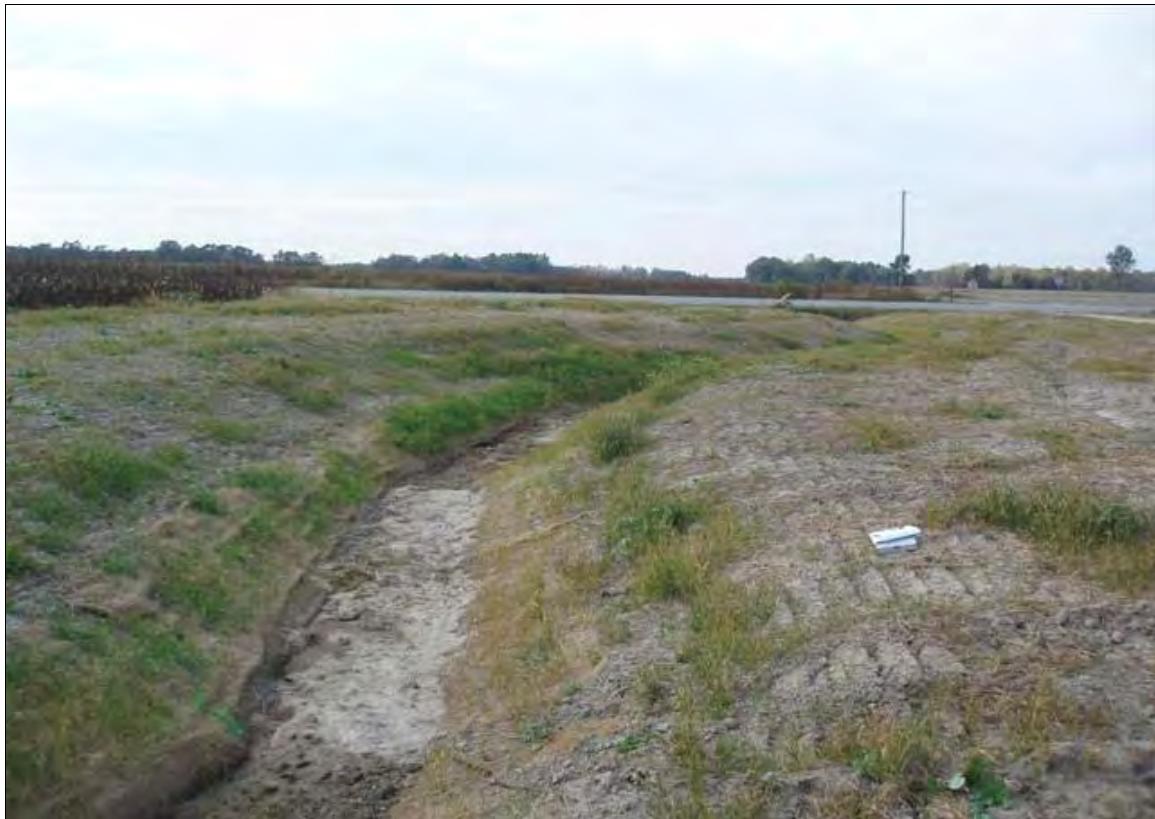
Photo Point S1: View looking upstream near Station 12+75. 11/7/07 – As-Built

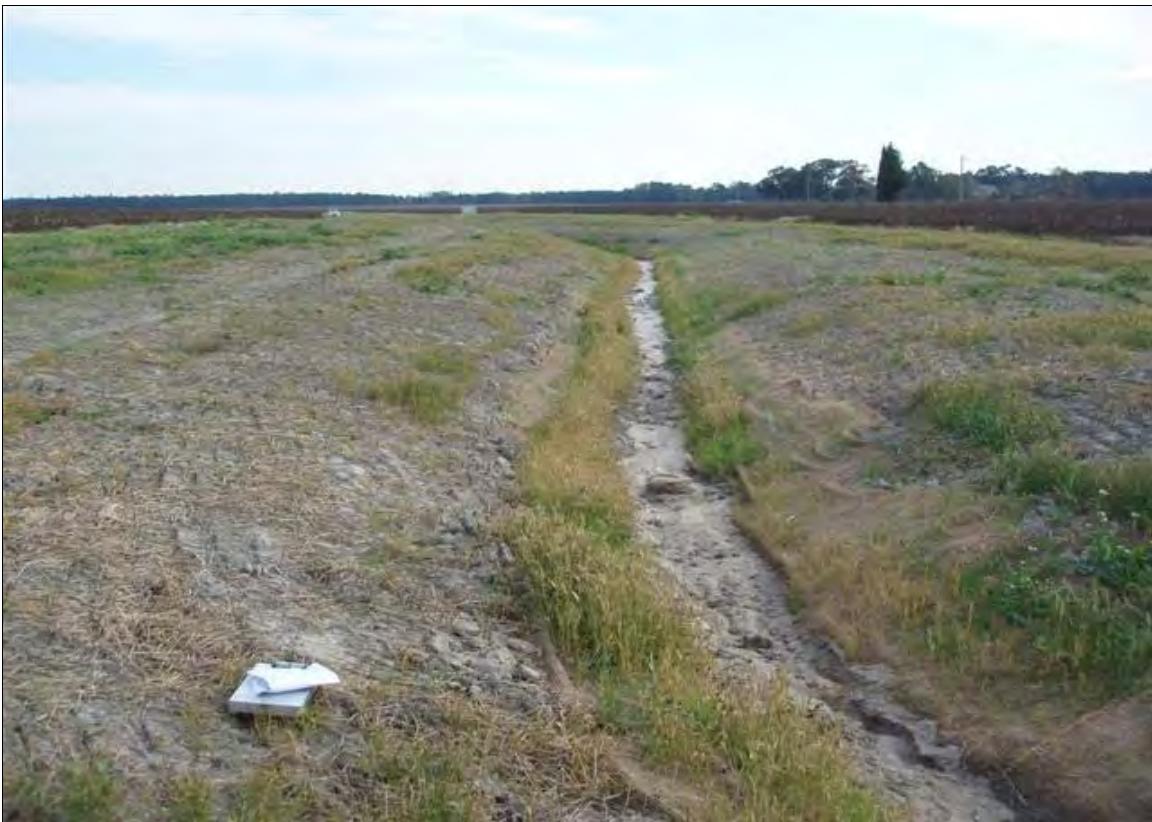
Photo Point S1: View looking downstream, near Station 12+75. 11/7/07 – As-Built

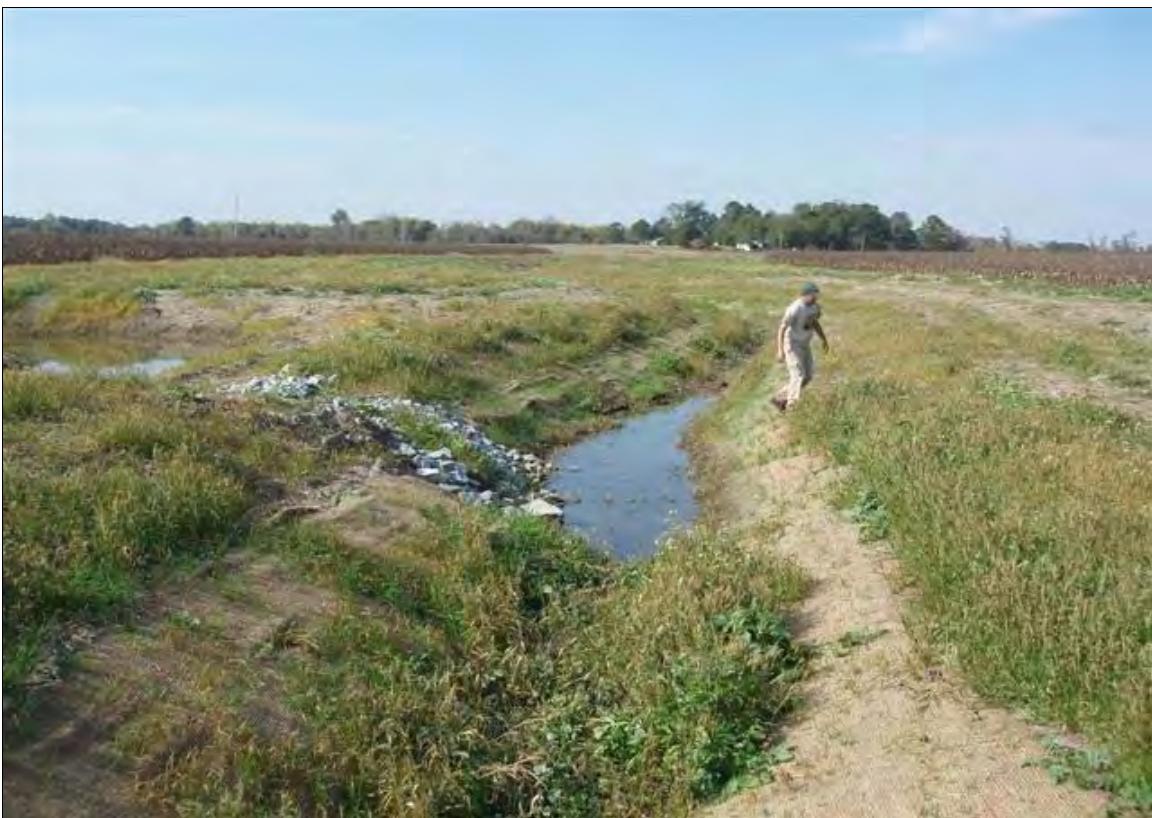
Photo Point S2: View looking upstream from farm road near Station 21+30. 11/7/07 – As-Built

There are certain sections of the stream that are experiencing localized bank erosion or bed degradation. Around Station 23+00, the right bank is eroding and the bed is downcut from the impacts of an upstream culvert. The bank and bed may need to be stabilized. A riffle at Stations 33+25-33+50 has downcut into the clay bed; this section will be watched to see if it stabilizes at its current grade or continues to cut down. An entering drainage ditch at Station 37+00 has unstable, eroding banks within the project easement. To address this problem, the banks will be sloped back and stabilized. Finally, at Station 44+00, surface flow has been draining into the stream and caused bank erosion. The erosion is isolated and will be monitored to see if it stabilizes as more vegetation becomes established. In general, KCI will continue to watch any problem areas along the project stream and address any maintenance issues as they arise.

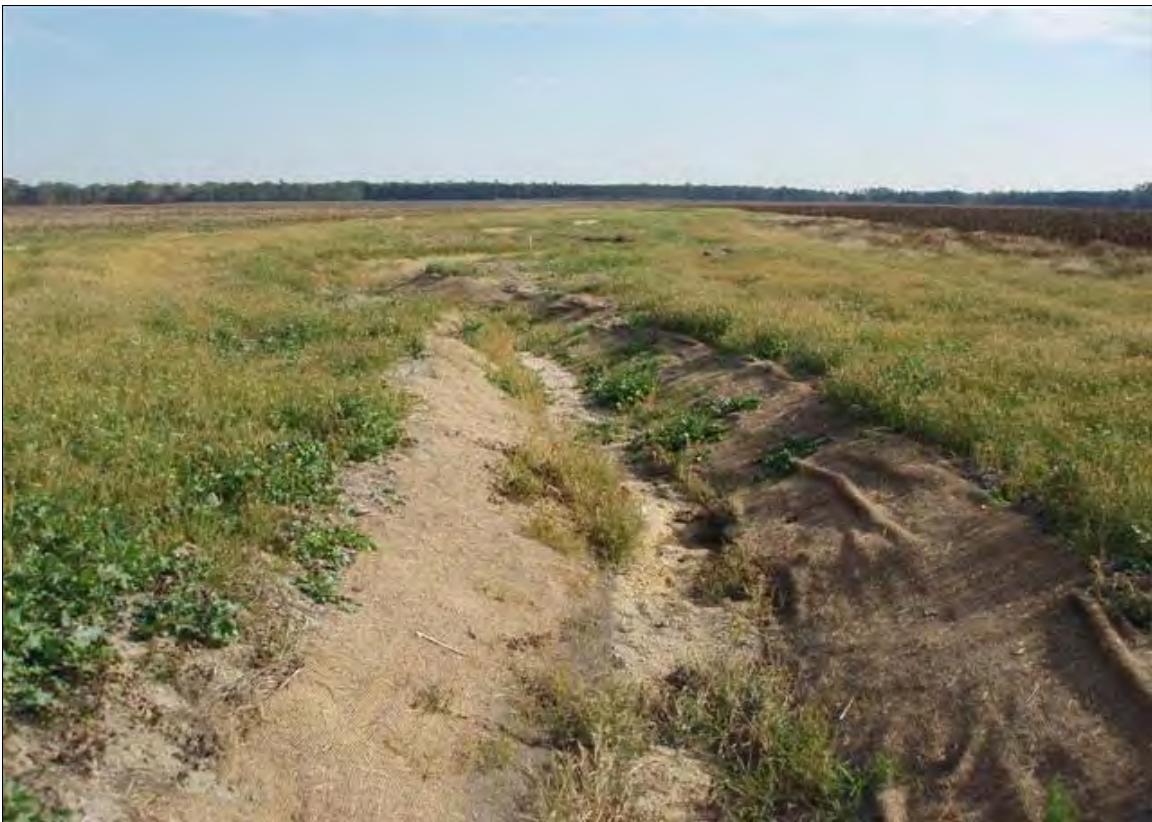
Photo Point S2: View looking downstream from farm road near Station 21+30. 11/7/07 - As-Built

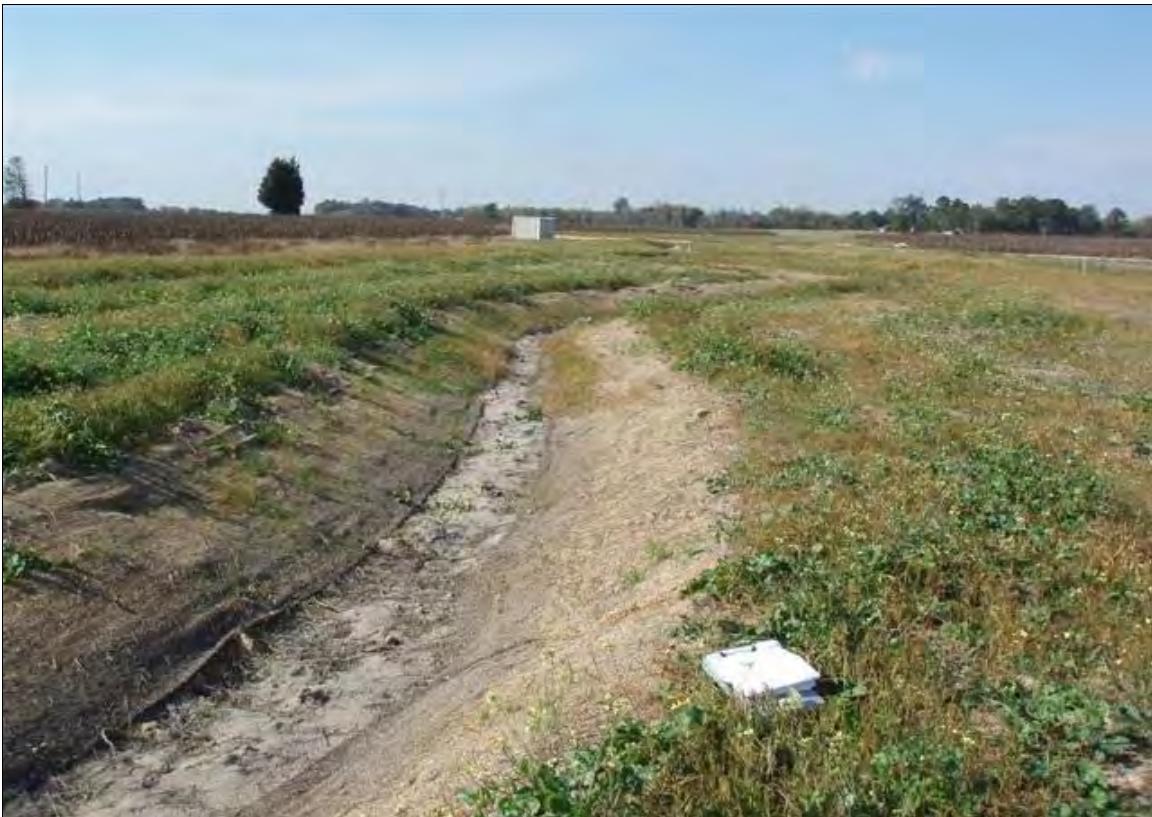
Photo Point S3: View looking upstream near Station 27+60. 11/7/07 – As-Built

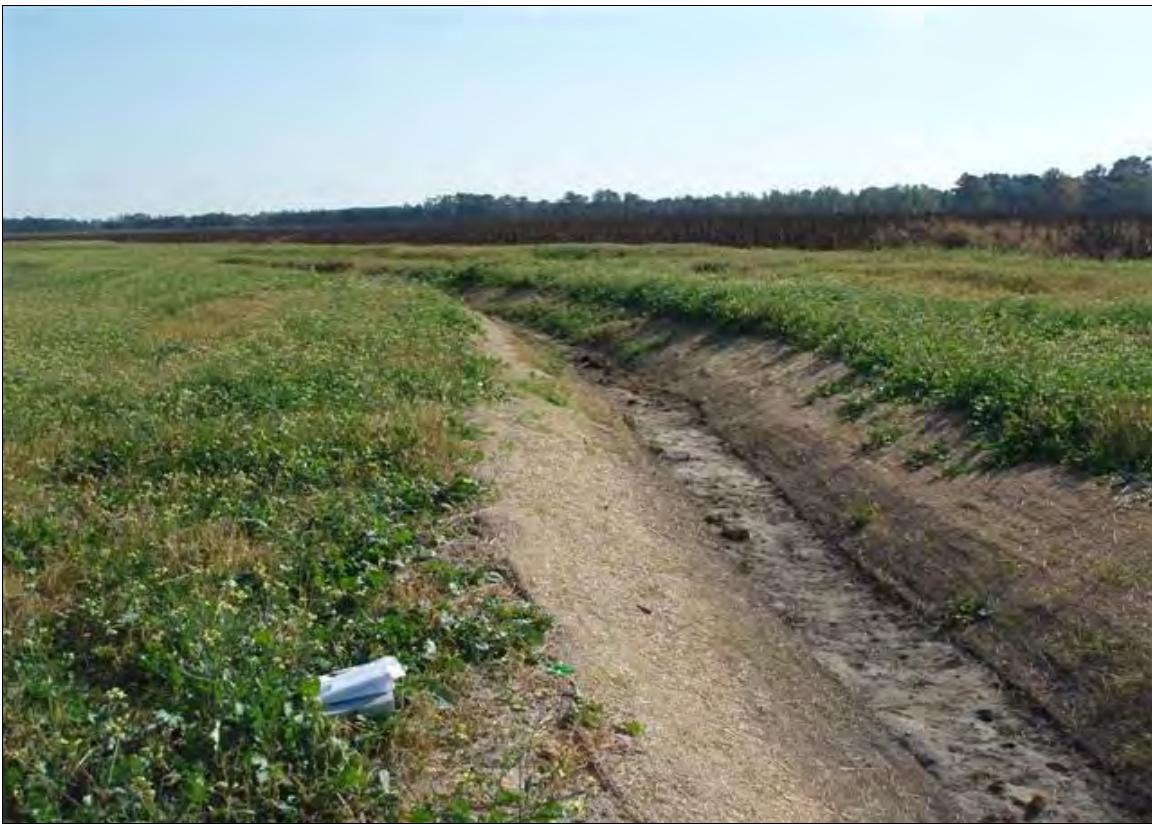
Point S3: View looking downstream near Station 27+60. 11/7/07 – As-Built

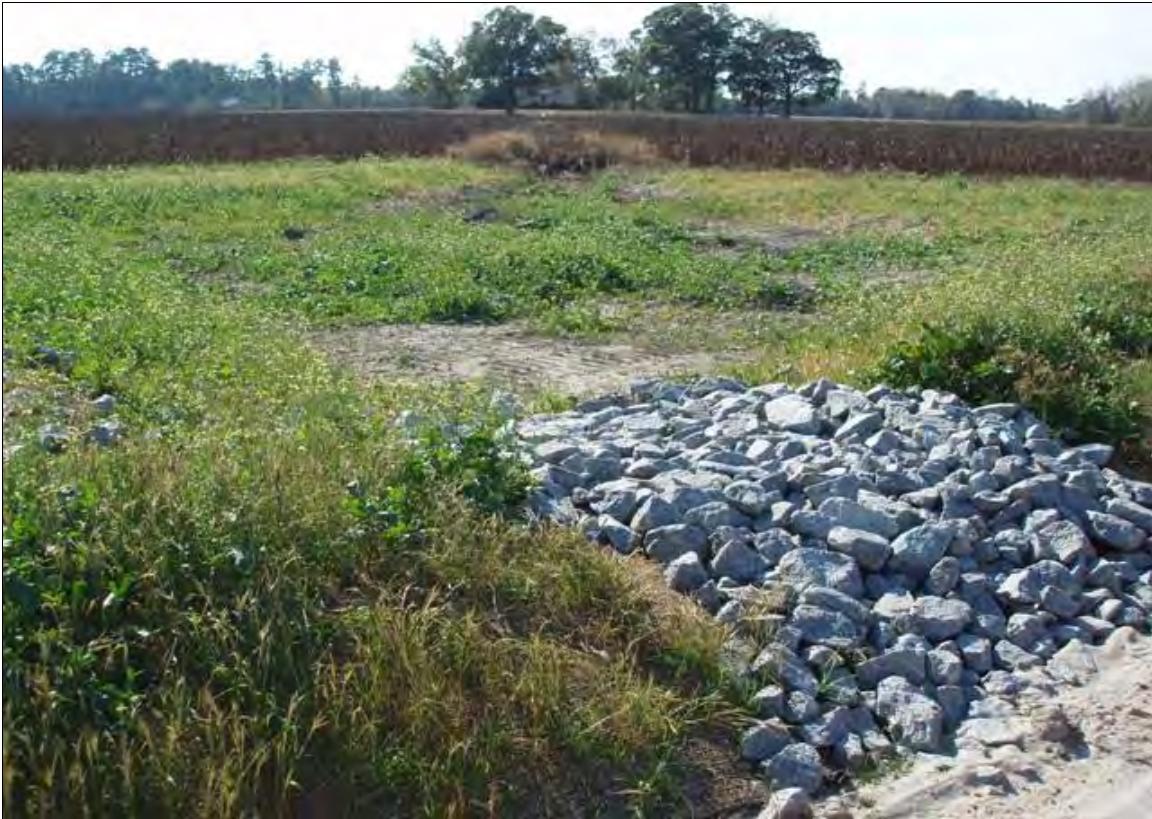
Photo Point S4: View of water quality treatment structure near Station 32+25. 11/7/07 – As-Built

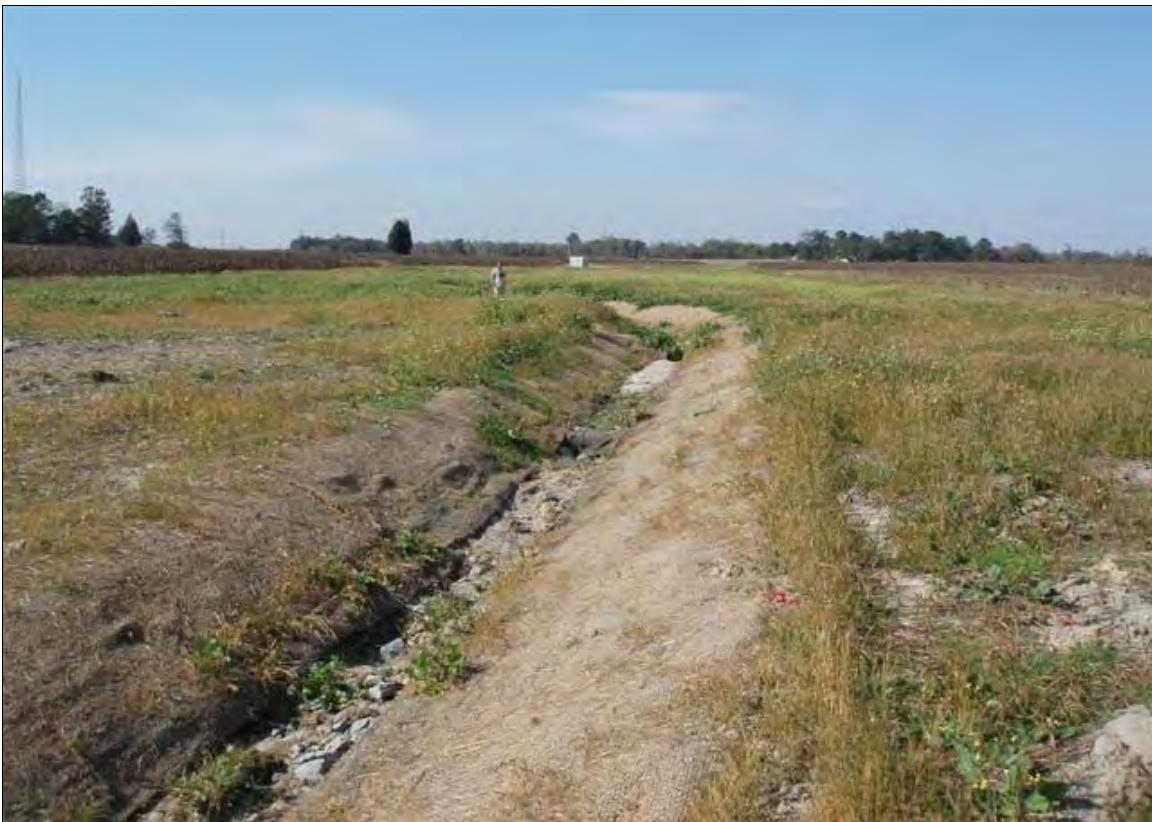
Photo Point S5: View looking at log drop structures, near Station 33+35. 11/7/07 – As-Built

The stream restoration included four separate reaches, which were restored based on a combination of Priority Levels 2 and 3. Log drop structures were used to control grade throughout the profile. The stream was restored to a B5c and C5 stream types. The as-built survey and baseline monitoring found that there were minimal deviations from the designed cross-sections and profile. The baseline monitoring revealed that the stream has already begun to exhibit the typical features associated with sand channels, such as the movement of dunes and anti-dunes along the longitudinal profile. The movement of the sand bed will cause variation in the monitored cross-sections and profiles, but these variations are expected and will be evaluated to determine if they are associated with normal stable channel processes or if they indicate a trend toward instability.

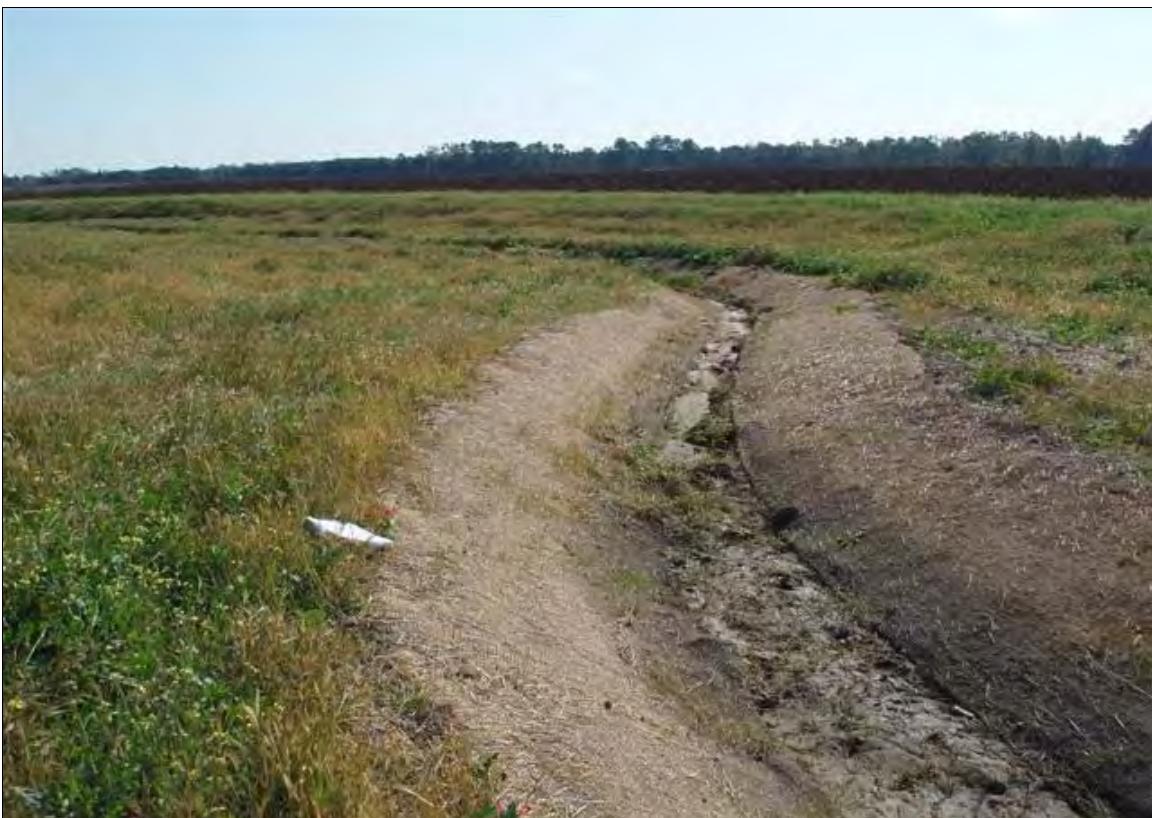
Photo Point S5: View looking downstream near Station 33+35. 11/7/07 – As-Built

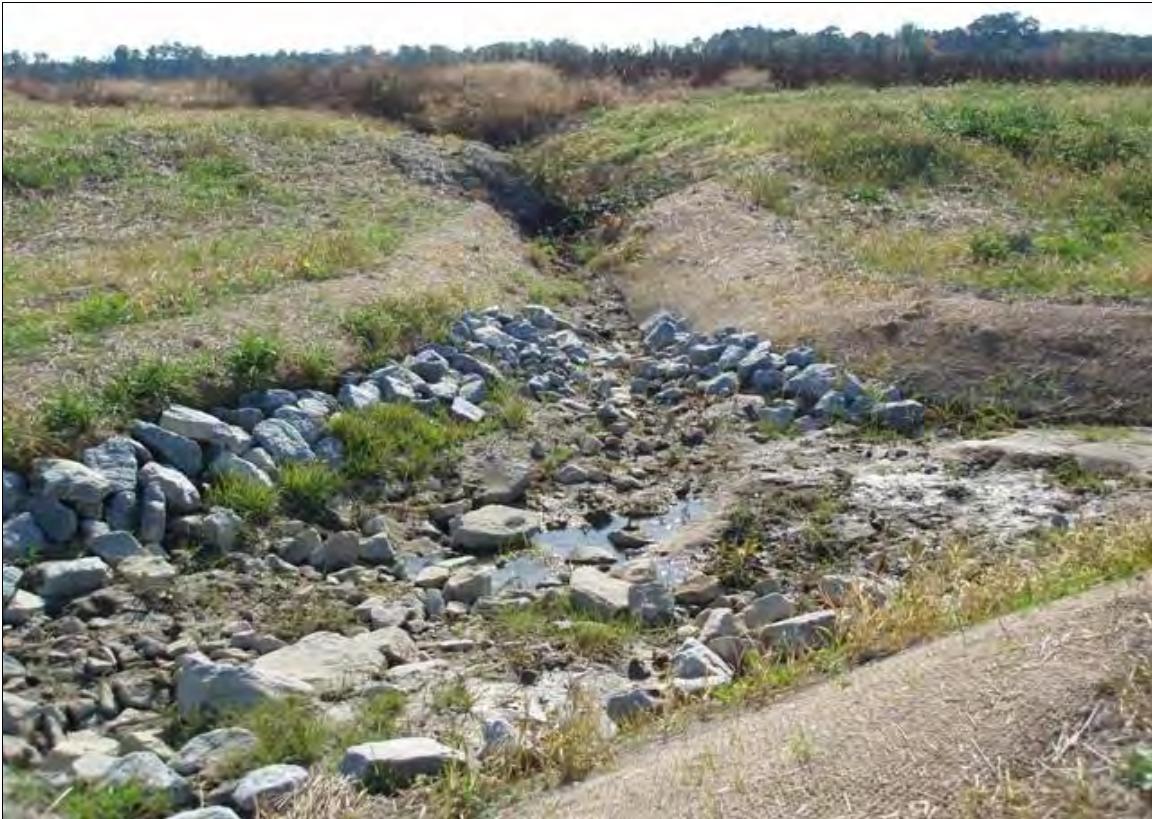
Photo Point S6: View of drainage ditch reinforcement, near Station 37+25. 11/7/07 – As-Built

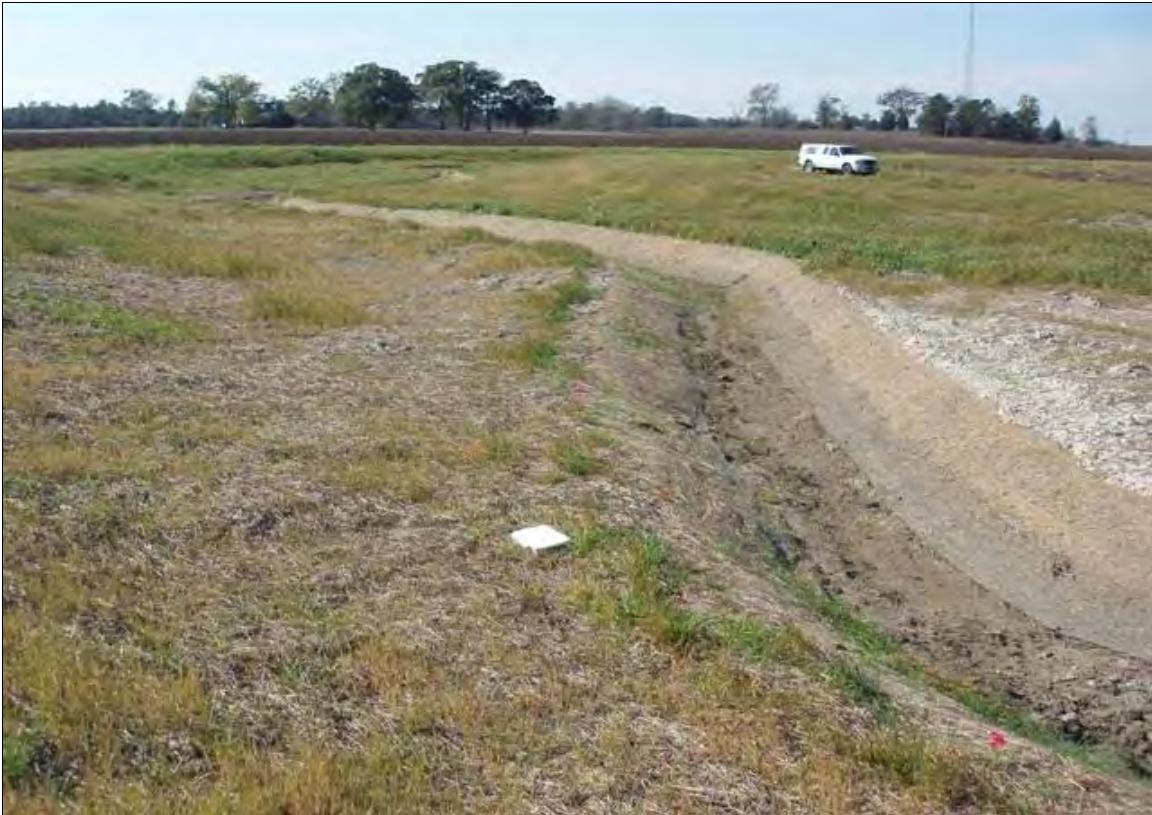
Photo Point S7: View looking upstream near Station 39+00. 11/7/07 – As-Built

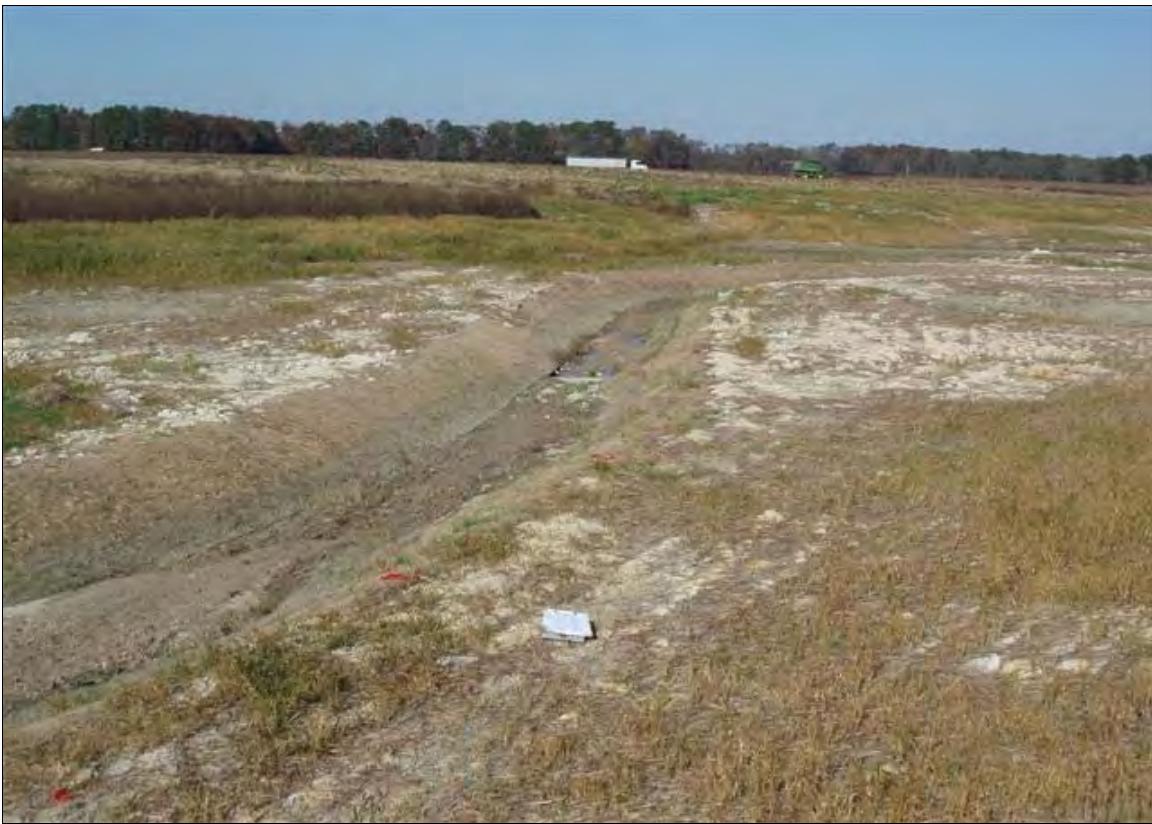
Photo Point S7: View looking downstream near Station 39+00. 11/7/07 – As-Built

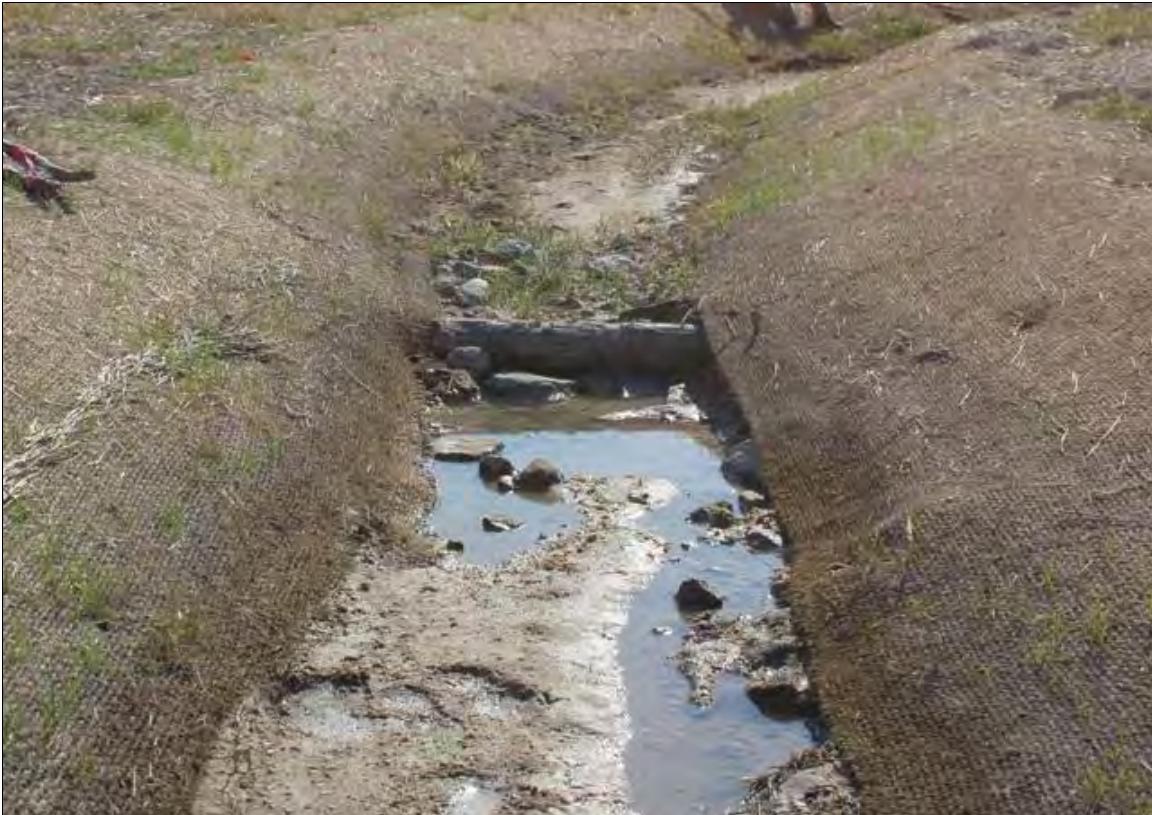
Photo Point S8: View of log drop structure near Station 39+50. 11/7/07 – As-Built

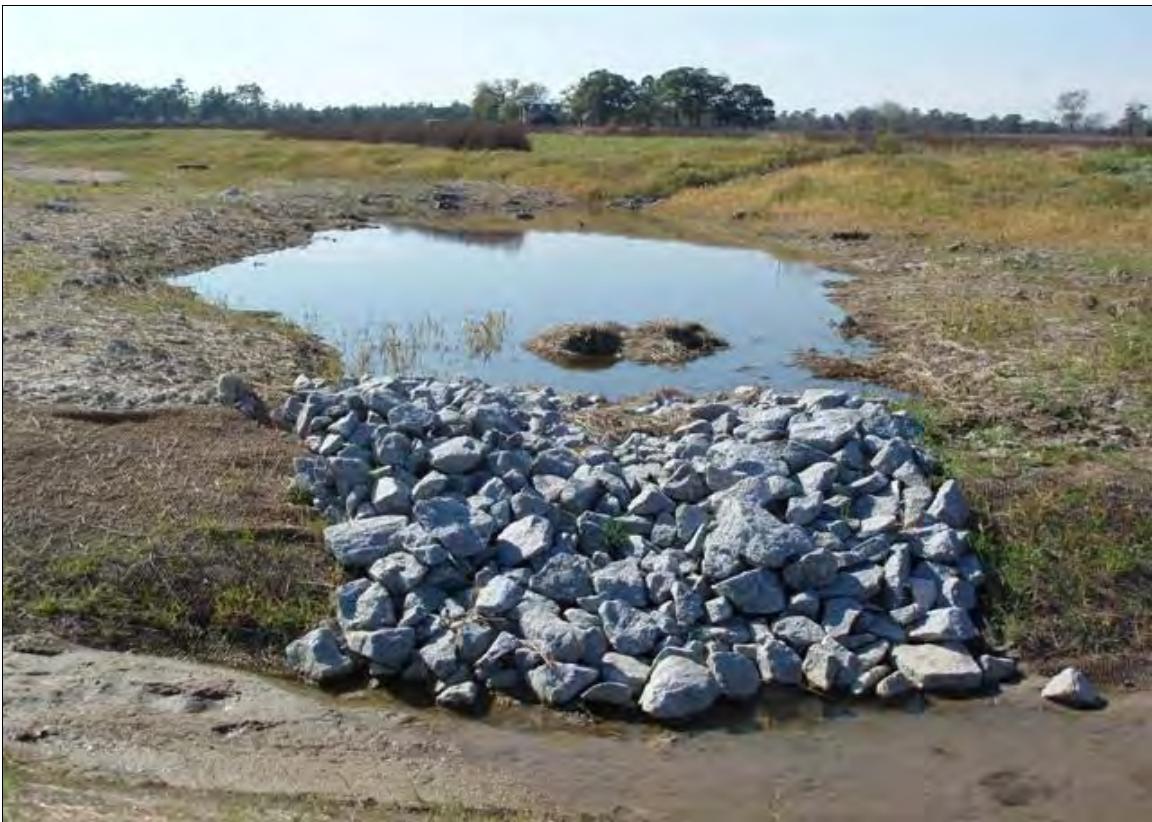
Photo Point S9: View of water quality treatment structure near Station 41+75. 11/7/07 – As-Built

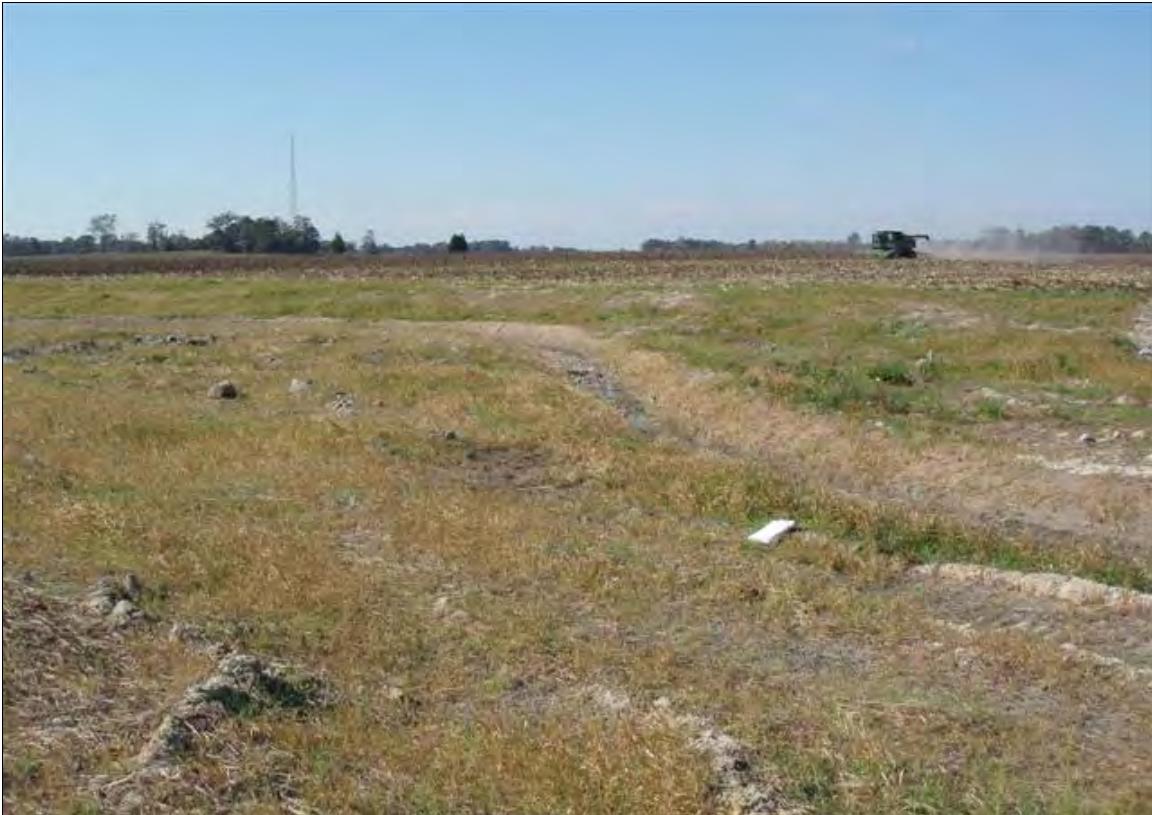
Photo Point S10: View looking upstream near Station 46+15. 11/7/07 – As-Built

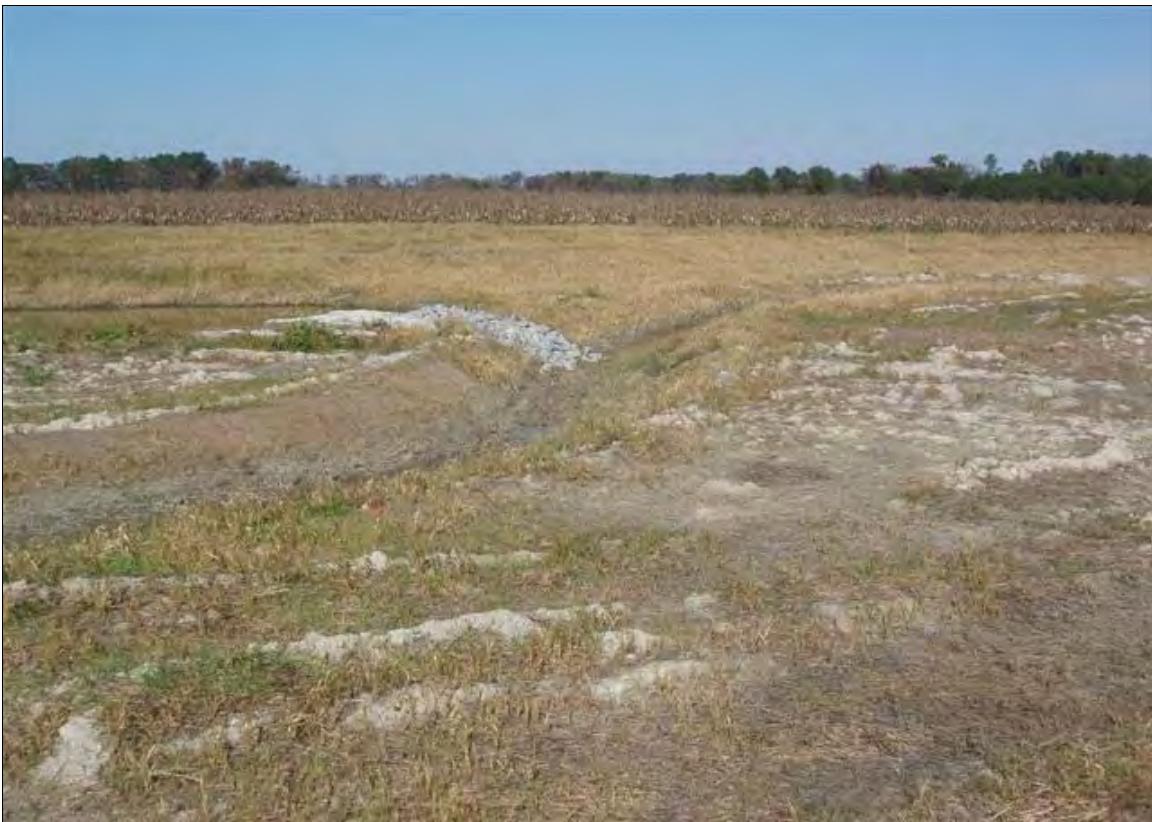
Photo Point S10: View looking downstream near Station 46+15. 11/7/07 – As-Built

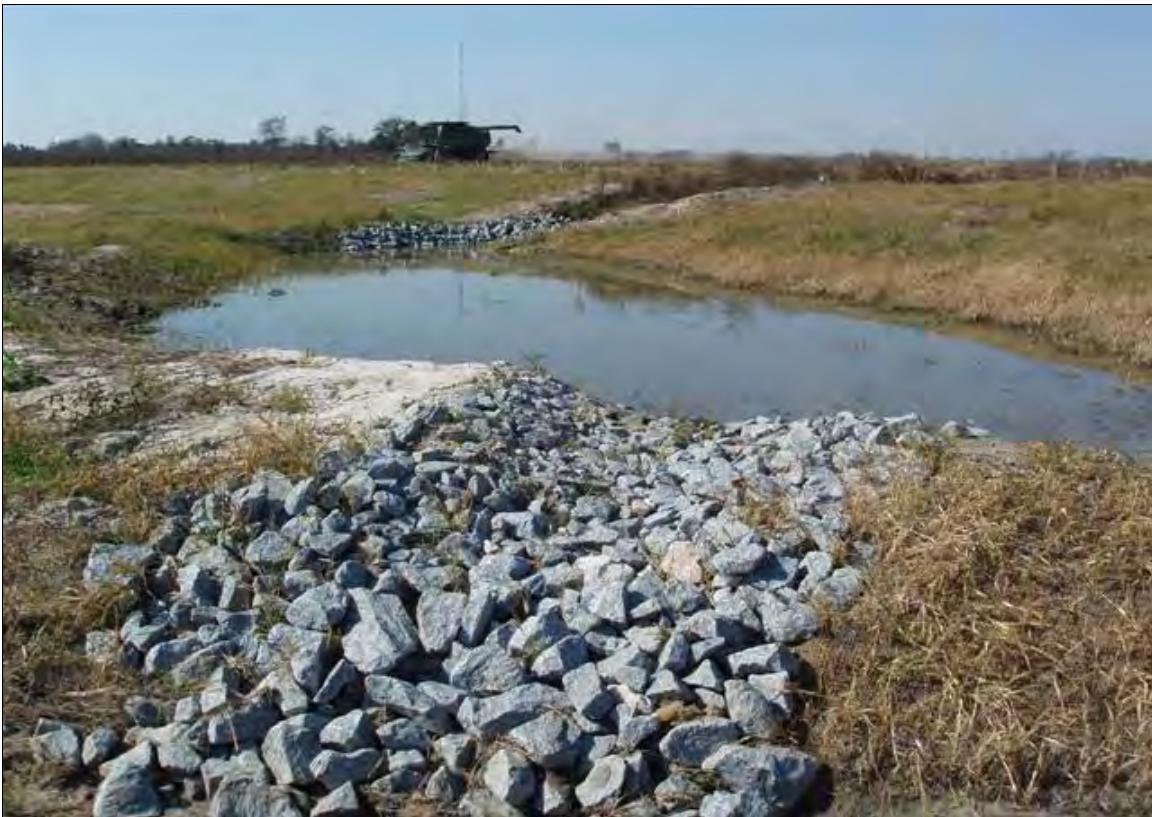
Photo Point S11: View of water quality treatment structure near Station 47+00. 11/7/07 - As-Built
