Harrell Farm Stream/Wetland Restoration Mitigation Plan Contract # D05025-1

March 2008

TYPE OF WORK: STREAM AND WETLAND RESTORATION

AS-BUILT PLAN

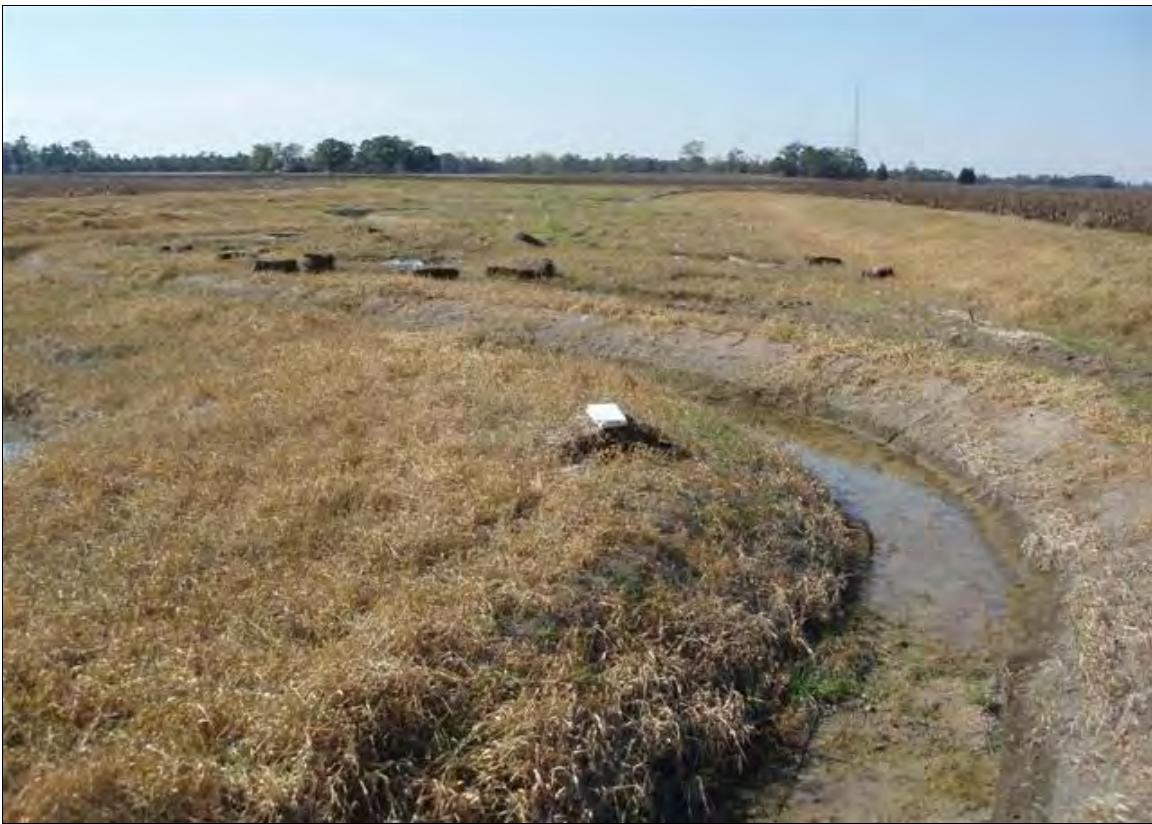
Photo Point S12: View looking upstream near Station 52+00. 11/7/07 – As-Built

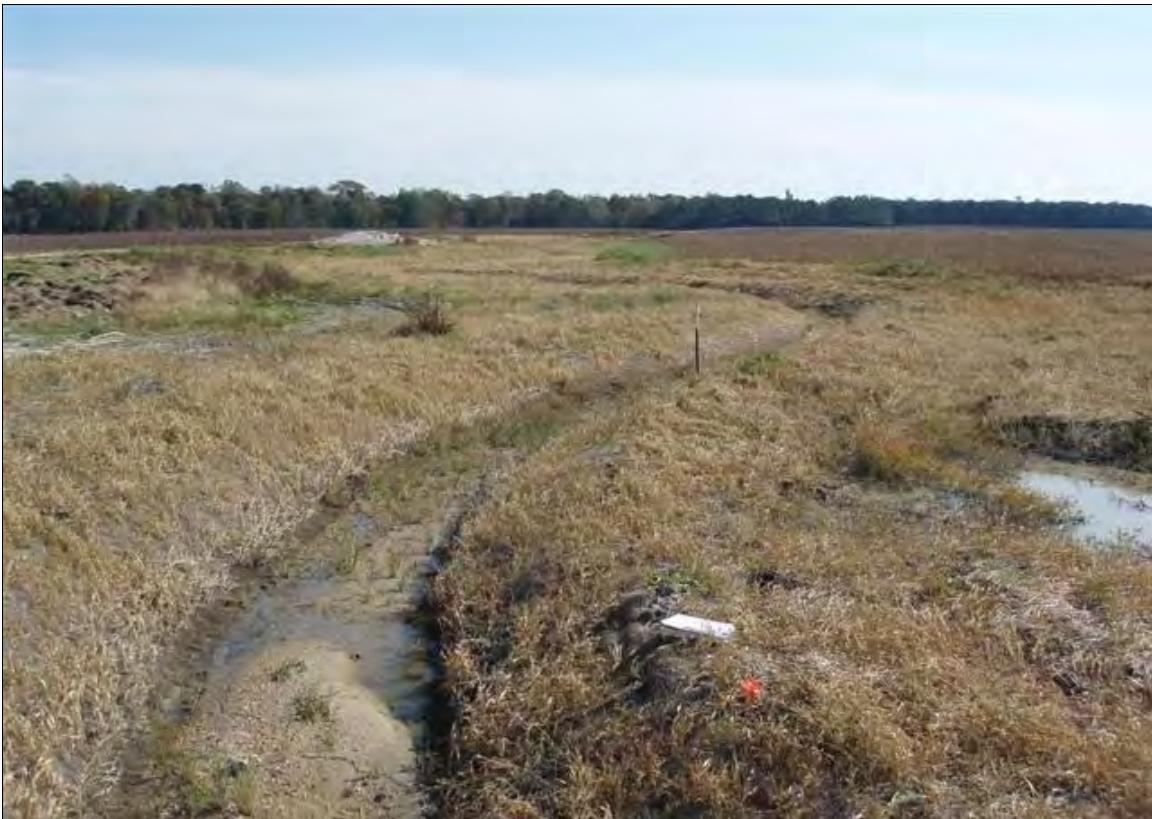
Photo Point S12: View looking downstream near Station 52+00. 11/7/07 – As-Built

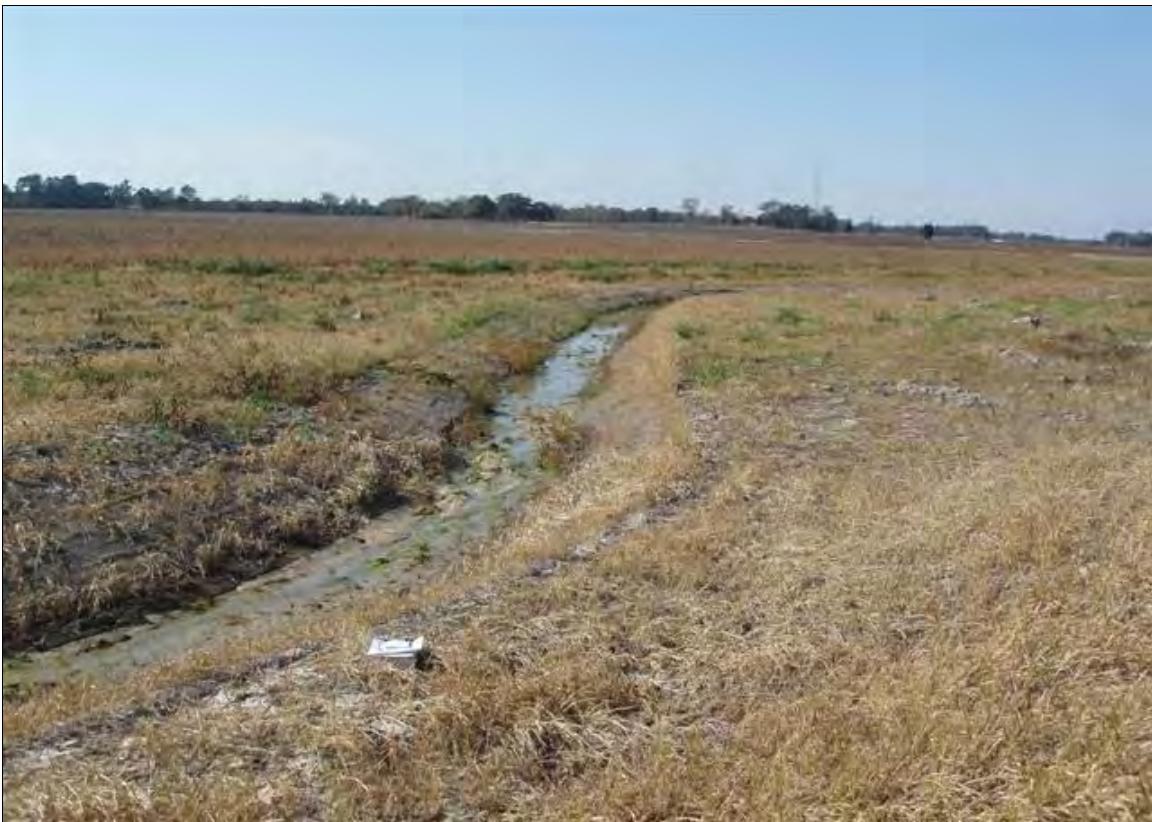
Photo Point S13: View looking upstream near Station 61+50. 11/7/07 – As-Built

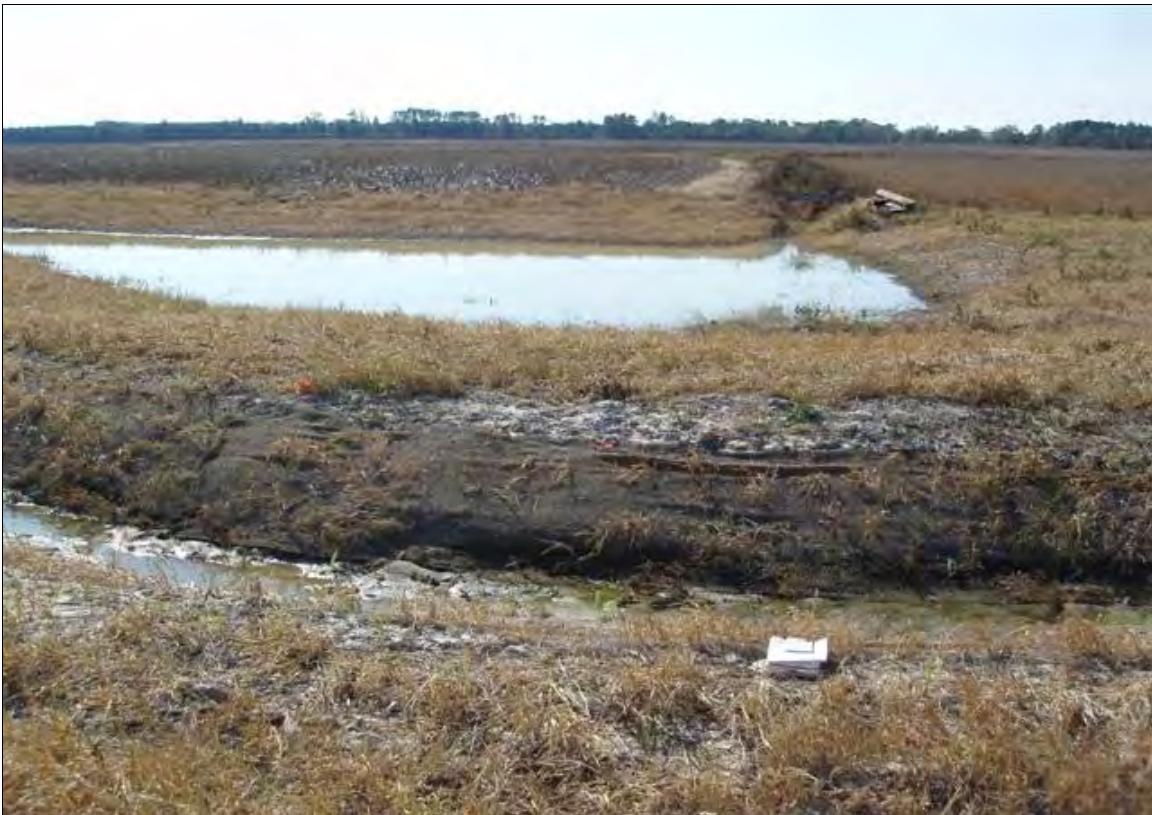
Photo Point S13: View of water quality treatment structure near Station 61+50. 11/7/07 - As-Built

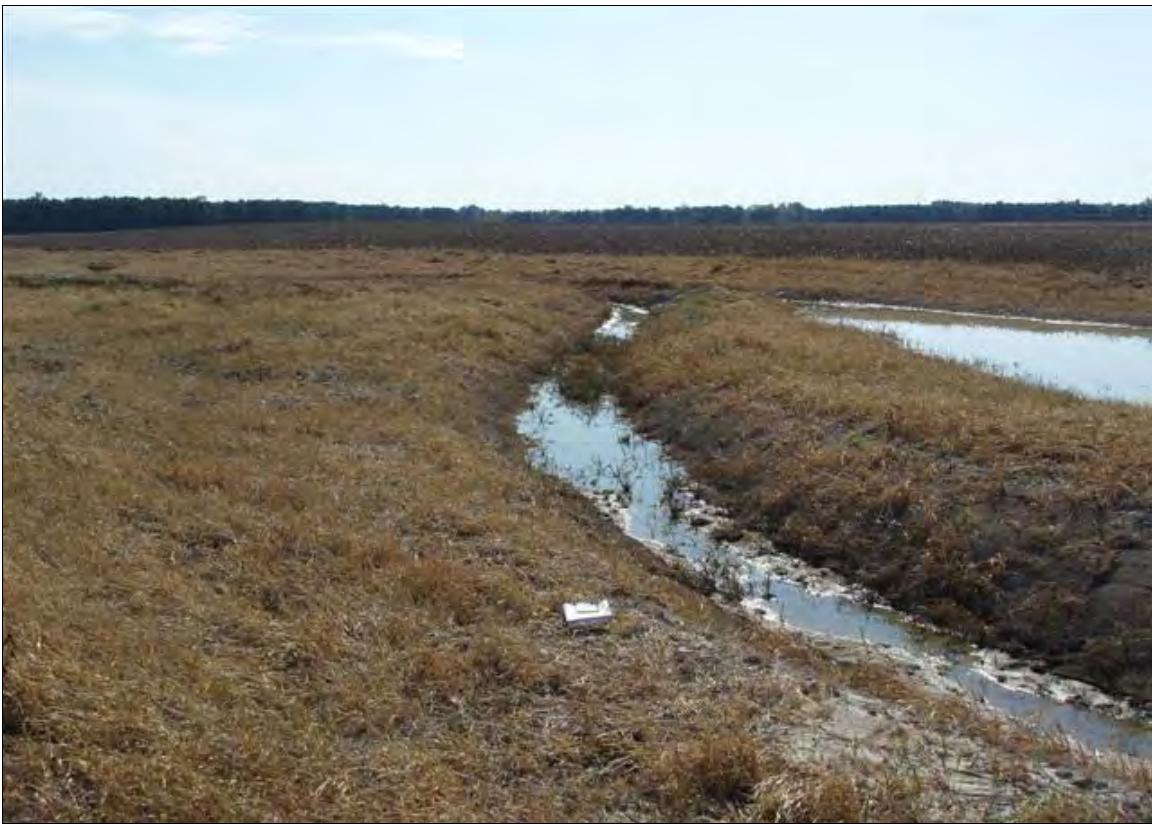
Photo Point S13: View looking downstream near Station 61+50. 11/7/07 – As-Built

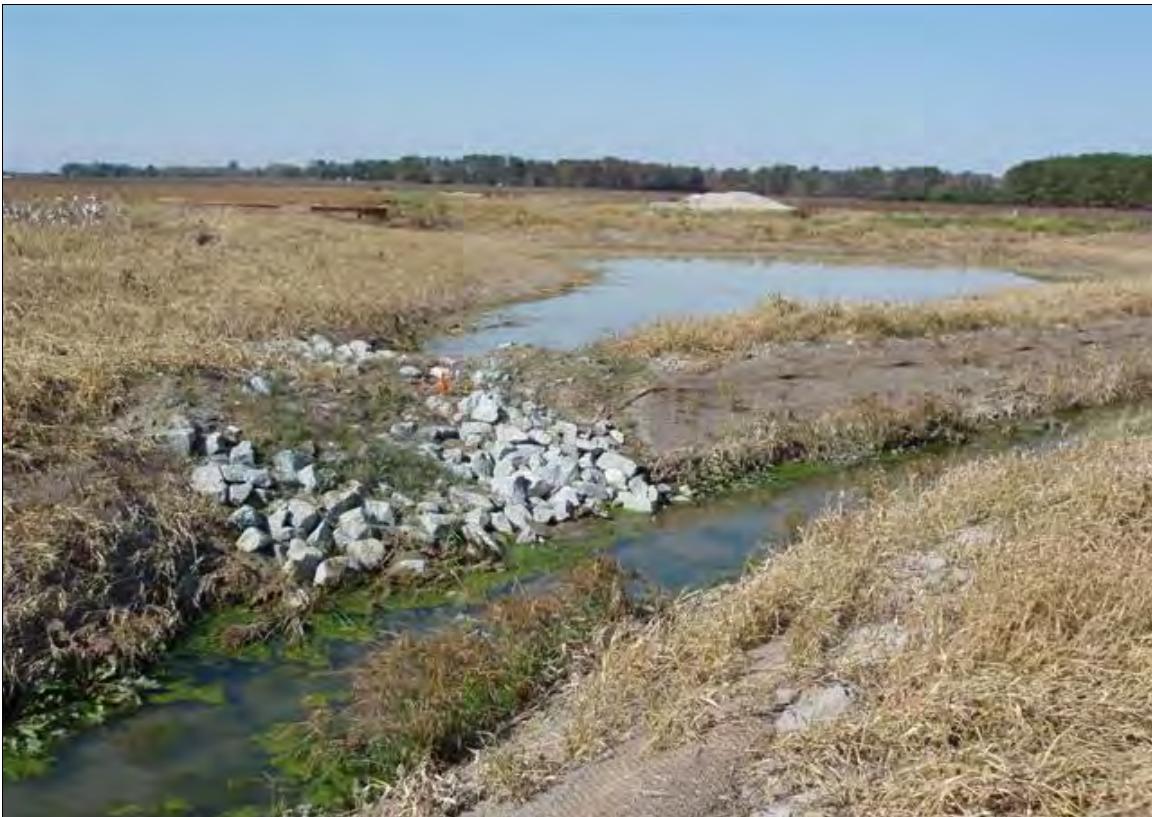
Photo Point S14: View of water quality treatment structure near Station 62+60. 11/7/07 - As-Built

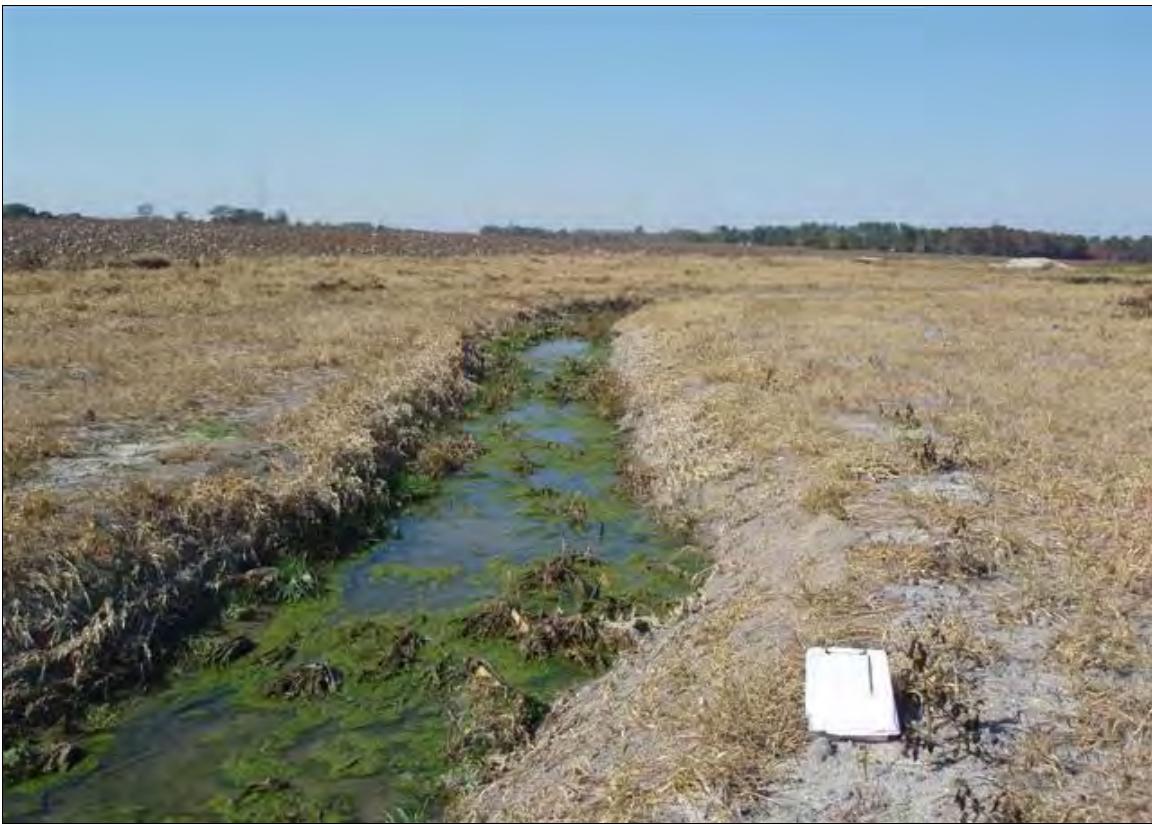
Photo Point S15: View looking upstream near Station 69+00. 11/7/07 – As-Built

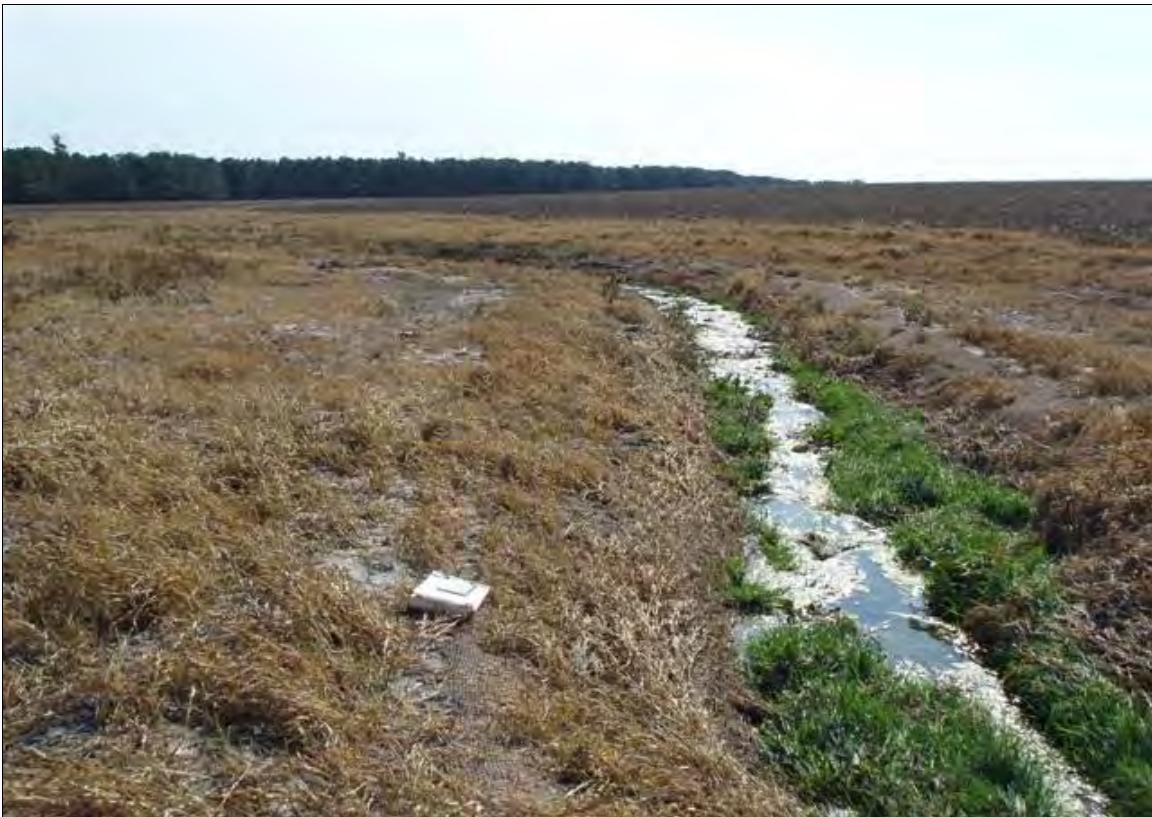
Photo Point S15: View looking downstream near Station 69+00. 11/7/07 – As-Built

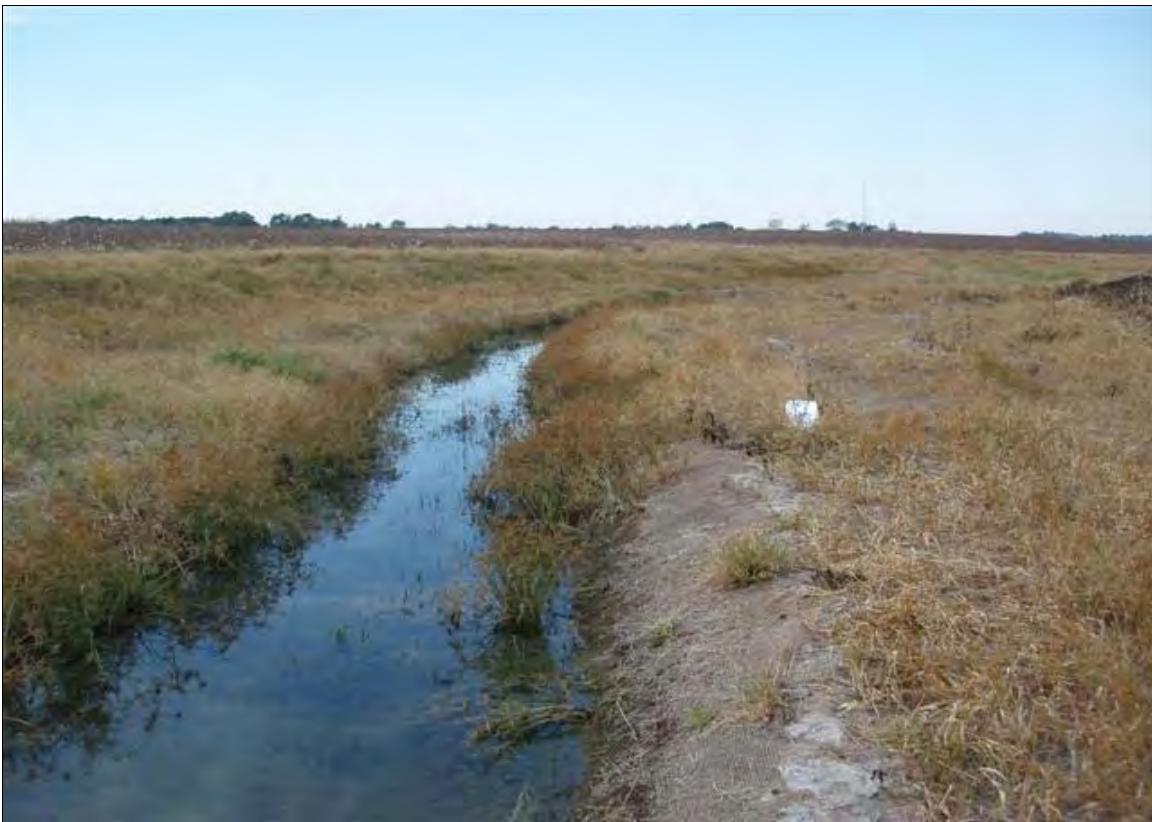
Photo Point S16: View looking upstream near Station 76+75. 11/7/07 – As-Built

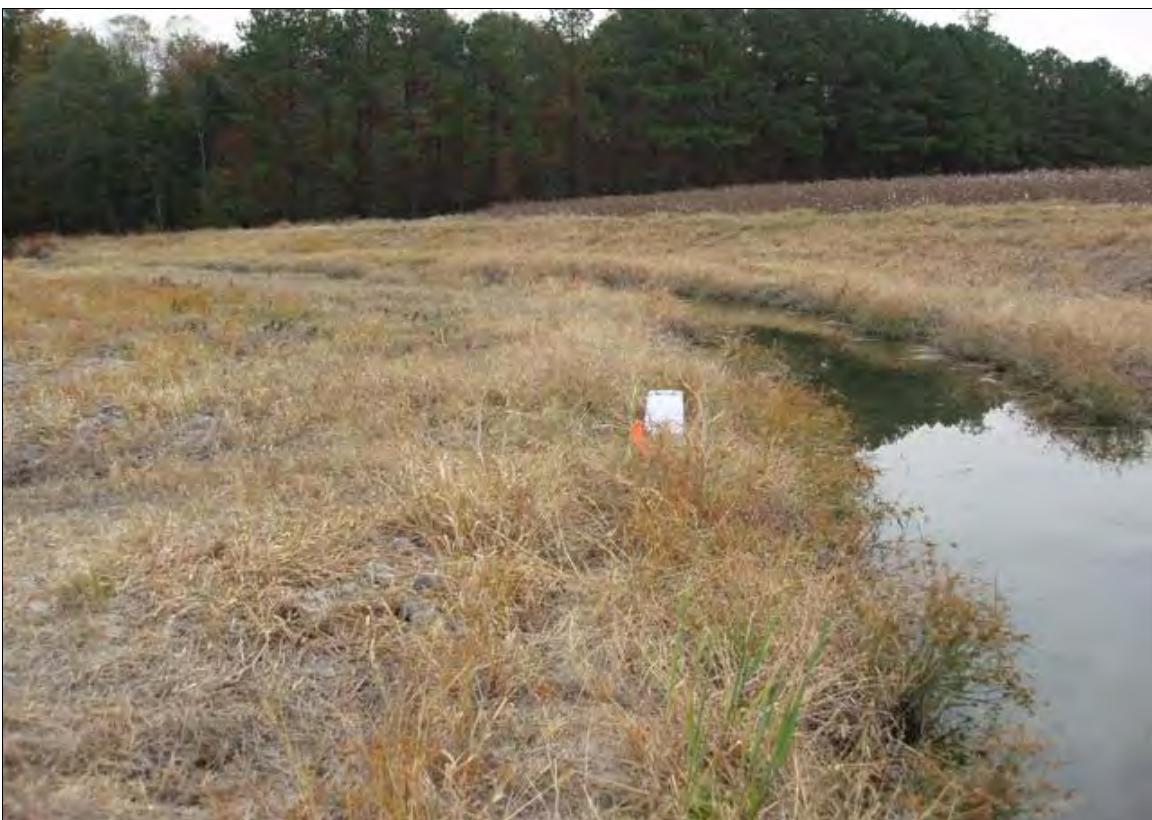
Photo Point S16B: View looking downstream toward project end before joining Swift Creek near Station 76+75. 11/7/07 – As-Built
