# AS-BUILT BASELINE MONITORING REPORT

## LITTLE PINE III STREAM AND WETLAND RESTORATION PROJECT

Alleghany County, NC
DEQ Contract D12010S
DMS Project Number 94903
DWR # 14-0041
USACE Action ID 2012-01299

## Wildlands Engineering, Inc.

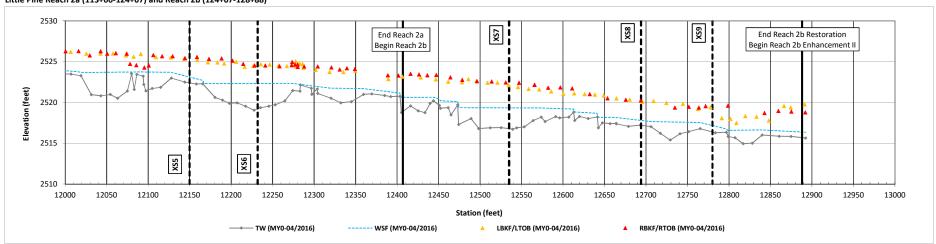
### Little Pine Reach 2a (113+66-124+07) and Reach 2b (124+07-128+88)

## **Longitudinal Profile Plots**

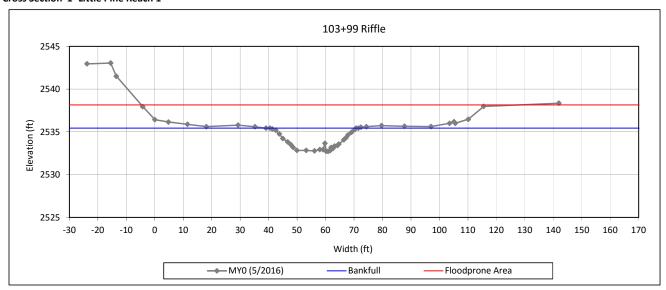
## Cross Section 1- Little Pine Reach 1

### **Bankfull Dimensions**

53.5	x-section	area	(ft.sq.)	
------	-----------	------	----------	--

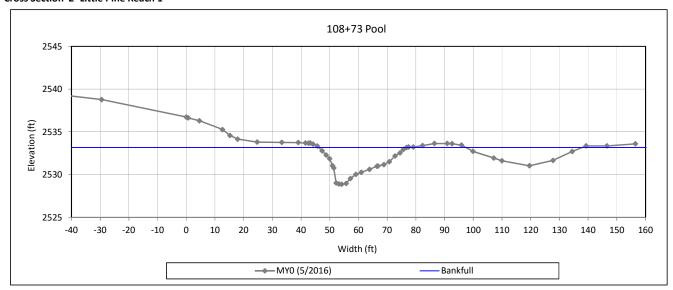
## Cross Section 2- Little Pine Reach 1

### **Bankfull Dimensions**

68.0 x-section area (ft.sq.)

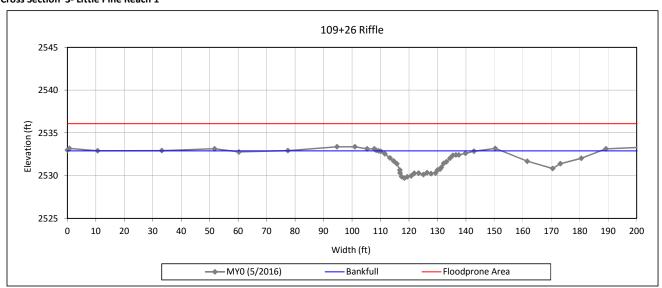
### Cross Section 3- Little Pine Reach 1

### **Bankfull Dimensions**

- 52.2 x-section area (ft.sq.)
- 33.5 width (ft)
- 1.6 mean depth (ft)
- 3.2 max depth (ft)
- 34.9 wetted perimeter (ft)
- 1.5 hydraulic radius (ft)
- 21.4 width-depth ratio
- >200 W flood prone area (ft)
- 6.0 entrenchment ratio
- 0.8 low bank height ratio
- Survey Date: 5/2016

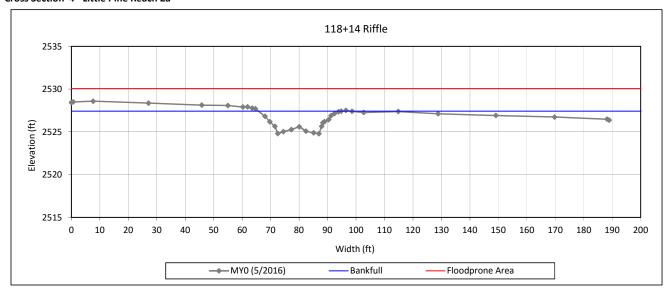
## Cross Section 4 - Little Pine Reach 2a

## **Bankfull Dimensions**

46.6	x-section area	(ft.sa.)

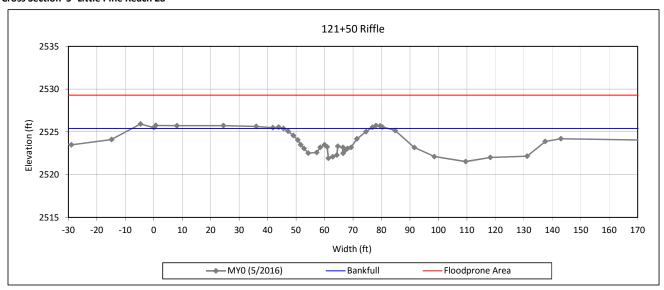
## Cross Section 5- Little Pine Reach 2a

### **Bankfull Dimensions**

56.9	x-section are	a (ft.sq.)	
------	---------------	------------	--

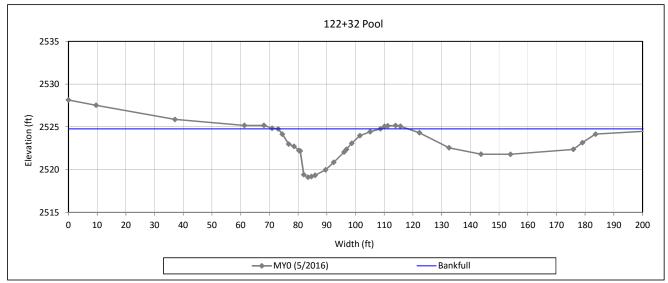
## Cross Section 6- Little Pine Reach 2a

### **Bankfull Dimensions**

93.4 x-section area (ft.sq.)

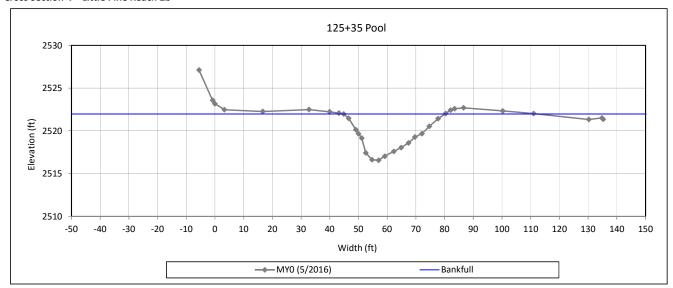
## Cross Section 7 - Little Pine Reach 2b

## **Bankfull Dimensions**

103.7 x-section area (ft.sq.)

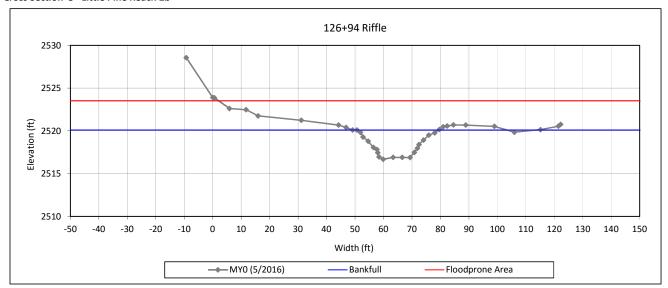
## Cross Section 8 - Little Pine Reach 2b

### **Bankfull Dimensions**

28.7	width (ft)
2.1	mean depth (ft)
3.4	max depth (ft)
30.1	wetted perimeter (ft)

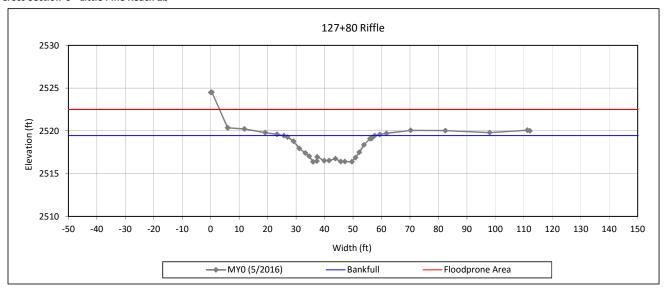
### Cross Section 9 - Little Pine Reach 2b

### **Bankfull Dimensions**

- 64.2 x-section area (ft.sq.)
- 31.9 width (ft)
- 2.0 mean depth (ft)
- 3.1 max depth (ft)
- 33.5 wetted perimeter (ft)
- 1.9 hydraulic radius (ft)
- 15.9 width-depth ratio
- >200 W flood prone area (ft)
- 6.3 entrenchment ratio
- 1.0 low bank height ratio
- Survey Date: 5/2016

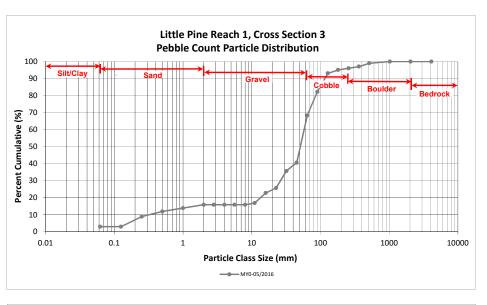
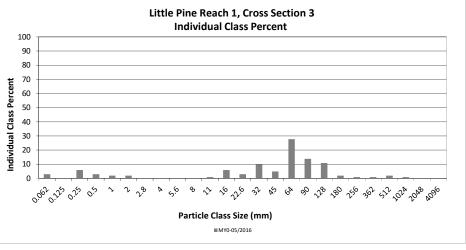
Cross Section 3						
Ch	Channel materials (mm)						
D <sub>16</sub> = 8.42							
D <sub>35</sub> =	31.28						
D <sub>50</sub> =	50.7						
D <sub>84</sub> =	95.5						
D <sub>95</sub> =	178.5						
D <sub>100</sub> =	1024.0

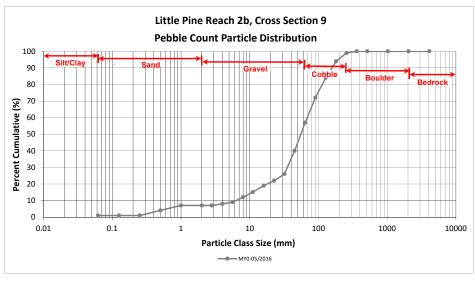
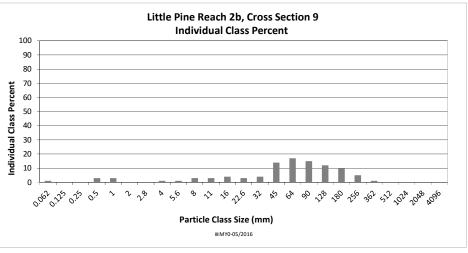
Cross Section 9				
Ch	annel materials (mm)				
D <sub>16</sub> = 12.08					
D <sub>35</sub> =	39.84				
D <sub>50</sub> =	55.4				
D <sub>84</sub> =	128.0				
D <sub>95</sub> =	193.1				
D <sub>100</sub> =	362.0

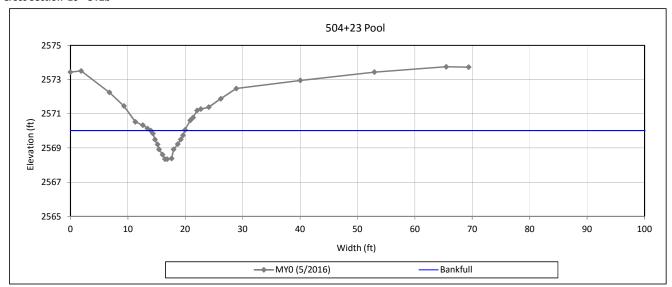
## Cross Section 10 - UT2b

### **Bankfull Dimensions**

- 5.7 x-section area (ft.sq.)
- 5.9 width (ft)
- 1.0 mean depth (ft)
- 1.7 max depth (ft)
- 7.1 wetted perimeter (ft)
- 0.8 hydraulic radius (ft)
- 6.1 width-depth ratio

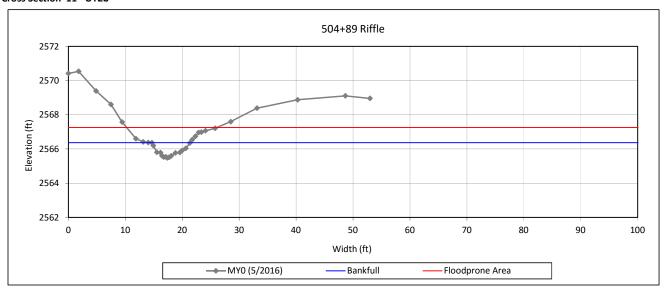
### Cross Section 11 - UT2b

### **Bankfull Dimensions**

- 3.7 x-section area (ft.sq.)
- 6.7 width (ft)
- 0.5 mean depth (ft)
- 0.9 max depth (ft)
- 7.1 wetted perimeter (ft)
- 0.5 hydraulic radius (ft)
- 12.2 width-depth ratio
- 15.9 W flood prone area (ft)
- 2.4 entrenchment ratio
- 1.0 low bank height ratio

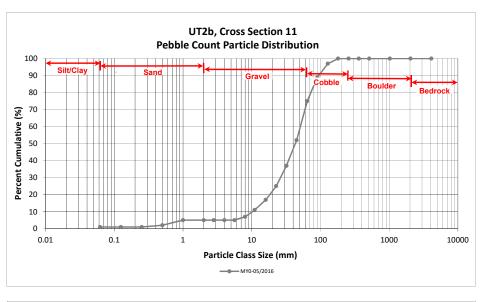
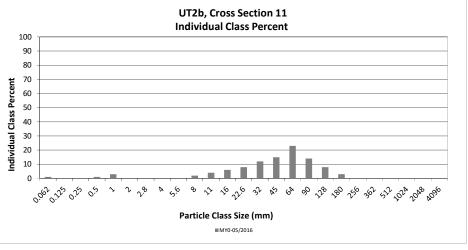
Cross Section 11				
Ch	annel materials (mm)			
D <sub>16</sub> = 15.03				
D <sub>35</sub> =	30.20			
D <sub>50</sub> =	43.0			
D <sub>84</sub> =	79.7			
D <sub>95</sub> = 117.2				
D <sub>100</sub> =	180.0

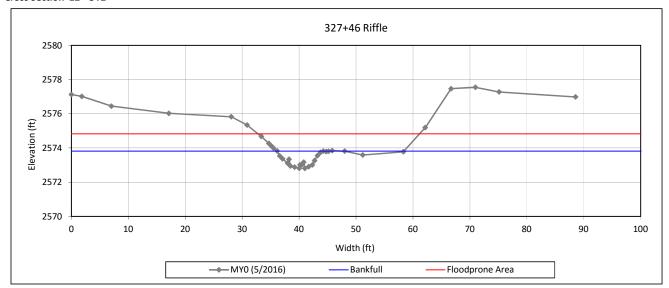
### Cross Section 12 - UT2

- 5.1 x-section area (ft.sq.)
- 8.1 width (ft)
- 0.6 mean depth (ft)
- 1.0 max depth (ft)
- 9.1 wetted perimeter (ft)
- 0.6 hydraulic radius (ft)
- 13.0 width-depth ratio
- 28.4 W flood prone area (ft)
- 3.5 entrenchment ratio
- 1.0 low bank height ratio
- Survey Date: 5/2016

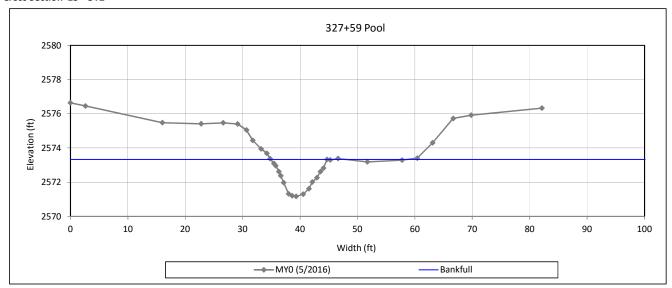
## Cross Section 13 - UT2

- 12.8 x-section area (ft.sq.)
- 9.8 width (ft)
- 1.3 mean depth (ft)
- 2.2 max depth (ft)
- 11.0 wetted perimeter (ft)
- 1.2 hydraulic radius (ft)
- 7.5 width-depth ratio

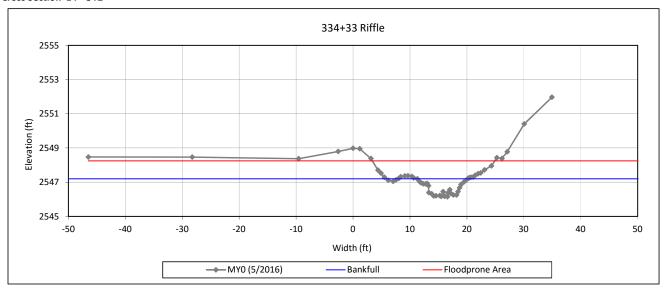
## Cross Section 14 - UT2

5.9	x-section area	(ft.sq.)	
-----	----------------	----------	--

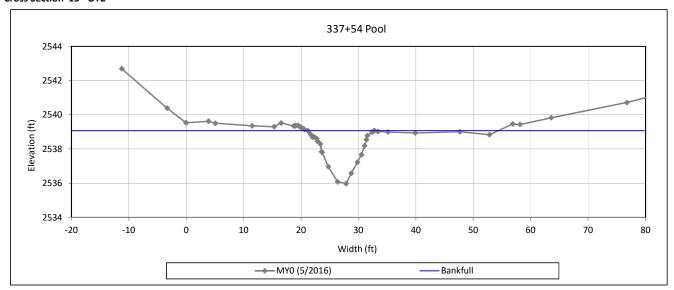
## Cross Section 15 - UT2

- 18.7 x-section area (ft.sq.)
- 12.2 width (ft)
- 1.5 mean depth (ft)
- 3.1 max depth (ft)
- 14.2 wetted perimeter (ft)
- 1.3 hydraulic radius (ft)
- 8.0 width-depth ratio

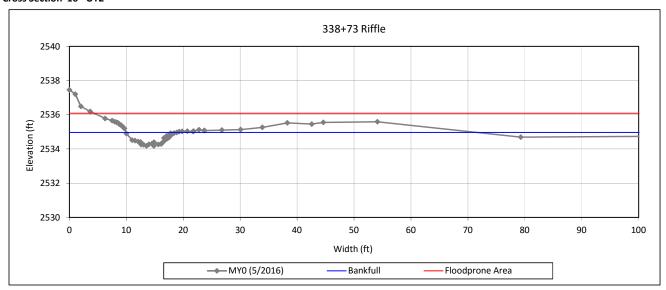
### Cross Section 16 - UT2

- x-section area (ft.sq.) 4.2
- 8.9 width (ft)
- 0.5 mean depth (ft)
- max depth (ft) 1.1
- 10.1 wetted perimeter (ft)
- hydraulic radius (ft) 0.4
- width-depth ratio 19.2
- >200 W flood prone area (ft)
- 22.4 entrenchment ratio
- low bank height ratio 1.0

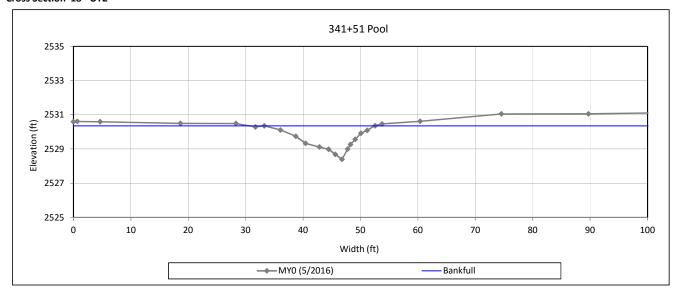
## Cross Section 18 - UT2

- 15.8 x-section area (ft.sq.)
- 19.3 width (ft)
- 0.8 mean depth (ft)
- 2.0 max depth (ft)
- 19.8 wetted perimeter (ft)
- 0.8 hydraulic radius (ft)
- 23.6 width-depth ratio

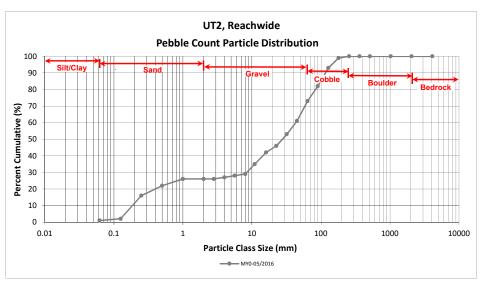
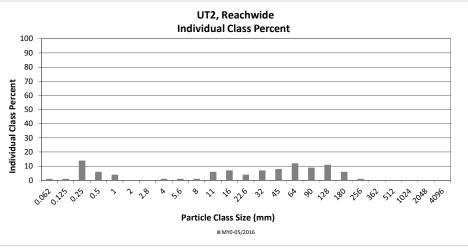
Reachwide					
Chann	Channel materials (mm)				
D <sub>16</sub> =	0.25				
D <sub>35</sub> =	11.00				
D <sub>50</sub> =	27.6				
D <sub>84</sub> =	96.0				
D <sub>95</sub> =	143.4				
D <sub>100</sub> =	256.0

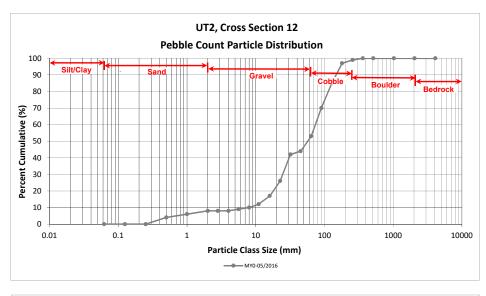
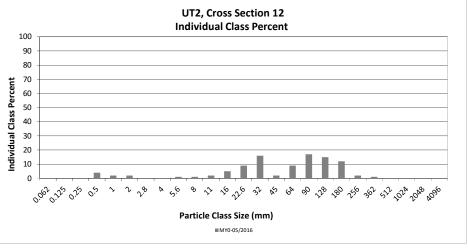
Cross Section 12					
Ch	Channel materials (mm)				
D <sub>16</sub> = 14.84					
D <sub>35</sub> =	27.48				
D <sub>50</sub> =	56.9				
D <sub>84</sub> =	125.0				
D <sub>95</sub> =	170.1				
D <sub>100</sub> =	362.0

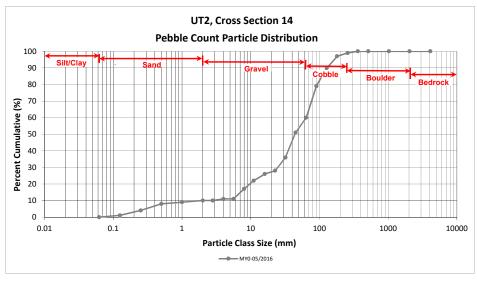
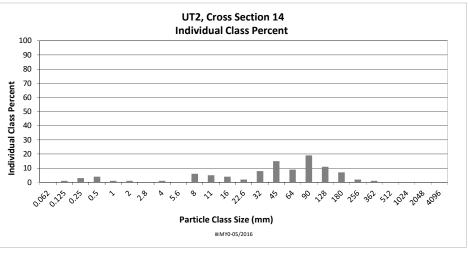
Cross Section 14				
Channel materials (mm)				
D <sub>16</sub> =	7.54			
D <sub>35</sub> =	30.64			
D <sub>50</sub> =	44.0			
D <sub>84</sub> =	105.6			
D <sub>95</sub> =	163.3			
D <sub>100</sub> =	362.0

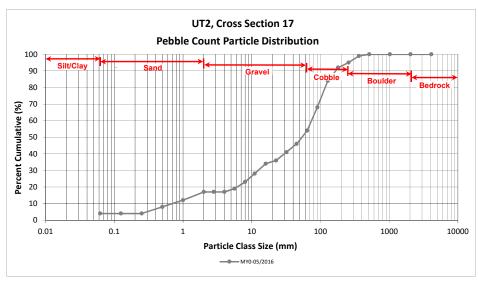
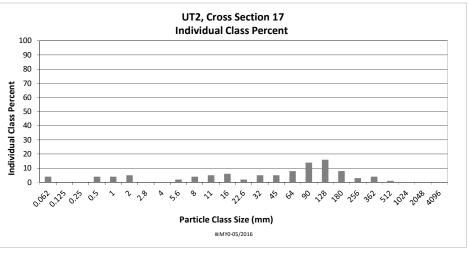
Cross Section 17					
Channel materials (mm)					
D <sub>16</sub> =	1.74				
D <sub>35</sub> =	19.02				
D <sub>50</sub> =	53.7				
D <sub>84</sub> =	128.0				
D <sub>95</sub> =	256.0				
D <sub>100</sub> =	512.0

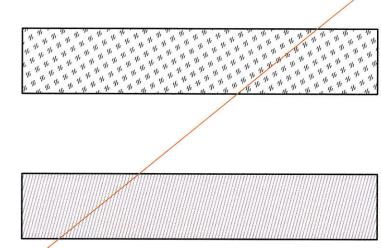
Live St.	akes and Herbacou	s Plugs			
Species	Common Name	Max. Spacing	Indiv. Spacing	Min. Size	Stratum	# Plants
Cornus amomum	Silky Dogwood	3 ft	3ft	0.5"-1.0" cal.		25%
Salix nigra	Black Willow	3 ft	3ft	0.5"-1.0" cal.		15%
Salix sericea	Silky Willow	3 ft	3ft	0.5"-1.0" cal.		50%
Sambucus nigra ssp canadensis	Elderberry	3 ft	3ft	0.5"-1.0" cal.		10%
Juncus effusus	Common Rush	5 ft	5ft	1"-2" plug		See Specs
