Little Troublesome Stream Restoration Site Rockingham County, North Carolina

Stream Restoration Plan

North Carolina Ecosystem Enhancement Program

FINAL June 2007

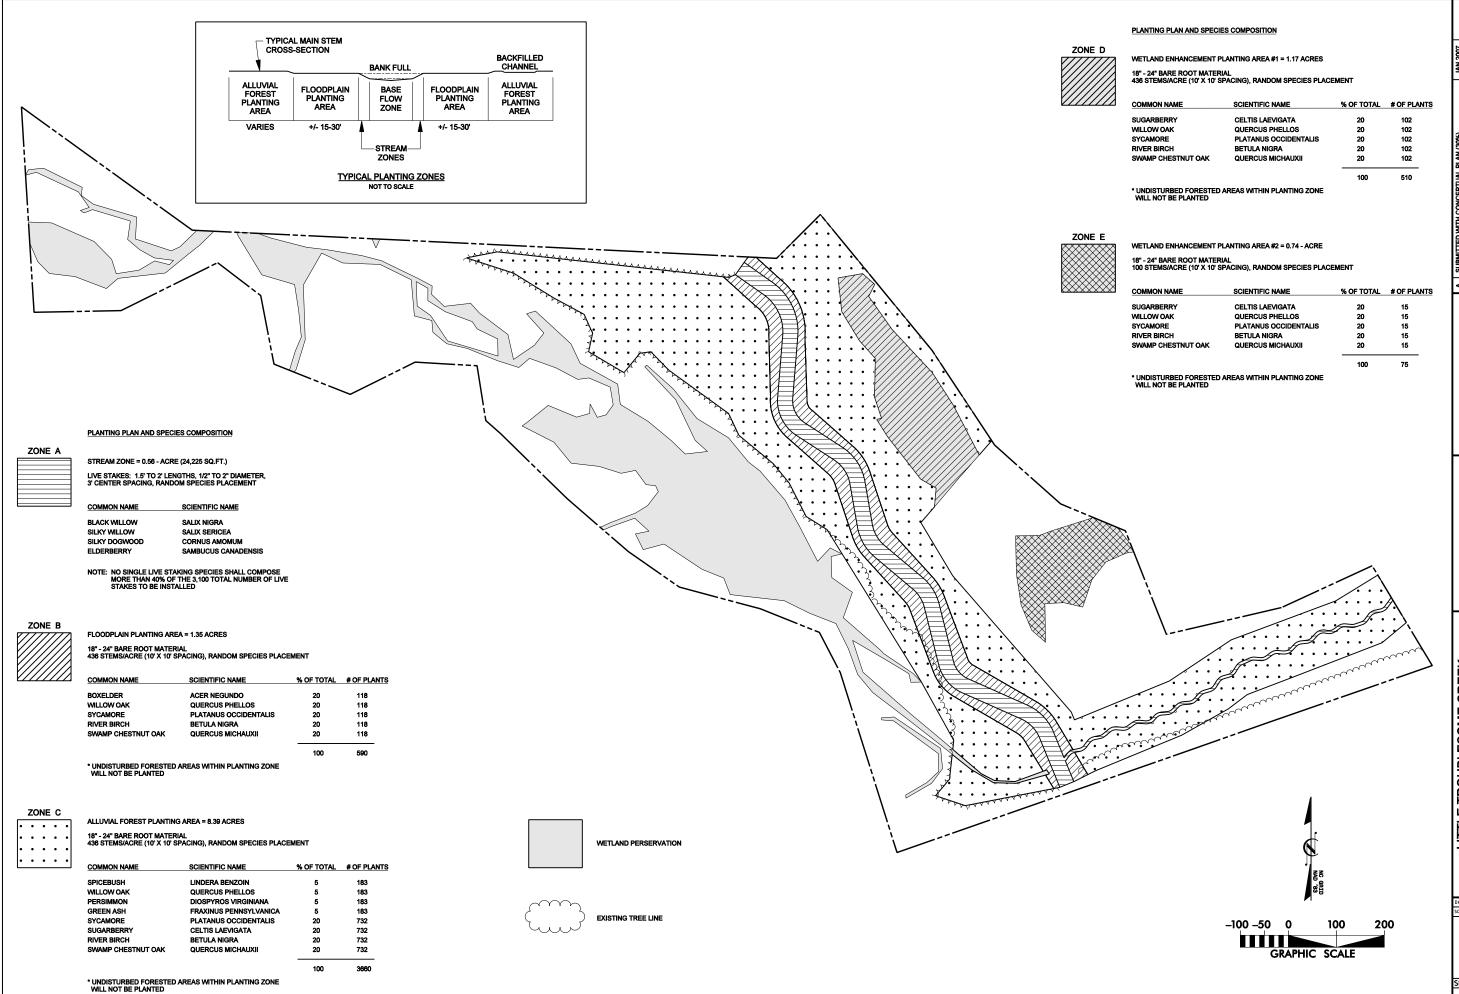
ION NAME	SCIENTIFIC NAME	% OF TOTAL	# OF PLANTS
RBERRY	CELTIS LAEVIGATA	20	102
WOAK	QUERCUS PHELLOS	20	102
MORE	PLATANUS OCCIDENTALIS	20	102
BIRCH	BETULA NIGRA	20	102
IP CHESTNUT OAK	QUERCUS MICHAUXII	20	102
		100	510

ION NAME	SCIENTIFIC NAME	% OF TOTAL	# OF PLANTS
RBERRY	CELTIS LAEVIGATA	20	15
W OAK	QUERCUS PHELLOS	20	15
MORE	PLATANUS OCCIDENTALIS	20	15
BIRCH	BETULA NIGRA	20	15
IP CHESTNUT OAK	QUERCUS MICHAUXII	20	15
		100	75

Five planting zones will be incorporated into the planting plan. Zone A is classified as a Stream Zone Area, which consists of the LTC and UT1 stream banks. Zone B is classified as a Floodplain Planting Area, which consist of the LTC floodplain and will be planted with higher moisture species. Zone C is classified as an Alluvial Forest Area, which consists of the existing Alluvial Forest Area adjacent to LTC and UT1. Zone D and E are classified as Wetland Enhancement Planting Areas with Zone D containing 456 stems/acre whereas Zone E contains 100 stems/acre. Plan Sheet 10 illustrates the five zones that will be used to target the riparian vegetation planting.

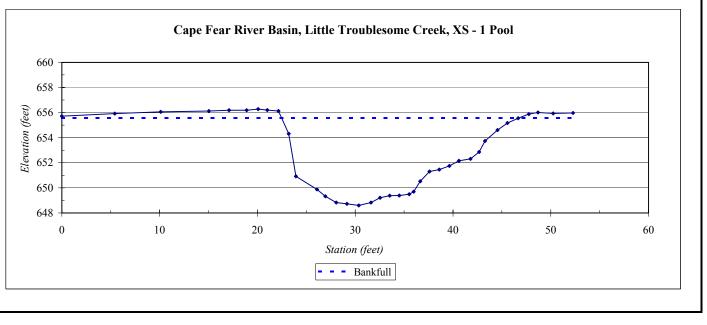
Cape Fear
Little Troublesome Creek
XS - 1 Pool
12.1
9/27/2006
A. Helms, A. French

SUMMARY DATA	
Bankfull Elevation:	655.6
Bankfull Cross-Sectional Area:	107.9
Bankfull Width:	24.3
Flood Prone Area Elevation:	-
Flood Prone Width:	-
Max Depth at Bankfull:	6.9
Mean Depth at Bankfull:	4.4
W / D Ratio:	-
Entrenchment Ratio:	-
Bank Height Ratio:	-
Water Surface Slope (ft/ft):	0.002

Date:	
Field Crew:	
Station	Elevation
0.0	655.72
5.4	655.92
10.1	656.06
15.0	656.13
17.1	656.19
18.9	656.19
20.1	656.27
21.0	656.20
22.1	656.13
23.2	654.31
23.9	650.91
26.1	649.88
27.0	649.33
28.1	648.83
29.2	648.73
30.4	648.60
31.6	648.82
32.5	649.21
33.5	649.38
34.5	649.39
35.5	649.49
36.0	649.69
36.6	650.52
37.6	651.31
38.6	651.45 651.74
39.6	
40.6	652.16
41.8	652.31
42.7	652.86
43.3	653.74
44.6	654.61
45.6	655.17
46.7	655.55
47.8	655.88
48.7	656.01
50.3	655.94
52.3	655.97

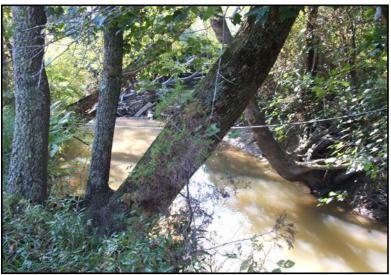
River Basin:		Cape Fear	
Watershed:		Little Troublesome Creek	
XS ID		XS - 4 Riffle	
Drainage Ar	ea (sq mi):	12.1	
Date:		9/27/2006	
Field Crew:		A. Helms, A. French	
Station	Elevation	SUMMARY DATA

0.0	655.05	Bankfull Elevation:	654.3
2.8	655.22	Bankfull Cross-Sectional Area:	106.1
6.9	655.32	Bankfull Width:	22.3
11.9	655.37	Flood Prone Area Elevation:	660.5

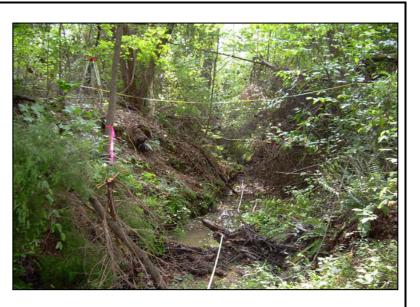
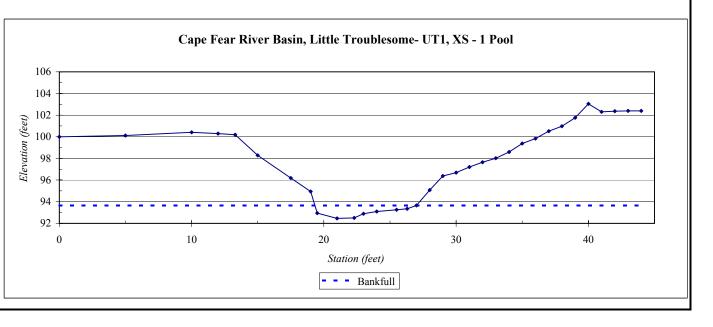
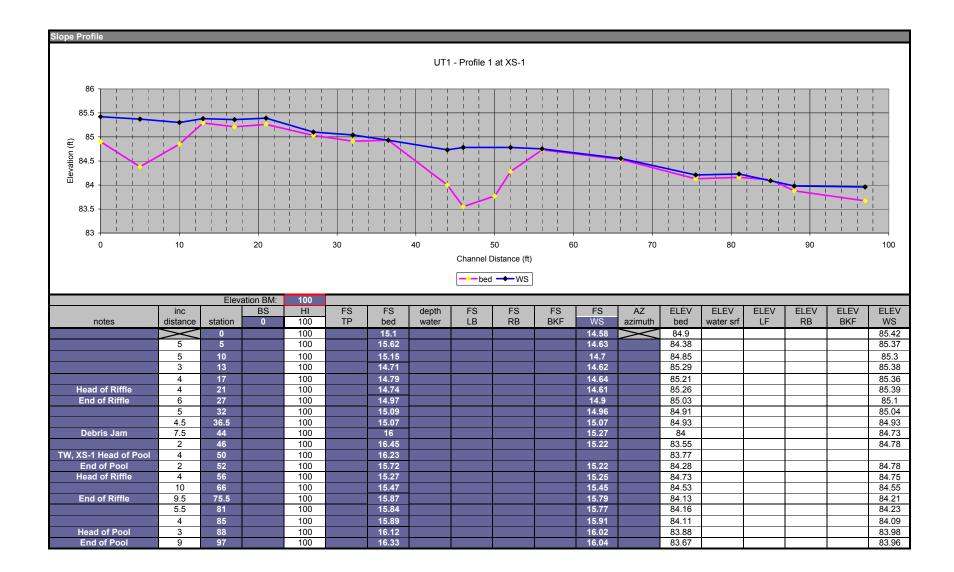
Elevation	SUMMARY DATA	
100.00	Bankfull Elevation:	93.7
100.11	Bankfull Cross-Sectional Area:	5.5
100.41	Bankfull Width:	7.7
100.29	Flood Prone Area Elevation:	-
100.19	Flood Prone Width:	-
98.29	Max Depth at Bankfull:	1.2
96.18	Mean Depth at Bankfull:	0.7
94.94	W / D Ratio:	-
92.94	Entrenchment Ratio:	-
92.46	Bank Height Ratio:	-
92.51	Water Surface Slope (ft/ft):	0.019

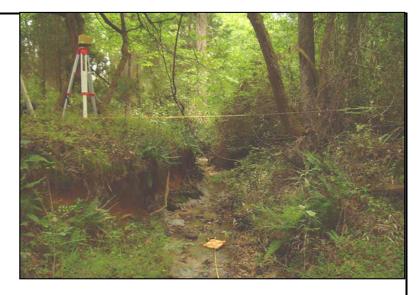
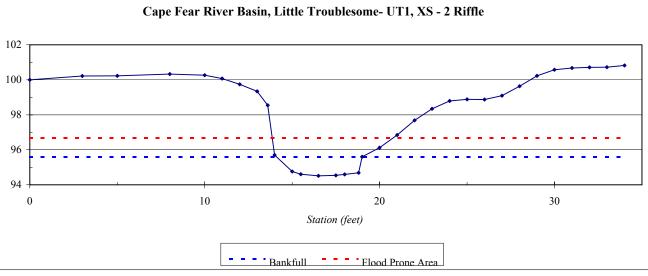
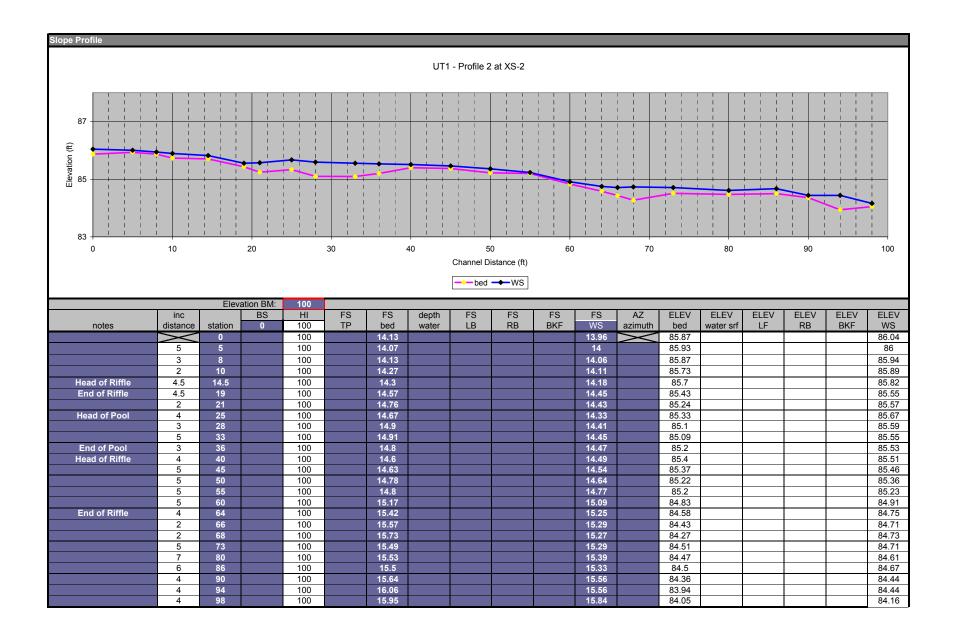
River Basin:			Cape Fear				
Watershed:			Little Troublesome- UT1				
XS ID			XS - 2 Riffle				
Drainage Ar	ea (sq mi):		0.1				
Date:			9/19/2006				
Field Crew:			A. Helms, B. Hayes				
Station	Rod Ht.	Elevation	SUMMARY DATA				
0	5.68	100.00	Bankfull Elevation:	95.6			
3	5.46	100.22	Bankfull Cross-Sectional Area:	4.3			
5	5.45	100.23	Bankfull Width:	4.9			
8	5.35	100.33	Flood Prone Area Elevation:	96.7			
10	5.42	100.26	Flood Prone Width:	7.0			
11	5.61	100.07	Max Depth at Bankfull:	1.1			
12	5.94	99.74	Mean Depth at Bankfull:	0.9			
13	6.34	99.34	W / D Ratio:	5.6

13.6	7.14	98.54	Entrenchment Ratio:	1.4			
14	9.98	95.70	Bank Height Ratio:	5.3			
15	10.92	94.76	Water Surface Slope (ft/ft):	0.019			
15.5	11.08	94.60

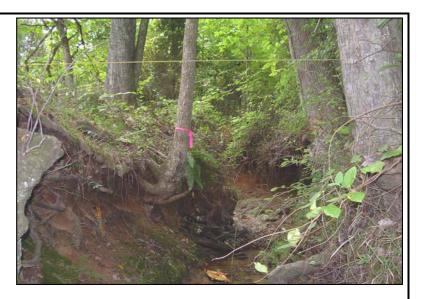
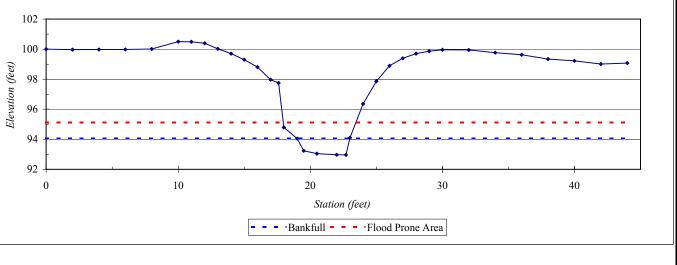
River Basin:	Cape Fear	
Watershed:	Little Troublesome- UT1	
XS ID	XS - 4 Riffle	
Drainage Area (sq mi):	0.1	
Date:	9/19/2006	
Field Crew:	A. Helms, B. Hayes

SUMMARY DATA	
Bankfull Elevation:	94.0
Bankfull Cross-Sectional Area:	3.6
Bankfull Width:	4.0
Flood Prone Area Elevation:	95.1
Flood Prone Width:	6.0
Max Depth at Bankfull:	1.1
Mean Depth at Bankfull:	0.9
W / D Ratio:	4.4
Entrenchment Ratio:	1.5
Bank Height Ratio:	6.5
Water Surface Slope (ft/ft):	0.019

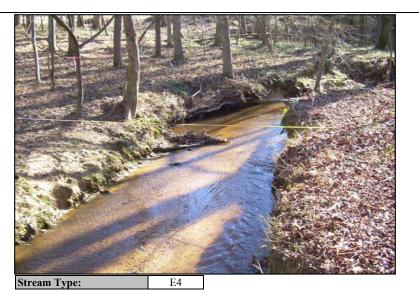
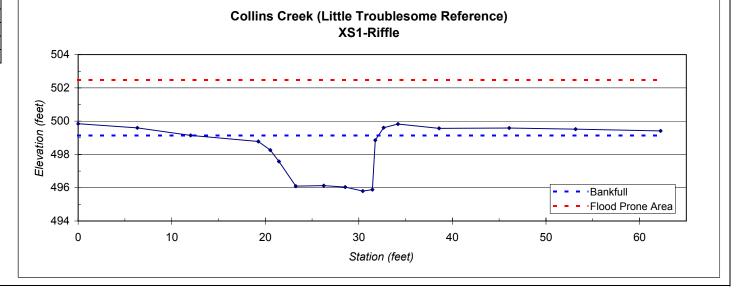
Station	Elevation
0.0	499.84
6.3	499.59
12.0	499.14
19.3	498.78
20.5	498.26
21.5	497.58
23.3	496.09
26.2	496.12
28.5	496.04
30.4	495.80
31.4	495.89
31.8	498.85
32.6	499.61
34.2	499.83
38.6	499.57
46.1	499.59
53.2	499.52
62.2	499.41

Bankfull Elevation:	499.14
Bankfull Cross-Sectional Area:	33.4
Bankfull Width:	20.1
Flood Prone Area Elevation:	502.48
Flood Prone Width:	>60
Max Depth at Bankfull:	3.34
Mean Depth at Bankfull:	1.66
W / D Ratio:	12.1
Entrenchment Ratio:	3.0
Bank Height Ratio:	0.89
Slope (ft/ft):	0.003
Discharge (cfs)	114

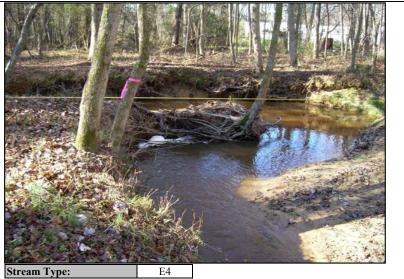
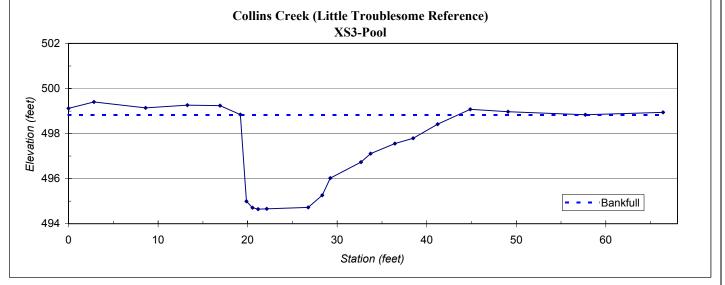
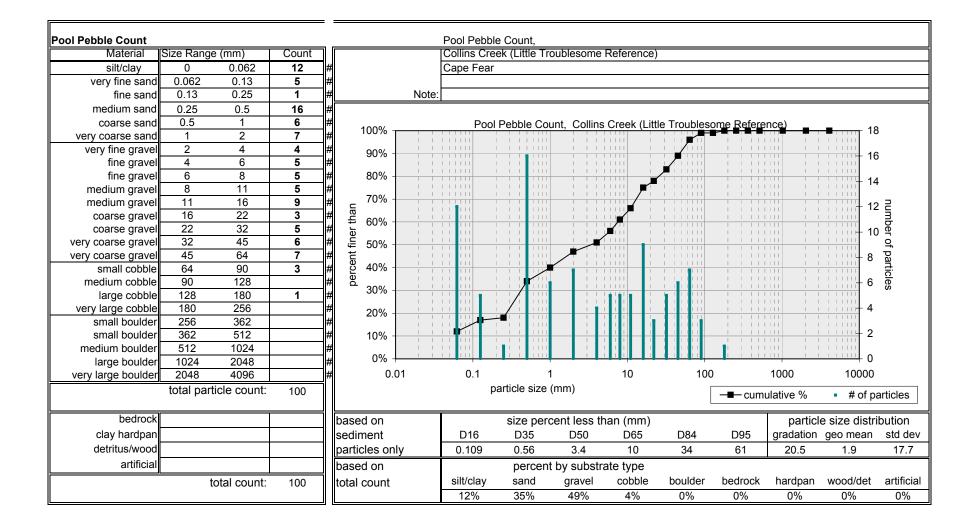
River Basin:	Cape Fear
Watershed:	Collins Creek (L:ittle Troublesome Ref
XS ID	XS3 Pool
Drainage Area (sq mi):	
Date:	12/27/2006
Field Crew:	A. Helms, A. Spiller, B. Roberts

SUMMARY DATA	
Bankfull Elevation:	498.83
Bankfull Cross-Sectional Area:	57.9
Bankfull Width:	24.3
Flood Prone Area Elevation:	-
Flood Prone Width:	-
Max Depth at Bankfull:	4.19
Mean Depth at Bankfull:	2.4
W / D Ratio:	-
Entrenchment Ratio:	-
Bank Height Ratio:	-
Slope (ft/ft):	0.003
Discharge (cfs)

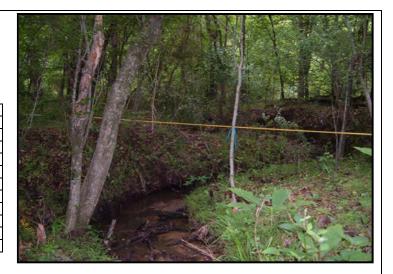
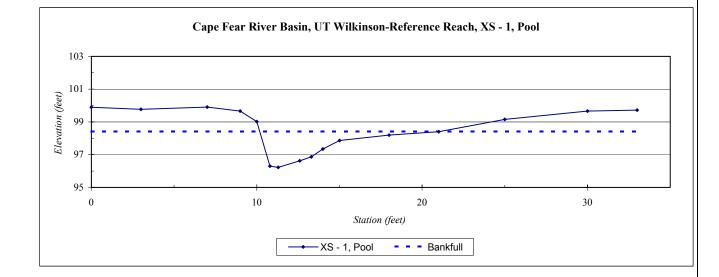
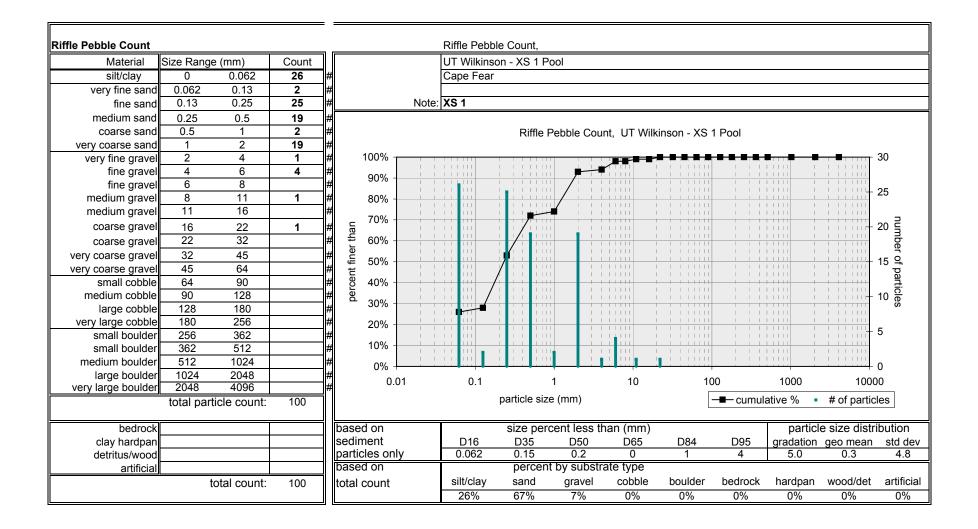
Station	Elevation
0	99.89
3	99.77
7	99.90
9	99.66
10	99.01
10.8	96.30
11.3	96.22
12.6	96.62
13.3	96.87
14	97.34
15	97.86
18	98.19
21	98.40
25	99.15
30	99.66
33	99.72

SUMMARY DATA	
Bankfull Elevation:	98.4
Bankfull Cross-Sectional Area:	8.6
Bankfull Width:	10.8
Flood Prone Area Elevation:	-
Flood Prone Width:	-
Max Depth at Bankfull:	2.2
Mean Depth at Bankfull:	0.8
W / D Ratio:	-
Entrenchment Ratio:	-
Bank Height Ratio:	-
Water Surface Slope (ft/ft):	0.018

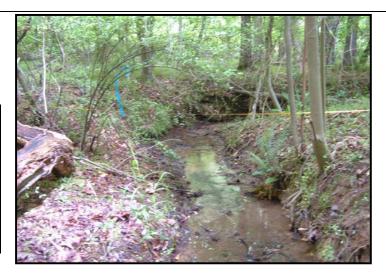
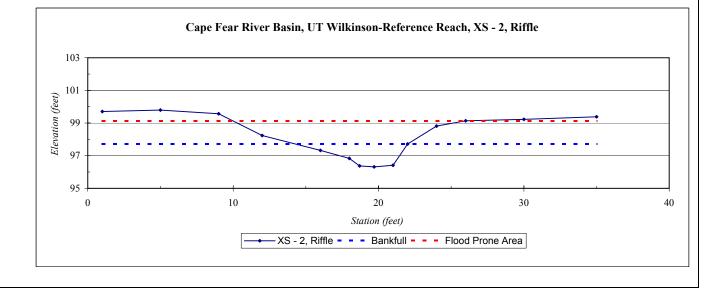
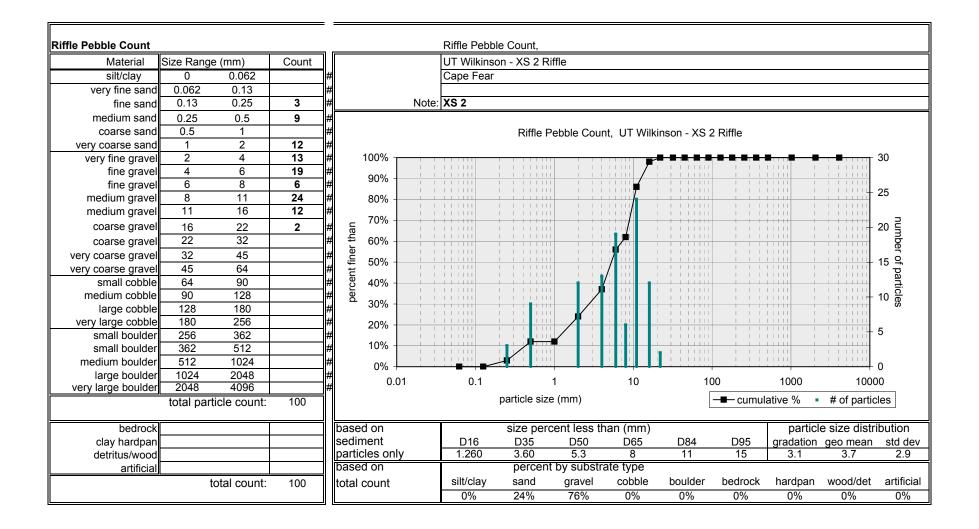
River Basin:	Cape Fear
Watershed:	UT Wilkinson-Reference Reach
XS ID	XS - 2, Riffle
Drainage Area (sq mi):	0.145
Date:	5/9/2006
Field Crew:	A. Helms, A. French

Station	Elevation
1	99.70
5	99.80
9	99.57
12	98.23
16	97.33
18	96.84
18.7	96.37
19.7	96.32
21	96.41
22	97.72
24	98.81
26	99.13
30	99.22
35	99.38

SUMMARY DATA	
Bankfull Elevation:	97.7
Bankfull Cross-Sectional Area:	6.2
Bankfull Width:	7.7
Flood Prone Area Elevation:	99.1
Flood Prone Width:	16.0
Max Depth at Bankfull:	1.4
Mean Depth at Bankfull:	0.8
W / D Ratio:	9.6
Entrenchment Ratio:	2.1
Bank Height Ratio:	2.0
Water Surface Slope (ft/ft):	0.018

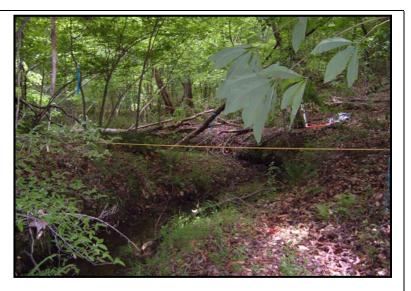
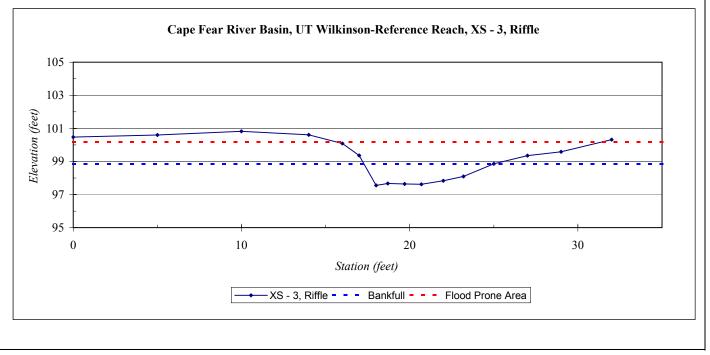
River Basin:	Cape Fear
Watershed:	UT Wilkinson-Reference Reach
XS ID	XS - 3, Riffle
Drainage Area (sq mi):	0.145
Date:	5/9/2006
Field Crew:	A. Helms, A. French

Station	Elevation
0	100.47
5	100.60
10	100.82
14	100.61
16	100.09
17	99.36
18	97.56
18.7	97.67
19.7	97.64
20.7	97.63
22	97.83
23.2	98.10
25	98.86
27	99.35
29	99.59
32	100.32
35	100.97
39	101.20

SUMMARY DATA	
Bankfull Elevation:	98.9
Bankfull Cross-Sectional Area:	7.0
Bankfull Width:	7.7
Flood Prone Area Elevation:	100.2
Flood Prone Width:	16.0
Max Depth at Bankfull:	1.3
Mean Depth at Bankfull:	0.9
W / D Ratio:	8.5
Entrenchment Ratio:	2.1
Bank Height Ratio:	2.3
Water Surface Slope (ft/ft):	0.018

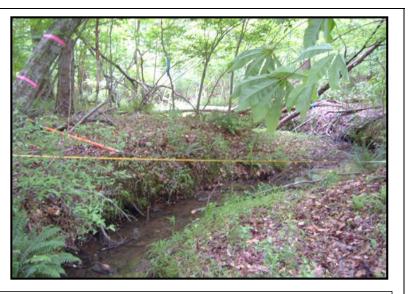
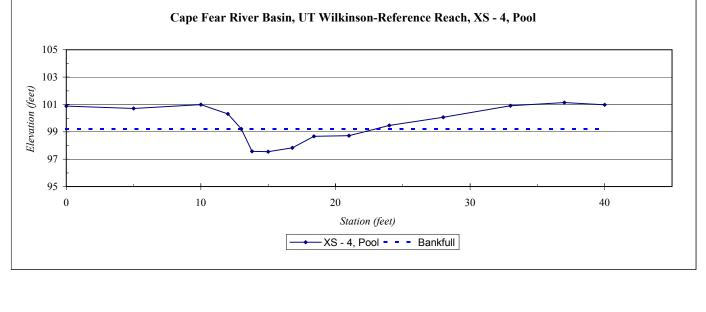
Station	Elevation
0	100.88
5	100.71
10	100.98
12	100.31
13	99.22
13.8	97.58
15	97.55
16.8	97.84
18.4	98.67
21	98.72
24	99.47
28	100.07
33	100.90
37	101.15
40	100.98

SUMMARY DATA	
Bankfull Elevation:	99.2
Bankfull Cross-Sectional Area:	8.8
Bankfull Width:	10.0
Flood Prone Area Elevation:	-
Flood Prone Width:	-
Max Depth at Bankfull:	1.7
Mean Depth at Bankfull:	0.9
W / D Ratio:	-
Entrenchment Ratio:	-
Bank Height Ratio:	-
Water Surface Slope (ft/ft):	0.018

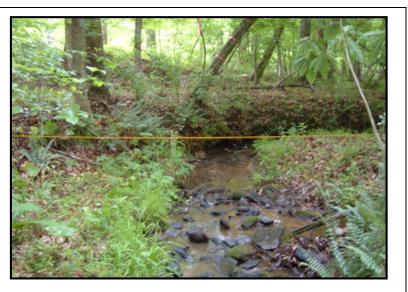
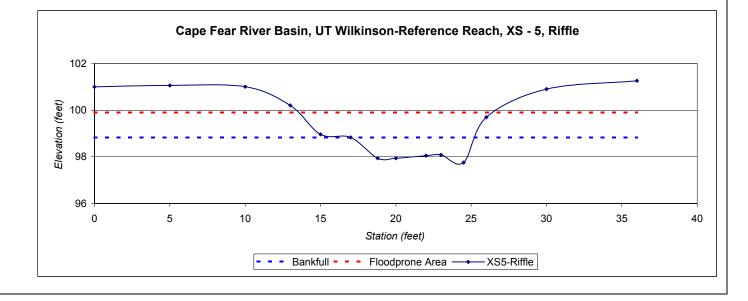
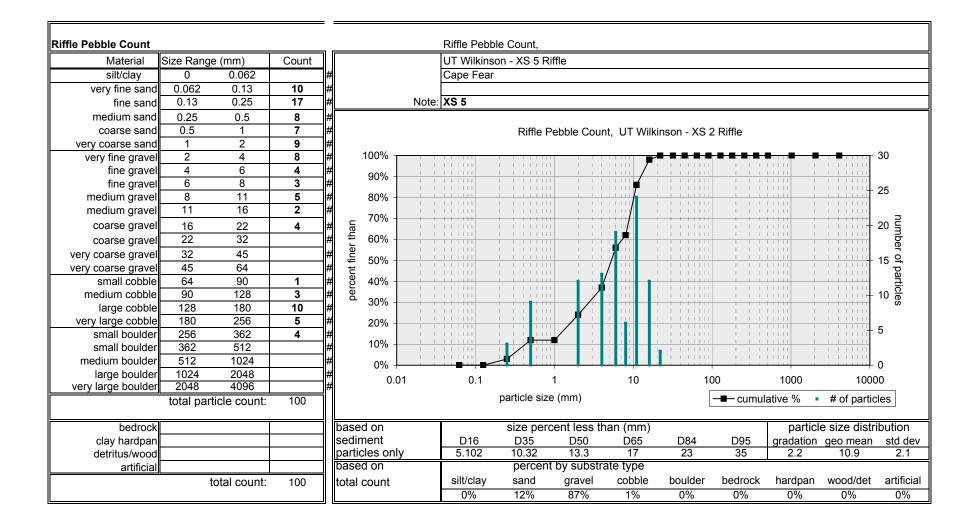
River Basin:	Cape Fear
Watershed:	UT Wilkinson-Reference Reach
XS ID	XS - 5, Riffle
Drainage Area (sq mi):	0.145
Date:	5/9/2006
Field Crew:	A. Helms, A. French

Station	Elevation
0.00	101.00
5.00	101.06
10.00	101.01
13.00	100.20
15.00	98.96
17.00	98.83
18.80	97.94
20.00	97.94
22.00	98.05
23.00	98.08
24.50	97.75
26.00	99.70
30.00	100.90
36.00	101.26

SUMMARY DATA	
Bankfull Elevation:	98.8
Bankfull Cross-Sectional Area:	6.1
Bankfull Width:	8.3
Flood Prone Area Elevation:	99.9
Flood Prone Width:	13.0
Max Depth at Bankfull:	1.1
Mean Depth at Bankfull:	0.7
W / D Ratio:	11.4
Entrenchment Ratio:	1.6
Bank Height Ratio:	2.7
Water Surface Slope (ft/ft):	0.018
