FINAL AS-BUILT BASELINE MONITORING REPORT MARTIN'S CREEK II MITIGATION PROJECT

Cherokee County, North Carolina EEP Project No. 92633 (Contract No. 005717) USACE Action ID No. SAW – 2009-00209/DWR Project No. 10-0952 SCO No. 08-07251-01

Axiom Environmental, Inc. 218 Snow Avenue Raleigh, North Carolina 27603

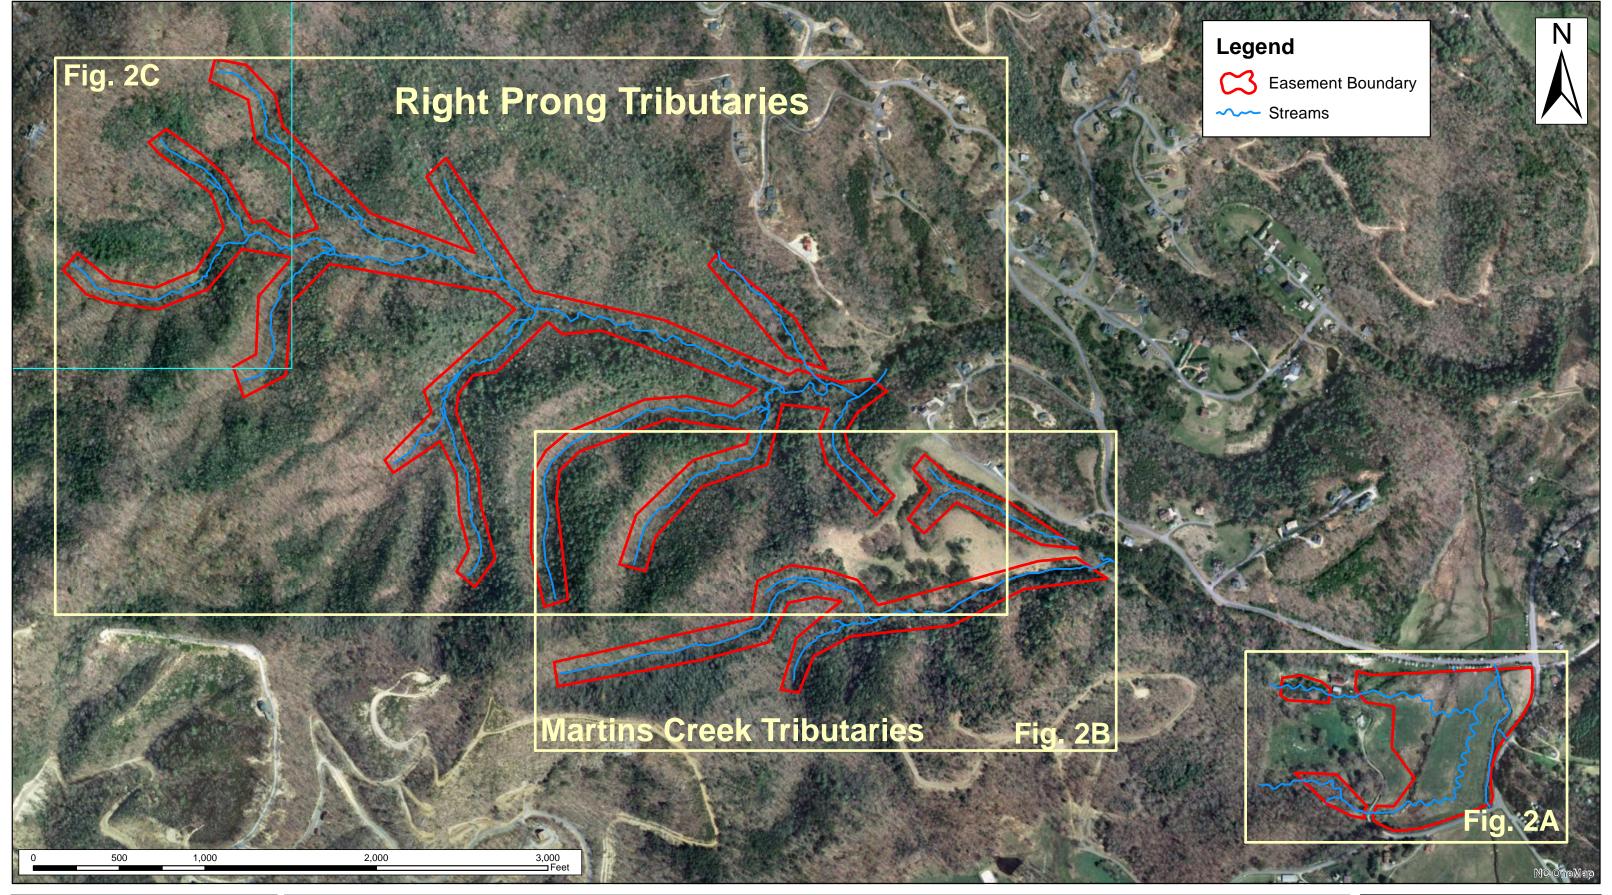
Dwn. by.	FICLIBE
KRJ	FIGURE
Date:	_
May 2014	2
Project:	
12-004.16

CURRENT CONDITIONS PLAN VIEW
MARTINS CREEK II
EEP PROJECT # 92633
Cherokee County, North Carolina

Monitoring of the Site's restoration efforts will be performed until agreed upon success criteria are fulfilled. Monitoring is proposed for the stream channel, riparian vegetation, and hydrology for a period of five years (Figures 2 & 2A-2C, Appendix A). Monitoring reports of collected data will be submitted no later than December of each monitoring year.

A total of 19 permanent cross-sections, 12 riffle and 7 pool, were established and will be used to evaluate stream dimension; locations are depicted on Figures 2, 2A, and 2B (Appendix B) Because riffle cross-sections are critical in determining bankfull design parameters, the number of riffle cross-sections established will generally outnumber pool cross-sections. Each cross-section will be marked on both banks with permanent pins to establish the exact transect used. A common benchmark will be used for cross-sections and consistently used to facilitate easy comparison of year-to-year data. The annual cross-section survey will include points measured at all breaks in slope, including top of bank, bankfull, inner berm, edge of water, and thalweg, if the features are present. Riffle cross sections will be classified using the Rosgen Stream Classification System.

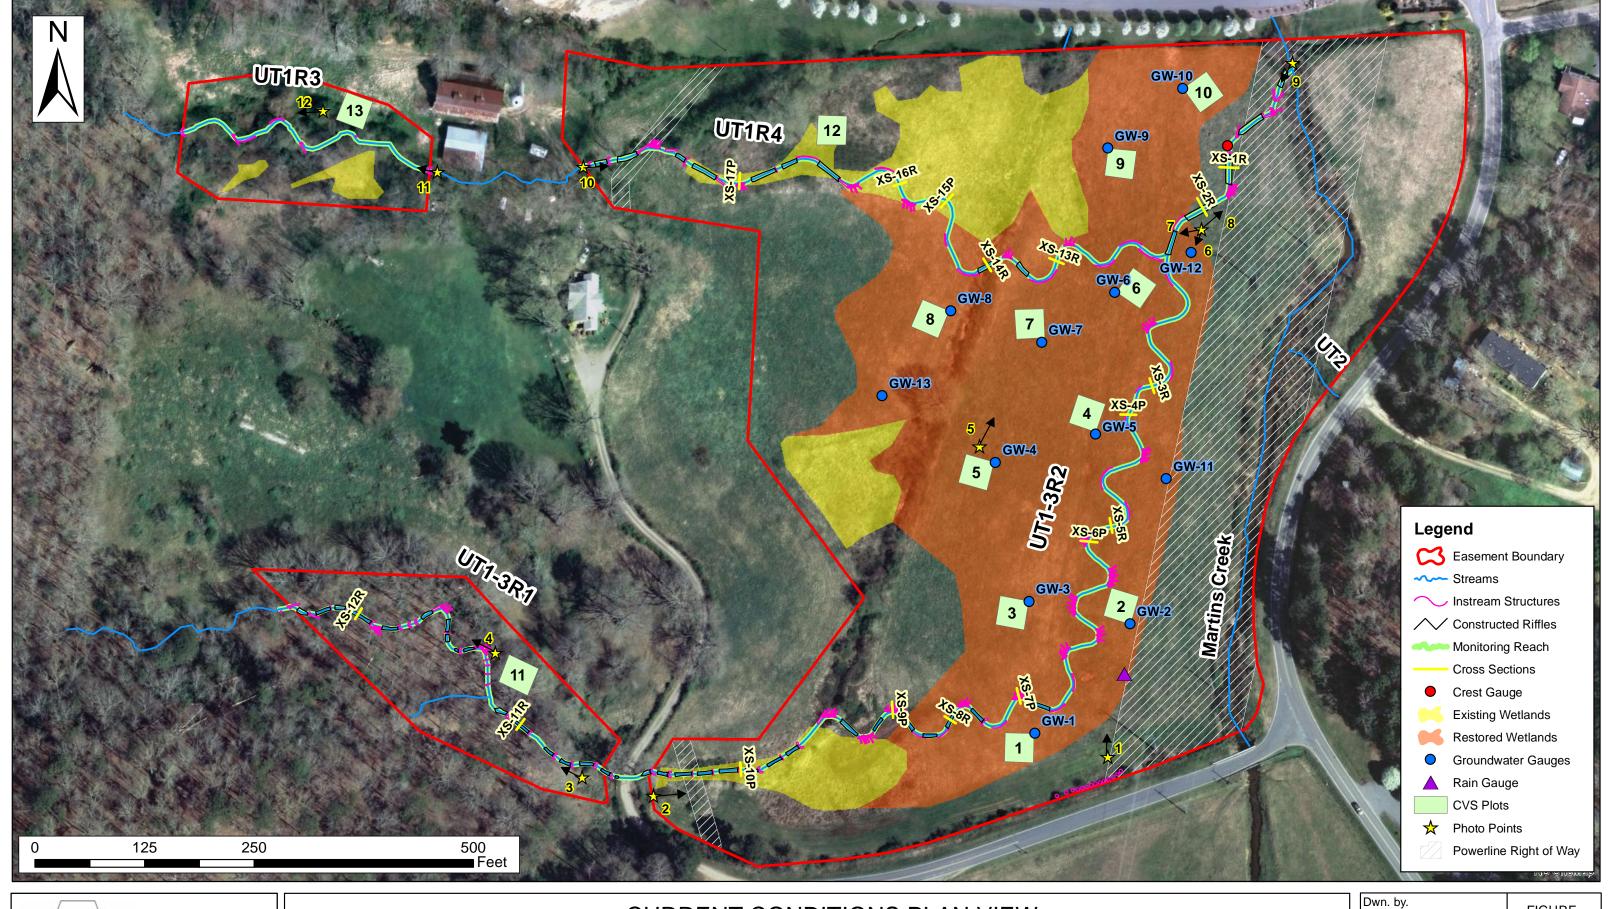
A

CURRENT CONDITIONS PLAN VIEW
MARTINS CREEK II
EEP PROJECT # 92633
Cherokee County, North Carolina

The occurrence of bankfull events within the monitoring period will be documented by the use of a crest gauge and photographs. One crest gauge was installed to record the highest watermark between site visits; the gauge will be checked each Site visit to determine if a bankfull event has occurred (Figure 2A, Appendix B). Photographs will be used to document the occurrence of debris lines and sediment deposition on the floodplain during monitoring site visits.

Thirteen groundwater monitoring gauges were installed within Site wetland restoration areas to monitor groundwater hydrology (Figure 2A, Appendix A). Hydrological sampling will continue for five years throughout the growing season at intervals necessary to satisfy hydrology success criteria. In addition, an on-site rain gauge will document rainfall data for comparison of groundwater conditions with extended drought conditions. Finally, groundwater gauges located within riverine wetlands adjacent to restored stream reaches will supplement crest gauge measurements to confirm overbank flooding events.

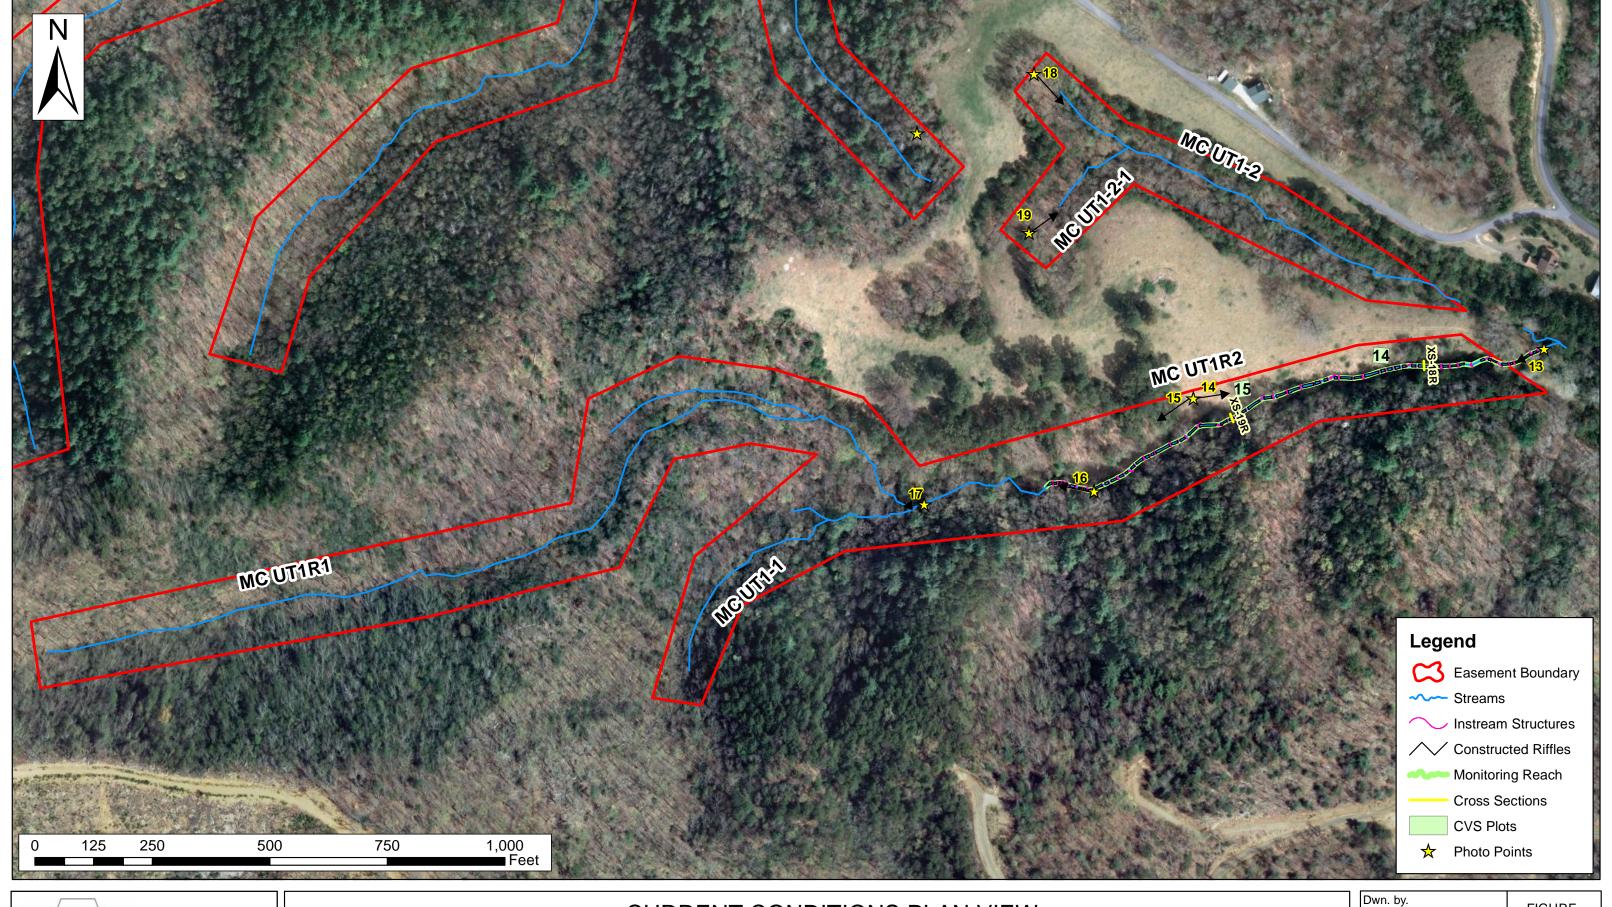
CURRENT CONDITIONS PLAN VIEW
MARTINS CREEK II (MARTINS CREEK TRIBUTARIES)
EEP PROJECT # 92633
Cherokee County, North Carolina

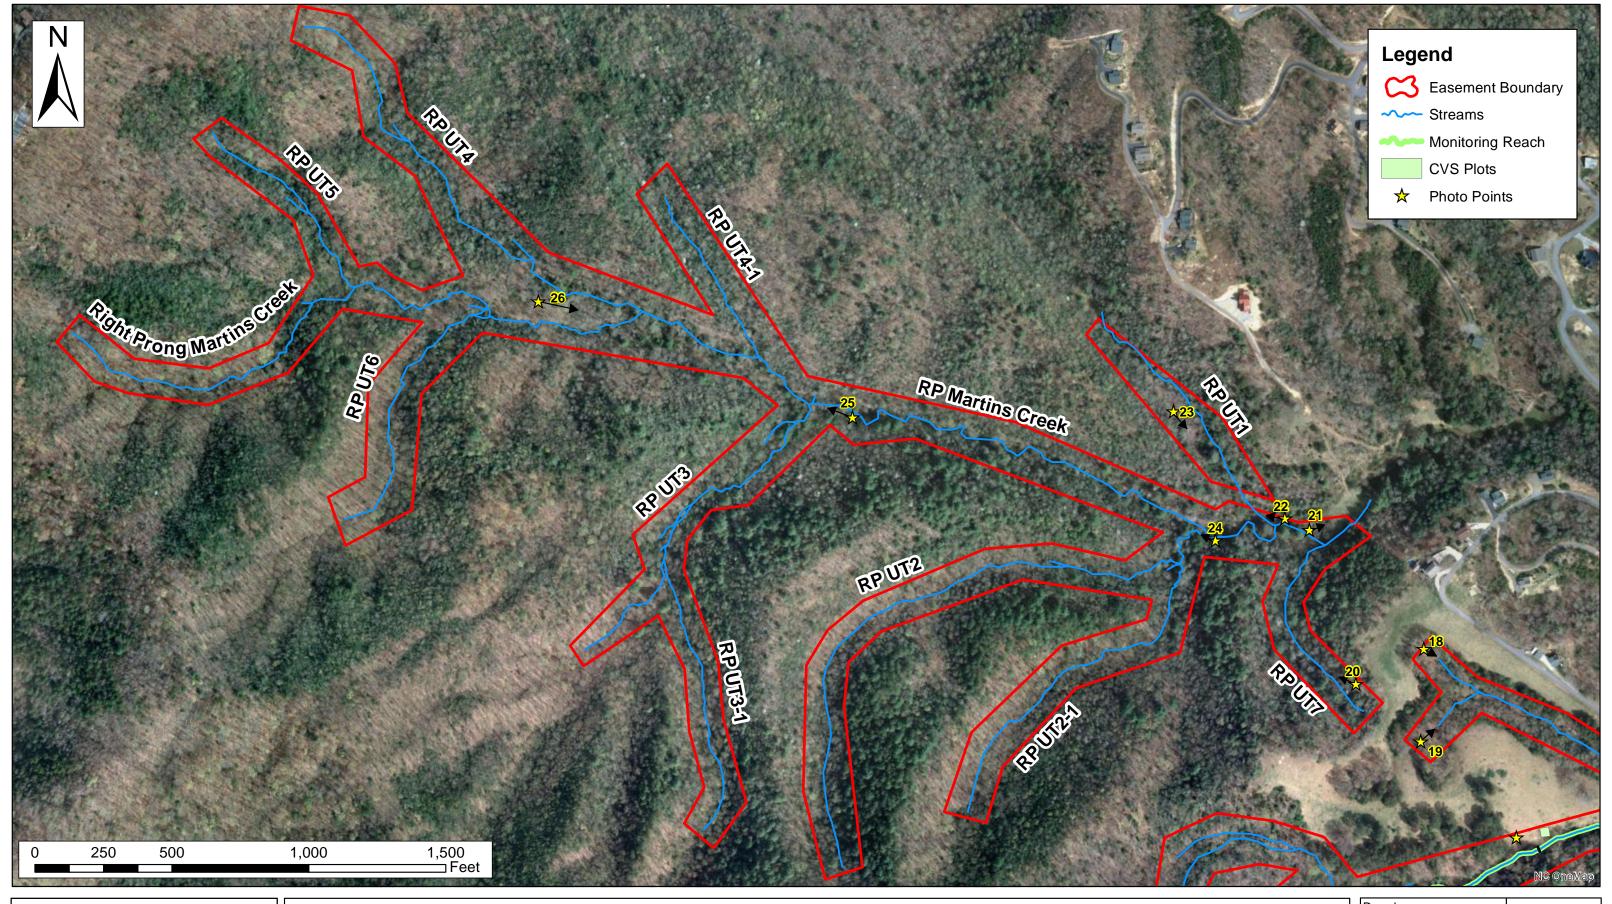
CURRENT CONDITIONS PLAN VIEW
MARTINS CREEK II (RIGHT PRONG TRIBUTARIES)
EEP PROJECT # 92633
Cherokee County, North Carolina

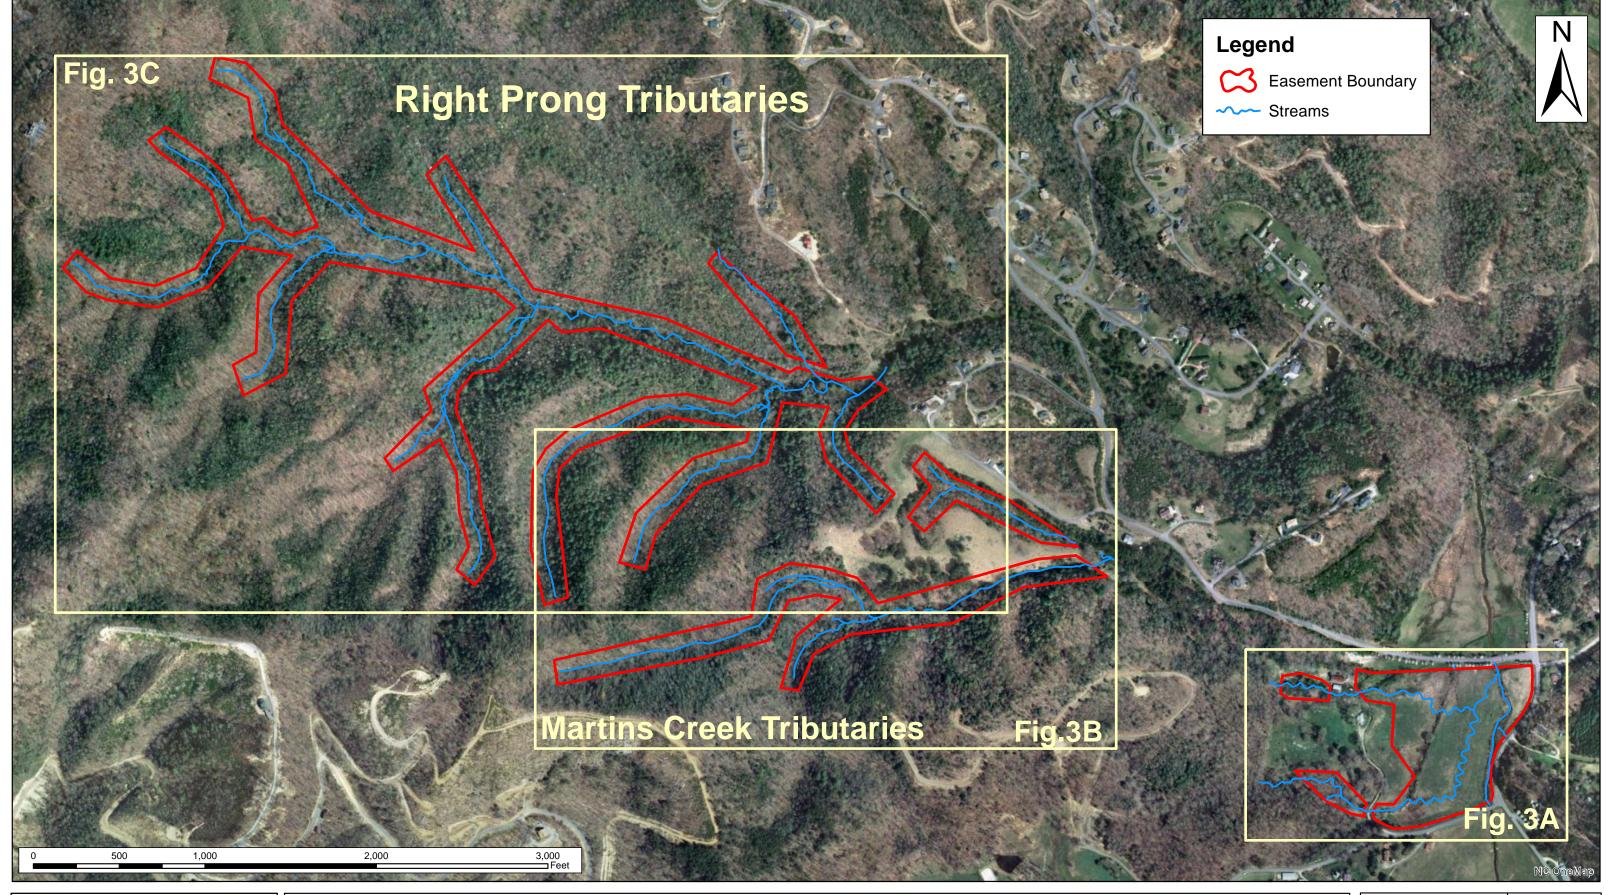
AND DESCRIPTION OF THE PERSON NAMED IN	N 1000
Dwn. by. KRJ	FIGURE
Date: May 2014	3
Project:	
12-004.16

PROJECT COMPONENTS MAP
MARTINS CREEK II
EEP PROJECT # 92633
Cherokee County, North Carolina

The Site mitigation plan was completed in March 2010 with the final design and construction plans completed in November 2010 (Table 2, Appendix A). Project construction was completed between October 2012-July 2013. The implemented mitigation is as follows (Figure 2, Appendix B and Table 1, Appendix A).

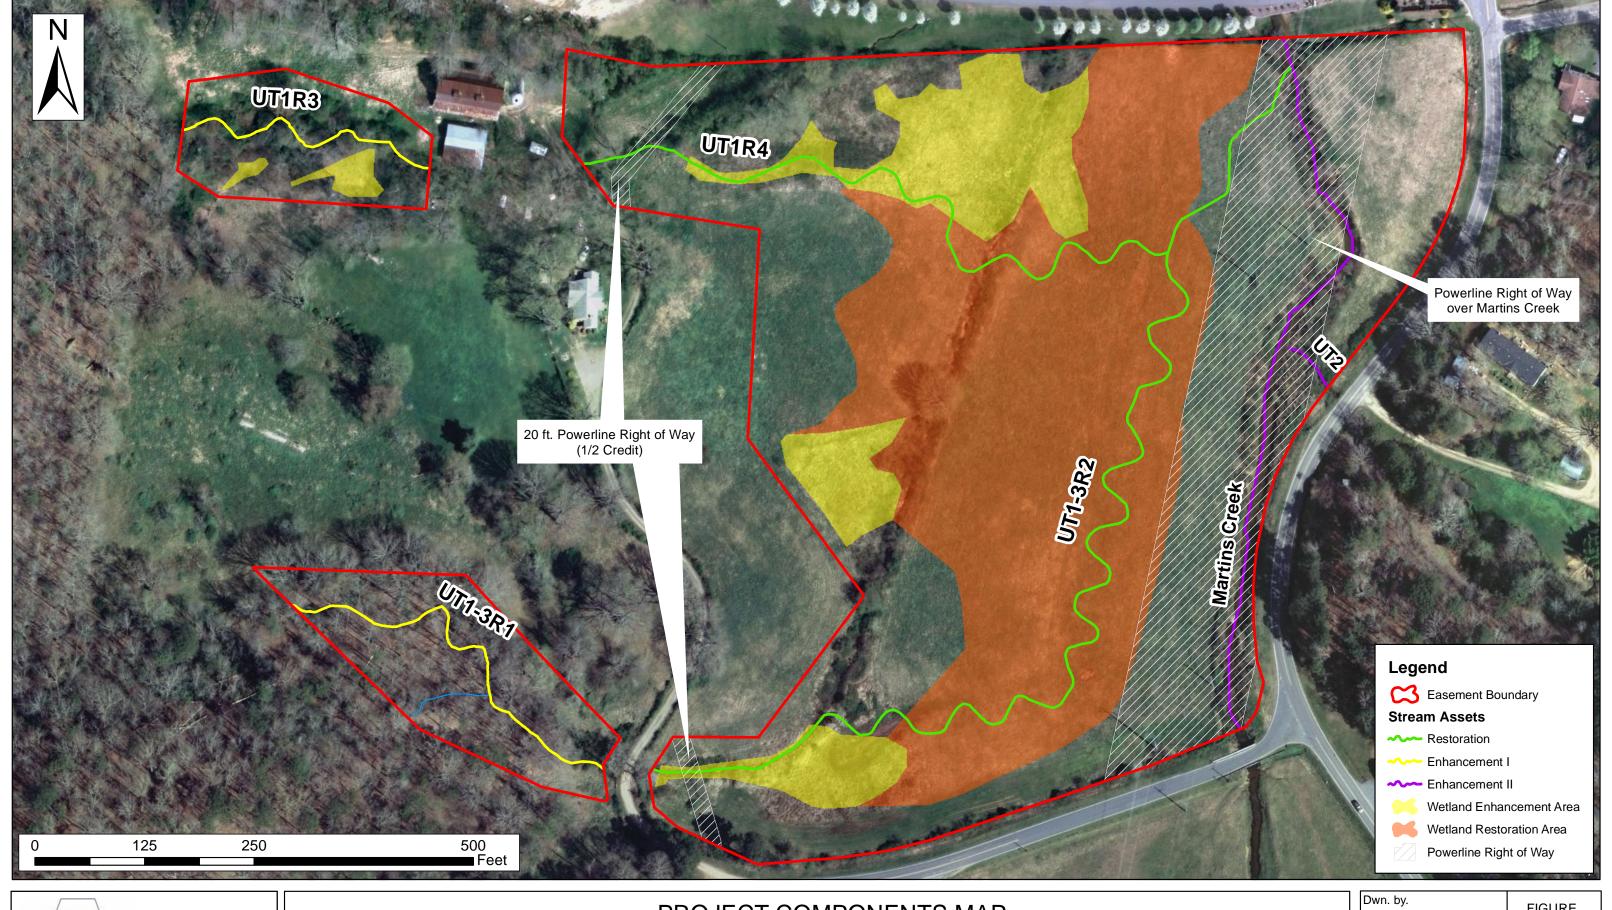
3A

PROJECT COMPONENTS MAP MARTINS CREEK II EEP PROJECT # 92633 Cherokee County, North Carolina KRJ

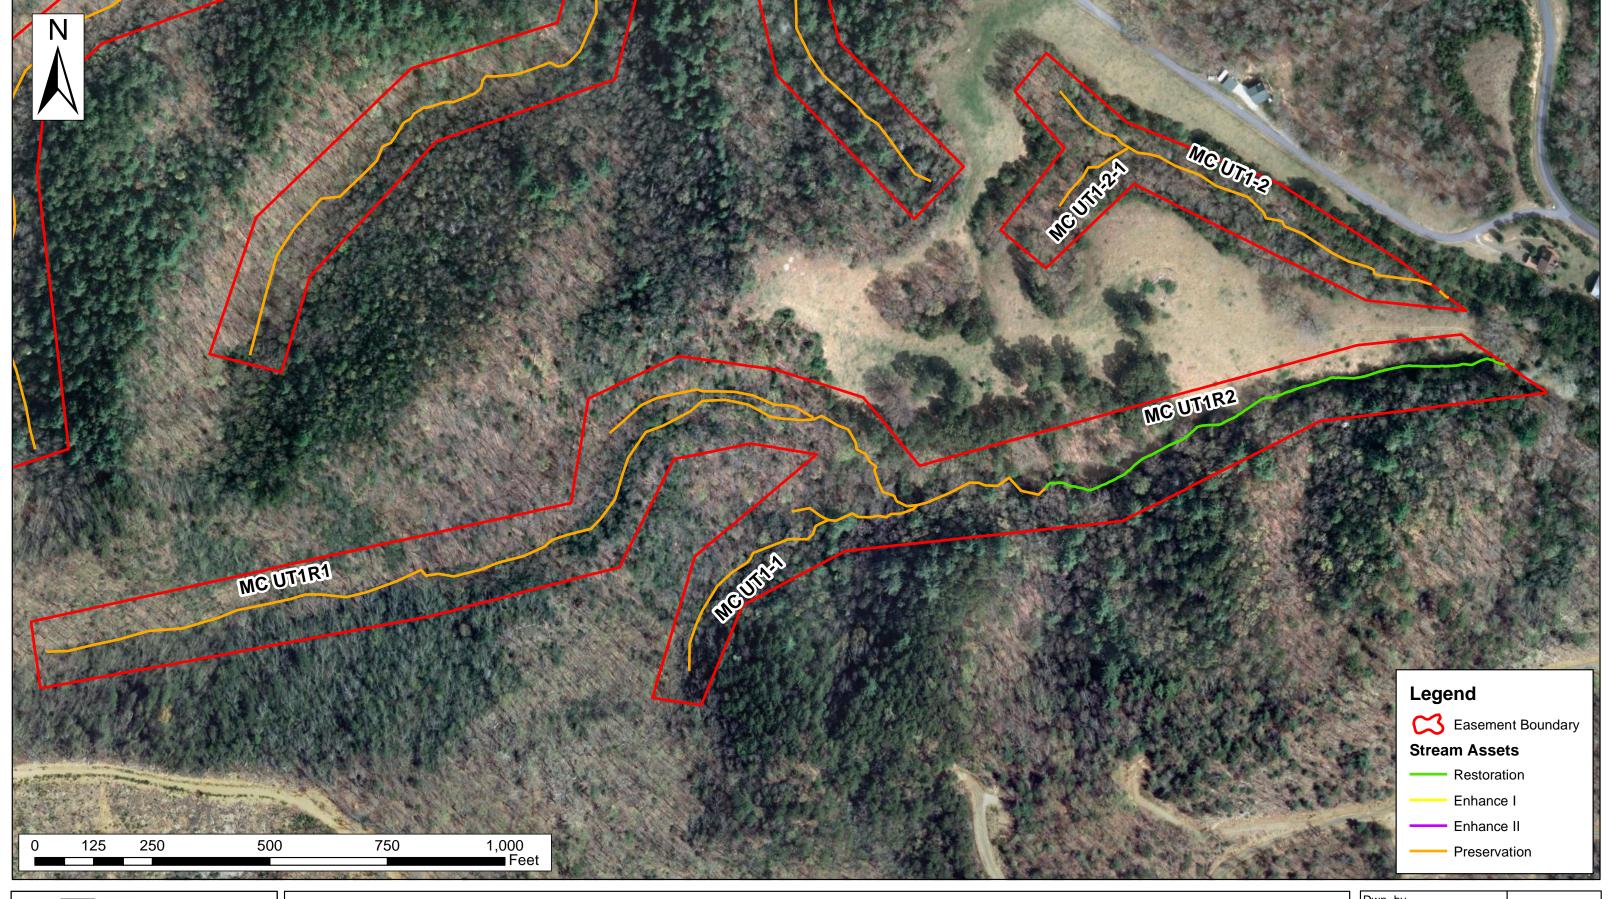
PROJECT COMPONENTS MAP
MARTINS CREEK II (MARTINS CREEK TRIBUTARIES)
EEP PROJECT # 92633
Cherokee County, North Carolina

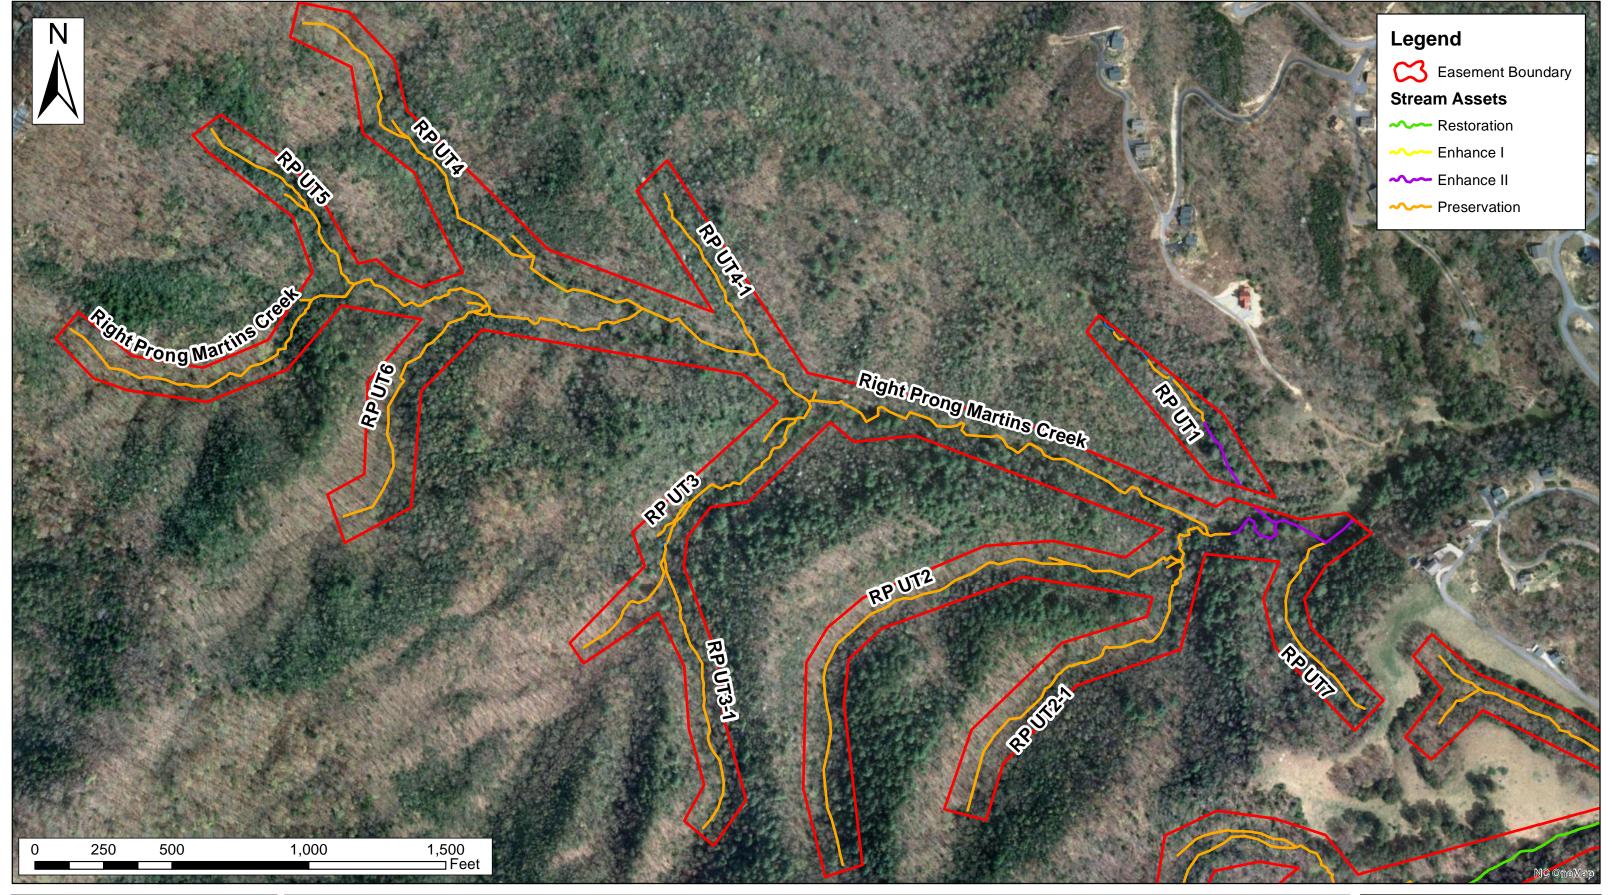
PROJECT COMPONENTS MAP
MARTINS CREEK II (RIGHT PRONG TRIBUTARIES)
EEP PROJECT # 92633
Cherokee County, North Carolina

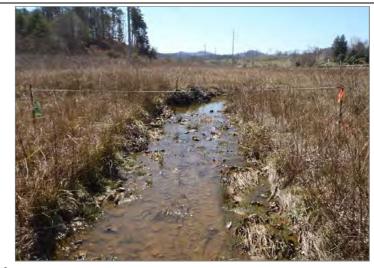
Site	Martins Creek II
Watershed:	Hiwassee
XS ID	XS - 2, Riffle
Feature	Riffle
Date:	4/1/2014
Field Crew:	Perkinson, Jernigan

Station	Elevation
0.00	96.08
1.81	96.06
3.11	96.06
4.60	95.30
5.51	94.90
6.18	94.82
7.18	94.69
8.66	94.57
10.07	94.57
11.16	94.64
11.97	94.64
12.85	94.82
15.08	95.76
15.78	95.80
17.26	95.70

SUMMARY DATA	
Bankfull Elevation:	95.8
Bankfull Cross-Sectional Area:	9.9
Bankfull Width:	11.4
Flood Prone Area Elevation:	97.0
Flood Prone Width:	100.0
Max Depth at Bankfull:	1.2
Mean Depth at Bankfull:	0.9
W / D Ratio:	13.1
Entrenchment Ratio:	8.8
Bank Height Ratio:	1.0

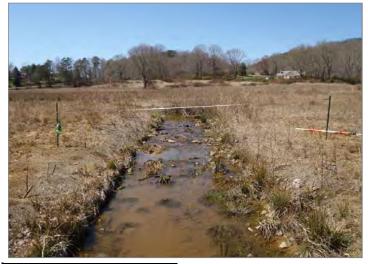
Site	Martins Creek II
Watershed:	Hiwassee
XS ID	XS - 3, Riffle
Feature	Riffle
Date:	4/1/2014
Field Crew:	Perkinson, Jernigan

Station	Elevation
0.00	96.86
1.50	96.92
2.49	96.57
3.87	95.99
4.66	95.93
6.03	95.98
7.06	95.97
8.36	96.09
9.51	96.49
11.30	96.71
	1

SUMMARY DATA	
Bankfull Elevation:	96.5
Bankfull Cross-Sectional Area:	2.8
Bankfull Width:	6.8
Flood Prone Area Elevation:	97.1
Flood Prone Width:	100.0
Max Depth at Bankfull:	0.6
Mean Depth at Bankfull:	0.4
W / D Ratio:	16.5
Entrenchment Ratio:	14.7
Bank Height Ratio:	1.0

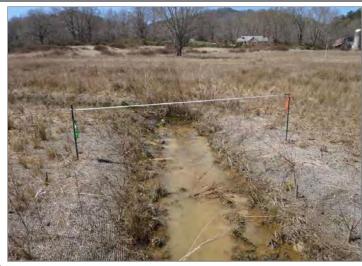
Site	Martins Creek II
Watershed:	Hiwassee
XS ID	XS - 4, Pool
Feature	Pool
Date:	4/1/2014
Field Crew:	Perkinson, Jernigan

Station	Elevation
0.0	96.9
1.7	97.0
2.8	96.7
3.4	95.4
4.5	94.9
5.4	94.7
5.8	95.2
6.9	95.8
7.7	96.1
8.8	96.2
9.9	96.6
11.3	96.8
12.9	97.1

SUMMARY DATA	
Bankfull Elevation:	96.7
Bankfull Cross-Sectional Area:	7.3
Bankfull Width:	7.7
Flood Prone Area Elevation:	NA
Flood Prone Width:	NA
Max Depth at Bankfull:	2.0
Mean Depth at Bankfull:	0.9
W / D Ratio:	NA
Entrenchment Ratio:	NA
Bank Height Ratio:	1.0

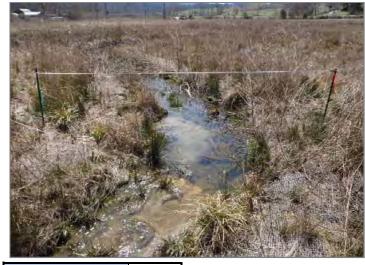
Site	Martins Creek II
Watershed:	Hiwassee
XS ID	XS - 5, Riffle
Feature	Riffle
Date:	4/1/2014
Field Crew:	Perkinson, Jernigan

Station	Elevation
0.00	97.38
1.80	97.40
2.94	97.07
3.94	96.69
4.82	96.15
5.84	96.24
6.88	96.21
7.82	96.40
8.91	96.89
10.27	97.48
12.32	97.52

SUMMARY DATA	
Bankfull Elevation:	97.4
Bankfull Cross-Sectional Area:	6.2
Bankfull Width:	8.3
Flood Prone Area Elevation:	98.6
Flood Prone Width:	100.0
Max Depth at Bankfull:	1.2
Mean Depth at Bankfull:	0.7
W / D Ratio:	11.1
Entrenchment Ratio:	12.0
Bank Height Ratio:	1.0

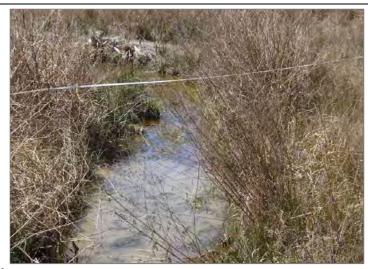
Site	Martins Creek II
Watershed:	Hiwassee
XS ID	XS - 6, Pool
Feature	Pool
Date:	4/1/2014
Field Crew:	Perkinson, Jernigan

Station	Elevation
0.00	97.71
1.66	97.92
3.06	97.97
4.87	94.39
6.27	94.23
7.09	95.19
8.22	95.26
8.89	95.71
9.54	95.97
10.08	96.29
11.01	96.51
11.69	96.81
12.85	96.94
14.34	97.13
16.37	97.34

SUMMARY DATA	
Bankfull Elevation:	96.9
Bankfull Cross-Sectional Area:	12.0
Bankfull Width:	9.2
Flood Prone Area Elevation:	NA
Flood Prone Width:	NA
Max Depth at Bankfull:	2.7
Mean Depth at Bankfull:	1.3
W / D Ratio:	NA
Entrenchment Ratio:	NA
Bank Height Ratio:	1.0

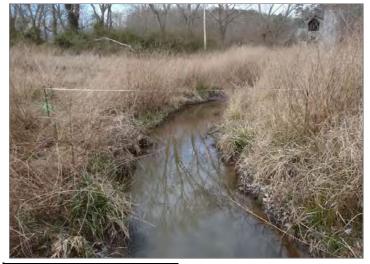
Site	Martins Creek II
Watershed:	Hiwassee
XS ID	XS - 17, Pool
Feature	Pool
Date:	4/1/2014
Field Crew:	Perkinson, Jernigan

Station	Elevation
0.00	105.98
2.51	105.77
3.66	105.49
4.94	105.02
6.03	104.66
6.74	104.35
7.65	104.04
8.56	103.54
10.08	103.79
10.88	103.32
11.72	103.98
12.39	106.29
13.29	106.46
15.24	106.50

SUMMARY DATA	
Bankfull Elevation:	105.8
Bankfull Cross-Sectional Area:	13.2
Bankfull Width:	9.7
Flood Prone Area Elevation:	NA
Flood Prone Width:	NA
Max Depth at Bankfull:	2.4
Mean Depth at Bankfull:	1.4
W/D Ratio:	NA
Entrenchment Ratio:	NA
Bank Height Ratio:	1.0

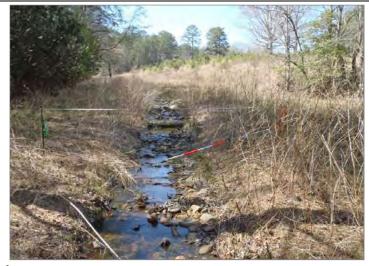
Site	Martins Creek II
Watershed:	Hiwassee
XS ID	XS - 18, Riffle
Feature	Riffle
Date:	4/1/2014
Field Crew:	Perkinson, Jernigan

Station	Elevation
0.00	75.60
2.40	75.49
4.05	74.86
5.49	74.60
6.28	74.46
7.17	74.24
8.23	74.33
9.27	74.41
9.75	74.66
10.93	75.30
12.16	75.34
13.56	75.50

SUMMARY DATA	
Bankfull Elevation:	75.3
Bankfull Cross-Sectional Area:	5.2
Bankfull Width:	8.0
Flood Prone Area Elevation:	76.4
Flood Prone Width:	25.0
Max Depth at Bankfull:	1.1
Mean Depth at Bankfull:	0.7
W / D Ratio:	12.3
Entrenchment Ratio:	3.1
Bank Height Ratio:	1.0

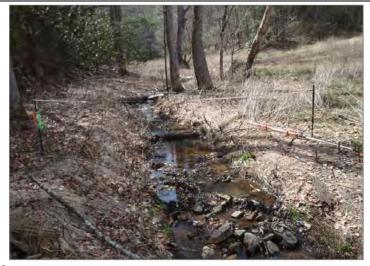
Site	Martins Creek II
Watershed:	Hiwassee
XS ID	XS - 19, Riffle
Feature	Riffle
Date:	4/1/2014
Field Crew:	Perkinson, Jernigan

Elevation
102.54
102.53
102.17
101.95
101.54
101.60
101.63
101.44
101.66
102.37
103.23
103.20

SUMMARY DATA	
Bankfull Elevation:	102.5
Bankfull Cross-Sectional Area:	5.9
Bankfull Width:	8.7
Flood Prone Area Elevation:	103.6
Flood Prone Width:	25.0
Max Depth at Bankfull:	1.1
Mean Depth at Bankfull:	0.7
W / D Ratio:	12.8
Entrenchment Ratio:	2.9
Bank Height Ratio:	1.0

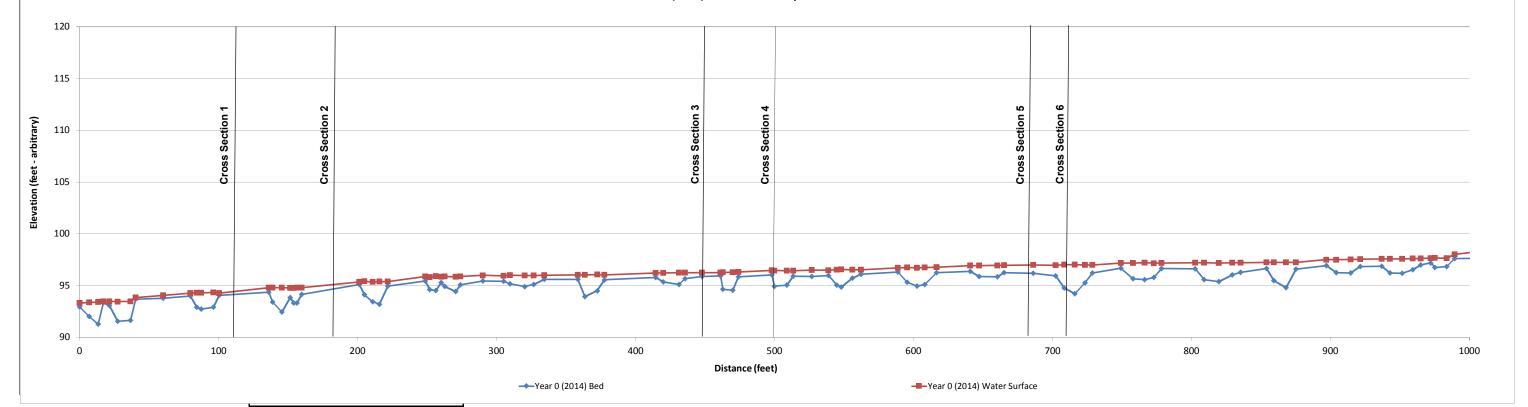
Project Name Reach Feature Date Martins II - Profile UT 1 - 3 Station 00+00 - 10+00

2014	2014	2015	2016	2017
Avg. Water Surface Slope	0.0161				
Riffle Length	20				
Avg. Riffle Slope	0.0185				
Pool Length	14				
Pool to Pool Spacing	34.0

After Site construction, approximately 4493 linear feet of longitudinal profile was completed to document baseline conditions. Longitudinal profile will be resurveyed annually for the duration of the five-year monitoring period. Measurements include thalweg, water surface, bankfull, and top of low bank. Each of these measurements will be taken at the head of each channel unit (e.g., riffle, pool) and at the maximum pool depth. The survey will be tied to a permanent benchmark.

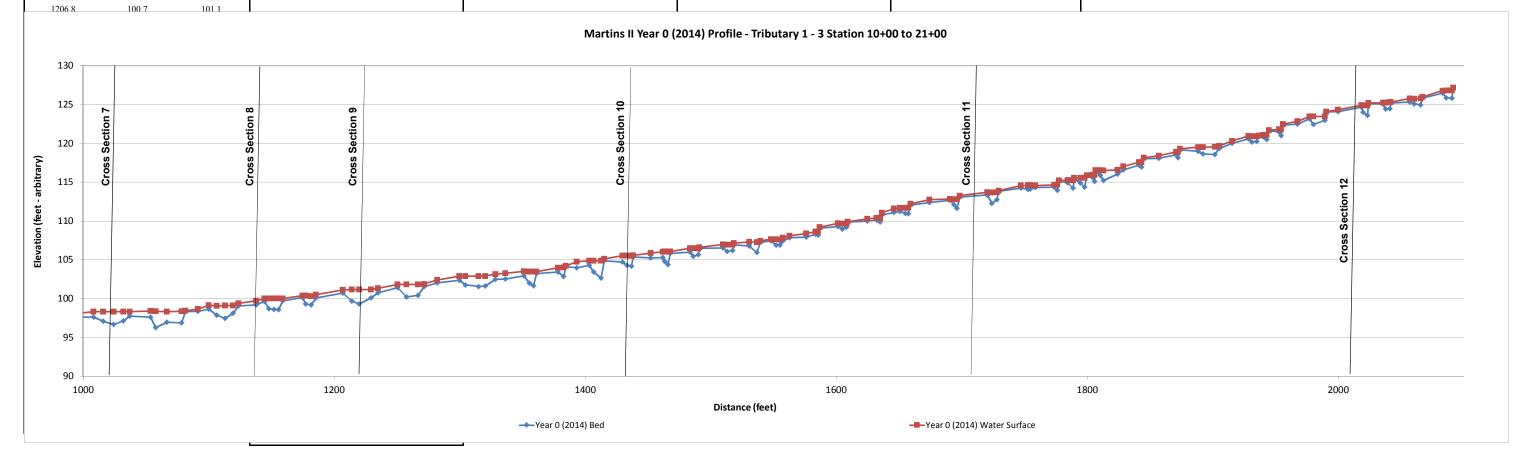
Martins II - Profile UT 1 - 3 Station 10+00 - 21+00

2014	2014	2015	2016	2017
Avg. Water Surface Slope	0.0161				
Riffle Length	20				
Avg. Riffle Slope	0.0185				
Pool Length	14				
Pool to Pool Spacing	34.0

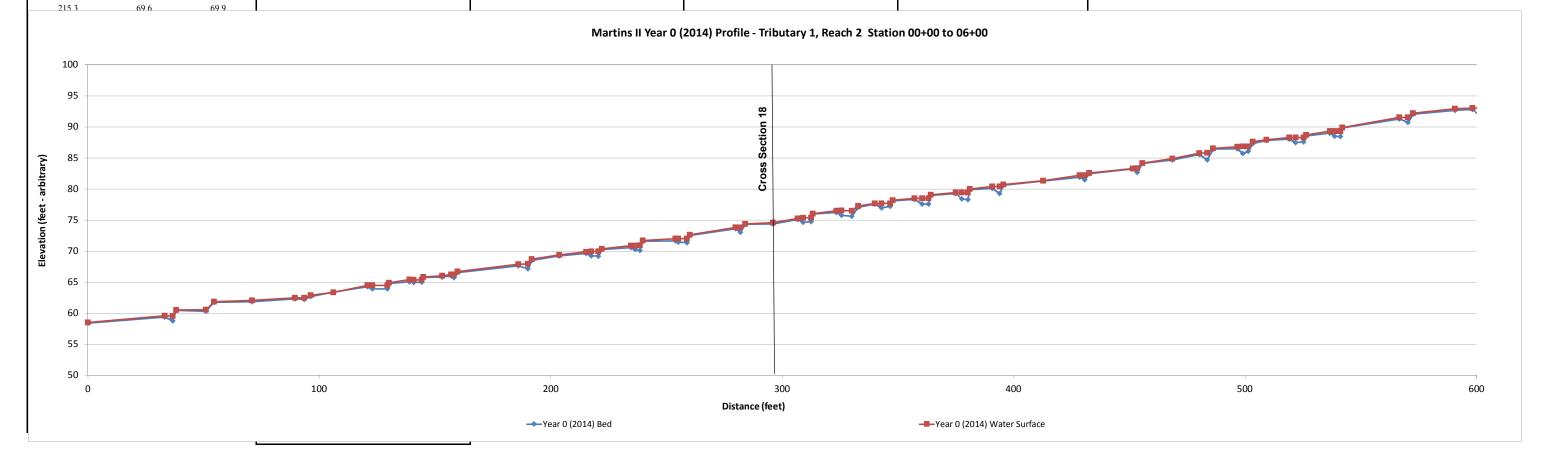
Martins II - Profile UT 1 Reach 2 - Station 00+00 - 06+00

2014	2014	2015	2016	2017
Avg. Water Surface Slope	0.0577				
Riffle Length	19				
Avg. Riffle Slope	0.0457				
Pool Length	6				
Pool to Pool Spacing	25.0

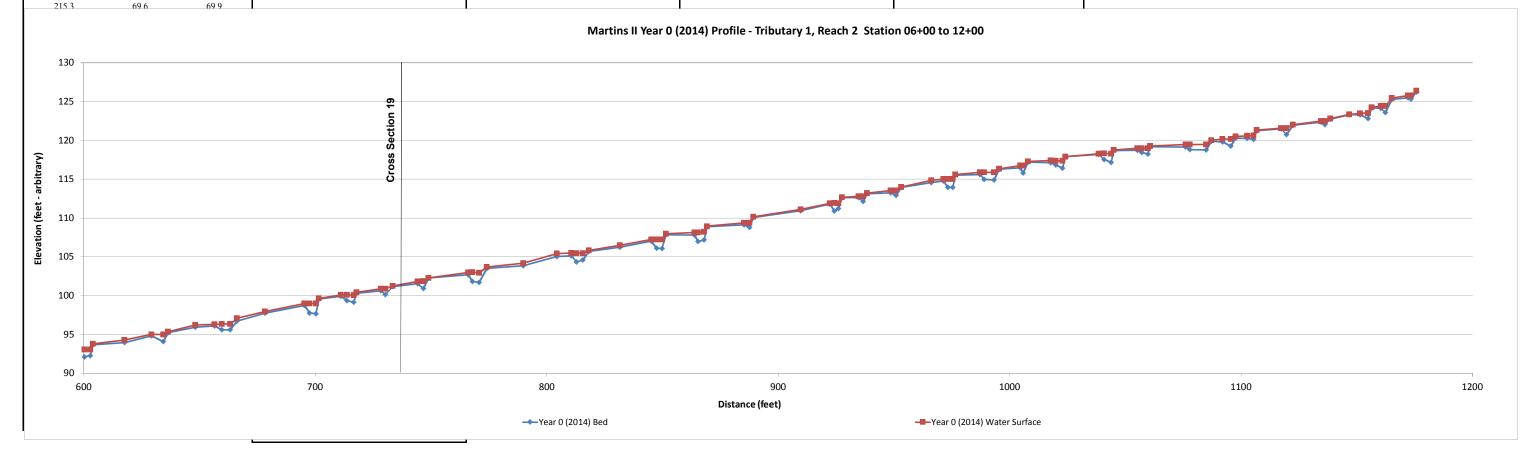
Martins II - Profile UT 1 Reach 2 - Station 06+00 - 12+00

2014	2014	2015	2016	2017
Avg. Water Surface Slope	0.0577				
Riffle Length	19				
Avg. Riffle Slope	0.0457				
Pool Length	6				
Pool to Pool Spacing	25.0

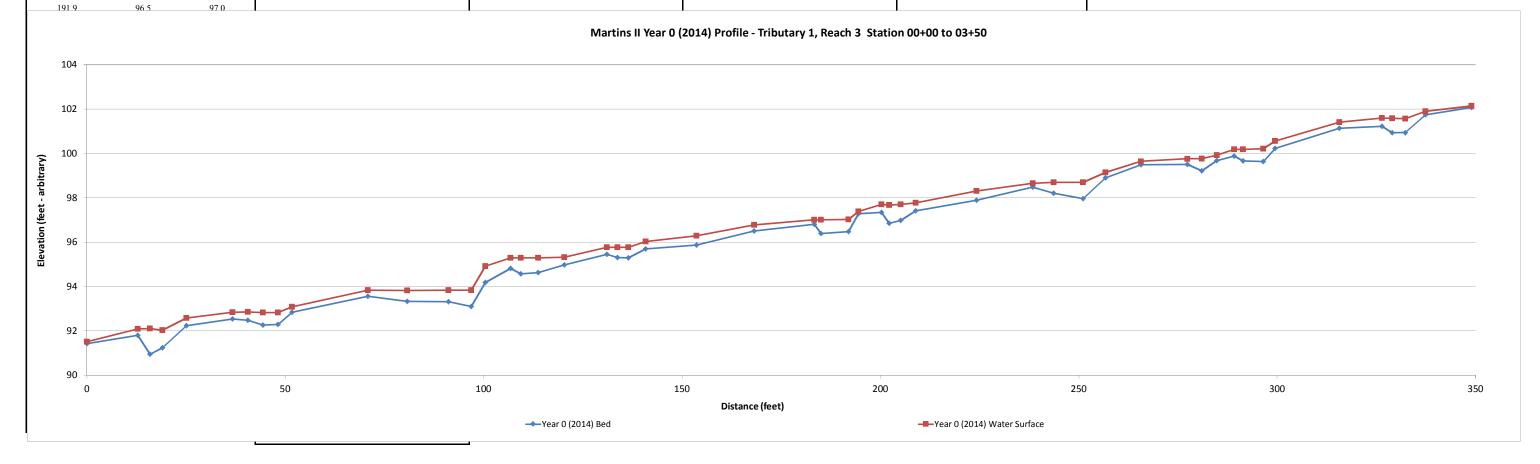
Martins II - Profile UT 1 Reach 3 - Station 00+00 - 03+50

2014	2014	2015	2016	2017
Avg. Water Surface Slope	0.0305				
Riffle Length	17				
Avg. Riffle Slope	0.0388				
Pool Length	13				
Pool to Pool Spacing	31.0

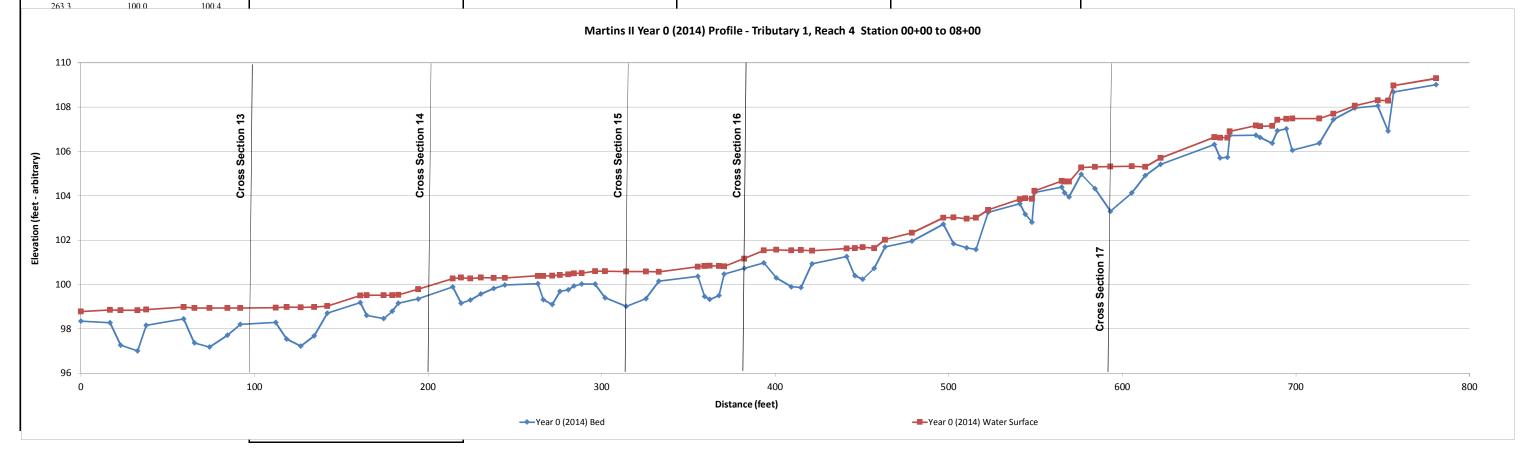
Martins II - Profile UT 1 Reach 4 - Station 00+00 - 08+00

2014	2014	2015	2016	2017
Avg. Water Surface Slope	0.0135				
Riffle Length	21				
Avg. Riffle Slope	0.0166				
Pool Length	22				
Pool to Pool Spacing	42.0
