Meredell Farm Stream Restoration Plan

Randolph County, North Carolina

Restoration Plan – September 2004

Prepared by Buck Engineering, PC

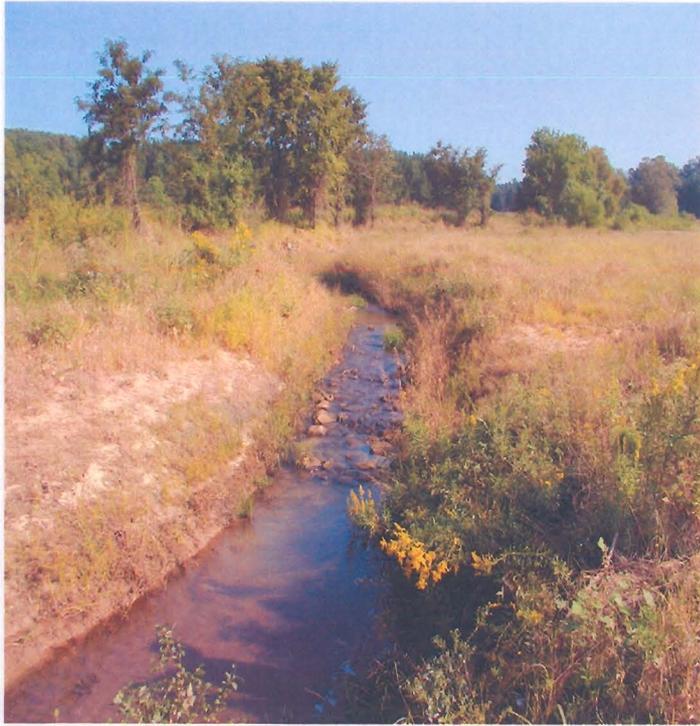
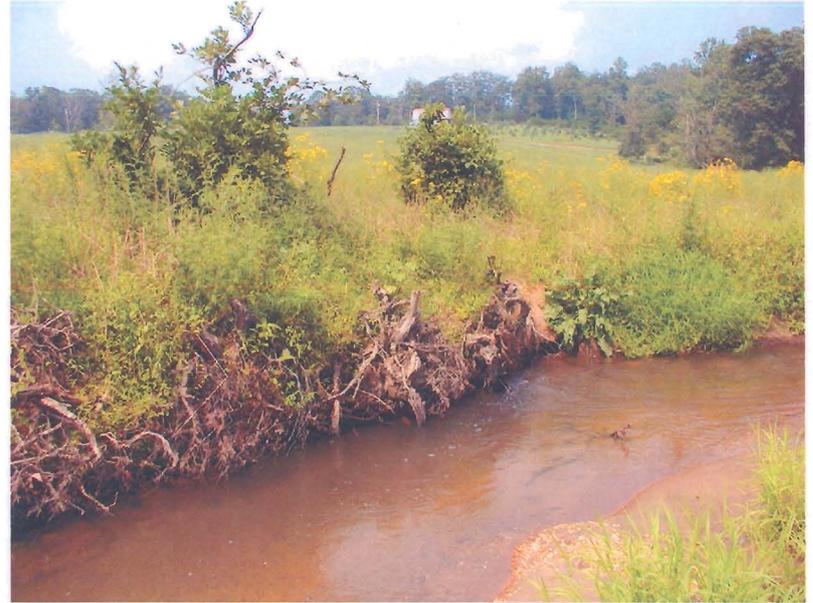
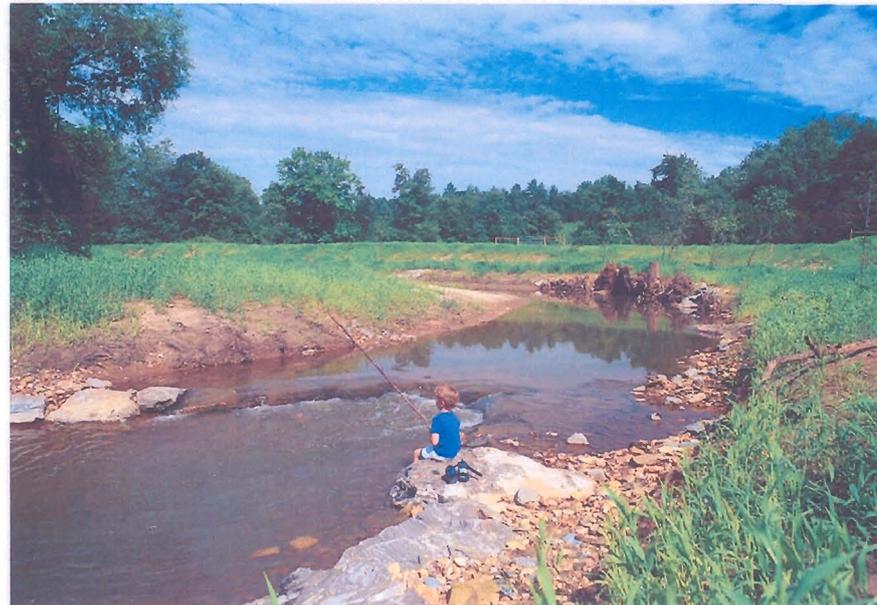
Constructed Riffle

Rootwads

Rock Cross Vane

Exhibit 2.7
Examples of Instream Structures
Meredell Farm Restoration Plan

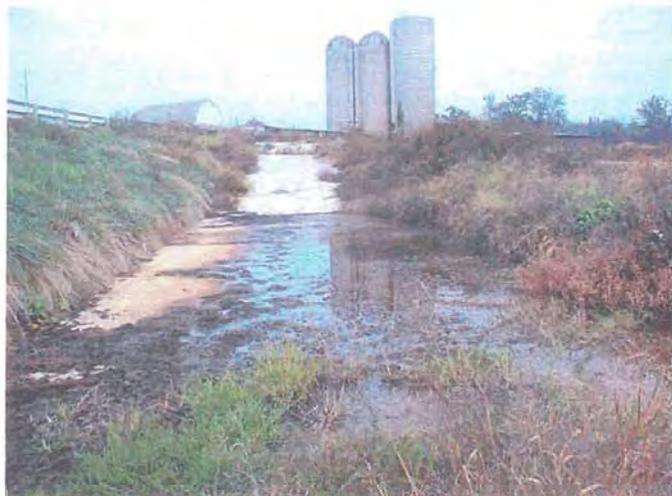
Runoff from dairy enters UT1

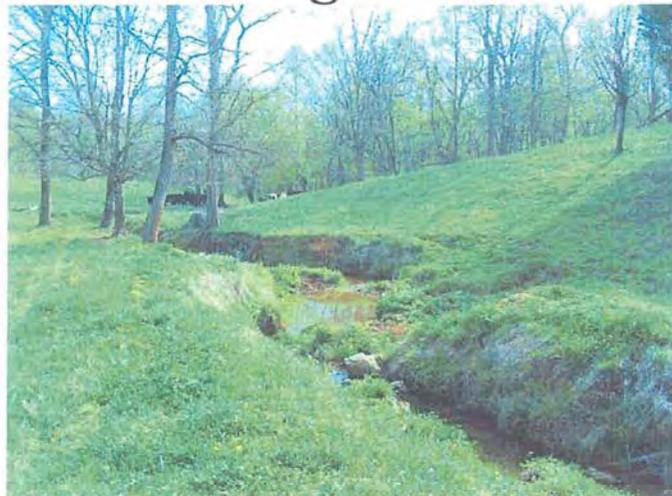
M1-Typical Bank Erosion

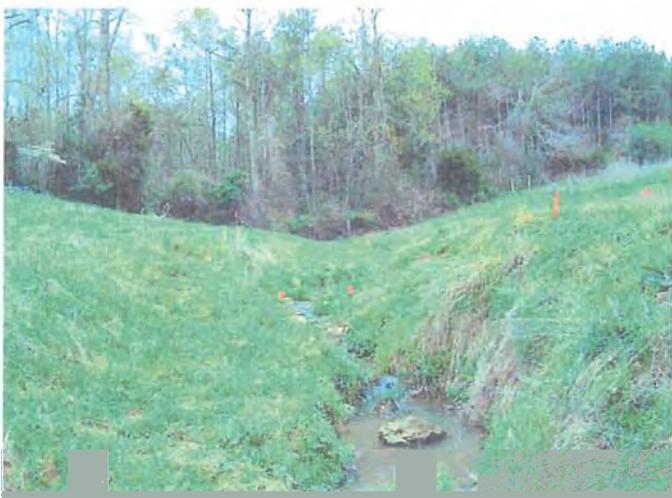
Begin UT1 - Headcut

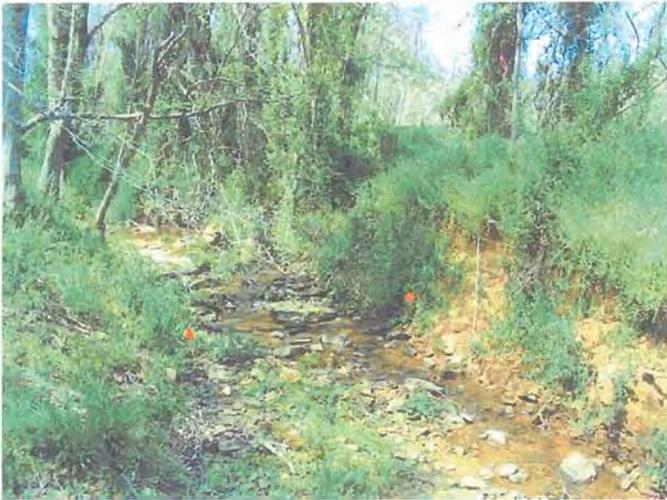
UT3b - Incised and eroding

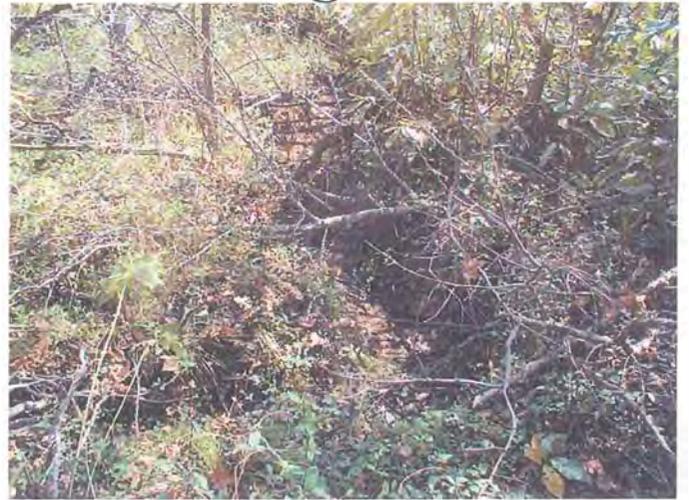
UT5 to be enhanced by preventing headcut and improving riparian buffer
