Year 4 Annual Monitoring Document

UT to Haw River (#747)

Alamance County

Data Collection Period: August 2015 Submission Date: January 2016

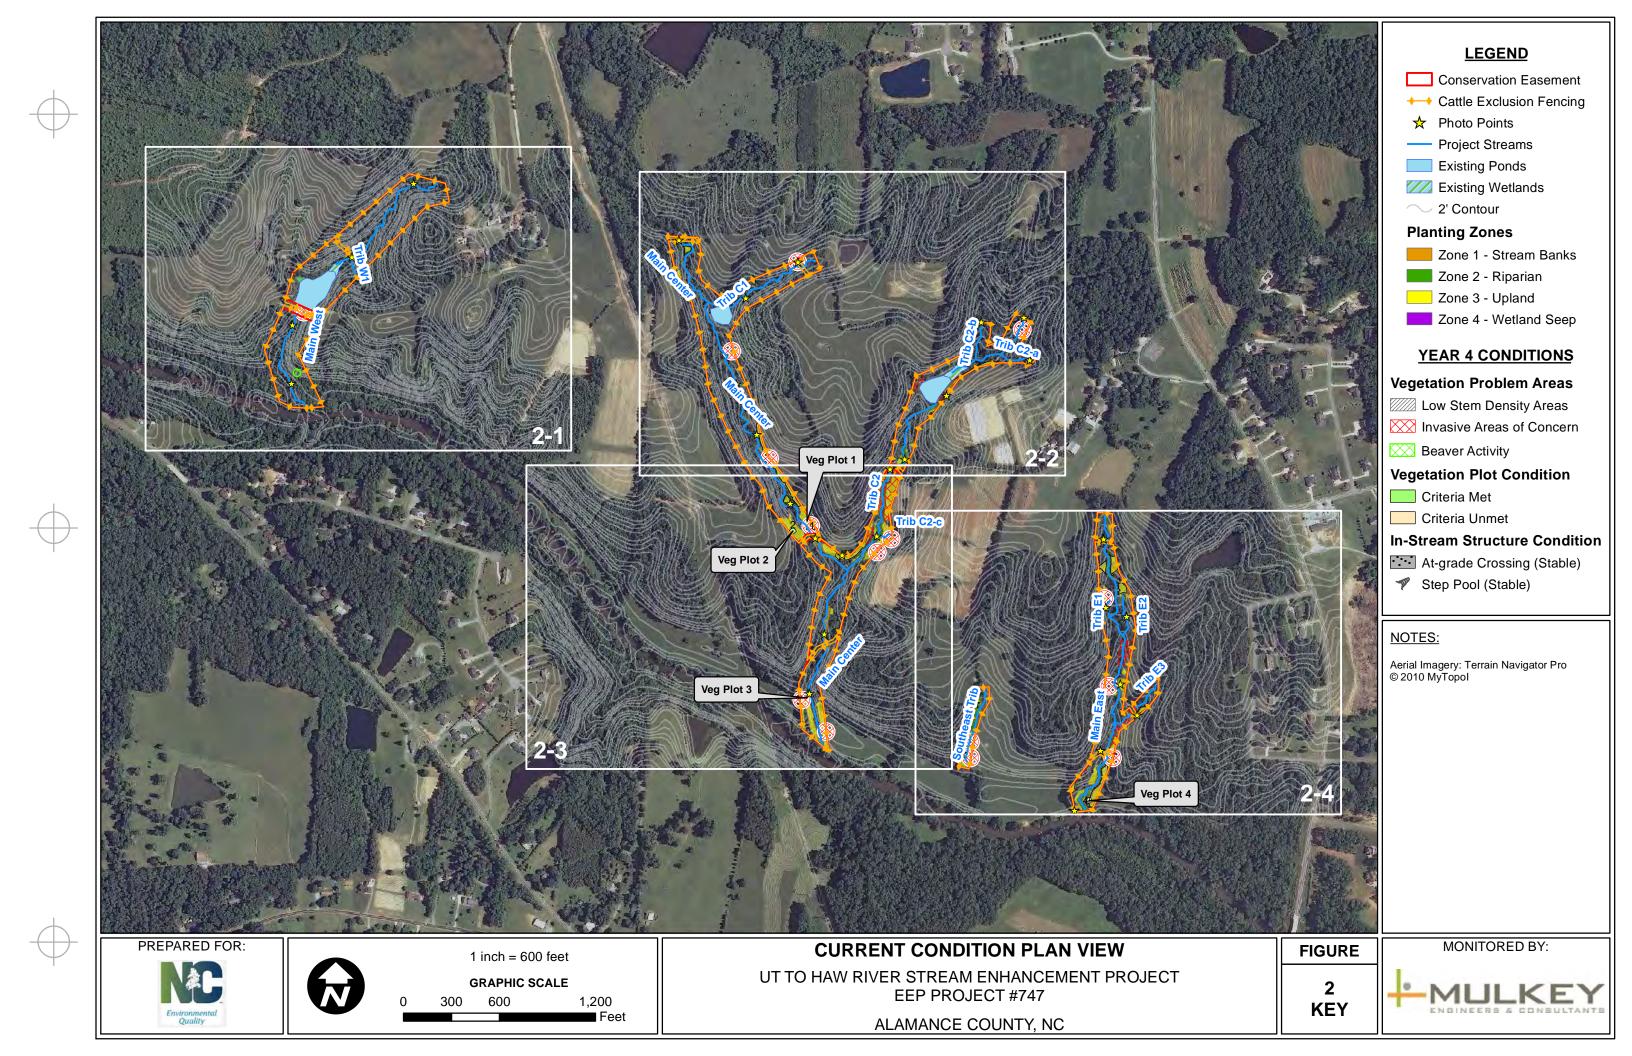
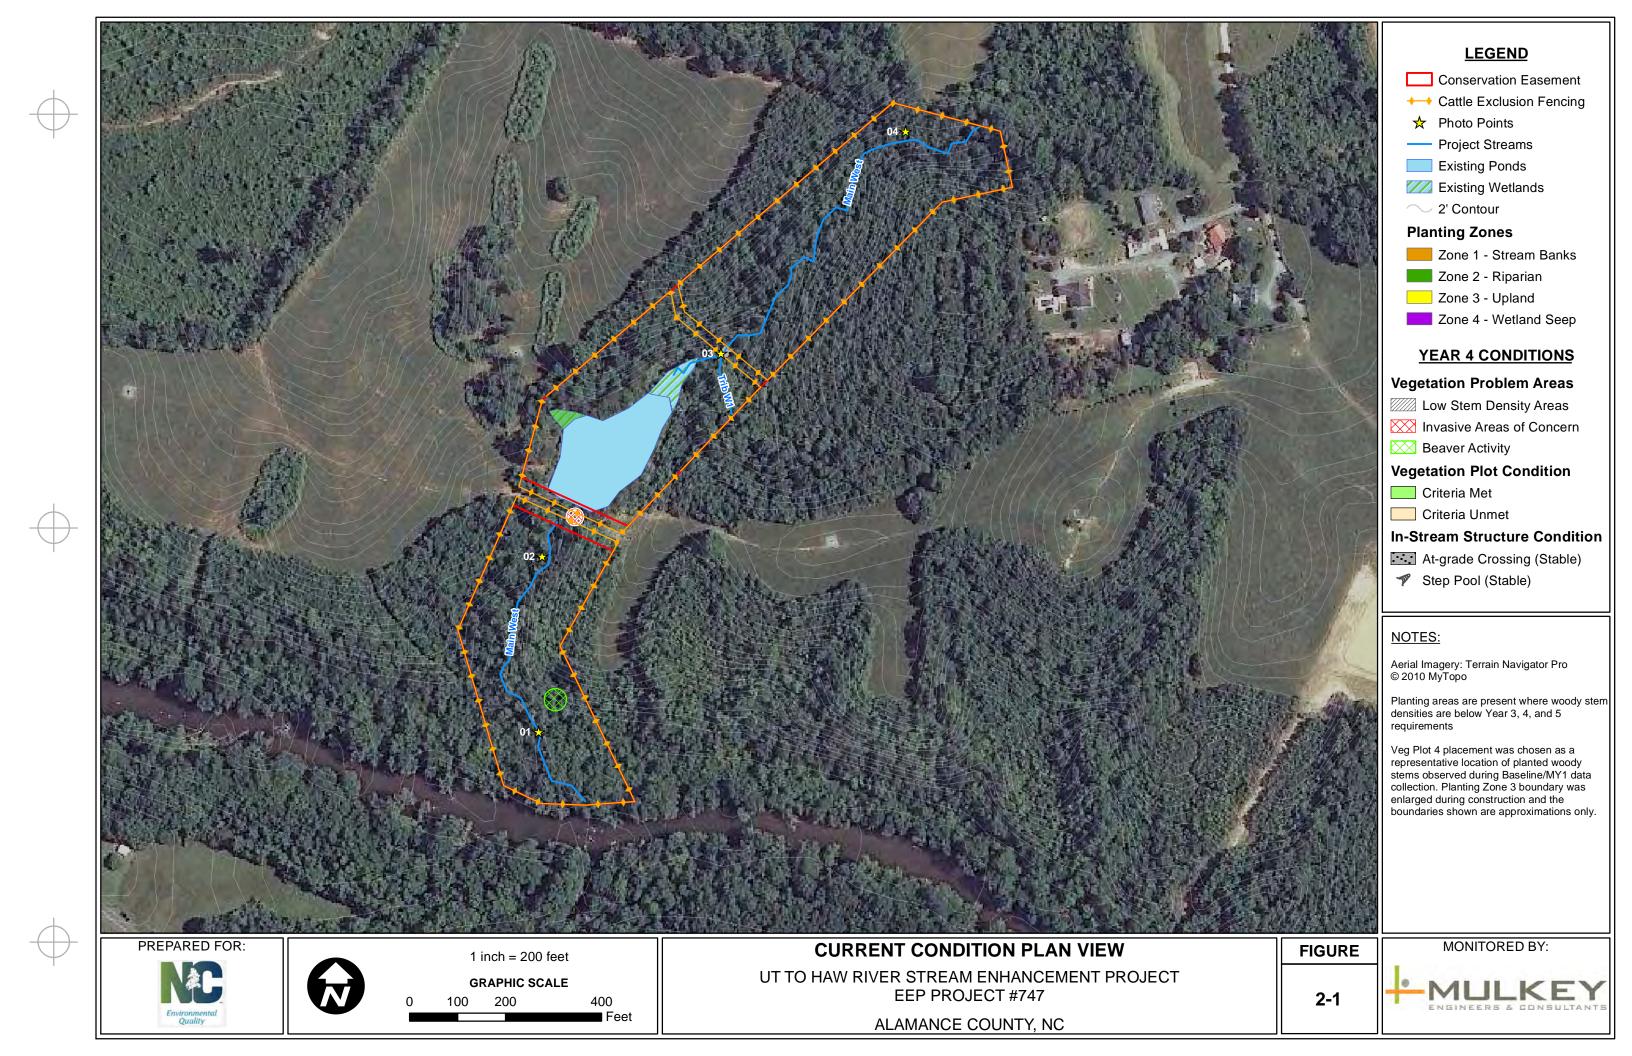
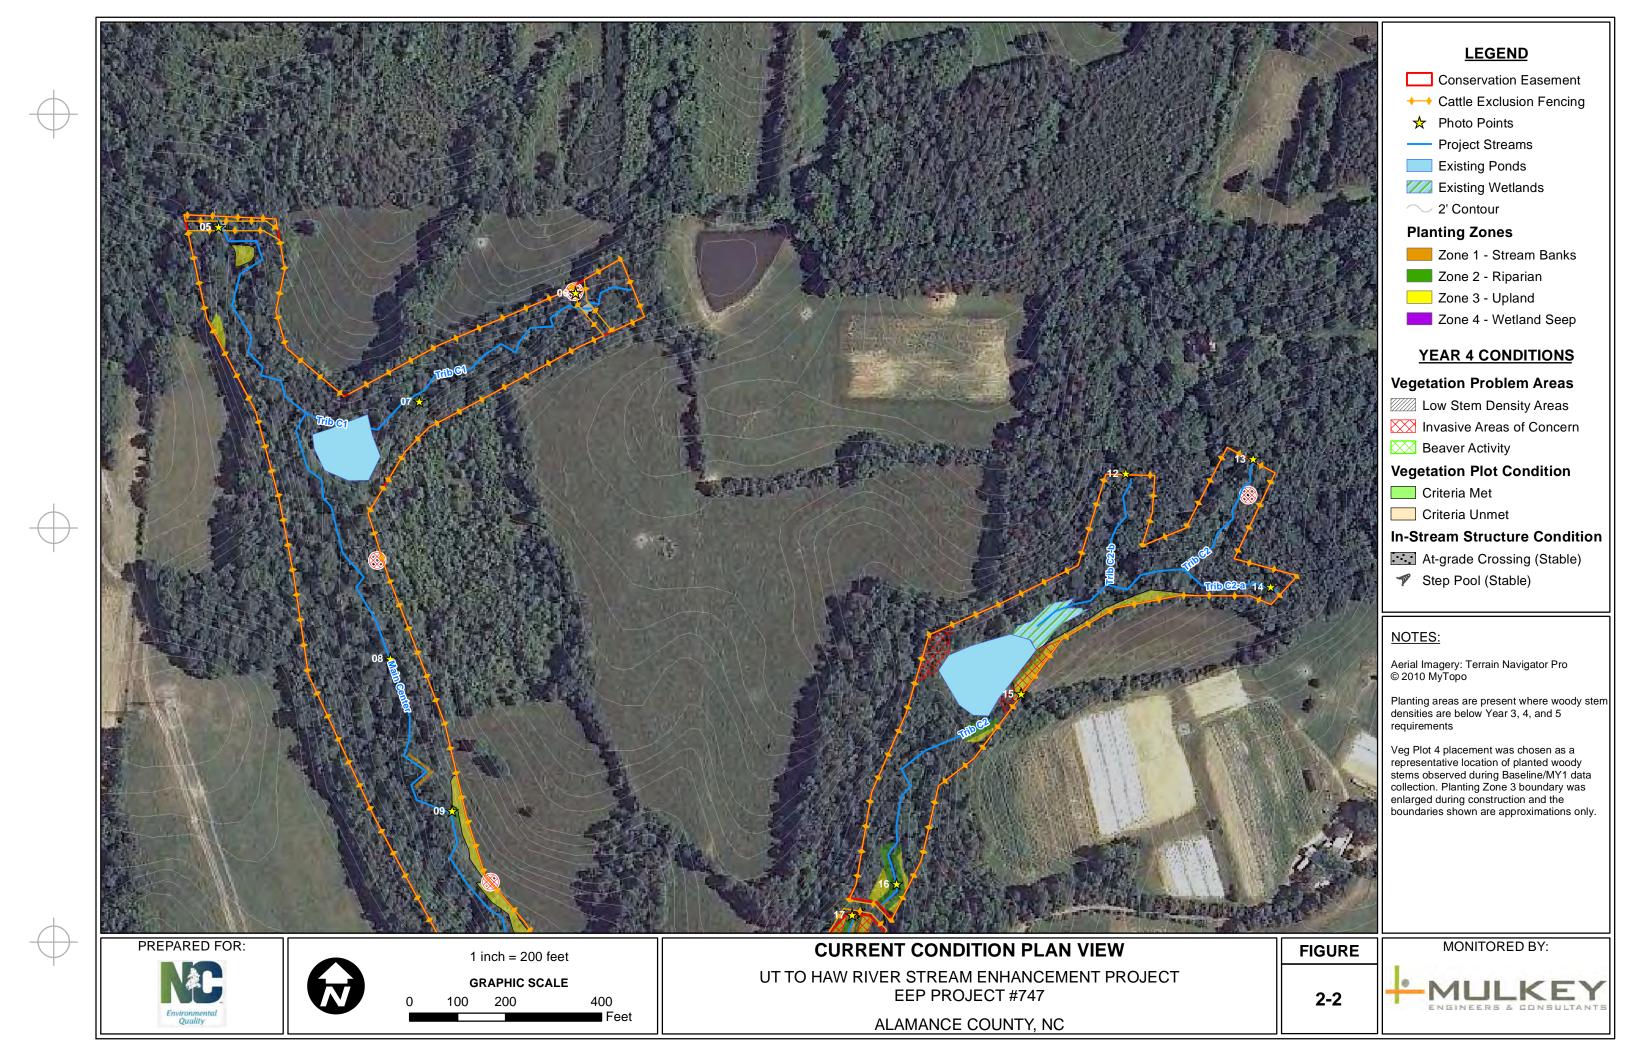
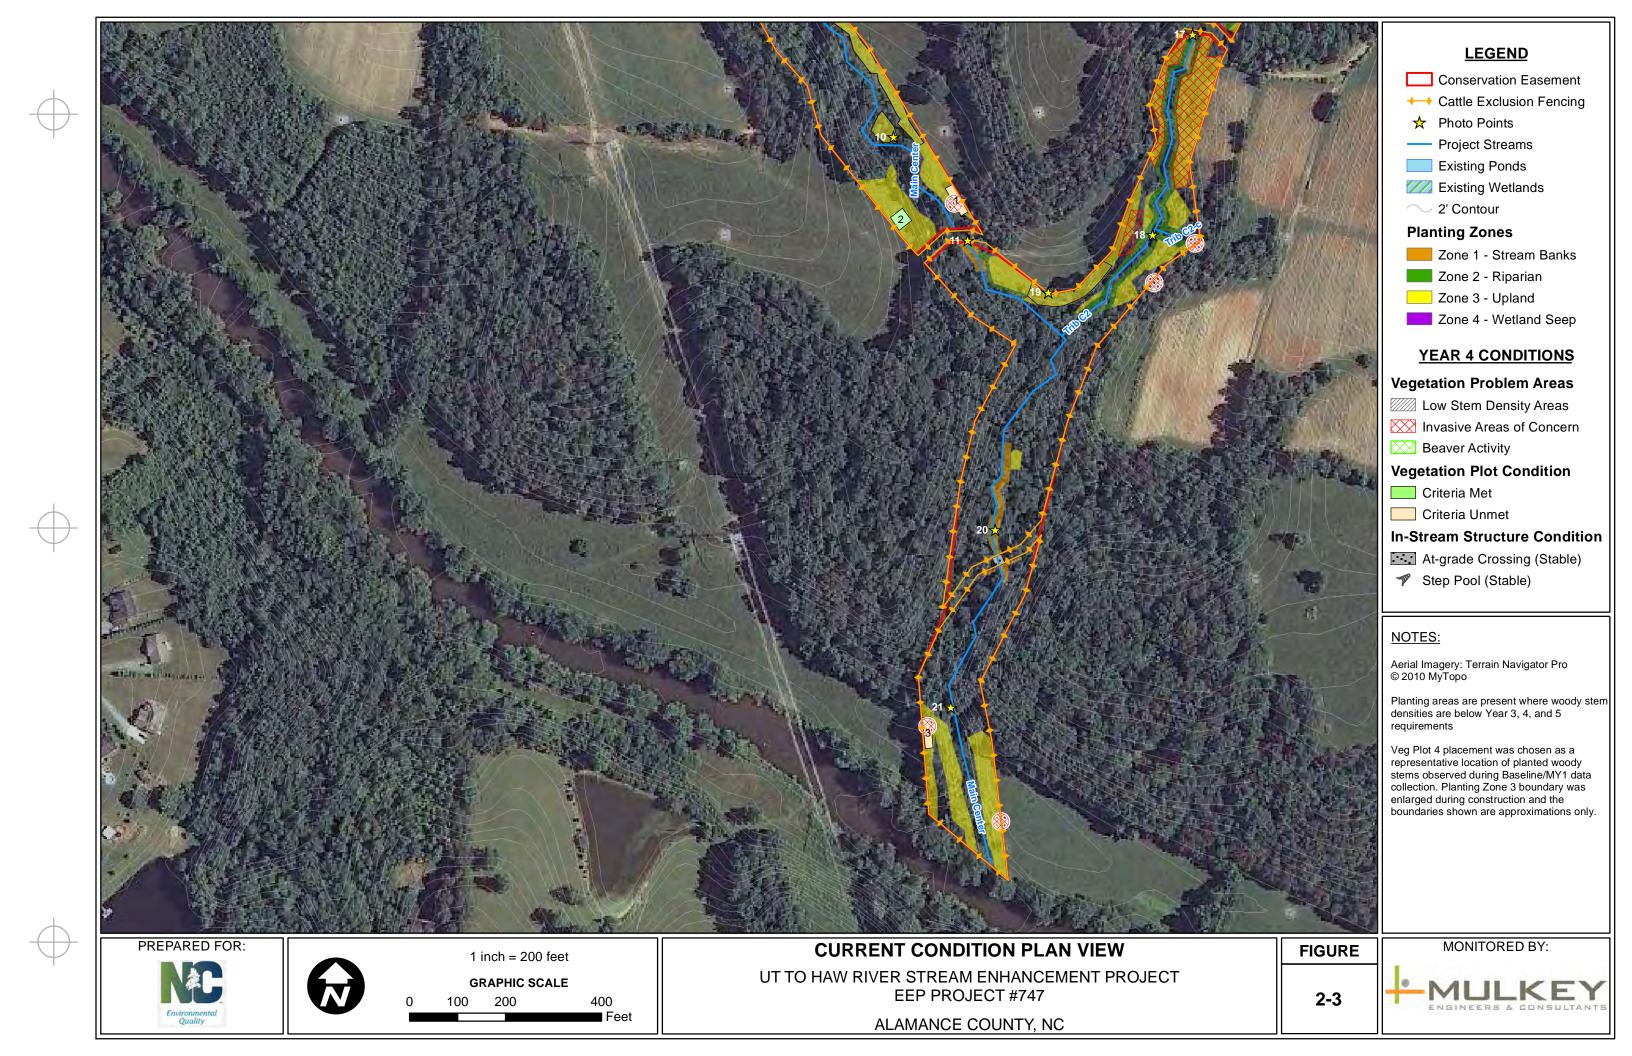
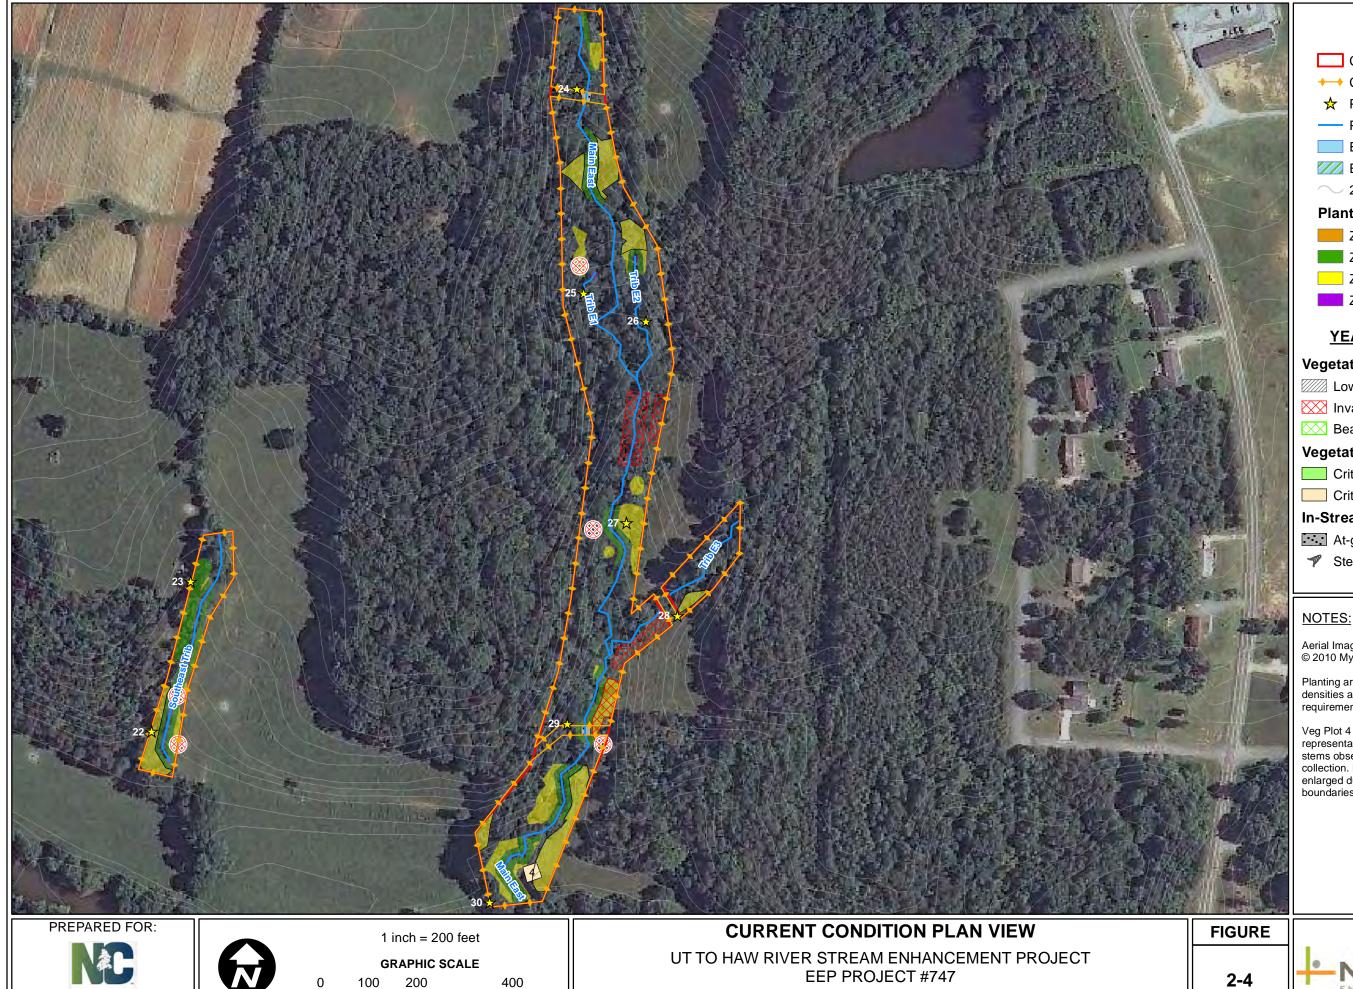
Current Condition Plan View (CCPV) Vegetation Condition Assessment Photo Point Photographs Figure 2. Table 5.

Veg Plot 4 placement was chosen as a representative location of planted woody stems observed during Baseline/MY1 data collection. Planting Zone 3 boundary was enlarged during construction and the boundaries shown are approximations only.

Numerous stems of Chinese privet (*Ligustrum sinense*) are located inside the easement boundary along Trib E2, Trib C2 and C1 near crossing. The locations of these populations are mapped on the Current Condition Plan View (CCPV) map (Figure 2). Additionally, several patches of multiflora rose (*Rosa multiflora*) are located along Main West, Main Center, Southwest trib, Trib C1, C2, C2a and E3 south of the pond. An invasive contract was negotiated in 2015; the site was treated for invasives November 2015 and there are plans for additional treatment in 2016.

Six at-grade stream crossings and one rock structure to stabilize an existing crossing were installed on project reaches at the Site during construction. The conditions of these features were observed during the site visit in August 2015. All of these features are stable and functioning properly as depicted on the CCPV.

The UT to Haw River project includes preservation and enhancement level II restoration. Since there were no changes made to dimension, pattern, or profile for any project reaches, no morphological characteristics were measured. Instead, project-wide stream monitoring was accomplished using visual assessment as well as photo documentation. Any areas showing evidence of aggradation, degradation, and/or bank erosion are identified and mapped on the CCPV.

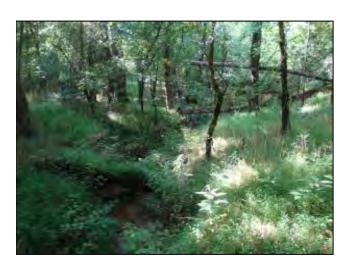
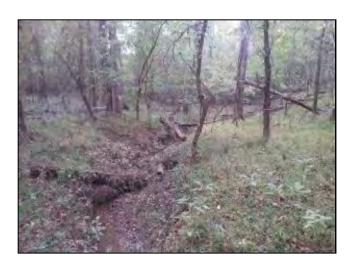
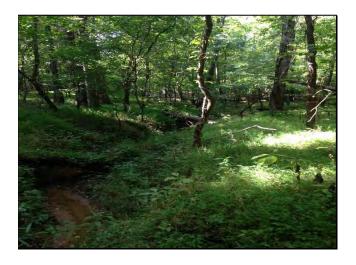
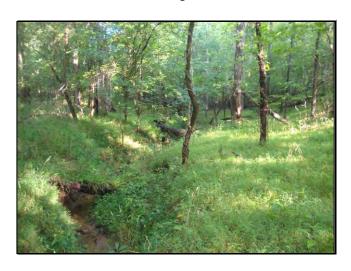
Photo Point 1: Looking Upstream on Main West

As-Built/Year 1 Survey: August 2012

Year 2 Monitoring: October 2013

Year 3 Monitoring: August 2014

Year 4 Monitoring: August 2015

Year 4 monitoring surveys along UT to Haw River project occurred in August 2015. Thirty photo point locations were reviewed and subsequent photographs taken during data collection at the Site. These photographs serve as documentation of the Year 4 stream condition as well as reference photos for future monitoring years. Based on available data and visual comparison

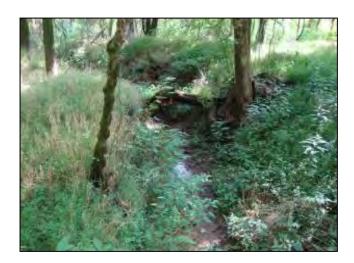
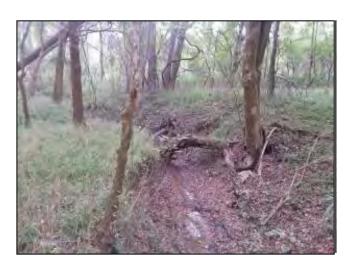
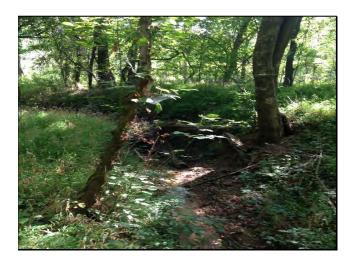
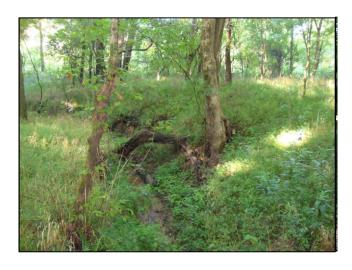
Photo Point 1: Looking Downstream on Main West

As-Built/Year 1 Survey: August 2012

Year 2 Monitoring: October 2013

Year 3 Monitoring: August 2014

Year 4 Monitoring: August 2015

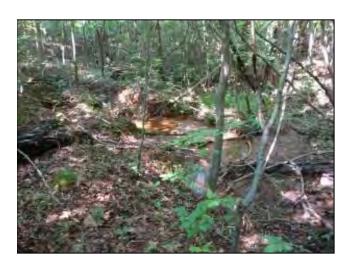
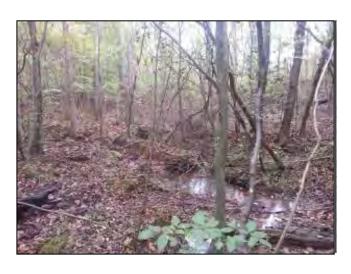
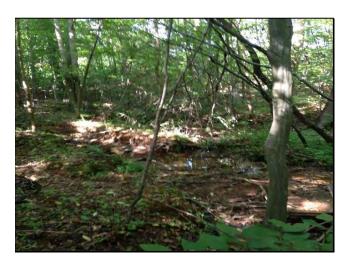
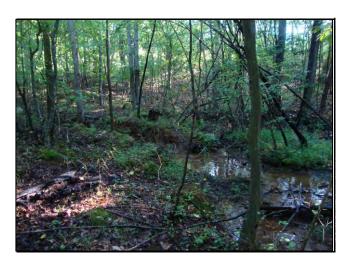
Photo Point 2: Looking Upstream on Main West

As-Built/Year 1 Survey: August 2012

Year 2 Monitoring: October 2013

Year 3 Monitoring: August 2014

Year 4 Monitoring: August 2015

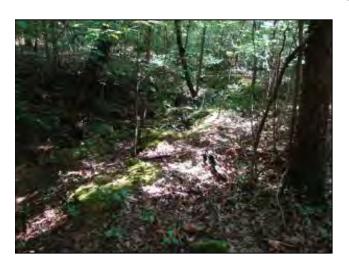
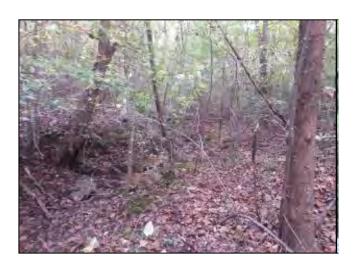
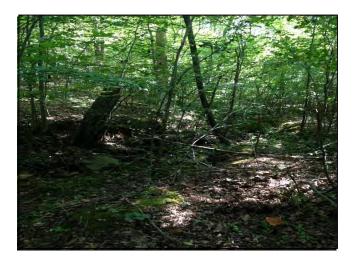
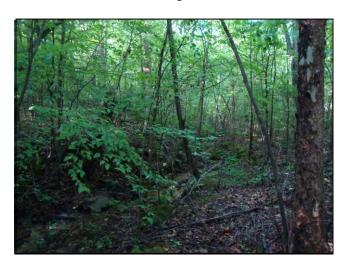
Photo Point 2: Looking Downstream on Main West

As-Built/Year 1 Survey: August 2012

Year 2 Monitoring: October 2013

Year 3 Monitoring: August 2014

Year 4 Monitoring: August 2015

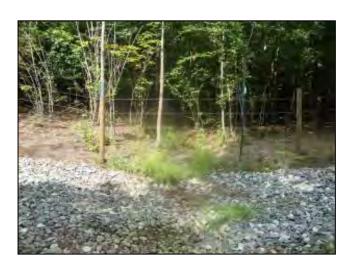
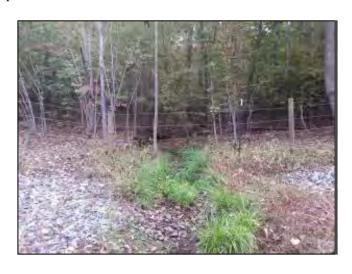
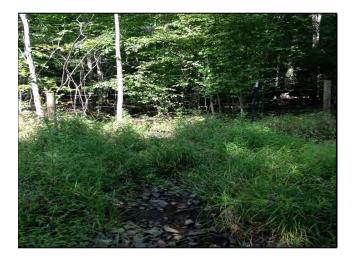
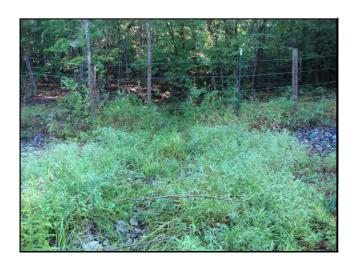
Photo Point 3: Looking Upstream Main West

As-Built/Year 1 Survey: August 2012

Year 2 Monitoring: October 2013

Year 3 Monitoring: August 2014

Year 4 Monitoring: August 2015

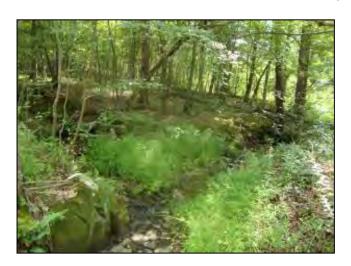
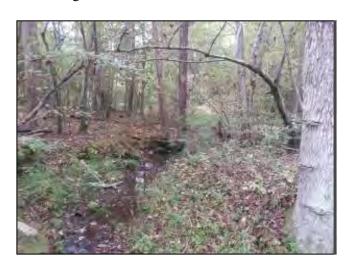
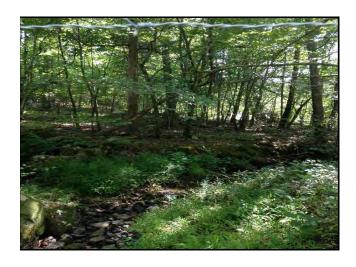
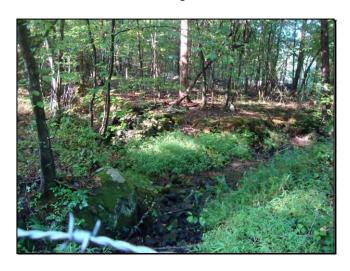
Photo Point 3: Looking Downstream Along Main West

As-Built/Year 1 Survey: August 2012

Year 2 Monitoring: October 2013

Year 3 Monitoring: August 2014

Year 4 Monitoring: August 2015

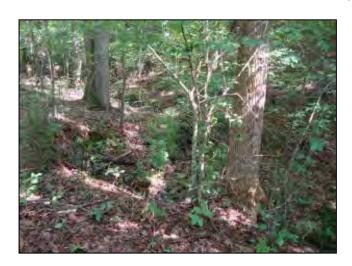
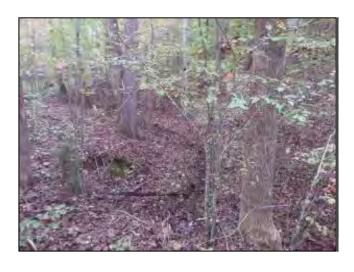
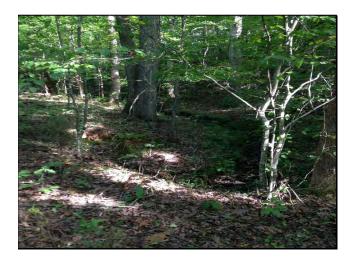
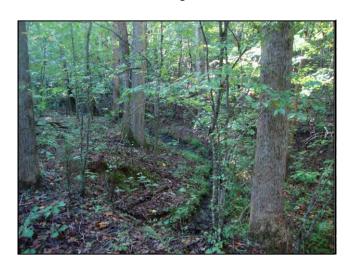
Photo Point 4: Looking Upstream Along Main West

As-Built/Year 1 Survey: August 2012

Year 2 Monitoring: October 2013

Year 3 Monitoring: August 2014

Year 4 Monitoring: August 2015

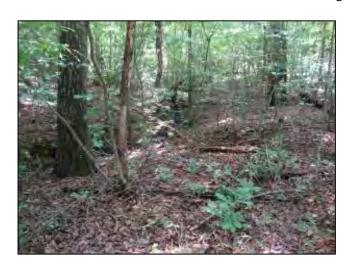
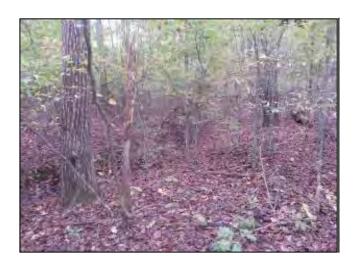
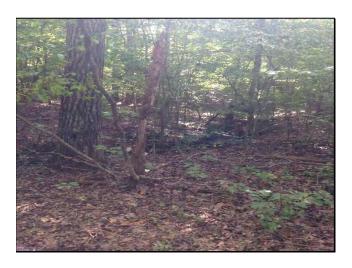
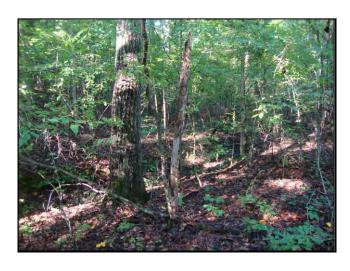
Photo Point 4: Looking Downstream Along Main West

As-Built/Year 1 Survey: August 2012

Year 2 Monitoring: October 2013

Year 3 Monitoring: August 2014

Year 4 Monitoring: August 2015

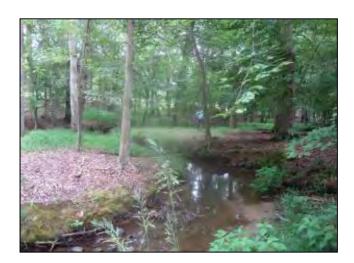
Photo Point 5: Looking Downstream Along Main Center

As-Built/Year 1 Survey: August 2012

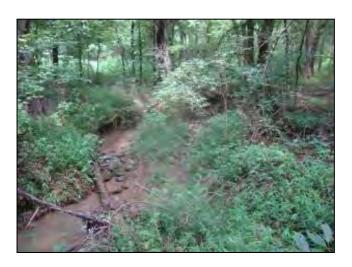
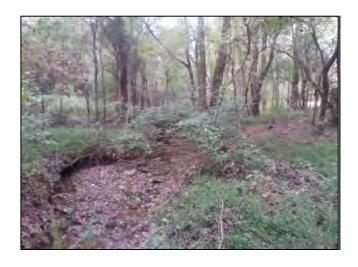
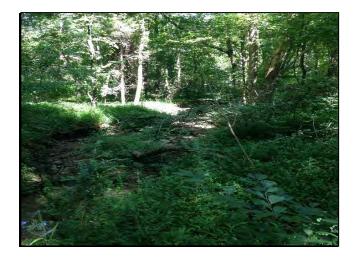
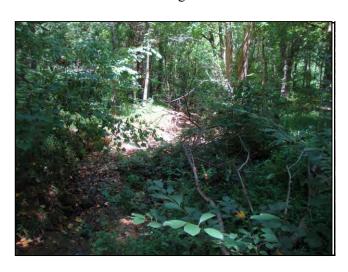
Photo Point 18: Looking Upstream Along Trib C2

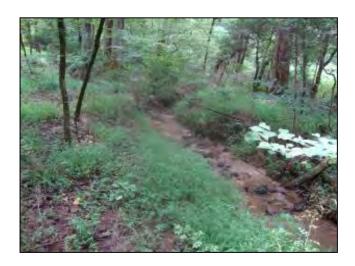
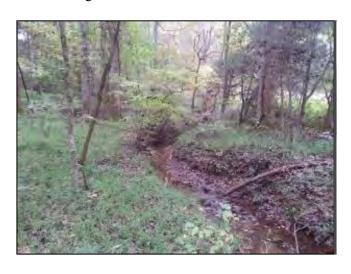
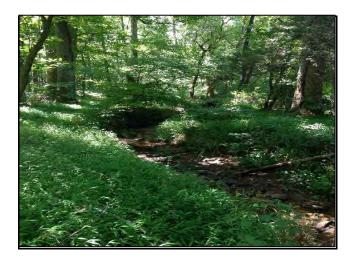
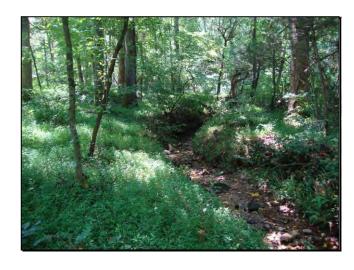
Photo Point 18: Looking Downstream Along Trib C2

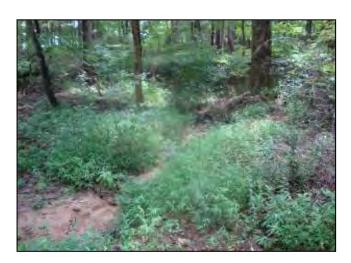
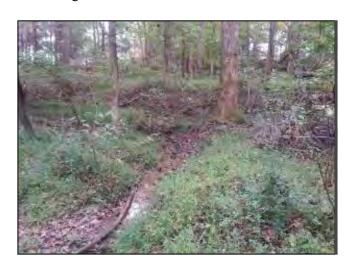
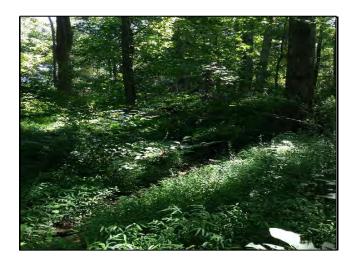
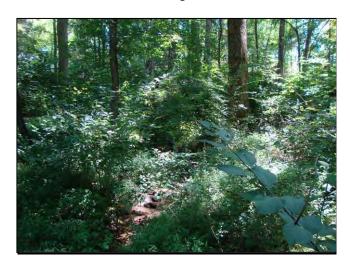
Photo Point 18: Looking Upstream Along Trib C2-c

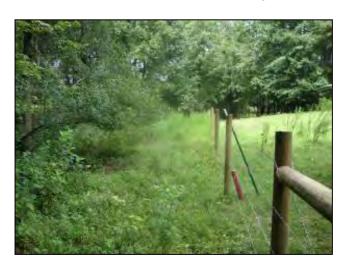
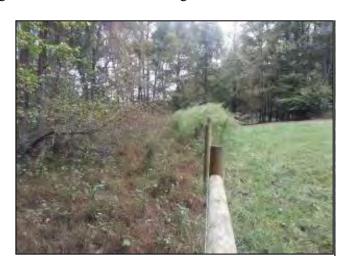
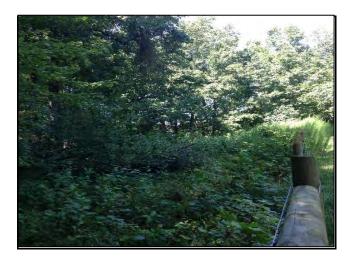
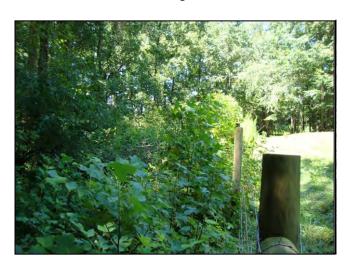
Photo Point 19: Looking Downstream Along Main Center - Invasive Management

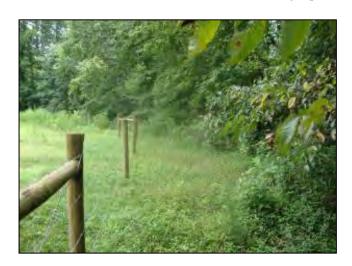
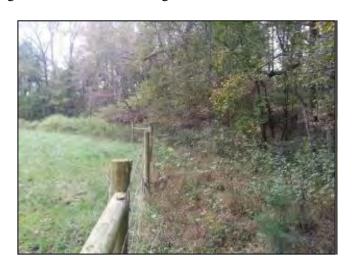
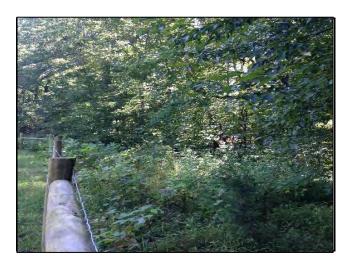
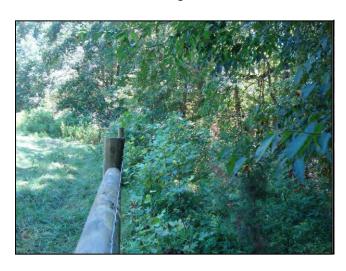
Photo Point 19: Looking Upstream Along Trib C2 - Invasive Management

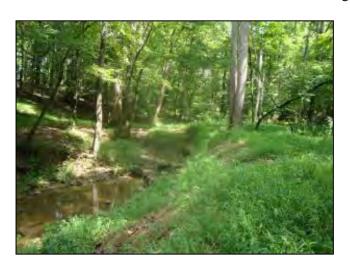
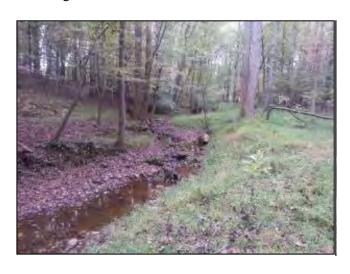
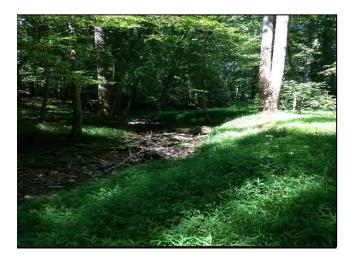
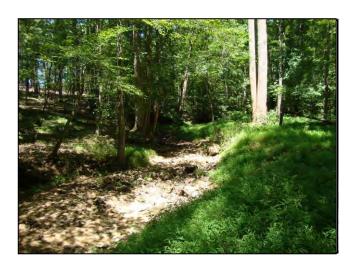
Photo Point 20: Looking Upstream Along Main Center

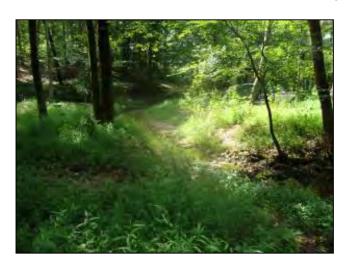
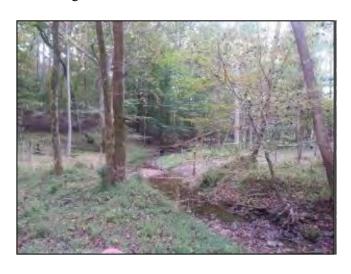
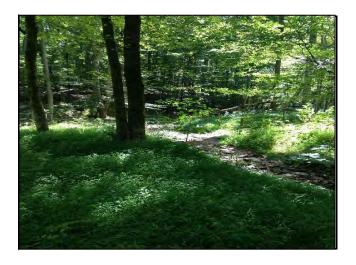
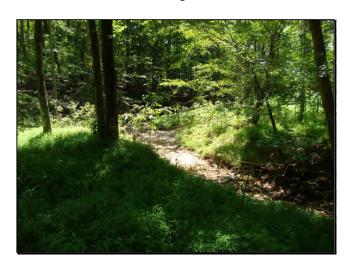
Photo Point 20: Looking Downstream Along Main Center

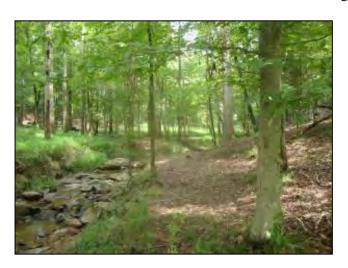
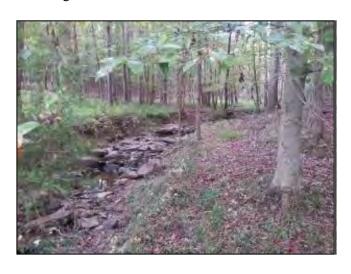
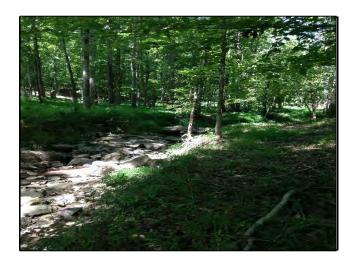
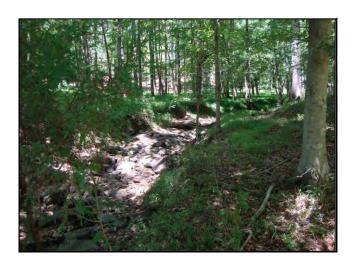
Photo Point 21: Looking Upstream Along Main Center

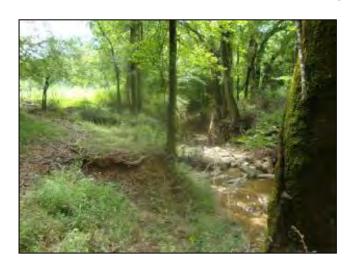
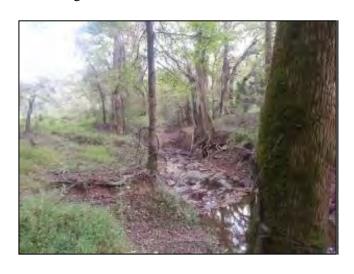
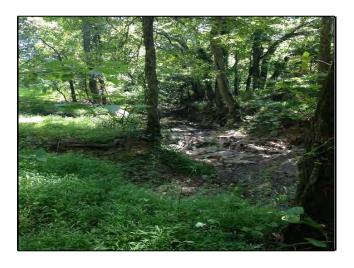
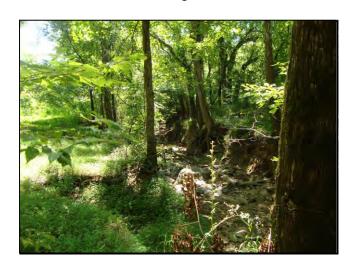
Photo Point 21: Looking Downstream Along Main Center

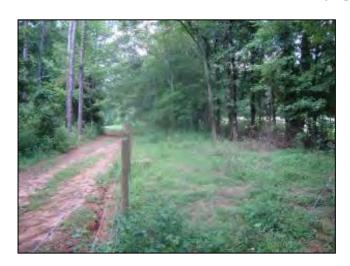
Photo Point 22: Looking Upstream Along Southeast Tributary
