# ANNUAL REPORT FOR 2008 Monitoring Year 3

# **SALT Mitigation Site**

Cape Fear River Basin, Moore County, North Carolina

#### SALT TRACT MITIGATION SITE 2008 Annual Monitoring Report (Year 3)

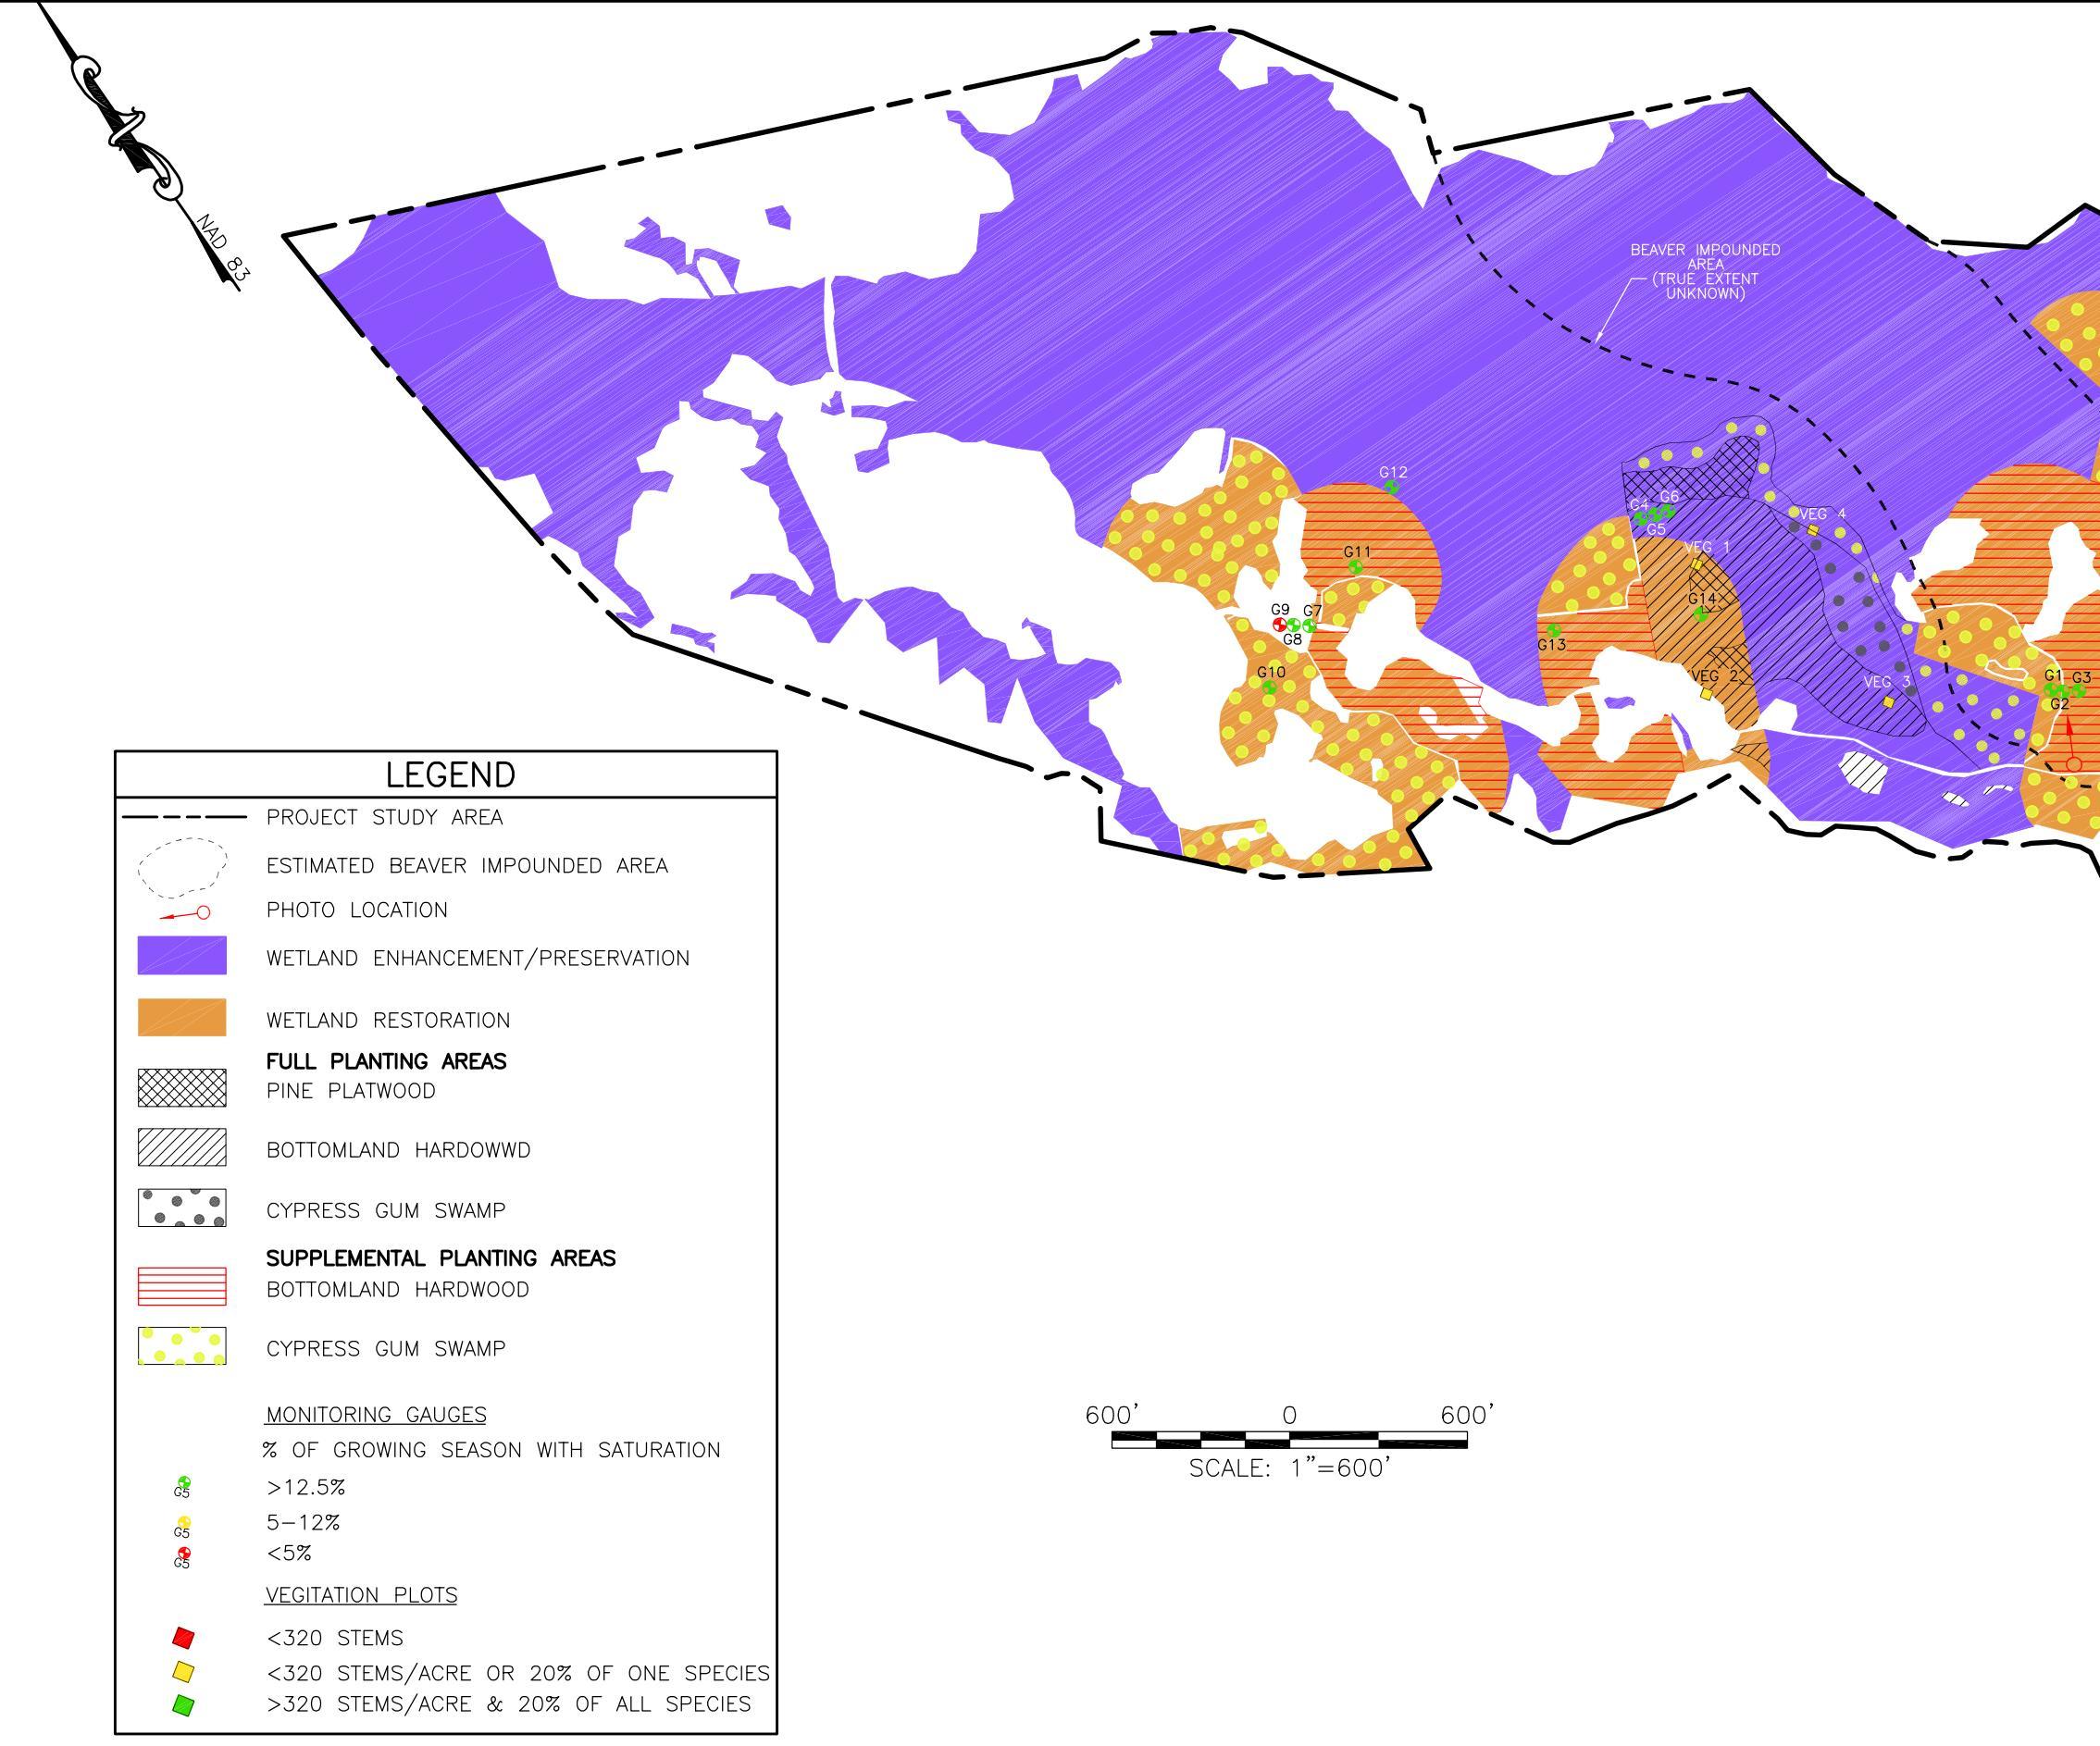
In January 2006, 13 Remote Data Systems (RDS) continuous logging groundwater gauges were installed. The on-site gauge locations are shown on Figure 2 (Appendix A). The monitoring gauges record daily readings of depth to groundwater. This year's data represents the third growing season that the gauges have been monitored. The Site was designed to receive hydrologic inputs from rainfall, groundwater, and surface water from overbanking events. Biologists first visited the Site for Year-3 monitoring in July 2008. During the visit, Gauges 1, 2, and 3 were found to be submerged underwater due to beaver activity and remained underwater during all subsequent site visits. As a result, there is no recorded data for these three gauges. Visual observations during Site visits confirm that this area of the Site stays inundated for 100 percent of the growing season, as evidenced by photos in Appendix C. Gauges 6 and 9 were found to be non-functional, and were replaced on July 22, 2008. Gauge 7 was not found, and no reference to its status was made in the Year-2 Annual Monitoring Report. All other gauges were found in working order. Rainfall data was recorded by an on-site tipping bucket rain gauge.

Figure 2 provides the hydrologic results for the current monitoring year. Gauges highlighted in green indicate wetland hydrology for more than 12.5 percent of the growing season. Gauges highlighted in yellow are those that had wetland hydrology between 5 and 12.5 percent of the growing season. Gauges highlighted in red are those that had wetland hydrology less than 5 percent of the growing season.

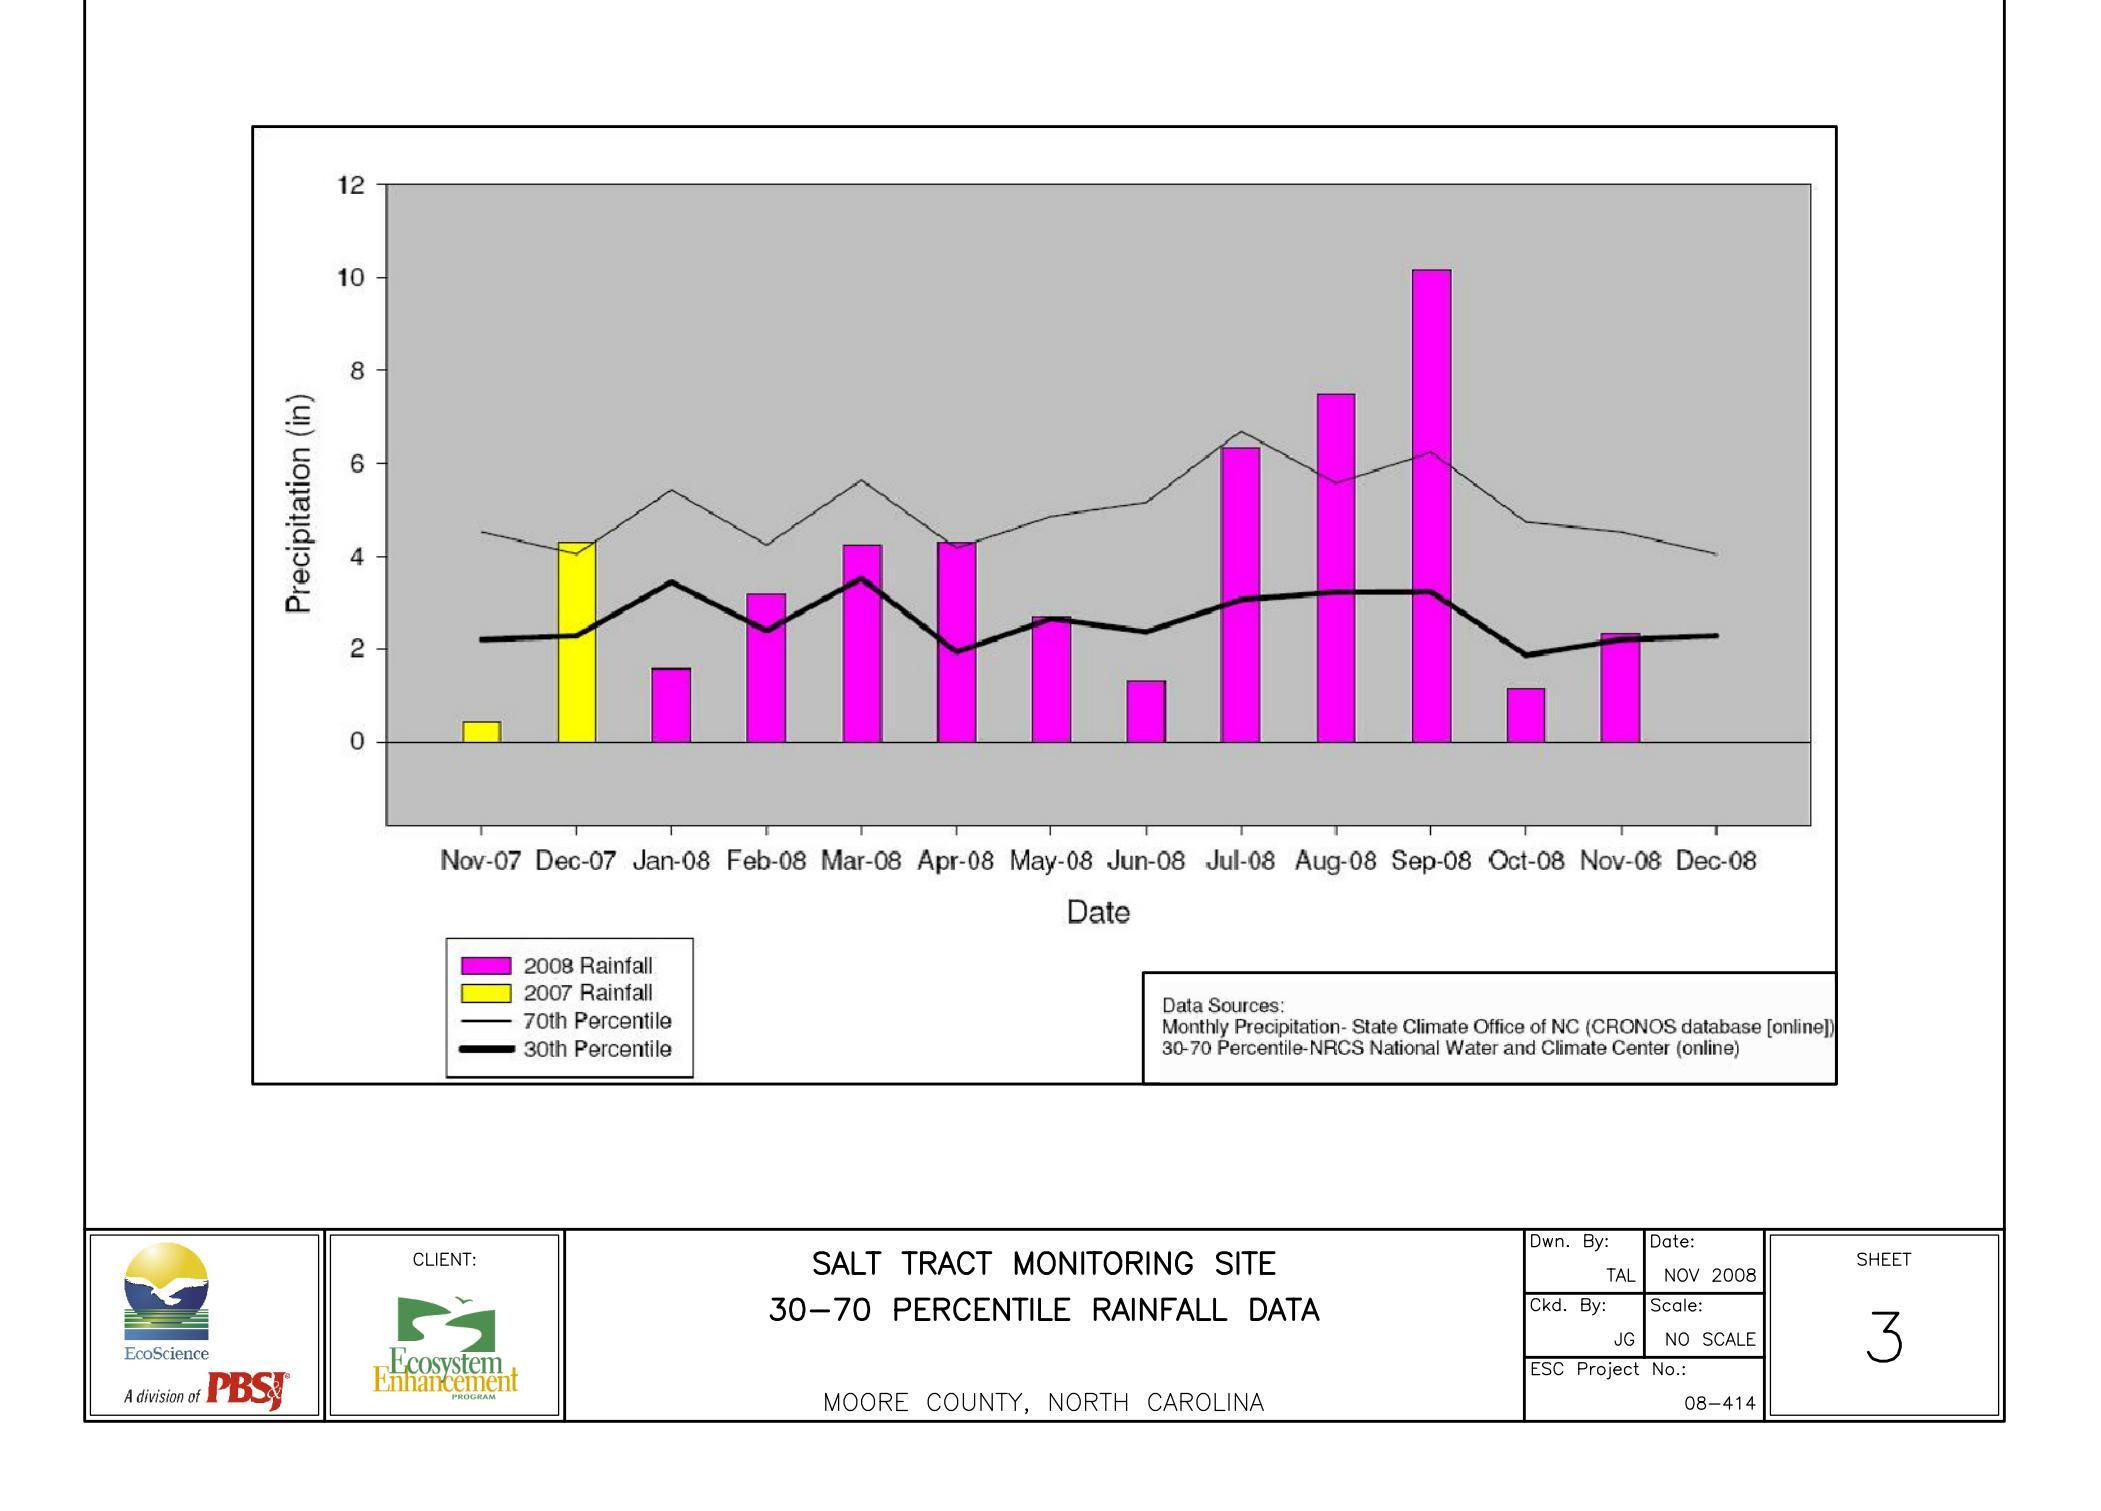
Figure 3 (Appendix A) provides an evaluation of the local climate in comparison with historical data in order to determine whether 2008 was a year with "average" rainfall. The bars are the monthly rainfall totals for the 2008 hydrologic year collected from the on-site rain gauge. Also represented on the figure are the 30<sup>th</sup> and 70<sup>th</sup> percentiles of monthly precipitation for the Clayton weather station. The historical data and monthly data were collected by the Natural Resources Conservation Service (Online NRCS, accessed 21 November, 2008).

A normal yearly rainfall in the area is approximately 48.9 inches. The total rainfall measured from November 2007 through November 2008 was approximately 49.4 inches. Months with below average rainfall include: November of 2007 and January, June, and October of 2008. August and September of 2008 received above average rainfall. All other months during this period fell within the 30<sup>th</sup> and 70<sup>th</sup> percentiles.

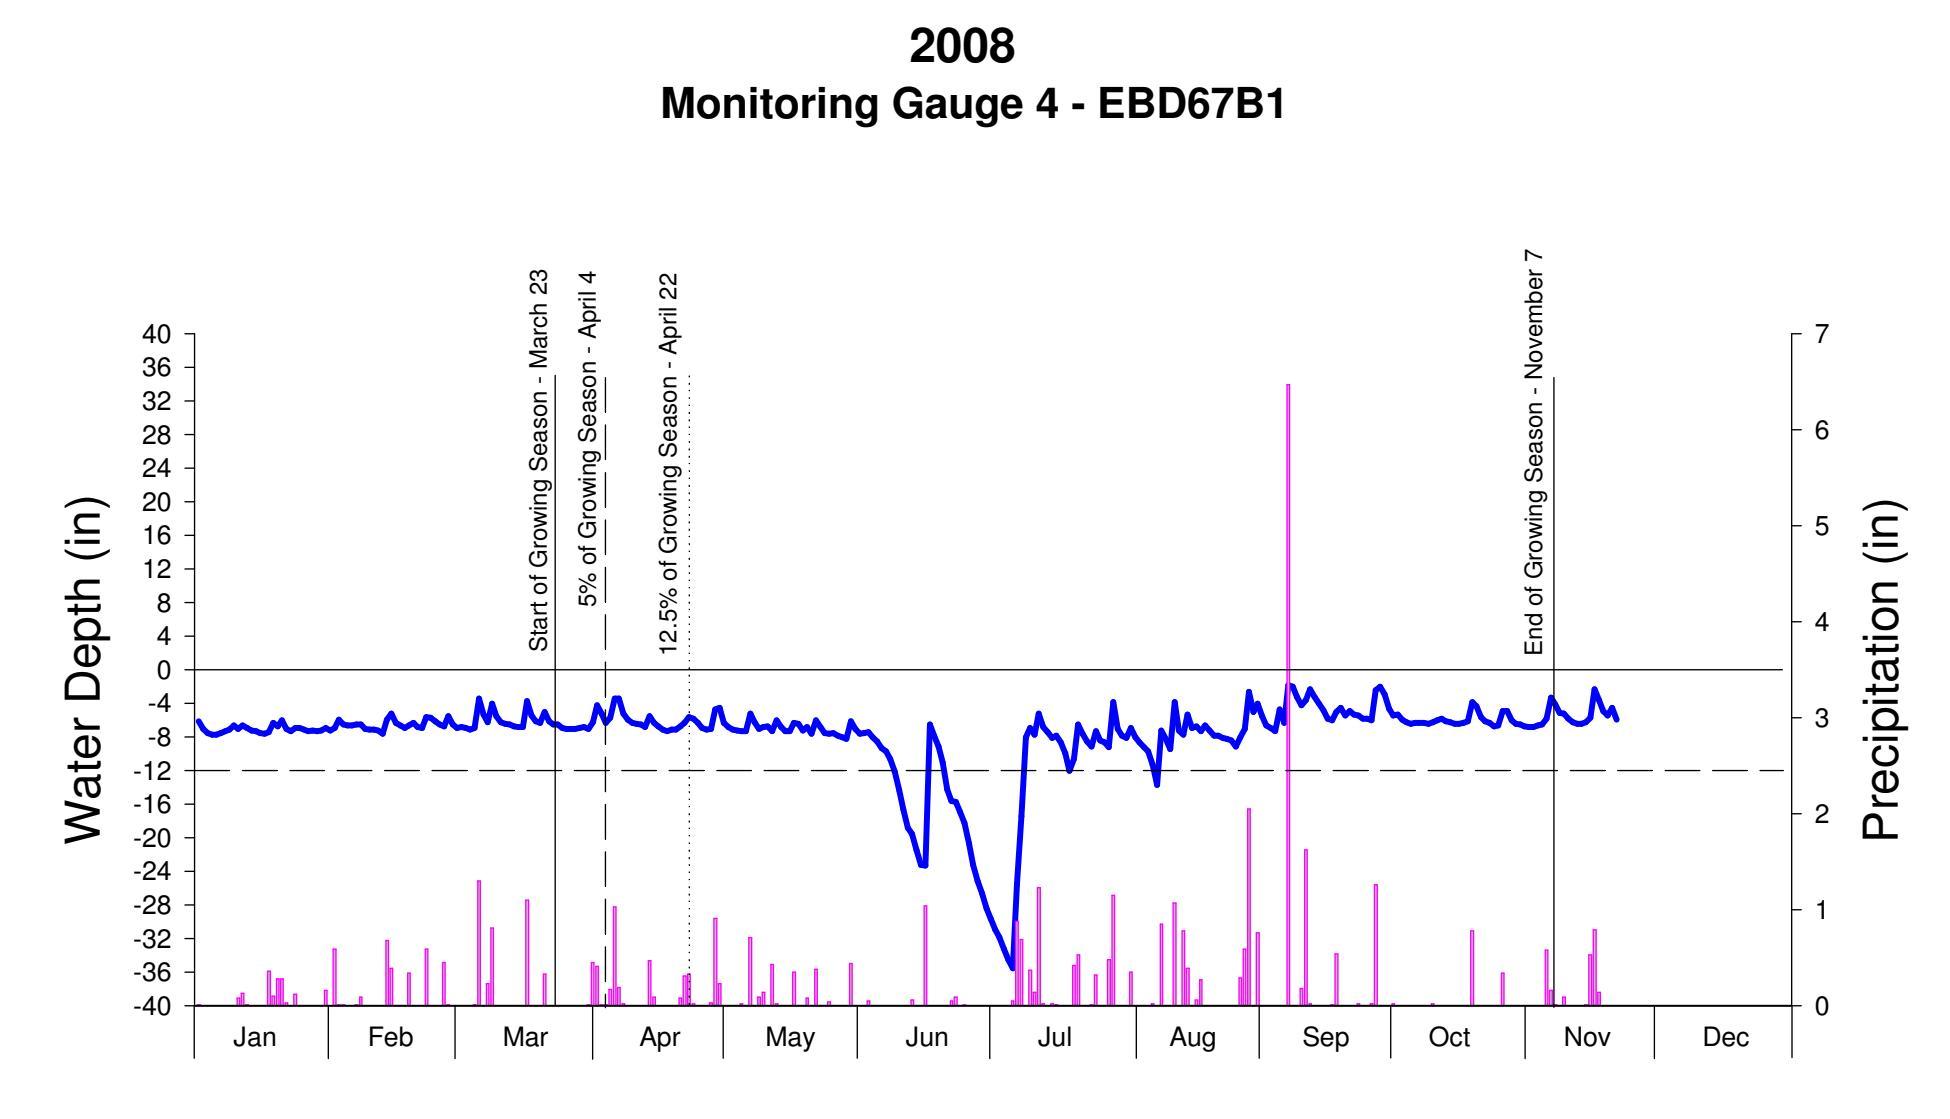
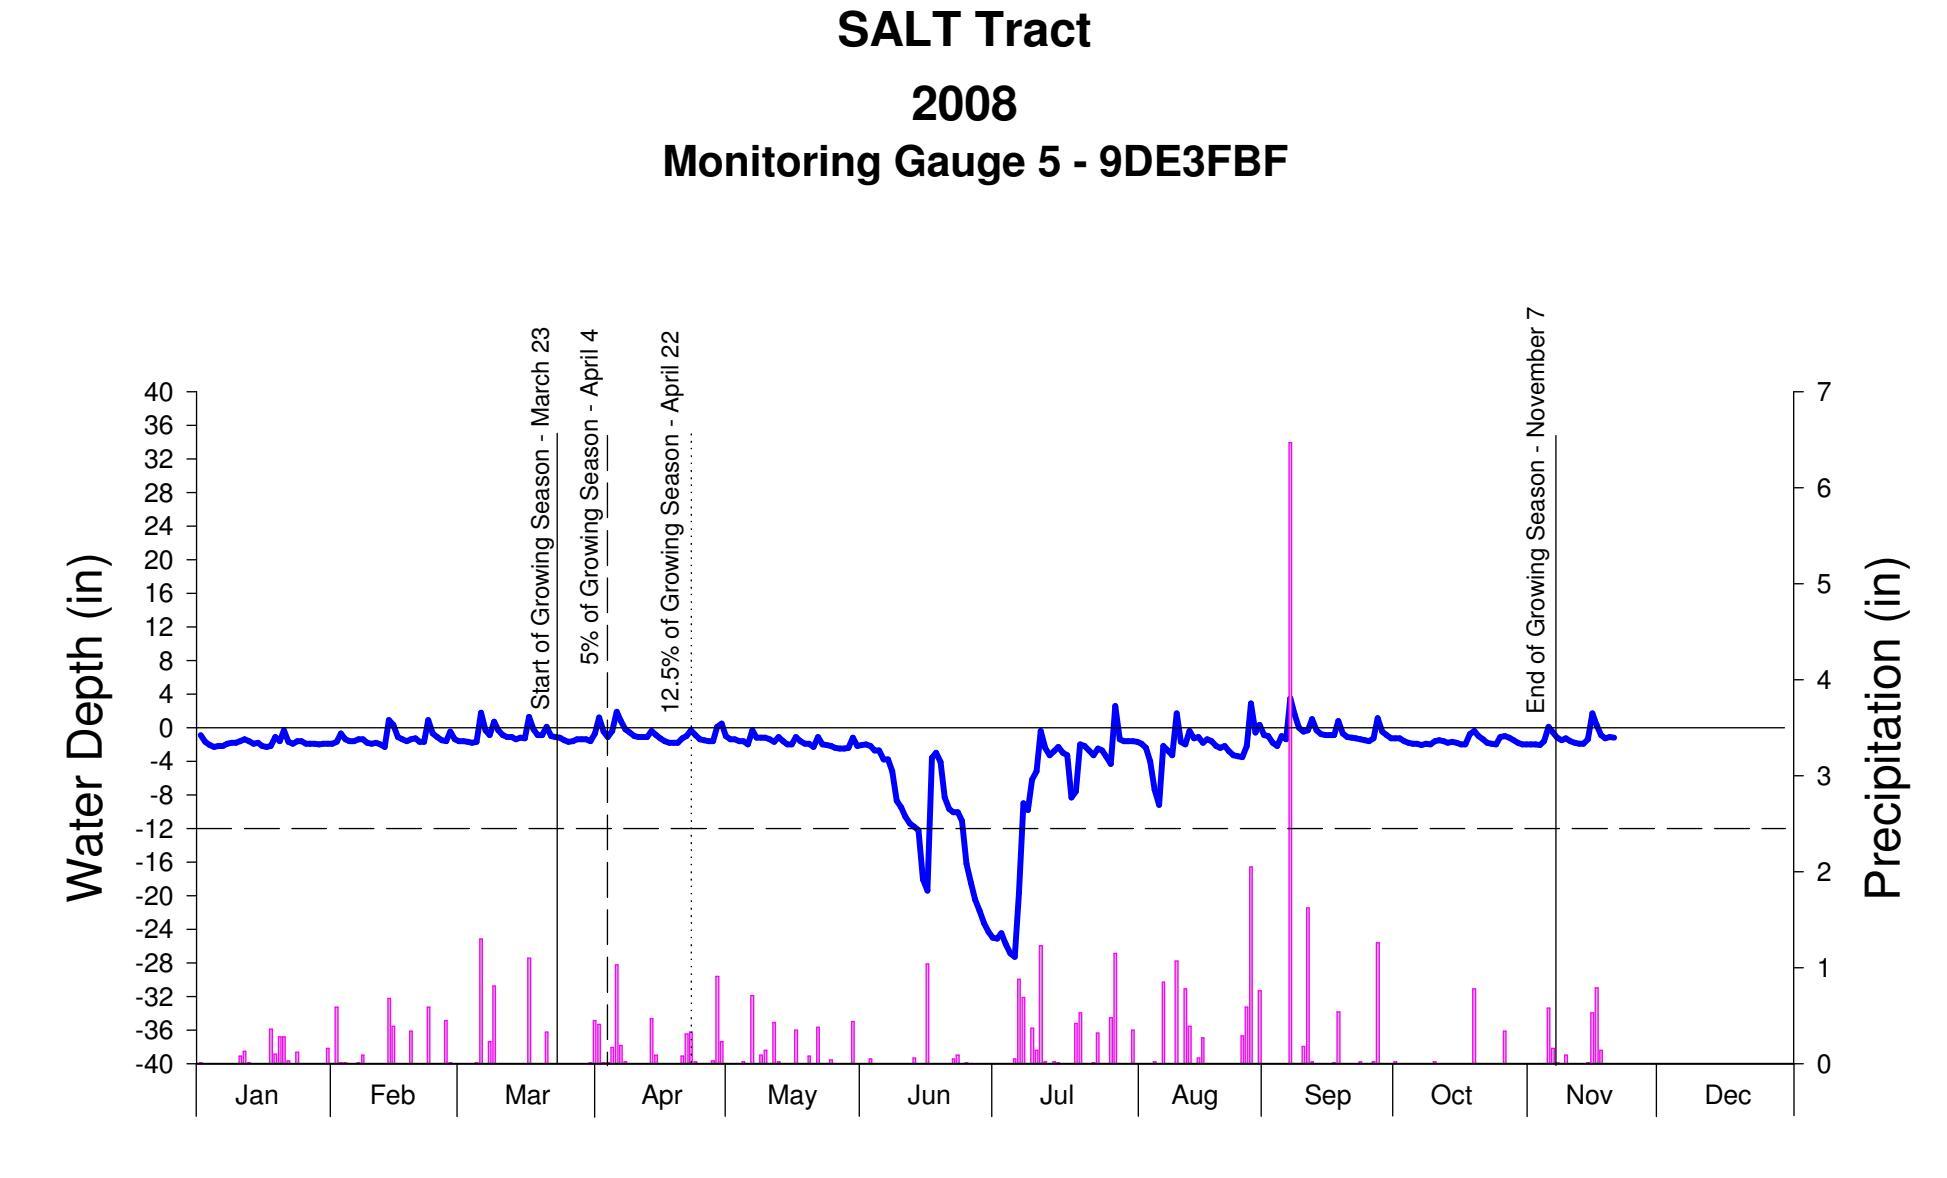
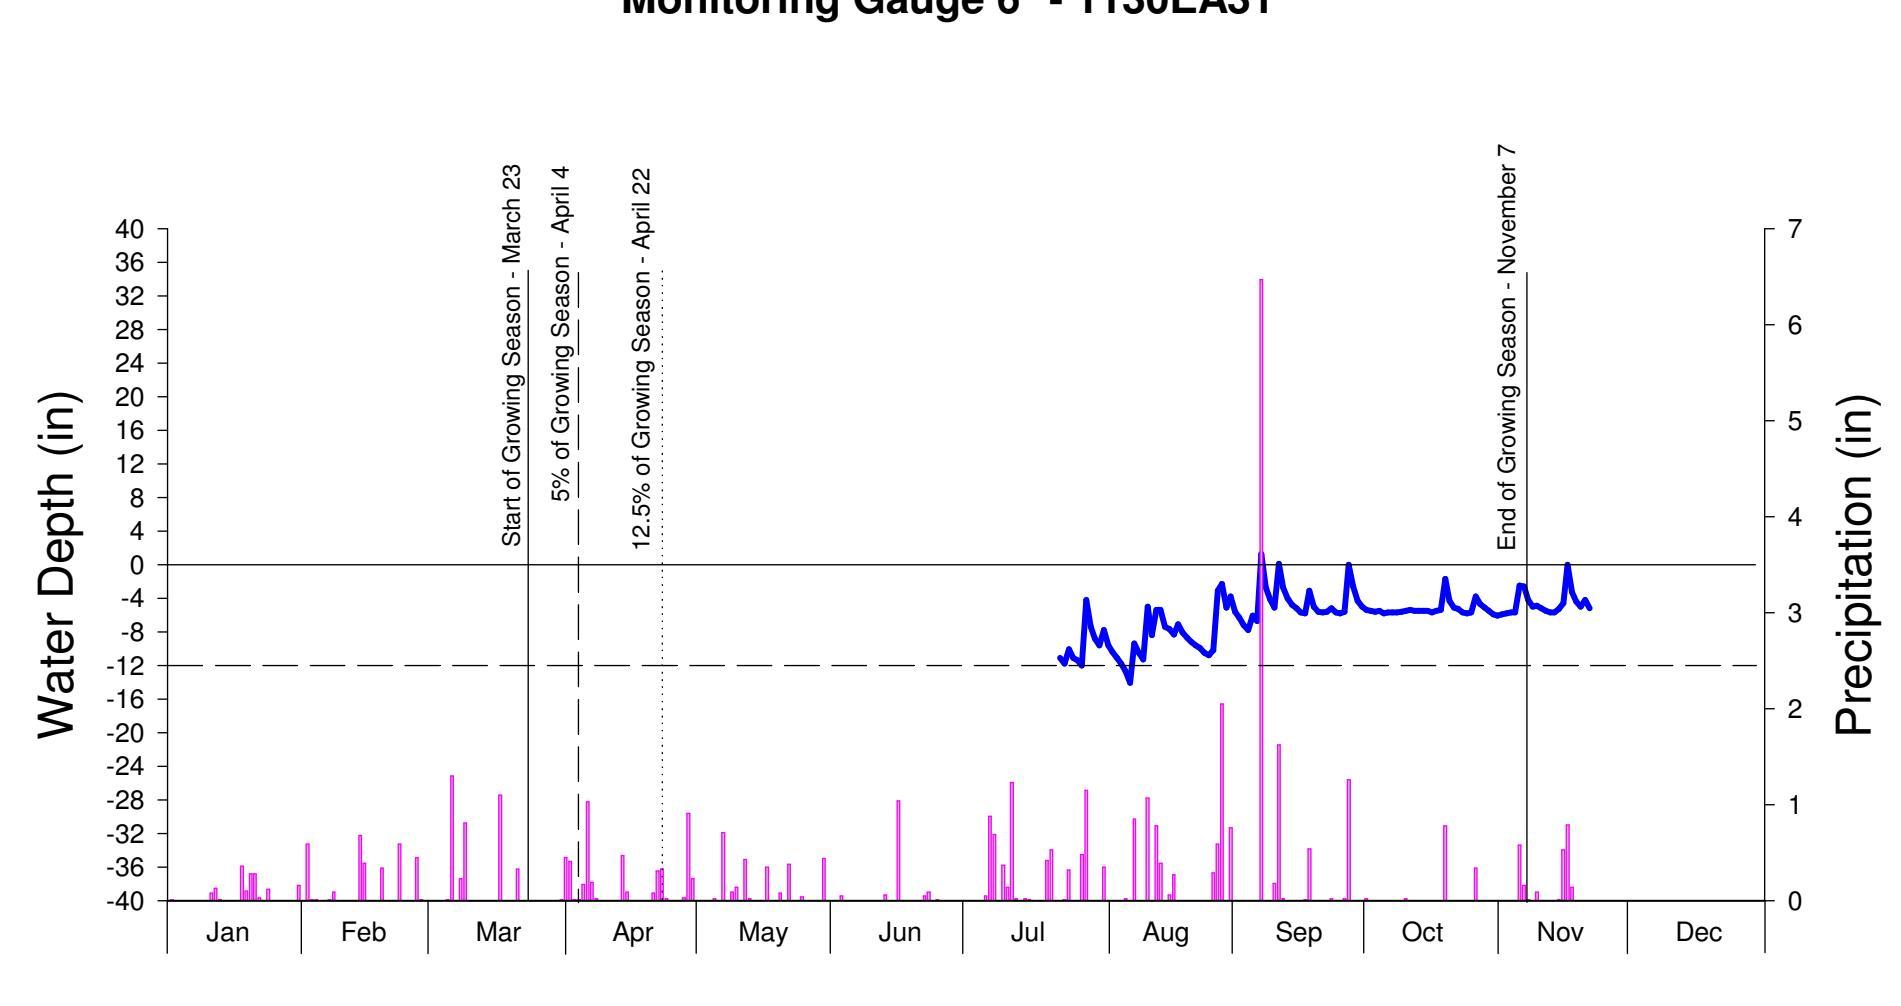
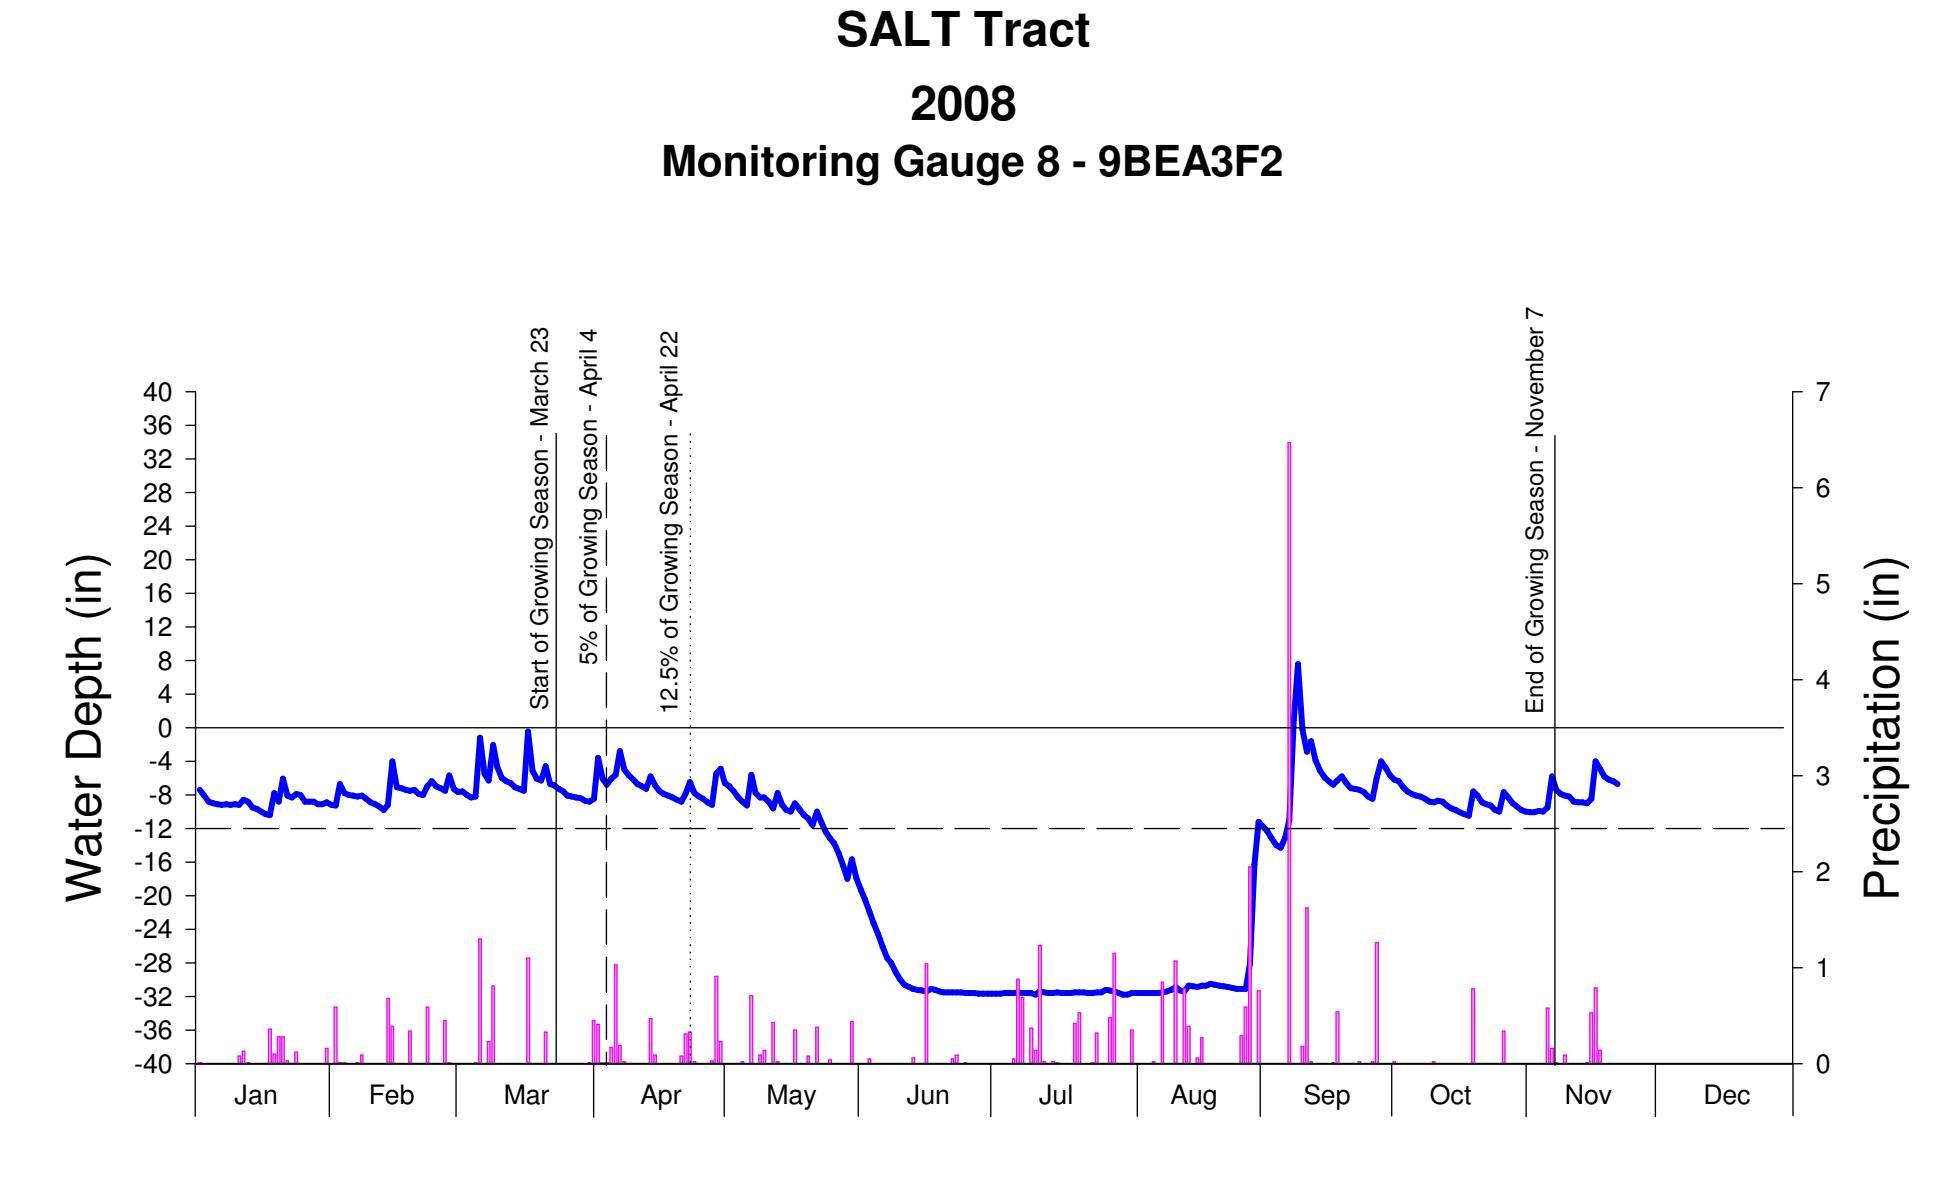
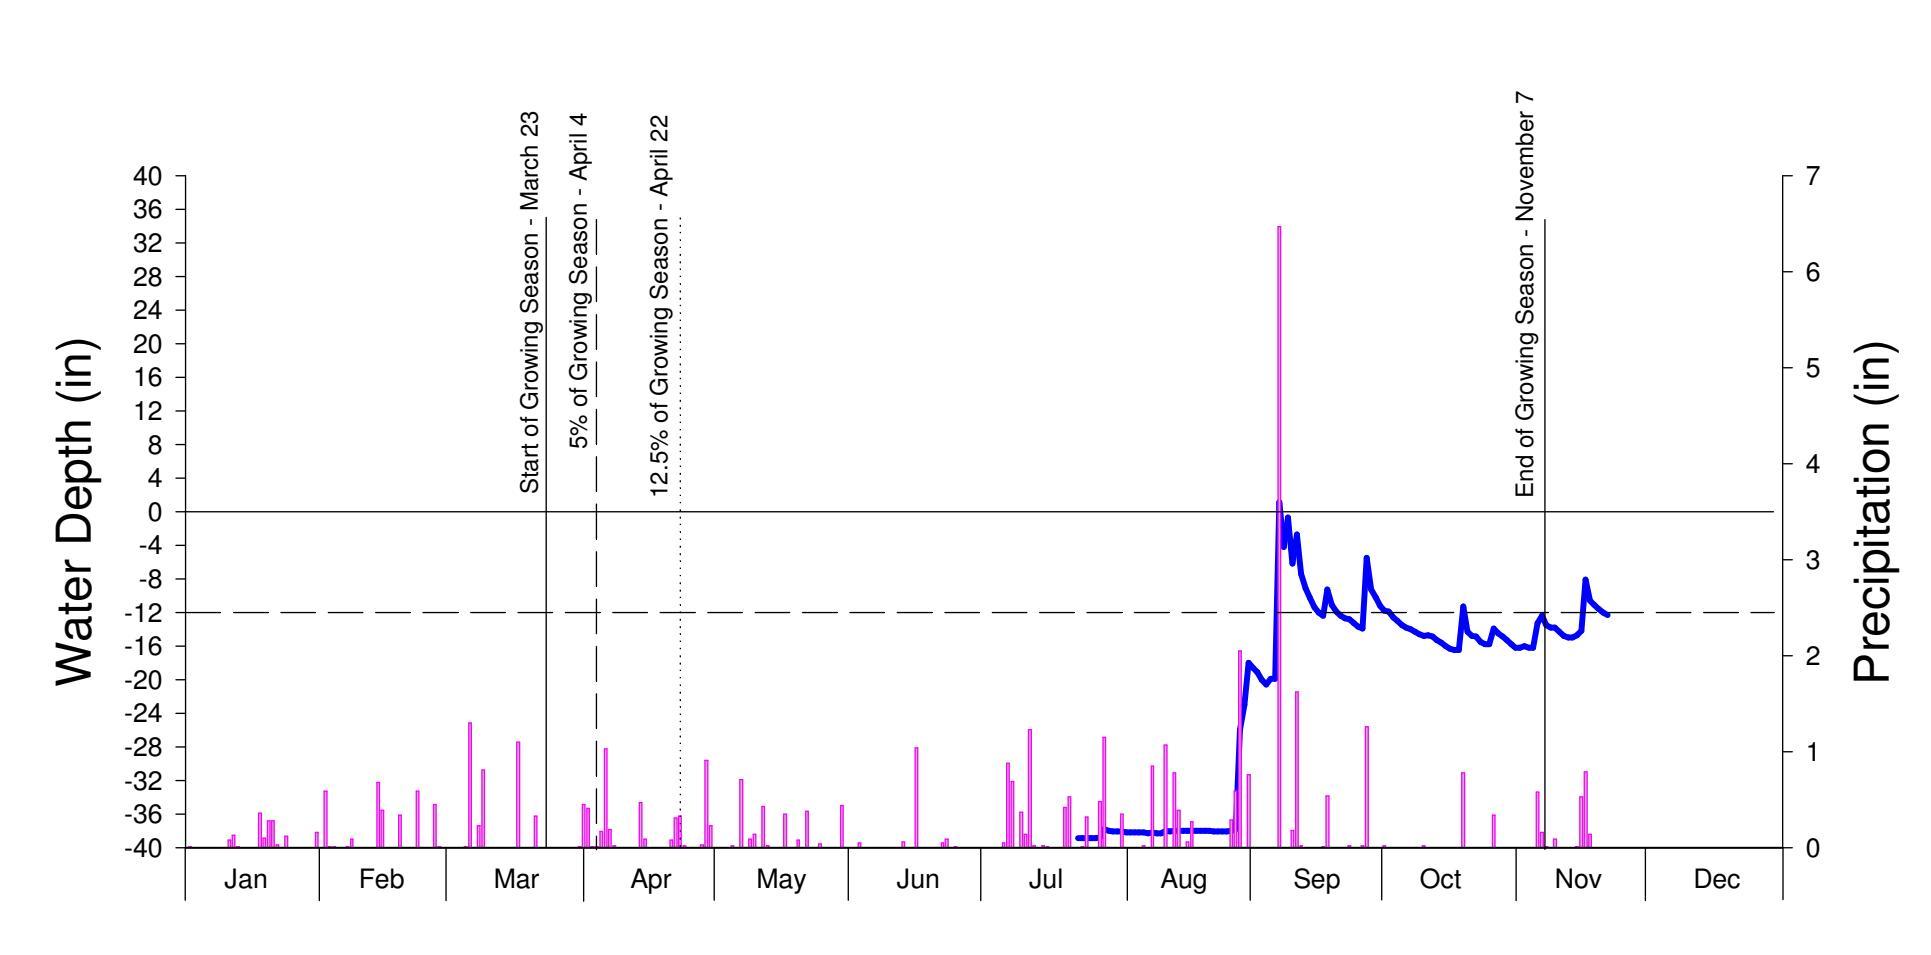
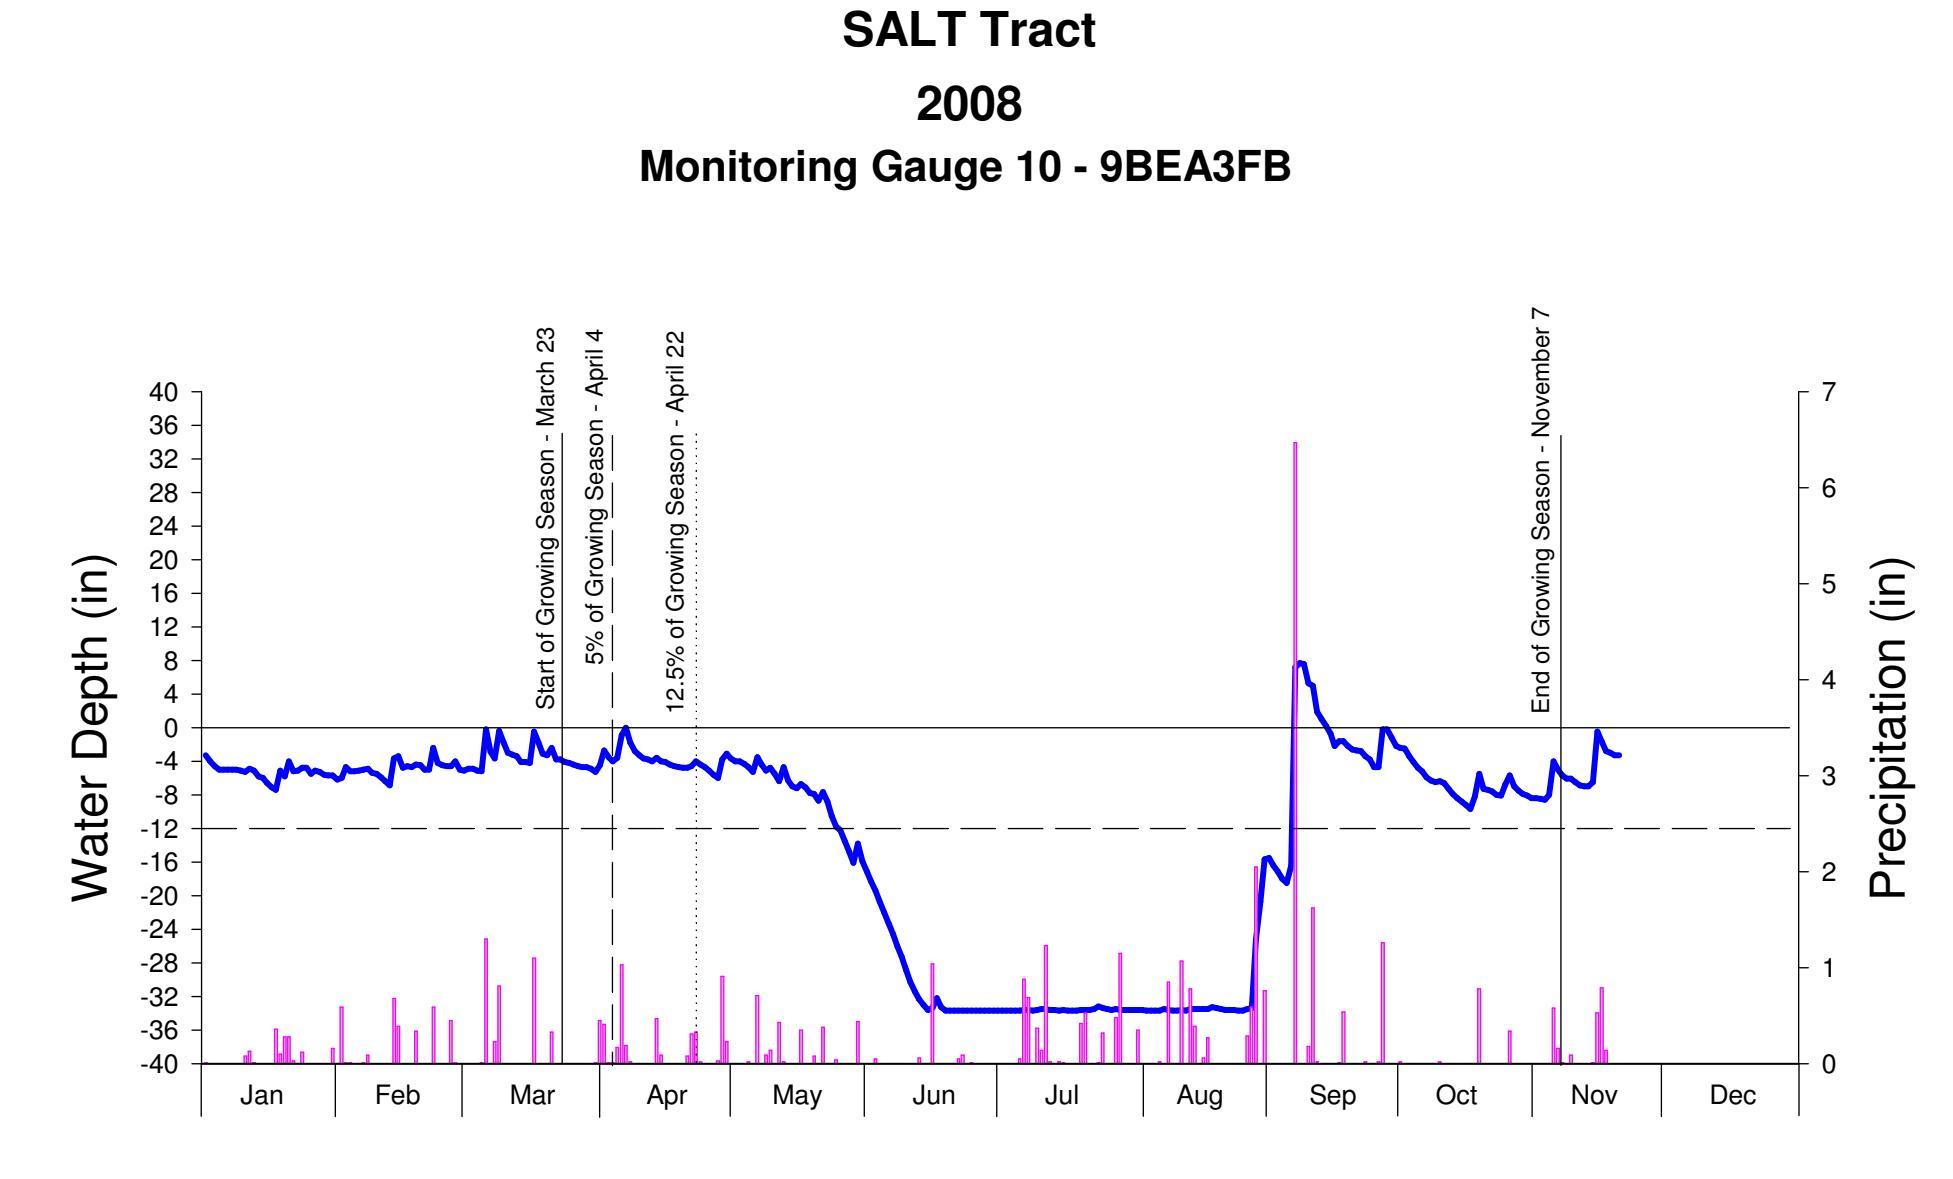
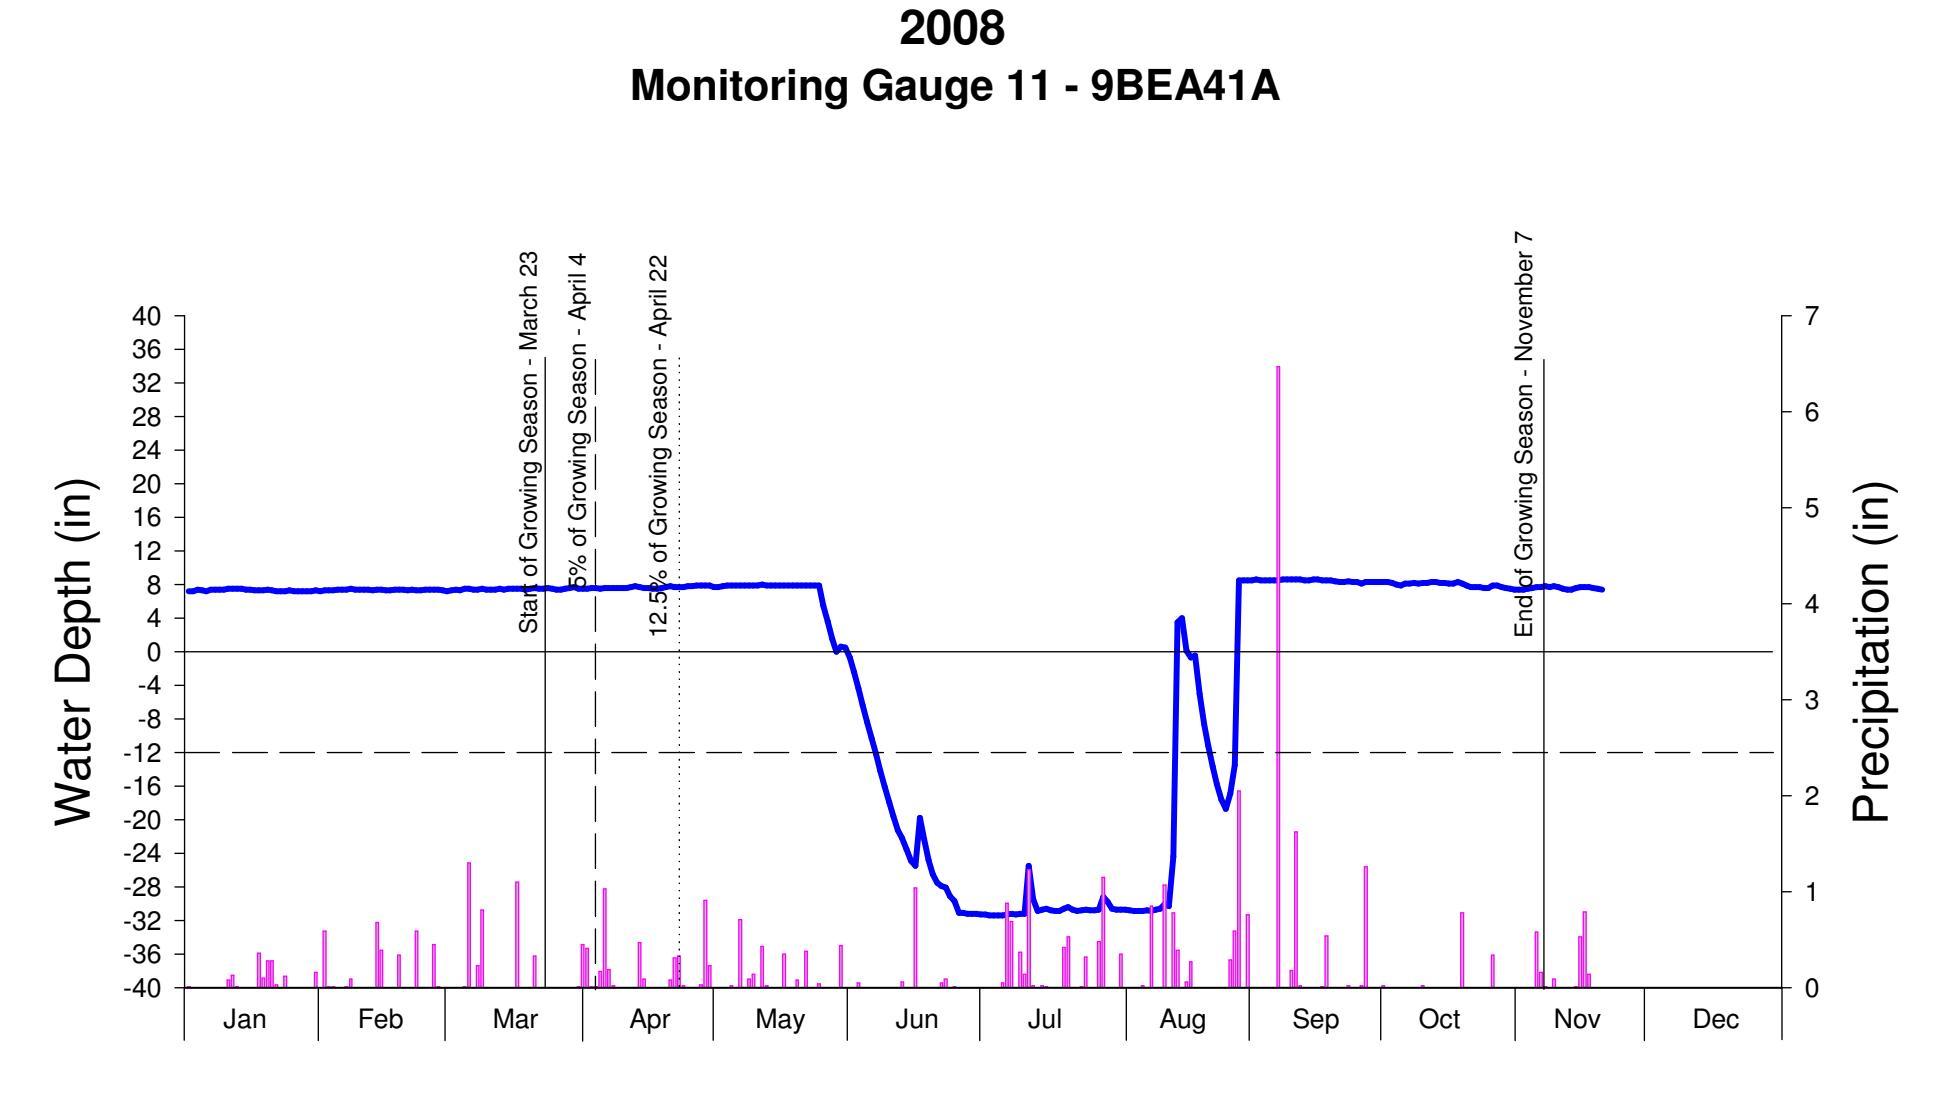
# **GROUNDWATER GAUGE HYDROGRAPHS**

Appendix B contains the hydrographs for each monitoring gauge for the current monitoring year. The corresponding rain data collected from the on-site rain gauge is also provided on each hydrograph.

The 2008 year represents the third year of hydrologic monitoring of the Site. In general, water levels showed a typical pattern of flooding during the spring, followed by a late summer and fall draw down period, punctuated by peaks associated with precipitation events. Overall, 9 of the 13 on-site monitoring gauges met the success criteria (groundwater within 12 inches of the surface for at least 12.5 percent of the growing season), and another three were permanently underwater. The remaining on-site monitoring gauge indicated groundwater within 12 inches of the surface for 4 percent of the growing season. It should be noted, however, that this gauge was not installed until August 8, 2008, and will continued to be monitored for future success.
