ANNUAL REPORT FOR 2002

Speight Branch Mitigation Site Wake County Project No. 8.1402601 TIP No. R-2541 WM

Prepared By: Office of Natural Environment & Roadside Environmental Unit North Carolina Department of Transportation January 2003

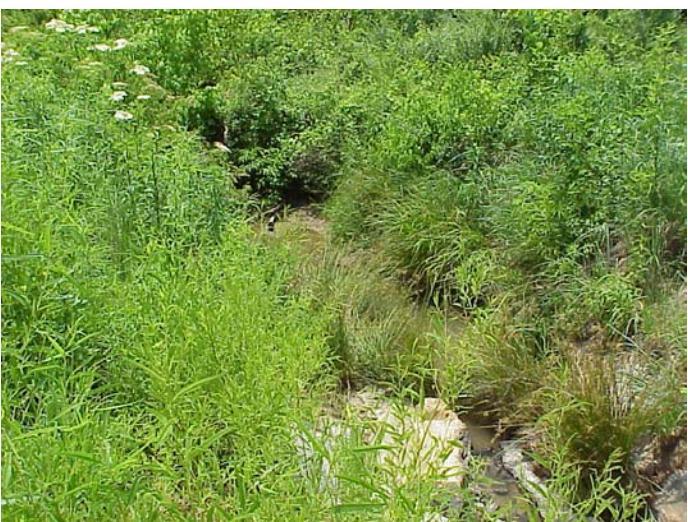
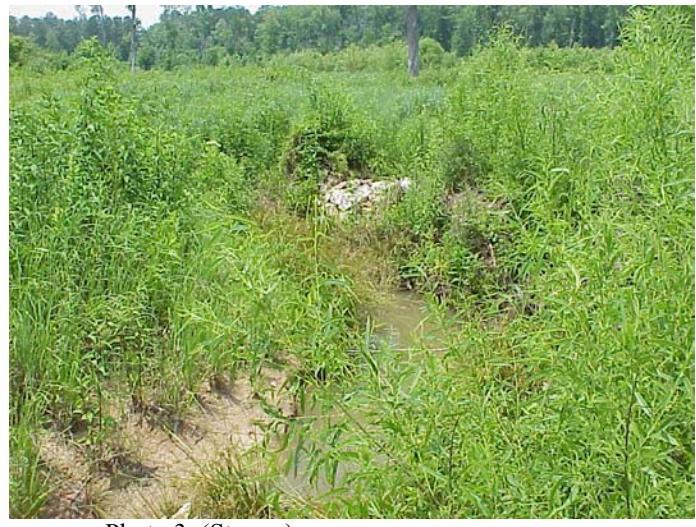
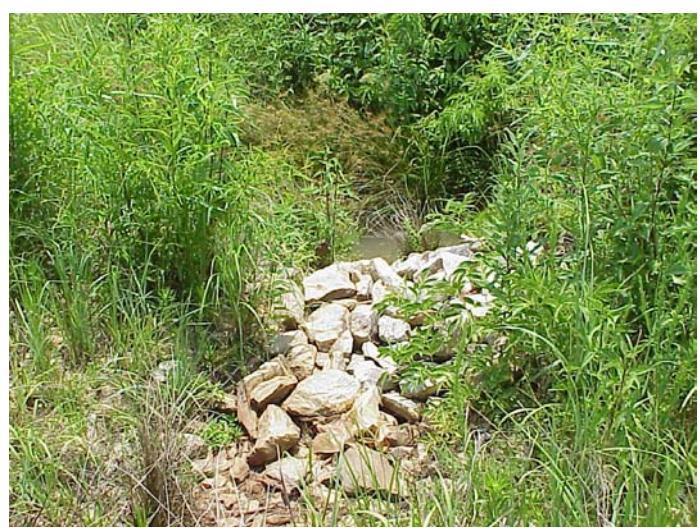
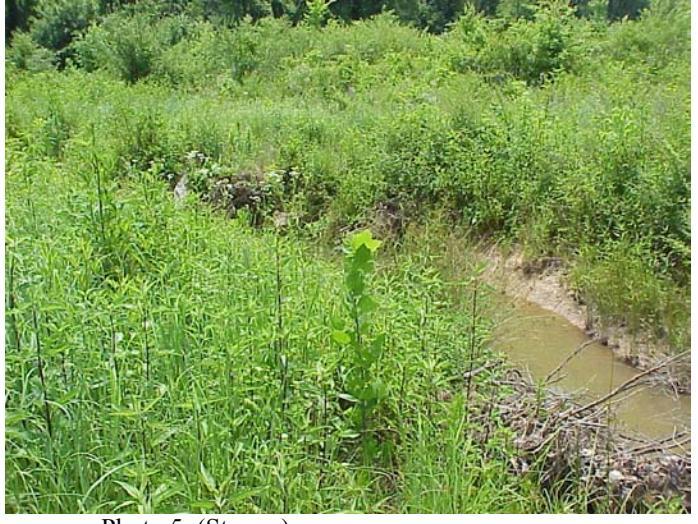
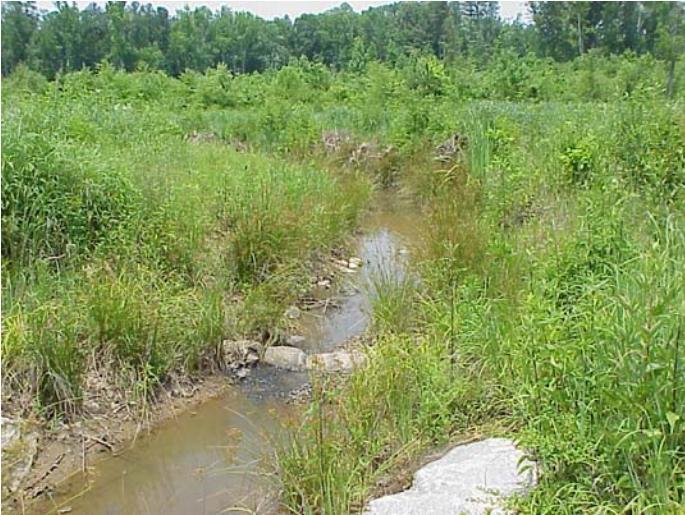
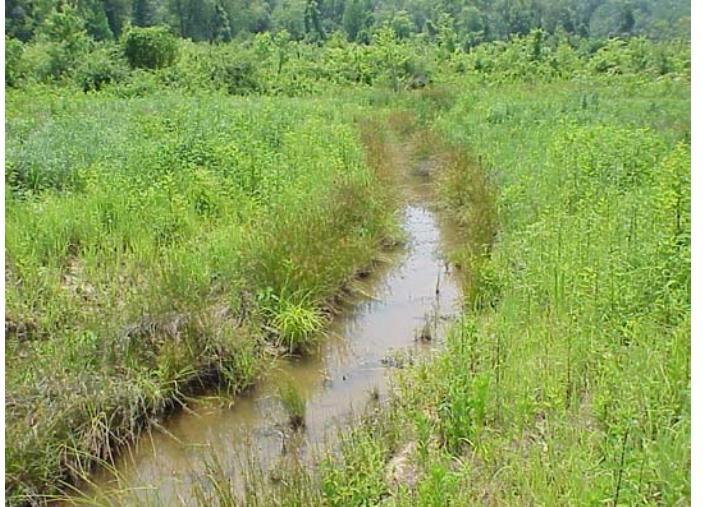
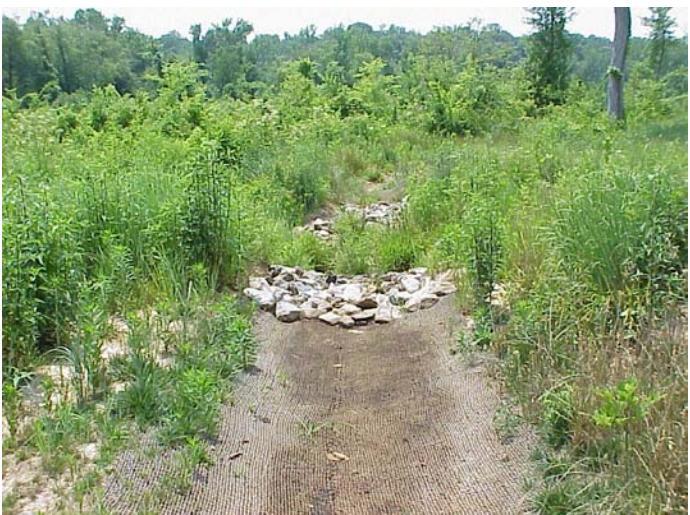
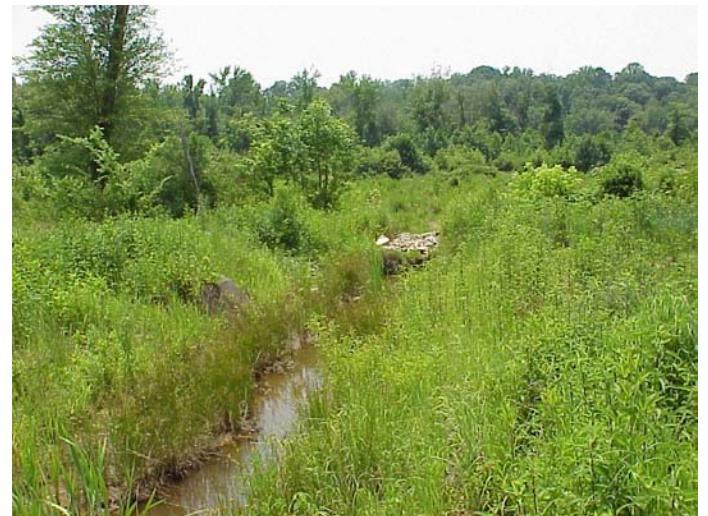
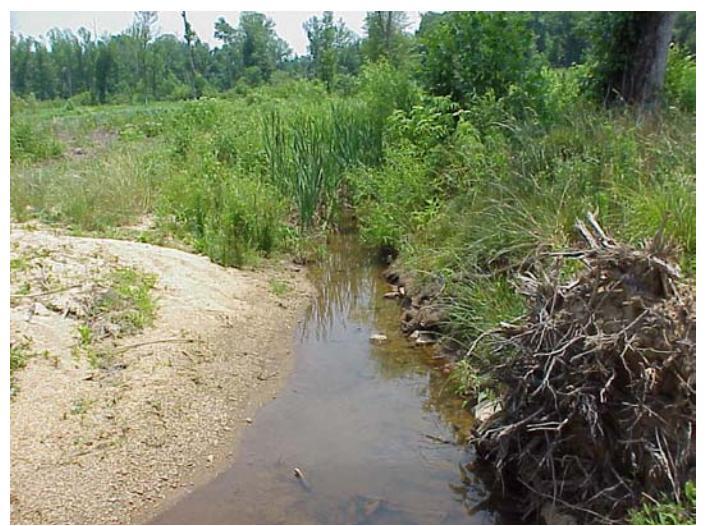
The stream channel was visually monitored during the annual vegetation monitoring of the site. The stream bank was heavily vegetated with herbaceous vegetation and stabilized throughout the length of the channel. Photos 2 through 9 and photo 11 show the conditions of the stream. No remedial actions are necessary.
